Part IV: BARANGAY SURVEYS, PENINSULAR & NEAR ISLANDS

Methodology

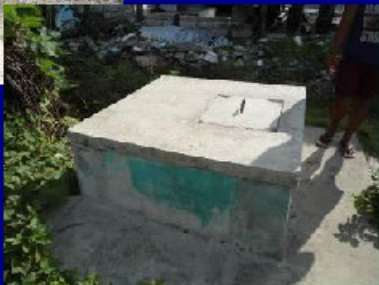
Well 20 Sapao **Grade 10**

Improvement Points 9 & 10 awarded for
a) Secure and Serviceable Cover—Superior designed cover prevents contamination, but can be safely removed and replaced by women, children, and the elderly.
b) Pump--manual, electric, etc.
“+” dual design for hatch cover makes for easy access.
