Preliminary Engineering Report Water System Improvements for the Florida River Estates Homeowner's Association, Durango, Colorado PWSID No. CO0134300

APRIL 2, 2018

Senior Engineer: Bruce Honisch, P.E.
Project Engineer: Robert Harries, P.E.
Project Number: 17-195

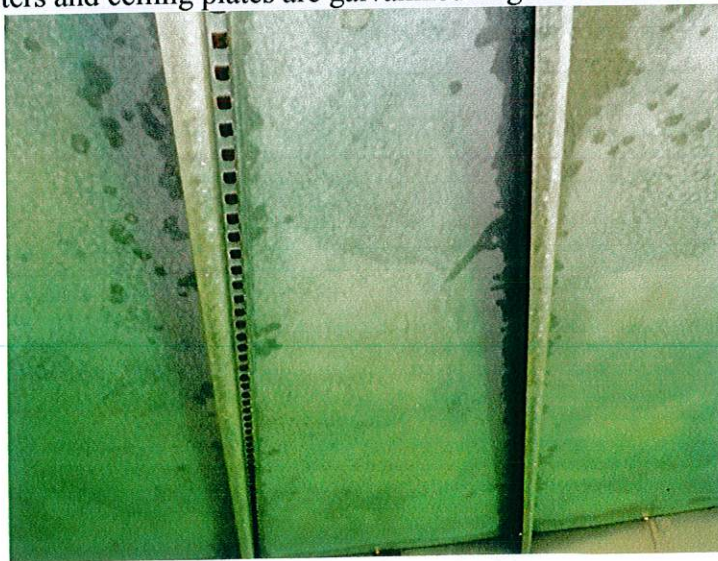
Rafters and ceiling plates are galvanized in good condition

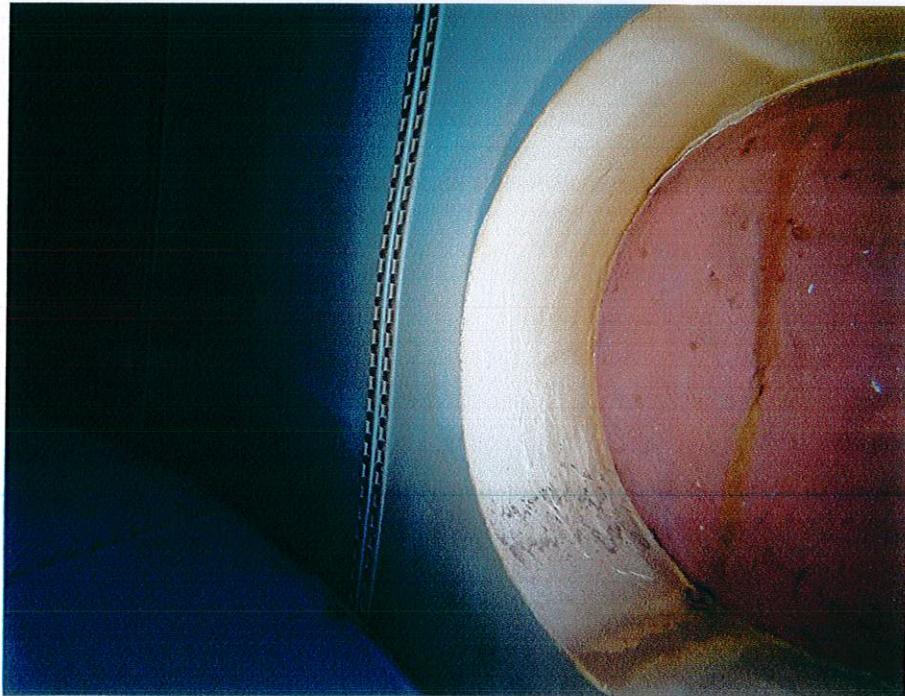
Shell manway @ 5:00 position

Minor corrosion at floor/shell area. Drain on floor.
