Barangay Summaries

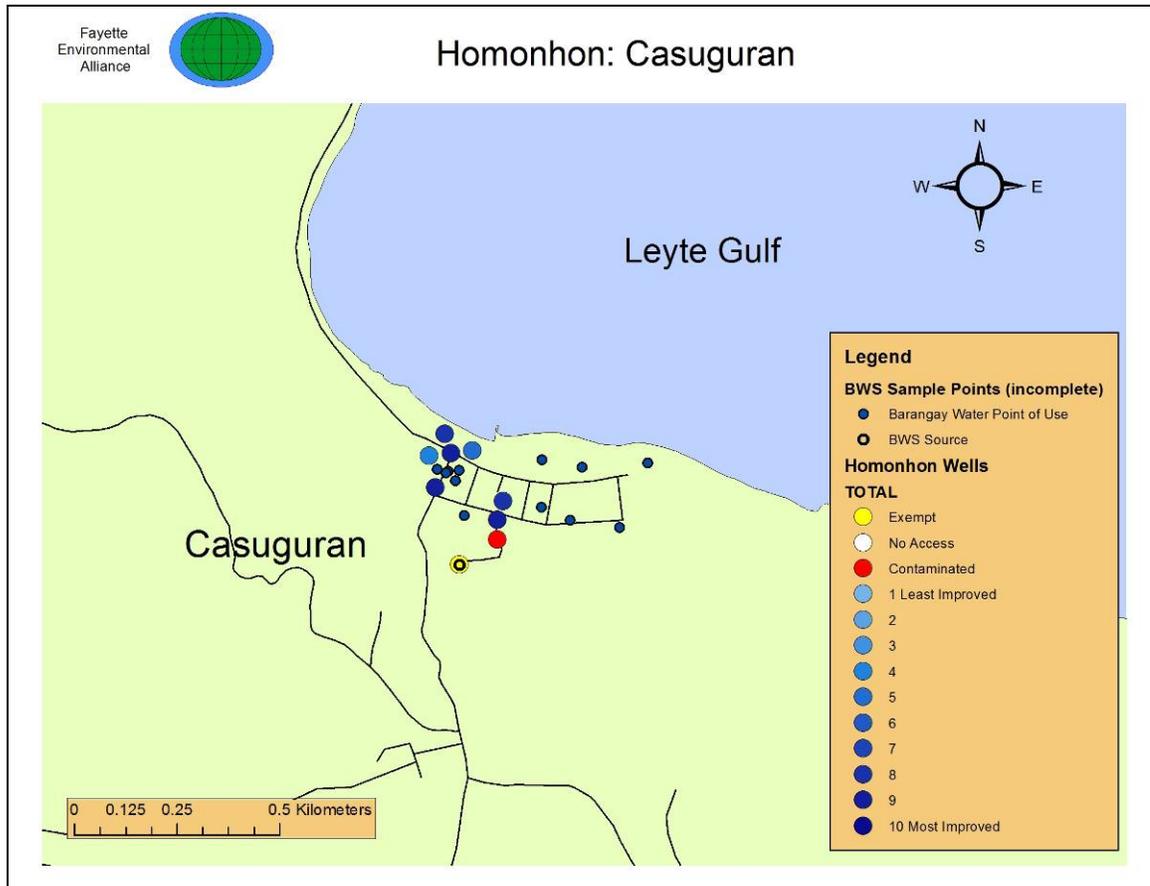
Number of Wells Sampled: 8
 Average Improvement Score: n/a

Casuguran is has two major streams, one of which is captured upstream, providing piped water to residents and common concrete basins throughout the barangay. There is also a stream running along one of the main roads that has a small waterfall and cascades on its way to the sea. One area of concern is an unused well behind the hospital that is collecting trash which includes broken florescent bulbs. It looks like this well may have been filled, when it was decommissioned. To properly decommissioned a well, it should be covered at or about the grade of the ground to prevent collection of trash that could leach into the ground water affecting the nearby water supply for the hospital.

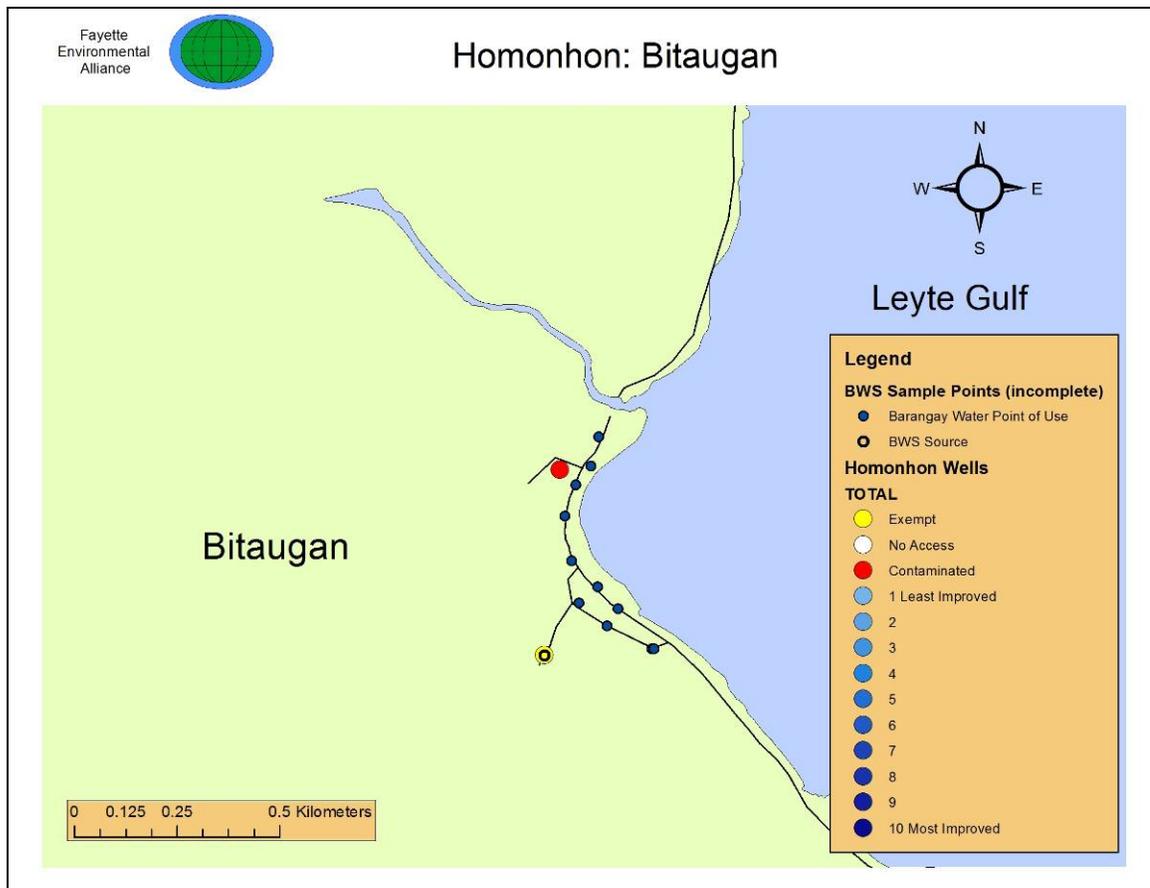
Number of Wells Sampled: 1
 Average Improvement Score: n/a

The stream capture box along the stream near the elementary school is secure and strong. Below the box there is a swimming pool for recreation, and other utility purposes. The well associated with the destroyed barangay "solar" system has been filled in with debris and trash. Since there is no other well that would be affected by any potential contamination, it is not a major concern.

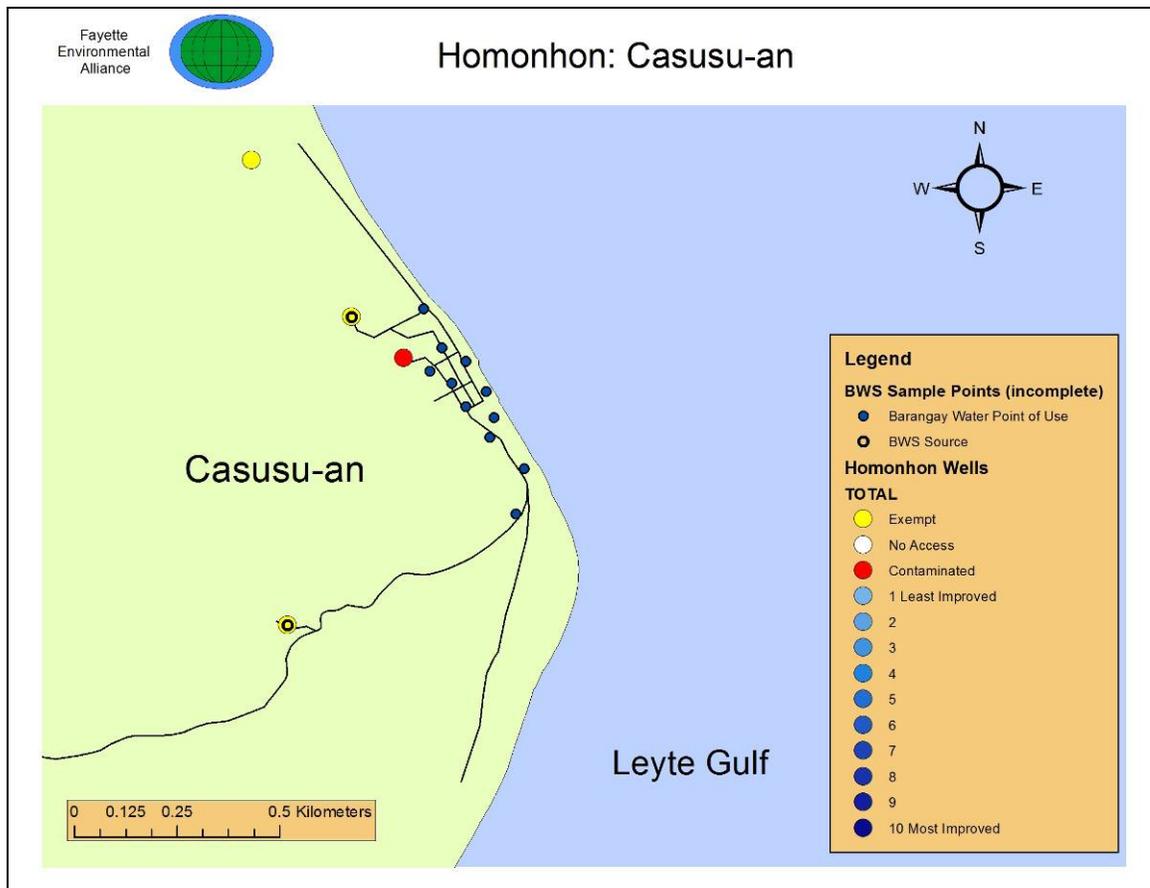
Number of Wells Sampled: 1
 Average Improvement Score: n/a

Casusu-an is exclusively served by a Piped Barangay Water system with two main sources. One is a capture box and the other is an upstream dam. The exempt well to the north of main population center is a small flow, spring capture pipe that serves a few houses. The Contaminated well is the former source of the "solar" BWS knocked out by Yolanda. It is now unsecured collecting debris. Not a major concern.

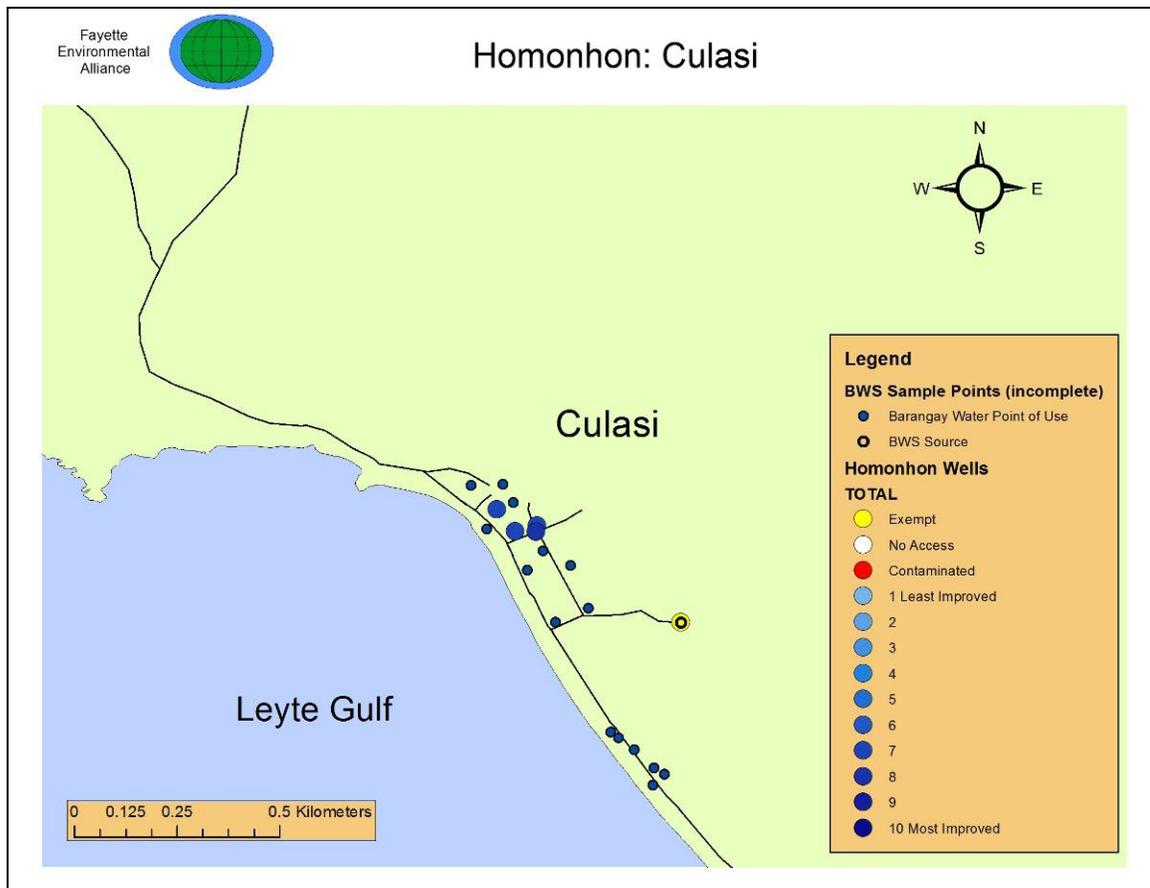
Number of Wells Sampled: 4
 Average Improvement Score: n/a

Culasi is served by a single stream capture box with water piped throughout the barangay. The four dug wells are secure, good design and most have a jetmatic pump. There is one elderly lady that needs help getting her pump fixed. I promised I would mention this in this report. Three of the wells do not have removable covers facilitating easy access in case of an emergency, pump problems, or a water quality problem. If the cover has to be removed, then perhaps the covers could be better designed when replaced.

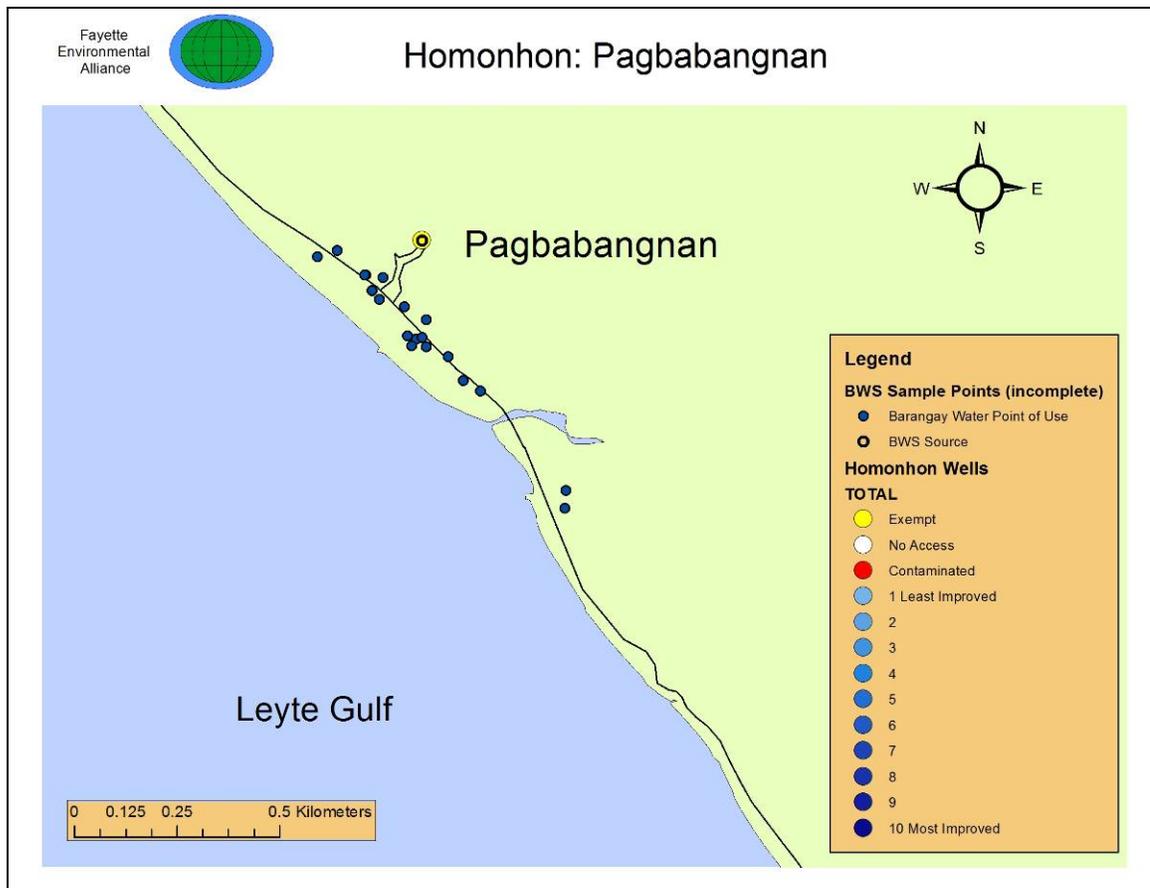
Number of Wells Sampled: 0
 Average Improvement Score: n/a

Pagbabangnan has a stream capture box, has no wells, and is served by a network of concrete walkways and roads. The barangay captain tells me that about 85% of households have water service and his goal is 100%. The water is so plentiful and high quality, that in first desperate days following Typhoon Yolanda, water was shipped from Pagbabangnan to Guiuan proper. There is a swimming pool/laundry area below the source that is well designed incorporating the natural aesthetics of the location with concrete additions. There are also public restroom facilities nearby.

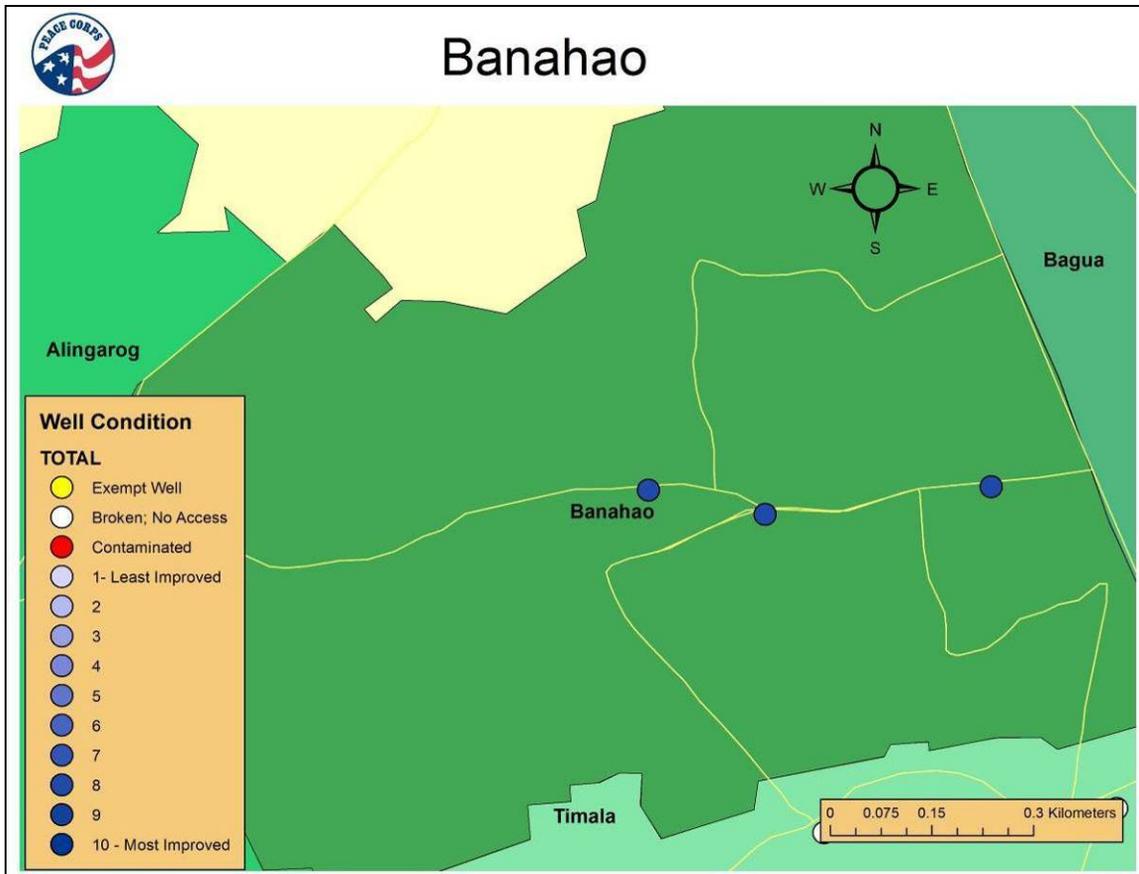
Number of Wells Sampled: 3
 Average Improvement Score: 8.0
 Issues: Few sources of Water
 Priorities: Bring Municipal Water System (Mercedes connection) online.
 Banahao is in the north of the Peninsula along the boundary with Mercedes bordering the National Road to the west. It had a newly installed stand-alone Barangay Water System (Y-S Men). There is a MWS line running from Mercedes that as of the survey date had yet to be brought on line.

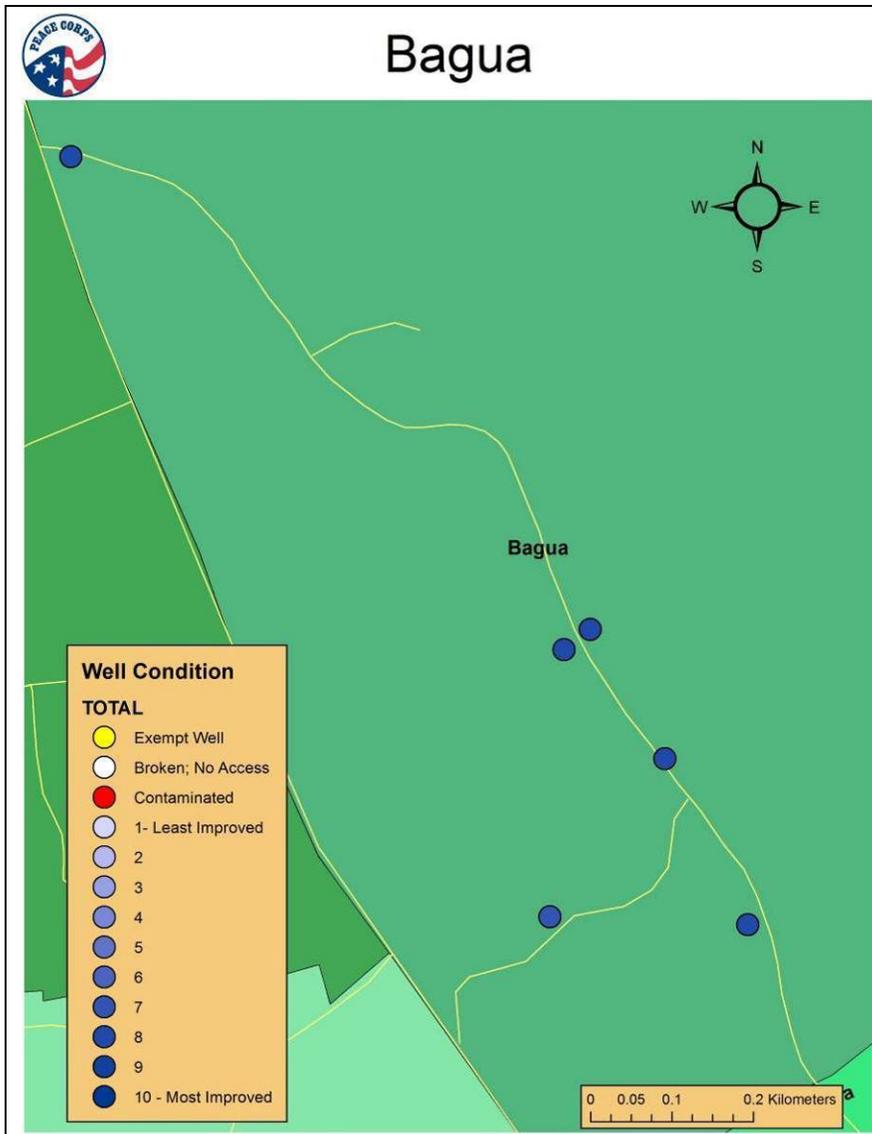
Number of Wells Sampled: 6

Issues: Few options for water along highway.

Bagua is in the north of the Peninsula along the boundary with Mercedes with the National Road on the west and the Pacific Coast Ridge to the east. Its wells are mainly of the "artesian" style with a newly installed pump (Operation Blessing) near the Plaza. There are MWS lines running from Mercedes, that as of the survey date (Sept-27), had yet to be brought on line.

Priorities: Bring Municipal Water System (Mercedes connections) online.

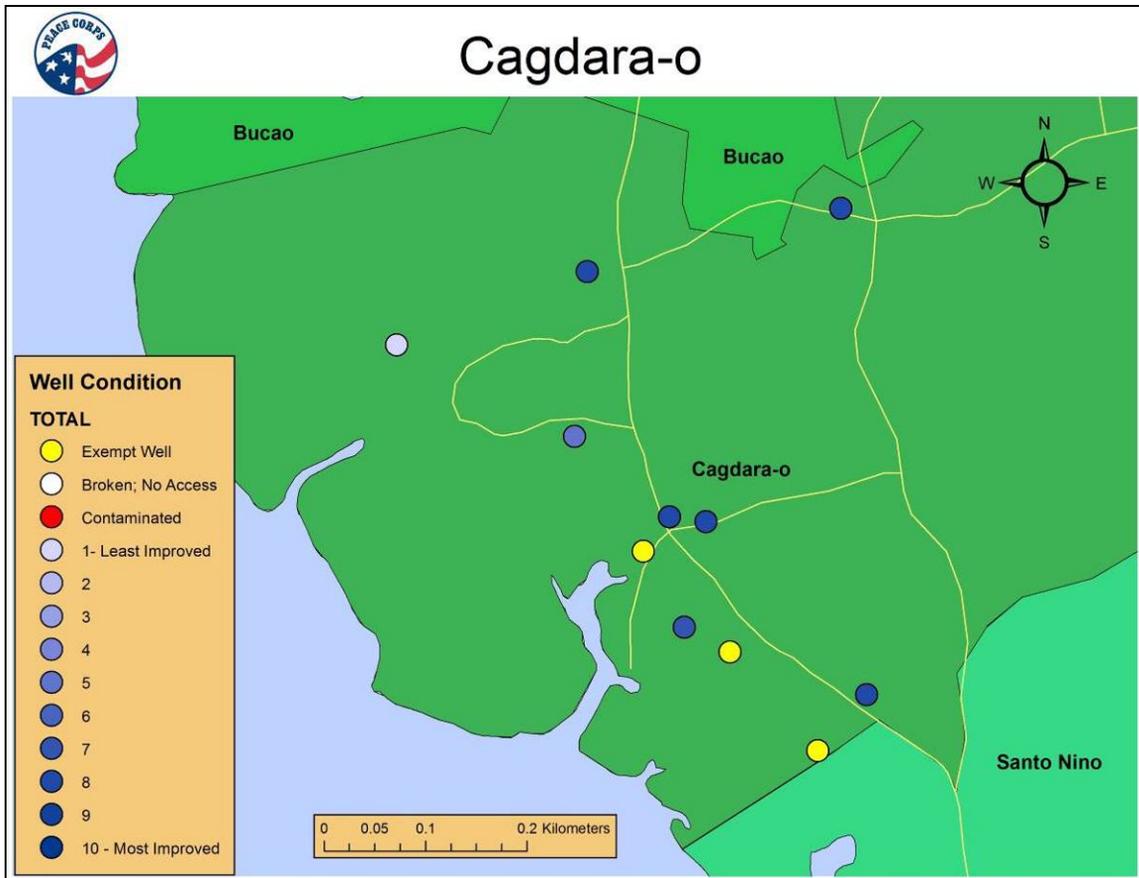
Number of Wells Sampled: 8

Issues: BWS not yet drinkable or reliable source for higher elevations of the barangay.

Barangay is blessed with three spring areas. One is a large swimming pool enjoyed by all age groups, for washing, bathing and recreation. Local leadership has improved the source extensively with a dam to control the flow from the sea and drainage channels to keep surface runoff from contaminating it. Two smaller springs are well maintained and deserve ongoing preservation in their current state.

Priorities: Expand BWS capability to higher elevations.

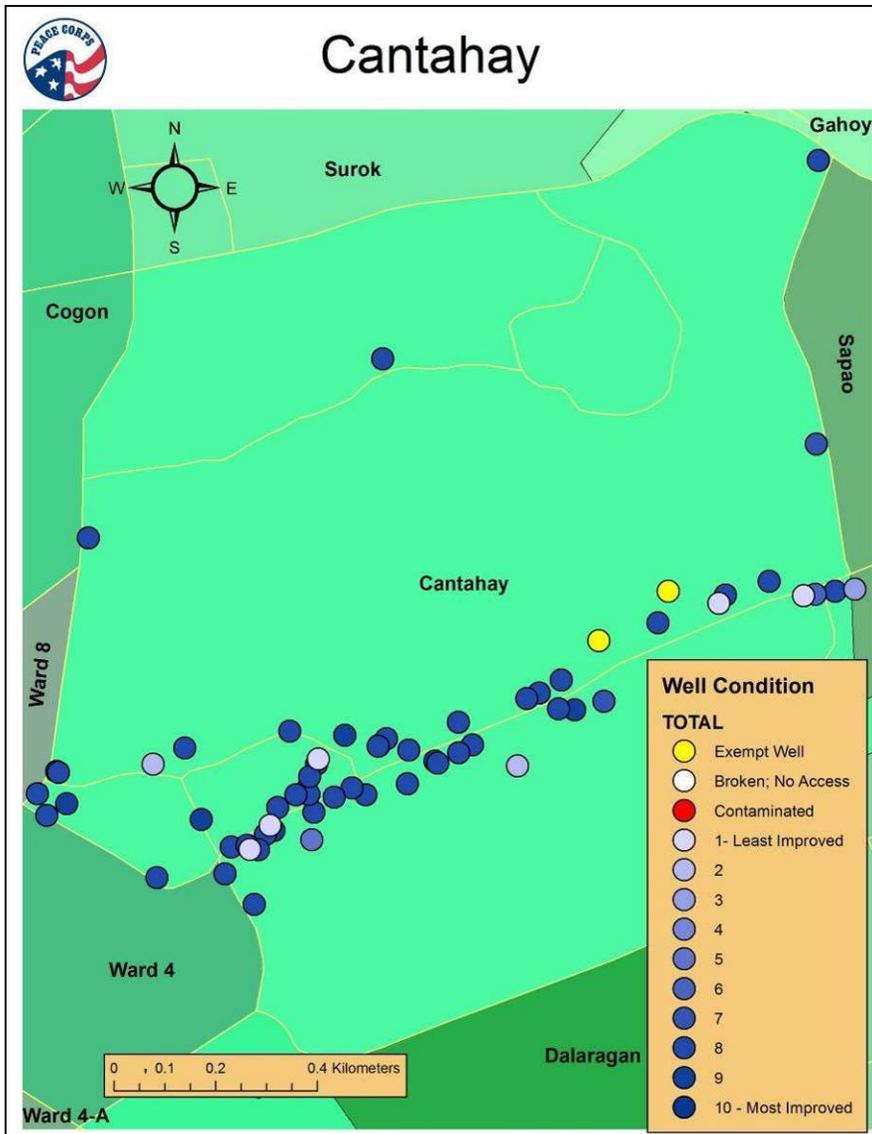
Number of Wells Sampled: 60

Issues: High density development along makes well source protection very important.

Cantahay is located inland on the Peninsula and contains the Airport. Its main development is along the abandoned tarmac of the former US Navy facility and contains the transition area from the elevated karst to the wetlands to the south. Having extensive impervious surfaces, it benefits directly from the recharge areas further north. Wells are generally improved. Two natural water sources (Well-10 & Well-11), very important in the days following Yolanda, are identified as needing special preservation. The area is served by the MWS at the western end along the provincial road and along the Navy Road to the North. Cantahay is home to three high capacity supply pumps that feed the large tanks located in the highlands. The barangay has a dedicated BWS (Well-60) serving the residents along the less densely populated northern road.

Priorities: Improve aprons and covers of wells.

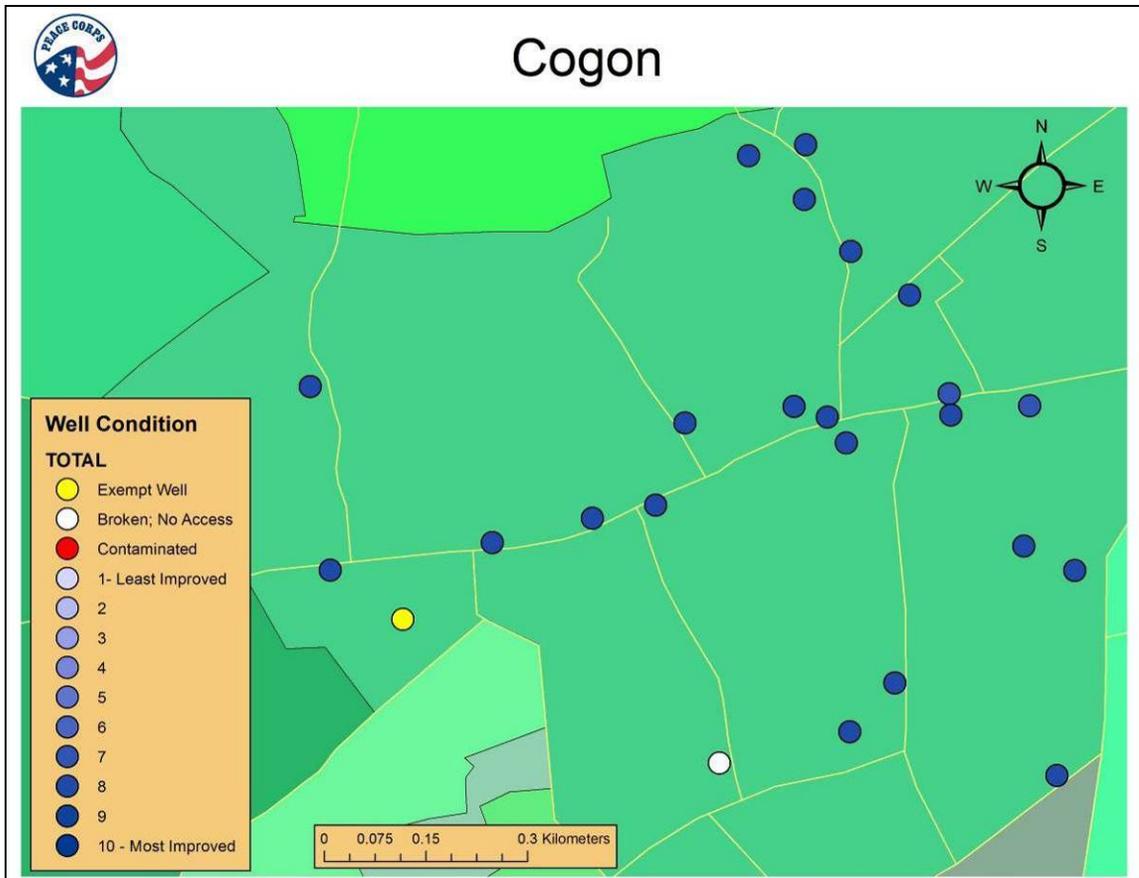
Number of Wells Sampled: 22

Issues: Minor issues only. Drainage around wells inadequate.

Cogon is an inland peninsular barangay located along the Navy Road. The wells in Cogon are consistently good. Other than the Legacy Well-21 proposed for exempt special preservation status. No open or unsecured water sources were observed in Cogon. Located along a major recharge area, identified by the surveyor as a possible collapsed cave, the water is readily available. Well-11 is a new Jetmatic application and does not produce water. The owner speculates that the depth to the water exceeds the maximum effective range of a suction type pump. Cogon is the location of a newly opened settlement of families affected by Yolanda. A well is located at each end of the settlement and a dedicated water system is scheduled to go on line soon.

Priorities: Improve aprons around high use wells. Improve drainage and apron around Well-21.

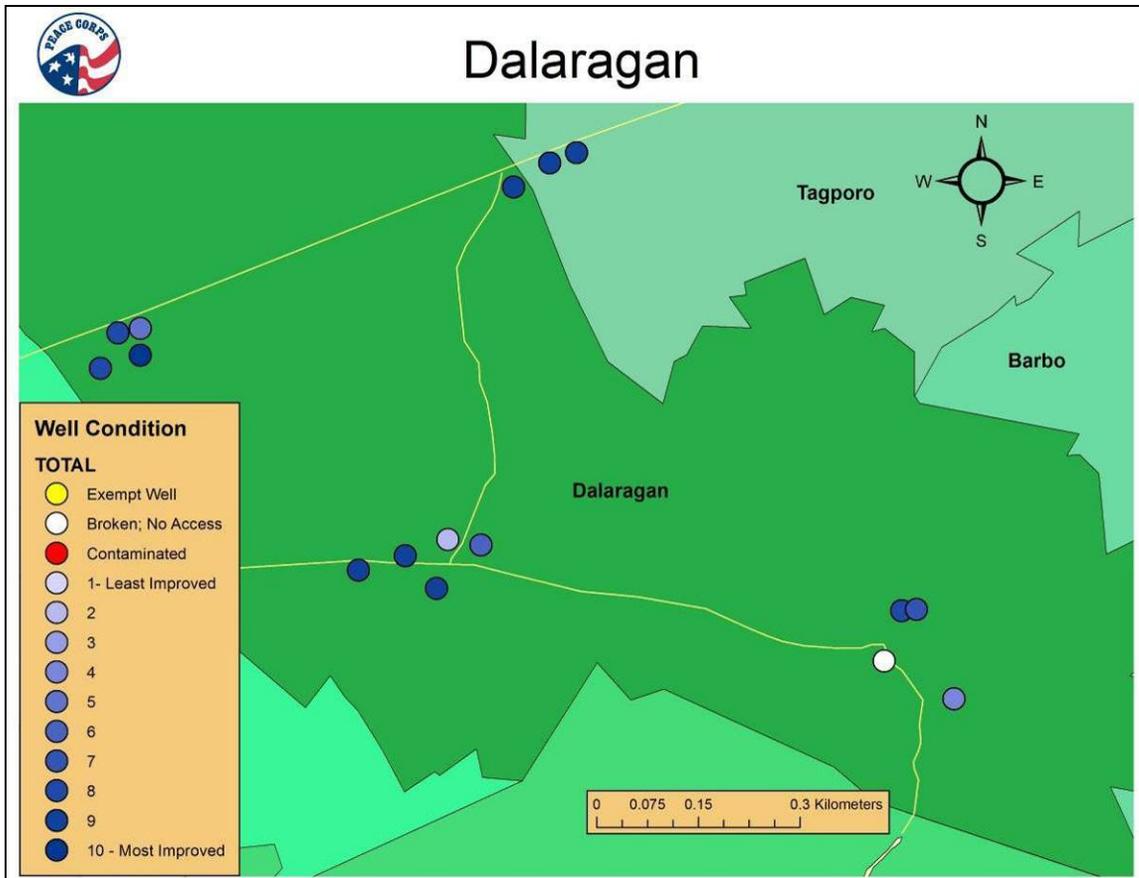
Number of Wells Sampled: 12

Issues: no major issues.

Dalaragan consists of three areas of residences that occupy the high spots of an extensive wetland area in the south of the main peninsula. The barangay has a recovered BWS located in the middle groups of residences and extends along the road to the lower main barangay area. The surveyor did not note any problems and water is available in most places at a pump or faucet. The upper group of residences contains one of the best-designed covers of wells found along the survey trail: Well-13.

Priorities: Maintain Continuous Improvement

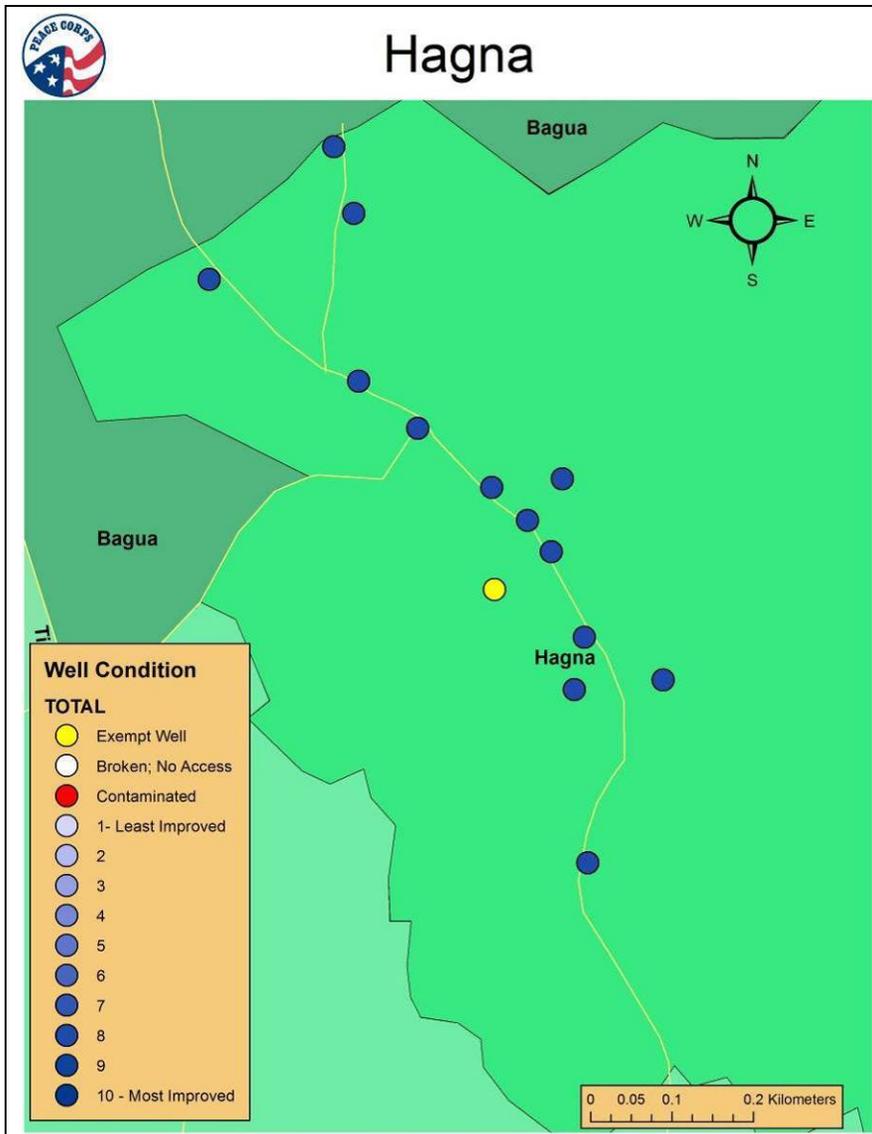
Number of Wells Sampled: 13

Issues: Minor improvements to well drainage.

Hagna is located inland on the peninsula adjacent to the Pacific Ridge. The wells in Hagna are consistently good. The only open well is the well designated for preservation in its present condition. As you go south from the north part of Hagna the elevation drops into a large sink area. The wells in the higher elevations, newer wells provided by Operation Blessing, are of the downhole type. As you go down, the wells transition to the suction type. Well-5 & Well-13 are old artesian installations that have been retrofitted with Jetmatics.

Old Well-07 is magnificent. With all the other wells safe and secure in Hagna, this well has a prominent place as a contingent source of water.

Priorities: Remove papaya trees from Old Well-07.

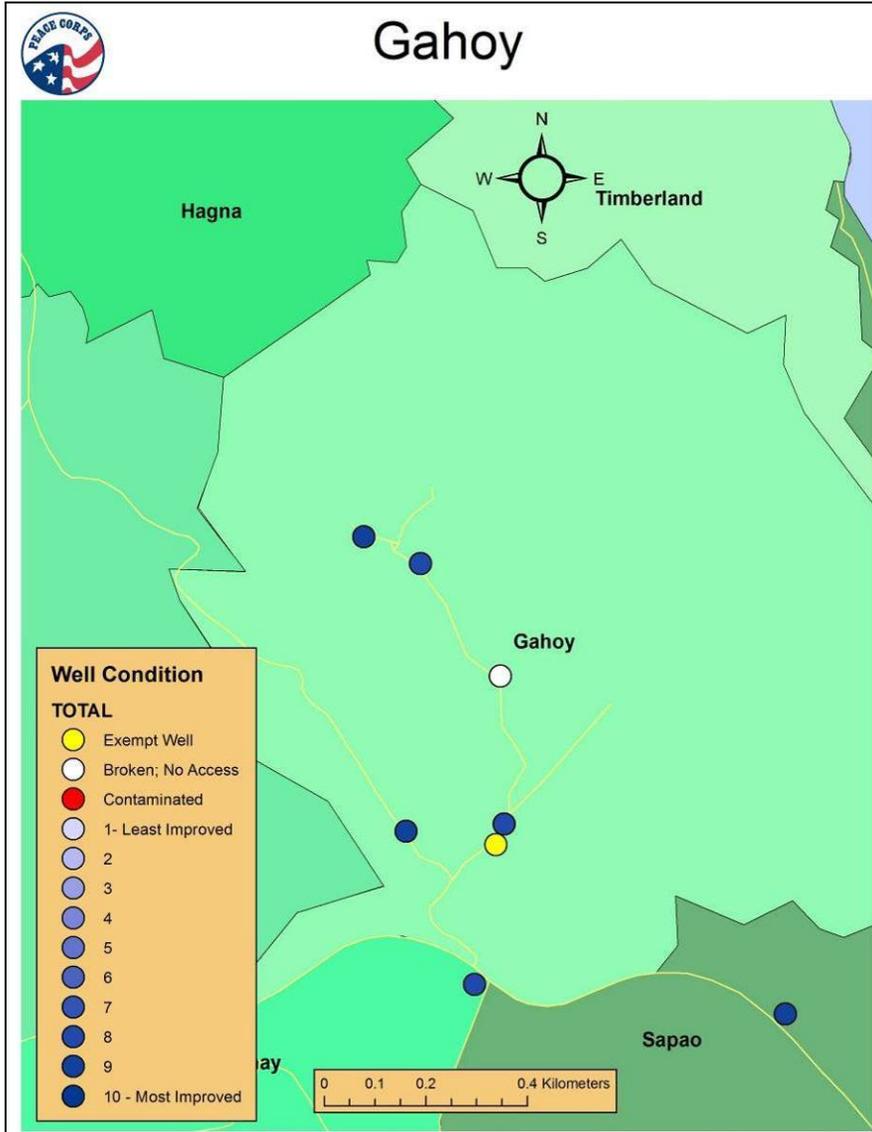
Number of Wells Sampled: 4

Issues: Development of sources.

Gahoy is served by the MWS so locally supplied water less of an issue. Well-01, is suggested for preservation, however, it still needs to be improved to prevent contamination of the water table. It is located at the end of a major recharge area and protections such as well drained usage areas and other impervious surfaces need to be installed. The private well with the motor on top is inaccessible in its current configuration. Perhaps the property owner can be encouraged to reconfigure the motor and piping to provide for contingent uses in addition to provide for serviceability.

Priorities: none major

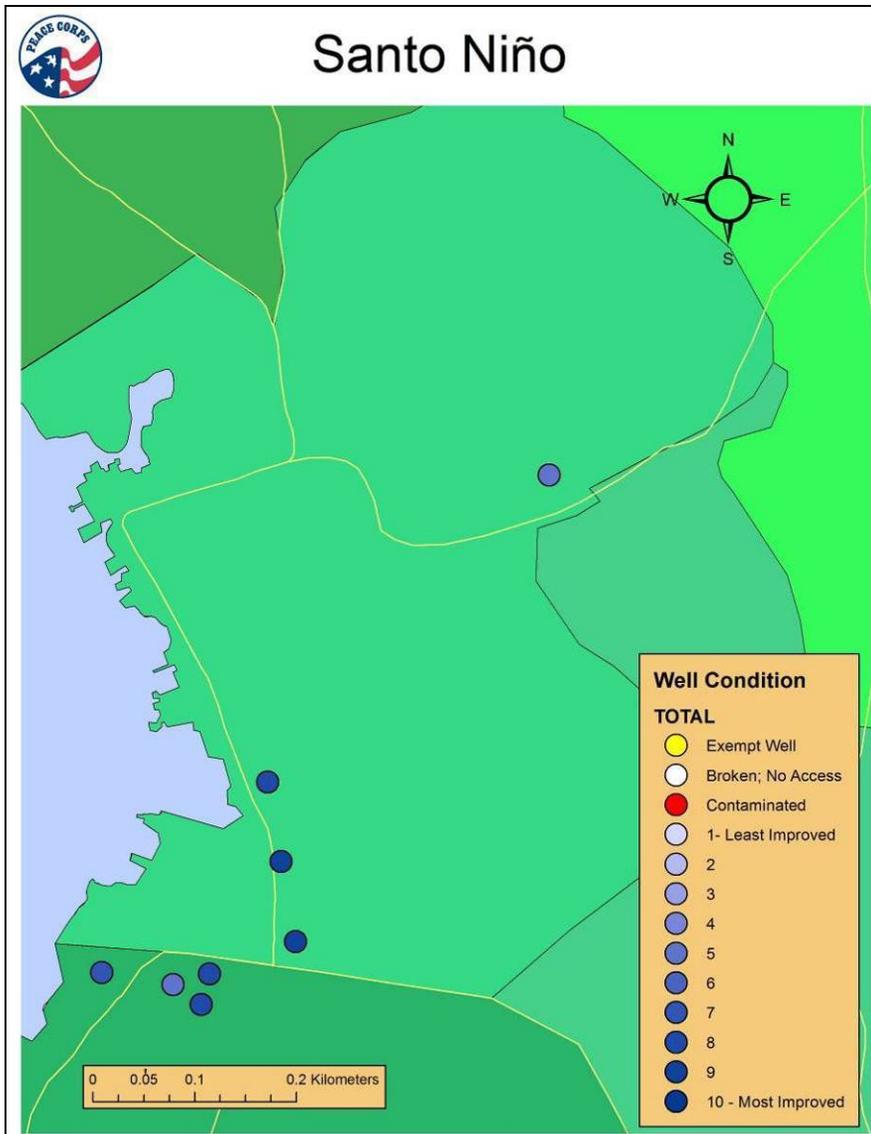
Number of Wells Sampled: 4
 Average Improvement Score: 7.7
 Issues: Land Fill Security
 Priorities: None Major

Santo Nino is located on the west coast of the peninsula and is extensively served by the MWS. Three wells are located near the coast and improved. Some are on private property and some associated with the now destroyed BWS. The open well in the sink area occupied by the Municipal Landfill is the only water source used by the community that is threatened. Santo Nino also has a substantial amount of water flow coming out of the highlands to the east and also drains the landfill area. The open well is significant due to the fact that it will be the first place that any contamination from leachate coming from the landfill will be detected.

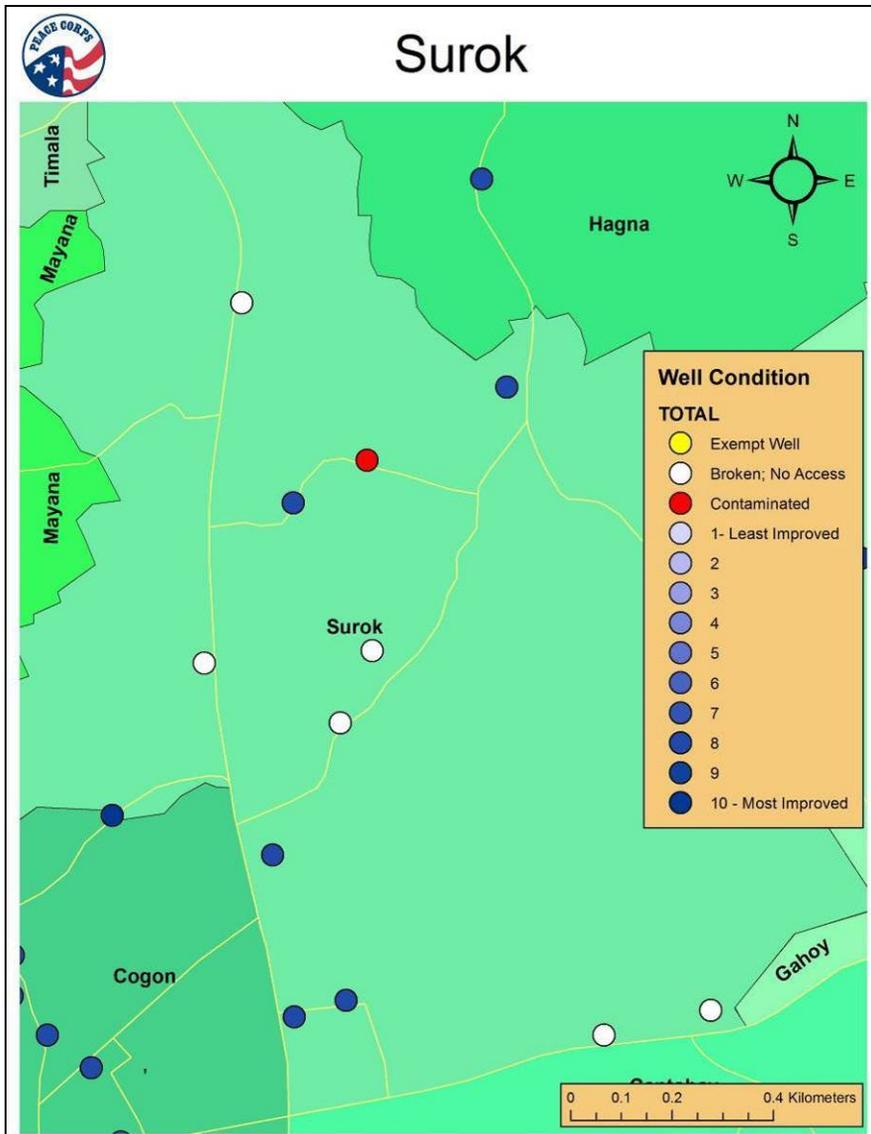
Number of Wells Sampled: 7

Issues: High number of out of service wells; contaminated well.

Surok has the one of the finest examples of a well that has benefited from continuous improvement: Well-6. A large area with relatively few wells, Surok also has the distinction of having more "artesian" wells that have fallen out of service. These monuments to maintenance failure dot the landscape. A small disused and contaminated well, Well-09, is located in a major recharge area. Surok is home to one of the main pumping stations supplying the water to the tanks in Cantahay and is served by the MWS along the National Road, the lower parts of the road to Hagna, and the Navy Road.

Priorities: Implement Continuous Improvement and recover wells.

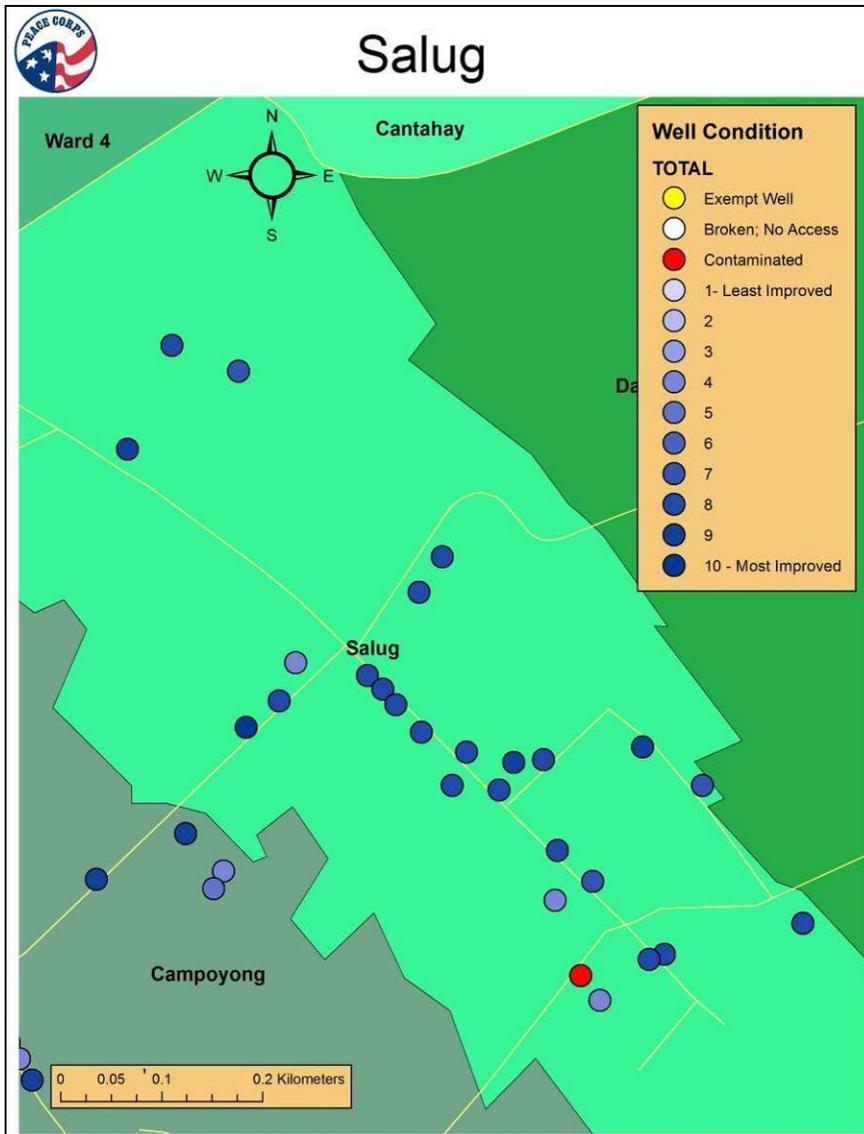
Number of Wells Sampled: 27

Issues: no major issues; a contaminated well.

Salug has the largest number of superior designed wells in its common areas. It is evident that there is a strong program of well improvement already in place. Near the pair of superior wells next to the Plaza is a large contaminated well. Salug is served by the MWS.

Priorities: Continue with well improvements

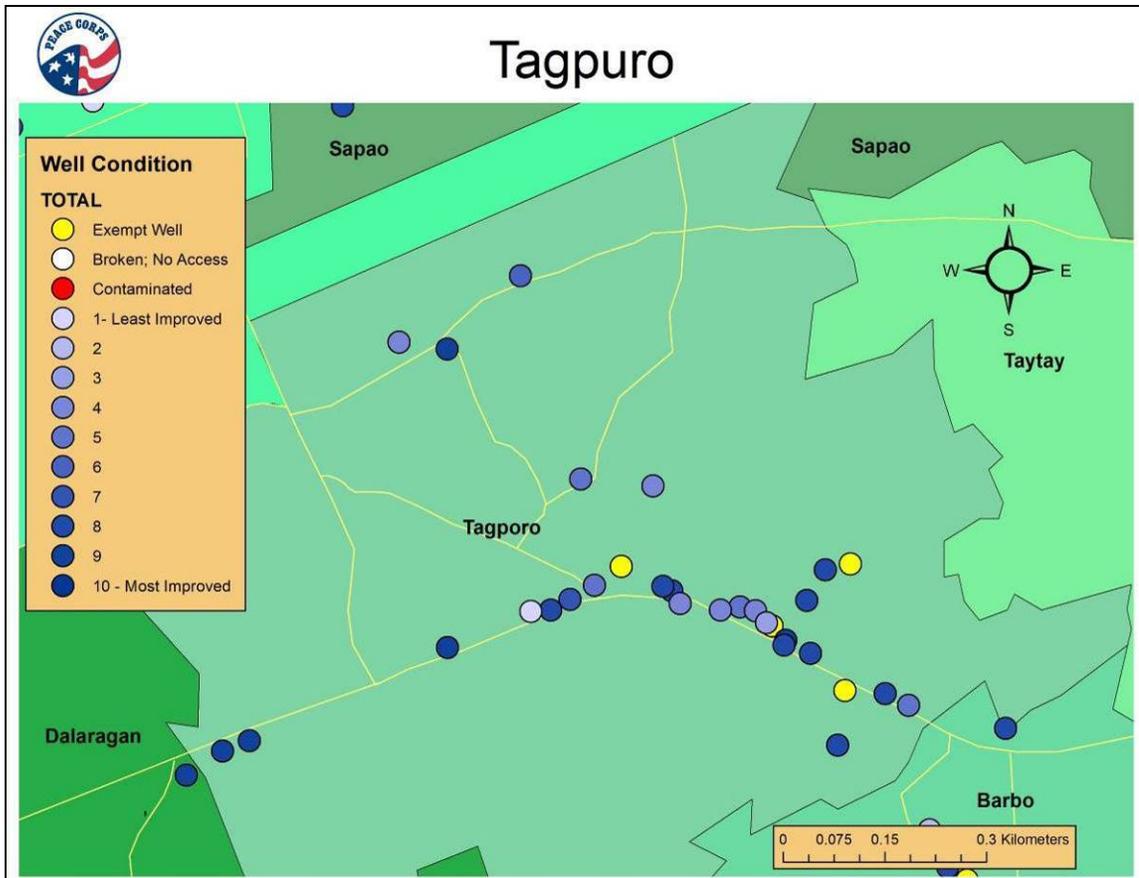
Number of Wells Sampled: 28

Issues: None specific

Tagpuro is located on the peninsula below the airport. It is served by a recovered BWS. As with most BWS water supplies, it is only available for a few hours in the morning. The surveyor suggests four wells for preservation mainly due to the natural locations or construction materials. Some relocated storm affected families are relocating in areas adjacent to the airport. In addition to the help the families are receiving in constructing their new homes, in some cases they need help in developing their water resources. While the neighboring barangays have access to the MWS, the surveyor found no connections in Tagpuro.

Priorities: Continuing improvement of existing sources

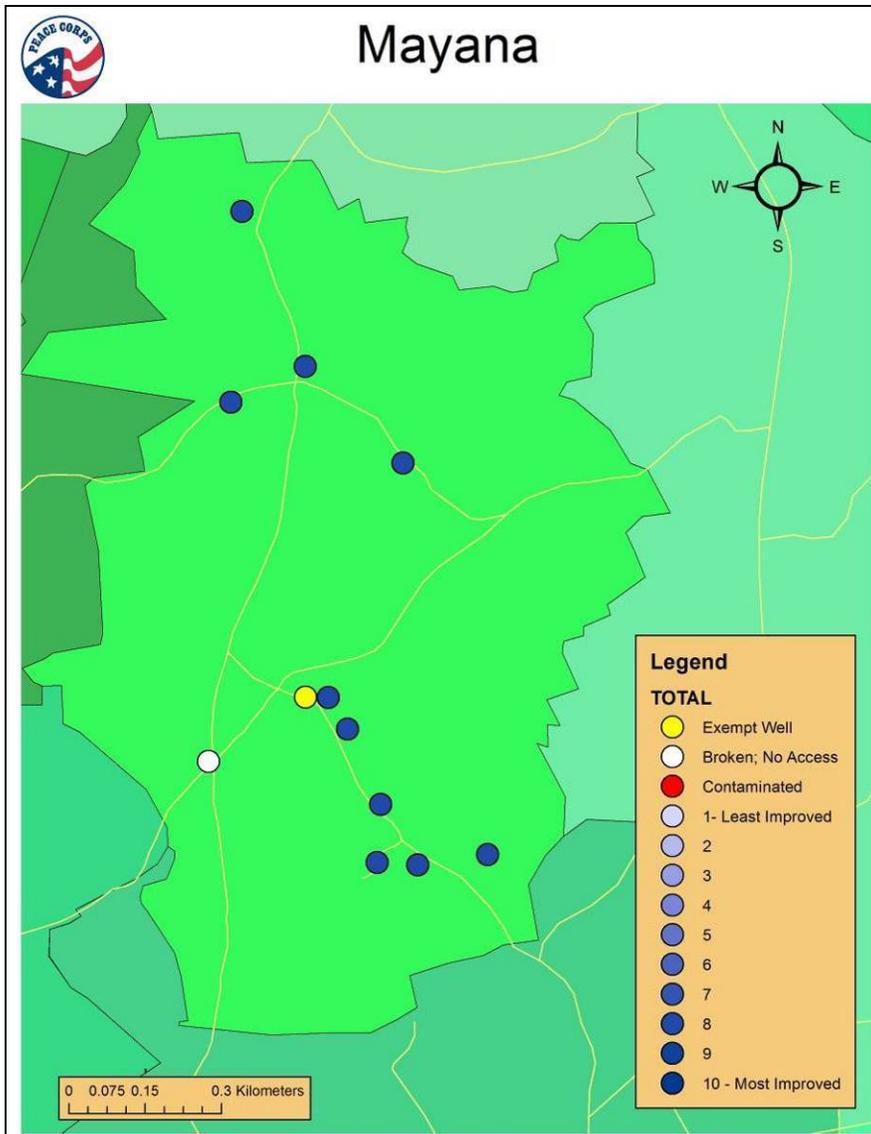
Number of Wells Sampled: 10

Issues: none Major

Mayana, like most barangays at higher elevations with limited access to the water table and fewer sources, has excellent wells. Most are of the "artesian" type. One complaint often heard about these wells, is the amount of work it takes to push the water to the surface along with the fact that it takes more pumping for the water to run clear. This may be due to oxidation of piping and linkages.

There is one open well that the surveyor proposes for preservation. It is the deepest open well in Guian. Situated beneath a large and tall tree, it dominates the landscape.

Priorities: Continue development of Sources

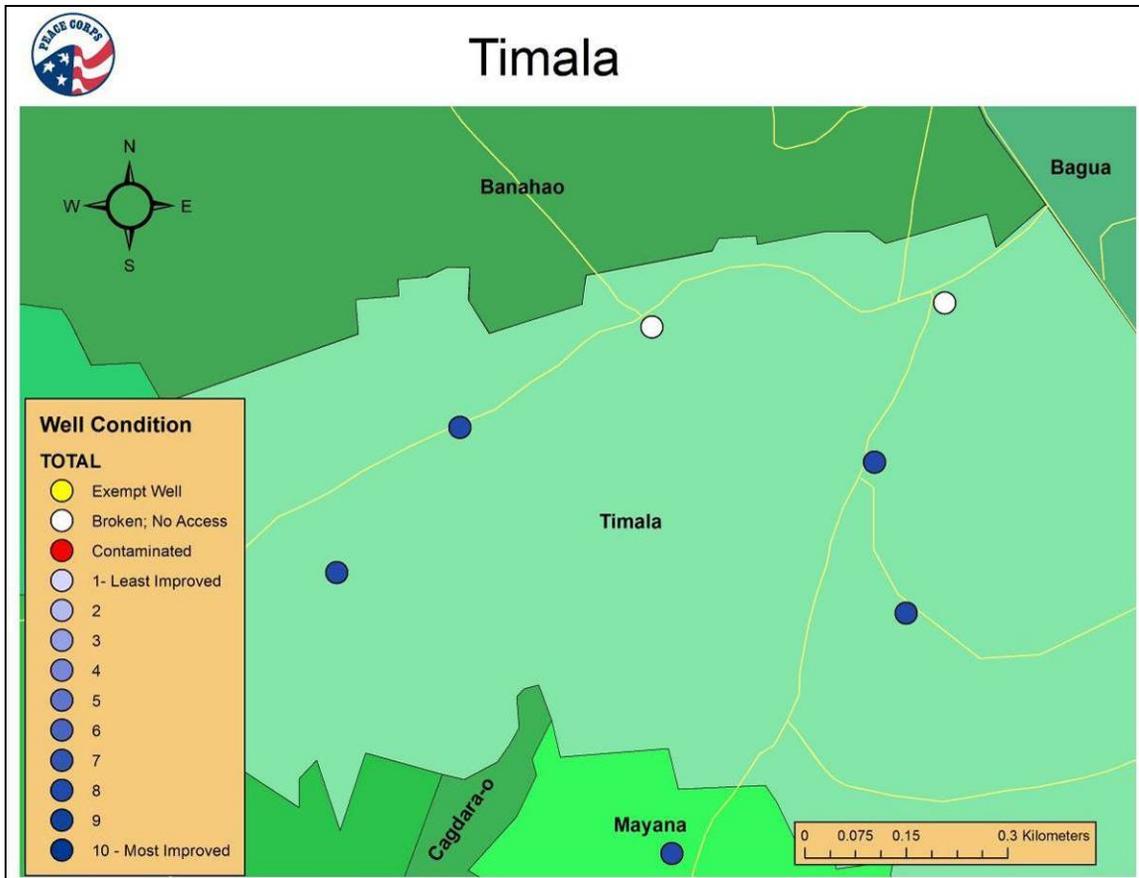
Number of Wells Sampled: 4

Issues: Few wells, un-repaired wells

Timala is an inland barangay found at the higher elevations. It boasts a cave locally famous for its access to the water table. Technically this cave is a contingent source of water but is not included in the survey. The high elevation makes residents dependant on downhole positive displacement pumps to bring the water to the surface. Two of the six wells being off-line is significant. The BWS has been restored with a new tank on the damaged "solar" tower. It was not determined if the MWS extends to the National Road border of Timala. At the Timala - Mayana Border is located also has a MWS tank that is currently off line.

Priorities: Return to service "artesian" wells that are broken
