Barangay Summaries

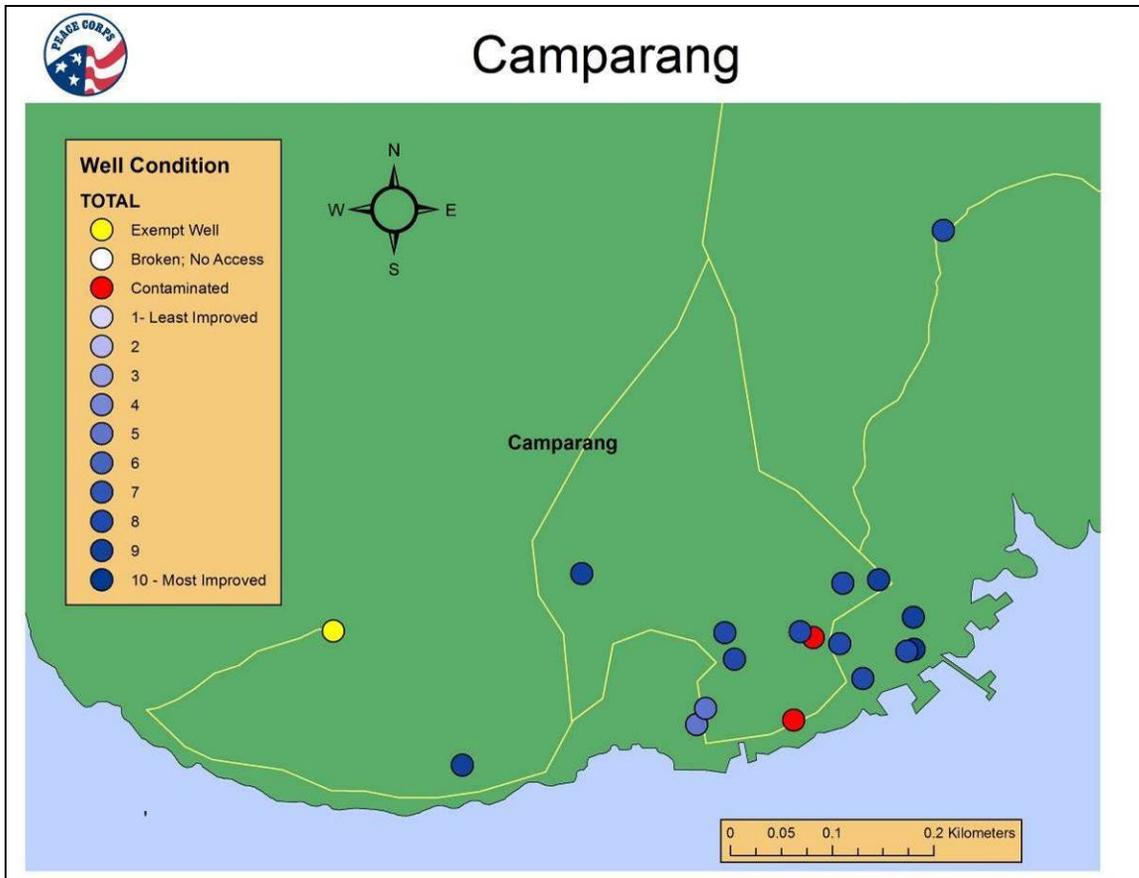
Number of Wells Sampled: 18

Issues: BWS not on-line

Camparang is found on the southern coast of Tubabao Island and is blessed with a spring and drinking water well. It is also the site of one of the Japanese philanthropic and development projects. Their maritime association helped rebuild their school and underwater storm resistant fish cages for lapu-lapu (grouper) culture is being developed.

The BWS of Camparang survived the storm relatively intact, but is not yet on line. Camparang also has the distinction of being a barangay where there were no observance of broken faucets among the BWS standpipes.

Wells are fair with two contaminated wells reducing the overall score. One is storm damaged. The other belongs to an elderly couple who seem not to have help maintaining their well.

Priorities: Clean and cover wells, Bring BWS online.

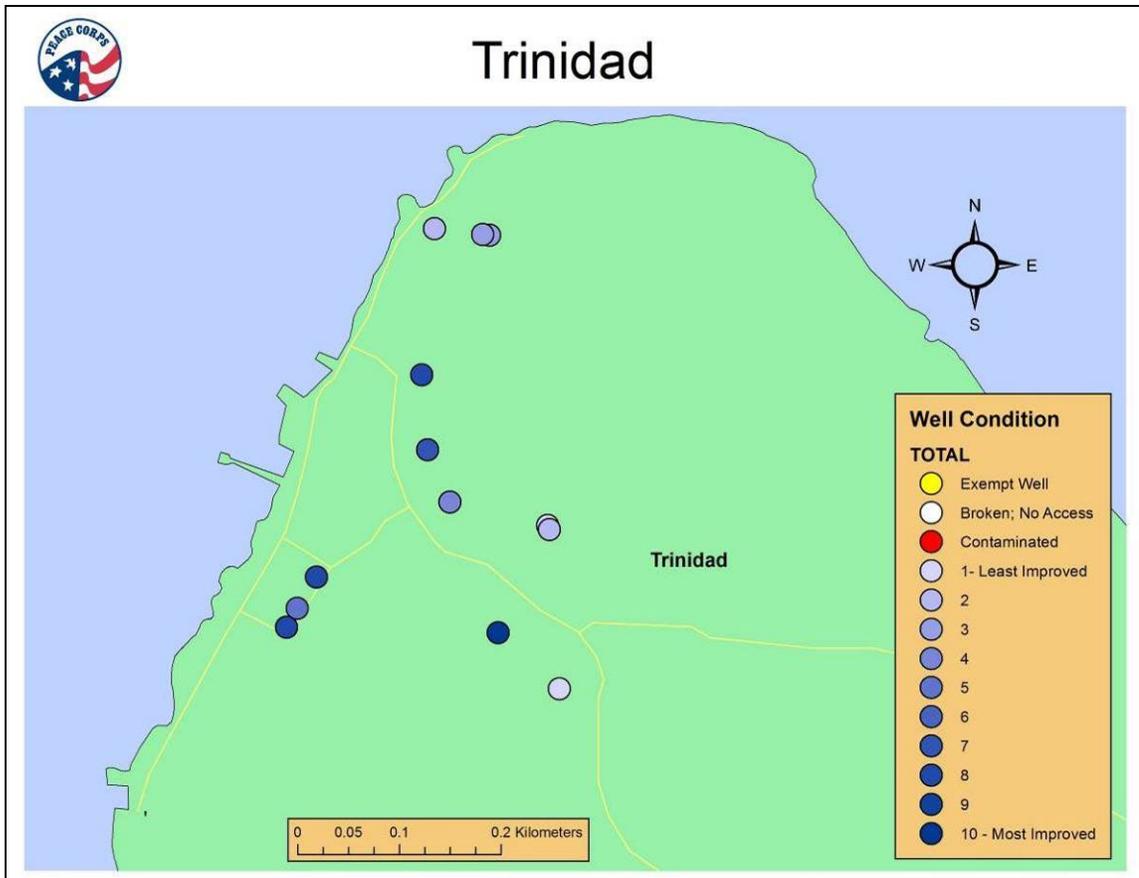
Number of Wells Sampled: 13

Issues: Uncovered and unimproved wells.

Trinidad residents occupy land very near the water table. Their inland wells have multiple jetmatic connections that run some distance to the coastal residents. One of these are a significant source, that once had an improved cover, however it is in a current state of disrepair. Trinidad has a stand-alone BWS that was recently installed. Primarily funded by the Japanese, it has a three stage filter that includes a softener stage.

Priorities: Continuous improvement; cover wells.

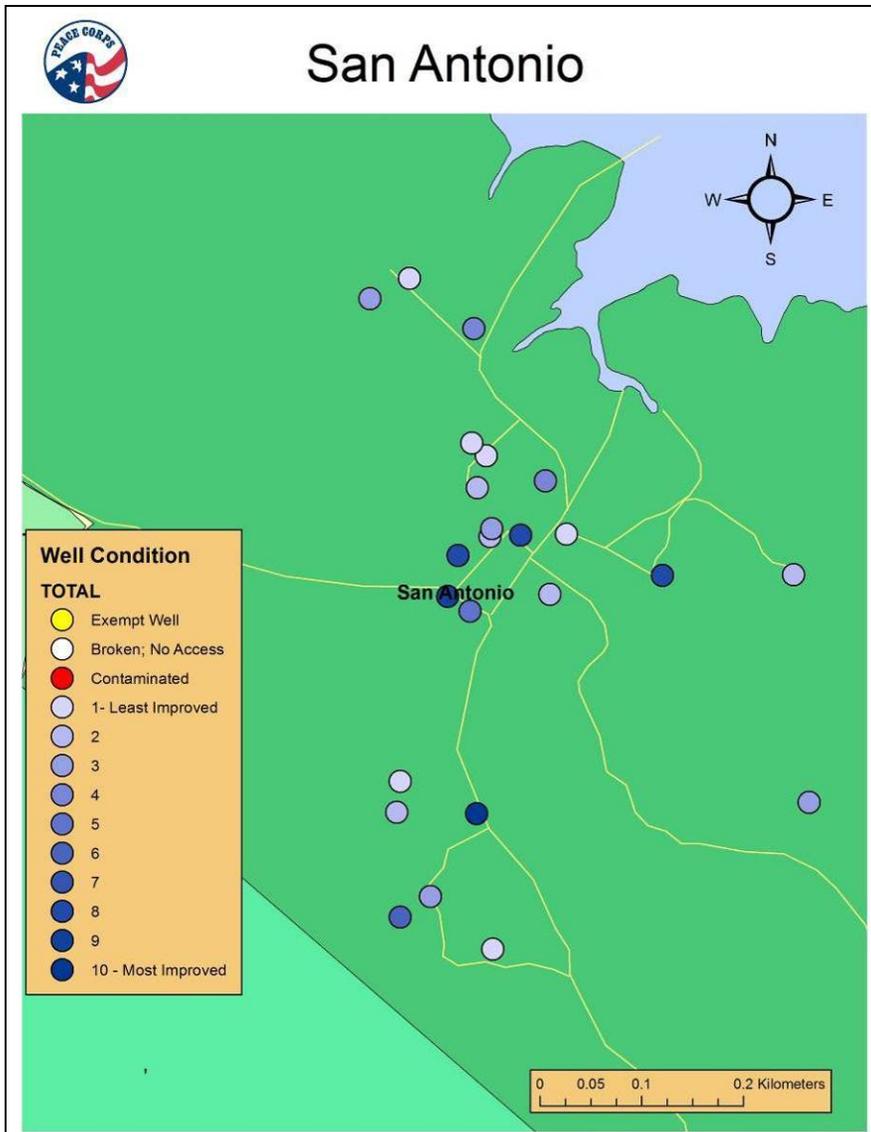
Number of Wells Sampled: 24

Issues: Unimproved wells.

San Antonio water table is less than a meter below grade. There are a lot of unimproved wells. One well (Well-6) in San Antonio is a result of Yolanda. When the storm came through, a large tree was up rooted and the resulting hole is being exploited as a well by one elderly gentleman. Their BWS is a stand-alone system at the plaza.

Priorities: Implement improvement plan.

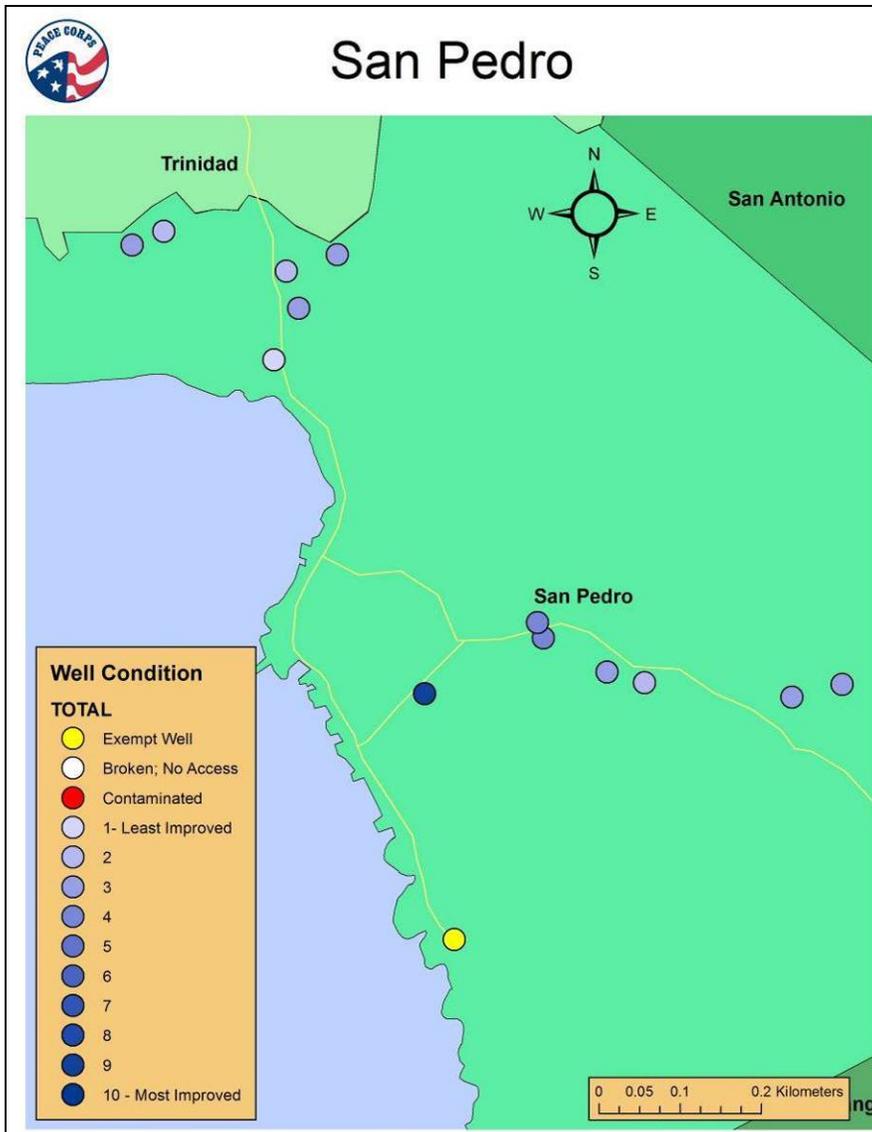
Number of Wells Sampled: 13
 Average Improvement Score: 3.2
 Issues: Unimproved wells.
 Priorities: Implement improvement plan.

San Pedro is home to one of the Yolanda surviving "Solar" tanks. It is also served by piped BWS water throughout the populated areas. It has a very nice traditional well (Well-6) that can accommodate a large laundry day crowd as well as young bathers. The large heavy cover is replaced at night. At the other end of the Coastal Road is a old well in a natural setting that is nominated for preservation (Well-7).

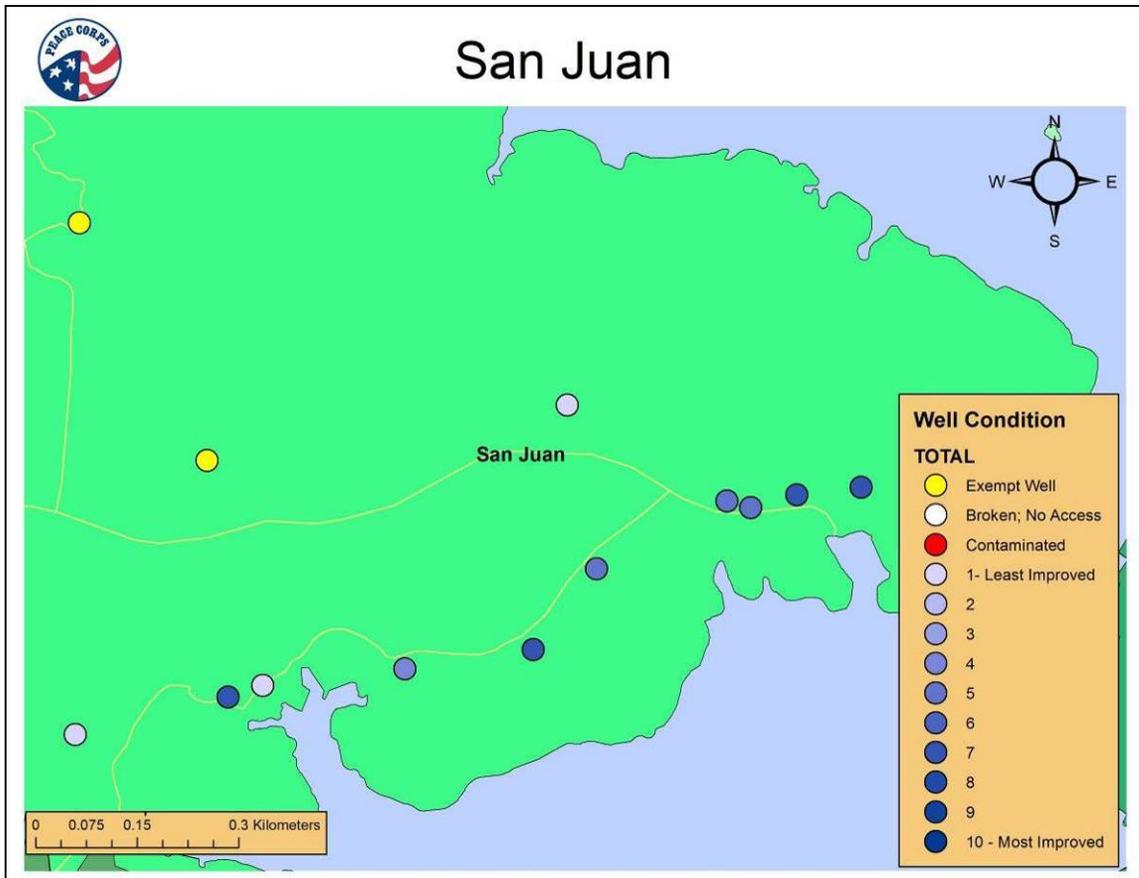
Number of Wells Sampled: 42
 Average Improvement Score: 6.3
 Issues: Lack of water at higher elevations.
 Priorities: General Improvement Plan.

San Juan water sources are found at the lower elevations as dug wells and along the hill sides as creeks and captured springs. Previously the BWS was located at a higher elevation and served the residents that occupied the ridge tops and along the main road going up to the central highland. With that system destroyed by Yolanda, the residents need to haul their water up hill some distance.

San Juan has a drinking water well (Well-4) that has a tap stand facility for the residents. One well slated for preservation, Well-1 is actually a series of spring capture structures. The top is used for drinking and the lower is used for washing. The other spring proposed for preservation is Well-13. This spring is unimproved. Basically springs and creeks do not fit readily into the model proposed by this report, however they can, and often are improved as a water source. Each community should decide on a case-by-case basis how to proceed. Another creek, on the border of Camparang and San Juan was not included in the scoring for the same reason. It is an important water resource with extensive improvements and should be protected or preserved as appropriate.

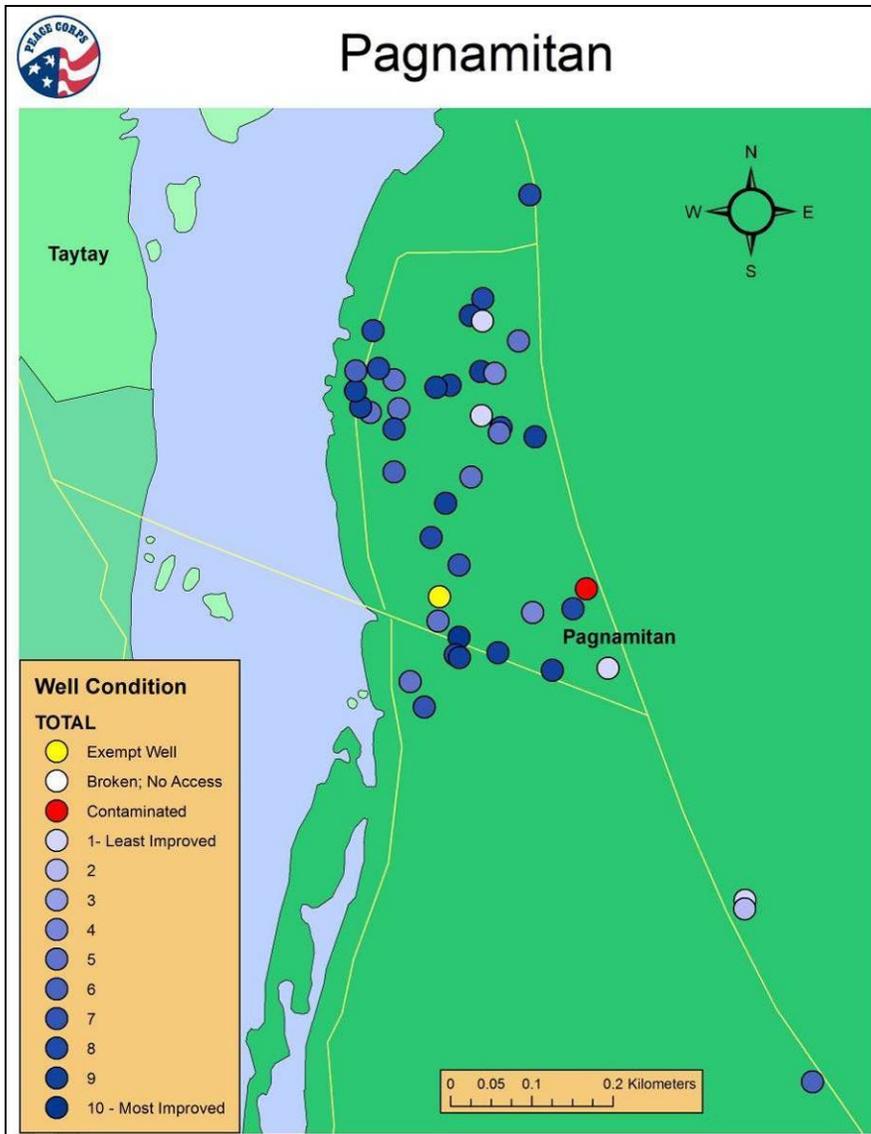
Number of Wells Sampled: 42

Average Improvement Score: 6.3

Well-42 and Well-43 have been "improved" with old motorcycle tires. This practice was observed in a couple of other barangays. The problem with old tires stacked one upon another to form a well shaft is that it forms a breeding habitat for mosquitoes. As water is drawn up with a bucket, water will slosh to the side filling the tire with stagnant water that will attract insects and other animals looking for a nook or cranny to occupy. It is better to leave a dug well with its natural matrix walls than to apply old tires.

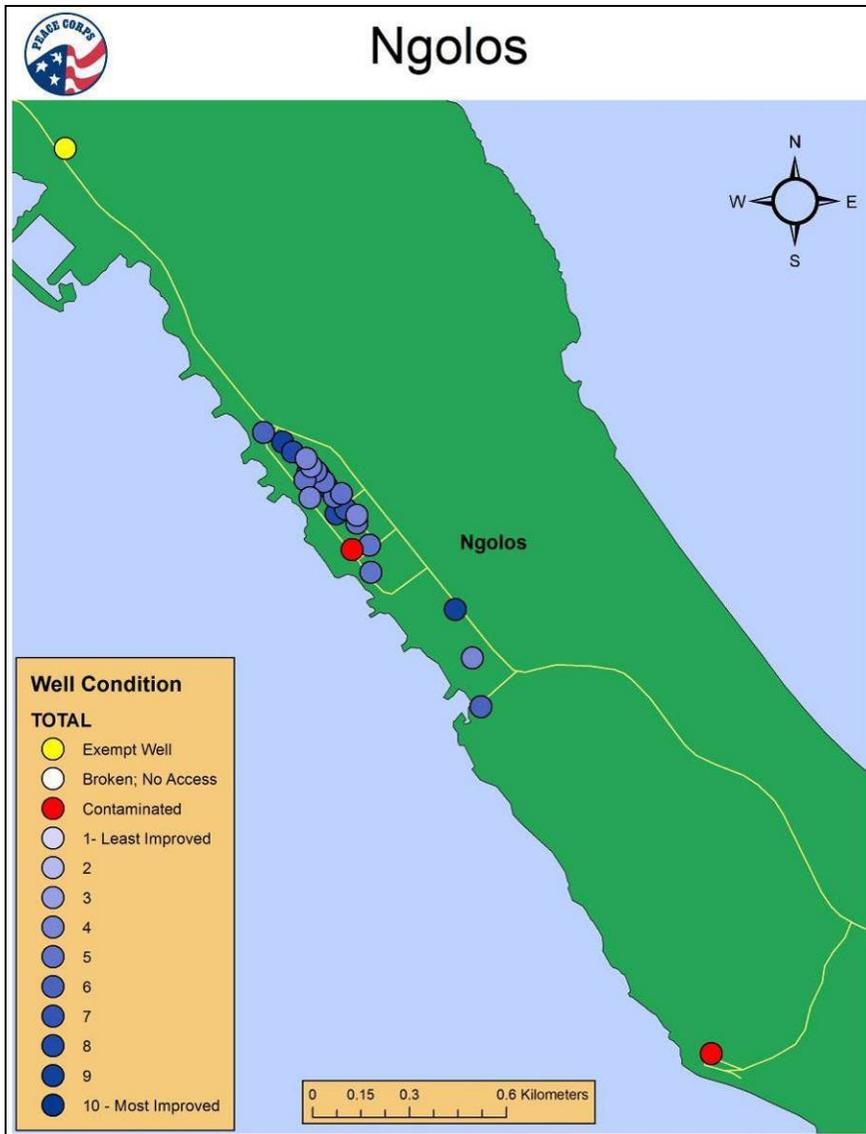
Number of Wells Sampled: 26
 Average Improvement Score: 5.5

Ngolos is the next barangay on Calicoan Island going south. It is also served by the MWS. There were no wells in Ngolos surveyed that were in an unimproved state. Most wells were with improved shafts, but without covers. Most improvement therefore will be simply securing the source with a cover and improving aprons. Two contaminated wells were noted. One supplied the pump near the elementary school Well-25. Well-1 is in a small fishing village to the south of the main population center. The residents noted that the well was salty and was not used because of the MWS supply taps, five in all. It appears that the residents attempted to close the well with stones and it hasn't gathered much trash. A little clean up with a non-removable secure cover will finish the job. The Barangay is installing a buffer tank positioned on a hill.

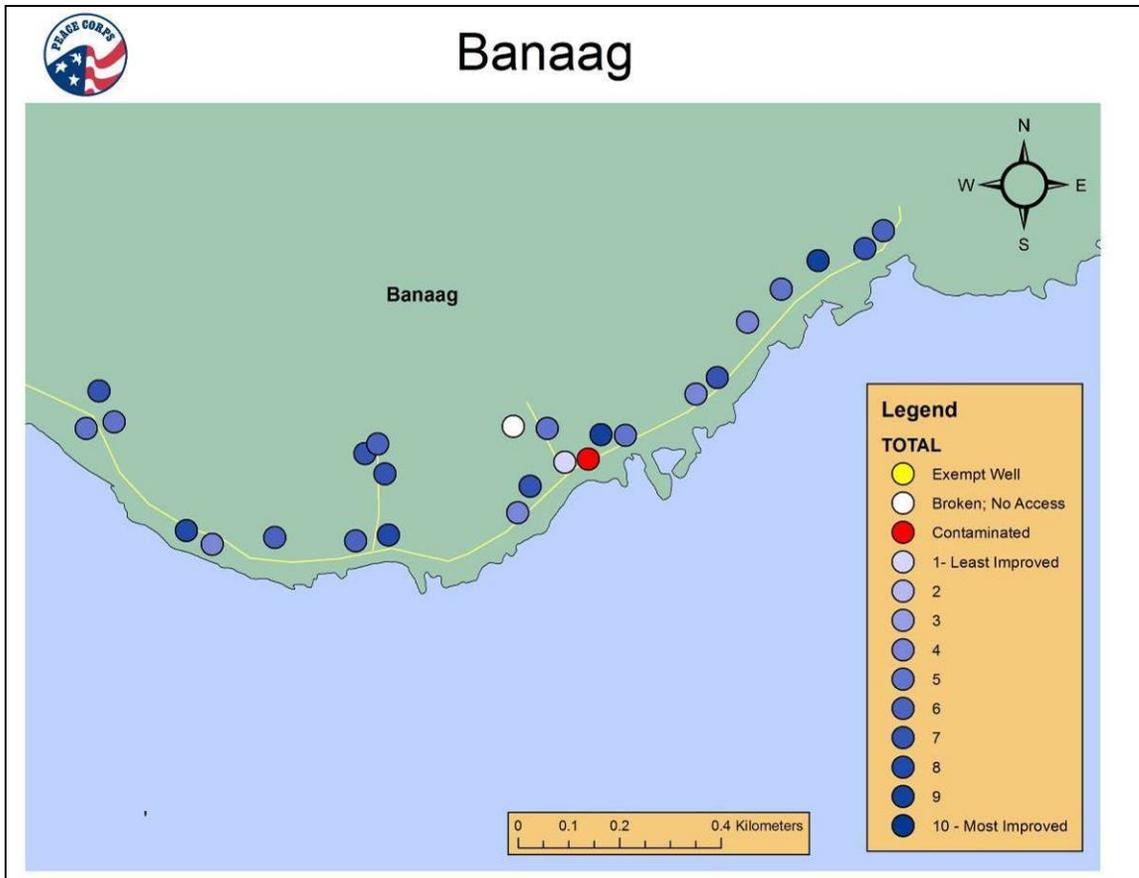
Number of Wells Sampled: 25

Average Improvement Score: 5.7

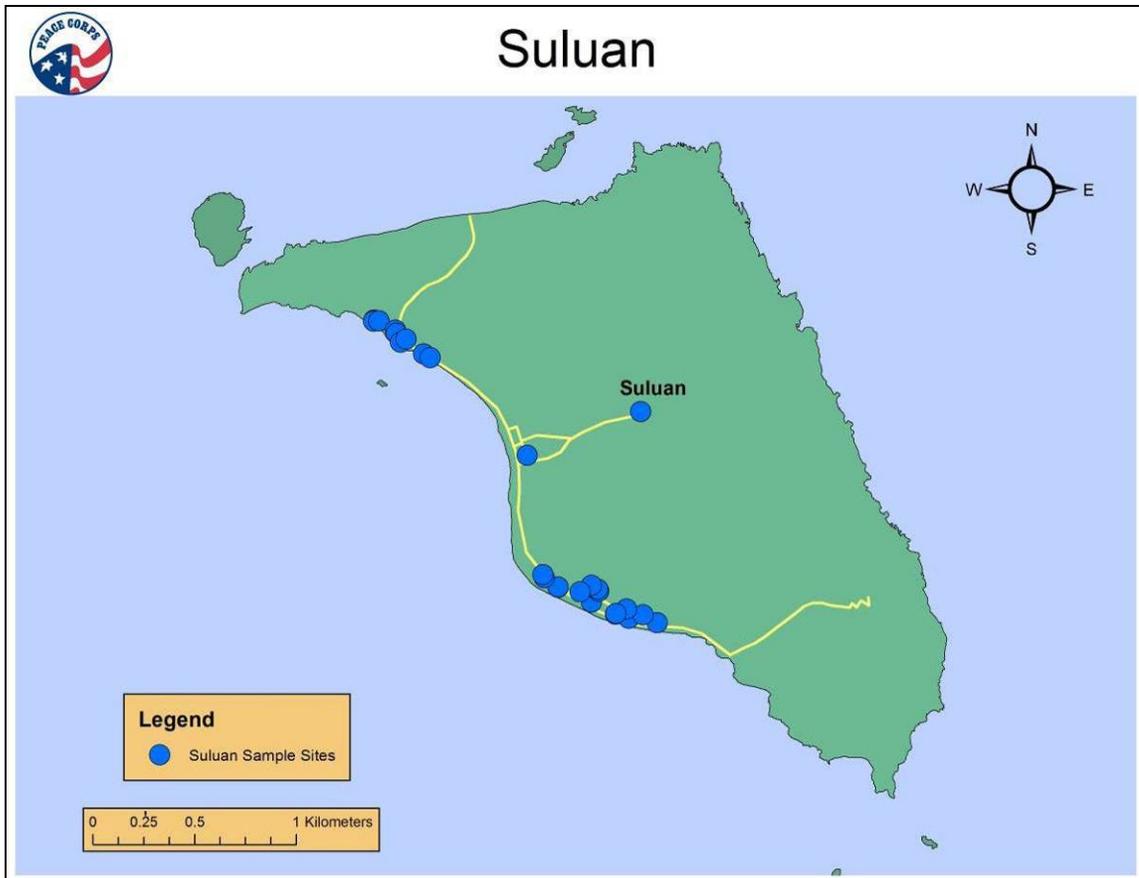
Number of Wells Sampled: 23

Average Improvement Score: N/A

Suluan has a BWS applying spring capture upland a short way from the population center, with apparently abundant piped water throughout the population center. The elevation of the supply is not that great, so pressure at the end of the runs is small. Residents have excavated pits to allow for more drop in flow. The Pipe extends to the edges of the rural areas. Since time on the island was limited, only the wells in the rural areas were surveyed. There is a large tidal effect on the wells and salt intrusion is a problem.

Priorities: Extend BWS to all areas.
