# 2009

# Church Ditch Master Plan

#### Ecological Resource Consultants, Inc.

Church Ditch Water Authority

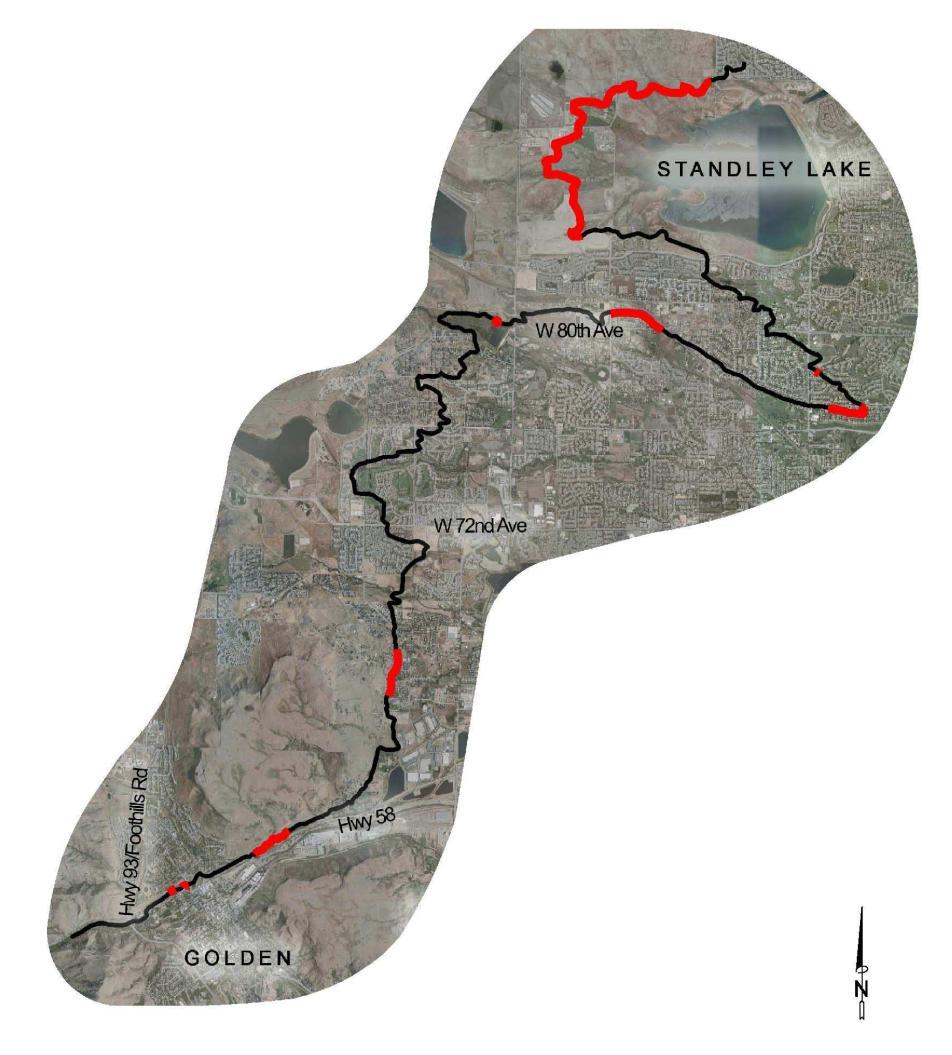
FIGURE 3 – LOCATIONS OF CAPACITY CONCERNS

Some areas along the Ditch may not have adequate capacity to effectively pass the design flows with the required two feet of freeboard. This issue may stem from sediment building up in the channel, areas where the cross section and slope of the channel are not adequate, a culvert or crossing that is not adequately sized or low ditch banks. As part of this analysis, Flowmaster models were created by ERC to analyze the hydraulic capacity in specific areas along the Ditch where capacity concerns exist. The areas analyzed were areas identified by the CDWA. A design flow of 125-cfs and an assumed slope of 0.1% was used for culverts and crossings in the analysis. Locations of capacity concerns that were evaluated as part of this study are found in Figure 3.

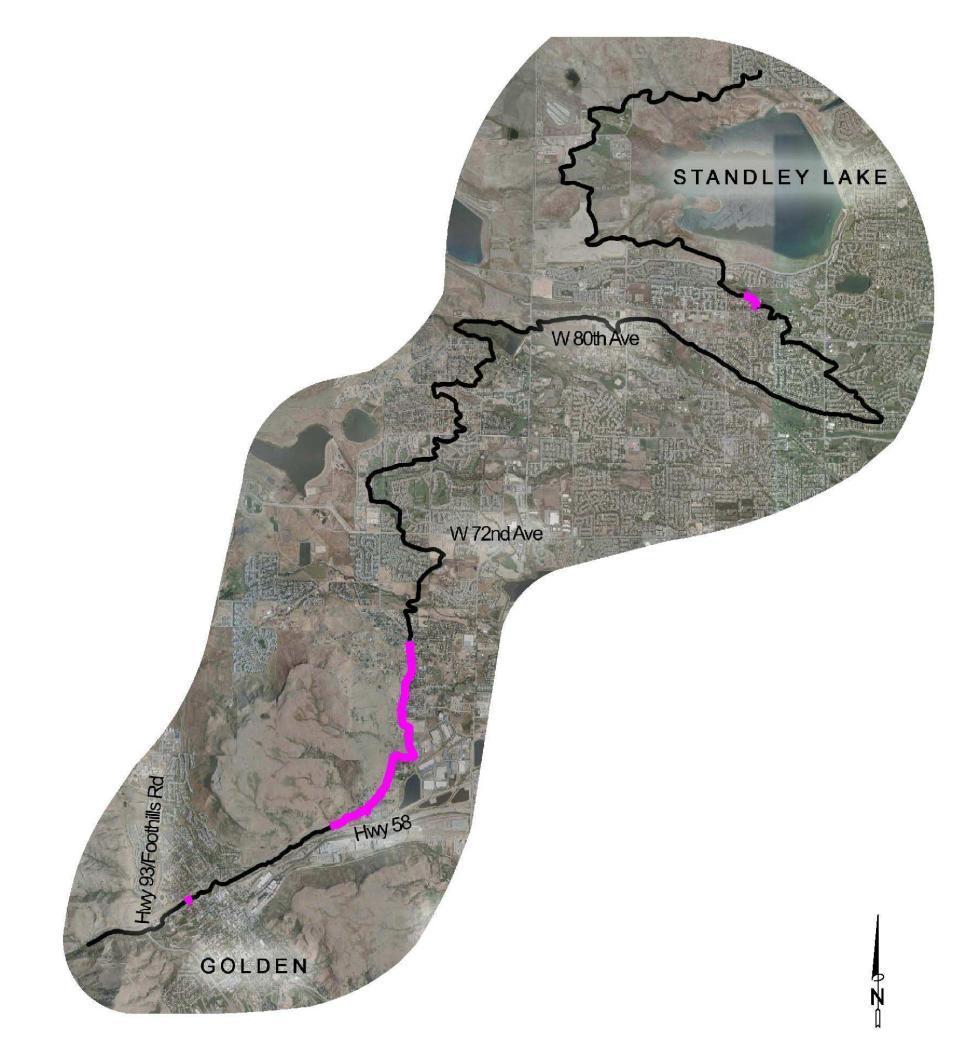
FIGURE 4 – LOCATIONS OF SEEPAGE CONCERNS

Areas with seepage concerns have primarily been identified by property owners located down gradient from the Ditch. The amount of water seen by these owners ranges from small amounts when digging holes to more consistent flows. Seepage is a concern not only because it may cause damage to private property but also because it decreases the amount of flow in the Ditch. It may also reduce stability or potentially undermine structures within the Ditch. Locations where seepage may be a cause for concern based on observations and the history of landowner complaints can be found in Figure 4.

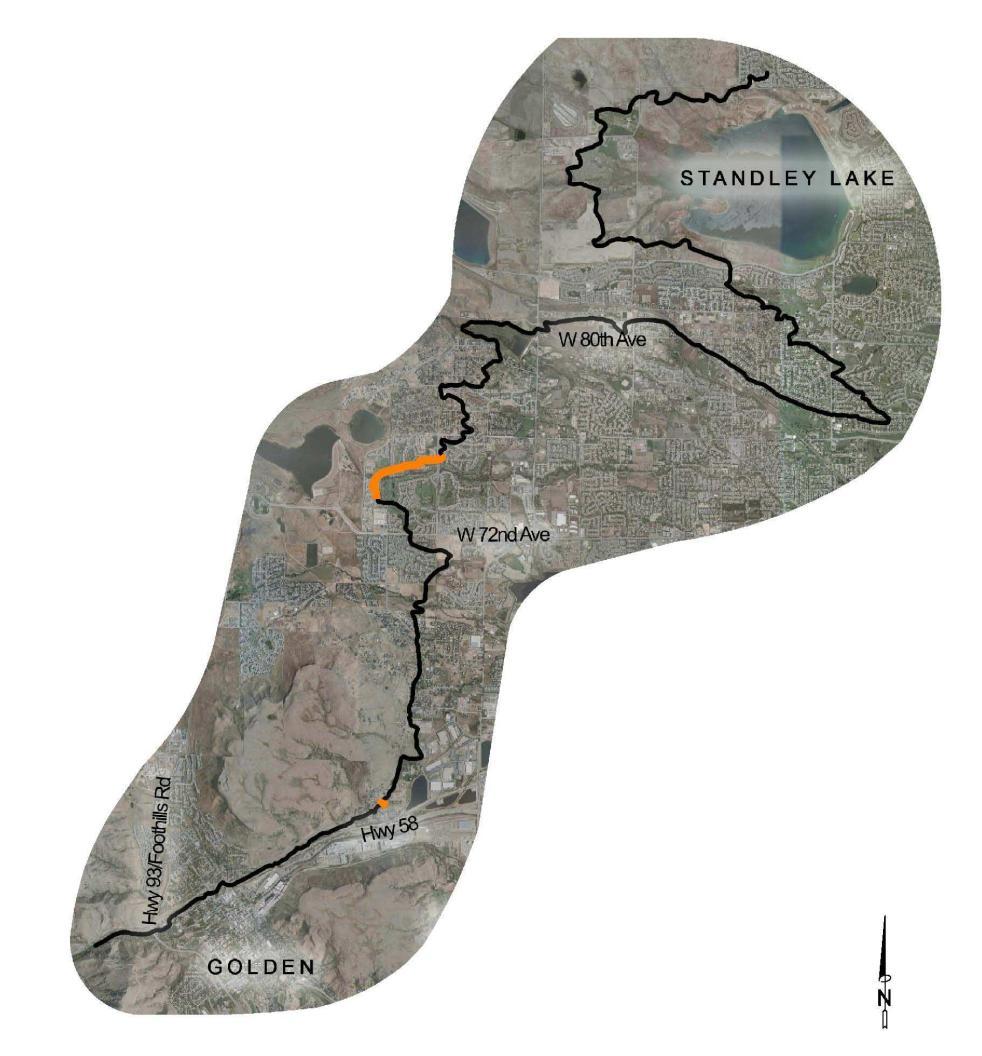
FIGURE 5 – LOCATIONS OF EROSION AND SEDIMENTATION CONCERNS

Erosion and sedimentation affect channel shape, capacity and water quality. Eroding banks can cause the ditch to widen, migrate laterally or create a new bend. An eroding channel bottom can create low points along the ditch and can alter the ditch's longitudinal slope and effect flow. The sediment from an eroding bank can settle along the bottom of the ditch and change the ditch's slope and capacity. Erosion and sedimentation can be found along many locations of the Ditch and range from minor surface erosion to undercutting. In some locations, the undercutting is stabilized by existing vegetation. Steep bank slopes are closely correlated with bank instability in severely eroded sections of the ditch.

New areas of bank instability may develop over time in sections that are not identified in this CDMP. Locations where erosion and sedimentation are occurring can be found in Figure 5.

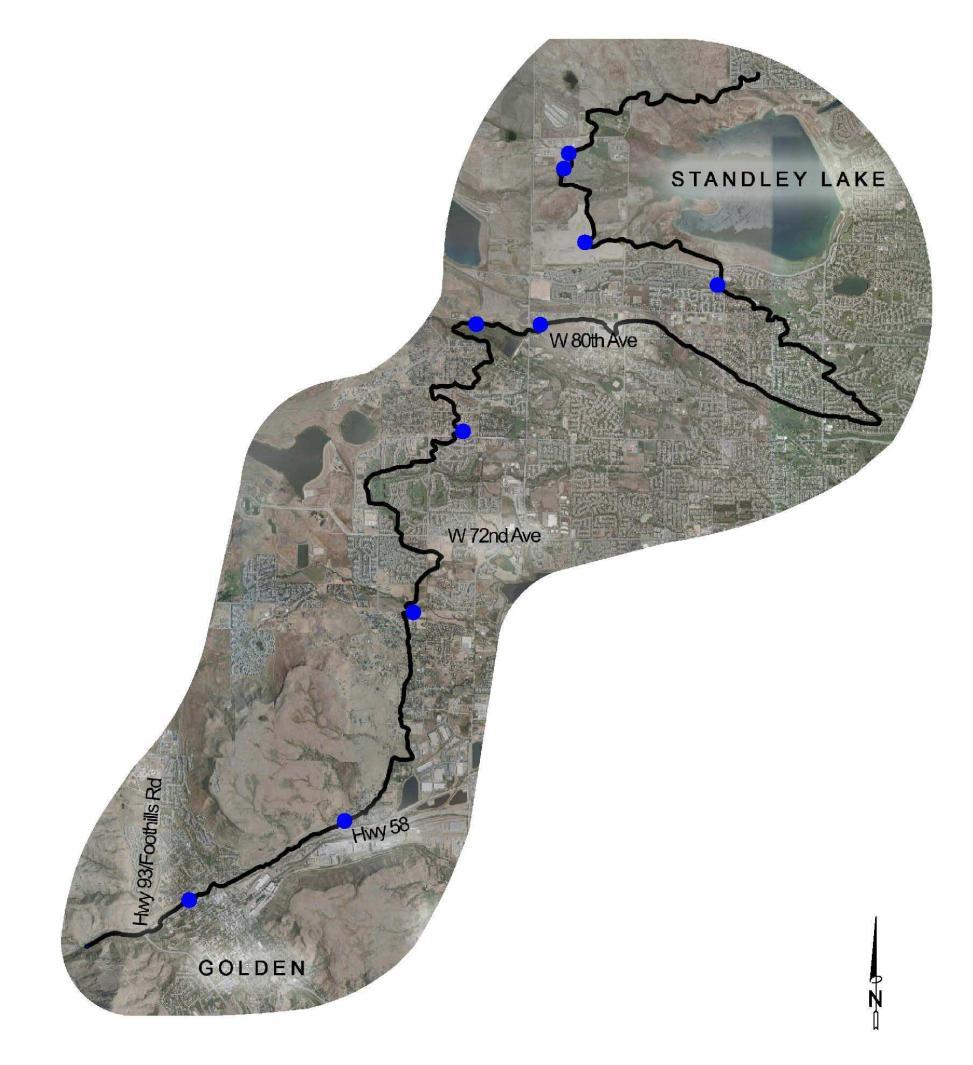
FIGURE 7 – LOCATIONS OF STORMWATER ENTRY POINTS

Stormwater enters the Church Ditch system at many points along the ditch. Stormwater may contain debris and trash that may create blockages in the Ditch and structures and may contain contaminants that decrease the water quality of the flow in the Ditch. Additionally, stormwater inflows add to the volume of flow carried in the Ditch and increase the potential for overtopping and flooding. Debris and trash in stormwater may also damage structures along the Ditch. Locations of stormwater entry points can be found in Figure 7.

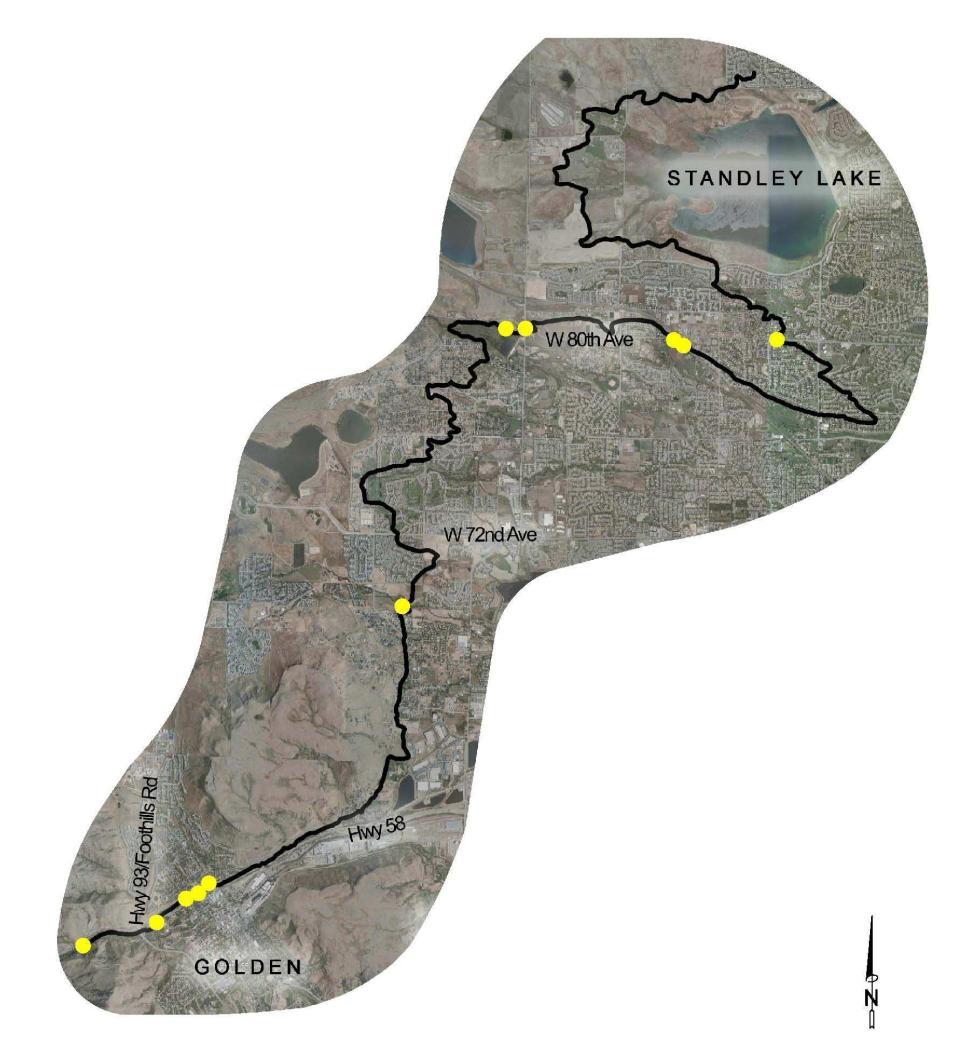
FIGURE 8 – LOCATIONS OF STRUCTURE CONCERNS

Concerns with the integrity of ditch structures exist in many areas along the Ditch. These concerns include leaking structures, structures needing repair or replacement and structures that may be causing a backwater condition. Structure concerns also occur in locations where the structure may not have the capacity to pass the flow adequately. Locations of structures that have issues can be found in Figure 8.

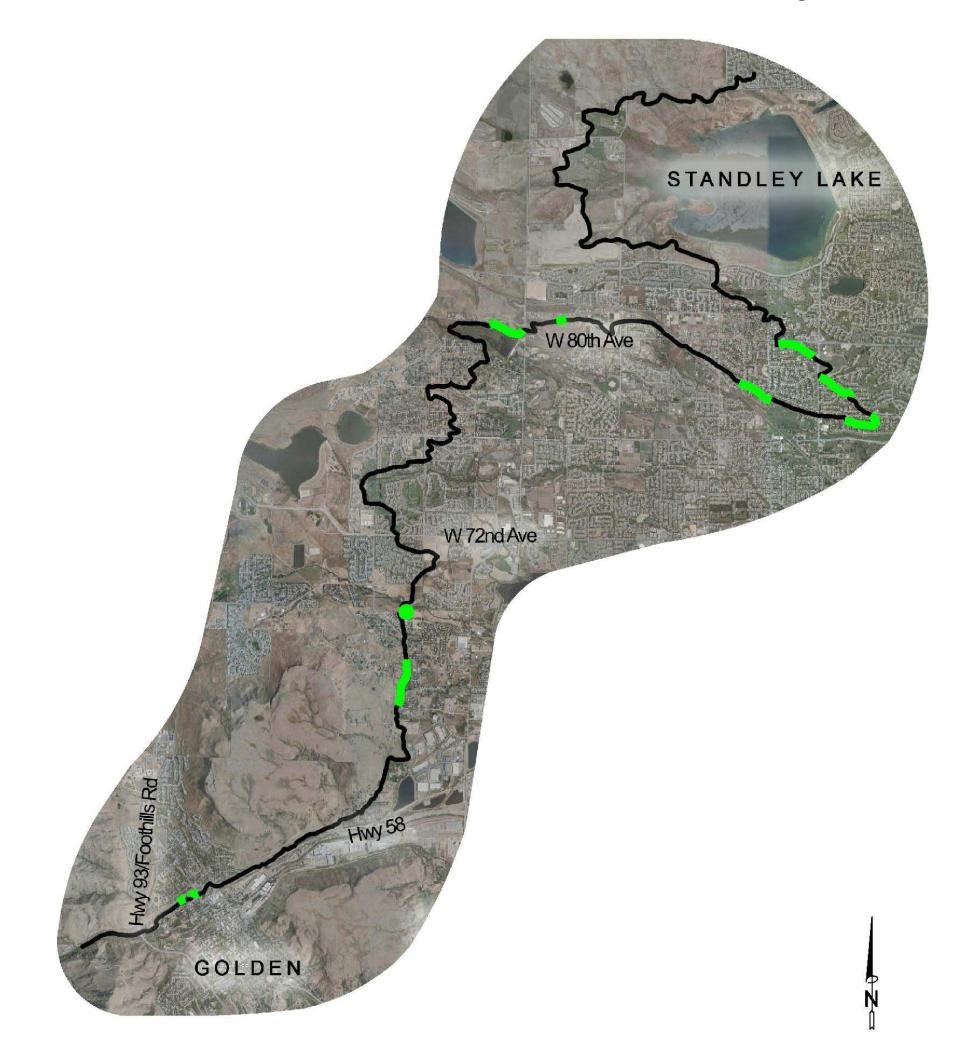
FIGURE 9 – AREAS WITH ACCESS CONCERNS

Adequate access to the Ditch is required for operations and maintenance and to protect the integrity of the Ditch. Along the project reach there are locations where access is currently not available. Access issues typically involve encroachment of private properties and structures precluding access roads or uncooperative land owners. Locations with access concerns can be found in Figure 9.

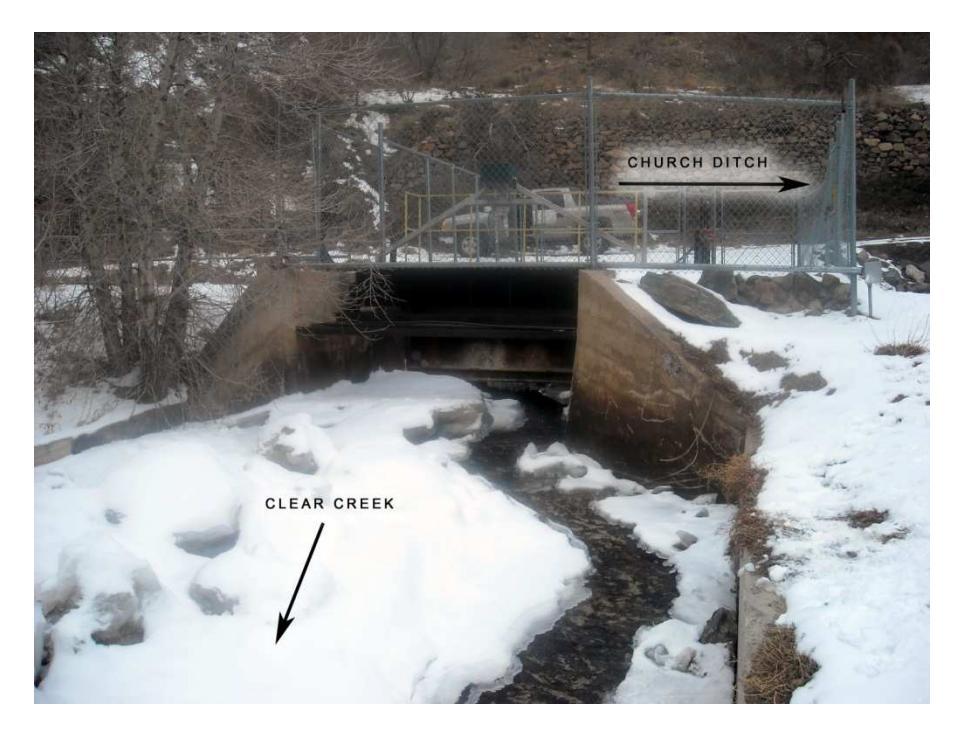
PHOTO 13 - DOWNDITCH SIDE OF THE CLEAR CREEK GATE

One additional gate that returns flow to Clear Creek is also located in this area. It is located upditch of the headworks and appears to be in good condition. The size of this gate could not be determined during the inspection due to inaccessibility.

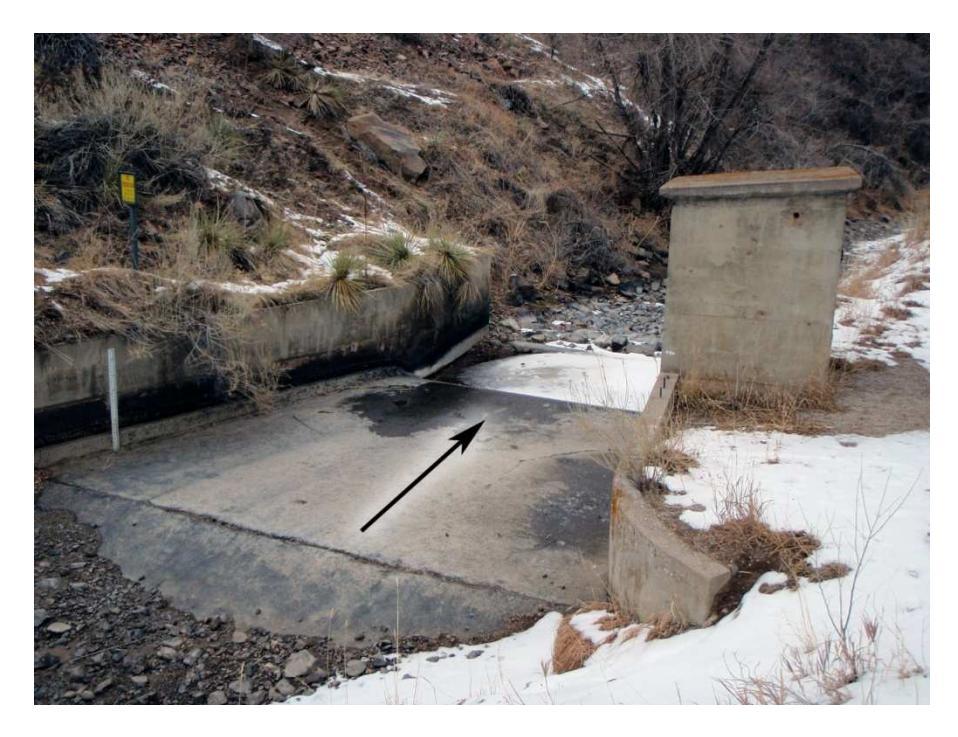
PHOTO 15 -MEASURING FLUME LOCATED DOWNDITCH OF THE CHURCH DITCH HEADWORKS

The measuring flume is in good working condition. There are no concerns regarding the flume.

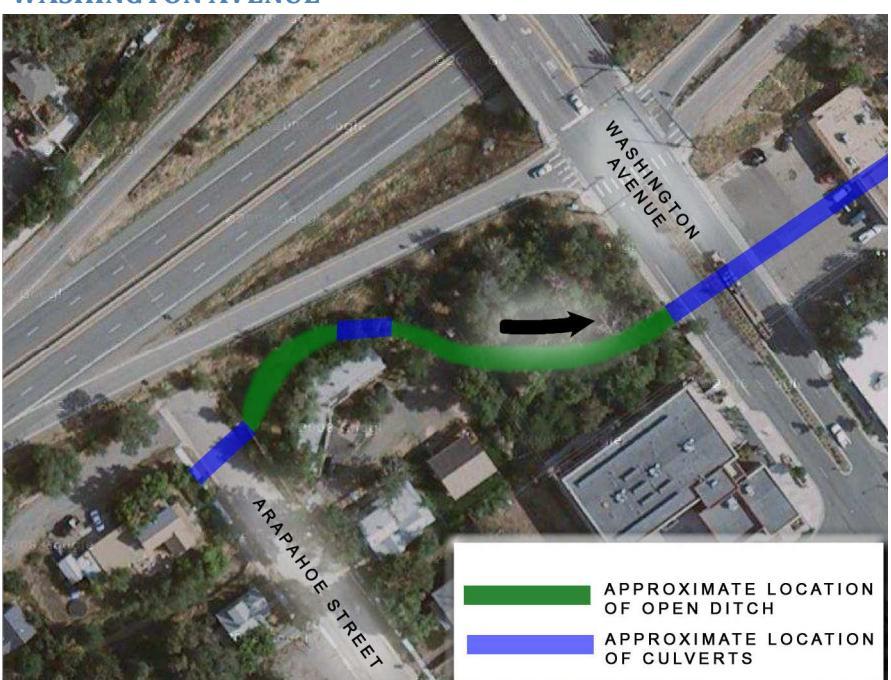
#### PHOTO 24 - SCHEMATIC OF AREA 8

Ditch capacity issues have been raised by the CDWA for this length of ditch. The area begins with a double 48" CMP culvert under Arapahoe Street. From here it enters an open ditch that is very close to

an existing dwelling on ditch right. It then enters a concrete box culvert (11'-8"x5' at its upditch end and 8' x 4'-7" at its downditch end). It then enters another open ditch section that is partially lined with stone before entering a 14'-5"x5' open span under Washington Avenue. The heavily vegetated banks combined with the ditch's close proximity to the adjacent roadway makes maintenance access very difficult. The extent of the seepage for this area has not been measured.

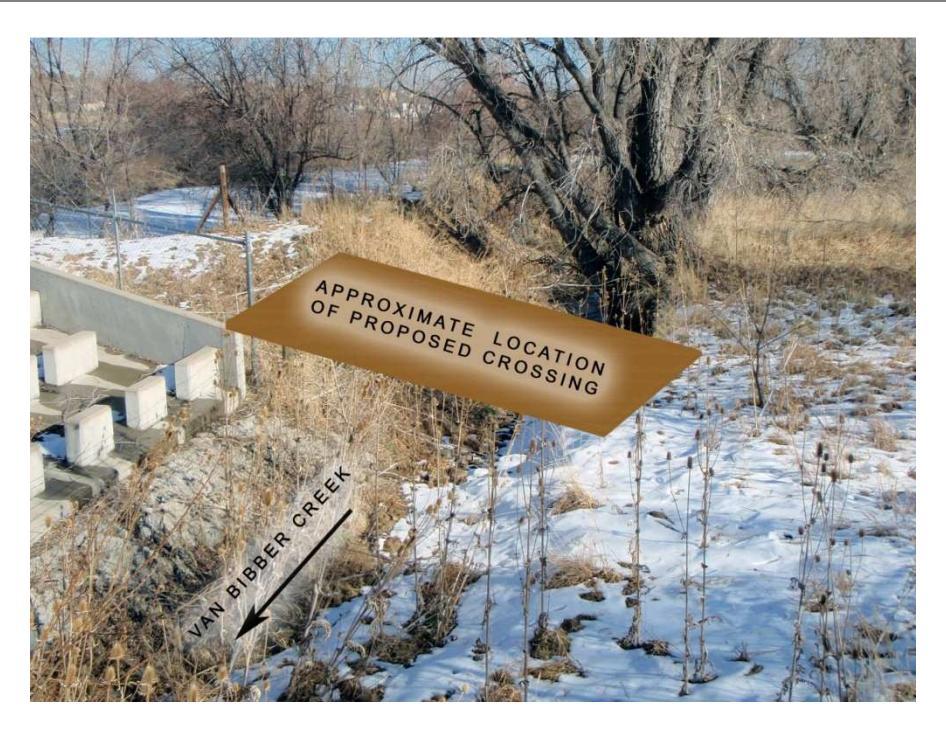
A road crossing over Van Bibber Creek that will connect two roadways that terminate at the creek is desired by the CDWA in this area. The roadway would be constructed adjacent to the emergency overflow structure located in this area. This area is located on private property indicating that approval from the property owner will be required prior to roadway construction.

PHOTO 36 – THE POPOSED LOCATION OF A ROADWAY CROSSING VAN BIBBER CREEK AND CONNECTING TWO EXISTING ROADWAYS
