CASE STUDY

RELIABILITY IMPROVEMENT PROJECT

MULTI-STAGE FABRICATED CENTRIFUGAL BLOWERS

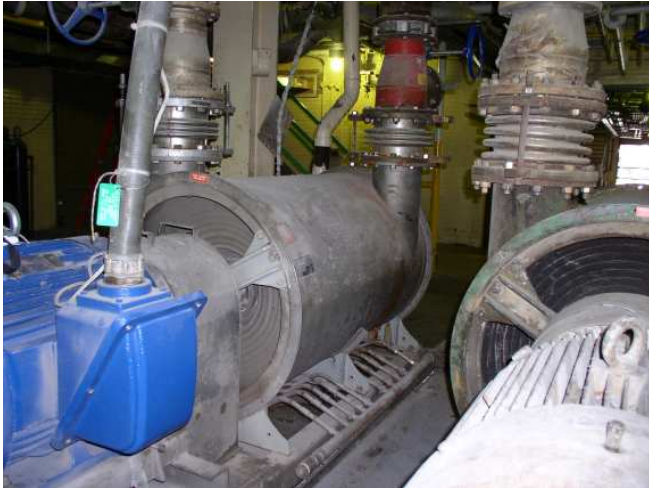
The blowers typically operated 12 to 18 months between failures rather than the expected five years. Bearing failures were the most common reported problem.

Figure 1. Photo of Multi-Stage Centrifugal Blowers.

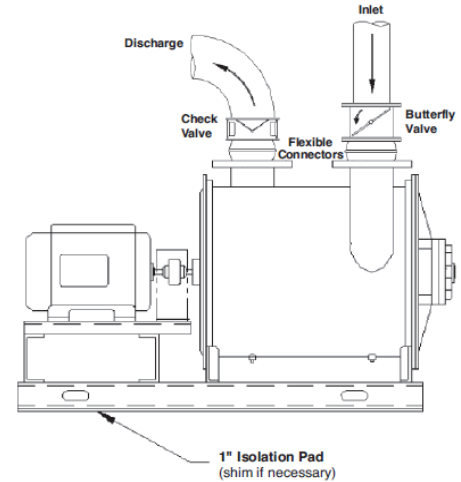
Figure 2. Showing Piping Connections and 1" Isolation Pad Under Skid.

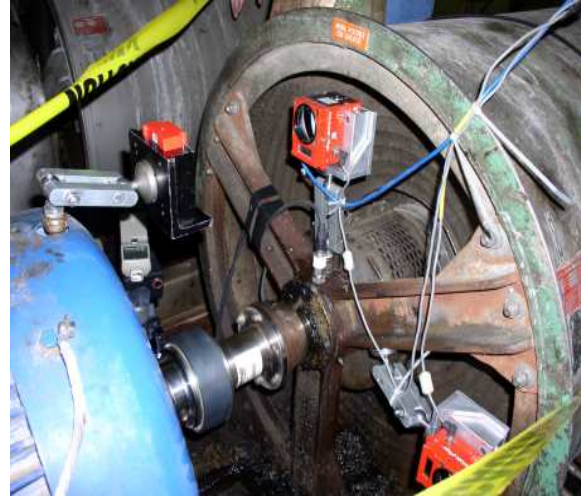
Continuous Vibration Acquisition: A multi-channel IOtech 618 Analyzer and eZ-Tomas rotating machinery software was used to measure vibration data from accelerometers magnetically attached to Blower DB19. The blower was started and had such high vibration levels that the optical tachometer and the Permalign laser alignment equipment, shown in **Figure 13**, vibrated out of position. The blower was shutdown and restarted a few minutes later. The blower ran for almost two hours and was shutdown. The blower was restarted about 40 minutes later and ran for about 2 ½ hours, see **Figure 14**.

Each startup and coastdown exhibited very high amplitude vibration at the shaft rotational frequency. A resonance or a blower rotor critical speed at 2400 RPM was indicated by the spin up vibration data. The radial vibration response at each blower bearing was in phase in both the horizontal and vertical directions which is in agreement with a rotor 1st mode or 1st critical speed, see the bode' plot in **Figure 15**, blower inboard bearing housing. However, the blower OEM indicated that the rotor critical was about 1600 RPM and our rotor-bearing model (developed later) calculated to about 1660 RPM. A between-bearing rotor rub acting as a third bearing was suspected. This would explain the rotor critical moving higher in frequency.

Figure 13. DB 19 With Laser Alignment and Vibration Sensors Attached.

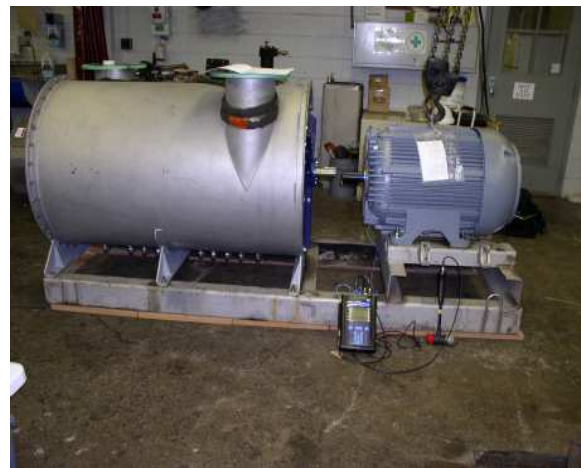
Modal Test of Blower & Motor Mounted on Skid: An experimental modal test was conducted on a blower and motor mounted to a skid in the maintenance shop, **Figure 18**. The skid was supported on 1" thick cork to simulate the installed condition. A medium sledge modal hammer and CSI two channel 2120 analyzer were used to acquire the data.

A very responsive natural frequency was identified by the test data frequency response functions (FRF) at 43.5 Hz ~ 2610 CPM. As shown in **Figure 20** the run speed frequency of the motor-blower was within the envelope of the natural frequency which would result in amplification of

Figure 18: Blower & Skid Supported on Cork in the Maintenance Shop During Modal Test.

Stiffening of the skid was recommended by welding 1/4" plate about 55" long to the inside of both frame rails at the motor end, as shown in **Figure 21**. The intent was to box the frame rails increasing the moment of inertia in the Z axis (vertical direction). It was hoped that this would stiffen the rails enough to raise the natural frequency well above the running speed frequency. Plates welded on top of the rails in the locations shown would further

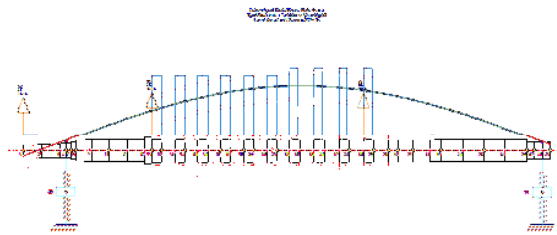
The rotor bearing 1st critical speed calculated to 1660 RPM, see **Figure 24**. Potential energy distribution, **Figure 25**, showed that the stiffness of the shaft was primarily controlling response at the 1st mode. The bearings calculated to have less than 1% of the potential energy which is well below the 20% recommended by Dr Gunter.^{Ref 2} This meant that the bearings would not contribute to the overall system damping; the rotor would be very sensitive to unbalance and high vibration at the 1st critical would expected.

Figure 24. Rotor 1st Mode. Nodal Points are About 4' Outside Each Bearing.

Mode No = 1, Critical Speed = 1660 rpm = 27.67 Hz
 Potential Energy Distribution (s/w=1)
 Overall: Shaft(S)= 78.10%, Bearing(Brg)= 1.68%, Support(F)= 20.22%

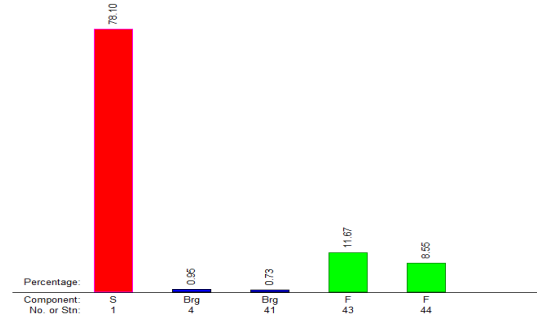
Figure 25. Potential Energy Distribution Showing Most Energy in the Shaft but the

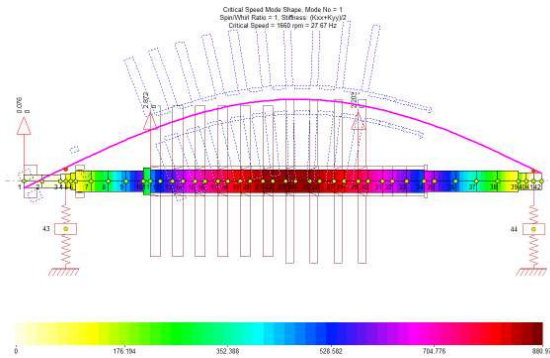
Maximum dynamic stress in bending at the 1st critical calculated to 881 psi, **Figure 26**, which was not a concern. The nodal points of the 1st mode were located approximately 4 inches outside each bearing.

Figure 26. Maximum Dynamic Stress in Bending at 1st Mode Calculated to 881 psi.

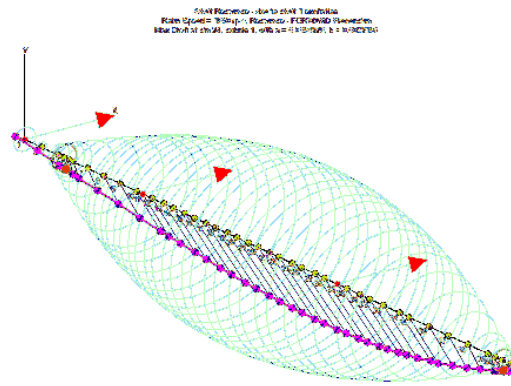
In **Figure 27**, is a 3D plot of the rotor response at the 1st mode to unbalance of 2.872 oz-in (G 6.3) in Impeller 10 and 2.203 oz-in in Impeller 1. Maximum shaft displacement mid-span for this unbalance calculated to about 11 mils p-p. The unbalance force at the bearings calculated to 184 lb_f at the drive end bearing and 157 lb_f at the opposite drive end bearing.

A rule of thumb for flexible rotor design is the 10:1 rule, i.e., the shaft diameter should not be less than 1/10 the bearing span. This design calculated to just over 20:1 which explains the high response at the 1st critical speed since the stiffness of the shaft, which is low due to the long span, offers the primary resistance to the unbalance force.

Figure 27: Rotor Response at 1st Critical to G 6.3 Unbalance in the 1st and 10th Stage Impellers. Maximum Orbit Mid-Span Calculated to About 11 mils pp.

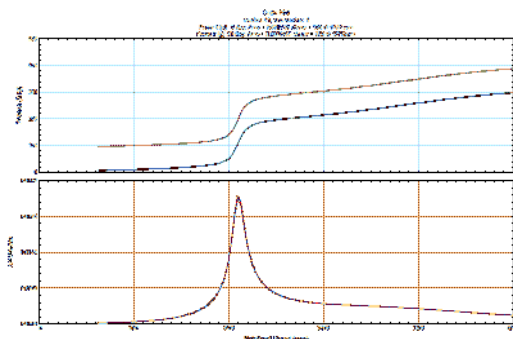
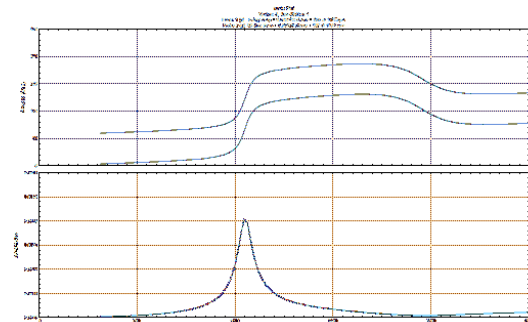
The damped unbalance response at the bearings for G6.3 unbalance in the 1st and 10th stage impellers is plotted in Bode' format in **Figures 28 & 29**.

Figure 28. Bode' Plot of Damped Unbalanced Response at the Opposite Drive End Bearing to G6.3 Unbalance in 1st and 10th Stage Impellers.

Figure 29. Bode' Plot of Damped Unbalanced Response at the Drive End Bearing to G6.3 Unbalance in 1st and 10th Stage Impellers.

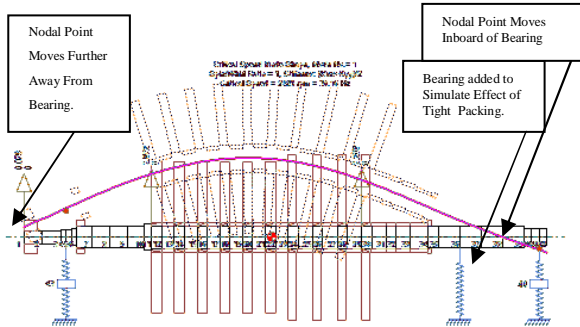
Figure 30. Spencer Blower Rotor Model with Bearing Added at the Packing Location to Simulate the Stiffening Effect of the Packing.

A third bearing was added to the DyRoBeS model at the packing location, station 36. The packing location was the only location identified at disassembly where significant contact with the shaft by a non-rotating component had occurred. Trying different values of stiffness it was found that 200,000 lb_f/in at the packing location calculated to raise the critical to about 2289 RPM as shown in **Figure 30**. Note that the mode nodal point then moves inboard of the opposite drive end bearing while the nodal point moves further away from the drive end bearing. Therefore, higher vibration would be expected at the drive end bearing (which was measured) than at the outboard bearing housing.

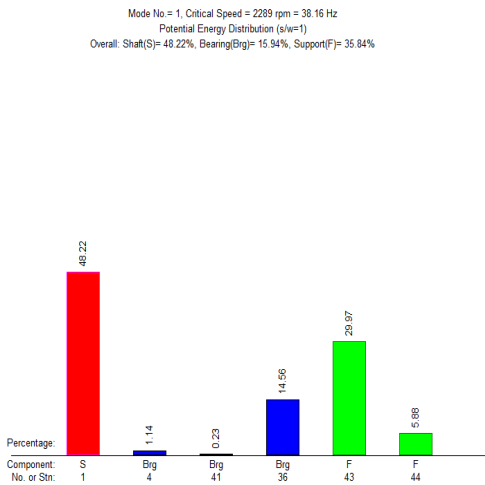
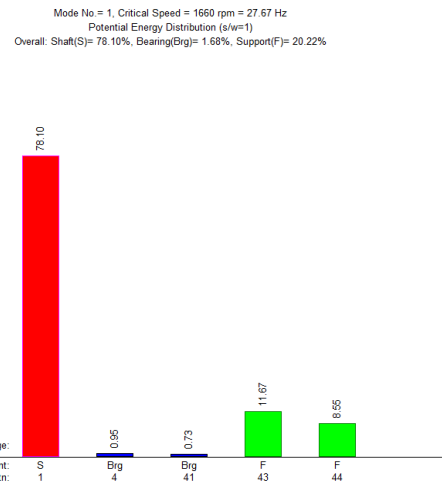
Strain energy distribution is shown in **Figure 31 & 32** with and without the packing acting as a bearing. The model predicted that the packing would see significant strain energy and also an increase in strain energy at the inboard bearing housing. This is in agreement with the vibration data which measured very high response at the inboard bearing housing.

Figure 31. Comparison of Strain Energy Distribution With Packing Acting as a Bearing.

Figure 32. Comparison of Strain Energy Distribution Without Packing Acting as a Bearing.

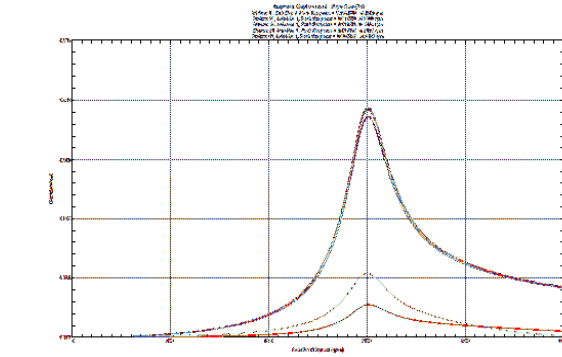
The damped unbalanced response at the bearings and mid-span of the rotor with the packing preload is shown in the overlaid plot in **Figure 33**. The maximum displacement at the mid-span stations calculated to about 11.5 mil pp at stations 22-24 at 2400 RPM.

Figure 33. Damped Unbalanced Response for Several Locations With Packing Rub Affect.

Based on the results of the rotor-bearing models, very careful attention to rotor machining tolerances, assembly and balancing would be required to achieve acceptable vibration levels through the critical speed region. The design uses a metal-to-metal interference fit of the impeller hubs to the shaft. After the rotor is balanced, it is disassembled. Then the rotor must be reassembled in the case and there is no opportunity to test or change the balance as each impeller is reinstalled on the shaft.

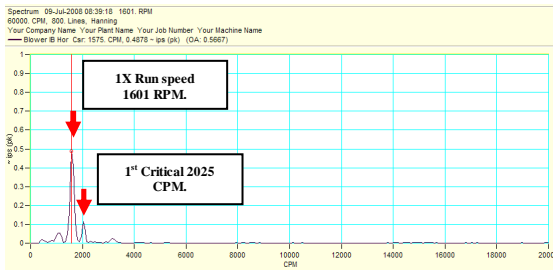
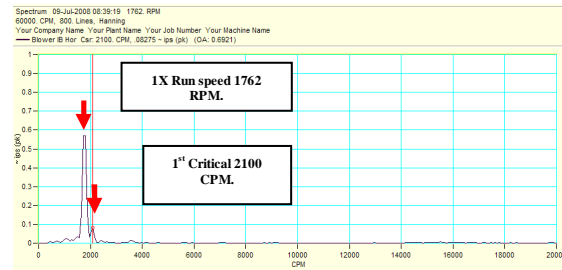
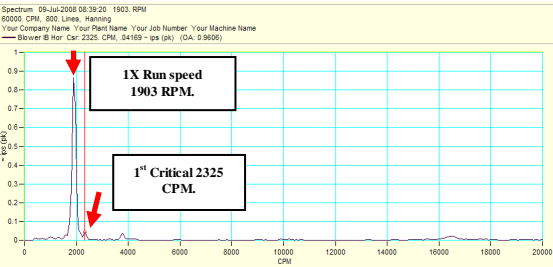
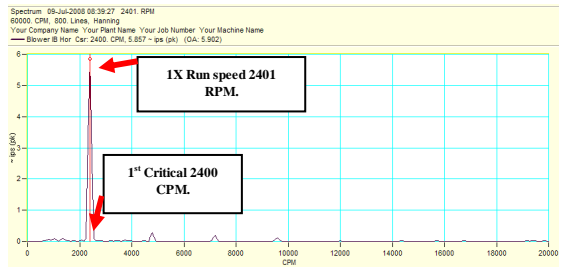
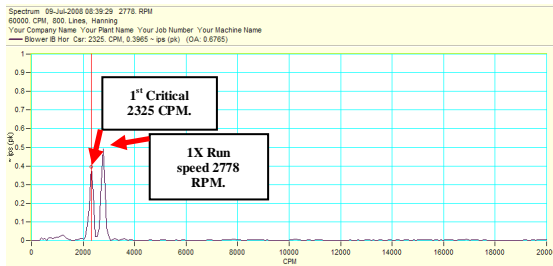
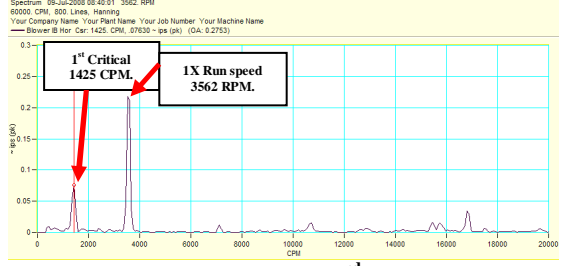
Frequency spectra are plotted in **Figures 34-A thru 34-F** that were measured on the Inboard Bearing Housing, Horizontal, during the 3rd startup of Blower DB 19. The spectra show the 1st critical shifting higher in frequency as the rotor bows out and rubs against the packing harder. Once the rotor is at speed and well above the rub affected critical, the 1st critical dropped to about 1425 CPM. This is lower than the calculated frequency of 1675 CPM. However, it was learned when the blower was disassembled that the shaft bearing fits were undersize and the bearing housing bores oversize. These increased clearances would lower the support stiffness thus lowering the 1st critical speed about 250 CPM from “as new” condition.

Figure 34-A. Blower DB 19, 3rd Startup, Frequency Spectrum at 1601 RPM.

Figure 34-B. Blower DB 19, 3rd Startup, Frequency Spectrum at 1762 RPM.

Figure 34-C. Blower DB 19, 3rd Startup, Frequency Spectrum at 1903 RPM.

Figure 34-D. Blower DB 19, 3rd Startup, Frequency Spectrum at 2401 RPM.

Figure 34-E. Blower DB 19, 3rd Startup, Frequency Spectrum at 2778 RPM.

Figure 34-F. Blower DB 19, 3rd Startup, Frequency Spectrum at 3562 RPM.

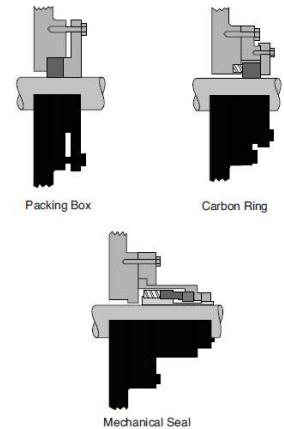
Shaft Seals: Three seal options were offered by the blower OEM, 1) Packing Box, 2) Carbon Ring and 3) Mechanical Seal, **Figure 35**.

The packing box is the lowest cost but the packing rubbing the shaft causes heat, thermal bowing of the shaft and as calculations and vibration data indicated can shift the rotor critical speed much higher. Up to 30 mils shaft wear is allowed at the packing location per the blower OEM's manual. Packing was used on the six blowers in this analysis.

Figure 35. Seal Options Offered by Blower OEM.

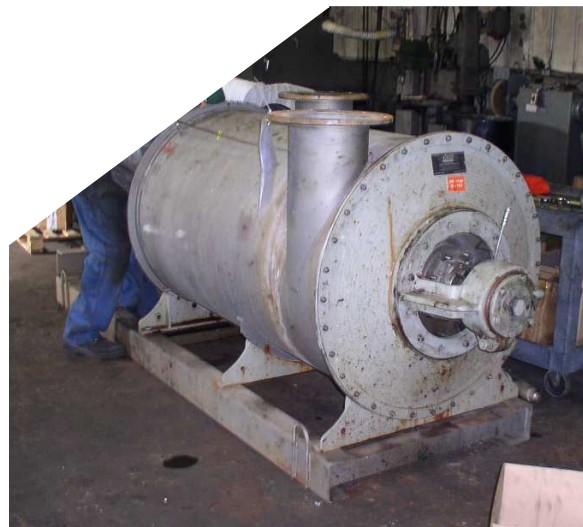
The blower as received at the service center is shown in **Figure 40**. During disassembly, the 1st stage impeller is shown in **Figure 42**, before removal from the shaft.

Figure 40. Blower DB 19 As Received at Factory Authorized Repair Facility.

Blower DB 19 Repair: DB 19 Blower was shipped to a Factory Authorized Service Center for disassembly, inspection, repairs, balancing, reassembly and run test. This process was witnessed by one of the authors.

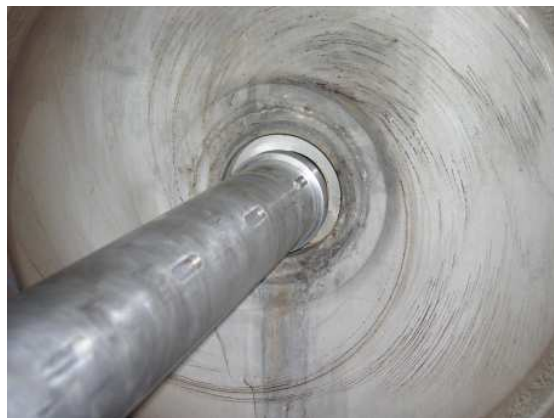
Keys were machined in an alternating manner on both sides of the shaft, see **Figure 44**. The keys in the shaft transferred torque to the impeller hubs.

Figure 44. Shaft Keyways Machined in Alternating Arrangement. Keys Transfer Torque to the Impeller Hubs.

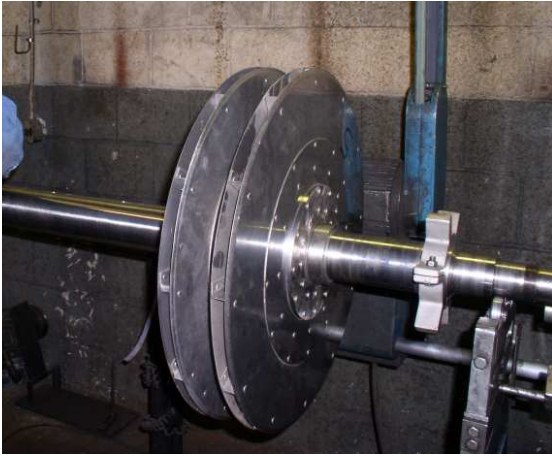
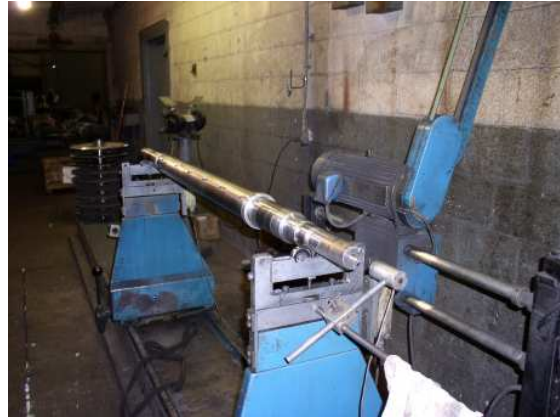
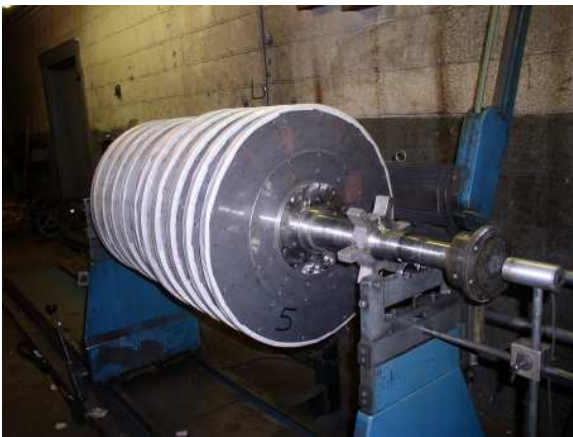
Figure 45. Impellers Being Installed on Shaft.

Figure 46. Bare Shaft in Balancing Machine. Impellers Are Stacked at the End of the Balance Machine.

Figure 47. Rotor Stacked, Impellers Taped For Wind Resistance For Balancing.

the rotor being stacked for balancing and final rotor assembly on the balance machine is shown in **Figures 45-47**.
