ECO-HYDROLOGICAL ANALYSIS & RESTORATION PLANNING

SOMERS BRANCH OF THE PIKE RIVER

March, 2014

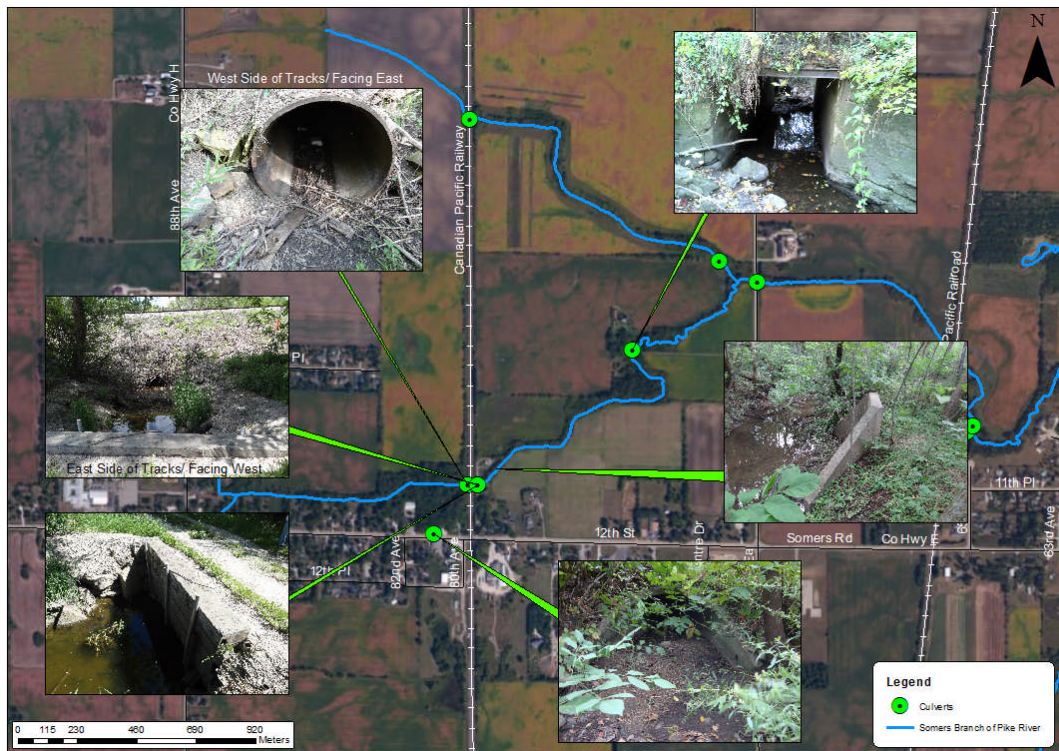
Figure 15- Stream Crossings and Culverts on Somers Branch near Canadian Pacific RR

The culverts underneath the Canadian Pacific Railway and the road to the Town of Somers maintenance garage (Figure 15) do not impede fish movement, but are significantly undersized for passing water during storm events. This is discussed in more detail below under hydrology. The large culvert under Hwy EA (Figure 16) appears of sufficient size to pass flood flows, but erosion on the downstream end has created a vertical barrier of nearly 20 inches from the streambed to the culvert bottom. The culverts
