1623 Carol Street  
Downers Grove, Illinois 60515  
Inspection Report for Property at:

Private Home Inspection for:

## 2 – General Information

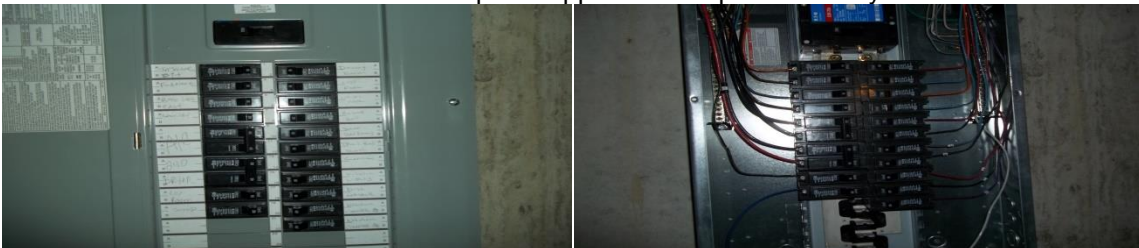
*Electrical Comments:* The main panel appears to be professionally installed.

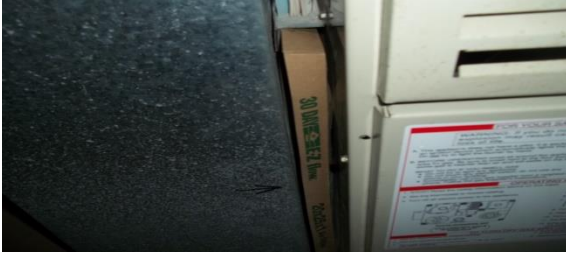
*Comments:* The furnace is a higher efficiency type equipped with induced draft and electronic ignition. Before each winter, clean humidifier and replace element as necessary. Remember to close humidifier damper during summer. The humidifier water supply valve is a pipe clamp type. These are known to fail. A regular plumbing shutoff valve is required.
