## **RESERVE STUDY**

**SPYGLASS LANDING CONDOMINIUM**

**MARSHFIELD, MASSACHUSETTS**

| DATE: | November 2016 |

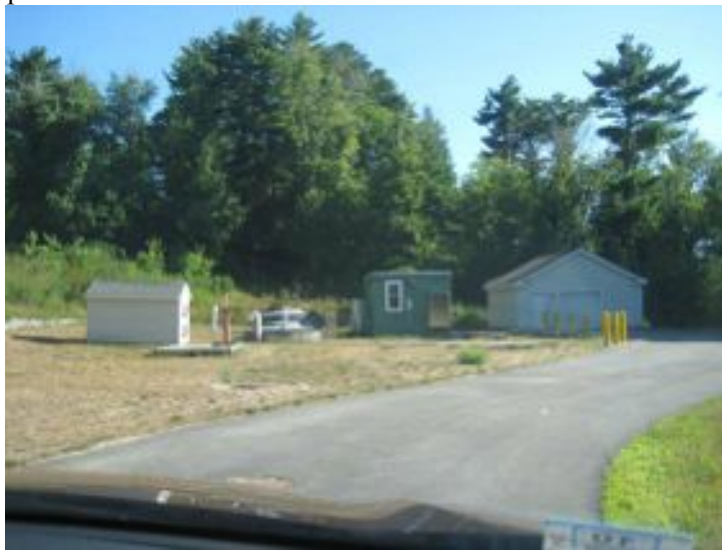
Wastewater Treatment Building & under ground Tanks

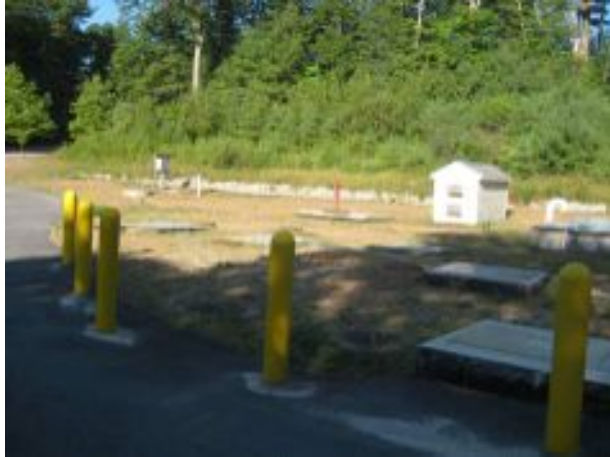
Underground tanks

The perimeter drain in place around the treatment plant site, the existence of impervious layers and the visual appearance of some infiltration in the tank seams, suggests that close attention should be of importance and that repairs of leaks be completed before they become large and impact the daily flow or the treatment process itself.

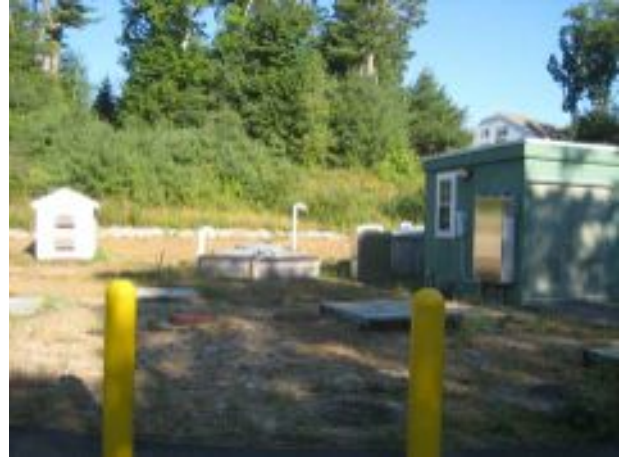
Bioclere units and Control building

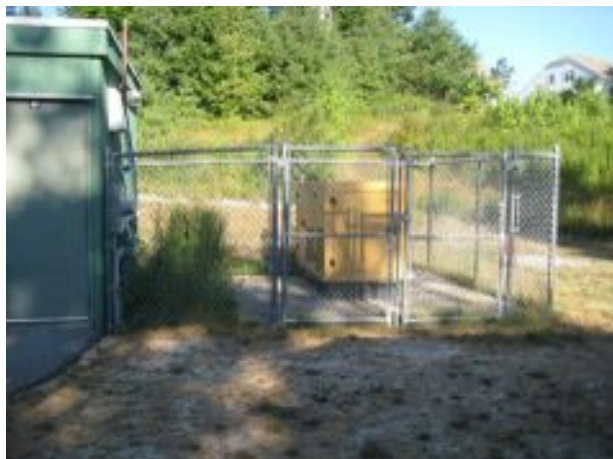
Back-up Generator: The existing generator provides back-up power, via an automatic transfer switch. Weston and Sampson Operations is responsible for its maintenance and exercising.

Back-up Generator
