TALON
Home Inspections

Inspection Report

Property Address:
4100 Mangini Street
Lexington KY 40509

Date: 9/15/2017	Time: 10:00 AM till 02:30 PM	Report ID: 170915BISHOP
Property: 4100 Mangini Street Lexington KY 40509	Customer: Ms. Amy Bishop	Real Estate Professional:

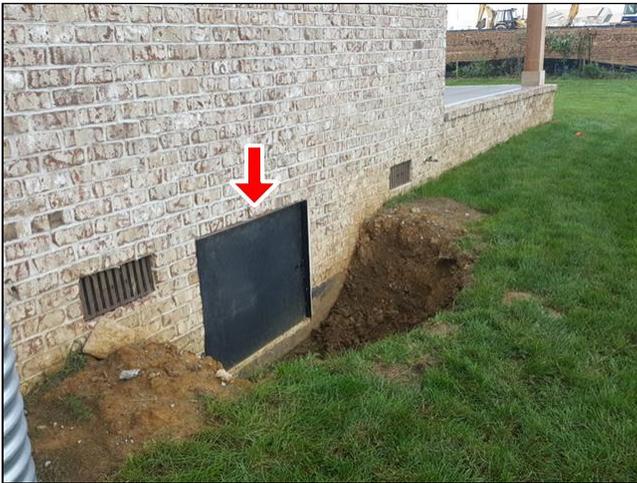
1.0 Item 1(Picture)

1.0 (1) Access to the crawlspace is located at the right side of the home.

1.0 (2) For safety, recommend a lock be installed on the crawlspace access door to prevent a child entering which could result in a injury or death occurring.

1.0 (3) The access door to the crawlspace is missing a window well. Water may enter which can lead to crawlspace leakage resulting in mold or mildew to form. Recommend one be installed by a general contractor prior to moving in as needed.

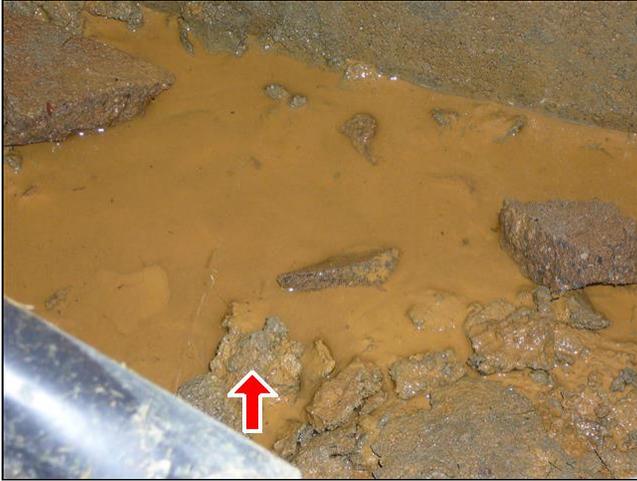
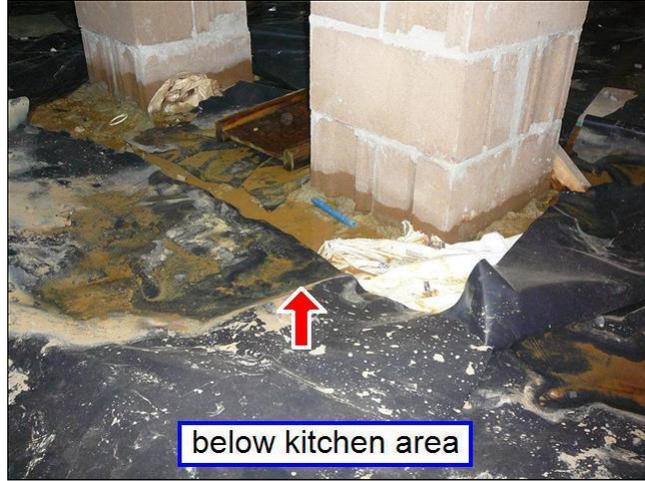
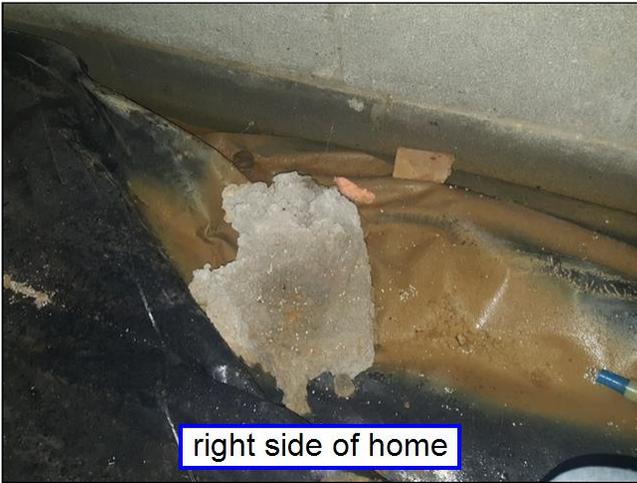
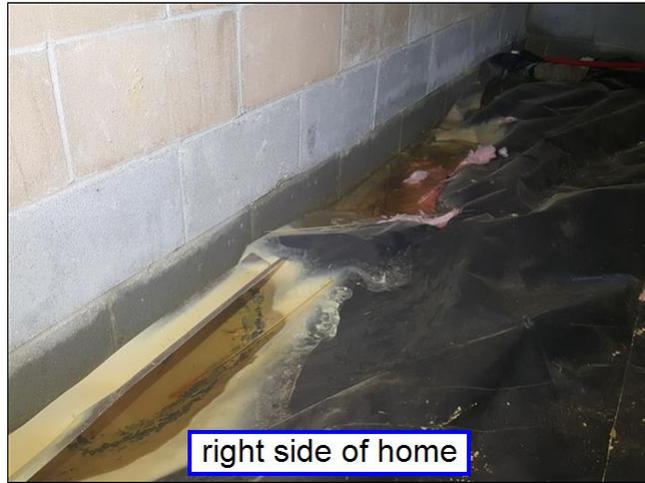
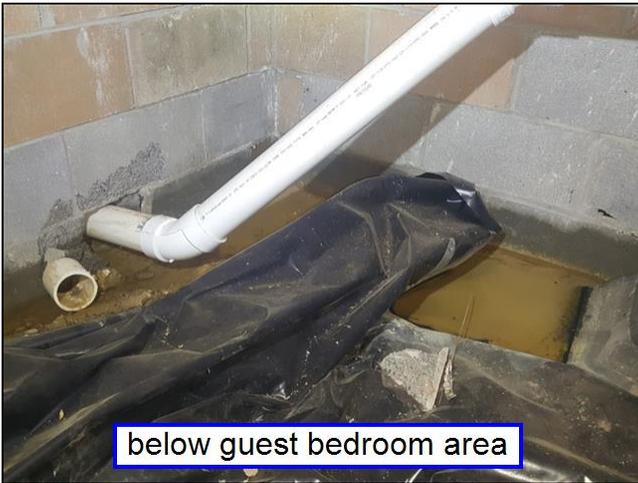
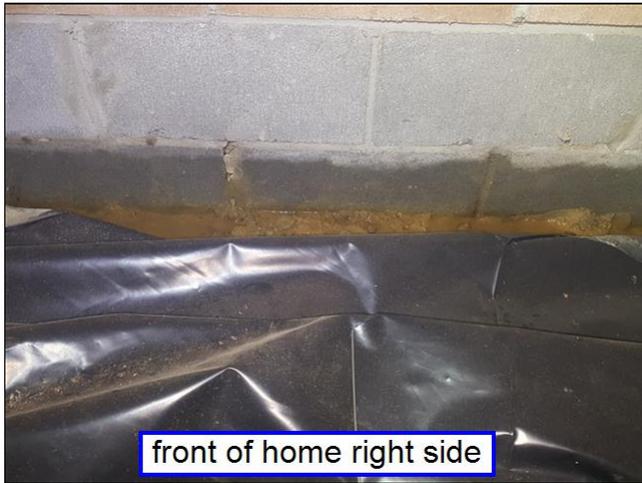
1.1 Standing water was observed in the crawlspace along the foundation walls around the perimeter of the home and under the kitchen area in the crawlspace at the time of the inspection. Wet crawl spaces risk building damage from rot, insects and can cause mold or mildew. Water intrusion if not corrected can lead to other problems including mold and cause excessive moisture to floor system that can lead to deterioration and increased repair cost. I am unable to determine the extent of intrusion or how often it occurs. A sump pump and drainage system could be installed or other methods maybe needed to correct intrusion. Recommend further investigation by a qualified licensed contractor to determine cause and remedy to eliminate water standing along the foundation walls in the crawlspace. Roof and Lot drainage repairs or improvements should be addressed as a first step to controlling water in the crawlspace.

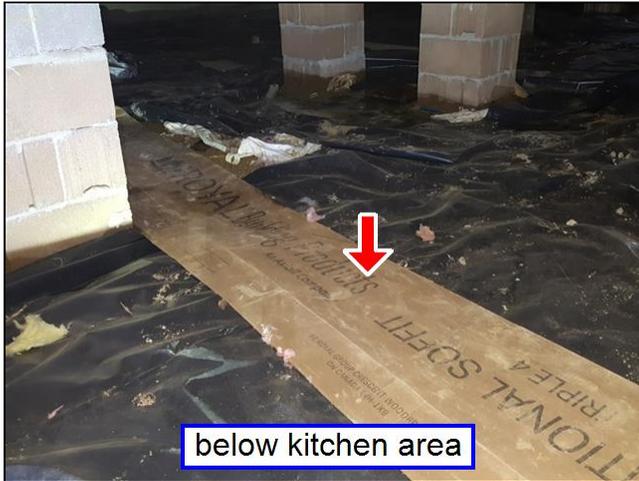
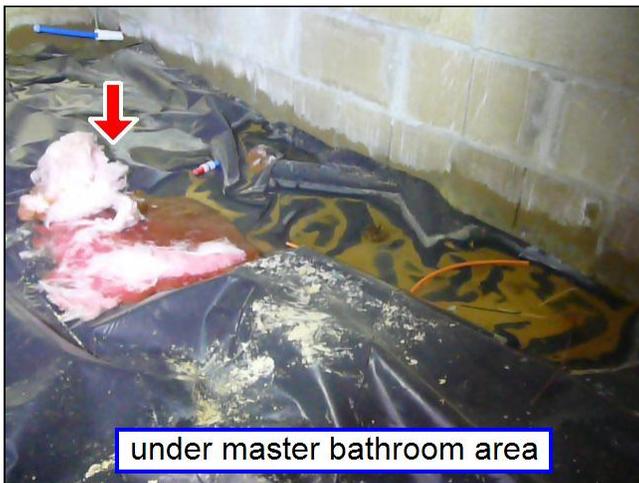
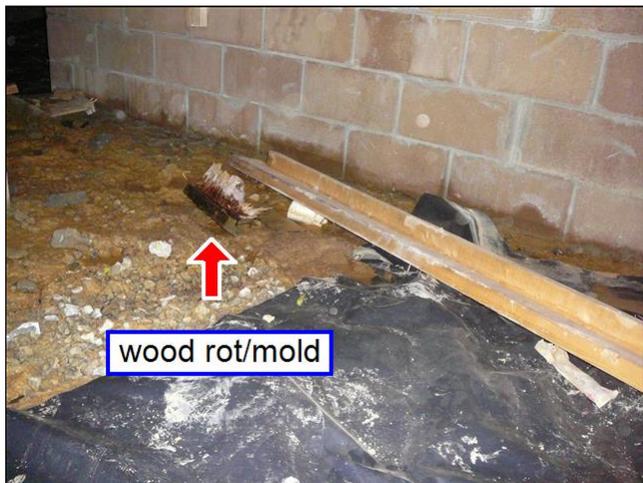
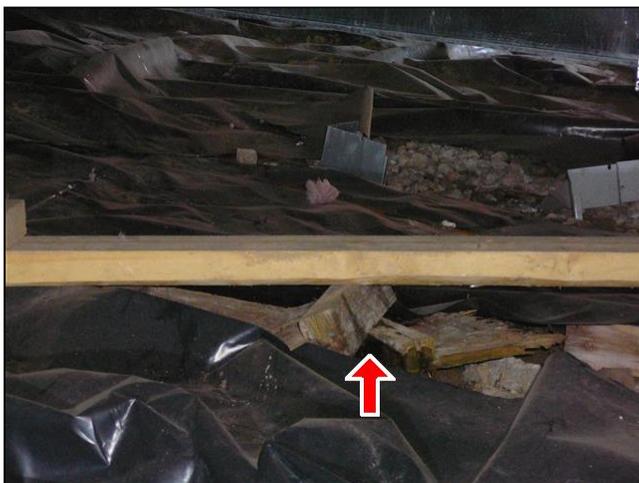
1.2 (1) All wood, cardboard, insulation and unused building materials should be removed from the crawlspace floor. The insulation will hold moisture creating condensation and possible mold growth on the wooden structure in the crawlspace. Wood debris risks rotting and can attract wood eating insects into the crawlspace which can lead to more costly repairs later. Recommend all types of debris resting on the crawlspace floor be removed to prevent damage to the wood structure of the home.

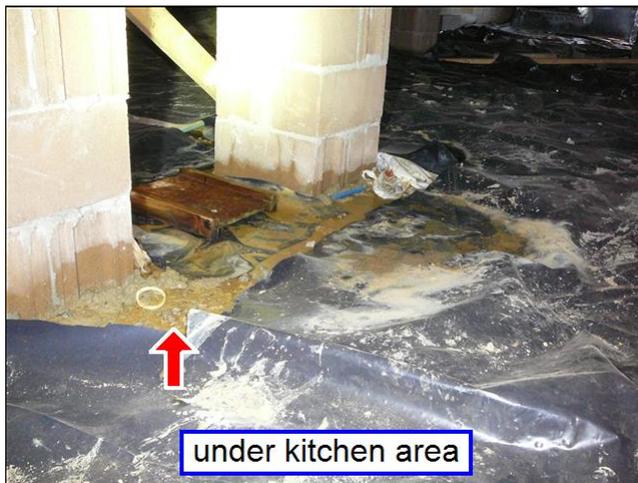
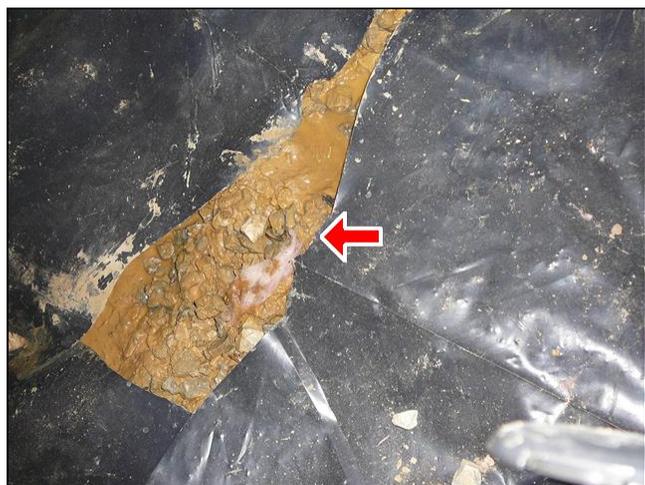
1.2 (2) There are some gaps in the coverage of the crawl space floor. A plastic vapour barrier should be installed in the missing areas and needs to be a minimum of 9mil thick in Kentucky (recommend using 15 or 20 mil) Recommend adding additional vapour barrier cover where needed to cover entire crawlspace floor to prevent excessive moisture entering which can lead to mold and deterioration of the floor structure and insulation in the crawl space. Recommend correcting and replacement using a qualified contractor.

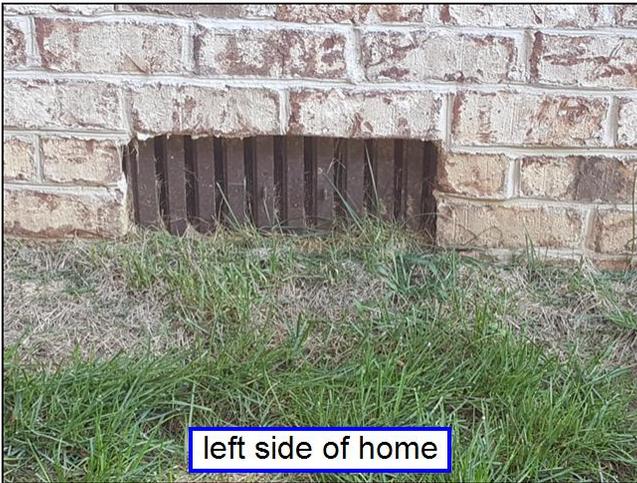
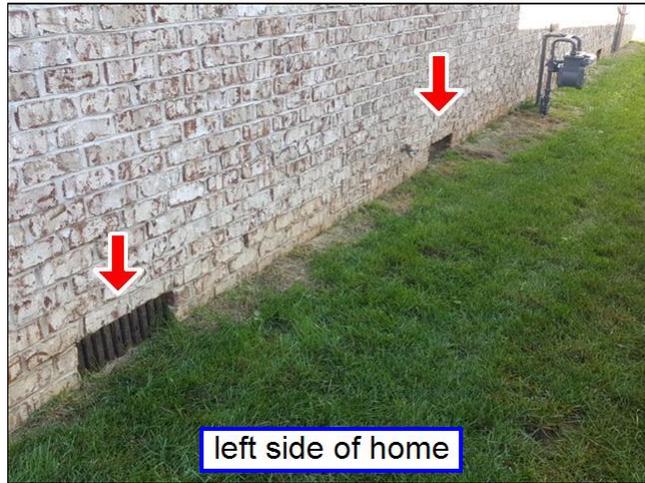
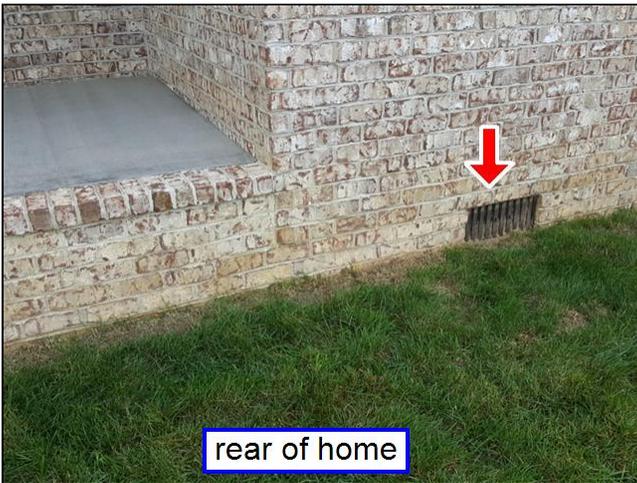
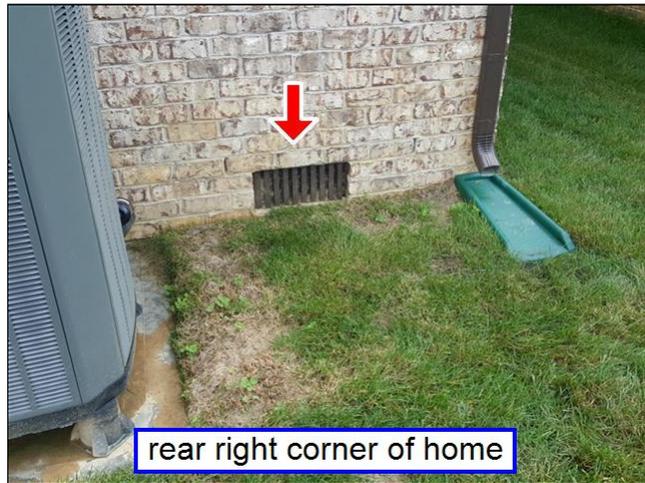
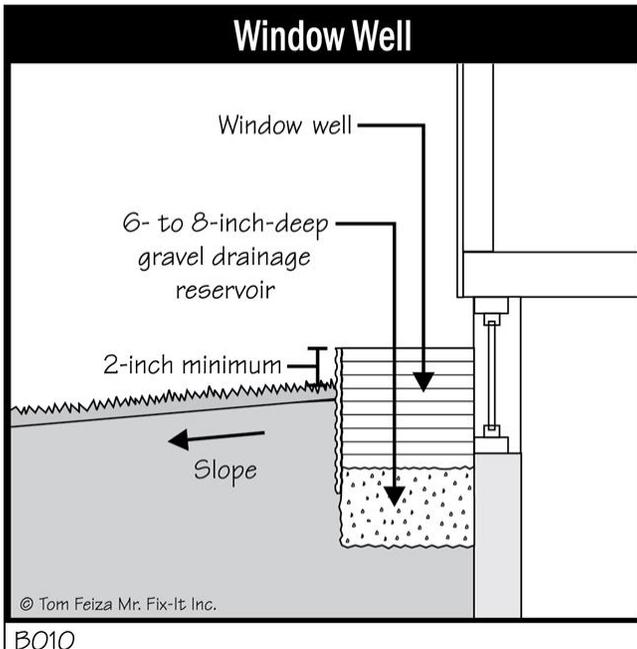
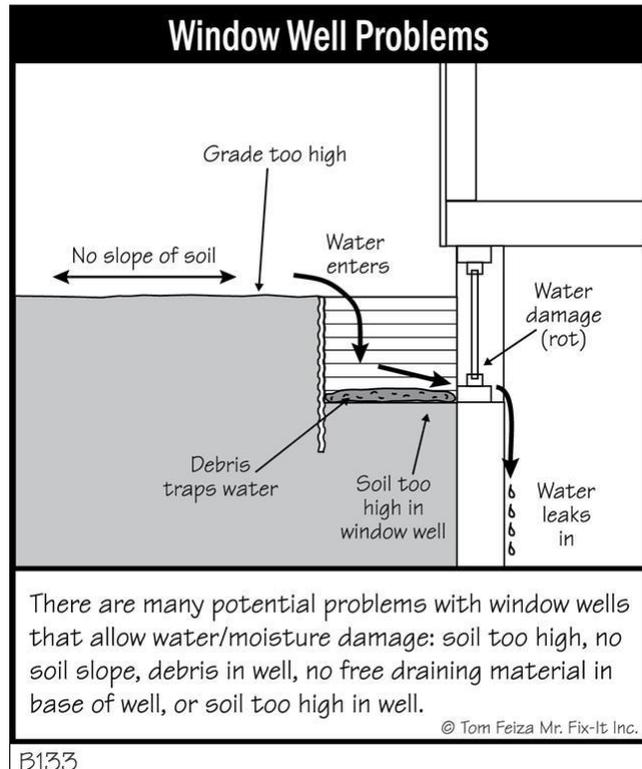
1.8 The foundation vent(s) at left side and rear right side of the home are at or near ground level. This can allow water entry into the crawlspace which was evident around the perimeter walls. Water intrusion in a crawlspace can lead to more costly repairs and cause mildew or mold to form. Recommend half-round window well be installed where needed. The dirt inside the well should be replaced with approximately four inches of gravel. A couple of inches clearance between the gravel and vent opening is recommended. Recommend a general contractor correct as needed.

left side of home

rear of home

rear right corner of home

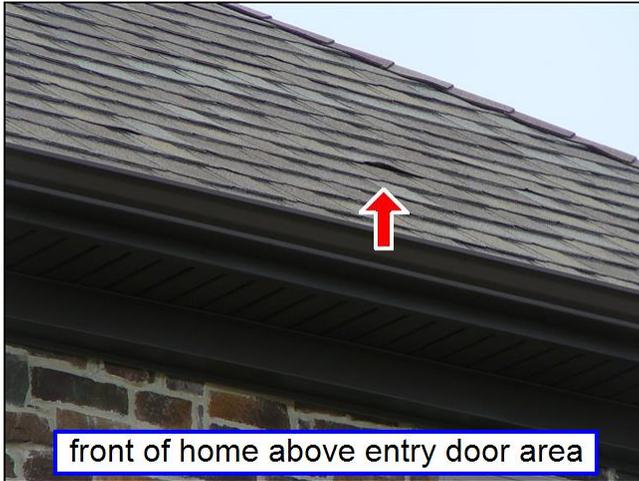
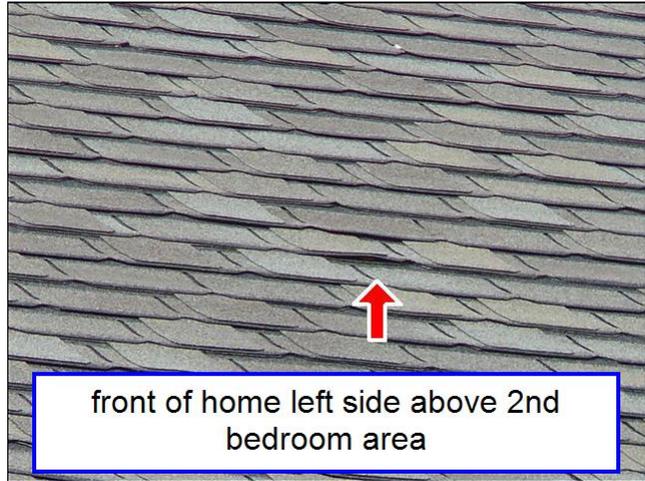
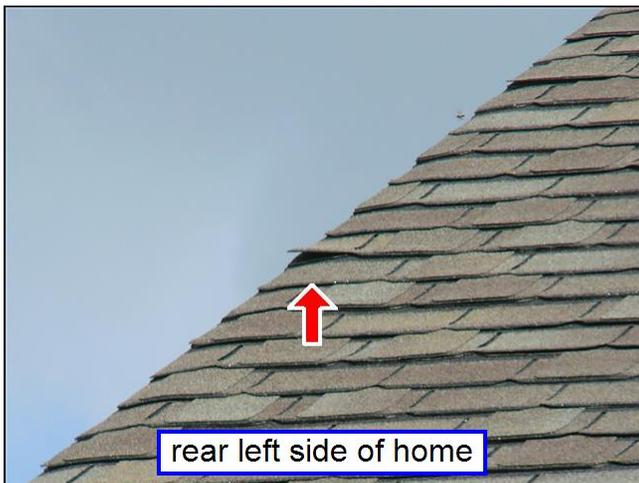
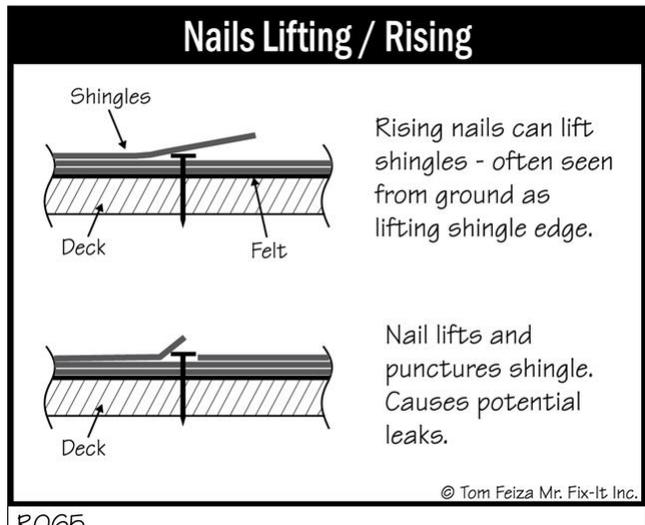
2.0 The shingles are lifting where indicated in the photos in various places, (see photos for location) due to nails are starting to "back out" which causes the shingle tabs to raise, or the sealant of the shingle tabs has failed. Shingle damage or roof leakage can occur at these areas. They are also at risk to be blown off by high winds. If they raise the shingle more than 1/2" the nails should be resealed to prevent water entry under the shingles. Recommend a qualified roofing contractor repair as needed.

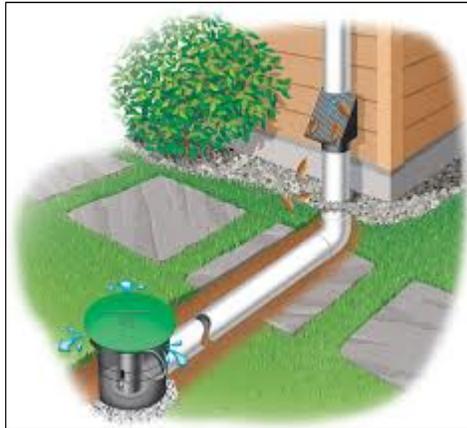
2.3 Item 4(Picture)

2.3 (3) Recommend the downspout(s) around the perimeter of the home be extended at least 5 feet and flow onto splashblocks. This will ensure water is kept away from the foundation perimeter, soil erosion does not occur and water cannot leak into the crawlspace area via the vent which may cause settlement of the foundation.

Note: You may wish to consider burying the extension to prevent a tripping hazard. See photos for example.

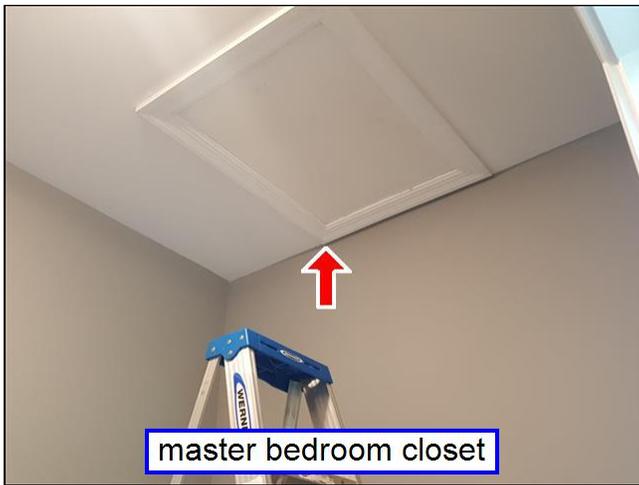
2.4 Item 1(Picture)

2.4 (1) Attic access location (see photo)

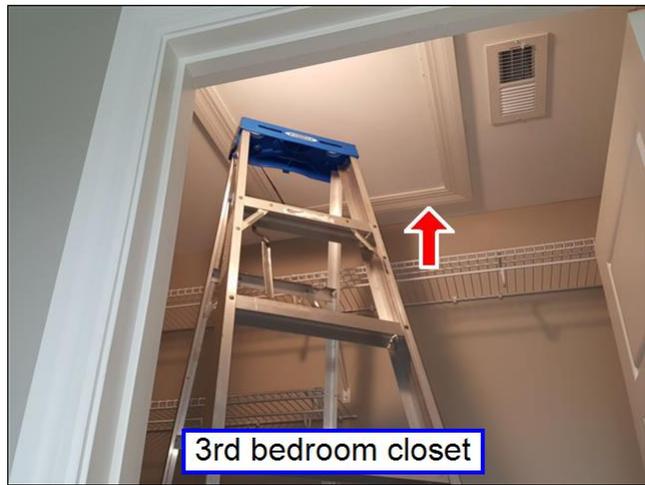
2.4 Item 2(Picture)

2.4 (2) The attic access in the 3rd bedroom door(s) does not fit the opening properly. This can cause some heat loss in winter and loss of cool air in summer if not corrected. Recommend replacement as needed.

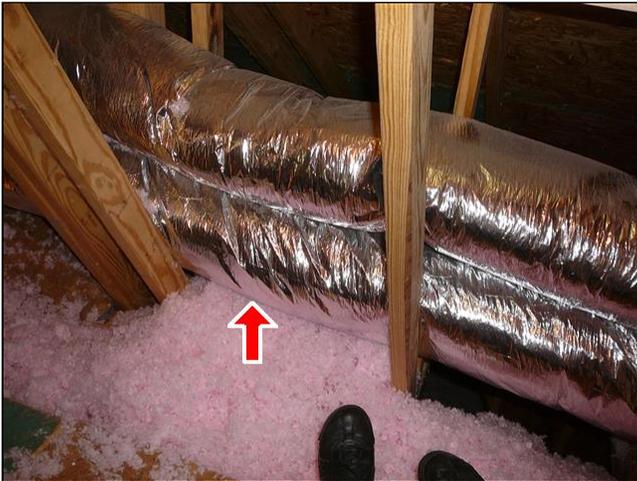
2.4 Item 5(Picture)

2.4 (4) The attic access above the guest bedroom was not inspected due to access. Ducts restricted access to ladder to enter this area.

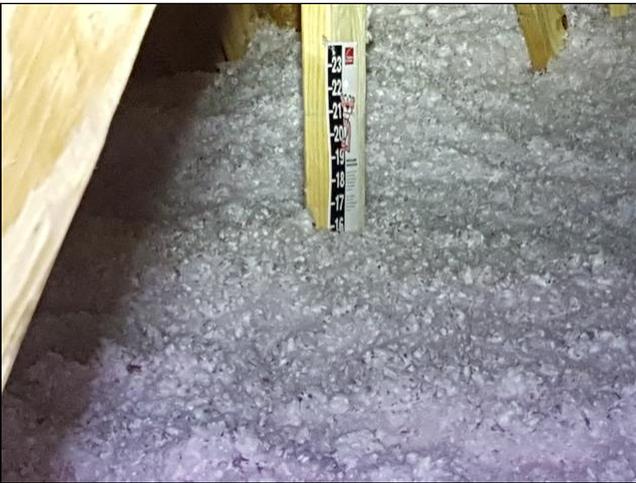
2.7 Item 1(Picture)

2.7 The insulation is about fourteen inches thick or just under 40 R-Value.

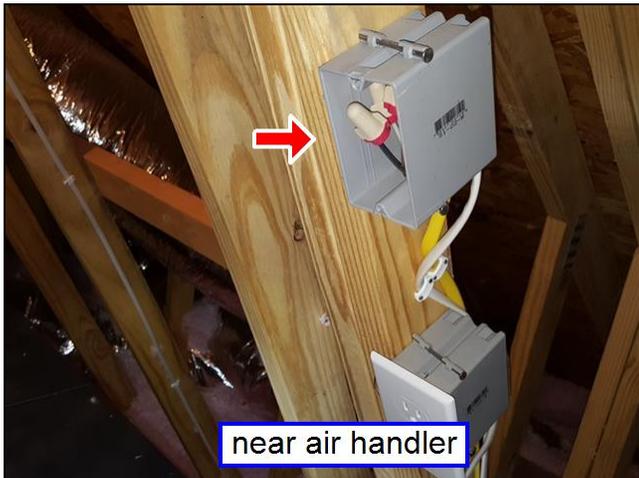
2.8 Item 1(Picture)

2.8 The junction box near the air handler in the attic (3rd bedroom closet area) should have a cover installed to prevent tampering, protect the wire connections, and for personal protection. This is a safety issue that needs to be corrected. Recommend a qualified licensed electrician correct as needed.

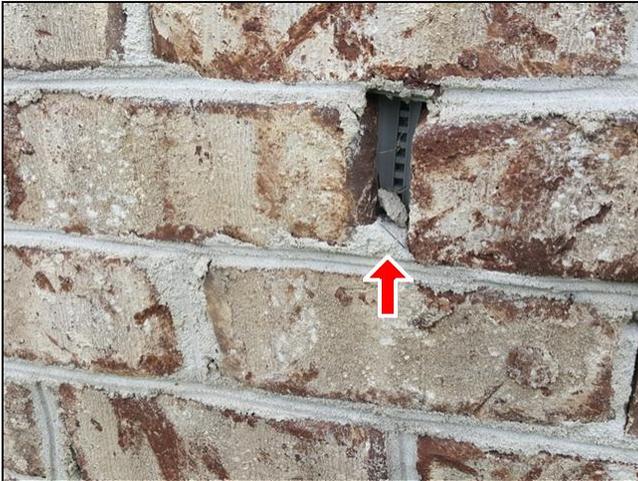
3.0 Item 1(Picture)

3.0 Missing mortar in these areas of the brick siding are known as weep holes. They allow moisture to escape from behind the wall siding. They should not be filled in. This is for your information.

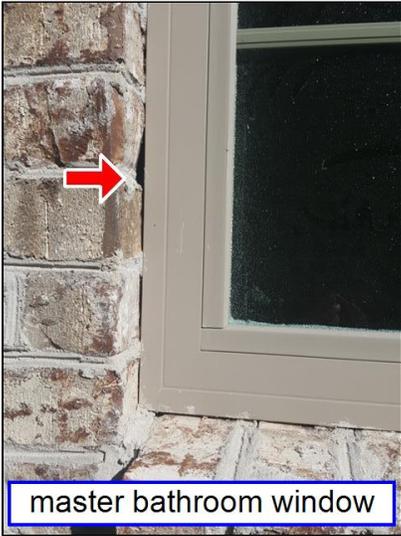
3.3 Item 1(Picture)

3.3 The majority of the window frames around the home have missing sealant between the siding and the window frames. Water and/or insects may enter and deterioration may occur behind the wall cavity and siding. This is a small repair. Recommend re-caulking as needed. [Which caulk to use](#)

master bathroom window

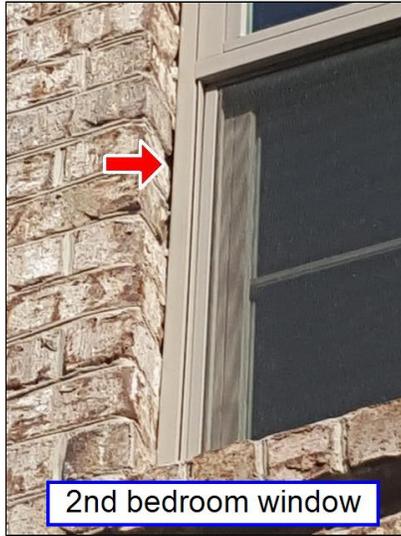
3.3 Item 2(Picture)

2nd bedroom window

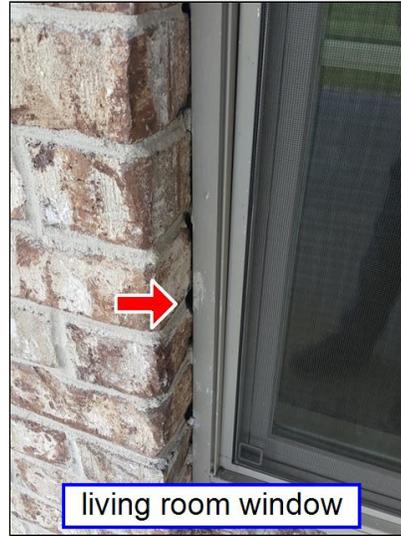
3.3 Item 3(Picture)

living room window

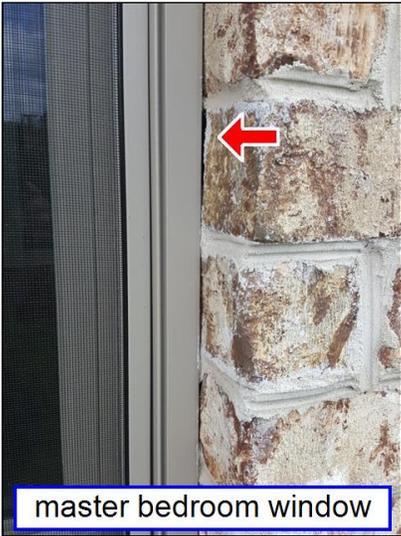
3.3 Item 4(Picture)

master bedroom window

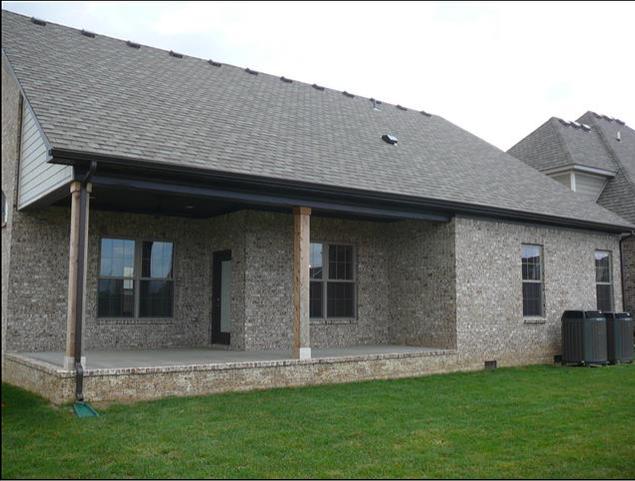
3.7 Item 1(Picture)

3.7 The rear patio floor area is above grade and is missing steps/staircase that leads to the ground. This is a potential safety issue which could result in a person injuring themselves via a fall. Strongly recommend a qualified contractor correct as needed for safety prior to moving in.

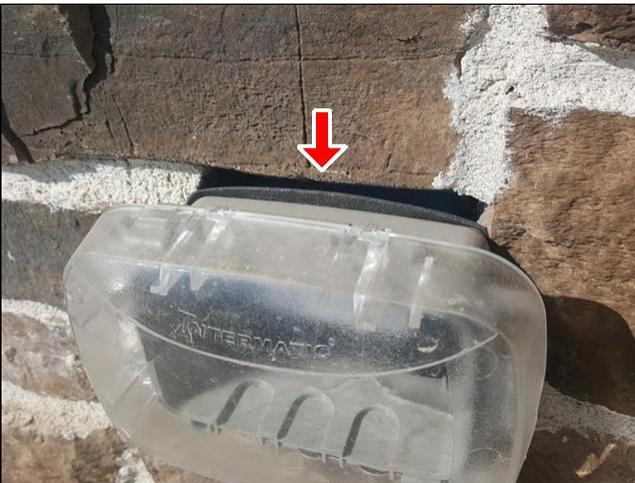
3.11 Item 1(Picture)

3.11 (1) Recommend sealing the gap between the wall and outlet at the front porch left side of door entry to prevent children being electrocuted by placing objects inside opening an to prevent water intrusion which may lead to a short or possible fire. This is a serious safety issue. Recommend repair as needed.

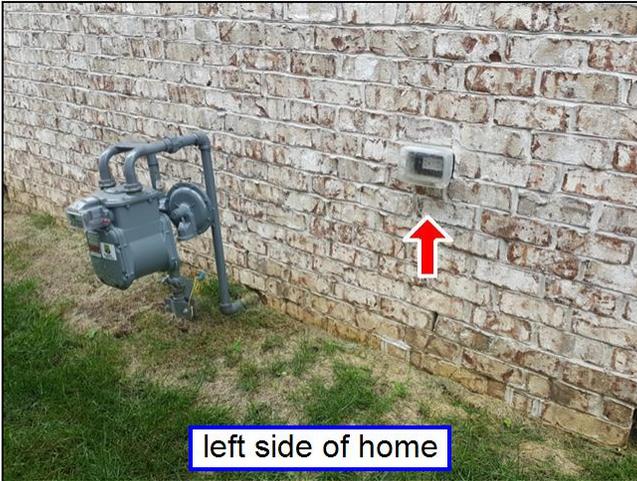
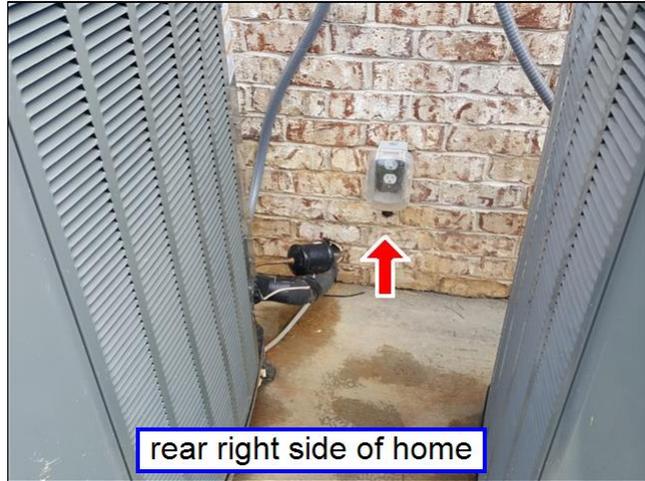
3.11 Item 2(Picture)

3.11 (2) The home exterior outlet(s) where indicated in the photos are GFCI protected however when tripped you need to reset them at the panel box at the appropriate breaker No. 33. This is for your information.

left side of home

rear right side of home

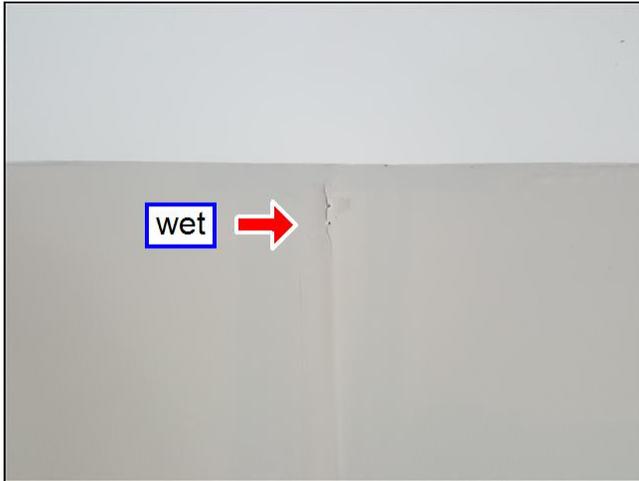
4.1 Item 1(Picture)

4.1 The wall in the garage right side is wet and moist. Mold and wood rot can occur if leakage is not repaired. This maybe due to the flashing, roof valley or roof leakage above between the outer wall and garage roof (see photo 4). Also refer to note 4.0. The step/side flashing was not inspected in this area due to visibility and access. Also could not access attic area. A diverter flashing may be needed in this area. Strongly recommend a qualified roofing contractor further investigate to determine cause and repair as needed prior to closing.

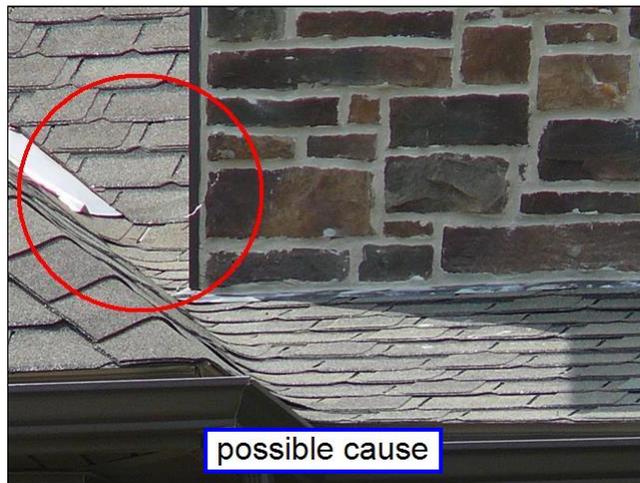
4.1 Item 4(Picture)

The wall in the garage right side is wet and moist. Mold and wood rot can occur if leakage is not repaired. This maybe due to the flashing, roof valley or roof leakage above between the outer wall and garage roof (see photo 4). Also refer to note 4.0. The step/side flashing was not inspected in this area due to visibility and access. Also could not access attic area. A diverter flashing may be needed in this area. Strongly recommend a qualified roofing contractor further investigate to determine cause and repair as needed prior to closing.

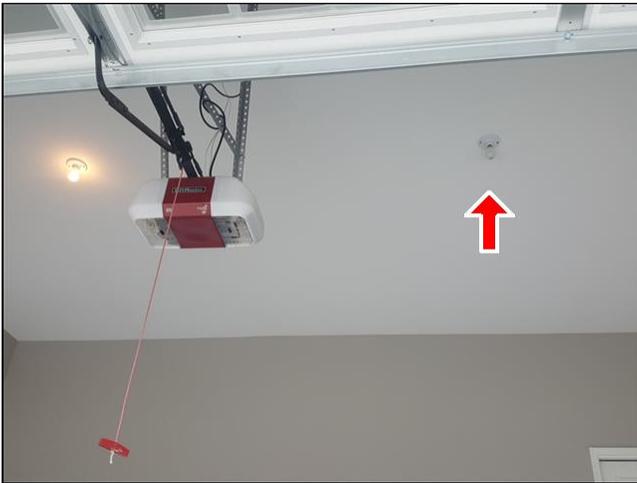
4.6 Item 1(Picture)

4.6 (3) The light fixture need bulbs replaced at the garage. This is for your information.

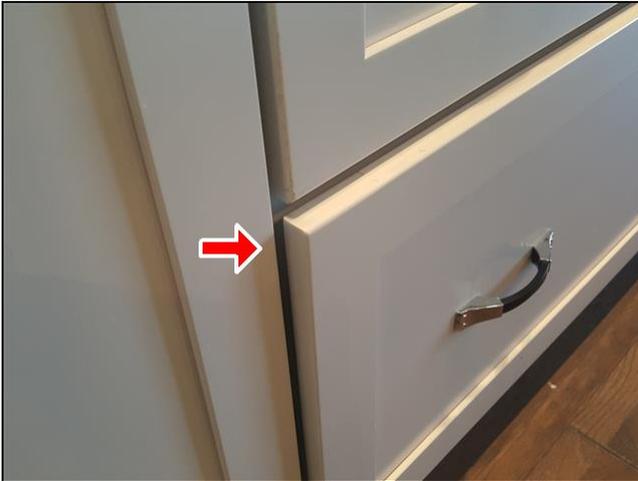
5.9 Item 1(Picture)

5.9 (1) drawer front below the stove top does not close flush against cupboard frame. Minor adjustment or replacement of hinges is required. This is a cosmetic issue for your information. Recommend repair or replace as necessary.

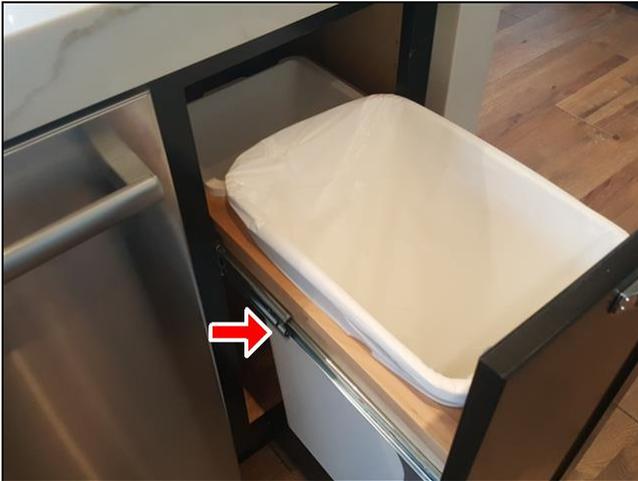
5.9 Item 2(Picture)

5.9 (2) The trash compartment drawer squeaks when operated. This can cause wear on the the tracks. Recommend a general contractor correct and repair as needed.

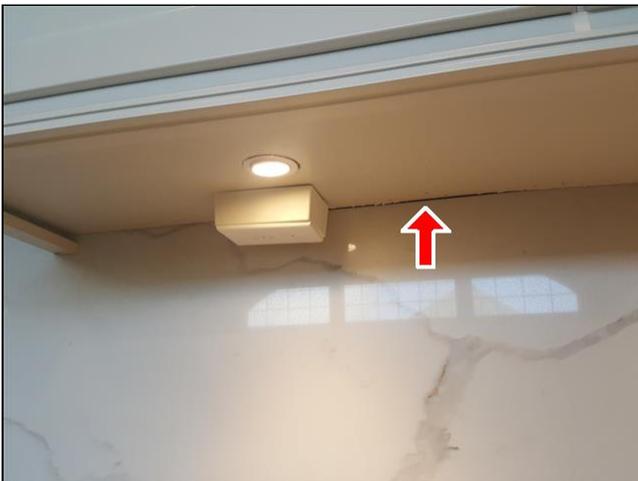
5.9 Item 4(Picture)

5.9 (3) Recommend sealing the gap between the upper cabinet and the splash tiles right of stove top.

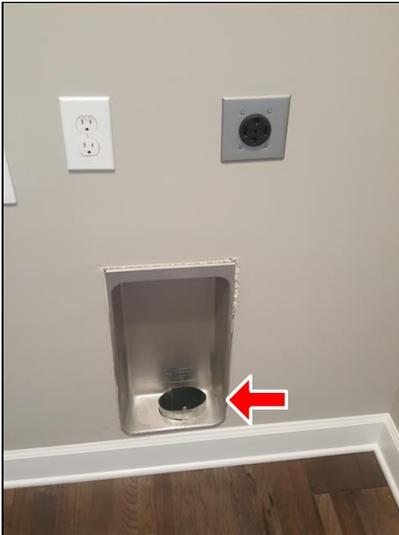
5.11 Item 2(Picture)

5.11 (2) When installing your dryer do not use flexible foil piping. The current recommendations are for dryer vents to be heavy flexible or solid metal to help prevent crushing and damage from fires. Dryer lint fires are reported to be the third leading cause of fires. Exhaust ducts should be constructed of minimum 0.016 inch thick rigid metal ducts, having smooth interior surfaces with joints running in the direction of air flow. Exhaust ducts shall not be connected with sheet metal screws or fastening means which extend into the duct. All dryer vents should be disconnected and cleaned twice a year. This is a very common cause of fires. This is for your information.

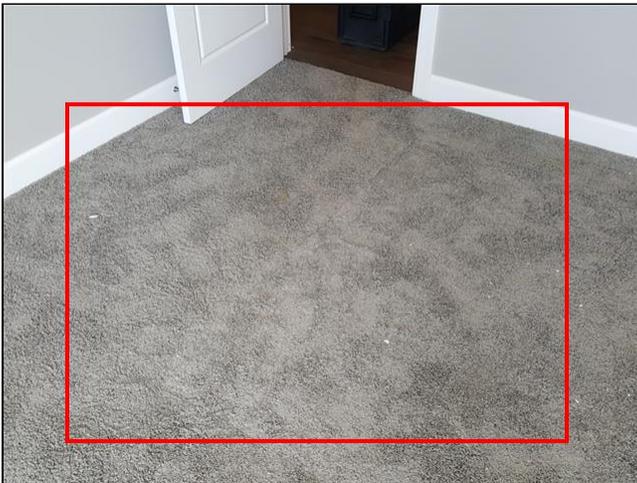
6.2 Item 1(Picture)

6.2 The floor squeaks in the 3rd bedroom as indicated in the photo(s) (nuisance only). This is for your information and is of no concern from a structural perspective. A qualified carpenter should know how to eliminate or reduce squeaks in the flooring. This will likely involve the removal of the floor covering to repair squeak in the floor. Repair as desired.

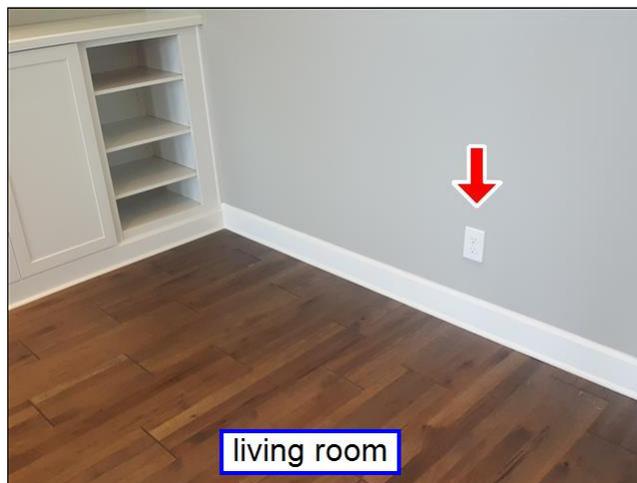
6.7 Item 1(Picture)

6.7 (1) The outlet(s) where indicated in the photo(s) are loose in the wall. Electrical issues are considered a hazard until repaired. This is a safety issue that needs to be corrected due to an electric shock or fire from loose connections could occur if not repaired. Recommend a qualified licensed electrical contractor correct as needed.

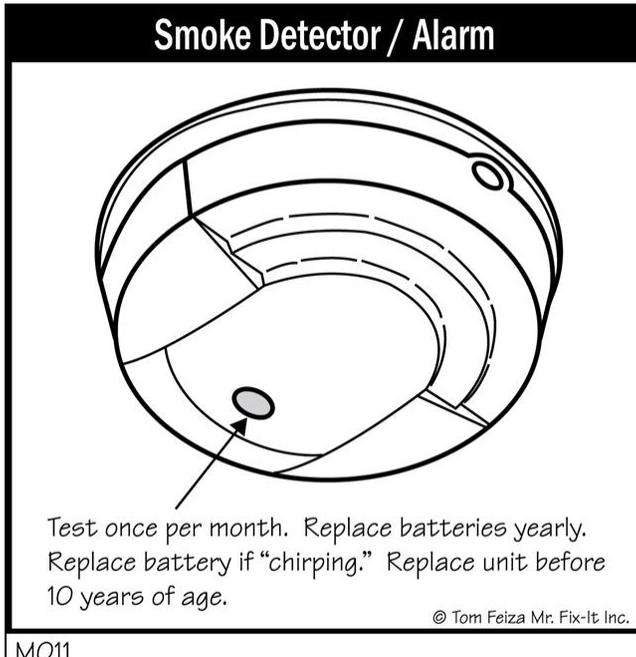
6.8 Item 1(Picture)

6.8 Testing of smoke and CO detectors is not part of a home inspection. We do not want to create a false alarm. All detectors in the home exhibit the active green light which indicates they are on and functioning. Recommend the smoke detectors be tested at common hallway to bedrooms upon moving in to home.

Note: If the smoke/CO alarm is 10 years old or older, recommend replacement. Ensure the smoke alarm is a photoelectric type. Here is a link explaining type of alarm to use by the [Dept. of Fire and Emergency Services](#)

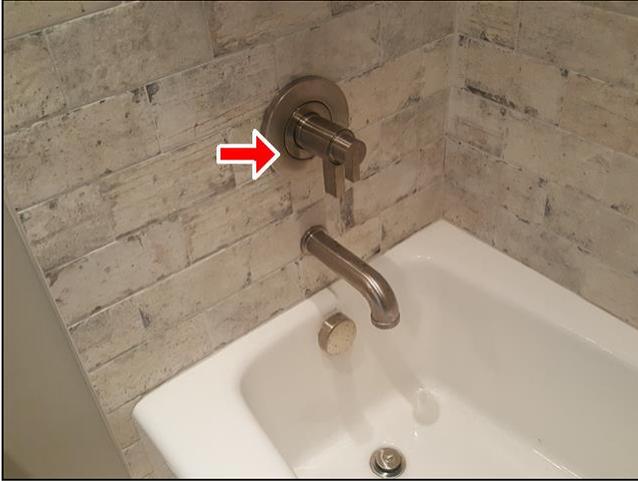
7.4 Item 1(Picture)

7.4 The faucet for the tub in the 2nd bathroom does not appear to direct all the cold water to the faucet when the lever is activated. Warm water was experienced only when the lever is set for cold water only. This can be a safety issue as a small child could injure themselves via scalding trying to receive cold water only. Recommend a licensed plumber further evaluate and repair or correct as needed.

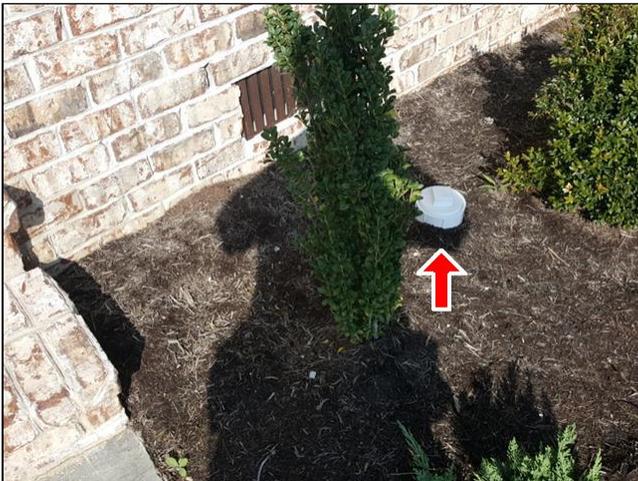
8.0 Item 1(Picture)

8.0 (1) The sewer clean out cap is located at the front left side of the home. This is for your information.

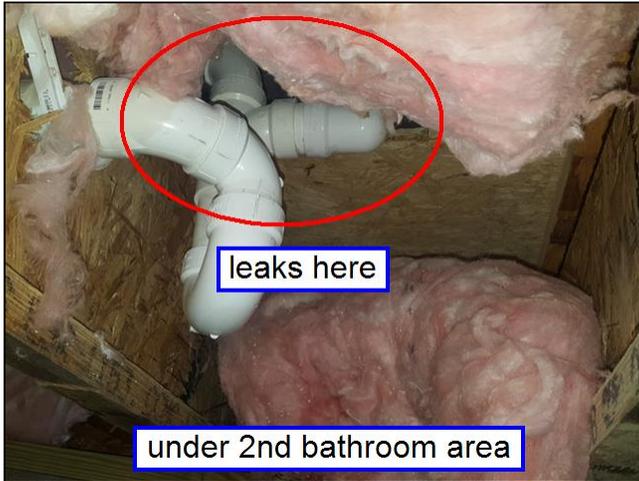
8.0 Item 2(Picture)

8.0 (2) The drain line in the crawlspace below the shower and tub in the 2nd bathroom area has a major water leak. Water leakage was experienced when faucet was turn on, drain plug sealed, and when water was drained in the tub. Cannot determine cause or how water is leaking. It maybe due to drain plug not sealing and there is a leak at the drain line. Water in a crawlspace can lead to mold or damage to the floor structure if not repaired. Recommend a qualified plumber further investigate, repair leaks prior to closing to prevent costly repairs in the future.

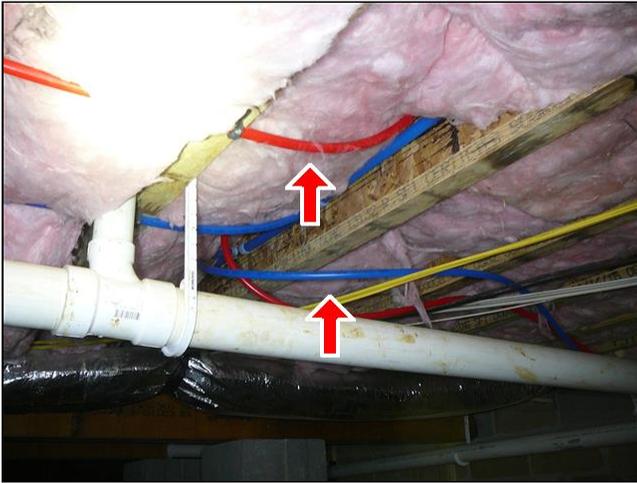
8.1 Item 1(Picture)

8.1 (2) Recommend insulating the water supply pipes underneath in the crawlspace (hot and cold) to ensure pipes do not freeze in winter which may cause a serious plumbing leak in the crawlspace, and to prevent heat loss of water when hot water is flowing into home. This will improve efficiency. This is for your information.

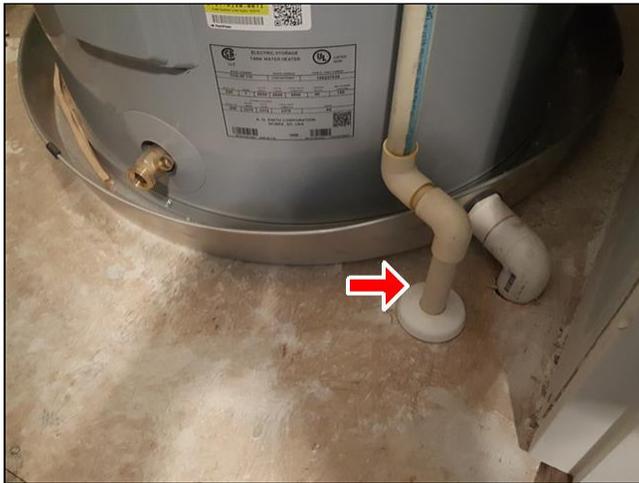
8.3 Item 1(Picture)

8.3 Location of the TPR (temperature pressure relief) drain line to exterior. (see picture)

Recommend installing a tray under the TP Drain line in the garage to prevent water entering on the floor to prevent damage to walls and trim.

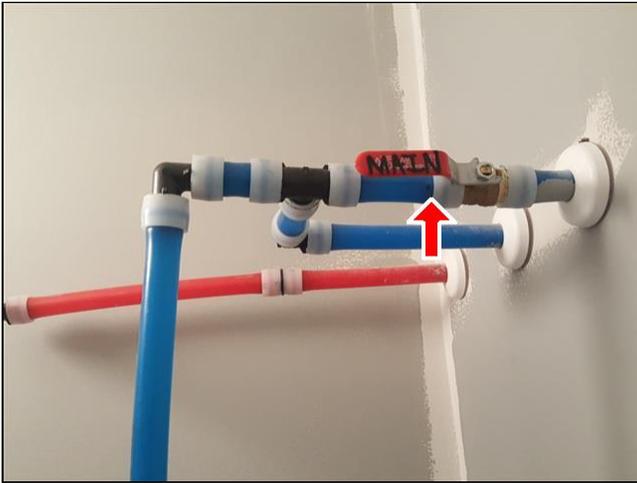
8.4 Item 1(Picture)

8.4 (1) The main shut off is the red lever located above the water heater underneath the staircase. You may wish to consider relocating main shut closer to the entry point in the crawlspace. Before the main shut off the supply line will always have water flowing regardless if water has been shut to the interior of the home. If a leak occurs in the supply line before the main water shut off water will leak and possibly flood the crawlspace floor area which will lead to costly repairs. This is for your information. A qualified licensed plumber will be able to relocate main shut off if desired. Best alternative to shutting water to the home will be at street meter and a water key will be required. This is for your information.

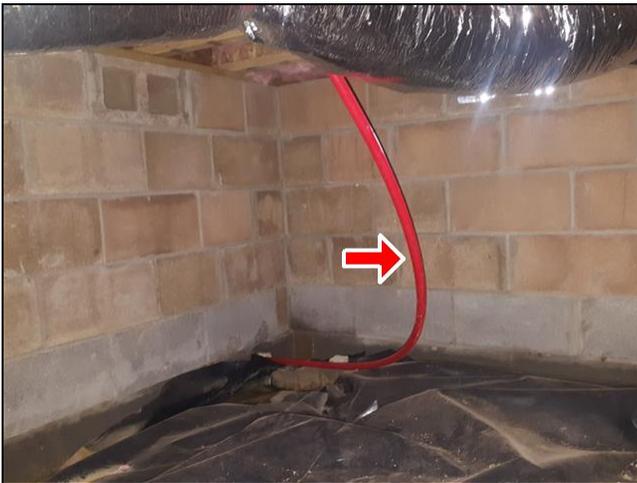
8.4 Item 3(Picture)

8.4 (2) Recommend insulating the main water supply line pipe in the crawlspace due to the pipe is located in an unconditioned area. This will ensure that the pipe does not freeze in winter which may cause a serious plumbing leak and prevent costly damage to the home. This is for your information.

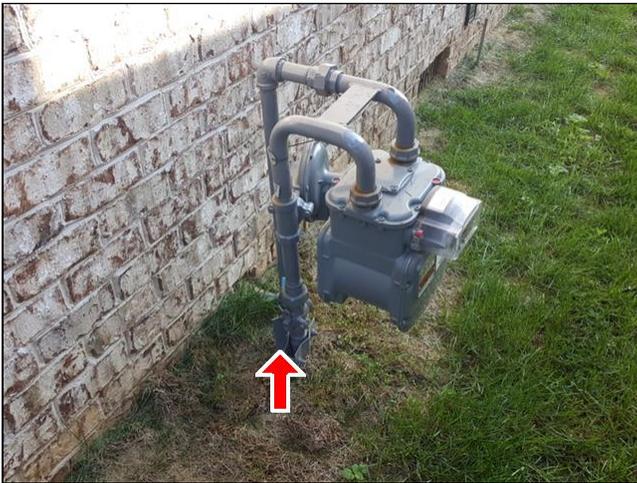
8.5 Item 1(Picture)

8.5 The main fuel shut off is at gas meter outside.

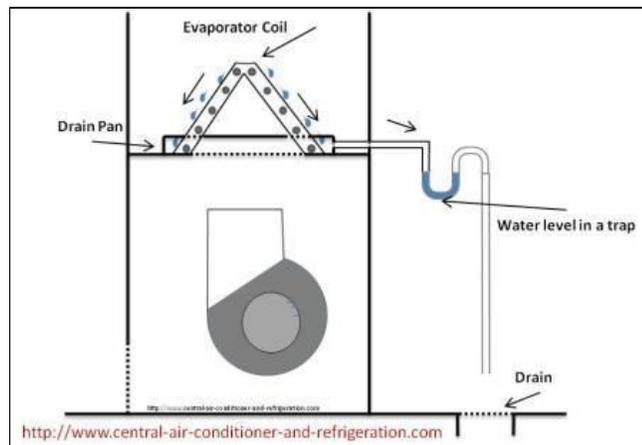
10.3.A Item 5(Picture)

10.3.A (3) There was no visible condensate trap installed at the condensate drain line for the Air Handler in the crawlspace. It is recommended by the manufacturer to have one. The purpose of the trap is to allow the water to drain freely, with out it air flowing in the drain line can cause the water to not flow (drain to the exterior). Recommend a qualified HVAC contractor correct as needed.

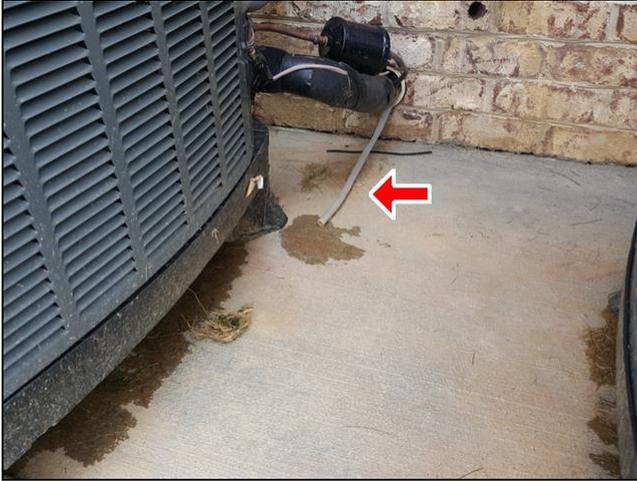
10.3.A Item 6(Picture)

10.3.A (4) Recommend the discharge for the condensate drain line be improved via extending the drain line at the rear right side of the home. This will prevent water pooling near the foundation which could cause settlement of the foundation wall and water leakage into the crawlspace. Also to prevent possible settling of the platform for the Heat Pumps. A qualified HVAC contractor is recommended for these repairs.

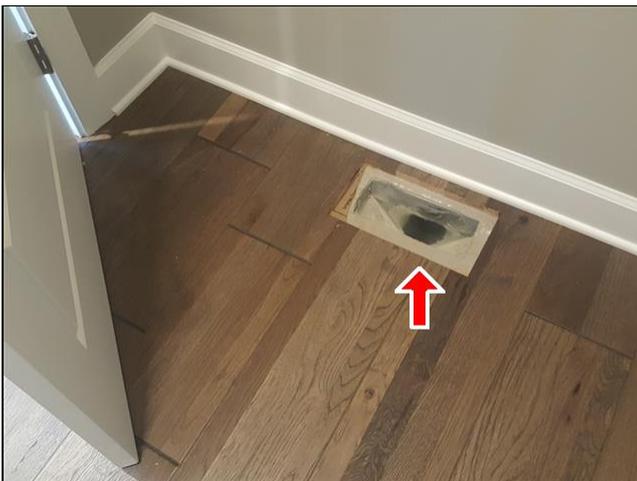
10.4.A Item 1(Picture)

10.4.A (2) The supply register is missing a cover grill at the Washer/Dryer room. This is a safety issue as a small child or pet may fall into the hole or get stuck which may cause an injury. Also objects may fall down inside causing a blockage of air flow which can cause damage to the blower or force duct joints to dislodge at the connection between the boot cover. Recommend installing a grille cover over the hole prior to moving in.

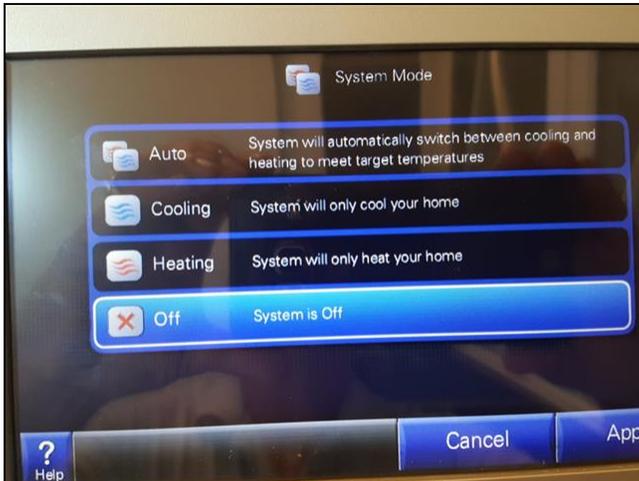
10.6.A Item 1(Picture)

10.6.A The thermostat does not have the emergency heat mode to suit the heat pump. Recommend replace as needed by a qualified HVAC contractor in order to operate the emergency heat at the heat pump when needed.
