TALON
Home Inspections

Inspection Report

Property Address:
4100 Mangini Street
Lexington KY 40509

Date: 9/15/2017	Time: 10:00 AM till 02:30 PM	Report ID: 170915BISHOP
Property: 4100 Mangini Street Lexington KY 40509	Customer: Ms. Amy Bishop	Real Estate Professional:

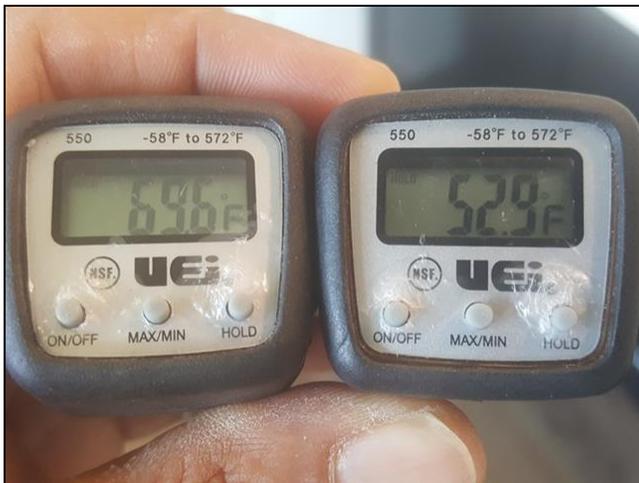
10.7.A Item 1(Picture)

10.7.A The Delta T air test was performed by using digital thermometers. Measurements were taken at the point of intake air and from the supply air at the registers closest to the air handler of Heat pump in cool mode to determine if the difference in temperatures of the supply and return air are between 15 degrees and 25 degrees which indicates that the unit is cooling as intended. The supply air temperature on your system read 53 degrees, and the return air temperature was 70 degrees. This indicates the range in temperature drop is normal.

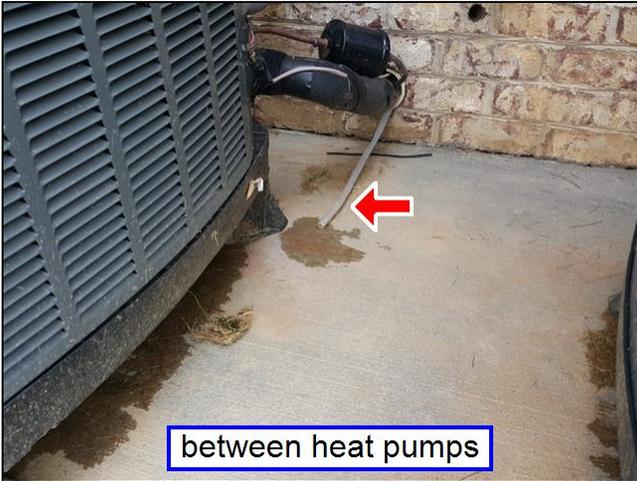
10.3.B Item 1(Picture)

10.3.B (1) The condensate drain line is directed to the condensate pump in the crawlspace then drains to the exterior. (see photo)

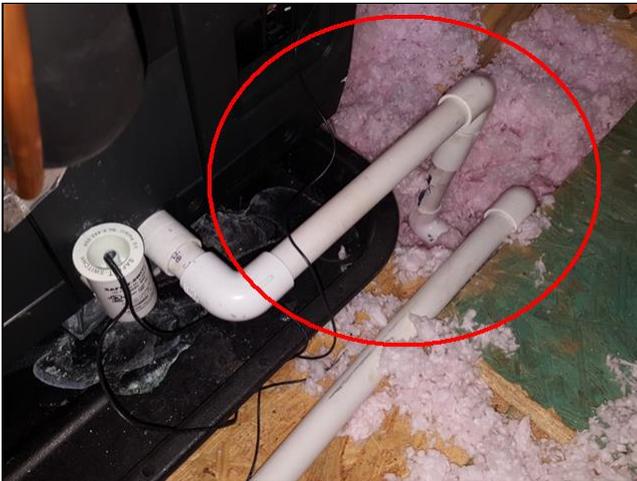
10.3.B Item 3(Picture)

10.3.B (2) There was no visible condensation trap installed at the condensate drain line for the Air Handler in the attic. It is recommended by the manufacturer to have one. The purpose of the trap is to allow the water to drain freely, with out it air flowing in the drain line can cause the water to not flow (drain to the exterior). Recommend a qualified HVAC contractor correct as needed.

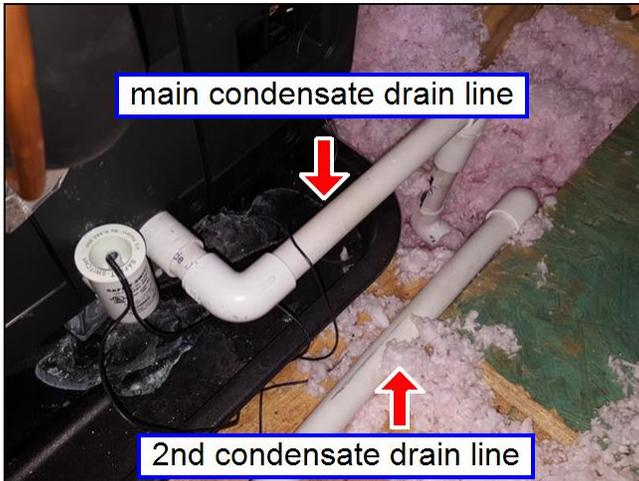
10.3.B Item 5(Picture)

10.3.B (3) The 2nd condensate drain line is connected to the main line in the attic which drains to the pump in the crawlspace. This is for your information.

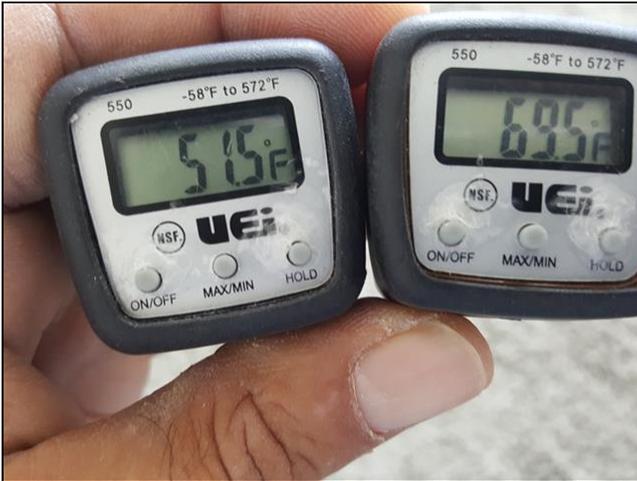
10.7.B Item 1(Picture)

10.7.B The Delta T air test was performed by using digital thermometers. Measurements were taken at the point of intake air and from the supply air at the registers closest to the air handler of Heat pump in cool mode to determine if the difference in temperatures of the supply and return air are between 15 degrees and 25 degrees which indicates that the unit is cooling as intended. The supply air temperature on your system read 51 degrees, and the return air temperature was 70 degrees. This indicates the range in temperature drop is normal.

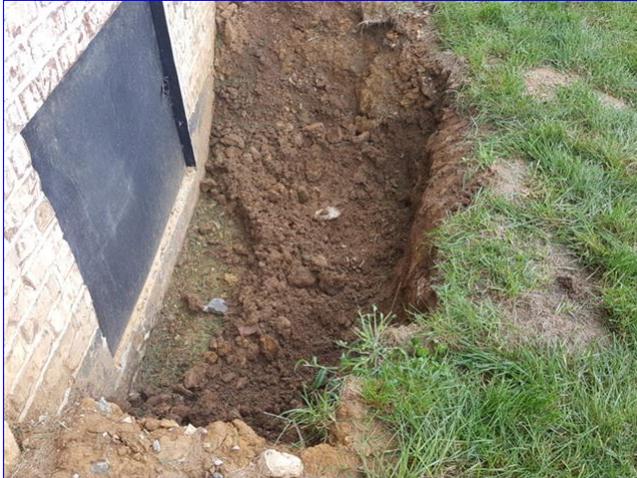
1.0 Item 2(Picture)

(3) The access door to the crawlspace is missing a window well. Water may enter which can lead to crawlspace leakage resulting in mold or mildew to form. Recommend one be installed by a general contractor prior to moving in as needed.

Note: Recommend installing a cover over the access port for the crawlspace. This will prevent water entering the pit and possible deterioration to the door. It will also prevent water possibly entering the crawlspace area. Have provided an example of cover type in photo 2.

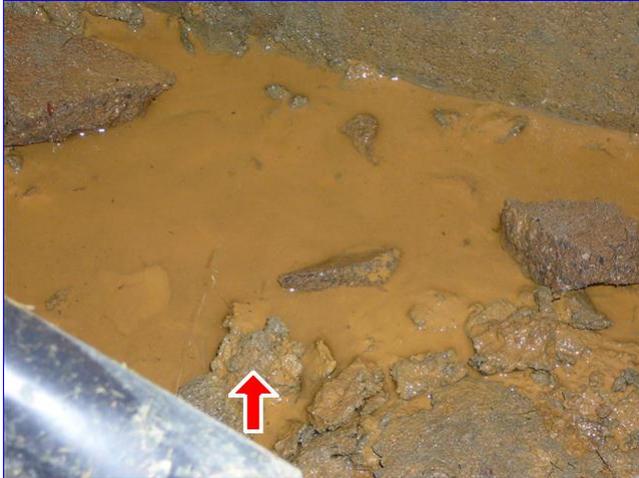
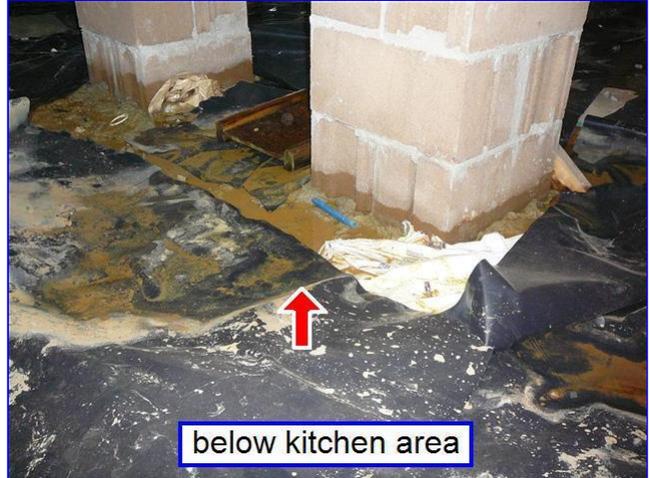
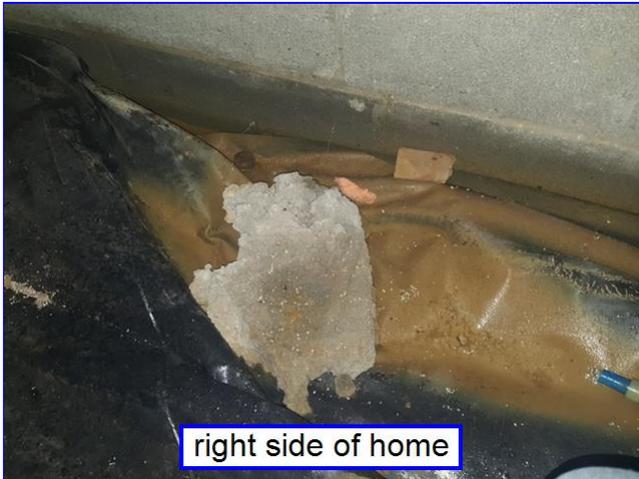
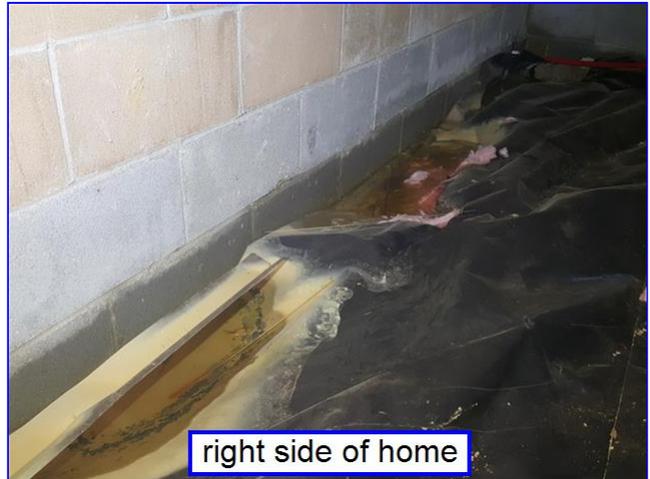
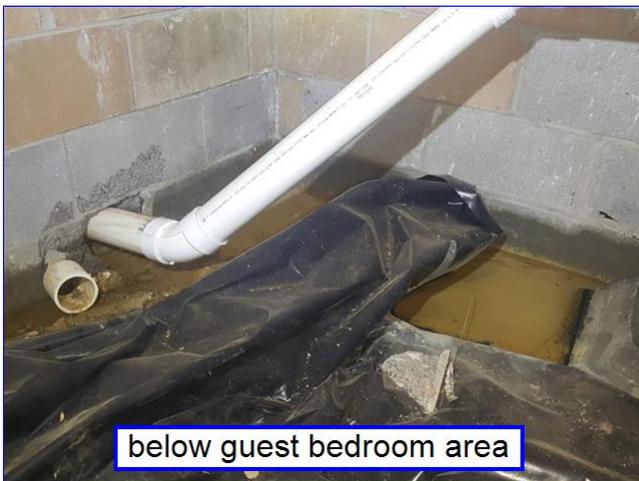
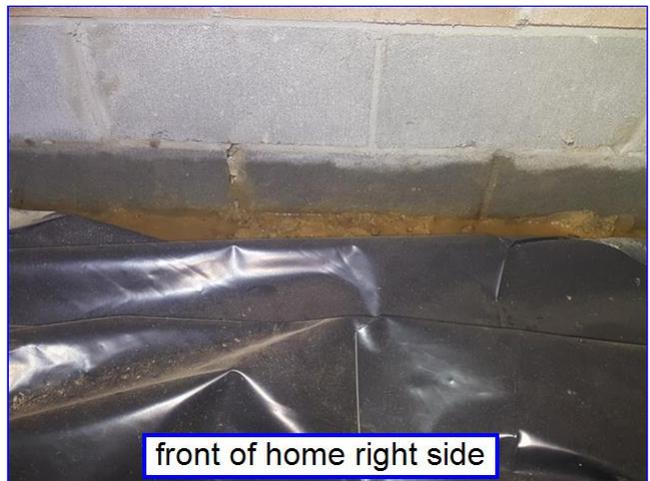
Standing water was observed in the crawlspace along the foundation walls around the perimeter of the home and under the kitchen area in the crawlspace at the time of the inspection. Wet crawl spaces risk building damage from rot, insects and can cause mold or mildew. Water intrusion if not corrected can lead to other problems including mold and cause excessive moisture to floor system that can lead to deterioration and increased repair cost. I am unable to determine the extent of intrusion or how often it occurs. A sump pump and drainage system could be installed or other methods maybe needed to correct intrusion. Recommend further investigation by a qualified licensed contractor to determine cause and remedy to eliminate water standing along the foundation walls in the crawlspace. Roof and Lot drainage repairs or improvements should be addressed as a first step to controlling water in the crawlspace.

below kitchen area

right side of home

below guest bedroom area

front of home right side

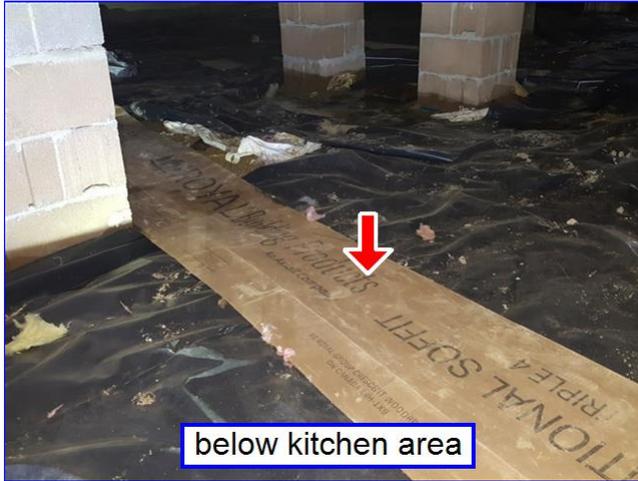
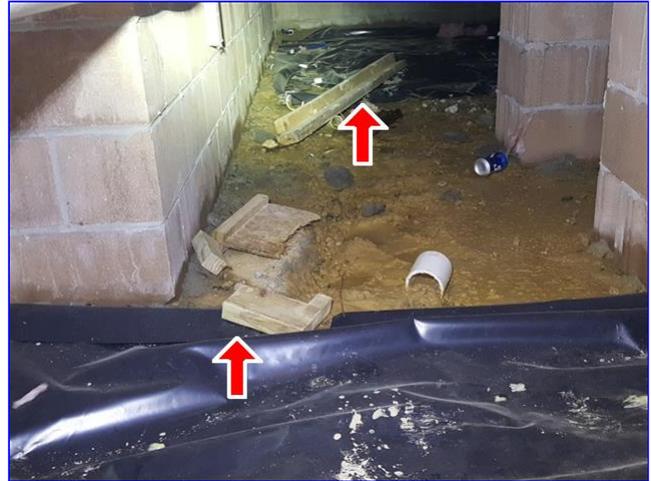
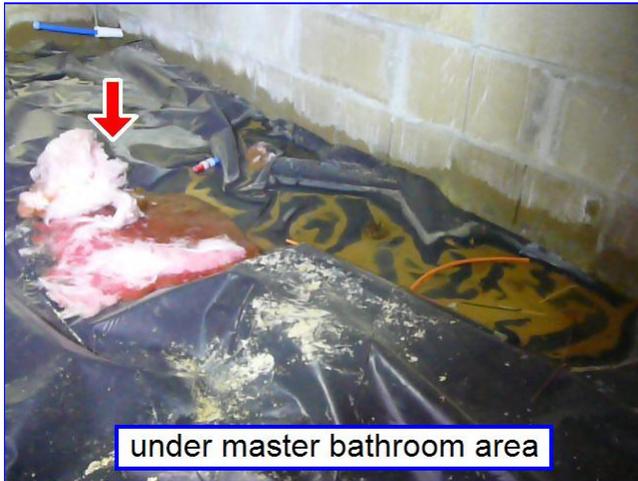
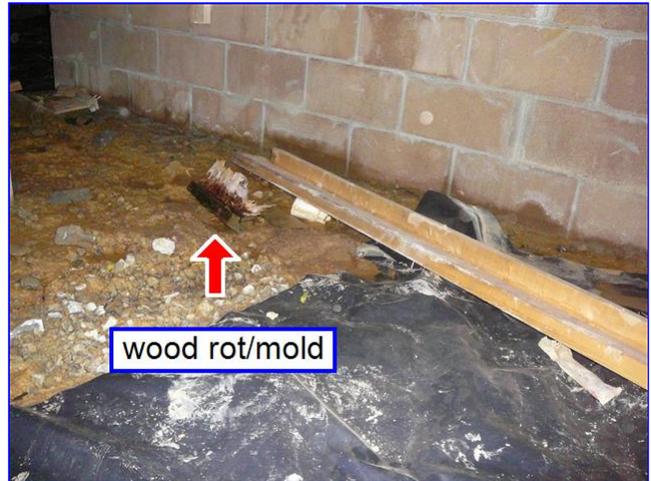
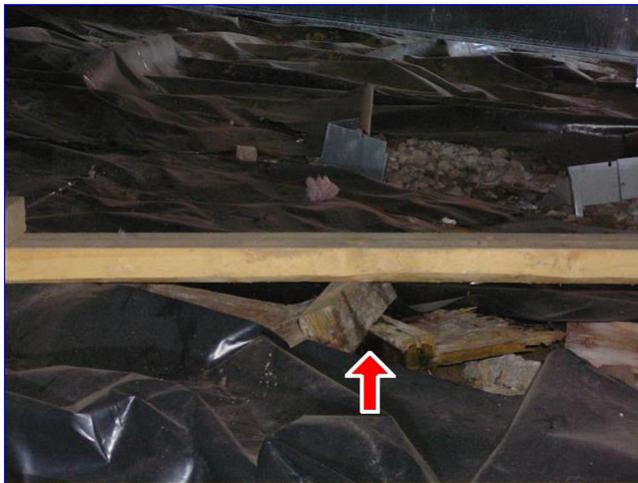
(1) All wood, cardboard, insulation and unused building materials should be removed from the crawlspace floor. The insulation will hold moisture creating condensation and possible mold growth on the wooden structure in the

crawlspace. Wood debris risks rotting and can attract wood eating insects into the crawlspace which can lead to more costly repairs later. Recommend all types of debris resting on the crawlspace floor be removed to prevent damage to the wood structure of the home.

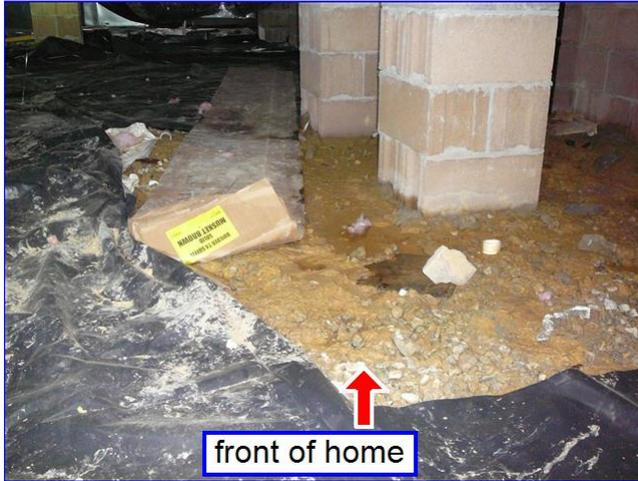
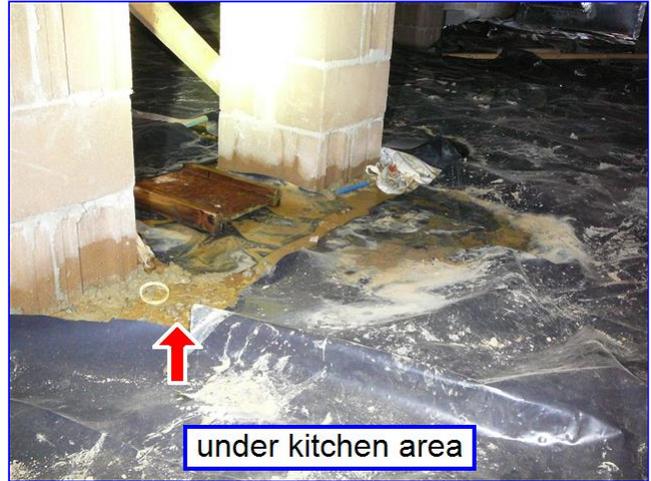
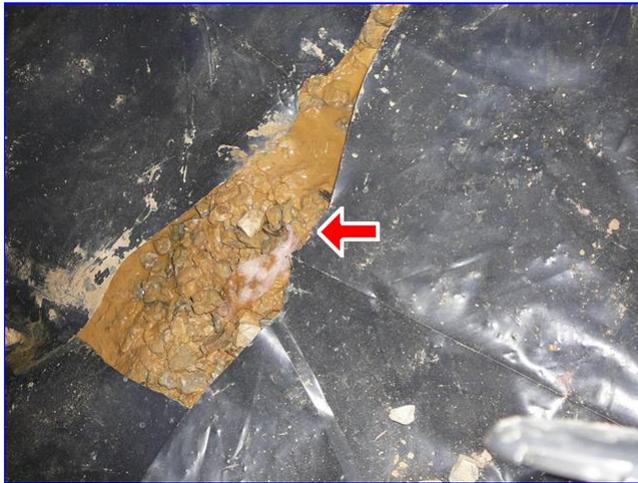
(2) There are some gaps in the coverage of the crawl space floor. A plastic vapour barrier should be installed in the missing areas and needs to be a minimum of 9mil thick in Kentucky (recommend using 15 or 20 mil) Recommend

adding additional vapour barrier cover where needed to cover entire crawlspace floor to prevent excessive moisture entering which can lead to mold and deterioration of the floor structure and insulation in the crawl space. Recommend correcting and replacement using a qualified contractor.

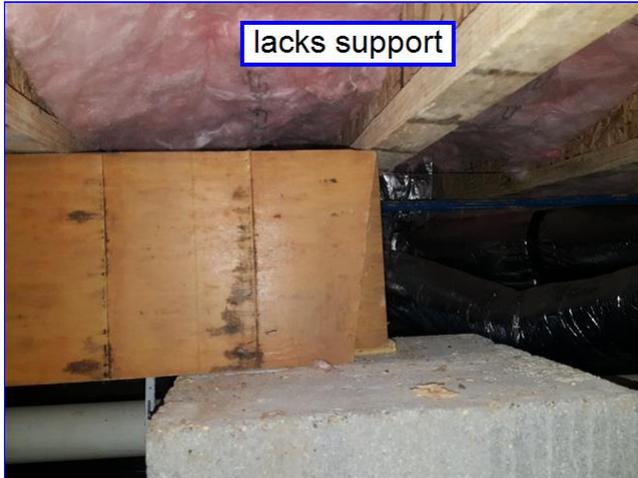
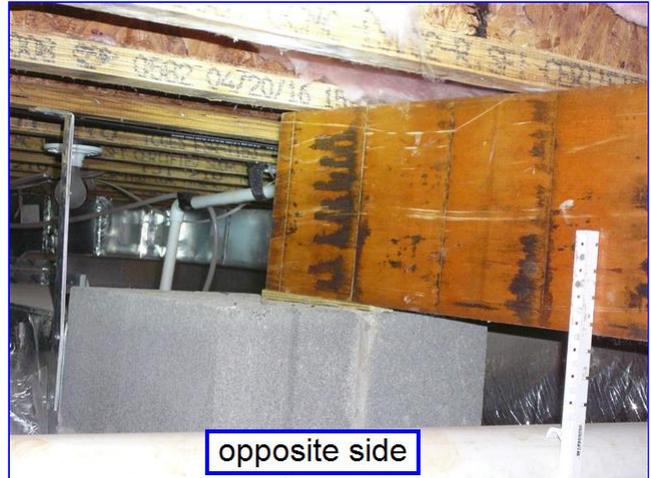
The wood beam in the middle of the crawlspace under the entry foyer area has insufficient end bearing to support the floor joist above. Additional support maybe needed to reduce risk of structural movement and damage to floor and wall above. Strongly recommend a qualified contractor or structural engineer be consulted to further evaluate and improve support for the wood joist and correct as needed.

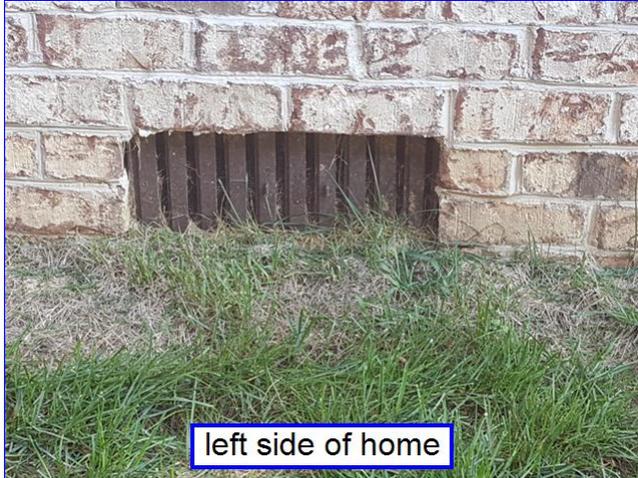
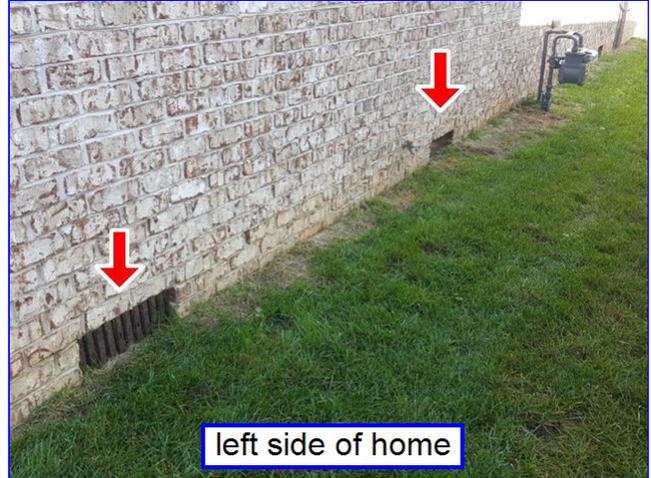
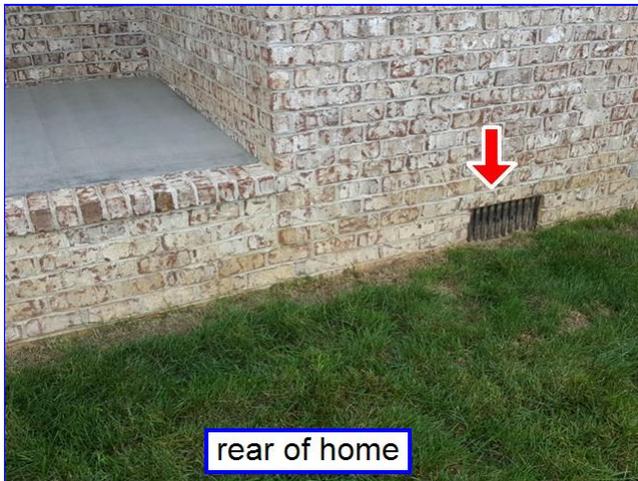
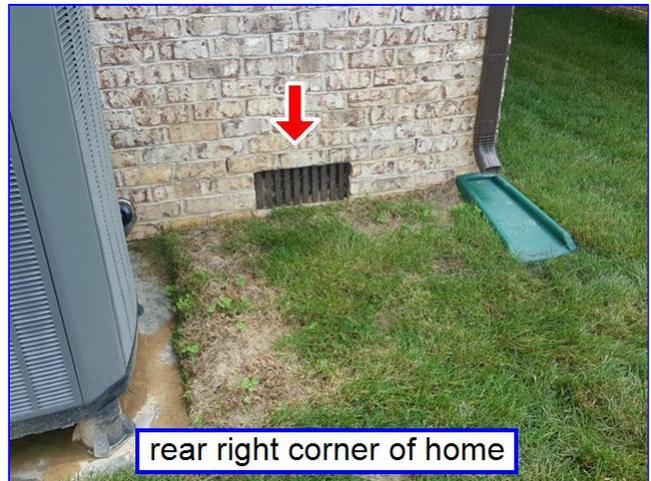
The foundation vent(s) at left side and rear right side of the home are at or near ground level. This can allow water entry into the crawlspace which was evident around the perimeter walls. Water intrusion in a crawlspace can lead to more costly repairs and cause mildew or mold to form. Recommend half-round window well be installed where needed. The dirt inside the well should be replaced with approximately four inches of gravel. A couple of inches clearance between the gravel and vent opening is recommended. Recommend a general contractor correct as needed.

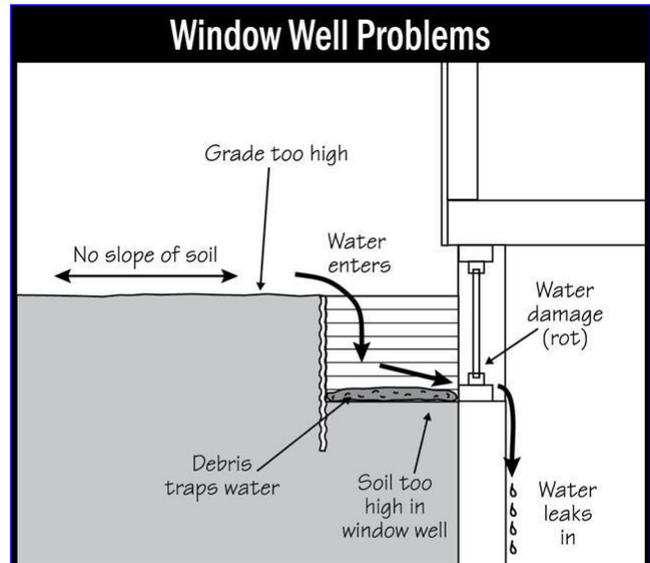
B133
1.8 Item 6(Picture)

There are many potential problems with window wells that allow water/moisture damage: soil too high, no soil slope, debris in well, no free draining material in base of well, or soil too high in well.

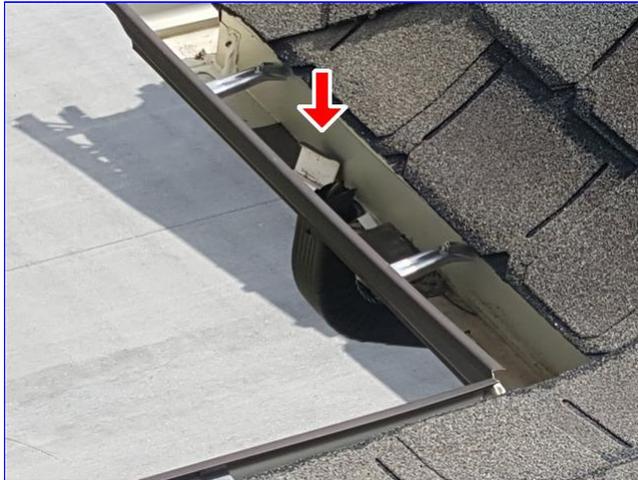
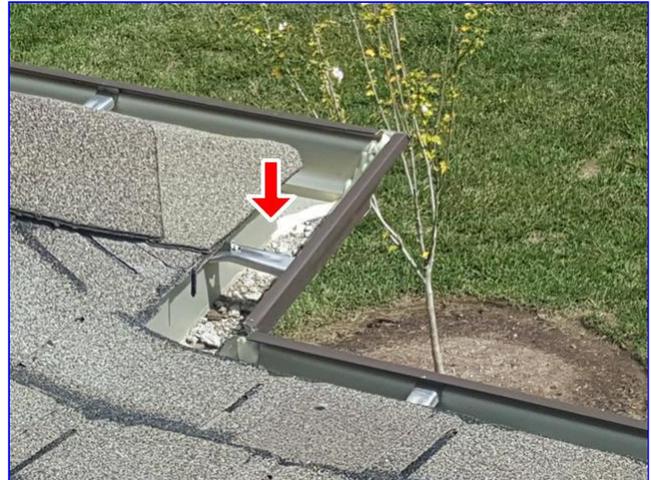
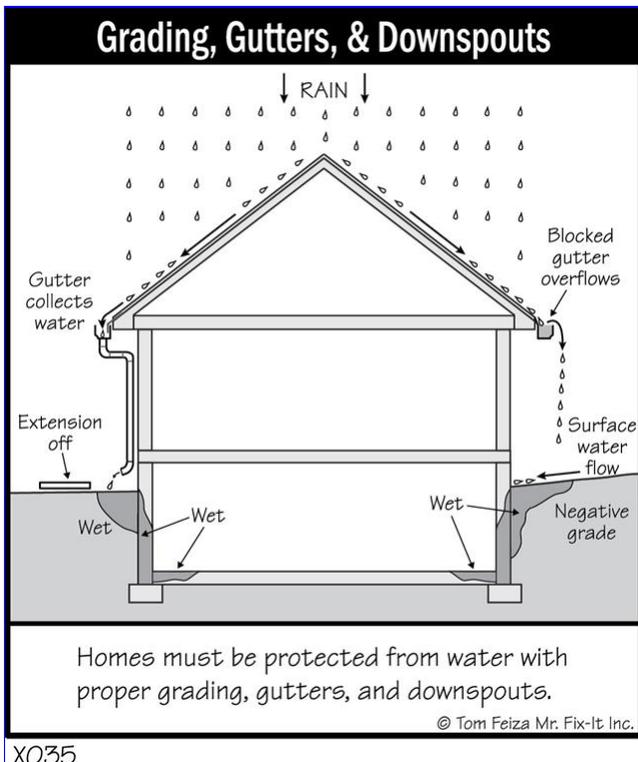
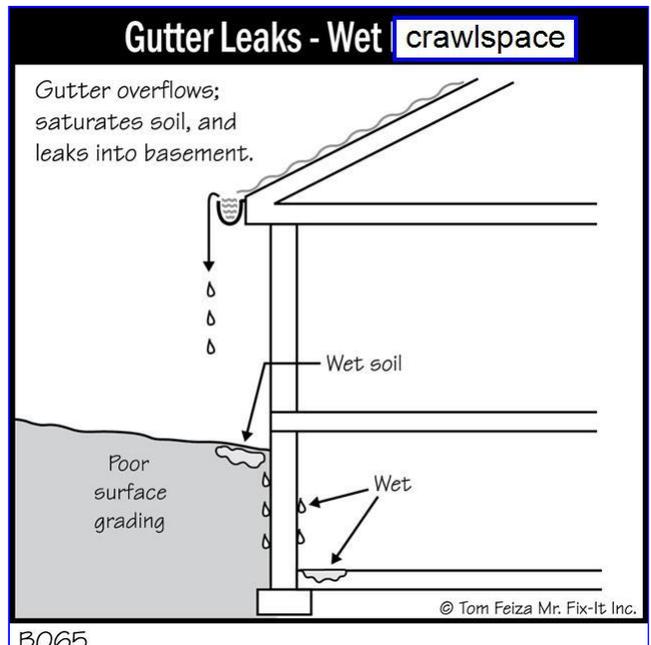
(4) The gutter(s) at the front of the home where indicated in the photos, especially where they drain into the downspouts, are full of debris and need to be cleaned. Gutters require cleaning to avoid spilling roof runoff around the building - a potential source of water entry or water damage. Recommend cleaning the gutters as needed.

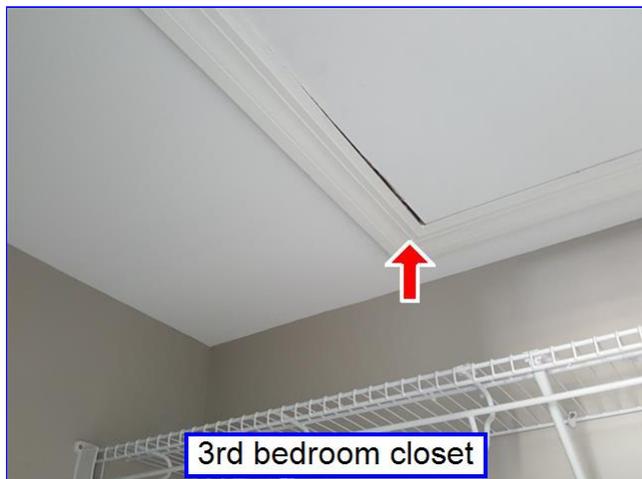
2.4 Item 3(Picture)

(2) The attic access in the 3rd bedroom door(s) does not fit the opening properly. This can cause some heat loss in winter and loss of cool air in summer if not corrected. Recommend replacement as needed.

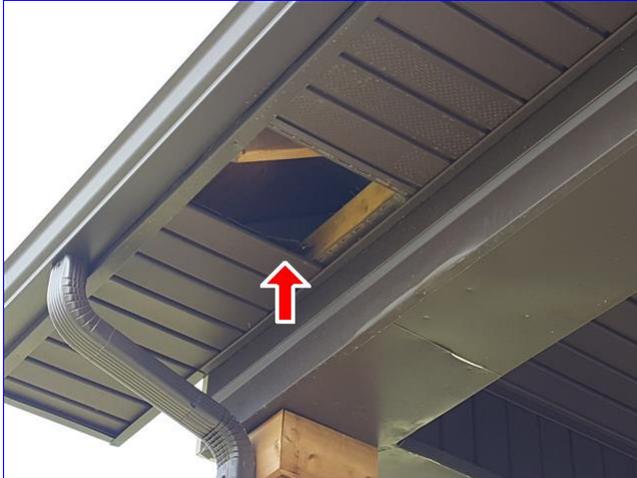
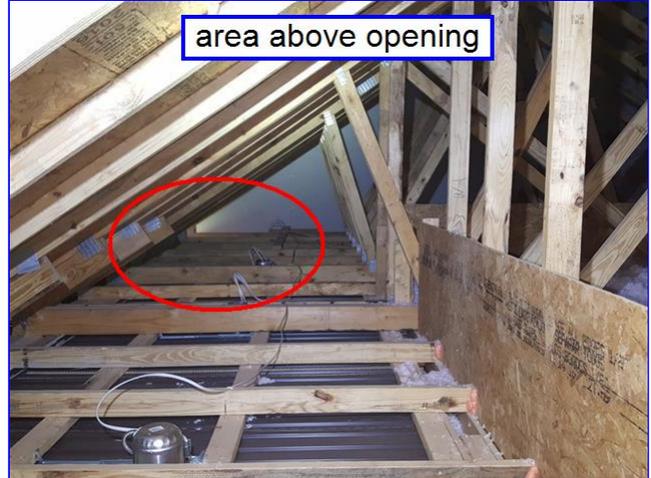
The soffit at the rear left corner of the home has an opening. These openings should be sealed to prevent entry of weather, rodents and insects. These openings can allow bees or wasps to enter which can lead to nests being formed in the attic. Also if water enters it can lead to deterioration of the roof structure and possible mold forming. Recommend a qualified contractor replace missing soffit.

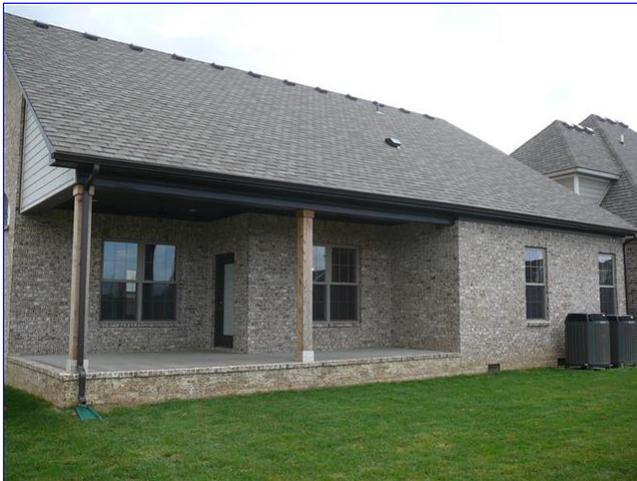
3.7 Item 1(Picture)

The rear patio floor area is above grade and is missing steps/staircase that leads to the ground. This is a potential safety issue which could result in a person injuring themselves via a fall. Strongly recommend a qualified contractor correct as needed for safety prior to moving in.

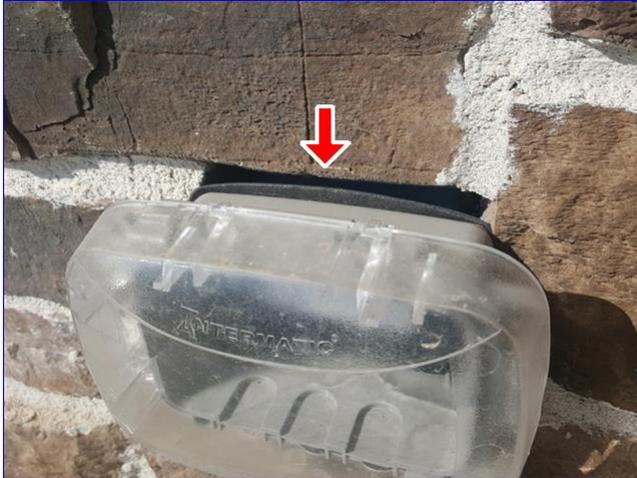
3.11 Item 1(Picture)

(1) Recommend sealing the gap between the wall and outlet at the front porch left side of door entry to prevent children being electrocuted by placing objects inside opening and to prevent water intrusion which may lead to a short or possible fire. This is a serious safety issue. Recommend repair as needed.

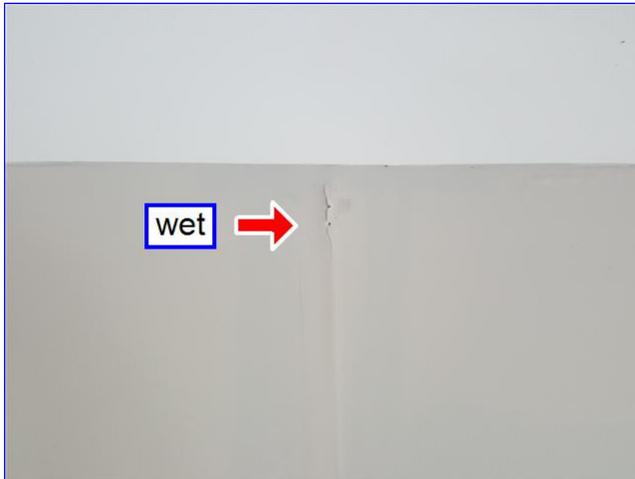
4.1 The wall in the garage right side is wet and moist. Mold and wood rot can occur if leakage is not repaired. This maybe due to the flashing, roof valley or roof leakage above between the outer wall and garage roof (see photo 4). Also refer to note 4.0. The step/side flashing was not inspected in this area due to visibility and access. Also could not access attic area. A diverter flashing may be needed in this area. Strongly recommend a qualified roofing contractor further investigate to determine cause and repair as needed prior to closing.

The wall in the garage right side is wet and moist. Mold and wood rot can occur if leakage is not repaired. This maybe due to the flashing, roof valley or roof leakage above between the outer wall and garage roof (see photo 4). Also refer to note 4.0. The step/side flashing was not inspected in this area due to visibility and access. Also could not access attic area. A diverter flashing may be needed in this area. Strongly recommend a qualified roofing contractor further investigate to determine cause and repair as needed prior to closing.

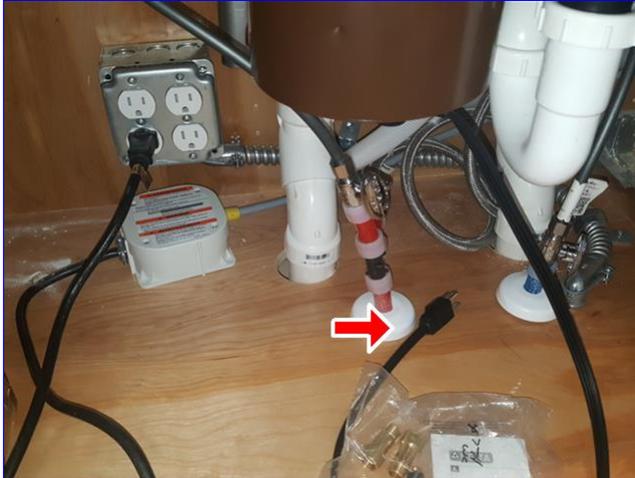
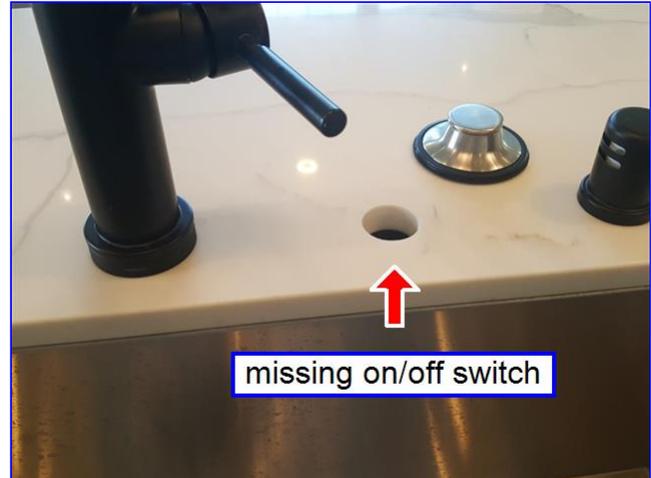
The disposer was not inspected for operation due to it was not connected to power at time of inspection. Also the on/off switch is missing. The disposer cannot be operated even if connected due to missing switch. Recommend a qualified appliance contractor install missing switch and verify disposal is operational prior to closing.

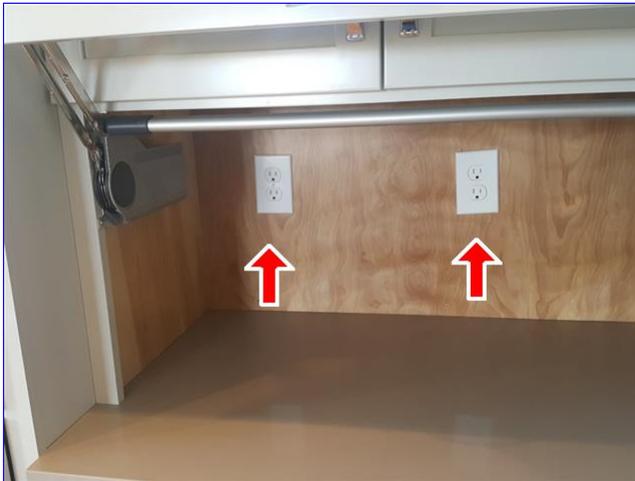
5.10 Item 1(Picture)

(3) The outlet(s) in the kitchen where indicated in the photo(s) are loose in the wall. Electrical issues are considered a hazard until repaired. This is a safety issue that needs to be corrected due to an electric shock or fire from loose connections could occur if not repaired. Recommend a qualified licensed electrical contractor correct as needed.

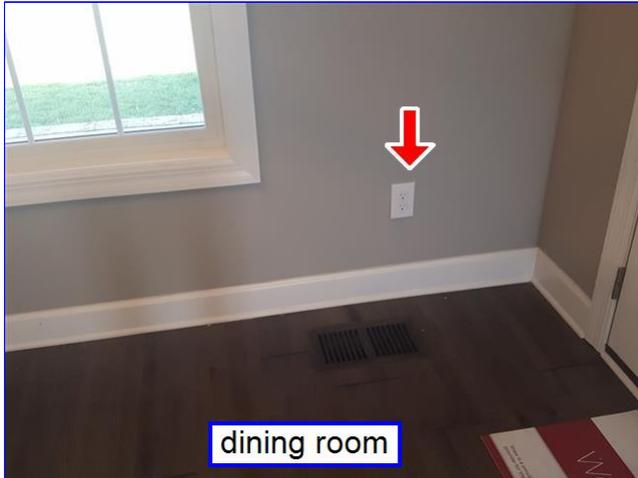
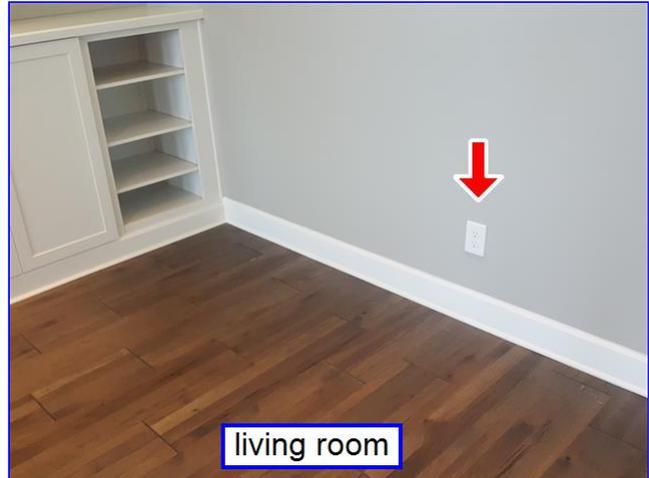
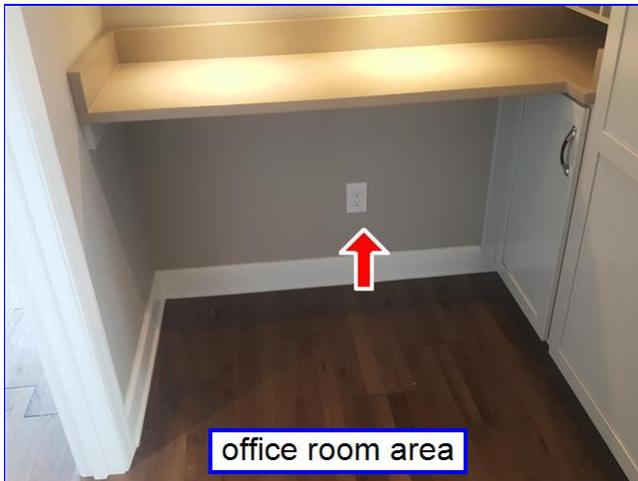
(1) The outlet(s) where indicated in the photo(s) are loose in the wall. Electrical issues are considered a hazard until repaired. This is a safety issue that needs to be corrected due to an electric shock or fire from loose connections could occur if not repaired. Recommend a qualified licensed electrical contractor correct as needed.

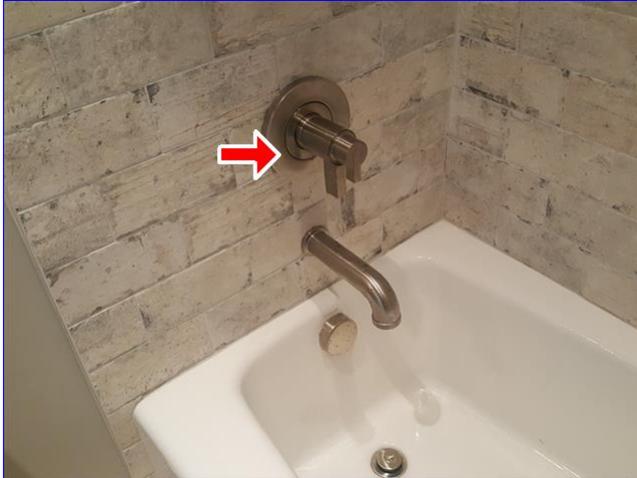
7.4 Item 1(Picture)

The faucet for the tub in the 2nd bathroom does not appear to direct all the cold water to the faucet when the lever is activated. Warm water was experienced only when the lever is set for cold water only. This can be a safety issue as a small child could injure themselves via scalding trying to receive cold water only. Recommend a licensed plumber further evaluate and repair or correct as needed.

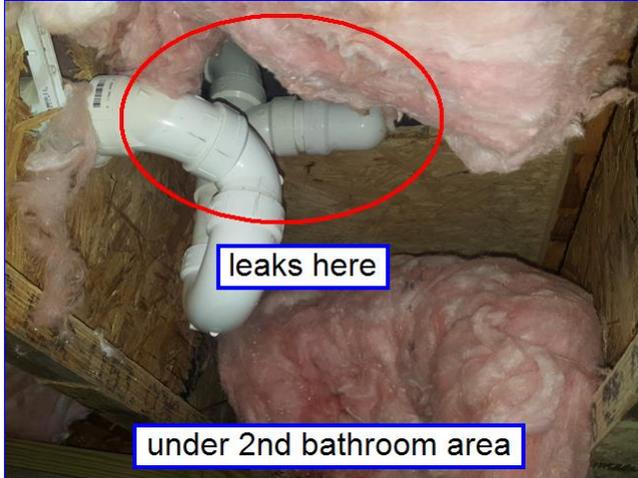
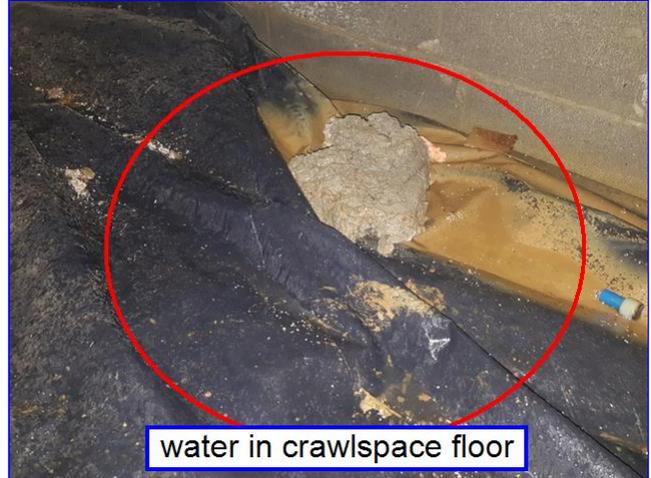
(2) The drain line in the crawlspace below the shower and tub in the 2nd bathroom area has a major water leak. Water leakage was experienced when faucet was turn on, drain plug sealed, and when water was drained in the tub. Cannot determine cause or how water is leaking. It maybe due to drain plug not sealing and there is a leak at the drain line. Water in a crawlspace can lead to mold or damage to the floor structure if not repaired. Recommend a qualified plumber further investigate, repair leaks prior to closing to prevent costly repairs in the future.

8.0 Item 4(Video) while faucet was turned on and water holding in tub

8.0 Item 5(Video) while tub was drained

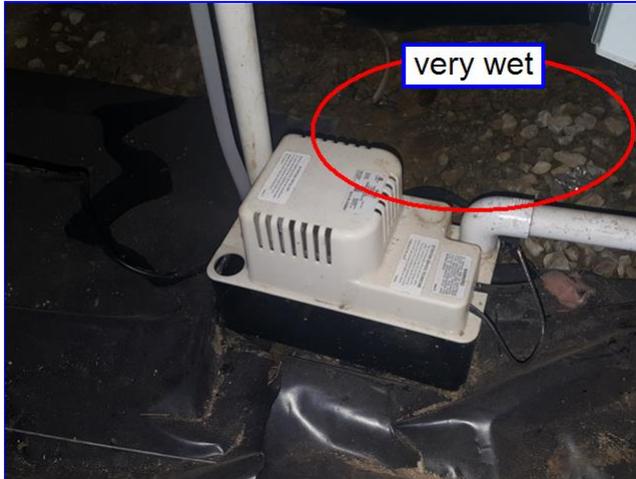
(2) The condensate pump did not appear to be functioning at the time of the inspection. Water was leaking at the pump onto the crawlspace floor. The unit was full of water. Water in a crawlspace can lead to mildew or mold to form. Recommend a qualified HVAC contractor further investigate and repair or replace as needed.

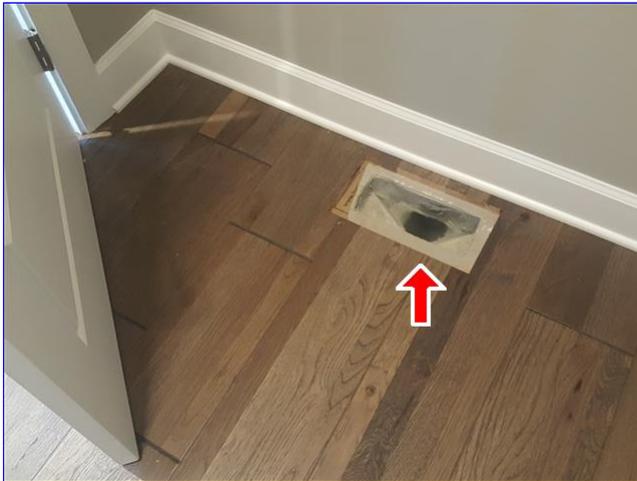
10.4.A Item 1(Picture)

(2) The supply register is missing a cover grill at the Washer/Dryer room. This is a safety issue as a small child or pet may fall into the hole or get stuck which may cause an injury. Also objects may fall down inside causing a blockage of air flow which can cause damage to the blower or force duct joints to dislodge at the connection between the boot cover. Recommend installing a grille cover over the hole prior to moving in.

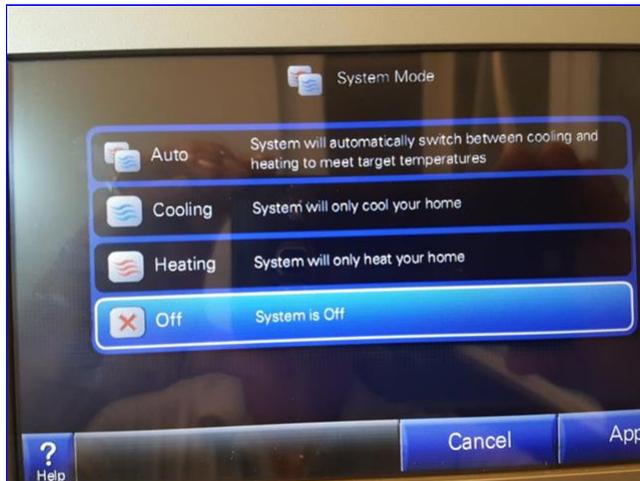
10.6.A Item 1(Picture)

The thermostat does not have the emergency heat mode to suit the heat pump. Recommend replace as needed by a qualified HVAC contractor in order to operate the emergency heat at the heat pump when needed.

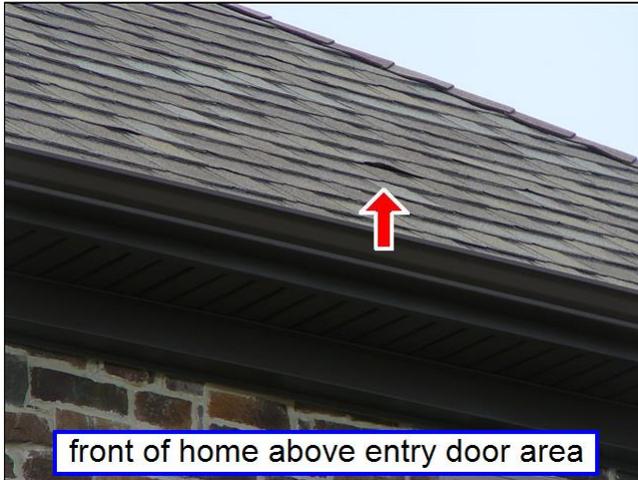
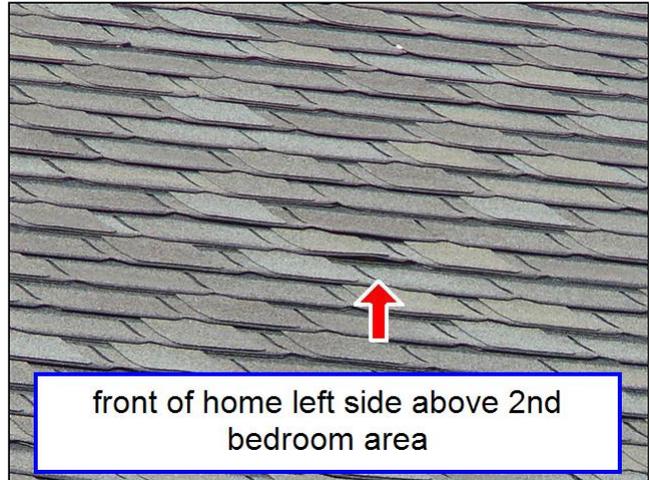
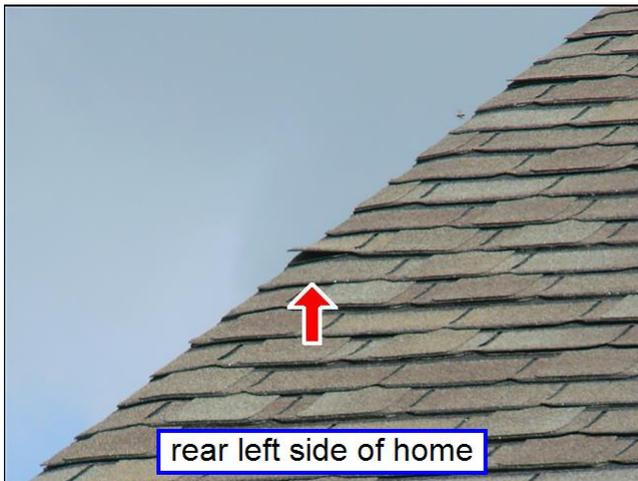
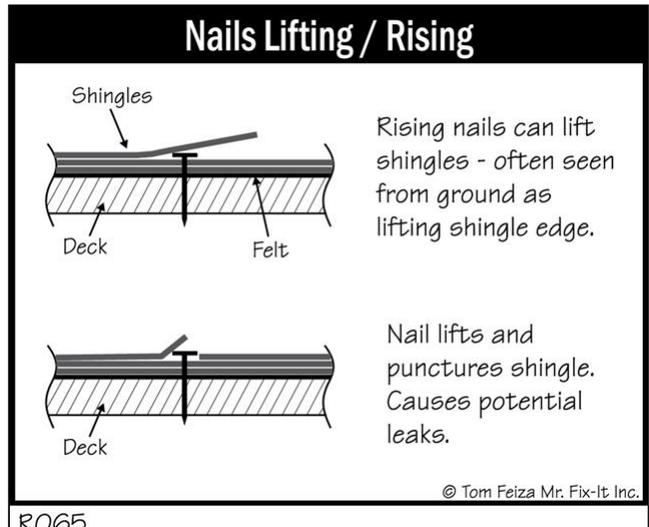
The shingles are lifting where indicated in the photos in various places, (see photos for location) due to nails are starting to "back out" which causes the shingle tabs to raise, or the sealant of the shingle tabs has failed. Shingle damage or roof leakage can occur at these areas. They are also at risk to be blown off by high winds. If they raise

the shingle more than 1/2" the nails should be reseated to prevent water entry under the shingles. Recommend a qualified roofing contractor repair as needed.

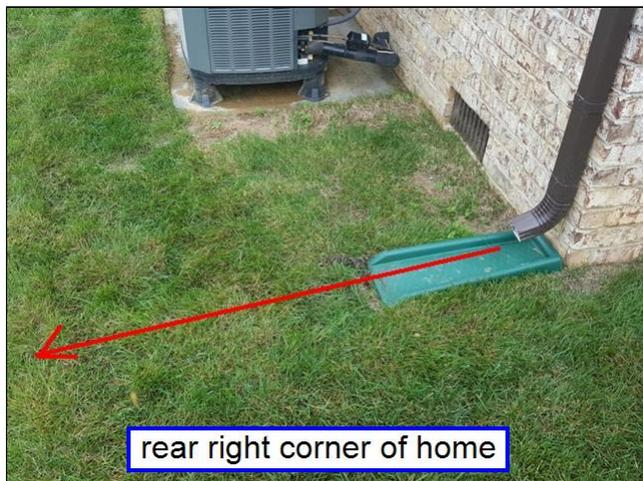
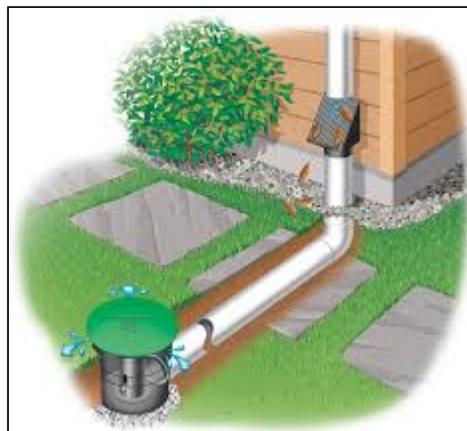
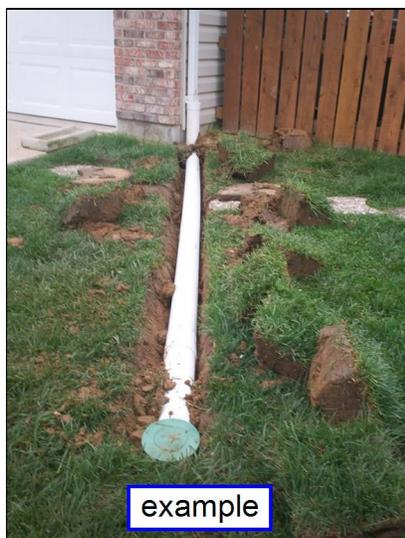
(3) Recommend the downspout(s) around the perimeter of the home be extended at least 5 feet and flow onto splashblocks. This will ensure water is kept away from the foundation perimeter, soil erosion does not occur and water cannot leak into the crawlspace area via the vent which may cause settlement of the foundation.

Note: You may wish to consider burying the extension to prevent a tripping hazard. See photos for example.

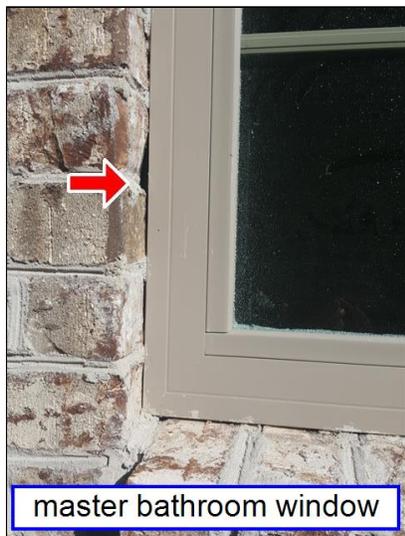
3.3 Item 1(Picture)

The majority of the window frames around the home have missing sealant between the siding and the window frames. Water and/or insects may enter and deterioration may occur behind the wall cavity and siding. This is a small repair. Recommend re-caulking as needed. [Which caulk to use](#)

master bathroom window

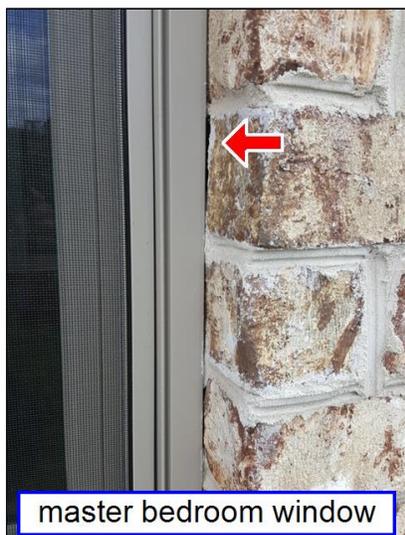
3.3 Item 4(Picture)

master bedroom window

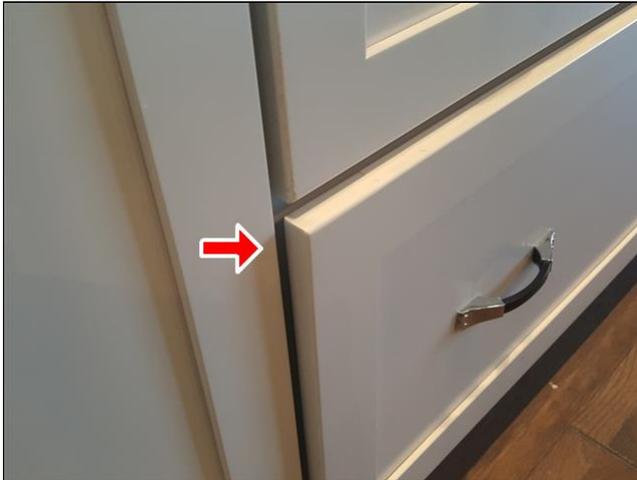
5.9 Item 1(Picture)

(1) drawer front below the stove top does not close flush against cupboard frame. Minor adjustment or replacement of hinges is required. This is a cosmetic issue for your information. Recommend repair or replace as necessary.

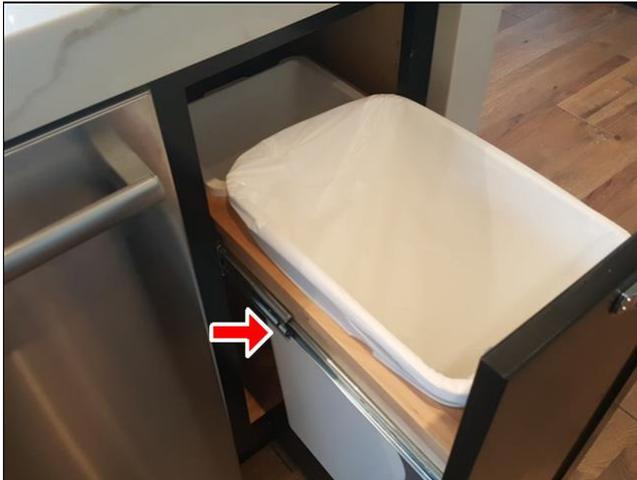
(2) The trash compartment drawer squeaks when operated. This can cause wear on the the tracks. Recommend a general contractor correct and repair as needed.

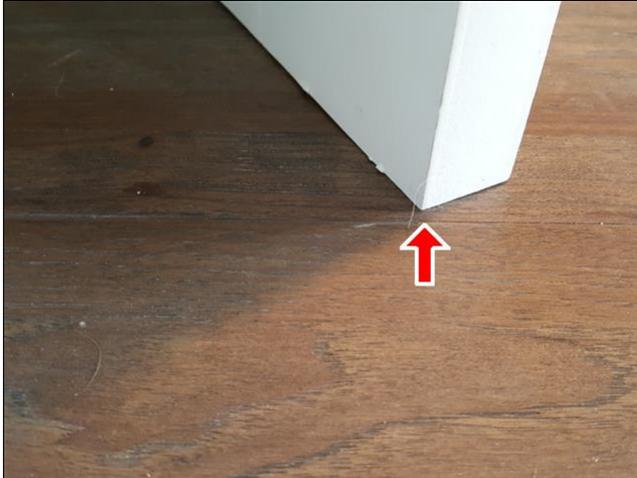
6.4 Item 1(Picture)

(1) The door between the main entry and the 2nd bathroom on the ground floor needs to be trimmed at the bottom. The door is difficult to operate and rubs the floor when opened which can damage the floor covering. Recommend a general contractor repair as needed.

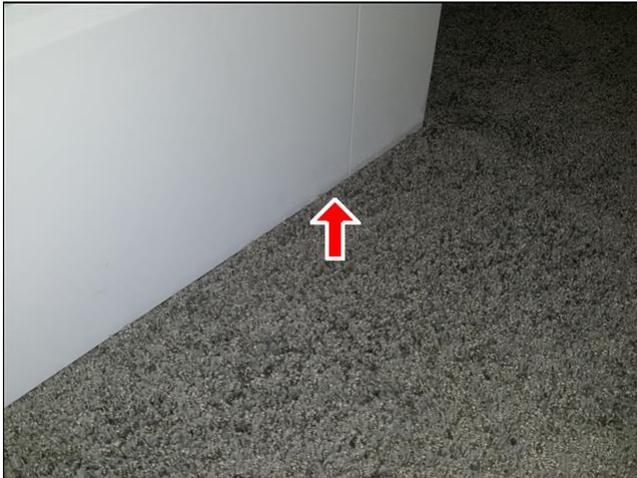
6.4 Item 2(Picture)

(2) The door in the 2nd Bedroom closet rubs on the carpet when opened and closed. The bottom of the door needs to be trimmed to prevent wearing the carpet. Recommend a general contractor repair as needed.
