TALON
Home Inspections

Inspection Report

Property Address:
4100 Mangini Street
Lexington KY 40509

Date: 9/15/2017	Time: 10:00 AM till 02:30 PM	Report ID: 170915BISHOP
Property: 4100 Mangini Street Lexington KY 40509	Customer: Ms. Amy Bishop	Real Estate Professional:

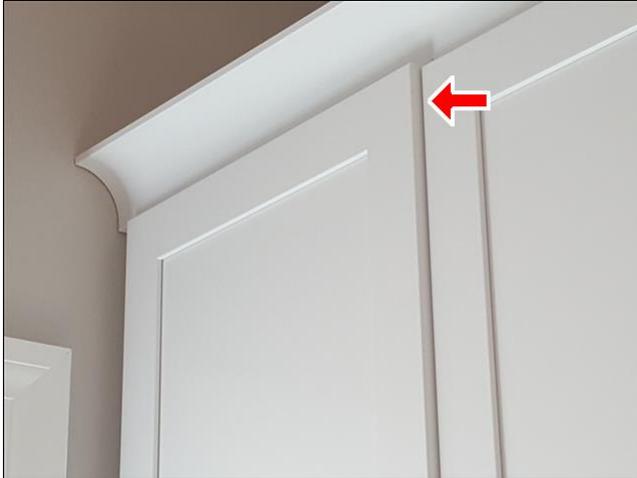
7.1 Item 1(Picture)

The cabinet door in the master bathroom near the window does not seal flush with the cabinet when closed. An adjustment of the hinge maybe required. Recommend repair or replace as necessary.

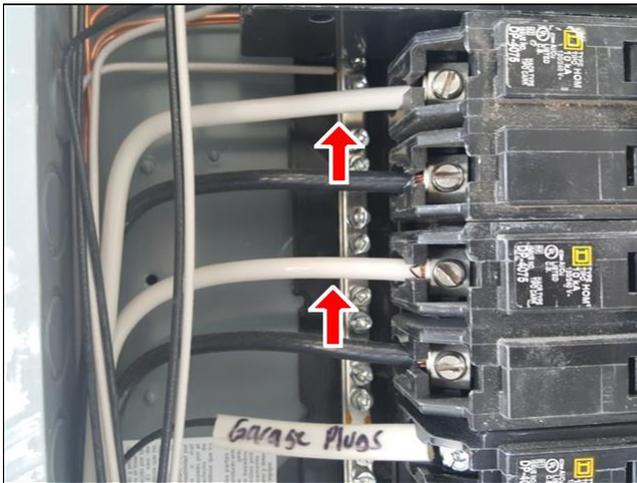
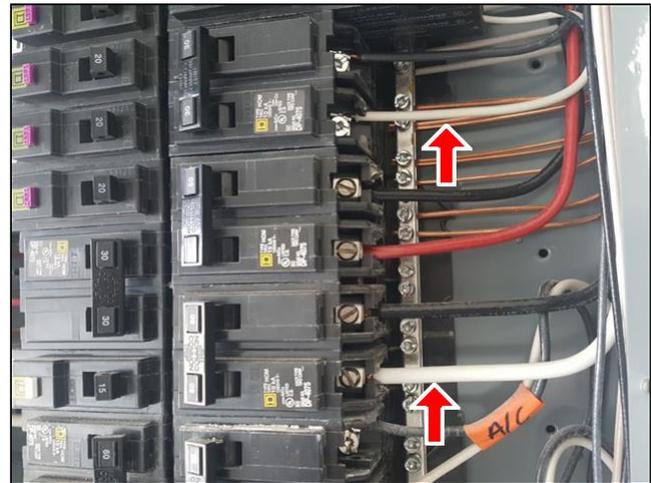
The white wire(s) that are connected to the circuit breaker(s) should be marked black to indicate that they are live (hot wires) and are being used for the flow of electricity to travel. Recommend an electrician correct due to safety.

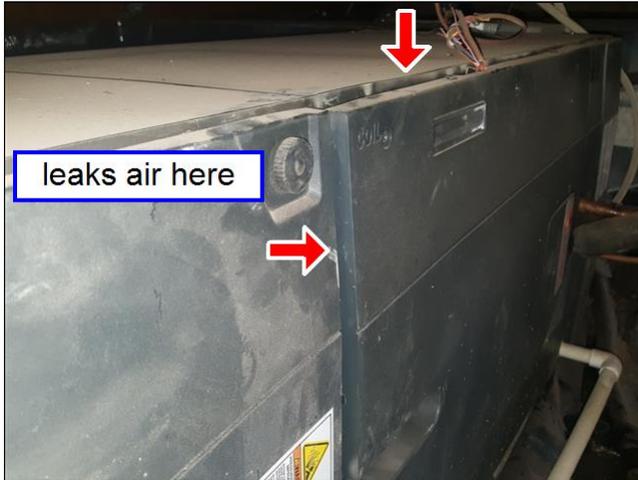
10.0.A Item 1(Picture)

(2) The cover is not secured correctly at the air handler in the crawlspace and leaks air. Besides inefficiency of cooling and heating the home the air escaping into the crawl can lead to mildew or condensation to form in the crawlspace. Though this wasn't evident at the time of the inspection, for efficiency would recommend a qualified licensed HVAC contractor correct and repair as needed.

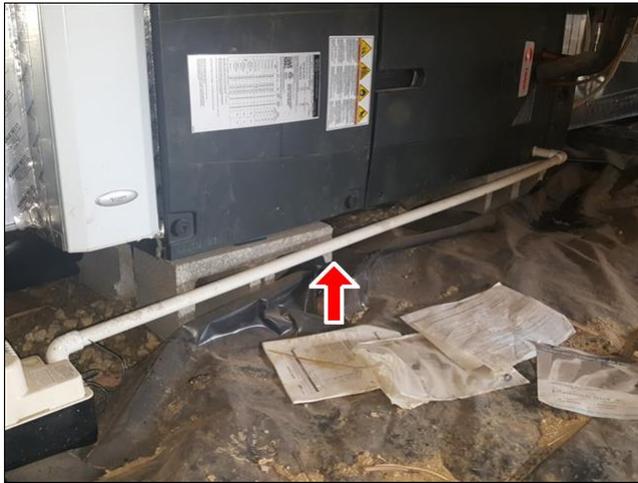
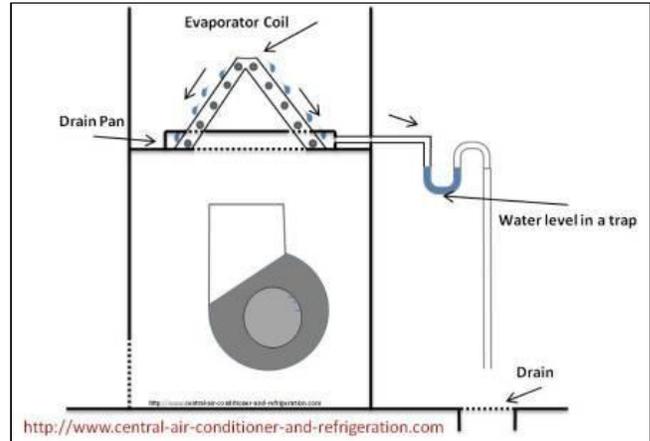
(3) There was no visible condensation trap installed at the condensate drain line for the Air Handler in the crawlspace. It is recommended by the manufacturer to have one. The purpose of the trap is to allow the water to drain freely, with out it air flowing in the drain line can cause the water to not flow (drain to the exterior). Recommend a qualified HVAC contractor correct as needed.

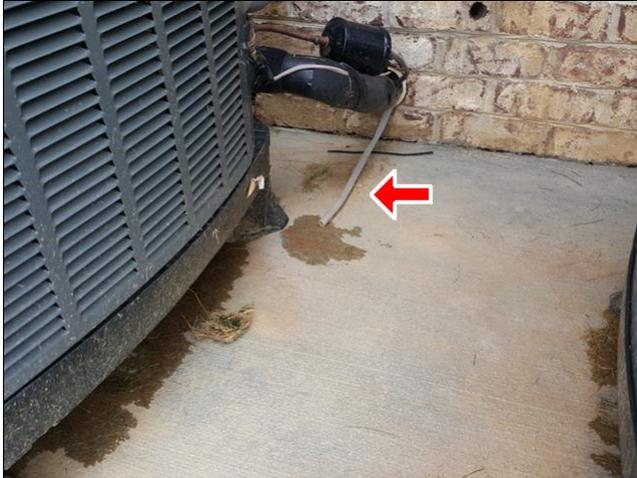
10.3.A Item 6(Picture)

(4) Recommend the discharge for the condensate drain line be improved via extending the drain line at the rear right side of the home. This will prevent water pooling near the foundation which could cause settlement of the foundation wall and water leakage into the crawlspace. Also to prevent possible settling of the platform for the Heat Pumps. A qualified HVAC contractor is recommended for these repairs.

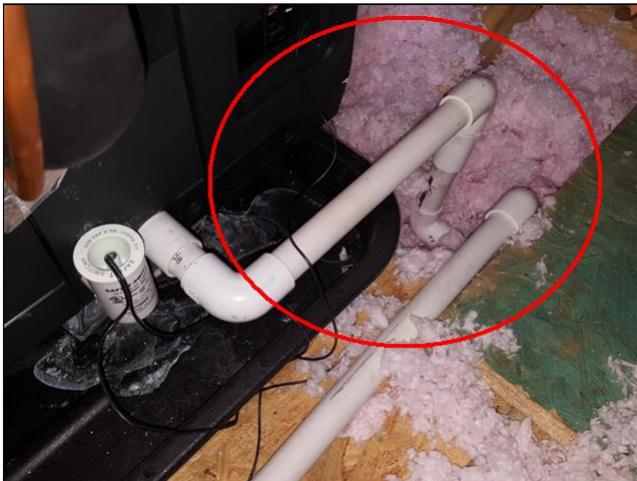
10.3.B Item 3(Picture)

(2) There was no visible condensation trap installed at the condensate drain line for the Air Handler in the attic. It is recommended by the manufacturer to have one. The purpose of the trap is to allow the water to drain freely, without air flowing in the drain line can cause the water to not flow (drain to the exterior). Recommend a qualified HVAC contractor correct as needed.
