Evaluation of Publicly Maintained Bioretention Facilities

Does good maintenance guarantee optimum performance?

Phase I and II studies

A Fairfax County, VA, publication
April, 2017

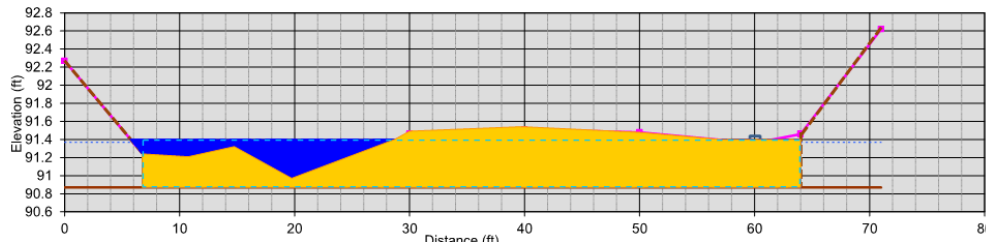
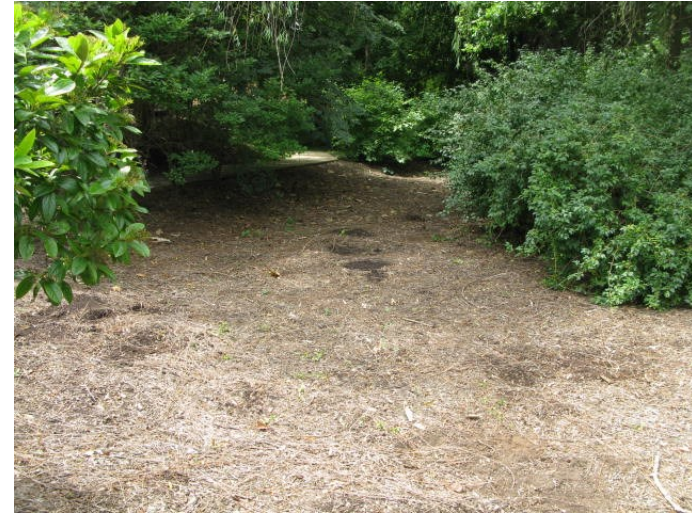
Repair priority rating criteria 1345BR

Evaluation	Design	Actual	Missing	Points
Ponding depth	0.5 ft.	0.1 ft.	80%	7.5
Infiltration rate	8.0 in/hour	24.0 in/hour	-	2
Structural damage				2
Total Points				11.5

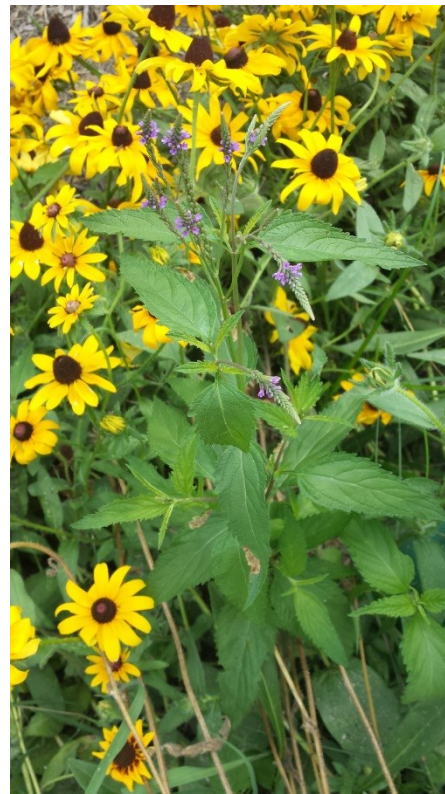
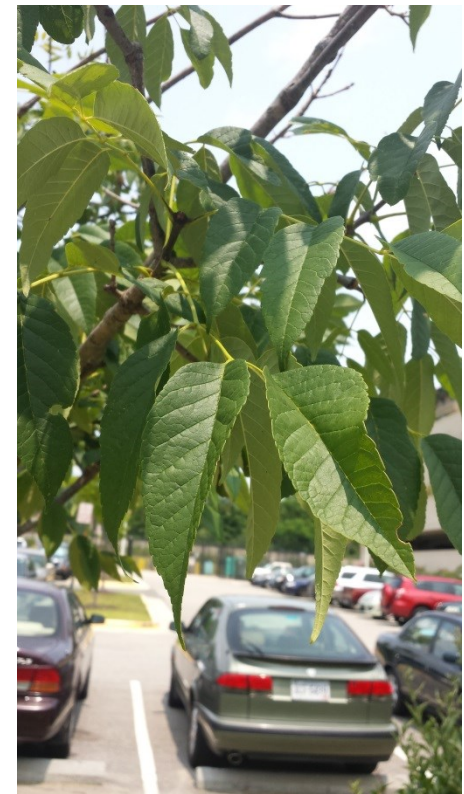
Plants Survey

- The survival rate of the original plantings*
- Plant species that survived best*
- Dominant voluntary plants (weeds, perennials, shrubs, and trees)*
