3871 Piedmont Avenue, #15, Oakland, CA 94611 www.stargroup.com Office – 510.482.8016
Residential and Commercial Building Inspections Since 1979

123 Easy Street
Oakland, CA
July 7, 2017 - 12:00 pm
Report Number 170707Customer

This Report Prepared for
Mr. Customer

We inspected the three-level, commercial building at 123 Easy Street in Oakland, California on July 7, 2017.

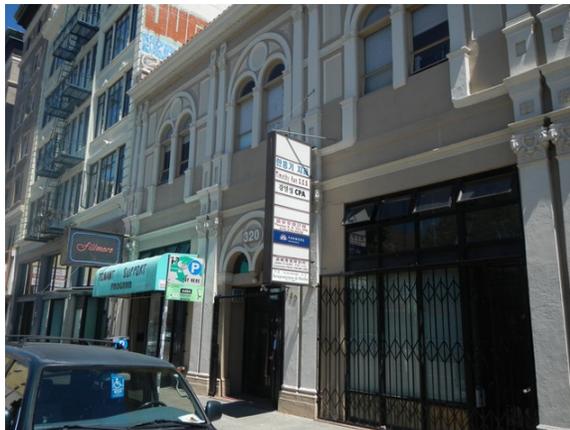
We were informed the building was constructed in 1920.

Modifications have been made to the building since its original construction, including the addition of a second floor between the original two floors. We recommend a permit history be obtained from the local building department to determine if modifications to the building were made with proper permits.
