Home Inspection Report

123 Main Street, Anytown, NY 12205

Inspection Date:

Friday, January 17, 2025

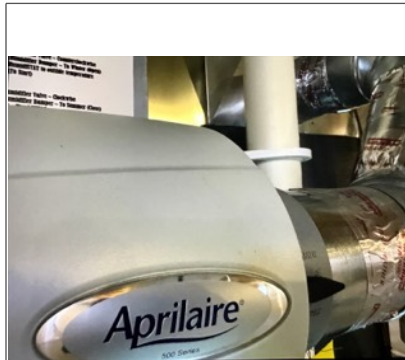
Humidifier

- The humidifier has lacked maintenance. Cleaning and repairs should be undertaken. Watch out for humidifier leaks into the furnace where costly (and hidden) damage can occur. As it is virtually impossible to balance the use of moisture in a furnace, use the humidifier only when needed and ideally not for long periods of time. Moisture in the duct work can risk the presence of insects and rusting of the ducts.

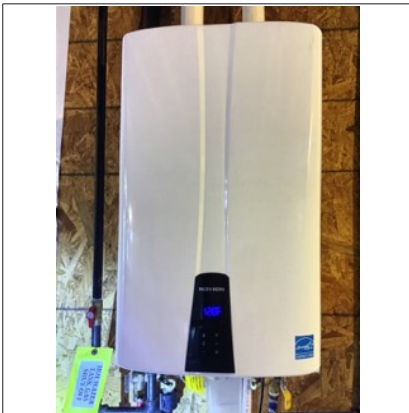
- Water heater** •**Tankless Combination Boiler Type Water Heater**
 •**Power Source: Gas**
 •**Manufacturer: Navien**
 •**Model Number: NPE180ANG**
 •**Serial Number: 7410R1261702238**
 •**Location: Basement**
 •**Manufactures Date: 2012**

- Water heater unit** •The existing unit is approaching the middle of its typical life age range. One cannot predict with certainty when replacement will become necessary.
