Report: 3732

Confidential Inspection Report

February 14, 2025

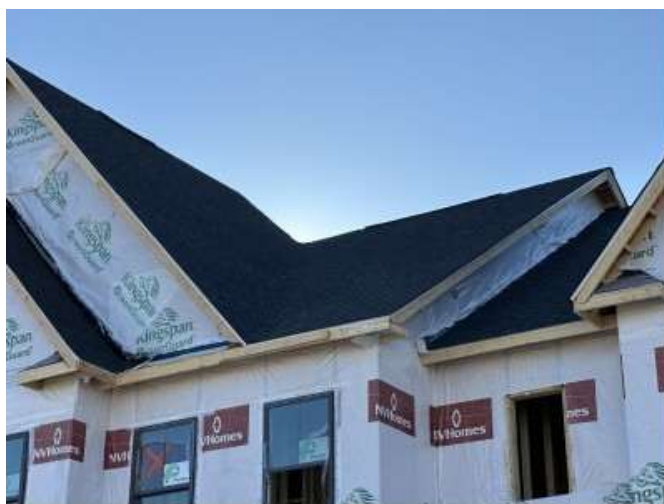
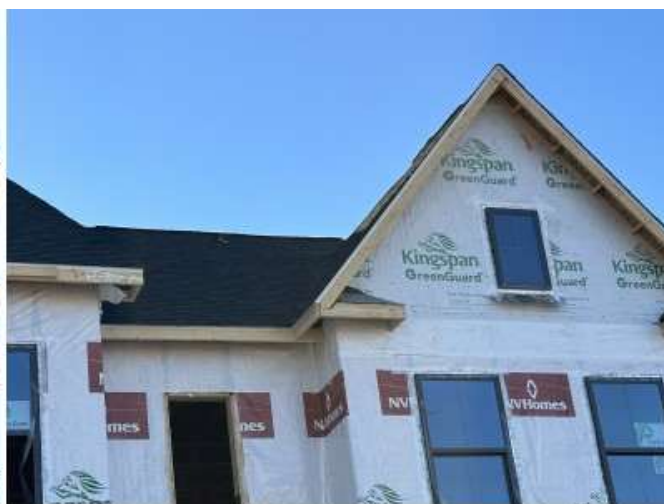
Gable.

New construction roofs are not walked on to protect the builder's installation. High winds prevented drone inspection.

Roofing material appears to be in good condition for its age and nature. Roof was observed for water flow management and proper installation standards. No defects were noted.

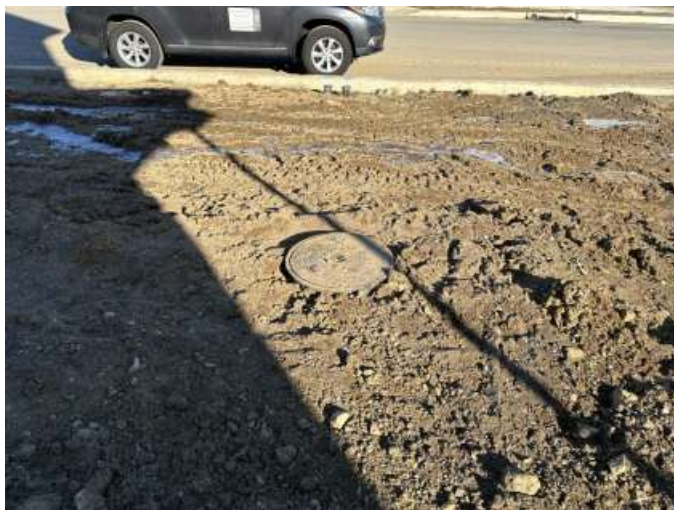
Public water, Meter located under cover at front exterior.
