# Inspection Report

CLARO HOME INSPECTIONS LLC

## Property Address:

Los Angeles, CA 90044

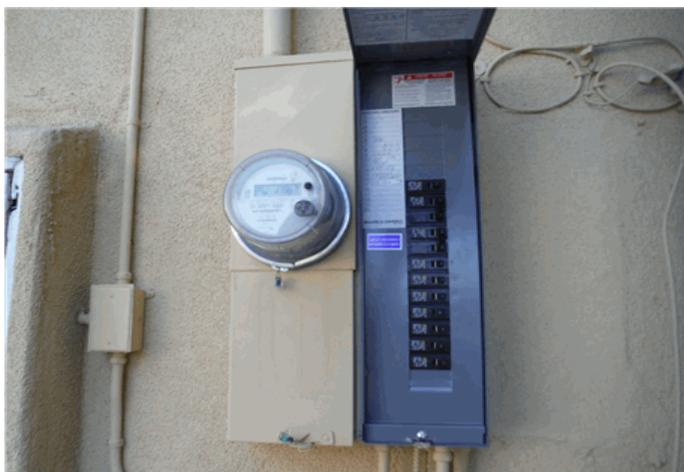
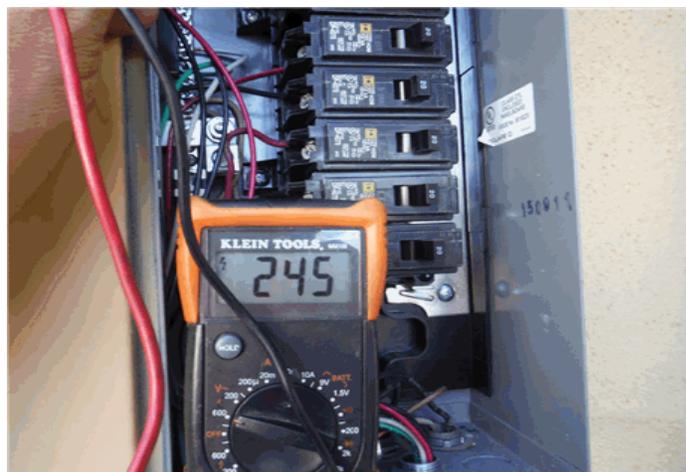
### 3) Electric Utility

Electrical service was provided to the home by the electrical public utility, via overhead service conductors. Voltage was tested and well within guidelines.

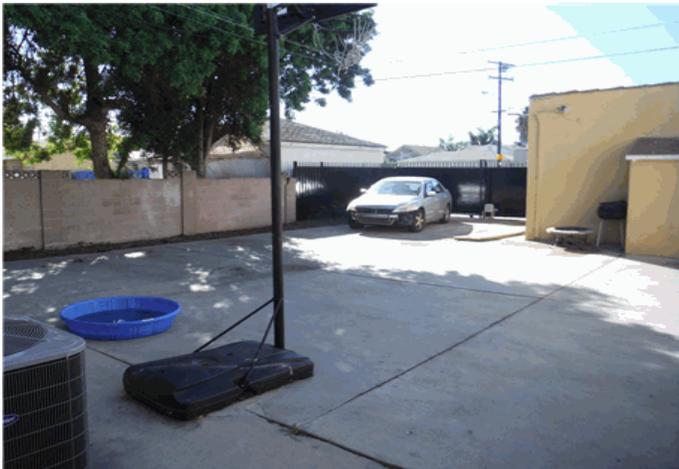
The driveway appeared to be in serviceable condition at the time of the inspection. Common cracks were observed in the driveway. Recommend maintenance as needed. Areas covered by parked car, could not be inspected.

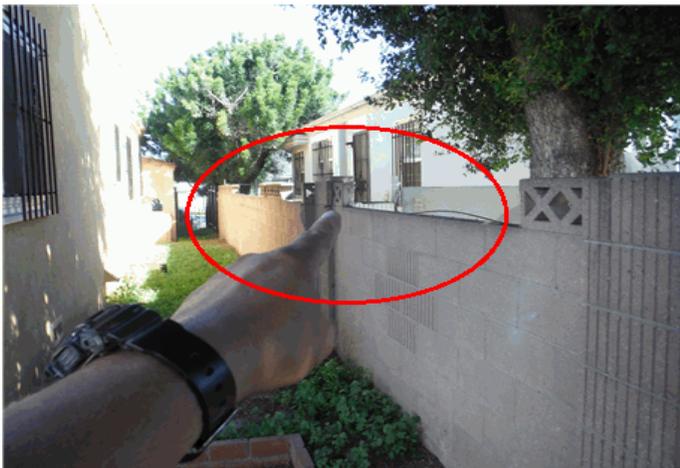
The visible and accessible portions of the block walls appeared to be in serviceable condition at the time of the inspection, **However settling, step cracks and missing blocks were noted. Monitor cracks and make repairs as needed.**

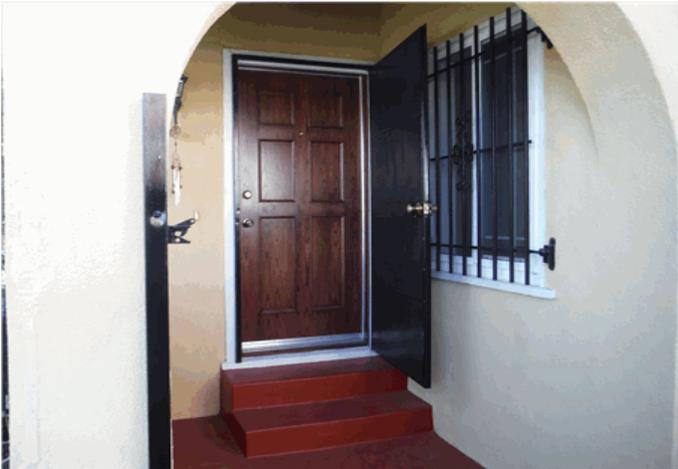
The main entry door was tested and found to be in functional condition. Door show signs of average daily use. The door had minor cosmetic blemishes. There were no signs of water infiltration at the time of the inspection.

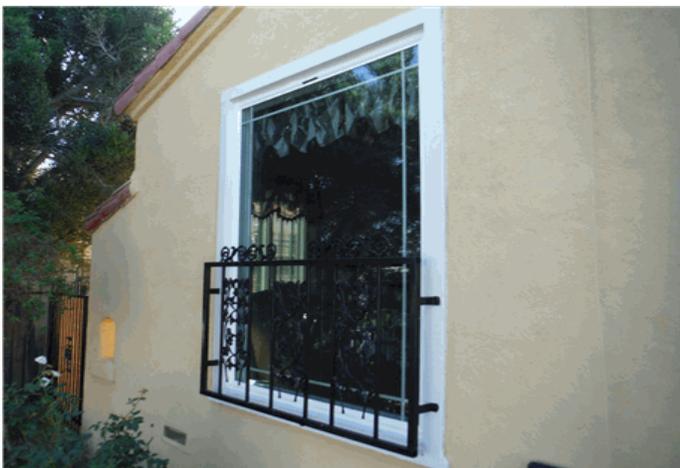
Windows that were tested were found to be in functional condition. Windows show signs of average normal wear and tear. Replace damaged or missing window screens as needed.

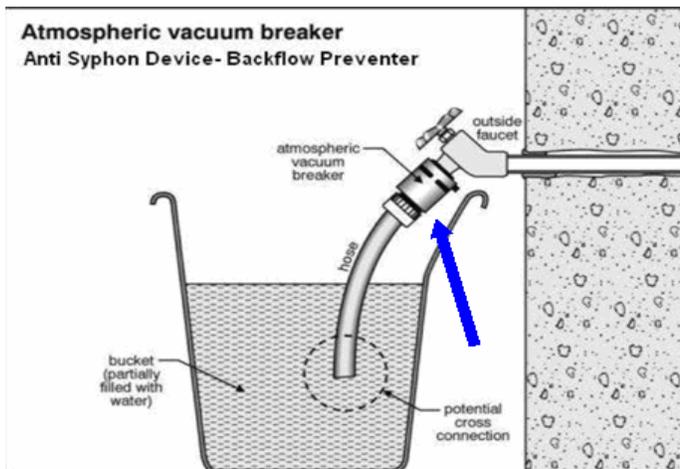
Back-flow preventers should be installed at all hose bibs to prevent back-flow contamination to the home's drinking water. Maintenance, such as tightening of the packing nut, or replacements may be needed to prevent leaks while hoses are in use.

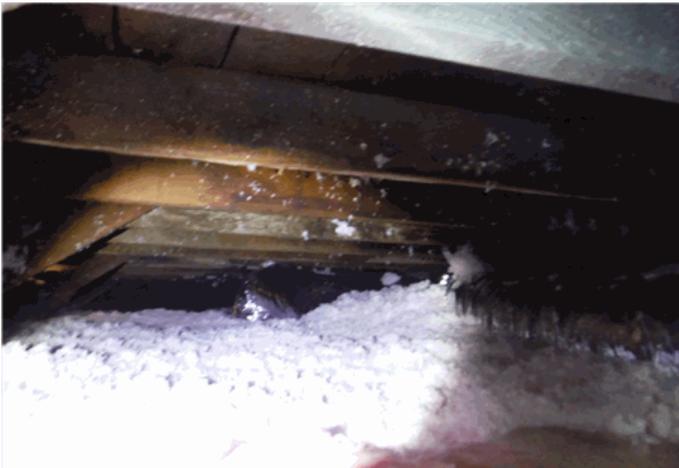
Approximately 5% of the roof deck was visible from the attic areas. There was no damage to roof deck in any of the visible areas.

Client should note that garage attic was not accessible for inspection.

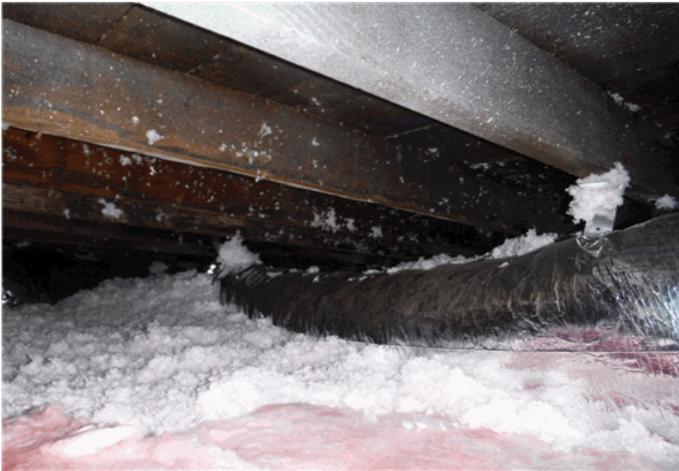
Insulated flexible ducting was utilized for distribution of heating and air were visible.

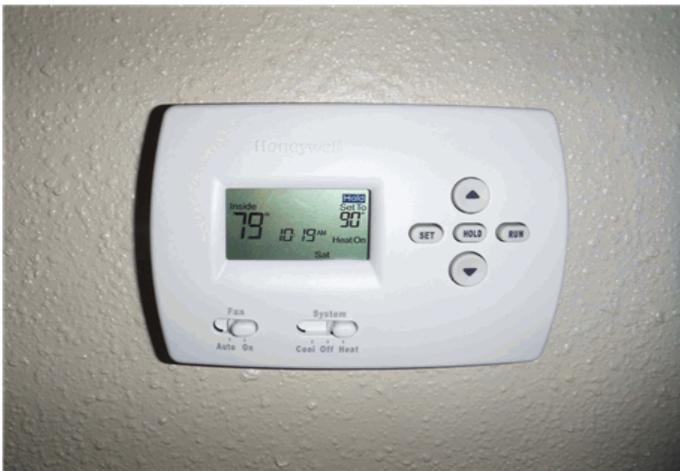
32) Thermostat Condition

The thermostat was tested and found to be functional on the day of inspection. Evaluating the calibration of the thermostat is outside the scope of the general home inspection.

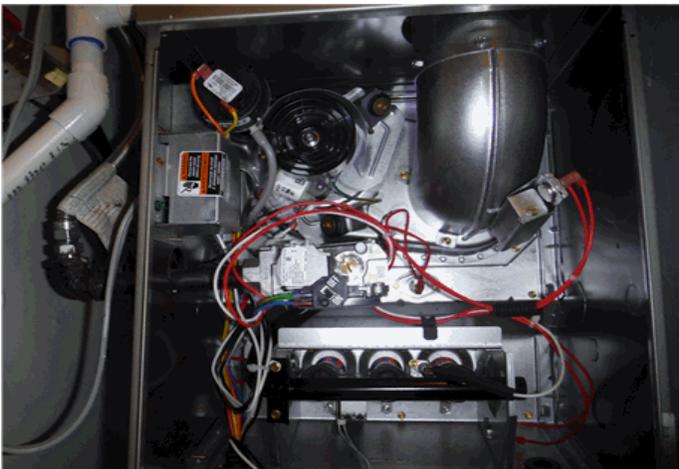
34) Shutoff Gas Valve, Line and Drip Leg

There were no apparent signs of gas leaks from this appliance.

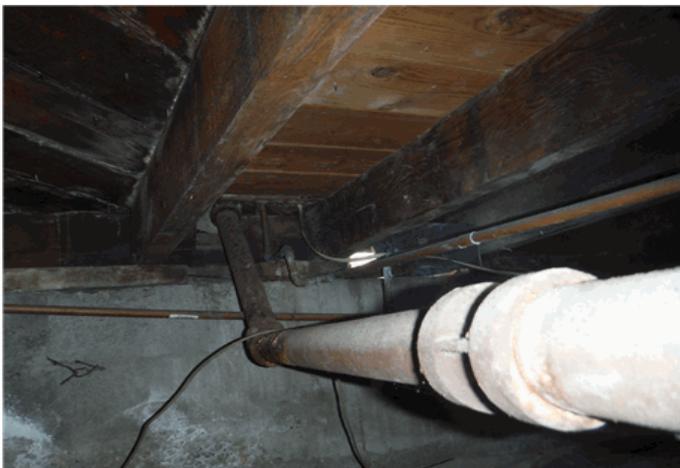
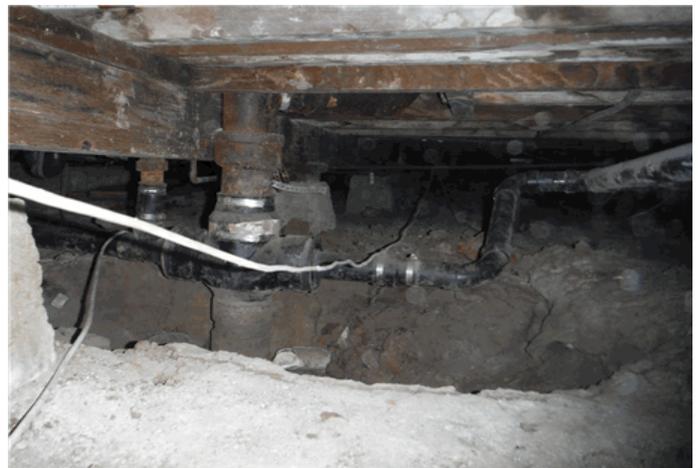
All drains that could be tested were inspected for connection and drain quality. Drains were free-flowing. Toilet paper is not utilized during testing of the drain lines. Client declined a sewer line inspection. This limits our liability regarding any drain line conditions below the home and under soil.

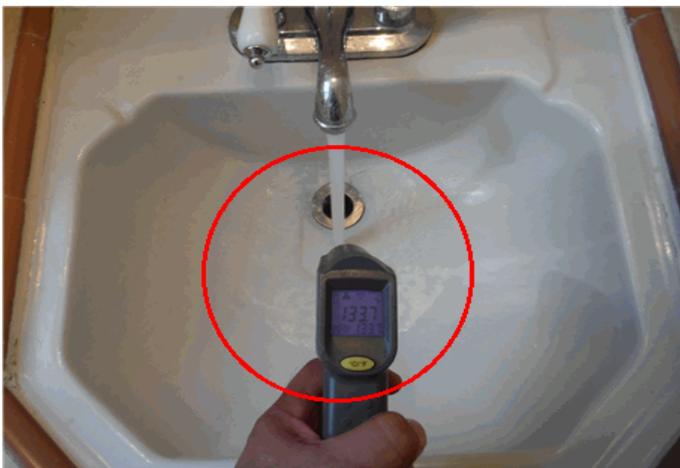
43) Water Heater Condition

The hot water heater is functioning beyond manufacturers life expectancy. Client should consider the cost of upgrades. Consult with a licensed plumber for cost of replacement. Hot water heater temperature was measure at 133°. A desirable temperature between 110° and 120° it's recommended for safety.

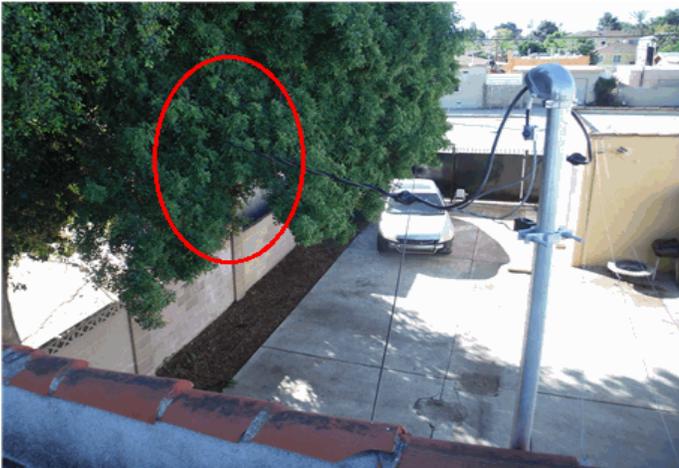
Power is fed to the structure via overhead service utility. This is a common method for providing power to modern residential homes. The main service entry appeared to be in serviceable condition at the time of inspection. The main service drop wires from the pole to the house were in contact with tree limbs. Local utility company should be contacted for trimming.

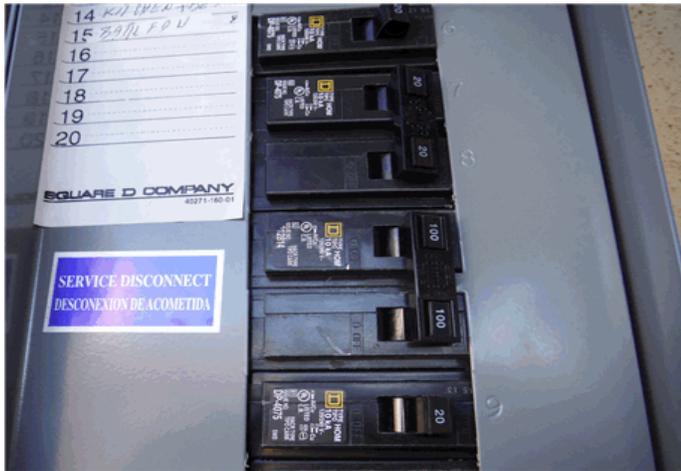
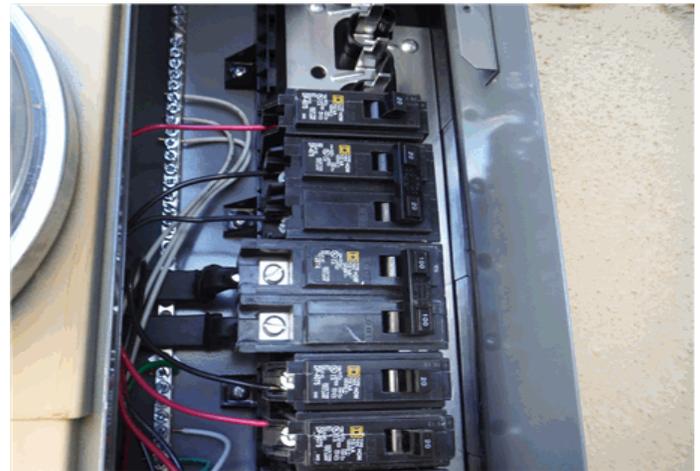
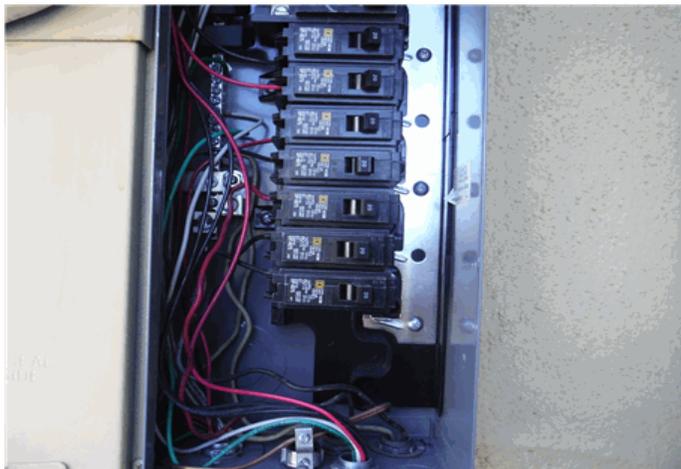
The main panel appeared to be in serviceable condition, there was no evidence of overheating, corrosion or damage at the time of the inspection.

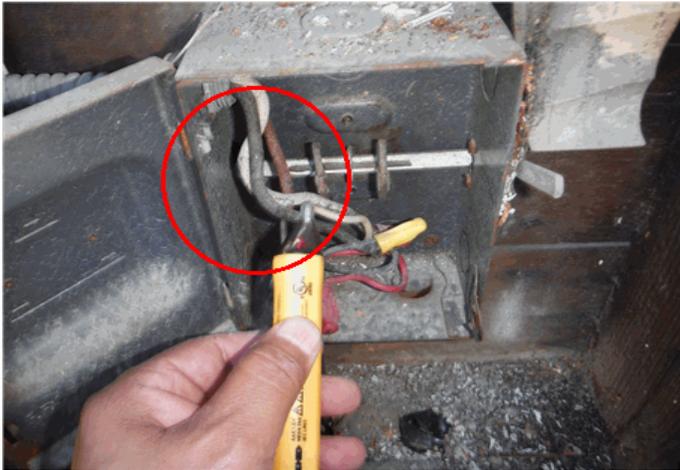
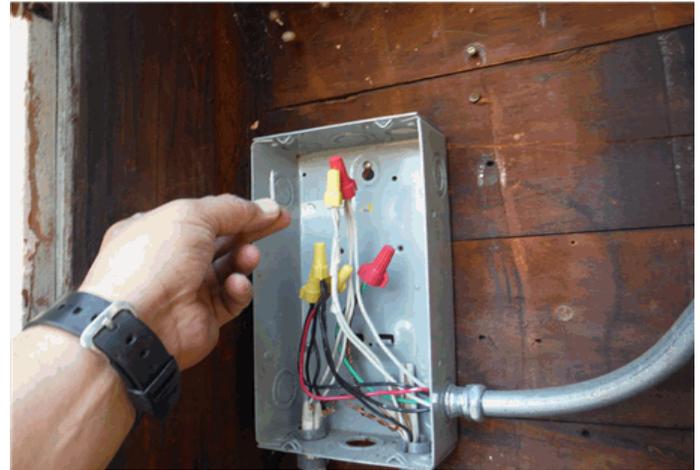
#### 51) Wiring Methods

The use of sheet metal screws at junction box observed, recommend replace with approved materials.

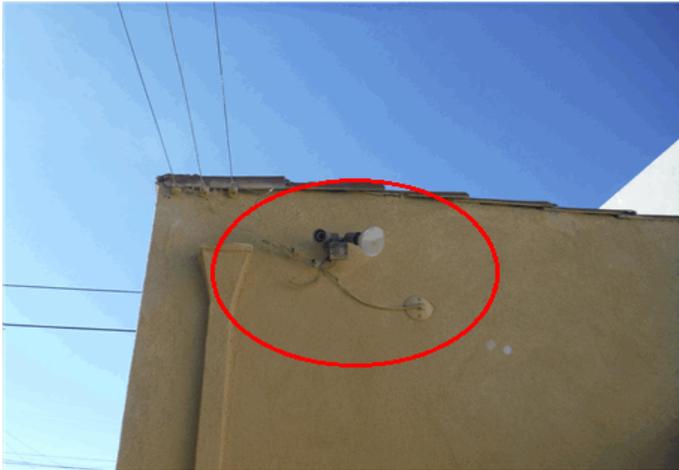
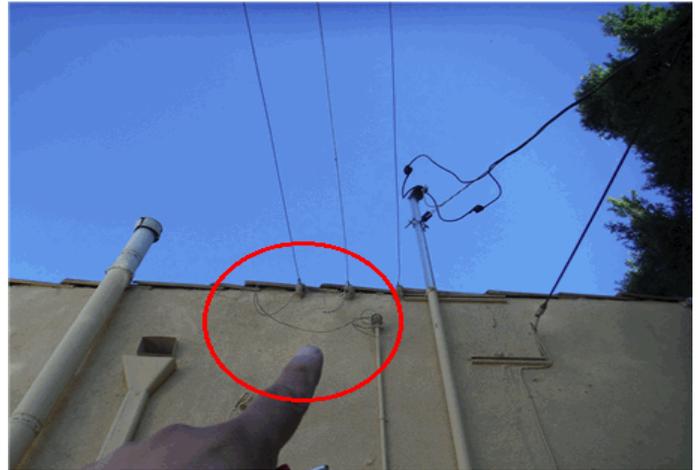
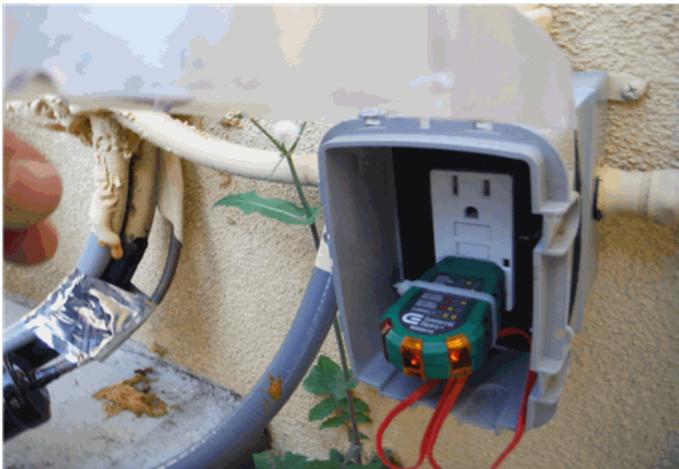
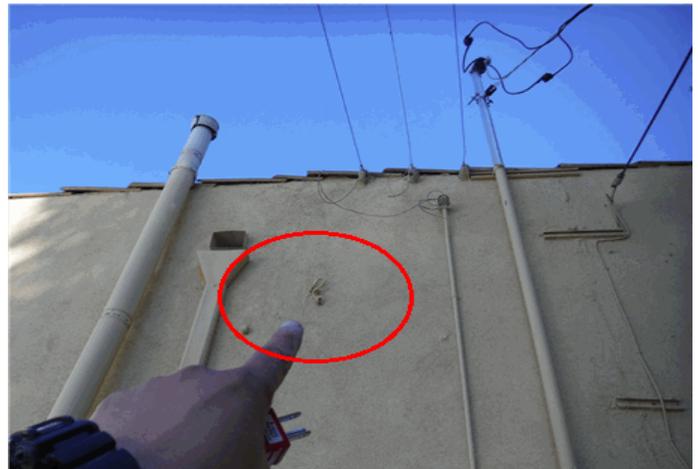
53) Exterior Lighting and Receptacles

Exterior receptacle outlets that were tested were found to be functional.  
 All exterior light fixtures should be properly sealed to the structure.  
 Consult a license electrician to install wiring in appropriate junction box for exterior use, missing junction box, not approved for exterior romex.

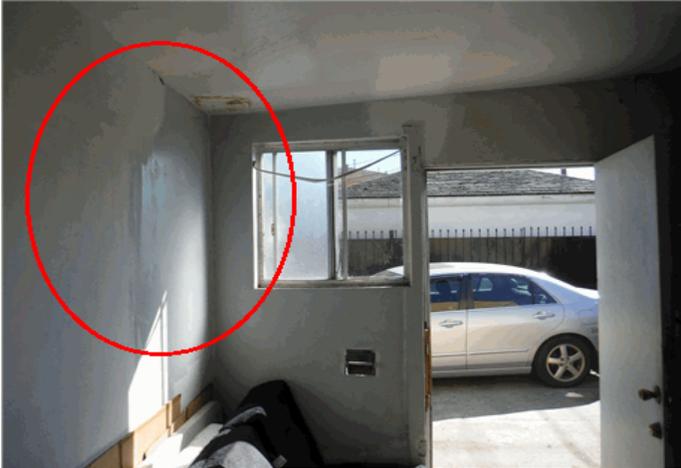
56) Wall Conditions

While the walls appeared in average condition, general patch and paint is needed in some areas.

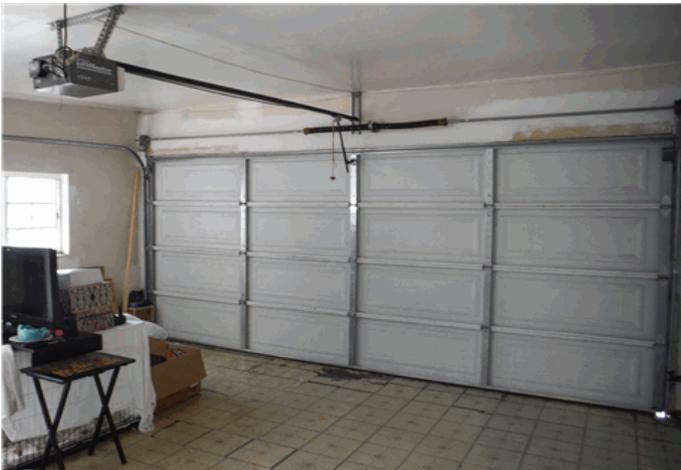
57) Ceiling Conditions

The ceilings were in functional condition for a garage location.

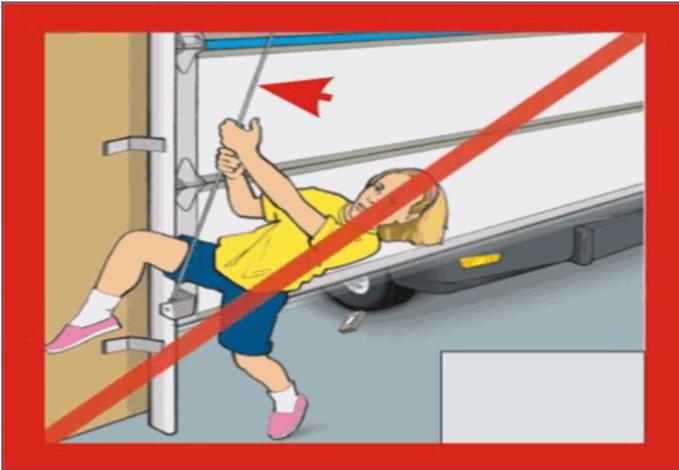
58) Garage Vehicle Door

The garage vehicle door was tested and found to be functional on the day of inspection. Sectional roll-up doors have a unique set of safety concerns. Pinch points and operable cables can cause severe injury. The door should not be operated while individuals or objects are in close proximity to moving components.

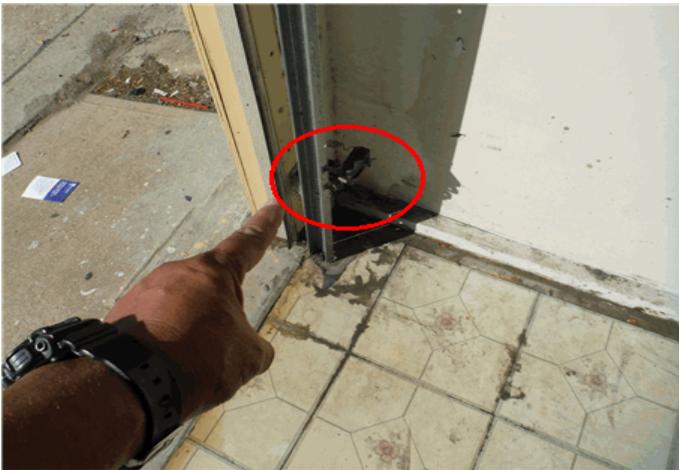
59) Opener and Safety Sensors

Garage door opener and safety sensors were tested and found to be functional.

All garage door safety sensor should be installed within 6" of the slab for safety. Safety sensors installed above this height pose additional risk for pets and personal items for potential injury or damage.

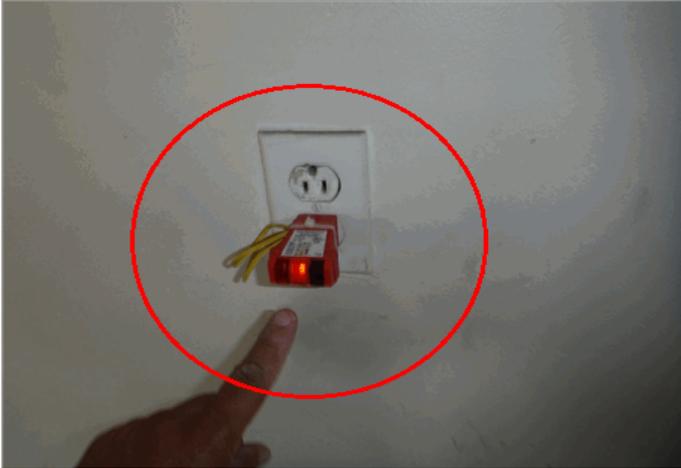
60) Electrical Conditions

Garage receptacle outlets were found to be functional.

However, it is a modern requirement that all garage receptacles be GFCI protected for occupants safety. Open neutral condition.

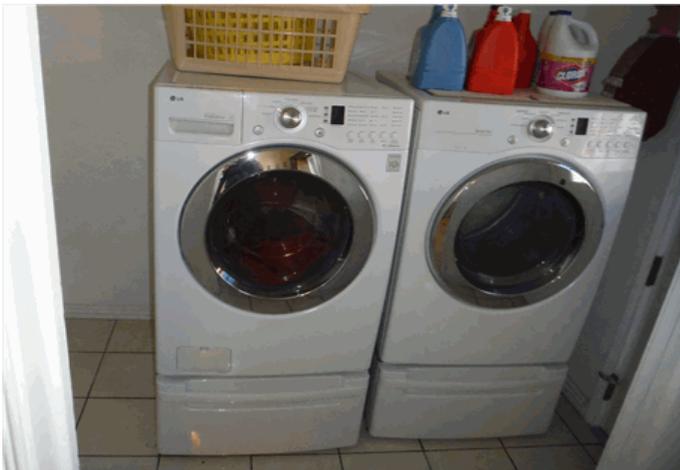
**62) Moisture** Sat There were no visible signs of moisture on the day of inspection.

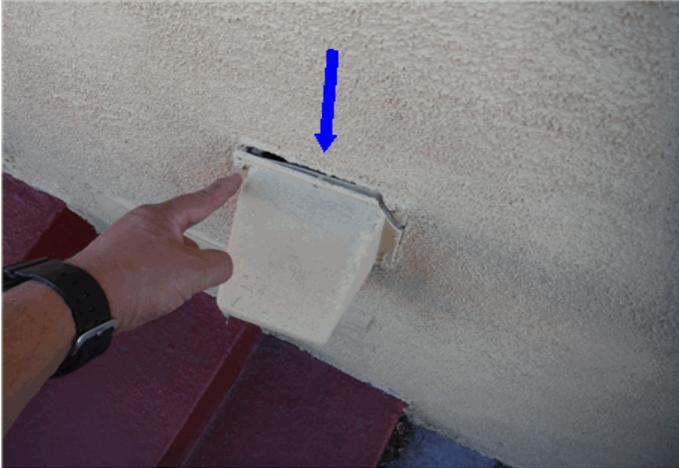
### 65) Dryer Vent

The dryer vent should be inspected and cleaned as needed or every 6 months as a part of good home and safety maintenance plan. [Recommend seal and caulk around exterior hood cover.](#)

Gas has been provided for dryer connection. There were no apparent signs of gas leaks from this appliance.

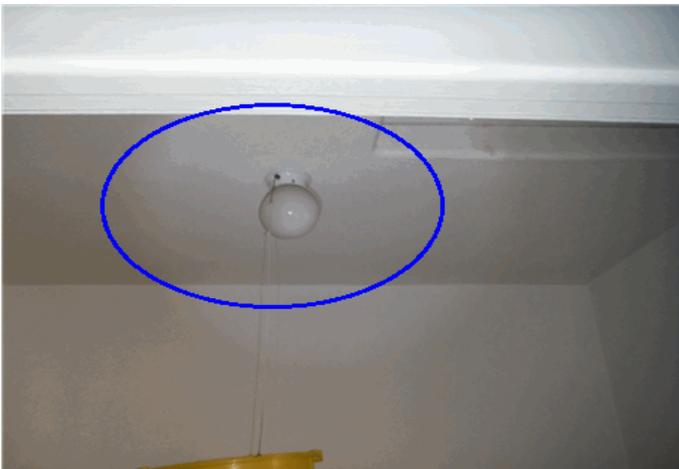
**Mtc** Laundry electrical outlets that were tested were found to be functional on the day of inspection. A 20 amp rated receptacle is recommended for all laundry areas. [A light\(s\) bulb\(s\) were out or inoperative at laundry .](#) Dismantling and testing of all light fixtures is not performed as part of this inspection. Recommend all lights be operable prior to close.

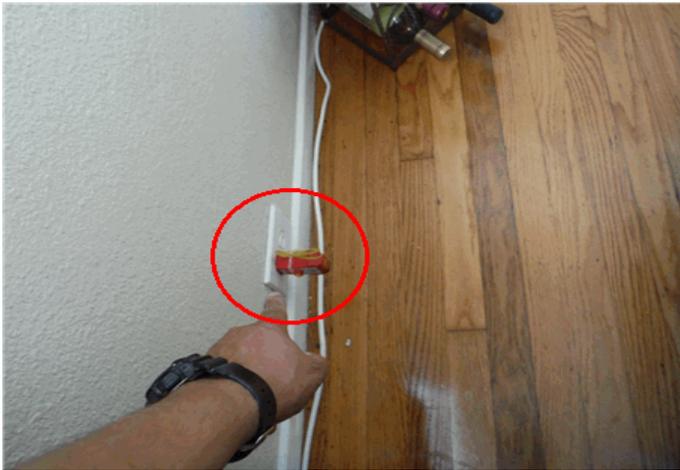
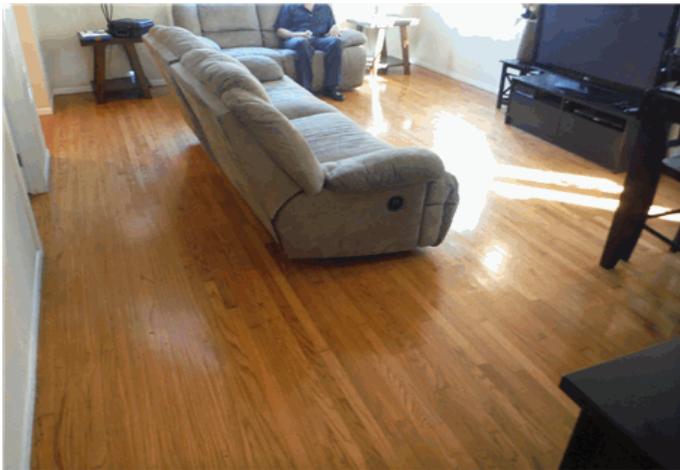
68) Floors Condition

Flooring was found to be in satisfactory condition. Harwood floors are showing signs of scratches from common traffic patterns. It is recommended client consult with a flooring contractor for evaluation and costs of repair/maintenance.

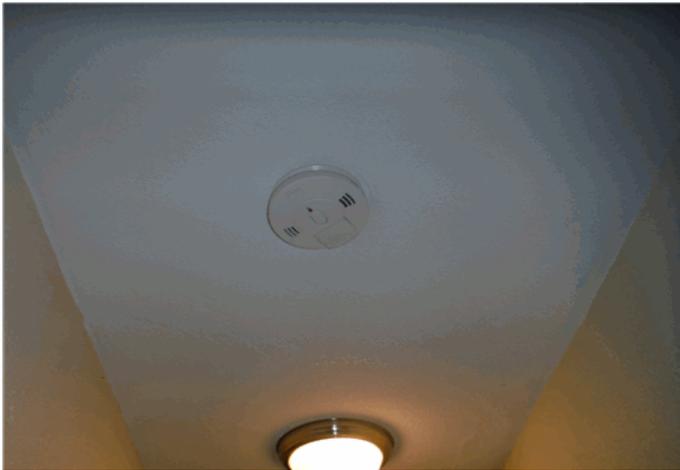
Carbon monoxide/smoke detectors outside sleeping quarters were tested and found to be functional on the day of the inspection. Smoke and carbon monoxide detectors should be replaced every 10 years. Re-test detectors every month for safety.

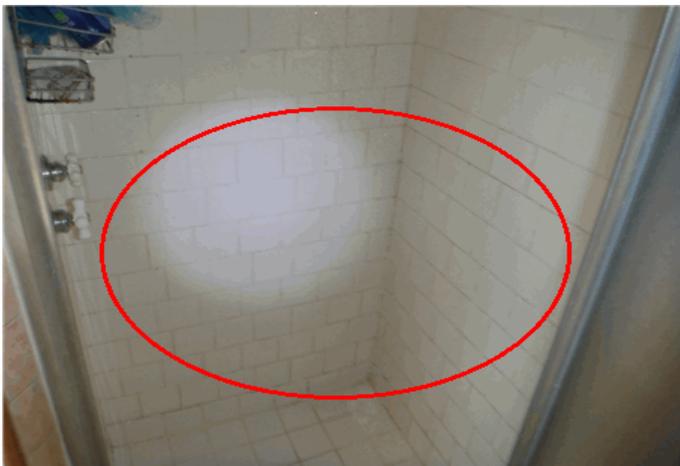
Sink was operational showing signs of average daily use. Faucet was functional. Hot and cold running water was present. Drain assemblies were functional with no signs of active leaks. Stoppers were not present or functional. Stoppers prevent accidental intrusion of foreign objects into the plumbing system. Replacement recommended. Cracked tiles were observed, consult a tile setter for repair.

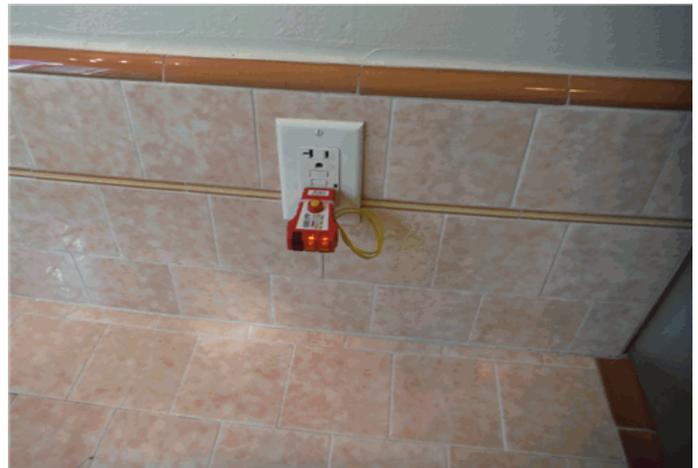
GFCI receptacle was present and functional.  
Lights and switches that were tested were found to be functional with appropriate cover plates properly installed.

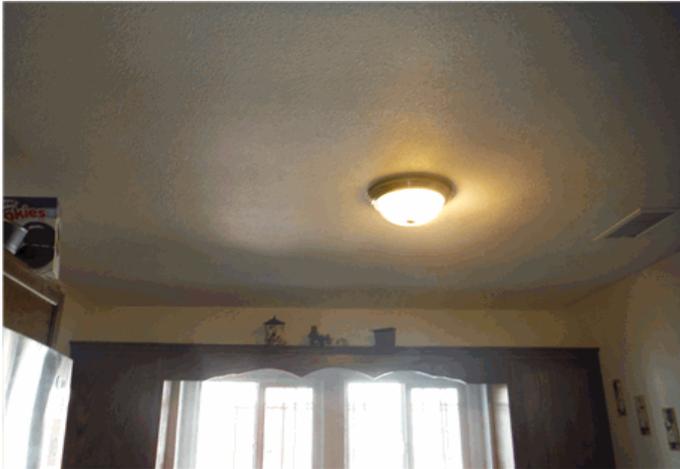
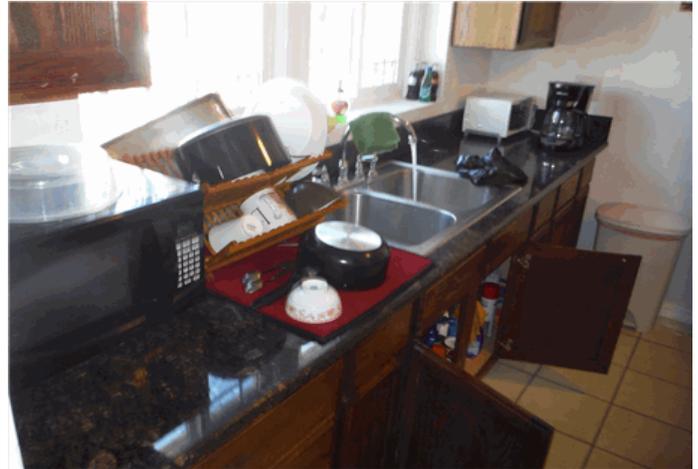
The tile floor was in satisfactory condition overall.

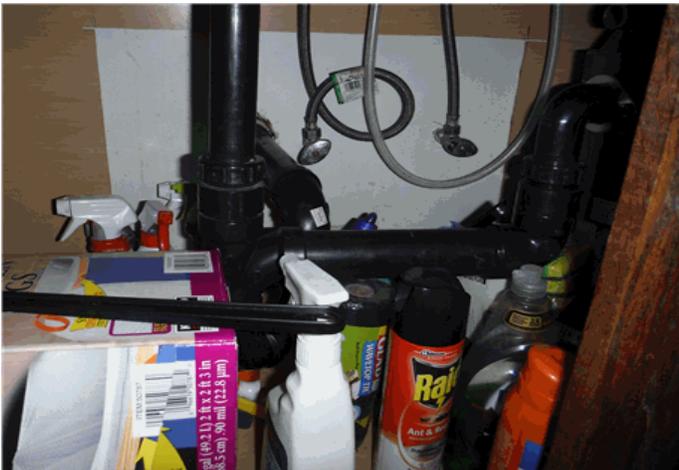
105) Cabinet Conditions

The kitchen cabinets appeared to be in serviceable condition at the time of inspection. Doors and drawers function normally.

Cabinet screws are recommended for the upper cabinets. This will help prevent accidental pullout during loading.

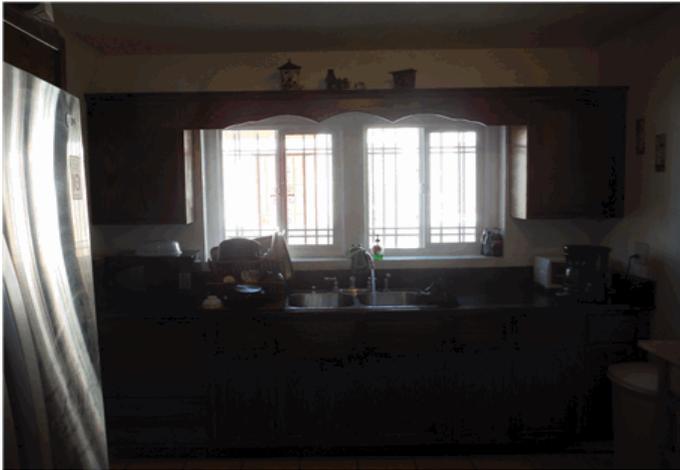
106) Garbage Disposal Condition

The disposal unit made unusual noise at the time of the inspection. Repairs are recommended.

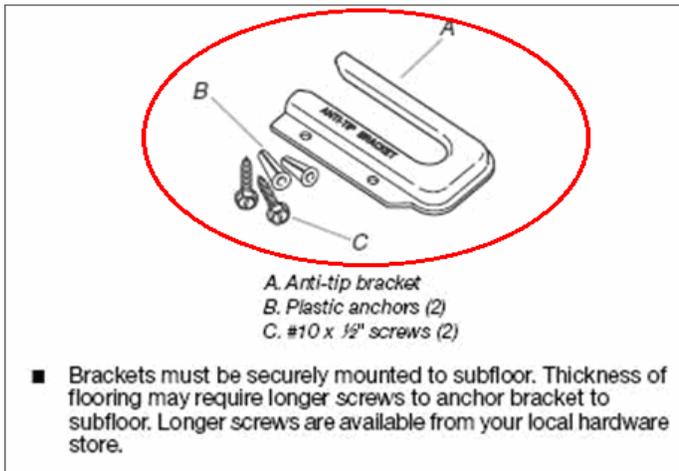
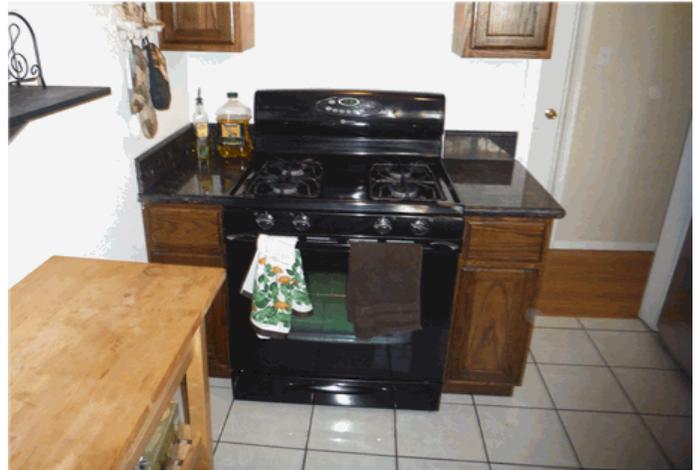
108) Stove - Range Condition

The gas range was tested by way of normal operating controls. It was found to be functional. Gas has been provided for stove/range connection. There were no apparent signs of gas leaks from this appliance. Gas range was missing an anti-tip bracket safety device. It is recommended client consult with an appliance technician for installation of anti-tip safety device.

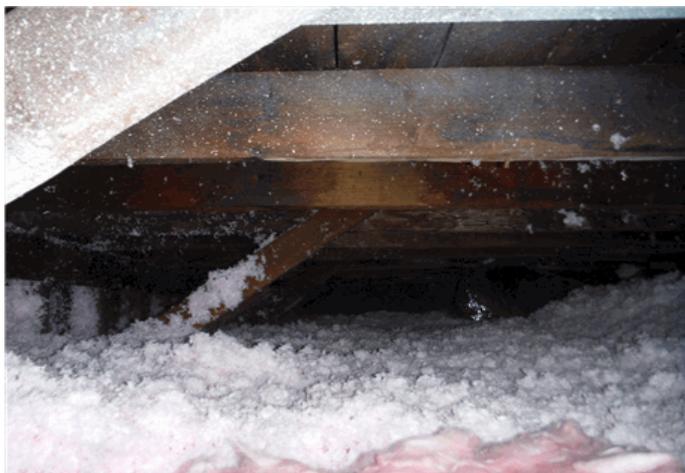
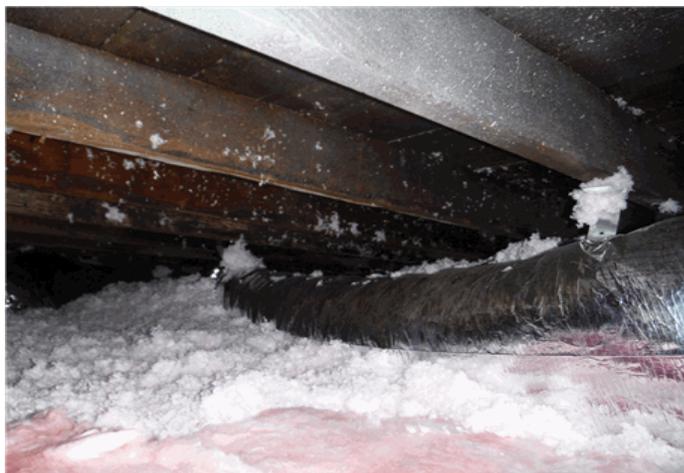
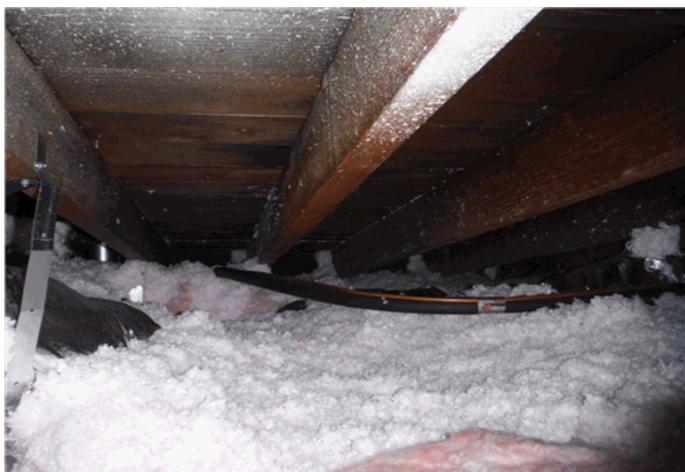
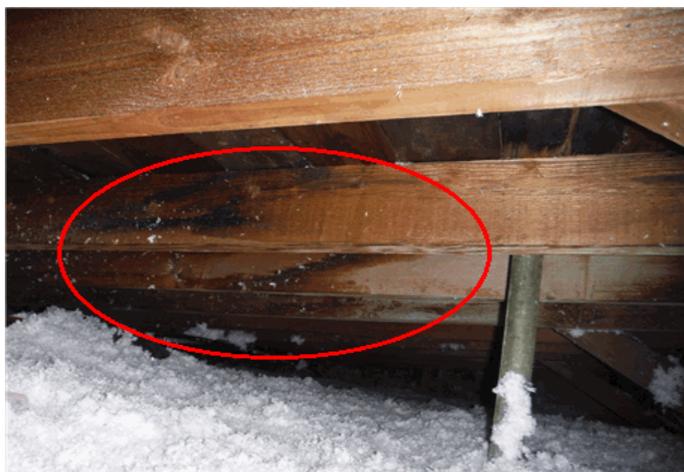
The roof rafters were in satisfactory condition with no significant signs of damage to the wood frame members. Roof supports and midspan bracing were in satisfactory condition.

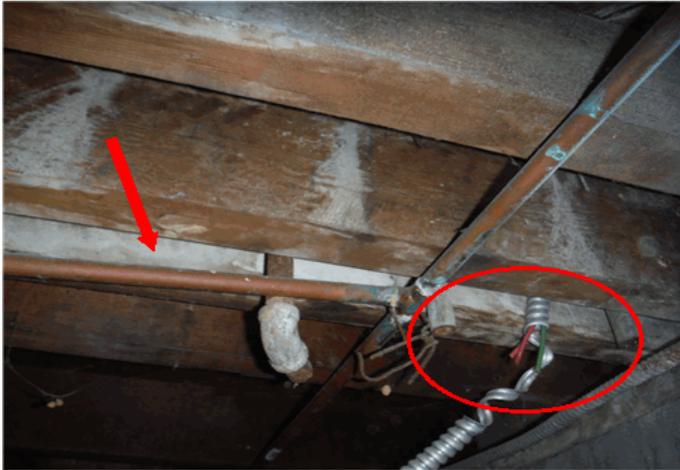
125) Electrical Conditions

Open junction boxes/nonterminated wiring were noted in the crawlspace. Consult with a licensed electrician for full review and repair.
