MINIMUM INSPECTION PROCEDURAL GUIDELINES
FOR BUILDING ELECTRICAL RECERTIFICATION

INSPECTION MADE BY: FLORIN FLOREA P.E.

a. Name on Title: Village at Dadeland Condominiums (J)

b. Street Address: 7600 SW 82nd St. Miami, Florida 33143

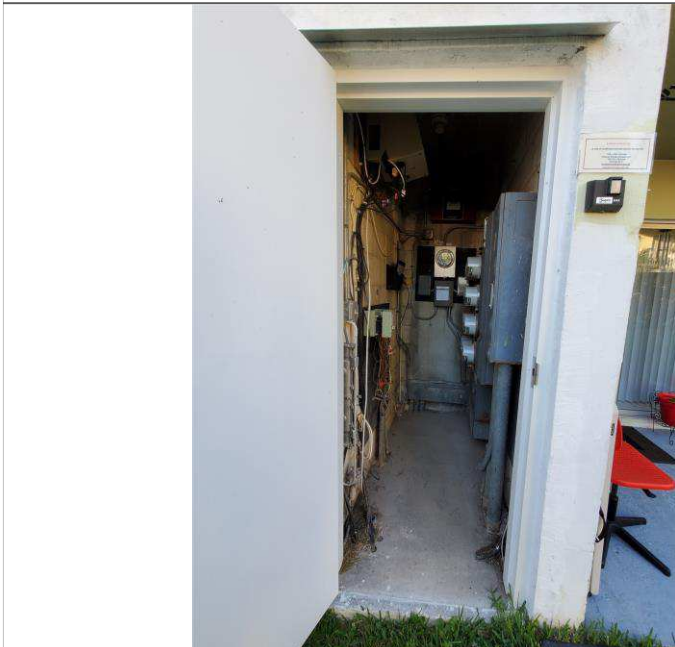
Photo 2 – Village of Dadeland Condominium Association

Existing Electrical Room - 1st FL
Main Switches for Apartments,
Meters, Gutter, and Fire Alarm
Panel

Insufficient clearance at
electrical components.

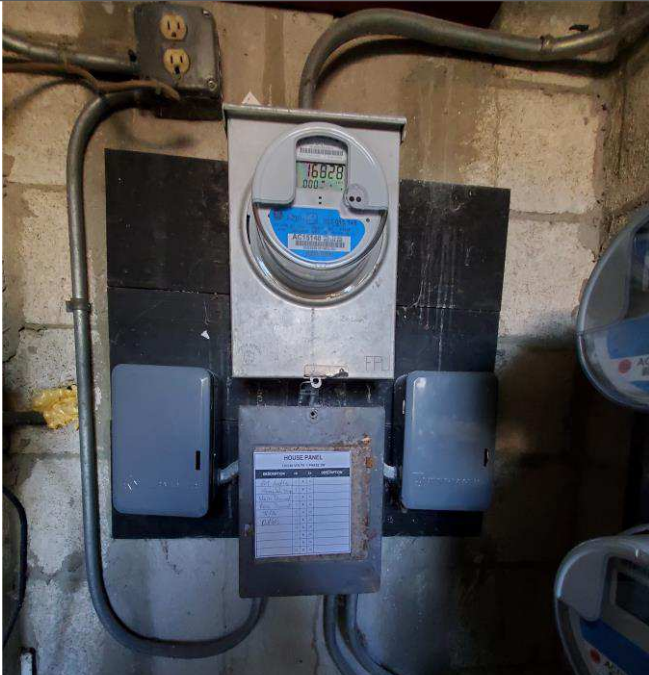
Photo 5 – Village of Dadeland Condominium Association

Existing Electrical Room - 1st FL
House Meter and Panel Board

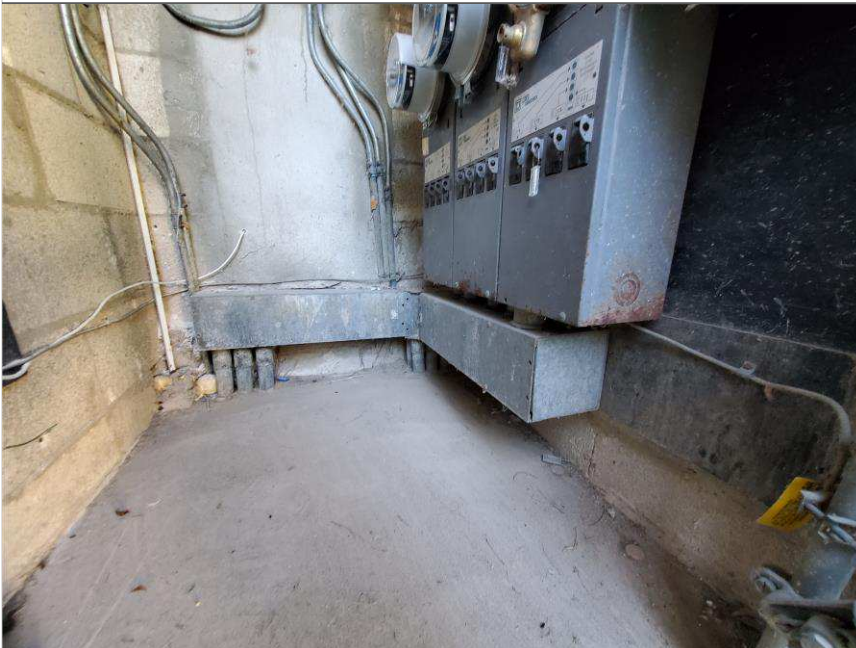
Photo 8 – Village of Dadeland Condominium Association

Existing Electrical Room - 1st FL
Main Switches for Apartments,
Meters, and Gutter.

Old and oxidized meter stacks.

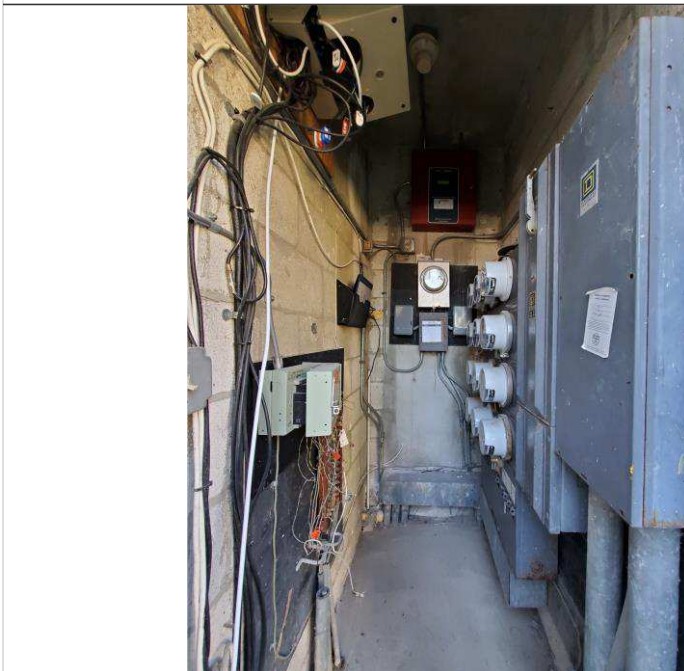
Photo 10 – Village of Dadeland Condominium Association

Existing Electric Room - 1st FL

Insufficient clearance at
electrical components.

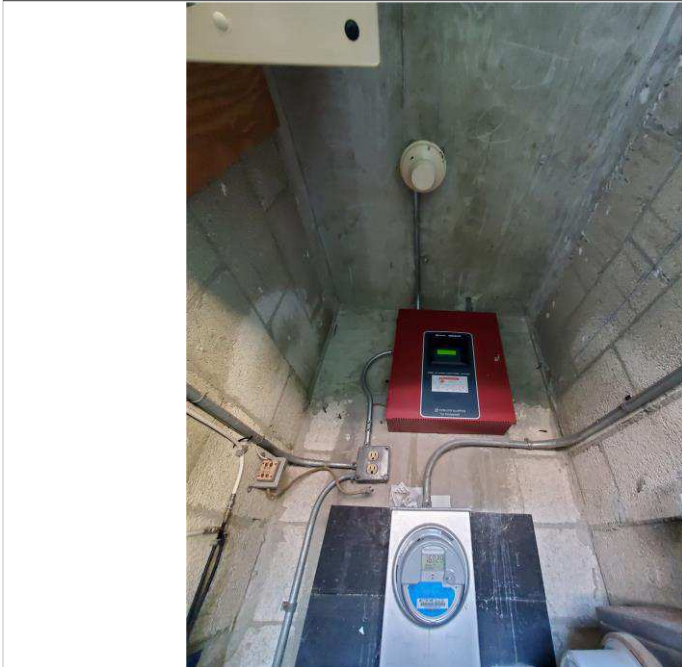
Photo 13 – Village of Dadeland Condominium Association

Existing Electrical Room - 1st FL
Fire Alarm Panel

Fire Alarm Panel is installed
high.

All penetrations or openings in
walls are to be fire caulked.

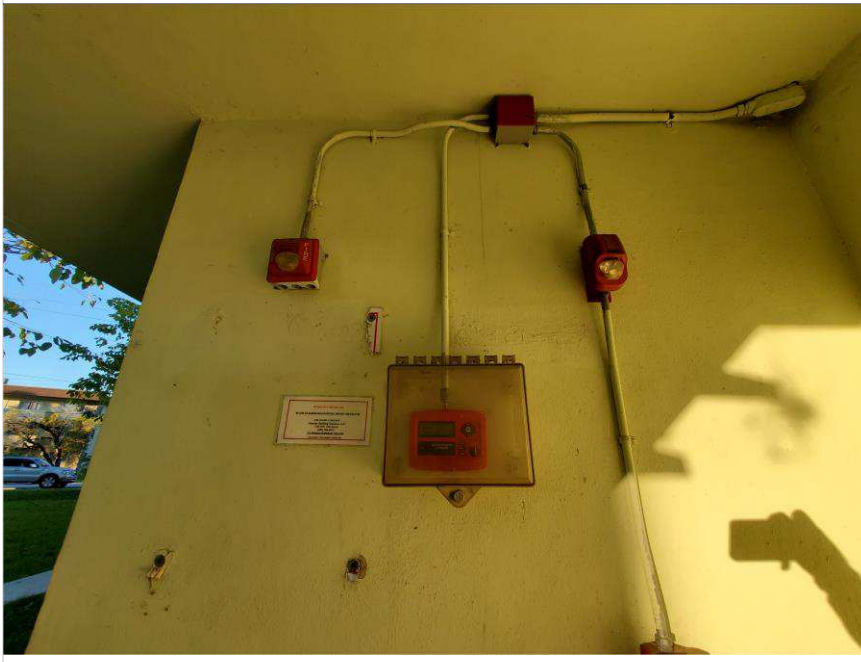
Photo 14 – Village of Dadeland Condominium Association

Level 1
Fire Alarm - Old and Weathered
Fire Alarm Devices and Control
Center

Old Strobe Horn/Strobe Device

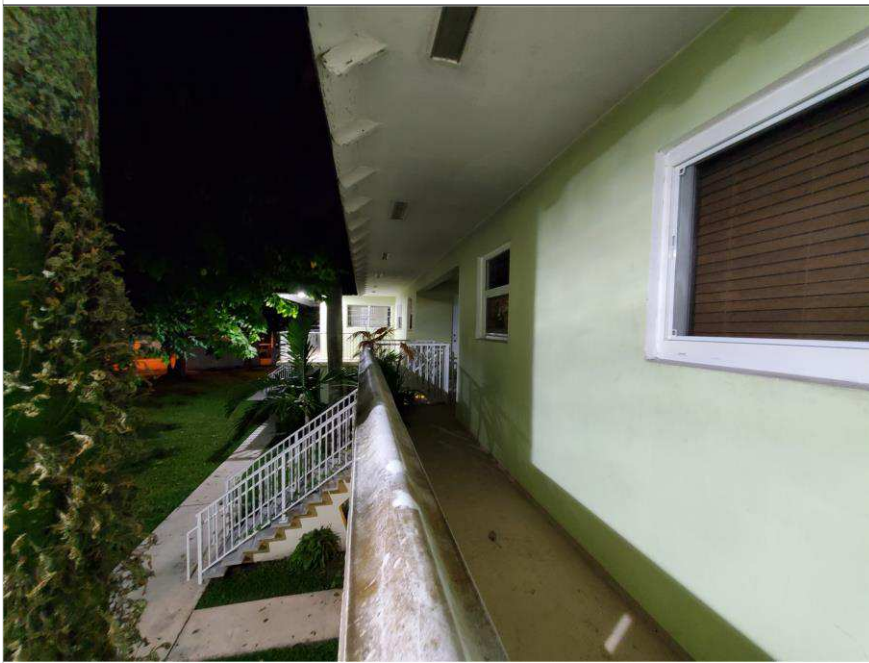
Photo 18 – Village of Dadeland Condominium Association

Points of Egress
Insufficient illumination at
Building Points of Egress,
catwalks, and sidewalks.
Exterior light not functional.

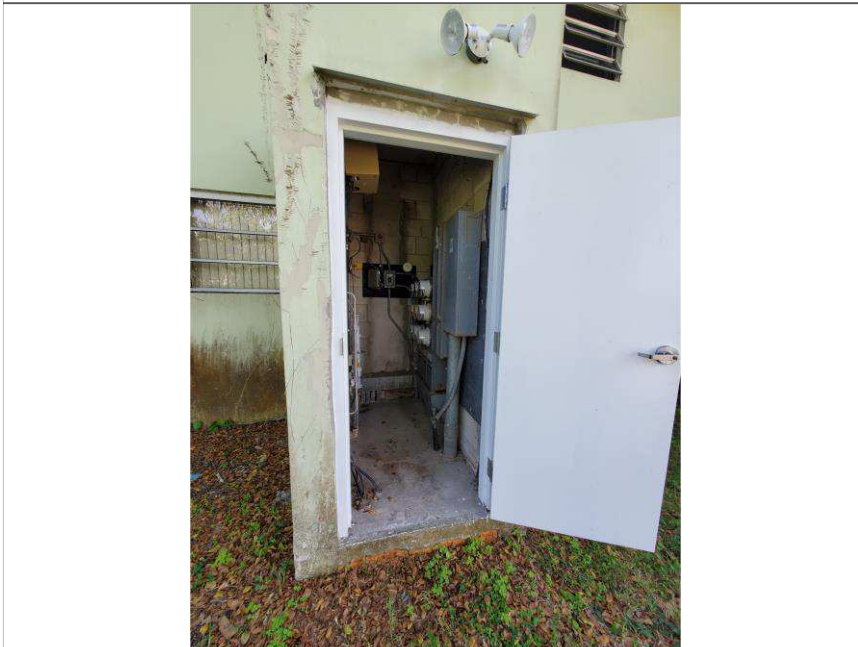
Photo 2 – Village of Dadeland Condominium Association

Existing Electrical Room - 1st FL
Main Switches for Apartments,
Meters, and Gutter.

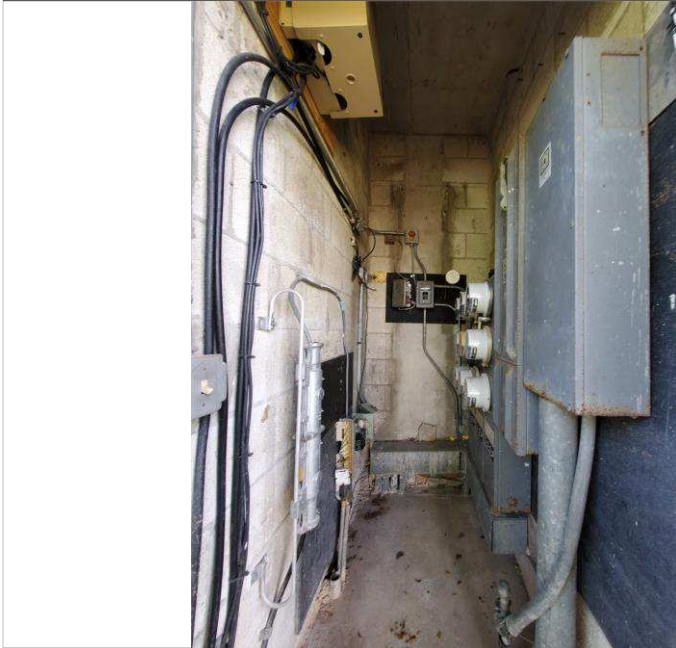
Photo 3 – Village of Dadeland Condominium Association

Existing Electrical Room - 1st FL
Main Disconnect and Meter
Stacks

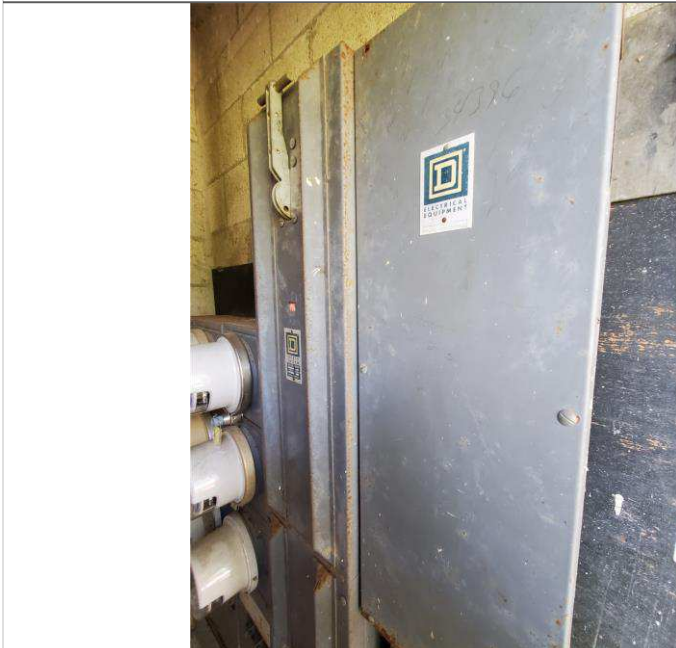
Photo 4 – Village of Dadeland Condominium Association

Existing Electrical Room - 1st FL
Main Disconnect

Oxidized tops and taps of
Electrical Components.

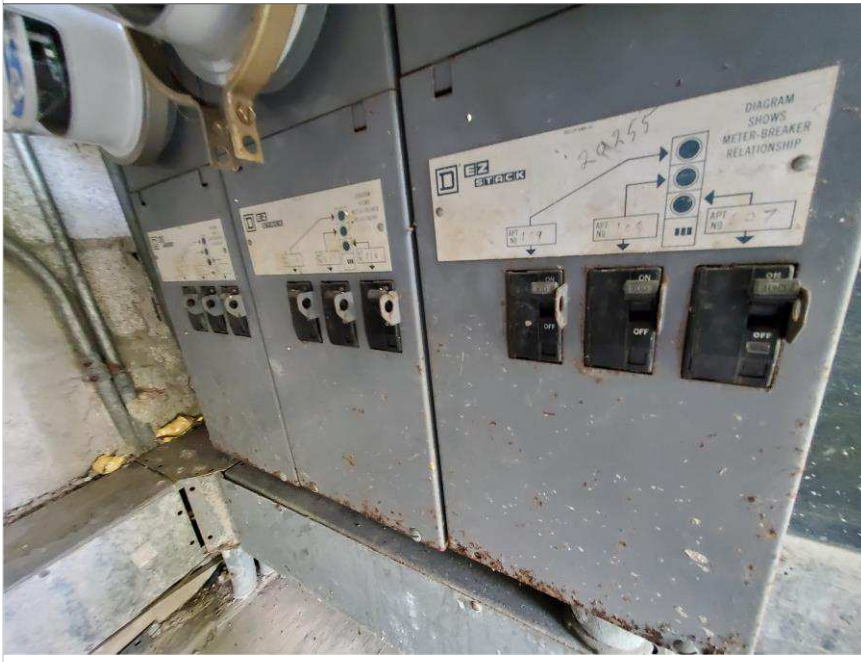
Photo 8 – Village of Dadeland Condominium Association

Existing Electrical Room - 1st FL
Apartment Meters and Main
Switches

Old and oxidized meter stacks.

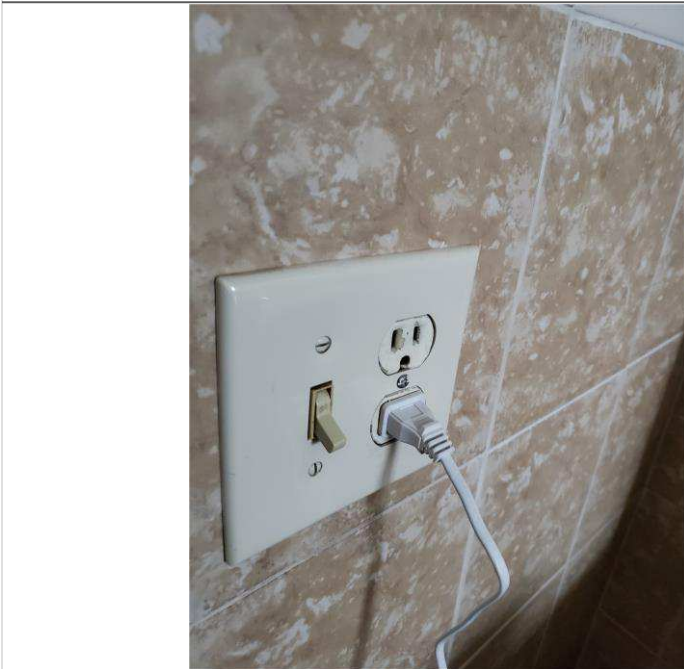
Photo 16 – Village of Dadeland Condominium Association

Apartments - Bathroom outlets are not GFCI type.

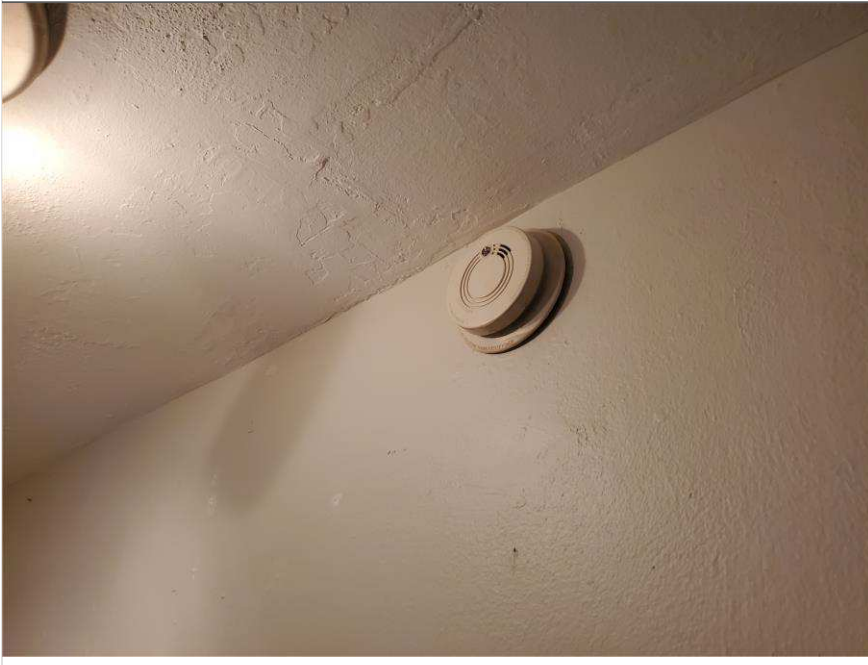
Photo 18 – Village of Dadeland Condominium Association

Apartments - Old Smoke Detectors

Apartments - Old Smoke or CO₂
detectors to be replaced.

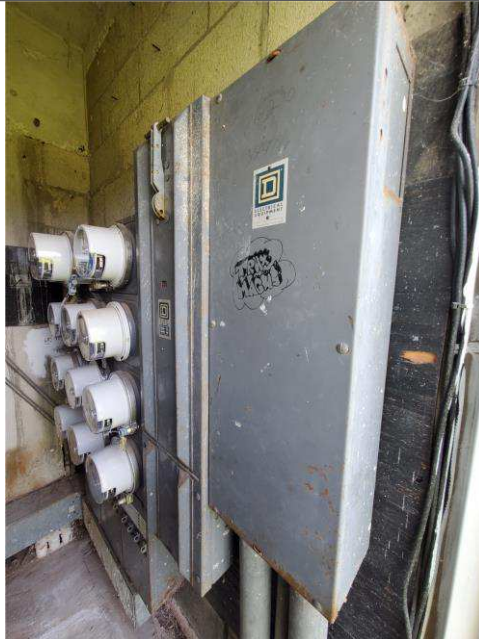
Photo 3 – Village of Dadeland Condominium Association

Existing Electrical Room - 1st FL
Main Disconnect and Meter
Stacks are oxidized.
50 year old electrical
components.

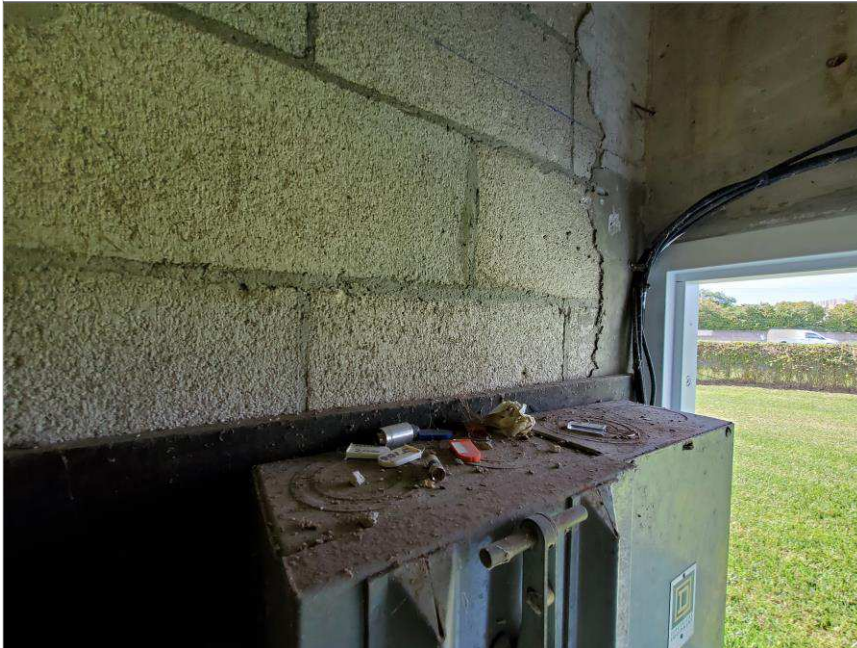
Photo 4 – Village of Dadeland Condominium Association

Existing Electrical Room - 1st FL
Building Main Disconnect is
oxidized.
50 year old electrical
component

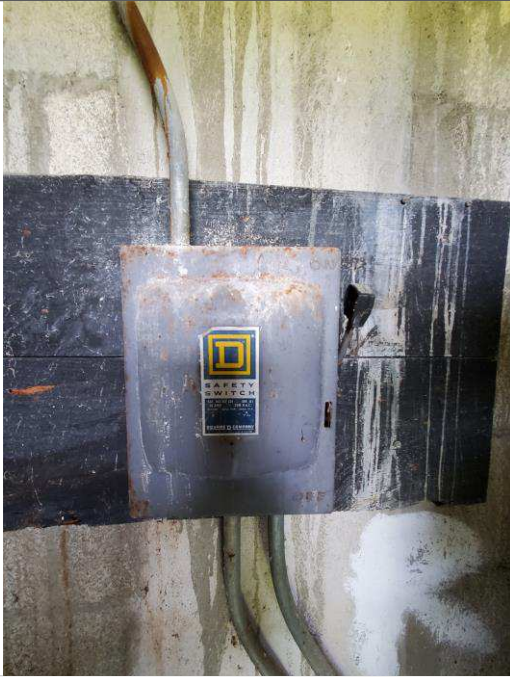
Photo 5 – Village of Dadeland Condominium Association

Existing Electrical Room - 1st FL
House Panel Disconnect Switch
is oxidized.
50 year old electrical
component.

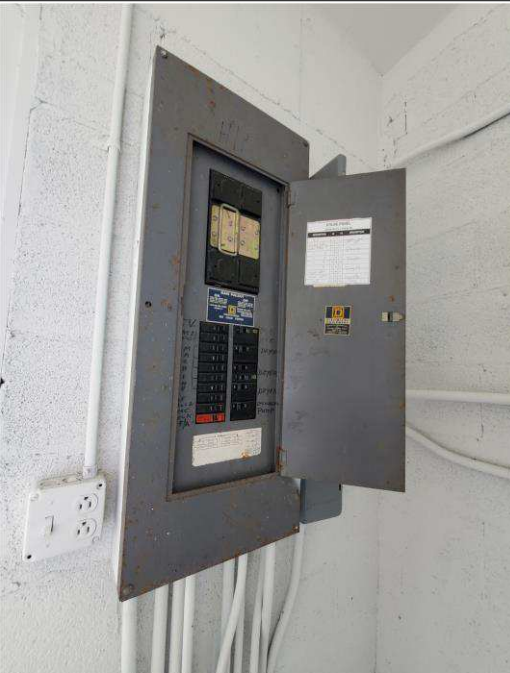
Photo 6 – Village of Dadeland Condominium Association

Laundry-Water Heater Room -
1st FL
House Panel Board is oxidized.
50 year old electrical
component.

Comments: Panel is old and has corrosion, replace panel.

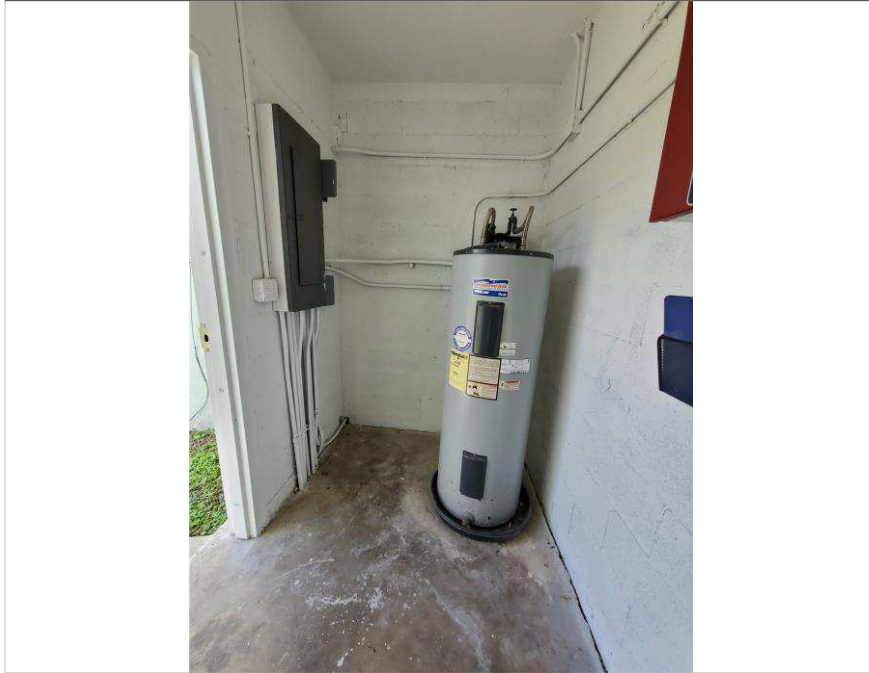
Photo 7 – Village of Dadeland Condominium Association

1st FL - Laundry/Water Heater Room

House Panel Board

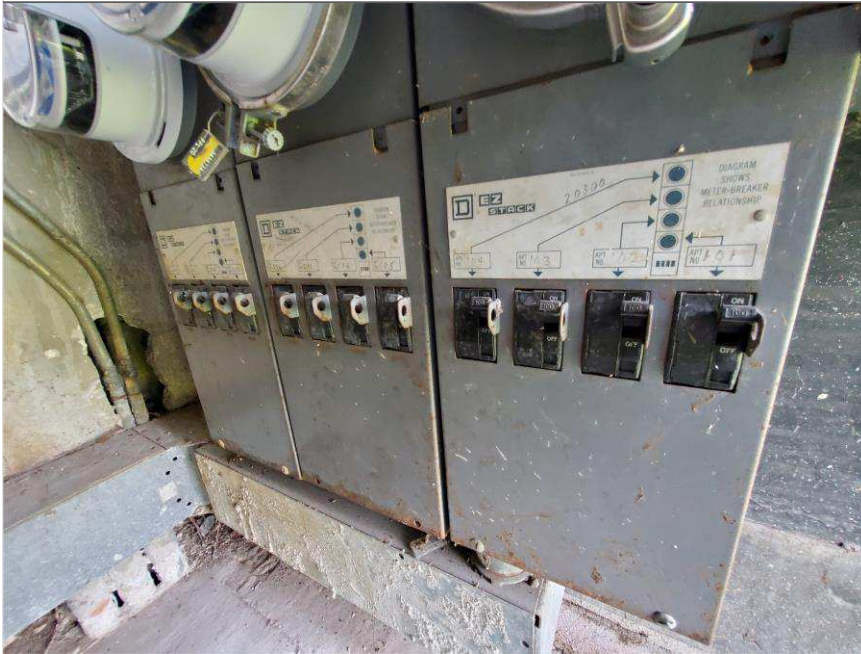
Photo 9 – Village of Dadeland Condominium Association

Existing Electrical Room - 1st FL
Main Switches for Apartments,
Meters, and Gutter.

Old and oxidized meter stacks
and breakers.

House Meter not labeled.
All meters to be clearly labeled.

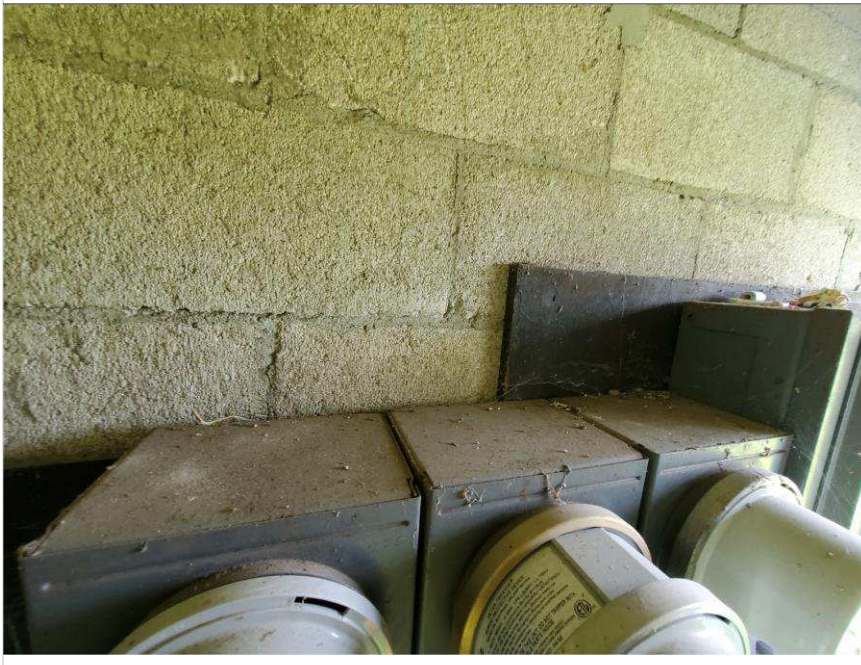
Photo 10 – Village of Dadeland Condominium Association

Existing Electrical Room - 1st FL
Main Switches for Apartments,
Meters, and Gutter.

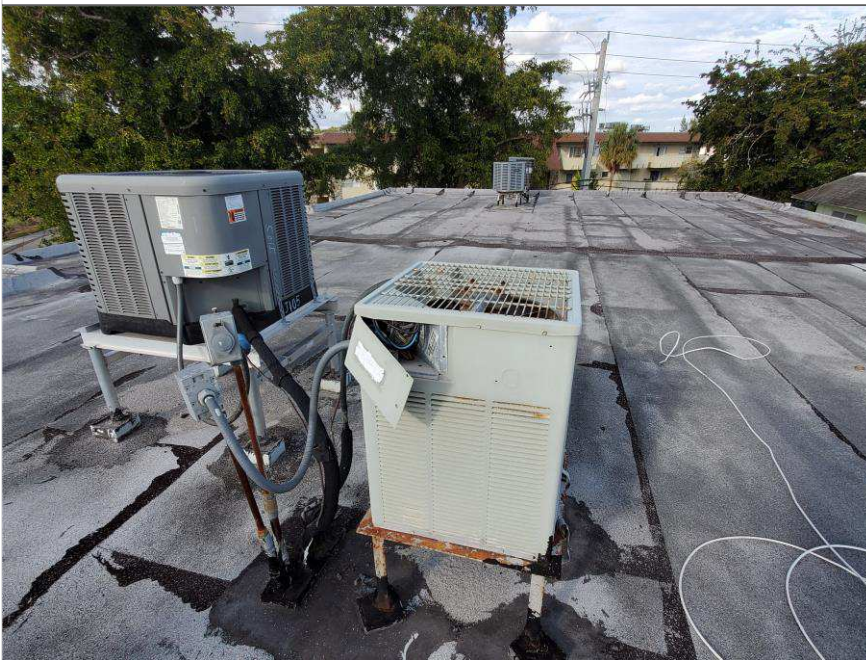
Photo 14 – Village of Dadeland Condominium Association

Rooftop Condenser Units -
Oxidized junction boxes and
conduits.

Junction boxes not properly
supported.

Missing disconnect switches.

Comments: 1. Mechanical Rooftop Equipment - Repairs/Replacement Required at all oxidized electrical disconnect boxes, supports, and conduit. All disconnect switches are to be operable and inside electrical components rust free. 2. All Rooftop Mechanical Equipment and Disconnect Switches to be properly identified.

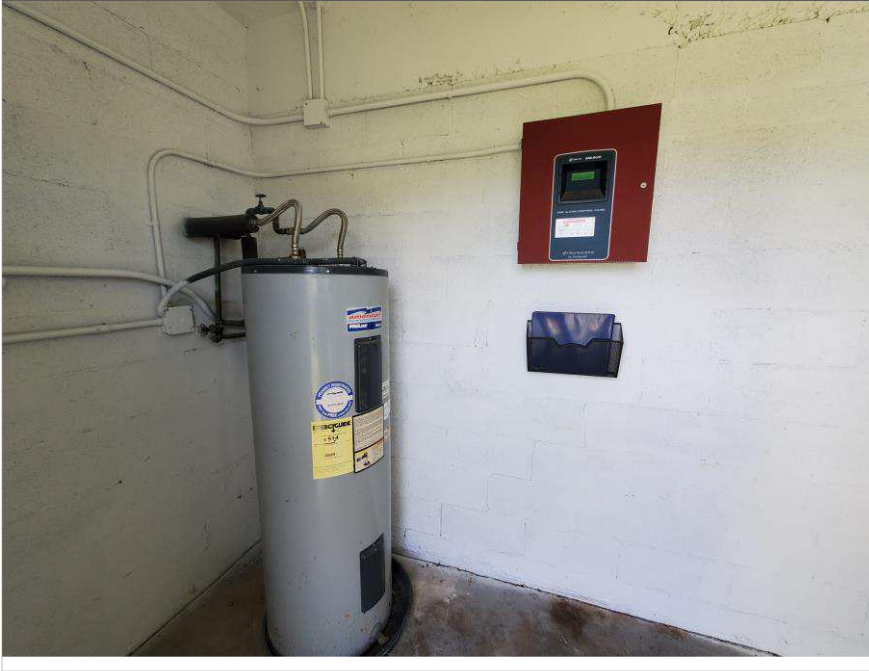
Photo 15 – Village of Dadeland Condominium Association

1st FL – Laundry/Water Heater Room

Fire Alarm Panel

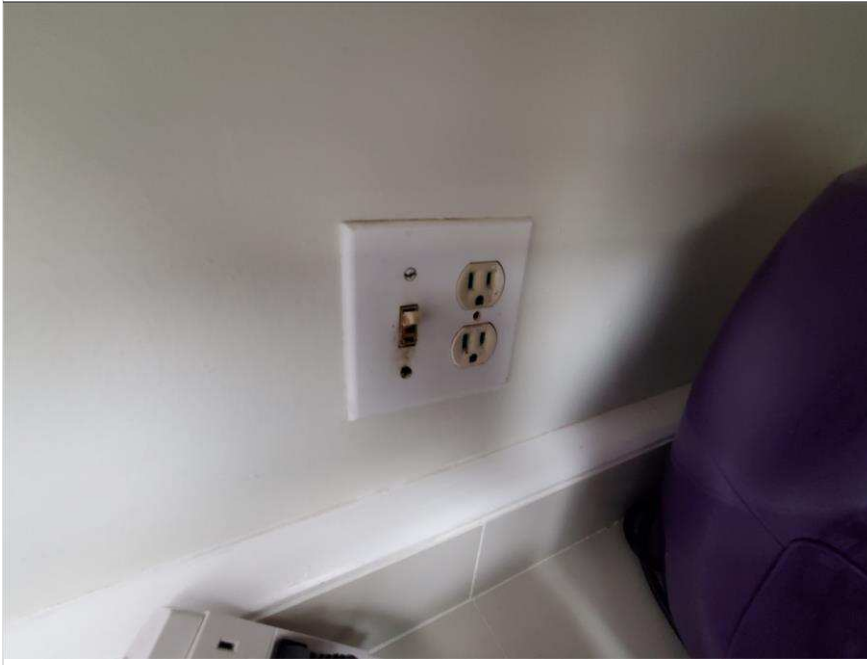
Photo 26 – Village of Dadeland Condominium Association

Apartments - Kitchen outlets
not GFCI type

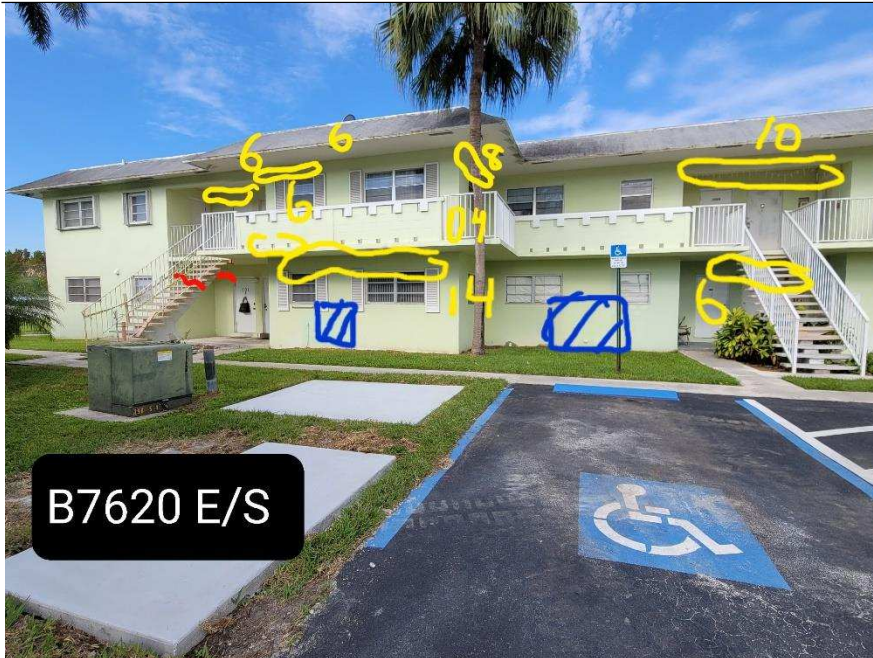
Photo #1:

Front elevation of building 7620 (Villa J)

The stuccoed envelope requires maintenance of the stucco exterior surfaces at many locations. Unsound stucco surfaces and surface cracks discovered at many areas of the exterior envelope.
