TALC
Home Inspe

Inspection Report

Property Address:
303 Wheeler Avenue
Georgetown KY 40324

Talon Home Inspections, LLC

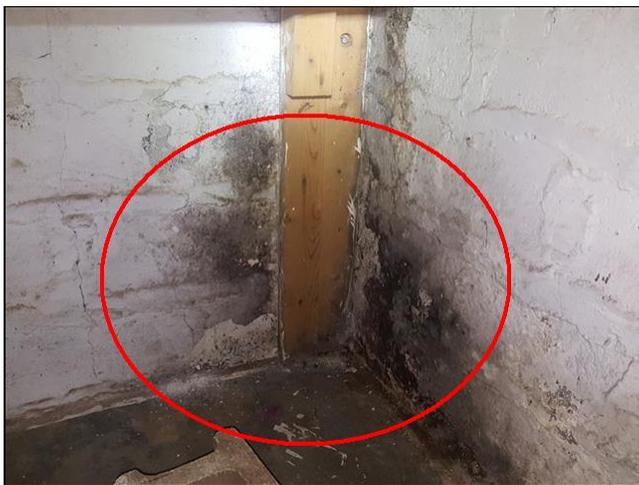
1.0 Item 1(Picture)

1.0 Visible signs of water intrusion/stains in the basement walls at the rear left and right corners of the basement wall was noted. 90% of water entry into the foundation walls has been found to be caused by improper grading or defective gutter/drainage systems. Refer to Roofing and Exterior of this report for improvements and recommendations. After corrections recommend these areas be monitored to see if other corrections are needed.

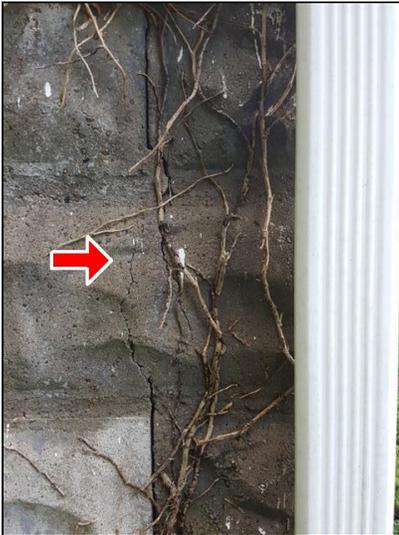
1.1 (1) Vertical cracks present on the foundation wall varied from hairline to approximately 1/16" in width. This implies that some structural movement of the building has occurred. Cracks of this type should be watched for any sign of additional movement. Some degree of settlement movement is common in older homes with this type of foundation wall. Since this type of movement generally occurs over an extended period of time, a wall monitoring system is recommended to observe any significant additional movement that would require a structural repair. In the absence of any sign of ongoing movement, repair should not be necessary. If these cracks become greater in width, a structural engineer who is familiar with foundation repair or a qualified foundation repair contractor should be consulted. Sealing the cracks is recommended by a qualified masonry contractor after correction of the grade, downspout run off and cleaning gutters. If the these measures are not corrected the condition could result in a major structural problem in the future.

1.1 Item 1(Picture) rear right corner of home

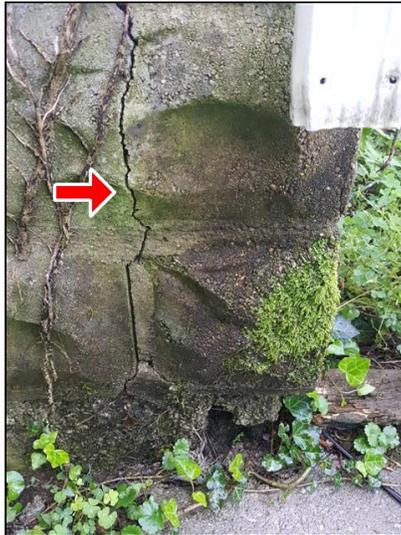
1.1 Item 2(Picture) rear right corner of home

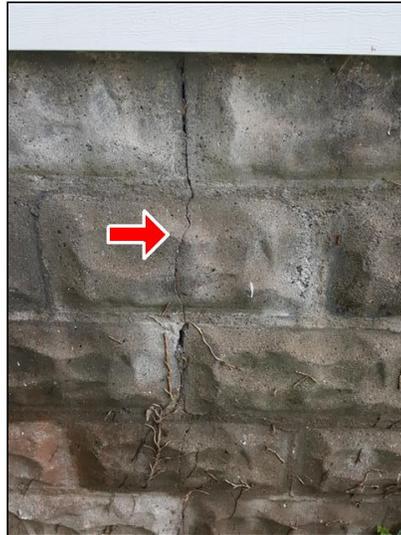
1.1 Item 3(Picture) rear right side of home

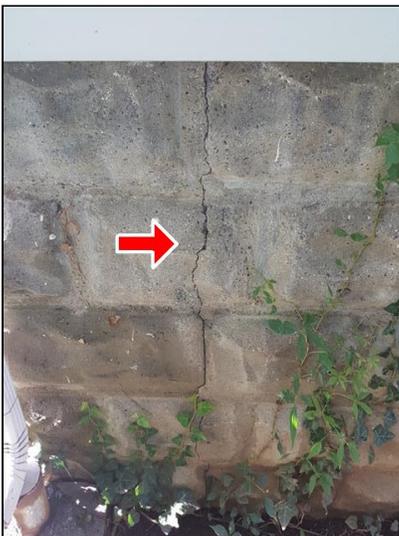
1.1 Item 4(Picture) rear left corner of home

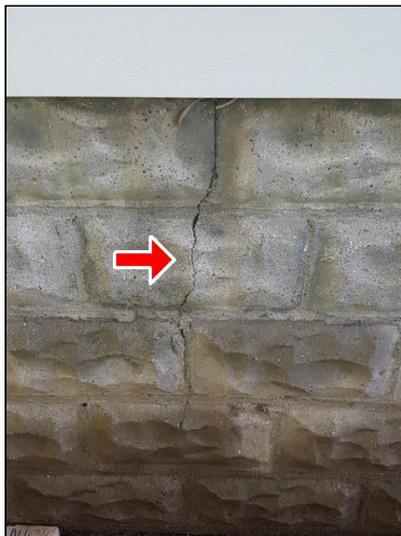
1.1 Item 5(Picture) rear left side of home

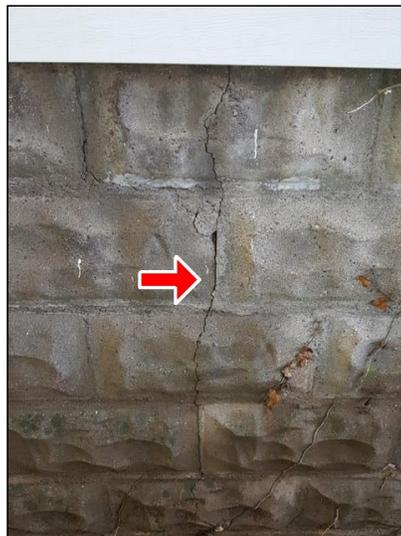
1.1 Item 6(Picture) rear center of home

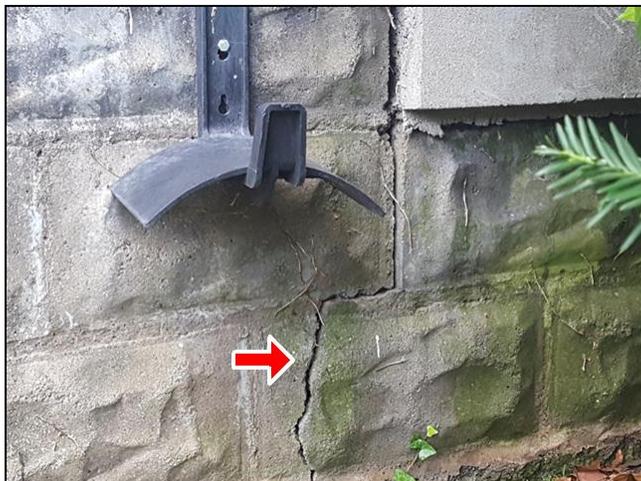
1.1 Item 7(Picture)

1.1 (2) The Typical settlement crack(s) in the foundation wall between the home and the side porch at the front of the home needs to be repaired. The cracks do not appear significant. This condition is common in many old homes and does not usually represent a serious structural concern unless the cracks are between an 1/8 or 1/4 inch thick. Recommend the crack be sealed to prevent water intrusion into the basement and minimize further deterioration. [Sealing Concrete Cracks](#) It is recommended that you monitor periodically to see if further movement occurs and if so a foundation contractor should be consulted to correct and prevent further movement.

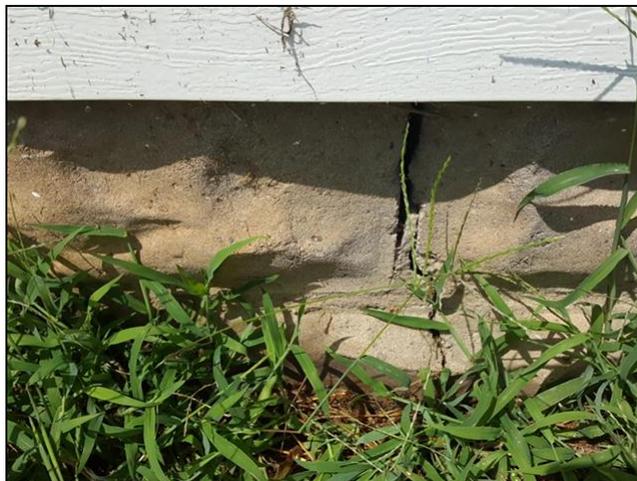
1.1 Item 8(Picture) right side of home

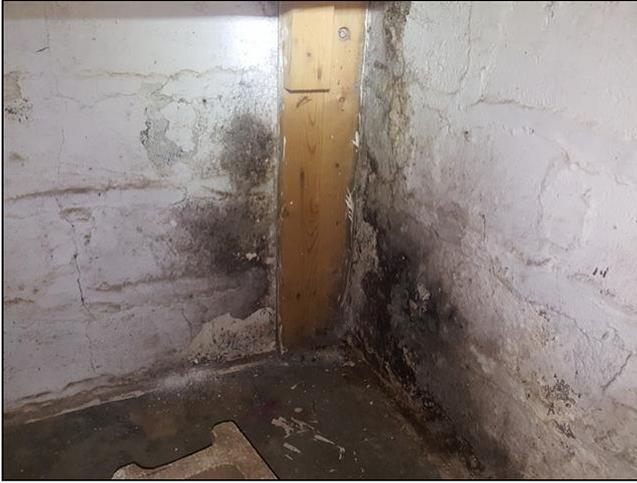
1.1 (3) Efflorescence was found on the bottom courses of the block walls at the unfinished basement where indicated in the photos which indicates moisture is in contact with the masonry. The white chemical deposits (Efflorescence) are caused by water evaporation from the exterior. This does not necessarily indicate that water intrusion is occurring in the basement. I recommend checking the gutters and the downspout drain lines for proper operation. Efflorescence is found on many homes without water intrusion occurring inside the home. But, it should alert you to the possibility that future steps may be needed.

1.1 Item 9(Picture) rear right corner of home

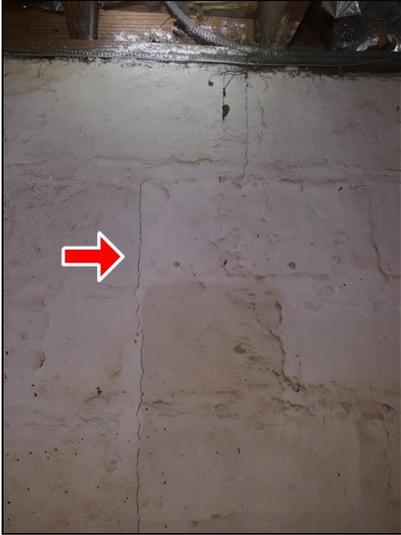
1.1 (4) The vertical settlement crack(s) in the foundation wall in the basement was noted. These cracks do not appear significant. This condition is common in many homes and does not usually represent a serious structural concern unless the cracks are between an 1/8 or 1/4 inch thick. Recommend the crack be sealed to prevent water intrusion into the basement and minimize further deterioration. [Sealing Concrete Cracks](#) It is recommended that you monitor periodically to see if further movement occurs and if so a foundation contractor should be consulted to correct and prevent further movement.

1.1 Item 12(Picture) left side of home

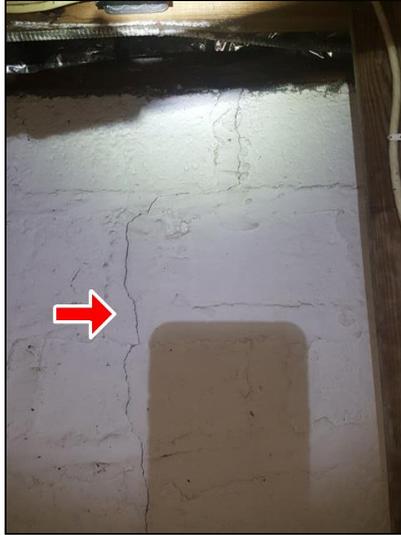
1.1 Item 13(Picture) rear wall center

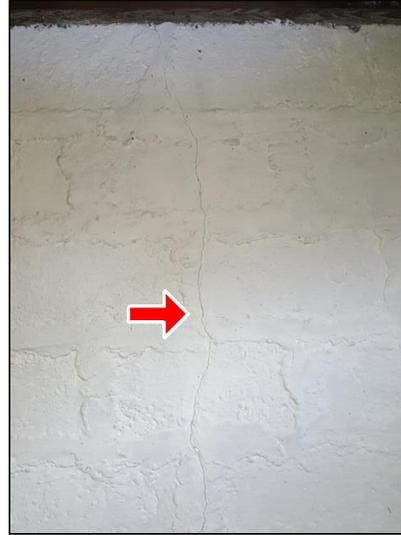
1.1 Item 14(Picture) rear left side of home

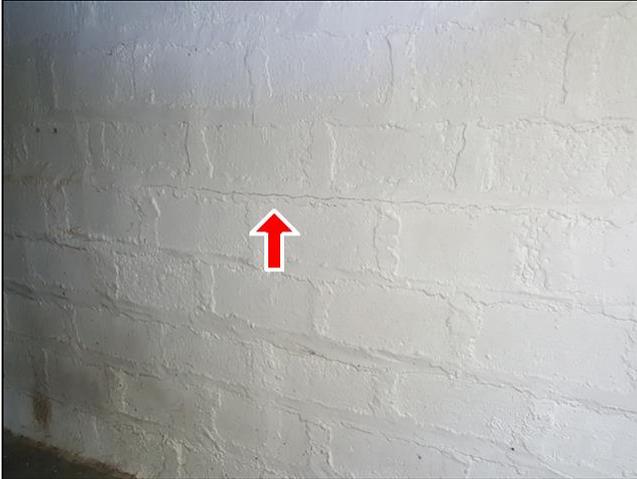
1.1 (5) Minor horizontal crack in the mortar was noted on the rear wall in the basement. Cracks of this nature are usually the result of soil or frost pressure due to freeze/thaw. The size, pattern and location of these cracks do not suggest a serious problem at present. Keep water away from the foundation: review the lot and roof drainage improvements in the Exterior and Roofing sections of this report. Recommend sealing these cracks with the appropriate caulk to prevent water intrusion and efflorescence, [Caulk for Concrete Cracks](#) . It is recommended that you monitor periodically after repairs. If these cracks should become greater and the wall starts to bow, a structural engineer who is familiar with foundation repair or qualified foundation repair contractor should be consulted.

1.1 Item 16(Picture) rear wall

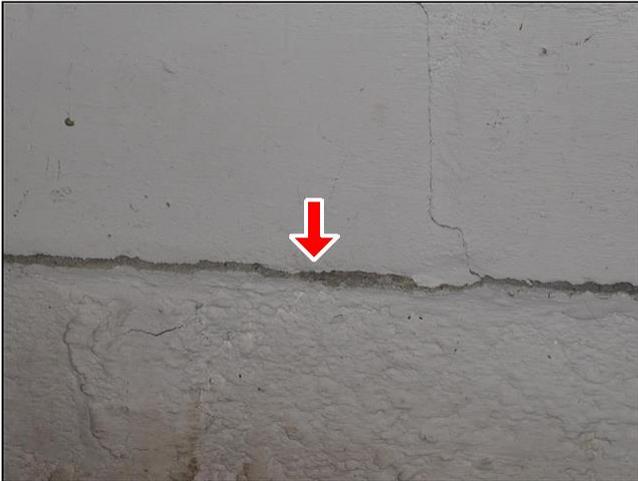
1.1 Item 19(Picture)

1.1 (6) The front basement wall under the formal dining room area has a horizontal crack greater than 1/8 inch in width and has slightly bowed between the original foundation wall. It appears some repair has been made and walls have been painted. Cracks seem to be re-appearing in some areas after repairs and corrections. Horizontal cracks is usually the result of excessive soil or frost pressure on the wall. If not corrected or addressed this can cause further settlement and result in more costly repairs in the future. The masonry block wall may need reinforcing. Recommend a structural engineer who is familiar with this type of repair or a company specializing in foundation repairs should be consulted to evaluate the condition and to suggest corrective measures. The rate of movement cannot be predicted during a one-time inspection.

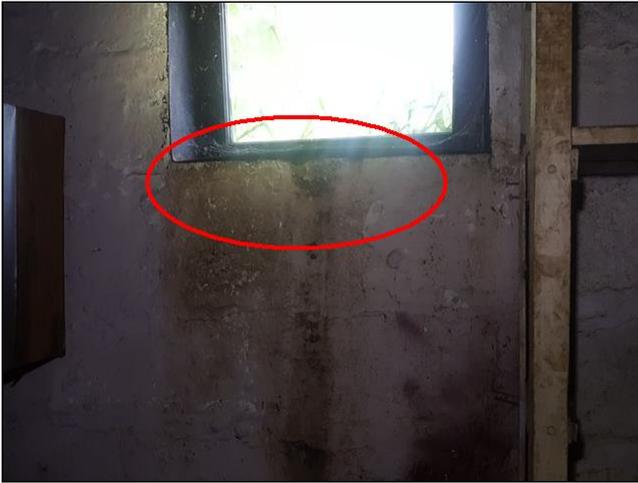
1.9 Item 1(Picture)

1.9 (1) Possible water leakage at the basement window on the right side underneath the kitchen area. Recommend a qualified contractor further investigate and correct as needed to prevent water intrusion and further deterioration of the window frame.

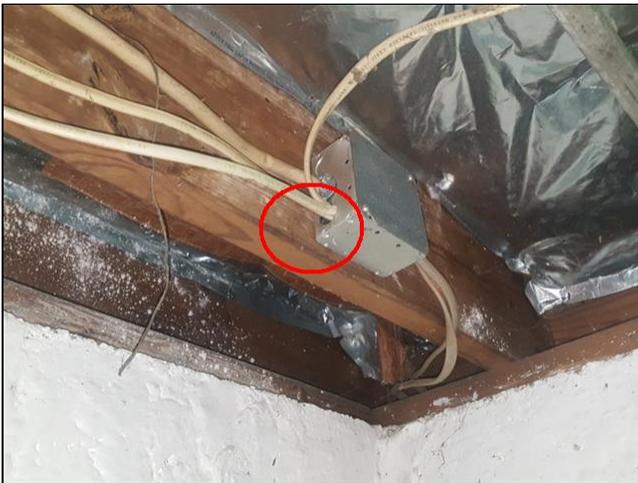
1.10 (1) Cable clamps (sometimes referred to as bushings or grommets) are required where wiring passes into the electrical junction boxes. Cable clamps serve to protect the wiring from the metal edges of the box to prevent a short from occurring or from the box becoming energized which can result in a death via electric shock. This is a safety issue. Recommend a qualified licensed electrician repair as needed.

1.10 Item 1(Picture) rear left corner

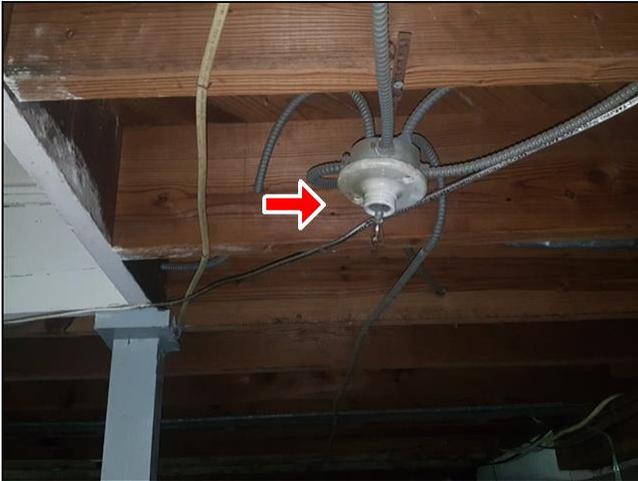
1.10 Item 3(Picture)

1.10 (2) The light fixture does not work (try bulb first) in the basement. If the bulb is not burned out, the fixture or circuit should be repaired using a qualified electrician.

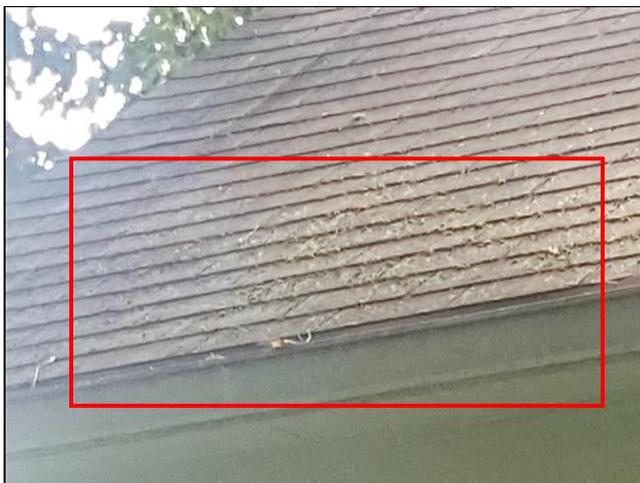
2.0 Item 1(Picture)

2.0 (1) Algae/moss was seen on the shingles at the rear left side of the home. This growth is common in shady areas and it holds moisture. This section of the home does not receive direct sunlight. Removal of moss is possible and can be removed with soap and water or chemicals made for this purpose. Be aware that this will not extend the useful life of the shingles but may only improve it's appearance for a few years. Replacement with an Algae resistant shingles is the only long lasting improvement.

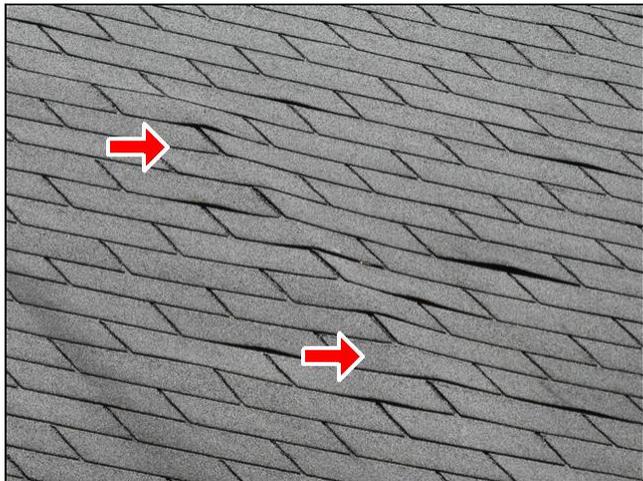
2.0 Item 2(Picture)

2.0 (2) The roof covering shows a mump-like appearance at the front left side of the home, see photo for location. These small little bumps might be caused by hot weather, in which some air beneath the cover layer has become hot and has expanded. These areas will eventually blister creating a water leak and the roof area will need replacing. Recommend a qualified roofing contractor further investigate and repair as needed as these bumps may cause ruptures, and cause leakage later on.

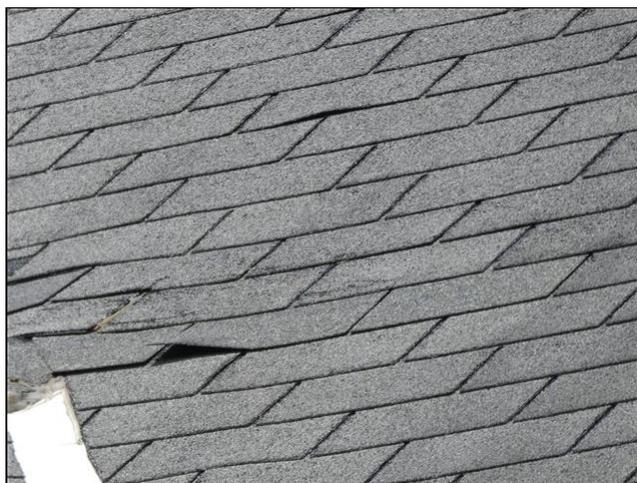
2.0 Item 5(Picture)

2.0 (4) Signs of loss of protective granules, curling and fibers exposed of the roof shingles are starting to appear especially at the front of the home. This indicates that the roof is close to the end of it's life span. This usually increases the potential for ultraviolet damage to the membrane. Recommend a qualified roofing contractor further evaluate the roof to determine if replacement is required now before roof leaks start to develop. If the roof is not to be replaced it should be closely watched and repaired or replaced at the first sign of leaking to prevent damage to the interior finishes or roof framing in the attic.

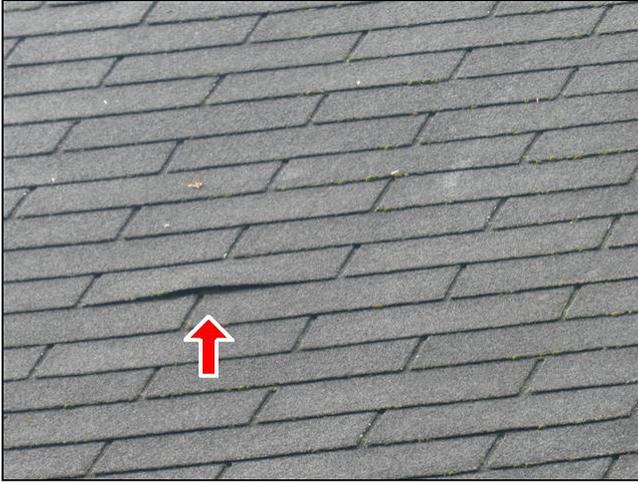
2.0 Item 6(Picture) rear left side of home

2.0 (5) The shingles are starting to lift a little bit at the "entire roof" of the home. This is probably due to a lack of ventilation or age of the covering. Generally, lifting shingles are caused by ventilation issues and the shingles are baked from the inside out. Over time, this heat causes the sealants on the back of the shingles to detach from the course underneath and the shingles start to lift. The shingles are less resistant to the action of ice and wind. Recommend a qualified roofing contractor further evaluate the roof to determine if replacement is needed now. If not then repair lifting shingles as needed.

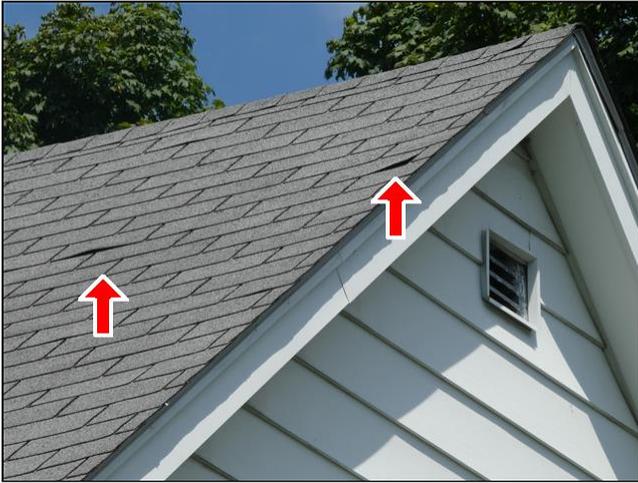
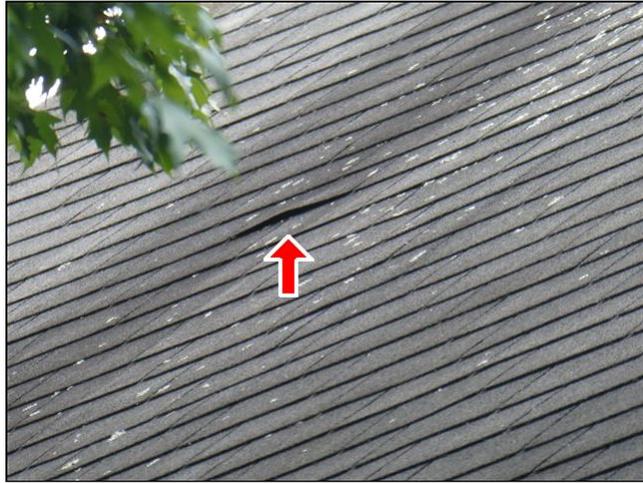
2.0 Item 12(Picture) front right side of home

2.0 Item 13(Picture) rear left side of home

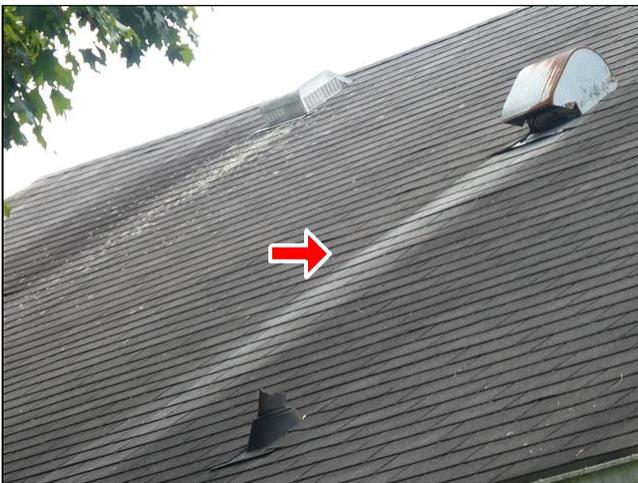
2.0 Item 15(Picture)

2.0 (6) Stains were noted on the shingles at the rear of the home. This is caused by water reacting with the metal flashing around the vents. The staining usually does not affect the longevity of the roof and is primarily a cosmetic concern.

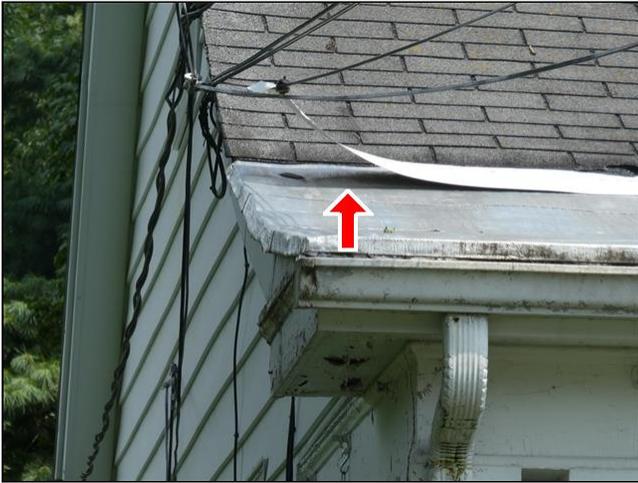
2.1 Item 1(Picture)

2.1 The flashing at the front of home (above porch roof) needs flattening and is loose. Recommend they be re-secured to prevent water entering underneath flashing and to allow ease of water runoff to reduce the risk of leaks. Recommend repair or replace as needed using a qualified roofing contractor.

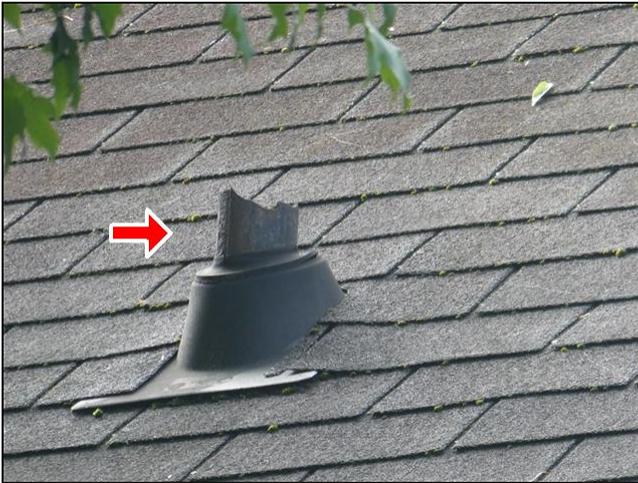
2.3 Item 1(Picture)

2.3 The plumbing vent stack is damaged/broken at the rear of the home center of the roof. Recommend replacement by a qualified contractor.

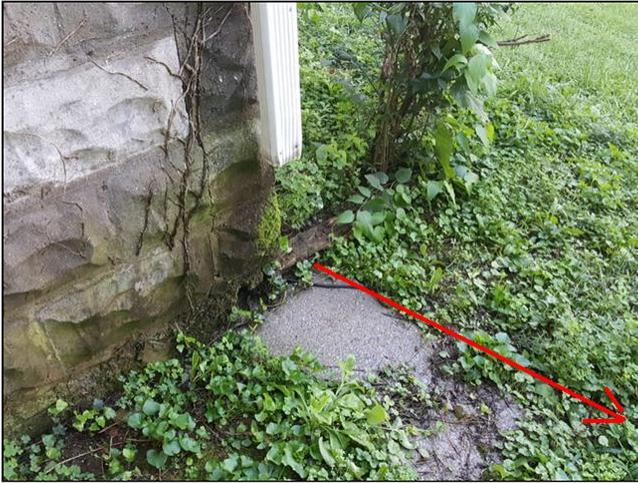
2.4 Item 1(Picture) rear right corner of home

2.4 (1) The downspout is missing a splashblock and is discharging on the ground next to the foundation of the home where indicated in the photos. The downspouts should discharge water through leaders then onto splash blocks at least 6 feet from the home. Storm water should be encouraged to flow away from the foundation/home at the point of discharge to prevent water entering the basement and to prevent settlement of the foundation. Recommend repair and correcting as needed by a general contractor.

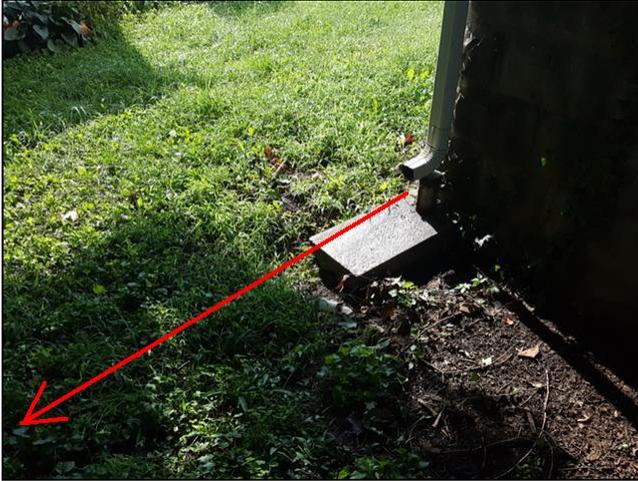
2.4 Item 6(Picture)

2.4 (2) Recommend the downspout(s) at the rear left corner of the home where indicated in the photo(s) be extended at least 6 feet and flow onto splashblocks. This will ensure water is kept away from the foundation perimeter, soil erosion does not occur and water cannot leak into the basement area which may cause settlement of the foundation.

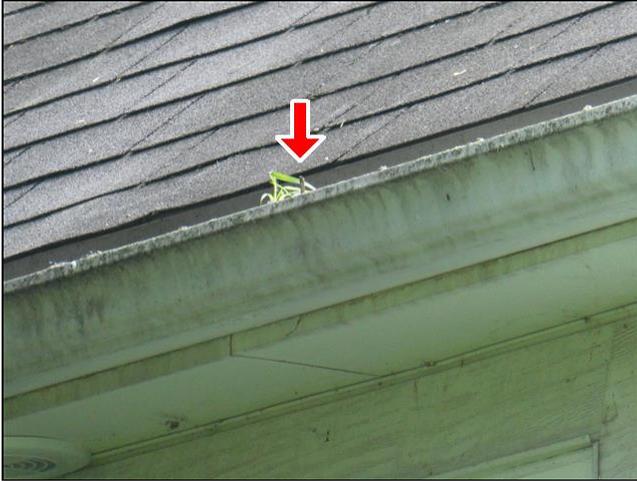
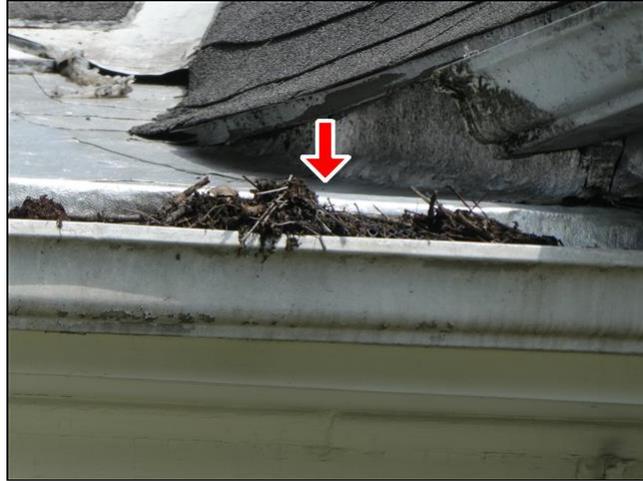
2.4 (3) The gutter(s) around the home, especially where they drain into the downspouts, are full of debris and need to be cleaned. The debris in gutters can also conceal rust, deterioration or leaks that are not visible until cleaned, and I am unable to determine if such conditions exist. Gutters require cleaning to avoid spilling roof runoff around the building - a potential source of water entry or water damage, and/or the fascia could become damaged. Recommend cleaning the gutters as needed.

2.4 Item 7(Picture) rear of home

2.4 Item 8(Picture) front left side of home

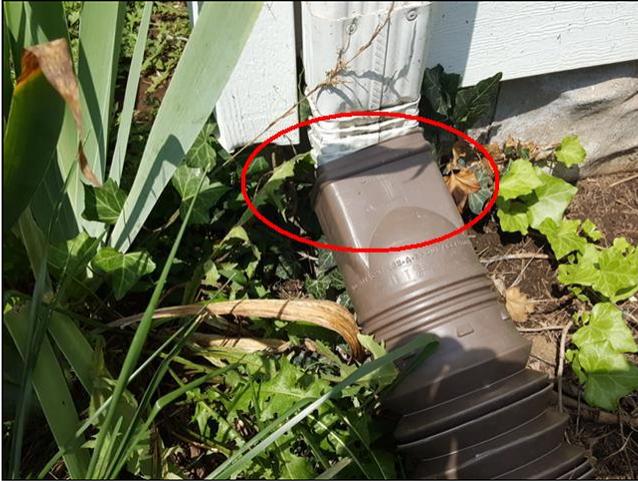
2.4 Item 11(Picture)

2.4 (4) Recommend the downspout extension(s) be attached to the downspout at the front right corner of the home by placing a screw at the top and bottom where it connects to the downspout to ensure the extension(s) does not pull away from the downspout(s). Failing to do this may create future problems to the foundation around the home due to soil erosion and water entering the basement which may result in the foundation settlement if the extension detaches from the downspout.

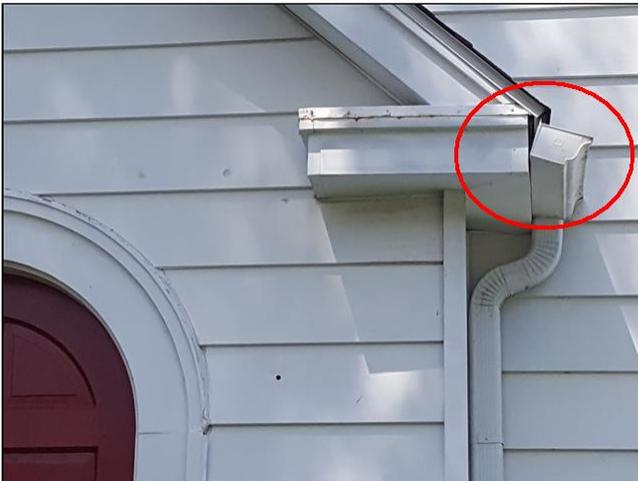
2.4 Item 12(Picture)

2.4 (5) The gutter needs to be tightened against the fascia and sealed at the front of the home where indicated in the photo. This may cause water to pool in this area and may cause the gutter to pull away and detach from the fascia. Recommend a general contractor repair as needed.

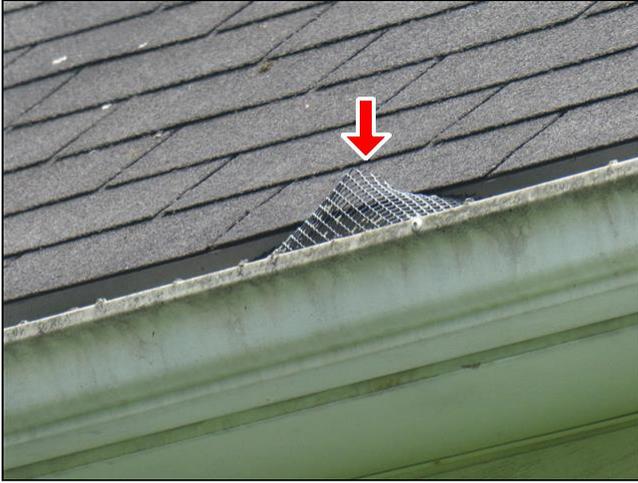
2.4 Item 13(Picture)

2.4 (6) The gutter screens are collapsed inside the gutters in some areas around the home. Gutters that drain poorly or clogged can lead to many costly problems such as deterioration of fascia, soffit or roof edge. It can also cause gutters to pull loose and lead to possible water intrusion. If the Gutter screens are not properly in place leaves can contribute to a clog which can cause deterioration of fascia, soffit or roof edge. It can also cause gutters to pull loose and lead to possible water intrusion. Recommend repair or replacement as needed by a general contractor.

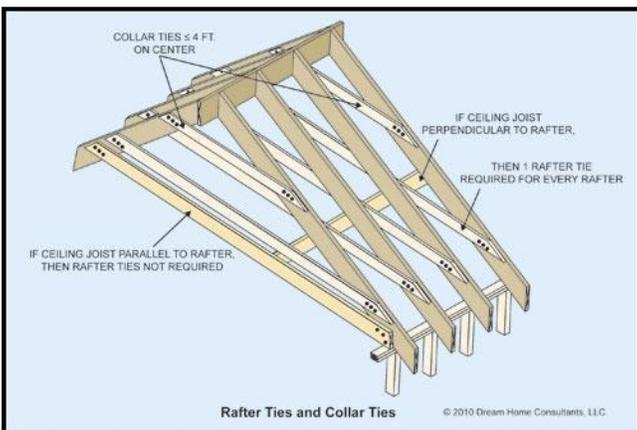
2.6 Item 1(Picture)

2.6 Recommend installing collar ties (horizontal members running between each rafter, near their mid span) be added to add extra support to the roof structure and to resist rafters and ridge beam from sagging in the future. Heavy loads such as snow may cause the ridge of the roof to sag, cracked rafters appearing or the roof to develop leaks near this area from stress. Recommend a qualified roof framing contractor perform these corrections/repairs. You may wish to seek a 2nd opinion by a qualified roofing contractor for further advice in strengthening the roof structure.

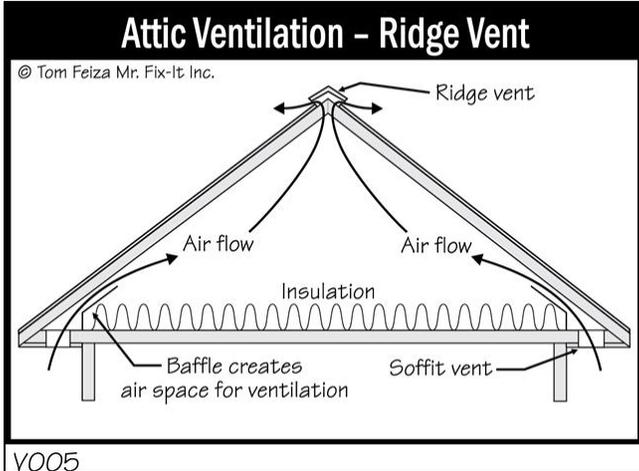
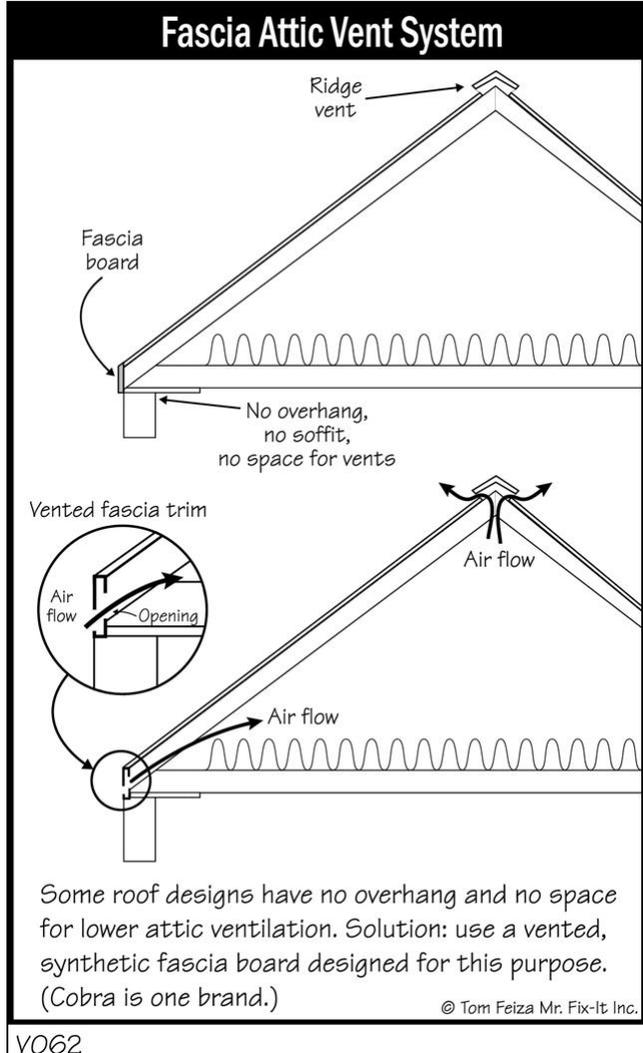
2.7 The level of ventilation is marginal and can be improved. Old homes tend to be constructed more loosely and have natural ventilation. It is generally recommended that one square foot of free vent area be provided for every one hundred and fifty square feet of ceiling area. Half of the ventilation should be at the ridge and the other half at the eaves. Proper ventilation will help to keep the house cooler during warm weather and extend the life of roofing materials. In the winter, it will help reduce the potential for ice dams on the roof and condensation within the attic. [Here is a link explaining ventilation. Look at Trap 4.](#) Recommend improving the ventilation at the next replacement of the roof coverings.

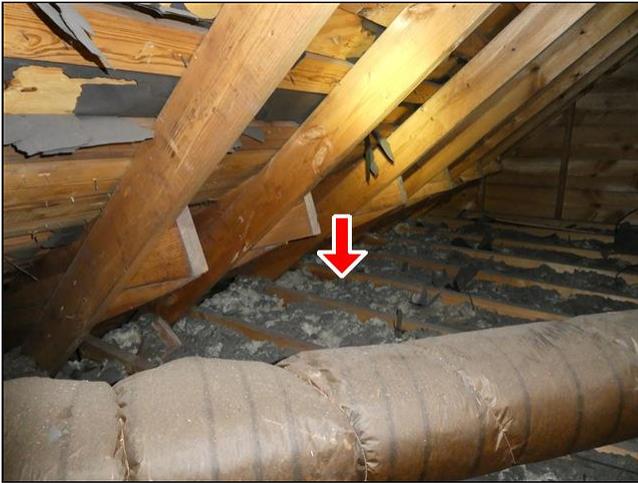
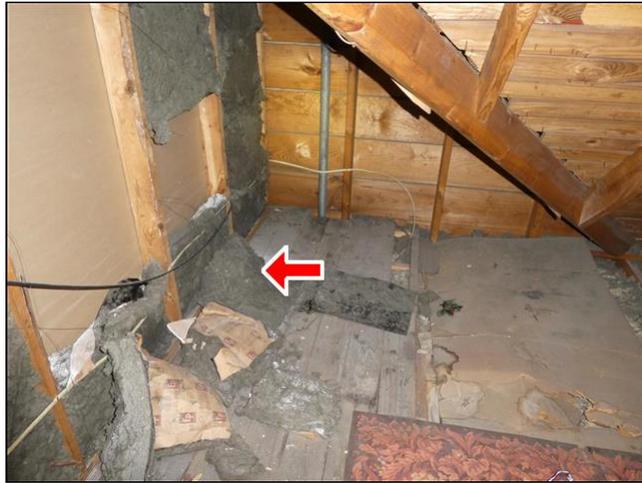
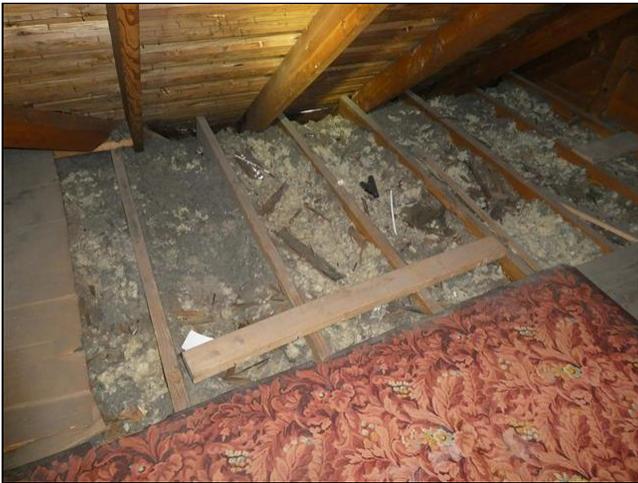
2.8 The insulation is old and has settled, and is less than six inches in thickness in the attic. Consider adding un-faced or loose insulation on top of the existing insulation in the attic to conserve energy. Insulation that has settled does not perform to the R-value that it once did. Heat loss can occur more on this home than one that is properly insulated. Recommend a qualified contractor replace as needed due to R factor is below R19.

Strongly recommend additional and/or replacement of the insulation by a qualified contractor where needed to reduce heat/cool loss within the home and to prevent possible ice dams forming in winter.

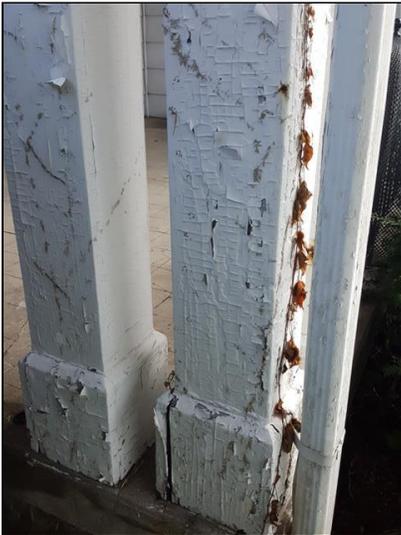
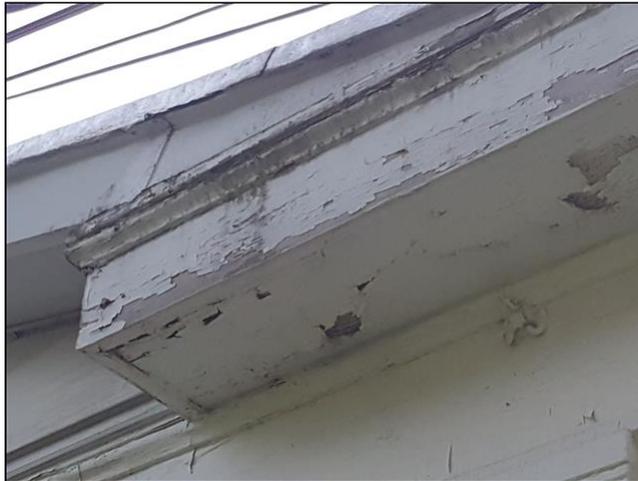
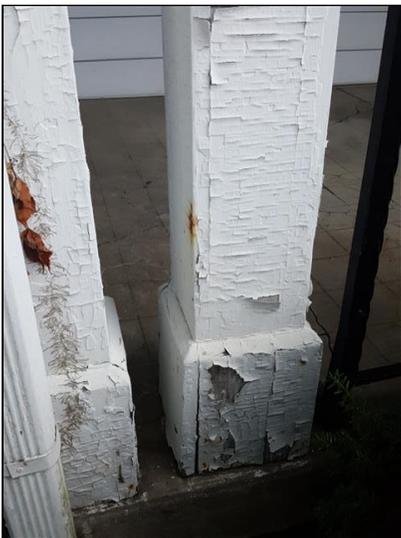
3.1 (1) The fascia and wood post for the side porch at the front of the home has peeling/missing paint in various areas. Deterioration and/or wood rot may occur if not corrected via water intrusion. Recommend these areas be painted to prevent deterioration of exposed wood. To reduce long term maintenance and improve appearance, it may be advantageous to install metal wrapping over these areas.

3.1 Item 3(Picture) front left corner of porch

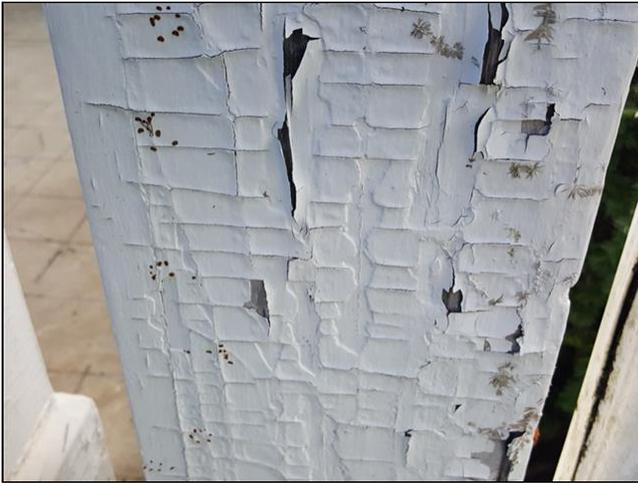
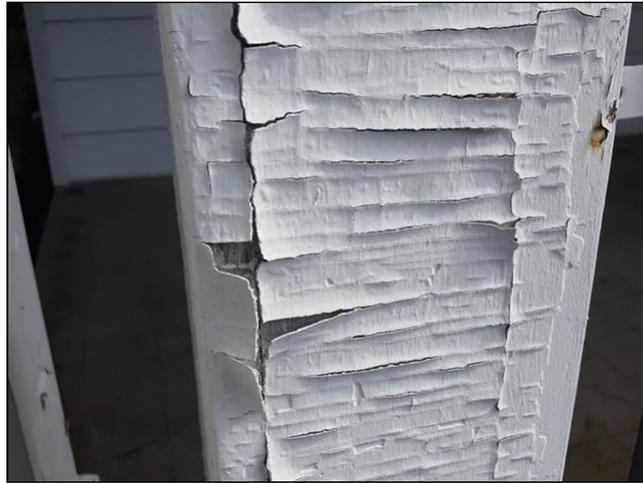
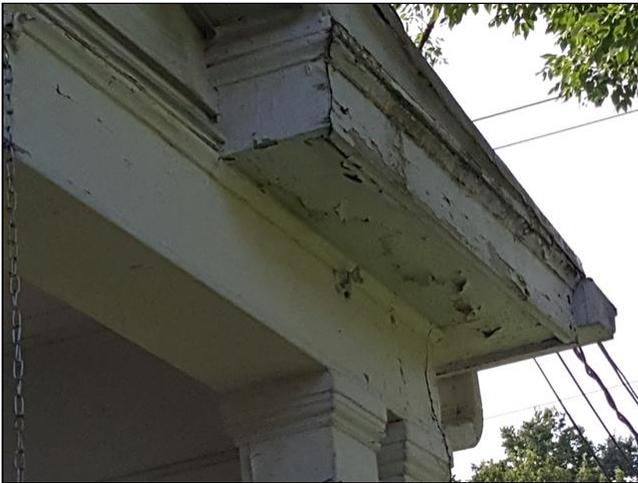
3.1 (2) It was noted that the posts at the side porch at the front of the home may have lead paint due to how the paint is cracking. Only laboratory testing can determine the presence or absence of this covering. Keeping the intact paint covered is considered safe in most cases. If renovations are to be done the proper methods should be explored for removal and disposal of the paint. It is recommended that a preliminary screening for lead based paint be conducted to determine the likelihood of the presence of lead before closing. Part of the procedures are for the "Certified LBP Contractors" included LBP dust sampling. The contractor can do his/her own sampling at the beginning or as part of the clearance testing.

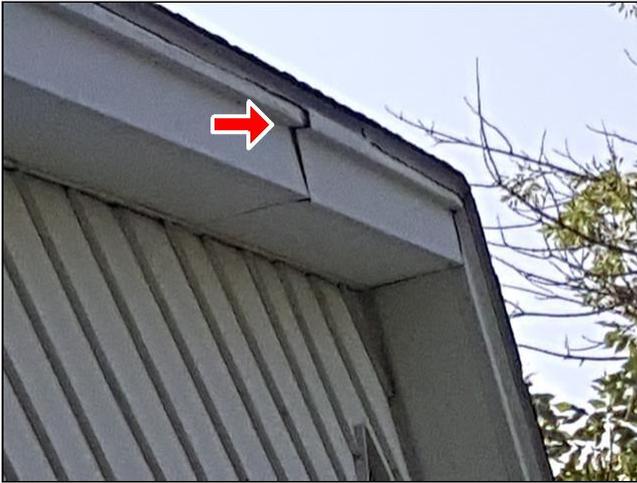
3.1 (3) The metal fascia wrap at the eave on the right side of the home is loose. Moisture or water could enter when raining and deterioration may occur of the fascia board if not corrected. A qualified person should repair or replace as needed.

3.1 Item 7(Picture) left side of home

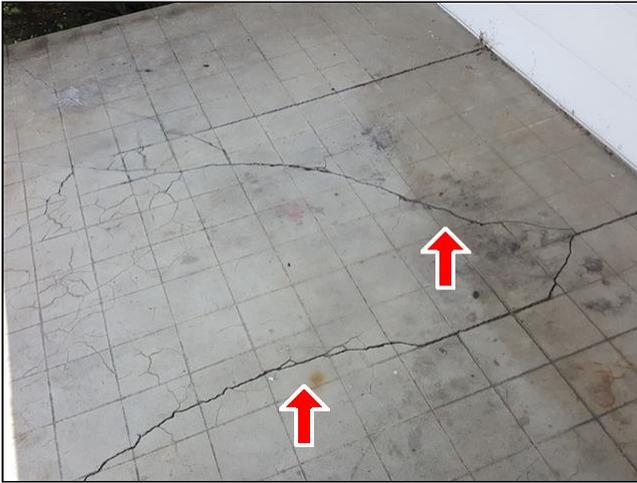
3.4 Item 1(Picture)

3.4 (1) The concrete porch is cracked and chipped in various areas. Further deterioration of the flooring can occur via water entry which could lead to possible cracking of concrete. Recommend these areas be repaired by a qualified masonry contractor.

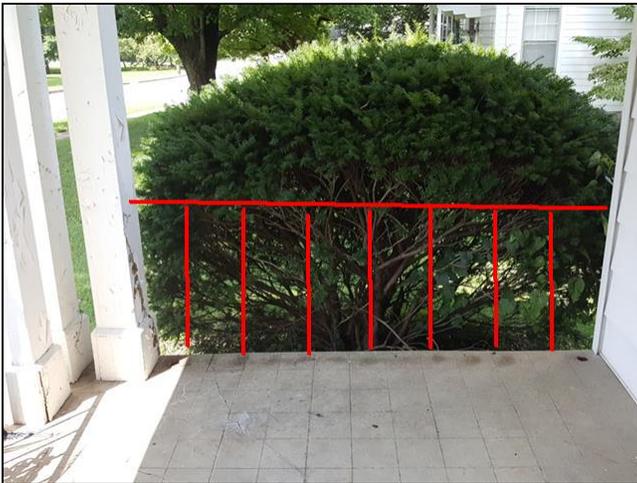
3.4 Item 3(Picture)

3.4 (2) Recommend a guard rail be installed at the left side of the front patio porch to prevent a fall from occurring which may result in an injury of a person. This is a potential safety issue. The railing needs to be at least 36 inches high and balusters need spacing to be at least 4 inches. Recommend a qualified contractor install one for safety.

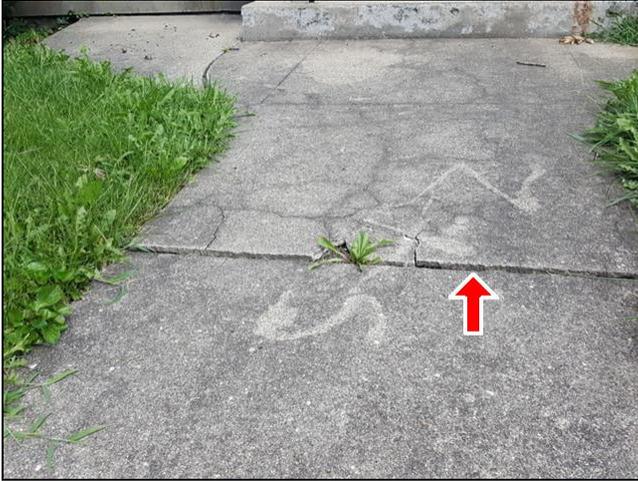
3.6 Item 1(Picture)

3.6 (1) The front walkway leading up to the porch at the front of the home has settled creating a tripping hazard. For safety recommend the walkway be repaired or replaced to prevent a tripping hazard and/or a fall or injury from occurring. Also the cracks need to be sealed to prevent further settlement via water intrusion. Recommend a qualified masonry contractor repair or replace as needed.

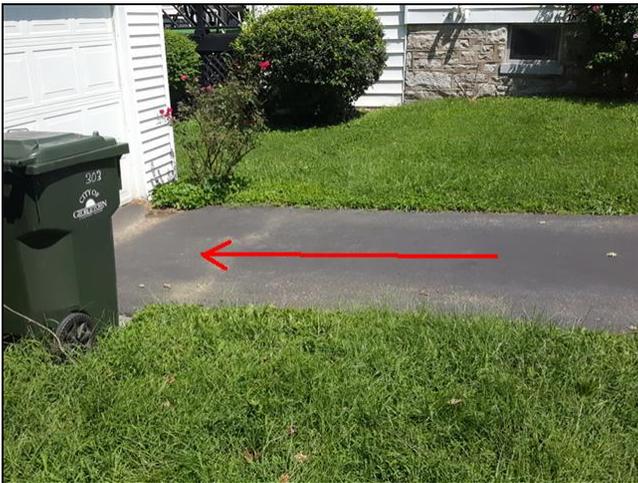
3.6 Item 2(Picture)

3.6 (2) The rear driveway slopes towards the detached garage. These areas can allow water to pool and drain towards the foundation of the garage which can lead to settlement of the garage floor slab, water intrusion, and possible settlement of the foundation wall in the future if not corrected. Recommend a qualified contractor further evaluate to determine repairs and correction to prevent settlement and water intrusion which could lead to more costly repairs to the detached garage in the future.

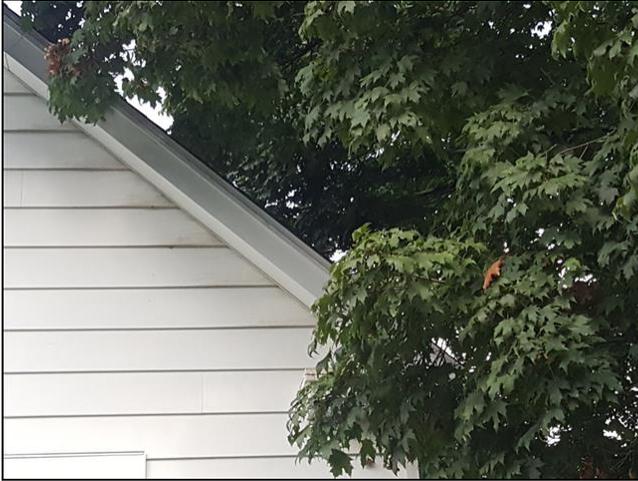
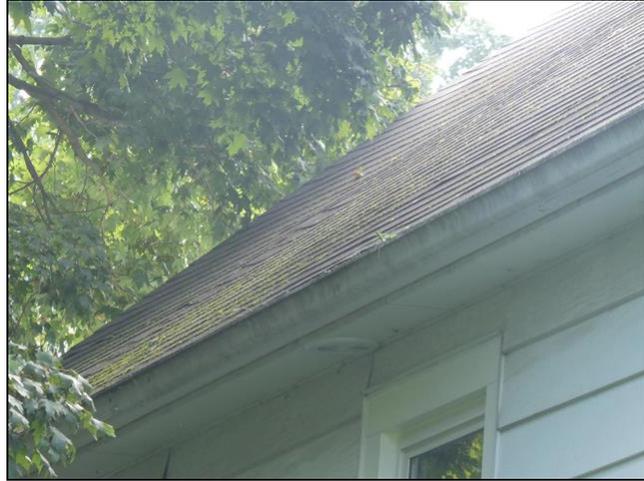
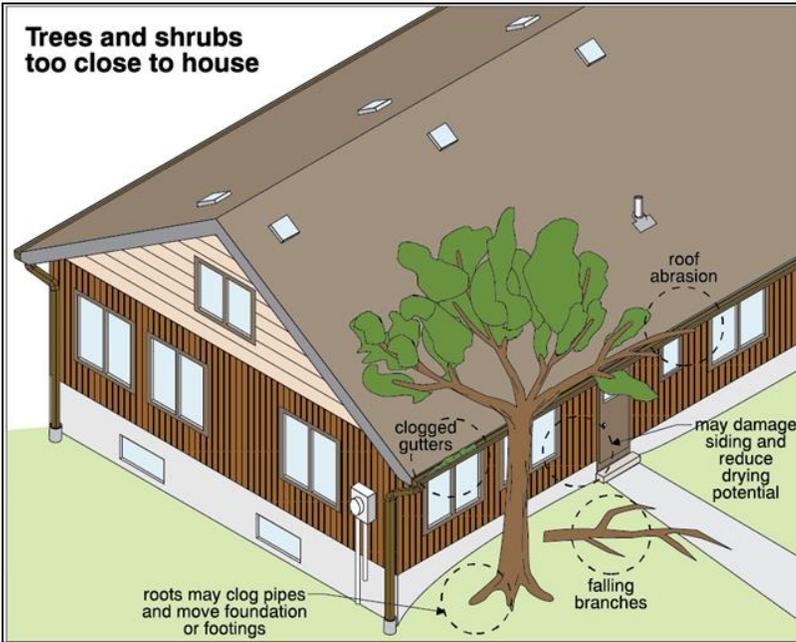
3.8 (1) The tree limbs that are in contact or hanging near the roof at the rear right side of the home should be trimmed to prevent damage to the shingles and from scraping on the roof surface. They will also clog gutters which will cause water run off problems around the home. Recommend cutting back tree branches as needed.

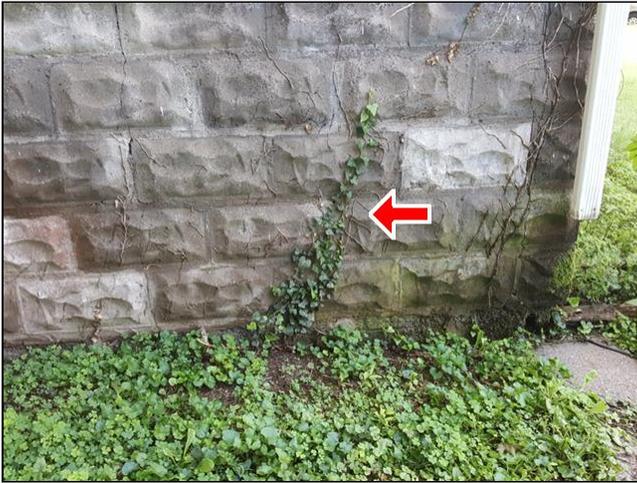
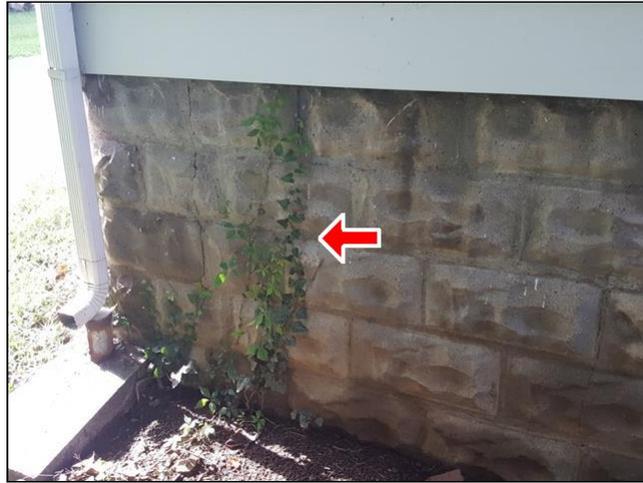
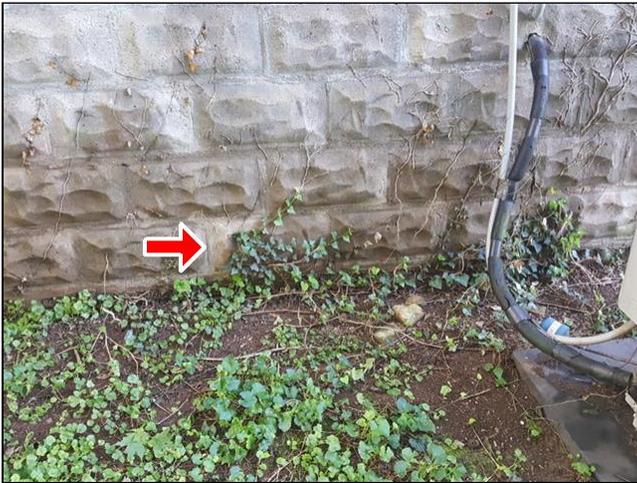
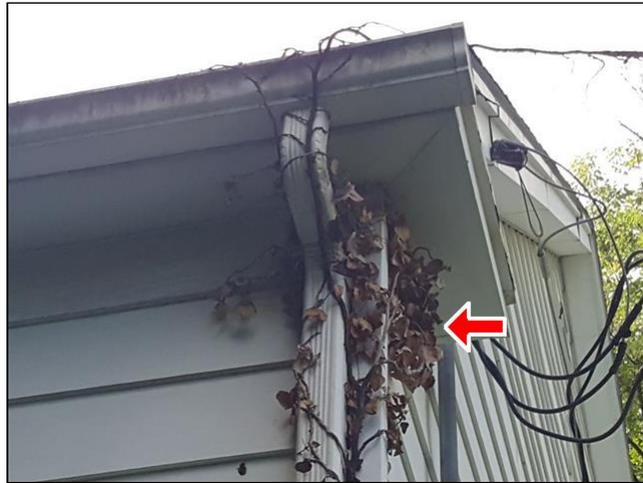
3.8 (2) Vines growing on exterior walls at the rear left and right corner of the home should not be in contact with siding, window trims and the eaves to reduce the risk of insect and water damage to the building. Recommend removing plant.
