TALC
Home Inspe

Inspection Report

Property Address:
303 Wheeler Avenue
Georgetown KY 40324

Talon Home Inspections, LLC

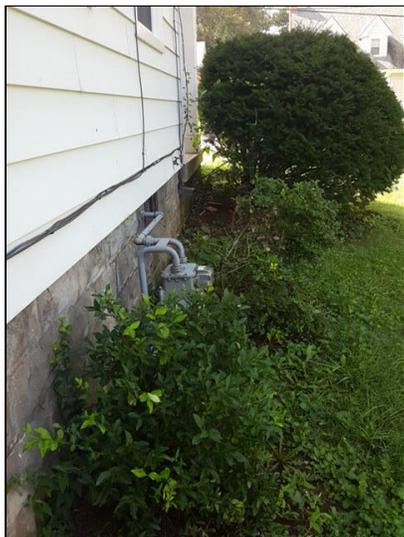
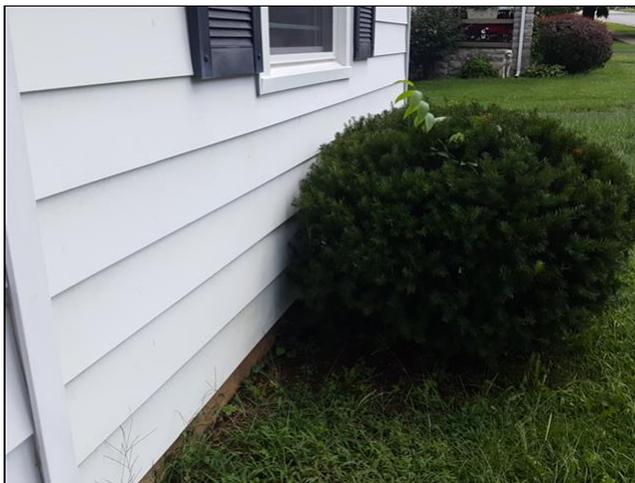
3.8 (3) The vegetation is overgrown around the perimeter of the home where indicated in the photo(s). Recommend that all bushes, shrubs and trees where applicable be kept neatly trimmed and away from the foundation, wall siding, and window frames to prevent damage to the home and allow proper venting and inspection of house. A 6" clearance is recommended.

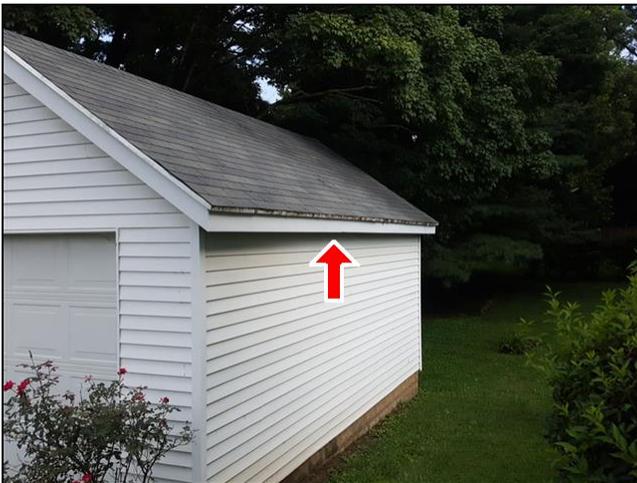
4.0 Item 1(Picture) right side

4.0 (1) The gutters are missing at the garage on both sides. This can possibly cause settlement of the foundation, water to enter under the slab, and/or soil erosion near the foundation perimeter. Recommend gutters be installed on both sides of the roof. Ensure downspouts drain water roof runoff away from the garage and have splash blocks installed to prevent soil erosion near the foundation perimeter. A qualified contractor is recommended for these repairs.

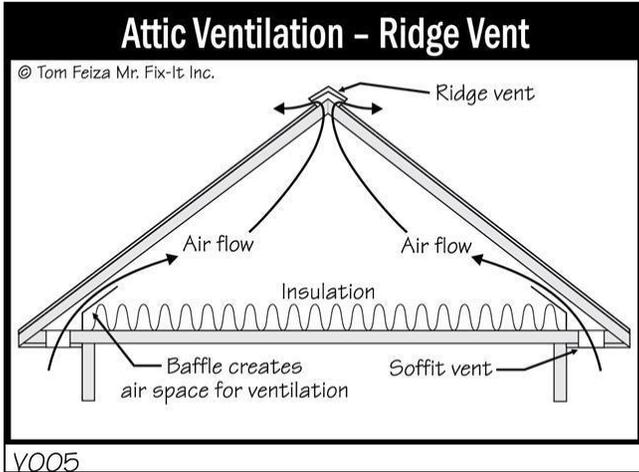
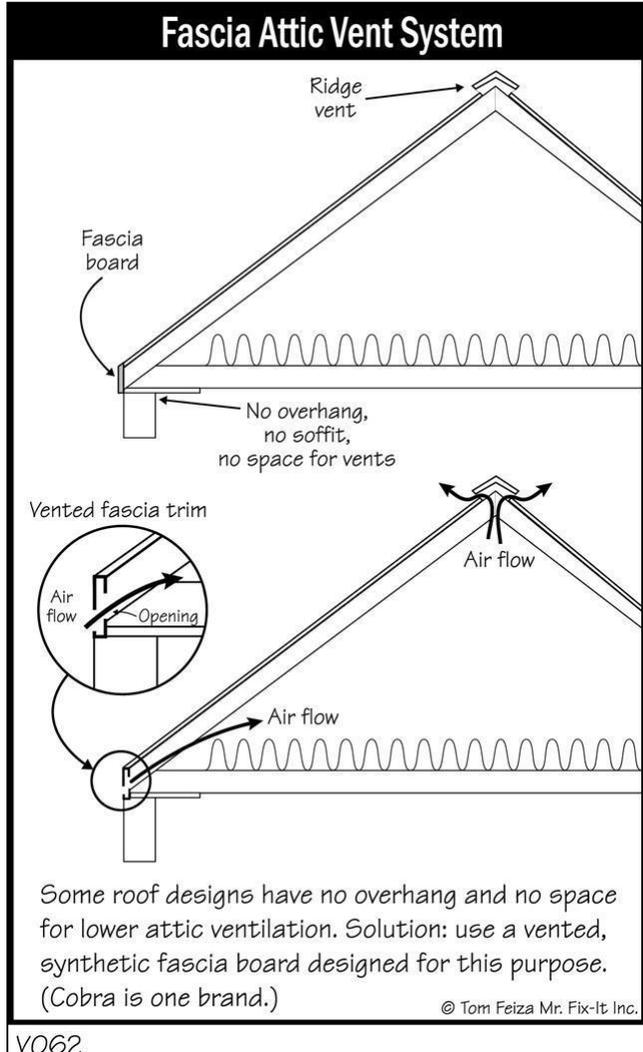
4.1 (1) Recommend additional collar ties (horizontal members running between each rafter, near their mid span) to add extra support to the roof structure and to resist rafters and ridge beam from sagging in the future. Heavy loads such as snow may cause the ridge of the roof to sag, cracked rafters appearing or the roof to develop leaks near this area from stress. Recommend a qualified roofing contractor make the necessary corrections as needed.

4.1 (2) There is no ventilation in the garage. It is generally recommended that one square foot of free vent area be provided for every one hundred and fifty square feet of ceiling area. Half of the ventilation should be at the ridge and the other half at the eaves. Proper ventilation will help to keep the garage cooler during warm weather and extend the life of roofing materials. In the winter, it will help reduce the potential for ice dams on the roof and condensation within the garage. [Here is a link explaining ventilation.](#) Recommend improving the ventilation at the next replacement of the roof coverings.

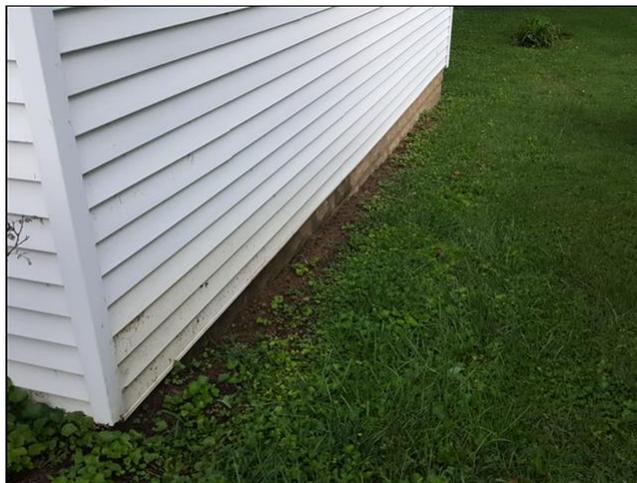
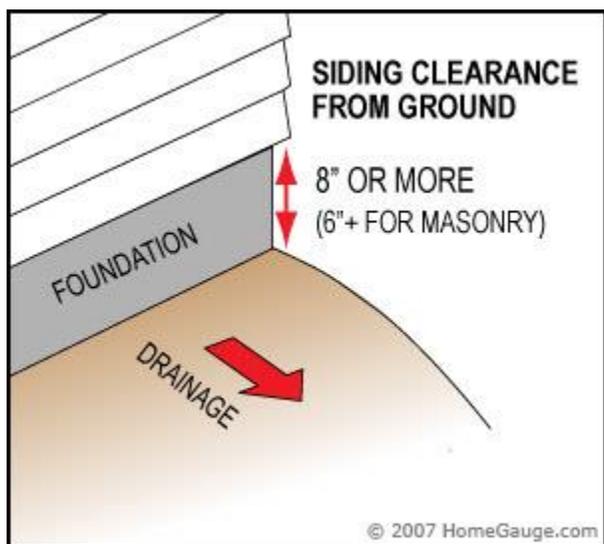
4.2 There are depressions in the soil around the foundation perimeter of the garage of the home. Recommend filling all depressions and re-grading the soil so the soil slopes away from the home around the foundation to ensure water pooling does not occur in these areas. Water pooling could lead to to garage leakage.

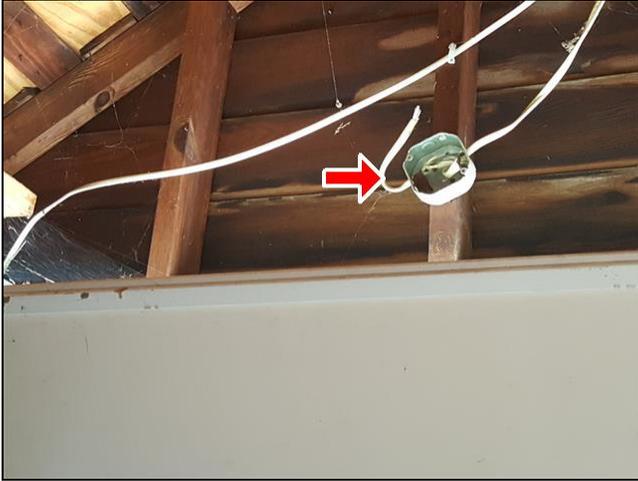
4.8 Item 1(Picture)

4.8 (2) All junction boxes in the garage should have covers installed to prevent tampering, protect the wire connections, and for personal protection. This is a safety issue that needs to be corrected. If a leak was to occur it could result in a short then a fire in the home. Recommend a qualified licensed electrician correct as needed.

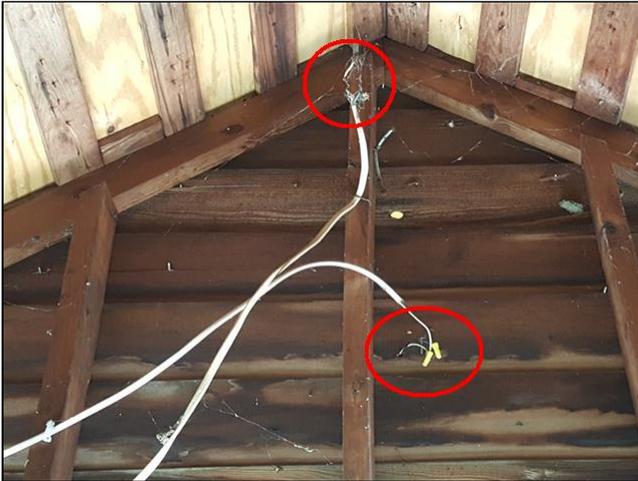
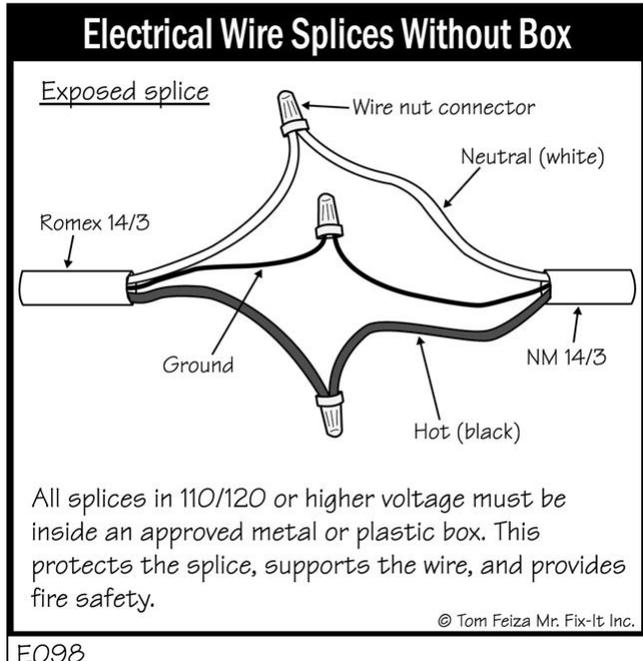
4.8 (3) Wires that are connected with twist caps in a garage need to be placed in a junction box to prevent tampering, protect the wire connections, and for personal protection. This is a safety issue that needs to be corrected. If a leak was to occur it could result in a short then a fire in the garage. Recommend a qualified licensed electrician correct as needed.

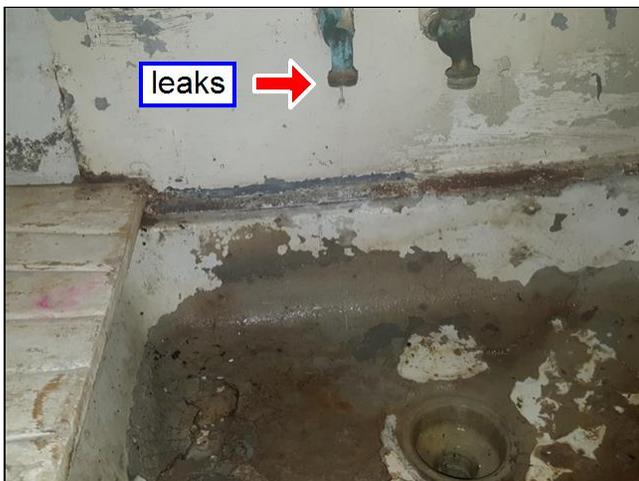
5.0 Item 2(Picture)

5.0 (2) The hot water faucet at the washer dryer sink in the basement leaks at the stem when water is turned off . Repairs by a licensed plumber is recommended.

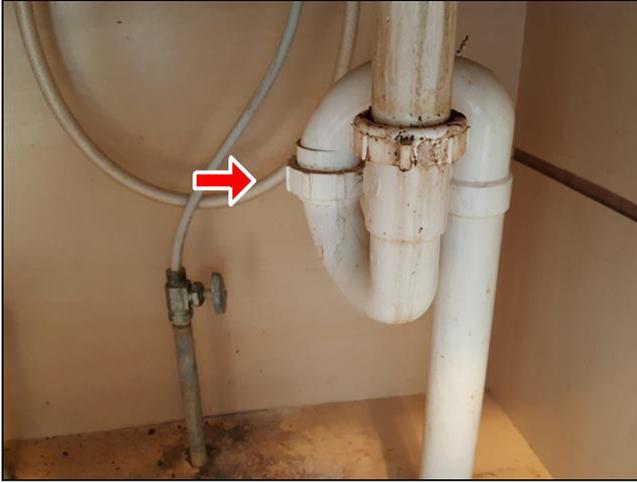
5.1 Item 1(Picture)

5.1 (1) An "S" trap is being used under the kitchen sink. "S" traps should be replaced during any new plumbing work as they are subject to siphoning problems. "S" Type drain traps do not meet today's standards and are now illegal to be used in Kentucky. This type of trap could allow all the water to drain from the trap and allow sewer gases to enter the house. Care should be taken to keep the trap "primed". Fixtures should be monitored for sewer odor. Examination of the drain trap and correction by a licensed plumber is recommended.

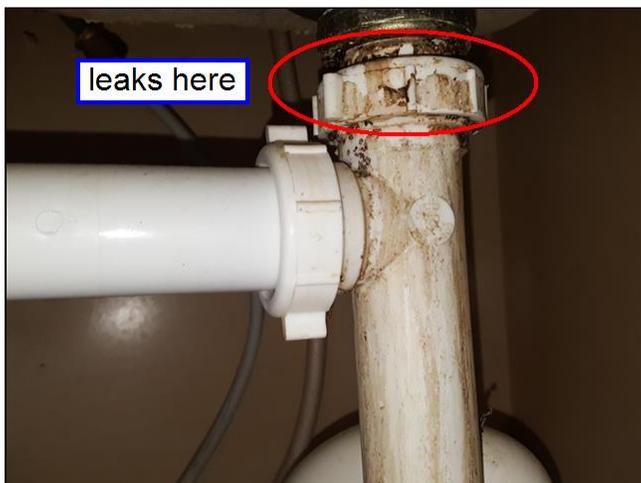
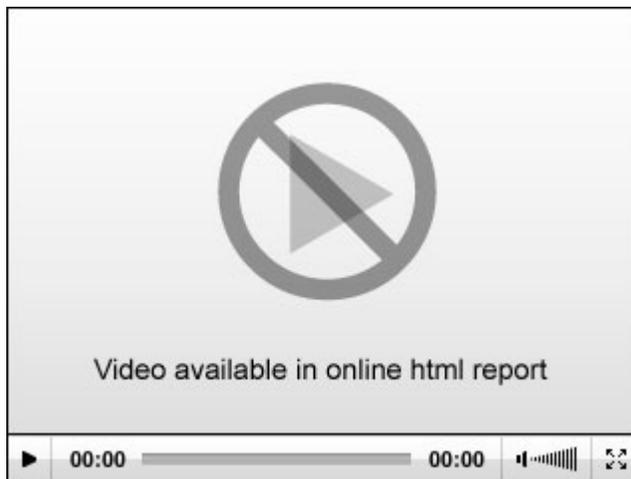
5.1 Item 4(Picture)

5.1 (2) The waste line is leaking at the connection underneath the sink in the kitchen. Repairs are needed to stop leaking water from damaging the cabinet bottom or to eliminate moisture that may contribute to fungi growth. A qualified licensed plumber is recommended for repairs as needed.

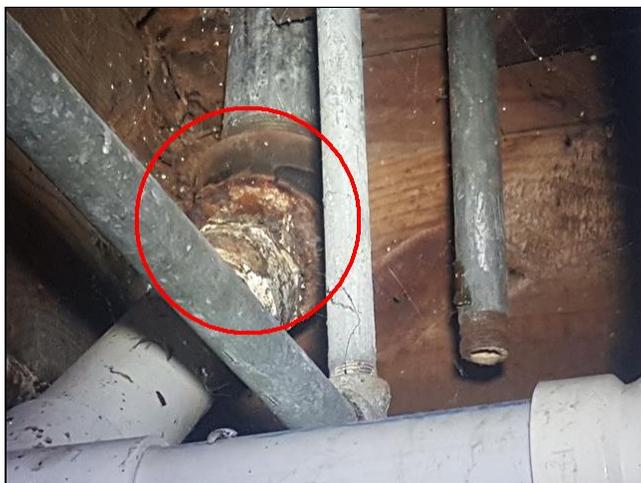
5.1 Item 6(Picture)

5.1 (3) Corrosion was noted at the waste line in the basement under the kitchen sink area. Recommend replacement by a qualified plumber to prevent a water leak occurring in the future. This will prevent damage to the wood framing and sill plate.

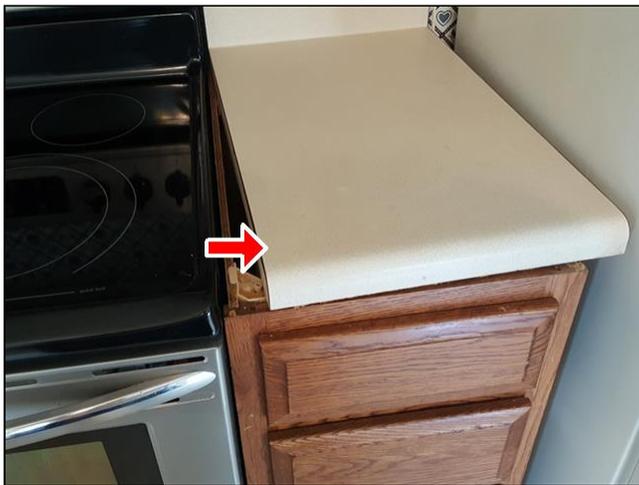
5.6 Item 1(Picture)

5.6 (1) The laminated countertop is loose and not fastened securely to the cabinet (right and left of stove). This is a safety issue as the top may fall causing an injury of a person. Recommend repair or replace as necessary.

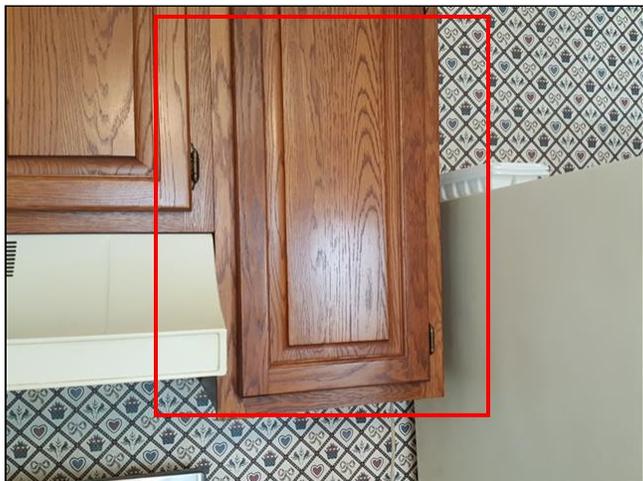
5.6 Item 3(Picture)

5.6 (2) The wall cabinet on the right side of the stove is not secured to the wall correctly. The top fasteners are missing. This is a safety issue as the cabinet may detach from the wall if excess weight is placed inside. Recommend a general contractor repair as needed prior to moving in.

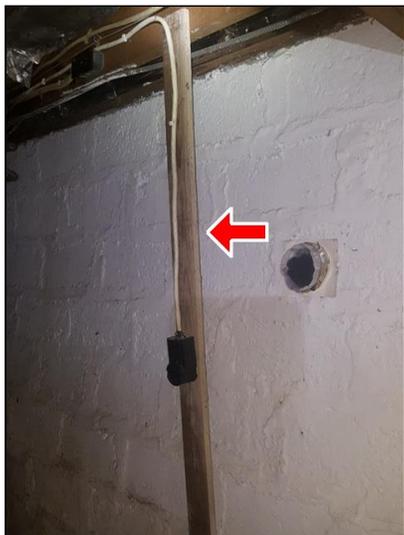
5.7 Item 4(Picture)

5.7 (5) The mount for the clothes dryer receptacle is loose and not secured correctly. It should be secured to the wall to prevent tugging on wires and causing damage to wire covering which could then be a shock hazard. Recommend repair by a qualified licensed electrician for safety.

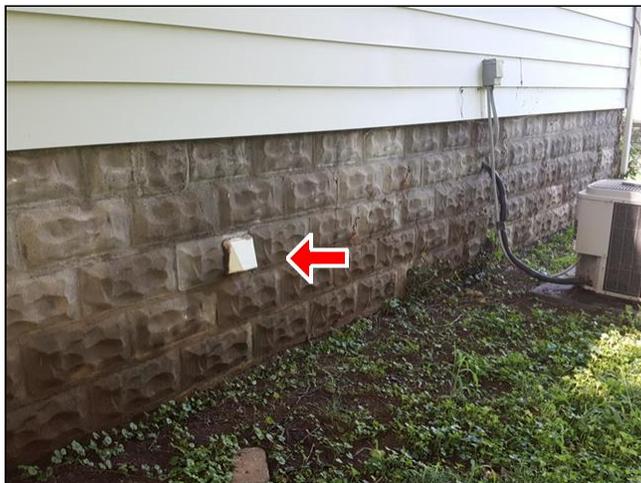
5.8 Item 1(Picture)

5.8 (1) The exterior port for the dryer vent pipe is located at the rear of the home. (see photo for location) This is for your information.

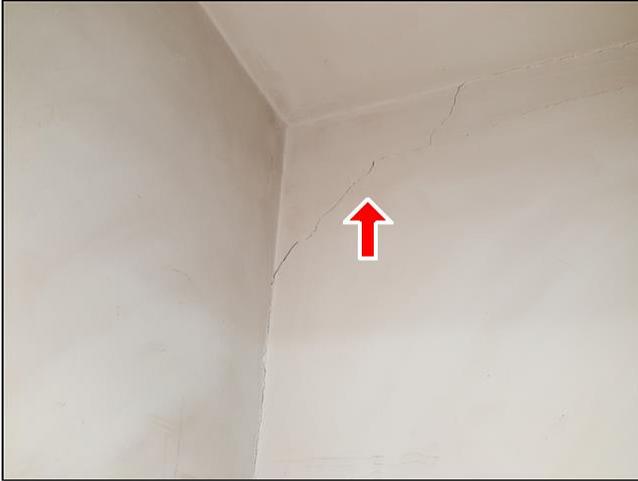
6.1 Item 1(Picture)

6.1 (1) The crack(s) noted on the walls where indicated in the photo(s) in the master bedroom closet are common minor settlement vertical and diagonal crack(s). Cracks larger than 1/8" wide are of concern only. Minor settlement of the home has occurred due to the age of the home and from perhaps via framing shrinkage. This damage is considered to be cosmetic and a small repair issue for your information. Recommend prep prime and paint as needed.

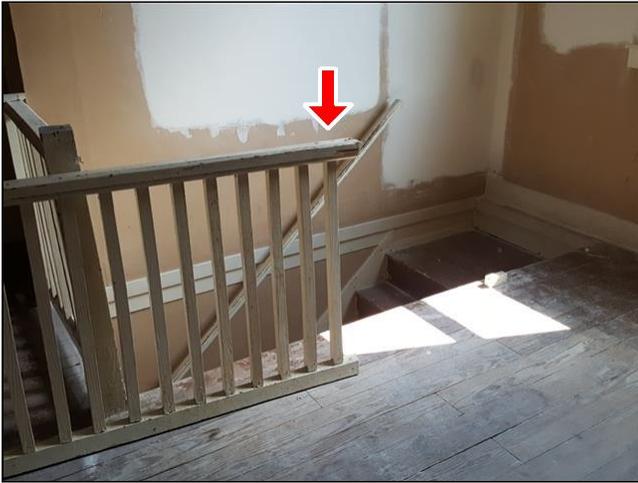
6.3 Item 1(Picture)

6.3 (1) The balcony railing is loose and not secured to the floor in the loft area. This is extremely dangerous and is a safety concern. An injury of a person will occur if not corrected. Recommend repair or replace by a qualified contractor before moving in.

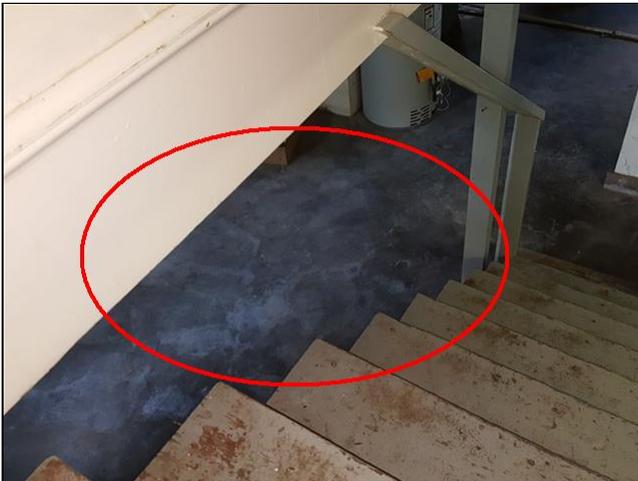
6.3 Item 2(Picture)

6.3 (2) The guard rails for the staircase leading to the basement are missing balusters. A fall or injury could occur if not corrected. This is a safety issue. Ensure the baluster spacing is 4 inches apart to prevent a child or pet from falling through. A qualified contractor should repair or replace as needed prior to moving in.

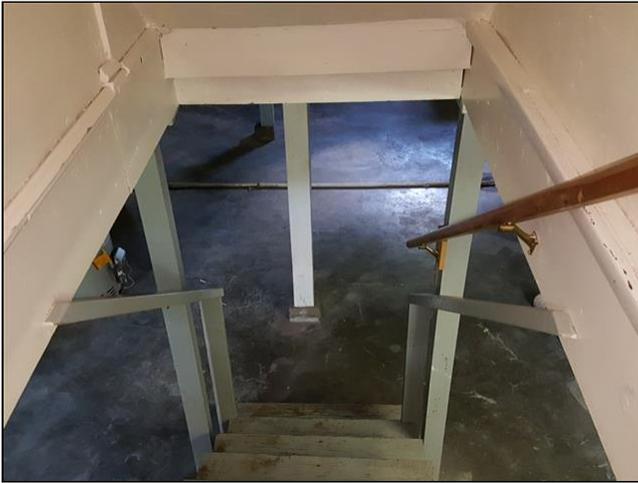
6.3 Item 4(Picture)

6.3 (3) There is low headroom at the staircase leading to the basement. This is normal for a home of this age. There are no real corrections that can be done to improve this situation. Extreme care should be practiced when using the stairs. This is for your information.

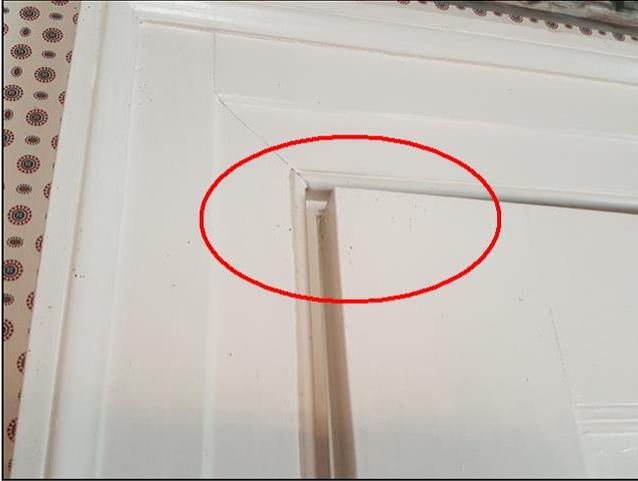
6.4 Item 1(Picture)

6.4 (1) The door in the formal dining room hits the door jamb at the top and does not close shut. This is a maintenance issue. Sometimes correcting the door opening can require door trim to be removed and painting touch up, and/or door hinges may need reseating to ensure correct closure of door. Recommend repair as needed by a general contractor.

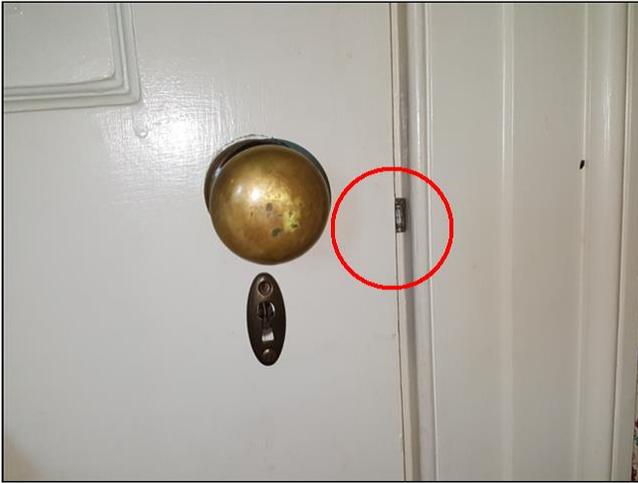
6.4 (2) The door knob hardware is not latching in the Master and 2nd Bedrooms where indicated in the photo. It requires an adjustment. The strike plate may need to be adjusted or trimmed to be able to lock/ close the door. Recommend repair as needed.

6.4 Item 4(Picture) master bedroom

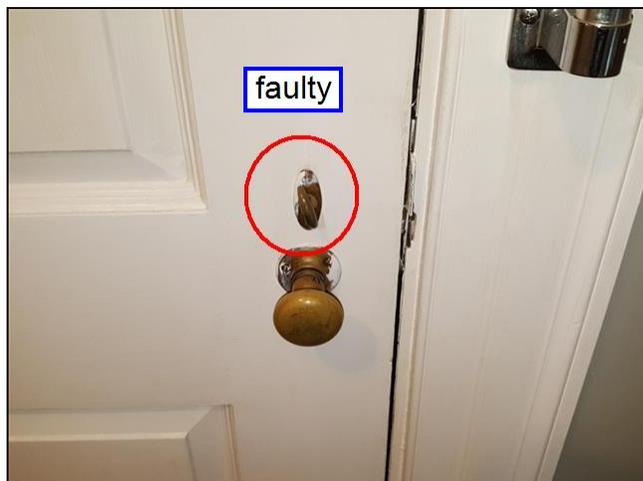
6.4 Item 7(Picture)

6.4 (3) The side entry door at the front of the home does not lock. The locking mechanism maybe faulty. Recommend replacement to ensure security within the home.

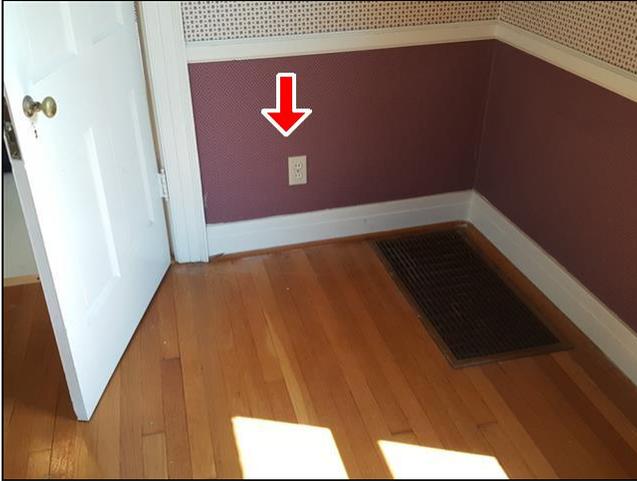
6.7 (2) The outlets in various rooms in this home are 2-slot and 3-slot ungrounded devices. Appliances that are equipped with 3-spade grounding plug, such as refrigerators, microwaves, clothes washers, sump pumps and personal computers, cannot be safely connected to these outlets. These appliances must be connected to 3-slot grounded outlets. The installation of new circuits with properly grounded 3-slot outlets will be required to allow appliances with 3-spade plugs to be safely used in the home. Recommend a qualified electrician correct where needed.

6.7 Item 2(Picture) formal dining room

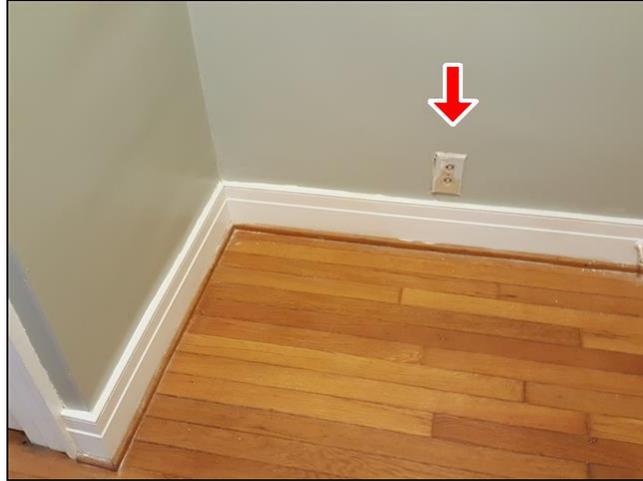
6.7 Item 3(Picture) entry hallway

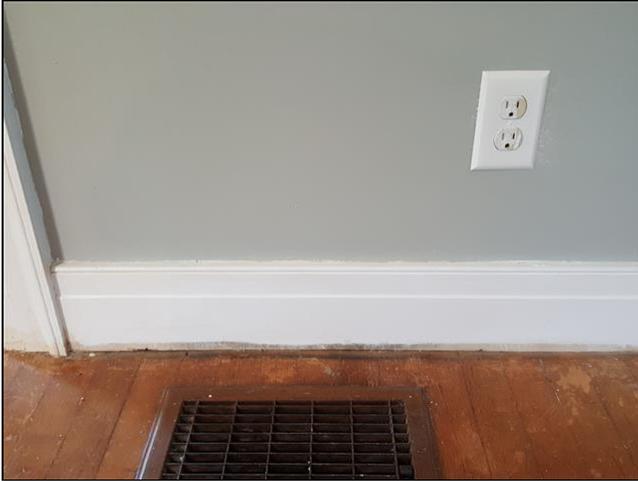
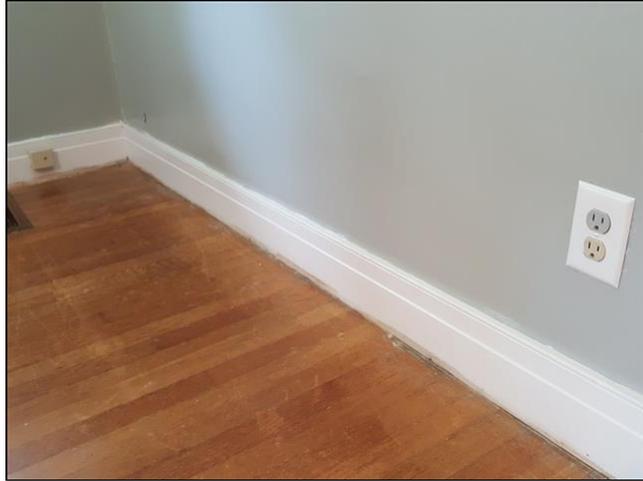
6.7 (3) Some of the outlets in the rooms have been painted. Paint clumps in crevices can clog the openings in the outlet, making it difficult to insert the blades from the plug. Forcing the blades in may damage them and/or lead to a poor connection with the internal contacts creating a hazardous condition causing a fire. Additionally, paint chips can fall off the outlet or switch after repeated use creating a health hazard for young children and pets. Recommend replacing outlets and covers where necessary for safety by an electrician.

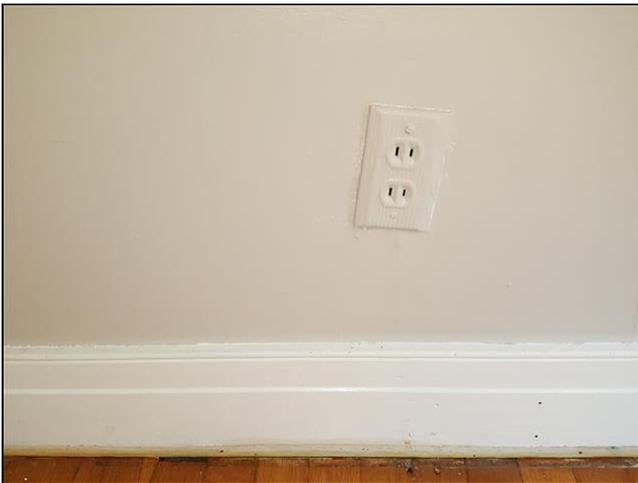
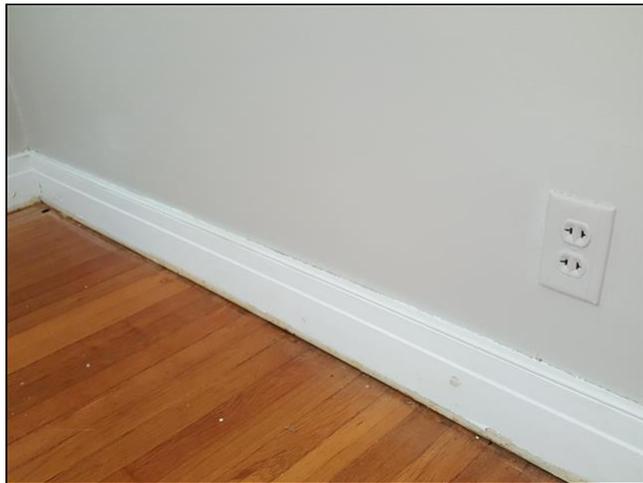
6.7 (4) The outlet in the 2nd bedroom where indicated in the photo(s) is loose at the wall or in the outlet box. Electrical issues are considered a hazard until repaired. This is a safety issue that needs to be corrected due to an electric shock or fire from loose connections could occur if not repaired. Recommend a qualified licensed electrical contractor correct as needed.

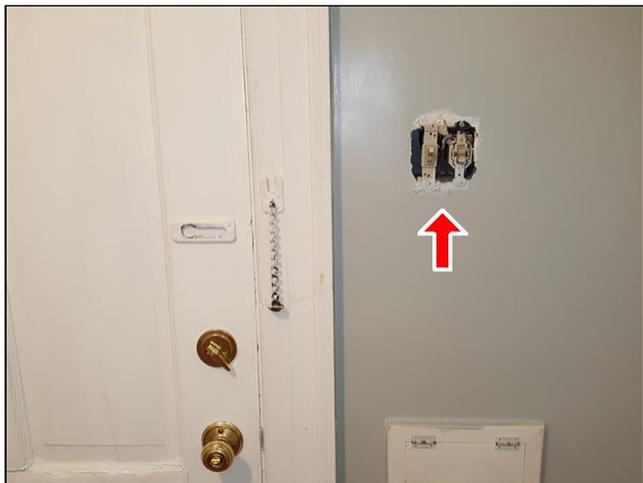
6.7 Item 15(Picture)

6.7 (5) The light switch(s) in the main entry hallway is missing a cover-plate. All missing switch covers should be installed to prevent touching the sides of the devices to prevent an electric shock which can cause an injury or death. Electrical issues are considered a hazard until repaired, and this is considered to be unsafe. A qualified licensed electrical contractor should correct as needed prior to moving in.

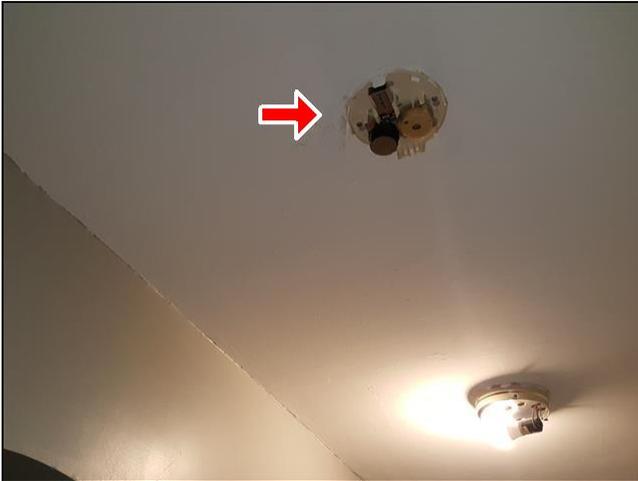
6.8 Item 1(Picture)

6.8 (3) The smoke detector is missing a cover at the hallway. Without a working smoke detector in your home you have no first alert to a possible fire. Recommend replacement as needed.

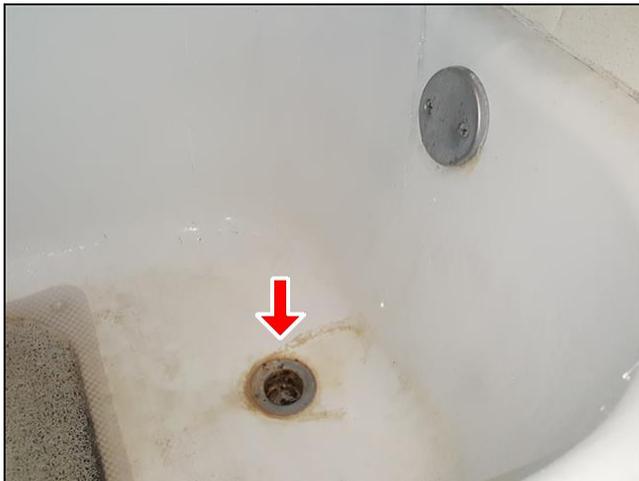
7.4 Item 1(Picture)

7.4 (1) The drain stopper is missing at the bath tub in the master bathroom. Recommend a qualified licensed plumber install one or a rubber stopper can be used.

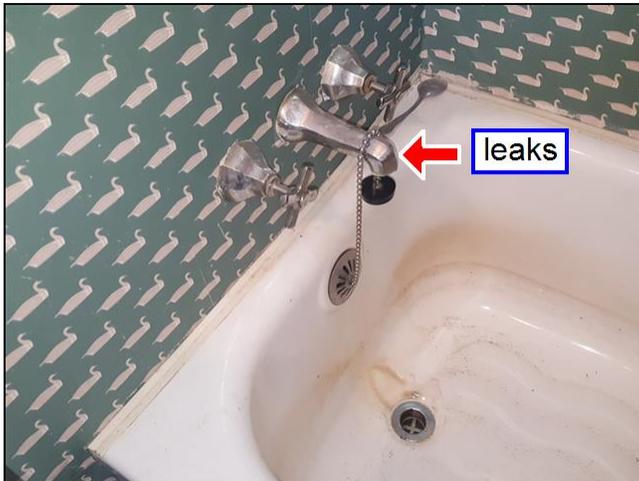
7.4 Item 2(Picture)

7.4 (2) The bath/shower water spout leaks when the water is turned off in the 2nd bathroom. Recommend a licensed plumber repair as needed.

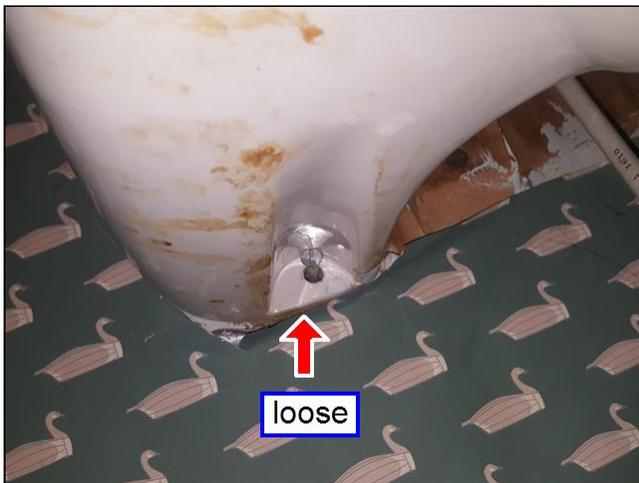
7.4 Item 4(Picture)

7.4 (4) The sink in the 2nd bathroom is loose and not fastened securely to the wall. This should be secured to prevent strain on supply and drainage lines which could result in a leak occurring. This may also be a safety issue as the sink bowl may fall resulting in an injury. Recommend a general contractor repair as as needed.

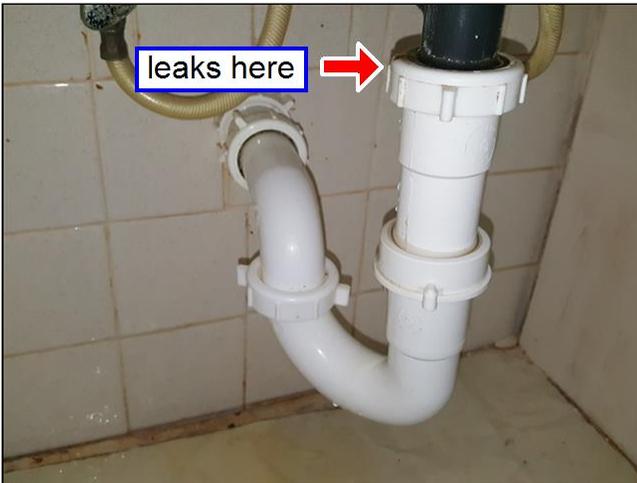
7.5 Item 1(Picture)

7.5 (1) The waste line is leaking at the connection underneath the sink in the master bathroom. Repairs are needed to stop leaking water from damaging the cabinet bottom or to eliminate moisture that may contribute to fungi growth. A qualified licensed plumber is recommended for repairs as needed.

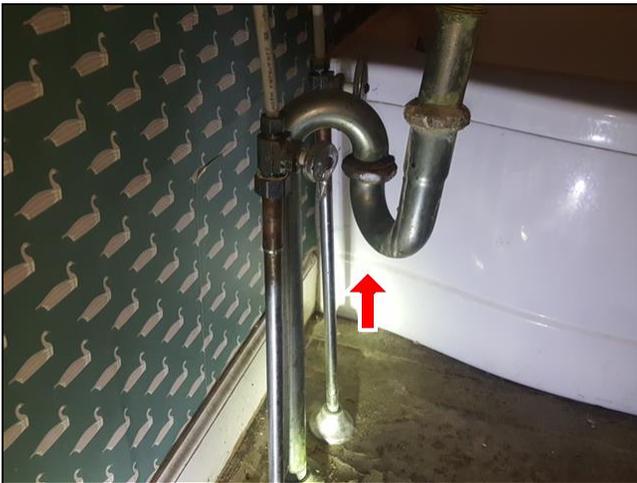
7.5 Item 3(Picture)

7.5 (2) An "S" trap is being used under the 2nd bathroom sink. "S" traps should be replaced during any new plumbing work as they are subject to siphoning problems. "S" Type drain traps do not meet today's standards and are now illegal to be used in Kentucky. This type of trap could allow all the water to drain from the trap and allow sewer gases to enter the house. Care should be taken to keep the trap "primed". Fixtures should be monitored for sewer odor. Examination of the drain trap and correction by a licensed plumber is recommended.

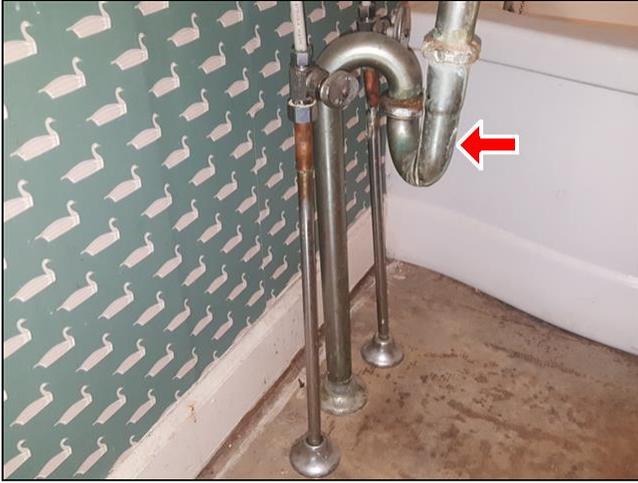
7.5 Item 5(Picture)

7.5 (3) The brass drain lines under the sinks in the 2nd bathroom are subject to corrosion by the acids that are present in a drain system. The downside of brass pipe (chrome plated) is that it's made of thin-wall brass and is known to leak at joints over time. The anticipated service life of thin-wall brass tubing is about 12-15yrs. By contrast, plastic piping is impervious to the acids therefore the expected life of the plastic pipe is 50+ years. The other distinct advantage of plastic piping is that it only costs a mere fraction of what the plated brass tubing would cost. This is for your information.

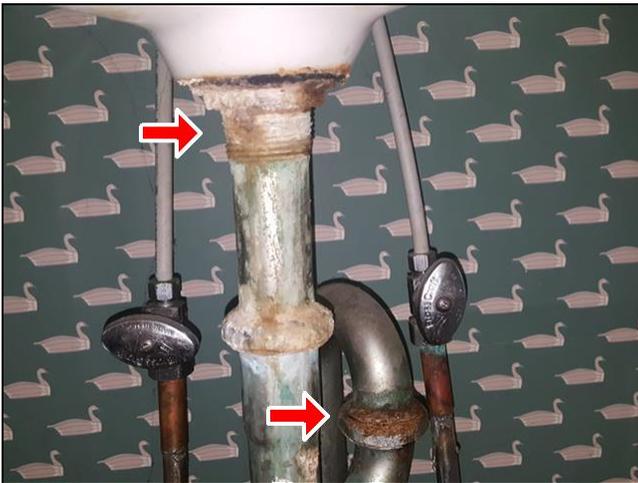
7.5 Item 6(Picture)

7.5 (4) Corrosion was noted at the waste line under the sink in the 2nd bathroom. Recommend replacement by a qualified plumber to prevent a water leak occurring in the future. This will prevent damage to the base cabinetry.

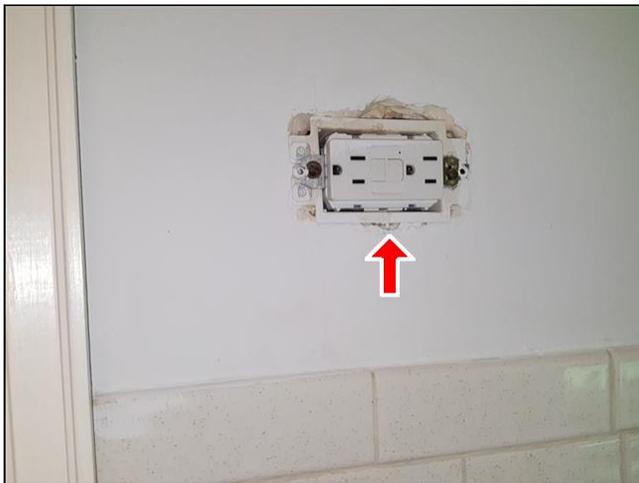
7.6 Item 1(Picture)

7.6 (1) The outlet(s) in the master bathroom where indicated in the photo(s) is missing a cover-plate. All missing covers should be installed to prevent touching the sides of the devices to prevent an electric shock which can cause an injury or death. Electrical issues are considered a hazard until repaired, and this is considered to be unsafe. A qualified licensed electrical contractor should correct as needed prior to moving in.

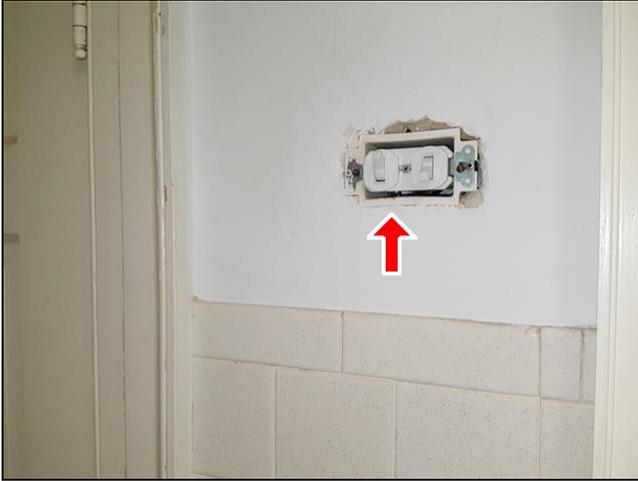
7.6 Item 2(Picture)

7.6 (2) The light switch(s) in the Master bathroom is missing a cover-plate. All missing switch covers should be installed to prevent touching the sides of the devices to prevent and electric shock which can cause an injury or death. Electrical issues are considered a hazard until repaired, and this is considered to be unsafe. A qualified licensed electrical contractor should correct as needed prior to moving in.

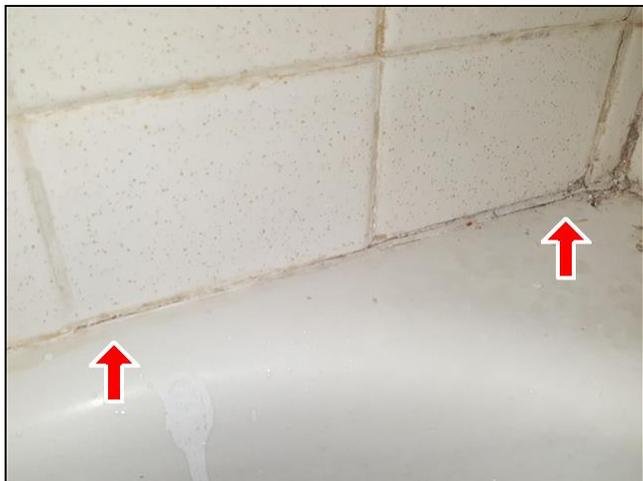
7.7 Item 1(Picture)

7.7 Old, shrinking, or dirty caulk with holes and cracks was seen in the master bathroom shower enclosure. All of the caulk should be kept in perfect condition to prevent further cracking or more holes appearing to reduce the possibility of water leaking underneath the shower enclosure and tiled wall. If not corrected mold and/or deterioration of the floor/wall framing can occur beneath the shower enclosure. Recommend re-caulking where needed to seal openings and deteriorated caulk. Use a quality silicone caulk that is expandable and moisture resistant. [Choosing the right caulk](#) Would recommend a qualified general contractor repair as needed.

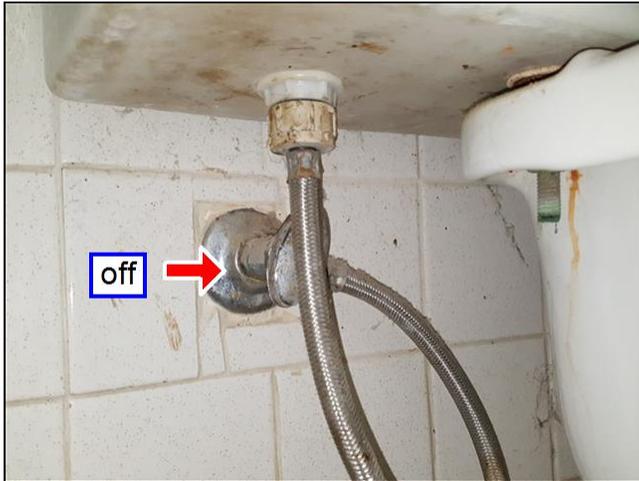
7.8 Item 1(Picture)

7.8 (1) The water supply is turned off at the supply line to the toilet at time of the inspection in the master bathroom. I cannot determine if any problems will arise after water supply is restored. Our company prohibits an inspector from turning on any water supply valves due to it may cause harm to the unit or damage to the building via a possible water leaks. Recommend checking with the owner to verify operation of the faucets and toilets and ask for reason why the water supply has been turned off prior to closing.

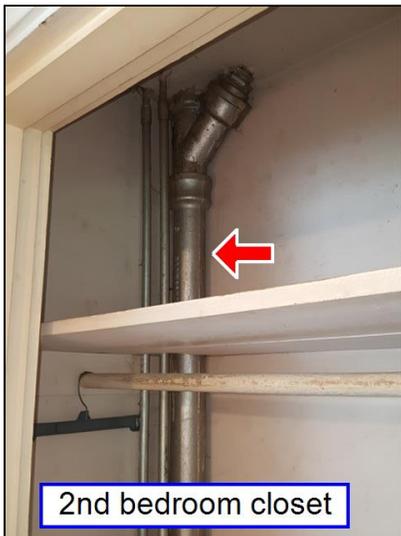
8.0 Item 1(Picture)

8.0 (1) Cast Iron drain lines are known to corrode internally and will leak at the joints after a long period of time. The corrosion will eventually restrict the drainage and leaks will occur. The cast iron drainage lines are fifty or more years old and could fail at any time. Replacement of the drainage lines should be strongly considered before major leaks occur. This is for your information. There were no present leaks visible at time of inspection.

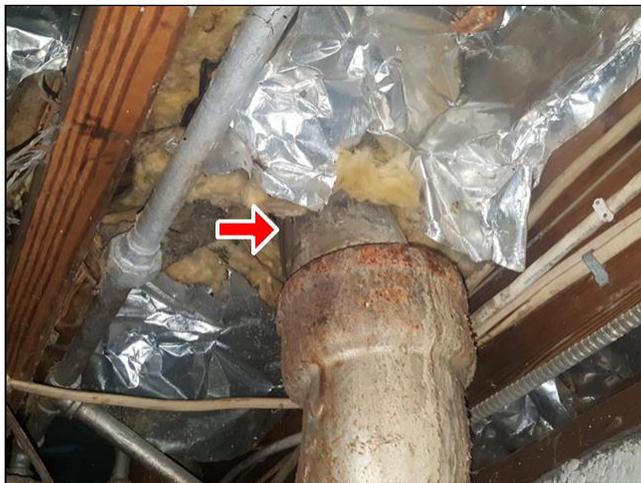
8.0 Item 3(Picture)

8.0 (2) The lead drain pipe for the master bathroom toilet in the basement was not leaking at the time of inspection. It does not warrant replacement at this time. Lead drainage pipes will leak at the joins as they are constructed with cast iron. Recommend this be monitored and if any plumbing work is required in the home in the future, it would be advisable to change out the lead drain pipe as well before a leak does develop. Provided there is no back siphonage of water this is safe. Ensure the toilet is equipped with an anti siphonage device in the tank.

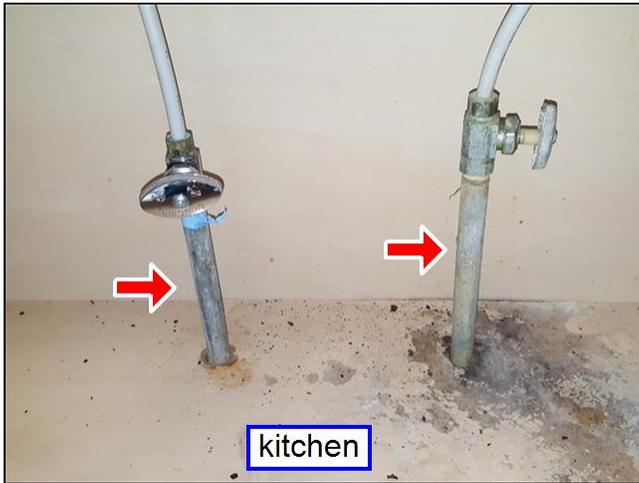
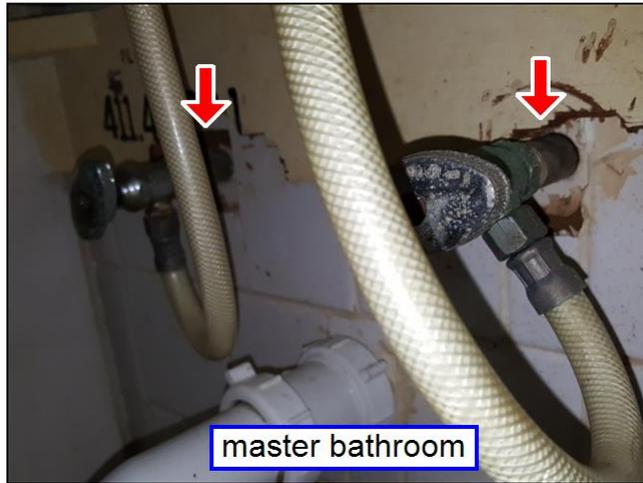
8.1 (1) Galvanized water lines were found in the home and are known to corrode internally and will leak after a long period of time. The corrosion will eventually restrict the water supply to the fixtures and the pressure will drop. These galvanized water lines are fifty or more years old and could fail at any time. Replacement of the galvanized water lines should be strongly considered before major leaks occur. This is for your information. There were no present leaks visible and water pressure was within normal parameters at time of inspection except for the 2nd bathroom at the sink. **See note 7.4(3).**

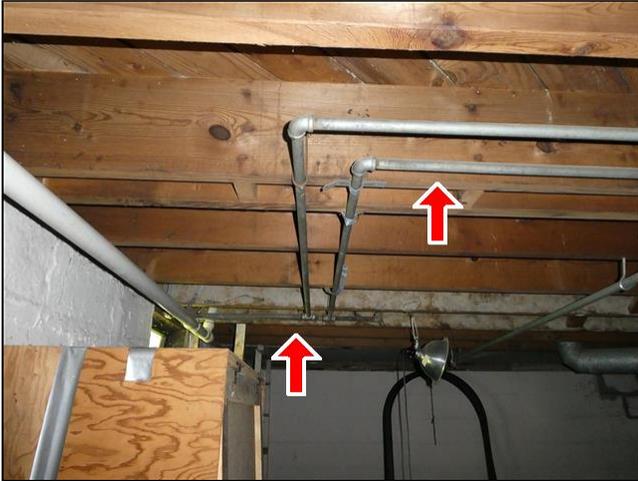
8.1 Item 5(Picture)

8.1 (3) Recommend insulating the water supply pipes in the basement (hot and cold) to ensure pipes do not freeze in winter which may cause a serious plumbing leak in the basement, and to prevent heat loss of water when hot water is flowing into home. This will improve efficiency. This is for your information.

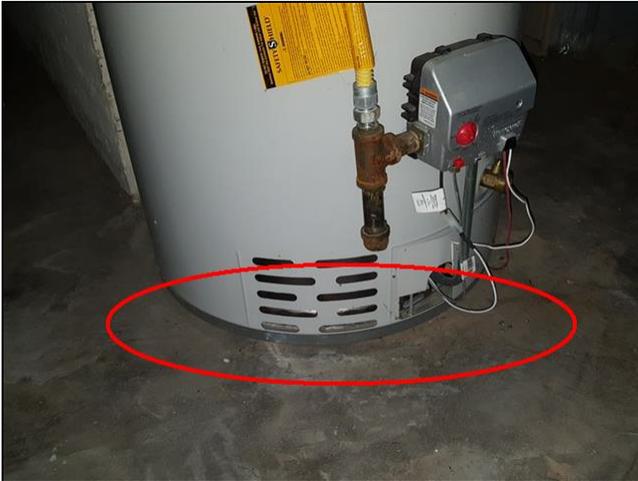
8.2 Item 2(Picture)

8.2 (2) Your water heater does not have a "Thermal Expansion tank" installed to prevent a possible leak at the TPR or "pop-off" valve. If the water pressure gets high enough it can damage valves in the plumbing fixtures, joints in the supply pipes and even the water heater. Thermal expansion always occurs in water heaters. Like most substances, water expands as it is heated. There were no visible leaks or drips at the TPR valve during the inspection. If your water heater does begin to drip or leak, then a thermal expansion tank may be needed. This is for your information.

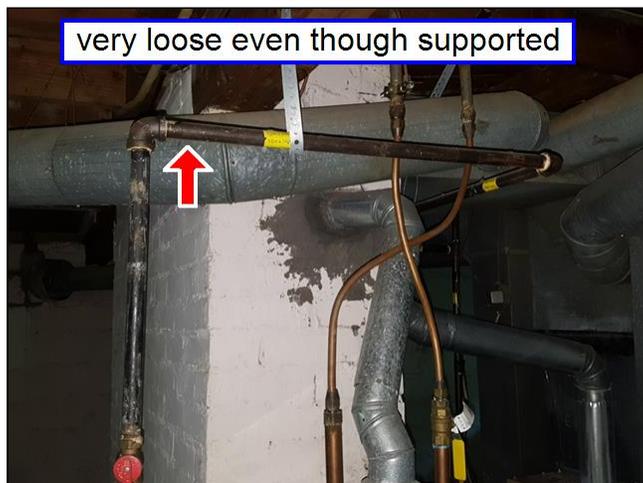
8.3 Item 1(Picture)

8.3 (1) The gas line to the water heater lacks proper support. This is a safety issue and hazardous. If the pipe is knocked it could cause stress at the joints and a possible gas leak could occur which could result in an explosion or house fire. Recommend a qualified contractor install the necessary supports prior to moving in.

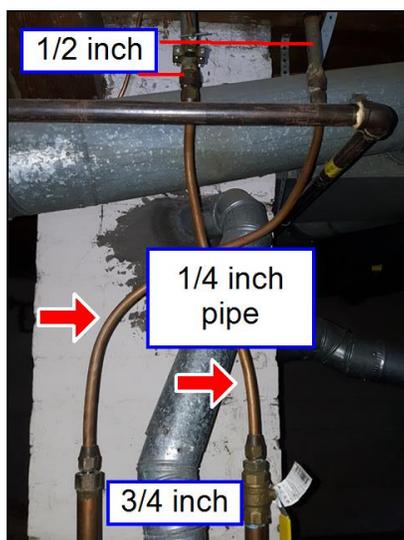
8.3 Item 2(Picture)

8.3 (2) The cold water supply line and the hot supply line pipes leading into the water heater have been reduced to 1/4 inch pipe. They should be 3/4 inch pipe. This reduces the water pressure leading in wards and outwards from the water heater which can cause damage to the unit and result in poor water pressure for the hot water supply lines in the home. Most manufacturers recommend the pipes that are connected to the water heater are to be 3/4 inch pipes in diameter. Recommend a qualified licensed plumber further investigate and repair/correct as needed prior to moving in.

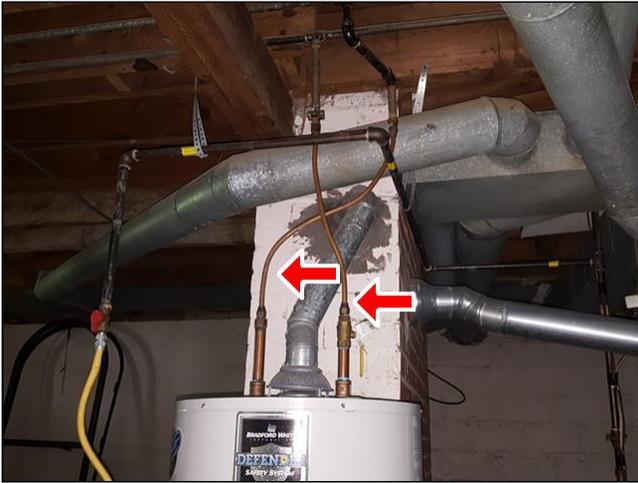
8.3 Item 3(Picture)

8.3 (3) Recommend insulating the water pipes leading into the water heater (hot and cold) to ensure pipes do not freeze in winter which may cause a serious plumbing leak in the basement or harm the water heater, and to prevent heat loss of water when hot water is flowing into the home. This will improve efficiency.

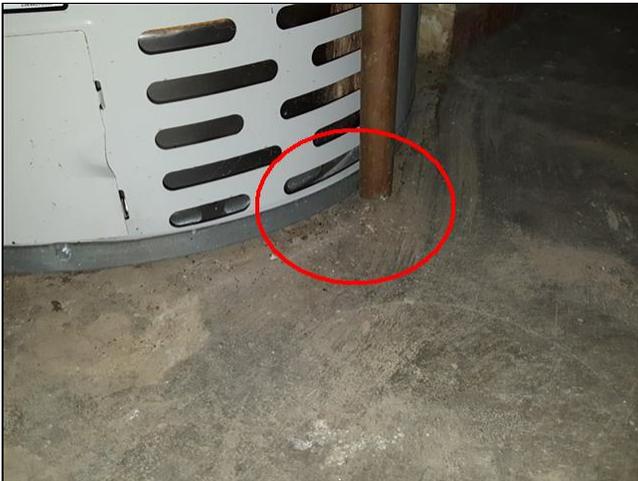
8.3 Item 4(Picture)

8.3 (4) The TPR (temperature pressure relief) drain line should be 6 inches from the ground. Recommend correcting drain line then install a bucket or tray to collect water so that water does not enter the basement floor and prevent rusting the base of the water heater.

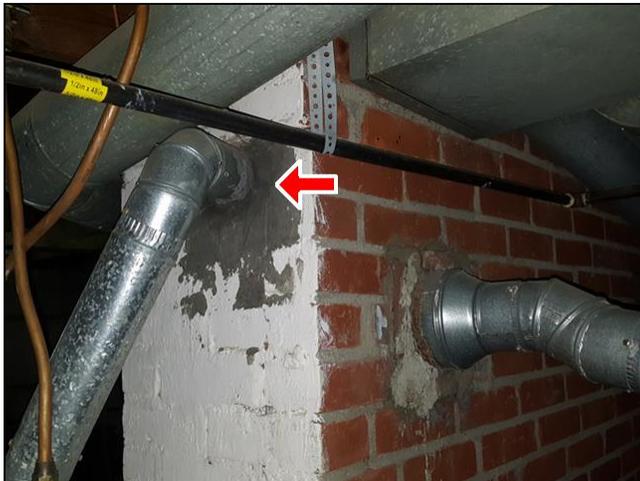
8.4 Item 1(Picture)

8.4 The chimney is being used for venting the gas water heater. A stainless steel vent pipe should be installed and properly sized for the gas appliance to prevent damage to the interior of the chimney mortar joints, possible entry of CO (carbon monoxide) gases into the home, and sized to promote good drafting of the gas appliance. Clay flue tile is usually too large to allow proper drafting. A cap should be installed at the same time. **Strongly** recommend that a qualified licensed plumber examine the chimney to determine if the chimney or flues have been damaged and require repairs to prevent CO entry into the home and to verify that the flue or clay liner is properly sized to provide good drafting of the gasses.
