TALC
Home Inspe

Inspection Report

Property Address:
303 Wheeler Avenue
Georgetown KY 40324

Talon Home Inspections, LLC

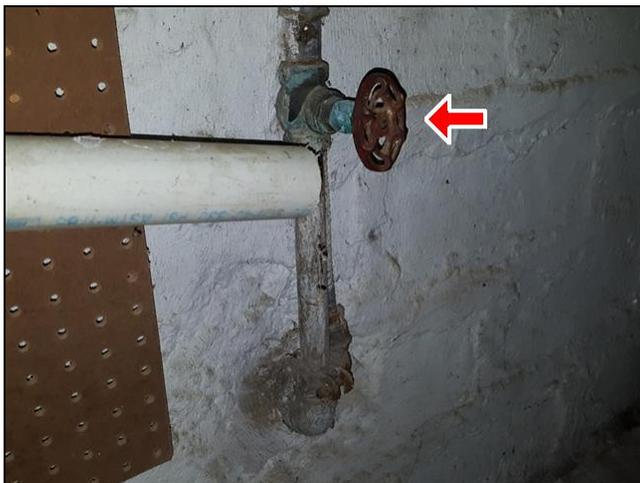
8.5 Item 1(Picture)

8.5 (1) The main water shut off is the red knob located in the basement under the living room area. This is for your information.

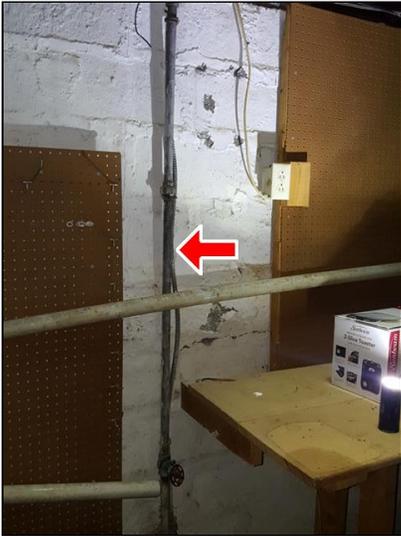
8.5 Item 2(Picture)

8.5 (2) The water supply line coming into the home is galvanized pipe. Galvanized pipe is known to corrode internally and restrict the water supply to the house and will eventually require updating. This older pipe can also begin leaking at any time and may require replacement of the supply line to the street. Recommend checking the line periodically to ensure there are no leaks. You may wish to budget for a replacement of the water line to the house.

8.5 (3) Recommend insulating the main water supply line pipe in the basement due to the pipe is located in an unconditioned area. This will ensure that the pipe does not freeze in winter which may cause a serious plumbing leak and prevent costly damage to the home. This is for your information.

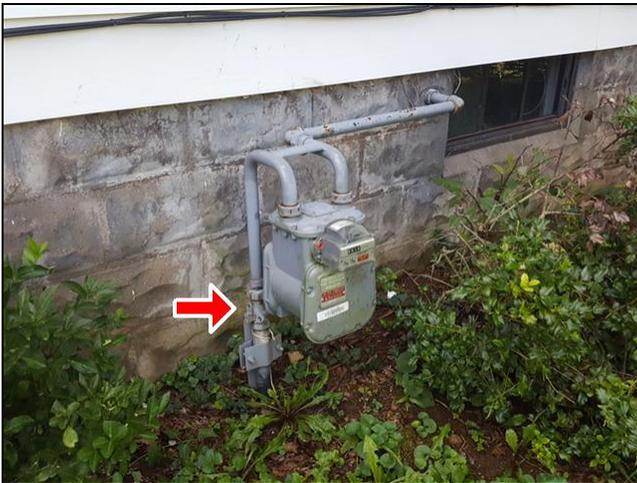
8.6 Item 1(Picture)

8.6 The main fuel shut off is at gas meter at the left side of the home outside.

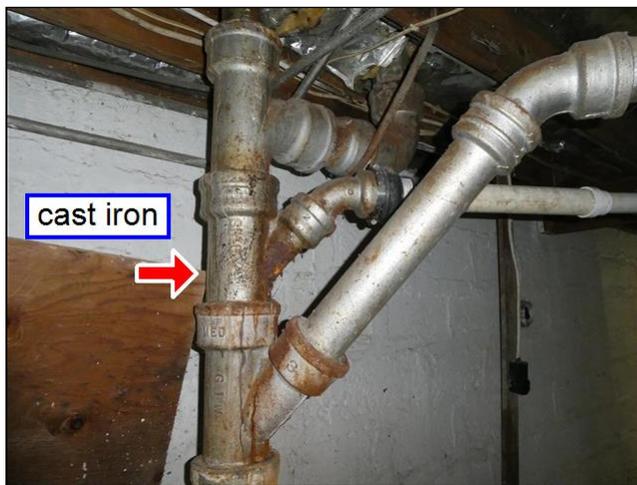
8.9 Item 2(Picture)

8.9 (1) Cast Iron drain lines and Galvanized water supply lines are known to corrode internally and will leak at the joints after a long period of time. The corrosion will eventually restrict the drainage and flow and leaks will occur. The cast iron drainage lines and galvanized supply lines are fifty or more years old and could fail at any time. Replacement of the both lines should be strongly considered before major leaks occur. This is for your information. There were no present leaks visible in the basement and water pressure was within normal parameters at time of inspection.

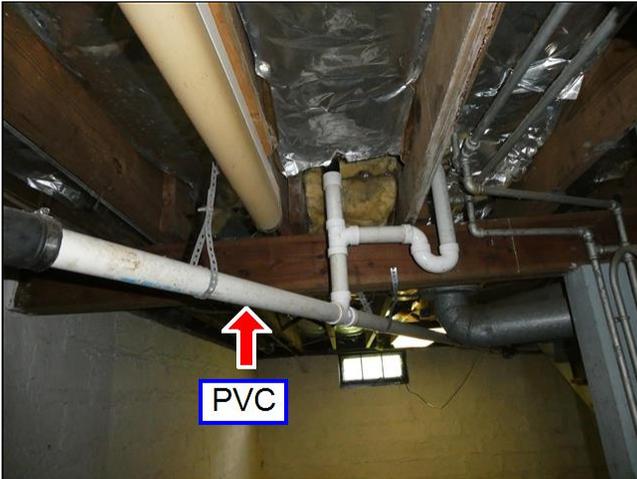
8.9 Item 4(Picture)

Please note that the drain lines in the basement are a combination of cast iron, PVC, and galvanize pipes combined. The ground floor and external faucets shut off valves are located in the basement in various areas between supply lines. Recommend as desired a licensed plumber or the owner identify which valves shut off water supply to various areas and tag these valves in order to determine which ones shut off water supply to various areas within the home.

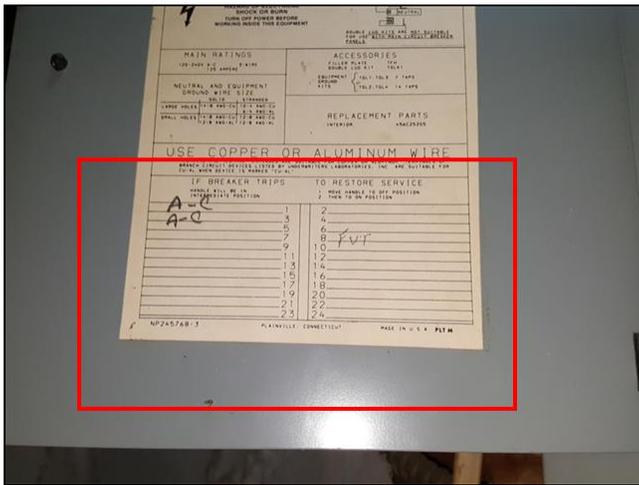
9.2 Item 1(Picture)

9.2 The circuit breakers are not labelled on the cover of the electrical panel. This is a safety issue. Could not check if breakers may be overloaded with appliances in the home. (example: Heating and air conditioning cannot be on the same circuit breaker even though they are used at different times of the year). The electrical panel should be indexed, identifying each circuit breaker. This will allow for quick de-energizing of a circuit under emergency situations. Recommend the panel be fully labelled to facilitate turning off breakers to circuits prior to moving in. A licensed electrician is recommended for this correction for safety.

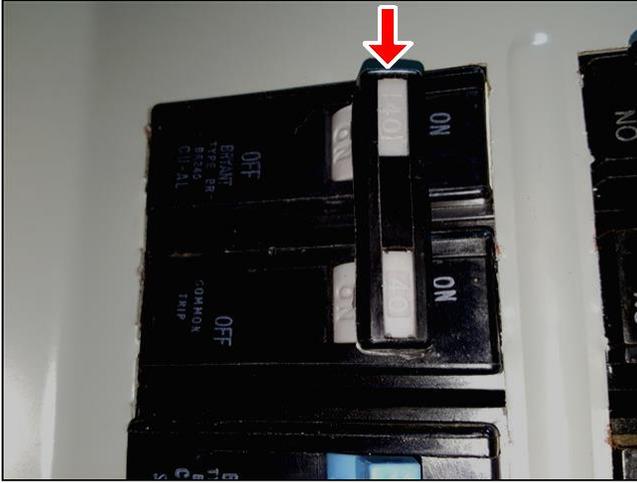
9.3 Item 1(Picture)

9.3 (1) The breaker for the Air Conditioner is oversized in the panel box. Currently it has a 40 amp breaker installed, whereas the data plate on the Air Conditioner specifies maximum breaker of 25 amps. The concern with an oversized breaker is typically causing possible damage to the equipment, and if the unit pulls more than 25 amps it could cause the insulation on the wires to start to melt. This will void warranty on the unit. Recommend a qualified HVAC contractor and/or electrician further evaluate to determine if correction is needed.

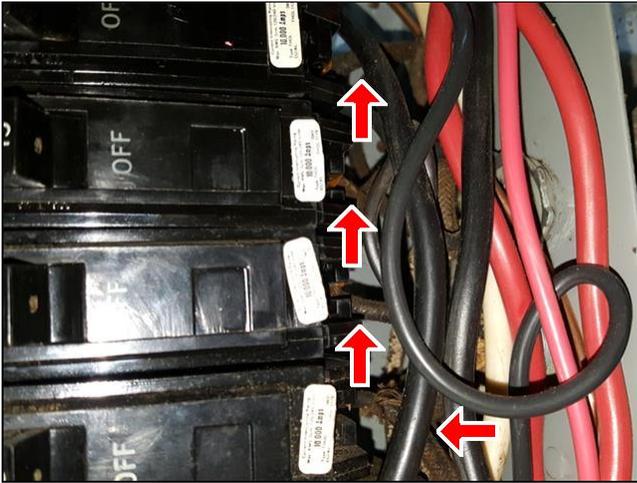
9.3 Item 4(Picture)

9.3 (4) Cloth covered wires are visible in the panel box. These circuits are older systems with cloth coverings that fray and become brittle with age. This is a safety issue. Be aware that some insurance companies will not issue policies on homes with this type of wiring. Recommend contacting a qualified licensed electrician and your insurance carrier to determine what needs to be done to make this system safer.

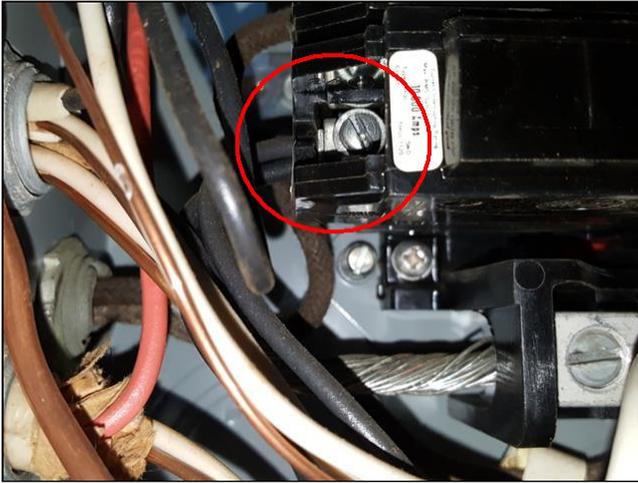
9.3 Item 6(Picture)

9.3 (5) Multiple tap wiring (more than one hot wire attached to the same breaker) was found in the panel. This panel and breakers are NOT MADE or DESIGNED to provide adequate holding power for multiple wires on a single breaker. A separate breaker should serve each circuit. This is a very hazardous and is a safety issue. May cause a fire or short. Recommend a qualified electrician further evaluate the panel box for further issues and repair and correct as needed.

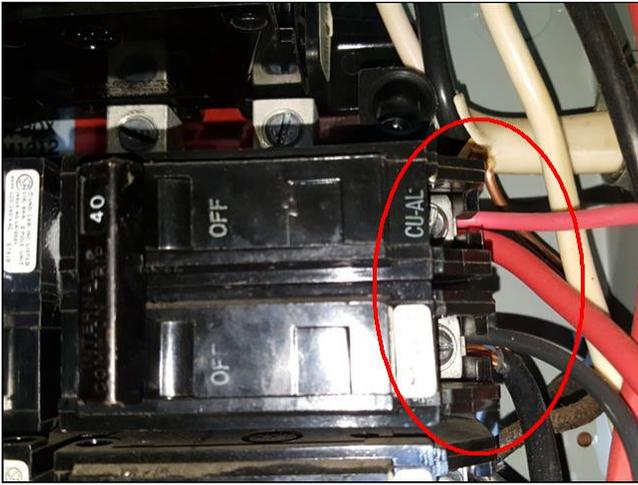
9.3 Item 11(Picture)

9.3 (6) There are incorrect amperage gauge wire sizes connected to non matching amperage circuit breakers in the panel box where indicated in the photo(s). This is extremely dangerous and could result in an electrical fire within the home. The wires could over heat and catch fire without tripping the circuit breakers. As an example a 30 amp wire should not be connected to a 40 amp circuit breaker. Recommend a licensed electrician further evaluate wire size connected to the circuit breaker in the panel box where indicated and for other faults or hazards then repair or replace as needed.

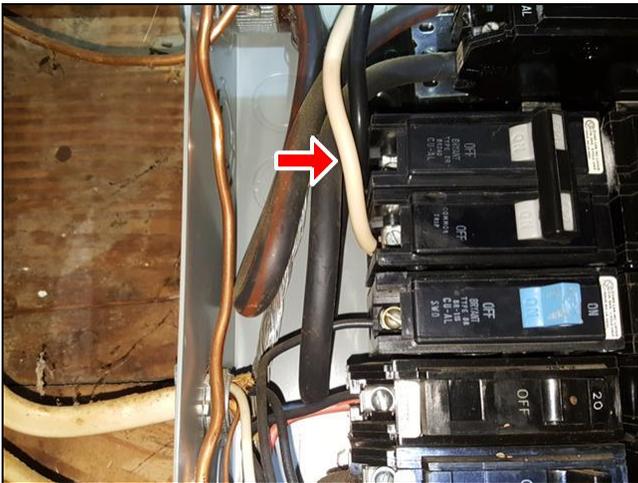
9.3 Item 13(Picture)

9.3 (7) The white wire(s) that are connected to the circuit breaker(s) should be marked black to indicate that they are live (hot wires) and are being used for the flow of electricity to travel. Recommend an electrician correct due to safety.

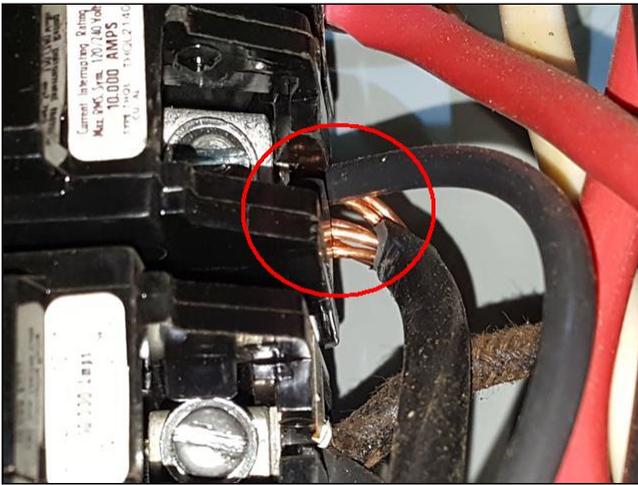
9.3 Item 14(Picture)

9.3 (8) The wire is not connected correctly in the breaker at the 40 amp breaker on the right side. Some of the strands are missing and the wire connection is weak. This could cause a short or a fire to develop. Recommend a qualified licensed electrician correct as needed for safety.

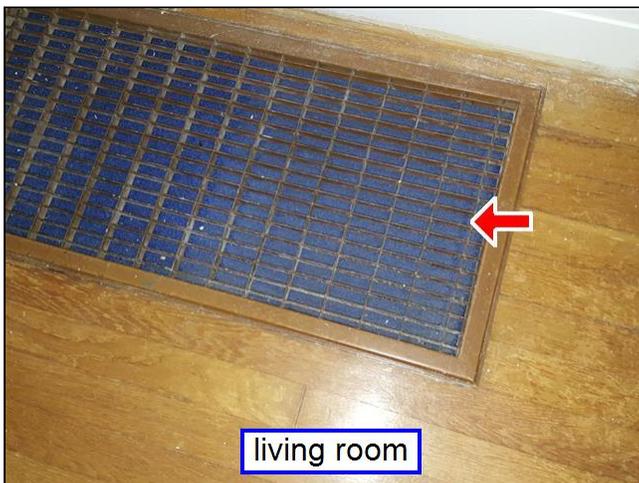
10.2 Item 1(Picture)

10.2 Filter location (see photo). The arrow on the filter should always point towards the blower.

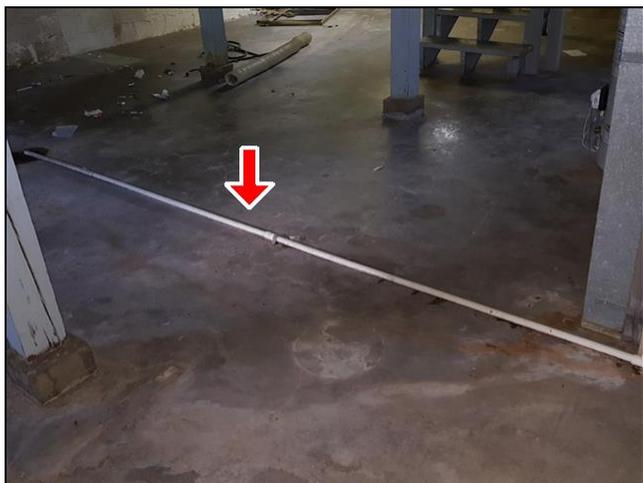
10.5 Item 2(Picture)

10.5 (2) The condensate drain line runs across the floor in the basement to the floor drain, which may be a tripping hazard. Recommend this be improved by installing a condensate drain pump that pumps the water to the exterior or directly into the drainage system.

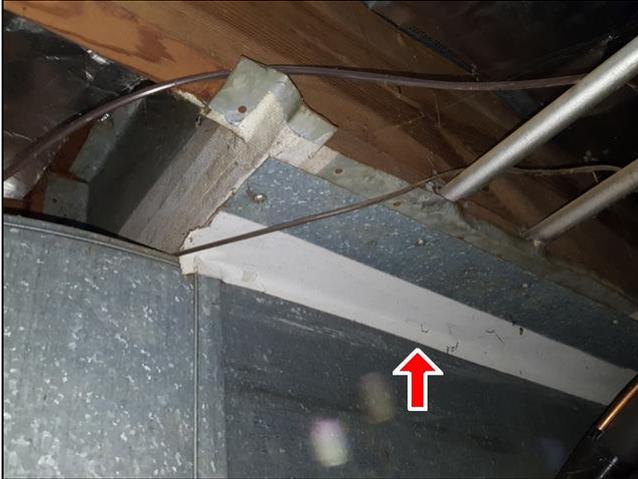
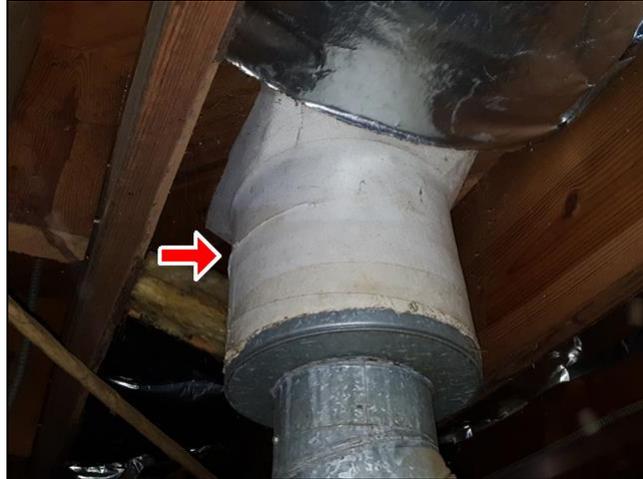
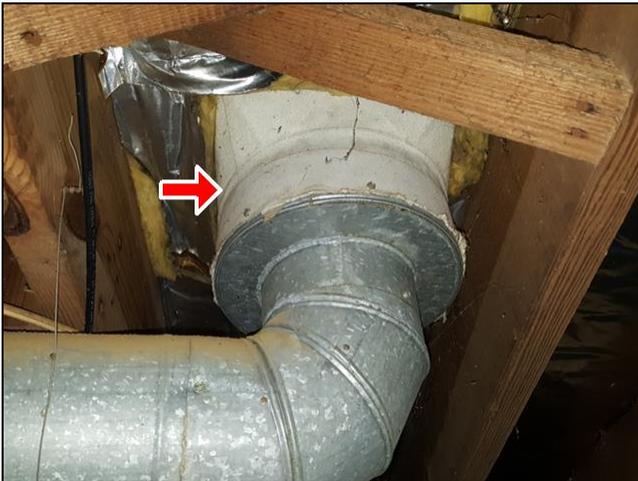
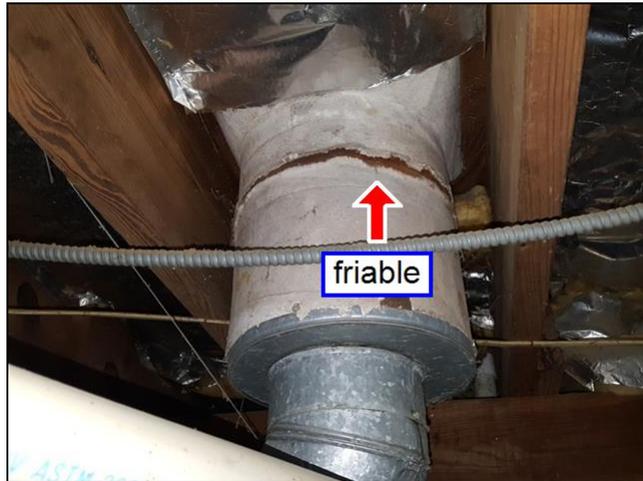
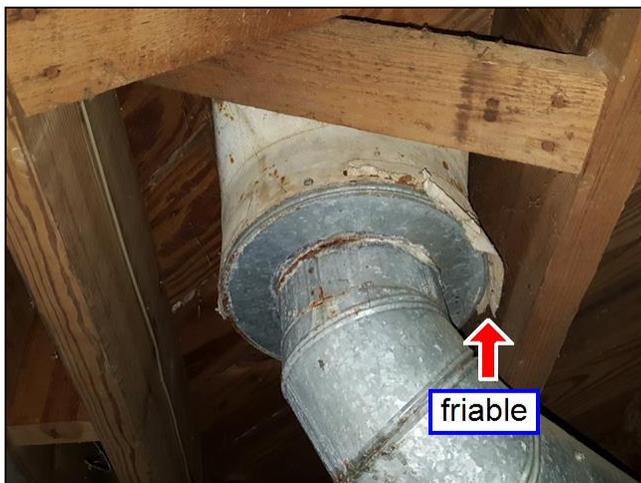
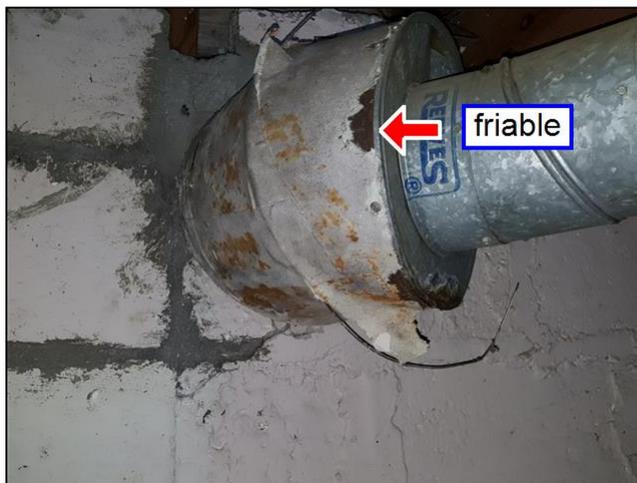
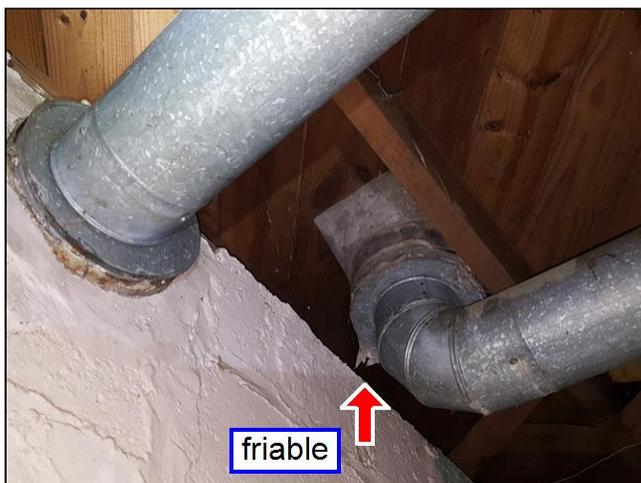
10.6 (3) The white tape covering some of the joints in the duct work in the basement may be asbestos. Some of the tape is damaged and maybe harmful to occupants in the home if the product is asbestos and due to the product is exposed and friable (damaged). Only laboratory testing can determine the presence of asbestos. Professional removal of any known asbestos material is sometimes needed. Covering the white material with furnace tape is suggested if the material is in good condition. This traps any particles and prevents spreading them into the home. [Here is a link to the EPA explaining more information about asbestos.](#) **Strongly** recommend a qualified asbestos contractor further inspect to determine if this product is asbestos and if correcting/removing product is needed prior to closing to ensure safety and health within the home. You may wish to have an air quality test done within the home also if the product is asbestos.

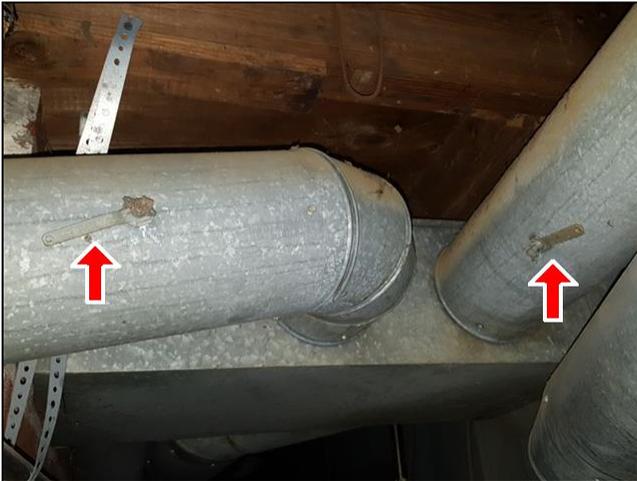
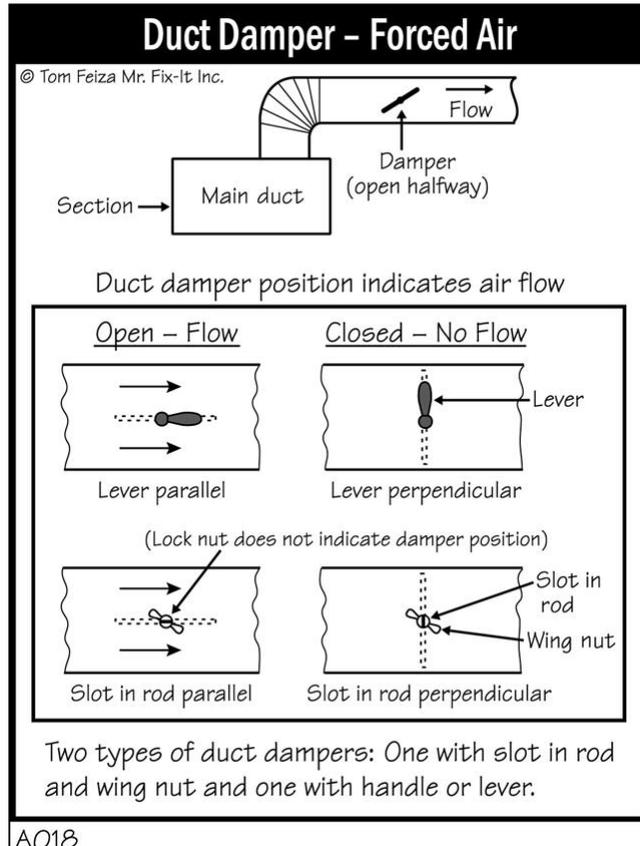
10.6 (4) The ducts in the basement have internal dampers to shut or direct the amount of air that goes to the supply registers in the basement. A damper is a valve or plate that stops or regulates the flow of air inside a duct, air handler, or other air handling equipment. A damper may be used to cut off central air conditioning (heating or cooling) to an unused room, or to regulate it for room-by-room temperature and climate control. This is for your information.

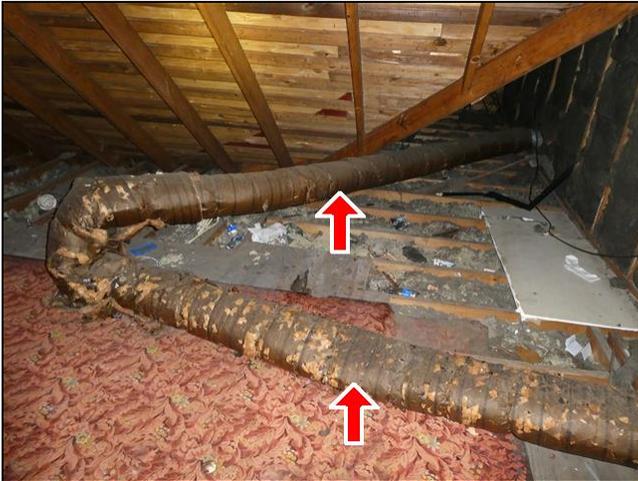
10.6 Item 10(Picture)

10.6 (5) The supply duct pipes are not insulated in the basement. This could cause condensation to form around duct pipes, this was not occurring during the inspection. Condensation in a Basement can lead to mold or mildew and cause damage to building materials. Also, insulating the exposed ducts will result in sometimes significant energy savings. Insulating the exposed metal duct work is recommended. Recommend a qualified HVAC contractor insulate duct pipes in the basement.

10.6 (6) The supply registers in the upstairs rooms have weak to low pressure of air. The registers may need to be opened or adjusted. If this does not increase air flow, recommend a qualified HVAC contractor further investigate and repair or correct as needed.

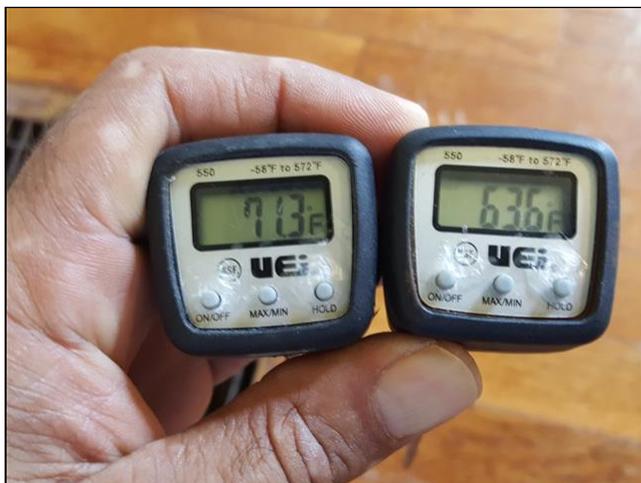
10.9 Item 1(Picture)

10.9 The ambient air test was performed by using thermometers at the registers closest to the blower to determine if the difference in temperatures of the supply and return air are between 14 degrees and 22 degrees which indicates that the unit is cooling as intended. The supply air temperature on your system read 63 degrees, and the return air temperature was 71 degrees. This indicates that the unit is **not** cooling properly and a qualified licensed Heat/Air contractor should inspect for cause or problem Note: There maybe a leak in the refrigerant line or the refrigerant levels need topping up..

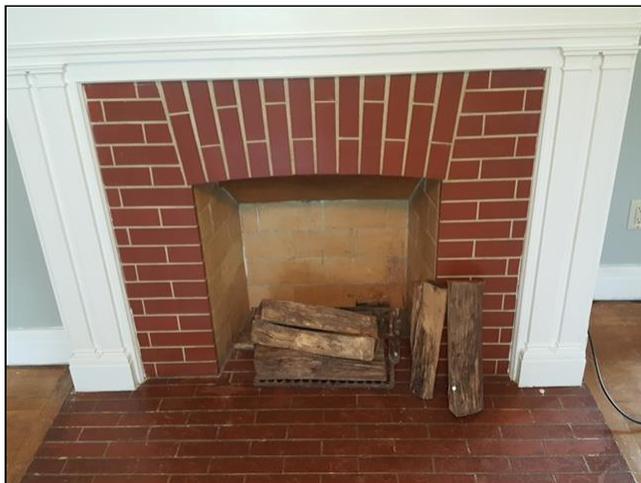
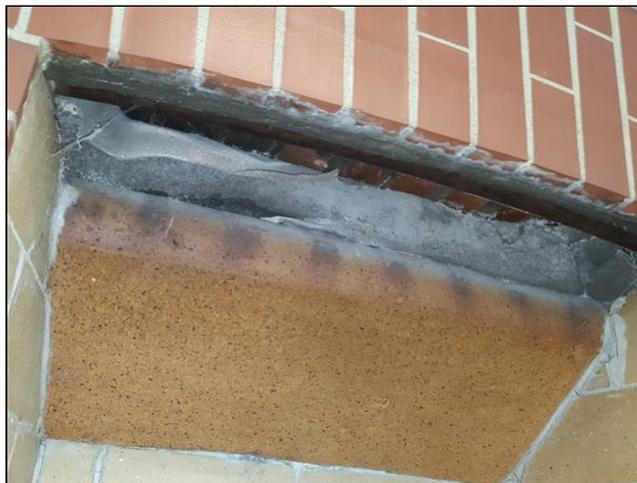
10.11 (1) The fireplace in the living room was sealed off. I did not inspect the fireplace for proper operation. Before considering using the fireplace, strongly recommend further investigation by a qualified fireplace contractor to determine if repairs are needed to determine function and safety of the fireplace and chimney.

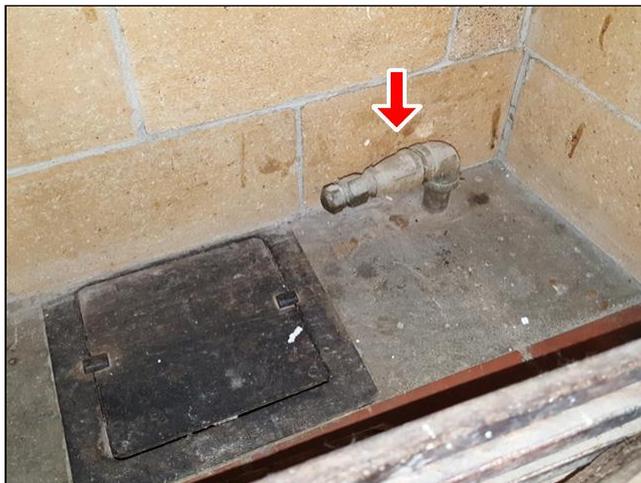
10.11 Item 3(Picture)

10.11 (2) There is a gas line in the fireplace. This is not connected, however it may be used for installing a gas ignitor or if you wish to convert the fireplace to gas logs. Before you consider adding gas logs, I would **strongly** recommend a qualified fireplace contractor further inspect the fireplace who is a member of the CSIA (Chimney Safety Institute of America) to determine if the fireplace is designed for vented or non vented gas logs. This is for your information.

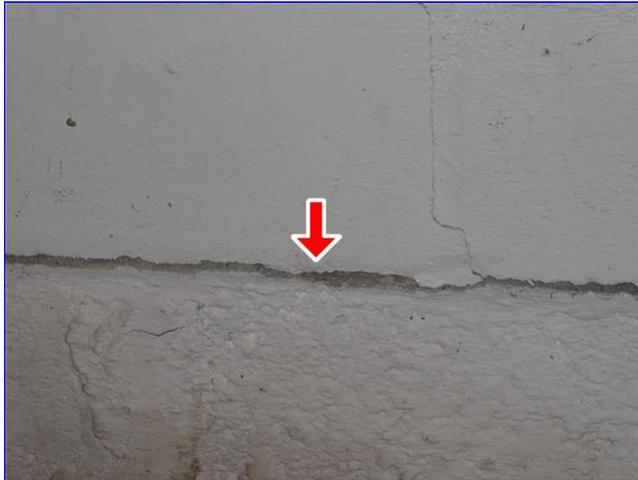
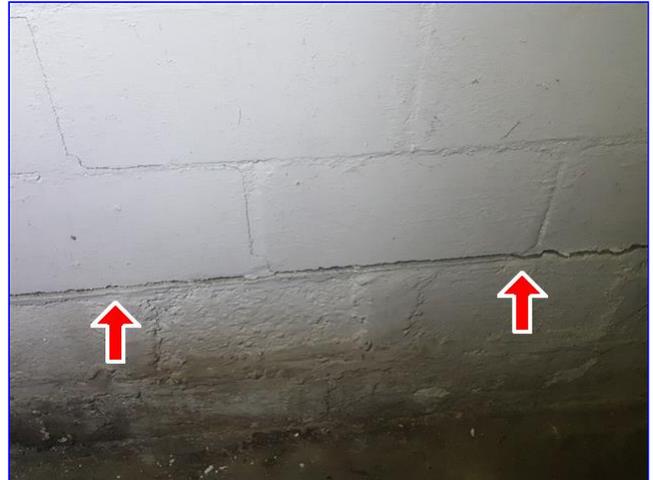
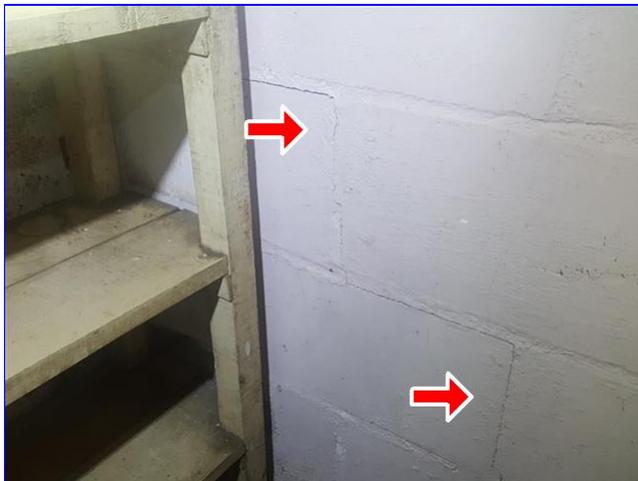
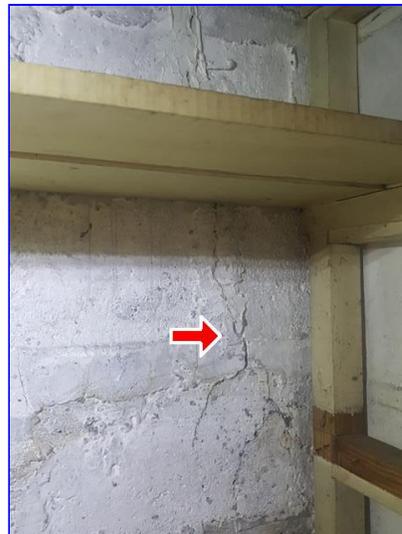
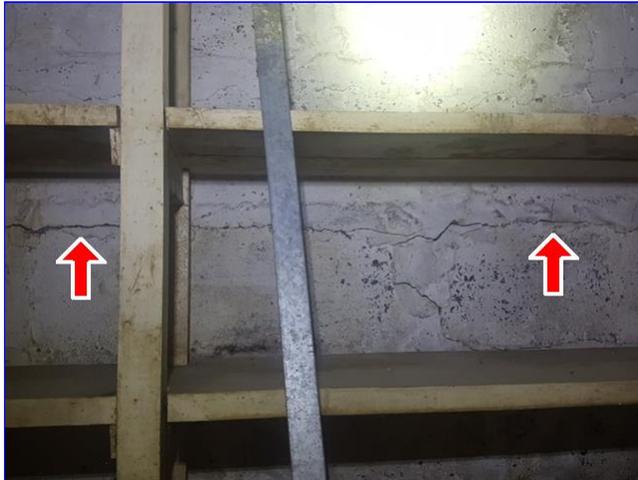
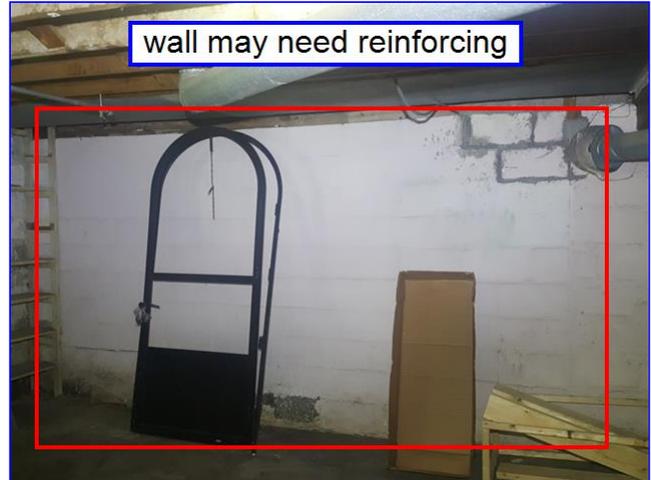
(6) The front basement wall under the formal dining room area has a horizontal crack greater than 1/8 inch in width and has slightly bowed between the original foundation wall. It appears some repair has been made and walls have been painted. Cracks seem to be re-appearing in some areas after repairs and corrections. Horizontal cracks is usually the result of excessive soil or frost pressure on the wall. If not corrected or addressed this can cause further settlement and result in more costly repairs in the future. The masonry block wall may need reinforcing. Recommend a structural engineer who is familiar with this type of repair or a company specializing in foundation repairs should be consulted to evaluate the condition and to suggest corrective measures. The rate of movement cannot be predicted during a one-time inspection.

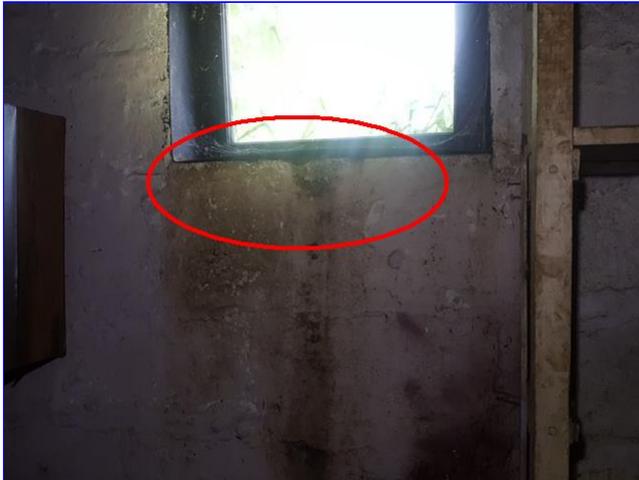
1.9 Item 1(Picture)

(1) Possible water leakage at the basement window on the right side underneath the kitchen area. Recommend a qualified contractor further investigate and correct as needed to prevent water intrusion and further deterioration of the window frame.

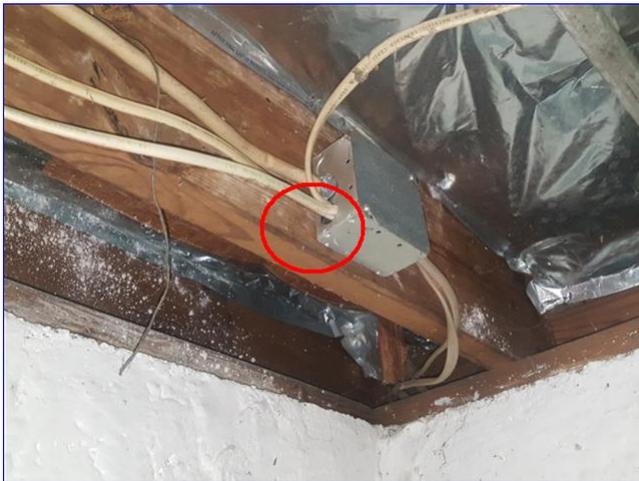
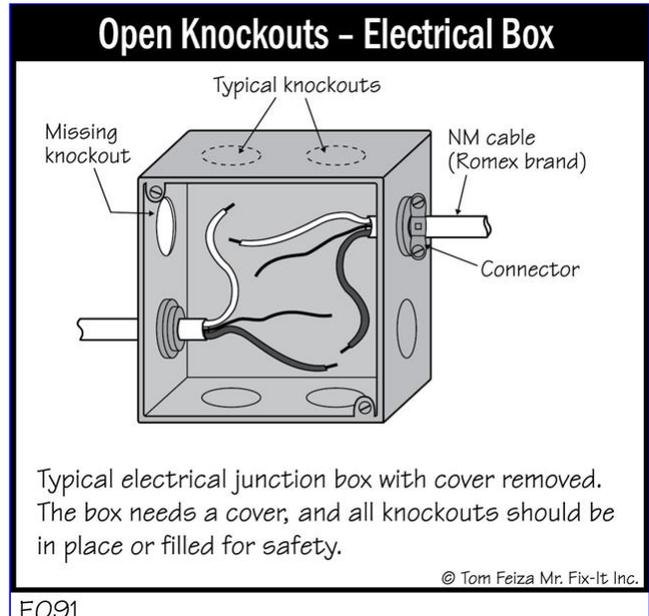
(1) Cable clamps (sometimes referred to as bushings or grommets) are required where wiring passes into the electrical junction boxes. Cable clamps serve to protect the wiring from the metal edges of the box to prevent a short from occurring or from the box becoming energized which can result in a death via electric shock. This is a safety issue. Recommend a qualified licensed electrician repair as needed.

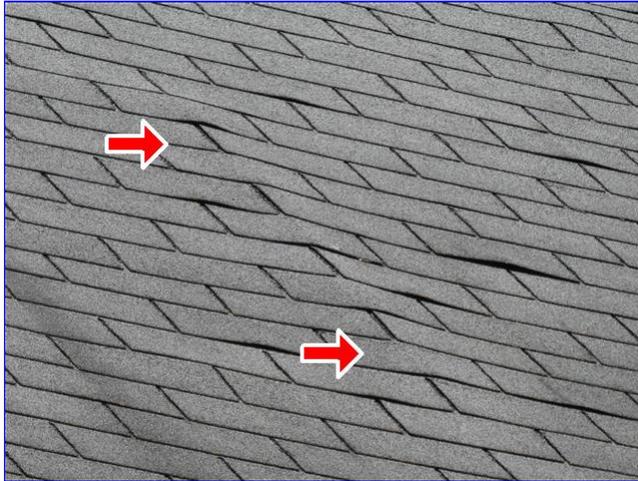
2.0 Item 2(Picture)

(2) The roof covering shows a mump-like appearance at the front left side of the home, see photo for location. These small little bumps might be caused by hot weather, in which some air beneath the

cover layer has become hot and has expanded. These areas will eventually blister creating a water leak and the roof area will need replacing. Recommend a qualified roofing contractor further investigate and repair as needed as these bumps may cause ruptures, and cause leakage later on.

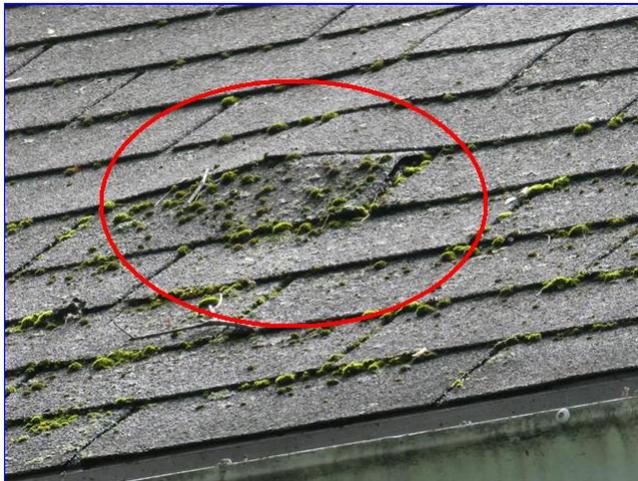
2.0 Item 3(Picture)

(3) The roof covering is lifted on the rear left side of the home. Recommend this be repaired by a roofing contractor to prevent water entering which can lead to damaged roof sheathing.

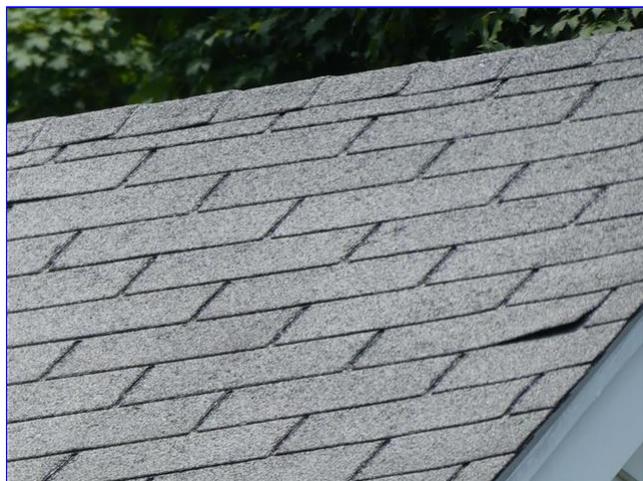
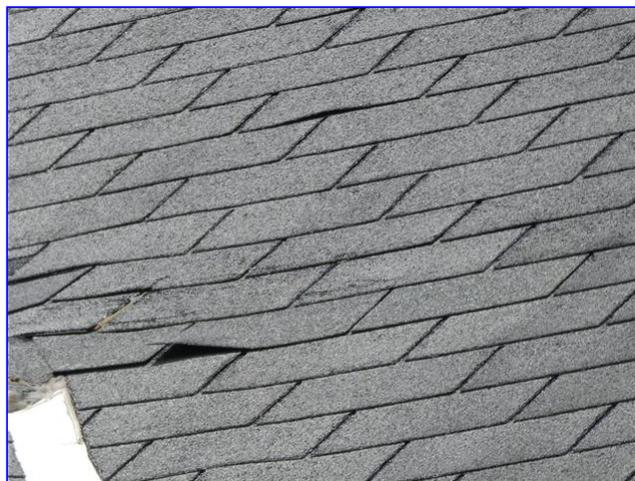
(4) Signs of loss of protective granules, curling and fibers exposed of the roof shingles are starting to appear especially at the front of the home. This indicates that the roof is close to the end of its life span. This usually increases the potential for ultraviolet damage to the membrane. Recommend a qualified roofing contractor further evaluate the roof to determine if replacement is required now before roof leaks start to develop. If the roof is not to be replaced it should be closely watched and repaired or replaced at the first sign of leaking to prevent damage to the interior finishes or roof framing in the attic.

Note: This part of the roof faces the sun all day thus reason why this area of the roof shingles are deteriorating faster than all other shingles on the roof at the rear of home. This section of the roof may need repairing earlier than the rest of roof.

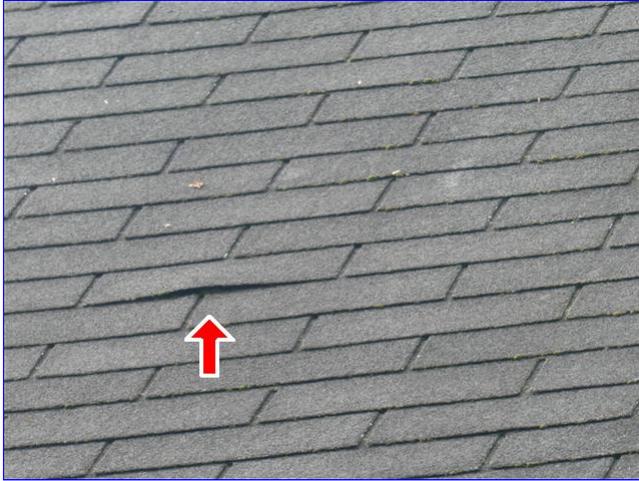
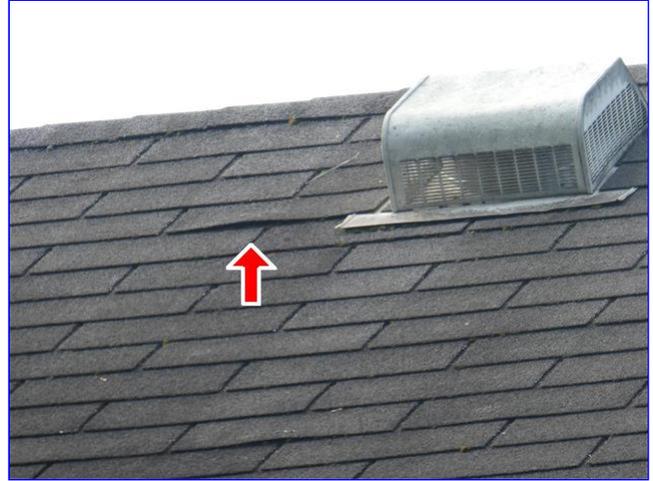
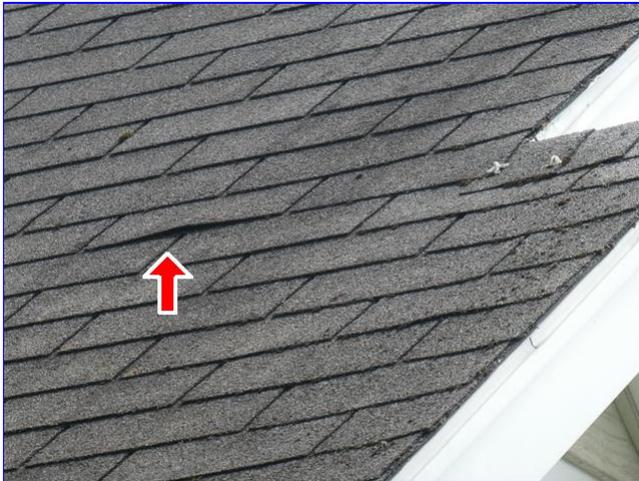
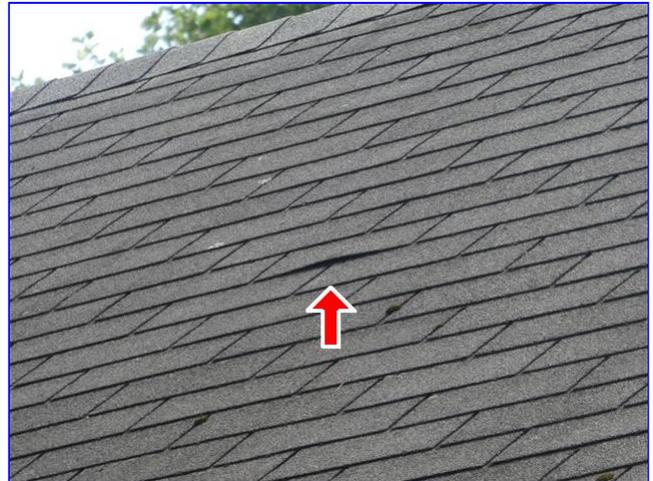
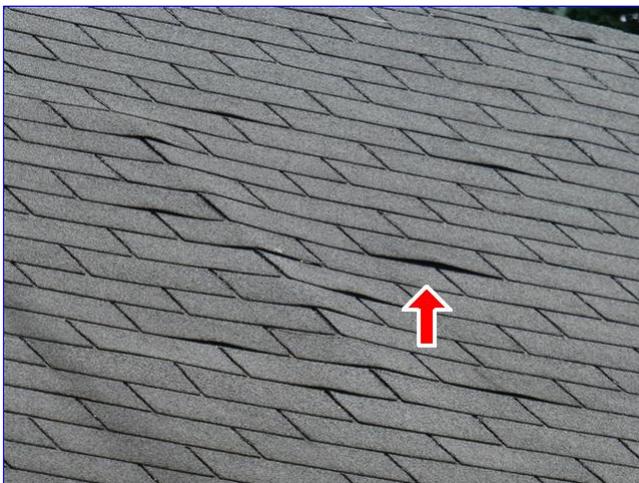
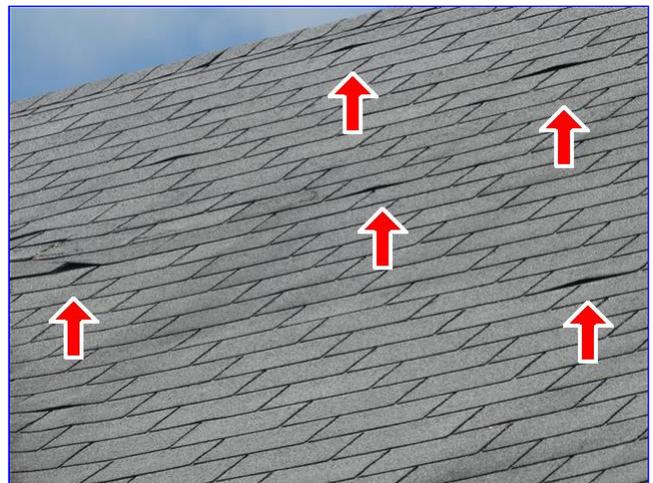
(5) The shingles are starting to lift a little bit at the "entire roof" of the home. This is probably due to a lack of ventilation or age of the covering. Generally, lifting shingles are caused by ventilation issues and the shingles are baked from the inside out. Over time, this heat causes the sealants on the back of the shingles to detach from the course underneath and the shingles start to lift. The shingles are less resistant to the action of ice and wind. Recommend a qualified roofing contractor further evaluate the roof to determine if replacement is needed now. If not then repair lifting shingles as needed.

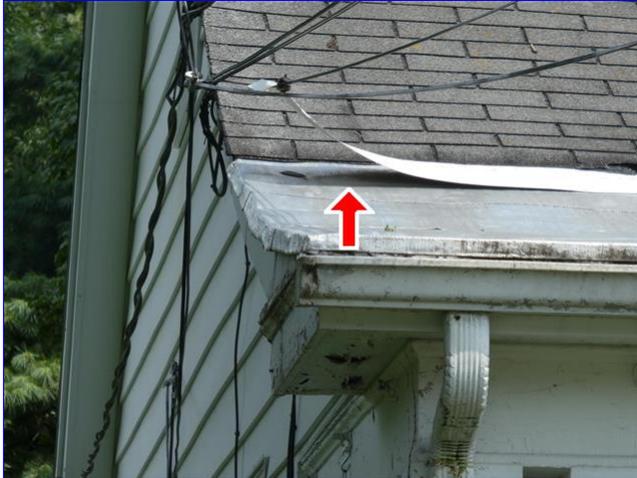
2.1 Item 1(Picture)

The flashing at the front of home (above porch roof) needs flattening and is loose. Recommend they be re-secured to prevent water entering underneath flashing and to allow ease of water runoff to reduce the risk of leaks. Recommend repair or replace as needed using a qualified roofing contractor.

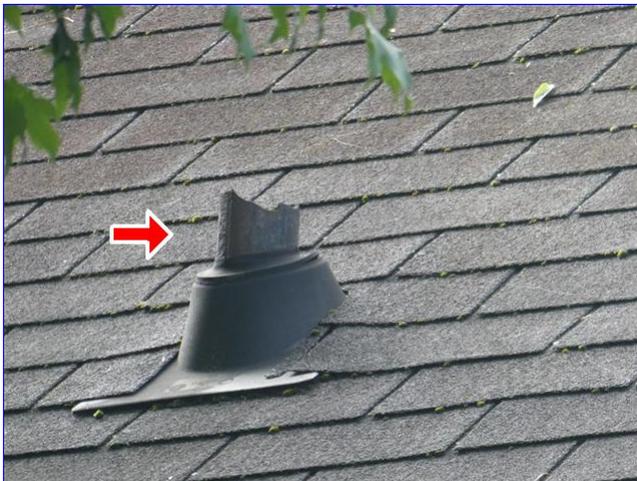
2.3 Item 1(Picture)

The plumbing vent stack is damaged/broken at the rear of the home center of the roof. Recommend replacement by a qualified contractor.

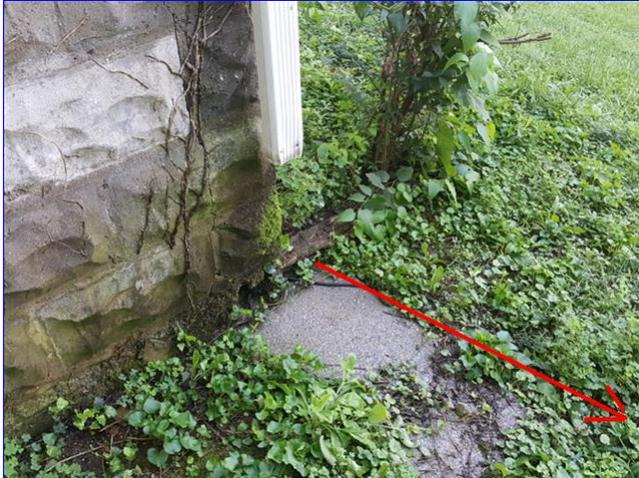
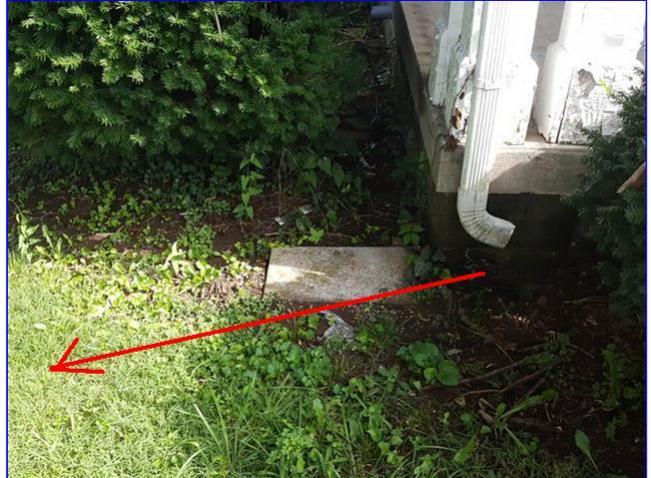
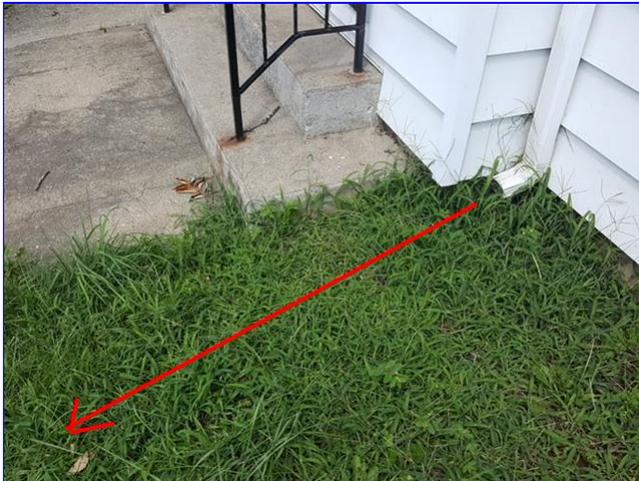
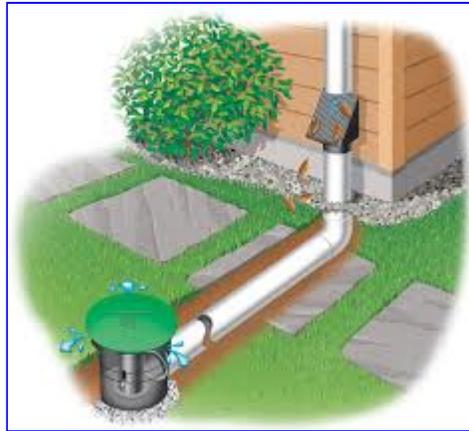
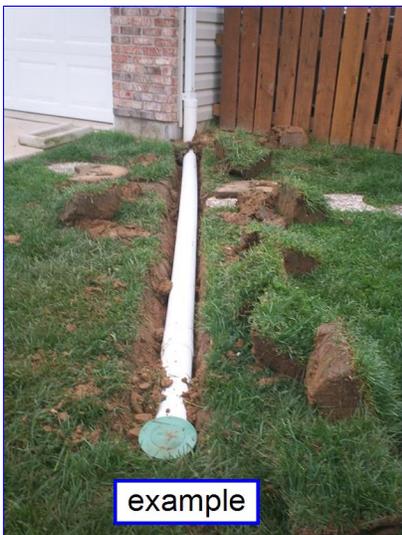
(1) The downspout is missing a splashblock and is discharging on the ground next to the foundation of the home where indicated in the photos. The downspouts should discharge water through leaders then onto splash blocks at least 6 feet from the home. Storm water should be encouraged to flow away from the foundation/home at the point of discharge to prevent water entering the basement and to prevent settlement of the foundation. Recommend repair and correcting as needed by a general contractor.

Note: You may wish to consider burying the extension to prevent a tripping hazard. See photos for example.

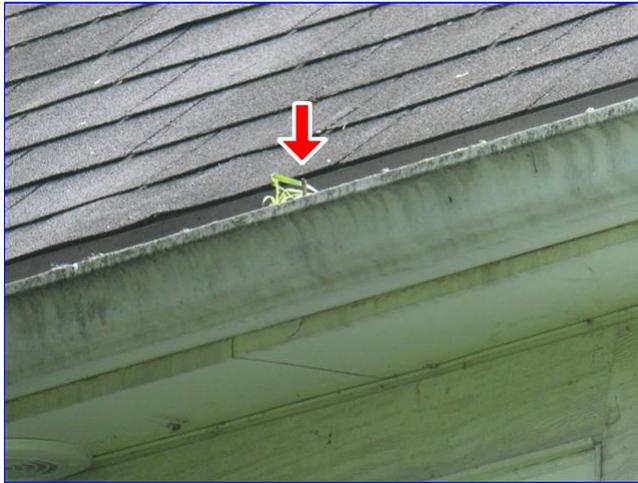
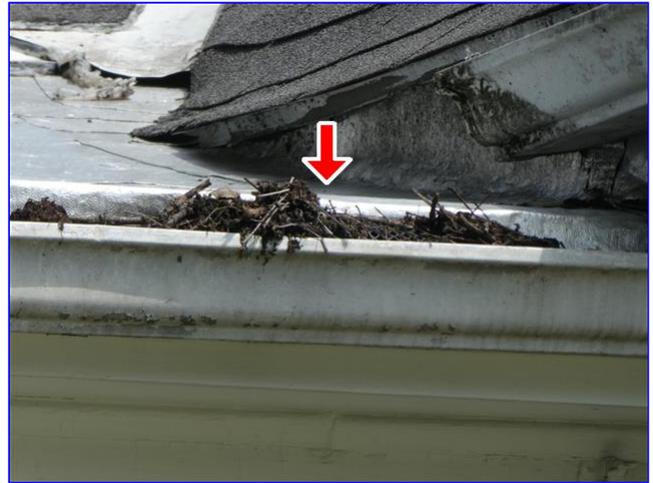
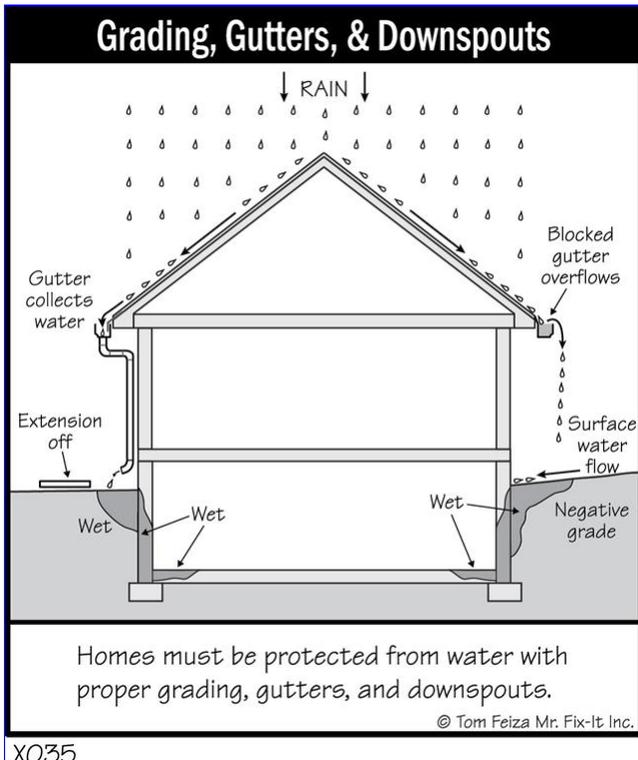
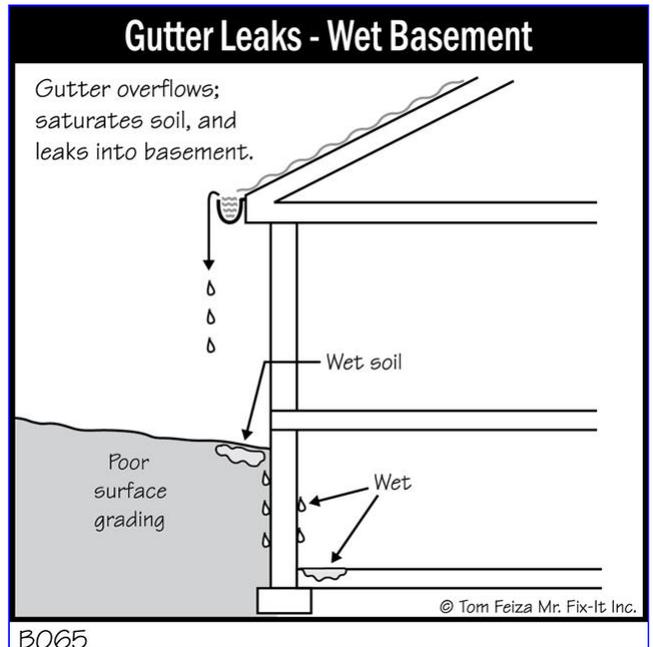
(3) The gutter(s) around the home, especially where they drain into the downspouts, are full of debris and need to be cleaned. The debris in gutters can also conceal rust, deterioration or leaks that are not visible until cleaned, and I am unable to determine if such conditions exist. Gutters require

cleaning to avoid spilling roof runoff around the building - a potential source of water entry or water damage, and/or the fascia could become damaged. Recommend cleaning the gutters as needed.
