TALC
Home Inspe

Inspection Report

Property Address:
303 Wheeler Avenue
Georgetown KY 40324

Talon Home Inspections, LLC

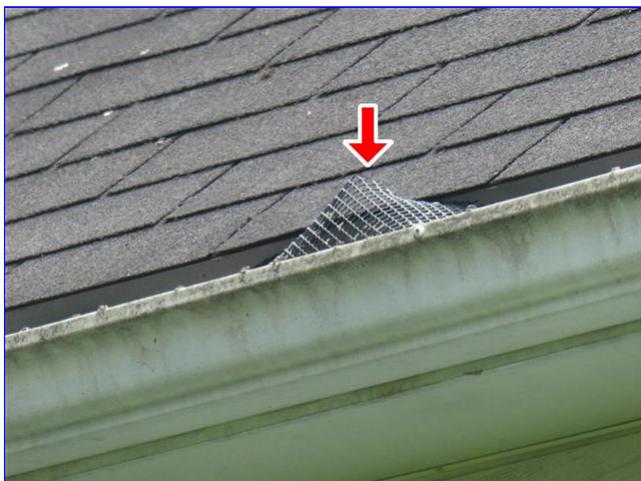
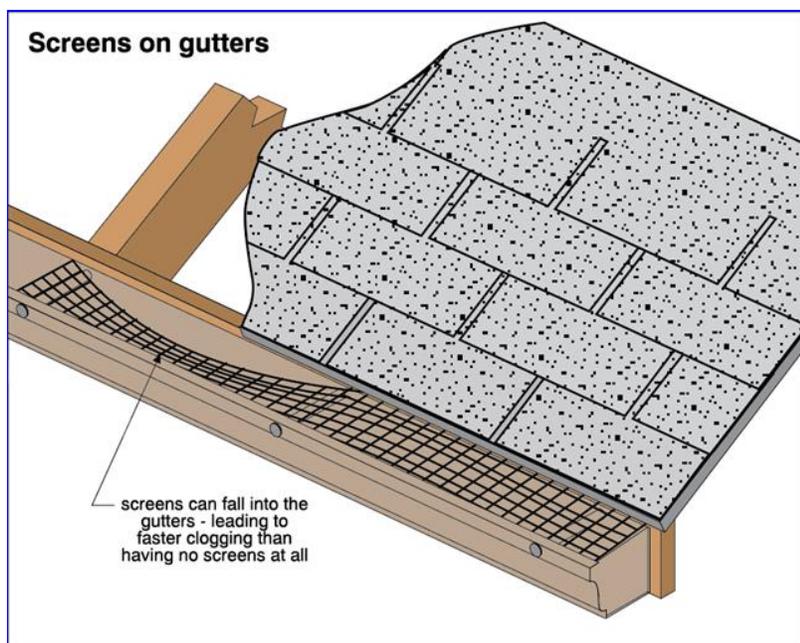
(6) The gutter screens are collapsed inside the gutters in some areas around the home. Gutters that drain poorly or clogged can lead to many costly problems such as deterioration of fascia, soffit or roof edge. It can also cause gutters to pull loose and lead to possible water intrusion. If the Gutter screens are not properly in place leaves can contribute to a clog which can cause deterioration of fascia, soffit or roof edge. It can also cause gutters to pull loose and lead to possible water intrusion. Recommend repair or replacement as needed by a general contractor.

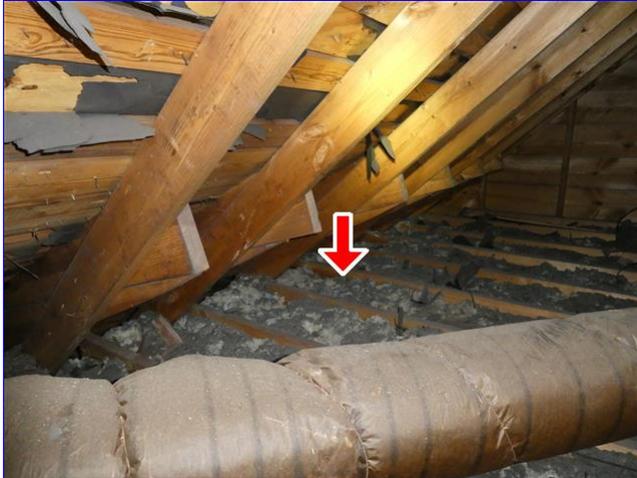
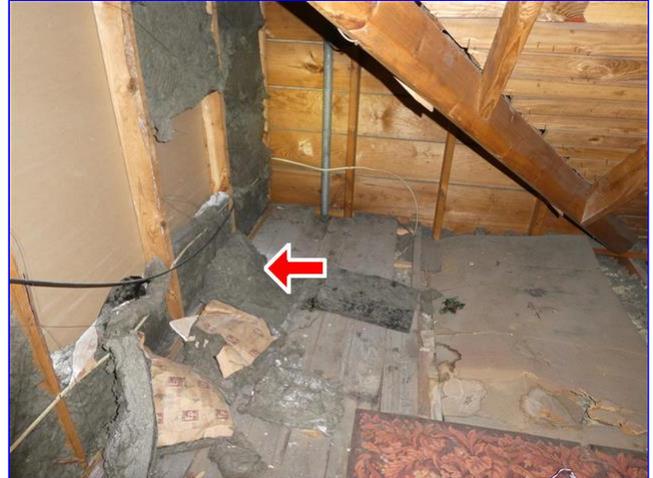
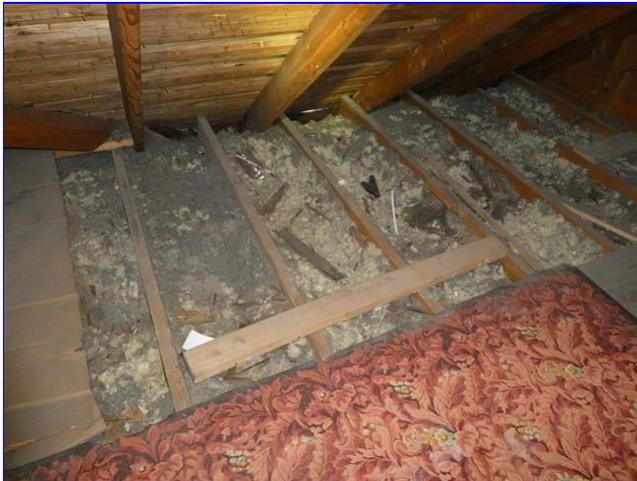
The insulation is old and has settled, and is less than six inches in thickness in the attic. Consider adding un-faced or loose insulation on top of the existing insulation in the attic to conserve energy. Insulation that has settled does not perform to the R-value that it once did. Heat loss can occur more on this home than one that is properly insulated. Recommend a qualified contractor replace as needed due to R factor is below R19.

Note: Low valued insulation will increase cooling and heating costs in the home which leads too high energy bills and puts stress on the HVAC system trying to keep the house cool and heated during the seasons. Strongly recommend additional and/or replacement of the insulation by a qualified contractor where needed to reduce heat/cool loss within the home and to prevent possible ice dams forming in winter.

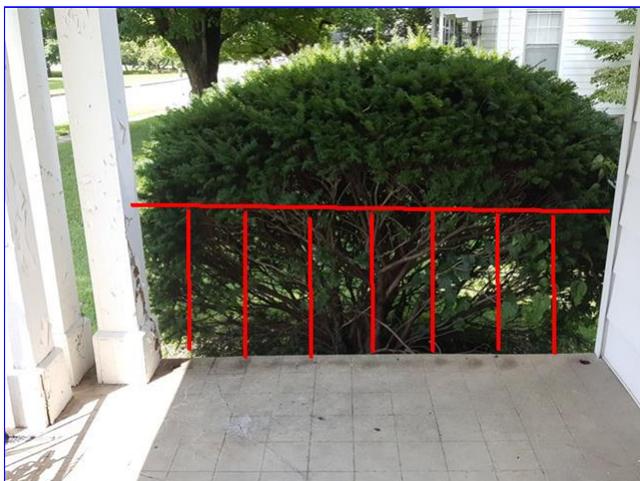
3.4 Item 3(Picture)

(2) Recommend a guard rail be installed at the left side of the front patio porch to prevent a fall from occurring which may result in an injury of a person. This is a potential safety issue. The railing needs to be at least 36 inches high and balusters need spacing to be at least 4 inches. Recommend a qualified contractor install one for safety.

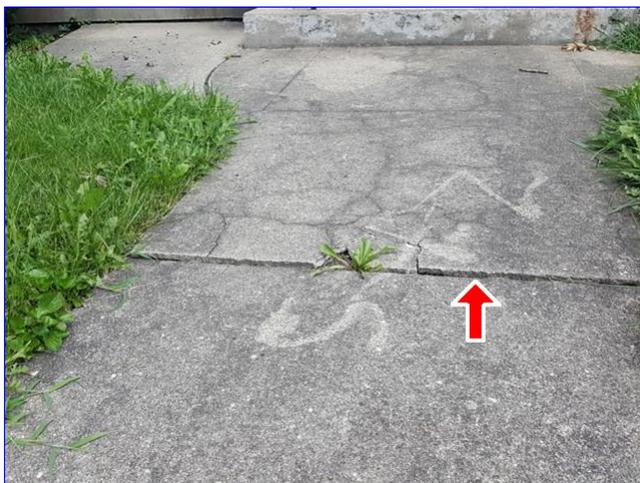
3.6 Item 1(Picture)

(1) The front walkway leading up to the porch at the front of the home has settled creating a tripping hazard. For safety recommend the walkway be repaired or replaced to prevent a tripping hazard and/or a fall or injury from occurring. Also the cracks need to be sealed to prevent further settlement via water intrusion. Recommend a qualified masonry contractor repair or replace as needed.

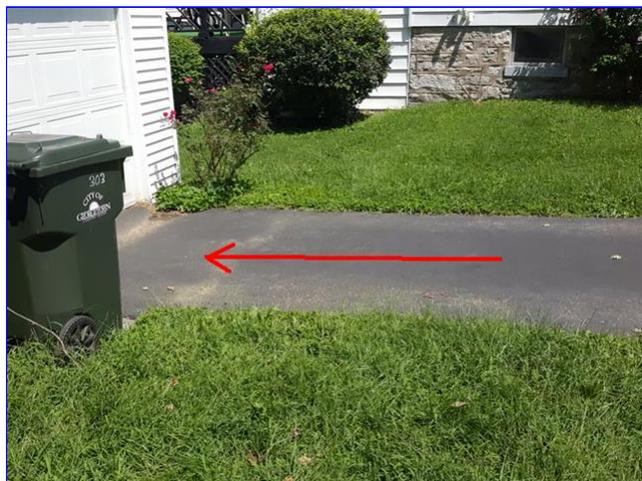
3.6 Item 2(Picture)

(2) The rear driveway slopes towards the detached garage. These areas can allow water to pool and drain towards the foundation of the garage which can lead to settlement of the garage floor slab, water intrusion, and possible settlement of the foundation wall in the future if not corrected. Recommend a qualified contractor further evaluate to determine repairs and correction to prevent settlement and water intrusion which could lead to more costly repairs to the detached garage in the future.

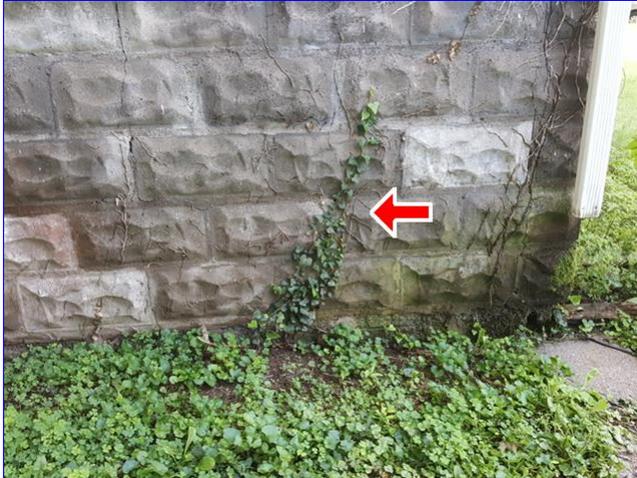
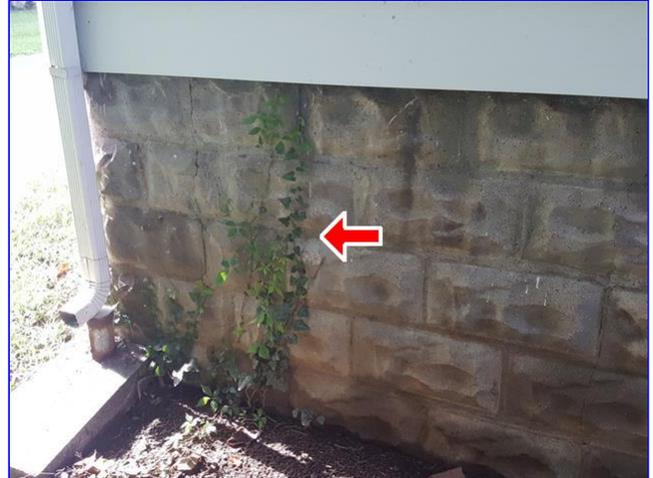
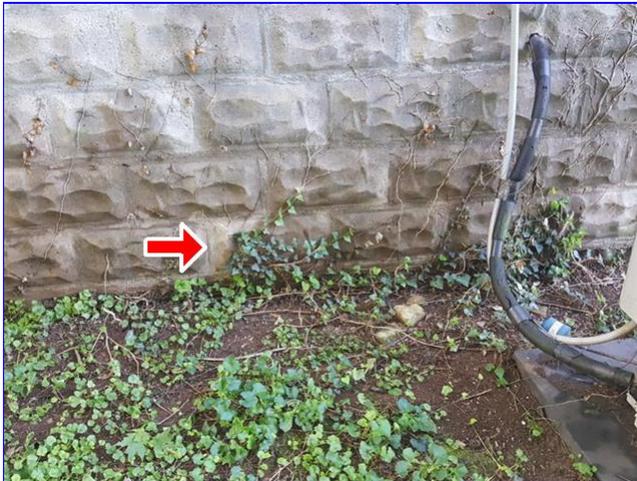
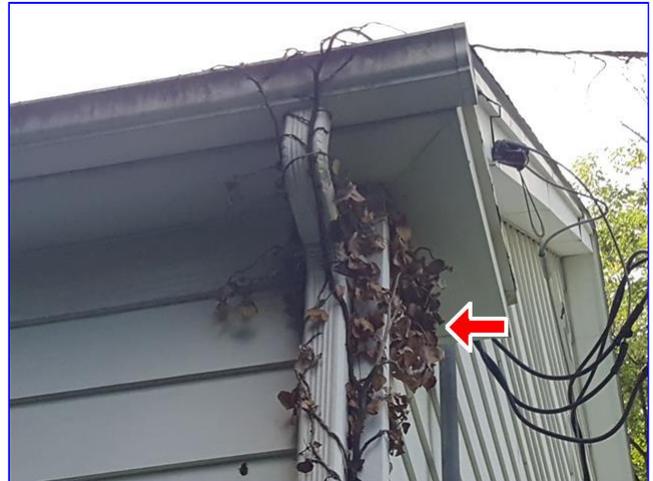
(2) Vines growing on exterior walls at the rear left and right corner of the home should not be in contact with siding, window trims and the eaves to reduce the risk of insect and water damage to the building. Recommend removing plant.

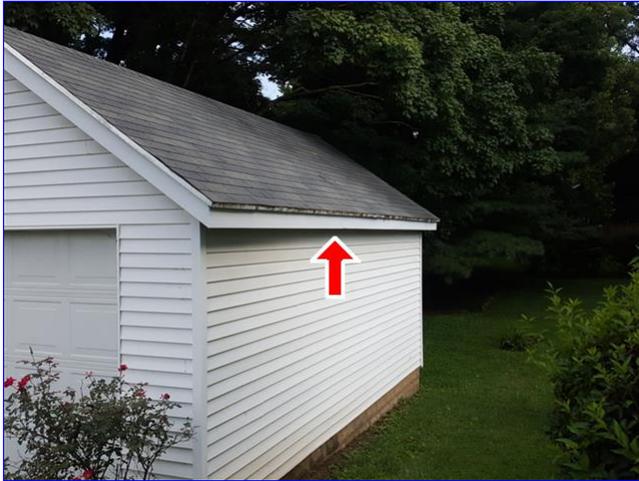
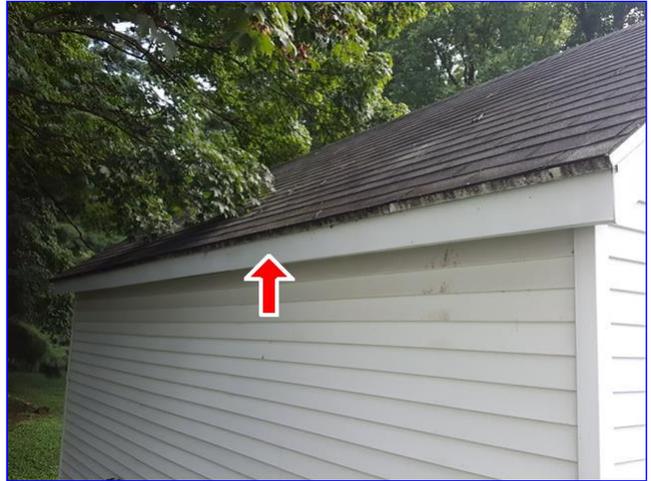
(1) The gutters are missing at the garage on both sides. This can possibly cause settlement of the foundation, water to enter under the slab, and/or soil erosion near the foundation perimeter. Recommend gutters be installed on both sides of the roof. Ensure downspouts drain water roof runoff away from the garage and have splash blocks installed to prevent soil erosion near the foundation perimeter. A qualified contractor is recommended for these repairs.

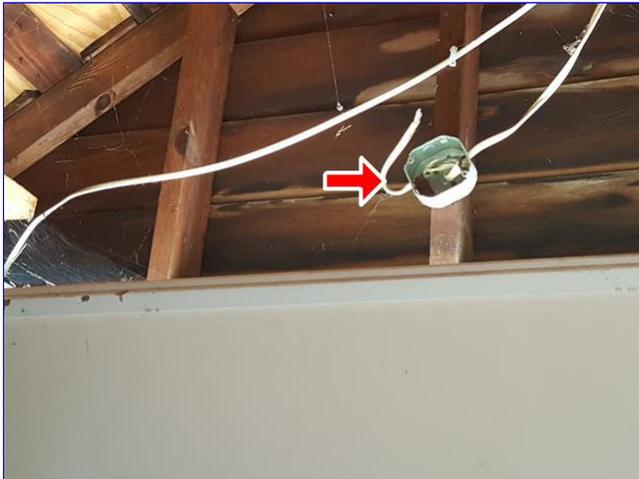
4.8 Item 1(Picture)

(2) All junction boxes in the garage should have covers installed to prevent tampering, protect the wire connections, and for personal protection. This is a safety issue that needs to be corrected. If a leak was to occur it could result in a short then a fire in the home. Recommend a qualified licensed electrician correct as needed.

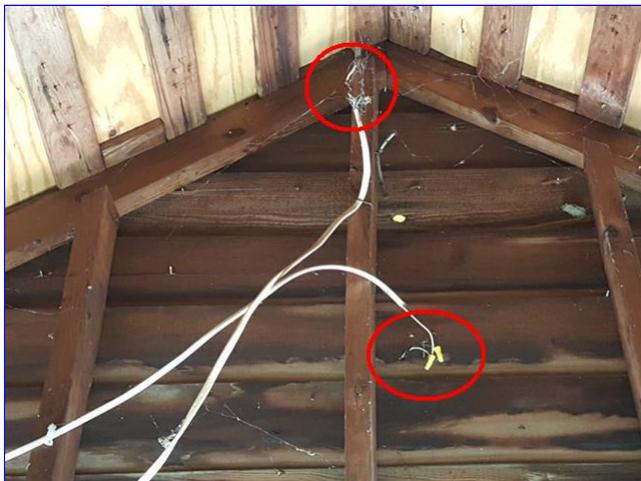
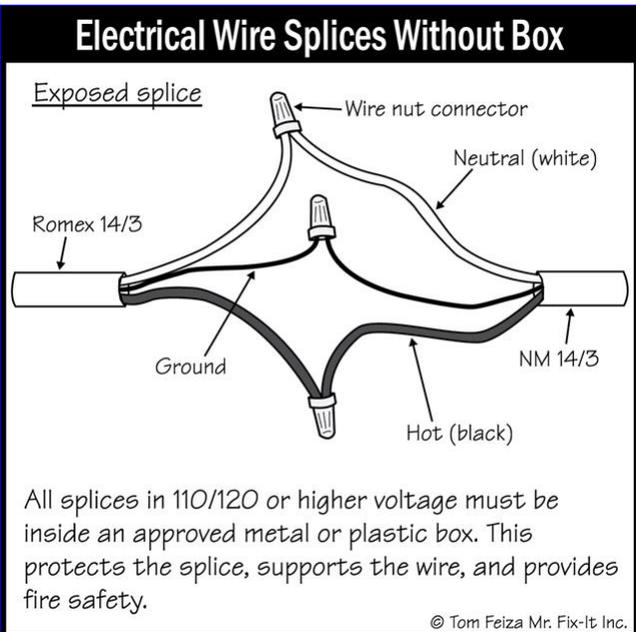
(3) Wires that are connected with twist caps in a garage need to be placed in a junction box to prevent tampering, protect the wire connections, and for personal protection. This is a safety issue that needs to be corrected. If a leak was to occur it could result in a short then a fire in the garage. Recommend a qualified licensed electrician correct as needed.

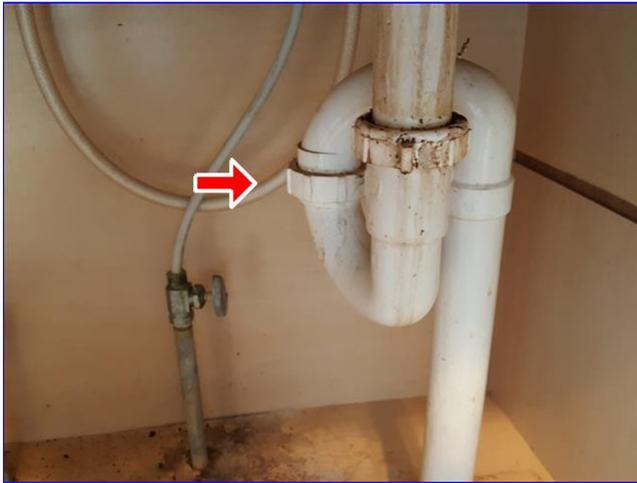
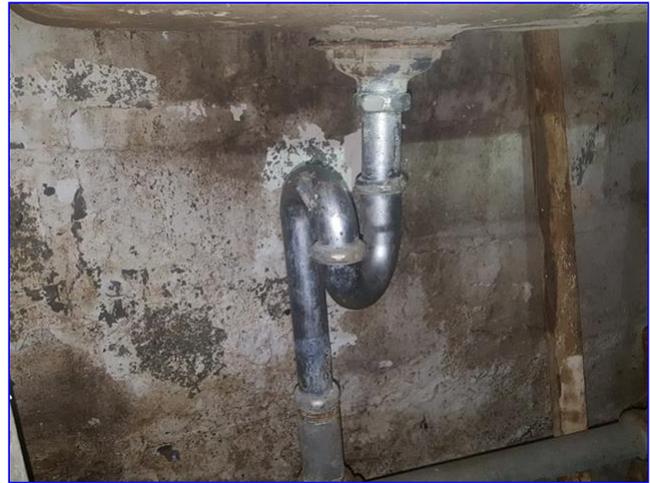
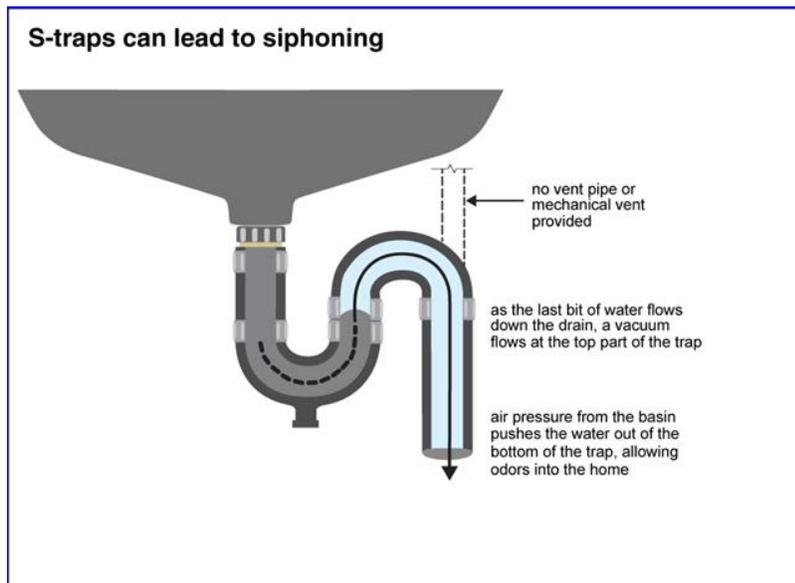
(1) An "S" trap is being used under the kitchen sink. "S" traps should be replaced during any new plumbing work as they are subject to siphoning problems. "S" Type drain traps do not meet today's standards and are now illegal to be used in Kentucky. This type of trap could allow all the water to drain from the trap and allow sewer gases to enter the house. Care should be taken to keep the trap

"primed". Fixtures should be monitored for sewer odor. Examination of the drain trap and correction by a licensed plumber is recommended.

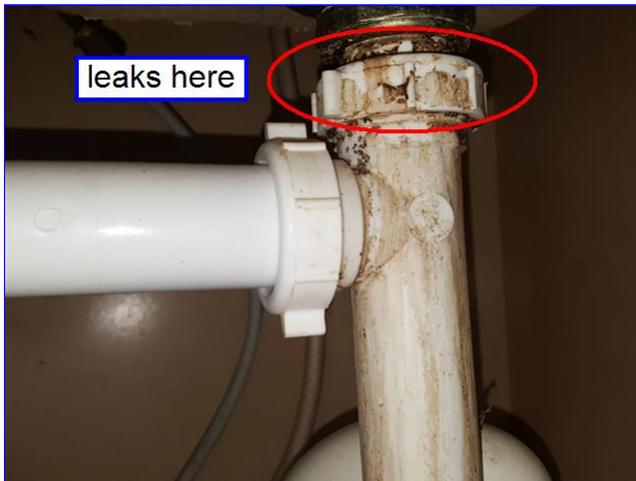
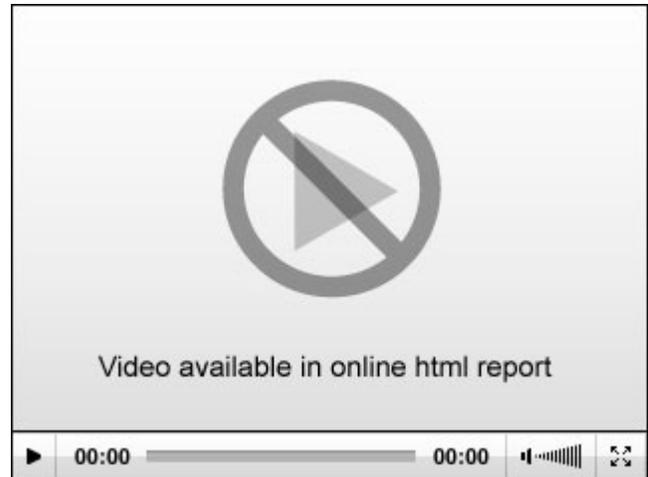
(2) The waste line is leaking at the connection underneath the sink in the kitchen. Repairs are needed to stop leaking water from damaging the cabinet bottom or to eliminate moisture that may contribute to fungi growth. A qualified licensed plumber is recommended for repairs as needed.

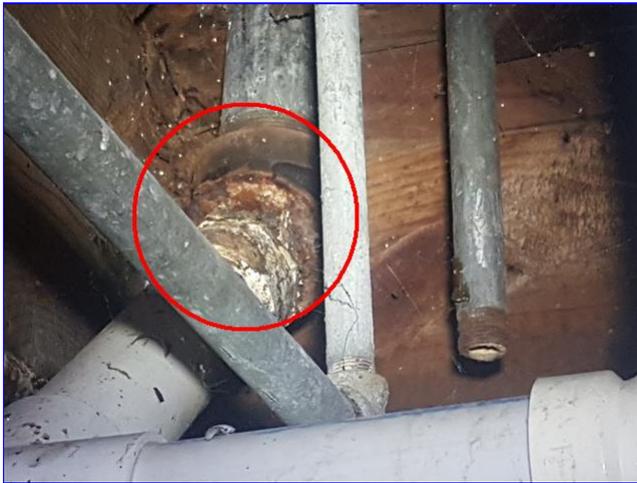
5.1 Item 6(Picture)

(3) Corrosion was noted at the waste line in the basement under the kitchen sink area. Recommend replacement by a qualified plumber to prevent a water leak occurring in the future. This will prevent damage to the wood framing and sill plate.

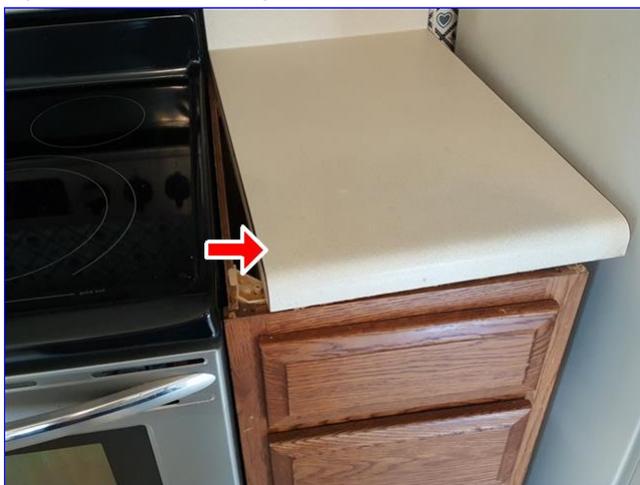
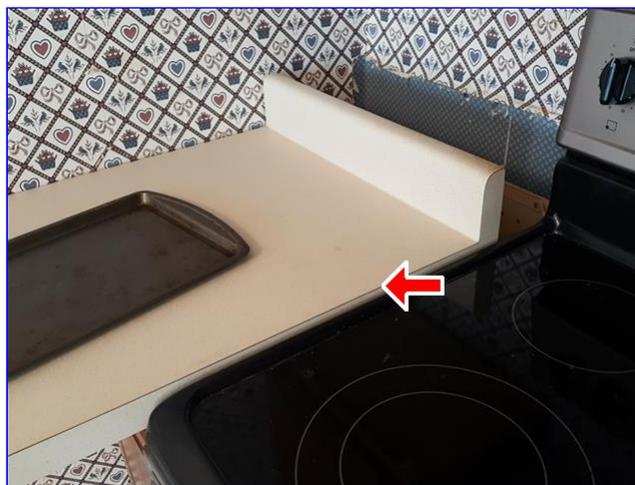
(1) The laminated countertop is loose and not fastened securely to the cabinet (right and left of stove). This is a safety issue as the top may fall causing an injury of a person. Recommend repair or replace as necessary.

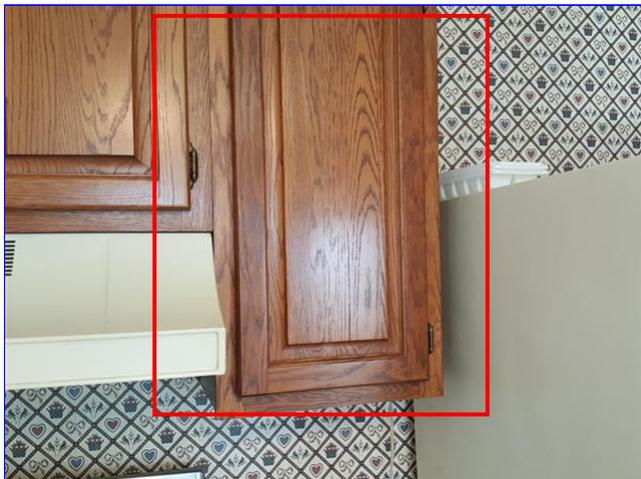
5.6 Item 3(Picture)

(2) The wall cabinet on the right side of the stove is not secured to the wall correctly. The top fasteners are missing. This is a safety issue as the cabinet may detach from the wall if excess weight is placed inside. Recommend a general contractor repair as needed prior to moving in.

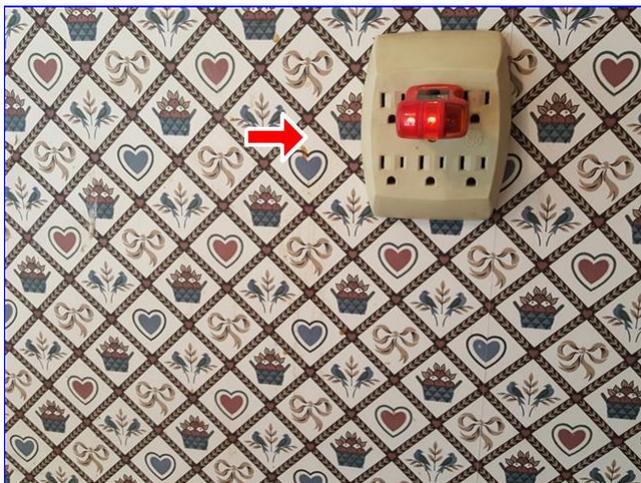
5.7 Item 2(Picture)

(3) The outlet in the kitchen where indicated in the photo(s) is improperly wired with the hot and neutral wires reversed. This is extremely dangerous and a potential shock hazard. You **CAN BE SHOCKED** causing a possible death when the switch to the appliance is off when plugged into the outlet. Recommend a qualified licensed electrician repair as needed for safety prior to moving.

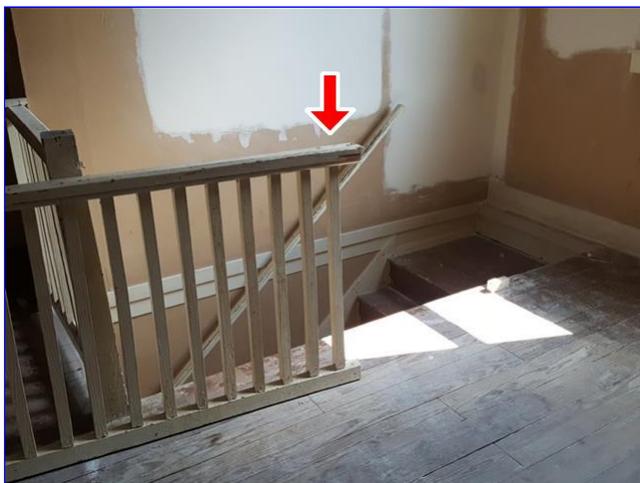
6.3 Item 1(Picture)

(1) The balcony railing is loose and not secured to the floor in the loft area. This is extremely dangerous and is a safety concern. An injury of a person will occur if not corrected. Recommend repair or replace by a qualified contractor before moving in.

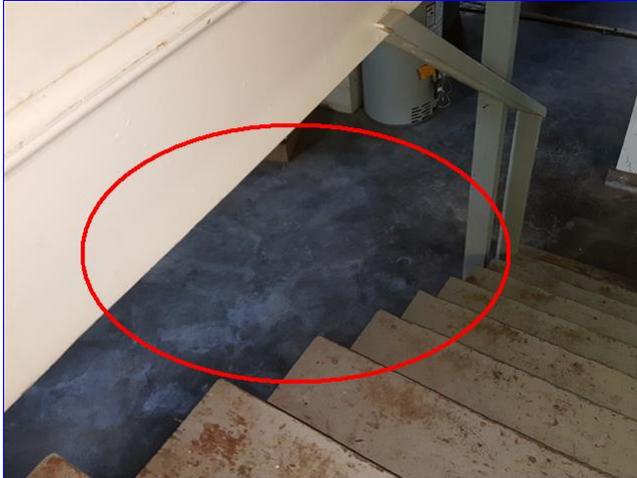
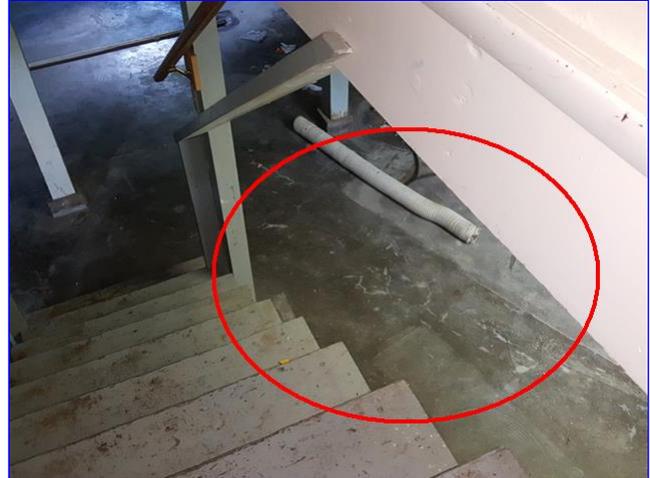
(2) The guard rails for the staircase leading to the basement are missing balusters. A fall or injury could occur if not corrected. This is a safety issue. Ensure the baluster spacing is 4 inches apart to prevent a child or pet from falling through. A qualified contractor should repair or replace as needed prior to moving in.

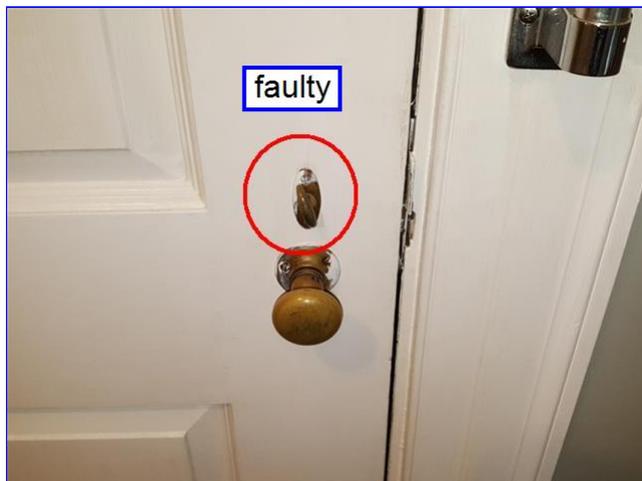
6.4 Item 7(Picture)

(3) The side entry door at the front of the home does not lock. The locking mechanism maybe faulty. Recommend replacement to ensure security within the home.

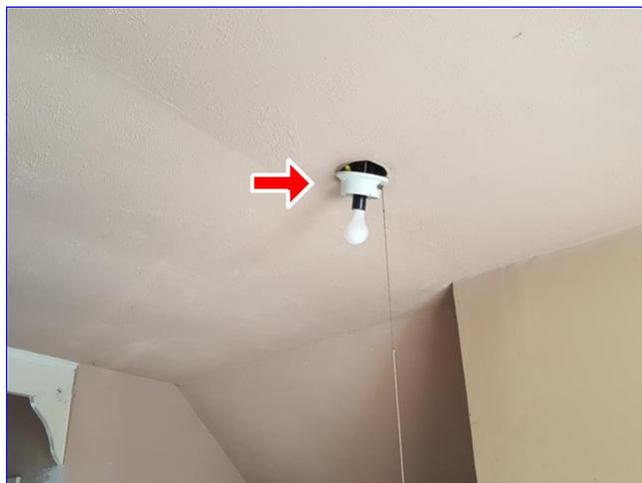
6.7 Item 1(Picture)

(1) The light fixture in the loft area upstairs is loose at the ceiling. This is a safety issue as the light fitting may fall causing an injury and/or wire connections come loose which may cause a short that could result in a fire. Recommend securing as needed. A qualified contractor or electrician maybe needed for repairs for safety.

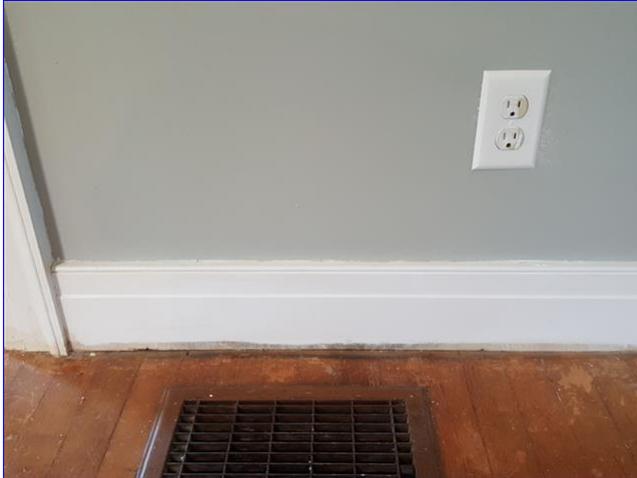
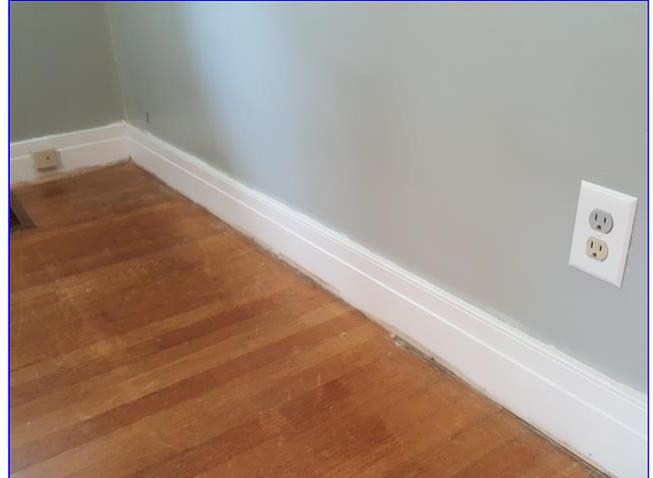
(3) Some of the outlets in the rooms have been painted. Paint clumps in crevices can clog the openings in the outlet, making it difficult to insert the blades from the plug. Forcing the blades in may damage them and/or lead to a poor connection with the internal contacts creating a hazardous condition causing a fire. Additionally, paint chips can fall off the outlet or switch after repeated use creating a health hazard for young children and pets. Recommend replacing outlets and covers where necessary for safety by an electrician.

6.7 Item 10(Picture) living room

6.7 Item 11(Picture) living room

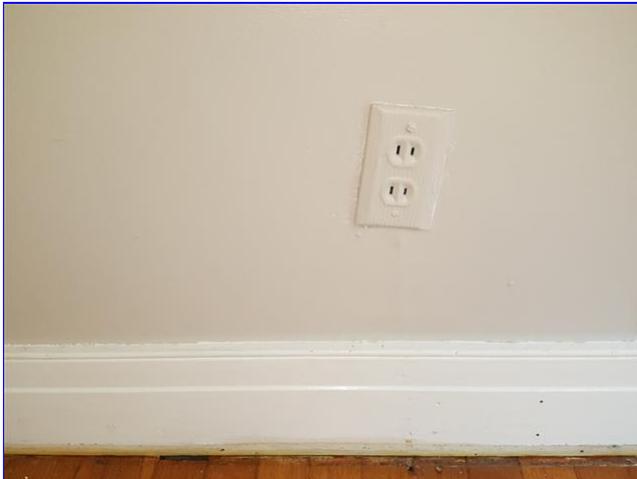
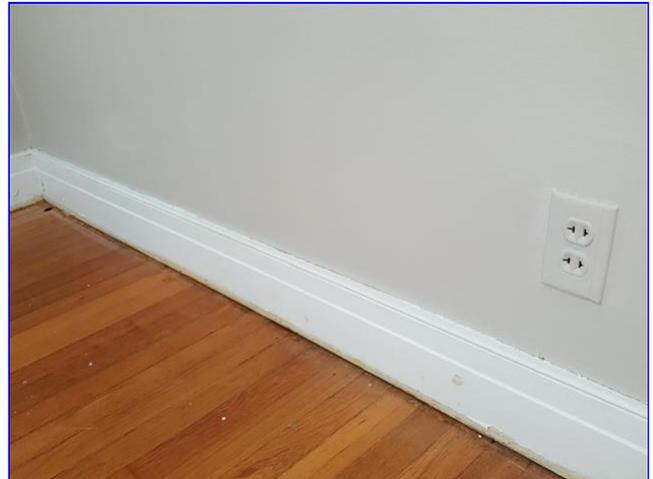
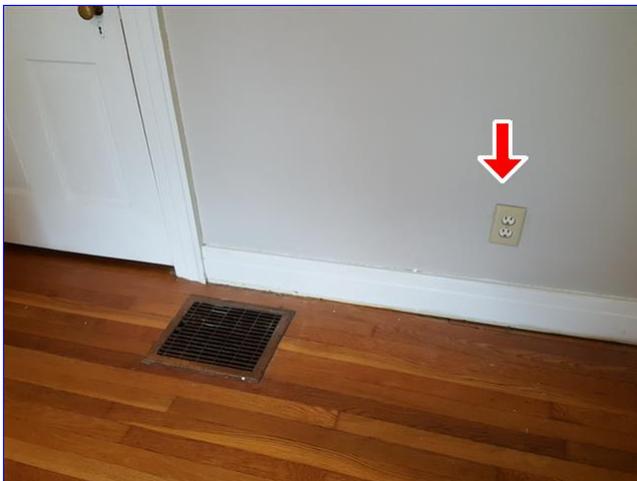
6.7 Item 12(Picture) 2nd bedroom

6.7 Item 13(Picture) 2nd bedroom

(4) The outlet in the 2nd bedroom where indicated in the photo(s) is loose at the wall or in the outlet box. Electrical issues are considered a hazard until repaired. This is a safety issue that needs to be corrected due to an electric shock or fire from loose connections could occur if not repaired. Recommend a qualified licensed electrical contractor correct as needed.

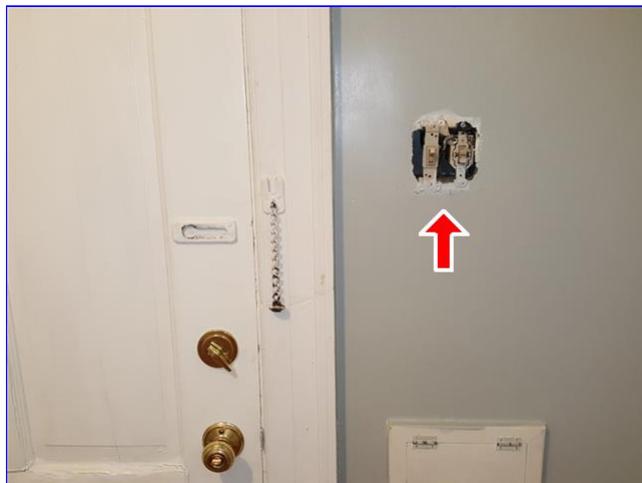
6.7 Item 15(Picture)

(5) The light switch(s) in the main entry hallway is missing a cover-plate. All missing switch covers should be installed to prevent touching the sides of the devices to prevent an electric shock which can cause an injury or death. Electrical issues are considered a hazard until repaired, and this is considered to be unsafe. A qualified licensed electrical contractor should correct as needed prior to moving in.

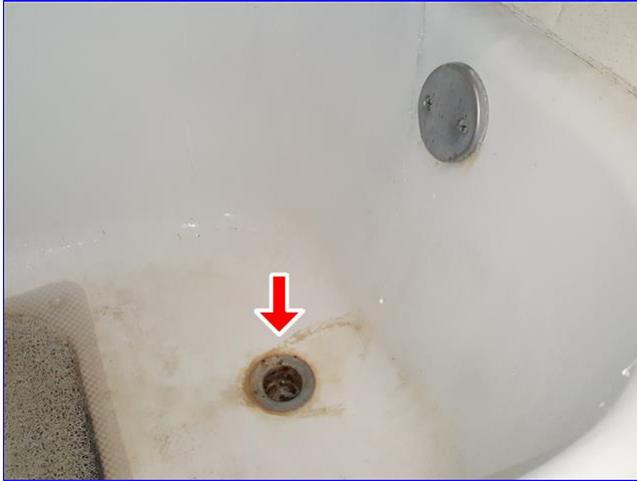
7.4 Item 1(Picture)

(1) The drain stopper is missing at the bath tub in the master bathroom. Recommend a qualified licensed plumber install one or a rubber stopper can be used.

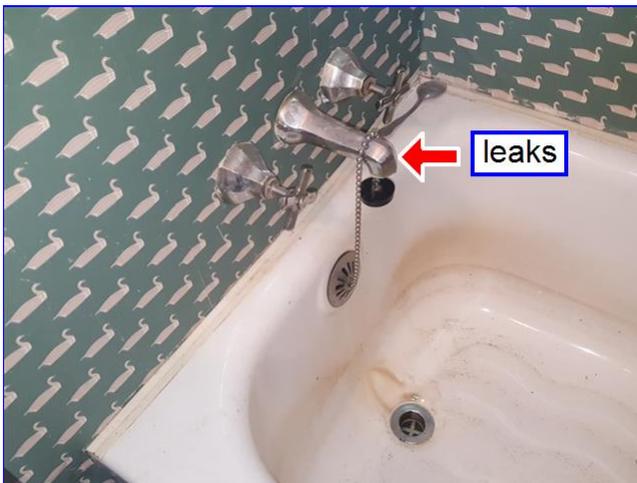
(2) The bath/shower water spout leaks when the water is turned off in the 2nd bathroom. Recommend a licensed plumber repair as needed.

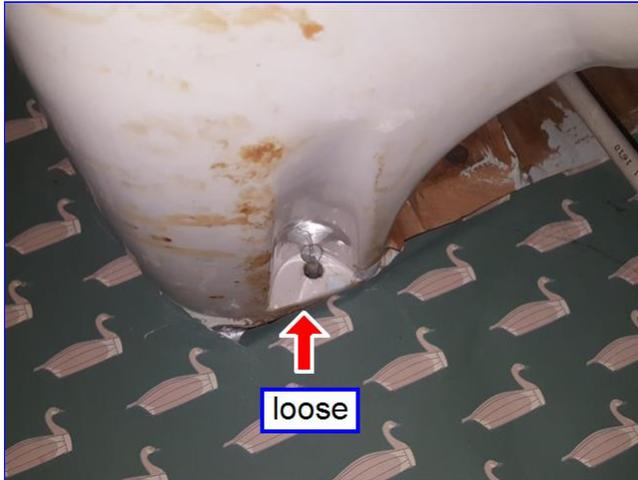
7.4 Item 4(Picture)

(4) The sink in the 2nd bathroom is loose and not fastened securely to the wall. This should be secured to prevent strain on supply and drainage lines which could result in a leak occurring. This may also be a safety issue as the sink bowl may fall resulting in an injury. Recommend a general contractor repair as as needed.

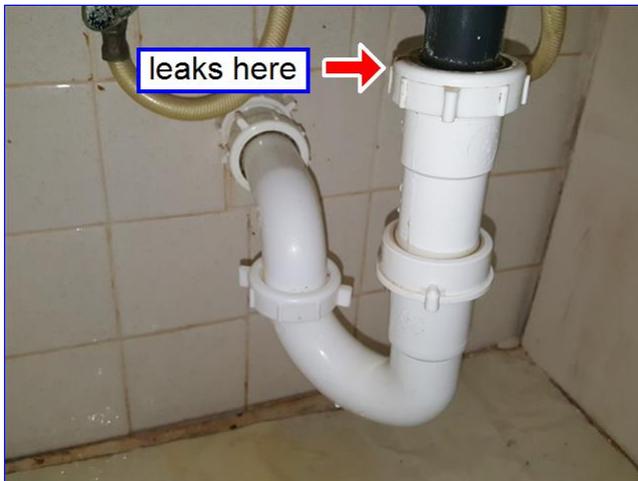
(1) The waste line is leaking at the connection underneath the sink in the master bathroom. Repairs are needed to stop leaking water from damaging the cabinet bottom or to eliminate moisture that may contribute to fungi growth. A qualified licensed plumber is recommended for repairs as needed.

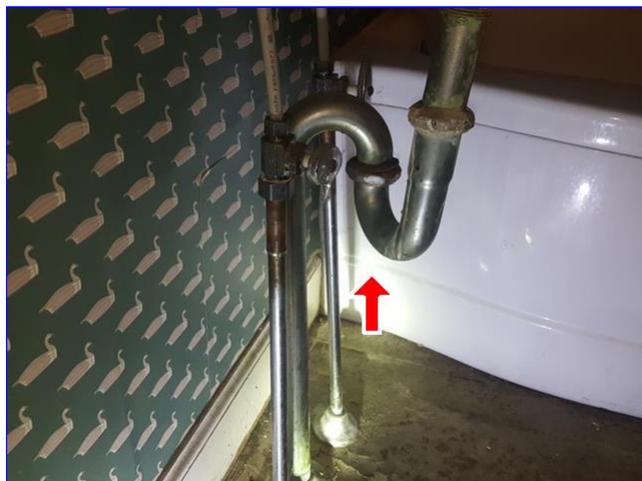
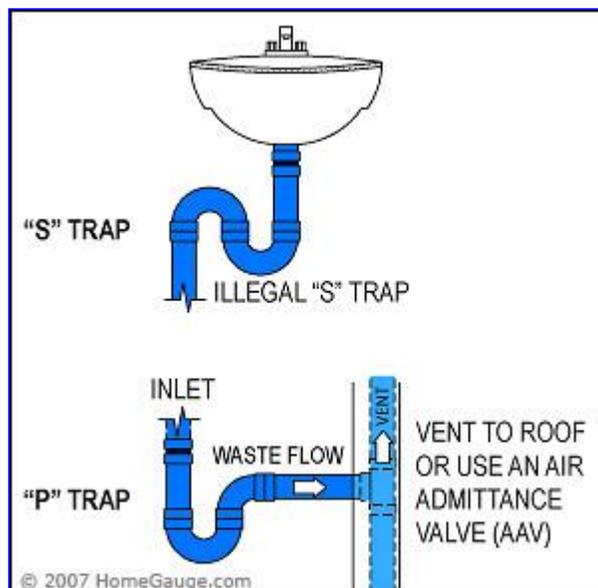
(2) An "S" trap is being used under the 2nd bathroom sink. "S" traps should be replaced during any new plumbing work as they are subject to siphoning problems. "S" Type drain traps do not meet today's standards and are now illegal to be used in Kentucky. This type of trap could allow all the water to drain from the trap and allow sewer gases to enter the house. Care should be taken to keep the trap "primed". Fixtures should be monitored for sewer odor. Examination of the drain trap and correction by a licensed plumber is recommended.

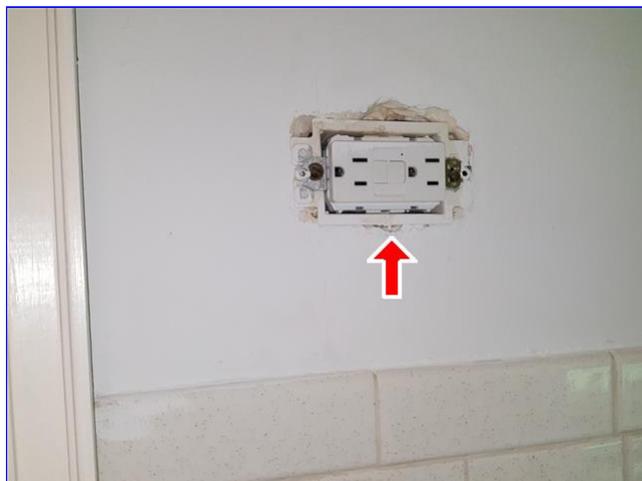
7.6 Item 1(Picture)

(1) The outlet(s) in the master bathroom where indicated in the photo(s) is missing a cover-plate. All missing covers should be installed to prevent touching the sides of the devices to prevent an electric shock which can cause an injury or death. Electrical issues are considered a hazard until repaired, and this is considered to be unsafe. A qualified licensed electrical contractor should correct as needed prior to moving in.

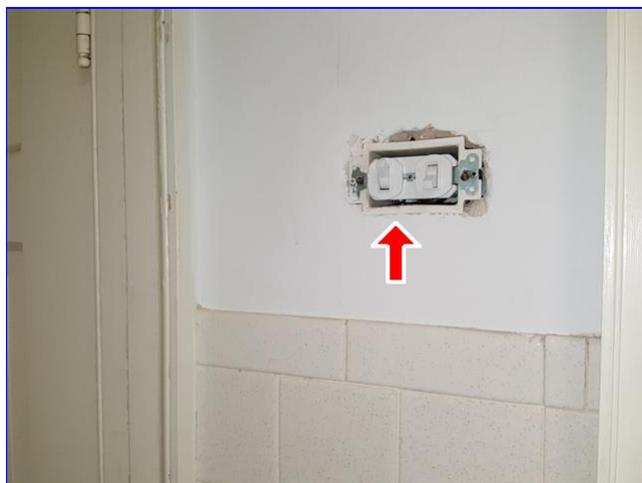
7.6 Item 2(Picture)

(2) The light switch(s) in the Master bathroom is missing a cover-plate. All missing switch covers should be installed to prevent touching the sides of the devices to prevent an electric shock which can cause an injury or death. Electrical issues are considered a hazard until repaired, and this is considered to be unsafe. A qualified licensed electrical contractor should correct as needed prior to moving in.

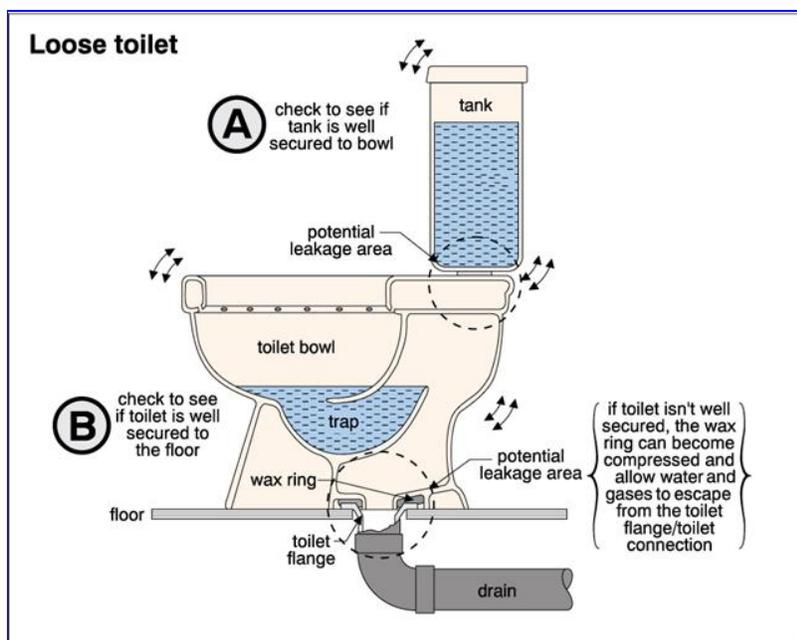
(2) The toilet tank base is loose at the floor in the 2nd bathroom. The screws may need tightening to secure the toilet base to the floor to prevent a water leak between the toilet and the drain line connection. If tightening the screws at the base of the toilet does not secure the toilet, repairs may involve re-setting the toilet on a new wax seal and/or repairs to the floor may be required. Recommend a qualified licensed plumber repair or correct as needed.

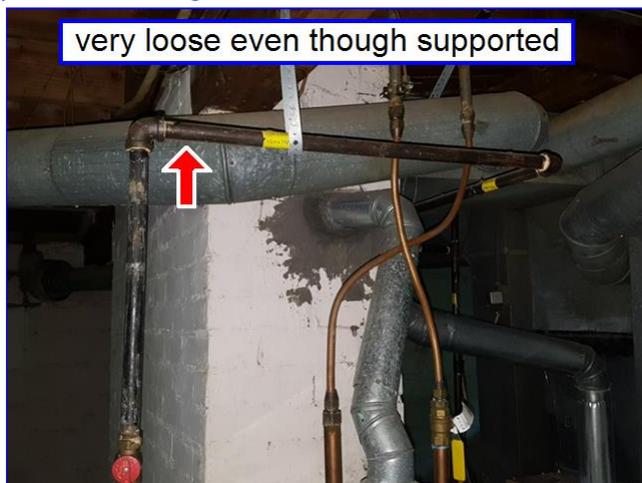
8.3 Item 1(Picture)

(1) The gas line to the water heater lacks proper support. This is a safety issue and hazardous. If the pipe is knocked it could cause stress at the joints and a possible gas leak could occur which could result in an explosion or house fire. Recommend a qualified contractor install the necessary supports prior to moving in.

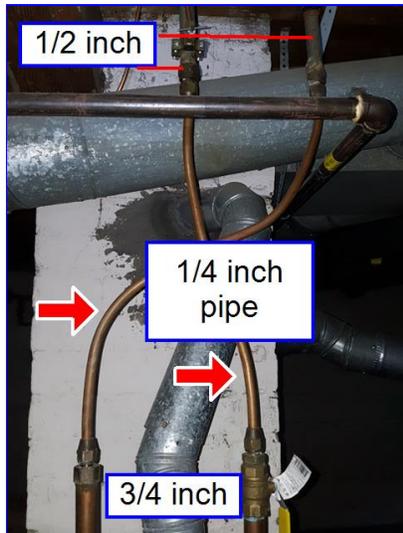
8.3 Item 2(Picture)

(2) The cold water supply line and the hot supply line pipes leading into the water heater have been reduced to 1/4 inch pipe. They should be 3/4 inch pipe. This reduces the water pressure leading in wards and outwards from the water heater which can cause damage to the unit and result in poor water pressure for the hot water supply lines in the home. Most manufacturers recommend the pipes that are connected to the water heater are to be 3/4 inch pipes in diameter. Recommend a qualified licensed plumber further investigate and repair/correct as needed prior to moving in.

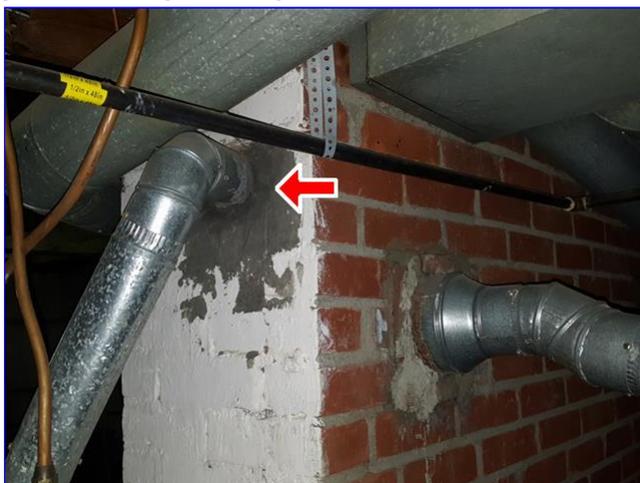
8.4 Item 1(Picture)

The chimney is being used for venting the gas water heater. A stainless steel vent pipe should be installed and properly sized for the gas appliance to prevent damage to the interior of the chimney mortar joints, possible entry of CO (carbon monoxide) gases into the home, and sized to promote good drafting of the gas appliance. Clay flue tile is usually too large to allow proper drafting. A cap should be installed at the same time. **Strongly** recommend that a qualified licensed plumber examine the chimney to determine if the chimney or flues have been damaged and require repairs to

prevent CO entry into the home and to verify that the flue or clay liner is properly sized to provide good drafting of the gasses.

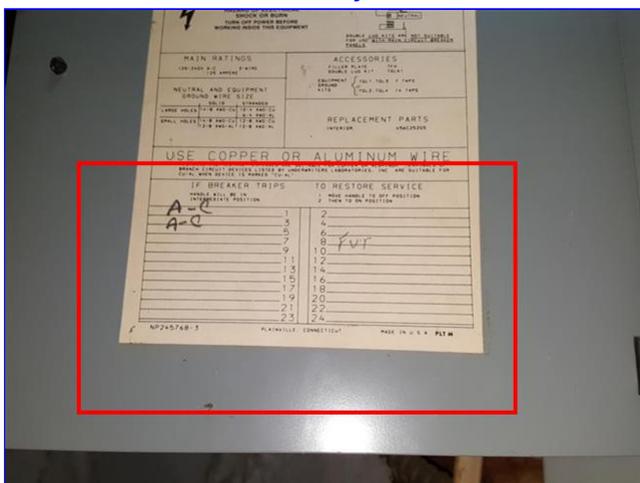
9.2 Item 1(Picture)

The circuit breakers are not labelled on the cover of the electrical panel. This is a safety issue. Could not check if breakers may be overloaded with appliances in the home. (example: Heating and air conditioning cannot be on the same circuit breaker even though they are used at different times of the year). The electrical panel should be indexed, identifying each circuit breaker. This will allow for quick de-energizing of a circuit under emergency situations. Recommend the panel be fully labelled to facilitate turning off breakers to circuits prior to moving in. A licensed electrician is recommended for this correction for safety.

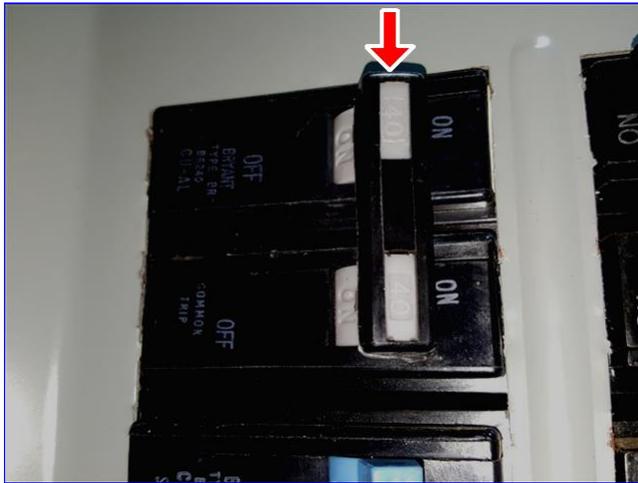
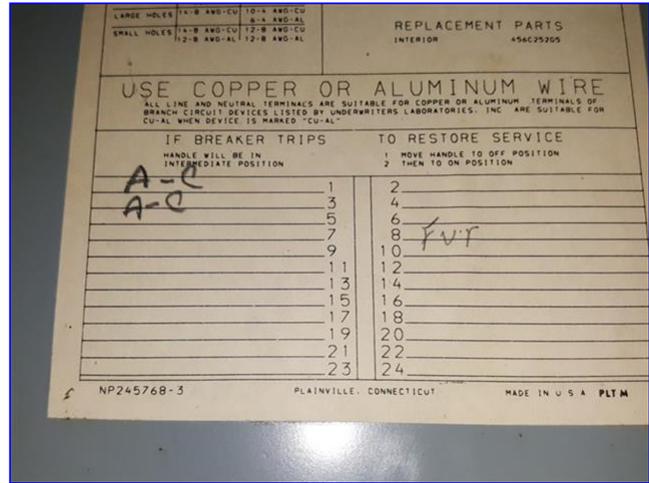
(1) The breaker for the Air Conditioner is oversized in the panel box. Currently it has a 40 amp breaker installed, whereas the data plate on the Air Conditioner specifies maximum breaker of 25

amps. The concern with an oversized breaker is typically causing possible damage to the equipment, and if the unit pulls more than 25 amps it could cause the insulation on the wires to start to melt. This will void warranty on the unit. Recommend a qualified HVAC contractor and/or electrician further evaluate to determine if correction is needed.

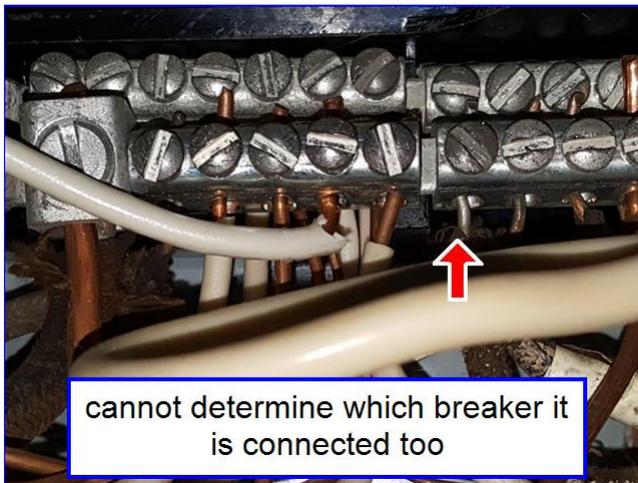
9.3 Item 3(Picture)

(2) Aluminum wire is installed on 120 VAC (volts (electrical pressure) of alternating current) branch electrical circuits in the subject house. These single strand, branch circuit aluminum wires were used widely in houses during the mid 1960s and 1970s. According to the U.S. Consumer Product Safety Commission, problems due to expansion can cause overheating at connections between the wire and devices (switches and outlets) or at splices, which has resulted in fires. For further information on aluminum wiring contact the U.S. Consumer Product Safety Commission via the Internet at <http://www.cpsc.gov/> . It is recommended that the electrical system be evaluated by a licensed electrical contractor.

cannot determine which breaker it is connected too

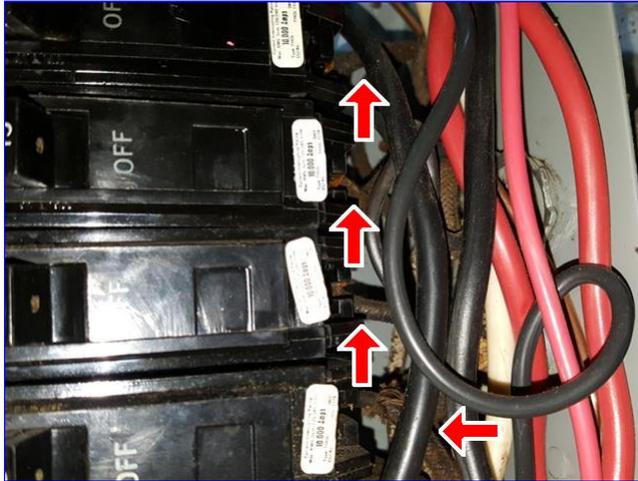
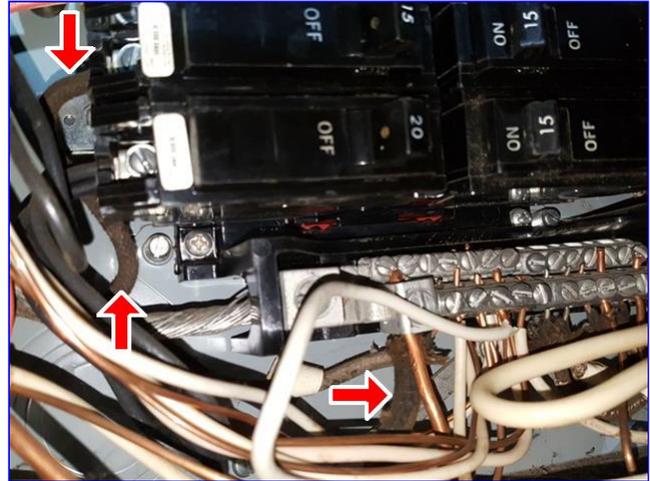
(3) When aluminium wiring is used as noted this panel at the 15 and 20 amp breakers it should be coated with a good antioxidant. The antioxidant grease is missing. When aluminium wire is exposed to the atmosphere a film of aluminium oxide forms. This is hazardous and a safety issue because the current is supplied at a much lower rate of voltage and as the oxidation builds up, it builds up resistance which creates heat. Also movement of the wire can occur from oxidation due to expansion/contraction of the wire and can cause loose connections. Recommend a qualified licensed electrician further inspect and repair as needed.

companies will not issue policies on homes with this type of wiring. Recommend contacting a qualified licensed electrician and your insurance carrier to determine what needs to be done to make this system safer.
