TALC
Home Inspe

Inspection Report

Property Address:
303 Wheeler Avenue
Georgetown KY 40324

Talon Home Inspections, LLC

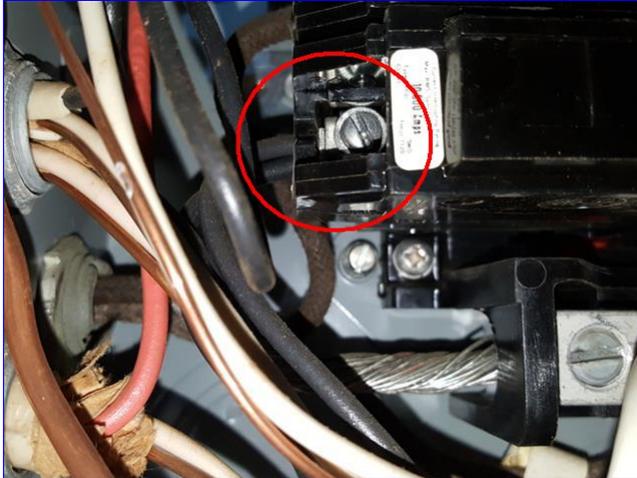
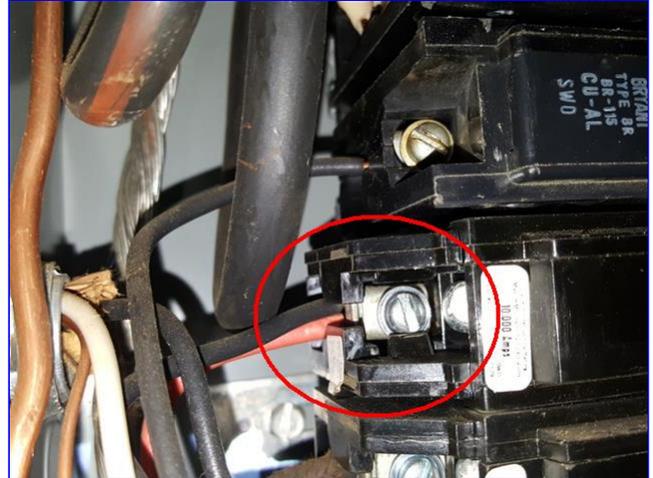
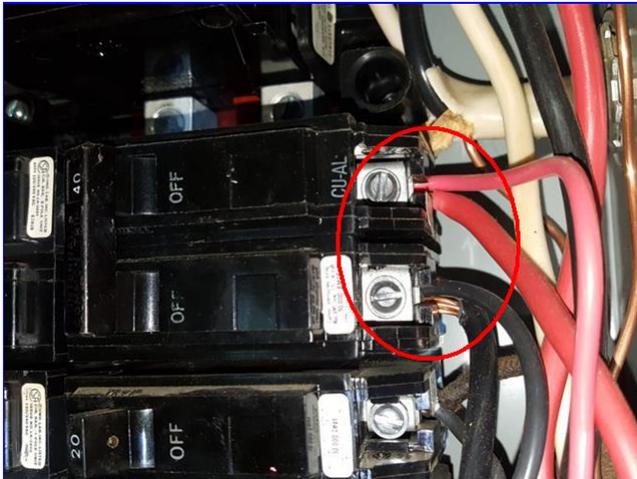
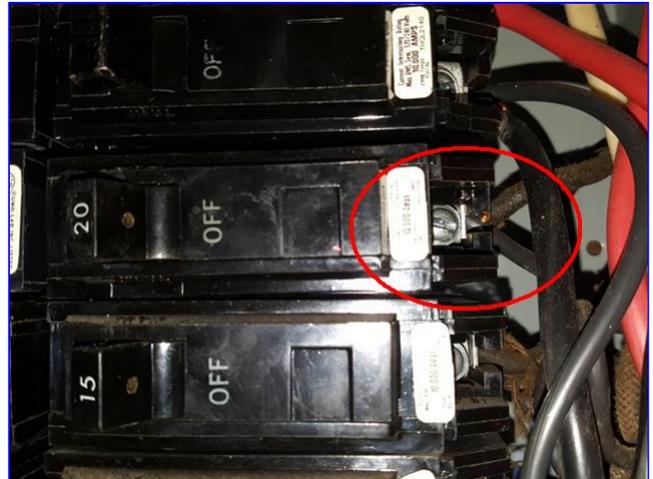
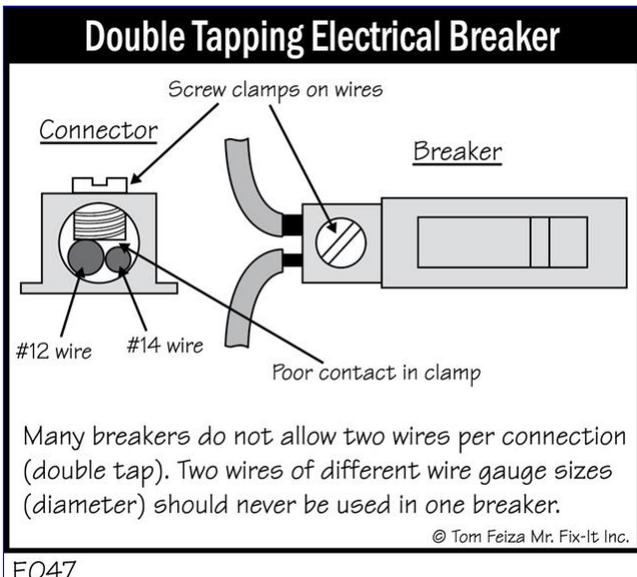
(5) Multiple tap wiring (more than one hot wire attached to the same breaker) was found in the panel. This panel and breakers are NOT MADE or DESIGNED to provide adequate holding power for multiple wires on a single breaker. A separate breaker should serve each circuit. This is a very hazardous and is a safety issue. May cause a fire or short. Recommend a qualified electrician further evaluate the panel box for further issues and repair and correct as needed.

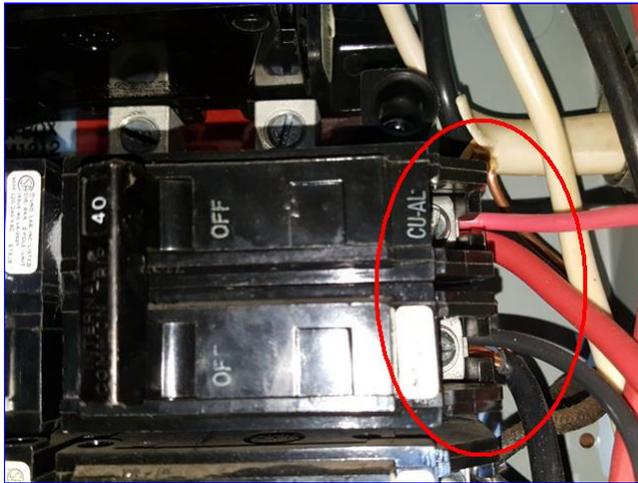
9.3 Item 11(Picture)

(6) There are incorrect amperage gauge wire sizes connected to non matching amperage circuit breakers in the panel box where indicated in the photo(s). This is extremely dangerous and could

result in an electrical fire within the home. The wires could over heat and catch fire without tripping the circuit breakers. As an example a 30 amp wire should not be connected to a 40 amp circuit breaker. Recommend a licensed electrician further evaluate wire size connected to the circuit breaker in the panel box where indicated and for other faults or hazards then repair or replace as needed.

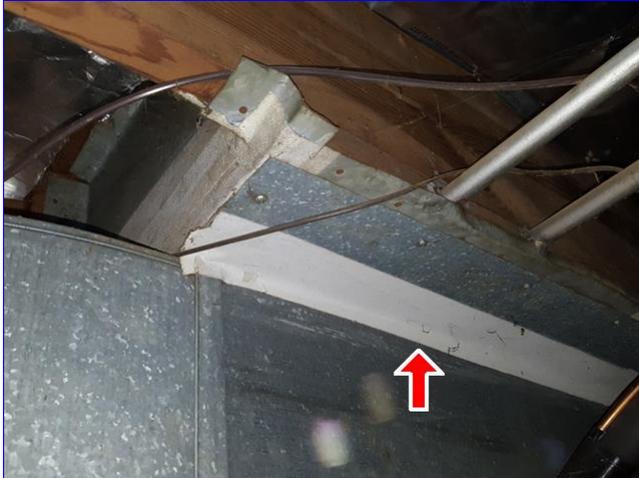
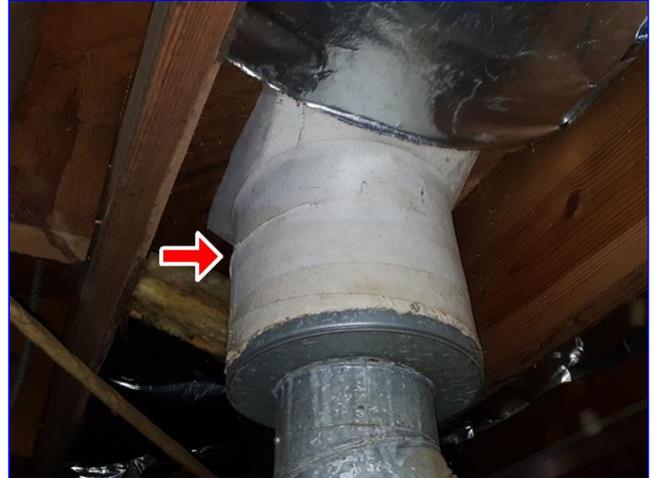
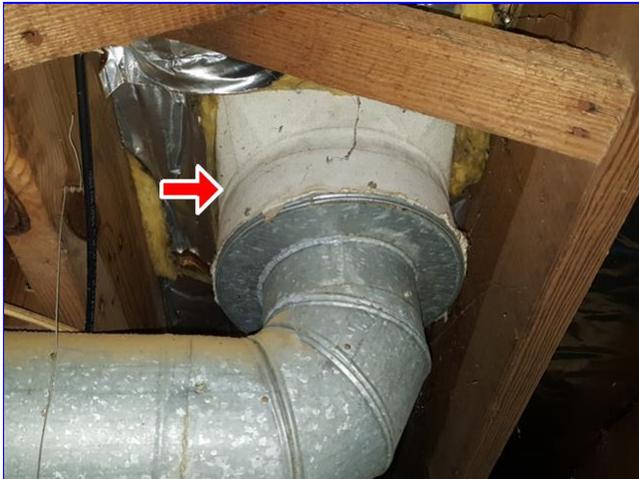
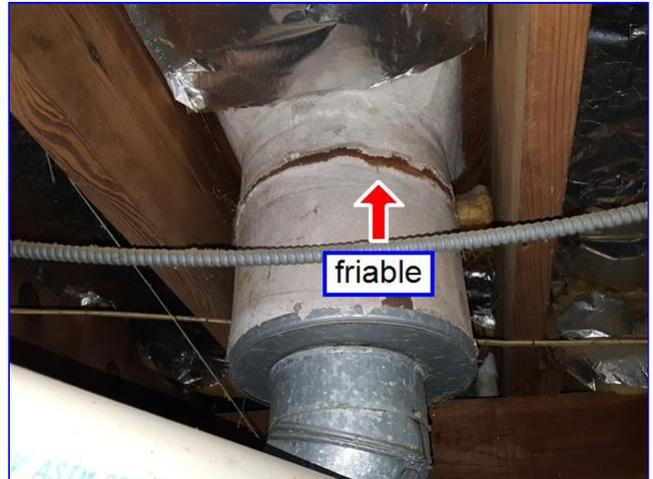
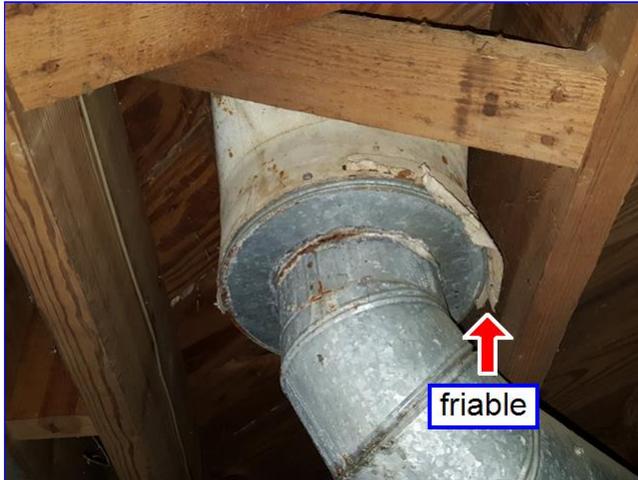
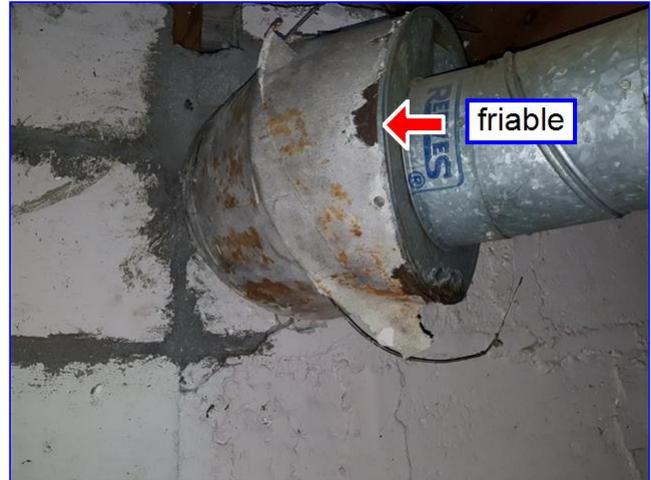
(3) The white tape covering some of the joints in the duct work in the basement may be asbestos. Some of the tape is damaged and maybe harmful to occupants in the home if the product is asbestos and due to the product is exposed and friable (damaged). Only laboratory testing can determine the presence of asbestos. Professional removal of any known asbestos material is sometimes needed. Covering the white material with furnace tape is suggested if the material is in good condition. This traps any particles and prevents spreading them into the home. [Here is a link to the EPA explaining more information about asbestos.](#) **Strongly** recommend a qualified asbestos contractor further inspect to determine if this product is asbestos and if correcting/removing product is needed prior to closing to ensure safety and health within the home. You may wish to have an air quality test done within the home also if the product is asbestos.

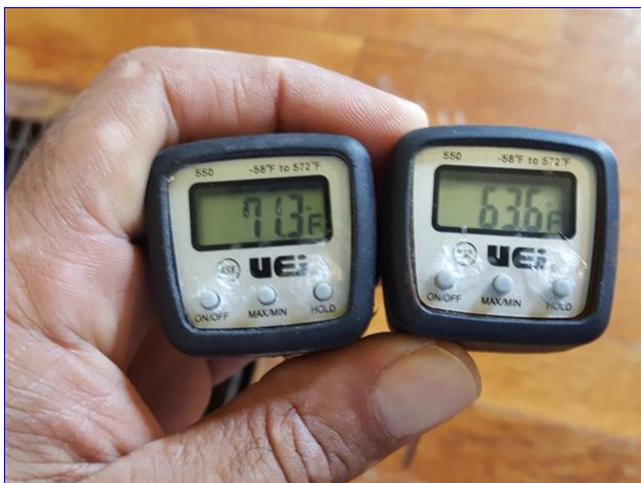
10.9 Item 1(Picture)

The ambient air test was performed by using thermometers at the registers closest to the blower to determine if the difference in temperatures of the supply and return air are between 14 degrees and 22 degrees which indicates that the unit is cooling as intended. The supply air temperature on your system read 63 degrees, and the return air temperature was 71 degrees. This indicates that the unit is **not** cooling properly and a qualified licensed Heat/Air contractor should inspect for cause or problem Note: There maybe a leak in the refrigerant line or the refrigerant levels need topping up..

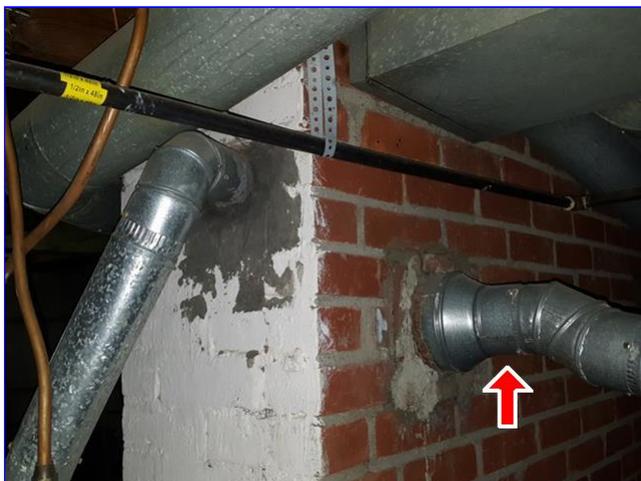
10.10 Item 1(Picture)

The chimney is being used for venting the gas furnace. A stainless steel vent pipe should be installed and properly sized for the gas appliance to prevent damage to the interior of the chimney mortar joints, possible entry of CO (carbon monoxide) gases into the home, and sized to promote good drafting of the gas appliance. Clay flue tile is usually too large to allow proper drafting. A cap should be installed at the same time. Strongly recommend that a qualified licensed plumber examine the chimney to determine if the chimney or flues have been damaged and require repairs to prevent CO entry into the home and to verify that the flue or clay liner is properly sized to provide good drafting of the gasses. There was no access to the chimney.

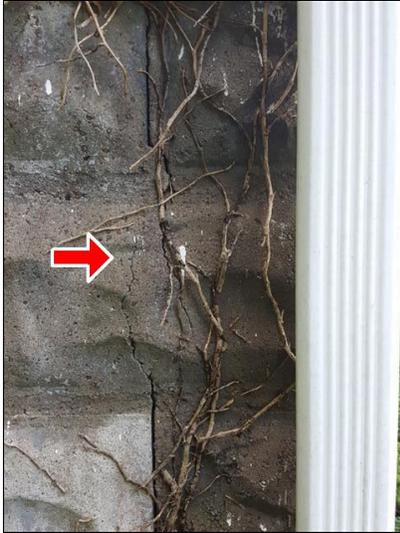
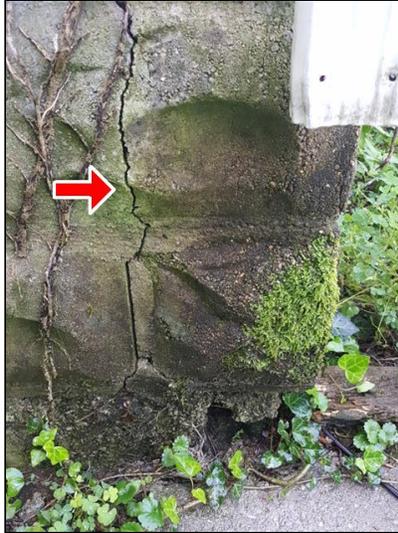
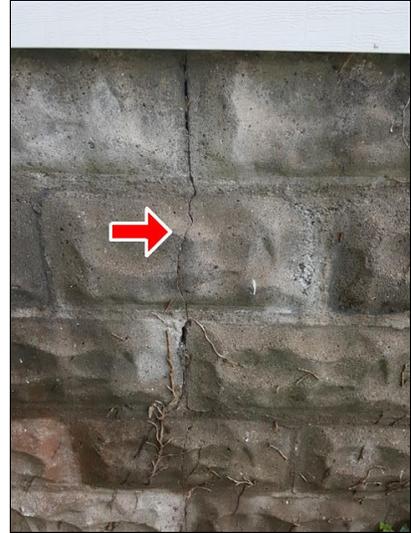
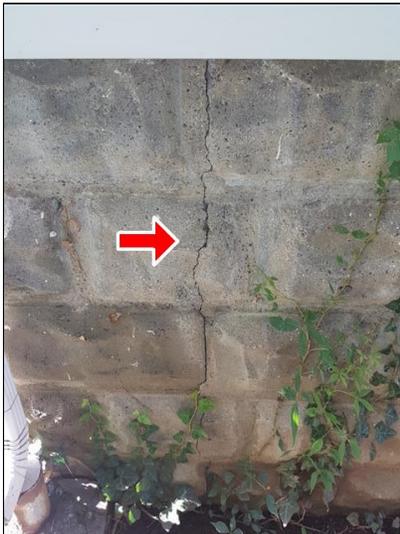
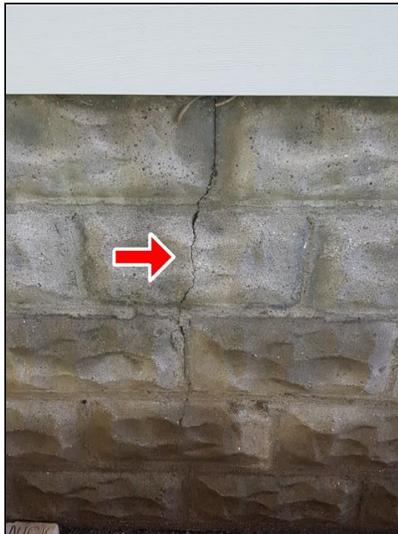
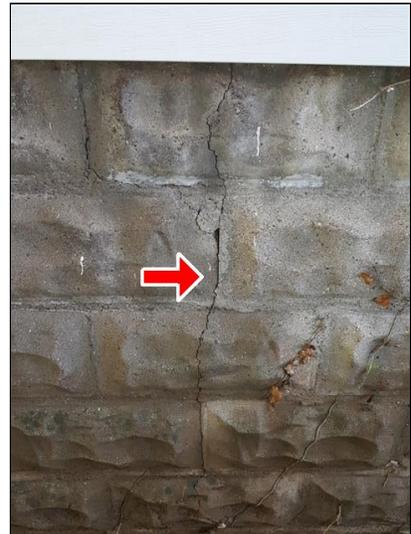
(1) Vertical cracks present on the foundation wall varied from hairline to approximately 1/16" in width. This implies that some structural movement of the building has occurred. Cracks of this type should be watched for any sign of additional movement. Some degree of settlement movement is common in older homes with this type of foundation wall. Since this type of movement generally occurs over an extended period of time, a wall monitoring system is recommended to observe any significant additional movement that would require a structural repair. In the absence of any sign of ongoing movement, repair should not be necessary. If these cracks become greater in width, a structural engineer who is familiar with foundation repair or a qualified foundation repair contractor should be consulted. Sealing the cracks is recommended by a qualified masonry contractor after correction of the grade, downspout run off and cleaning gutters. If the these measures are not corrected the condition could result in a major structural problem in the future.

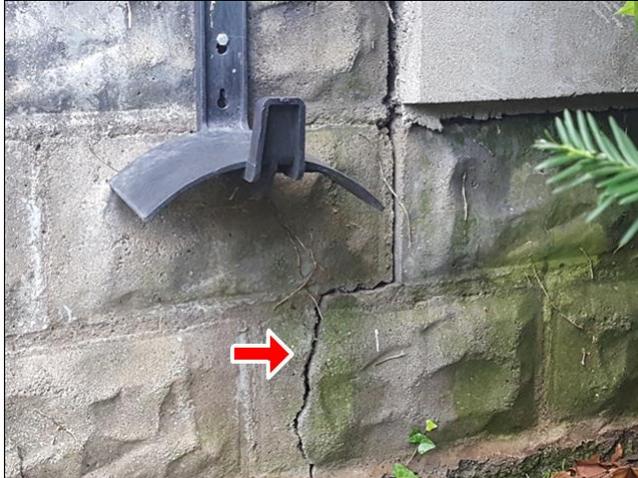
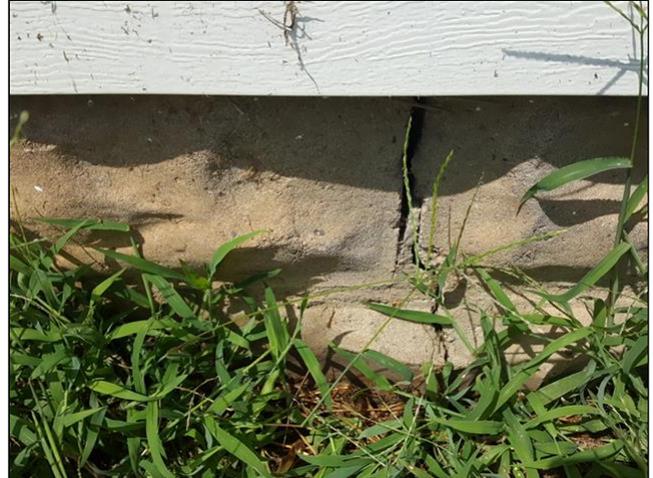
(2) The Typical settlement crack(s) in the foundation wall between the home and the side porch at the front of the home needs to be repaired. The cracks do not appear significant. This condition is common in many old homes and does not usually represent a serious structural concern unless the cracks are between an 1/8 or 1/4 inch thick. Recommend the crack be sealed to prevent water intrusion into the basement and minimize further deterioration. [Sealing Concrete Cracks](#) It is recommended that you monitor periodically to see if further movement occurs and if so a foundation contractor should be consulted to correct and prevent further movement.

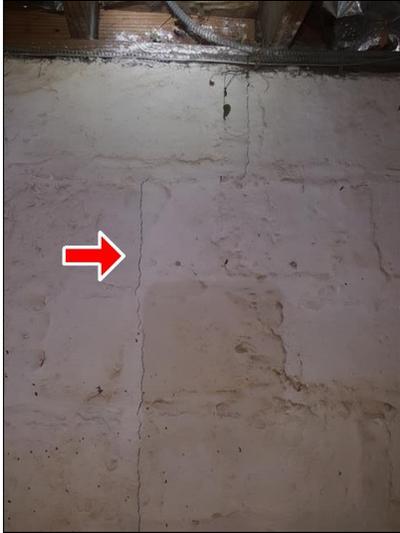
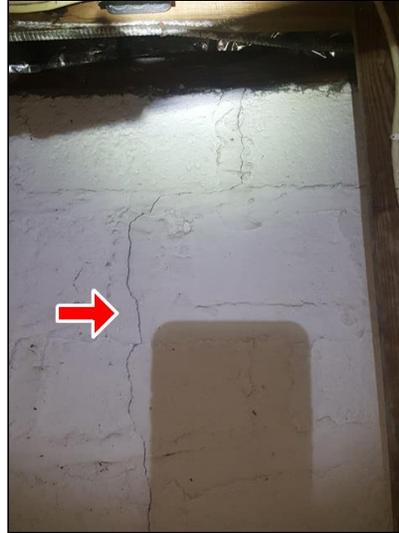
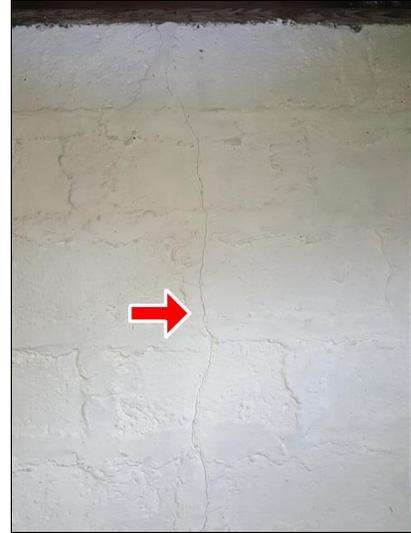
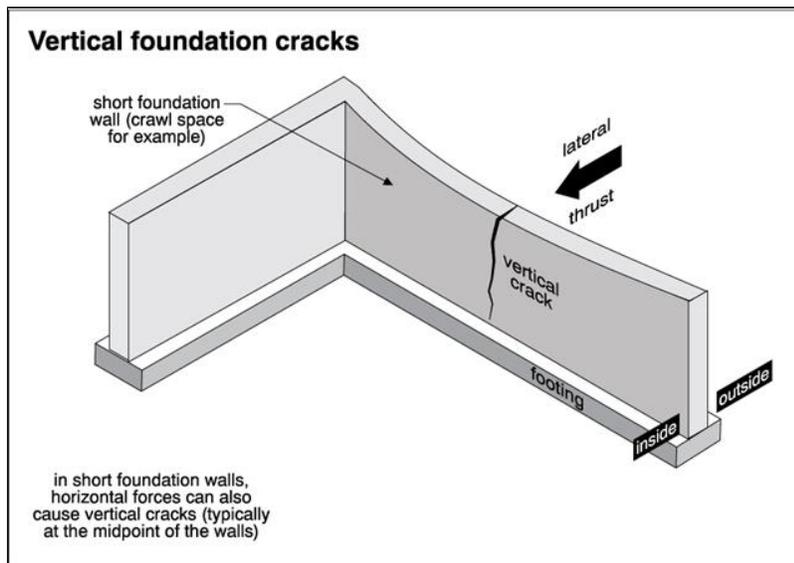
(4) The vertical settlement crack(s) in the foundation wall in the basement was noted. These cracks do not appear significant. This condition is common in many homes and does not usually represent a serious structural concern unless the cracks are between an 1/8 or 1/4 inch thick. Recommend the crack be sealed to prevent water intrusion into the basement and minimize further deterioration. [Sealing Concrete Cracks](#) It is recommended that you monitor periodically to see if further movement occurs and if so a foundation contractor should be consulted to correct and prevent further movement.

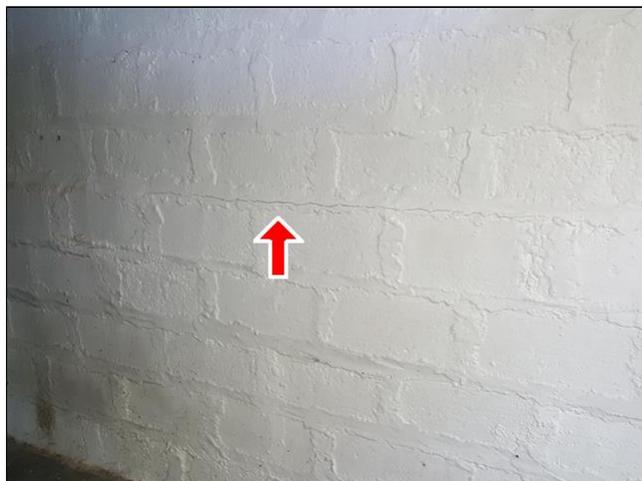
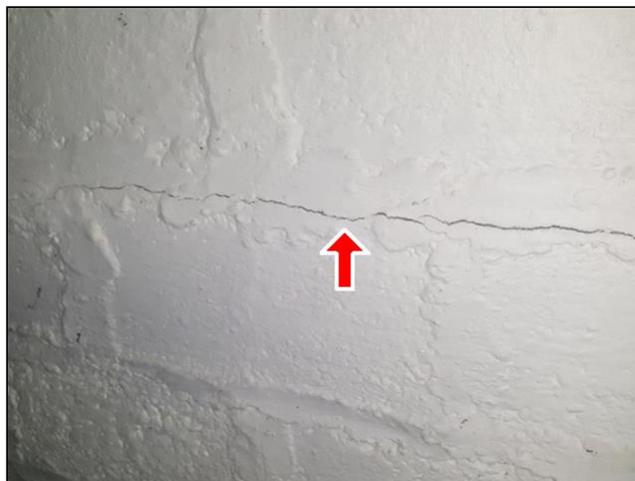
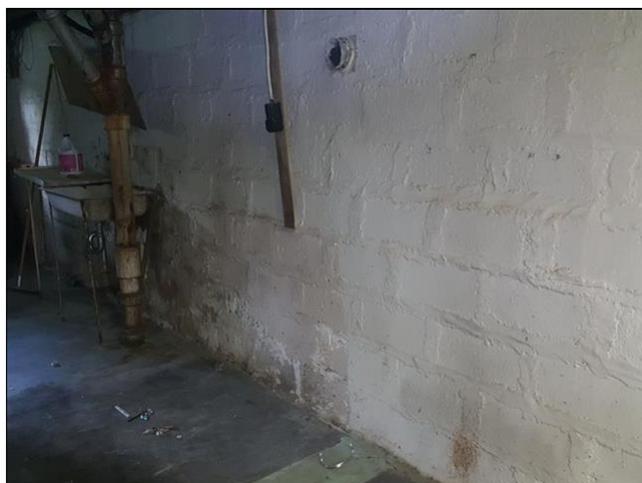
(5) Minor horizontal crack in the mortar was noted on the rear wall in the basement. Cracks of this nature are usually the result of soil or frost pressure due to freeze/thaw. The size, pattern and location of these cracks do not suggest a serious problem at present. Keep water away from the foundation: review the lot and roof drainage improvements in the Exterior and Roofing sections of this report. Recommend sealing these cracks with the appropriate caulk to prevent water intrusion and efflorescence, [Caulk for Concrete Cracks](#) . It is recommended that you monitor periodically after repairs. If these cracks should become greater and the wall starts to bow, a structural engineer who is familiar with foundation repair or qualified foundation repair contractor should be consulted.

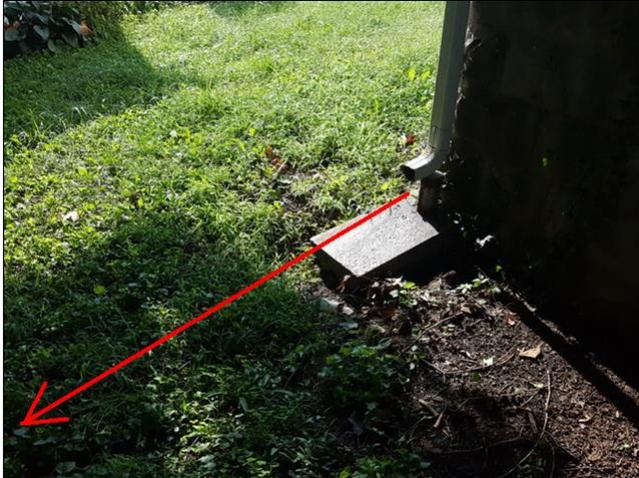
2.4 Item 6(Picture)

(2) Recommend the downspout(s) at the rear left corner of the home where indicated in the photo(s) be extended at least 6 feet and flow onto splashblocks. This will ensure water is kept away from the foundation perimeter, soil erosion does not occur and water cannot leak into the basement area which may cause settlement of the foundation.

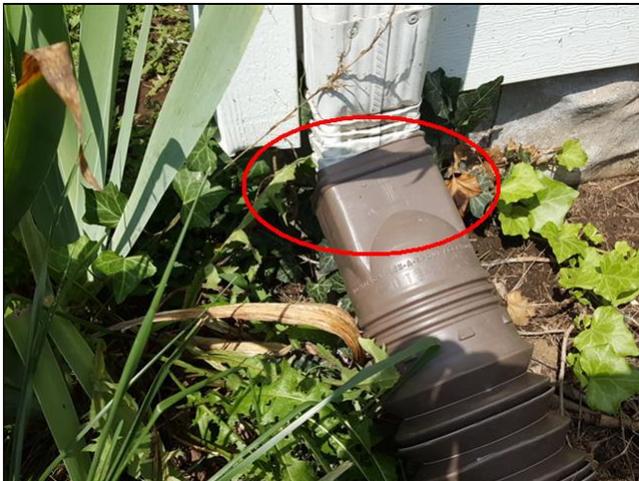
2.4 Item 11(Picture)

(4) Recommend the downspout extension(s) be attached to the downspout at the front right corner of the home by placing a screw at the top and bottom where it connects to the downspout to ensure the extension(s) does not pull away from the downspout(s). Failing to do this may create future problems to the foundation around the home due to soil erosion and water entering the basement which may result in the foundation settlement if the extension detaches from the downspout.

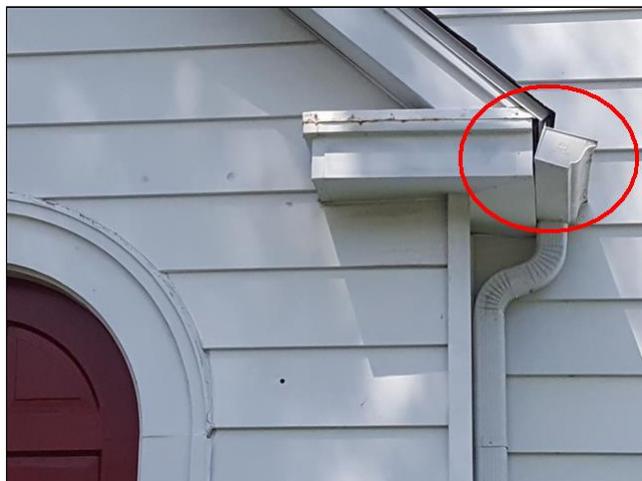
2.4 Item 12(Picture)

(5) The gutter needs to be tightened against the fascia and sealed at the front of the home where indicated in the photo. This may cause water to pool in this area and may cause the gutter to pull away and detach from the fascia. Recommend a general contractor repair as needed.

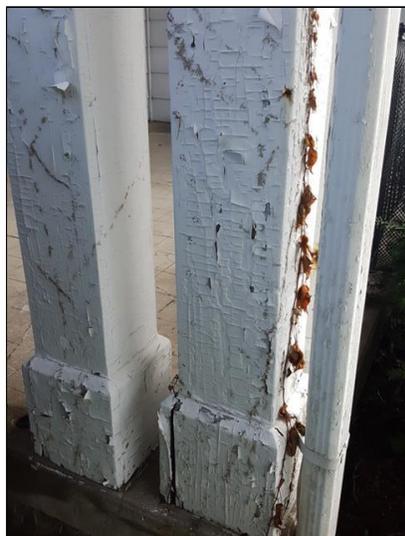
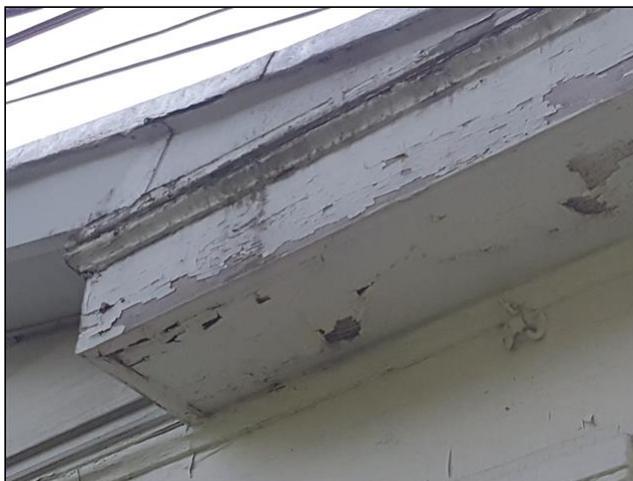
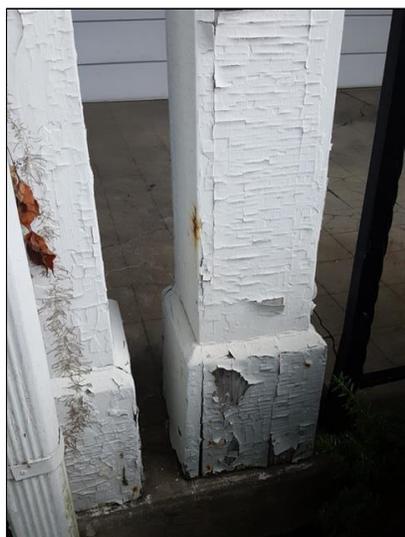
(1) The fascia and wood post for the side porch at the front of the home has peeling/missing paint in various areas. Deterioration and/or wood rot may occur if not corrected via water intrusion. Recommend these areas be painted to prevent deterioration of exposed wood. To reduce long term maintenance and improve appearance, it may be advantageous to install metal wrapping over these areas.

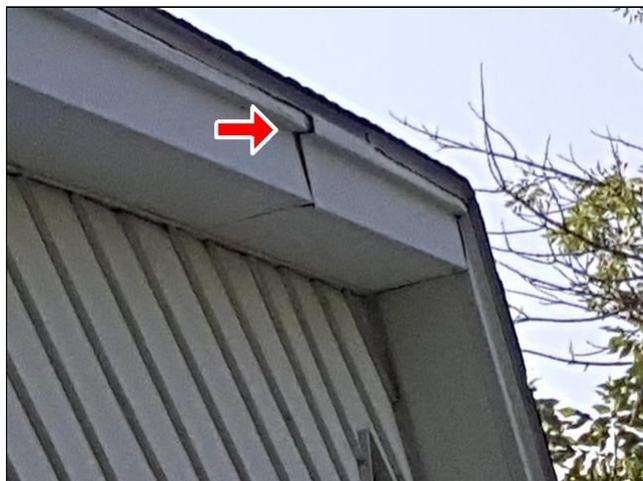
3.1 Item 7(Picture) left side of home

(3) The metal fascia wrap at the eave on the right side of the home is loose. Moisture or water could enter when raining and deterioration may occur of the fascia board if not corrected. A qualified person should repair or replace as needed.

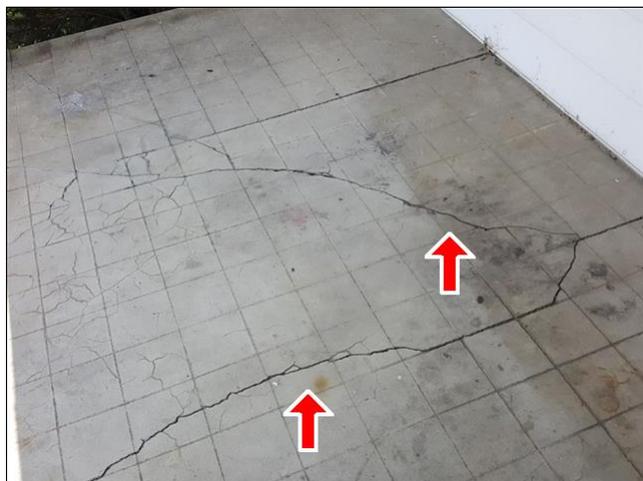
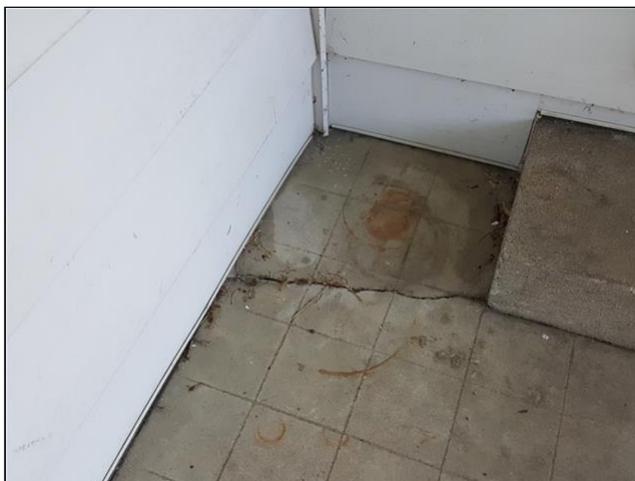
(1) The concrete porch is cracked and chipped in various areas. Further deterioration of the flooring can occur via water entry which could lead to possible cracking of concrete. Recommend these areas be repaired by a qualified masonry contractor.

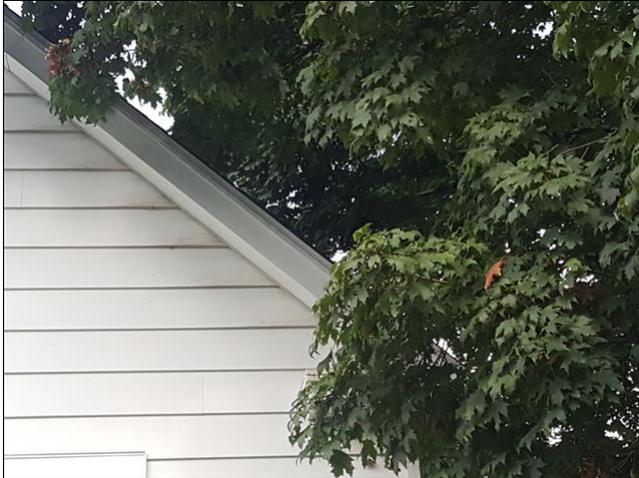
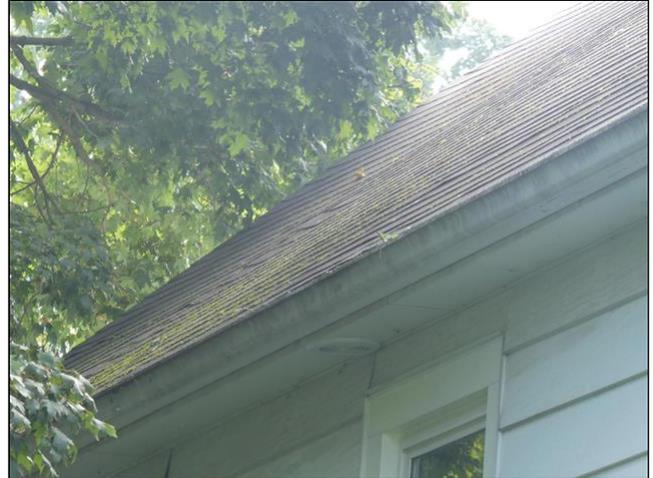
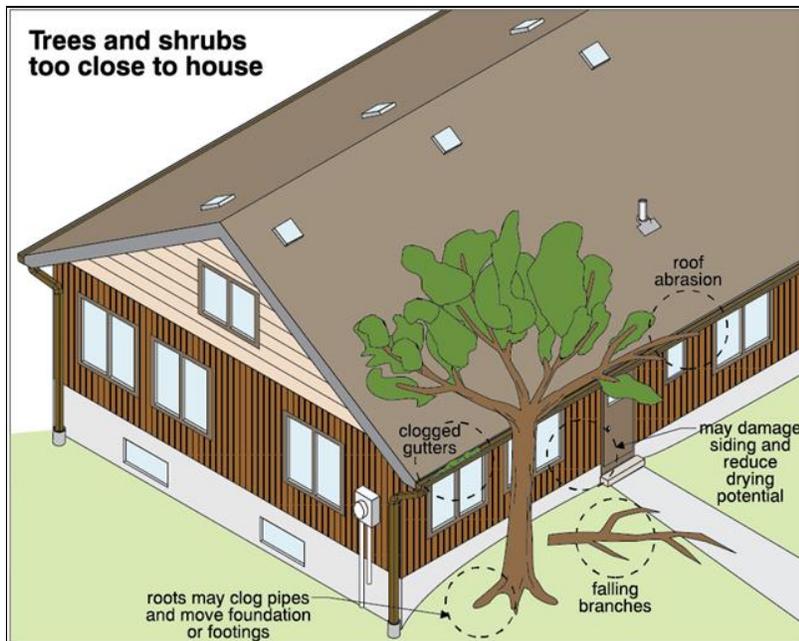
(1) The tree limbs that are in contact or hanging near the roof at the rear right side of the home should be trimmed to prevent damage to the shingles and from scraping on the roof surface. They will also clog gutters which will cause water run off problems around the home. Recommend cutting back tree branches as needed.

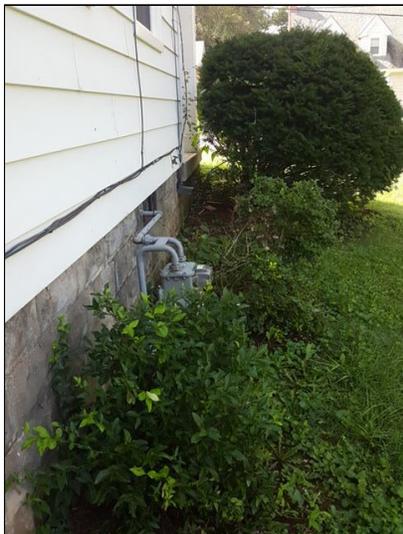
3.8 Item 8(Picture) left side of home

(3) The vegetation is overgrown around the perimeter of the home where indicated in the photo(s). Recommend that all bushes, shrubs and trees where applicable be kept neatly trimmed and away from the foundation, wall siding, and window frames to prevent damage to the home and allow proper venting and inspection of house. A 6" clearance is recommended.

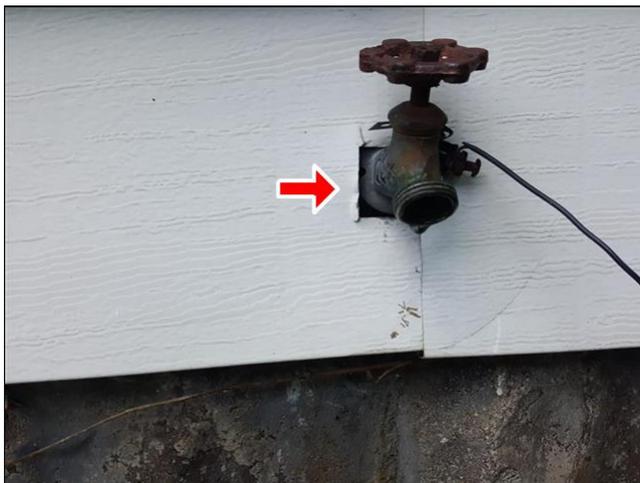
3.9 Item 1(Picture) left side of home

(2) The outside water faucet has an opening where the pipe protrudes the wall at the right side of the home. The opening can allow insects or water to enter which can cause deterioration of the wall structure. Recommend a general contractor repair as needed.

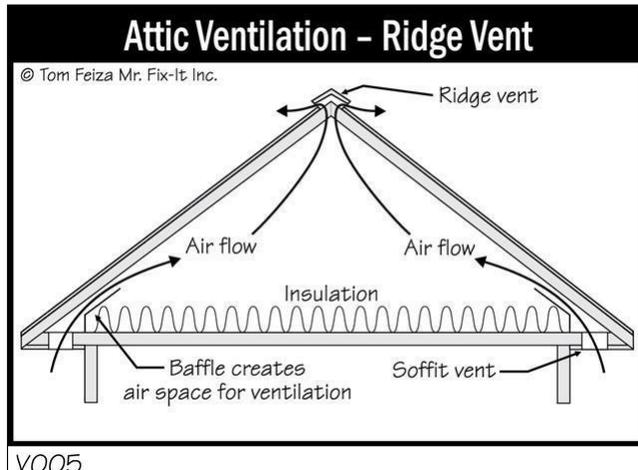
4.1 Item 1(Picture)

(1) Recommend additional collar ties (horizontal members running between each rafter, near their mid span) to add extra support to the roof structure and to resist rafters and ridge beam from sagging in the future. Heavy loads such as snow may cause the ridge of the roof to sag, cracked rafters appearing or the roof to develop leaks near this area from stress. Recommend a qualified roofing contractor make the necessary corrections as needed.

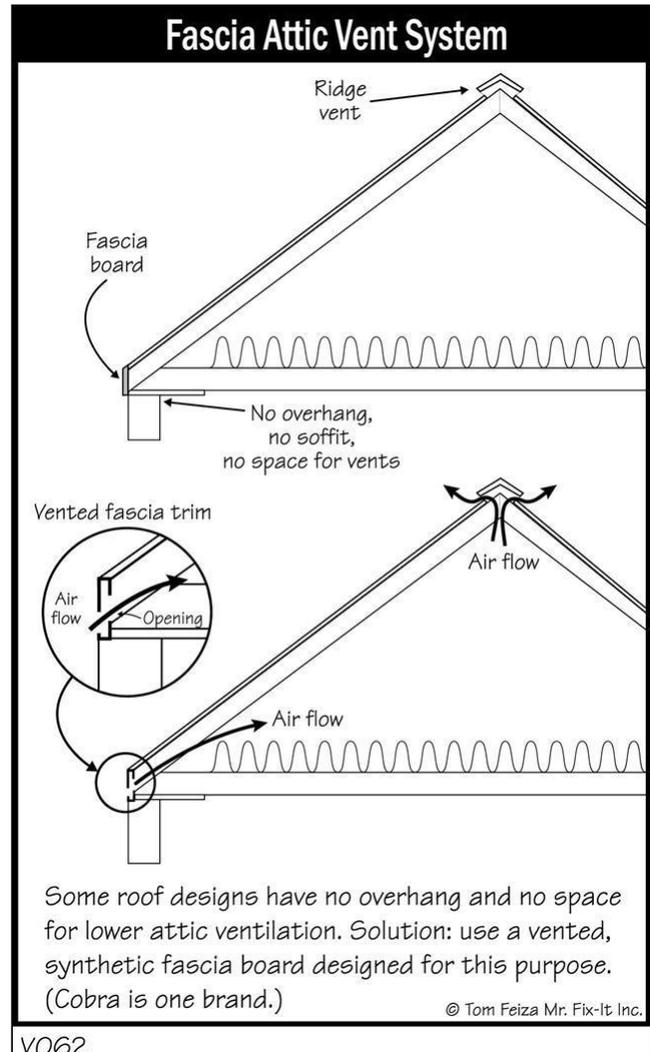
4.1 Item 2(Picture)

(2) There is no ventilation in the garage. It is generally recommended that one square foot of free vent area be provided for every one hundred and fifty square feet of ceiling area. Half of the ventilation should be at the ridge and the other half at the eaves. Proper ventilation will help to keep the garage cooler during warm weather and extend the life of roofing materials. In the winter, it will help reduce the potential for ice dams on the roof and condensation within the garage. [Here is a link explaining ventilation.](#) Recommend improving the ventilation at the next replacement of the roof coverings.

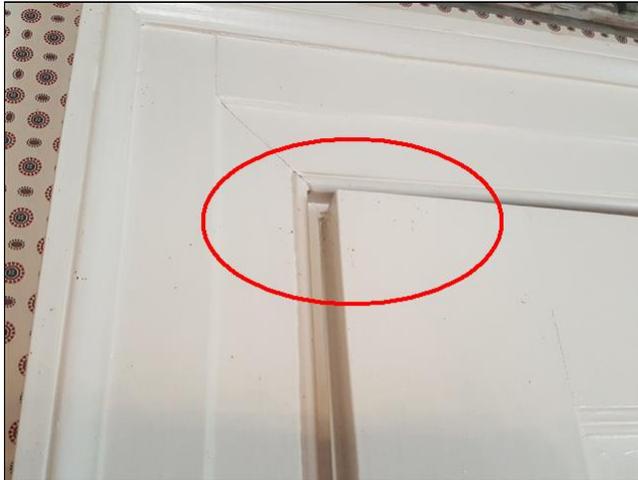
6.4 Item 1(Picture)

(1) The door in the formal dining room hits the door jamb at the top and does not close shut. This is a maintenance issue. Sometimes correcting the door opening can require door trim to be removed and painting touch up, and/or door hinges may need reseating to ensure correct closure of door. Recommend repair as needed by a general contractor.

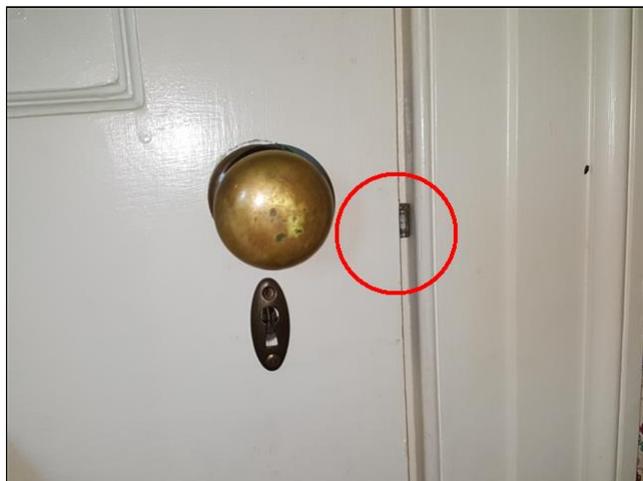
6.4 Item 4(Picture) master bedroom

(2) The door knob hardware is not latching in the Master and 2nd Bedrooms where indicated in the photo. It requires an adjustment. The strike plate may need to be adjusted or trimmed to be able to lock/close the door. Recommend repair as needed.

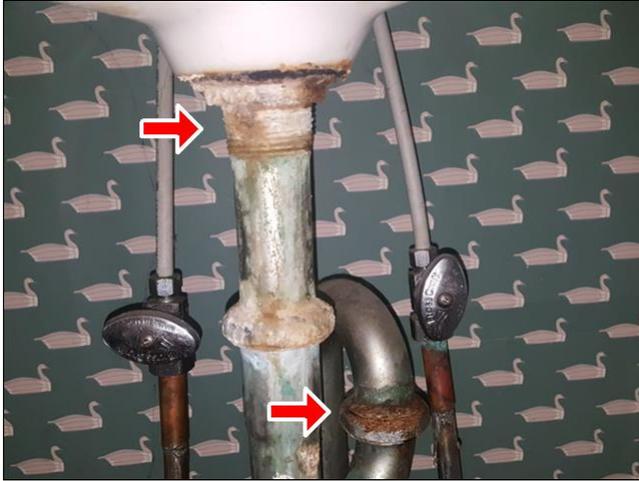
7.5 Item 6(Picture)

(4) Corrosion was noted at the waste line under the sink in the 2nd bathroom. Recommend replacement by a qualified plumber to prevent a water leak occurring in the future. This will prevent damage to the base cabinetry.

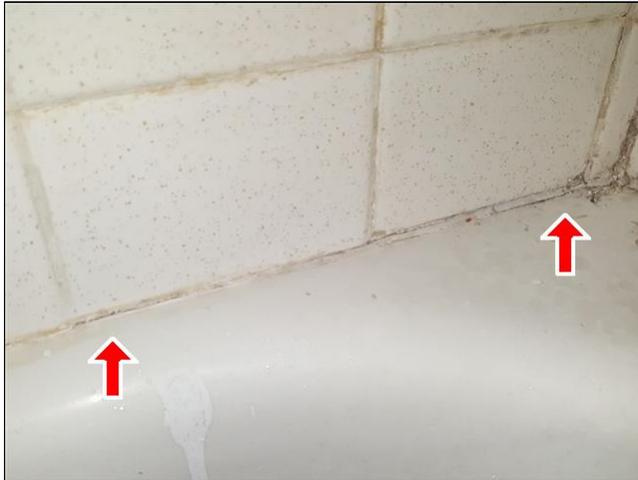
7.7 Item 1(Picture)

Old, shrinking, or dirty caulk with holes and cracks was seen in the master bathroom shower enclosure. All of the caulk should be kept in perfect condition to prevent further cracking or more holes appearing to reduce the possibility of water leaking underneath the shower enclosure and tiled wall. If not corrected mold and/or deterioration of the floor/wall framing can occur beneath the shower enclosure. Recommend re-caulking where needed to seal openings and deteriorated caulk. Use a quality silicone caulk that is expandable and moisture resistant. [Choosing the right caulk](#) Would recommend a qualified general contractor repair as needed.

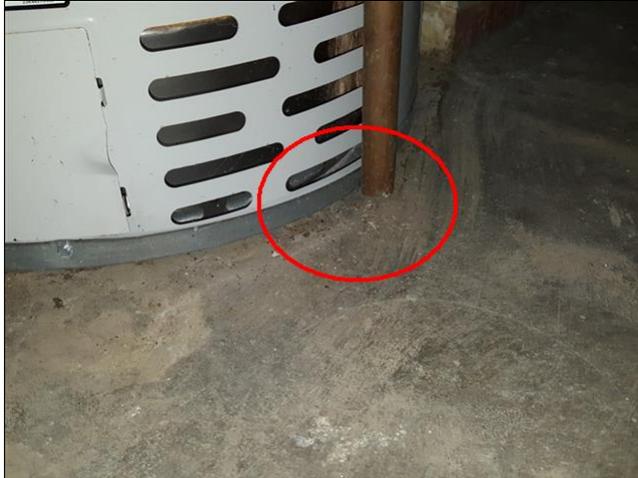
8.3 Item 4(Picture)

(4) The TPR (temperature pressure relief) drain line should be 6 inches from the ground. Recommend correcting drain line then install a bucket or tray to collect water so that water does not enter the basement floor and prevent rusting the base of the water heater.

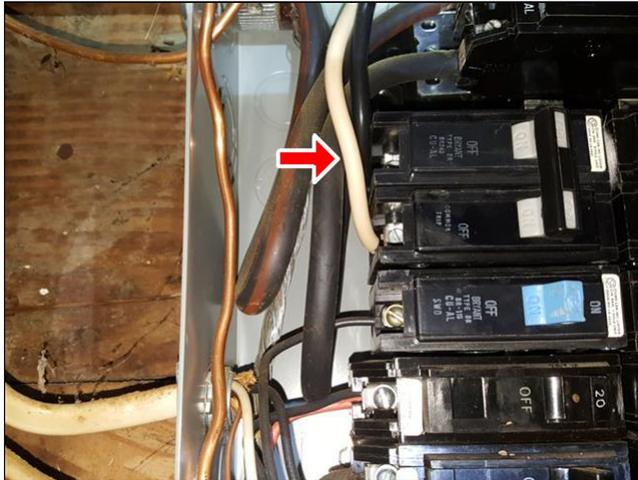
9.3 Item 13(Picture)

(7) The white wire(s) that are connected to the circuit breaker(s) should be marked black to indicate that they are live (hot wires) and are being used for the flow of electricity to travel. Recommend an electrician correct due to safety.
