DEPARTMENT OF REGULATORY
AND ECONOMIC RESOURCES

MINIMUM INSPECTION PROCEDURAL GUIDELINES
FOR BUILDING ELECTRICAL RECERTIFICATION

- a. Name on Title: Village at Dadeland Condominiums (H)
- b. Street Address: 7650 SW 82nd St. Miami, Florida 33143
- c. Legal Description: Village at Dadeland Condominiums
- d. Owner's Name: Village at Dadeland Condominiums
- e. Owner's Mailing Address: 7650 SW 82nd St. Miami, Florida 33143
- f. Folio Number of Property on which Building is Located: 30-4035-047-XXXX
- g. Building Code Occupancy Classification: R2 - Residential
- h. Present Use: Condominium, Residential
- i. General Description, Type of Construction, Size, Number of Stories, and Special Features

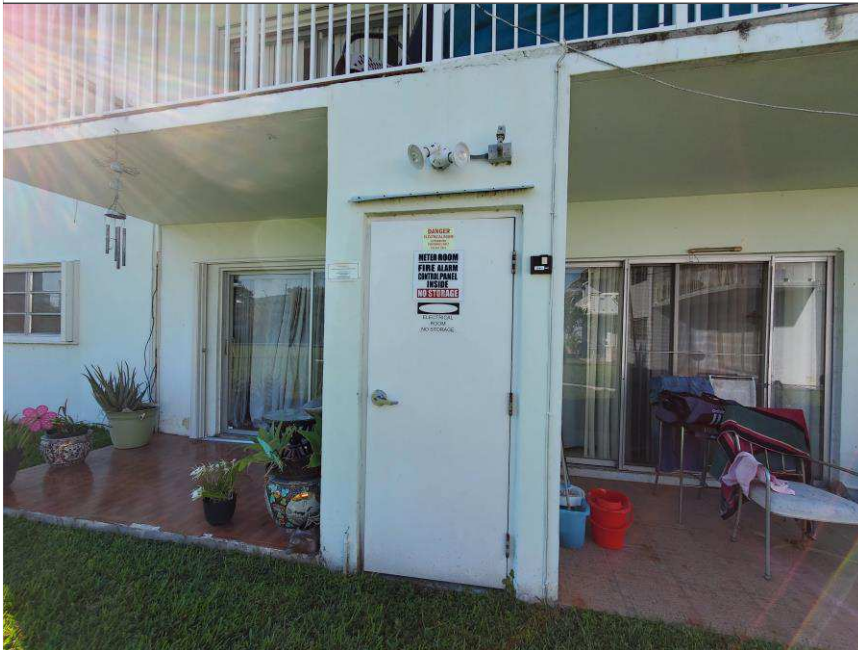
Photo 1 – Village of Dadeland Condominium Association

Existing Electrical Room - 1st FL
Provide sign with Building
Number.

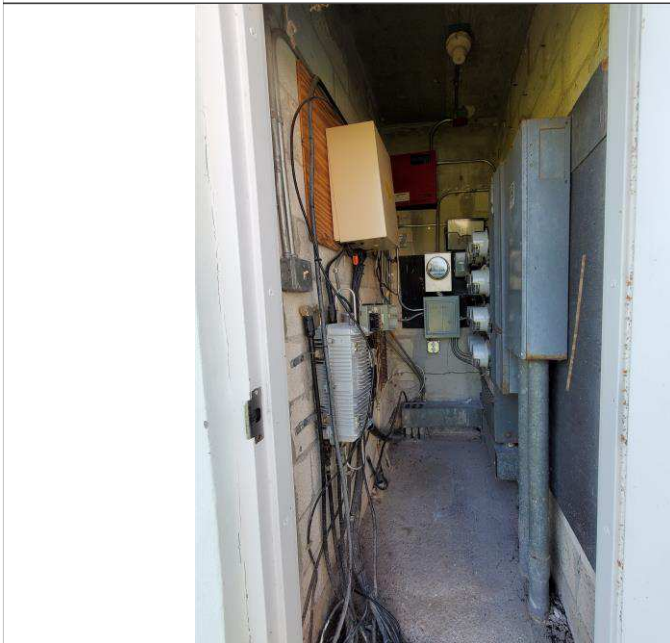
Photo 2 – Village of Dadeland Condominium Association

Existing Electrical Room - 1st FL
Main Switches for Apartments,
Meters, Gutter, and Fire Alarm
Panel

Insufficient clearance at
electrical components.

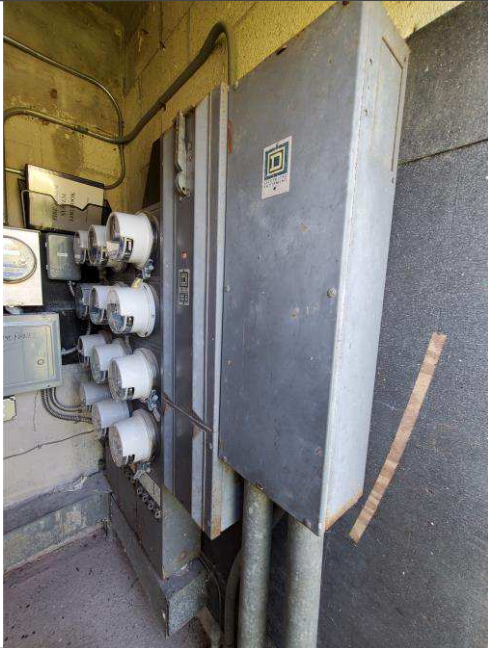
Photo 3 – Village of Dadeland Condominium Association

Existing Electrical Room - 1st FL
Building Main Disconnect is
oxidized.
50 year old electrical
component.

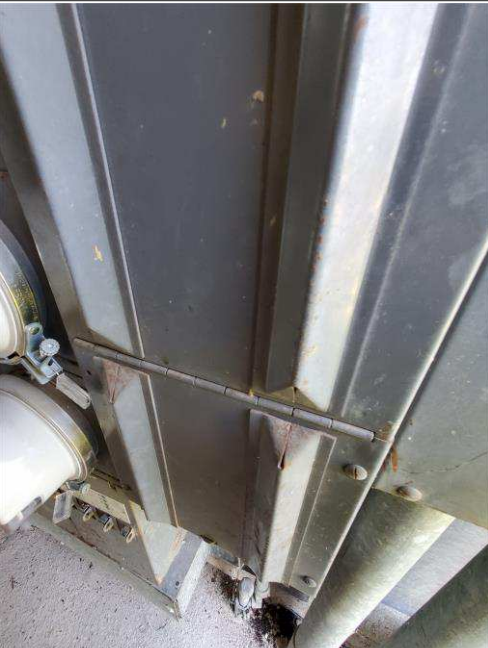
Photo 4 – Village of Dadeland Condominium Association

Existing Electrical Room - 1st FL
Building Main Disconnect is
oxidized.
50 year old electrical
component.

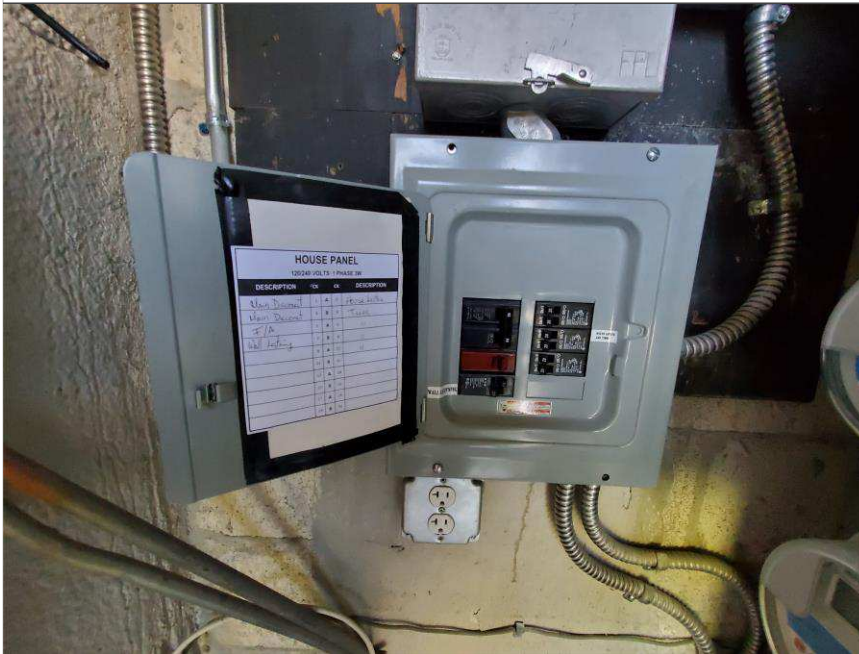
Photo 6 – Village of Dadeland Condominium Association

Existing Electrical Room - 1st FL
House Panel Board and
breakers.

Panel nameplate is covered.

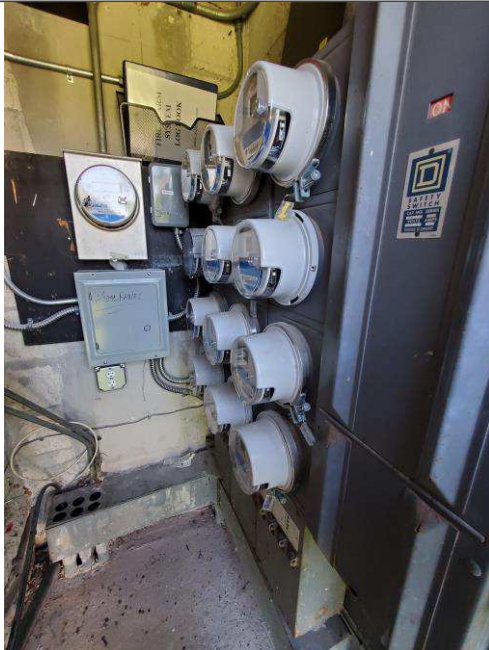
Photo 7 – Village of Dadeland Condominium Association

Existing Electrical Room - 1st FL
Main Switches for Apartments,
Meters, and Gutter.

Old and oxidized meter stacks.

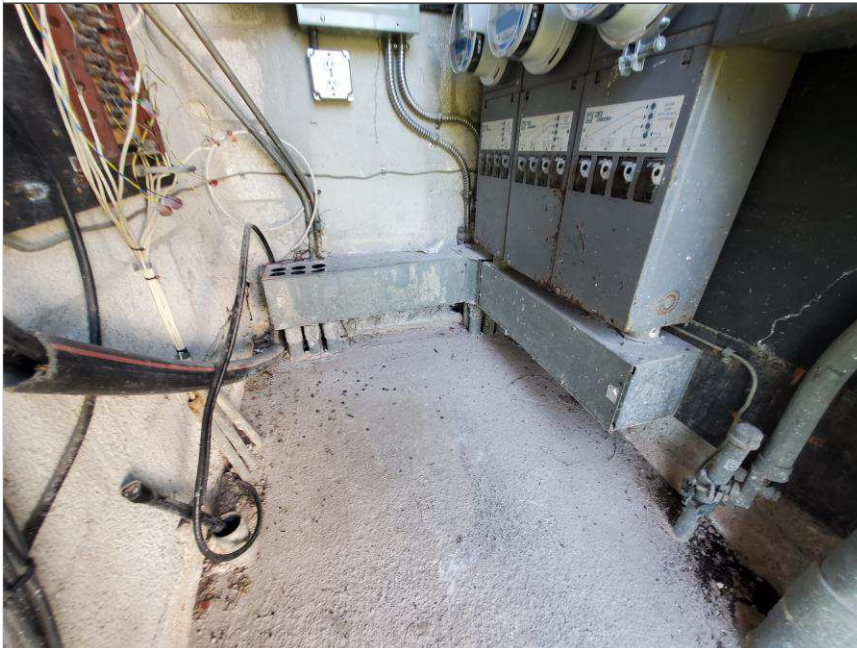
Photo 8 – Village of Dadeland Condominium Association

Existing Electrical Room - 1st FL
Main Switches for Apartments,
Meters, and Gutter.

Old and oxidized meter stacks.

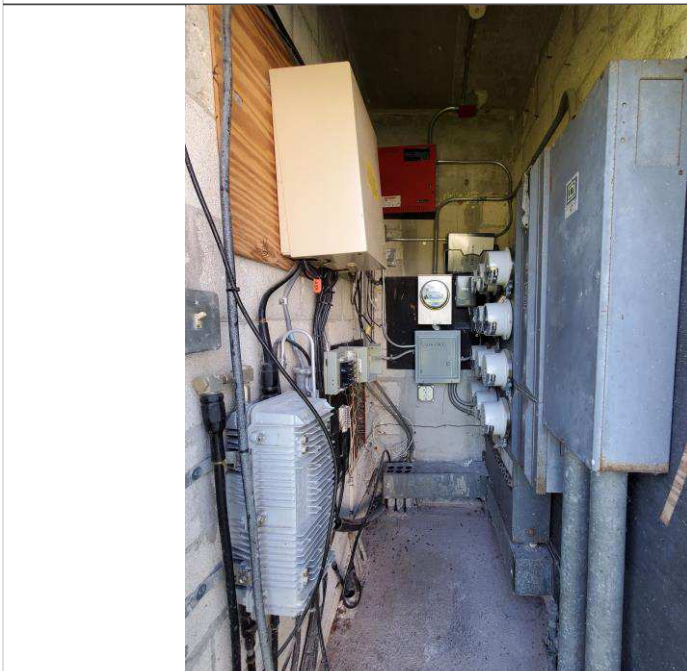
Photo 10 – Village of Dadeland Condominium Association

Existing Electric Room - 1st FL
Apartment and Main -
Distribution

Insufficient clearance at
electrical components.

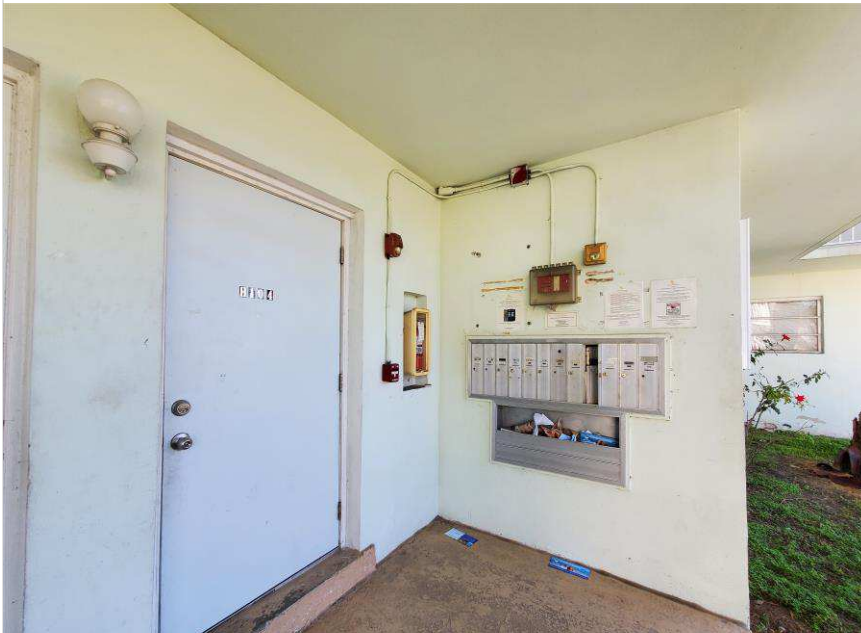
Photo 13 – Village of Dadeland Condominium Association

Level 1:
Fire Alarm - Old and Weathered
Fire Alarm Devices and Control
Center

Old Strobe Horn/Strobe Device

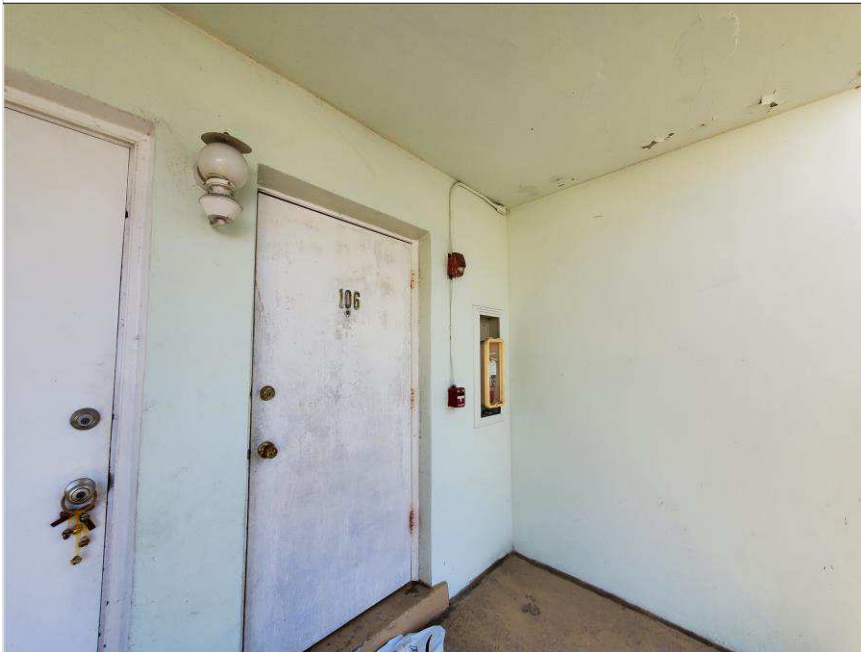
Photo 14 – Village of Dadeland Condominium Association

Level 1:
Fire Alarm - Old and Weathered
Fire Alarm Devices and Control
Center

Old Strobe Horn/Strobe Device
and Pull Stations

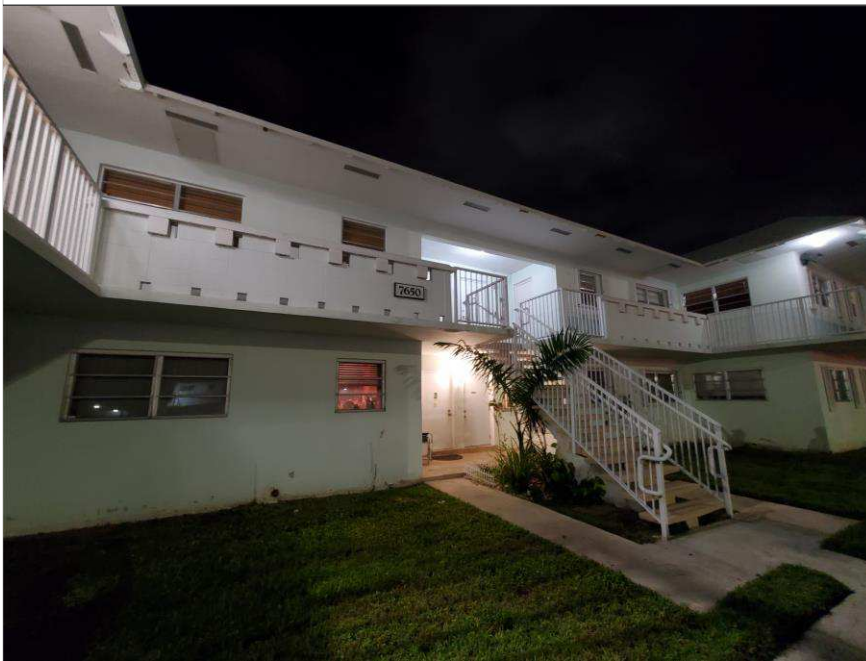
Photo 16 – Village of Dadeland Condominium Association

Parking/Catwalks - Poorly
illuminated Building Points of
Egress and Catwalks.
Exterior lights not functional.

Insufficient illumination at
stairs, catwalks, and sidewalks.

Insufficient illumination at
Parking Areas.

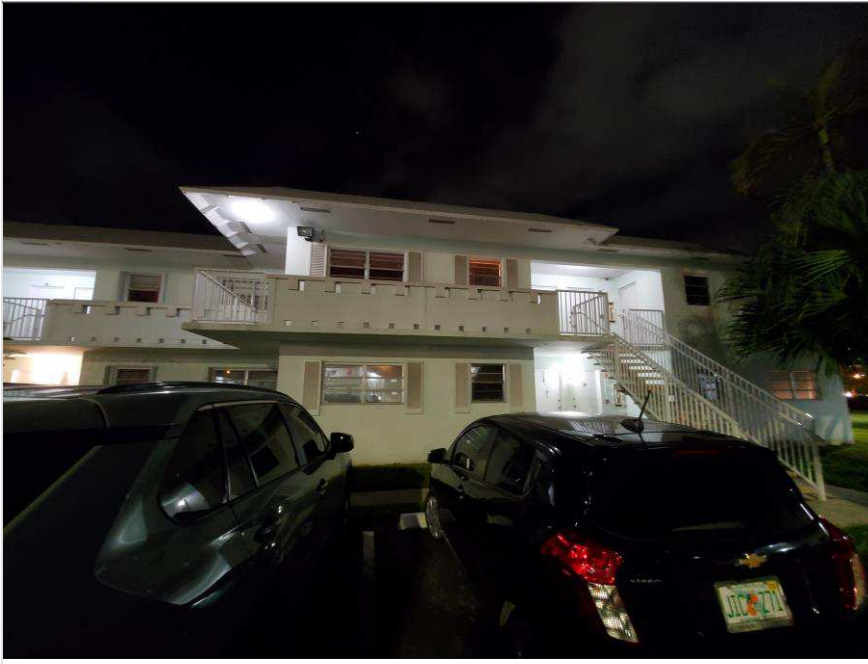
Photo 17 – Village of Dadeland Condominium Association

Points of Egress - Poorly illuminated areas.
Exterior lights not functional.

Insufficient illumination at sidewalks and points of egress.

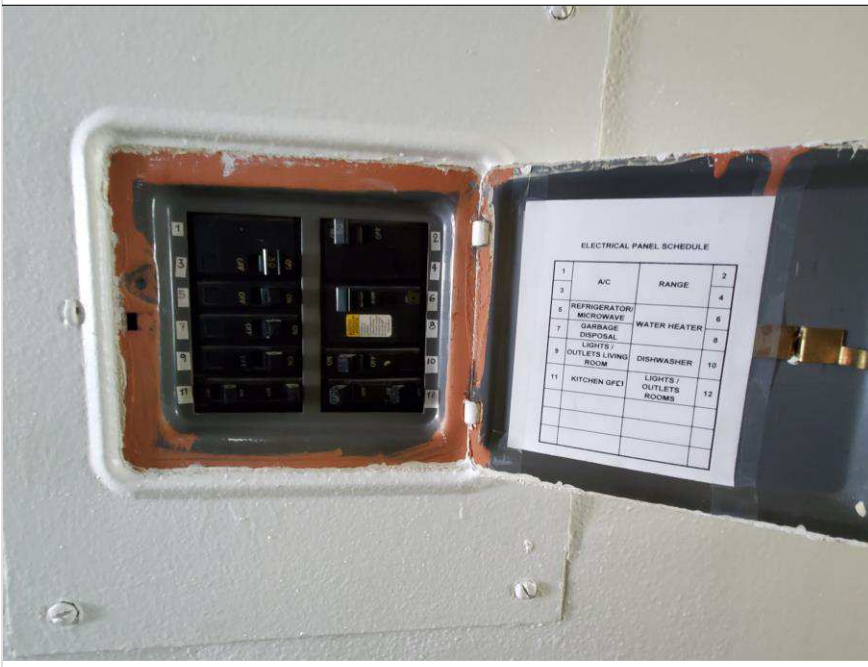
Photo 18 – Village of Dadeland Condominium Association

Apartments - Old Electrical Panels

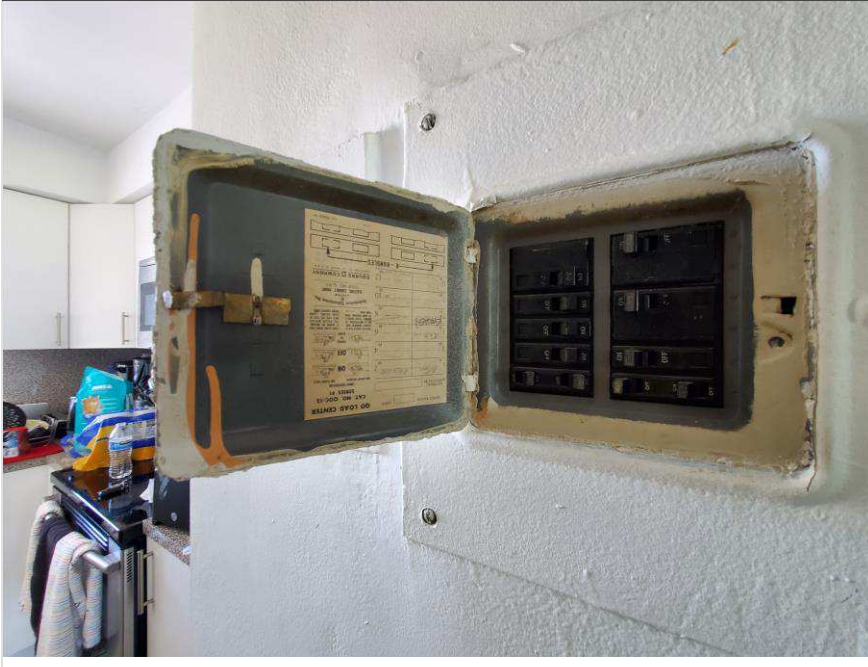
Photo 19 – Village of Dadeland Condominium Association

Apartments - Old Electrical
Panels

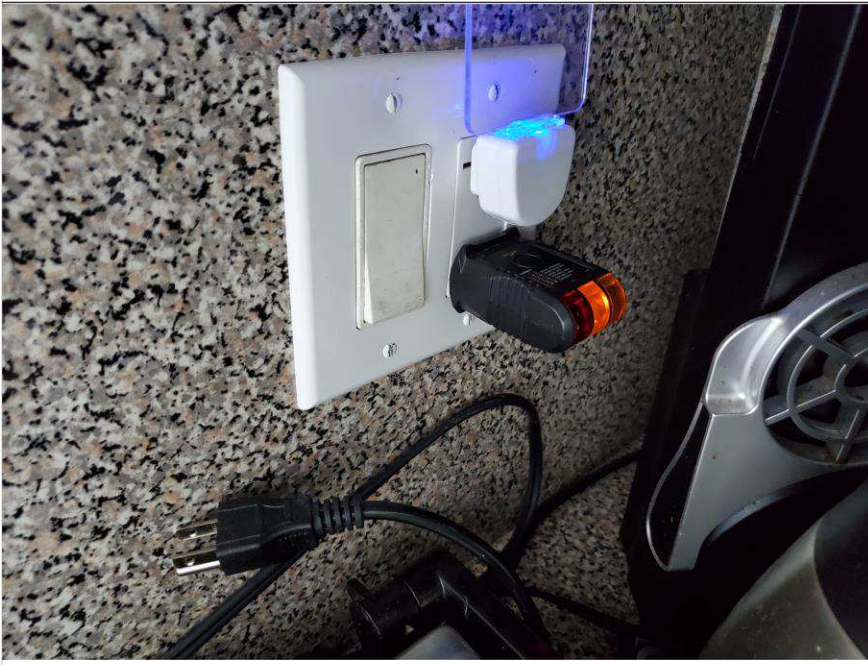
Photo 20 – Village of Dadeland Condominium Association

Apartments - Kitchen outlets
not GFCI type or GFCI that are
not working.

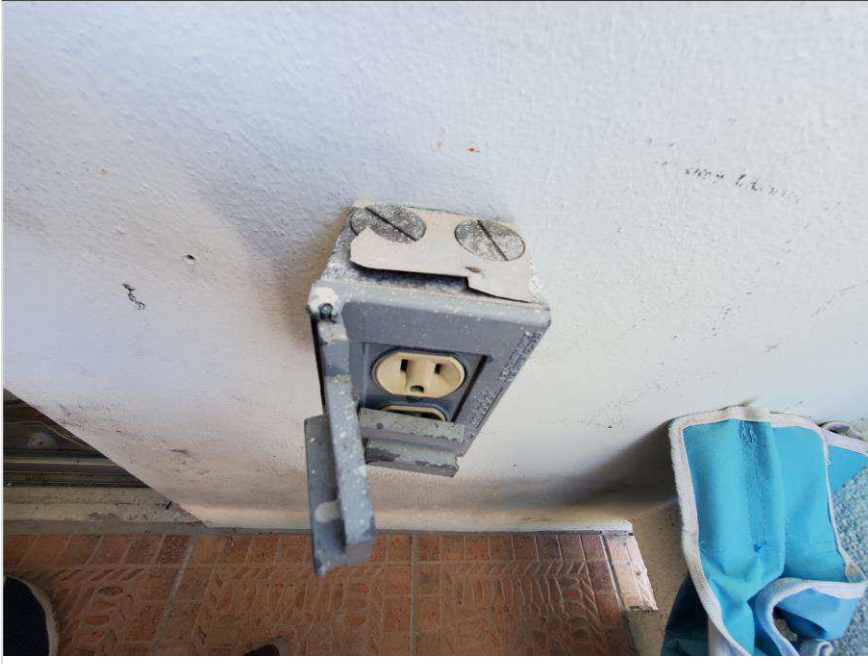
Photo 21 – Village of Dadeland Condominium Association

Apartments - Balcony/Patio outlets not GFCI type or GFCI that are not working.

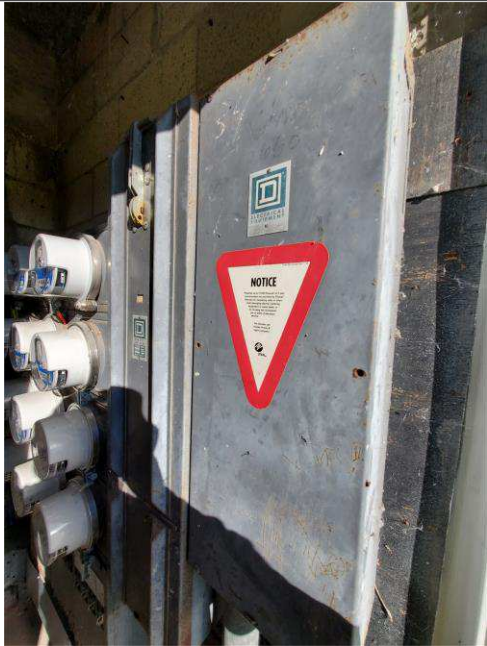
Photo 3 – Village of Dadeland Condominium Association

Existing Electrical Room - 1st FL
Main Disconnect and Meter
Stacks are oxidized.
50 year old electrical
components.

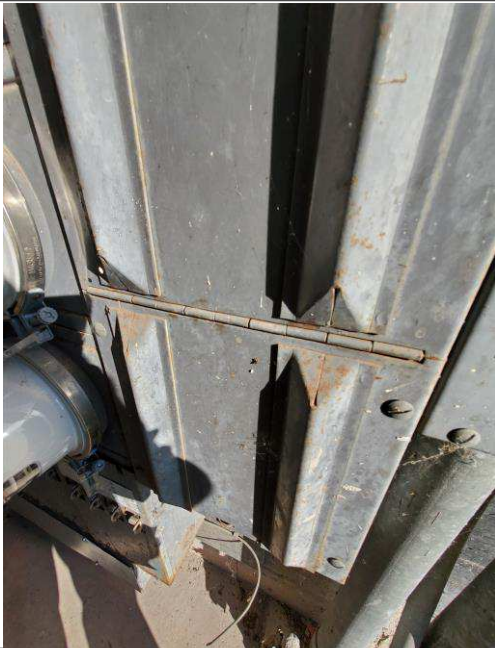
Photo 4 – Village of Dadeland Condominium Association

Existing Electrical Room - 1st FL
Building Main Disconnect is
oxidized.
50 year old electrical
component.

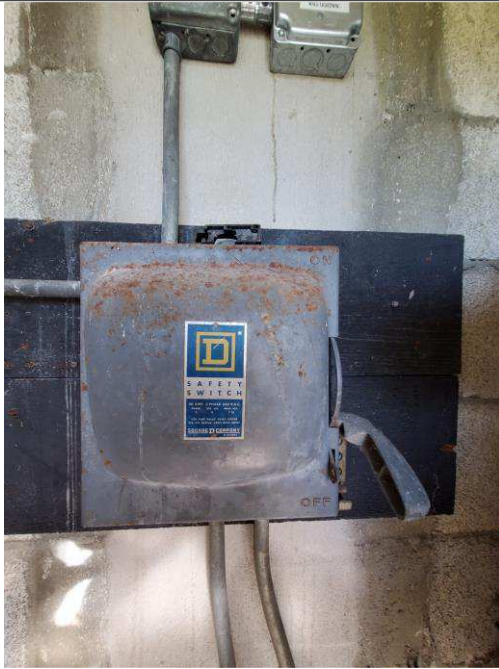
Photo 5 – Village of Dadeland Condominium Association

Existing Electrical Room - 1st FL
House Panel Disconnect Switch
is oxidized.
50 year old electrical
component.

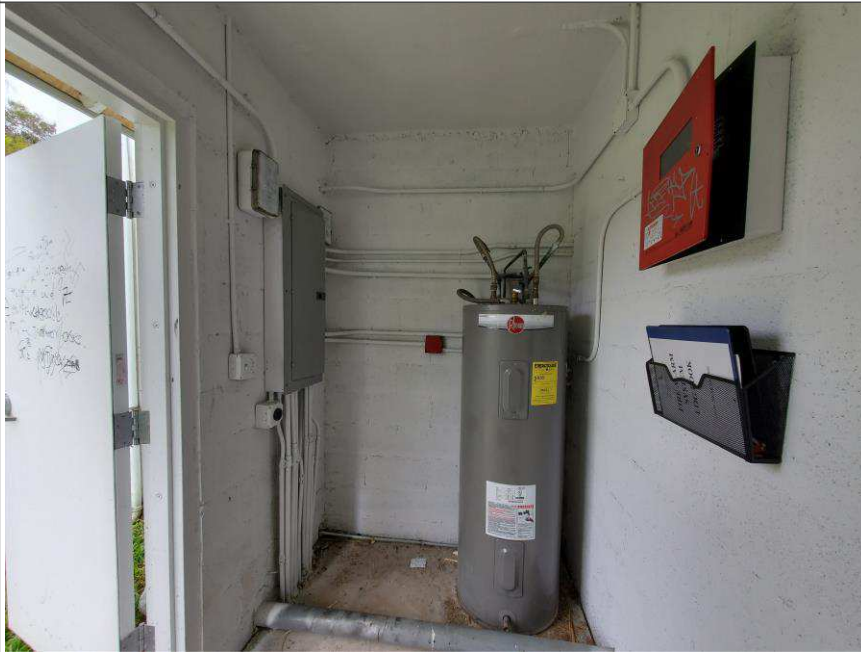
Photo 7 – Village of Dadeland Condominium Association

1st FL - Laundry/Water Heater Room
House Panel Board

House Panel Board installed in front of Water Heater.

There is insufficient clearance in front of panel.

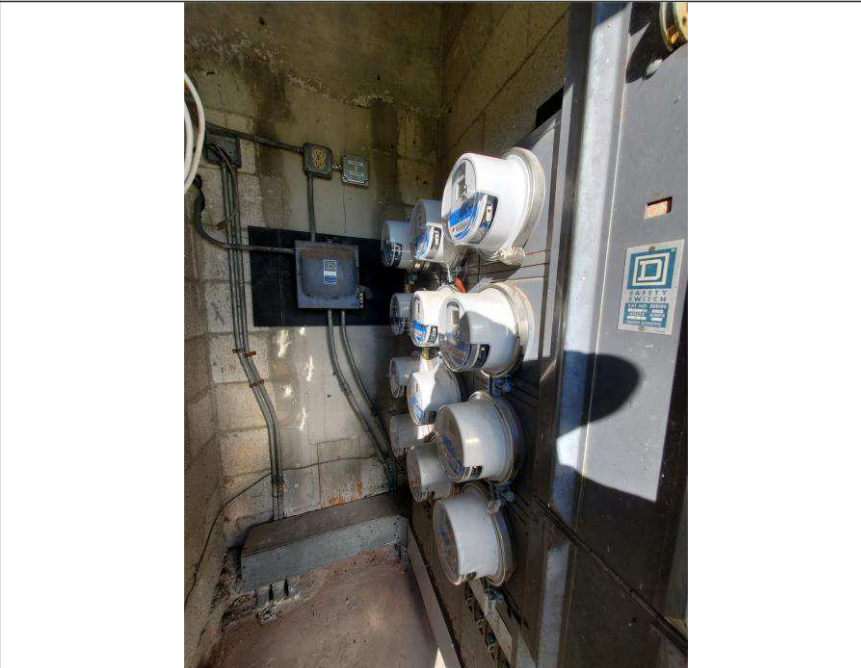
Photo 8 – Village of Dadeland Condominium Association

Existing Electrical Room - 1st FL
Main Switches for Apartments,
Meters, and Gutter.

Old and oxidized meter stacks.

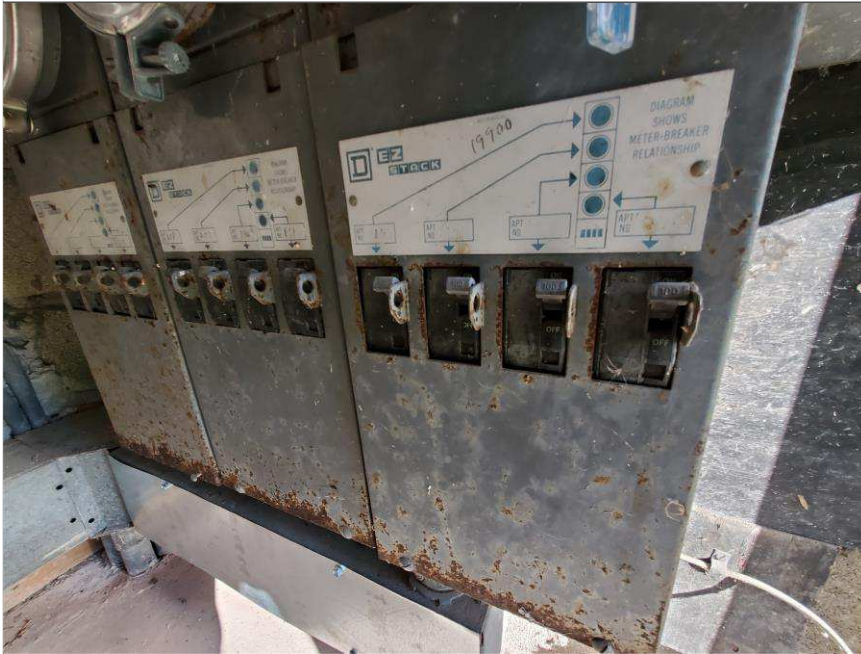
Photo 9 – Village of Dadeland Condominium Association

Existing Electrical Room - 1st FL
Main Switches for Apartments,
Meters, and Gutter.

Old and oxidized meter stacks
and breakers.

House Meter not labeled.
All meters to be clearly labeled.

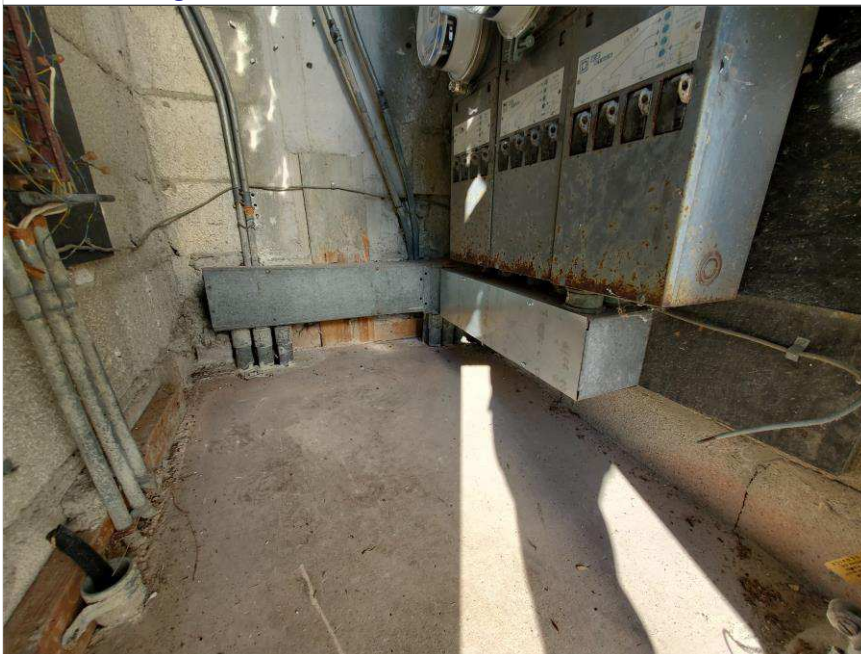
Photo 10 – Village of Dadeland Condominium Association

Existing Electrical Room - 1st FL
Main Switches for Apartments,
Meters, and Gutter.

Oxidized taps and conduits

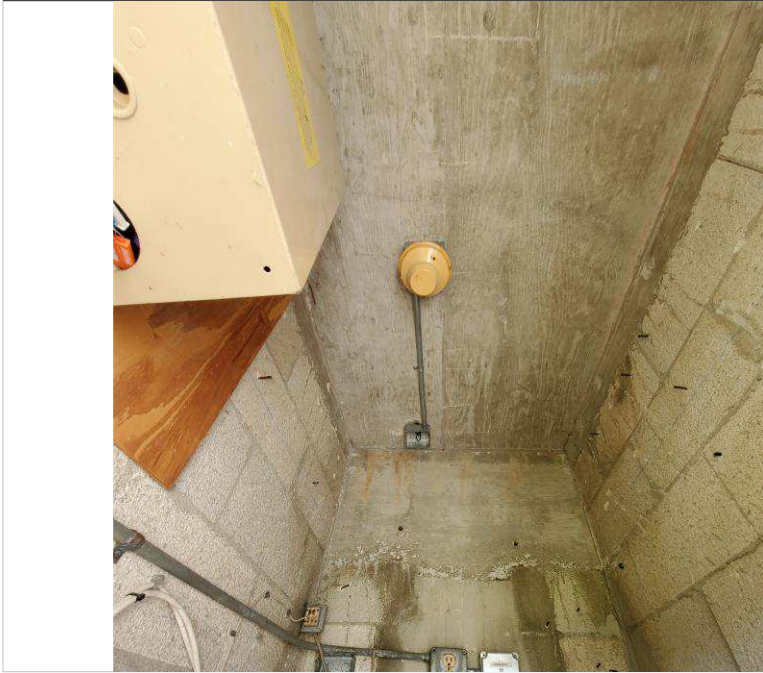
Photo 11 – Village of Dadeland Condominium Association

Existing Electrical Room - 1st FL

Old smoke detector.

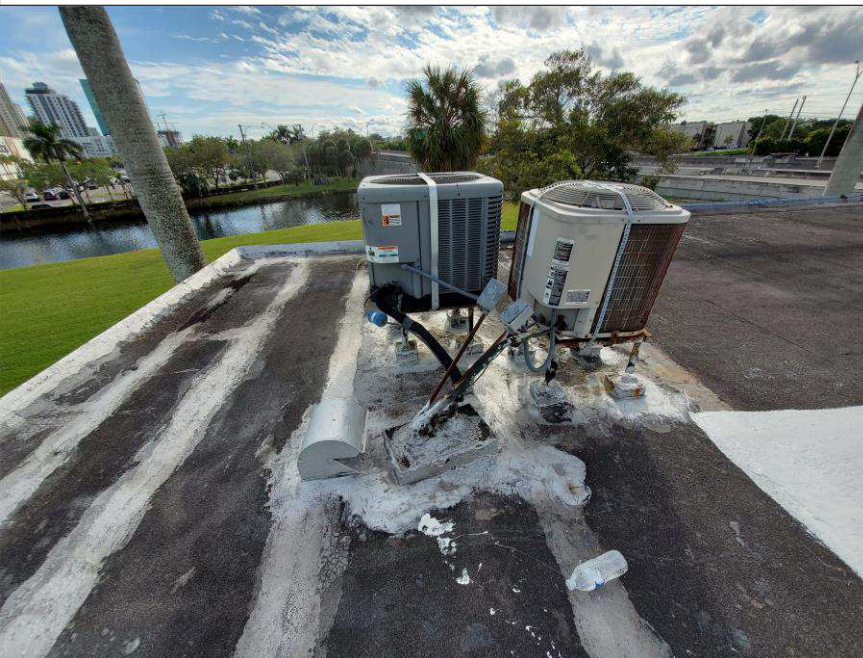
Photo 14 – Village of Dadeland Condominium Association

Rooftop Condenser Units -
Oxidized junction boxes and
conduits.

Junction boxes not properly
supported.

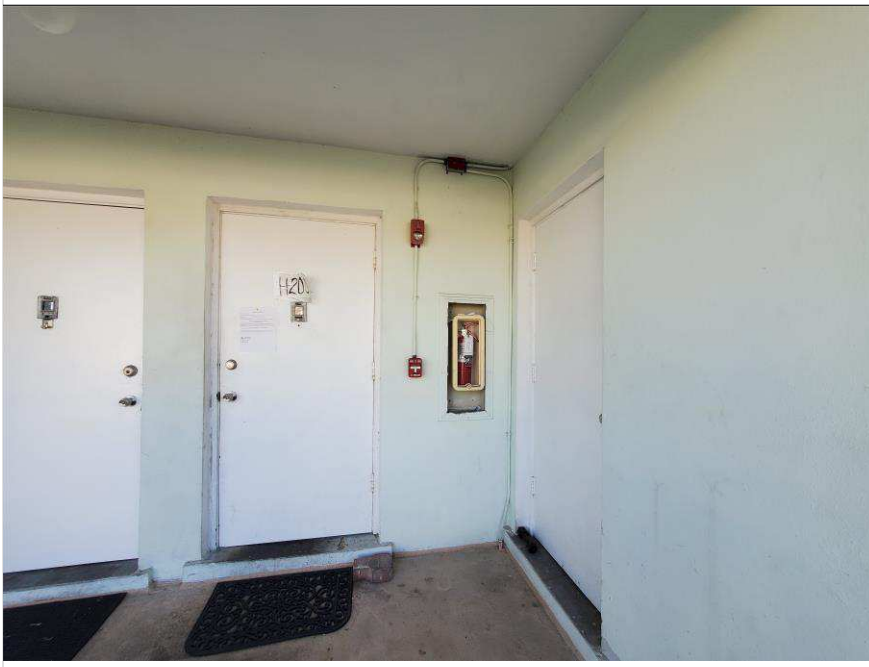
Photo 18 – Village of Dadeland Condominium Association

Level 2

Fire Alarm - Old and Weathered
Fire Alarm Devices and Control
Center

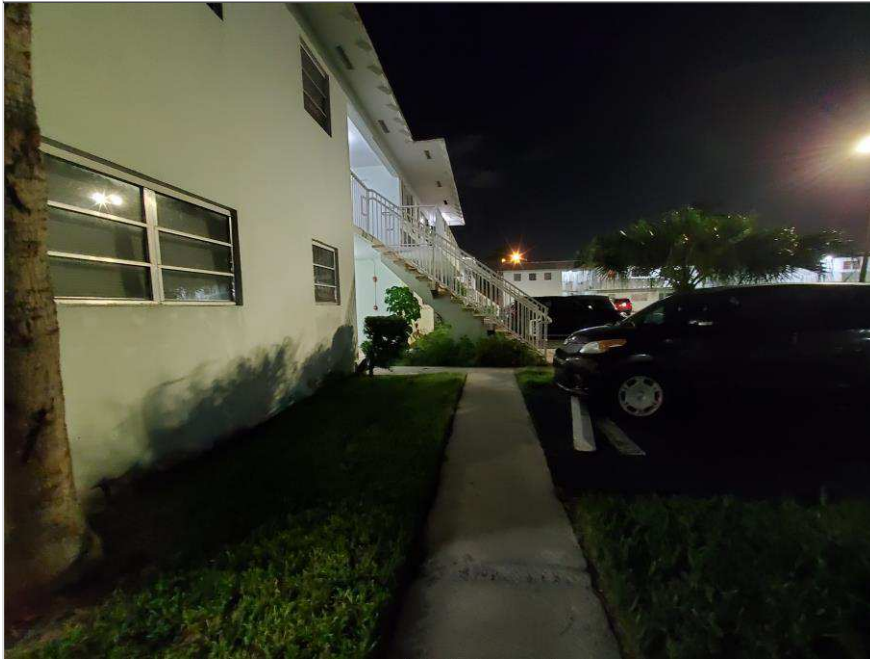
Photo 20 – Village of Dadeland Condominium Association

Egress Components
Poorly illuminated Catwalks and
Points of Egress.
Exterior lights not functional.

Insufficient illumination at stairs
sidewalk, and catwalks.

Parking
Insufficient illumination at
sidewalks and parking areas.

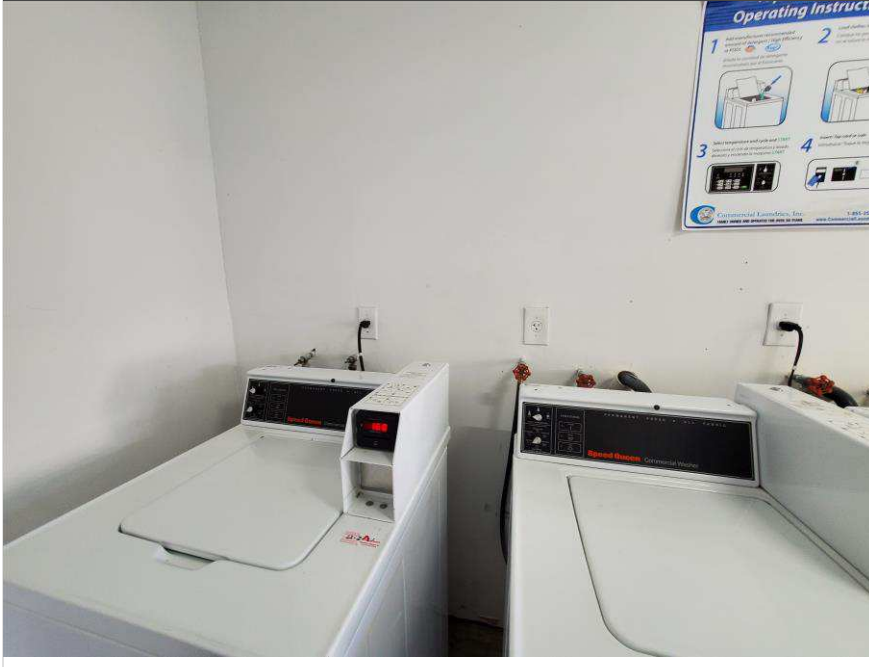
Photo 21 – Village of Dadeland Condominium Association

Laundry Room - Outlets are not GFCI type.

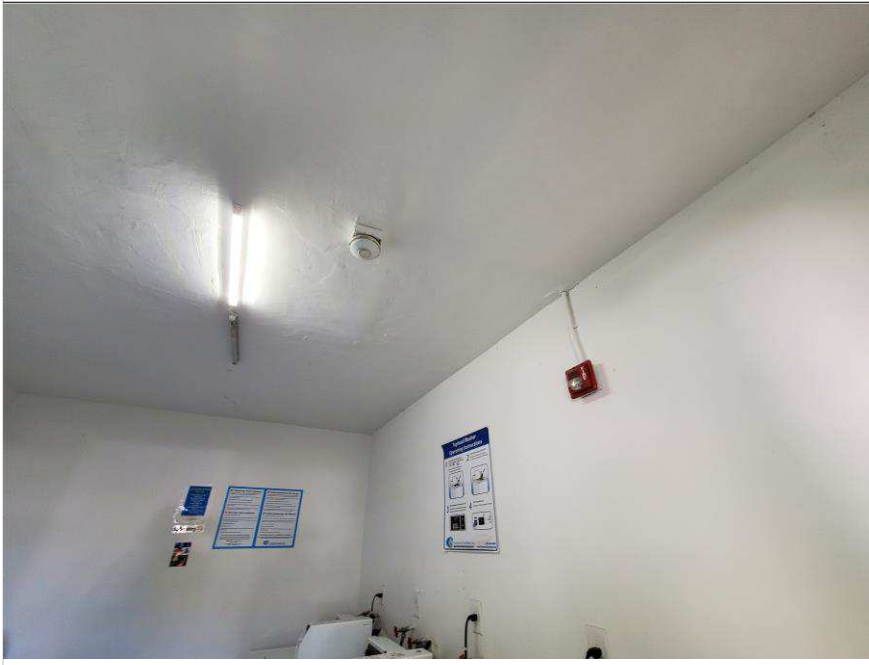
Photo 22 – Village of Dadeland Condominium Association

Laundry Room -
Old smoke detector.

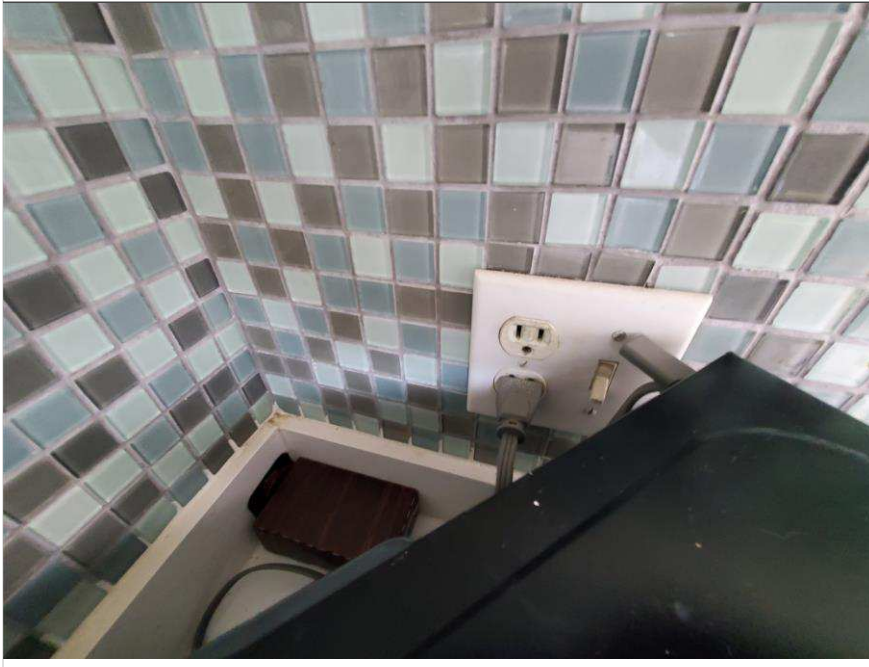
Photo 25 – Village of Dadeland Condominium Association

Apartments - Kitchen outlets
not GFCI type

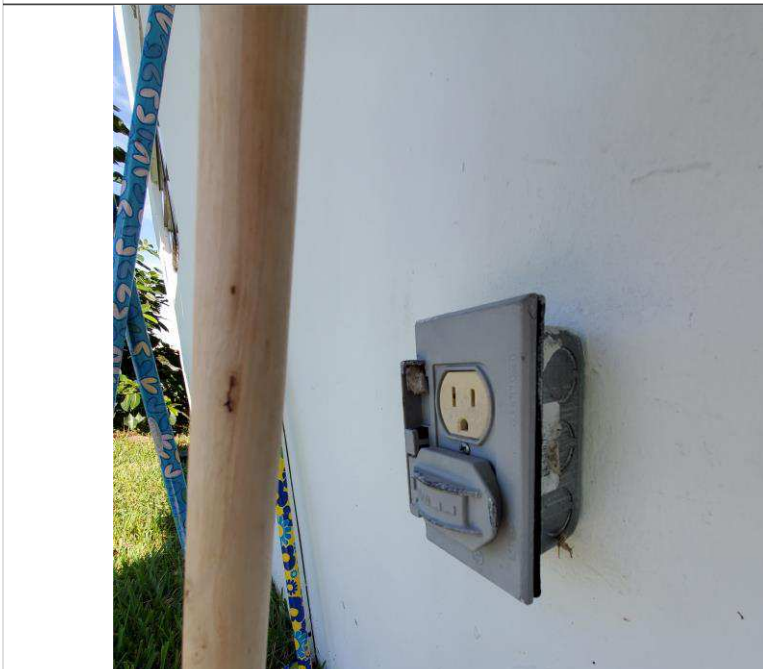
Photo 26 – Village of Dadeland Condominium Association

Apartments - Balcony/Patio
outlets not GFCI type and
electrical box not rated for the
environment.

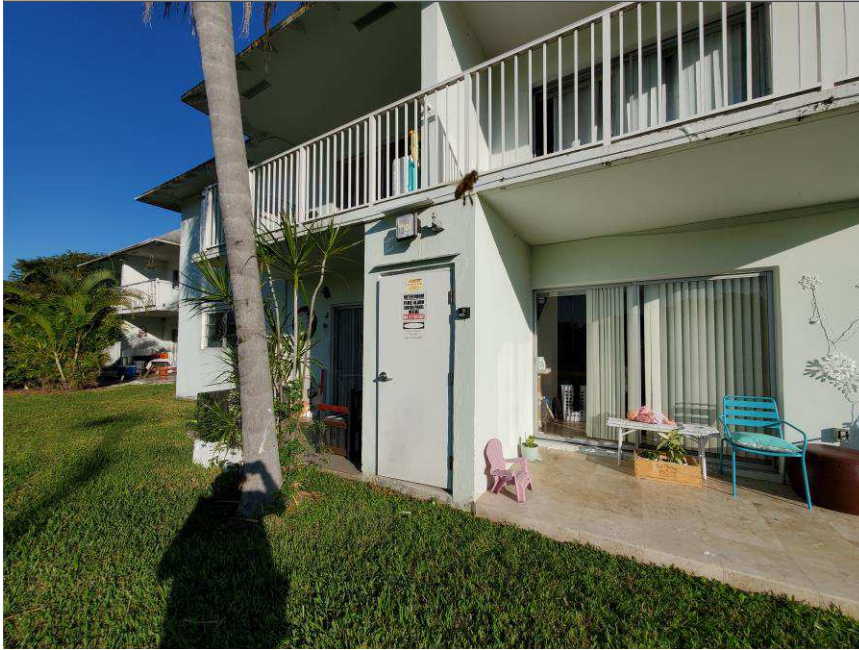
Photo 1 – Village of Dadeland Condominium Association

Existing Electrical Room - 1st FL
Provide sign with Building
Number

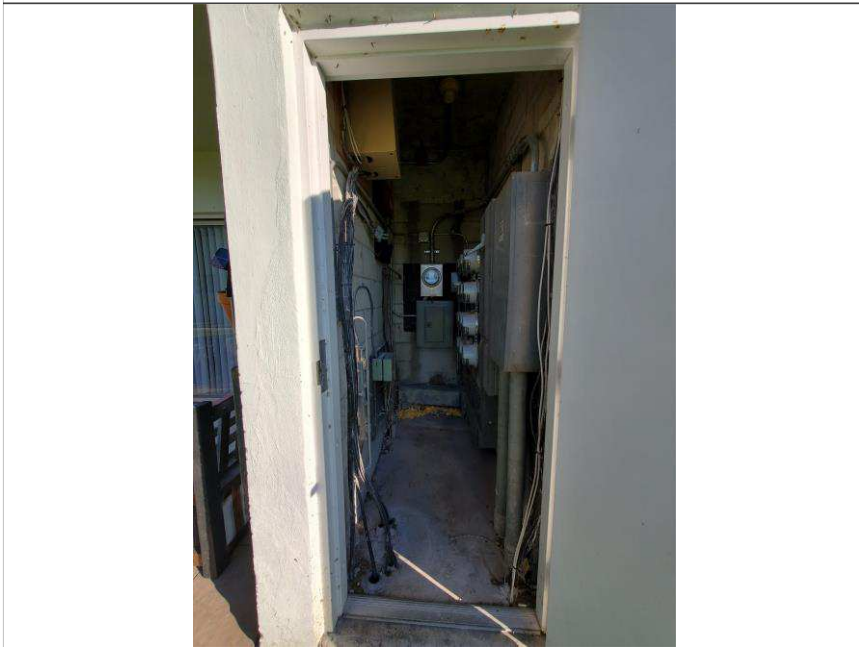
Photo 2 – Village of Dadeland Condominium Association

Existing Electrical Room - 1st FL
Main Switches for Apartments,
Meters, Gutter, and Fire Alarm
Panel

Insufficient clearance at
electrical components.

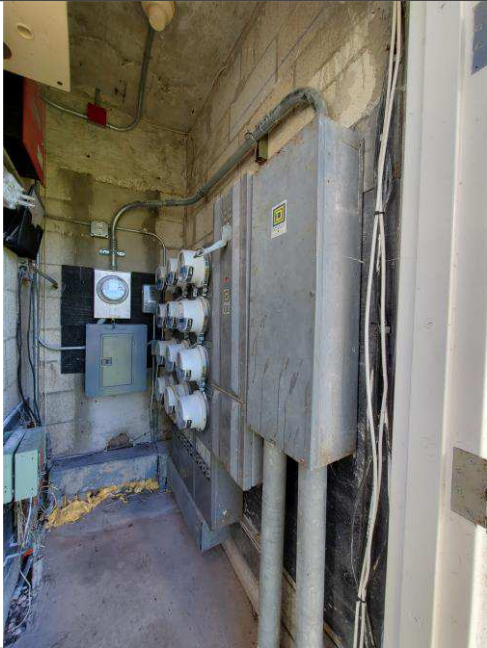
Photo 3 – Village of Dadeland Condominium Association

Existing Electrical Room - 1st FL
Building Main Disconnect is
oxidized.
50 year old electrical
component.

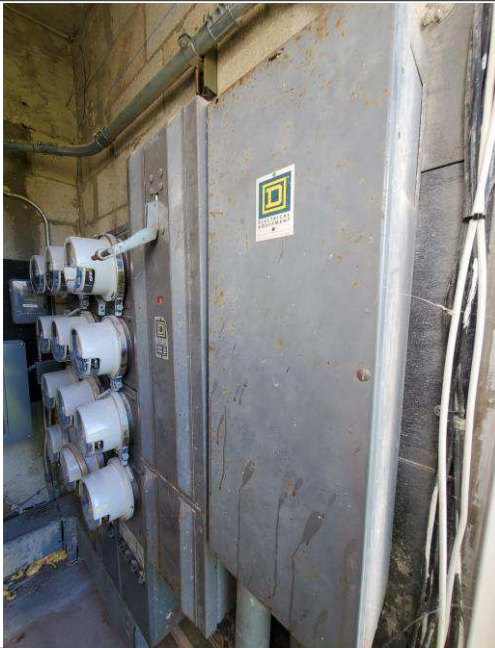
Photo 4 – Village of Dadeland Condominium Association

Existing Electrical Room - 1st FL
Building Main Disconnect is
oxidized.
50 year old electrical
component.

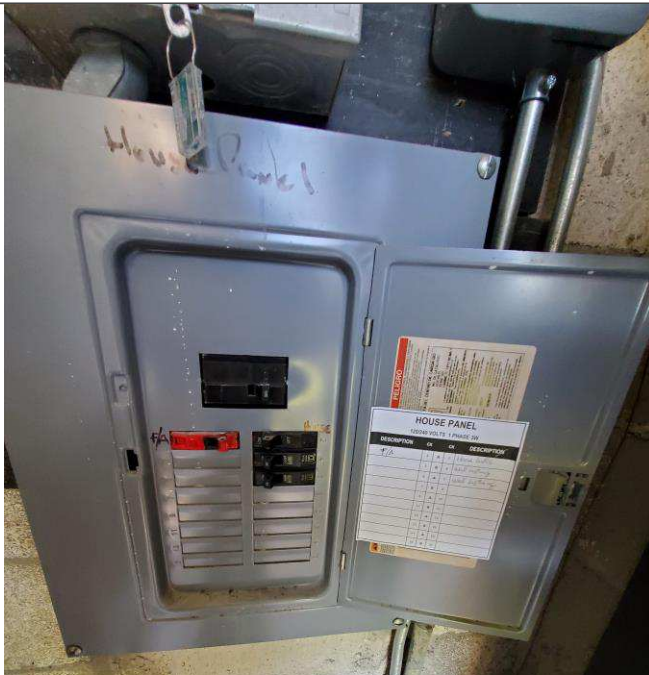
Photo 6 – Village of Dadeland Condominium Association

Existing Electrical Room - 1st FL
House Panel Board and
breakers

Panel nameplate is covered.

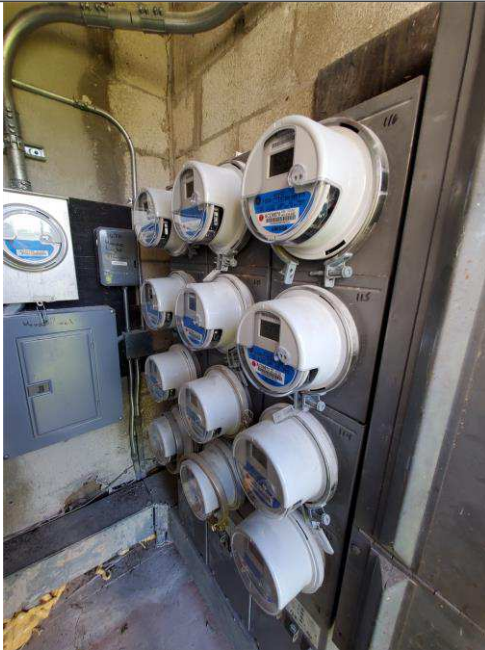
Photo 7 – Village of Dadeland Condominium Association

Existing Electrical Room - 1st FL
Main Switches for Apartments,
Meters, and Gutter.

Old and oxidized meter stacks.

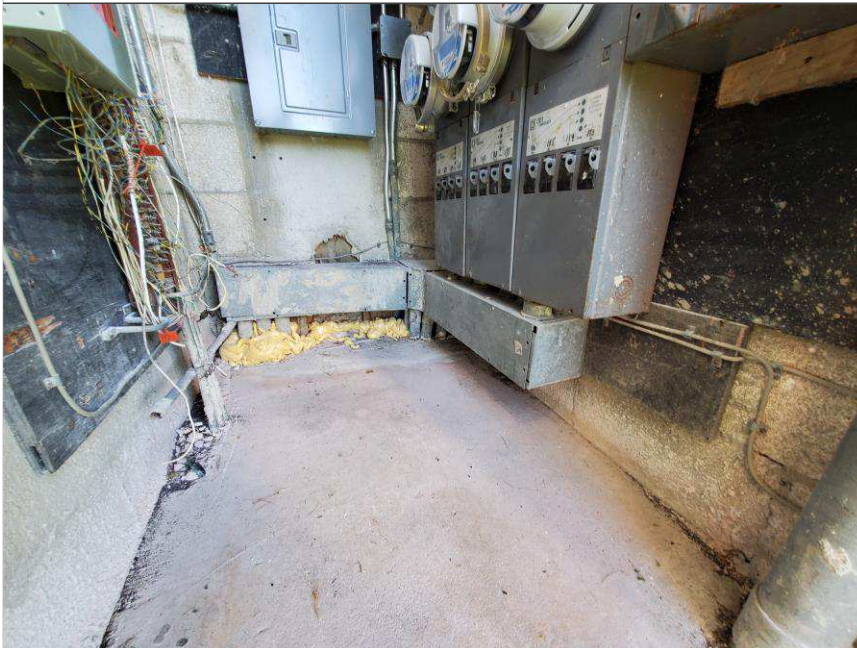
Photo 8 – Village of Dadeland Condominium Association

Existing Electrical Room - 1st FL
Main Switches for Apartments,
Meters, and Gutter.

Old and oxidized meter stacks.

Oxidized Main Gutter.

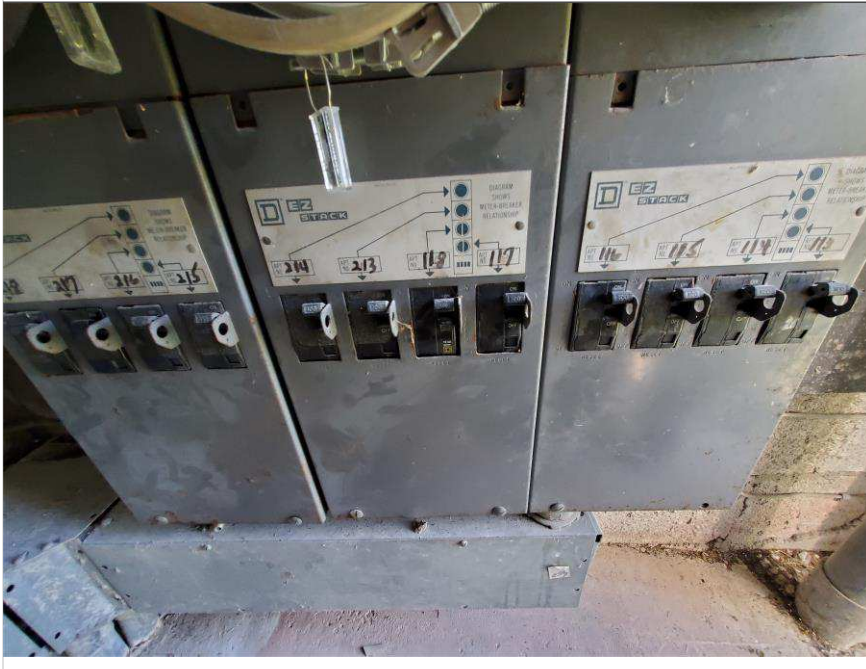
Photo 9 – Village of Dadeland Condominium Association

Existing Electrical Room - 1st FL
Main Switches for Apartments,
Meters, and Gutter.

Old and oxidized meter stacks.

Old Breakers

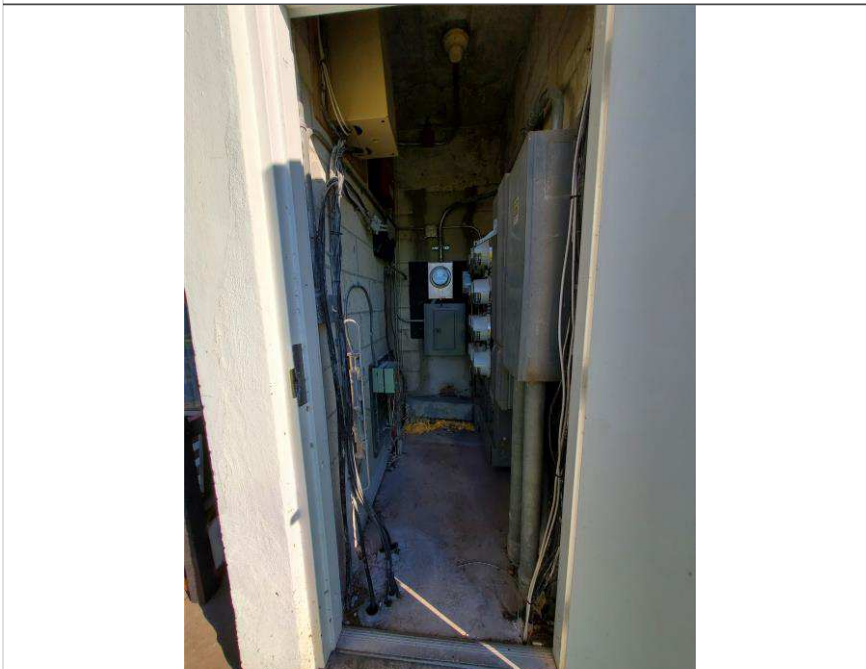
Photo 10 – Village of Dadeland Condominium Association

Existing Electric Room - 1st FL

Insufficient clearance at
electrical components.

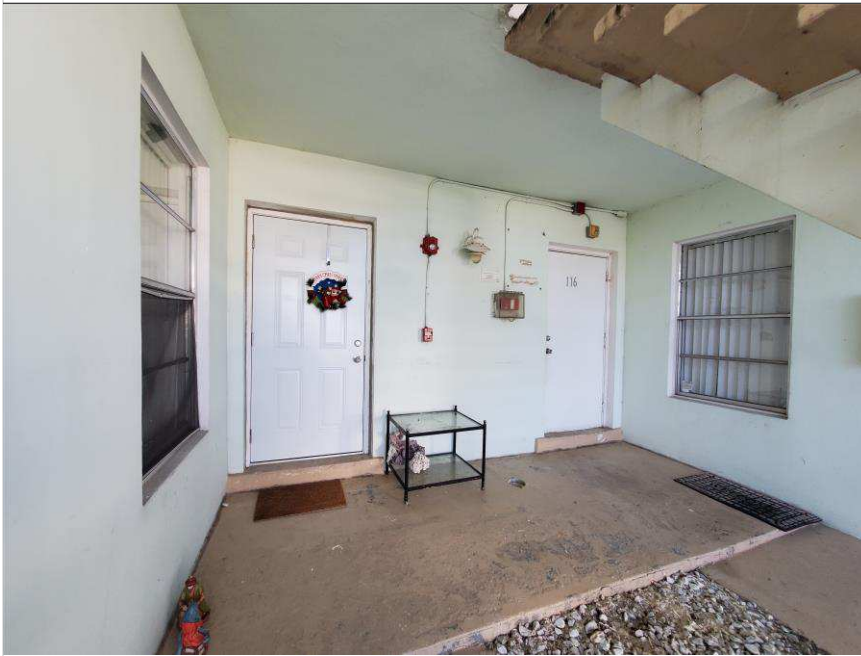
Photo 14 – Village of Dadeland Condominium Association

Level 1
Fire Alarm - Old and Weathered
Fire Alarm Devices and Control
Center

Old Strobe Horn/Strobe Device

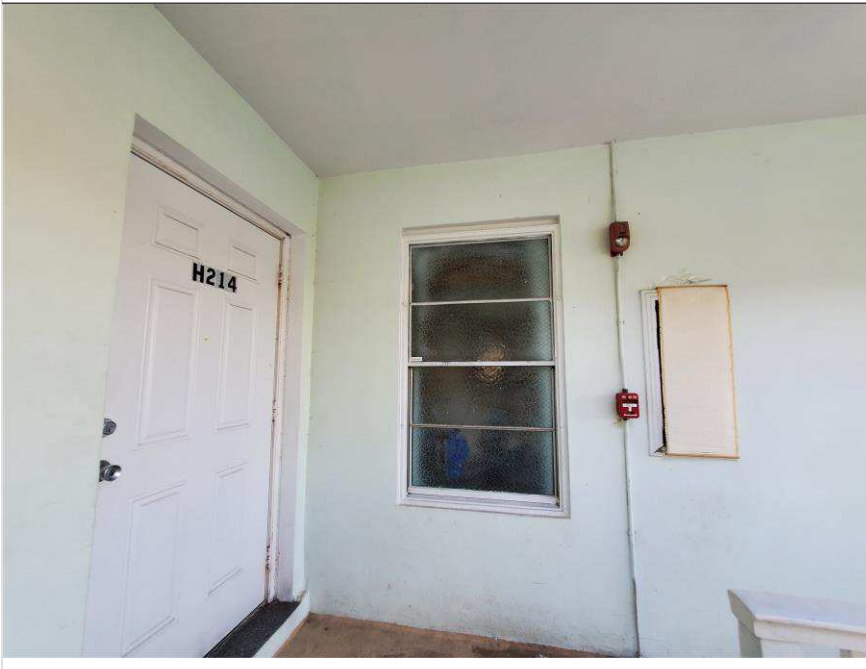
Photo 16 – Village of Dadeland Condominium Association

Level 2

Fire Alarm - Old and Weathered
Fire Alarm Devices and Control
Center

Old Strobe Horn/Strobe Device
and Pull Stations
