DEPARTMENT OF REGULATORY
AND ECONOMIC RESOURCES

MINIMUM INSPECTION PROCEDURAL GUIDELINES
FOR BUILDING ELECTRICAL RECERTIFICATION

- a. Name on Title: Village at Dadeland Condominiums (H)
- b. Street Address: 7650 SW 82nd St. Miami, Florida 33143
- c. Legal Description: Village at Dadeland Condominiums
- d. Owner's Name: Village at Dadeland Condominiums
- e. Owner's Mailing Address: 7650 SW 82nd St. Miami, Florida 33143
- f. Folio Number of Property on which Building is Located: 30-4035-047-XXXX
- g. Building Code Occupancy Classification: R2 - Residential
- h. Present Use: Condominium, Residential
- i. General Description, Type of Construction, Size, Number of Stories, and Special Features

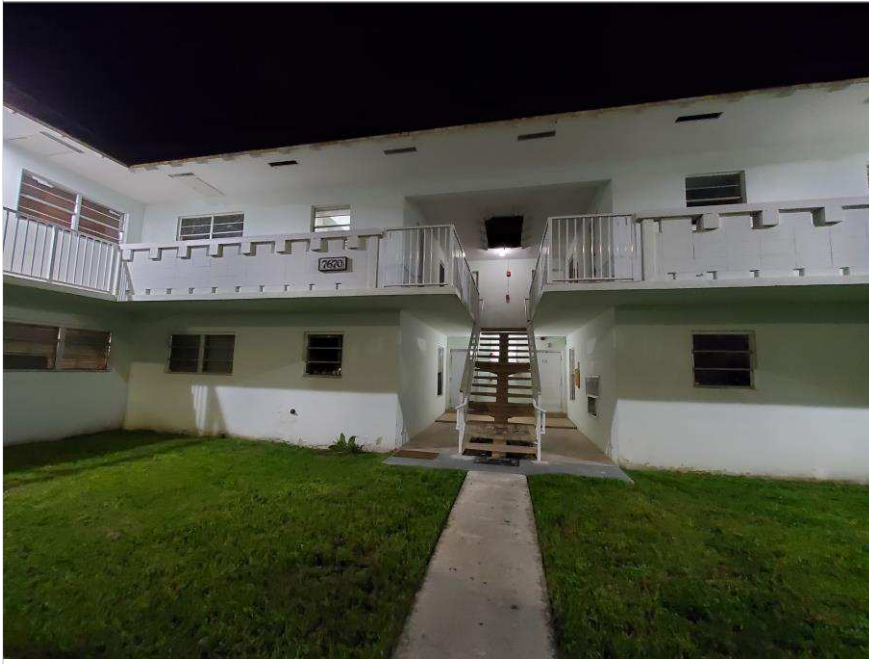
Photo 17 – Village of Dadeland Condominium Association

Points of Egress -
Insufficient illumination at
Building Points of Egress,
catwalks, and sidewalks.
Exterior lights not functional

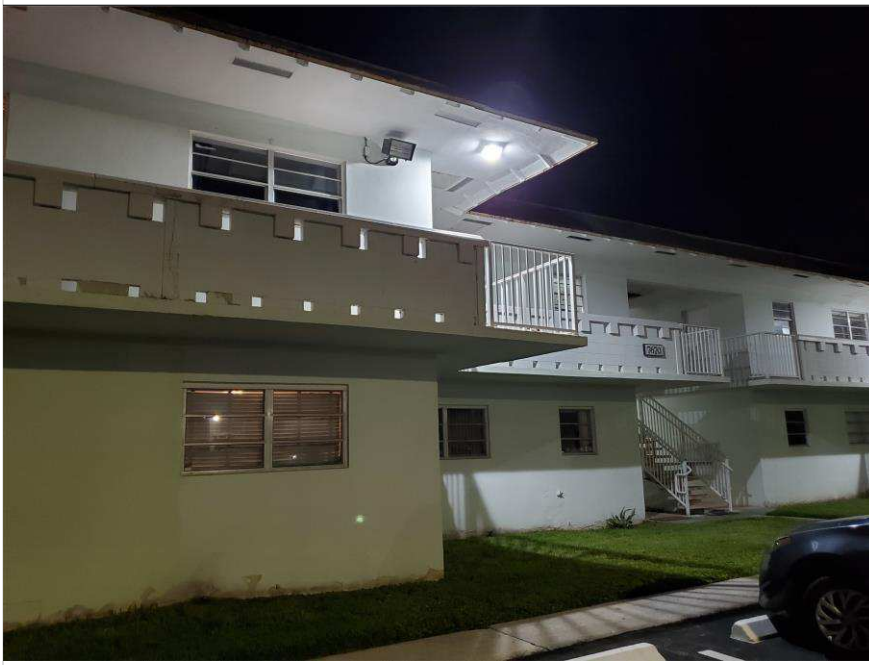
Photo 18 – Village of Dadeland Condominium Association

Points of Egress
Insufficient illumination at
Building Points of Egress,
catwalks, and sidewalks.
Exterior light not functional

Parking
Insufficient illumination

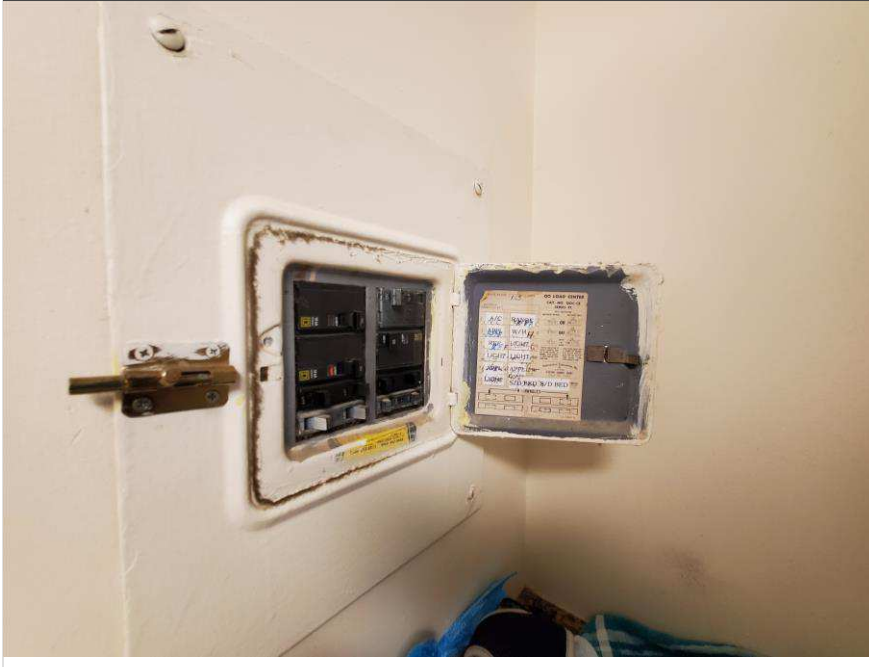
Photo 19 – Village of Dadeland Condominium Association

Apartments - Old Electrical
Panels

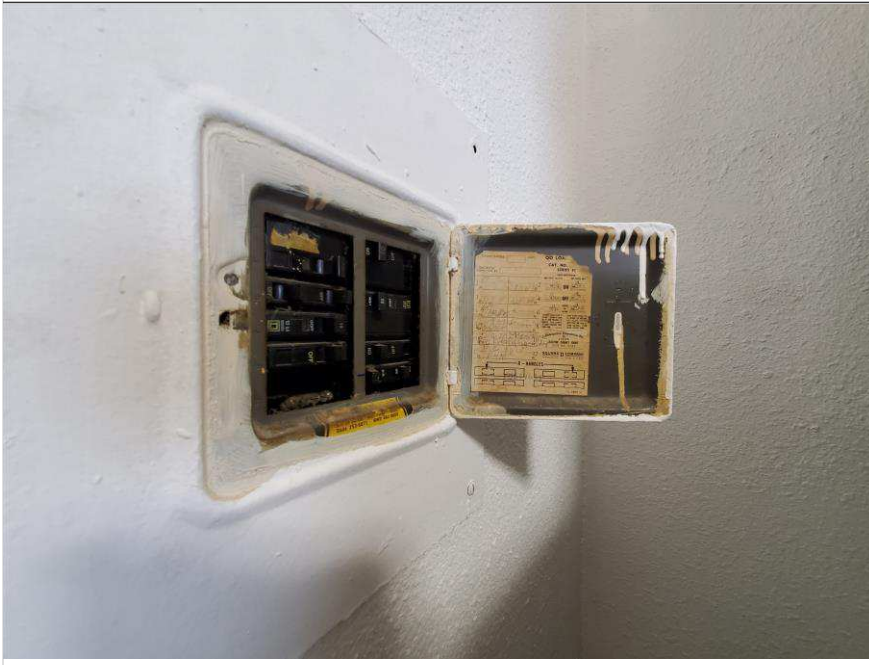
Photo 20 – Village of Dadeland Condominium Association

Apartments - Old Electrical
Panels

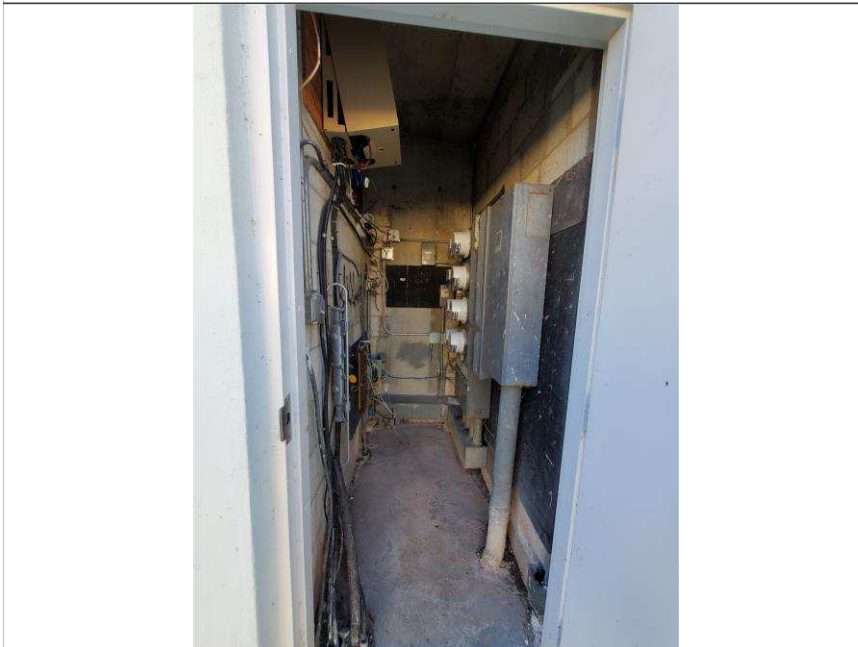
Photo 2 – Village of Dadeland Condominium Association

Existing Electrical Room – 1st FL
Main Switches for Apartments,
Meters, and Gutter.

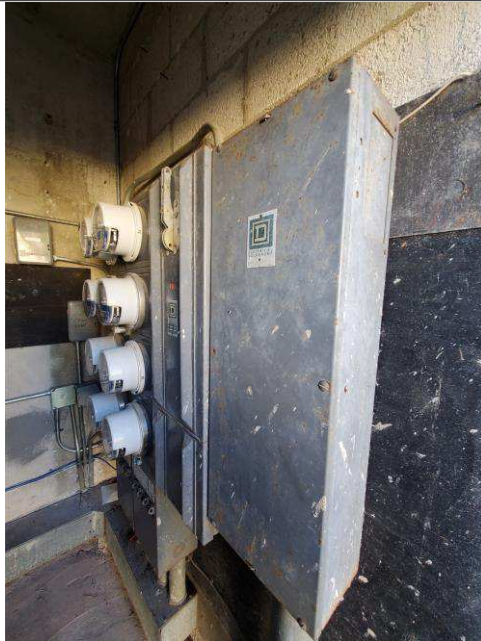
Photo 3 – Village of Dadeland Condominium Association

Existing Electrical Room – 1st FL
Main Disconnect and Meter
Stacks

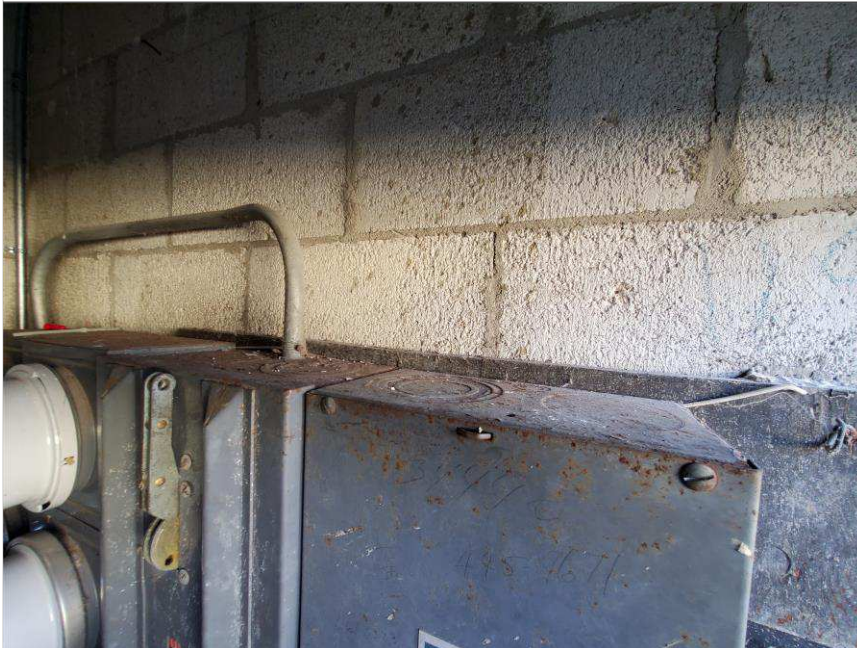
Photo 4 – Village of Dadeland Condominium Association

Existing Electrical Room – 1st FL
Main Disconnect

Oxidized tops and taps of
Electrical Components.

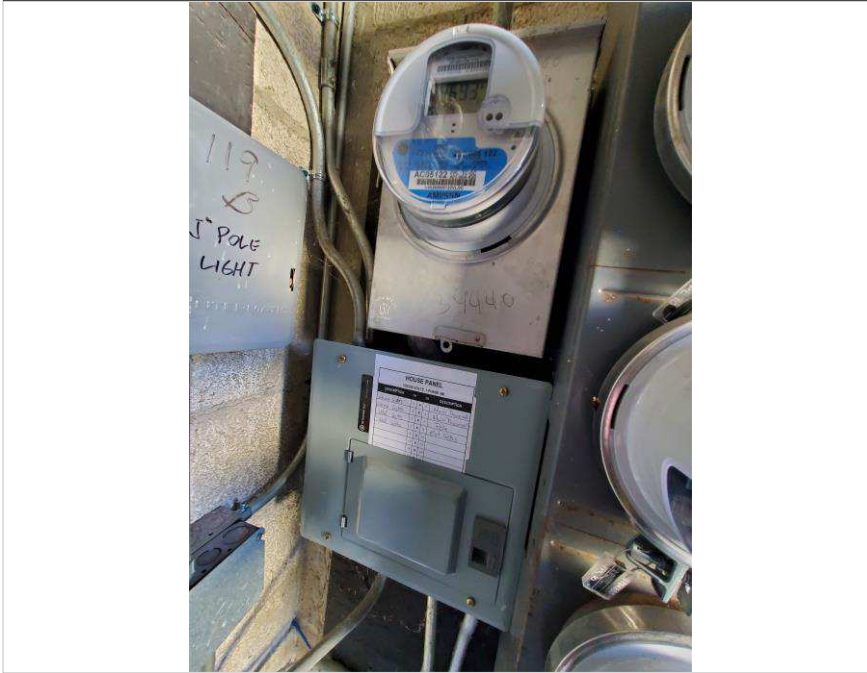
Photo 5 – Village of Dadeland Condominium Association

Existing Electrical Room – 1st FL
House Panel and Meter

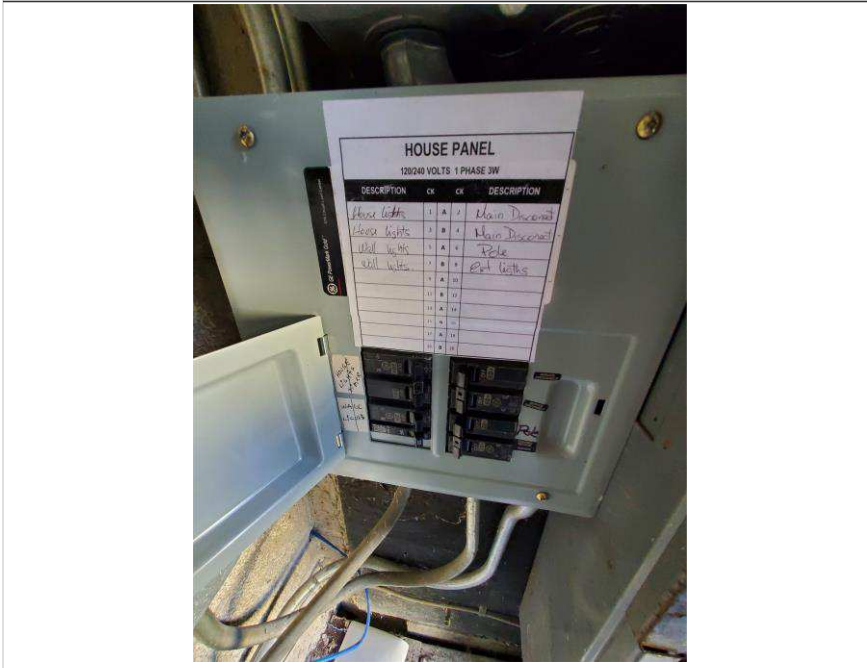
Photo 6 – Village of Dadeland Condominium Association

Existing Electrical Room – 1st FL
House Panel Board and breakers

Name plate on panel is covered.

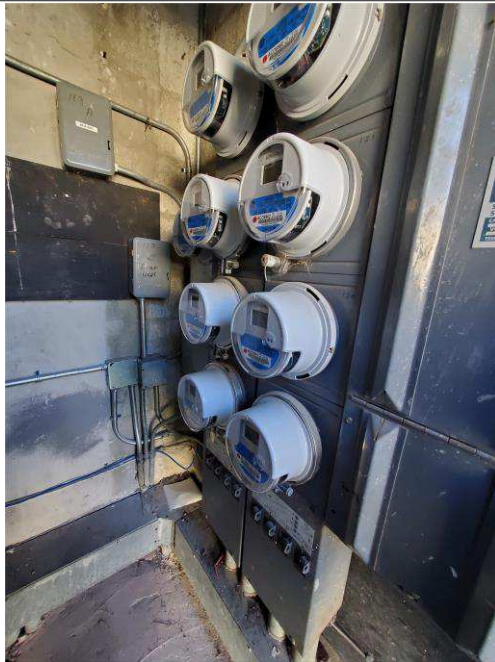
Photo 7 – Village of Dadeland Condominium Association

Existing Electrical Room – 1st FL
Main Switches for Apartments,
Meters, and Gutter.

Old and oxidized meter stacks.

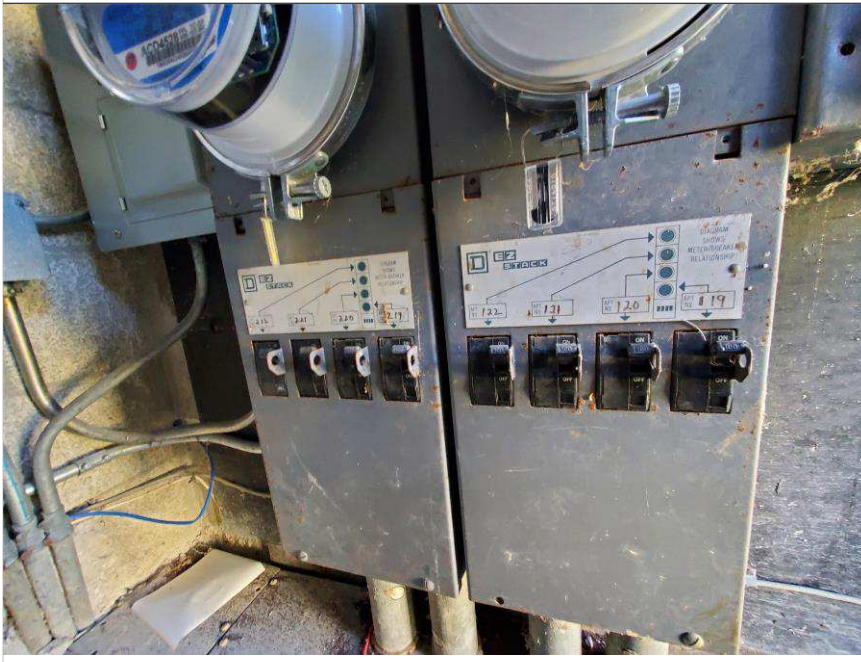
Photo 8 – Village of Dadeland Condominium Association

Existing Electrical Room – 1st FL
Apartment Meters and Main
Switches

Old and oxidized meter stacks.

Apartment Disconnect Switches
are old.

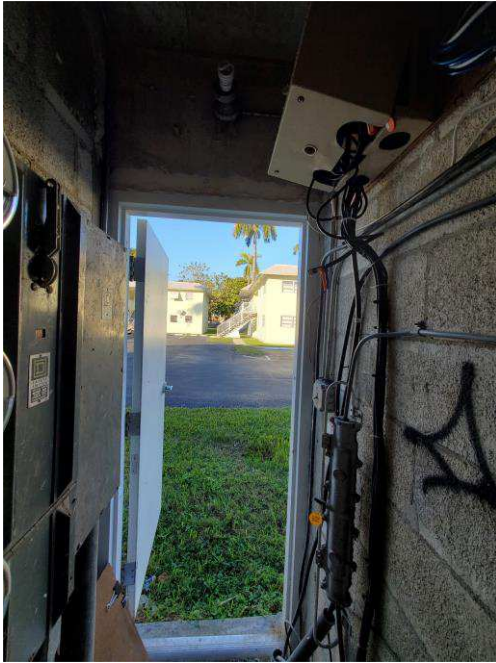
Photo 9 – Village of Dadeland Condominium Association

Existing Electrical Room – 1st FL
Main Switches for Apartments,
Meters, and Gutter.

Insufficient clearance at
electrical components.

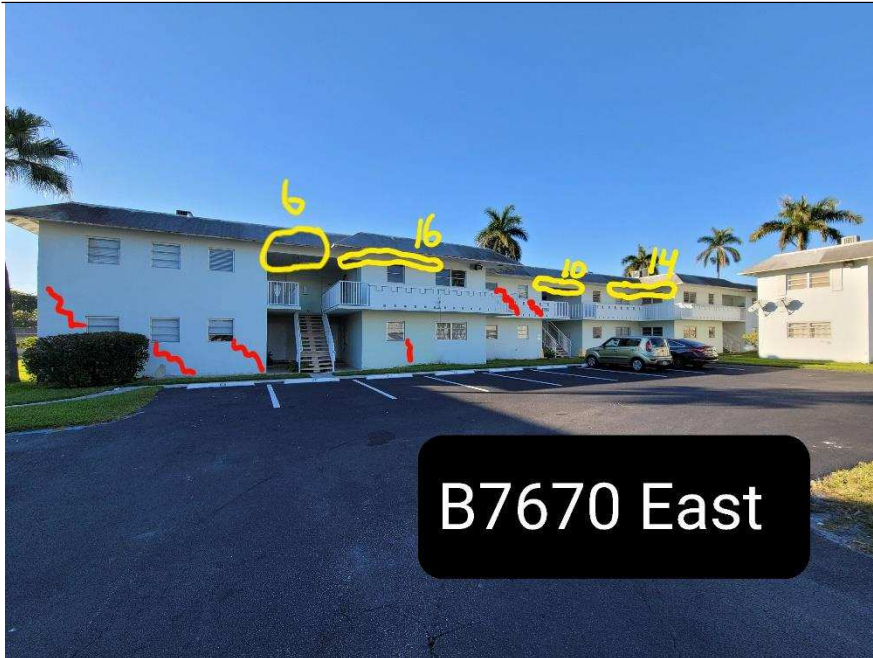
Photo #1:

Front elevation of building 7670 (Villa H)

The stuccoed envelope requires maintenance of the stucco exterior surfaces at many locations. Unsound stucco surfaces and surface cracks discovered at many areas of the exterior envelope.

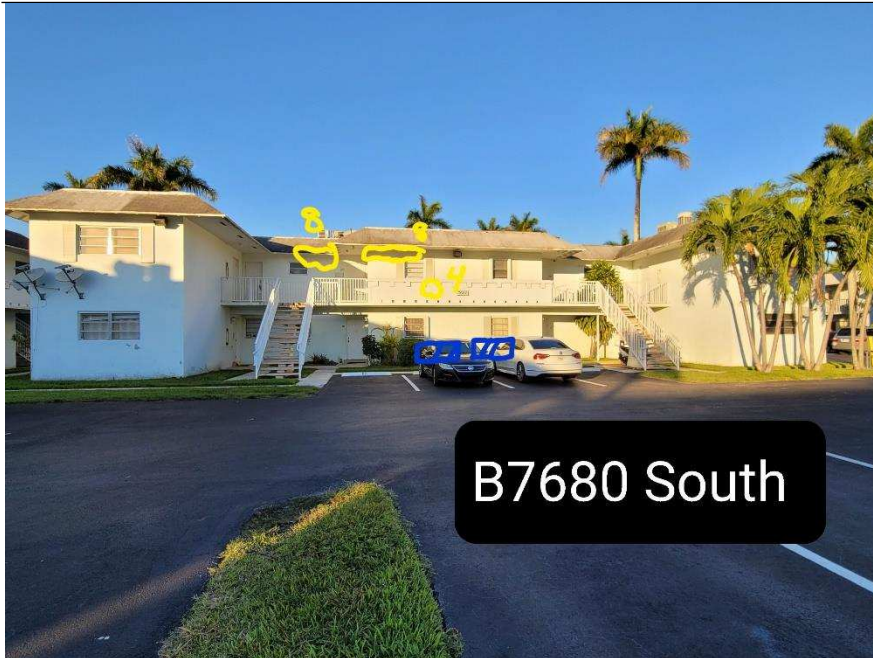
Photo #1:

Front elevation of building 7680 (Villa H)

The stuccoed envelope requires maintenance of the stucco exterior surfaces at many locations. Unsound stucco surfaces and surface cracks discovered at many areas of the exterior envelope.
