Home Inspection Report

738 Maple Row, North Harbor, NY 12020

Report Number:

01172512

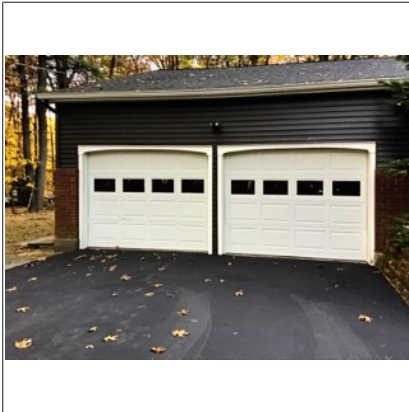
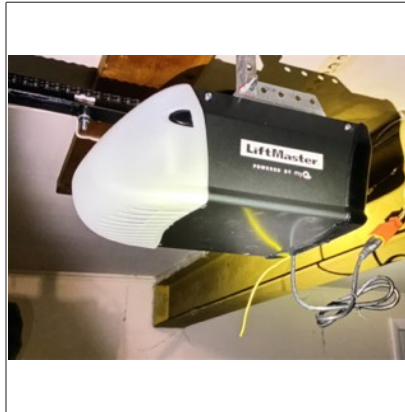
- Wall covering** •Vinyl Siding
•Stone (facade)
- Eaves / soffits / fascias** •Vinyl Soffits
•Metal Fascias
- Doors** •Solid
•Sliding Glass
- Window/door frames and trim** •Wood and Vinyl-Covered Windows
•Metal-Covered Trim
- Entry driveways** •Concrete
- Entry walkways and patios** •Concrete Front Walkway
•Rear Patio: Pavers
- Porch / deck / steps / railings** •Concrete Front Porch
•Wood Rear Deck
- Overhead garage door(s)** •2 Steel
•1 Automatic Opener Installed
•Automatic Opener Manufacturer: Lift Master
