"Full" Reserve Study

Casa del Cielo HOA Scottsdale, AZ

Report #: 34714-0
For Period Beginning: January 1, 2019
Expires: December 31, 2019

Date Prepared: October 9, 2018

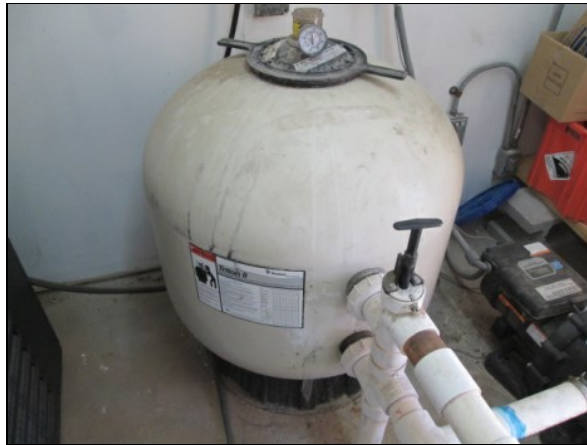
Comp #: 1240 Pool Filter - Replace

History: Replaced in 2003.

Comments: This is an older filter with some surface staining. No visible leaks or issues noted though.

Useful Life:
15 years

Remaining Life:
2 years

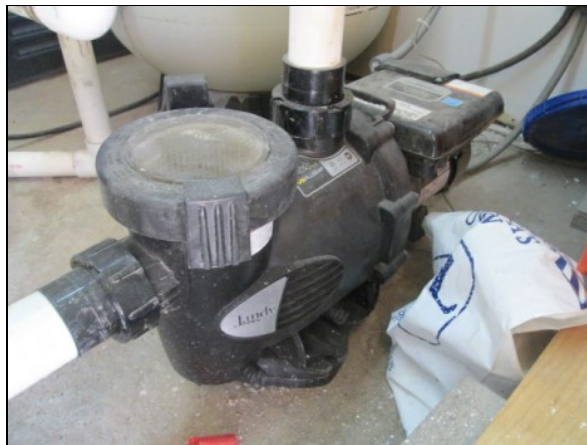
Comp #: 1242 Pool Pump - Replace

History: Replaced in 2017.

Comments: This pump is newer and in good condition. Periodic repair and motor replacement should be addressed as a maintenance issue. This component funds for replacement of the pump and motor assembly.

Useful Life:
12 years

Remaining Life:
10 years

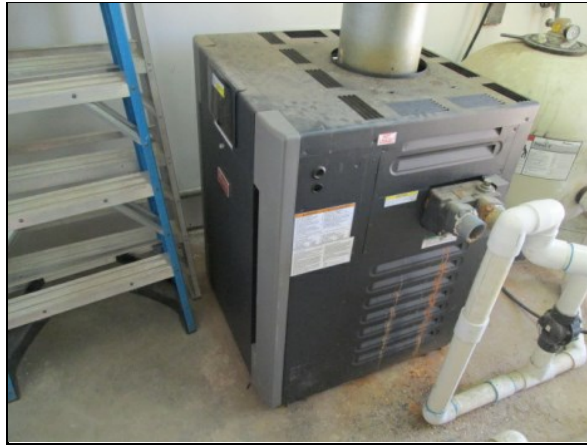
Comp #: 1246 Pool Heater - Replace

History: Replaced around 2016.

Comments: Heater appears to be in good shape. It was disconnected at the time of inspection, because it was reportedly sending rust into the pool. This problem is expected to be fixed in 2018 as a maintenance project.

Useful Life:
8 years

Remaining Life:
5 years

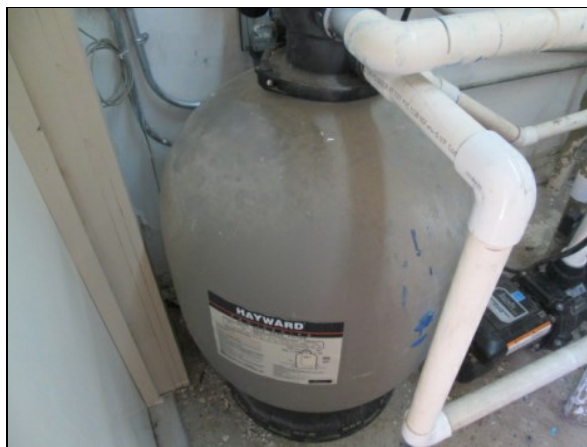
Comp #: 1250 Spa Filter - Replace

History: Replaced around 2016.

Comments: Smaller filter, appears to be in good shape. No problems observed or reported.

Useful Life:
15 years

Remaining Life:
12 years

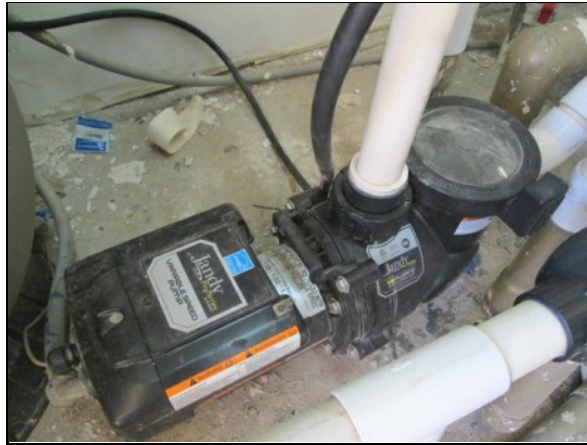
Comp #: 1252 Spa Filter Pump - Replace

History: Replaced in 2016.

Comments: This pump is newer and in good condition. Periodic repair and motor replacement should be addressed as a maintenance issue. This component funds for replacement of the pump and motor assembly.

Useful Life:
12 years

Remaining Life:
9 years

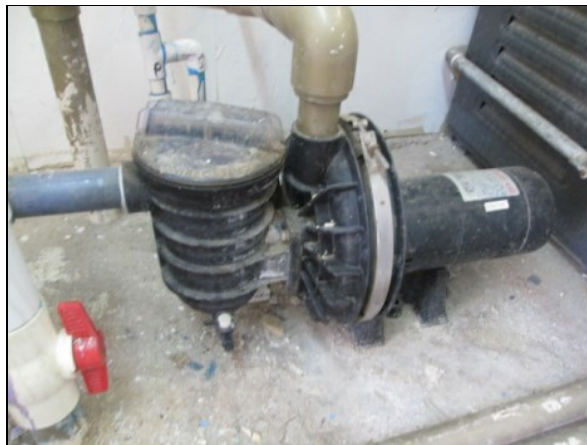
Comp #: 1253 Spa Jet Pump - Replace

Comments: This is an old pump with no visible information. Periodic repair and motor replacement should be addressed as a maintenance issue. This component funds for replacement of the pump and motor assembly.

Useful Life:
15 years

Remaining Life:
2 years

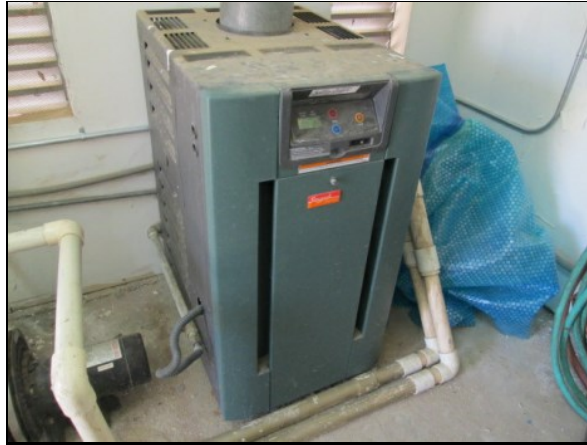
Comp #: 1256 Spa Heater - Replace

History: Replaced in 2009.

Comments: This heater is older and should be nearing time for replacement. Some soot inside, but no significant rusting noted.

Useful Life:
8 years

Remaining Life:
0 years

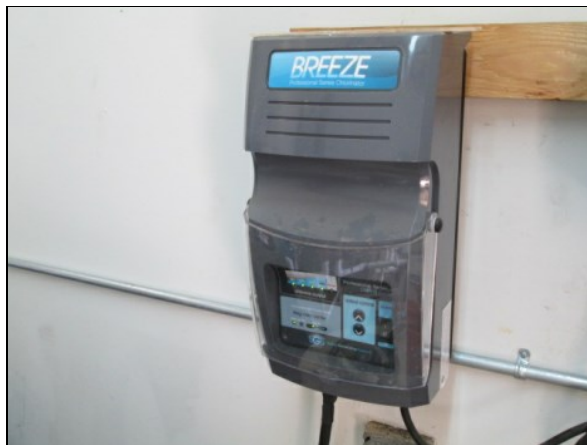
Comp #: 1280 Salt Chlorinators - Replace

Comments: These are salt water chlorination systems. They are new and expected to be in good working condition. This component funds to replace the entire system. Repairs and salt cell replacement should be funded as an Operating expense.

Useful Life:
4 years

Remaining Life:
3 years
