Mar 13th, 2024

48 N. Temple, Indianapolis, IN, 46201

Home Inspection Report

Kyle Pfeifer / Pfeifer Home Inspection

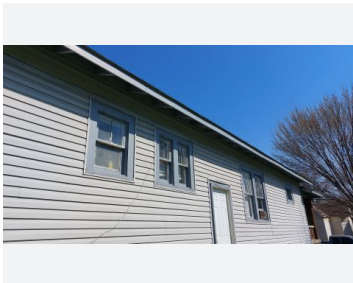
Currently, the home is without a gutter system. A qualified contractor will need to install new gutters.

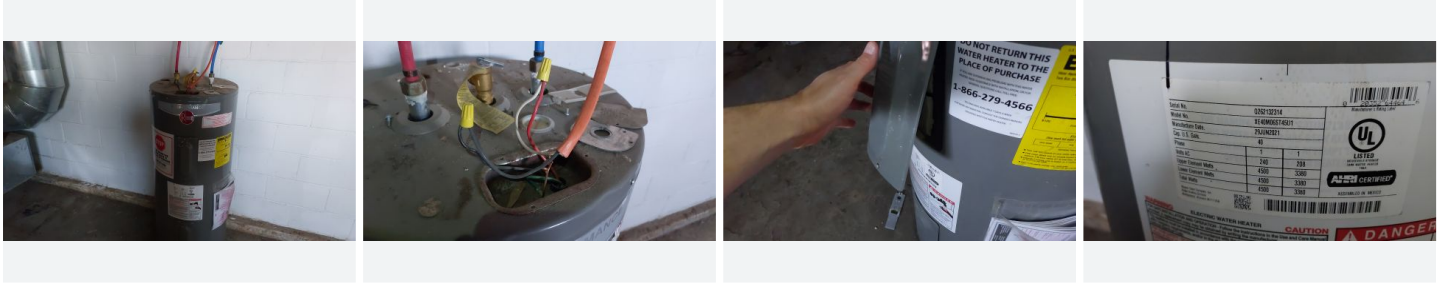
13.1 WATER HEATER OPERATION

This particular hot water heater was functioning properly during our inspection. The wiring powering the unit needs to be enclosed as expected. Additionally, one of the covers for the heating element needs addressed as well.

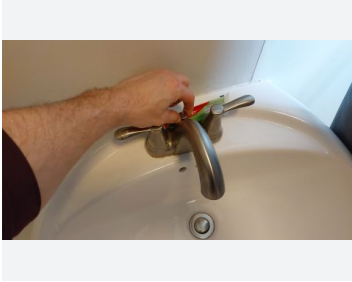
14.2 SINK/BASIN

The drain lever is not working properly. We attempted to move the lever up and down but could not. A qualified contractor will need to review for the correct repair.

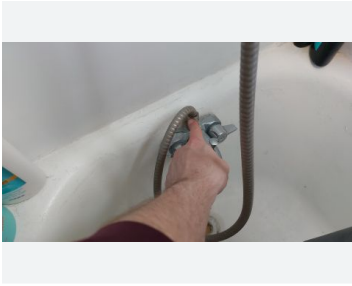
14.4 SHOWER/SURROUND

The shower supply line where it connects to the diverter was leaking immediately after turning the water on. A qualified contractor will need to review for the proper repairs.

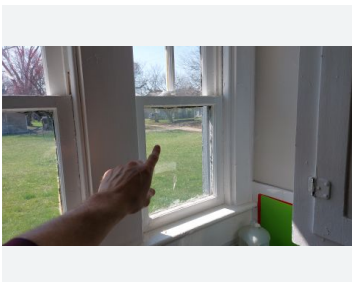
16.4 WINDOWS

One of the windows in this room is cracked and needs to be addressed. A qualified contractor will need to remove and replace any damaged glass.

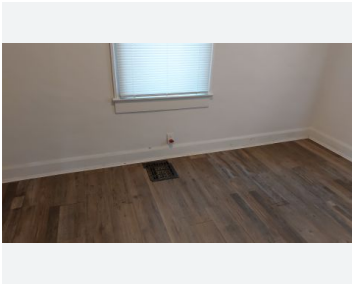
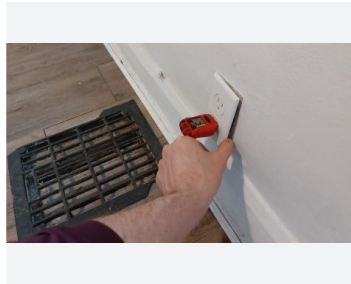
19.3 ELECTRICAL

We attempted to test the pictured outlets; however, they were not working. A qualified contractor will need to review for the correct repair.

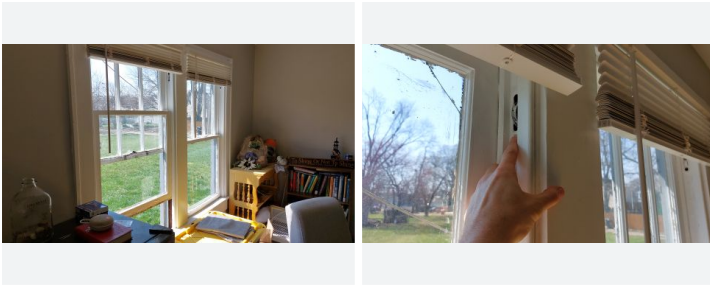
20.2 WINDOWS

The sash cords are missing/damaged for several of the single hung windows in this room. We attempted to open the window, however were unable as they fell down immediately. A qualified contractor will need to review for the proper repairs.

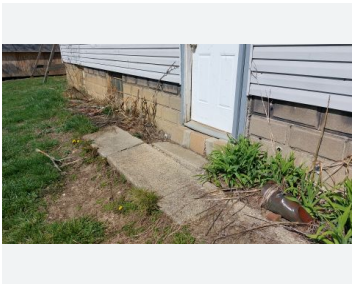
The grading has a negative slope and water is pooling against the foundation in several areas. A qualified contractor will need to evaluate to determine the proper repair.

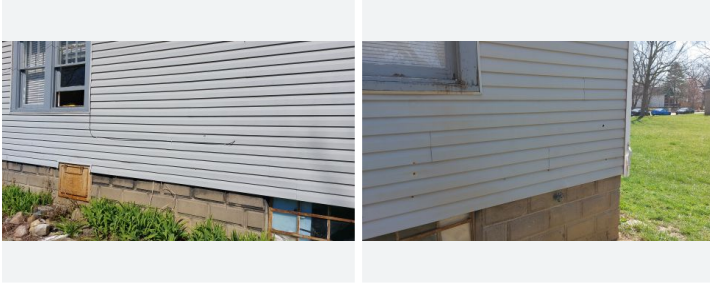
2.1 EXTERIOR SIDING

A few small cracks/holes were observed in the vinyl siding as we reviewed the exterior of the property. A qualified contractor will need to repair/replace all the damaged siding.

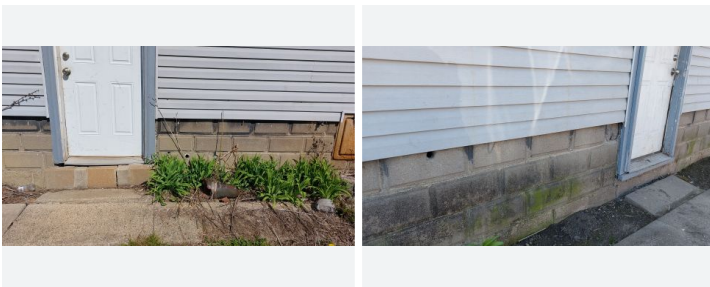
2.2 FOUNDATION

Several small holes were found in the cement block foundation. They appear to be old holes for gas and electrical lines. If desired, the holes could be filled with mortar.

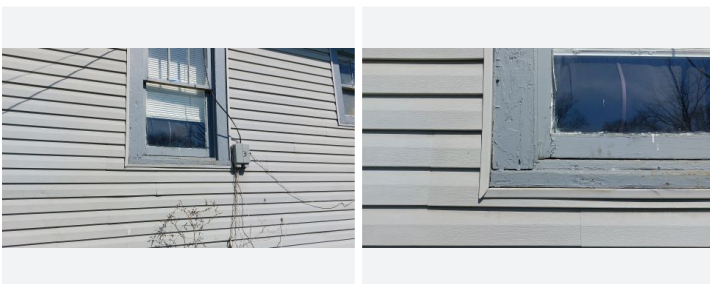
2.3 EXTERIOR TRIM

We recommend painting the exterior trim. We found several small cracks in the trim that will allow water in slowly rotting the boards over time.

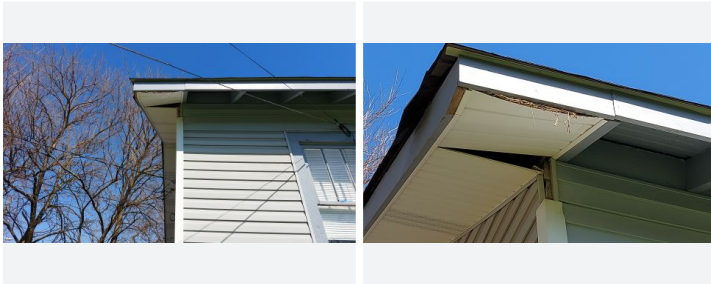
2.4 SOFFITS

A few minor repairs will be needed to the pictured soffit box. The corner of the soffit box will need re-attached if desired.

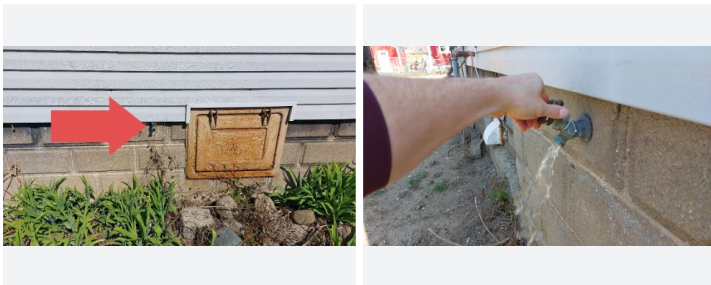
2.5 HOSE BIBS

One of the hose bibbs on the side yard is missing a handle. A new handle will need to be installed. If a new handle cannot be installed the hose bibb will need to be replaced by a qualified contractor.

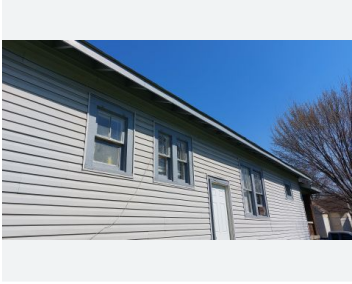
3.2 GUTTERS

Currently, the home is without a gutter system. A qualified contractor will need to install new gutters.

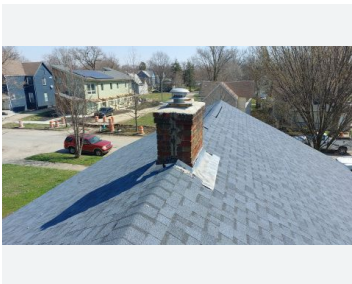
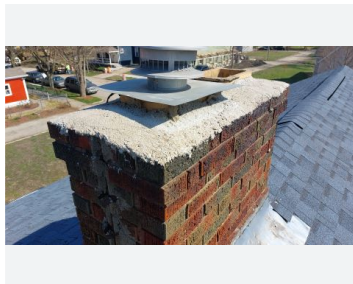
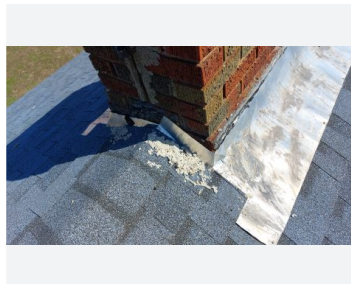
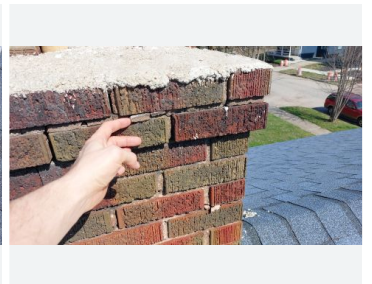
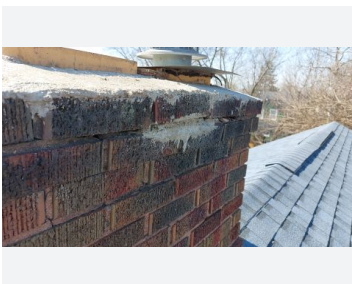
3.3 CHIMNEY

Overall, the brick chimney is not in bad shape for its age. The chimney is structurally sound and not leaning inward or outward. The mortar between the brick has deteriorated and falling apart in certain areas. No issues were observed with the chimney crown or cap. A qualified contractor will need to review.

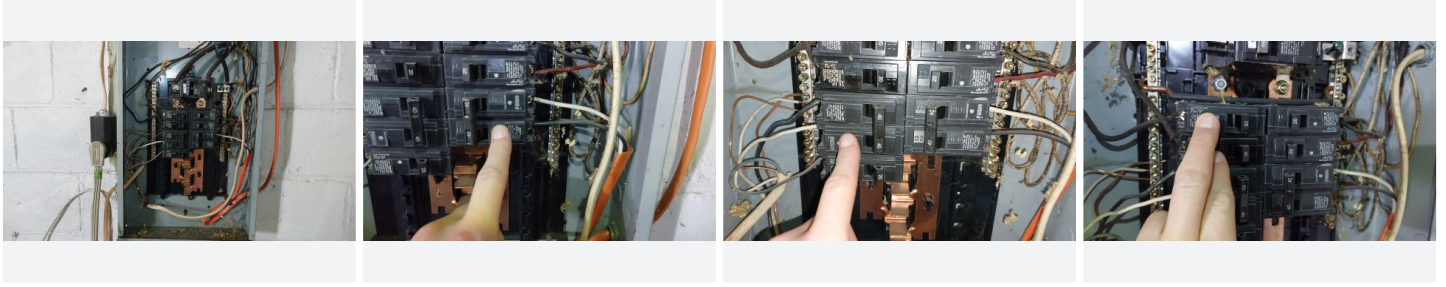
4.2 ELECTRICAL PANEL

We reviewed the pictured electrical panel we found several breakers that are over fused and attached to the wrong wire. No other issues were found. A qualified contractor will need to review the panel.

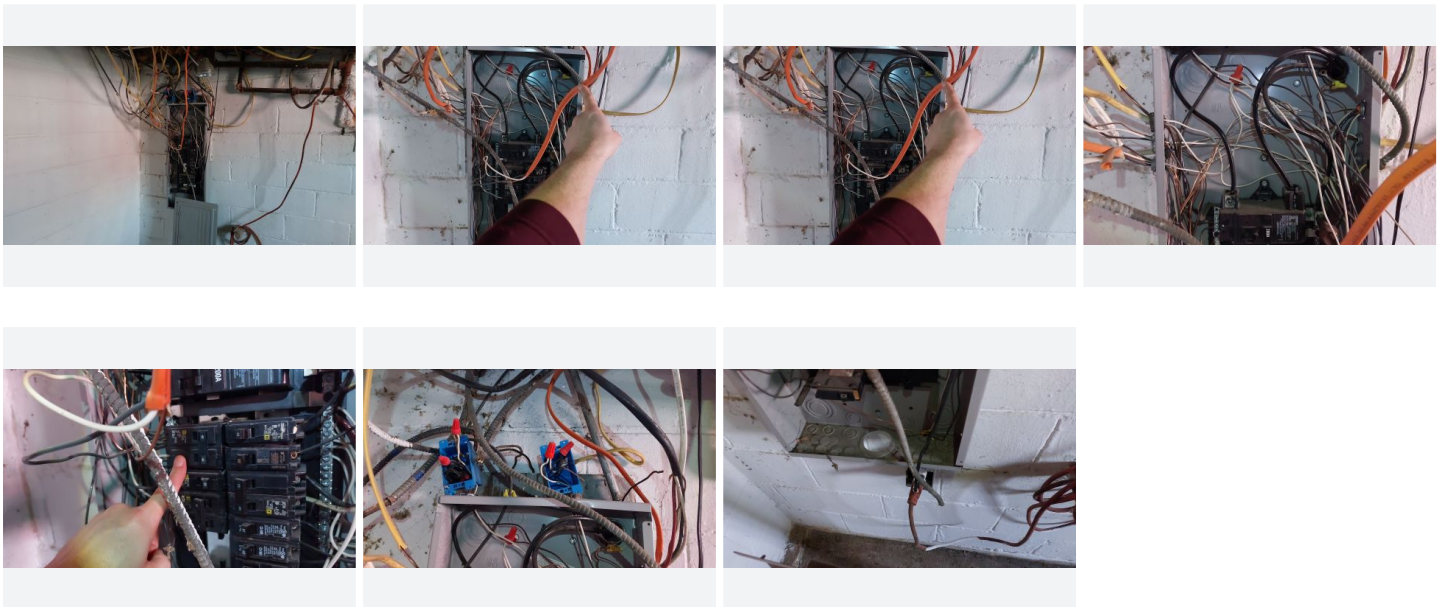
5.1 ELECTRICAL PANEL

We reviewed the pictured electrical panel we found several issues needing reviewed by a qualified contractor. A few electrical circuits were not installed correctly. The wiring was not installed through the top or side of the panel. As such the cover for the panel can not be installed. Directly, above the panel we found two junction boxes needing covered and attached. The over fused 40amp breaker needs to be removed. Lastly, all loose/abandoned wiring needs addressed as well.

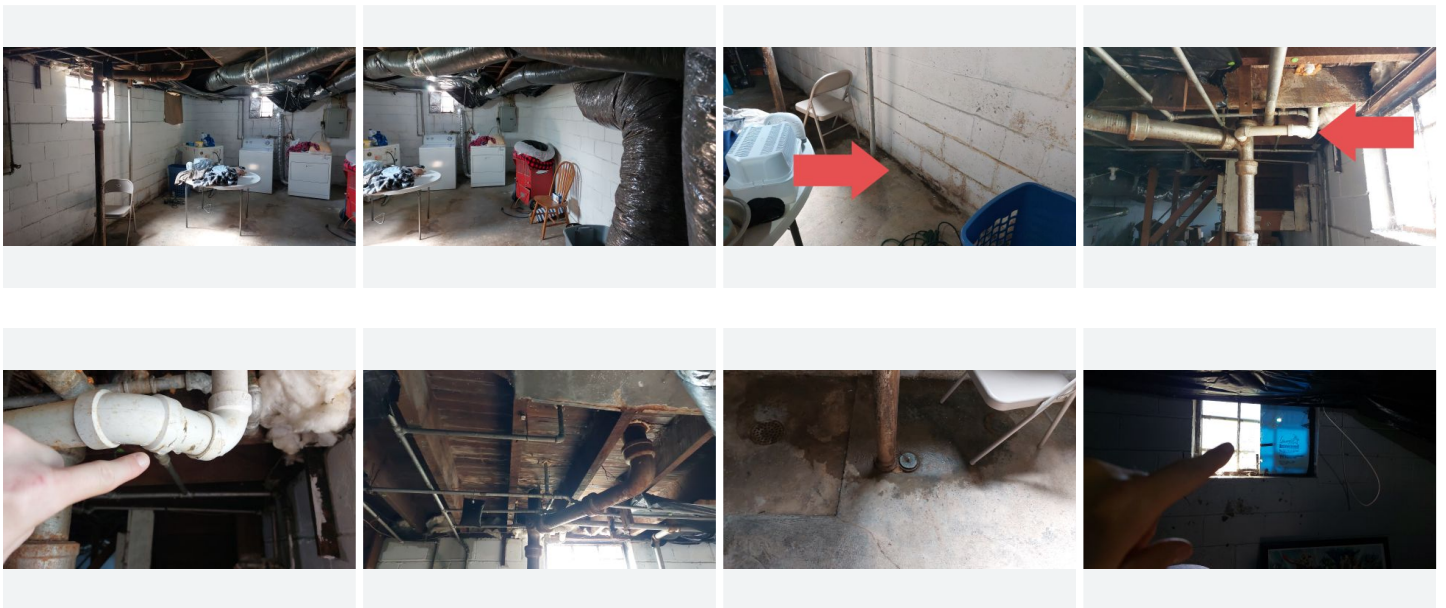
7.1 WALLS

The space downstairs was relatively dry with a little moisture present. With that said, we still recommend running a dehumidifier to alleviate any moisture issues that will build up. We did observe water entering from the outside and through the foundation walls. The grading and downspouts need to be reviewed to ensure they are draining away from the home. As a result, we observed a white substance that appears to be mold throughout the space. In pictures four and five we found an active leak coming from one of the drainage lines. We could not identify exactly where the leak was coming from. Several of the basement windows are cracked and need addressed. No major issues were observed with the wooden or cement block structure of the home. The main sewer line from the home to the street is cast iron. We recommend having the sewer line scoped to ensure it has not collapsed or has tree roots growing in it. A qualified contractor will need to review all issues.

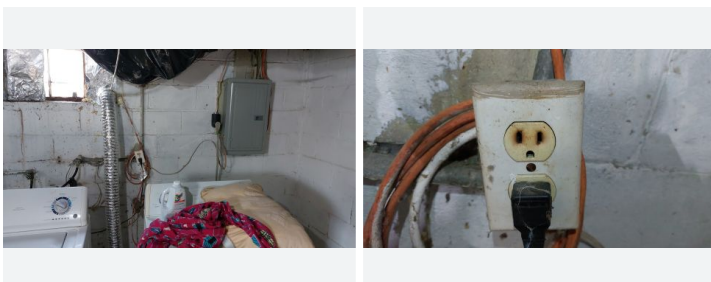
7.2 ELECTRICAL

The outlet in pictures one and two has 'shorted out' and needs to be replaced immediately. At one point the circuit 'arced' burning up the outlet and wiring. Further investigation is needed.

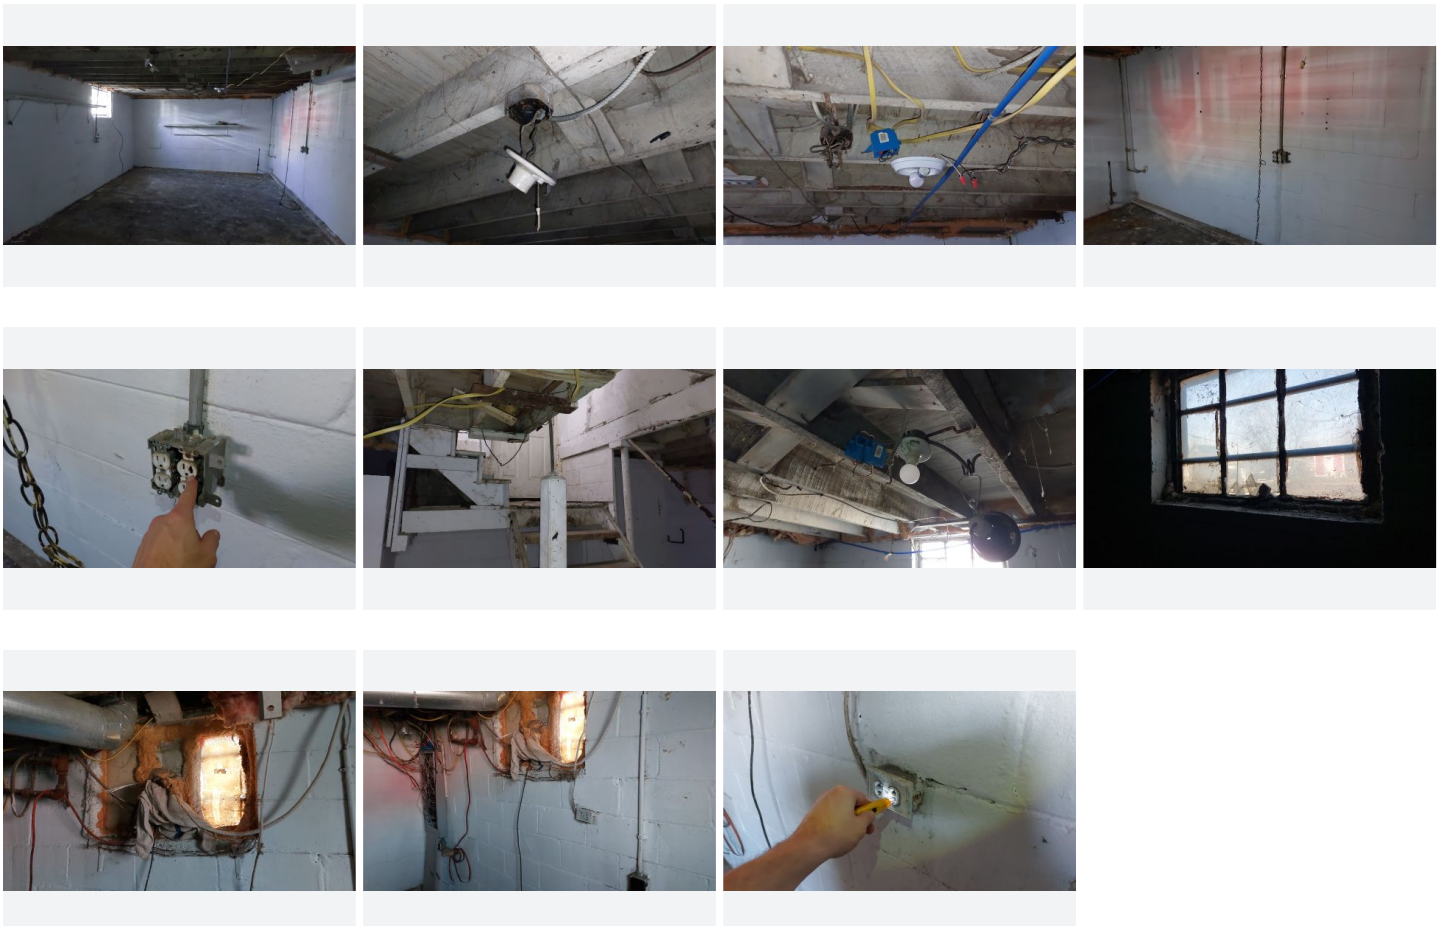
Defective

The space downstairs was relatively dry with a little moisture present. With that said, we still recommend running a dehumidifier to alleviate any moisture issues that will build up. We did observe water entering from the outside and through the foundation walls. The grading and downspouts need to be reviewed to ensure they are draining away from the home. All of the electrical wiring and junction boxes need reviewed for multiple reasons. In photos four and five we found an arced outlet needing replaced. Several of the basement windows are cracked and will need replaced. In photo six an adjustable flooring jack was used to support several flooring joists by the stairs. We recommend removing the jack and supporting this area in a different way. All open or abandoned plumbing lines need addressed. A qualified contractor will need to review all issues.

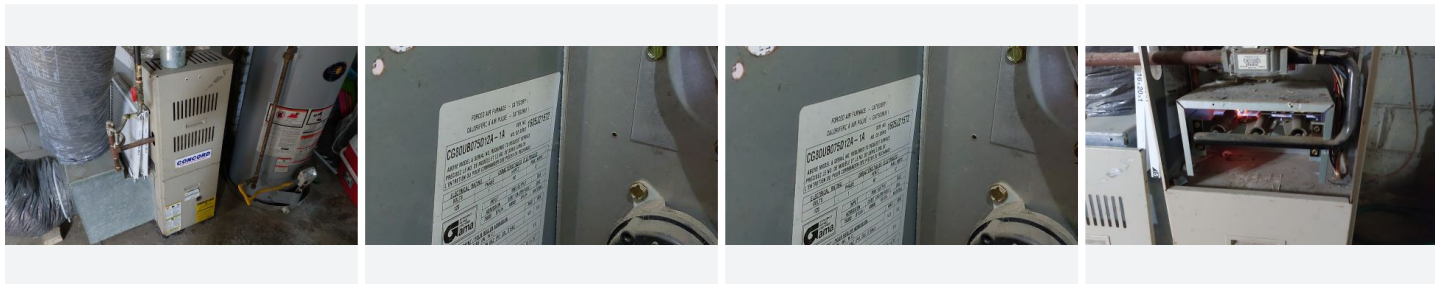
Marginal

The furnace was tested and in working order during our inspection. With that said, the unit is from 2005 and almost at the end of a typical life cycle. We recommend budgeting for a new unit.

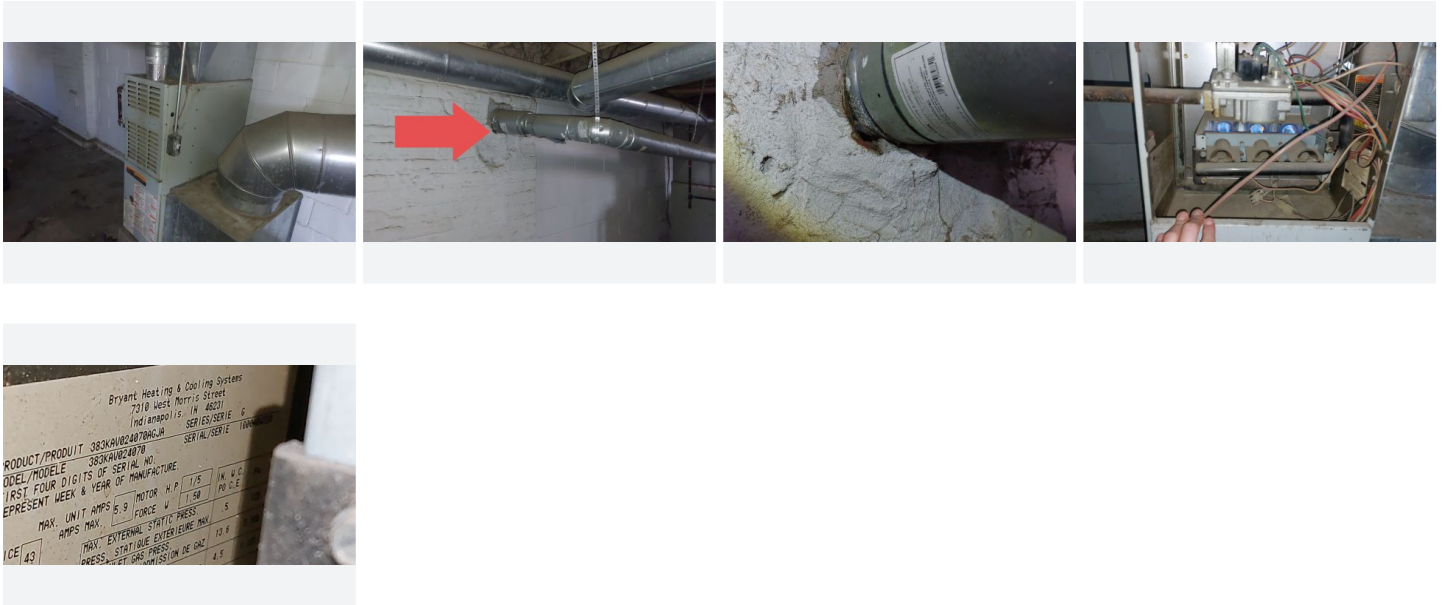
Defective

The furnace was tested and in working order during our inspection. With that said, the unit is from 2000 and almost at the end of a typical life cycle. In pictures two and three we found an opening around the exhaust line where it enters the chimney. This opening will need to be closed.

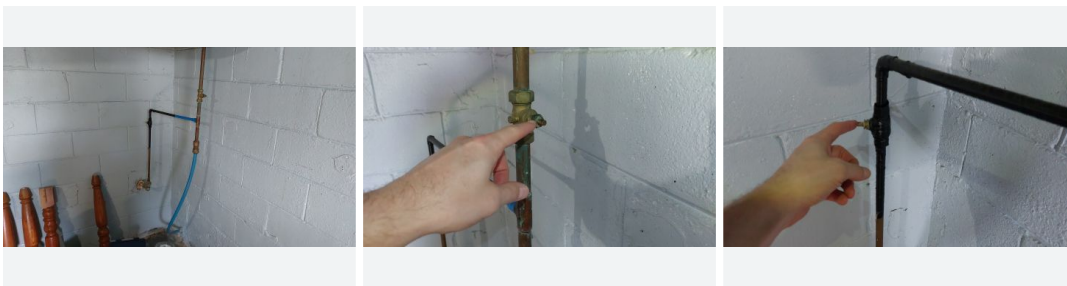
📌 Marginal

Two of the pictured shut off valves will need to have new handles installed as they are currently missing.

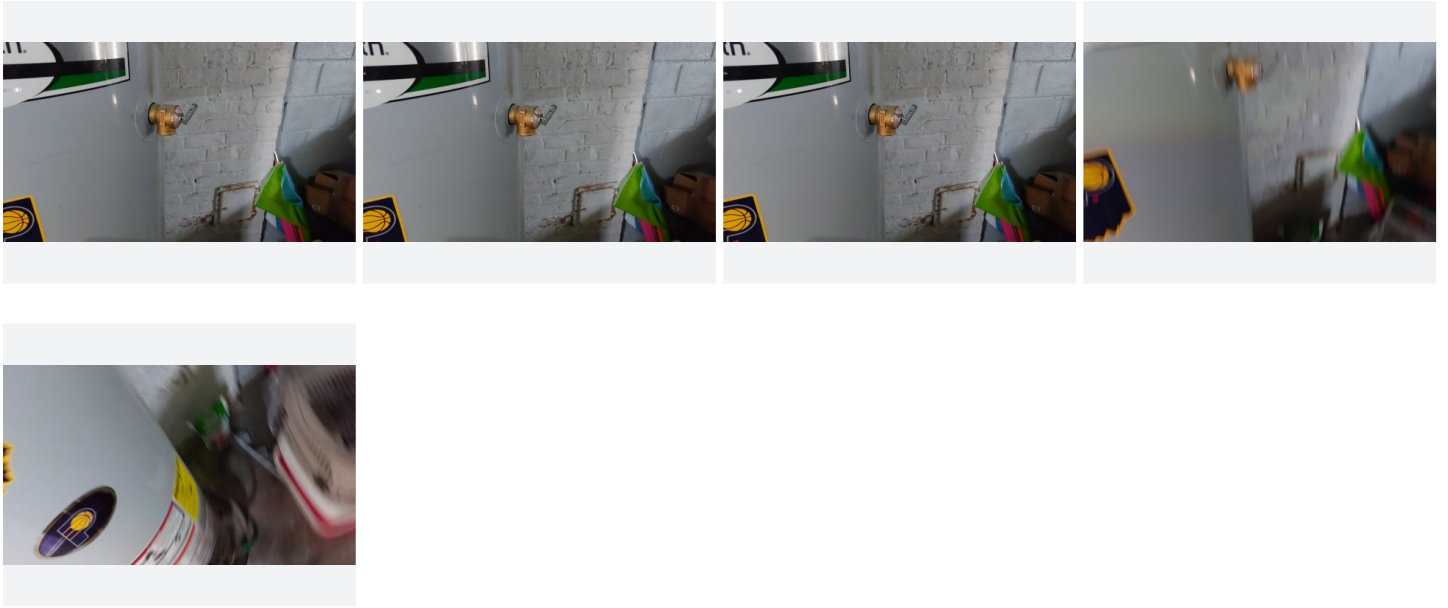
🔧 Maintenance

Per code, all hot water heaters are required to have a copper/CPVC drainage line piped between 6-24 inches of the floor. Here the pipe is missing. A qualified contractor will need to add an extension to the hot water heater.

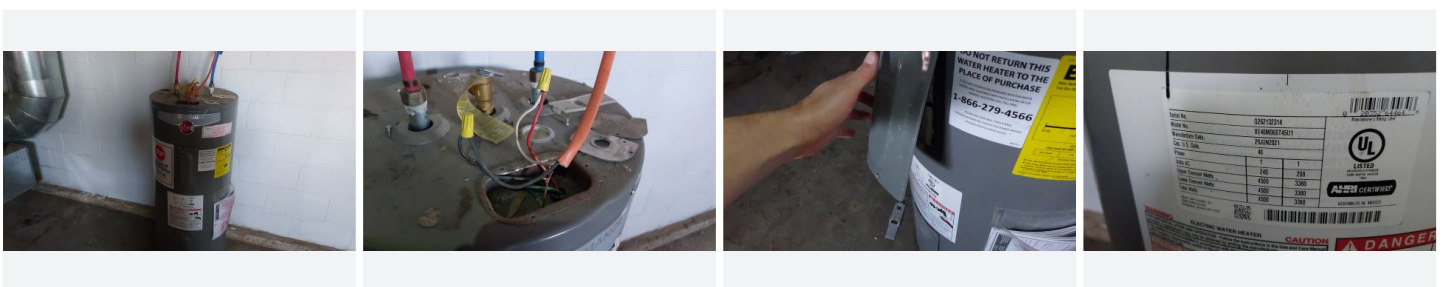
Maintenance

This particular hot water heater was functioning properly during our inspection. The wiring powering the unit needs to be enclosed as expected. Additionally, one of the covers for the heating element needs addressed as well.

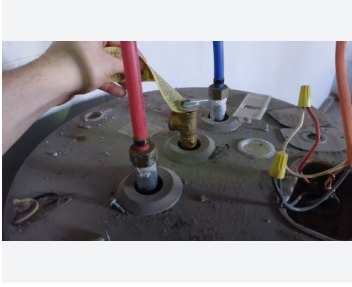
Maintenance

Per code, all hot water heaters are required to have a copper/CPVC drainage line piped between 6-24 inches of the floor. Here the pipe is missing. A qualified contractor will need to add an extension to the hot water heater.

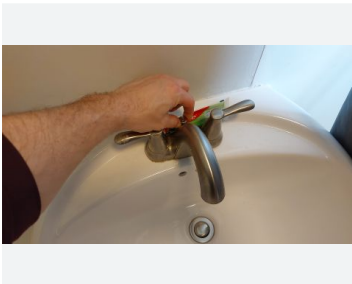
Maintenance

The drain lever is not working properly. We attempted to move the lever up and down but could not. A qualified contractor will need to review for the correct repair.

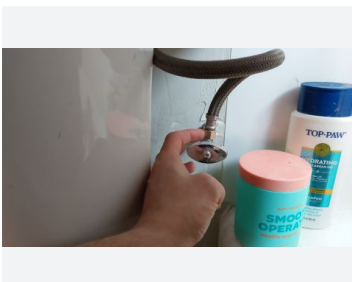
Defective

We found a slow leak where the cold-water supply connects to the shut off valve. A qualified contractor will need to review.

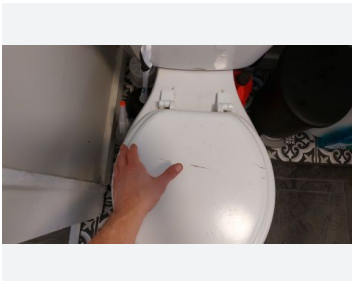
The base of the toilet is loose as we shifted the entire toilet during our review. We were able to shake the toilet from side to side. A qualified contractor will need to review for the correct repairs.

Maintenance

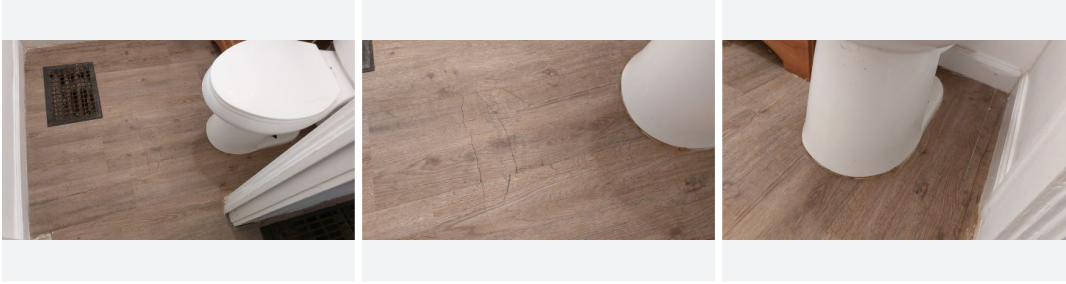
Several soft areas in the subflooring were found around the toilet. Further evaluation is needed to determine the proper repairs.

Marginal

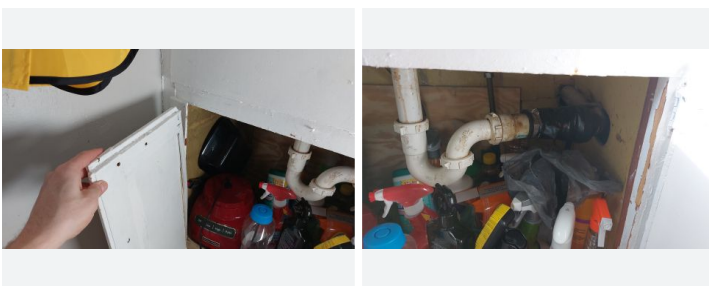
The cabinet doors are loose and need to be re-attached. Furthermore, electrical tape is currently being used to hold the drainage line together. A qualified contractor will need to review.

Marginal

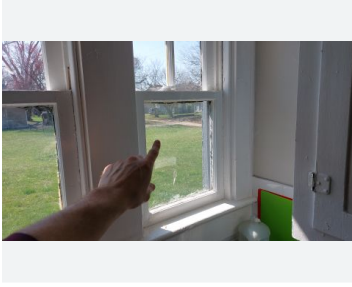
Defective

One of the windows in this room is cracked and needs to be addressed. A qualified contractor will need to remove and replace any damaged glass.

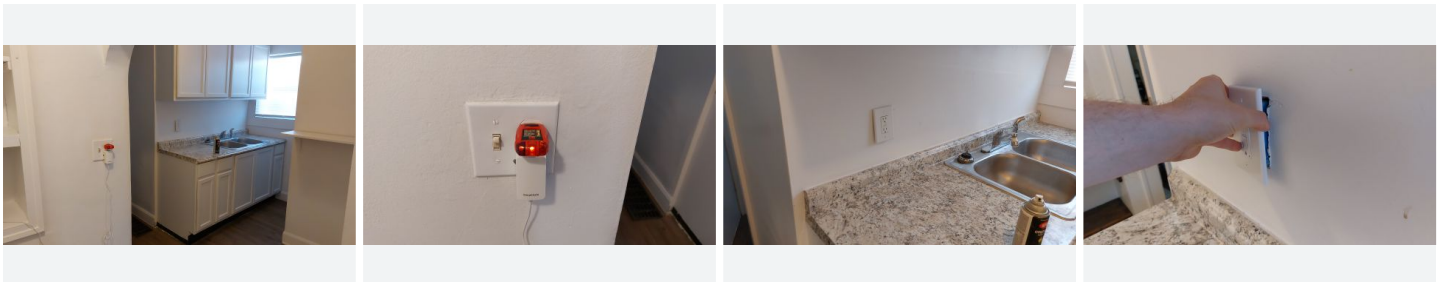
The electrical outlet in pictures one and two is indicating 'reverse polarity.' Reverse polarity is when the hot and neutral wires are reversed. We also noticed a really loose outlet next to the sink. A qualified contractor will need to review for the correct repair.

Defective

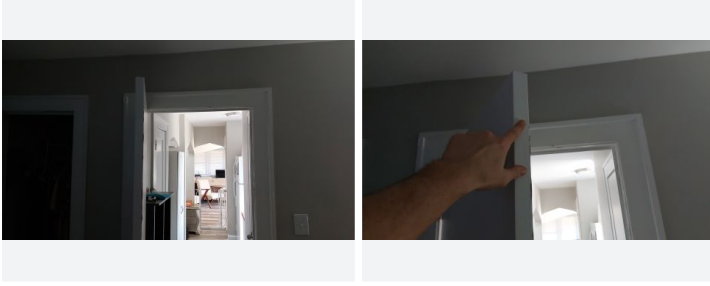
The entry door will not completely shut. The door will not close all the way as the latch is just missing the strike plate. A qualified contractor will need to review for the proper repairs.

Maintenance

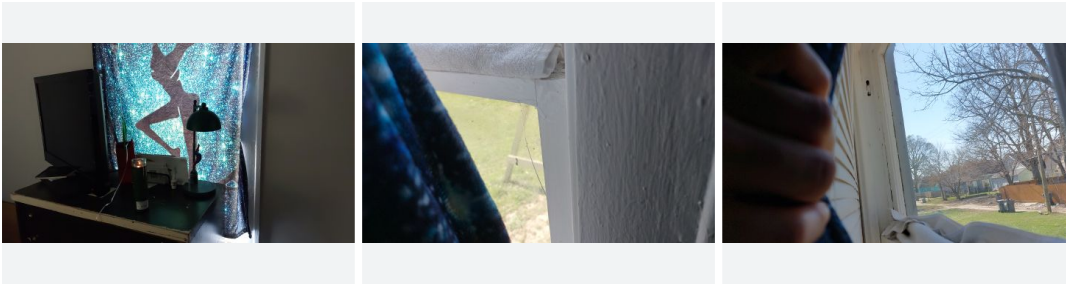
One of the windows in this room is cracked and needs to be addressed. Furthermore, several of the sash cords are missing. A qualified contractor will need to remove and replace any damaged glass.

Defective

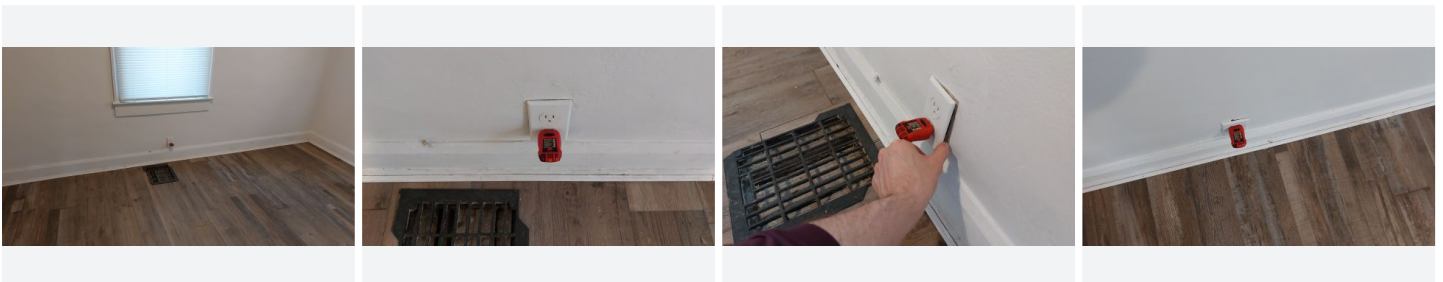
Defective

We attempted to test the pictured outlets; however, they were not working. A qualified contractor will need to review for the correct repair.

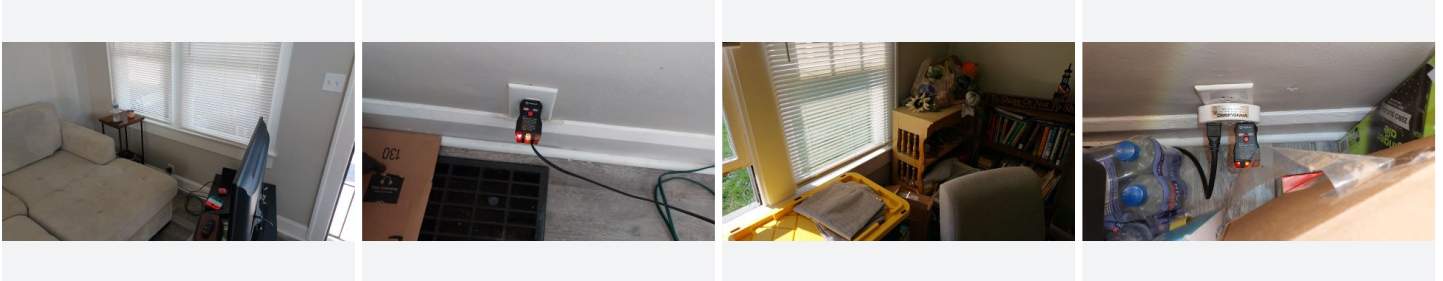
Several of the electrical outlets in this room are indicating 'reverse polarity.' Reverse polarity is when the hot and neutral wires are reversed. A qualified contractor will need to review for the correct repairs.

Defective

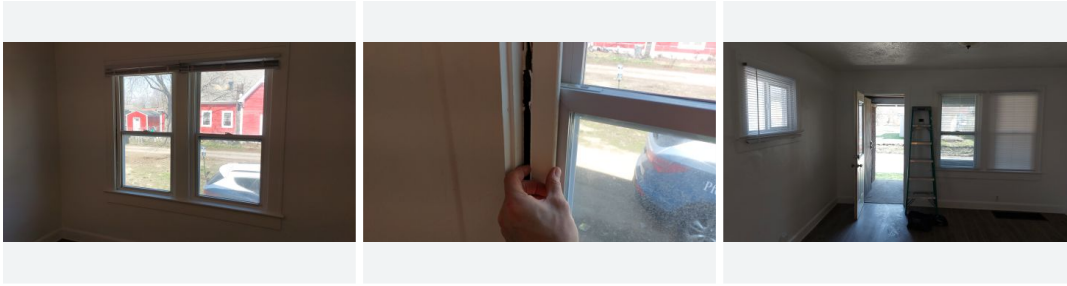
The sash cords are missing/damaged for several of the single hung windows in this room. We attempted to open the window, however were unable as they fell down immediately. A qualified contractor will need to review for the proper repairs.

Marginal

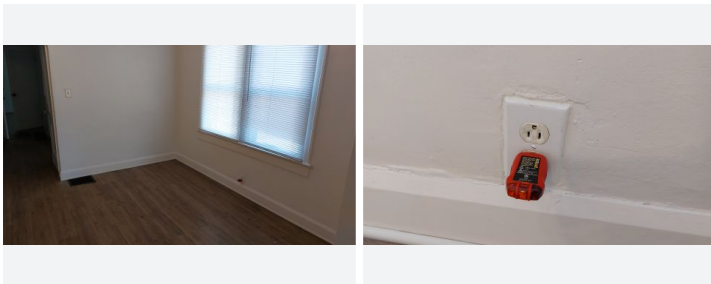
We attempted to test the pictured outlet, however it was not working. A qualified contractor will need to review for the correct repair.

Defective

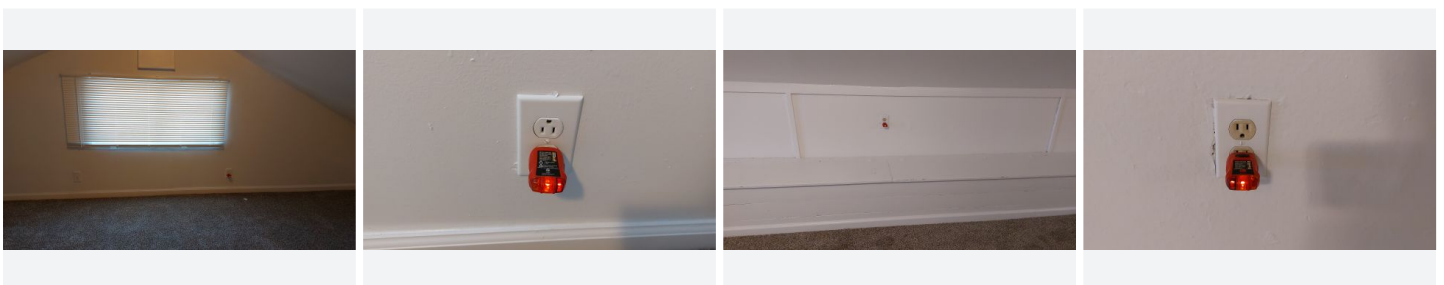
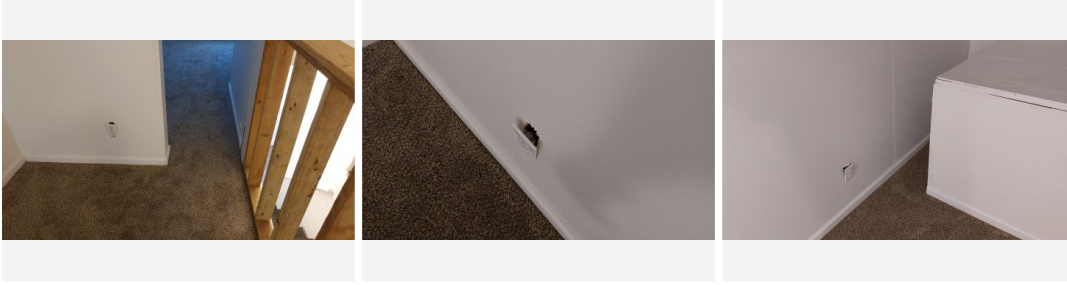
Several of the outlets in this room are indicating 'reverse polarity.' Reverse polarity is when the hot and neutral wires are reversed. Additionally, several outlets are loose and need to be re-attached. A qualified contractor will need to review for the correct repair.

Defective

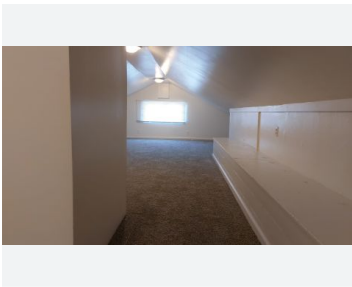
Defective

We did not see a return line connected to the HVAC system in the finished attic. Currently, air is not being exchanged between floors. Further evaluation is needed.
