Wheel Separations

by Mark Bailey MASc, PEng, PE

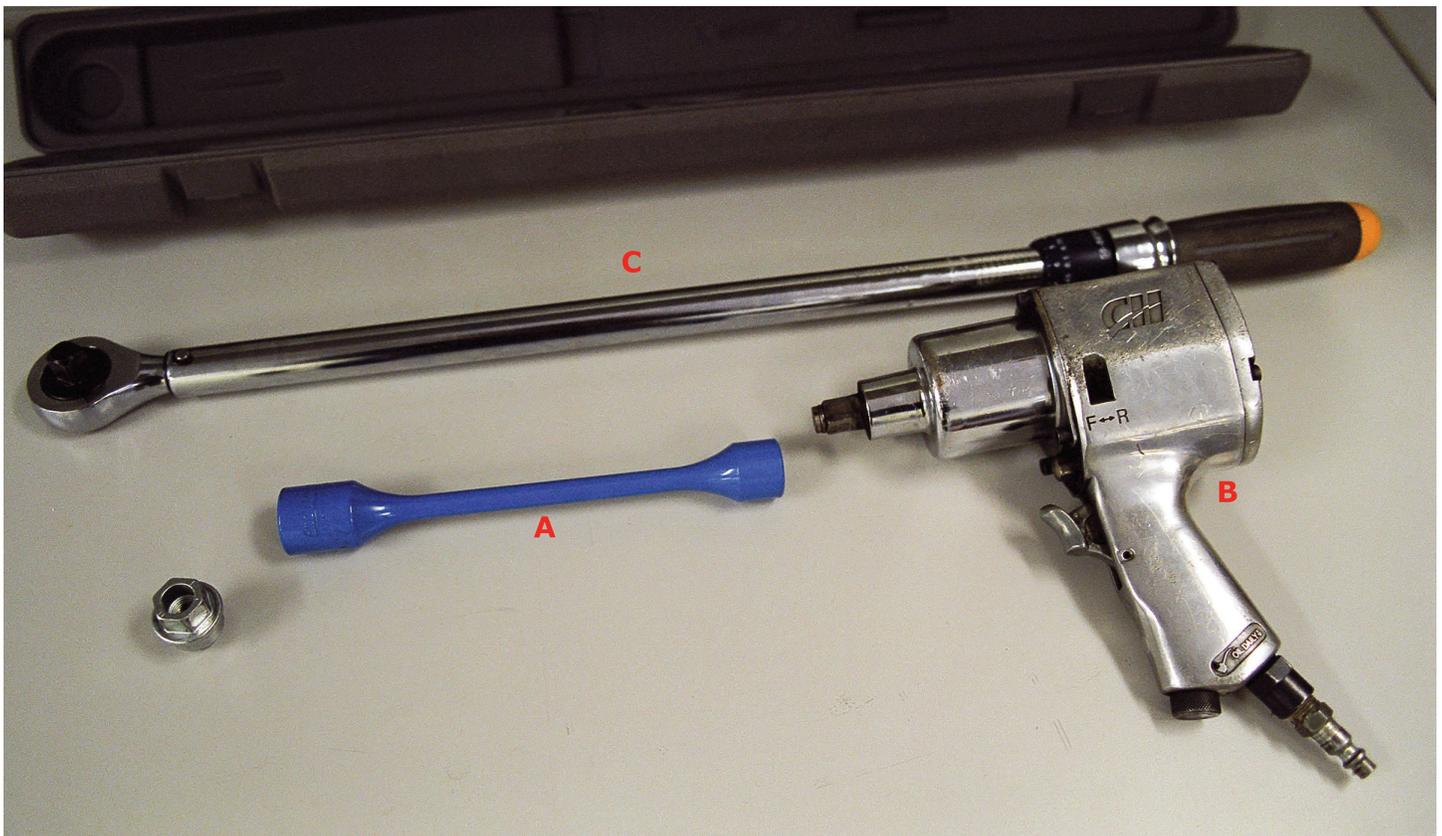
commonly use a 'Torq Stik' on the air wrench, like the one shown in Figure 8. A Torq Stik is a precision-made steel bar that applies a target torque to a wheel nut. There are different sizes of Torq Stiks for different values of torque. The one in Figure 8 is meant to produce 80 foot-pounds. Whether they use a Torq Stik or not, wheel installers should always use a calibrated manual torque wrench, like the one shown in the top of Figure 8, to ensure the proper wheel nut torque is achieved.

Figure 8. A: an 80 foot-pound Torq Stik. B: air wrench that Torq Stik attaches to. C: A manual torque wrench.
