TALCO
Home Inspection

Inspection Report

Property Address:
125 Crimea Drive
Nicholasville KY 40356

Date: 11/6/2018	Time: 10:00 AM till 02:00 PM	Report ID: 181106ANTHONY
Property: 125 Crimea Drive Nicholasville KY 40356	Customer: Ms. Sharon Anthony	Real Estate Professional:

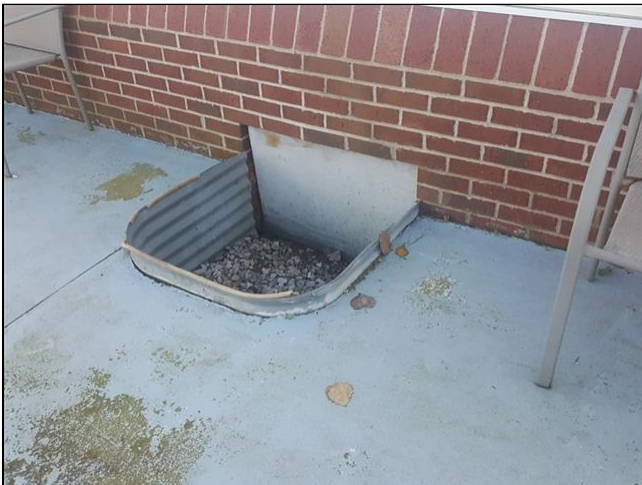
1.0 Item 1(Picture)

1.0 (1) Access to the crawlspace is located at the rear of the home.

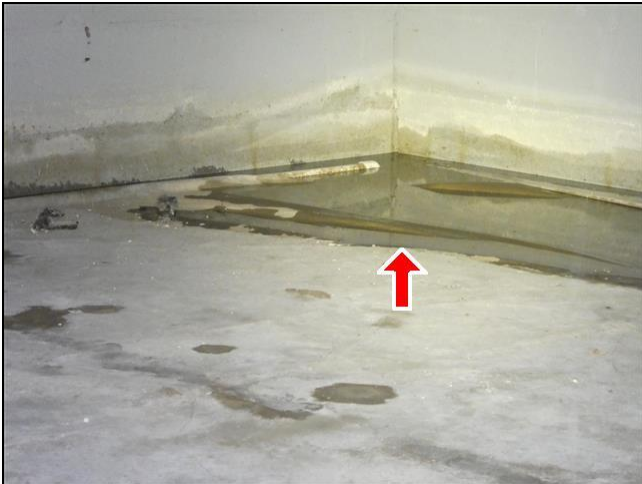
1.2 Item 1(Picture) rear right corner of home

1.2 Visible signs of water intrusion along the perimeter walls and standing water in the crawlspace was present at time of inspection. Water intrusion can lead to more costly repairs and increase damage if not corrected. Water intrusion if not corrected can lead to other problems including mold and cause excessive moisture to the floor system that can lead to deterioration and increased repair cost. Roof and Lot Drainage repairs or improvements should be addressed as a first step to controlling water entering in the crawl space. After corrections, recommend monitoring the crawlspace to see if additional steps are needed to prevent water intrusion.

Note: You may wish to consider installing a sump pump and drainage system in the crawlspace in removing the water. You may wish to seek an opinion from a qualified crawlspace contractor to further inspect crawlspace.

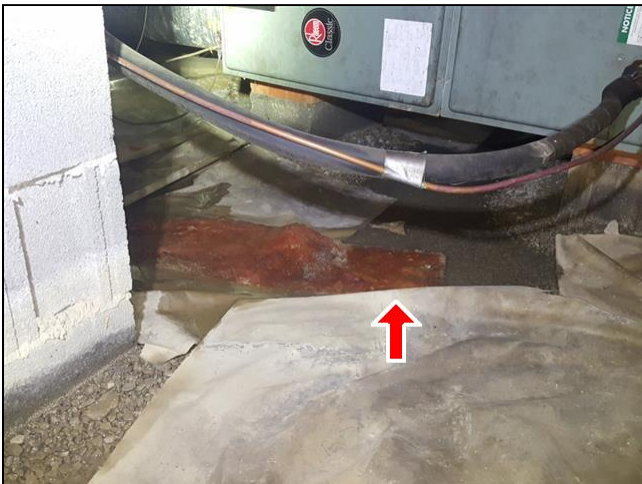
1.2 Item 3(Picture) near air handler

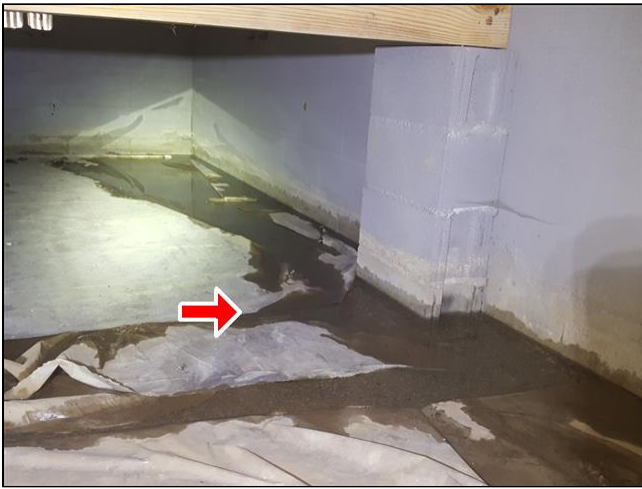
1.2 Item 5(Picture) front left corner of home

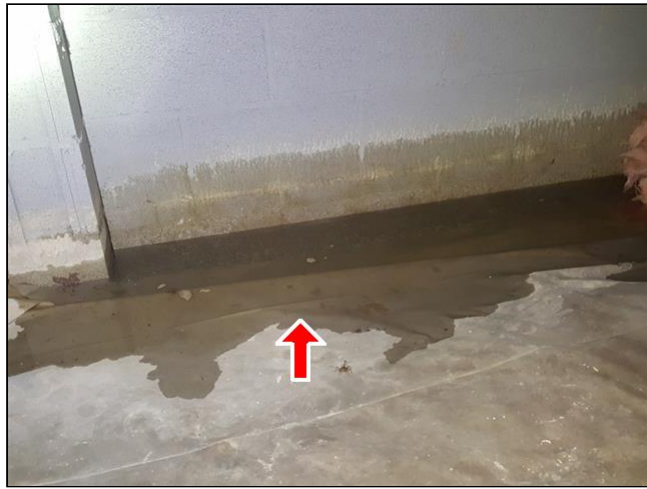
1.2 Item 6(Picture) left side of home

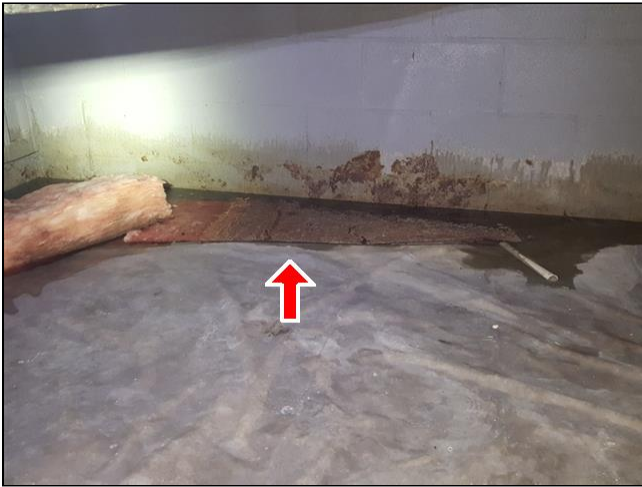
1.2 Item 7(Picture) front right corner of home

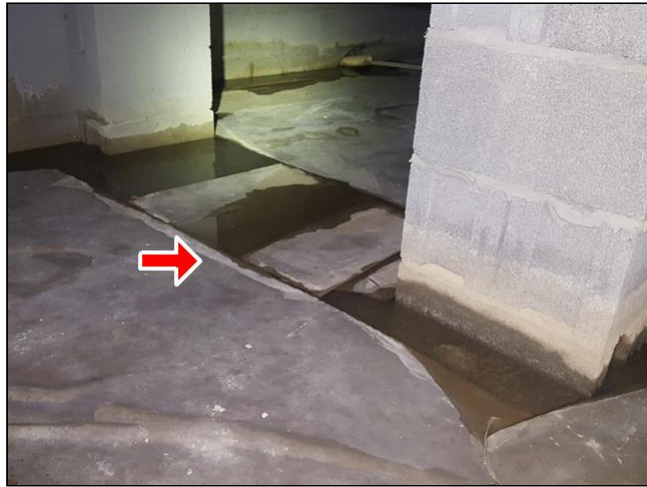
1.2 Item 8(Picture) center of home

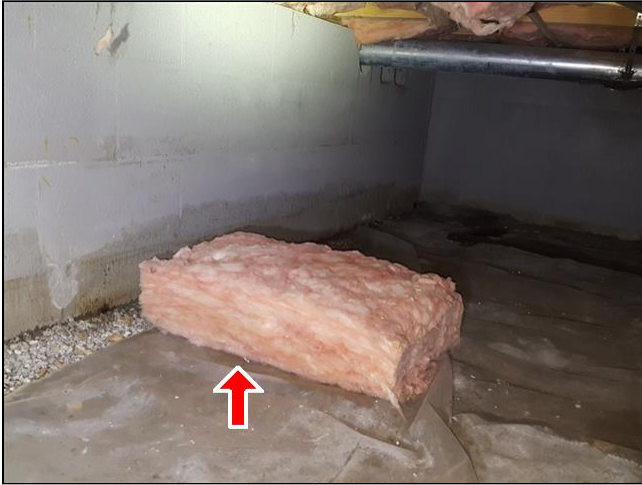
1.3 (1) All insulation and wood should be removed from the crawlspace floor. The insulation will hold moisture creating condensation and possible mold growth on the wooden structure in the crawlspace. Wood debris risks rotting and can attract wood eating insects into the crawlspace which can lead to more costly repairs later. Recommend all types of debris resting on the crawlspace floor be removed to prevent damage to the wood structure of the home.

1.3 Item 1(Picture) under master bathroom area

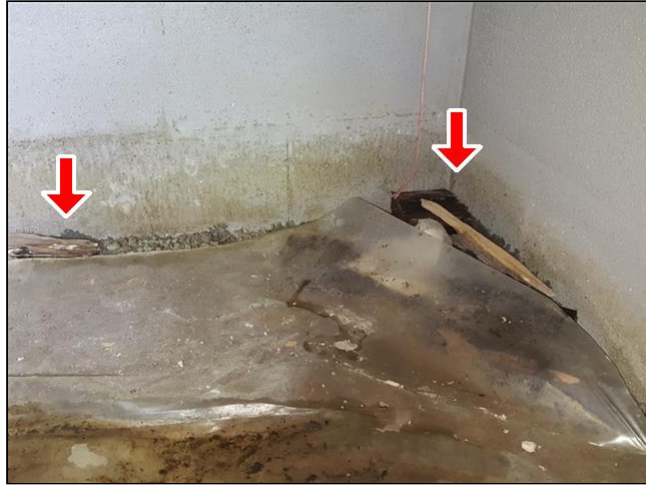
1.3 Item 2(Picture) front right corner of home

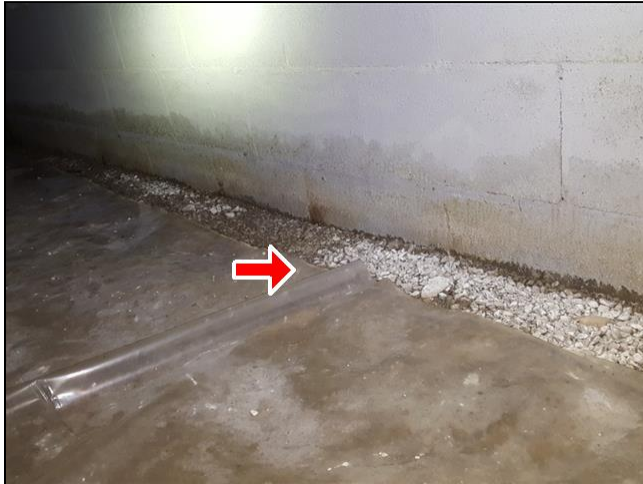
1.3 (2) There are some gaps in the coverage of the vapour barrier in the crawl space floor where indicated in the photo(s). The vapor barrier in the crawl space floor should be adjusted to cover all areas of exposed soil. These gaps are allowing moisture vapor entry and water into the crawl space which promotes condensation, humidity and mold/mildew growth on the floor joists. The plastic vapour barrier should be a minimum of 9mil thick in Kentucky (recommend using 15 or 20 mil) straightened and/or added to as needed to cover the entire crawlspace floor to prevent excessive moisture entering. Recommend correcting as needed using a qualified contractor.

1.3 Item 4(Picture) right side of home

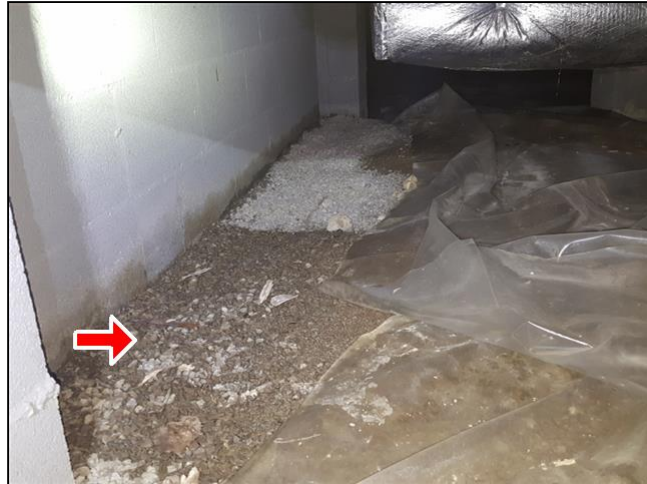
1.3 Item 5(Picture) front right side of home

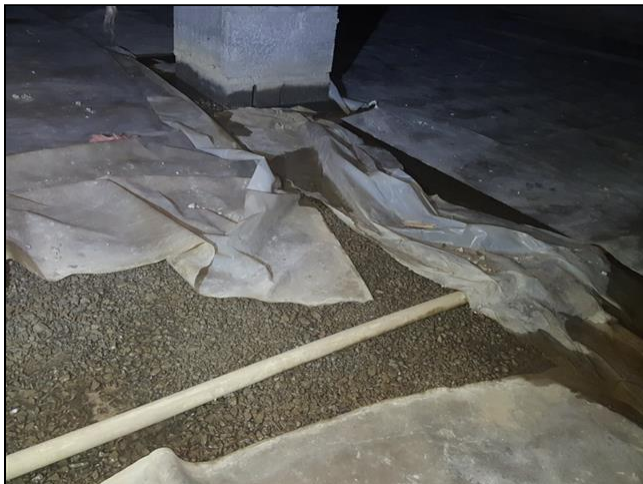
1.3 Item 6(Picture) under dining room area

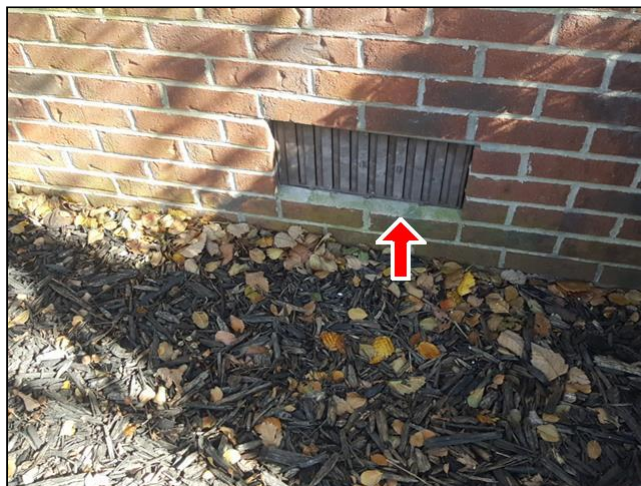
1.9 (1) The vents have been closed/sealed where indicated in the photos for the crawl space. However the crawlspace has not been prepared for encapsulation. Though there was no condensation noted at the time of the inspection. Proper ventilation will help control humidity and reduce the potential for wood rot and condensation forming in the crawlspace. It is recommended that One (1) square foot of free vent area should be provided for every 500 square feet of crawlspace. Recommend the vents be opened. [Information about venting or not venting a crawlspace](#)

1.9 Item 2(Picture) left side of home

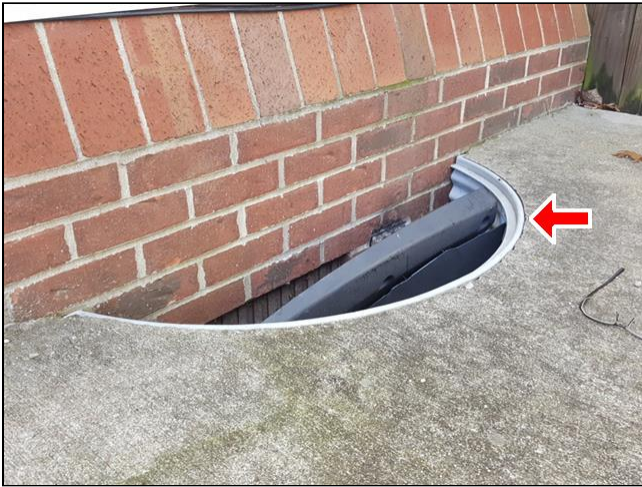
1.9 Item 3(Picture)

1.9 (2) The top of the window well for the crawlspace vent at the right side of the home is close to grade level where indicated in the photos. This can allow water to enter the crawlspace if not corrected which may end up resulting in mold to occur and/or deterioration of the floor structure in the crawlspace. Recommend raising the height to avoid water entering the crawlspace. Recommend correcting as needed by a general contractor repair as needed.

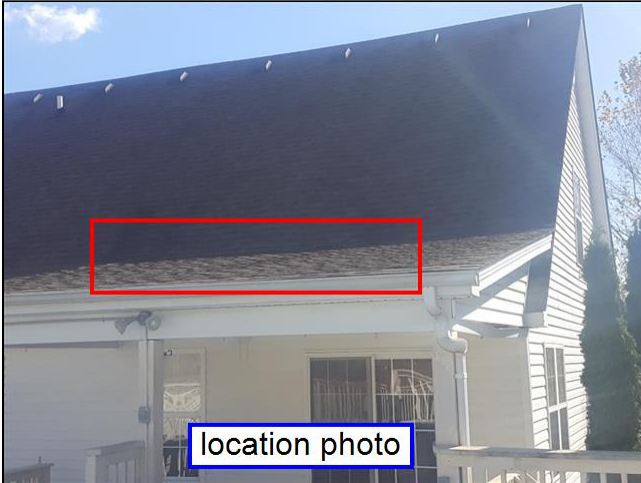
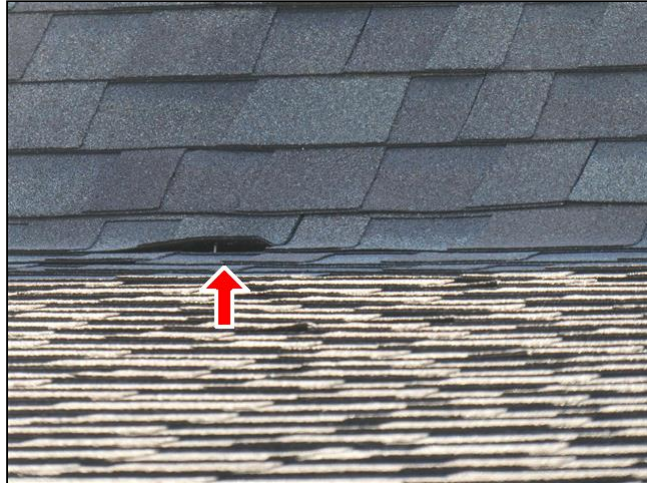
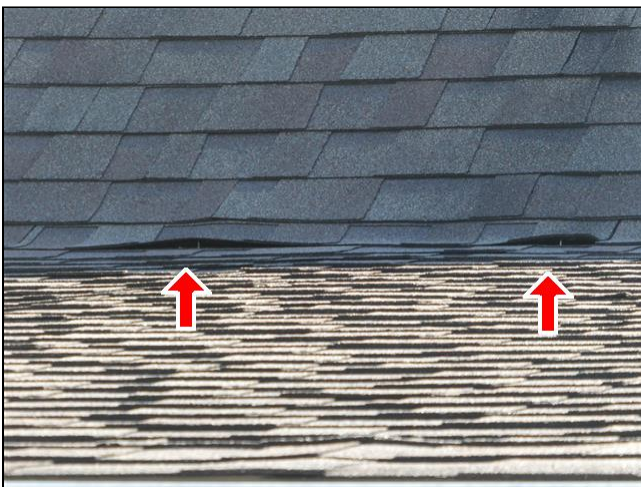
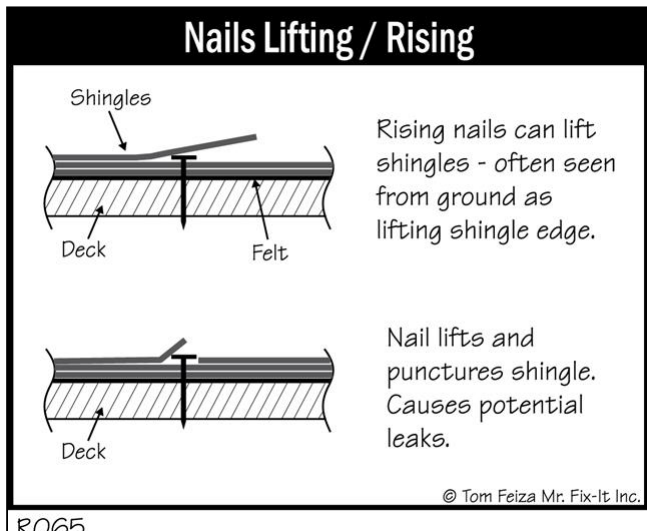
2.0 (1) The shingles are lifting at the rear right side of the home in various places, (see photos for location) due to nails are starting to "back out" which causes the shingle tabs to raise, or the sealant of the shingle tabs has failed. Shingle damage or roof leakage can occur at these areas. They are also at risk to be blown off by high winds. If they raise the shingle more than 1/2" the nails should be reseted to prevent water entry under the shingles. Recommend a qualified roofing contractor repair as needed.

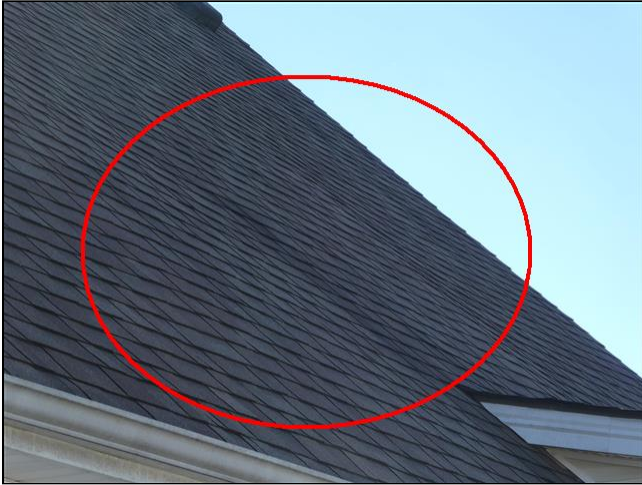
2.0 Item 5(Picture)

2.0 (2) The roof covering shows a mump-like appearance at the rear center of the home, see photos for location. These small little bumps might be caused by hot weather, in which some air beneath the cover layer has become hot and has expanded. These areas will eventually blister creating a water leak and the roof area will need replacing. Recommend a qualified roofing contractor further investigate and repair as needed as these bumps may cause ruptures, and cause leakage later on.

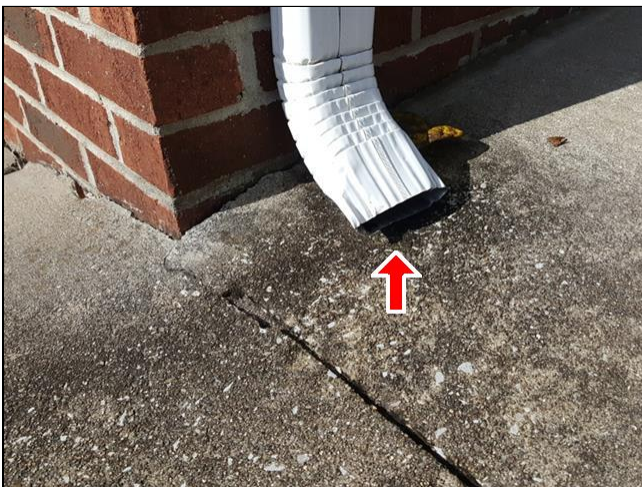
2.3 Item 1(Picture)

2.3 (1) The downspout is crushed at the end at the front right corner of the garage. This is restricting the discharge of water. Evidence of gutter overflowing in this area was observed which may be caused by restricting flow or clogged gutters. Recommend the downspout be repaired or replaced by a general contractor at the end so water will flow freely .

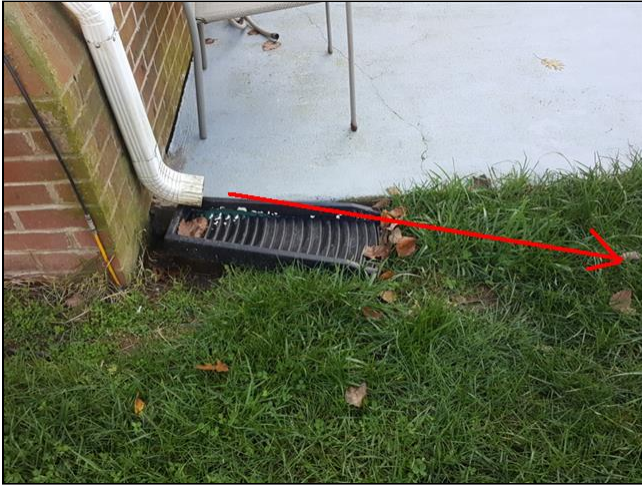
2.3 (2) Recommend the downspout(s) where indicated in the photo(s) be extended at least 6 feet and flow onto splashblocks. This will ensure water is kept away from the foundation perimeter, soil erosion does not occur and water cannot leak into the crawlspace area which may cause settlement of the foundation.

2.3 Item 2(Picture) rear left corner of home

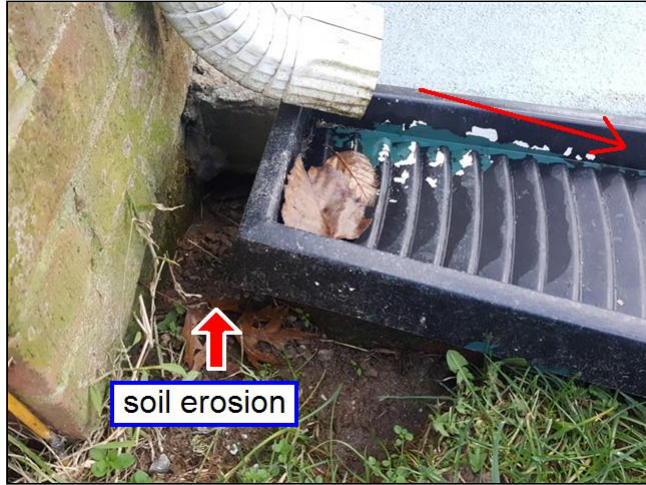
2.3 Item 3(Picture) rear left corner of home

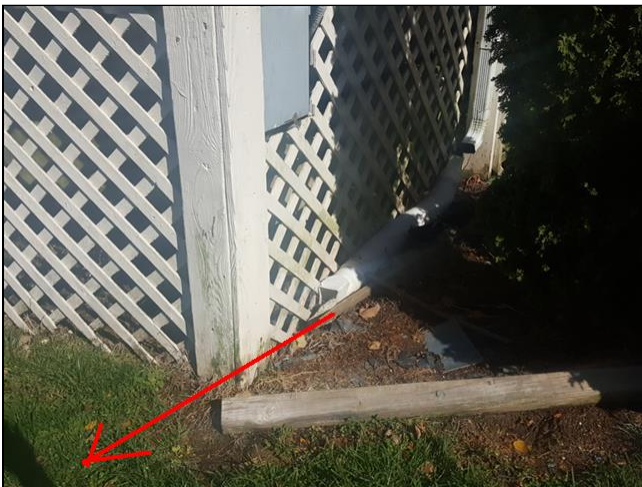
2.3 Item 4(Picture) rear right corner of patio porch

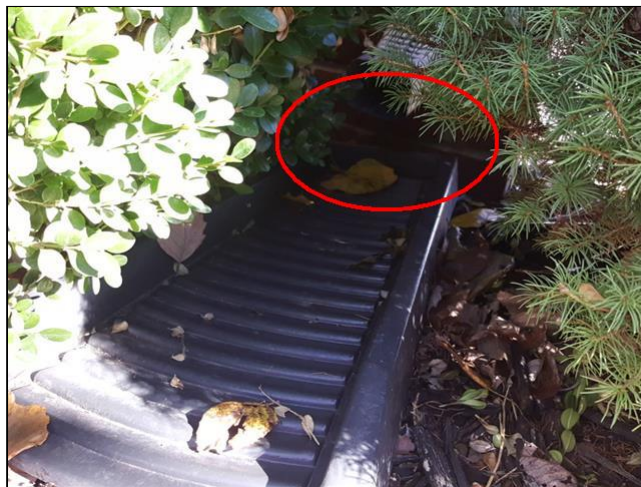
2.3 (3) Recommend the downspouts where indicated in the photos be extended or corrected to ensure water is draining correctly after the brick border and walkway in the garden bed. This will ensure and prevent excess water not being trapped in the front garden bed which may cause leakage into the crawlspace and/or settlement of the foundation of the home. Repair as needed by a general contractor.

2.3 Item 9(Picture) front left corner of garage

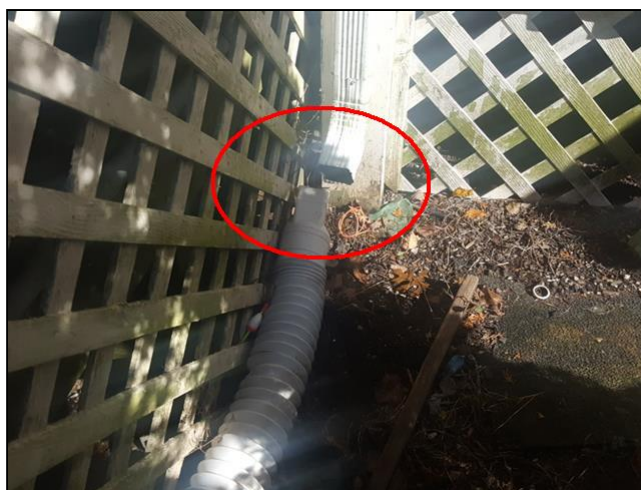
2.3 (4) Recommend the downspout extension(s) be attached to the downspout where indicated in the photos by placing a screw at the top and bottom where it connects to the downspout to ensure the extension(s) does not pull away from the downspout(s). Failing to do this may create future problems to the foundation around the home due to soil erosion and water entering the crawlspace which may result in the foundation settlement if the extension detaches from the downspout.

2.3 Item 11(Picture) rear right corner of patio porch

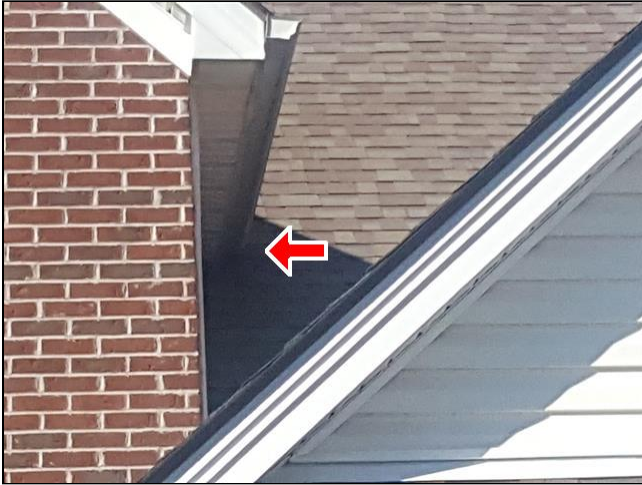
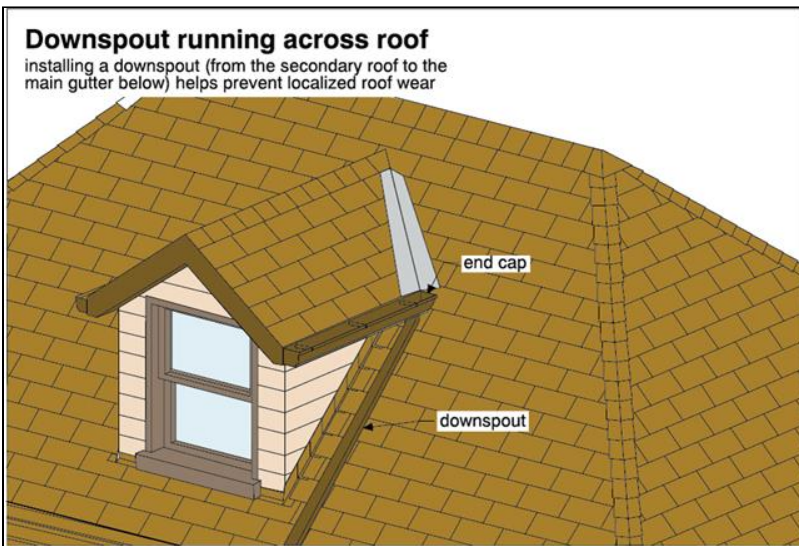
2.3 (6) Recommend the gutters(s) that discharge onto the roof have downspout extensions attached and be extended to discharge water directly into the gutter below. This condition, if left unattended, can result in premature deterioration and staining of the roofing material under the end of the gutter. The excessive discharge of storm water onto the roof also puts stress on building materials designed to prevent water entry into the structure of home. Recommend correcting as needed using a qualified gutter installer.

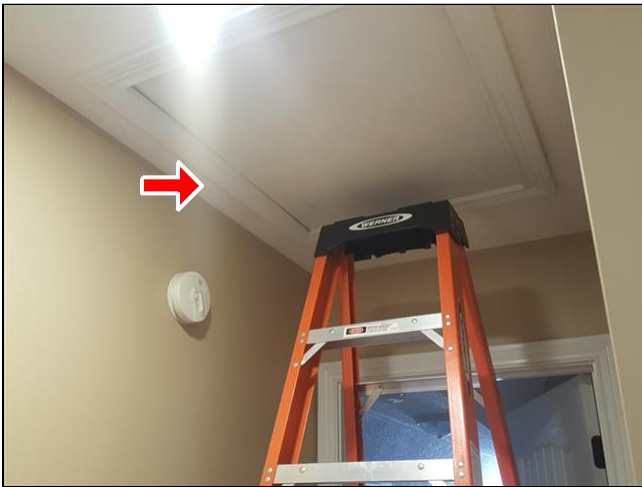
2.4 (1) Attic access location (see photo)

2.4 Item 1(Picture) hallway ceiling upstairs

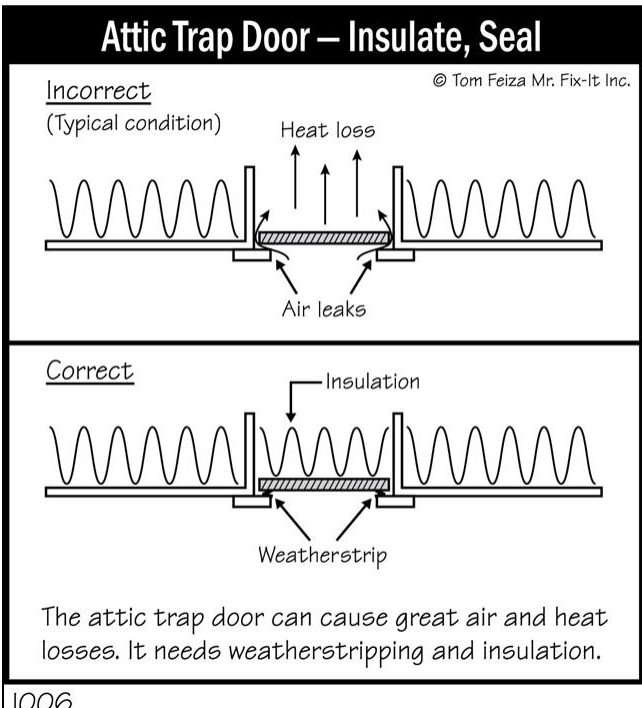
2.4 Item 2(Picture)

2.4 (2) Recommend the attic access hatch be insulated to prevent air and heat loss for energy conservation.

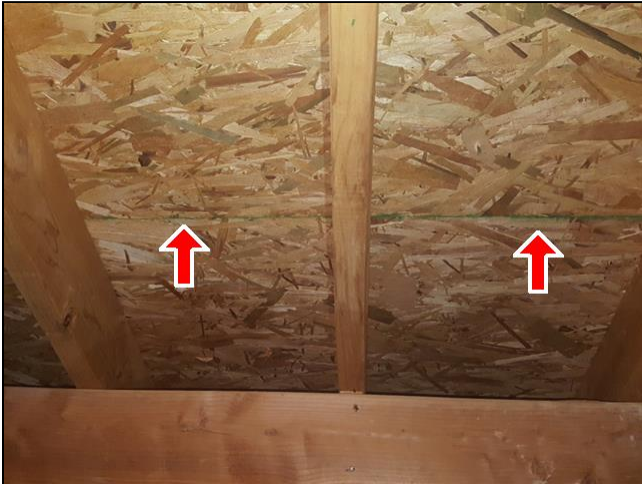
2.5 Item 1(Picture)

2.5 (1) There is no 1/8" spacing or ply clips at the ends, joins or sides of the roof sheathing as is recommended. Without this space the edges of the sheathing could raise if moisture enters and expands the sheathing. The raised areas could then be easily seen as the shingles conform to the surface of the roof sheathing on the outside. No problems were found at time of inspection. If this condition appears and is bothersome the shingles will need to be removed and the sheathing replaced or if possible a relief joint cut at the edges of the sheathing by a qualified roofing contractor. At the moment this is not a high priority. Strongly recommend that when a new roof is installed that this be done then.

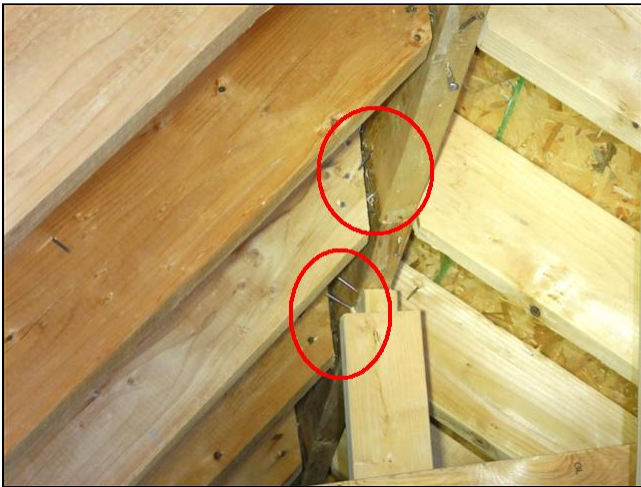
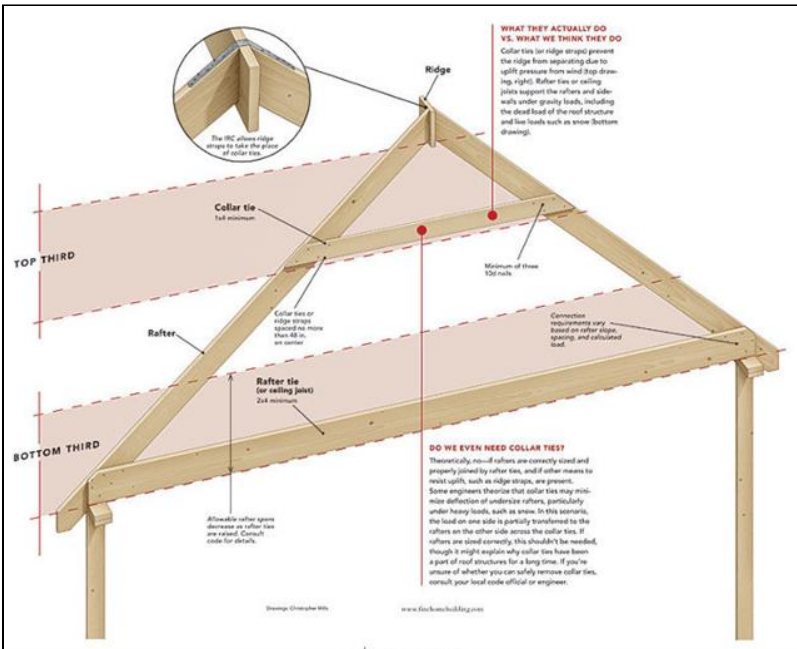
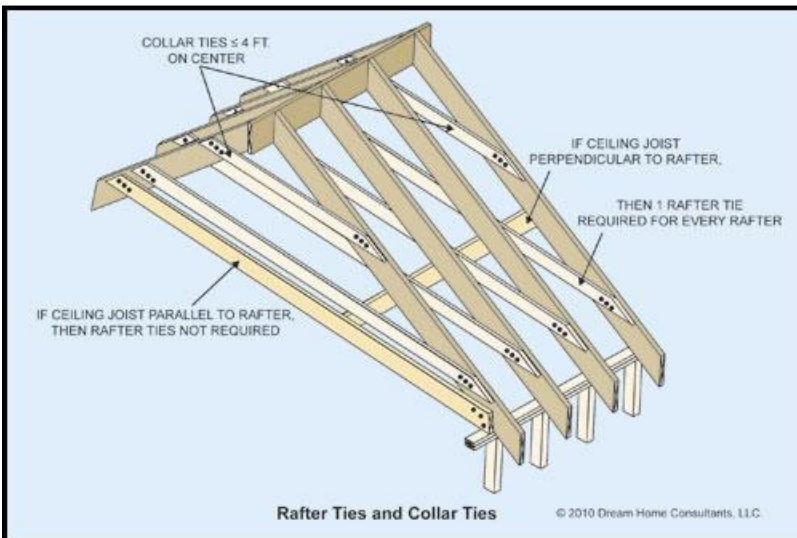
2.5 (2) Various rafters are pulling away at the joins in the attic. Repairs are needed to maintain the stability of the roof. Excess loads on the roof like snow can cause further separation if not reinforced. Recommend additional collar ties (horizontal members running between each rafter, near their mid span) or vertical supports to the rafters in the attic to add extra support to the roof structure and to resist rafters from separation in the future. Recommend a qualified framing roofing contractor further investigate and make any necessary improvements or repairs to the roof structure as needed and correct any other problems found prior to closing.

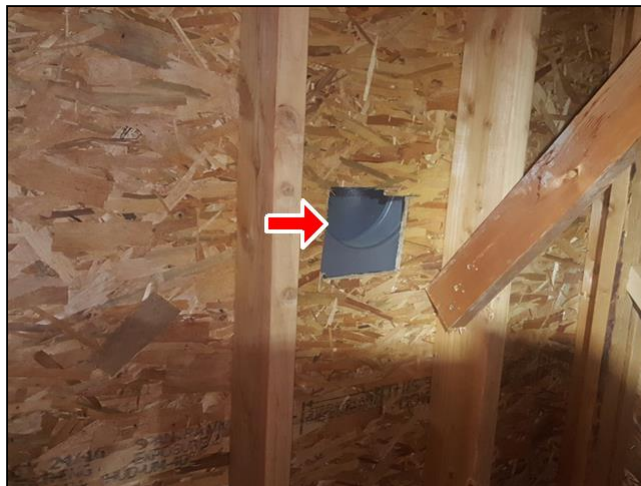
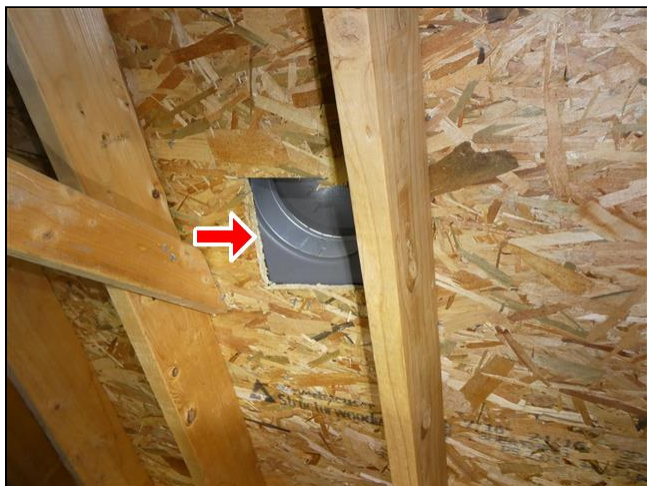
2.6 The roof sheathing was not cut open correctly when the passive exhaust vents were installed. The exhaust venting is partially blocked. This will prevent proper airflow through the roof space and provide proper ventilation of the attic. Proper ventilation will help to keep the house cooler during warm weather and extend the life of roofing materials. In the winter, it will help reduce the potential for ice dams on the roof and condensation within the attic. It doesn't warrant for corrections to be made now due to no real issues noted in the attic from this condition. However when the roof is replaced in the future, strongly recommend the roofing contractor repair as needed to allow for proper exhaust venting.

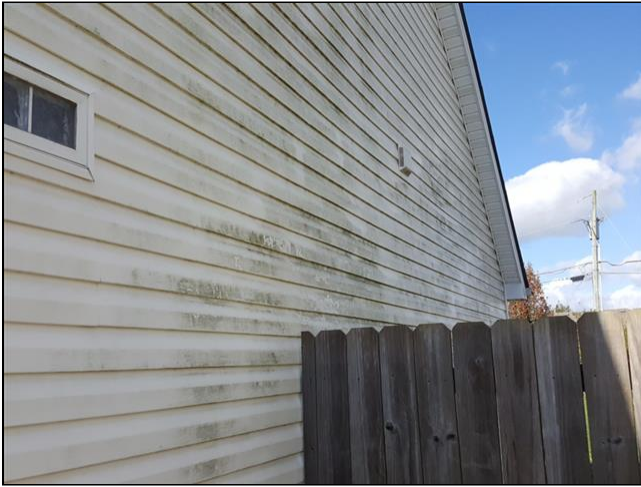
3.1 Item 1(Picture)

3.1 Algae was seen on the Vinyl siding on the right side of the home. This side of the home does not receive direct sunlight and this growth is common in shady areas. Recommend cleaning with soap and water and also removal of plants that are in contact with the wall siding as they attract moisture.

Always work "bottom up" when washing vertical surfaces and keep the lower area damp. This prevents streaks and stains from dirty wash water on a dry surface.

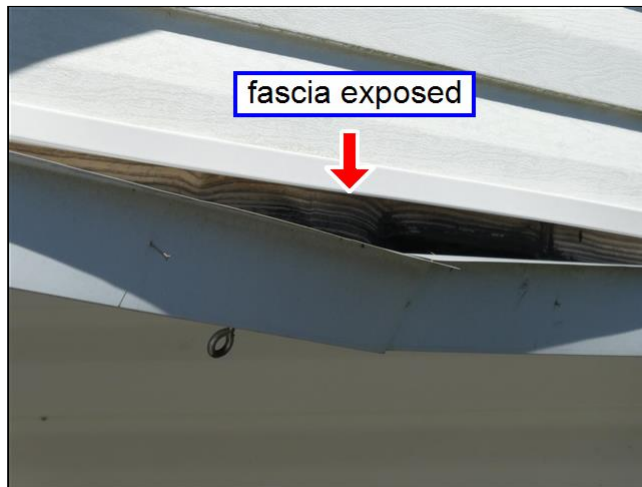
3.2 Item 2(Picture)

3.2 The fascia board at the right side of the patio roof where indicated in the photo(s) has a metal wrapping which is separated and hanging loose and is exposing the wood fascia to the weather. These areas need to be sealed/covered to prevent possible water intrusion which can cause the fascia to deteriorate leading to costly repairs if not corrected. Recommend a qualified contractor repair as needed.

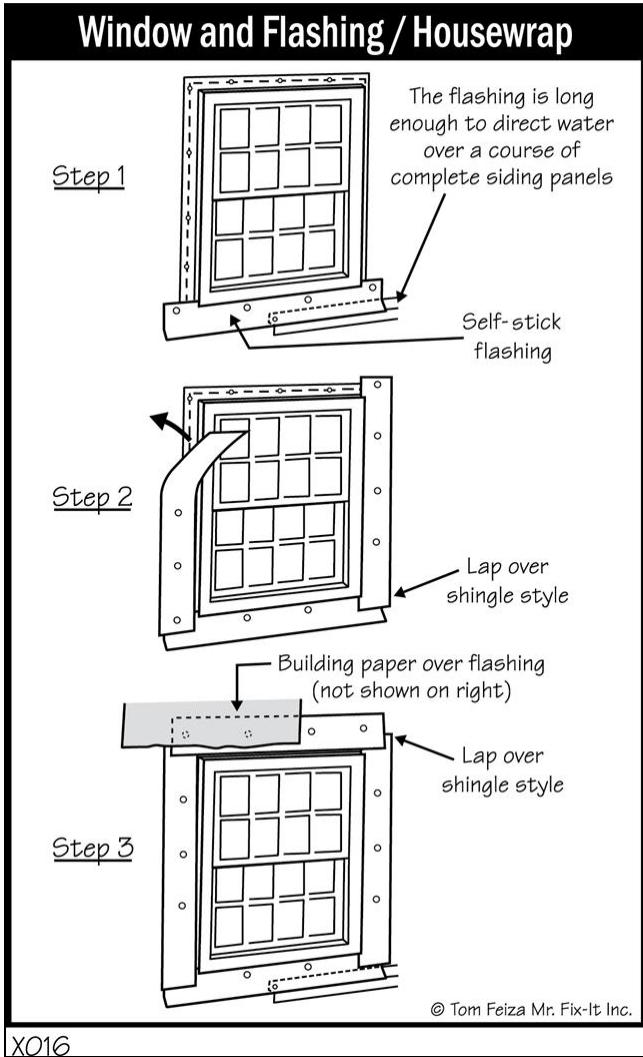
3.4 Item 1(Picture)

3.4 (1) Most flashings are not visible for inspection and some windows and doors have hidden flashings that are never visible. Exterior wall building paper or house wrap and flashings connections are not visible.

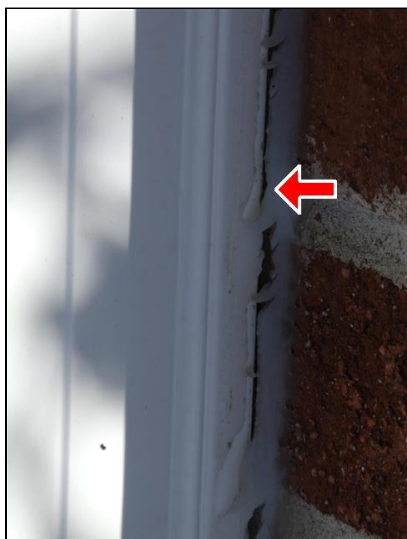
3.4 (2) The window frame at the front left side of the home has cracked sealant between the siding and the window frame. Water and/or insects may enter and deterioration may occur behind the wall cavity and siding. This is a small repair. Recommend re-caulking as needed. [Which caulk to use](#)

3.4 Item 2(Picture) formal dining room window

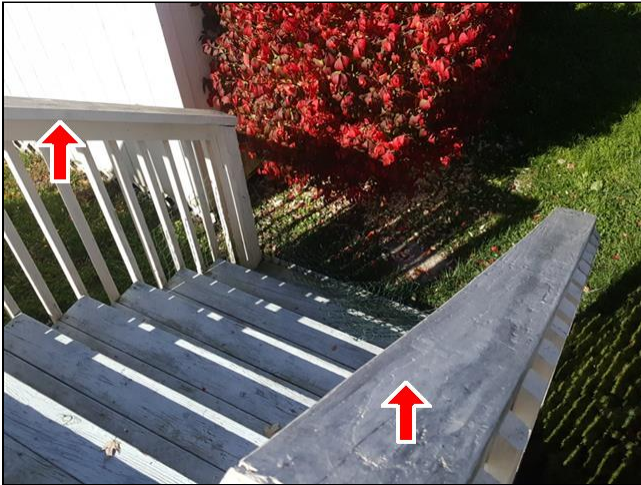
3.6 Item 1(Picture)

3.6 2x6s are installed for handrails for the deck staircase and are not considered "gripable" by industry standards. This is a safety issue and an injury could occur if not corrected. Recommend that a standard approved handrail be installed for safety by a general contractor.

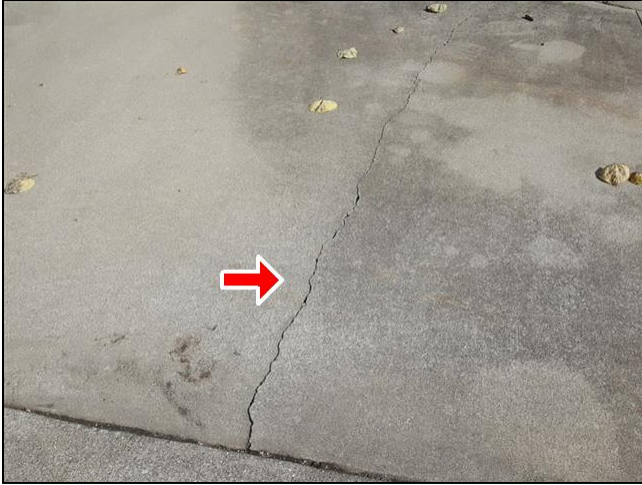
3.7 Item 1(Picture)

3.7 Common settlement crack(s) were noted at the concrete drive. This is not a tripping hazard as yet at this time. I also do not see these small cracks as an indication of a structural issue. Further deterioration and/or settlement can occur to the driveway/walkway via water intrusion if not repaired. Recommend repairs via a masonry caulk as needed then monitor annually. Here is a link for [Sealing Concrete Cracks](#)

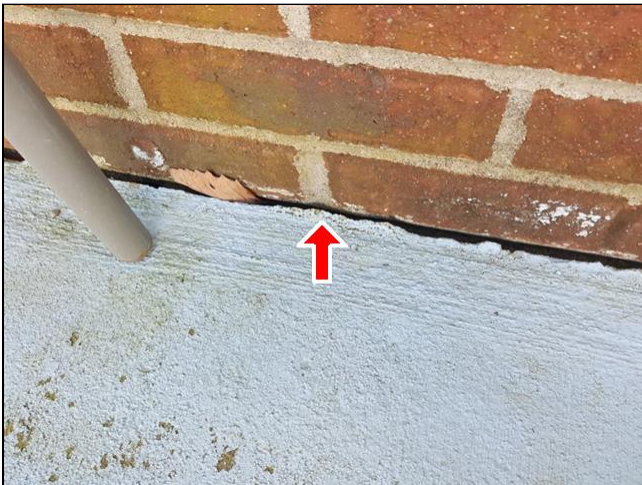
3.8 Item 1(Picture)

3.8 The gaps between the patio floor at the rear of home should be sealed where it meets the house to prevent water impingement against the foundation wall. This will avoid water intrusion in the crawlspace and possible settling of the foundation perimeter and patio slab of the home. Here is a link that can be helpful. [Foundation and Concrete Cracks Fillers](#)

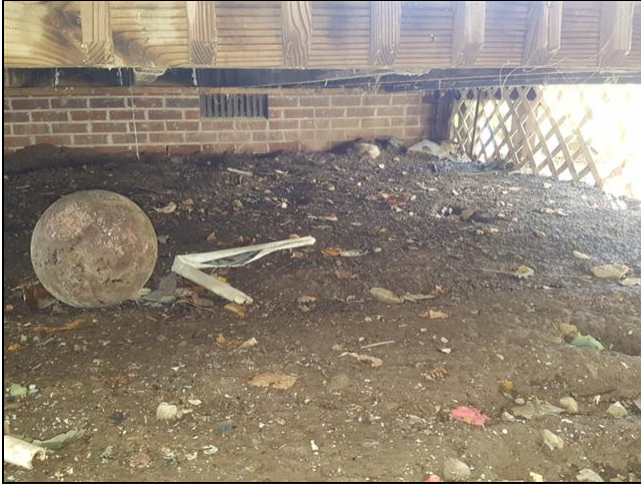
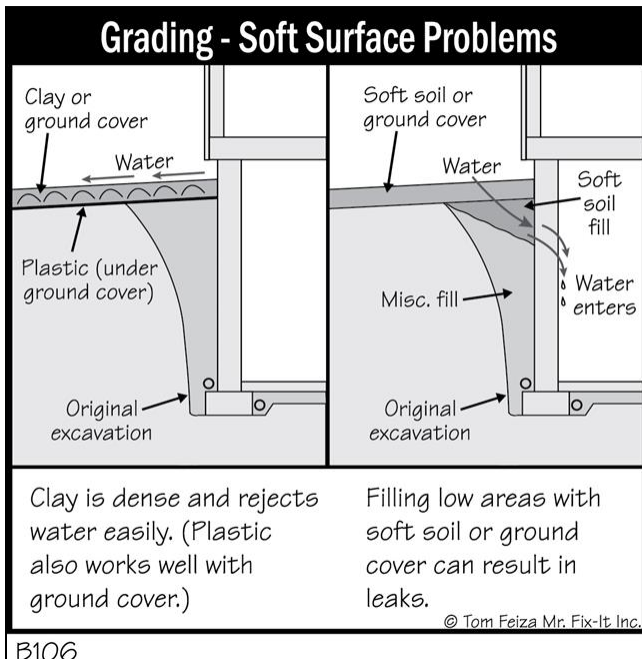
3.10 (1) Recommend installing a plastic sheet covering under the deck at the rear of the home at about 2 feet wide or entire underneath of the deck to prevent water entering the crawlspace. This improvement will prevent excess water draining into the soil along the foundation which can lead to water intrusion inside the crawlspace and prevent settlement of the deck post.

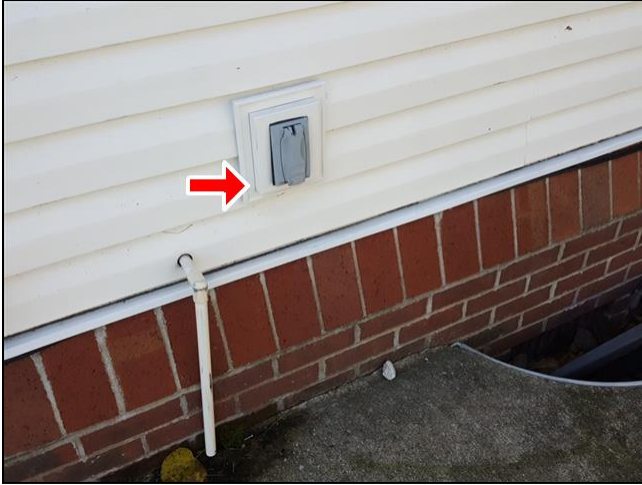
3.13 Item 1(Picture)

3.13 The outlet(s) on the right side of the home is loose in the wall. Electrical issues are considered a hazard until repaired. This is a safety issue that needs to be corrected due to an electric shock or fire from loose connections could occur if not repaired. Recommend a qualified licensed electrical contractor correct as needed.

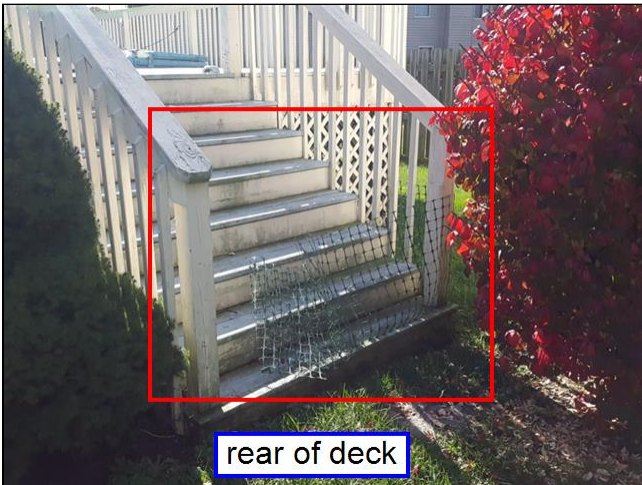
3.14 Item 1(Picture)

3.14 Please note our company does not inspect pools however it is recommended for safety that a gate be installed at the entry points at the deck to the pool to prevent an accidental death of a child via drowning if they were to fall in. Ensure the fencing surrounding the property and exterior gates leading into back yard are always kept in perfect condition and working order. This is for your information.

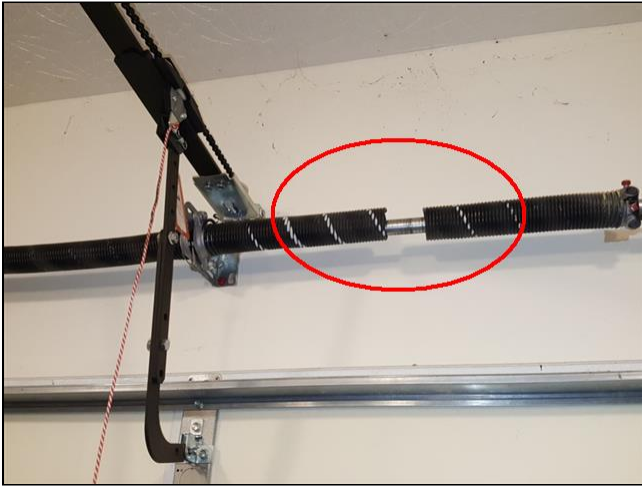
4.3 Item 1(Picture)

4.3 (1) The torsion spring is broken on the right side in the garage. This can cause strain on the moving parts and shaft when the door is opened and closed which could lead to broken cables, door opener or the door could fail if not repaired. Recommend a qualified garage installer replace torsion spring as needed.

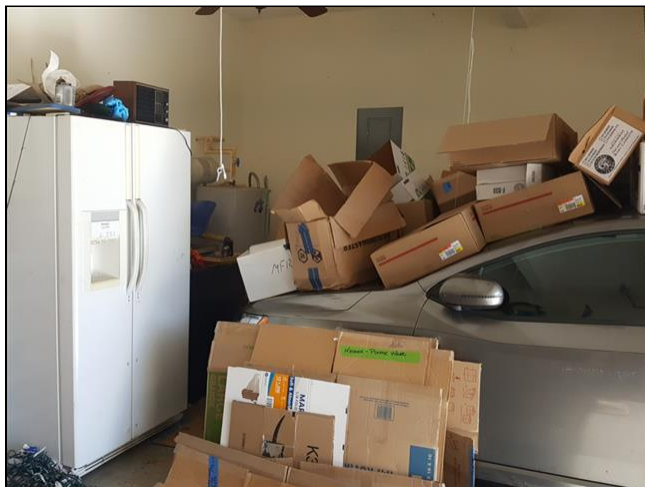
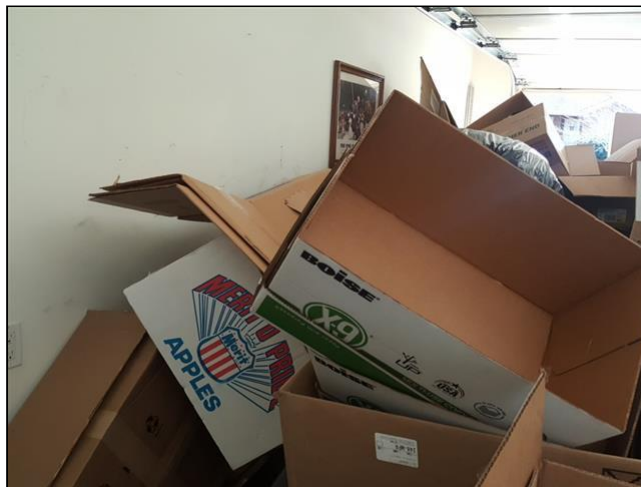
4.7 Note: Limited Inspection of the garage was performed due to excessive personal property, unable to view most of the walls, slab and access switches and outlets. Recommend further inspection of these item(s) / areas prior to closing.

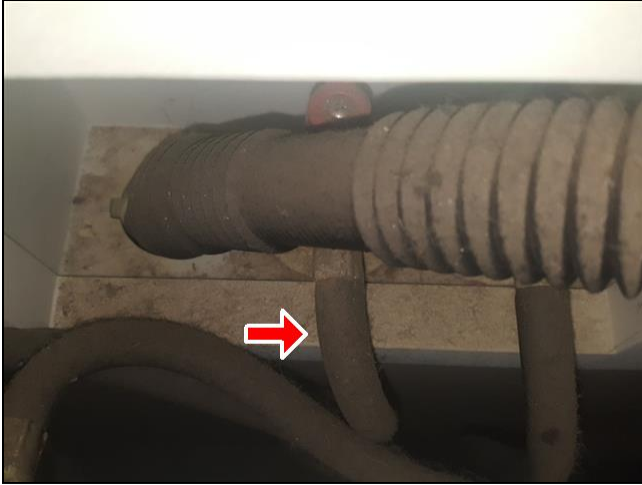
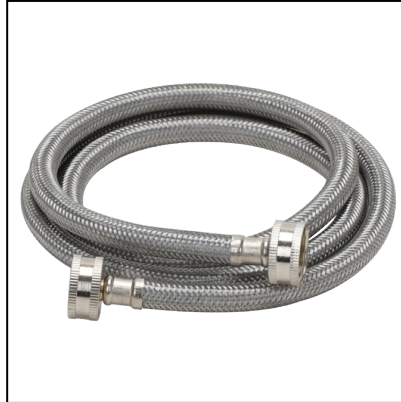
5.0 Your washing machine is connected to rubber hoses. These hoses are under constant water pressure and are prone to leaks or even bursting overtime. This will cause damage to your home. You may wish to convert hoses to "No-burst hoses" which are encased in a woven metal sleeve that prevents weak spots in the rubber from developing into leaks. This is for your information.

The hoses connected to your clothes washer are always pressurized (unless you turn the valve off.) Use special reinforced hoses or hoses that automatically turn off if they sense a leak.

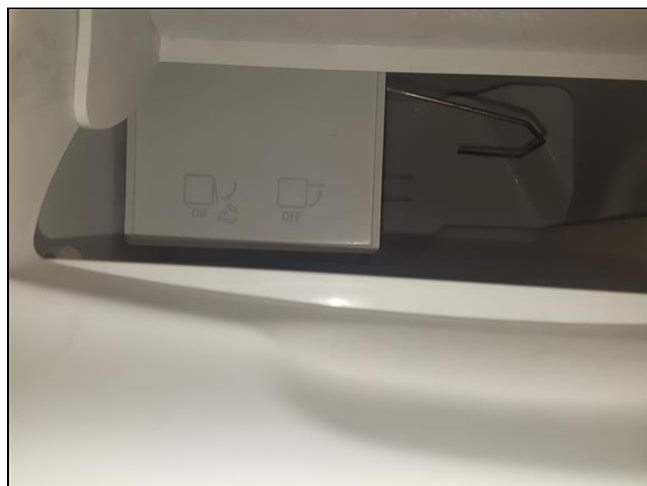
5.6 Item 1(Picture)

5.6 The refrigerator does have a water supply line connected to it. The ice maker was turned off at time of inspection. Therefore the ice dispenser was not inspected. The water dispenser does work. This is for your information.

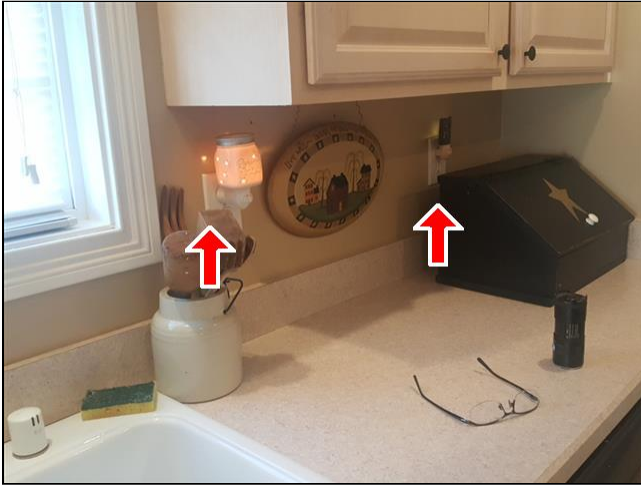
5.9 Item 1(Picture)

5.9 (2) The outlets in the kitchen where indicated in the photo(s) are not GFCI protected. GFCI (Ground fault circuit interrupters) outlets should be considered for installation as a safety upgrade in all locations where water is present if the outlets are not presently connected to a GFCI. They are now required in all bathrooms, kitchen, unfinished basements, garages, exterior outlets, or other locations within 6' of a water source or sink. GFCI outlets may not have been required when this house was built but should be considered for safety. Recommend a licensed electrician replace as needed.

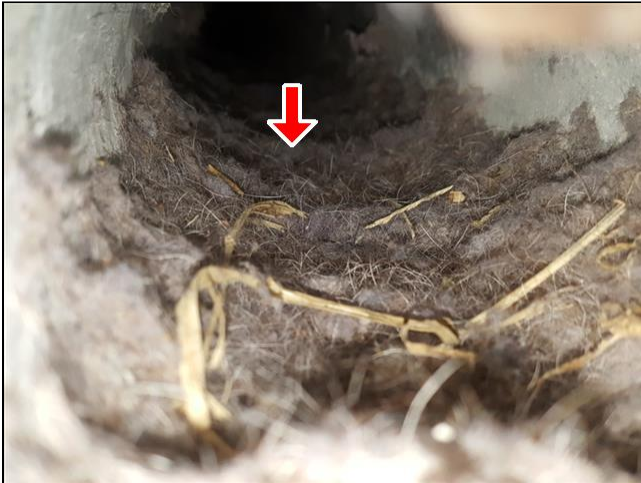
5.10 Item 1(Picture)

5.10 (1) The dryer vent pipe has a large build up of lint inside. This is restricting the flow and may cause a back-draft. This can cause a fire to occur due to excessive heat build up in the vent pipe. Also your dryer runs longer, putting more wear and tear on it and therefore cutting the machines life in half. Strongly recommend cleaning the dryer vent for safety before moving in and operating dryer.

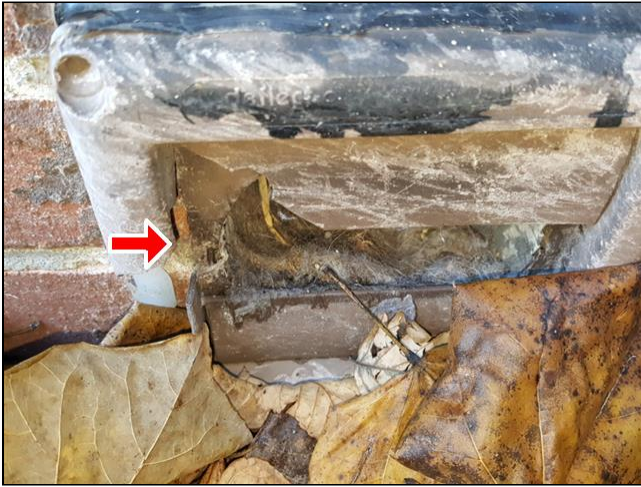
5.10 Item 2(Picture)

5.10 (2) The dryer vent cover is damaged and has missing louvres at the right side of the home. The opening can allow rodents or birds to enter then building a nest which may cause a blockage that could result in fire and/or poor venting. Recommend a new vent cover be installed as needed.
