TALCO
Home Inspection

Inspection Report

Property Address:
125 Crimea Drive
Nicholasville KY 40356

Date: 11/6/2018	Time: 10:00 AM till 02:00 PM	Report ID: 181106ANTHONY
Property: 125 Crimea Drive Nicholasville KY 40356	Customer: Ms. Sharon Anthony	Real Estate Professional:

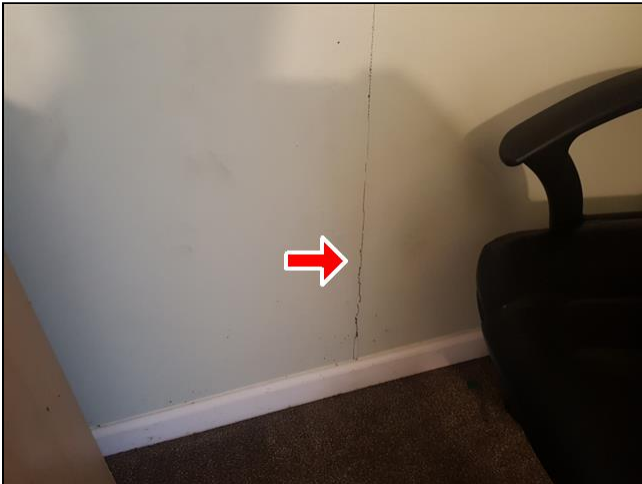
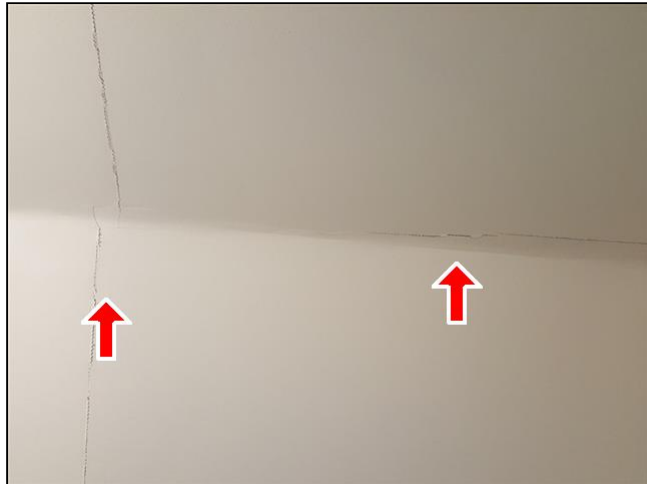
6.0 (3) The cracks in the ceiling in the 2nd bedroom closet (see photos for location) appear to be common settlement and/or shrinkage cracks. Cracks larger than 1/8" are of concern only. Cracks of this nature are caused by moisture, changing temperature, or framing shrinkage due to a lack of ventilation of vaulted ceilings and in the room. Recommend repairing cracks, replace solid door with a louver door to allow for ventilation to prevent high humidity in the room, then paint and monitor. If cracks reappear and become larger than 1/8" then would recommend a qualified contractor further investigate to determine cause and suggest repairs.

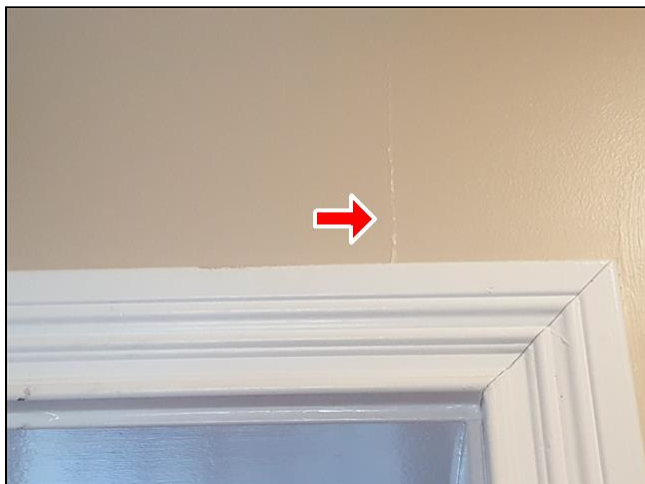
6.1 Item 1(Picture)

6.1 The crack(s) noted on the wall into the kitchen above the door entry way, (see photos for location) are common minor settlement vertical crack(s). Cracks larger than 1/8" wide are of concern only. Minor settlement of the home has occurred due to the age of the home and from perhaps via framing shrinkage. This damage is considered to be cosmetic and a small repair issue for your information. Recommend prep prime and paint as needed.

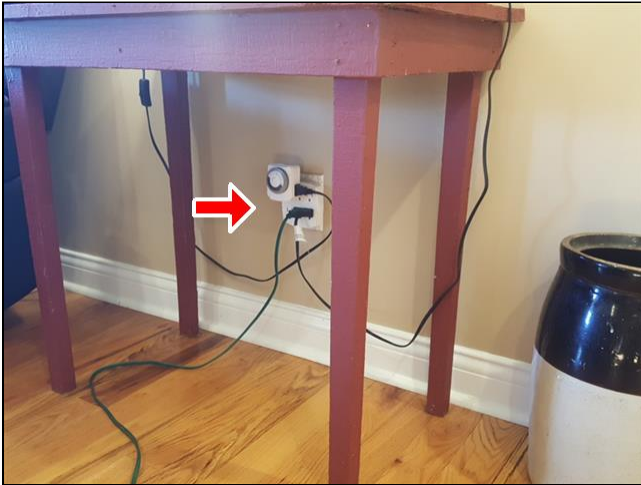
6.7 Item 1(Picture) living room

6.7 (1) It is not recommended that these adapters be used in the outlets as they can overheat and cause a fire. This is for your safety. Especially in areas like kitchens where numerous appliances can be connected. If additional outlets are required, recommend a qualified electrician install them as needed.

Do not use adapters that allow multiple cords into one outlet. You may overload the outlet/circuit. They often have no ground, resulting in poor connections, excessive heat – posing a fire hazard!

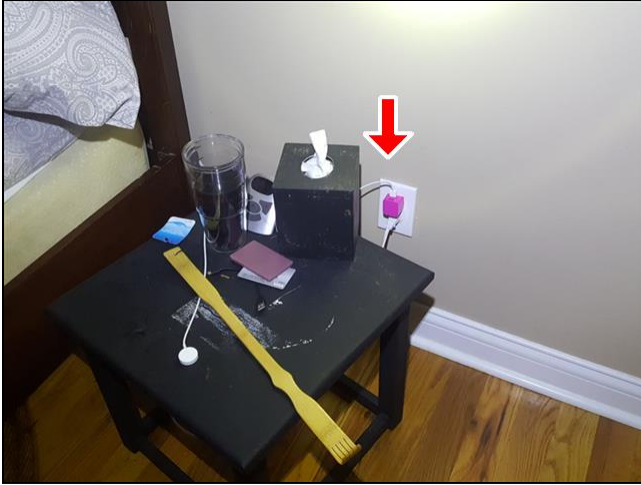
6.7 Item 5(Picture) master bedroom

6.7 (2) The outlet(s) in the rooms where indicated in the photo(s) are loose at the wall or in the outlet box. Electrical issues are considered a hazard until repaired. This is a safety issue that needs to be corrected due to an electric shock or fire from loose connections could occur if not repaired. Recommend a qualified licensed electrical contractor correct as needed.

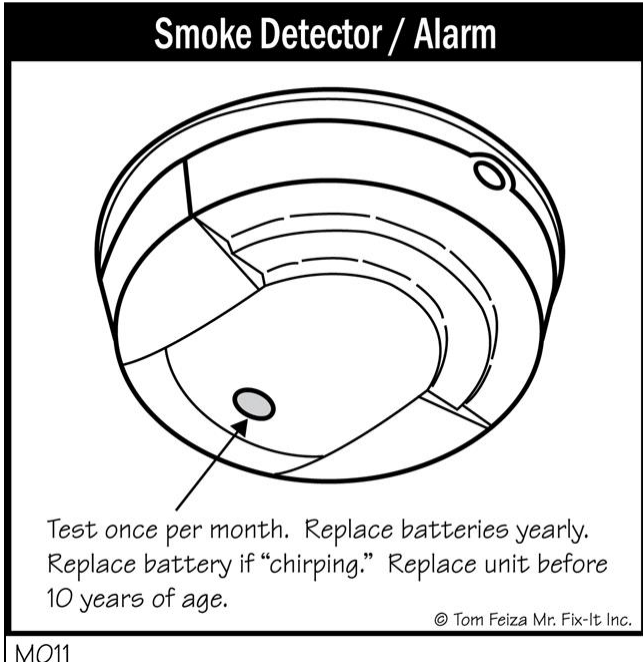
6.8 Item 1(Picture)

6.8 Testing of smoke and CO detectors is not part of a home inspection. We do not want to create a false alarm. All detectors in the home exhibit the active green light which indicates they are on and functioning. Recommend the smoke detectors be tested at common hallway to bedrooms upon moving in to home. Note: If the smoke/CO alarm is 10 years old or older, recommend replacement. Ensure the smoke alarm is a photoelectric type. Here is a link explaining type of alarm to use by the [Dept. of Fire and Emergency Services](#)

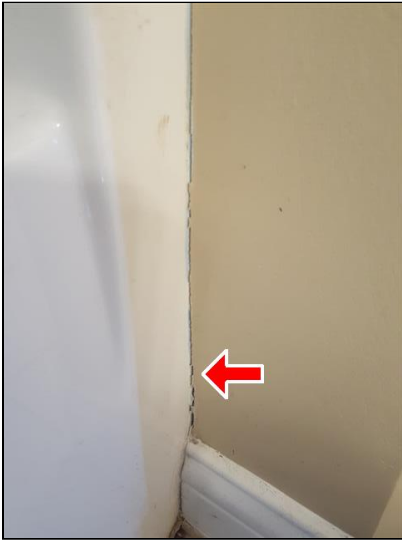
7.0 Item 1(Picture)

7.0 (1) Cracks in the caulk between the tub and the wall in the master bathroom should be sealed to prevent water intrusion behind the wall. If not corrected mold and/or deterioration of the wall framing can occur. Recommend caulking or grout to repair. [Choosing the right caulk](#)

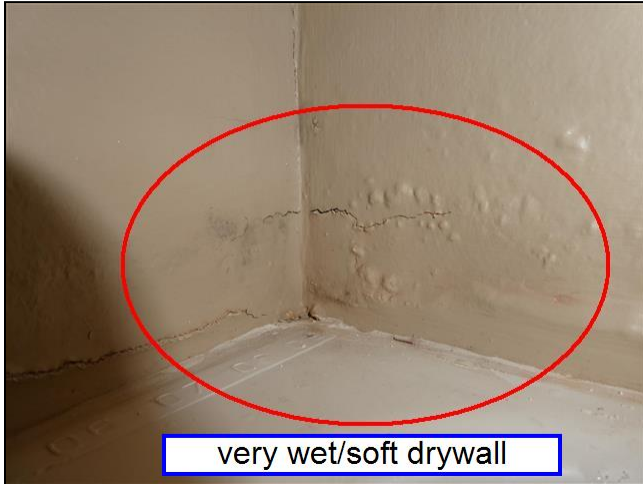
7.0 Item 2(Picture)

7.0 (2) The drywall was very damp on the wall where it butts up to the shower enclosure in the 2nd bathroom. This indicates there is water leak somewhere. There were no signs of leakage in the attic. I am unable to determine cause of dampness. The repair work will likely involve the removal of the covering in order to determine where the leak is coming from and if it still exists. The extent of the damage cannot be realized until the covering is removed. There could be mold behind the drywall. Recommend a plumber and/or roofing contractor further inspect, evaluate and repair/correct as needed.

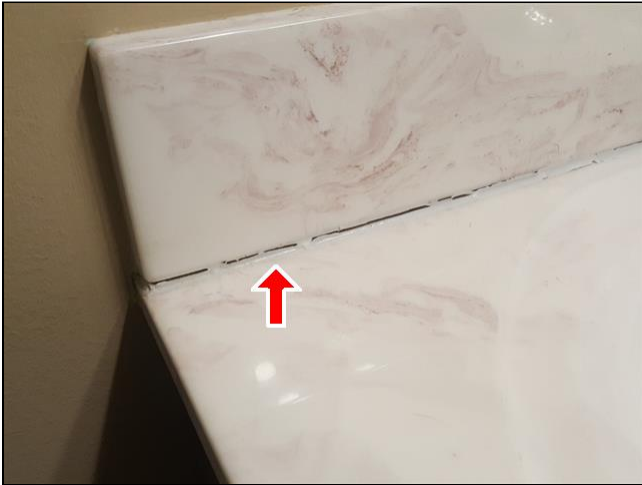
7.2 Item 1(Picture)

7.2 Recommend caulking around the counter top in the master bathroom to seal the crack. Water may enter which can cause damage to the drywall and cabinets, then result in possible mold forming. Repair using a quality caulk that is resistant to moisture and is expandable. Here is a link on [How to Choose the right Caulk](#)

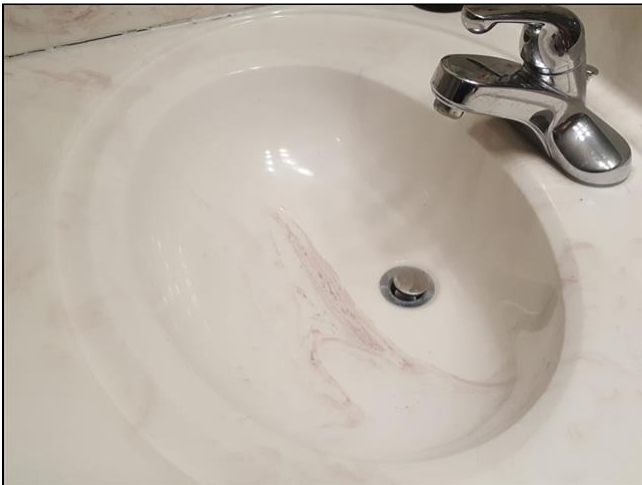
7.4 Item 1(Picture) master bathroom

7.4 The sink(s) in all the bathrooms do not have overflow holes. Over flow holes are recommended at all sinks to prevent water spillage which can lead to damage cabinets or flooring. This is for your information.

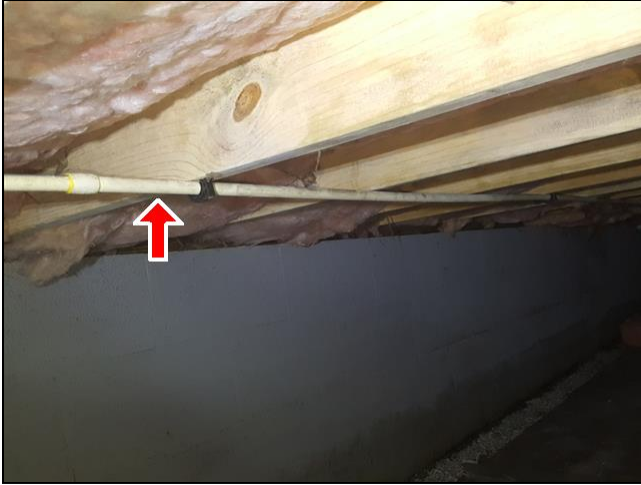
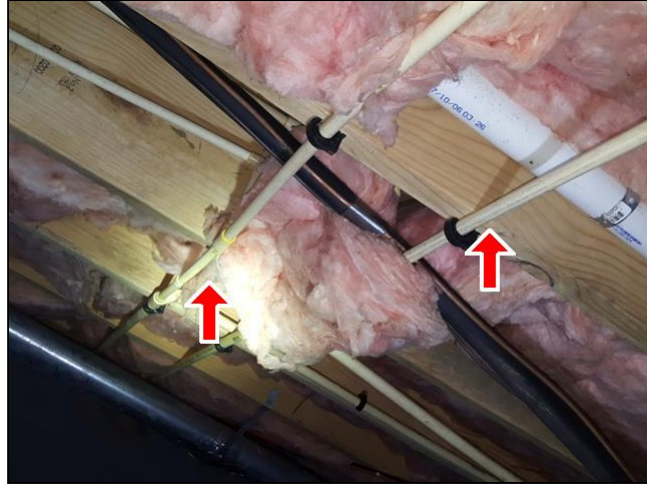
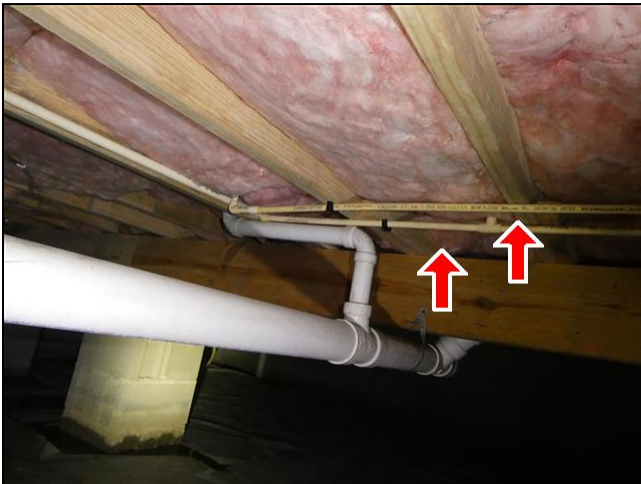
8.1 (2) Recommend insulating the water supply pipes underneath in the crawlspace (hot and cold) to ensure pipes do not freeze in winter which may cause a serious plumbing leak in the crawlspace, and to prevent heat loss of water when hot water is flowing into home. This will improve efficiency. This is for your information.

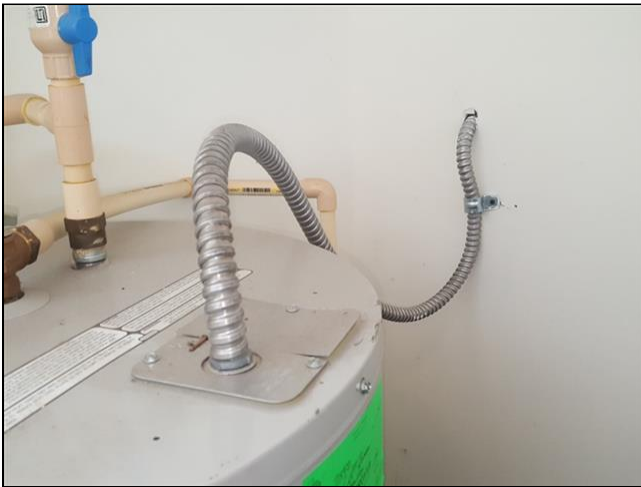
8.2 Item 1(Picture)

8.2 (3) There is no direct electrical disconnect for the water heater. The unit can only be turned off at the breaker in the panel box. Recommend one be installed when the water heater is replaced to provide ease of turning off the unit. This is for your information.

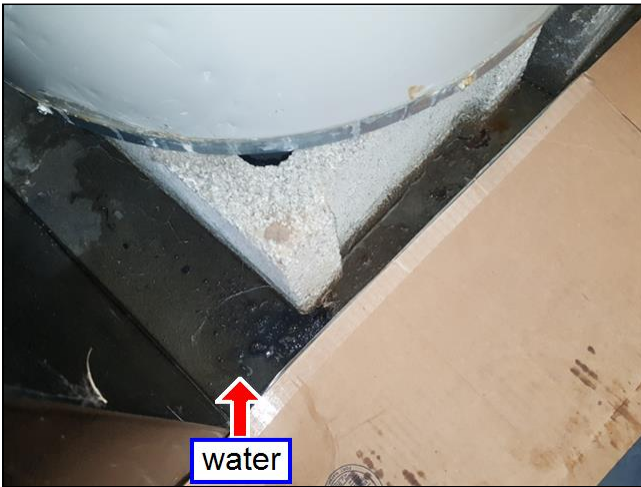
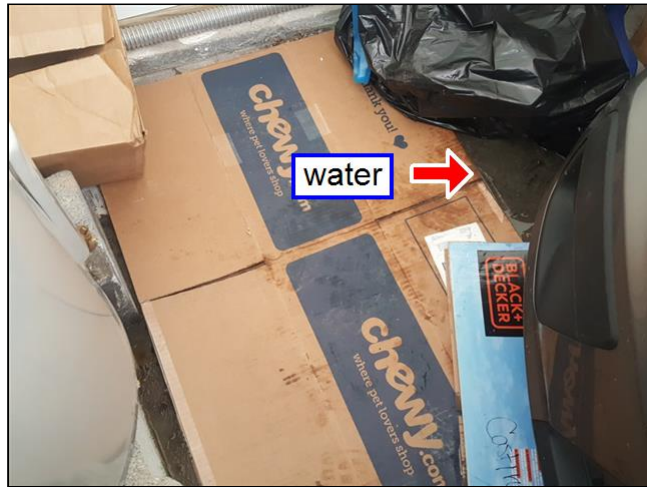
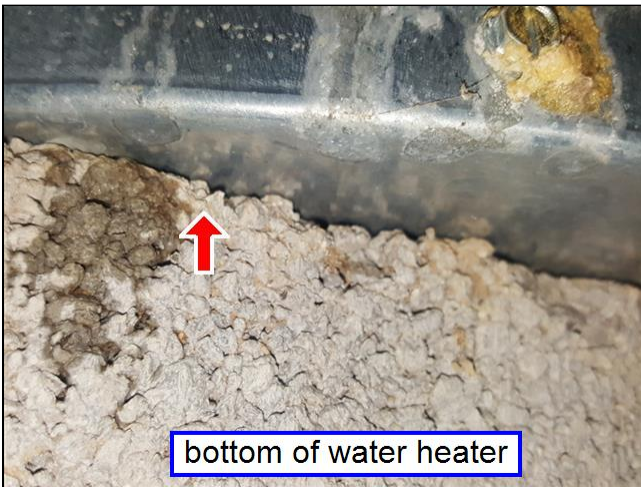
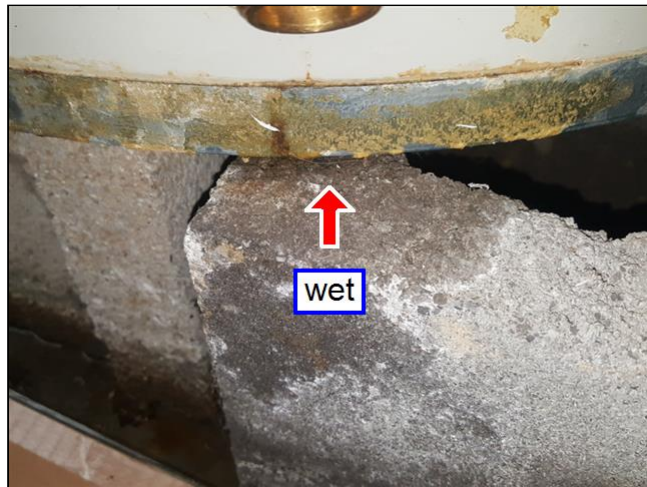
8.2 (5) The water heater appears to be leaking at the bottom suggesting a possible replacement. A more thorough inspection by a qualified contractor is needed. Recommend a licensed plumber inspect further and repair or replace if needed.

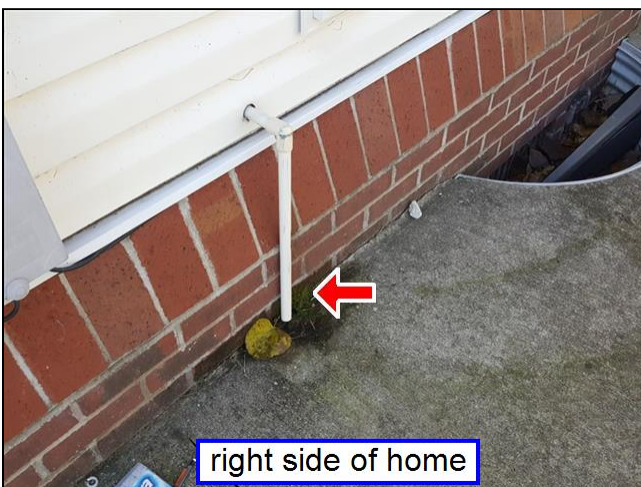
8.3 Item 1(Picture)

8.3 Location of the TPR (temperature pressure relief) drain line to exterior. (see picture)

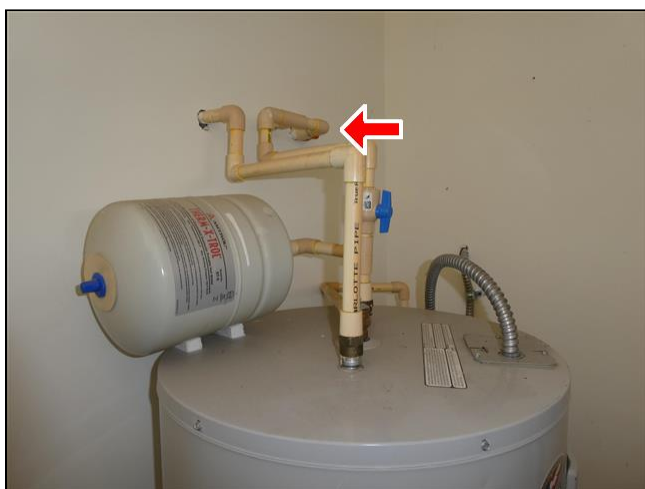
8.4 Item 1(Picture)

8.4 (1) The main water shut off is the orange lever located in the garage above the water heater area. You may wish to consider relocating the main shut off closer to the entry point in the crawlspace. Before the current main shut off valve, the supply line will always have water flowing regardless if the water has been shut to the interior of the home. If a leak occurs in the supply line before the main water shut off water will leak and possibly flood the crawlspace floor area which will lead to costly repairs. This is for your information. A qualified licensed plumber will be able to relocate main shut off if desired. This is for your information.

Note: Before the main water shut off valve, the water supply line will always have water flowing regardless if water has been shut to the interior of the home. If a leak occurs in the supply line before the main water shut off, water will leak inside the wall and garage area which will lead to costly repairs. Best alternative to shutting water to the home will be at street meter and a water key will be required. This is for your information.

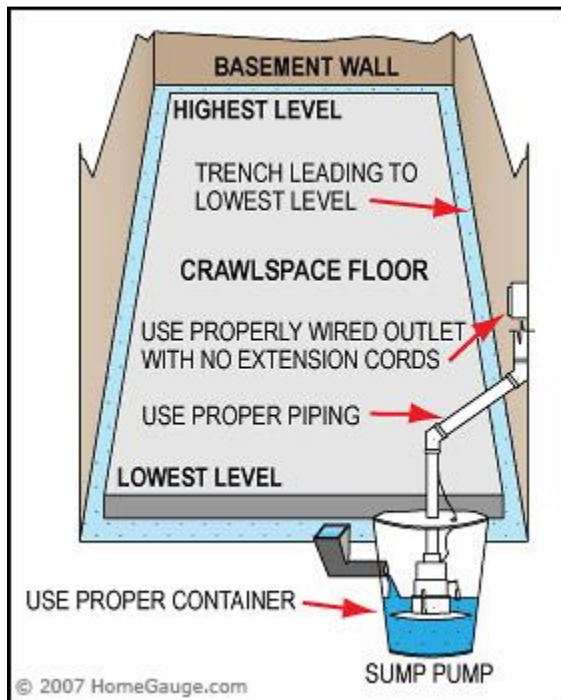
8.5 Item 1(Picture)

8.5 You may wish to consider installing a sump pump in the crawlspace in the event that if a serious plumbing leak occurs due to freezing water pipes or an elevated water table to prevent possible damage in the crawlspace which can lead to costly repairs. This is for your information.

Note: Water was experienced in the crawl due to recent rainfall. See note 1.2.

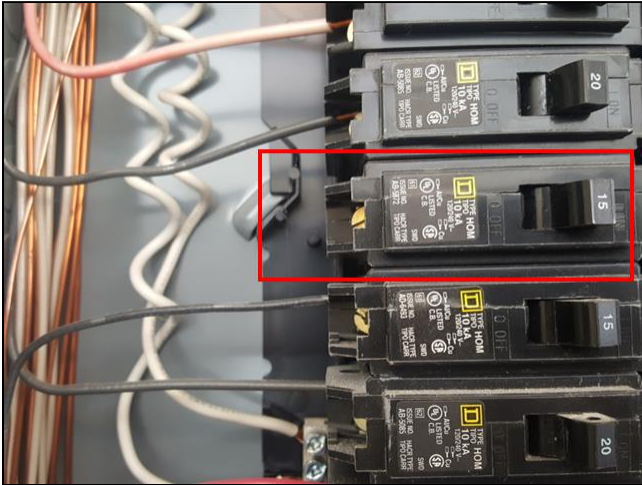
9.3 Item 1(Picture)

9.3 There were no wires connected to the breaker yet the breaker is in the on position. Recommend the breaker be turned off and for a qualified electrician to perhaps remove the breaker from the panel box and install a knock out cover to cover opening when the breaker is removed.

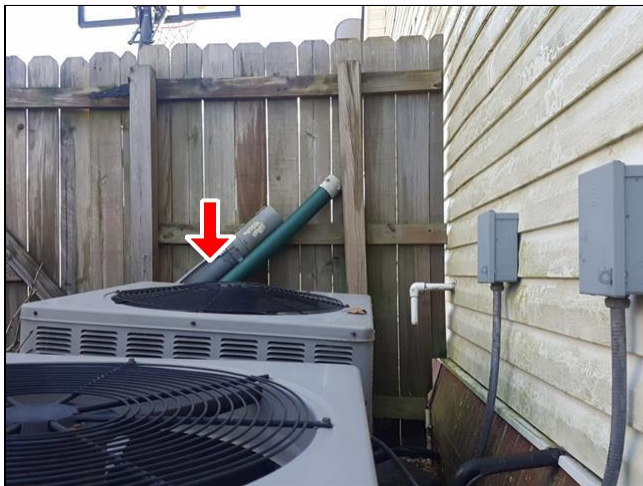
10.0.A Item 1(Picture)

10.0.A (1) The outdoor Heat Pump unit is not leveled. This may cause wear to the bearing housing and it can shorten the life span of the unit and can cause it to run inefficiently. If the unit settles due to the soil it can also cause damage to the refrigerant lines which may result in leakage of refrigerant gases. Recommend correcting the platform so that the unit is leveled. A qualified HVAC contractor is recommended for this correction.

AC Condenser - Not Level

If an AC condenser settles with the soil, the refrigerant lines can be damaged and the compressor may be damaged if operated.

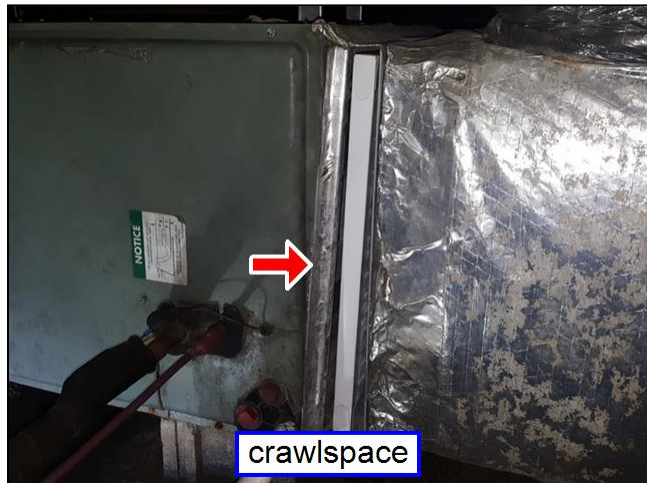
10.1.A Item 1(Picture)

10.1.A Filter location (see photo). The arrow on the filter should always point towards the blower.

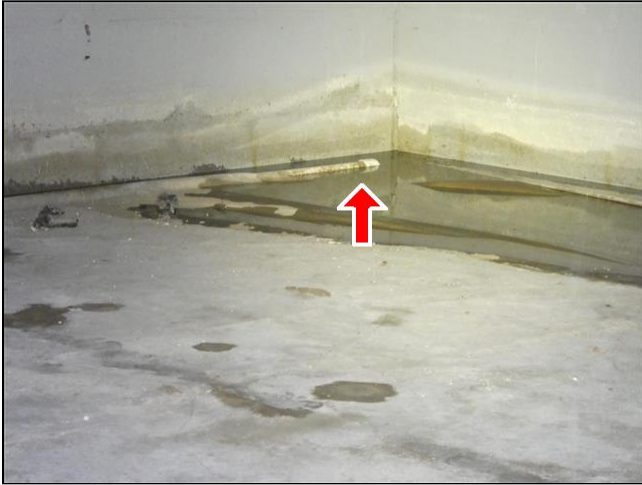
10.3.A Item 1(Picture)

10.3.A The condensate drain line is discharging in the crawlspace. This is adding moisture and water into the crawlspace which can lead to condensation in the crawl which can create wood rot and/or mold from occurring. It can also cause settlement of the foundation wall over time. Recommend a qualified HVAC contractor correct so that water is discharged to the exterior and away from the crawl and foundation of home. A condensate pump may be required to achieve this result.

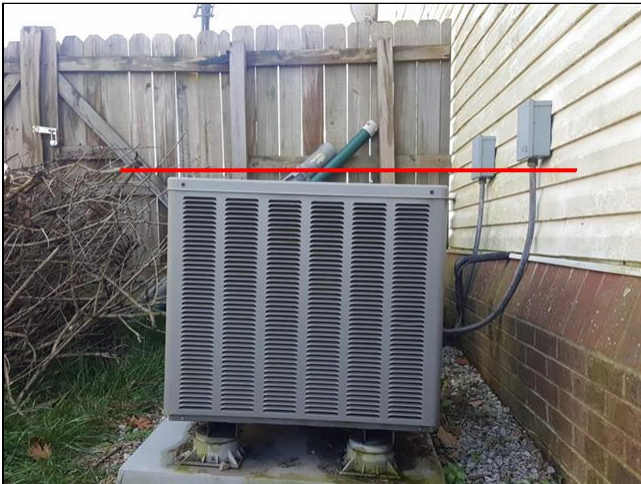
10.0.B Item 1(Picture)

10.0.B (1) The outdoor Heat Pump unit is not leveled. This may cause wear to the bearing housing and it can shorten the life span of the unit and can cause it to run inefficiently. If the unit settles due to the soil it can also cause damage to the refrigerant lines which may result in leakage of refrigerant gases. Recommend correcting the platform so that the unit is leveled. A qualified HVAC contractor is recommended for this correction.

AC Condenser – Not Level

If an AC condenser settles with the soil, the refrigerant lines can be damaged and the compressor may be damaged if operated.

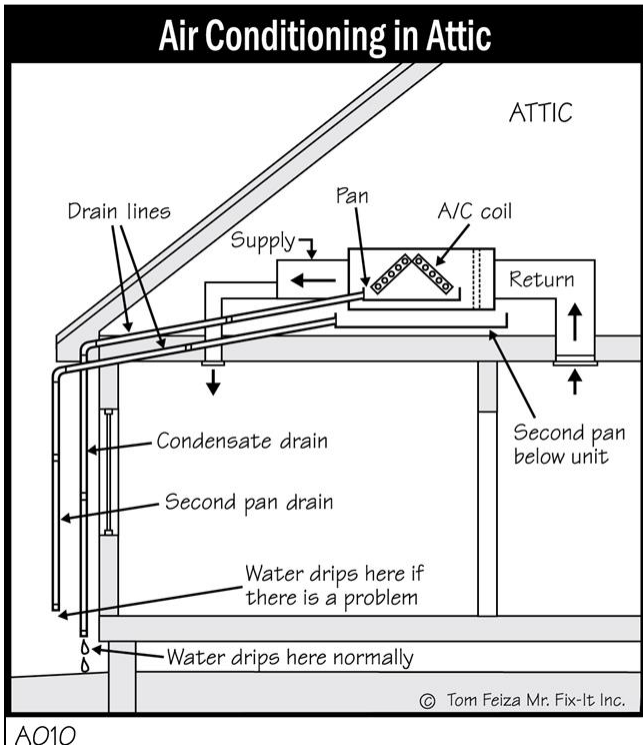
A010
10.0.B Item 3(Picture)

10.0.B (3) The Air Handler in the attic has a condensate drip tray under the unit. In the event that the condensate drain line malfunctions or water overflows into the tray below, the additional condensate line will drain the water to the outside from the drain pan. Recommend that you check the drain pan each quarter to see if there is any water in the pan.

Note: Strongly recommend an aqua guard safety switch be installed in the drain pan under the Air Handler in the attic to prevent damage to the home in the event that the evaporative coil leaks and the 2nd condensate drain line fails. A qualified HVAC contractor is recommended for this installation. This will ensure that the unit shuts down when the unit is leaking water and that water will not leak in the attic. This is for your information.

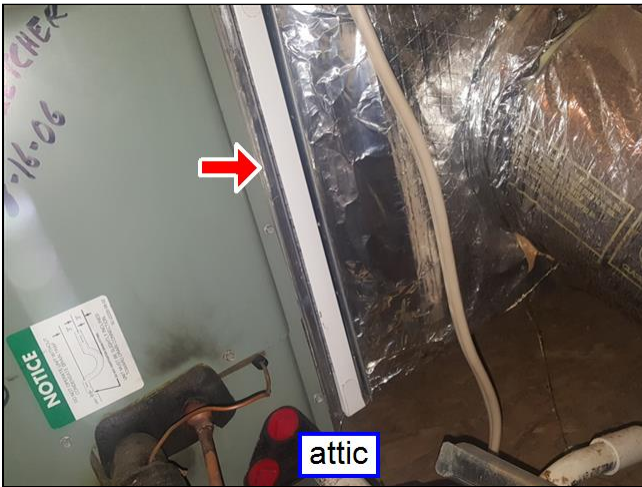
10.1.B Item 1(Picture)

10.1.B Filter location (see photo). The arrow on the filter should always point towards the blower.

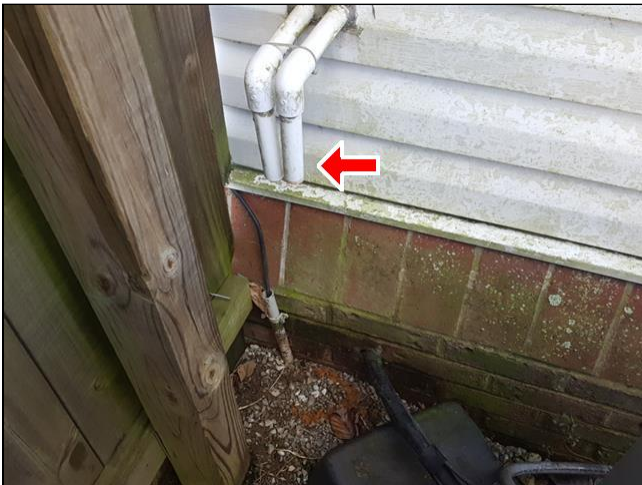
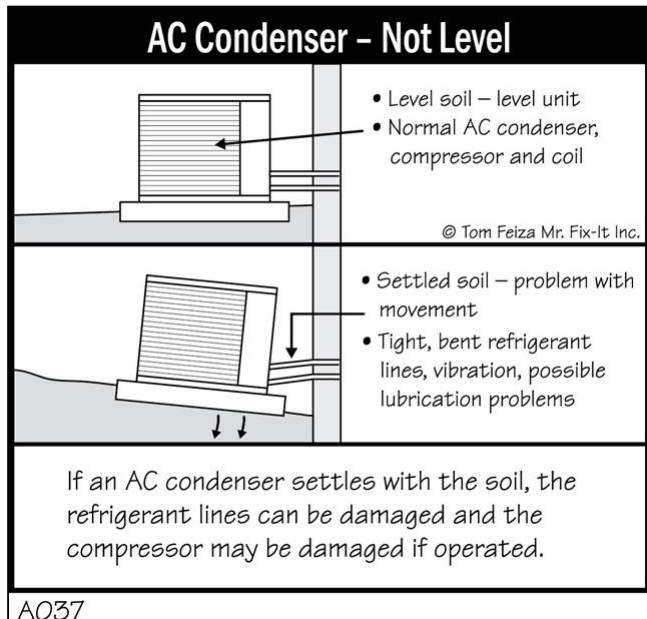
10.3.B Recommend the discharge for the condensate drain lines be improved via installing a splash block and extending the drain line at the right side of the home. This will prevent water pooling near the foundation which could cause settlement of the foundation wall, soil erosion and water leakage into the crawlspace. Also to prevent possible settling of the platform for the Heat Pump. A qualified HVAC contractor is recommended for these repairs.

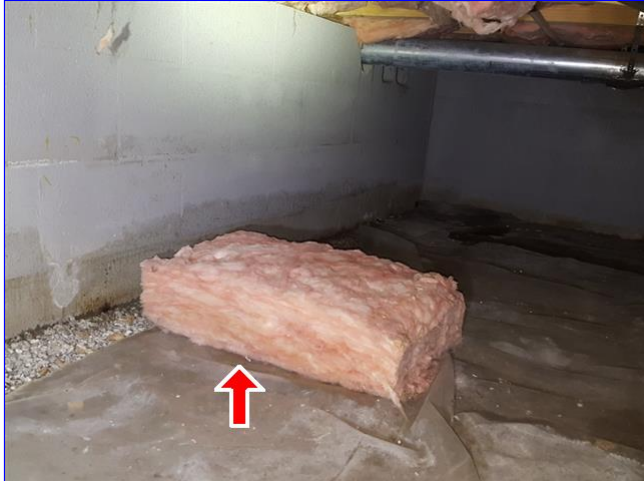
1.3 Item 1(Picture) under master bathroom area

(1) All insulation and wood should be removed from the crawlspace floor. The insulation will hold moisture creating condensation and possible mold growth on the wooden structure in the crawlspace. Wood debris risks rotting and can attract wood eating insects into the crawlspace which can lead to more costly repairs later. Recommend all types of debris resting on the crawlspace floor be removed to prevent damage to the wood structure of the home.

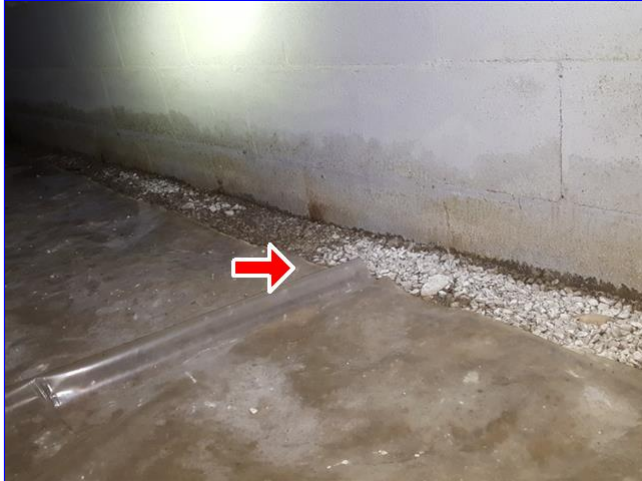
1.3 Item 4(Picture) right side of home

(2) There are some gaps in the coverage of the vapour barrier in the crawl space floor where indicated in the photo(s). The vapor barrier in the crawl space floor should be adjusted to cover all areas of exposed soil. These gaps are allowing moisture vapor entry and water into the crawl space which promotes condensation, humidity and mold/mildew growth on the floor joists. The plastic vapour barrier should be a minimum of 9mil thick in Kentucky (recommend using 15 or 20 mil) straightened and/or added to as needed to cover the entire crawlspace floor to prevent excessive moisture entering. Recommend correcting as needed using a qualified contractor.

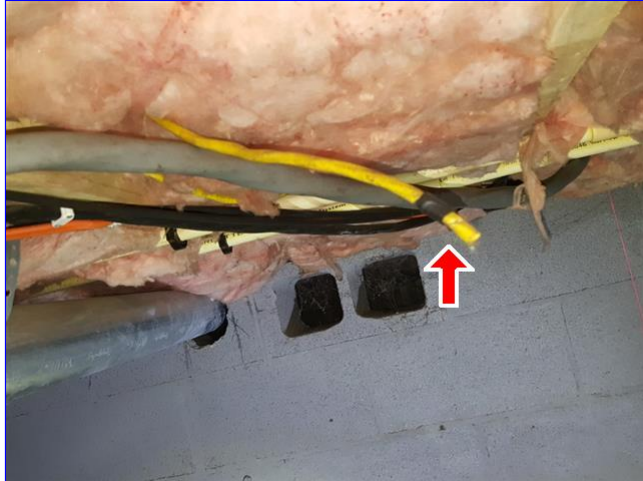
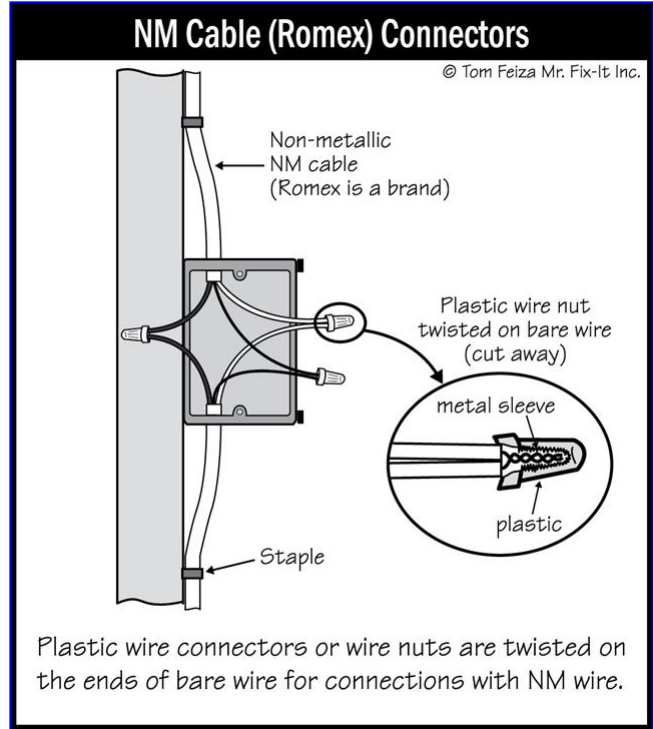
1.10 Item 1(Picture)

Exposed wires that are not in use in the crawlspace under the master bathroom area should be terminated with twist caps and placed in a junction box or completely removed if not in use. The wire was not energized at the time of the inspection, however it could be if a switch is turned on somewhere in the home. This is a potential safety issue. An electric shock can occur if touched and if a water leak develops above this it may cause a short resulting in a fire in the home if the wire becomes energized. Recommend a qualified electrician repair and correct for safety prior to moving in.

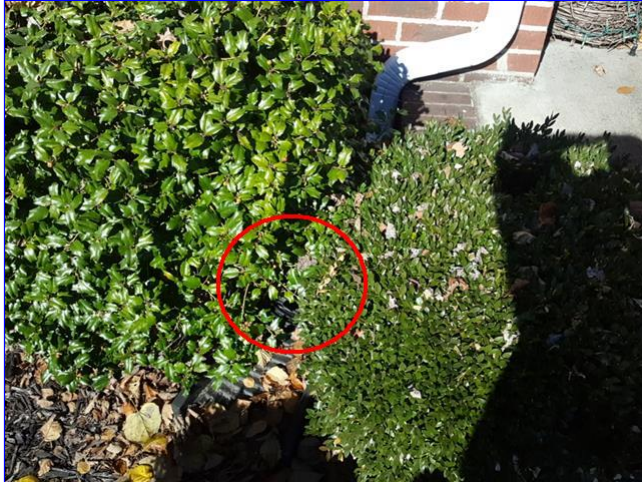
2.3 Item 8(Picture) front left corner of porch

(3) Recommend the downspouts where indicated in the photos be extended or corrected to ensure water is draining correctly after the brick border and walkway in the garden bed. This will ensure and prevent excess water not being trapped in the front garden bed which may cause leakage into the crawlspace and/or settlement of the foundation of the home. Repair as needed by a general contractor.

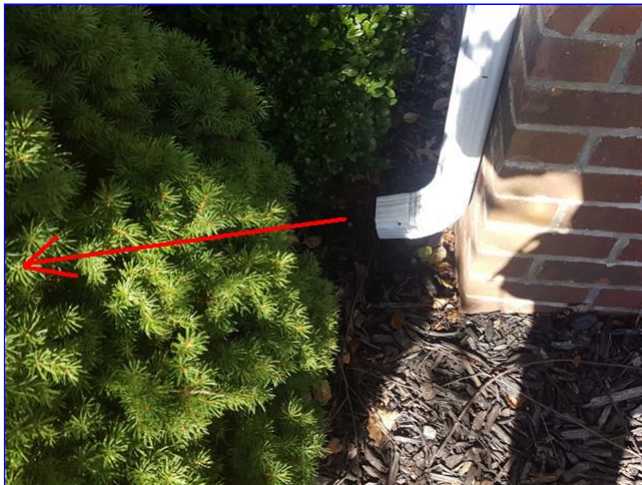
2.3 Item 12(Picture)

(5) The downspout at the front left corner of the home is missing a splashblock and is discharging on the ground next to the foundation of the home where indicated in the photos. The downspouts should discharge water through leaders then onto splash blocks at least 6 feet from the home. Storm water should be encouraged to flow away from the foundation/home at the point of discharge to prevent water entering the crawlspace and to prevent settlement of the foundation. Recommend repair and correcting as needed by a general contractor.

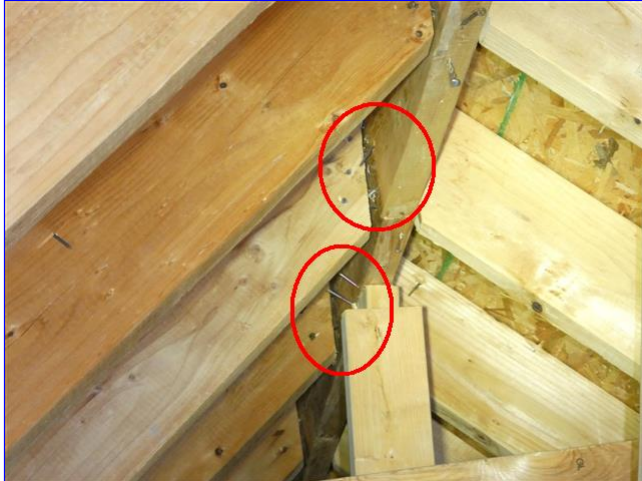
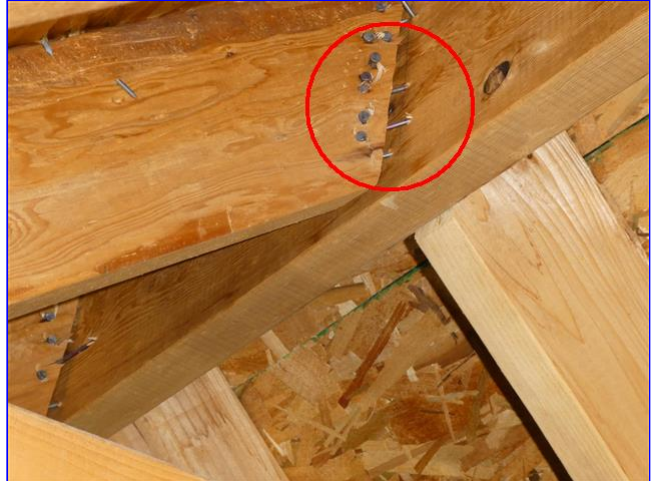
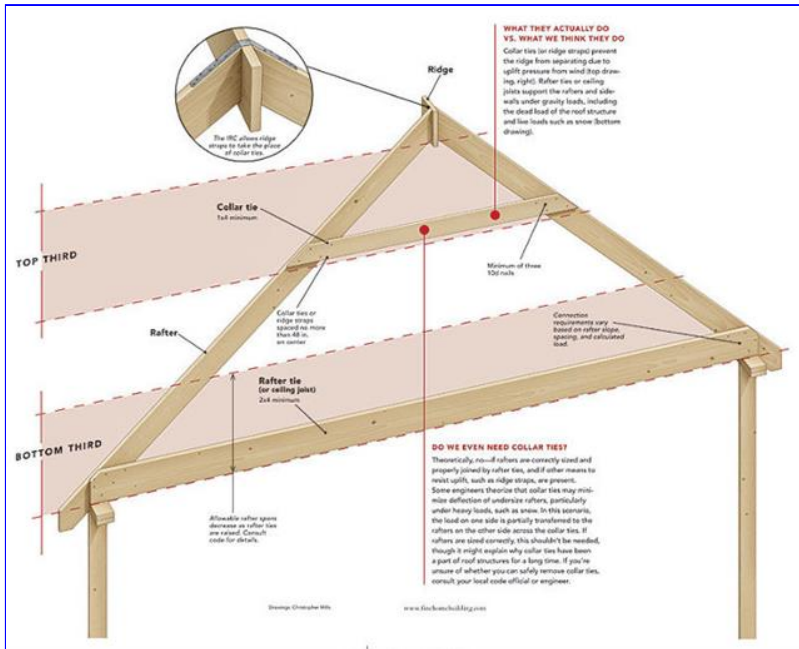
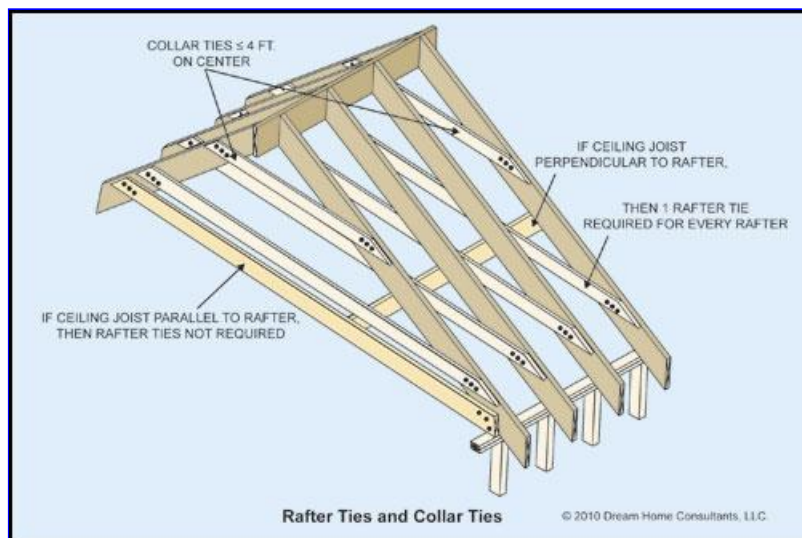
(2) Various rafters are pulling away at the joins in the attic. Repairs are needed to maintain the stability of the roof. Excess loads on the roof like snow can cause further separation if not reinforced. Recommend additional collar ties (horizontal members running between each rafter, near their mid span) or vertical supports to the rafters in the attic to add extra support to the roof structure and to resist rafters from separation in the future. Recommend a qualified framing roofing contractor further

investigate and make any necessary improvements or repairs to the roof structure as needed and correct any other problems found prior to closing.

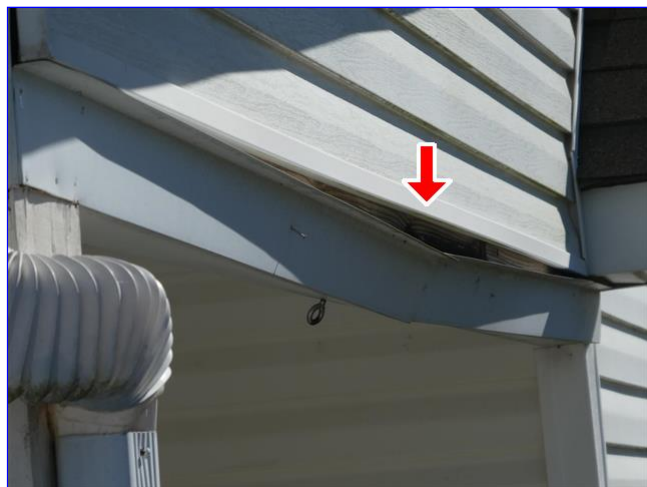
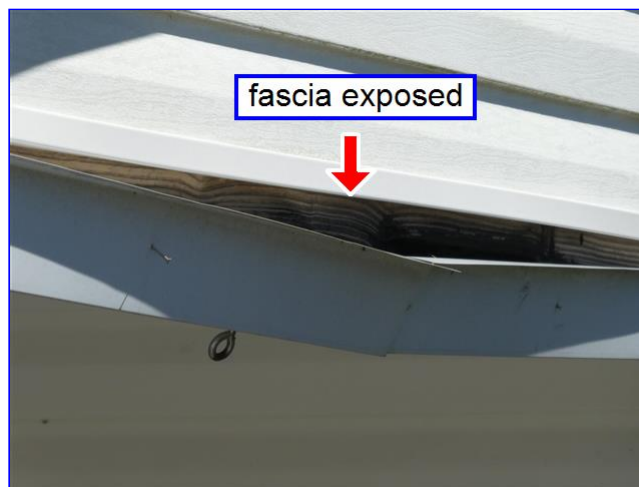
The fascia board at the right side of the patio roof where indicated in the photo(s) has a metal wrapping which is separated and hanging loose and is exposing the wood fascia to the weather. These areas need to be sealed/covered to prevent possible water intrusion which can cause the fascia to deteriorate leading to costly repairs if not corrected. Recommend a qualified contractor repair as needed.

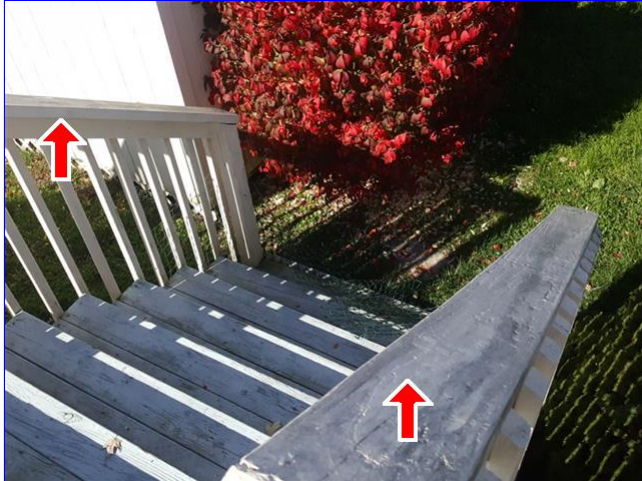
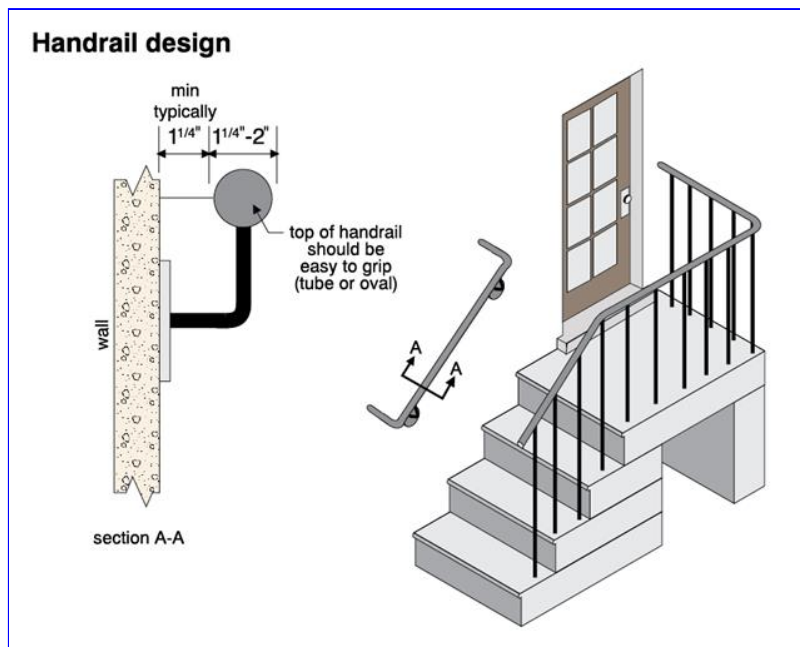
2x6s are installed for handrails for the deck staircase and are not considered "gripable" by industry standards. This is a safety issue and an injury could occur if not corrected. Recommend that a standard approved handrail be installed for safety by a general contractor.

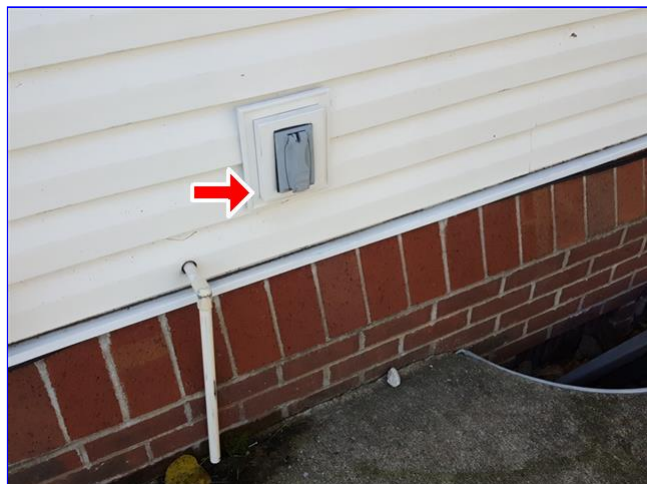
3.13 Item 1(Picture)

The outlet(s) on the right side of the home is loose in the wall. Electrical issues are considered a hazard until repaired. This is a safety issue that needs to be corrected due to an electric shock or fire from loose connections could occur if not repaired. Recommend a qualified licensed electrical contractor correct as needed.

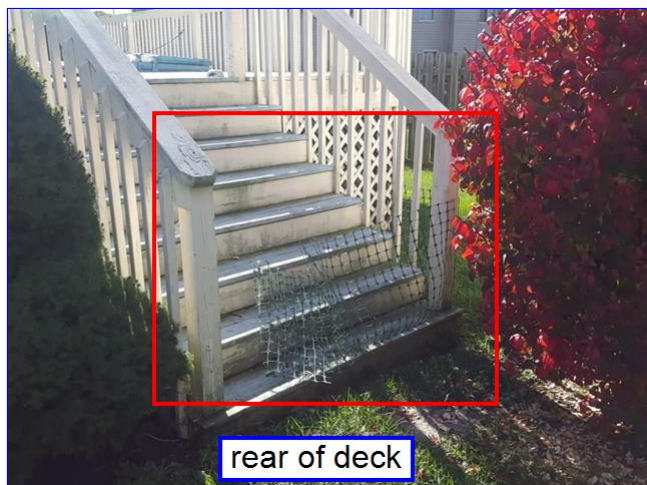
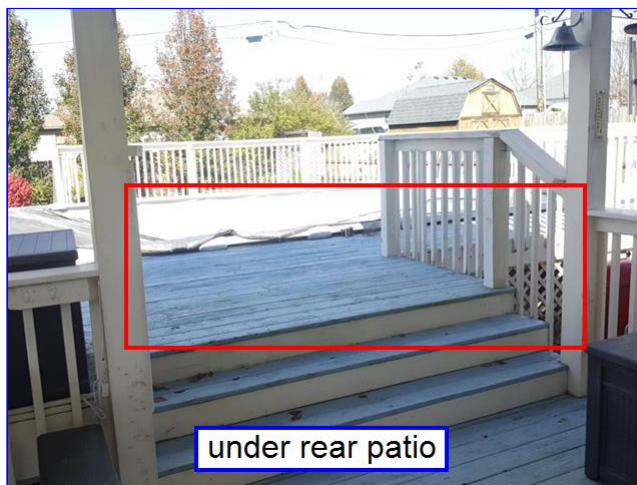
Please note our company does not inspect pools however it is recommended for safety that a gate be installed at the entry points at the deck to the pool to prevent an accidental death of a child via drowning if they were to fall in. Ensure the fencing surrounding the property and exterior gates leading into back yard are always kept in perfect condition and working order. This is for your information.

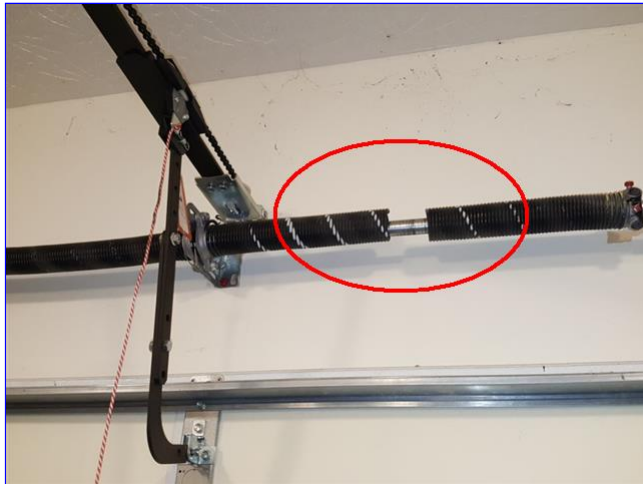
4.3 Item 1(Picture)

(1) The torsion spring is broken on the right side in the garage. This can cause strain on the moving parts and shaft when the door is opened and closed which could lead to broken cables, door opener or the door could fail if not repaired. Recommend a qualified garage installer replace torsion spring as needed.

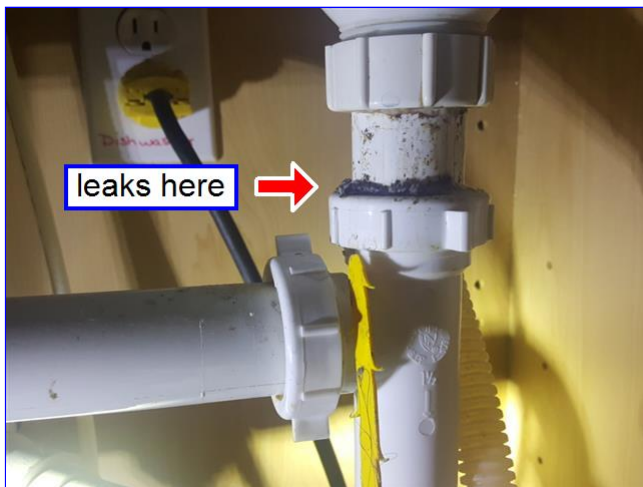
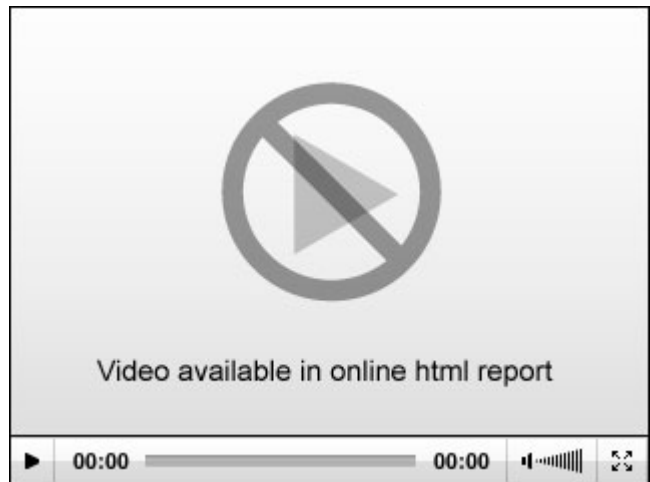
The waste line is leaking at the connection underneath the right sink in the kitchen. Repairs are needed to stop leaking water from damaging the cabinet bottom or to eliminate moisture that may contribute to fungi growth. A qualified licensed plumber is recommended for repairs as needed.

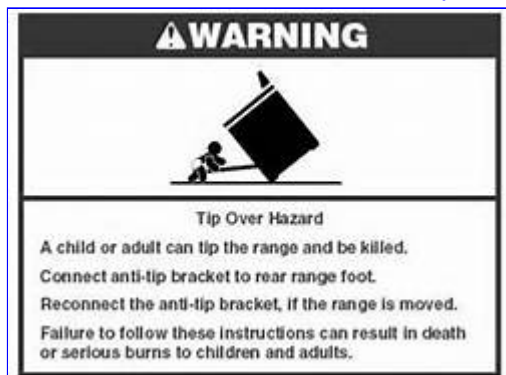
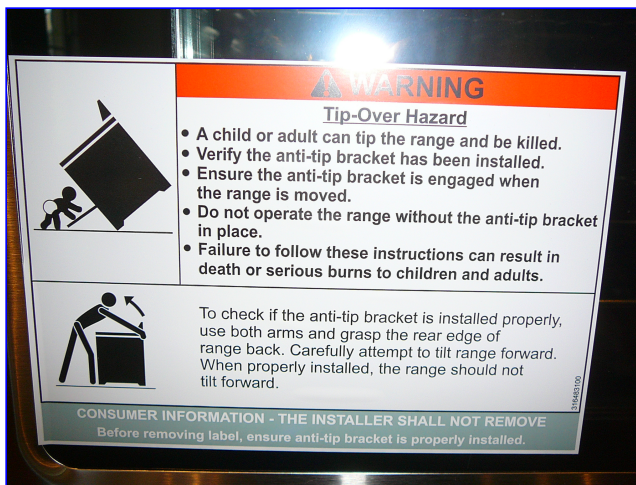
The "Anti Tip" bracket for the range has not been installed as required by manufacturer's installation instructions. This could allow the range to tip if it is pulled or if the oven door is pushed down or stepped on. This is a safety issue. A tip over hazard exists for small children and a serious injury or

death could occur. Strongly recommend the bracket be installed for safety around small children or others. [Information about "anti tip" bracket](#)

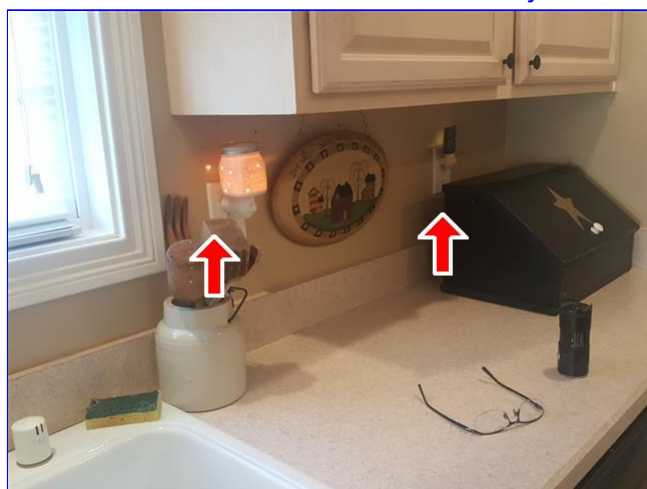
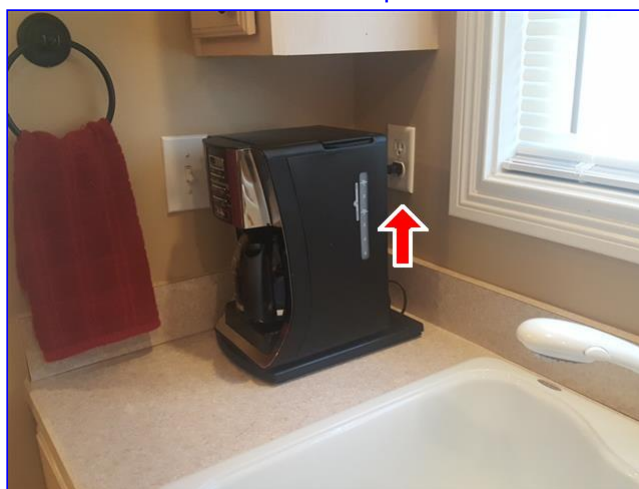
(2) The outlets in the kitchen where indicated in the photo(s) are not GFCI protected. GFCI (Ground fault circuit interrupters) outlets should be considered for installation as a safety upgrade in all locations where water is present if the outlets are not presently connected to a GFCI. They are now required in all bathrooms, kitchen, unfinished basements, garages, exterior outlets, or other locations within 6' of a water source or sink. GFCI outlets may not have been required when this house was built but should be considered for safety. Recommend a licensed electrician replace as needed.
