TALCO
Home Inspection

Inspection Report

Property Address:
125 Crimea Drive
Nicholasville KY 40356

Date: 11/6/2018	Time: 10:00 AM till 02:00 PM	Report ID: 181106ANTHONY
Property: 125 Crimea Drive Nicholasville KY 40356	Customer: Ms. Sharon Anthony	Real Estate Professional:

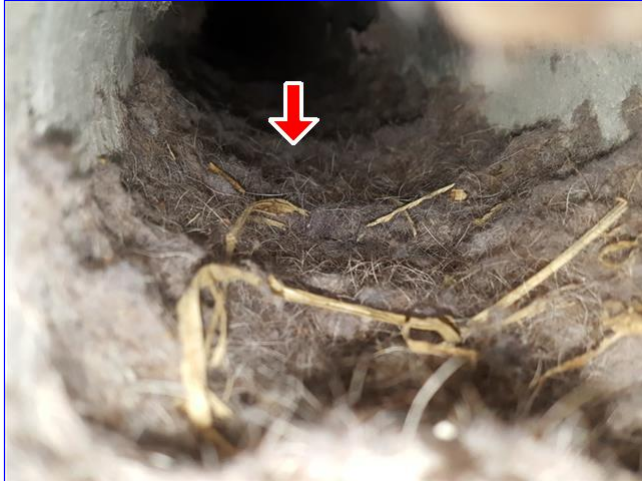
5.10 Item 1(Picture)

(1) The dryer vent pipe has a large build up of lint inside. This is restricting the flow and may cause a back-draft. This can cause a fire to occur due to excessive heat build up in the vent pipe. Also your dryer runs longer, putting more wear and tear on it and therefore cutting the machines life in half. Strongly recommend cleaning the dryer vent for safety before moving in and operating dryer.

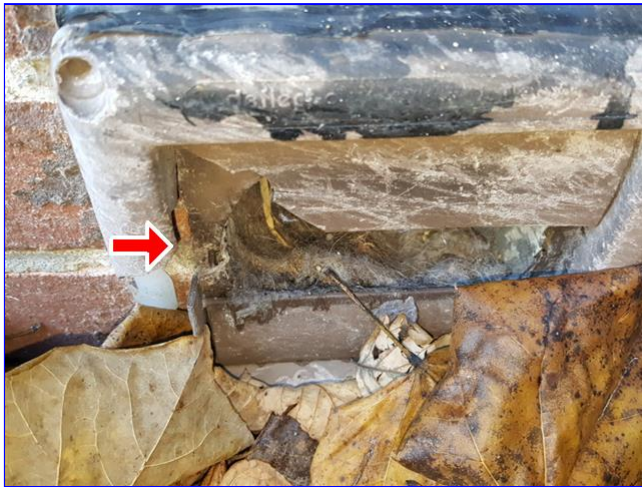
5.10 Item 2(Picture)

(2) The dryer vent cover is damaged and has missing louvres at the right side of the home. The opening can allow rodents or birds to enter then building a nest which may cause a blockage that could result in fire and/or poor venting. Recommend a new vent cover be installed as needed.

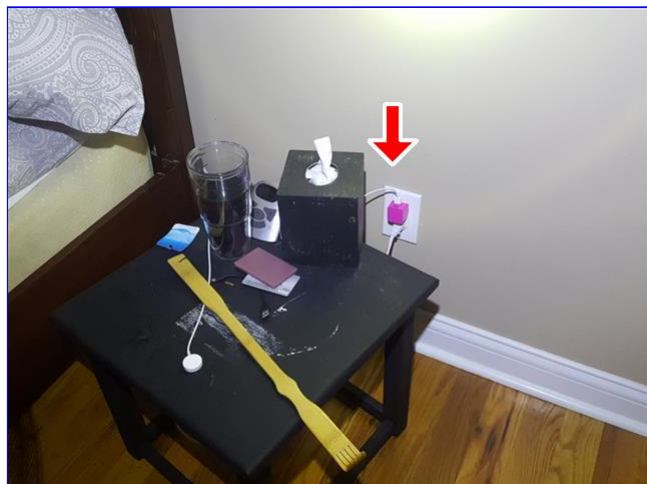
6.7 Item 5(Picture) master bedroom

(2) The outlet(s) in the rooms where indicated in the photo(s) are loose at the wall or in the outlet box. Electrical issues are considered a hazard until repaired. This is a safety issue that needs to be corrected due to an electric shock or fire from loose connections could occur if not repaired. Recommend a qualified licensed electrical contractor correct as needed.

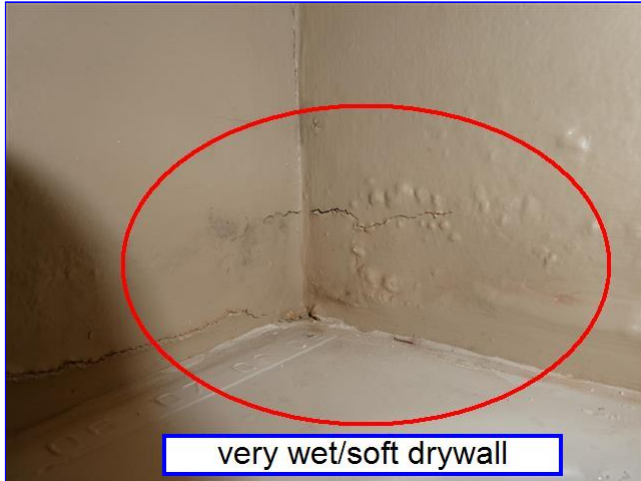
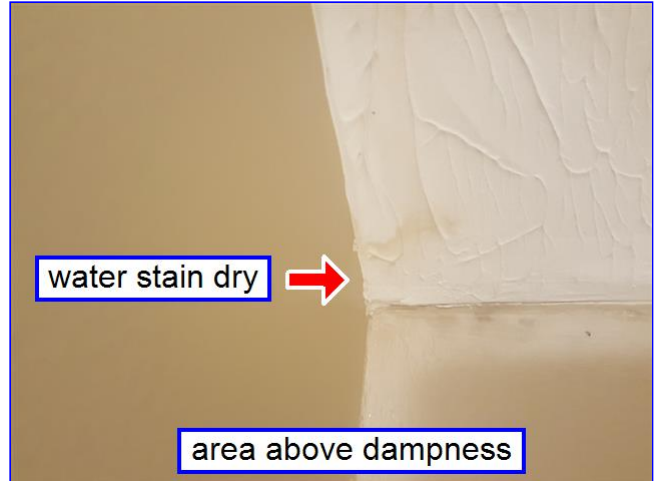
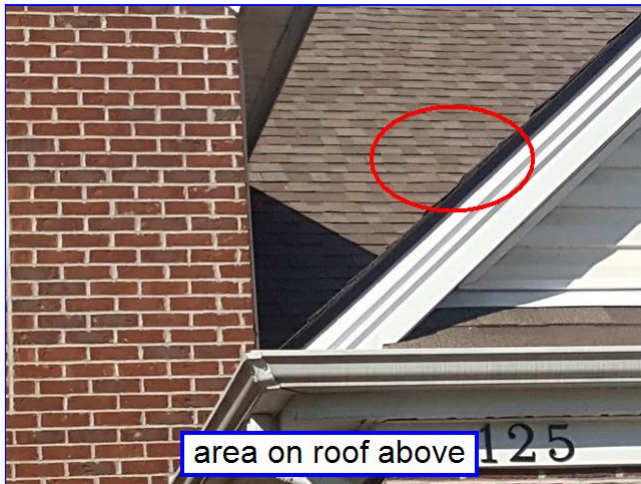
(2) The drywall was very damp on the wall where it butts up to the shower enclosure in the 2nd bathroom. This indicates there is water leak somewhere. There were no signs of leakage in the attic. I am unable to determine cause of dampness. The repair work will likely involve the removal of the covering in order to determine where the leak is coming from and if it still exists. The extent of the damage cannot be realized until the covering is removed. There could be mold behind the drywall. Recommend a plumber and/or roofing contractor further inspect, evaluate and repair/correct as needed.

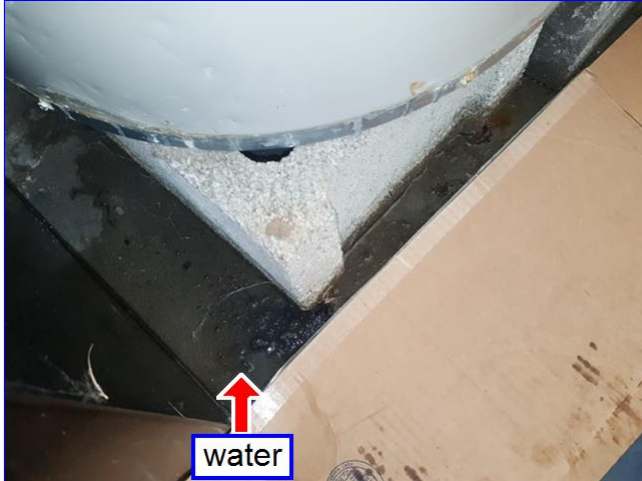
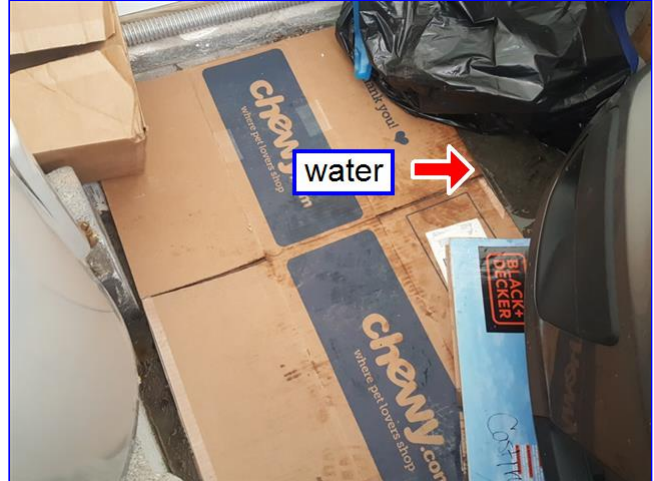
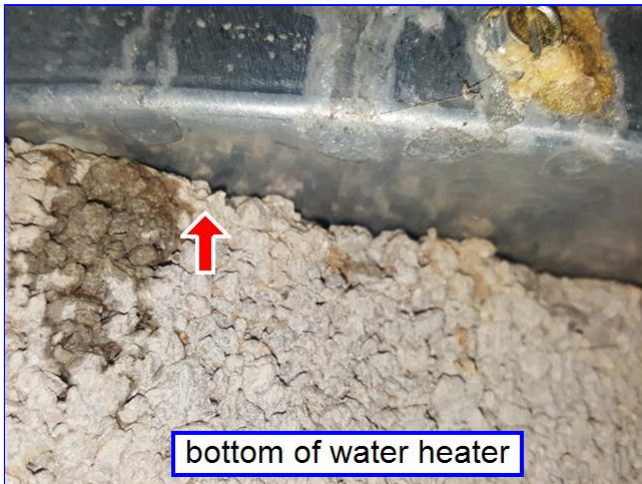
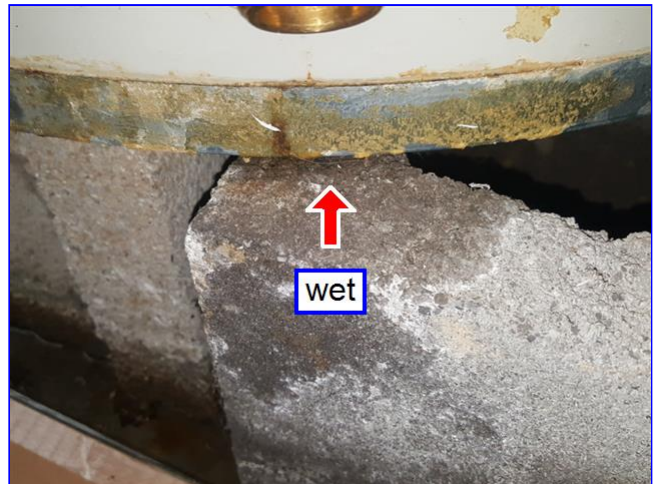
(5) The water heater appears to be leaking at the bottom suggesting a possible replacement. A more thorough inspection by a qualified contractor is needed. Recommend a licensed plumber inspect further and repair or replace if needed.

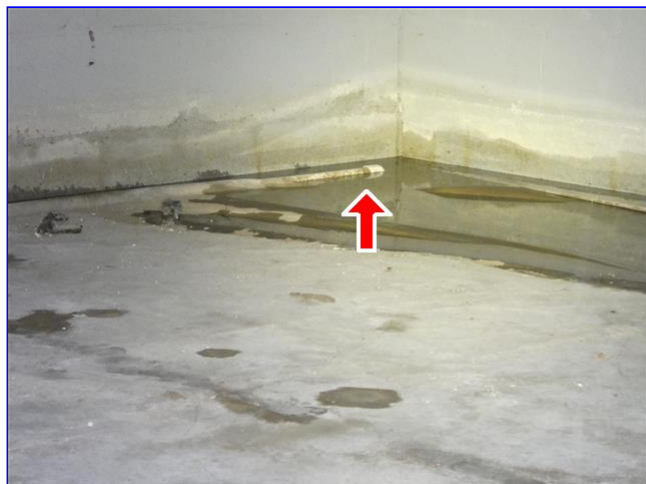
10.3.A Item 1(Picture)

The condensate drain line is discharging in the crawlspace. This is adding moisture and water into the crawlspace which can lead to condensation in the crawl which can create wood rot and/or mold from occurring. It can also cause settlement of the foundation wall over time. Recommend a qualified HVAC contractor correct so that water is discharged to the exterior and away from the crawl and foundation of home. A condensate pump may be required to achieve this result.

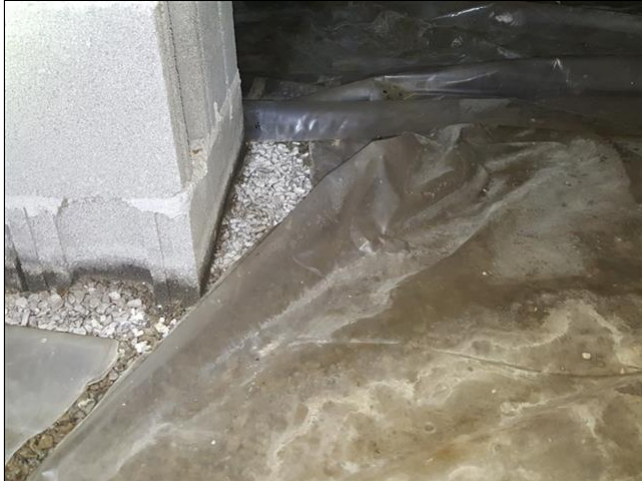
1.3 Item 7(Picture)

(3) The vapor barrier (plastic) on the crawlspace ground needs to be sealed at the joins to prevent water rising and pooling on top of the barrier in the crawlspace. Placing blocks or heavy weights at the joins is not recommended. A vapor barrier provides added protection to the floor system from moisture or dampness that can enter from ground. Recommend a general contractor repair as needed.

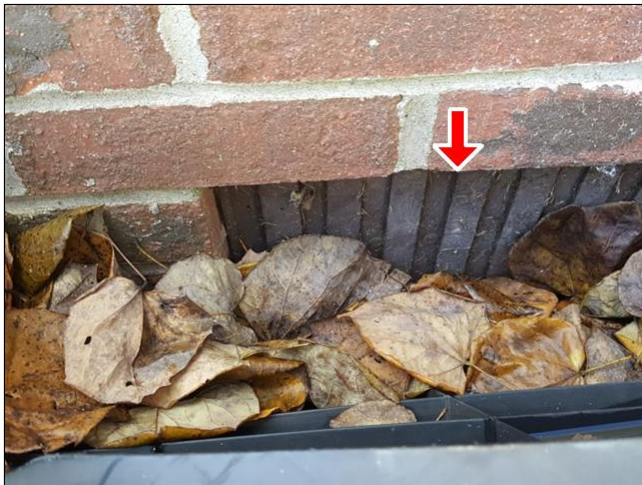
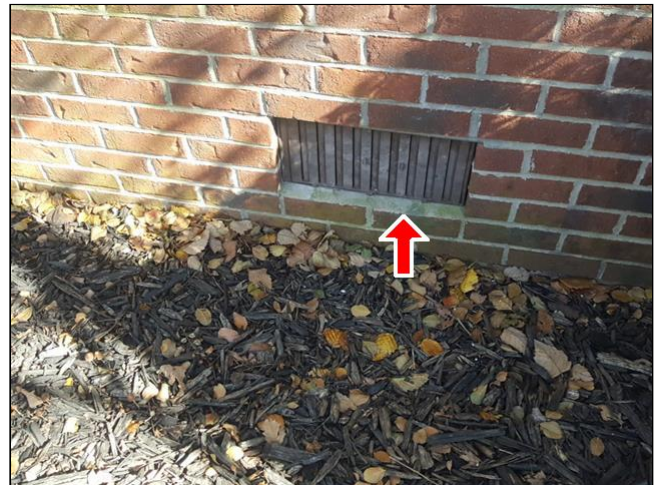
(1) The vents have been closed/sealed where indicated in the photos for the crawl space. However the crawlspace has not been prepared for encapsulation. Though there was no condensation noted at the time of the inspection. Proper ventilation will help control humidity and reduce the potential for wood rot and condensation forming in the crawlspace. It is recommended that One (1) square foot of free vent area should be provided for every 500 square feet of crawlspace. Recommend the vents be opened. [Information about venting or not venting a crawlspace](#)

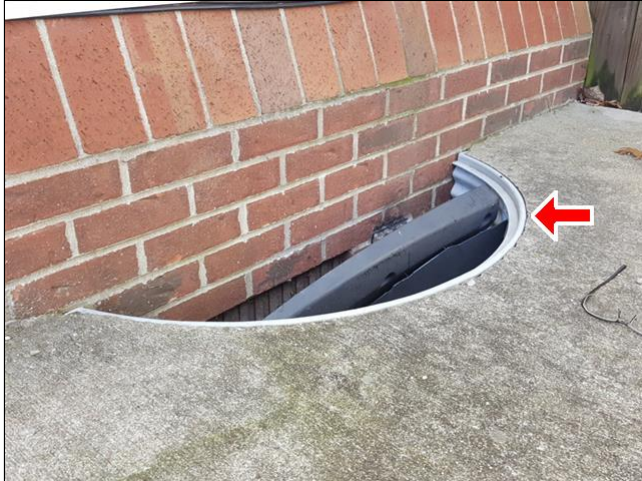
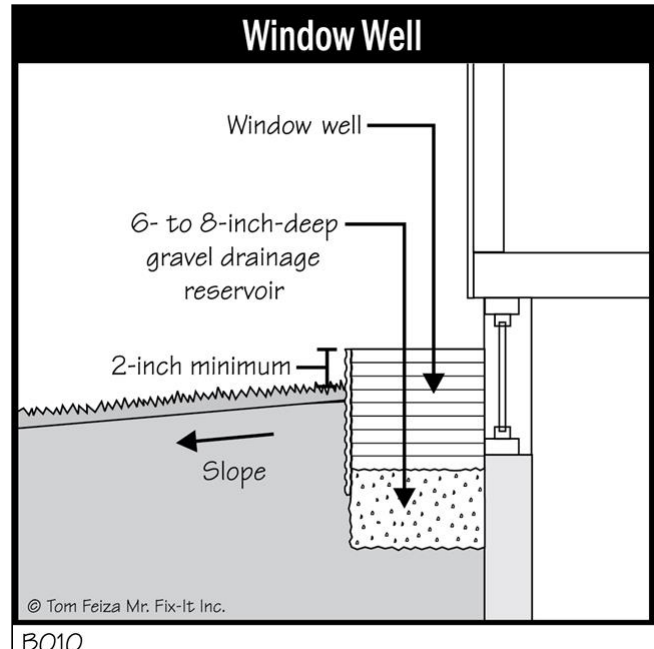
(2) The top of the window well for the crawlspace vent at the right side of the home is close to grade level where indicated in the photos. This can allow water to enter the crawlspace if not corrected which may end up resulting in mold to occur and/or deterioration of the floor structure in the crawlspace. Recommend raising the height to avoid water entering the crawlspace. Recommend correcting as needed by a general contractor repair as needed.

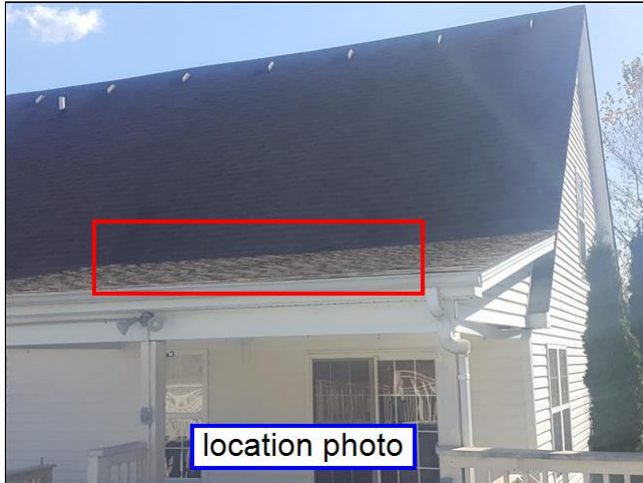
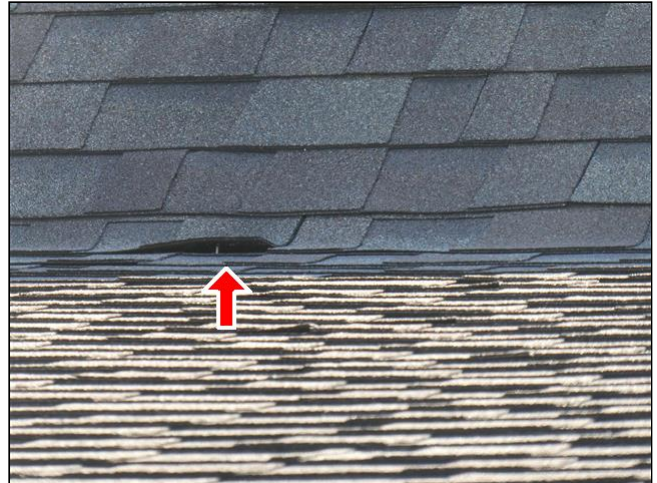
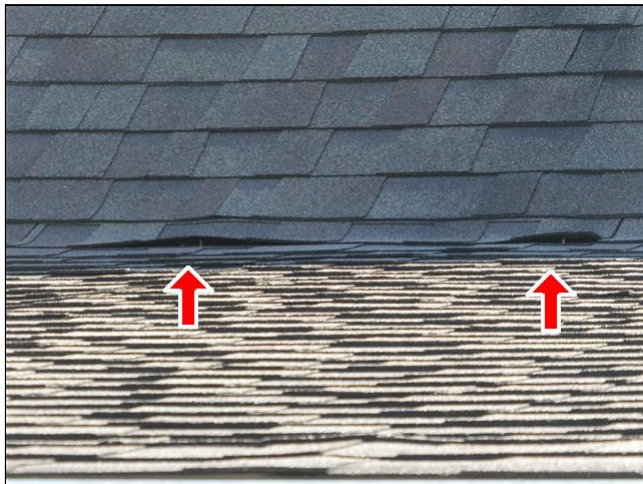
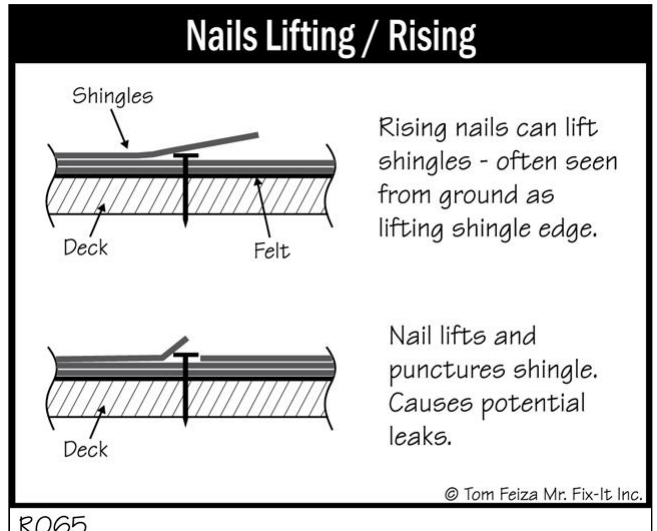
(1) The shingles are lifting at the rear right side of the home in various places, (see photos for location) due to nails are starting to "back out" which causes the shingle tabs to raise, or the sealant of the shingle tabs has failed. Shingle damage or roof leakage can occur at these areas. They are also at risk to be blown off by high winds. If they raise the shingle more than 1/2" the nails should be resealed to prevent water entry under the shingles. Recommend a qualified roofing contractor repair as needed.

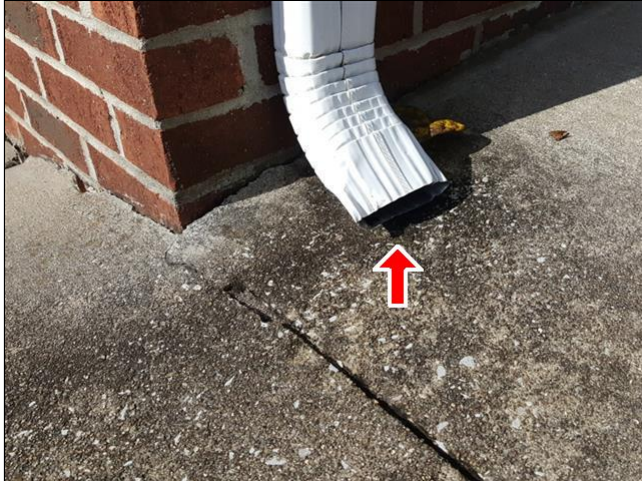
2.3 Item 1(Picture)

(1) The downspout is crushed at the end at the front right corner of the garage. This is restricting the discharge of water. Evidence of gutter overflowing in this area was observed which may be caused by restricting flow or clogged gutters. Recommend the downspout be repaired or replaced by a general contractor at the end so water will flow freely .

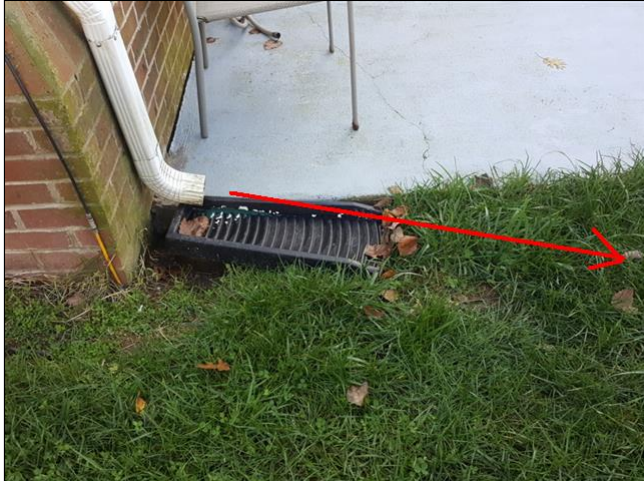
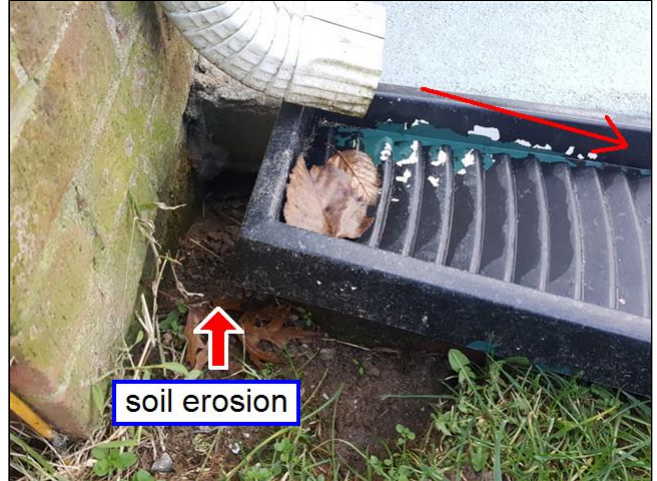
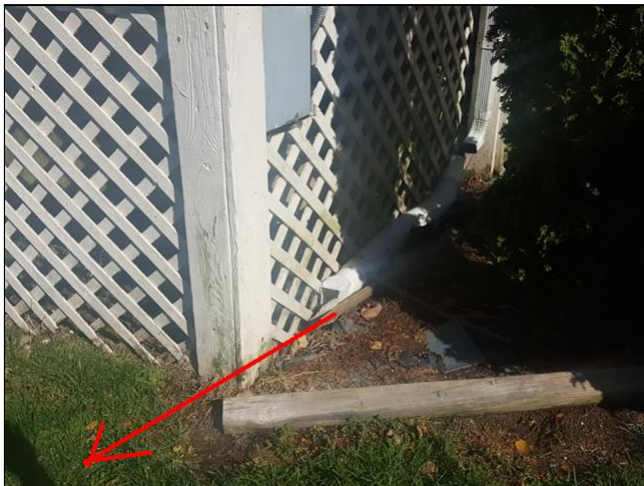
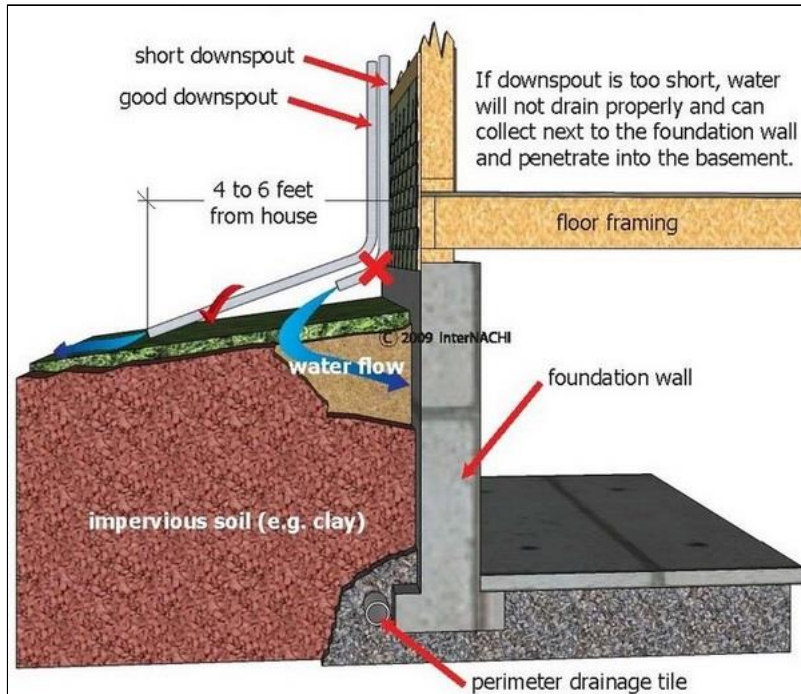
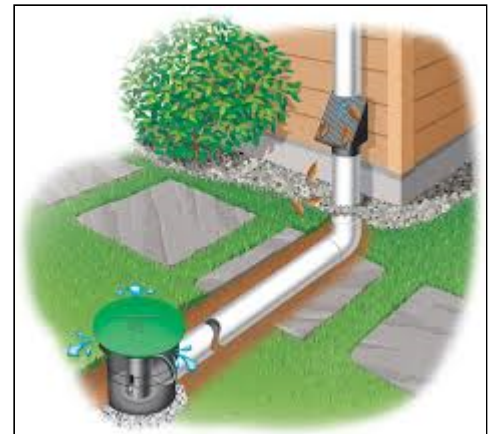
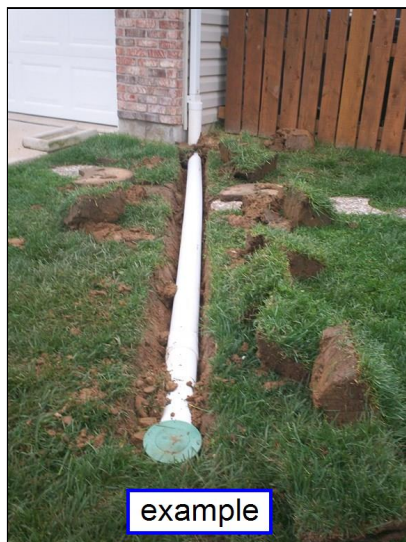
(2) Recommend the downspout(s) where indicated in the photo(s) be extended at least 6 feet and flow onto splashblocks. This will ensure water is kept away from the foundation perimeter, soil erosion does not occur and water cannot leak into the crawlspace area which may cause settlement of the foundation.

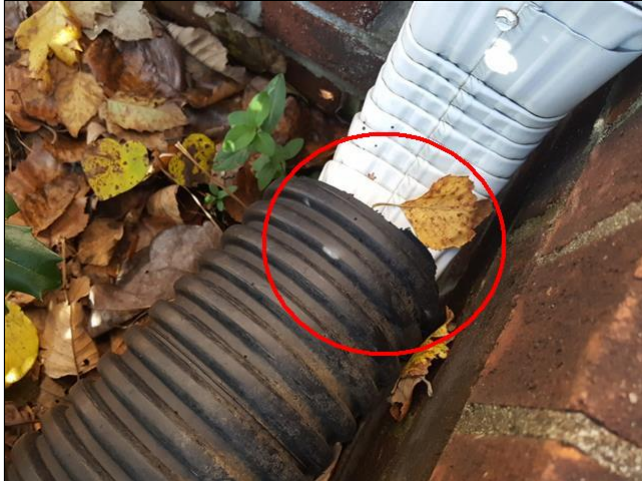
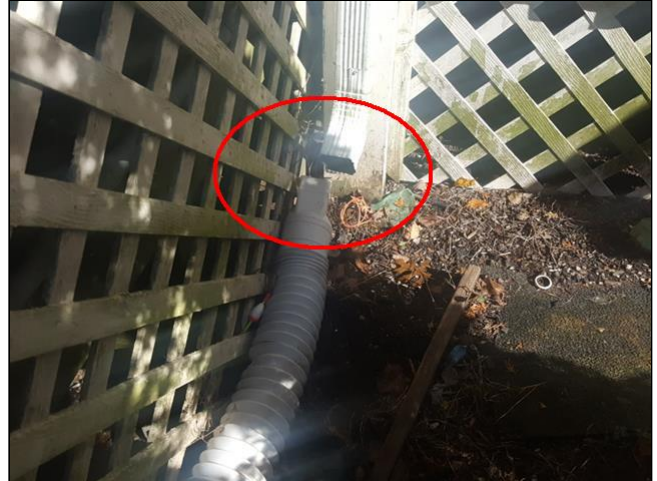
(4) Recommend the downspout extension(s) be attached to the downspout where indicated in the photos by placing a screw at the top and bottom where it connects to the downspout to ensure the extension(s) does not pull away from the downspout(s). Failing to do this may create future problems to the foundation around the home due to soil erosion and water entering the crawlspace which may result in the foundation settlement if the extension detaches from the downspout.

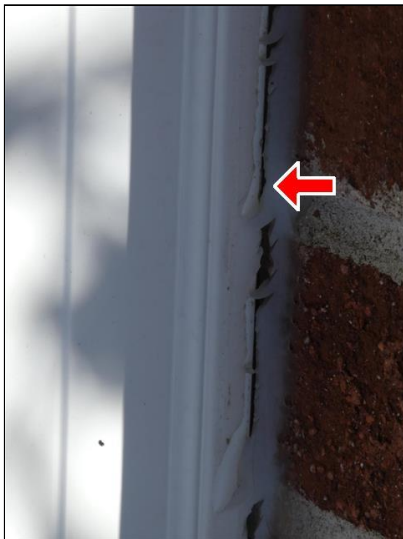
(2) The window frame at the front left side of the home has cracked sealant between the siding and the window frame. Water and/or insects may enter and deterioration may occur behind the wall cavity and siding. This is a small repair. Recommend re-caulking as needed. [Which caulk to use](#)

3.4 Item 2(Picture) formal dining room window

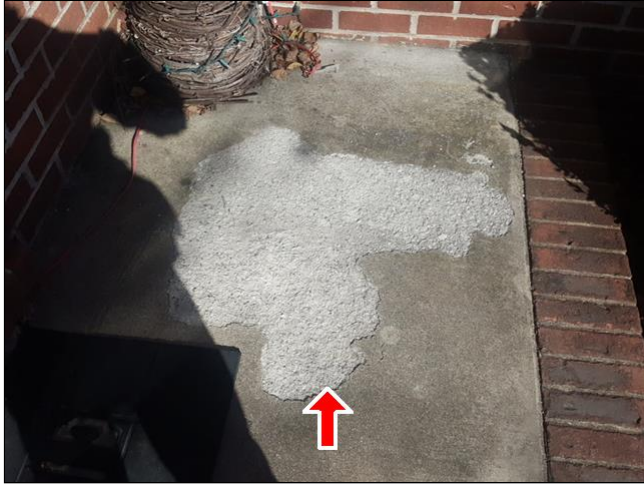
3.5 Item 1(Picture)

The concrete porch is pitted and chipped in various areas. Further deterioration of the porch can occur via water entry which could lead to possible cracking of concrete. Recommend these areas be repaired by a qualified masonry contractor.

Please Note: This may have been caused by placing salt on the front porch in winter to prevent ice occurring on the front porch. Salt eats away at the concrete surface.

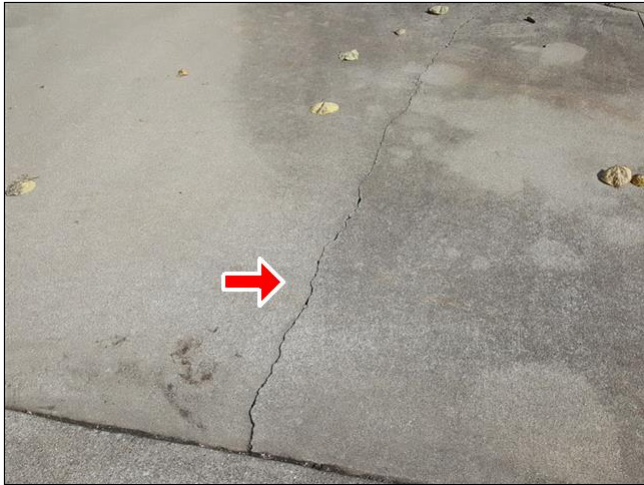
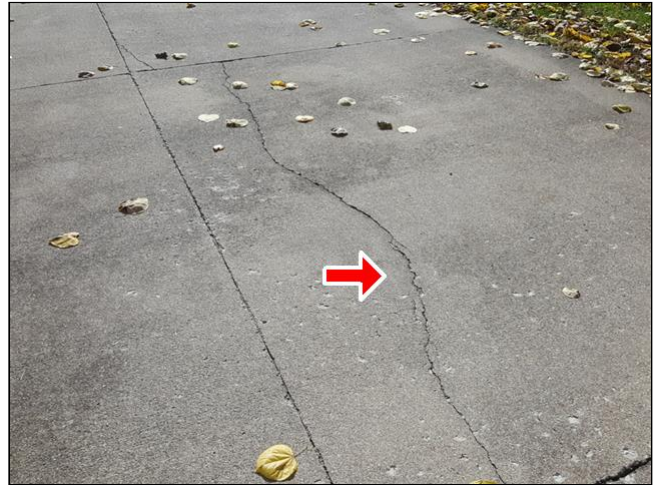
Common settlement crack(s) were noted at the concrete drive. This is not a tripping hazard as yet at this time. I also do not see these small cracks as an indication of a structural issue. Further deterioration and/or settlement can occur to the driveway/walkway via water intrusion if not repaired. Recommend repairs via a masonry caulk as needed then monitor annually. Here is a link for [Sealing Concrete Cracks](#)

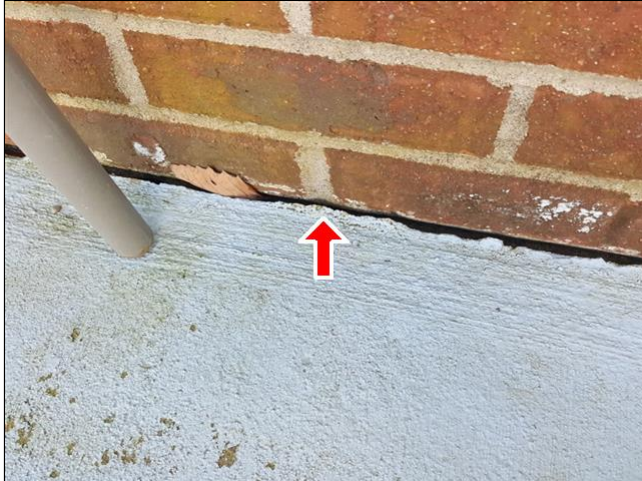
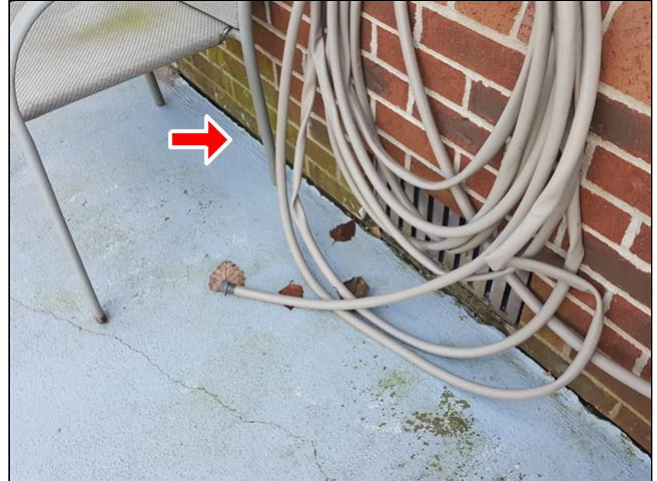
The gaps between the patio floor at the rear of home should be sealed where it meets the house to prevent water impingement against the foundation wall. This will avoid water intrusion in the crawlspace and possible settling of the foundation perimeter and patio slab of the home. Here is a link that can be helpful. [Foundation and Concrete Cracks Fillers](#)

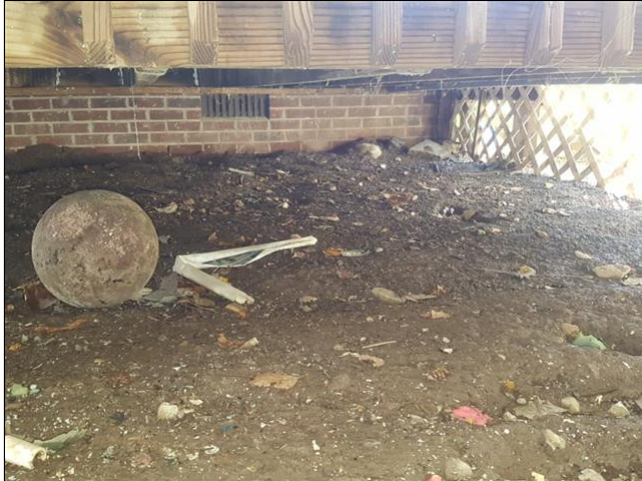
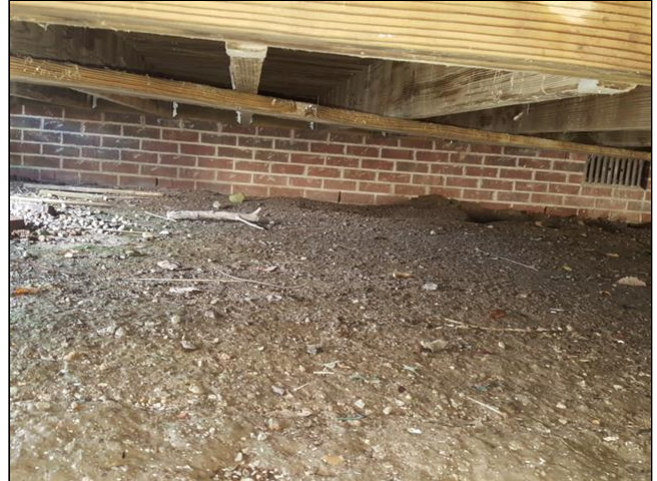
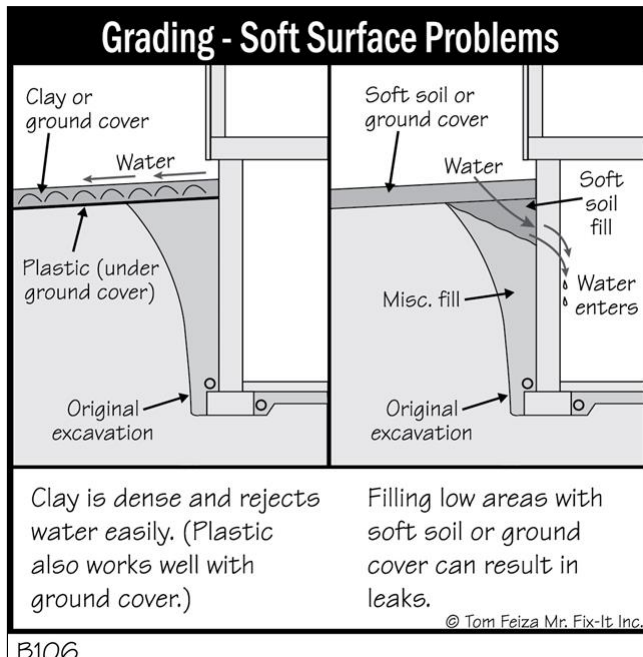
(1) Recommend installing a plastic sheet covering under the deck at the rear of the home at about 2 feet wide or entire underneath of the deck to prevent water entering the crawlspace. This improvement will prevent excess water draining into the soil along the foundation which can lead to water intrusion inside the crawlspace and prevent settlement of the deck post.

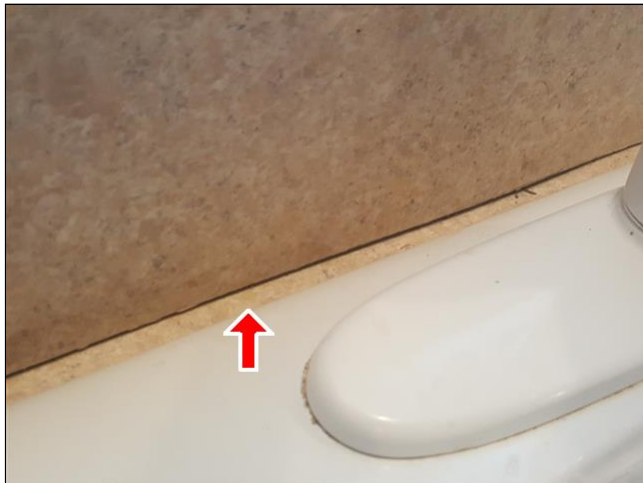
5.8 Item 1(Picture)

Recommend better sealing between the laminated counter and trim. This will prevent water entering which may cause damage to the counter top near the sink area and then may result in possible mold forming. Repair using a quality caulk that is resistant to moisture and is expandable. Repair as needed.

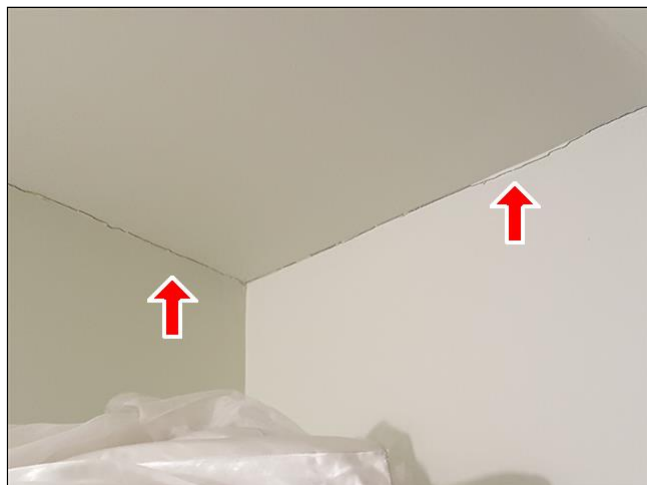
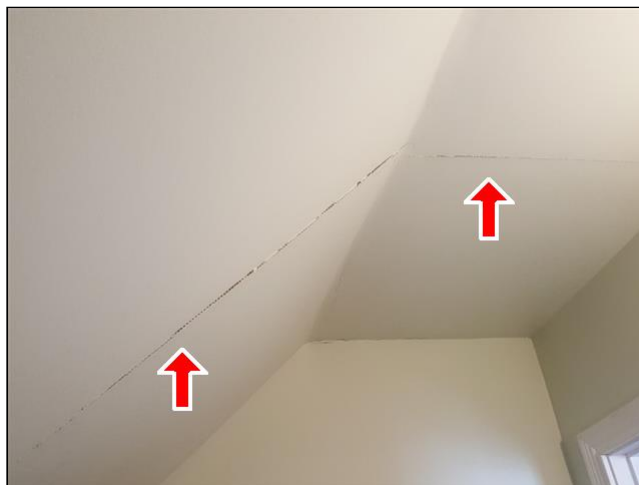
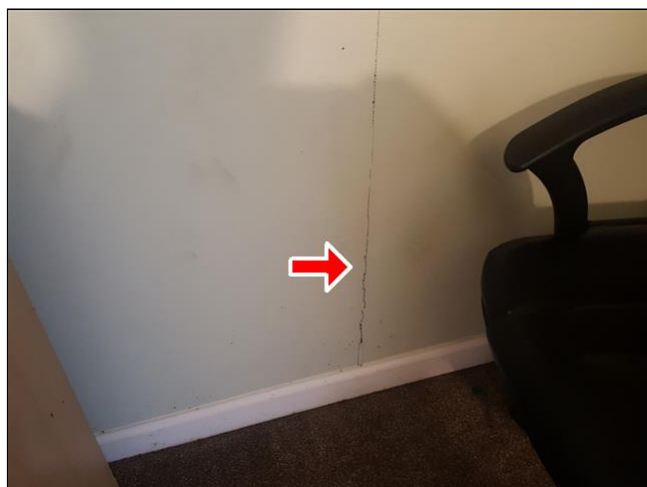
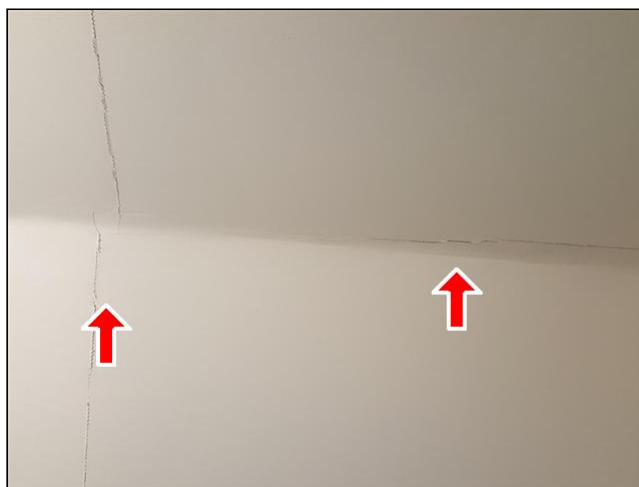
(3) The cracks in the ceiling in the 2nd bedroom closet (see photos for location) appear to be common settlement and/or shrinkage cracks. Cracks larger than 1/8" are of concern only. Cracks of this nature are caused by moisture, changing temperature, or framing shrinkage due to a lack of ventilation of vaulted ceilings and in the room. Recommend repairing cracks, replace solid door with a louver door to allow for ventilation to prevent high humidity in the room, then paint and monitor. If cracks reappear and become larger than 1/8" then would recommend a qualified contractor further investigate to determine cause and suggest repairs.

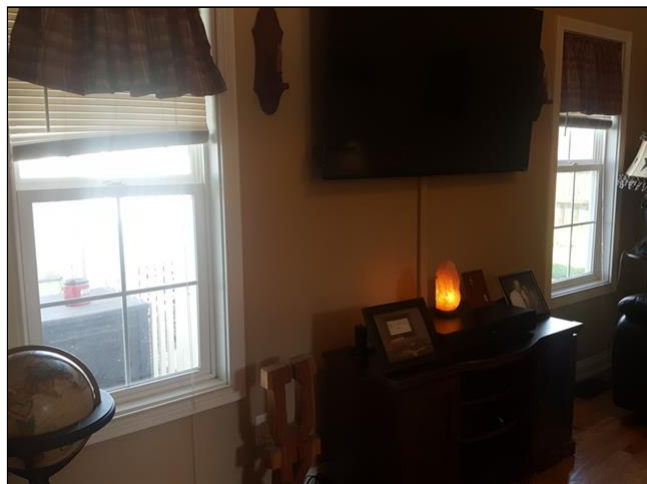
6.5 Item 1(Picture)

The windows in the living room where indicated in the photos are missing screens. Recommend these be installed to prevent insects entering the home when the window is opened. Replace as needed.

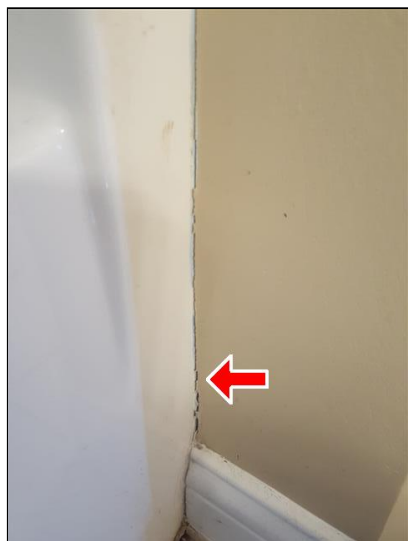
7.0 Item 1(Picture)

(1) Cracks in the caulk between the tub and the wall in the master bathroom should be sealed to prevent water intrusion behind the wall. If not corrected mold and/or deterioration of the wall framing can occur. Recommend caulking or grout to repair. [Choosing the right caulk](#)

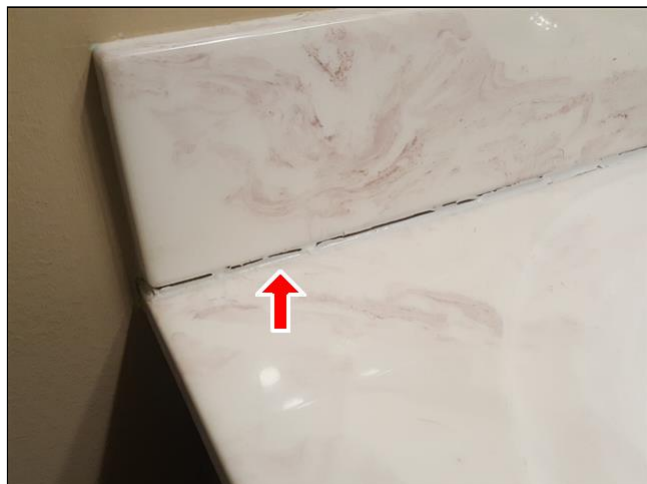
7.2 Item 1(Picture)

Recommend caulking around the counter top in the master bathroom to seal the crack. Water may enter which can cause damage to the drywall and cabinets, then result in possible mold forming. Repair using a quality caulk that is resistant to moisture and is expandable. Here is a link on [How to Choose the right Caulk](#)

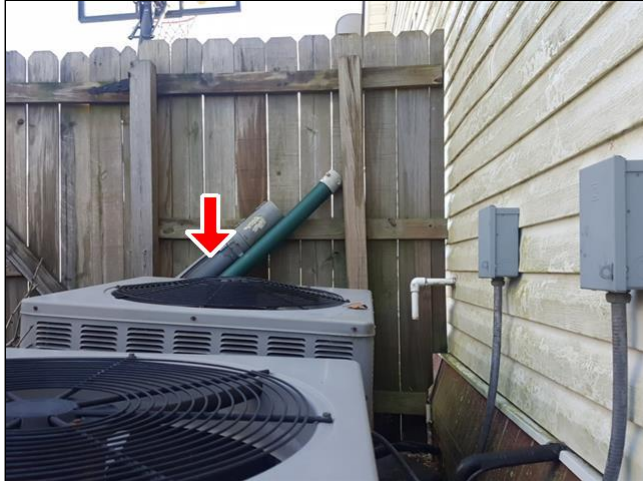
10.0.A Item 1(Picture)

(1) The outdoor Heat Pump unit is not leveled. This may cause wear to the bearing housing and it can shorten the life span of the unit and can cause it to run inefficiently. If the unit settles due to the soil it can also cause damage to the refrigerant lines which may result in leakage of refrigerant gases. Recommend correcting the platform so that the unit is leveled. A qualified HVAC contractor is recommended for this correction.

If an AC condenser settles with the soil, the refrigerant lines can be damaged and the compressor may be damaged if operated.

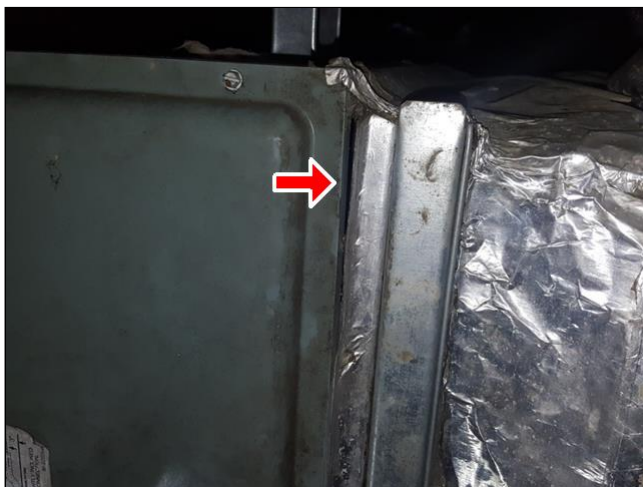
10.4.A Item 1(Picture)

(3) The return air duct is not sealed at the plenum at the Air Handler in the crawlspace. This is allowing unfiltered air in the crawlspace to enter the home via the blower which is allowing contaminants to enter the unit. This is a health issue. This can also cause damage to the unit and blower, increase heating/cooling costs. Recommend a qualified HVAC repair ductwork where necessary.

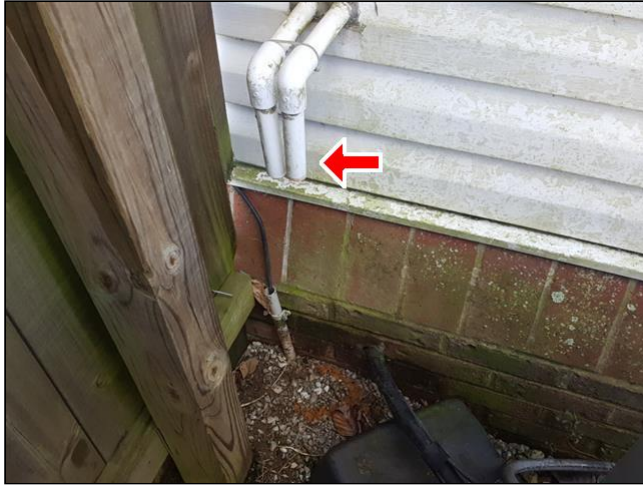
10.3.B Item 1(Picture)

Recommend the discharge for the condensate drain lines be improved via installing a splash block and extending the drain line at the right side of the home. This will prevent water pooling near the foundation which could cause settlement of the foundation wall, soil erosion and water leakage into

the crawlspace. Also to prevent possible settling of the platform for the Heat Pump. A qualified HVAC contractor is recommended for these repairs.
