Home Inspection Report

1 Main Street, Anytown, NY 12866

Inspection Date:

Monday, May 6, 2019

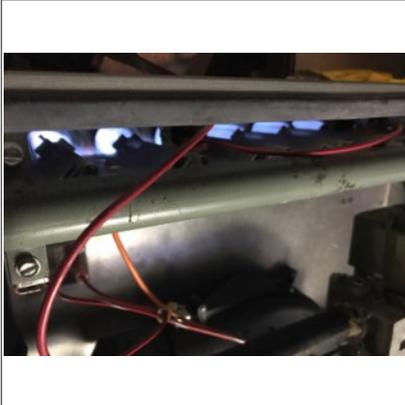
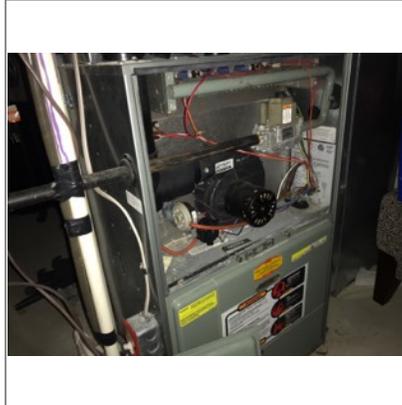
System type • **Forced Air Furnace**
• **Manufacturer: Bryant**
• **Model Number: 350MAV0360ADKA**
• **Serial Number: 4799A01525**
• **Manufactures Date: 1999**

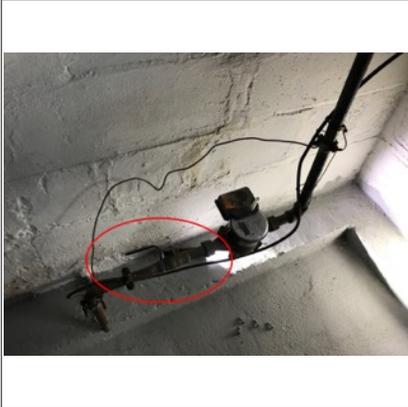
Water supply source •Public Water Supply
Service pipe to house •Copper
Main water valve location •Front Wall of Basement - Ball Valve
