**ARCHAEOLOGICAL ASSESSMENT REPORT**  
**on the**  
**COLORADO-YULE MARBLE CO. FINISHING MILL SITE**  
**Town of Marble, Gunnison County, Colorado**

SHF Grant No. 2003-AS-005

November 2002

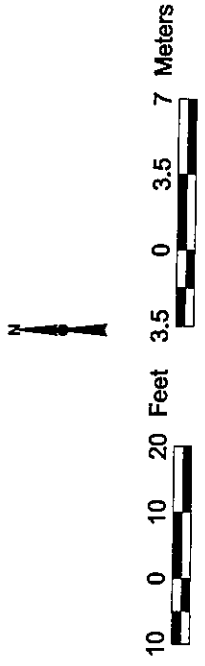
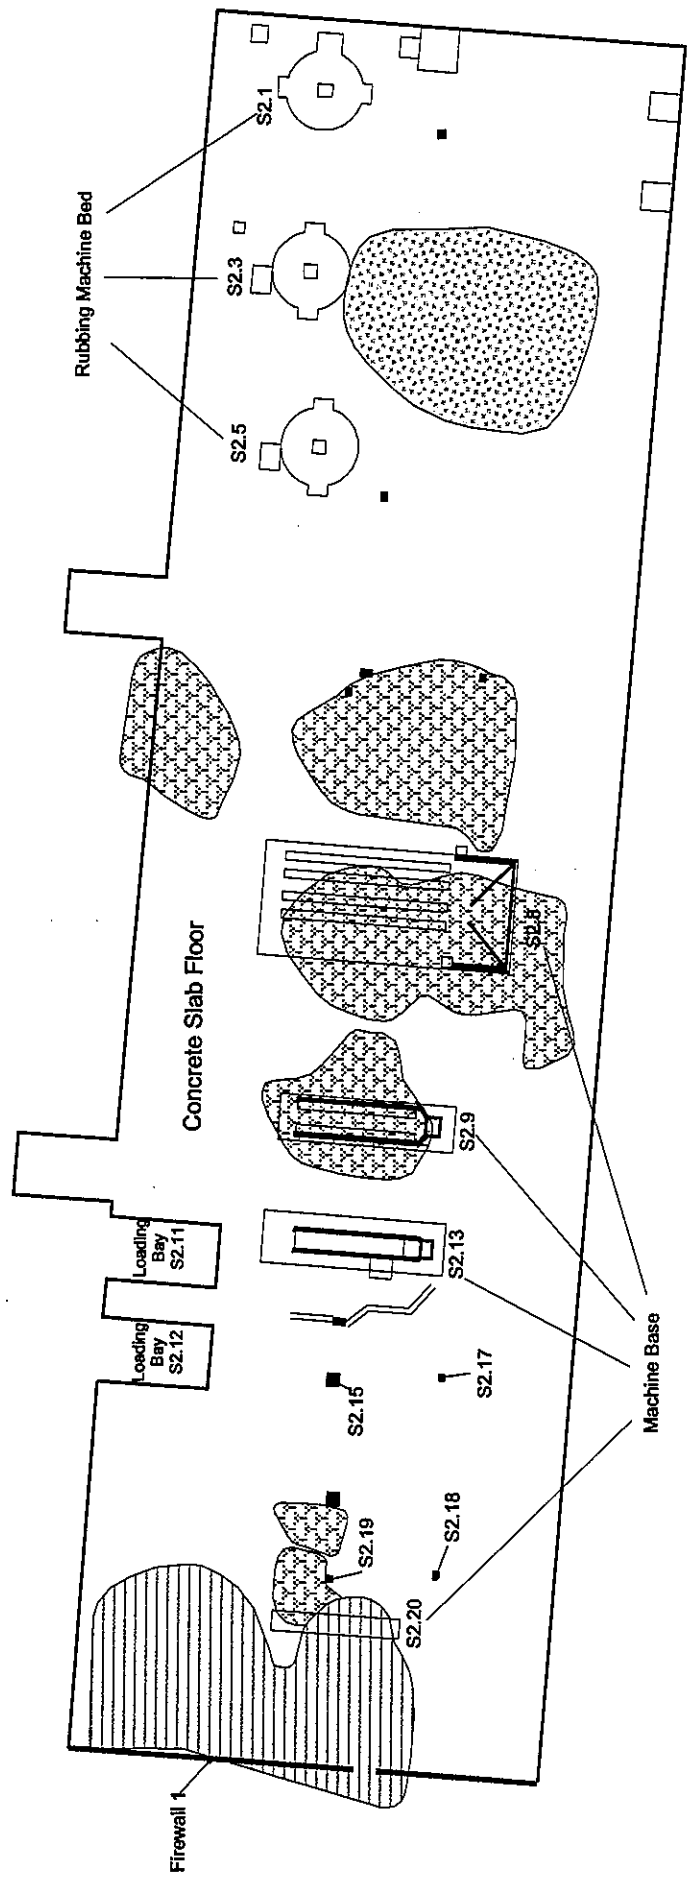
Figure 6. Plan view drawing of Shop 2 remains.

Footprints of three of the four rubbing machines are evident at the east end of the shop. The fourth is most likely underneath a marble sand pile adjacent to the others (Figure 6: features S2.1, S2.3, S2.5). This sand pile is probably a remnant of the marble grinding operation the Basic Chemical Co. was running in the early 1950s. Several historic photographs of these machines provide a great deal of information about their placement and how they operated (Figure 8; see Appendix B for an historic explanation of the machine's operation). Half of feature S2.3 was excavated to discover the shape of its smooth concrete base, which is pitched downward from both the center concrete support pier and from the outer edges toward the center of the circular base (Figure 9). The purpose of the pitch was to channel the rubbing compound slurry toward a drain on the east side of the machine. The slurry was then pumped into the two rectangular sumps adjacent to the machines (Figure 9) from where it was recirculated. Two rectangular footings with four mounting bolts each are on the east and west sides in line with each other. It is likely that these were the mounts for the horizontal wood beam that spanned the diameter machine as seen in Figure 8.

West of the rubbing machines, three large machine bases were discovered, obscured by dense patches of vegetation growing among them (Figure 6: features S2.8, S2.9, S2.13 and Figure 10). Some subsurface exploration revealed the shape and dimensions of the bases as shown on Figure 6. Several historic photos taken in 1909 are helpful in determining which machines corresponded with

5. Remove the pile of marble sand that covers the fourth rubbing machine base on the east end of the shop. Otherwise, leave it intact and use an interpretive sign to tell visitors about the other industrial uses of the 99 percent pure Yule marble that was ground up by Basic Chemical in the 1950s.

6. Remove some of the dense vegetation to expose the shop's south foundation wall. Removal of all vegetation is not necessary nor recommended. Remove some of the vegetation along the north side of the shop as well.

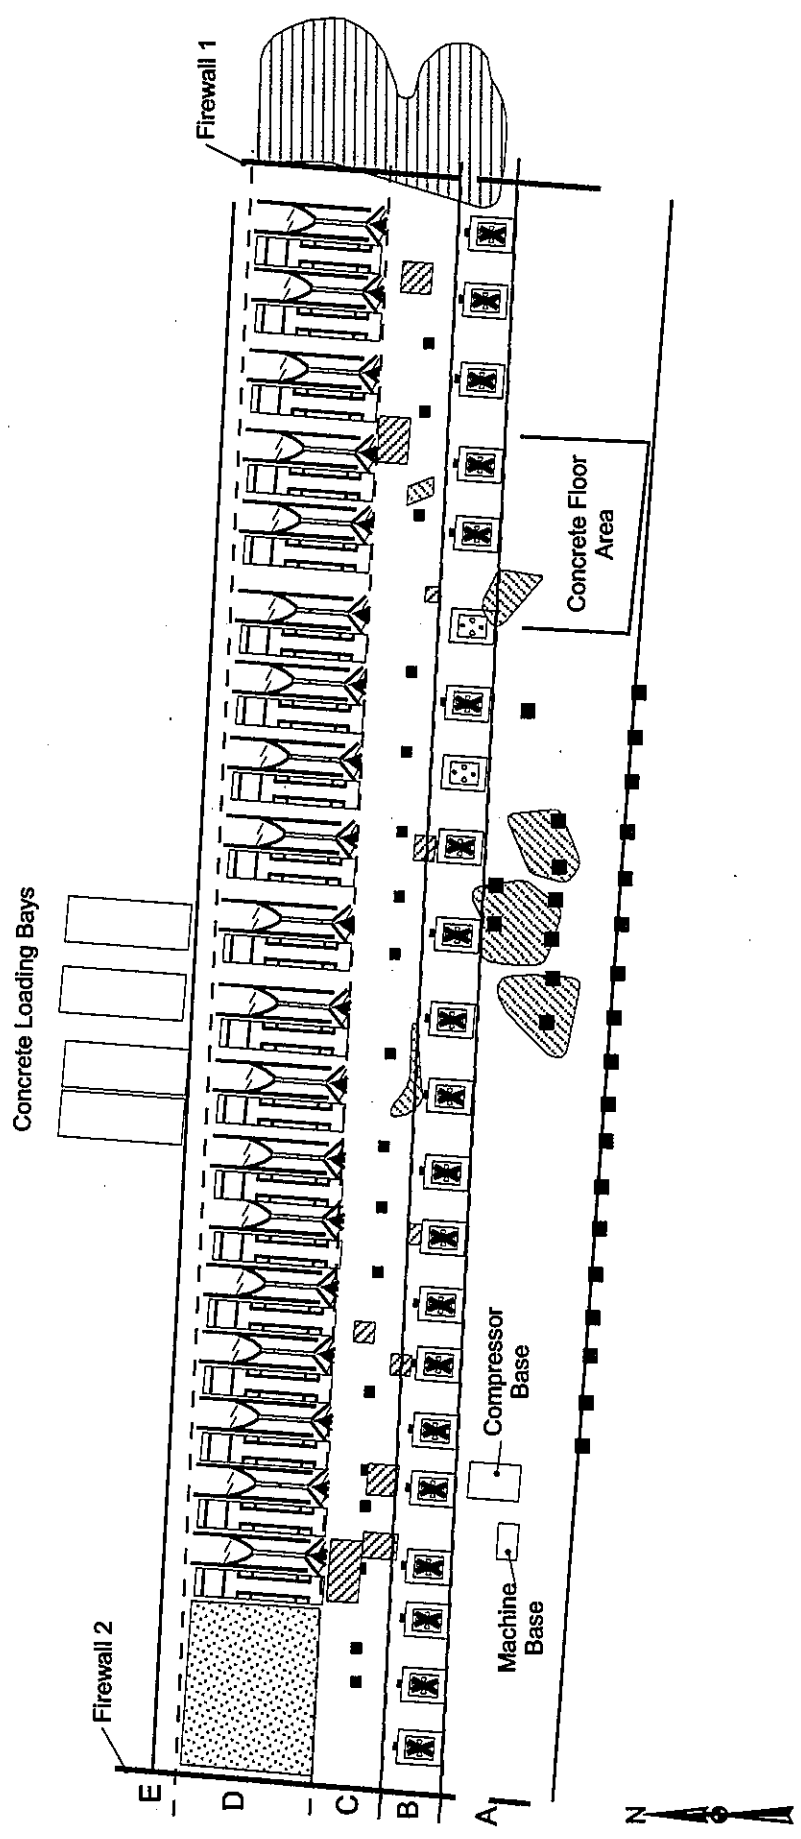
Figure 13. Plan view drawing of Mill B remains.

The overall dimensions of Mill B are 314 by 76 feet. Its eastern boundary begins on the west side of Firewall No. 1 adjacent to Shop 2. Its western boundary is the east side of Firewall No. 2. The same situation exists here as with Shop 2 where the southern boundary of the mill is clearly identified by its foundation wall, whereas the northern boundary is more obscure. The south foundation begins as a continuous dry-laid stone wall that becomes a line of 1½-foot square marble support pillars spaced about 5 feet apart. Remains of the north foundation wall are most clearly seen on the west side of Mill B, closest to Firewall No. 2. The majority of the north foundation wall is buried beneath massive marble blocks, structural and organic debris, and artifacts that were probably pushed there by bulldozer from the direction of the Stone Yard. This line of heaped debris covers most of Mill B's Stone Yard loading bays and many of the rear ends of the gang saw beds. The entire area of the mill is covered in dense vegetation, is severely disturbed, eroded, broken, or buried, and lacks a high degree of integrity. Figure 13 gives the archaeological plan of the remains at Mill B.

Although Mill B is quite large and its current condition is chaotic, it is not difficult to understand. It is easiest to divide the mill's area into five longitudinal sections from north to south, as indicated in Figure 13. A repetition of features and characteristics exists within each section. Section A begins at the south foundation wall and ends at the hard concrete edge of the machine base floor. This section is 27 feet wide. Its east end is characterized by a three-sided marble block enclosure adjacent to Firewall No. 1 and another enclosure of poured concrete just to the west. The rest of the section westward is characterized by partly filled depressions between rows of support piers. The interior piers are dry-laid stone, and exterior piers are wet-laid marble. The fill between the piers is highly organic and contains an abundance of structural debris and artifacts on the surface. It is expected that large numbers of artifacts are buried as well. The activity in this section of Mill B was hand polishing (Figure 14). Little remains of the concrete floor in this section. As shown in the photograph, an interior plank wall running east to west separated this section from the rest of Mill B. At the west end of Section A is a unique machine base (feature MB.62) that probably mounted an air compressor.

Section B begins at the south hard edge of the concrete machine base floor and ends at the north hard edge of the same floor. This section is 11 feet wide and runs the length of the mill. It contains 22 machine bases associated with powering the gang saws in Section D (Figure 15). The machine bases are of poured concrete, approximately 8½ by 6½ feet, and are spaced 12 feet apart, oriented north to south and aligned east to west. These bases mounted machines with a common mounting bolt pattern; however, they are not all identical. The bases on the west end of the mill are of the same concrete material and are badly deteriorated, whereas the bases on the east end are of variable material and are much more intact. Differences in the east end bases include different aggregate, concrete color and consistency, as well as variations in base sizes. It is likely that these bases represent later installations of new or different machinery as the mill evolved. Two explanations are possible for the differences in the machine bases on the east and west ends of the mill. In 1925, a fire devastated Shops 3, 4, and Mill B (Figure 16). These structures were not replaced, and only a small portion of Mill B's east end was reconstructed for continued use. The machine bases on the west end were first exposed to a fire and have been exposed to the elements since 1925. The east end bases may have been recovered and maintained between 1925 and 1941 before being abandoned to the elements. The machines on these bases were associated with driving gang saws that sat across from each one.

2. To compliment the fence at the east and west ends, another fence can be installed in the Stone Yard area along the length of the northern boundary of Mill B, between the two firewalls. Once again, this type of fence is not designed to completely block access. An iron post, single-chain fence about 4½ feet high would be enough, and it would be visually unobtrusive. Hang signs along the fence that tell visitors to stay out of the Mill B area for safety reasons.
3. To help prevent visitor accidents in Mill B and to protect resources from further deterioration, it is advisable to fill open holes in Section C with clean sand. This includes sumps, areas of floor collapse, pits, drains, and so on.

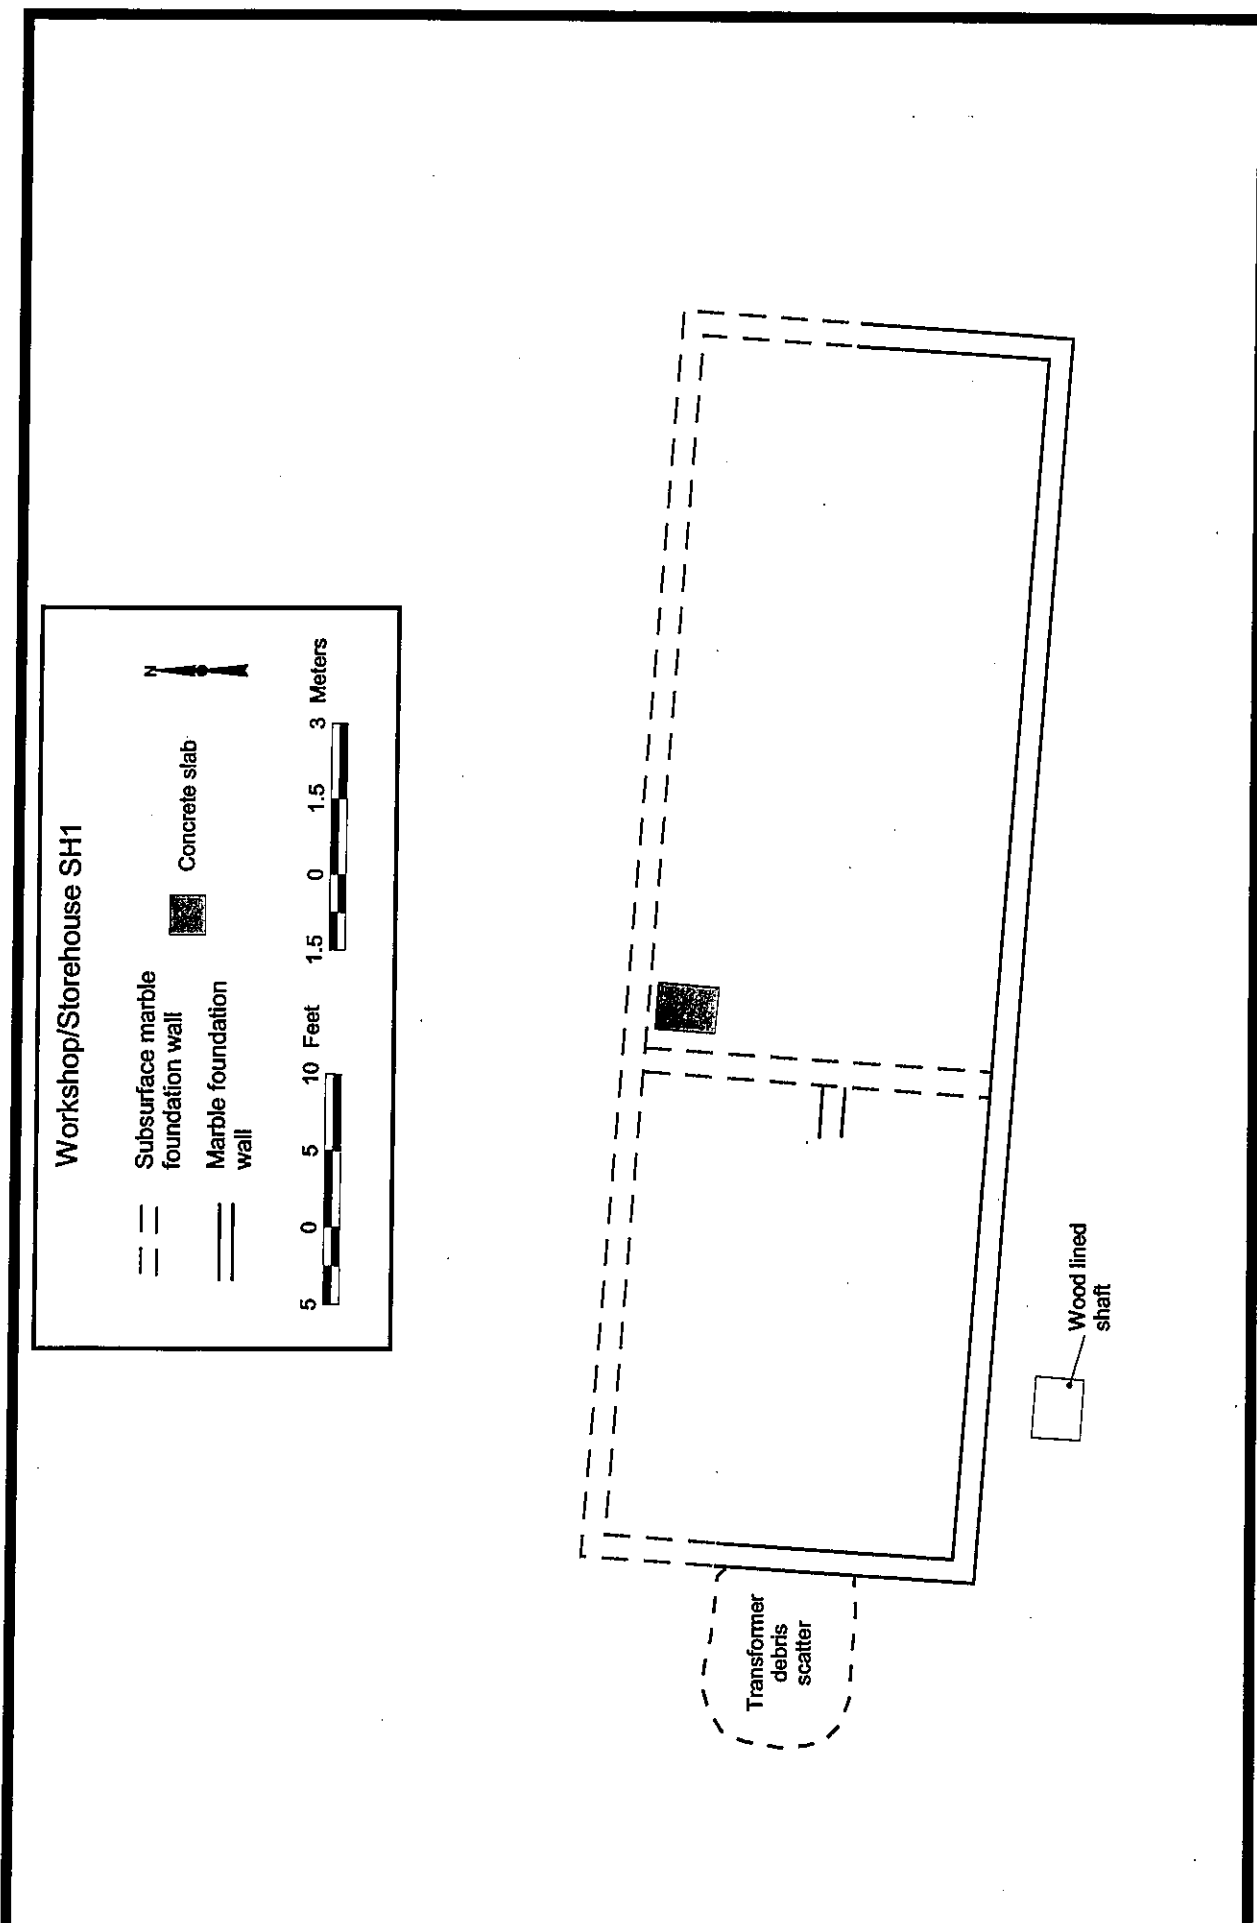
Figure 26. Plan view drawing of ancillary structure SH1 foundation remains.

Two ancillary structures were constructed during this area during 1907-1908 whose remains are visible today. As seen in Figure 25, they are distinguished by the dormer and large windows on the one closest to the blacksmith shop (east side), while the other has no windows and is not whitewashed (west side). The west side building is labeled on several maps as a storehouse, but the other building is not labeled. Because of the four large windows and the dormer, this structure probably functioned as a workshop and not as another storehouse. The structure was expanded westward in 1911, but was destroyed by an avalanche in 1912, along with the blacksmith shop. The blacksmith shop was rebuilt, but the other workshop was not. The marble foundation of the structure is visible today (Figure 26 and Figure 27). Its length is 82 feet, and its width is approximated at 25 feet. An internal concrete footing 30 feet from the west wall may mark the 1911 addition. A fair number of artifacts are visible on the surface within the foundation walls, including sheet metal, a large spool of one-inch-diameter wire rope, structural debris, wire nails, and structural hardware. A 3 by 4-foot, 6-foot-deep wood plank-lined shaft with an internal ladder on its west wall is located three feet from the foundation's southwest corner (Figure 26). The function of the shaft is unknown. Immediately west of the foundation wall is a 9 by 11-foot surface scatter of electrical transformer fins and what appears to be a large mound of disturbed earth farther to the west. It is likely that the remains of the storehouse building are just below the surface here. They should be left undisturbed.

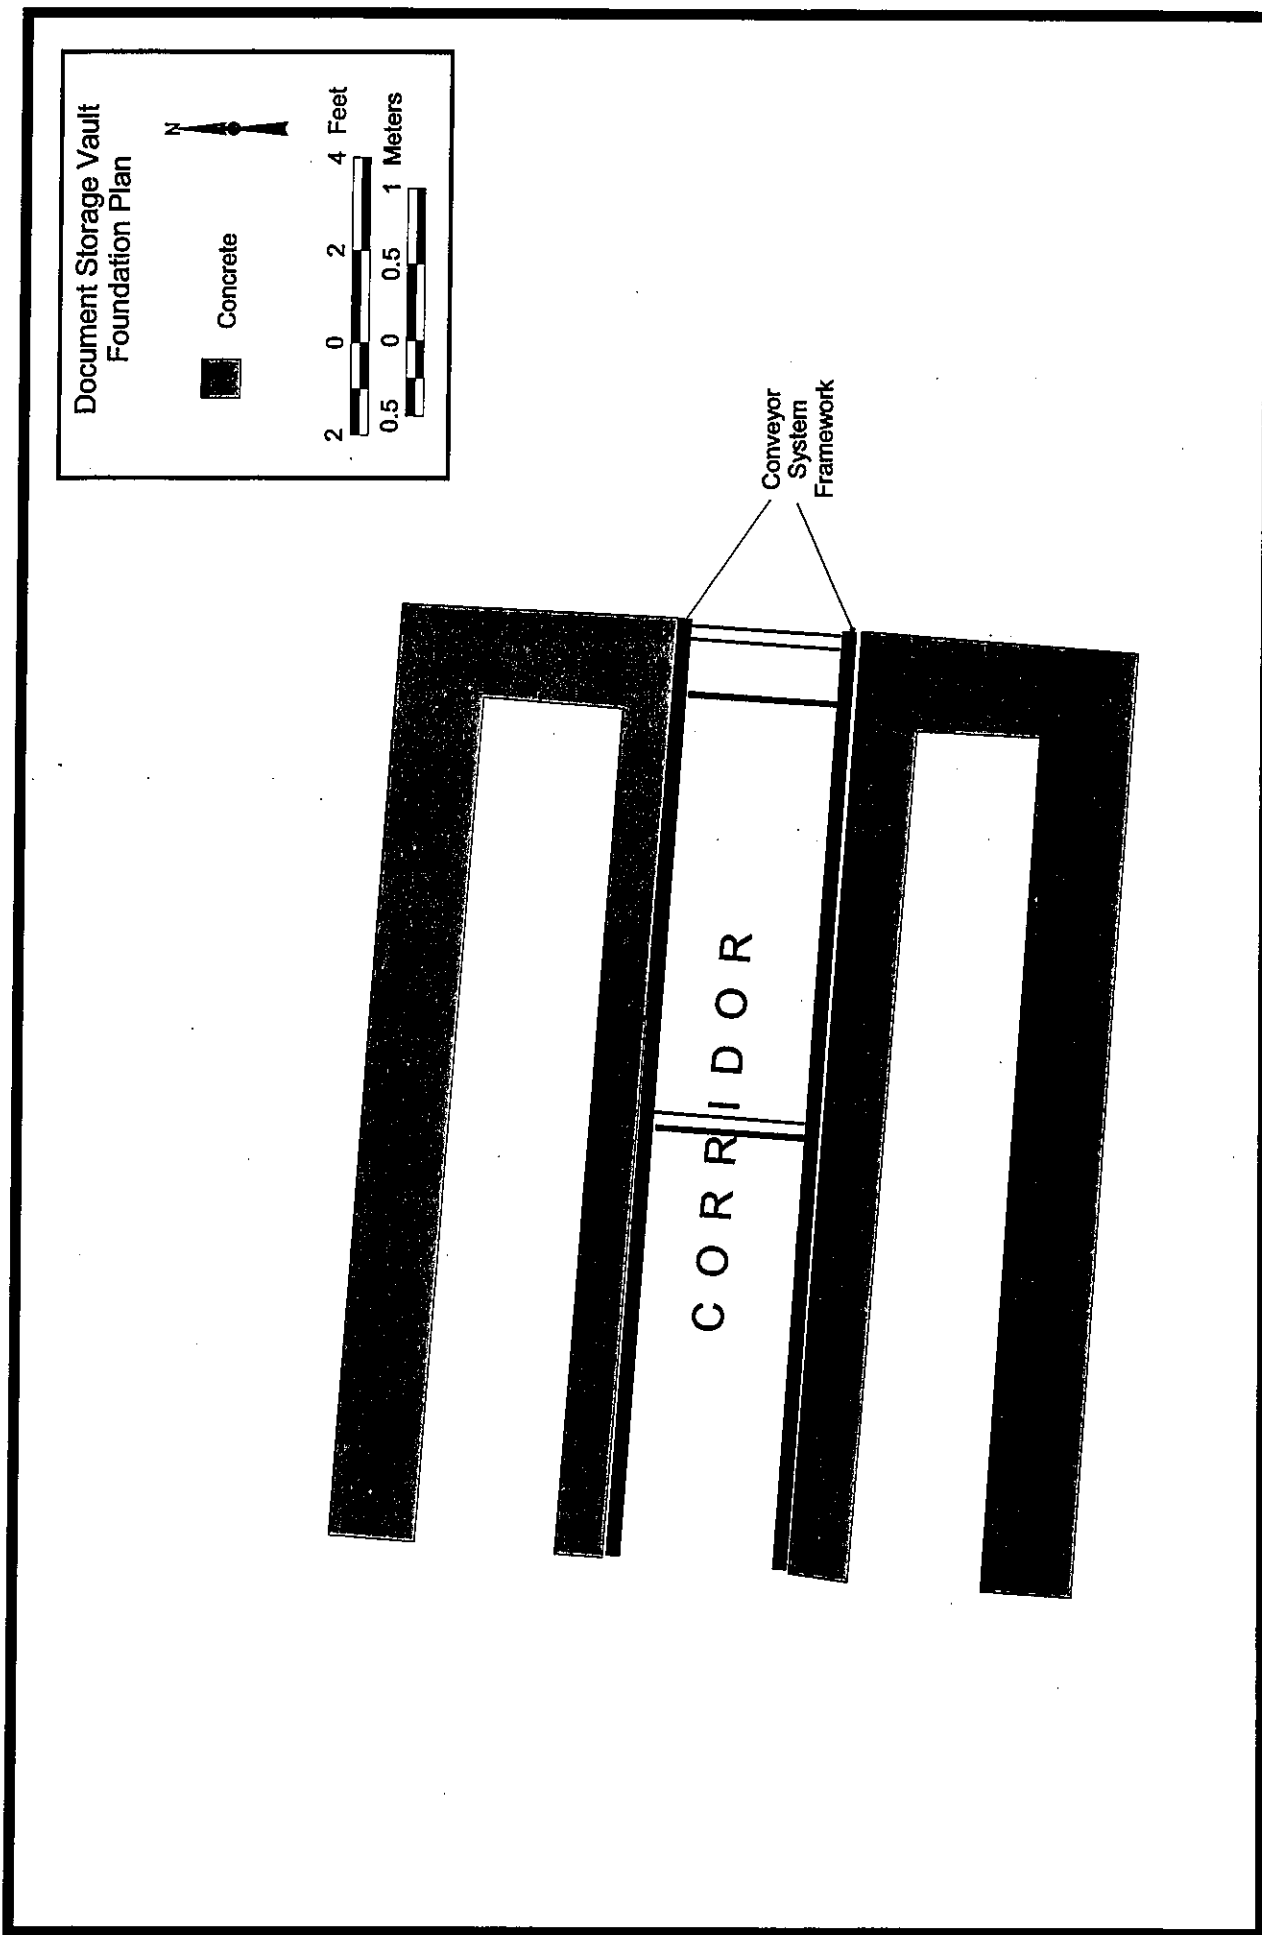
Figure 30. Plan view drawing of the Document Storage Vault foundation showing conveyor frame running through the length of the foundation.

The gable roof on the vault today is clearly not original, but was installed to protect it from further water damage. There is a large 6-foot 7-inch by 7-foot 4-inch doorway on the north side and a 3-foot by 3-inch by 4-foot 8-inch window opening on the east side, neither of which are original. Their construction and reinforcement are roughly done, with little concern for finish or appearance. On the west side, an original 3 by 6-foot doorway that provided the only access to the vault from the Front Offices. The concrete foundation is exposed on three sides where it is obvious that the surrounding fill has been removed some time ago. The southwest foundation corner of the structure is exposed just over 7 feet from the ground level to bottom of the first course of stone. It is likely that most of the vault's foundation is exposed on the south and east sides. The foundation itself is of a curious design because it was left open at the rear (west) side of the building (Figure 30). The 3 by 5-foot corridor through the center of the foundation contains a 2-foot-high iron framework constructed of standard and narrow gauge rail. Its function was part of a conveyor system installed in the 1950s by the Basic Chemical Co. to move crushed marble from the Front Offices area into trucks for transportation to market.

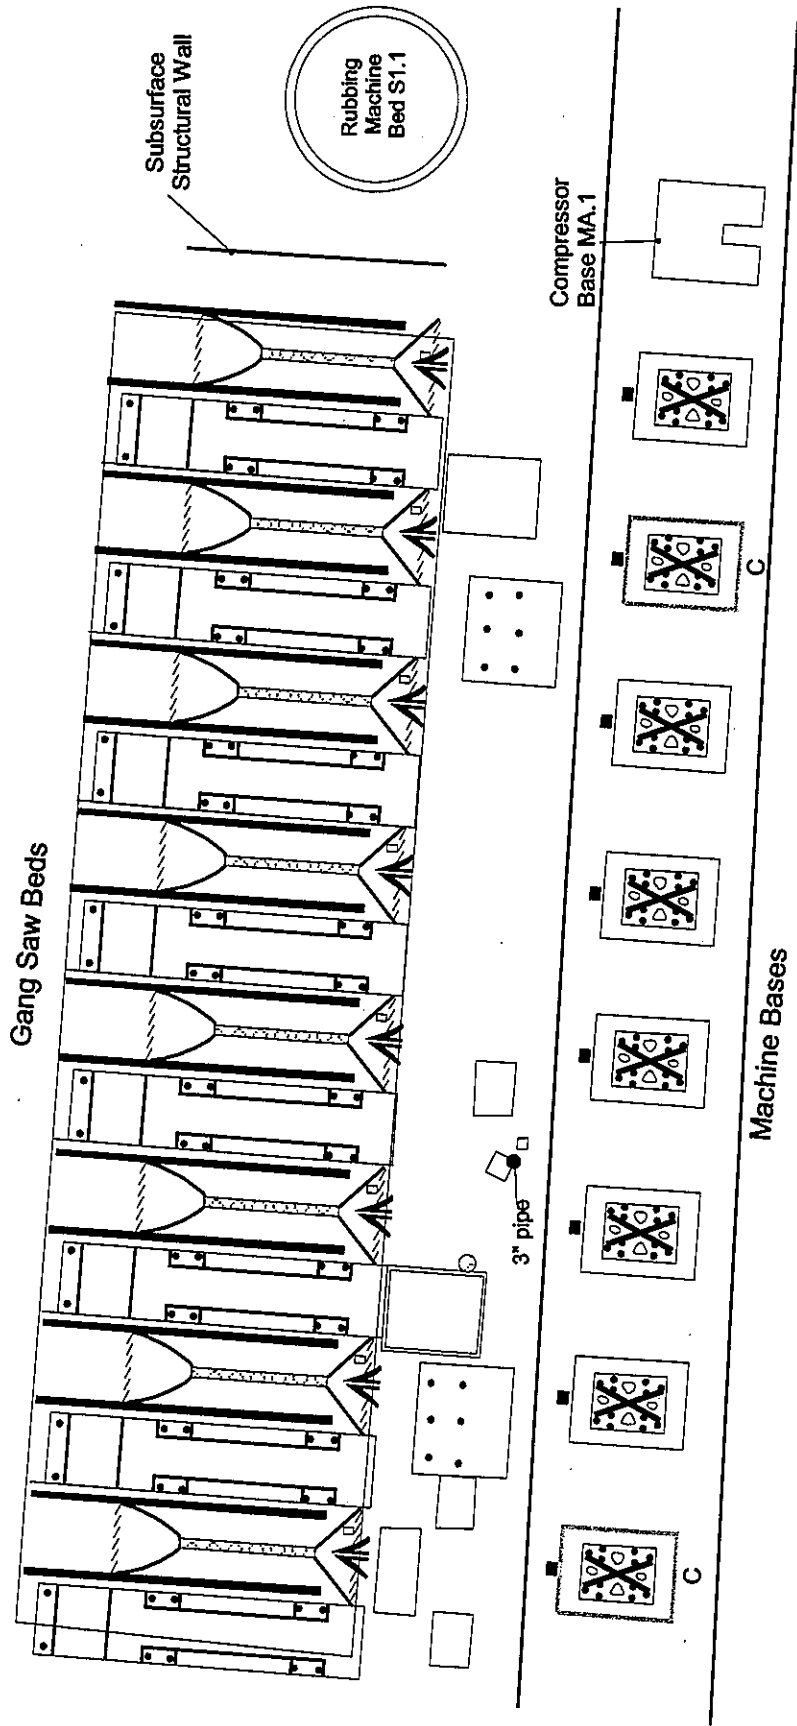
Figure 34. Plan view drawing of Mill A remains.

Mill A is just west of the Shop 1/Front Offices leveled area described above. Its eastern boundary begins at feature S1.1 (Figure 34). The northern boundary is the mill building's north foundation wall, which is not visible above ground. Its southern boundary is defined by the hard concrete edge of the machine floor. This edge is not the mill building's south foundation wall, however, which is visible as an earth and stone berm with a soft edge. The western boundary is defined by the edge of the concrete floor that separates Mill A from Shop 2. As Mill A was constructed within Shop 2, there was no structural wall separating the two spaces; however, historic photos show that there may have been a plank wall separator. The overall dimensions of Mill A are approximately 124 by 50 feet.

The remains of Mill A consists of eight 6½ by 8½-foot concrete machine bases and one 7½ by 8-foot machine base on the south side; eight gang saw beds of various dimensions, approximately 20 by 10 feet on the north side; and one 12½-foot-wide area of collapsed concrete floor between these features (Figure 35). The eight similar machine bases on the south side of the mill each mounted a belt drive/fly wheel combination for driving a gang saw across from it on the north side. These bases have a similar bolt mounting pattern, but are different in their concrete structure. The difference is in color, aggregate, and texture, indicating that two were poured at different times than the other six. The six light grey ones are likely original installations, whereas the two light tan bases may have replaced earlier mounts. It is not certain when these replacements were made, but they also

correspond with color differences in the concrete material of the saw beds across from them. The bases are in line from east to west and spaced approximately 8 feet apart. The last machine base on the east end of the line, the ninth one, is dissimilar to the others. A ca.1913 Sanborn Fire Insurance map shows an air compressor at the spot, and the last machine base may have been its mount.

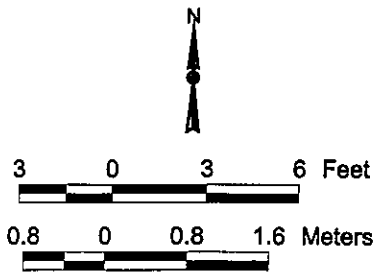
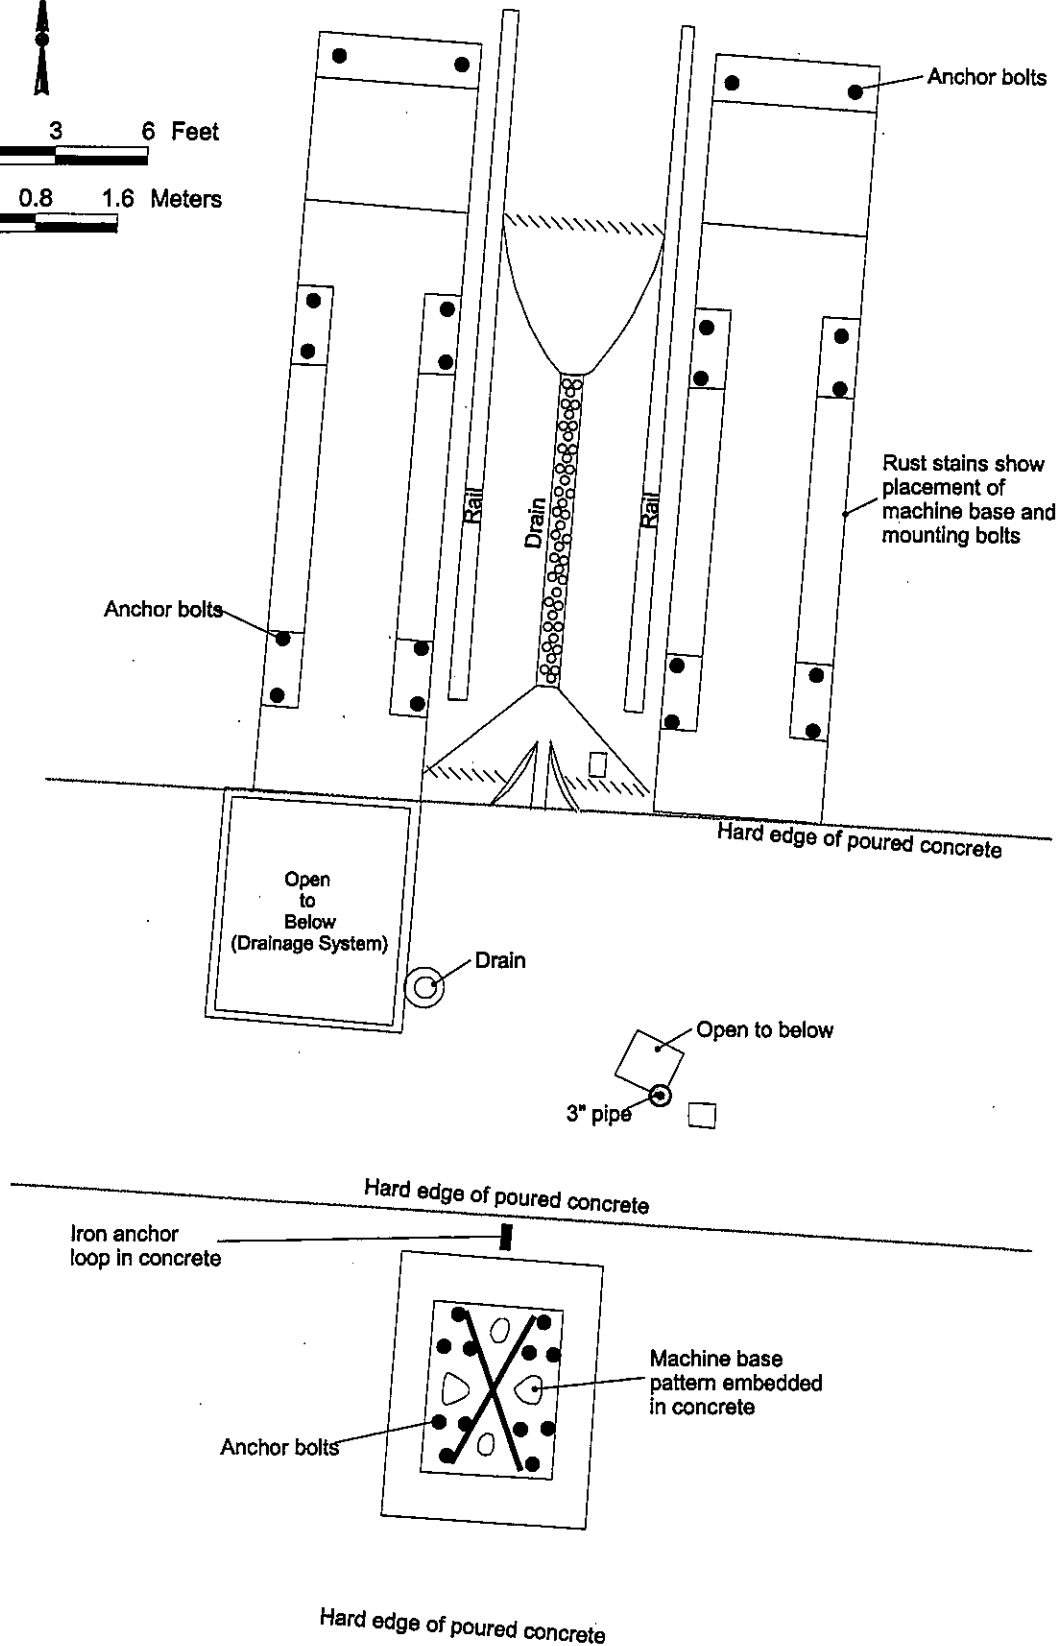
Gang Saw Bed and Machine Footing, Mill A

Figure 38. Detail drawing of Gang Saw arrangement in Mill A.

manageable for visitors. The gang saw remains here are practically identical to those in the much larger Mill B and are in better condition, are less hazardous, and do not require as much clean-up and maintenance of vegetation.

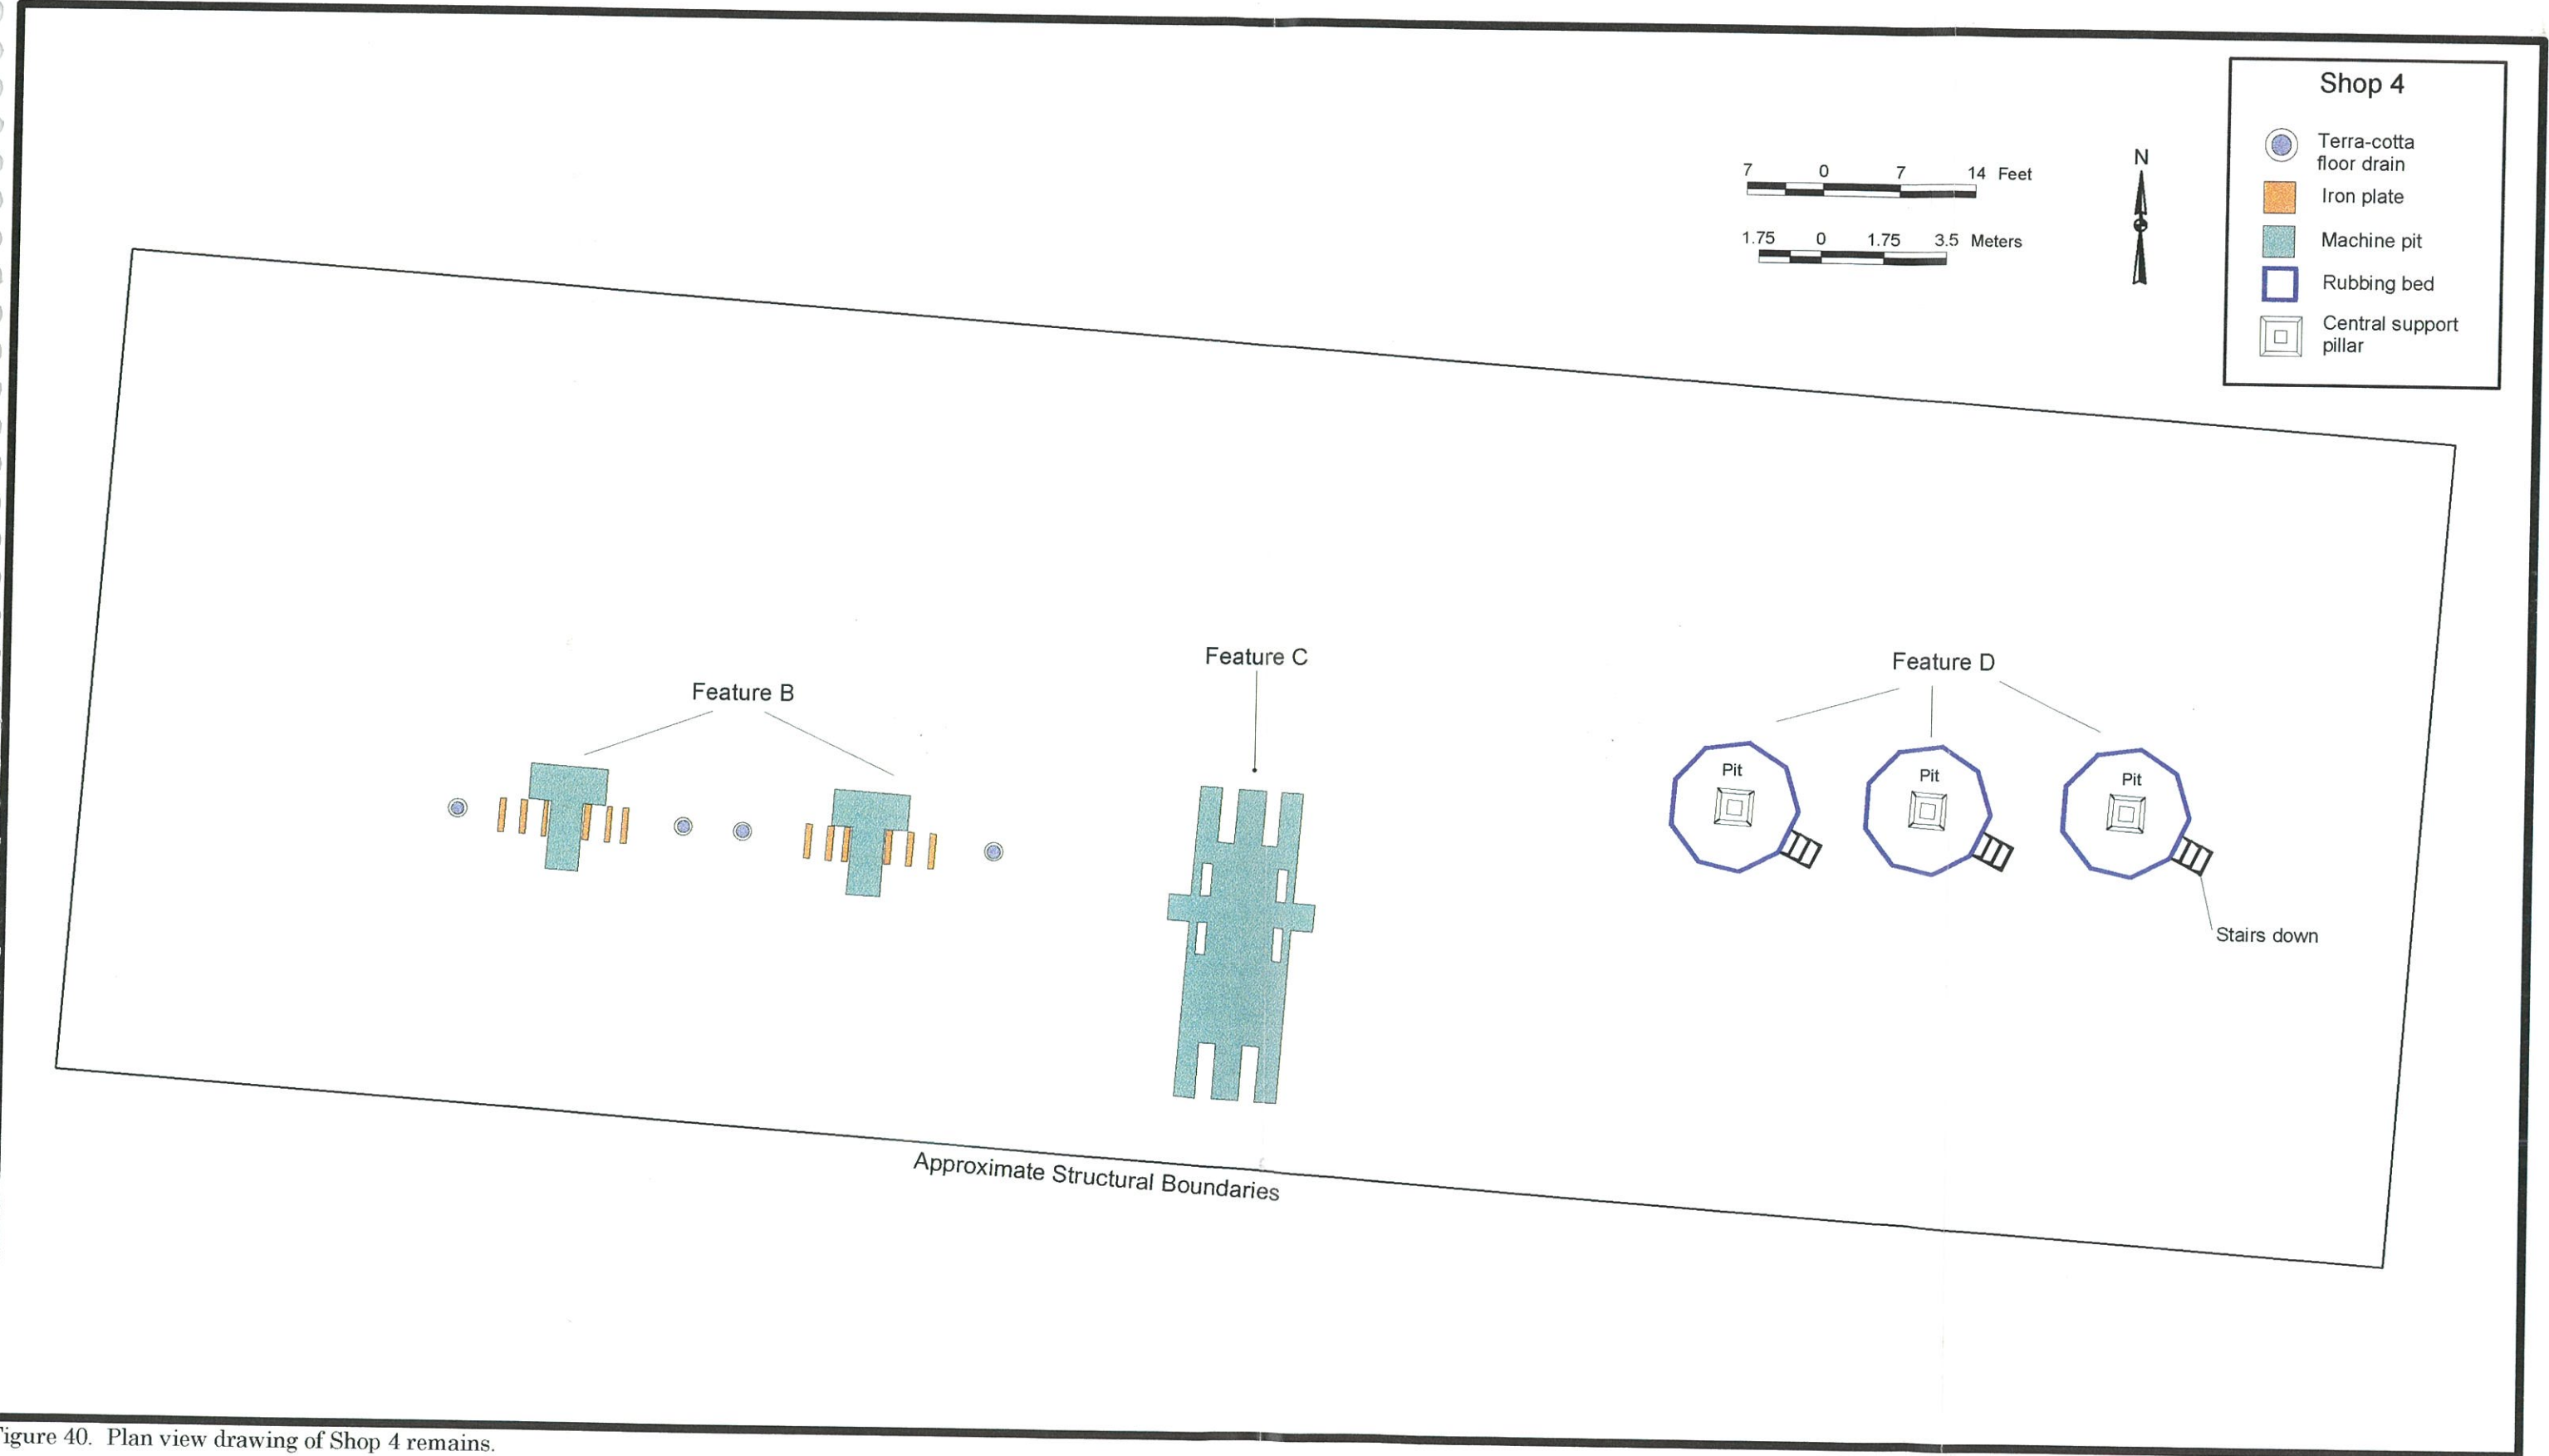
Beginning close to the western boundary of the shop and moving east, Feature A is a flat concrete machine base approximately 10 by 25 feet that is barely discernible due to its deteriorated condition. Two 4-inch-wide flat iron bands sticking up near its south end are badly twisted. What mounted to this base is unknown. Feature B lies east of Feature A, consisting of two 7 by 10-foot T-shaped concrete pits, their associated 2-foot-diameter terra-cotta floor drains, and iron mounting plates with bolts on the east and west edges of the pits (Figure 40). A repetition of the pattern and dimensions of these features indicates that two machines were probably mounted in this area. A rough but obvious concrete floor is associated with these, but its edges are not visible due to the heavy organic fill and overgrowth. East of Feature B and in line with it is Feature C, a 28 by 10-foot badly deteriorated, concrete pit with several internal rectangular footings (Figure 40). The south end of the pit is not visible, as it is covered by large blocks of marble debris. The north and west edges are barely discernible and several of the internal concrete footings have been displaced by trees growing inside of the pit. Any concrete floor around the feature is not visible. Feature C is most likely a large concrete machine base, but it is not known what type of machine was mounted here. Finally, east of Feature C lies Feature D, an area occupied by three rubbing machine bases (Figure 40 and Figure 41). These are in line east to west. Although their pattern and 12-foot diameters are similar to the rubbing beds in Shop 2, these are different in construction. Instead of having shallow concrete bottoms at the shop floor level with wooden sides, Shop 4's rubbing beds are poured concrete pits excavated approximately 3 feet below the shop floor level. Each pit has three concrete stairs adjacent that lead into the pit from the shop floor. The stairs of all three are heavily encrusted with the solidified iron filings/sand slurry substance described earlier in Mill A. A 12-inch-diameter round drain covered by wire mesh is near the stairs on the south side of each bed.

Figure 40. Plan view drawing of Shop 4 remains.

Shop 4 was one of the structures consumed in the 1925 fire, and its area has remained open to the elements since then. Between the fire damage itself and more than 75 years of exposure, even the concrete features of the shop's floor have seriously deteriorated. From an interpretive perspective, this area is a difficult one. It has been virtually reclaimed by nature at this point, and looking across its area does not show it to be much more than a part of the natural landscape (Figure 43). This is unfortunate because the largest of the machines at the mill were housed here, and the largest and most prestigious project the mill had was carried out here. Although the shop's boundaries are obscure, they can be closely estimated on the ground. Enough visible features remain to warrant further historic and archaeological research to discern what they are and to discover others. It would help to clear this area of smaller vegetation in order to visually define its boundaries, but doing so would still not reveal the shop floor that is either buried or deteriorated. The question, then, is whether or not it is wise to disrupt the path of nature's reclamation for a limited number of interpretive features.

1. Conduct further archaeological and historical study to find out more about the remains of the shop. Limited excavations can determine the actual extent of the shop's boundaries, the placement of the central tramway rails, and the condition of other ephemeral concrete features. A sound archaeological map can also be developed at the same time. Historical research can reveal more exact information about each of the large tools that occupied the shop so that they can be placed by dimension or association with the actual remains. These are important first steps that will determine the potential for further interpretive development, ranging from removing a limited amount of vegetation to completely exposing the area.

2. A limited interpretation presents the area for what it is: the former Shop 4 that was first burned and then reclaimed by nature over more than 75 years. Signage can give the history of the shop with historic photos of it to illustrate the details of the massive tools and all of the people that worked there. Visitors can be informed that the natural reclamation process is well underway and that what little remains of the shop does not warrant interrupting this process. Ground surface organic material and small brush may be removed to give the features more visual definition.
