Inspection Report

Property Address:
2914 Crimea Street
Versailles KY 40383

Talon Home Inspections, LLC

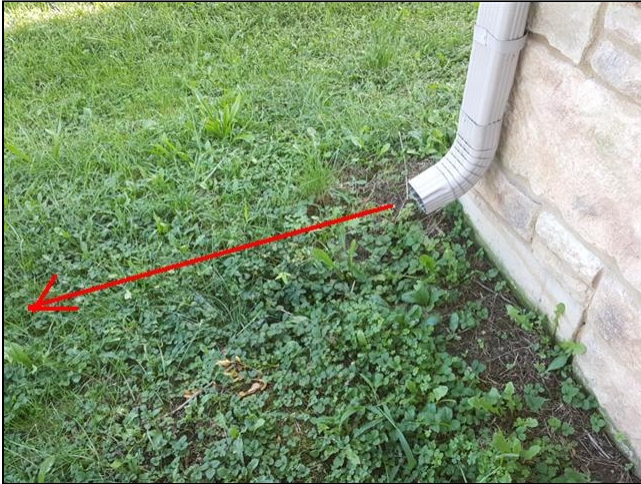
2.3 Item 1(Picture) rear left corner of home

2.3 (1) The downspout is missing a splashblock and is discharging on the ground next to the foundation of the home where indicated in the photos. The downspouts should discharge water through leaders then onto splash blocks at least 5 feet from the home. Storm water should be encouraged to flow away from the foundation/home at the point of discharge to prevent water entering the basement and to prevent settlement of the foundation. Recommend repair and correcting as needed by a general contractor.

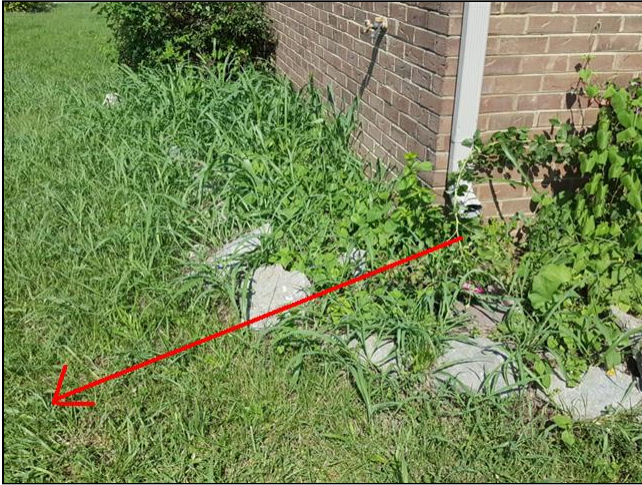
2.3 Item 5(Picture)

2.3 (2) Recommend the downspout(s) at the front left corner of the home where indicated in the photo(s) be re-directed and extended at least 6 feet and flow onto splashblocks so water flows away from the foundation perimeter. This will ensure water is kept away from the foundation perimeter, soil erosion does not occur and water cannot leak into the basement. Also this will prevent settlement from occurring around the foundation perimeter. Recommend repair and replacement as needed.

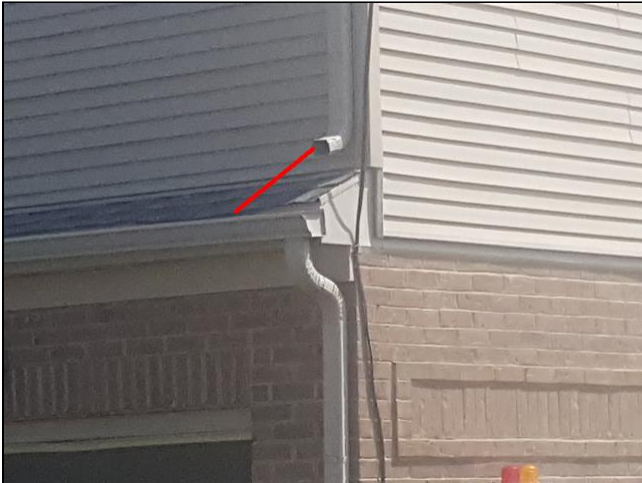
2.3 (3) Recommend the downspout(s) that discharge onto the roof be extended to discharge water directly into the gutter below. This condition, if left unattended, can result in premature deterioration and staining of the roofing material under the end of the downspout. The excessive discharge of storm water onto roof from downspout also puts stress on building materials designed to prevent water entry into the structure of home. Recommend correcting all around the home as needed using a qualified gutter installer.

2.3 Item 6(Picture) rear right corner of home

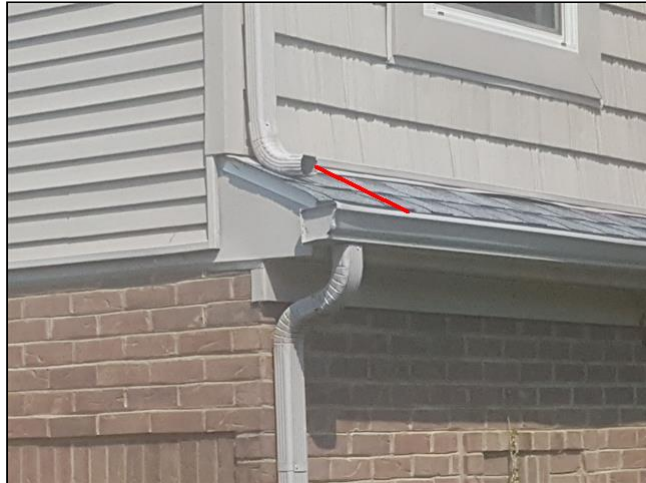
2.3 Item 7(Picture) front left corner of home

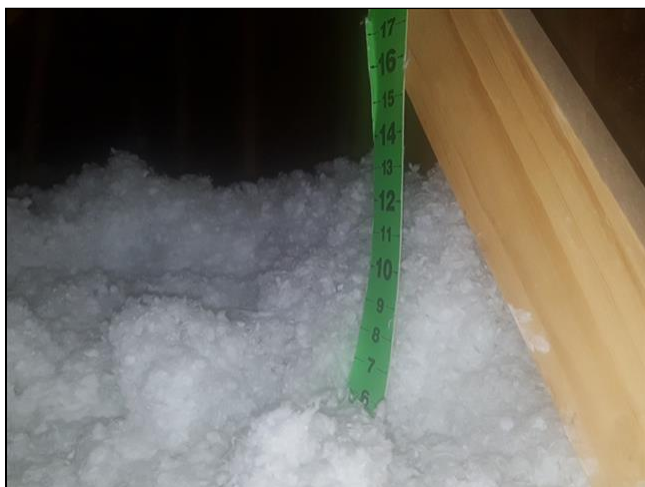
2.7 Item 1(Picture)

2.7 The insulation is about fourteen inches thick or just under 40 R-Value.

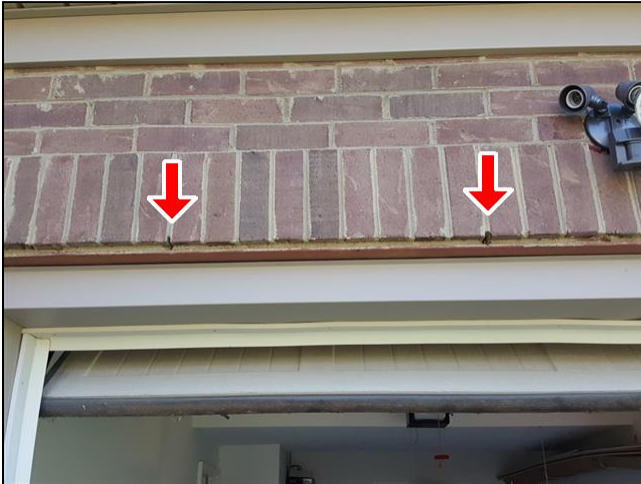
3.0 Missing mortar in these areas of the brick siding are known as weep holes. They allow moisture to escape from behind the wall siding. They should not be filled in. This is for your information.

3.0 Item 1(Picture) above garage

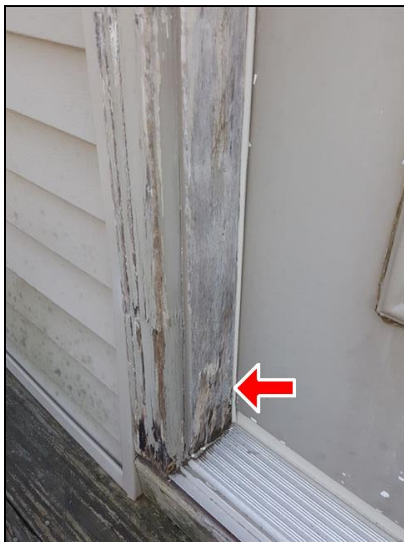
3.3 Item 2(Picture)

3.3 (2) The entry door frame at the rear of the home is weathered/has missing paint and needs prep and paint (exterior) around the door frame to prevent water intrusion. Deterioration may occur via wood rot if not painted. Recommend prep and paint as needed.

As an additional note you may wish to consider wrapping the door frames with metal wrapping. This will ensure frames are sealed and not exposed to the weather. It will eliminate the need for maintenance in regards to painting wooden frames so that moisture will not penetrate.

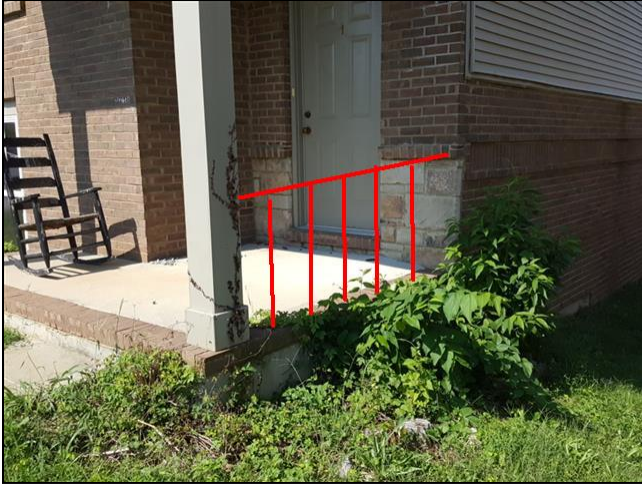
3.5 Item 1(Picture)

3.5 Recommend a guard rail be installed around the front porch on the right side to prevent a fall from occurring which may result in an injury of a person. This is a potential safety issue. The railing needs to be at least 36 inches high and balusters need spacing to be at least 4 inches. Recommend a qualified contractor install one for safety.

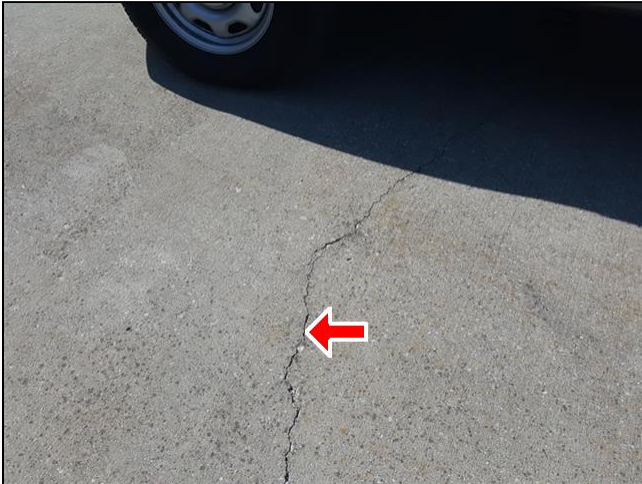
3.7 Item 1(Picture)

3.7 The concrete drive at the rear of home has minor shrinkage cracks. Water intrusion can cause further deterioration if not repaired and sealed properly. Recommend repair as needed using a masonry caulk.

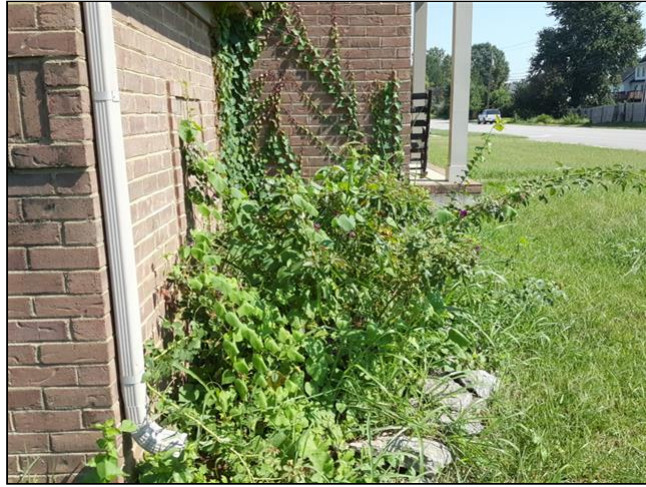
3.11 (1) The vegetation where indicated in the photos should not to be in contact with the home, especially dense foliage and ivy. Plants can hold moisture against the building, slow down the drying effect of circulating air and they provide a hiding place for rodents. Recommend that all vegetation be kept neatly trimmed and away from the foundation, wall siding, and window frames to prevent damage to the home and allow proper venting and inspection of house. A 6" clearance is recommended. Cutting back plants from the walls is a good idea.

3.11 Item 2(Picture) front left side of home

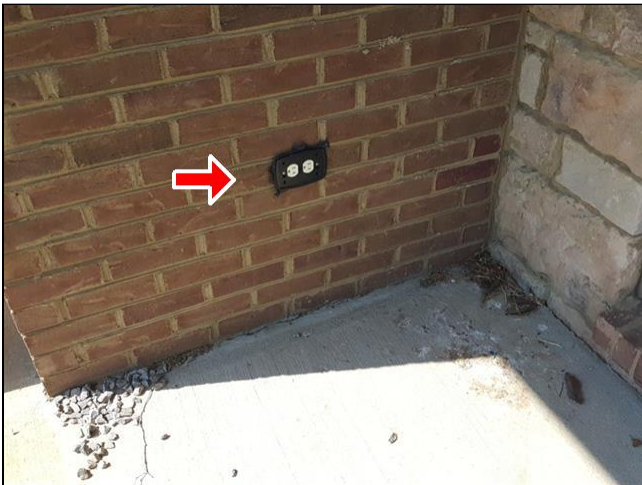
3.13 Item 1(Picture)

3.13 (2) The exterior outlet at the front of the porch does not have a weatherproof cover installed and/or the cover(s) is missing. This is a safety issue. Water could enter causing a short or an electric shock. Recommend a qualified electrician correct as needed.

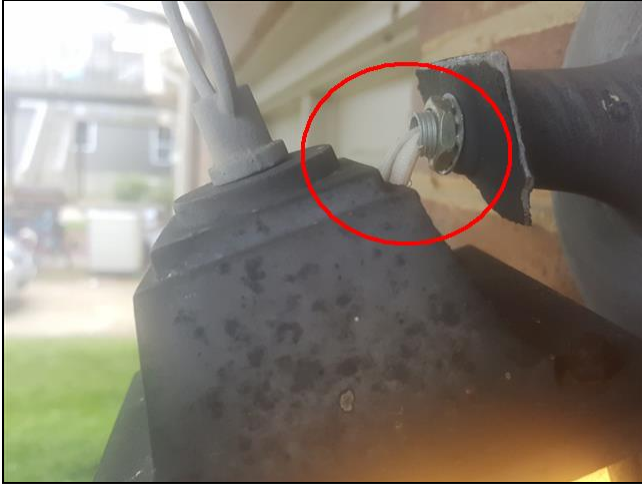
3.13 Item 3(Picture)

3.13 (3) The light fixture is loose at the wall and there is exposed wiring at the light fixture at the rear of the home. This is a safety issue and is hazardous. Wires should not be exposed to weather or tampering. This is also placing stain on the wire connections. Recommend a licensed electrician correct and/or repair as needed prior to moving in.

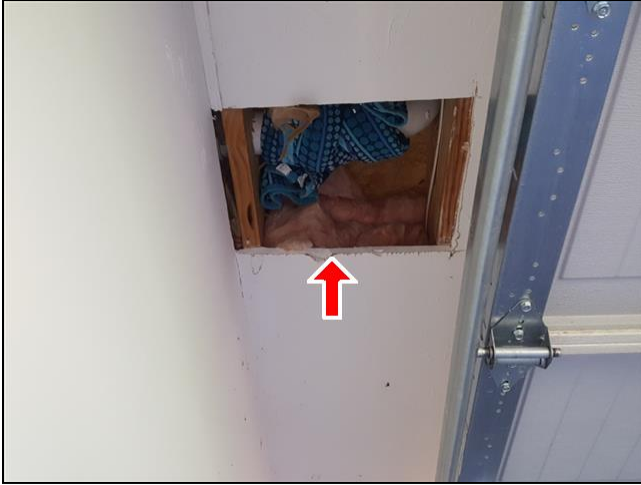
4.0 Item 1(Picture)

4.0 Openings in the ceiling of the garage were noted and are hazardous. Openings and exposed wood may allow a garage fire to quickly spread into the home. These openings should be well sealed to prevent fire spreading into the above living areas in the home. This is a safety issue. Recommend a qualified contractor repair holes and openings in the garage ceiling as needed for your safety.

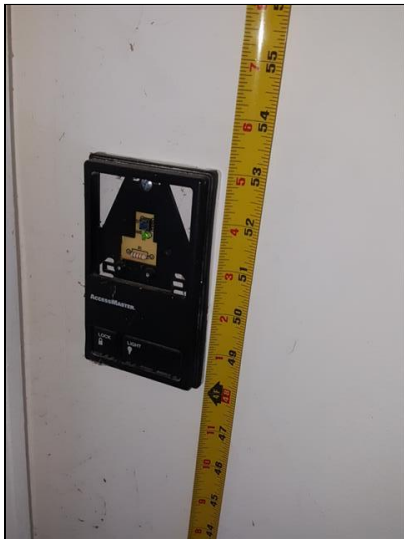
4.3 Item 2(Picture)

4.3 (3) The garage door button is lower than the manufacturers recommended 5 feet above the floor. This is a safety issue. Recommend this be raised to prevent unauthorized use by children as an injury may occur or damage to a motor vehicle when the door is opened or closed automatically. A qualified licensed electrician is recommended for correcting.

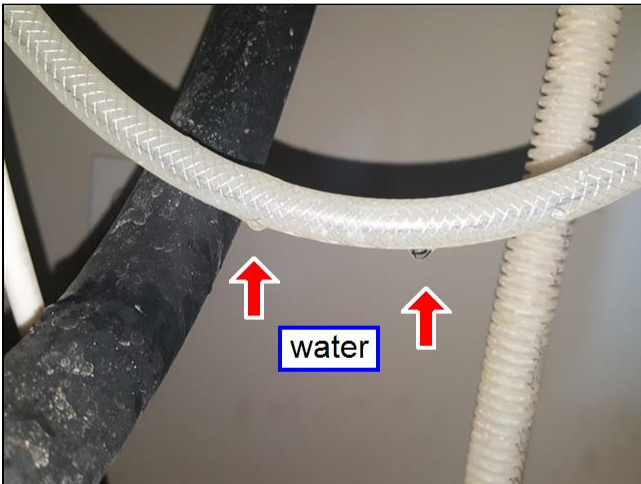
5.0 Item 1(Picture)

5.0 (1) There appears to be a minor water leak at the line for the spray nozzle in the kitchen. Recommend a plumber repair as needed to prevent damage to the base of the cabinet and to prevent mold from occurring.

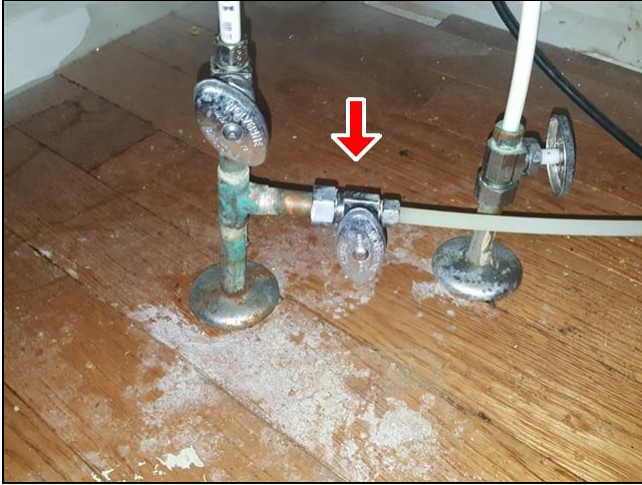
5.2 Item 1(Picture)

5.2 The dishwasher was not inspected for operation due to the water shutoff valve for the water supply appears to be turned off under the sink. The inspector is **NOT** required to turn on any water supply valves for safety and to prevent damage if a leak exists. This is for your information. Recommend the owner verify the dishwasher is working prior to closure.

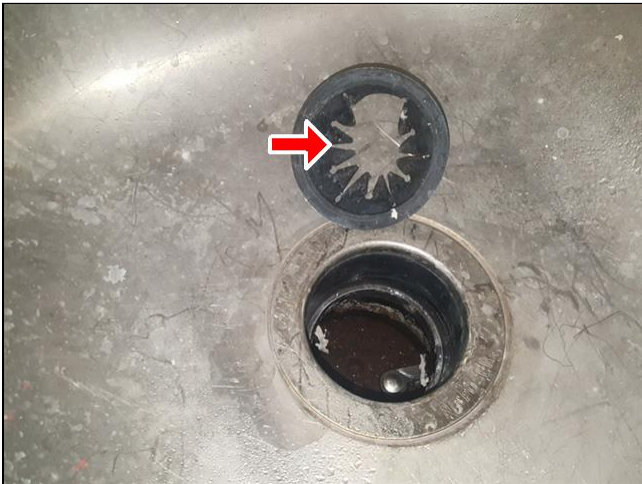
5.3 Item 1(Picture)

5.3 The food disposer rubber strainer/guard is damaged and no longer works as intended. This could allow waste to be expelled through the top. Recommend replacement of the rubber guard as needed for safety.

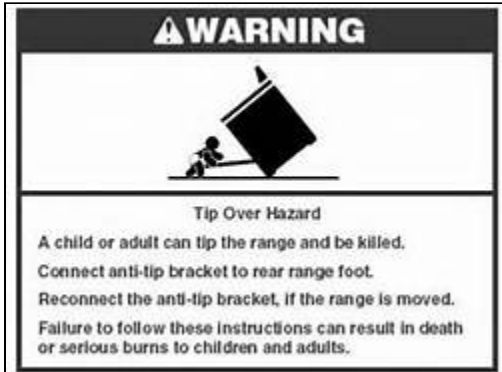
5.4 Item 1(Picture)

5.4 The "Anti Tip" bracket for the range has not been installed as required by manufacturer's installation instructions. This could allow the range to tip if it is pulled or if the oven door is pushed down or stepped on. This is a safety issue. A tip over hazard exists for small children and a serious injury or death could occur. Strongly recommend the bracket be installed for safety around small children or others. [Information about "anti tip" bracket](#)

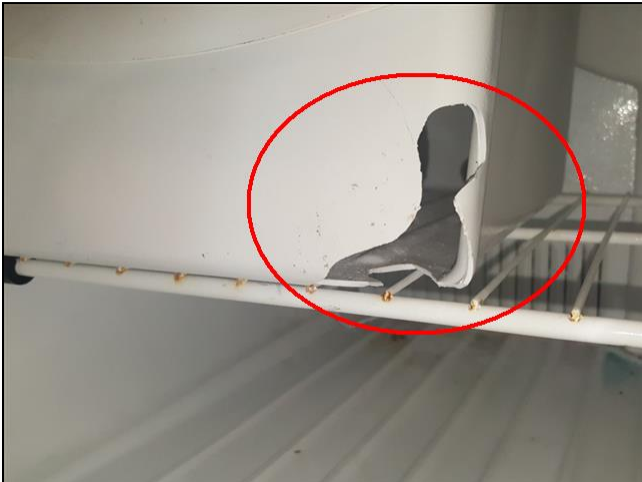
5.6 Item 3(Picture)

5.6 (3) The ice tray is broken in the refrigerator. Recommend replacement.

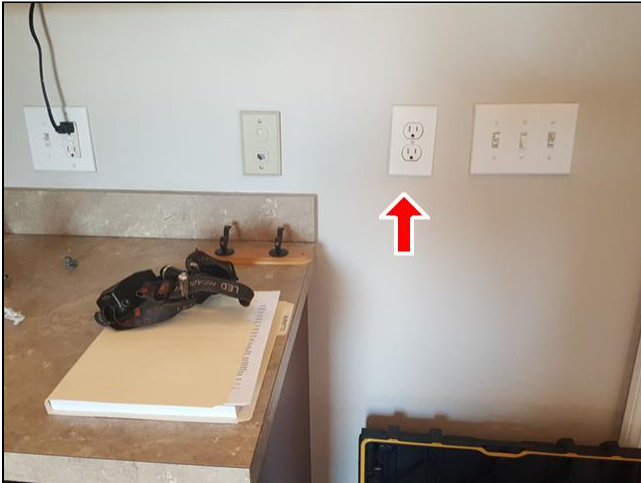
5.9 Item 2(Picture)

5.9 (3) The outlet(s) in the kitchen where indicated in the photo(s) are loose at the wall or in the outlet box. Electrical issues are considered a hazard until repaired. This is a safety issue that needs to be corrected due to an electric shock or fire from loose connections could occur if not repaired. Recommend a qualified licensed electrical contractor correct as needed.

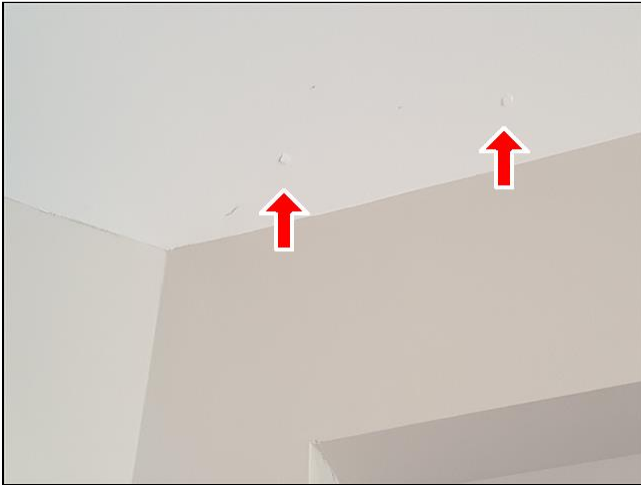
6.0 Item 1(Picture) kitchen

6.0 The Drywall at the ceiling has some "nail pops," (cosmetic) where indicated in the photo(s). As wood studs shrink, nail heads 'pop' out from the drywall surface causing a bump and/or a blemish on the wall or ceiling. Nail pops in drywall walls or ceilings are usually a minor cosmetic issue that is common in most homes. This is a small repair issue for your information. Recommend repair as desired. Note: If nail pops have been recurrent you may want to install two drywall screws about 1/2-inch on either side of the popped drywall nail to prevent further movement in this area.

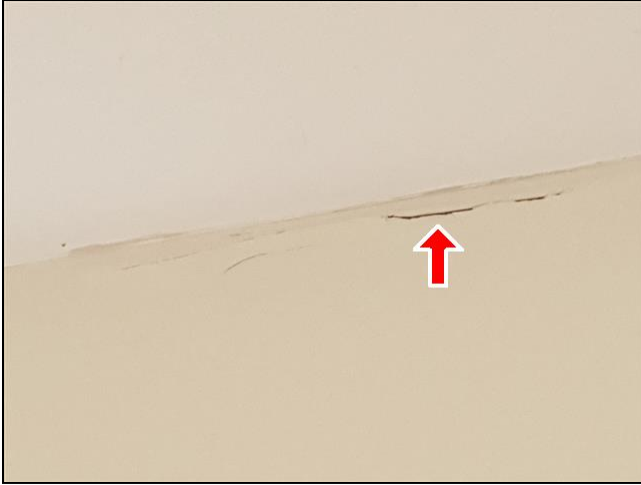
6.1 Item 1(Picture) living room above door right side

6.1 The crack(s) noted on the walls where indicated in the photo(s) are common minor settlement horizontal crack(s). Cracks larger than 1/8" wide are of concern only. Minor settlement of the home has occurred perhaps via framing shrinkage. This damage is considered to be cosmetic and a small repair issue for your information. Recommend prep prime and paint as needed.

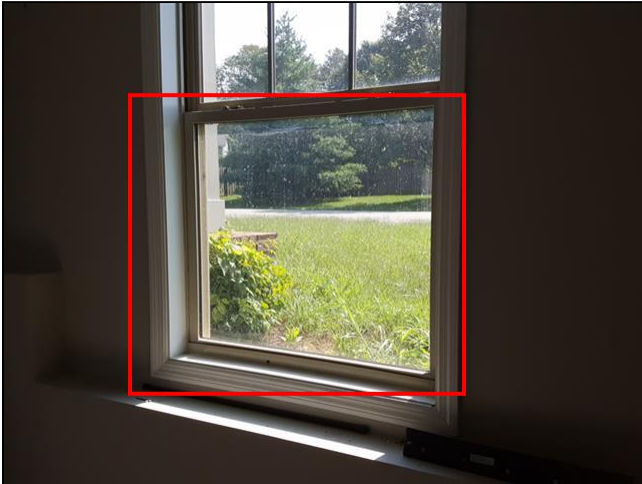
6.5 Item 1(Picture)

6.5 The window in the 2nd bedroom is missing a screen. Recommend these be installed to prevent insects entering the home when the window is opened. Replace as needed.

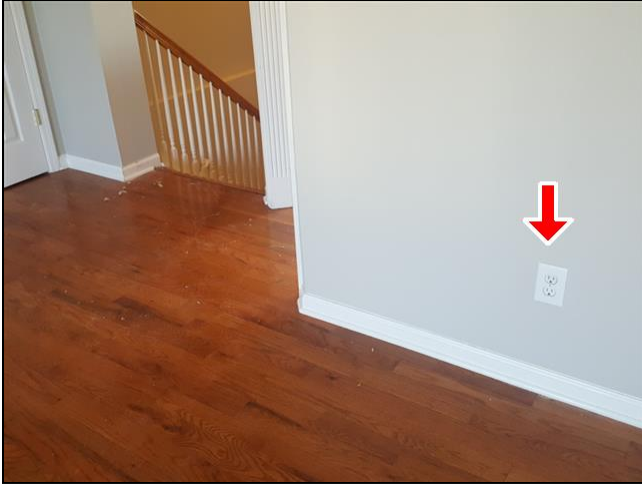
6.7 Item 1(Picture) living room

6.7 (1) The outlet(s) where indicated in the photo(s) are/is loose at the wall or in the outlet box. Electrical issues are considered a hazard until repaired. This is a safety issue that needs to be corrected due to an electric shock or fire from loose connections could occur if not repaired. Recommend a qualified licensed electrical contractor correct as needed.

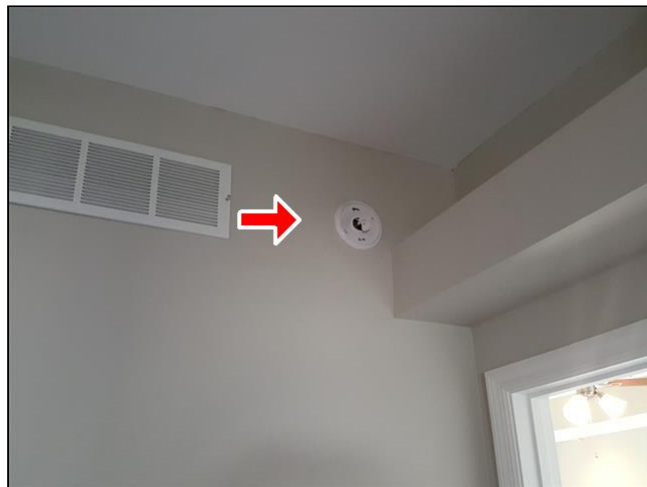
6.8 Item 2(Picture) living room

6.8 The majority of the smoke detectors in the home have been disconnected intentionally and removed where indicated in the photo(s). Without a working smoke detector in your home you have no first alert to a possible fire. This is a safety issue. Strongly recommend installing or replace the smoke detector for your safety in the home. Recommend a qualified contractor install one before closing.

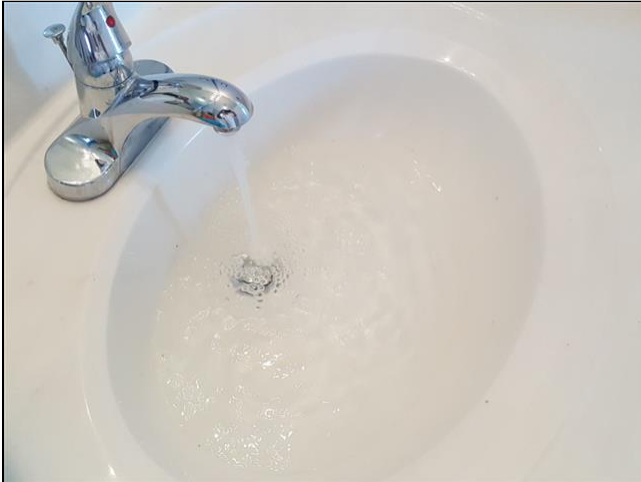
7.4 Item 1(Picture) master bathroom

7.4 The sink(s) in all the bathrooms do not have overflow holes. Over flow holes are recommended at all sinks to prevent water spillage which can lead to damage cabinets or flooring. This is for your information.

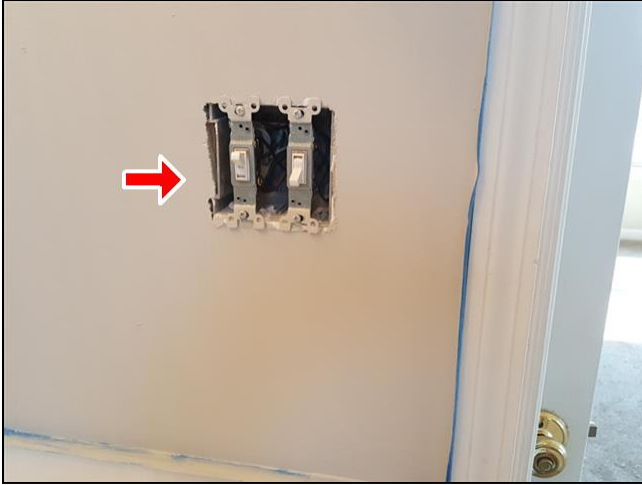
7.6 Item 2(Picture)

7.6 (3) The light switch(s) in the Master bathroom is missing a cover-plate. All missing switch covers should be installed to prevent touching the sides of the devices to prevent and electric shock which can cause an injury or death. Electrical issues are considered a hazard until repaired, and this is considered to be unsafe. A qualified licensed electrical contractor should correct as needed prior to moving in.

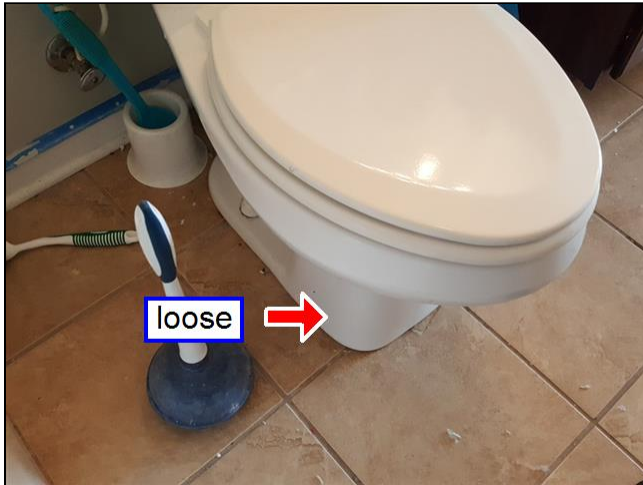
7.8 Item 1(Picture)

7.8 The toilet tank base is loose at the floor in the master bathroom. The screws may need tightening to secure the toilet base to the floor to prevent a water leak between the toilet and the drain line connection. If tightening the screws at the base of the toilet does not secure the toilet, repairs may involve re-setting the toilet on a new wax seal and/or repairs to the floor may be required. Recommend a qualified licensed plumber repair or correct as needed.

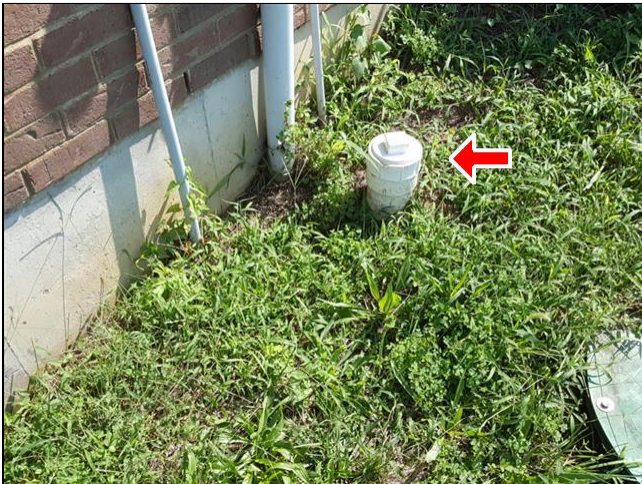
8.0 Item 1(Picture)

8.0 (2) The sewer clean out cap is located at the left side of the home. This is for your information.

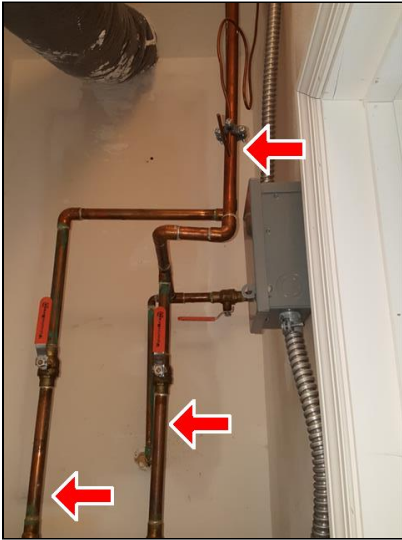
8.3 Item 2(Picture)

8.3 (2) Recommend insulating the water pipes leading into the water heater (hot and cold) to ensure pipes do not freeze in winter which may cause a serious plumbing leak in the garage or harm the water heater, and to prevent heat loss of water when hot water is flowing into the home. This will improve efficiency.

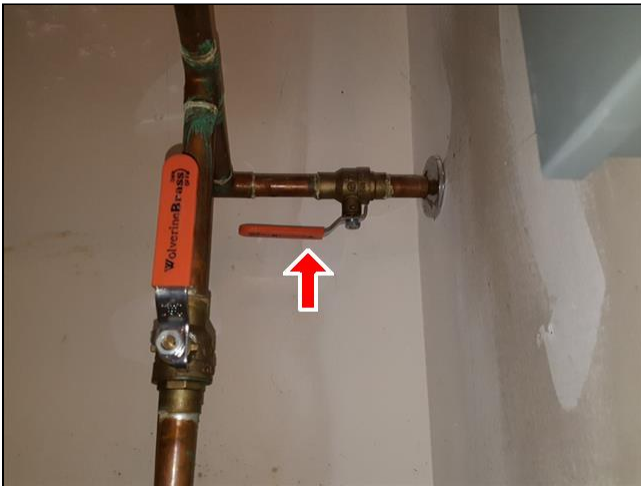
8.4 Item 1(Picture)

8.4 The main water shut off is the orange lever located in the garage above the water heater area. This is for your information.

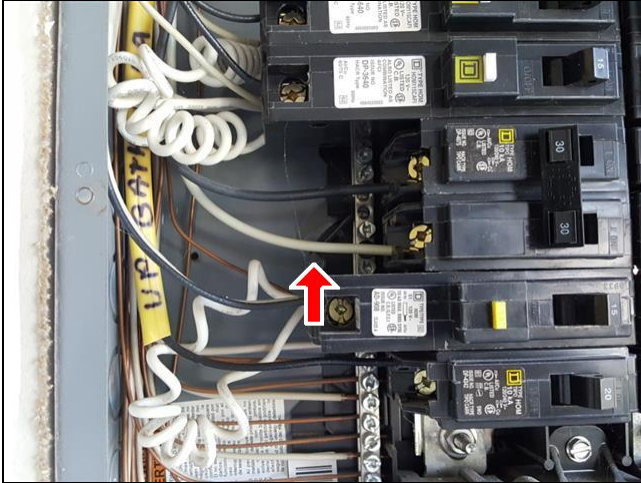
9.3 Item 1(Picture)

9.3 The white wire(s) that are connected to the circuit breaker(s) should be marked black to indicate that they are live (hot wires) and are being used for the flow of electricity to travel. Recommend an electrician correct due to safety.

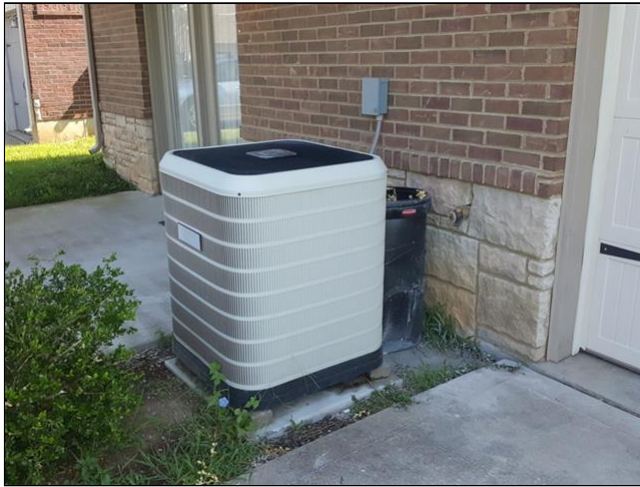
heat pump/rear of home

10.0 (3) The Heat Pump was continuously running during the inspection period. This indicates that the unit is not running efficiently. This can cause a shorter life span on the compressor and damage to the unit. The unit may need servicing. Recommend a qualified HVAC contractor further evaluate and repair as needed.

10.0 (4) The heat pump was functioning in the cooling mode, however it may be undersized for heating and cooling the home. This can cause high energy bills and place strain on the system causing early wear and tear. The thermostat was set at 71 degrees and it did not reach the desired temperature after 3.5 hours at the inspection. It is generally recommended that for every 600 square feet of space requires 1 ton capacity. The square footage of the home is approximately 1450 square feet (including basement area) which means the HVAC system should be a minimum of 2.5 ton. The liveable area of the home is rated at 1450 square feet which would require a 2.5 ton system. The current system installed in the home is only 2 ton. Strongly recommend a qualified HVAC contractor further evaluate prior to closing to determine if replacement of the system is required.

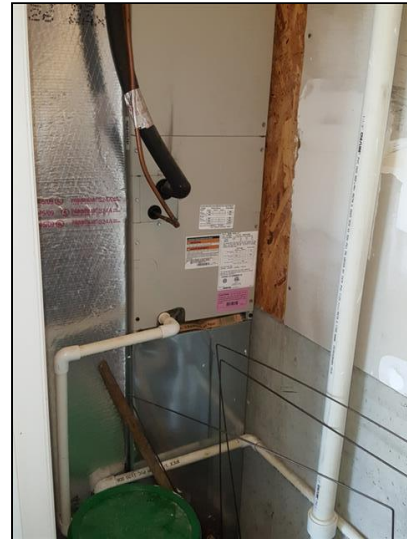
air handler/garage utility room

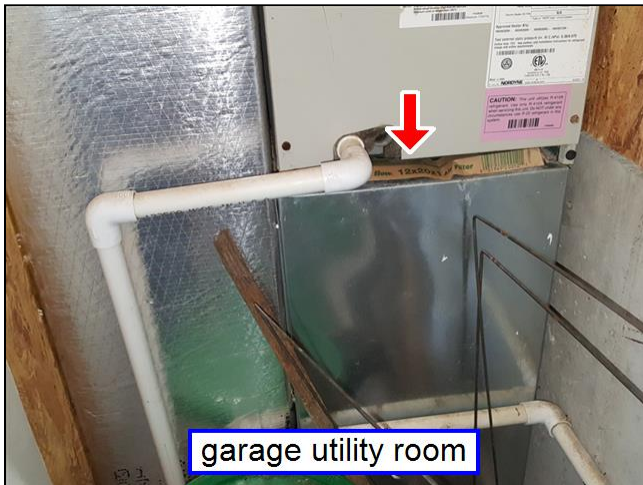
10.1 Item 1(Picture)

10.1 (1) Filter location (see photo). The arrow on the filter should always point towards the blower.

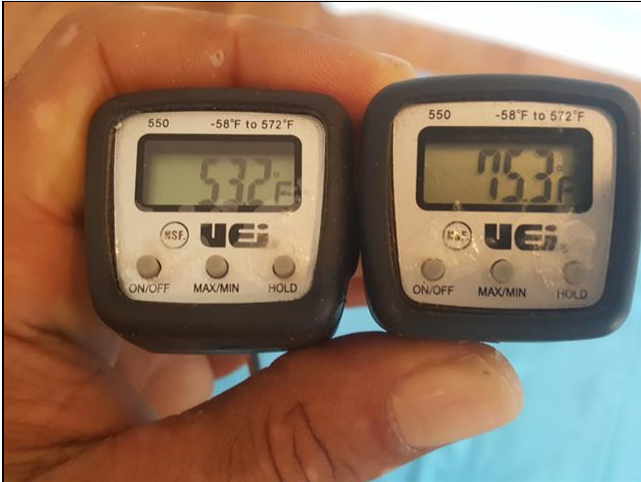
10.7 Item 1(Picture)

10.7 The ambient air test was performed by using thermometers at the registers closest to the blower to determine if the difference in temperatures of the supply and return air are between 14 degrees and 22 degrees which indicates that the unit is cooling as intended. The supply air temperature on your system read 53 degrees, and the return air temperature was 75 degrees. This indicates the range in temperature drop is normal.

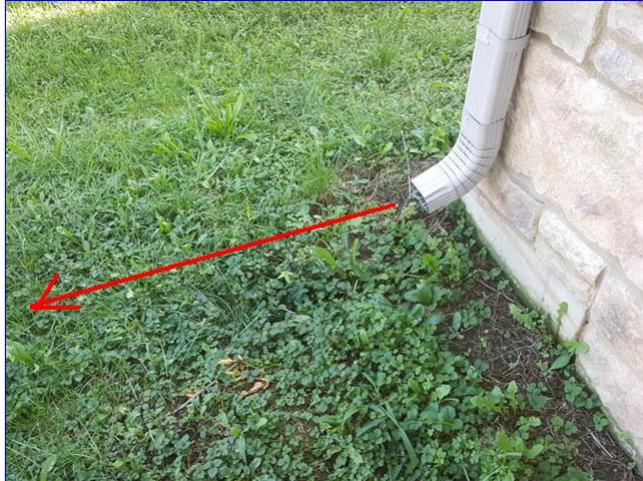
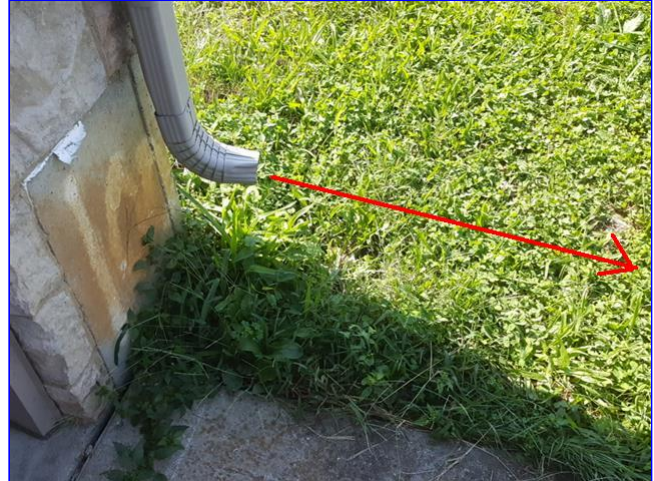
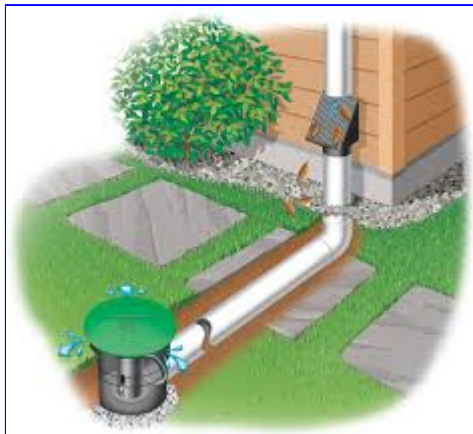
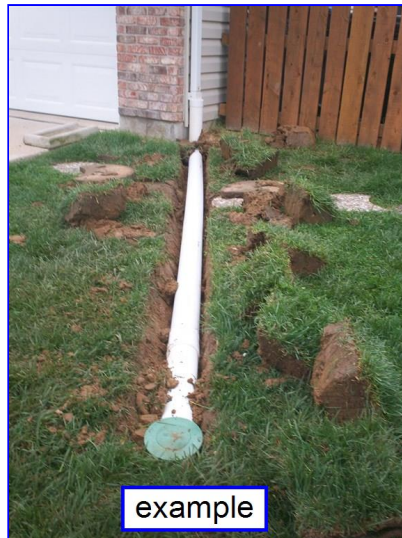
(1) The downspout is missing a splashblock and is discharging on the ground next to the foundation of the home where indicated in the photos. The downspouts should discharge water through leaders then onto splash blocks at least 5 feet from the home. Storm water should be encouraged to flow away from the foundation/home at the point of discharge to prevent water entering the basement and to prevent settlement of the foundation. Recommend repair and correcting as needed by a general contractor.

2.3 Item 1(Picture) rear left corner of home

2.3 Item 2(Picture) rear right corner of home

Note: You may wish to consider burying the extension to prevent a tripping hazard. See photos for example.

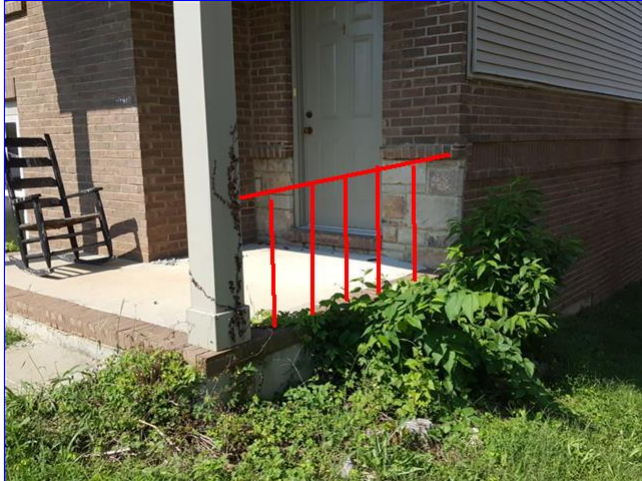
3.5 Item 1(Picture)

Recommend a guard rail be installed around the front porch on the right side to prevent a fall from occurring which may result in an injury of a person. This is a potential safety issue. The railing needs to be at least 36 inches high and balusters need spacing to be at least 4 inches. Recommend a qualified contractor install one for safety.

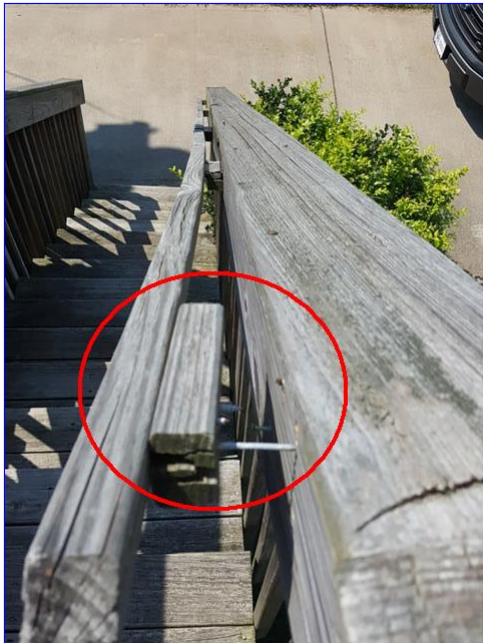
3.6 Item 3(Picture)

(2) The stair case rail on the on the left side at the rear deck is not secured properly. This is extremely dangerous and is a safety concern. For your safety it should be strengthened and secured. Recommend a qualified contractor repair as needed before closing.

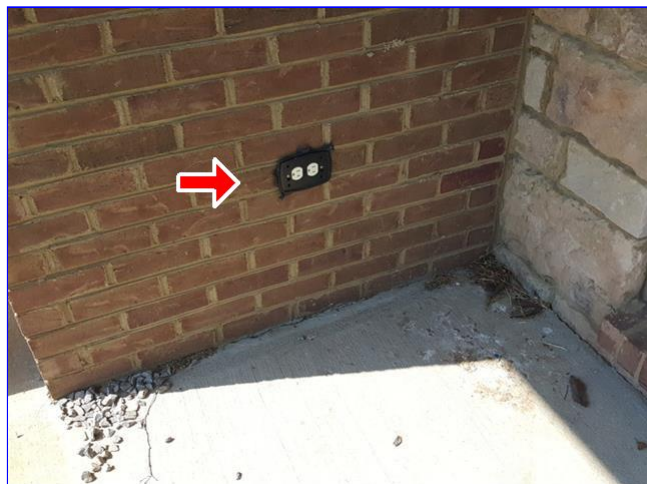
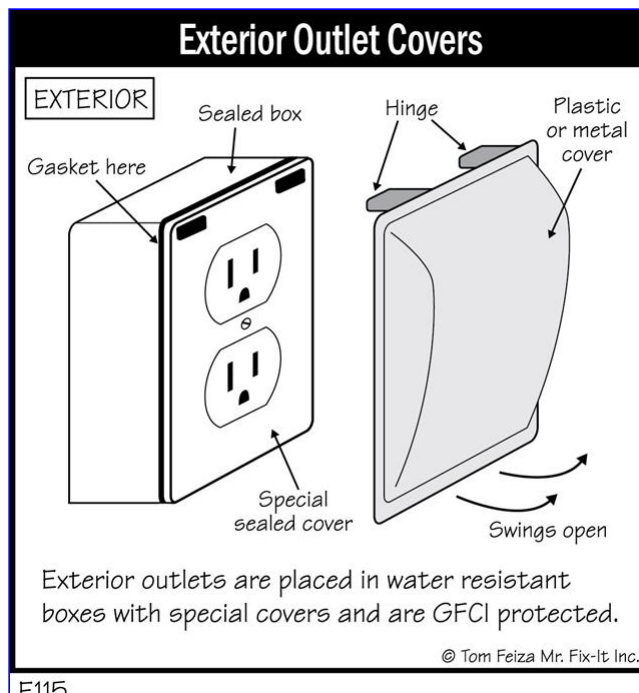
(2) The exterior outlet at the front of the porch does not have a weatherproof cover installed and/or the cover(s) is missing. This is a safety issue. Water could enter causing a short or an electric shock. Recommend a qualified electrician correct as needed.

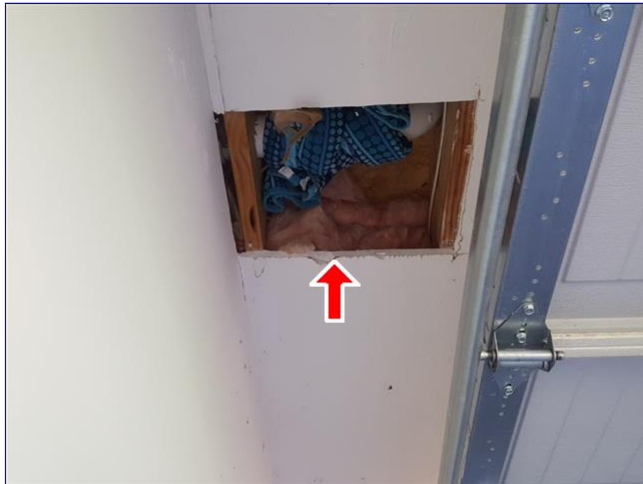
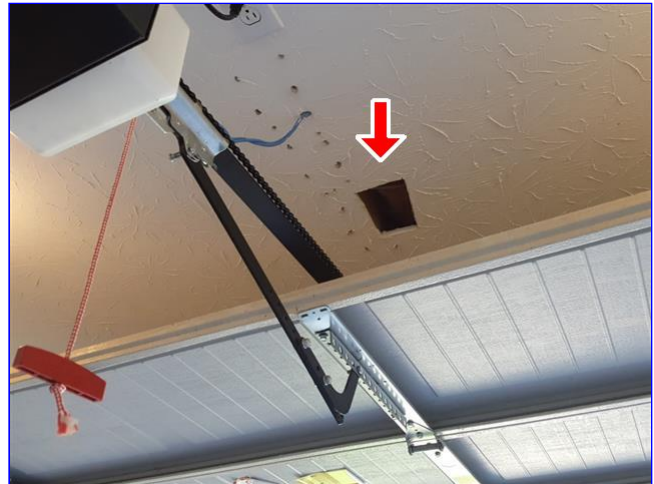
Openings in the ceiling of the garage were noted and are hazardous. Openings and exposed wood may allow a garage fire to quickly spread into the home. These openings should be well sealed to prevent fire spreading into the above living areas in the home. This is a safety issue. Recommend a qualified contractor repair holes and openings in the garage ceiling as needed for your safety.

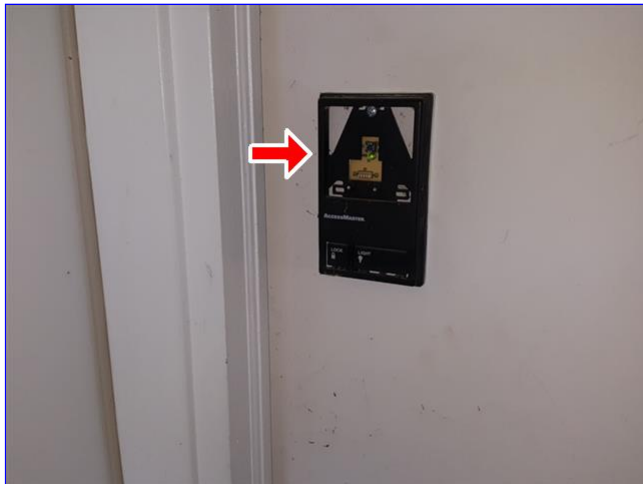
4.3 Item 1(Picture)

(2) The garage door opener is missing a cover. Recommend one be installed to allow ease of opening the garage door and to prevent a possible electric shock.

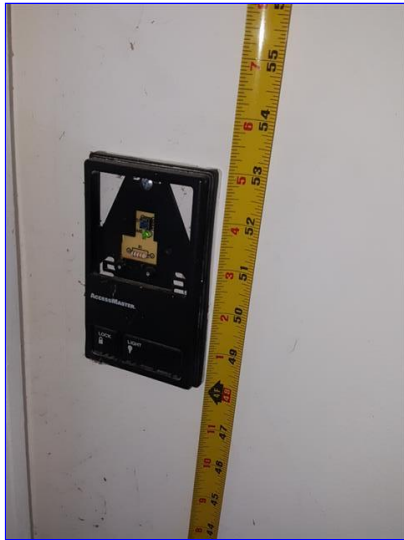
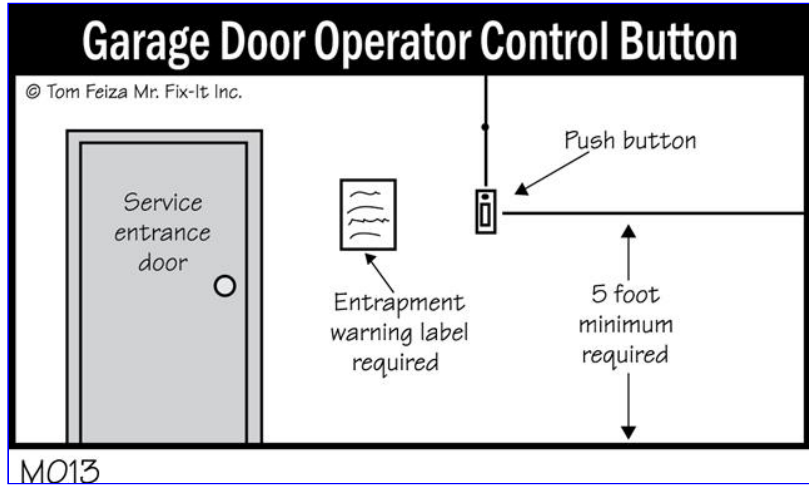
(3) The garage door button is lower than the manufacturers recommended 5 feet above the floor. This is a safety issue. Recommend this be raised to prevent unauthorized use by children as an injury may occur or damage to a motor vehicle when the door is opened or closed automatically. A qualified licensed electrician is recommended for correcting.

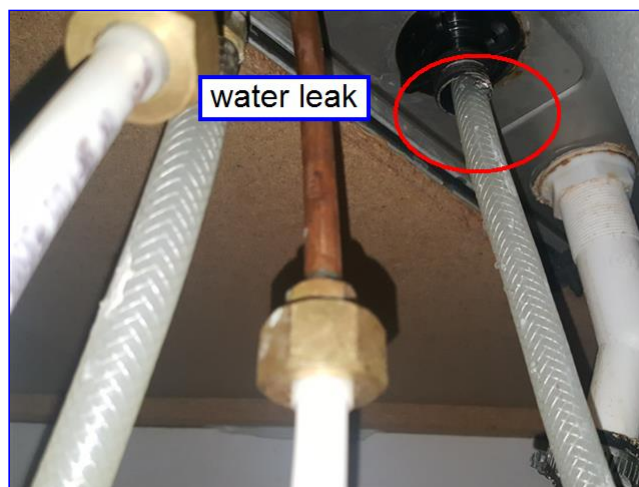
5.0 Item 2(Picture)

(1) There appears to be a minor water leak at the line for the spray nozzle in the kitchen. Recommend a plumber repair as needed to prevent damage to the base of the cabinet and to prevent mold from occurring.

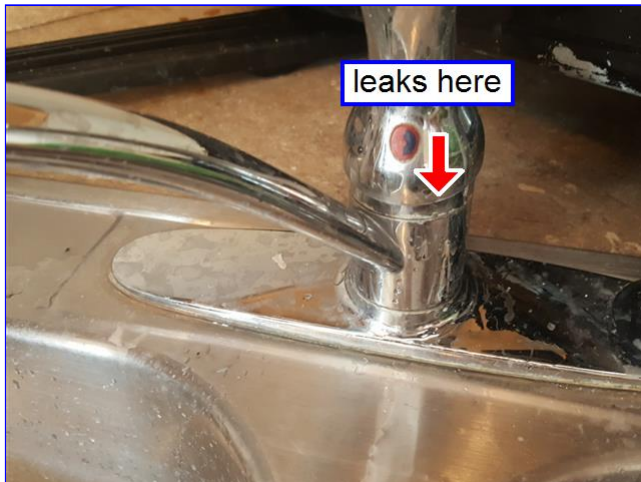
(4) The water faucet faucet leaks at the stem when water is turned on at the sink in the kitchen. Repairs by a licensed plumber is recommended to prevent possible damage to the counter top and base of the cabinet as water dripping was experienced under the cabinet at the time of the inspection. Recommend a qualified plumber repair as needed to prevent possible mold from occurring under the sink and to prevent damage to the bottom of the cabinet.

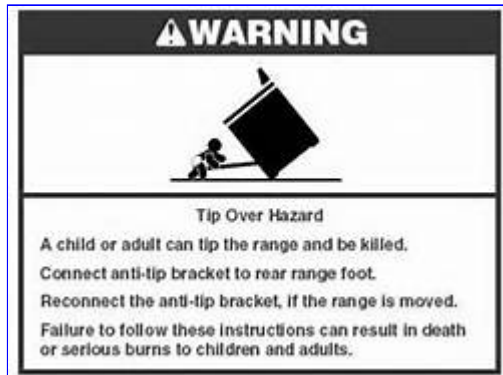
5.4 Item 1(Picture)

The "Anti Tip" bracket for the range has not been installed as required by manufacturer's installation instructions. This could allow the range to tip if it is pulled or if the oven door is pushed down or stepped on. This is a safety issue. A tip over hazard exists for small children and a serious injury or death could occur. Strongly recommend the bracket be installed for safety around small children or others. [Information about "anti tip" bracket](#)

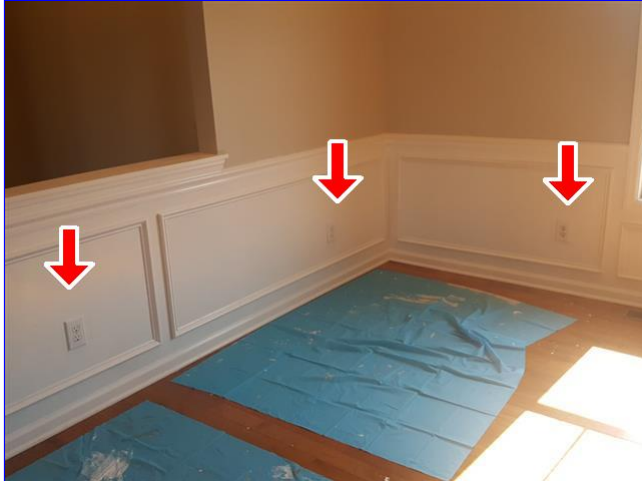
5.9 Item 1(Picture)

(2) The outlets in the kitchen are not GFCI protected where indicated in the photo. GFCI (Ground fault circuit interrupters) outlets should be considered for installation as a safety upgrade in all locations where water is present if the outlets are not presently connected to a GFCI. They are now required in all bathrooms, kitchen, unfinished basements, garages, exterior outlets, or other locations within 6' of a water source or sink. GFCI outlets may not have been required when this house was built but should be considered for safety. Personally recommend a licensed electrician replace or correcting as needed.

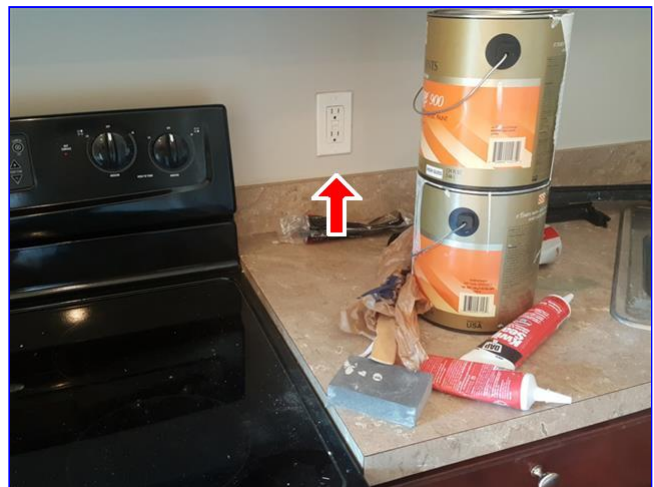
5.9 Item 3(Picture)

(3) The outlet(s) in the kitchen where indicated in the photo(s) are loose at the wall or in the outlet box. Electrical issues are considered a hazard until repaired. This is a safety issue that needs to be corrected due to an electric shock or fire from loose connections could occur if not repaired. Recommend a qualified licensed electrical contractor correct as needed.

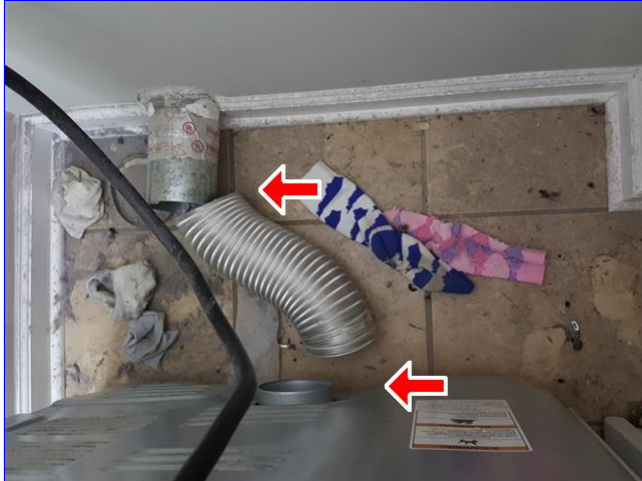
5.10 Item 1(Picture)

(1) The dryer vent piping is not connected to dryer or the to the exhaust port in the washer/dryer room closet. This is allowing lint and moisture to be released in the air and is not healthy in closed rooms. Recommend repair as needed prior to using the dryer in the home.

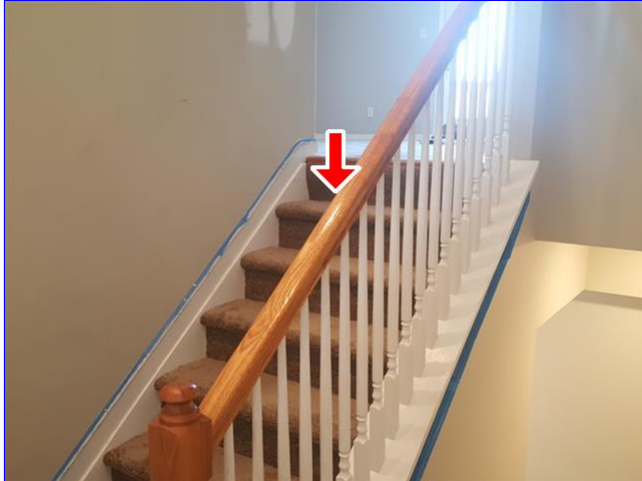
6.3 Item 1(Picture)

The stair case rail on the on the right side is unstable and not secured properly. This is extremely dangerous and is a safety concern. It may fail under a medium or heavy force or if someone was pushed against or was leaning on the railing. For your safety it should be strengthened and secured. Recommend a qualified contractor repair as needed before closing.
