Inspection Report

Property Address:
2914 Crimea Street
Versailles KY 40383

Talon Home Inspections, LLC

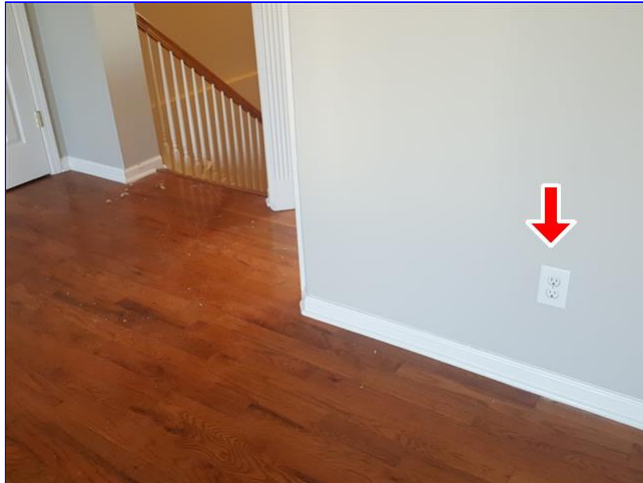
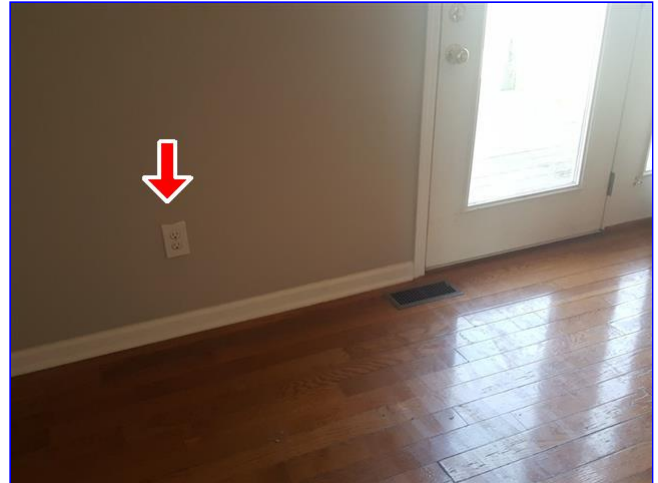
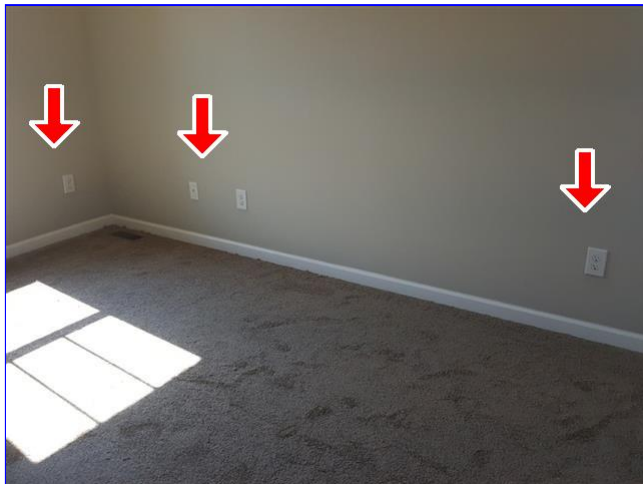
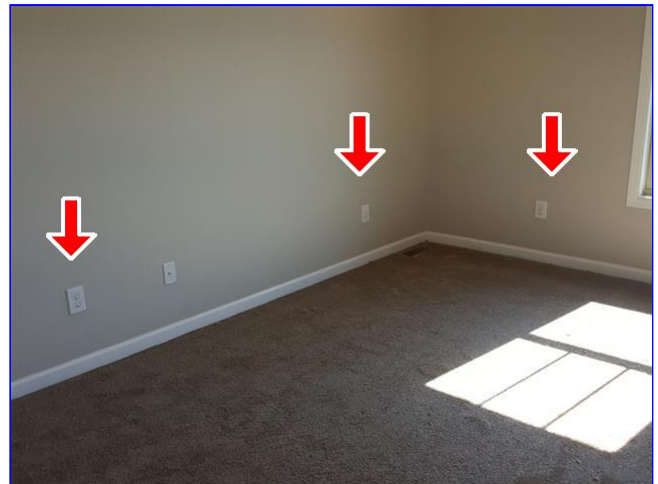
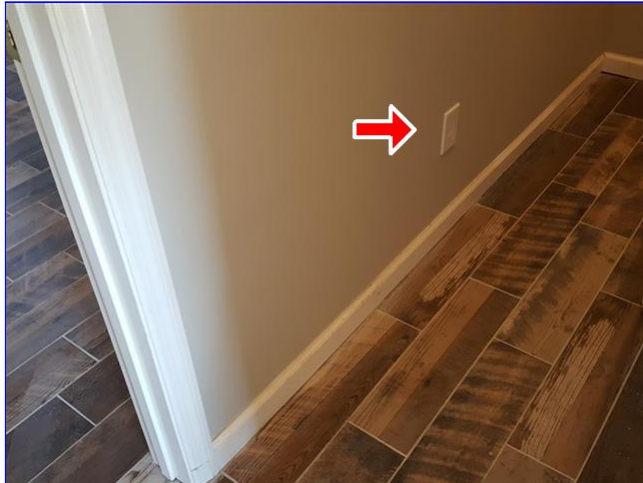
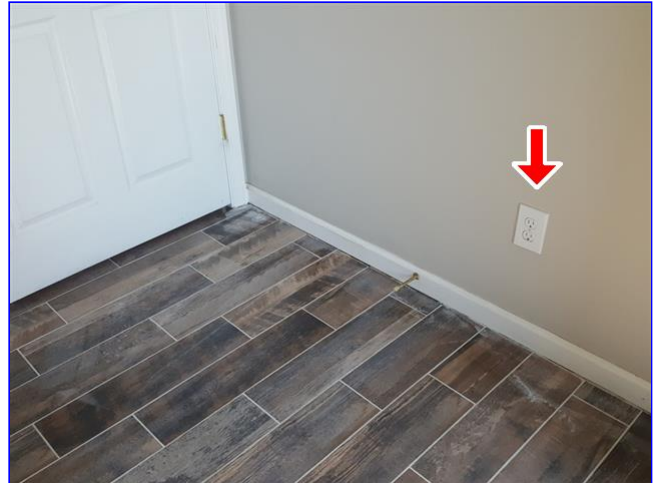
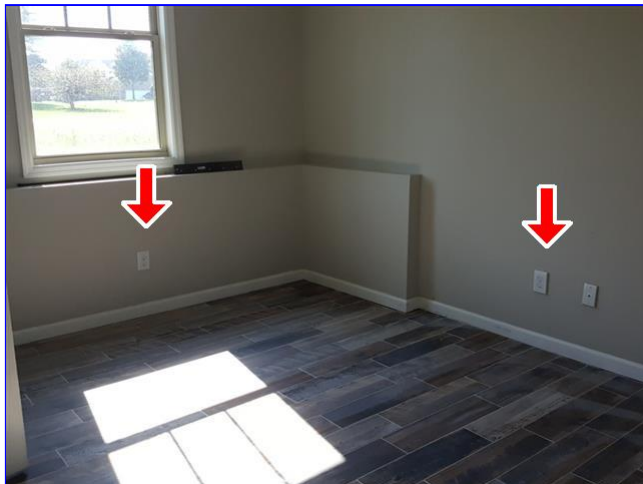
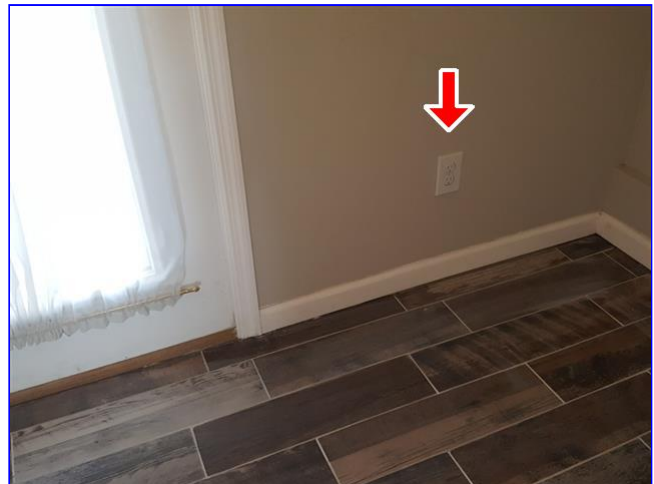
(1) The outlet(s) where indicated in the photo(s) are/is loose at the wall or in the outlet box. Electrical issues are considered a hazard until repaired. This is a safety issue that needs to be corrected due to an electric shock or fire from loose connections could occur if not repaired. Recommend a qualified licensed electrical contractor correct as needed.

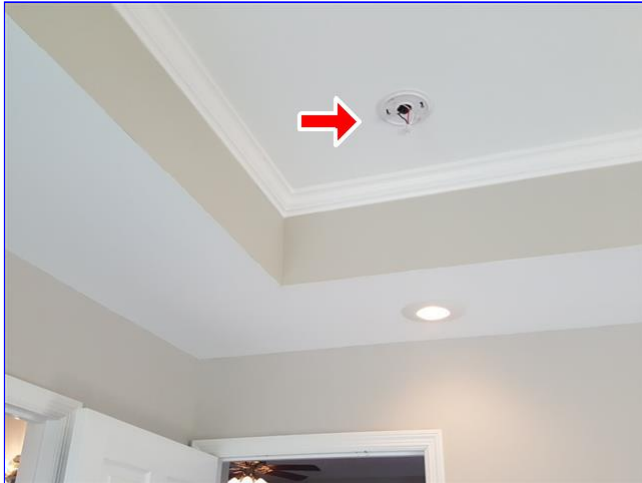
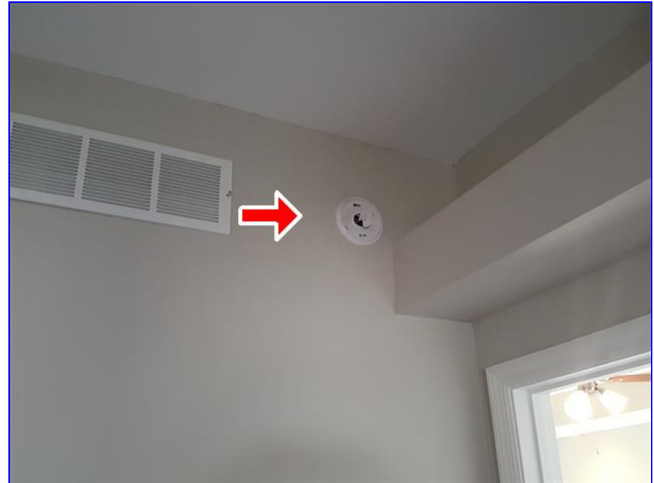
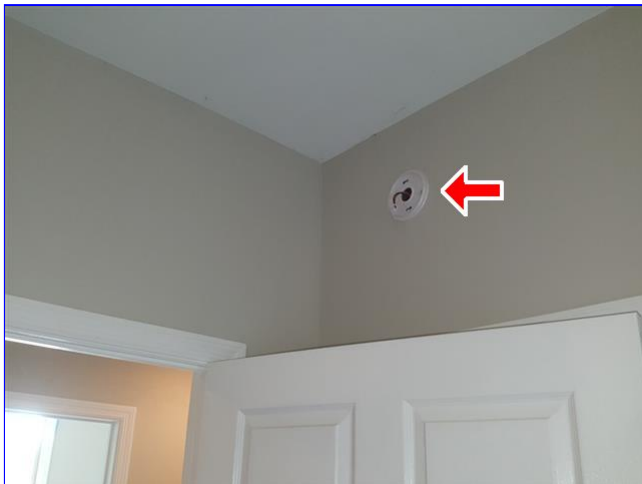
The majority of the smoke detectors in the home have been disconnected intentionally and removed where indicated in the photo(s). Without a working smoke detector in your home you have no first alert to a possible fire. This is a safety issue. Strongly recommend installing or replace the smoke detector for your safety in the home. Recommend a qualified contractor install one before closing.

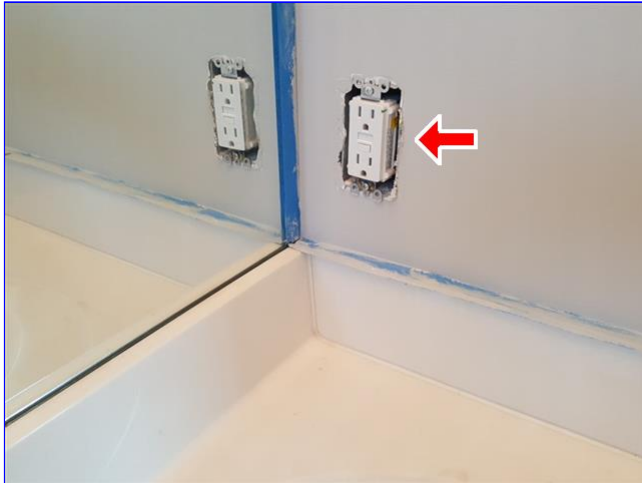
7.6 Item 1(Picture)

(2) The outlet(s) in the master bathroom is missing a cover-plate. All missing covers should be installed to prevent touching the sides of the devices to prevent an electric shock which can cause an injury or death. Electrical issues are considered a hazard until repaired, and this is considered to be unsafe. A qualified licensed electrical contractor should correct as needed prior to moving in.

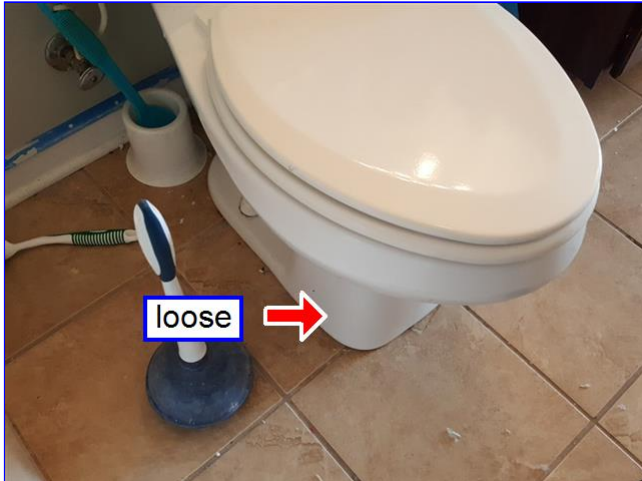
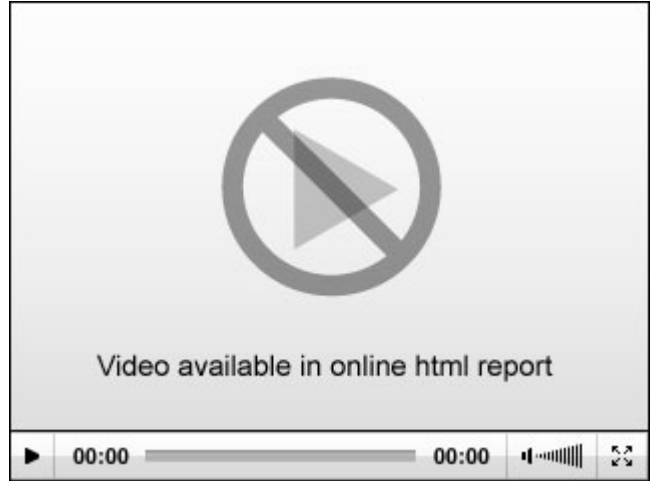
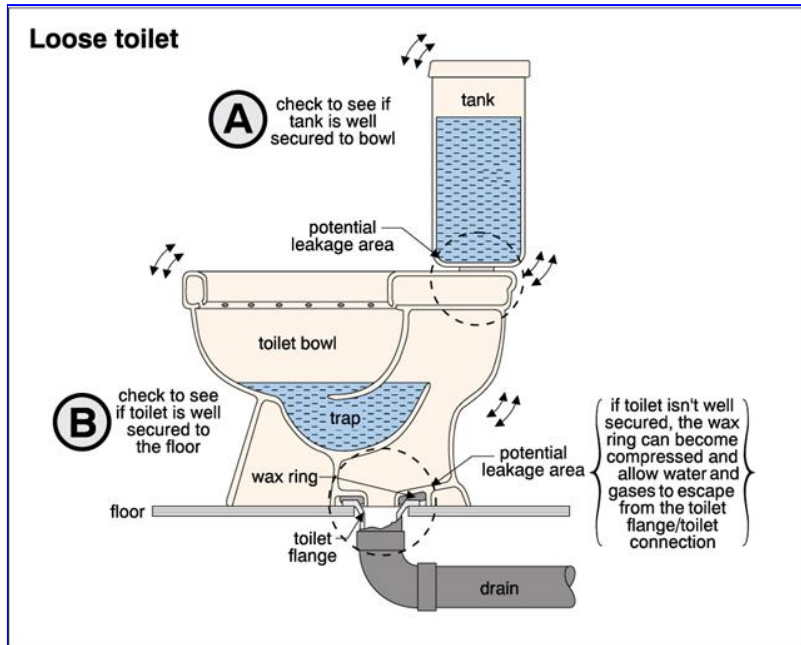
The toilet tank base is loose at the floor in the master bathroom. The screws may need tightening to secure the toilet base to the floor to prevent a water leak between the toilet and the drain line connection. If tightening the screws at the base of the toilet does not secure the toilet, repairs may involve re-setting the toilet on a new wax seal and/or repairs to the floor may be required. Recommend a qualified licensed plumber repair or correct as needed.

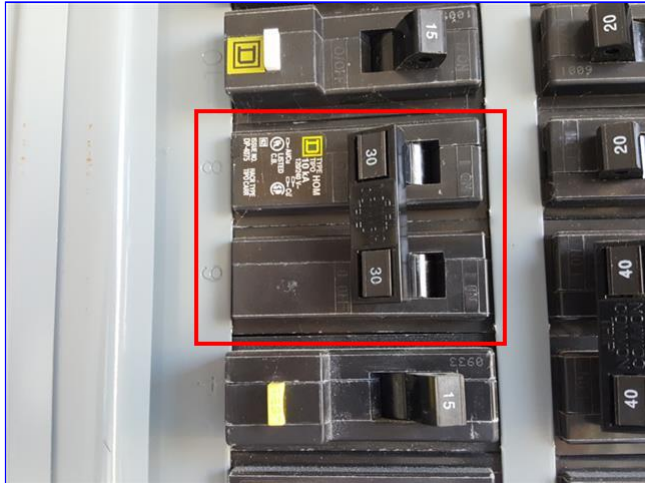
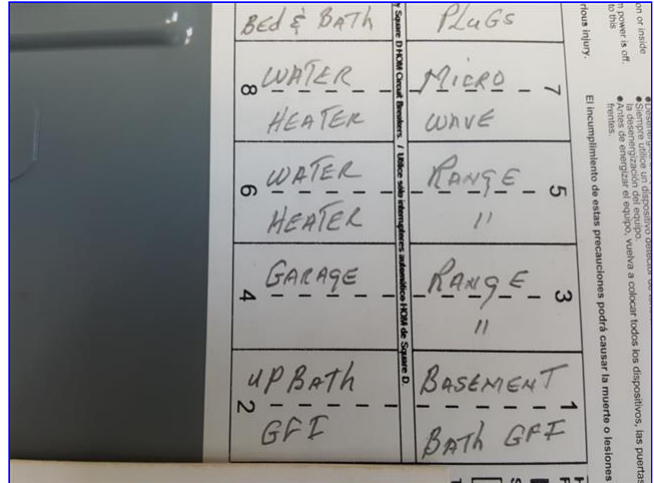
(2) The water heater was not inspected for function due to the breaker was turned off at the panel box. The inspector is prohibited from turning on any breakers in a panel box to operate a component for safety. The unit may be off for a reason. Recommend contacting the owner and have the water heater turned on and check unit for operation prior to closing. This is for your information.

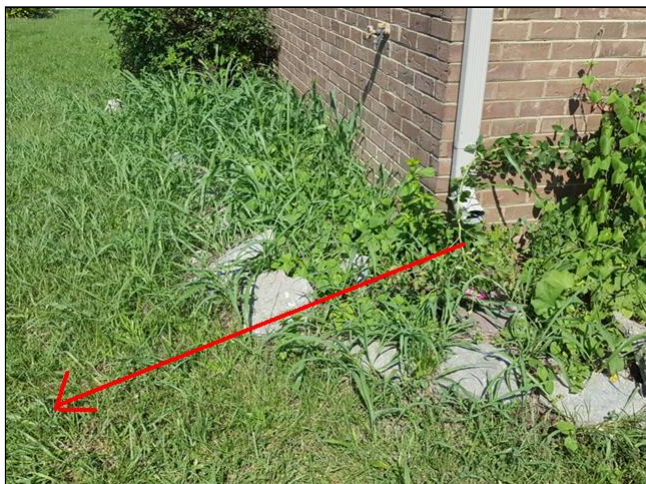
2.3 Item 5(Picture)

(2) Recommend the downspout(s) at the front left corner of the home where indicated in the photo(s) be re-directed and extended at least 6 feet and flow onto splashblocks so water flows away from the foundation perimeter. This will ensure water is kept away from the foundation perimeter, soil erosion does not occur and water cannot leak into the basement. Also this will prevent settlement from occurring around the foundation perimeter. Recommend repair and replacement as needed.

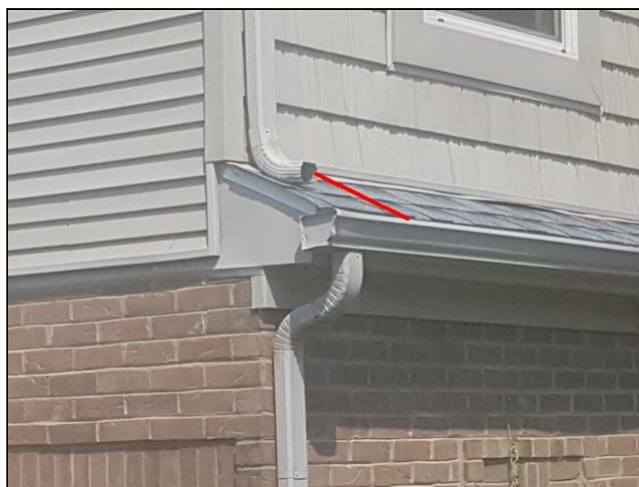
2.3 Item 7(Picture) front left corner of home

(3) Recommend the downspout(s) that discharge onto the roof be extended to discharge water directly into the gutter below. This condition, if left unattended, can result in premature deterioration and staining of the roofing material under the end of the downspout. The excessive discharge of storm water onto roof from downspout also puts stress on building materials designed to prevent water entry into the structure of home. Recommend correcting all around the home as needed using a qualified gutter installer.

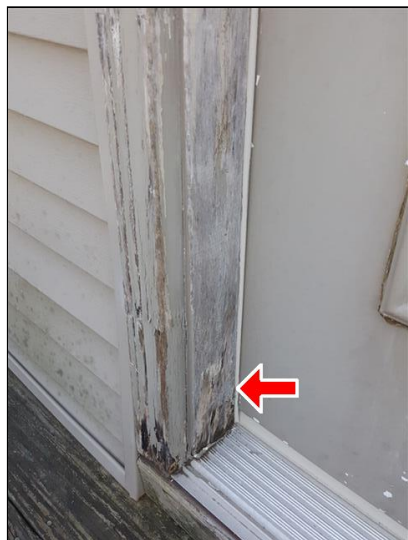
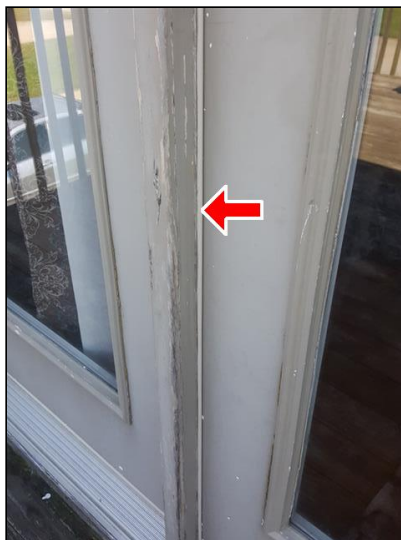
(2) The entry door frame at the rear of the home is weathered/has missing paint and needs prep and paint (exterior) around the door frame to prevent water intrusion. Deterioration may occur via wood rot if not painted. Recommend prep and paint as needed.

As an additional note you may wish to consider wrapping the door frames with metal wrapping. This will ensure frames are sealed and not exposed to the weather. It will eliminate the need for maintenance in regards to painting wooden frames so that moisture will not penetrate.

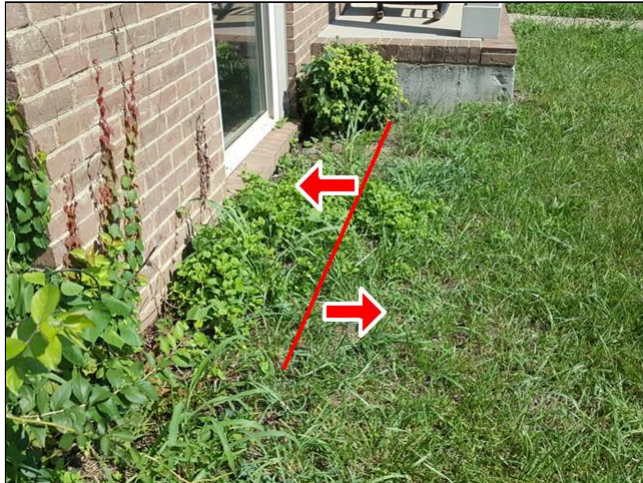
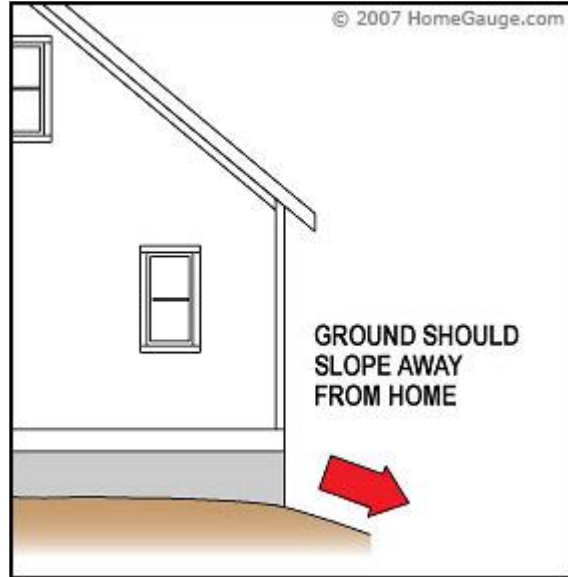
There are depressions in the soil around the foundation perimeter at the front left side of the home. Recommend filling all depressions and re-grading the soil so the soil slopes away from the home around the foundation to ensure water pooling does not occur in these areas. Water pooling could lead to to basement leakage.

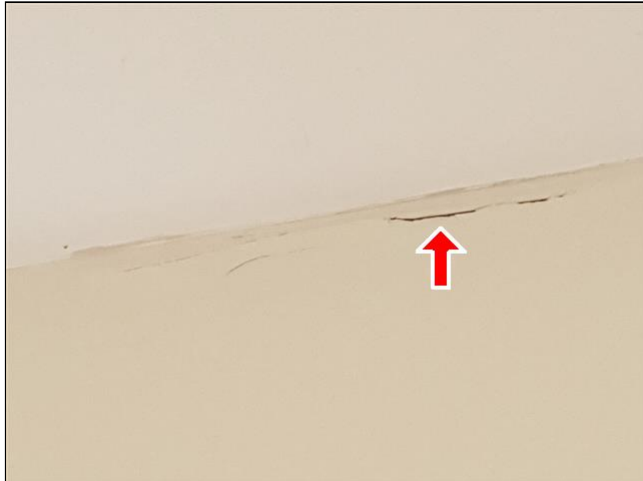
6.1 Item 1(Picture) living room above door right side

The crack(s) noted on the walls where indicated in the photo(s) are common minor settlement horizontal crack(s). Cracks larger than 1/8" wide are of concern only. Minor settlement of the home has occurred perhaps via framing shrinkage. This damage is considered to be cosmetic and a small repair issue for your information. Recommend prep prime and paint as needed.

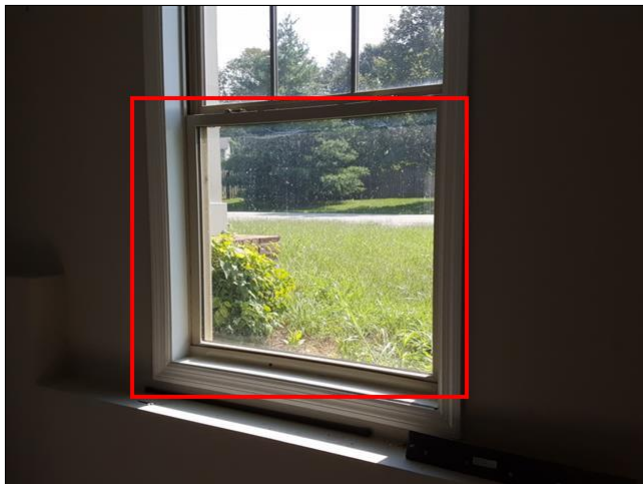
6.5 Item 1(Picture)

The window in the 2nd bedroom is missing a screen. Recommend these be installed to prevent insects entering the home when the window is opened. Replace as needed.

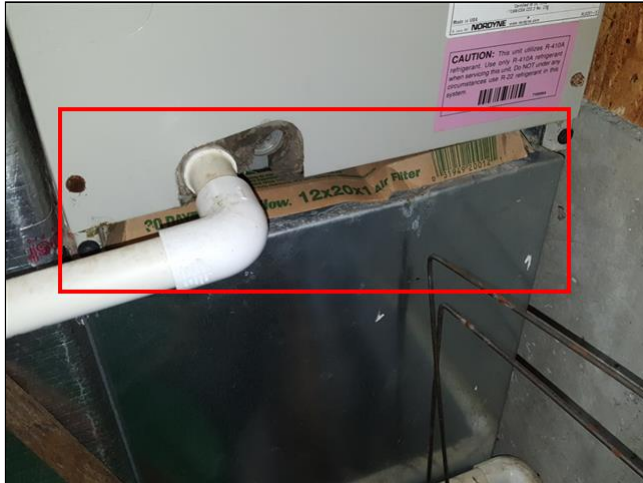
10.1 Item 2(Picture)

(2) The door to access the filter next to the Air Handler is missing at the garage utility room. This can allow dirt and debris to bypass the filter. The filter ensures clean air is distributed within the home and also protects the equipment from small debris entering which can lead to problems with the unit and duct work. Recommend replacement/correcting as needed by a qualified HVAC contractor.
