TALC
Home Inspe

Inspection Report

Property Address:
211 Wellington Road
Paris KY 40361

Date: 10/17/2018	Time: 10:00 AM till 02:00 PM	Report ID: 181017SCNEIDER
Property: 211 Wellington Road Paris KY 40361	Customer: Ms. Gail Schnieder	Real Estate Professional:

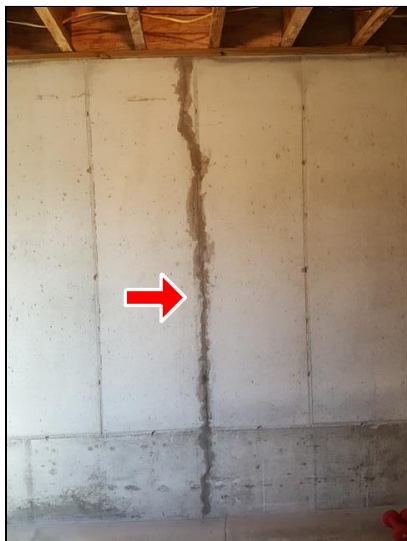
1.1 Item 1(Picture)

1.1 (1) Previous repair(s) was noted on the rear wall under the master bedroom area in the basement was noted. This appears to be due to settlement of the home. Recommend these areas be monitored and if cracks reappear you should consult a qualified foundation contractor to determine cause and repairs to prevent further movement or cracking. This is for your information.

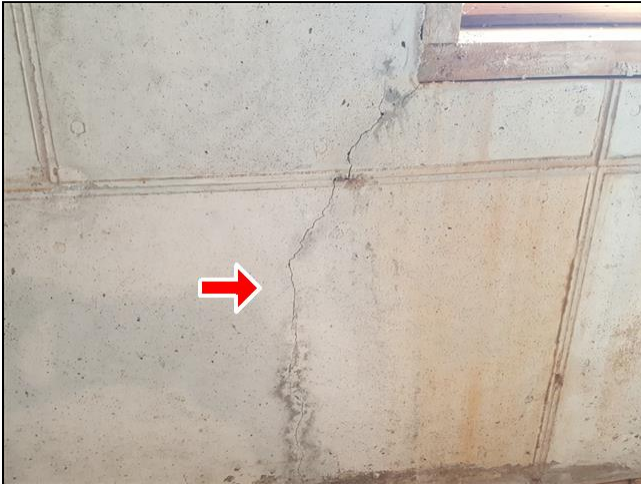
1.1 Item 2(Picture) below basement window

1.1 (2) The shrinkage/settlement crack(s) in the foundation wall in the basement was noted where indicated in the photos. These cracks do not appear significant. This condition is common in many homes and does not usually represent a serious structural concern unless the cracks are between an 1/8 or 1/4 inch thick. Recommend the cracks be sealed before the walls are painted or the basement is finished to prevent water intrusion and to minimize further deterioration. [Sealing Concrete Cracks](#) It is recommended that you monitor periodically to see if further movement occurs and if so a foundation contractor should be consulted to correct and prevent further movement.

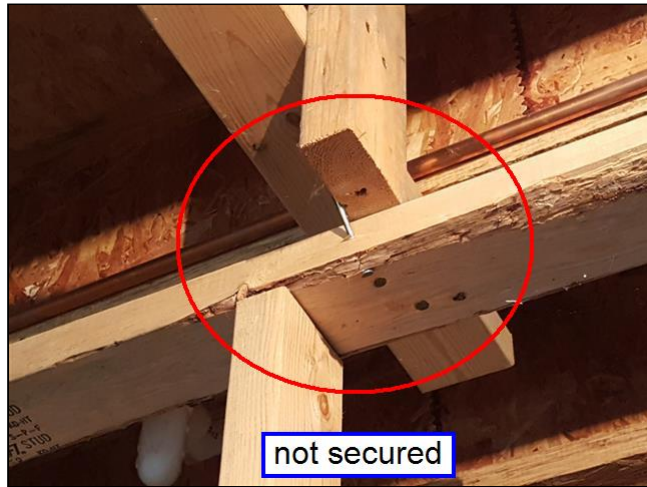
1.1 Item 7(Picture)

1.1 (3) The wall framing is loose and not secured to the ceiling or wall in the basement. This is a safety issue as the wall could fall causing an injury of a person or damage to appliances/equipment in the basement. Recommend a qualified contractor correct and repair as needed prior to closing. This is not a structural wall.

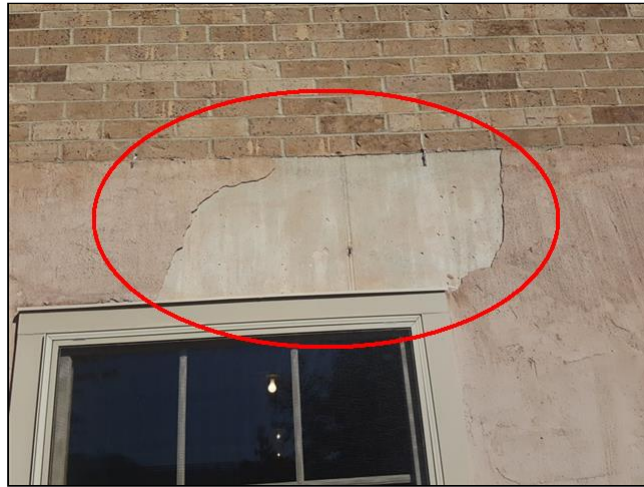
1.1 Item 11(Picture) left side of home

1.1 (4) Surface deterioration (cracking, spalling, crumbling material) was observed on the foundation walls on the concrete parging where indicated in the photos. This condition does not usually represent a serious structural concern unless there is a substantial loss of material. The concrete parging is designed to protect the concrete walls from moisture penetration. In an effort to prevent long term deterioration, recommend re-parging over deteriorated areas then sealing concrete with an exterior paint to prevent moisture penetration. [Here is a link explaining how to parge a foundation wall.](#)

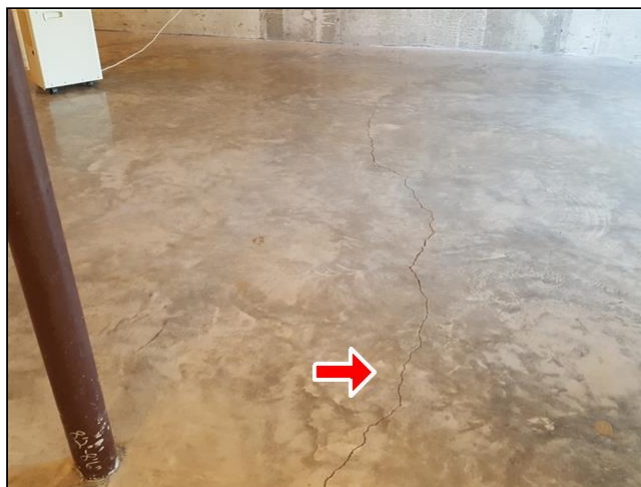
1.3 Item 2(Picture)

1.3 The basement flooring has typical cracks in areas highlighted in photos. These cracks do not appear significant and seem typical. Cracks that are usually 1/8 inch or wider are need for concern. The cracks are usually the result of shrinkage or settling of the slab. Recommend these cracks be sealed then apply an epoxy coating on the floor to ensure water intrusion does not occur. It is recommended that you monitor annually after repairs. [Caulk for Concrete Cracks](#)

Note: some of the cracks are located in areas where there is substantial weight/force placed on flooring and most cracks. It could be the result of missing control/expansion joints placed on the concrete flooring. If these cracks re-appear after repairs and are over 1/8 inch in opening, a structural engineer who is familiar with foundation repair or qualified foundation repair contractor should be consulted.

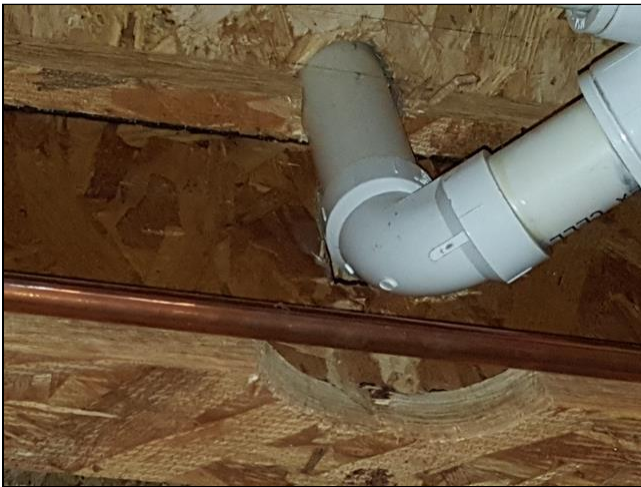
1.6 Item 1(Picture)

1.6 (2) I joist has been cut

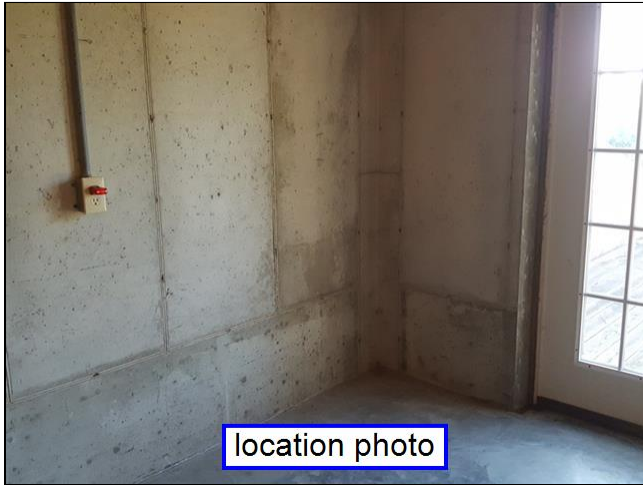
1.8 Item 1(Picture)

1.8 (1) The receptacle outlet in the basement where indicated in the photo(s) is improperly wired with the hot and neutral wires reversed. This is extremely dangerous and a potential shock hazard. You **CAN BE SHOCKED** causing a possible death when the switch to the appliance is off when plugged into the outlet. Recommend a qualified licensed electrician repair as needed for safety prior to moving.

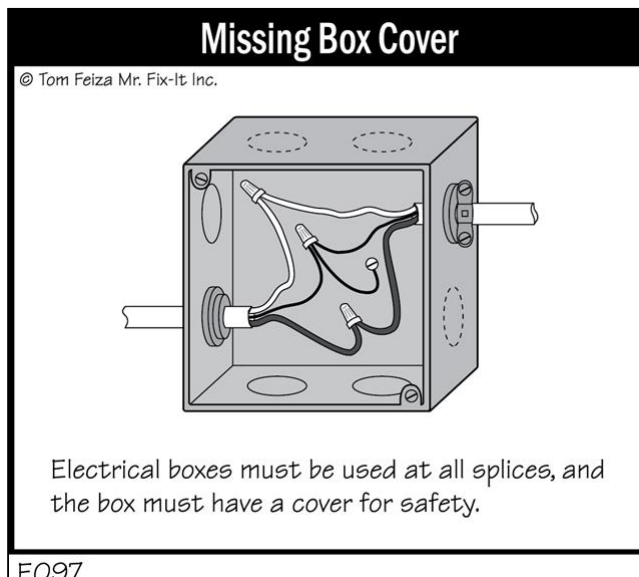
1.8 Item 5(Picture)

1.8 (3) All junction boxes in the basement should have covers installed to prevent tampering, protect the wire connections, and for personal protection. This is a safety issue that needs to be corrected. If a leak was to occur it could result in a short then a fire in the home. Recommend a qualified licensed electrician correct as needed.

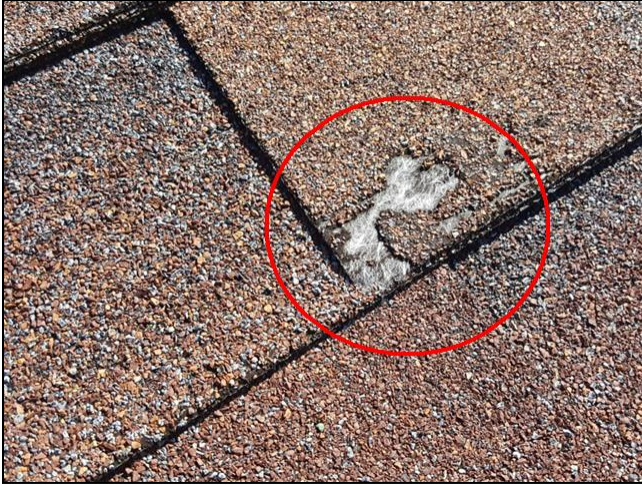
2.0 Item 1(Picture) below master bedroom area rear of home

2.0 (1) Gravel covering is missing due to possible hail damage on the shingles of the home where indicated in photos. This usually leads to a shortened life expectancy and increases the potential for ultraviolet damage to the membrane which may result in roof leaking. Shingles with missing gravel should be replaced or repaired before leaks occur. Recommend repair as needed by a qualified roofer.

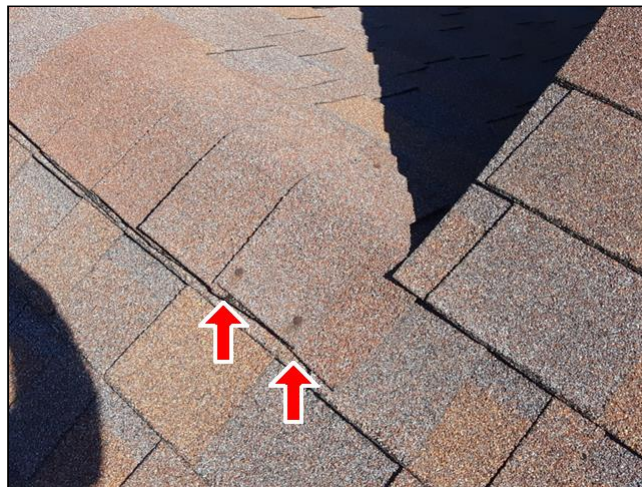
2.0 Item 3(Picture)

2.0 (2) Exposed nail heads were seen at the roof near the peak ends. All exposed nails should be properly sealed by a qualified roofing contractor. A sealant compatible with the roofing or flashing material should be applied to the nail. This will prevent and reduce future water entry and/or leaks into the attic.

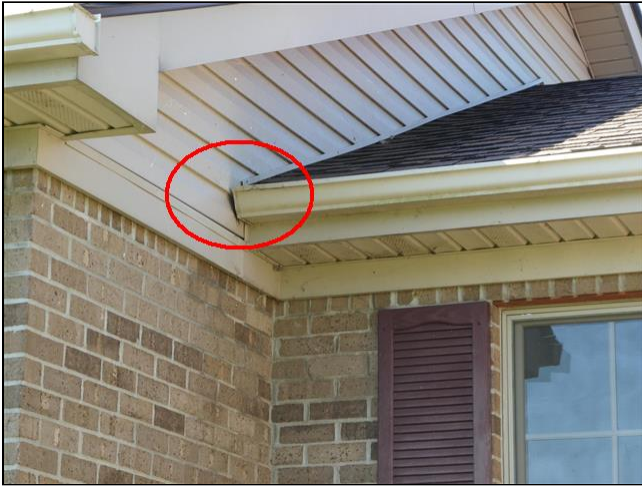
2.1 Item 1(Picture) front right side of home

2.1 (2) The diverter flashing/step flashing is missing between the roof and wall at the front and rear of home where indicated in the photos. Water stains on the exterior brick siding was noted. This can cause damage to the siding and may allow water intrusion between the gutter and the wall structure. Recommend a qualified roofing contractor further evaluate and repair as needed.

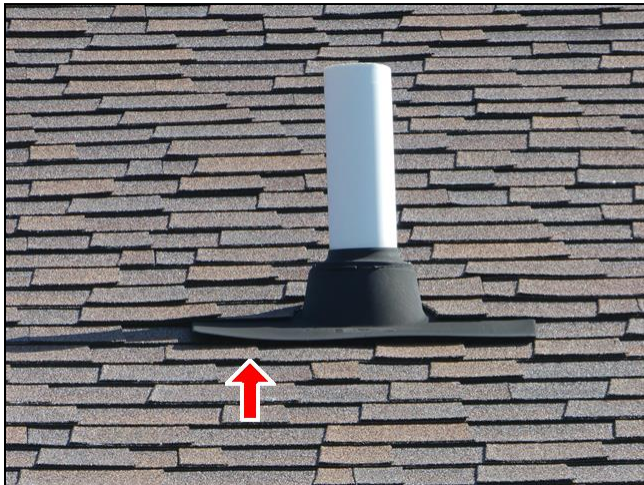
2.2 Item 1(Picture)

2.2 The flashing on the roof below the plumbing vent at the rear right side of the home has lifted and needs flattening to avoid water leaks. Water leaks can cause deterioration of the roof sheathing and trim. Recommend they be re-secured by a qualified roofing contractor to prevent water entering underneath the flashing and to allow the ease of water runoff to reduce the risk of leaks in the home.

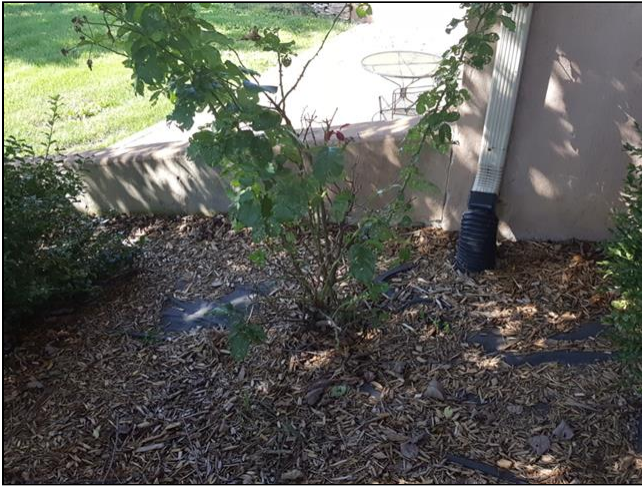
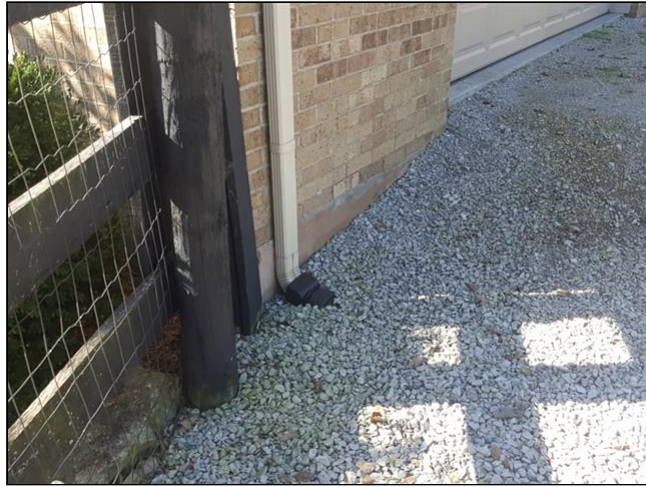
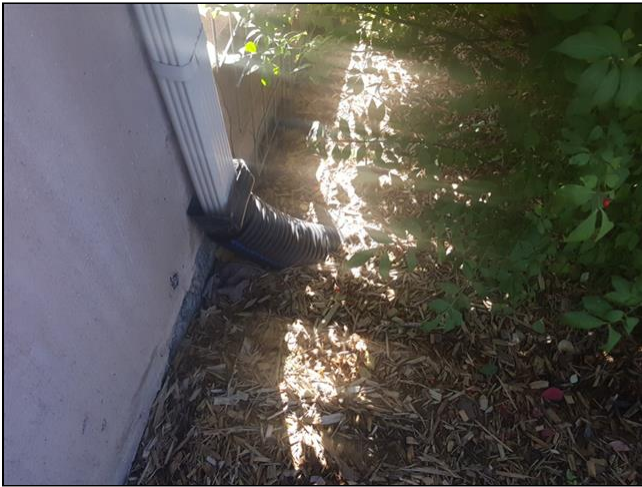
2.3 (1) Downspouts that discharge below grade level should be monitored. If they are ever suspected to be clogged or disconnected below grade, they should be redirected to discharge at least 10 feet from the building or into a storm sewer system. Foundation leakage adjacent to a downspout is an indication of a problem below grade.

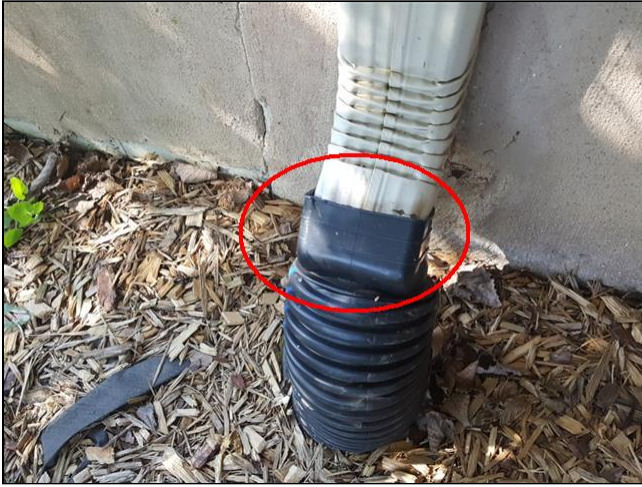
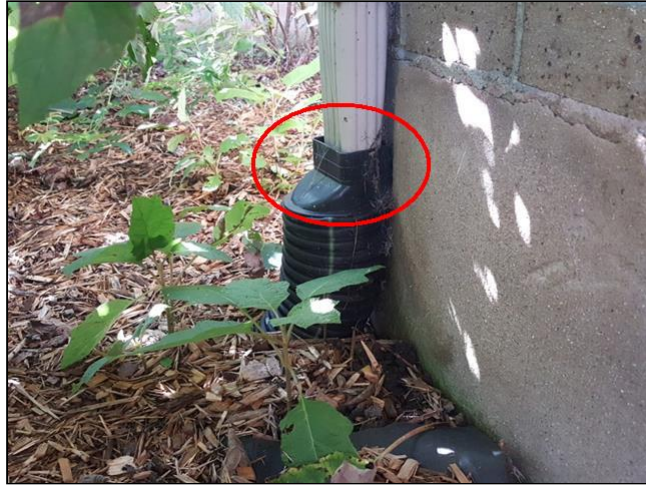
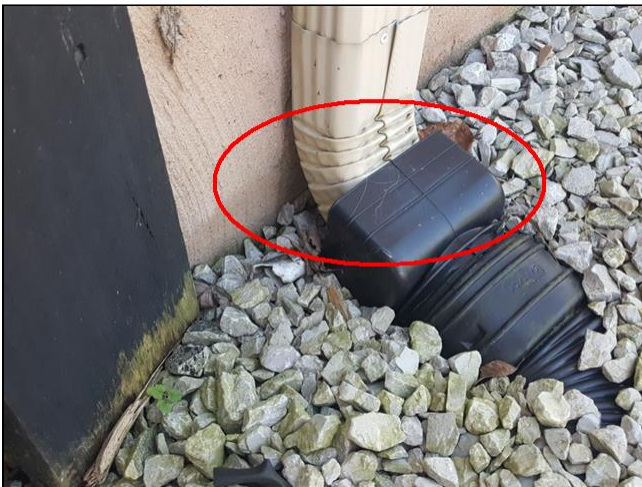
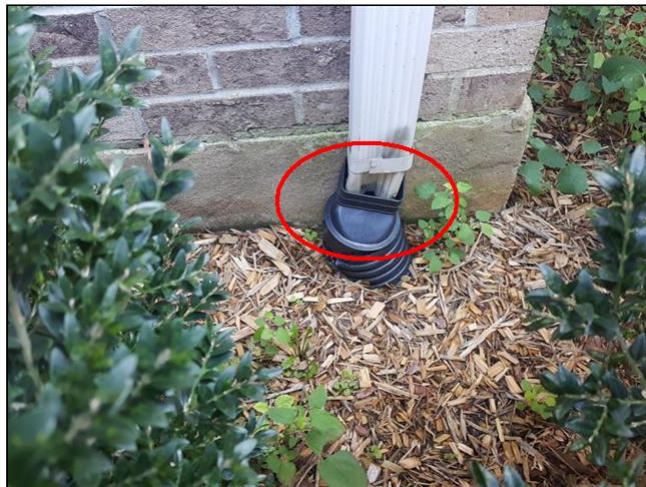
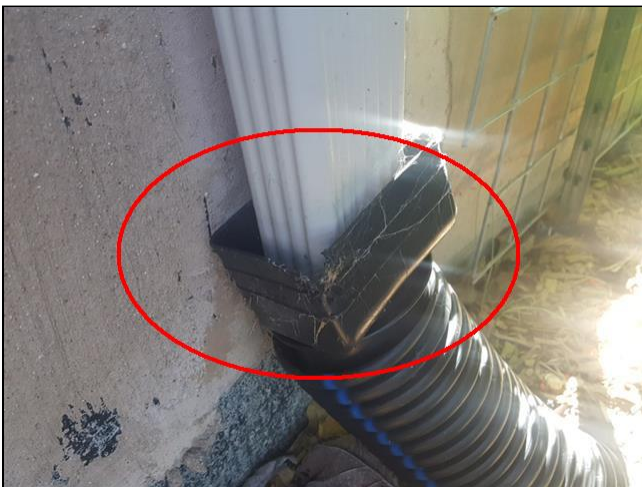
2.3 (2) Recommend the downspout extension(s) be attached to the downspout where indicated in the photos by placing a screw at the top and bottom where it connects to the downspout to ensure the extension(s) does not pull away from the downspout(s). Failing to do this may create future problems to the foundation around the home due to soil erosion and water entering the basement which may result in the foundation settlement if the extension detaches from the downspout.

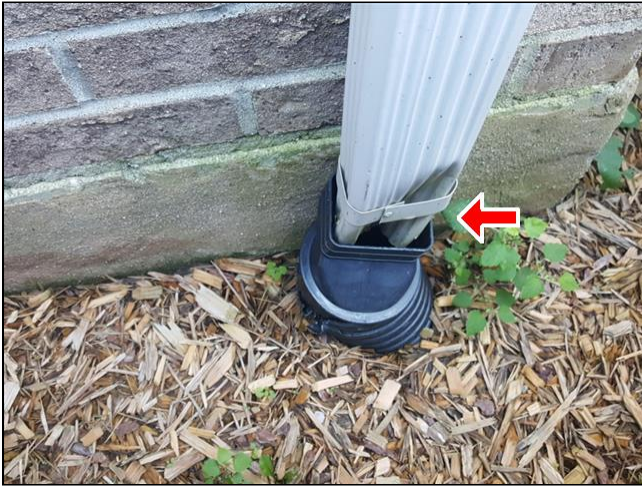
2.3 Item 12(Picture) between garage and home at the rear

2.3 (3) The downspout is crushed at the end where indicated in the photo. This is restricting the discharge of water. Recommend the downspout be repaired at the end so water will flow freely and extend into the downspout extension. A general contractor should repair or replace as needed.

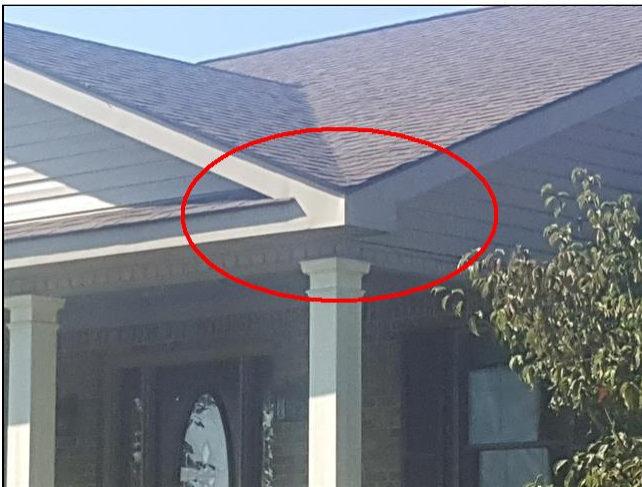
2.3 Item 13(Picture)

2.3 (4) Gutter and downspout is missing and should be installed at the front right and left corners of the porch at the home above the porch area to avoid spilling roof runoff around the building - a potential source of water entry or water damage. It could cause settlement of the front porch in the future if not corrected. Recommend a qualified contractor install a gutter system. This will prevent soil erosion below and possible water leakage into the basement.

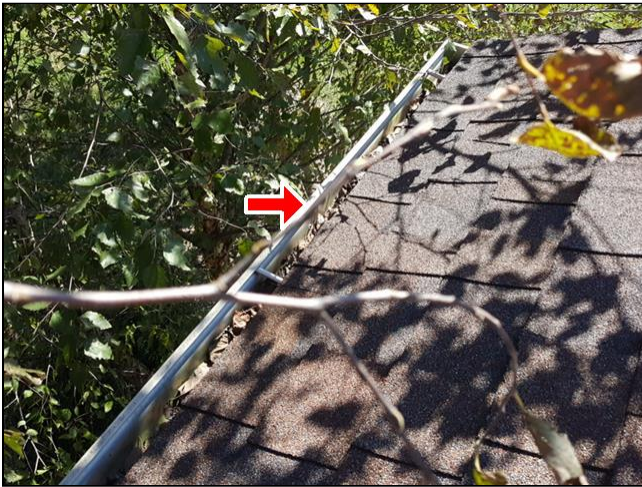
2.3 Item 15(Picture)

2.3 (5) The gutter(s) at the front left side of the home where indicated in the photo, especially where they drain into the downspouts, are full of debris and need to be cleaned. The debris in gutters can also conceal rust, deterioration or leaks that are not visible until cleaned, and I am unable to determine if such conditions exist. Gutters require cleaning to avoid spilling roof runoff around the building - a potential source of water entry or water damage, and/or the fascia could become damaged. Recommend cleaning the gutters as needed.

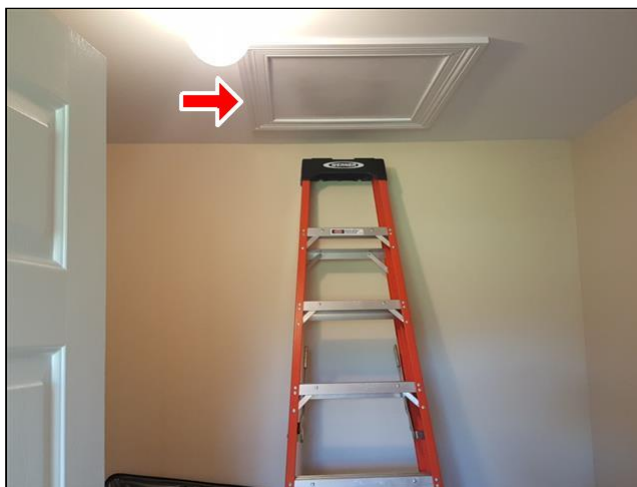
2.4 Item 2(Picture) master bedroom closet

2.4 (2) Recommend the attic access hatch in the master bedroom closet be insulated to prevent air and heat loss for energy conservation.

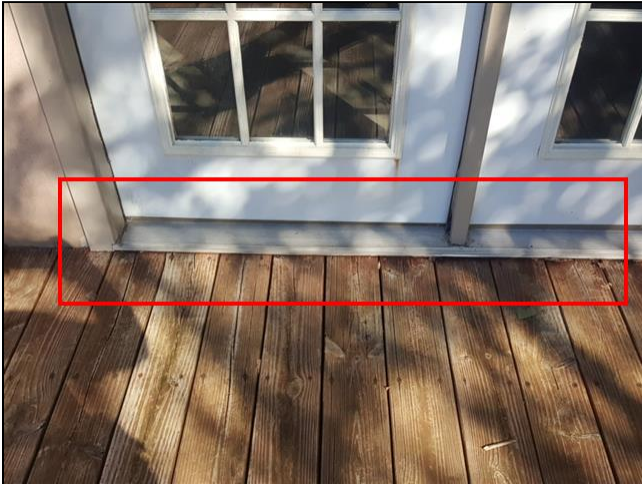
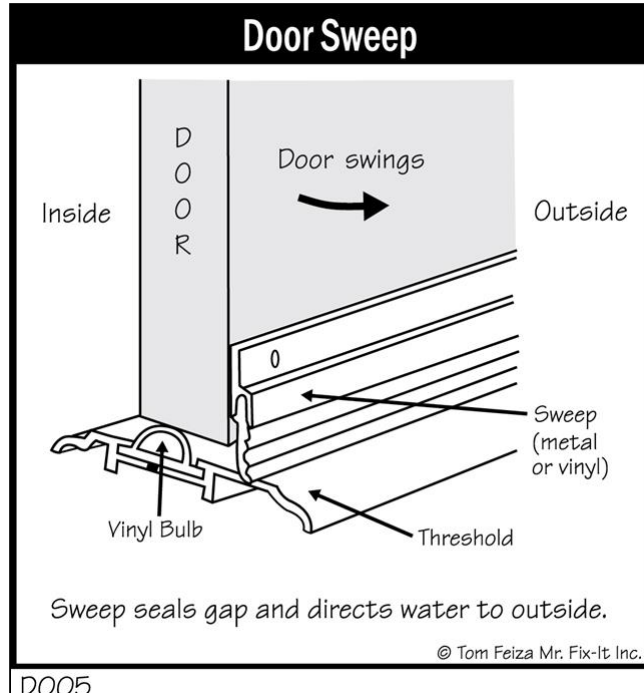
3.3 I would recommend a door sweep be installed at the basement door of the home to ensure water intrusion does not occur especially in winter when it snows. This is for your information

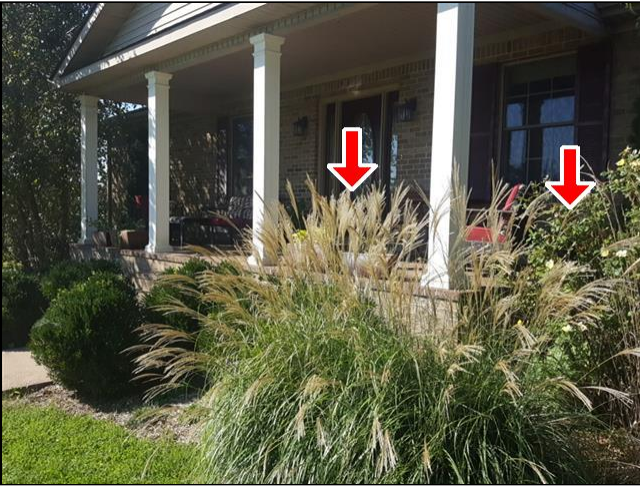
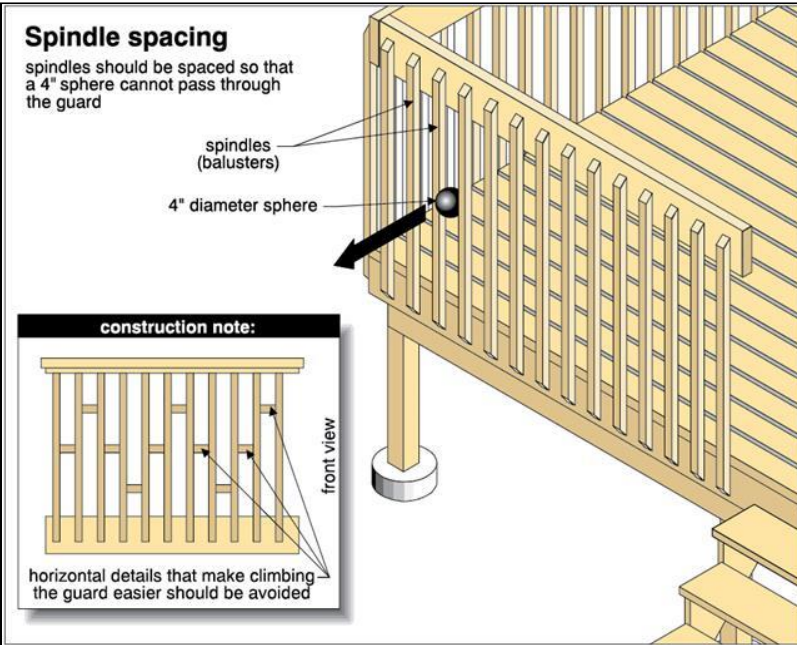
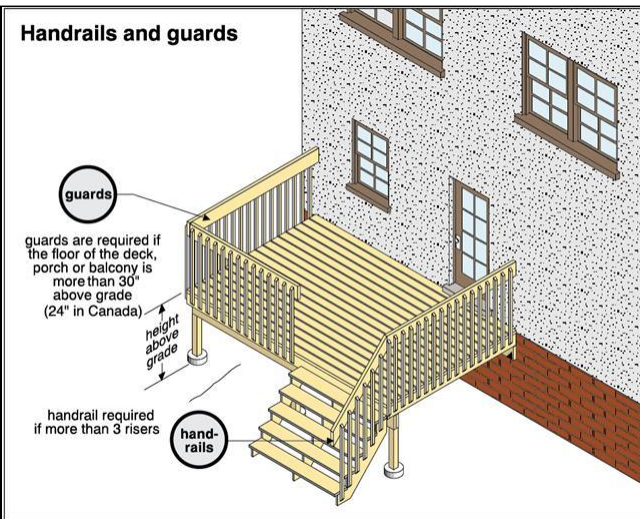
3.5 Recommend a guard rail be installed around the front of the porch to prevent a fall from occurring which may result in an injury of a person. This is a potential safety issue. The railing needs to be at least 36 inches high and balusters need spacing to be at least 4 inches. Recommend a qualified contractor install one for safety.

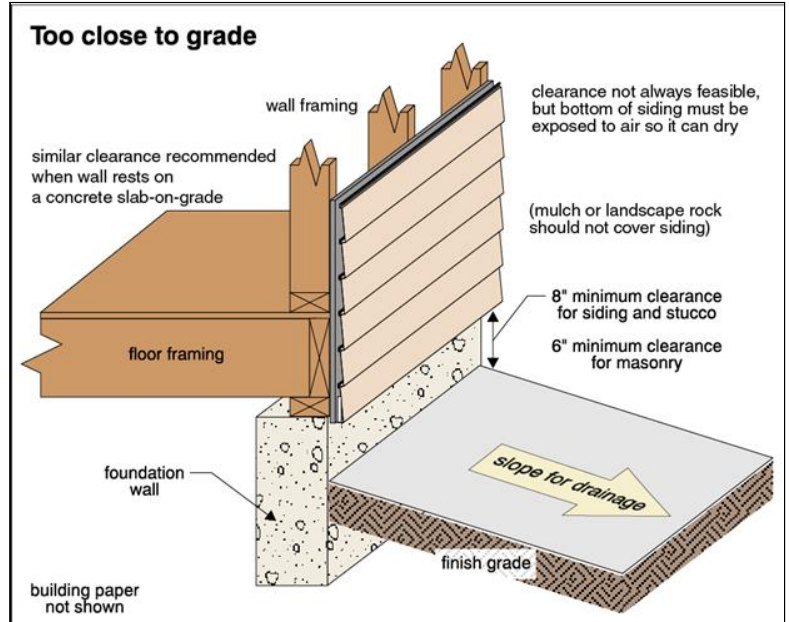
3.9 Item 2(Picture)

3.9 (1) There are depressions in the soil around the foundation perimeter at the front right side of the home near the electric meter. Recommend filling all depressions and re-grading the soil so the soil slopes away from the home around the foundation to ensure water pooling does not occur in these areas. Water pooling could lead to to basement leakage.

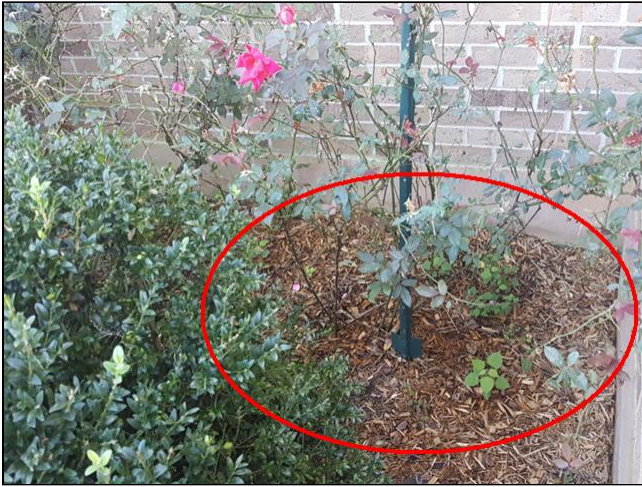
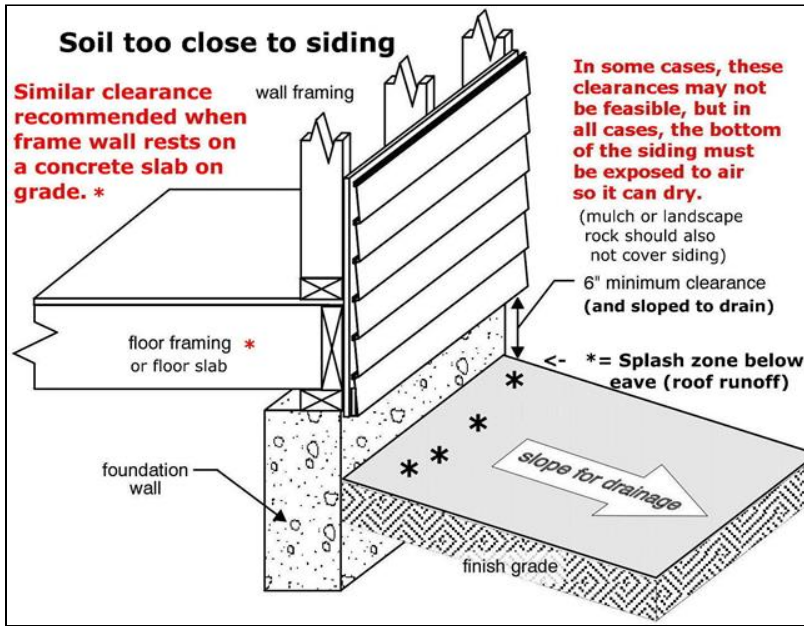
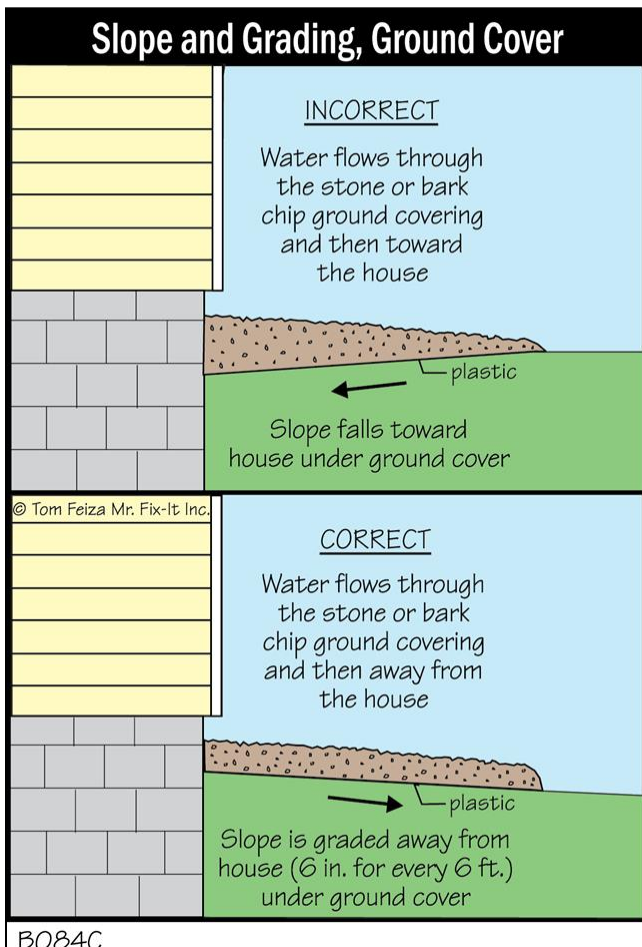
3.9 (2) The grading of soil at the rear left side of the home between the garage and the washer dryer room area should be improved to promote the flow of storm water away from the foundation perimeter. This can often be accomplished by the addition of top soil. (Ensure that the soil is at least 6 inches below siding). The ground should slope away from the house at a rate of one inch per square foot. This slope should extend at least five to six feet from the home and will also prevent water intrusion near the foundation perimeter to prevent house from settlement and basement leakage. Recommend correcting as needed.

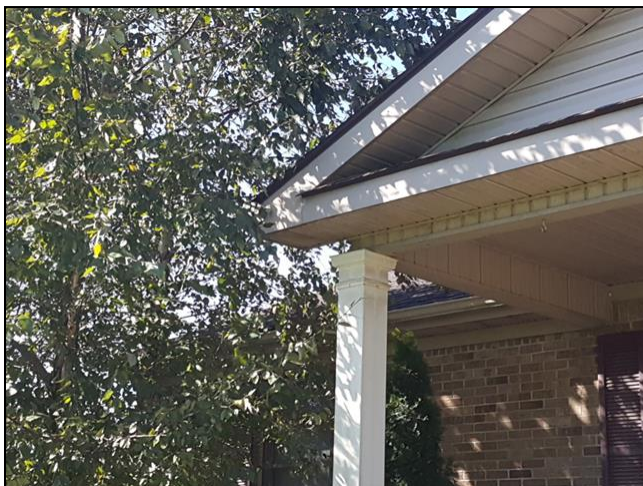
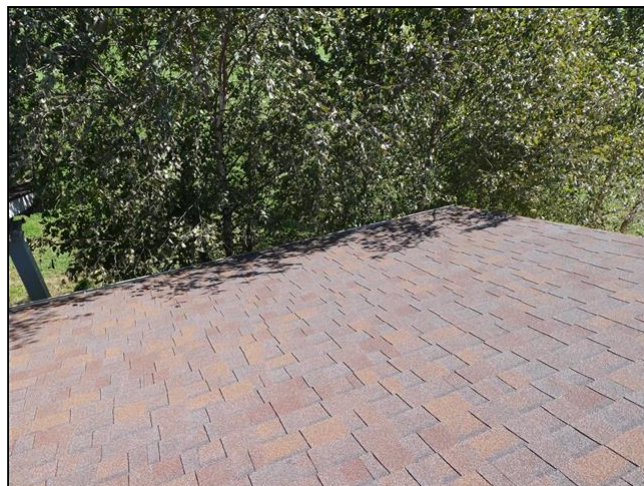
3.10 (1) The tree limbs that are in contact or hanging near the roof at the front left corner of the home should be trimmed to prevent damage to the shingles and from scraping on the roof surface. They will also clog gutters which will cause water run off problems around the home. Recommend cutting back tree branches as needed.

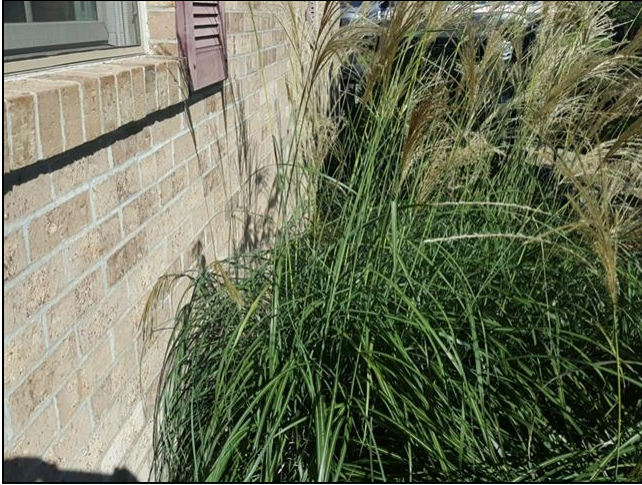
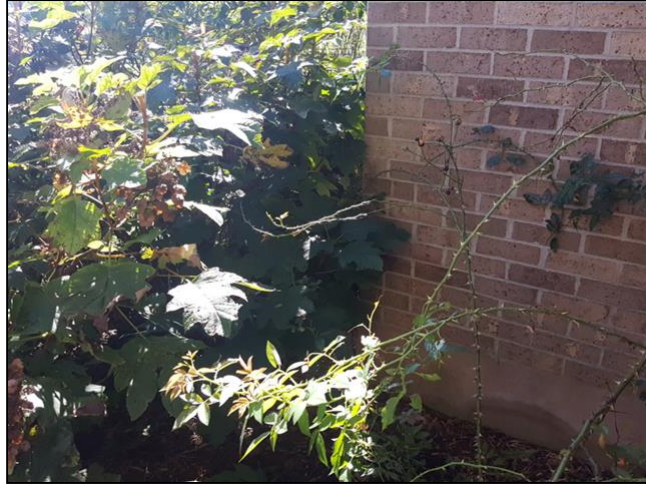
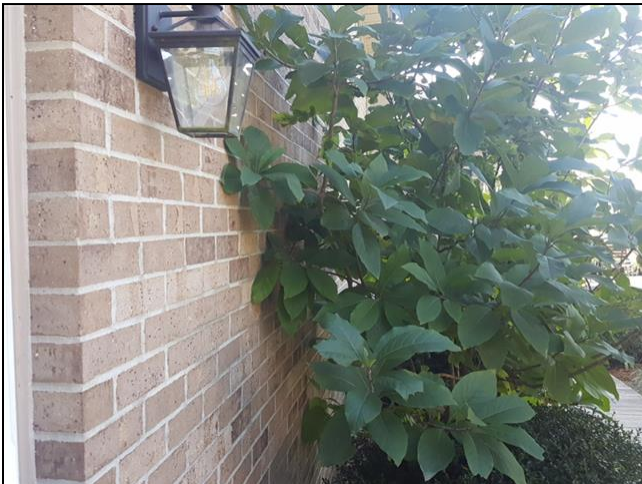
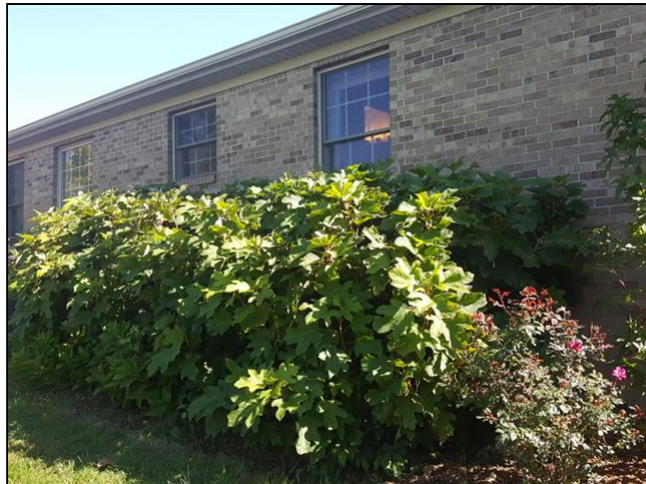
3.10 (2) The vegetation is overgrown around the perimeter of the home where indicated in the photo(s). Recommend that all bushes, shrubs and trees where applicable be kept neatly trimmed and away from the foundation, wall siding, and window frames to prevent damage to the home and allow proper venting and inspection of house. A 6" clearance is recommended.

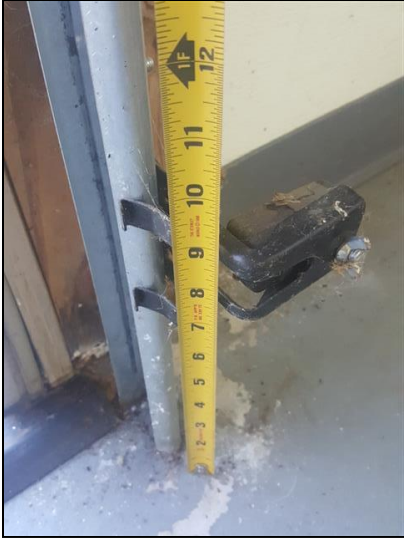
4.3 Item 1(Picture)

The sensors are in place for the garage door(s) and will reverse the door(s) when interrupted.

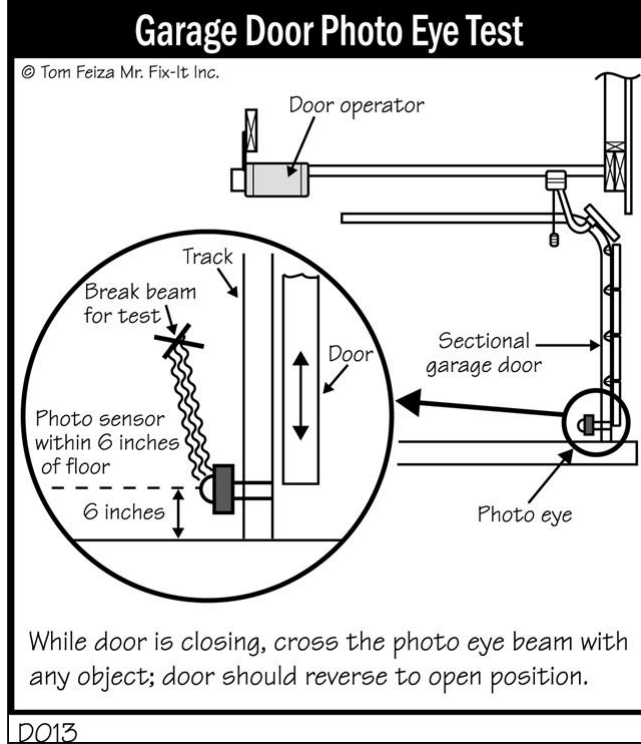
4.3 Item 2(Picture)

4.3 (2) The garage door opener electric eyes are installed too high. There is a serious risk of injury, particularly to children or pets, under this condition. The eyes should be placed 4" to 6" off the floor or as otherwise indicated in the installation manual. This should be dealt with immediately by a qualified garage installer.

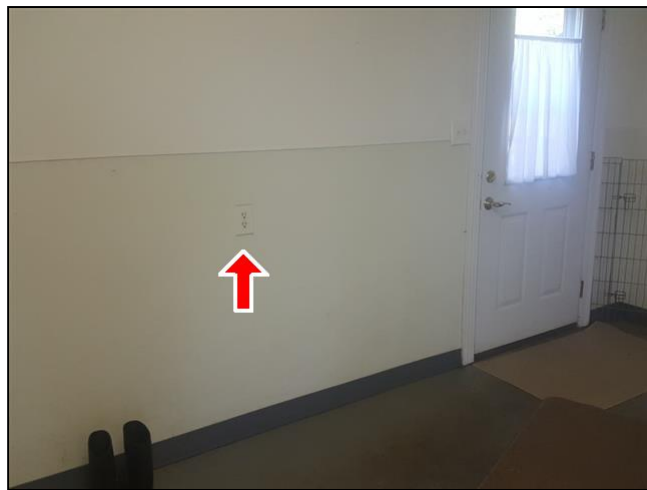
4.8 Item 2(Picture)

4.8 The GFCI outlet(s) in the garage where indicated in the photo(s) did not trip in response to testing during the inspection. This is a safety issue. The GFCI offers protection from shock or electrocution. Recommend a qualified licensed electrician repair as needed.

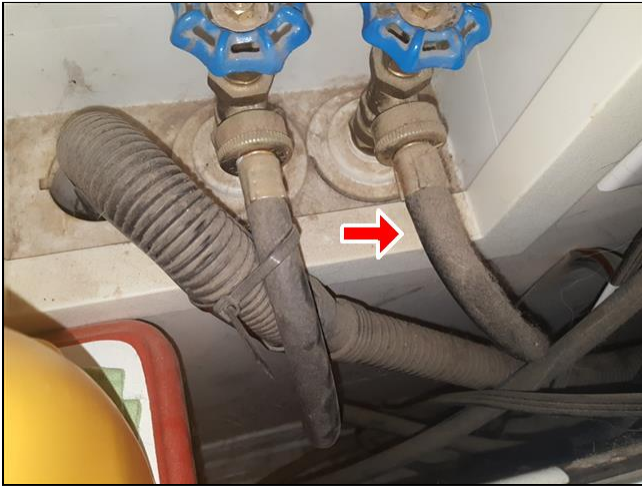
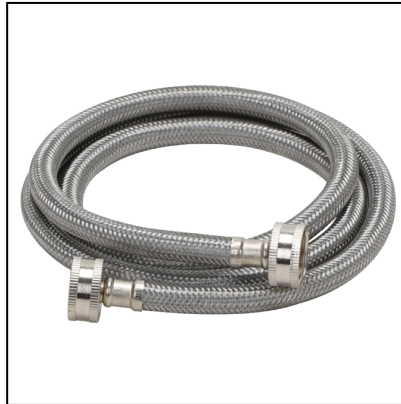
5.0 Your washing machine is connected to rubber hoses. These hoses are under constant water pressure and are prone to leaks or even bursting overtime. This will cause damage to your home. You may wish to convert hoses to "No-burst hoses" which are encased in a woven metal sleeve that prevents weak spots in the rubber from developing into leaks. This is for your information.

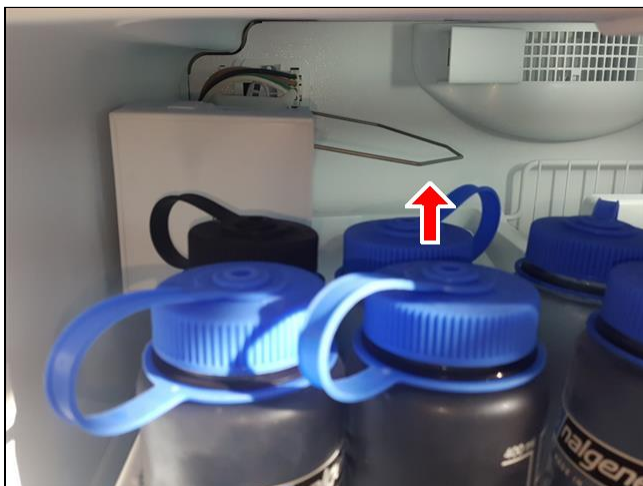
5.5 Item 1(Picture)

5.5 (1) The ice maker was turned off at time of inspection.

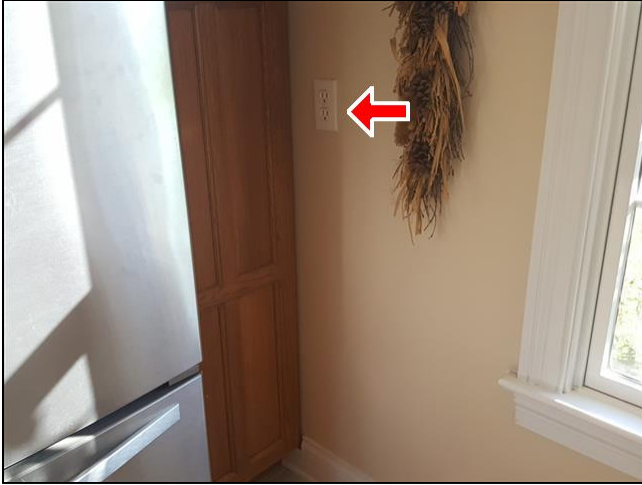
5.8 Item 1(Picture)

5.8 (3) The outlet(s) in the kitchen where indicated in the photo(s) are loose at the wall or in the outlet box. Electrical issues are considered a hazard until repaired. This is a safety issue that needs to be corrected due to an electric shock or fire from loose connections could occur if not repaired. Recommend a qualified licensed electrical contractor correct as needed.

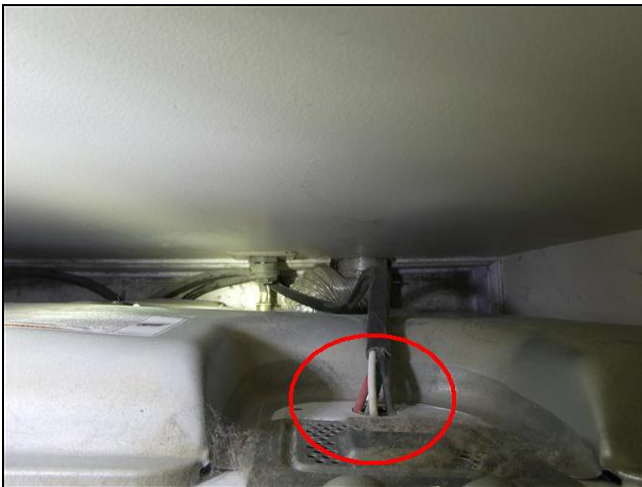
5.9 Item 1(Picture)

5.9 There is no strain-relief clamp connected to the wire at the back of the dryer. This is a safety issue. The insulation on the wires could be damaged via vibrations when the dryer is being used which could cause a short. Also, a child or person could easily pull the wire out of the disposal, touch an energized conductor, and be electrocuted causing possible death. Recommend a qualified licensed electrician repair as needed for safety prior to closing and using the dryer.

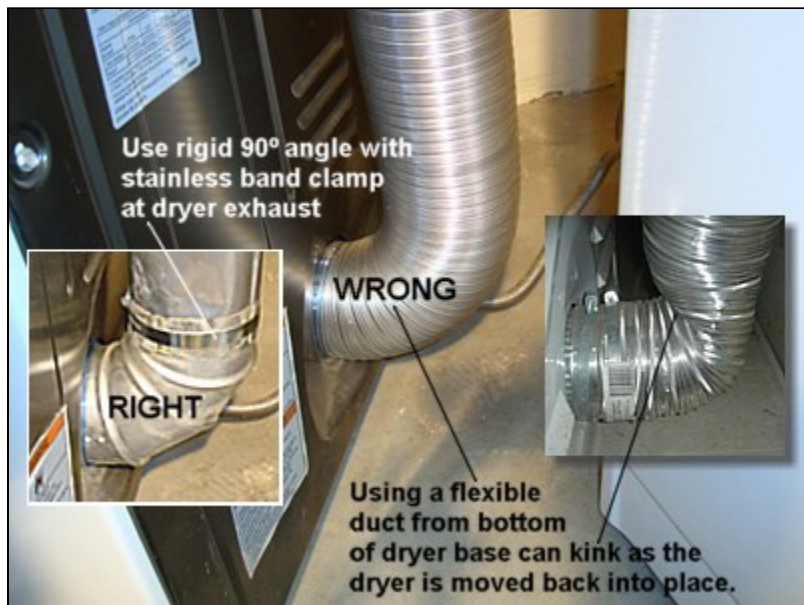
5.10 Item 3(Picture)

5.10 (1) A pleated Foil flex pipe is currently installed from the dryer to the exhaust vent. The current recommendations are for dryer vents to be heavy flexible or solid metal to help prevent crushing and damage from fires. Dryer lint fires are reported to be the third leading cause of fires. Exhaust ducts should be constructed of minimum 0.016 inch thick rigid metal ducts, having smooth interior surfaces with joints running in the direction of air flow. Exhaust ducts shall not be connected with sheet metal screws or fastening means which extend into the duct. All dryer vents should be disconnected and cleaned twice a year. This is a very common cause of fires. Recommend replacing duct for proper operation and for your safety using a qualified contractor.

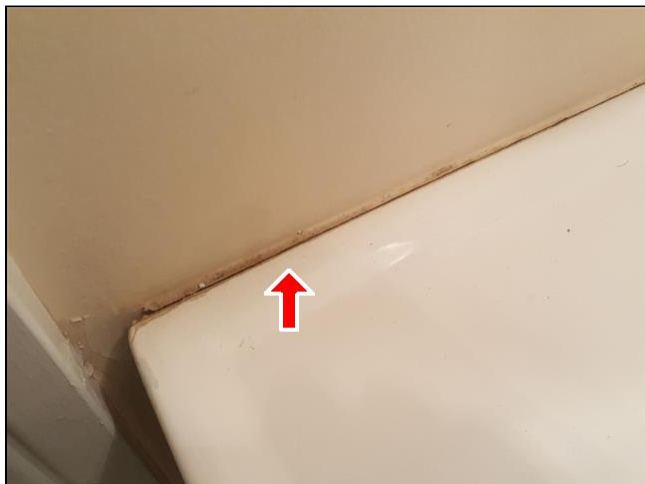
7.1 Item 2(Picture)

7.1 (2) Recommend caulking around the counter top in the 2nd bathroom to seal the crack. Water may enter which can cause damage to the drywall and cabinets, then result in possible mold forming. Repair using a quality caulk that is resistant to moisture and is expandable. Here is a link on [How to Choose the right Caulk](#)

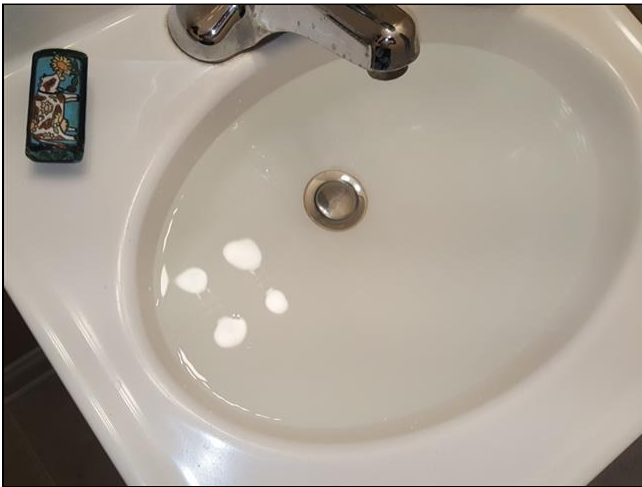
7.4 Item 1(Picture) half bath

7.4 (1) The sink(s) in the half bath and the 2nd bathroom do not have overflow holes. Over flow holes are recommended at all sinks to prevent water spillage which can lead to damage cabinets or flooring. This is for your information.

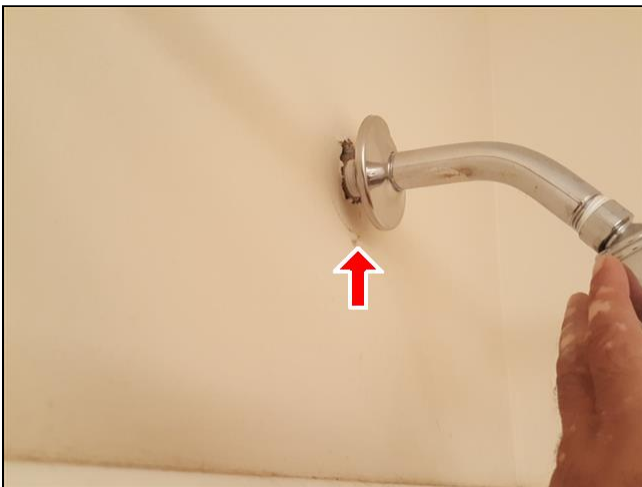
7.4 Item 3(Picture)

7.4 (2) The shower head is loose and not secured to the wall and does not seal against the enclosure correctly in the 2nd bathroom. Recommend it be secured and sealed correctly to prevent a possible plumbing leak from occurring at the pipe joints. If a leak develops this can cause mold to develop and deterioration of the wall framing can occur. A qualified plumber is recommended for these repairs.

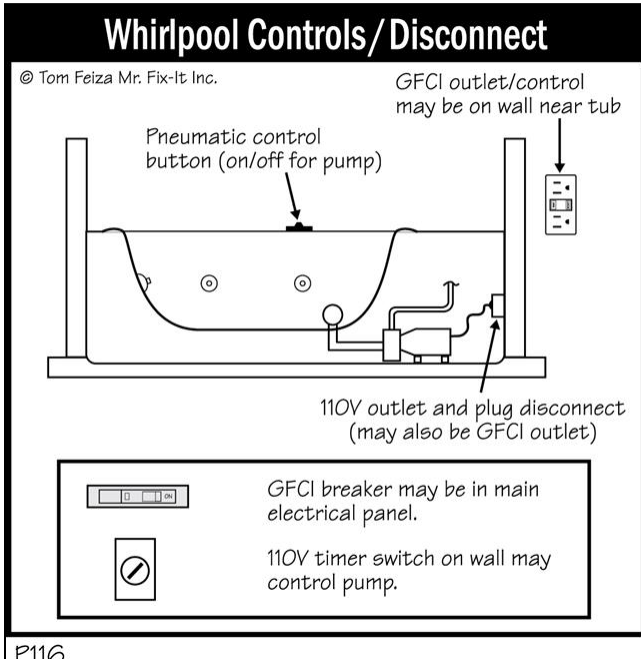
7.8 Item 2(Picture)

7.8 (2) The jacuzzi tub worked properly at the time of the inspection in the master bathroom and the GFCI outlet did trip when tested. This is for your information.

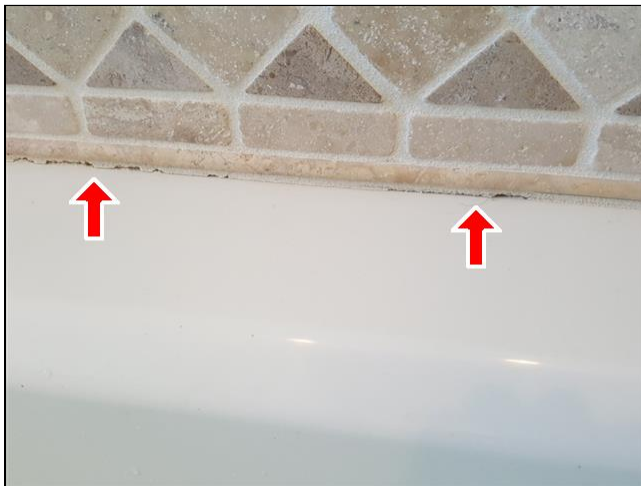
7.8 Item 4(Picture)

7.8 (3) Cracked grout around the jacuzzi enclosure should be cleaned or removed and replaced with new grout to prevent water entry behind the finished materials. If the grout is damaged and not properly repaired it could allow water entry. Water entry can damage the walls, framing or loosen the tiles and cause mold growth. A qualified contractor should be able to make any repairs that are needed.

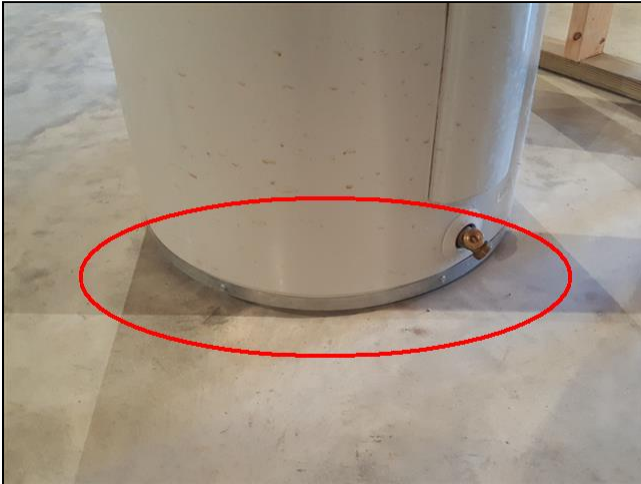
8.2 Item 1(Picture)

8.2 (1) The normal life expectancy of a water heater is between 12-16 years. This is for your information.

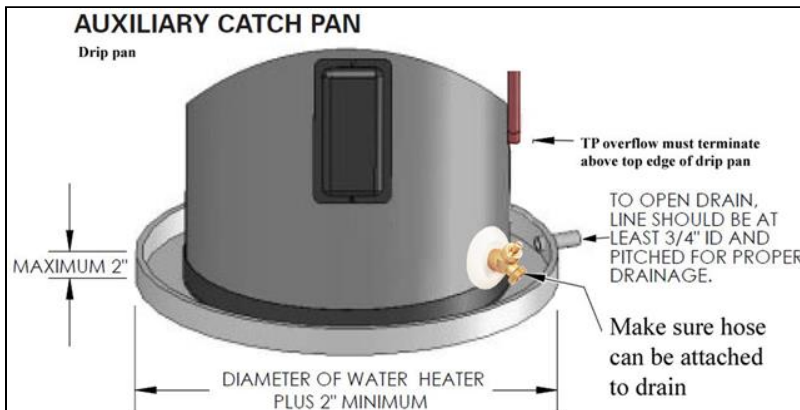
8.2 Item 2(Picture)

8.2 (2) The water heater on a finished floor or in a basement has the potential to cause severe damage if a leak should develop. Consider installing a drain pan under the water heater to prevent damage to the home if a leak develops. This will allow any water leaks to safely drain without damaging the finished materials, floor or furnishings. A qualified plumber could examine and install the drainage pan and drain line, but may need to install a drain line with a trap to the current drainage system. As an inexpensive safe-guard a drain pan with a moisture alarm can easily be installed as another option. Recommend a qualified plumber make the necessary corrections if desired.
