TALC
Home Inspe

Inspection Report

Property Address:
211 Wellington Road
Paris KY 40361

Date: 10/17/2018	Time: 10:00 AM till 02:00 PM	Report ID: 181017SCNEIDER
Property: 211 Wellington Road Paris KY 40361	Customer: Ms. Gail Schnieder	Real Estate Professional:

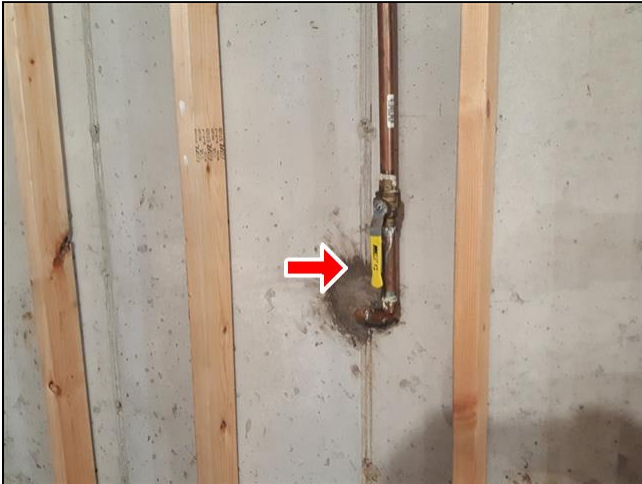
8.4 Item 1(Picture)

8.4 The main water shut off is the yellow lever located in the basement on the front wall under the kitchen area. This is for your information.

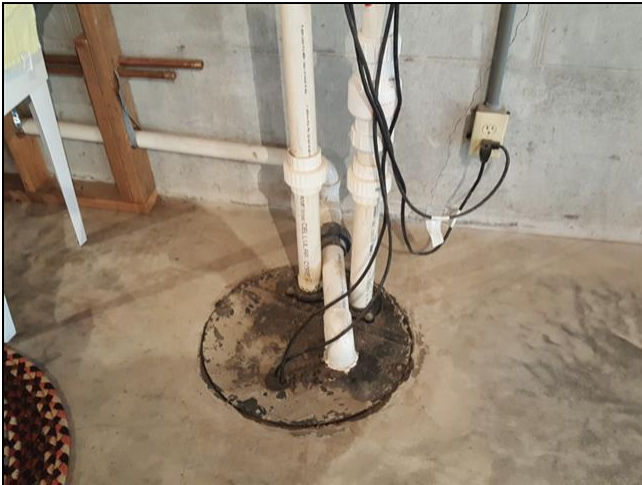
8.5 Item 1(Picture)

8.5 The sewer ejector pump was operational at the time of inspection. Check the device often and you may wish to consider to have some type of alarm installed in case of failure.

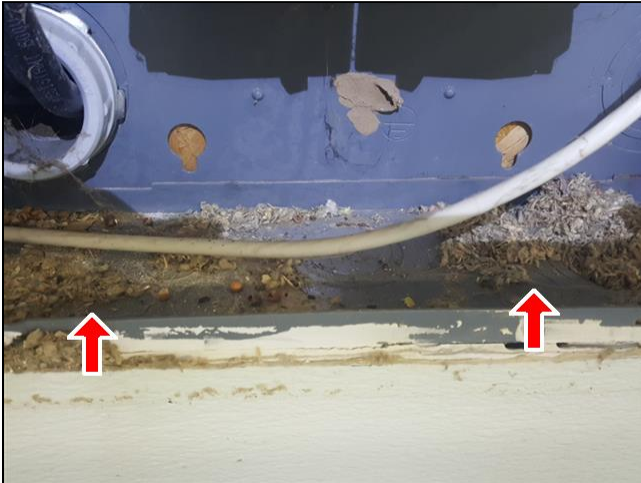
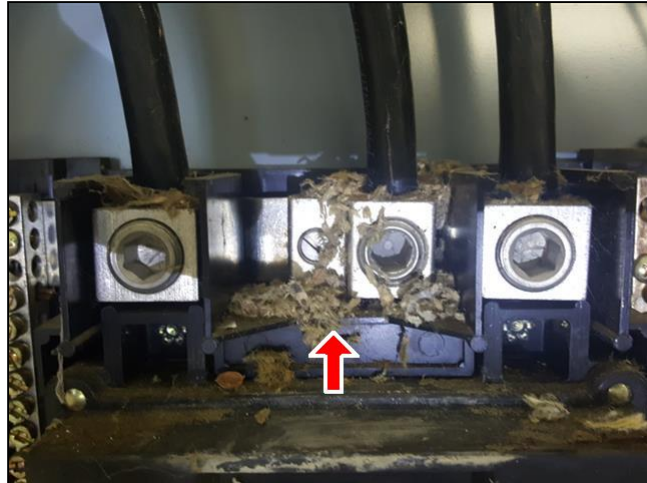
9.2 (1) The panel box has insulation (debris) inside and at the top of the entry cables. This is a safety issue that needs to be corrected. The insulation can attract moisture which can lead to connections or breakers corroding which may cause a fire. Recommend a qualified licensed electrician clean as needed for safety.

(1) The panel box has insulation (debris) inside and at the top of the entry cables. This is a safety issue that needs to be corrected. The insulation can attract moisture which can lead to connections or breakers corroding which may cause a fire. Recommend a qualified licensed electrician clean as needed for safety.

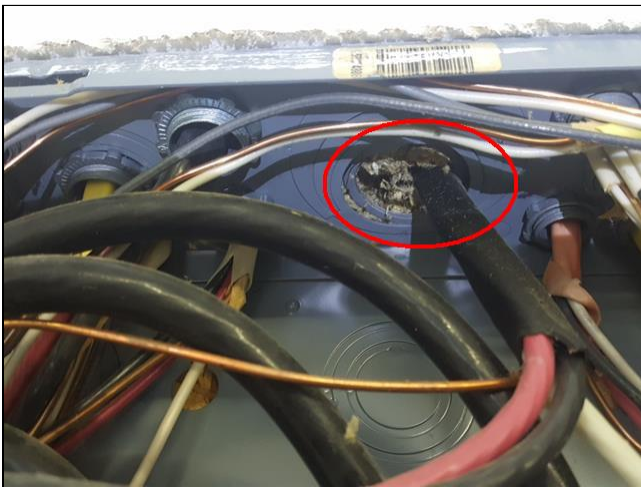
9.2 Item 3(Picture)

9.2 (2) Cable clamps (sometimes referred to as bushings or grommets) are required where wiring passes into the electrical panel box. Cable clamps serve to protect the wiring from the metal edges of the panel box to prevent a short from occurring or from the panel box becoming energized which can result in a death via electric shock. This is a safety issue. Recommend a qualified licensed electrician repair as needed.

(2) Cable clamps (sometimes referred to as bushings or grommets) are required where wiring passes into the electrical panel box. Cable clamps serve to protect the wiring from the metal edges of the panel box to prevent a short from occurring or from the panel box becoming energized which can result in a death via electric shock. This is a safety issue. Recommend a qualified licensed electrician repair as needed.

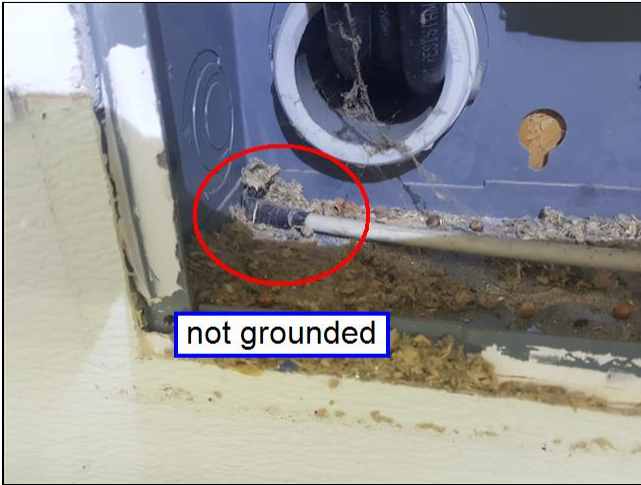
9.3 Item 1(Picture)

9.3 (1) The 50 amp gauge wire is not grounded in the panel. The current wire is connected to a 50 amp breaker. Could not determine what the function of the breaker is for. This is a potential safety issue as the appliance is not grounded. Strongly recommend a qualified electrician further evaluate and correct as needed prior to closing for safety of occupants in the home and to protect appliance.

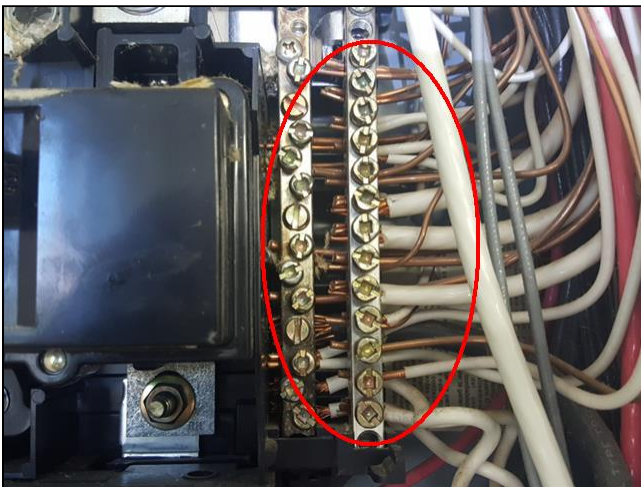
9.3 Item 3(Picture)

9.3 (2) More than one common (white wires) on a single lug of the neutral bar is not recommended but was found in this panel. Separation of these commons is recommended when any other electrical work is done by a qualified licensed electrician.

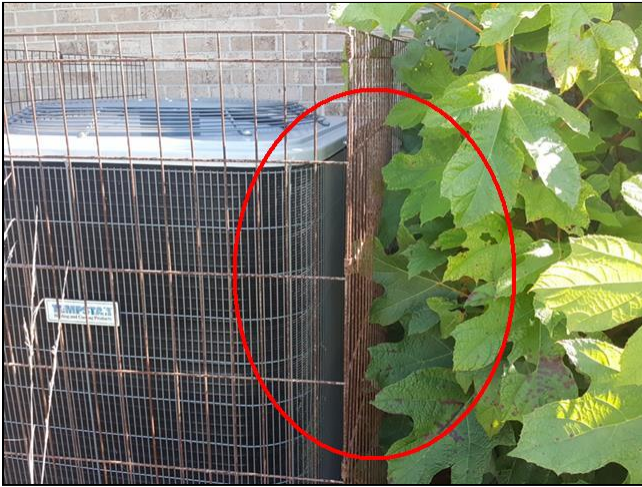
10.0 Item 1(Picture)

10.0 (3) Vegetation in the vicinity of the outdoor unit of the Heat Pump should be cut back to prevent obstruction of the airflow. This can cause damage to the unit via running hot ,shorten it's life expectancy, and cause it to run inefficient. Recommend removing all the vegetation surrounding the unit so that the fins are not obstructed.

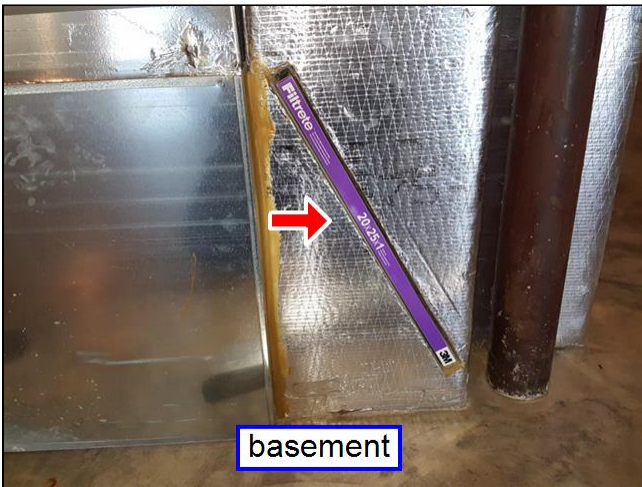
10.1 Item 1(Picture)

10.1 Filter location (see photo). The arrow on the filter should always point towards the blower.

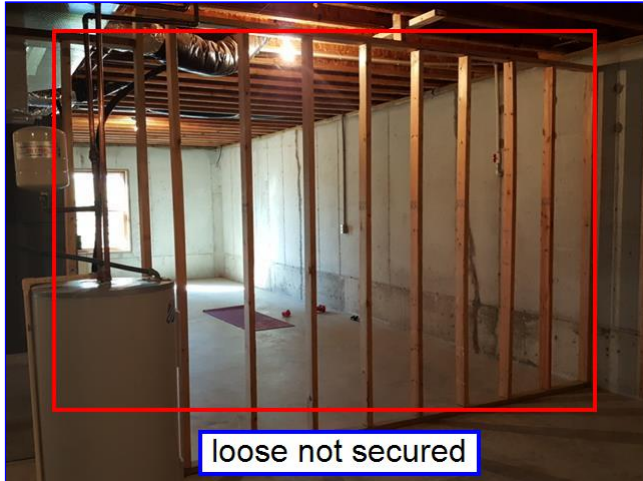
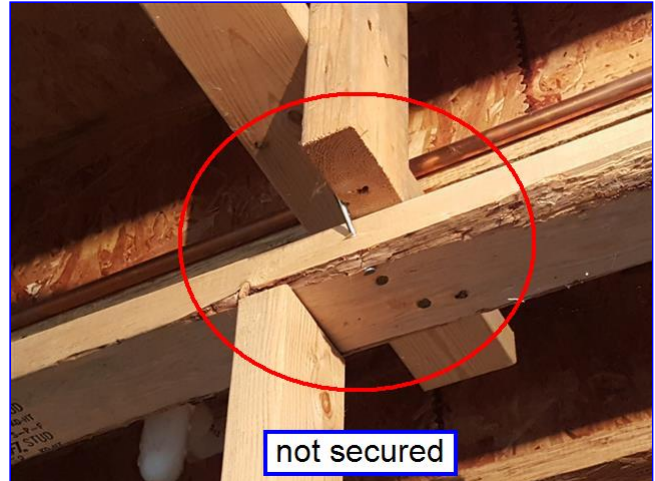
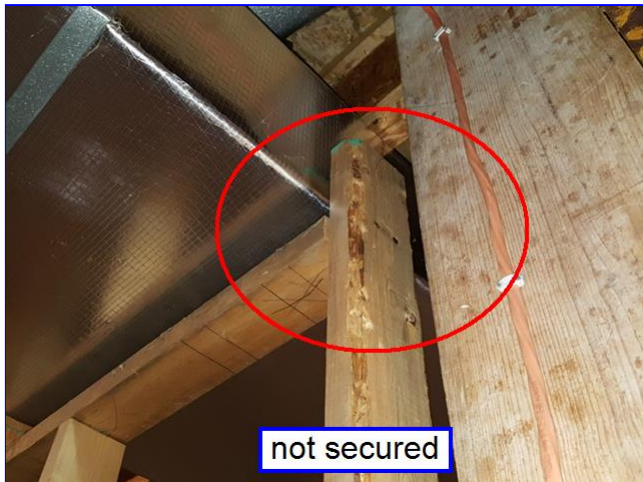
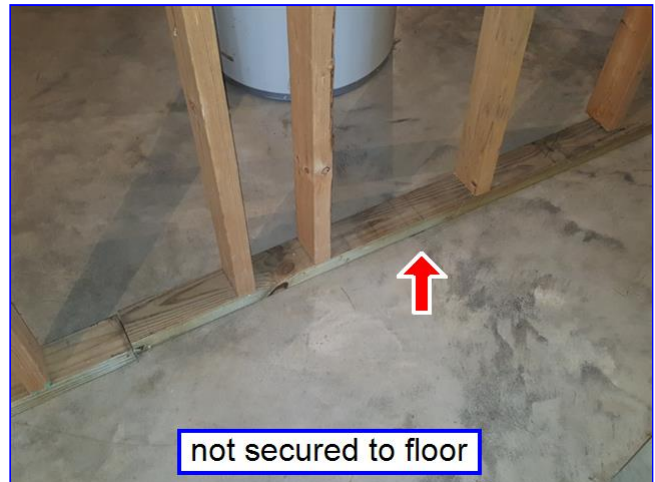
(3) The wall framing is loose and not secured to the ceiling or wall in the basement. This is a safety issue as the wall could fall causing an injury of a person or damage to appliances/equipment in the basement. Recommend a qualified contractor correct and repair as needed prior to closing. This is not a structural wall.

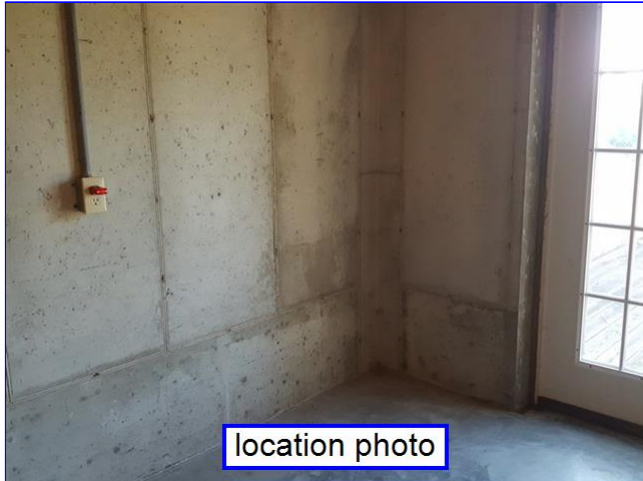
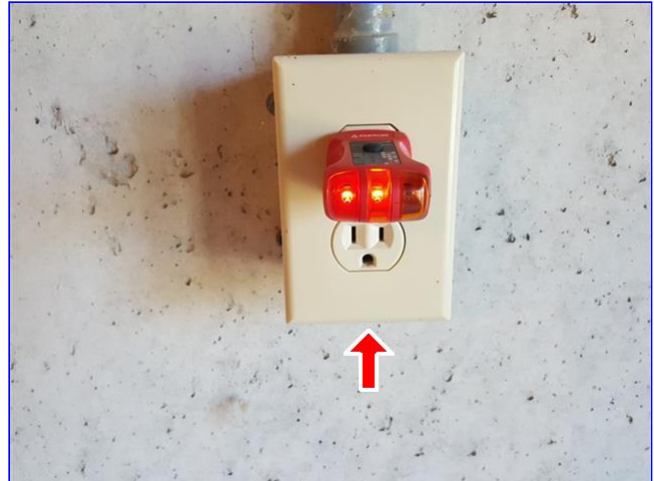
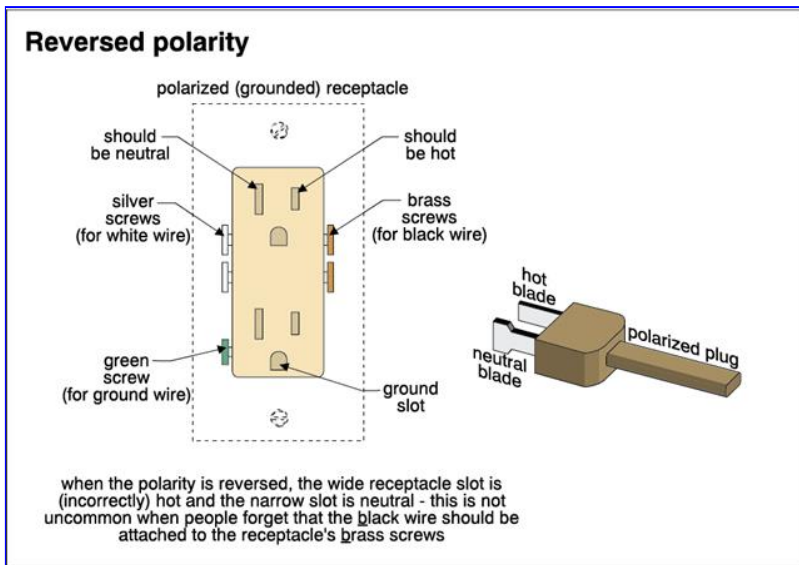
(1) The receptacle outlet in the basement where indicated in the photo(s) is improperly wired with the hot and neutral wires reversed. This is extremely dangerous and a potential shock hazard. You **CAN BE SHOCKED** causing a possible death when the switch to the appliance is off when plugged into the outlet. Recommend a qualified licensed electrician repair as needed for safety prior to moving.

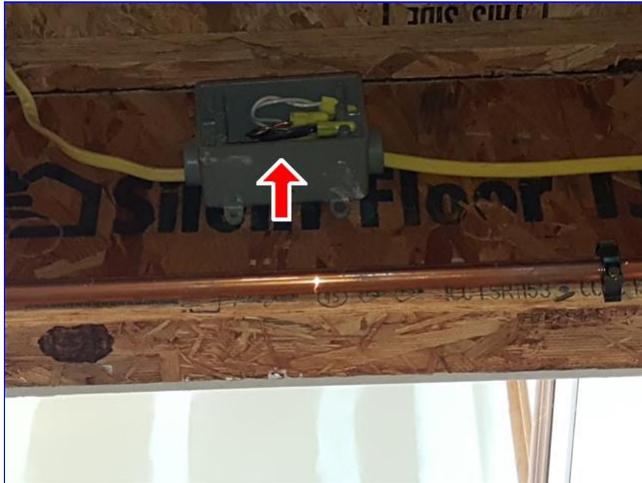
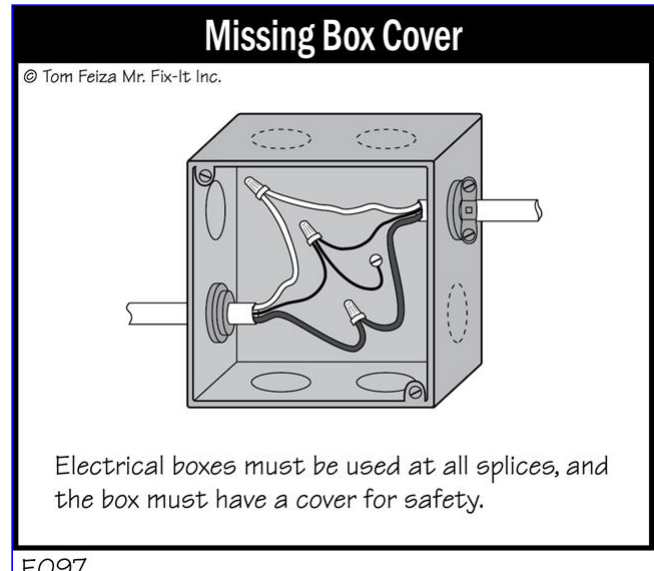
(3) All junction boxes in the basement should have covers installed to prevent tampering, protect the wire connections, and for personal protection. This is a safety issue that needs to be corrected. If a leak was to occur it could result in a short then a fire in the home. Recommend a qualified licensed electrician correct as needed.

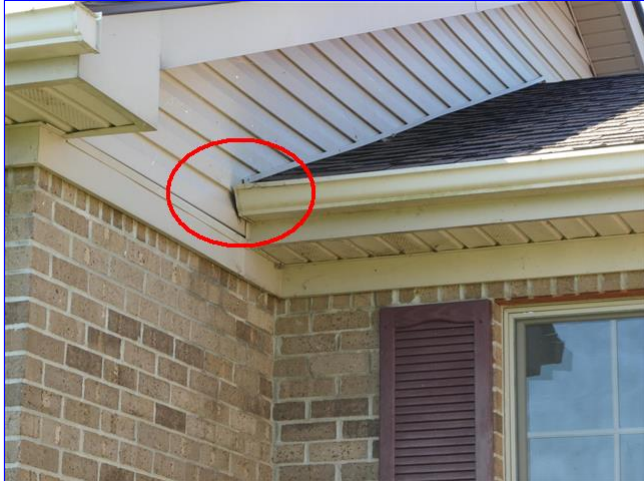
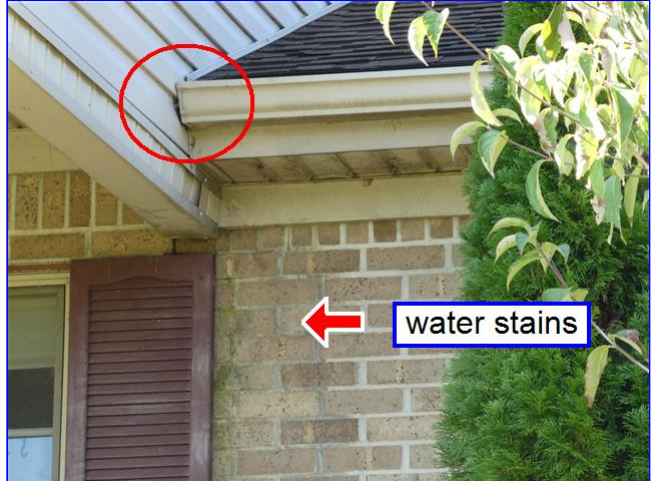
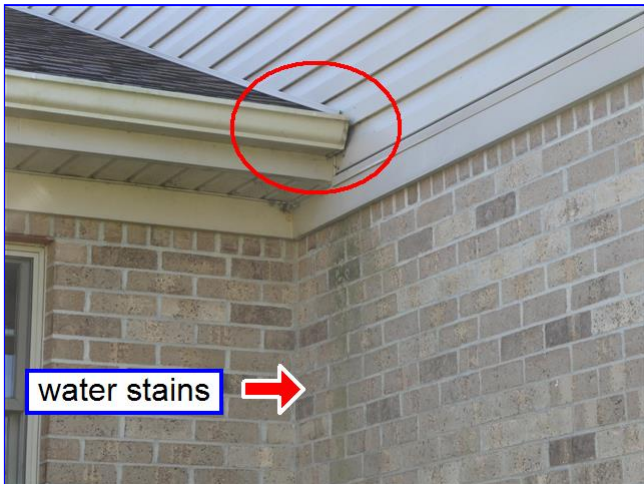
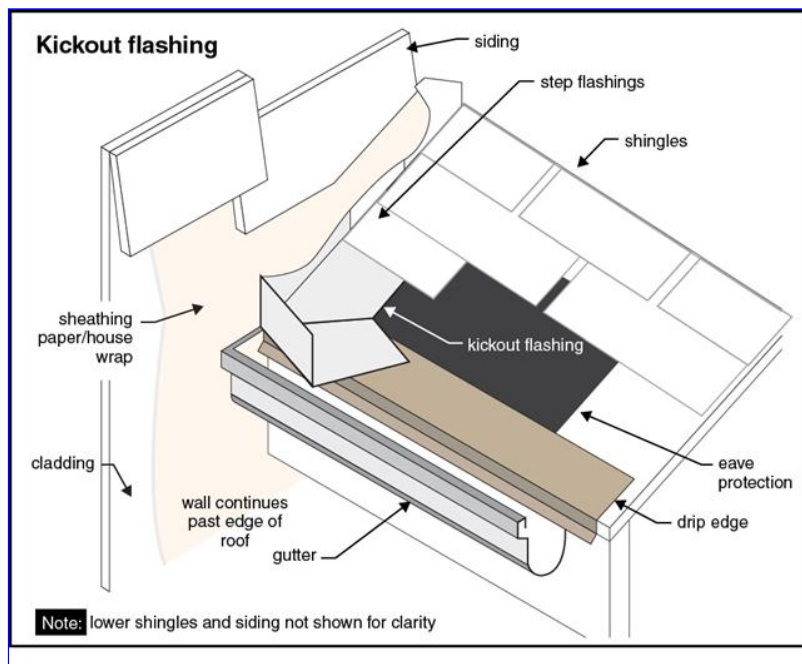
(2) The diverter flashing/step flashing is missing between the roof and wall at the front and rear of home where indicated in the photos. Water stains on the exterior brick siding was noted. This can cause damage to the siding and may allow water intrusion between the gutter and the wall structure. Recommend a qualified roofing contractor further evaluate and repair as needed.

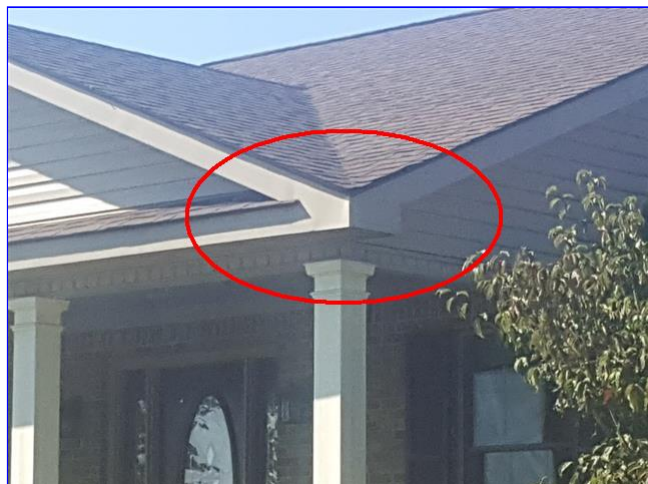
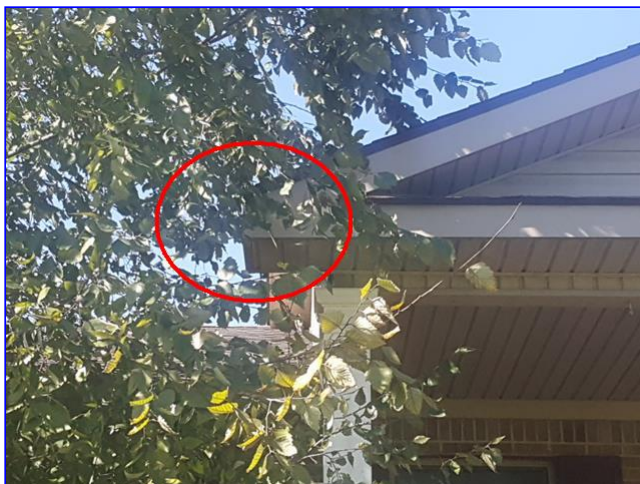
(4) Gutter and downspout is missing and should be installed at the front right and left corners of the porch at the home above the porch area to avoid spilling roof runoff around the building - a potential source of water entry or water damage. It could cause settlement of the front porch in the future if not corrected. Recommend a qualified contractor install a gutter system. This will prevent soil erosion below and possible water leakage into the basement.

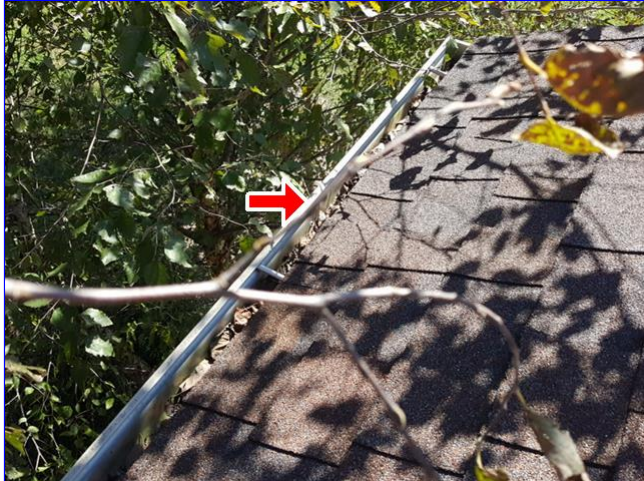
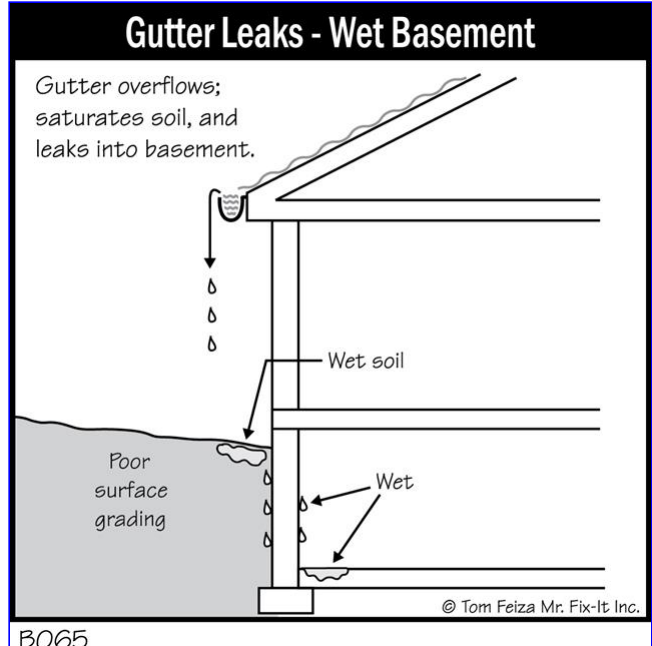
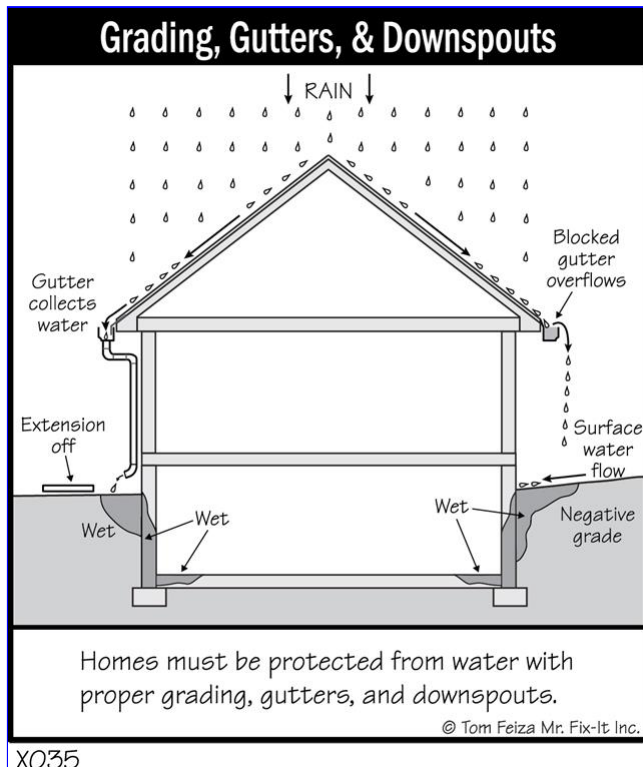
(5) The gutter(s) at the front left side of the home where indicated in the photo, especially where they drain into the downspouts, are full of debris and need to be cleaned. The debris in gutters can also conceal rust, deterioration or leaks that are not visible until cleaned, and I am unable to determine if such conditions exist. Gutters require cleaning to avoid spilling roof runoff around the building - a potential source of water entry or water damage, and/or the fascia could become damaged. Recommend cleaning the gutters as needed.

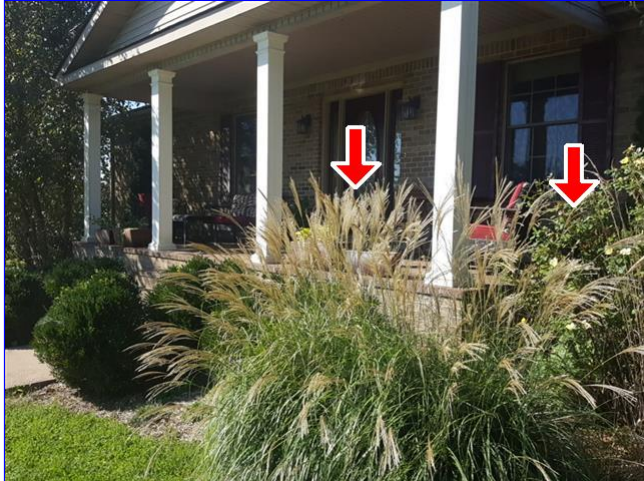
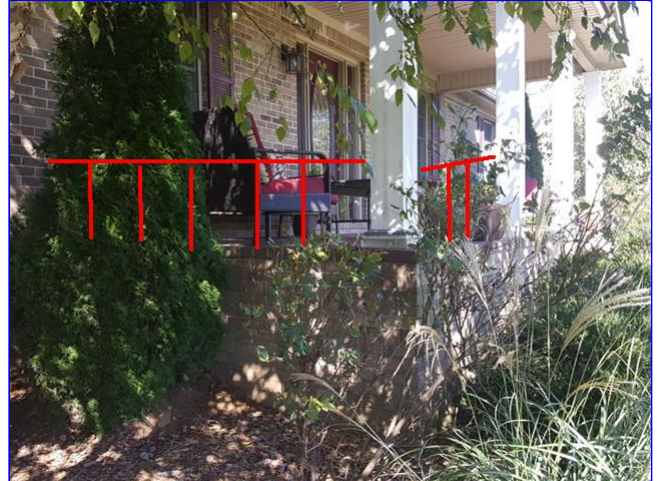
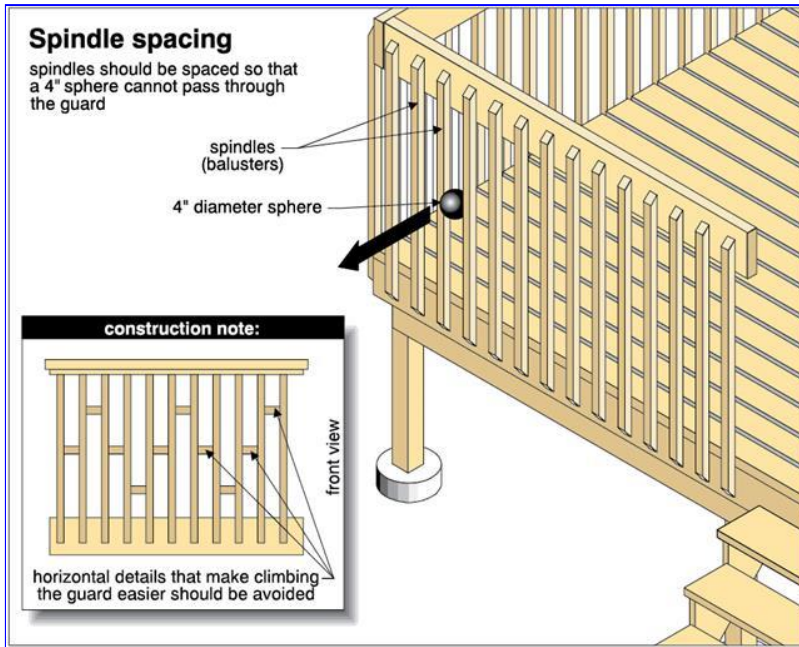
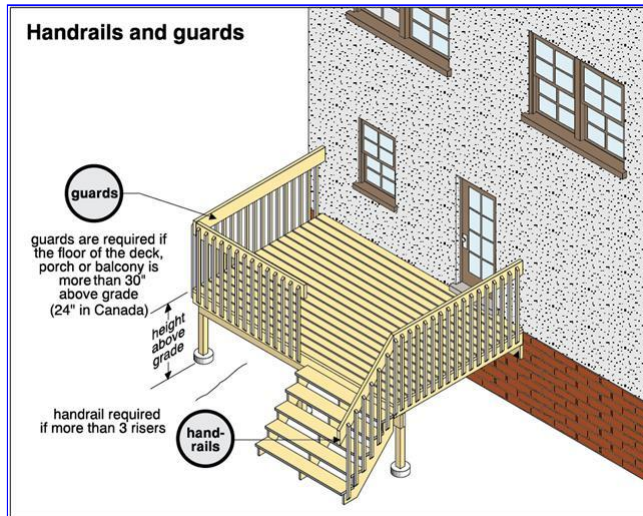
Recommend a guard rail be installed around the front of the porch to prevent a fall from occurring which may result in an injury of a person. This is a potential safety issue. The railing needs to be at least 36 inches high and balusters need spacing to be at least 4 inches. Recommend a qualified contractor install one for safety.

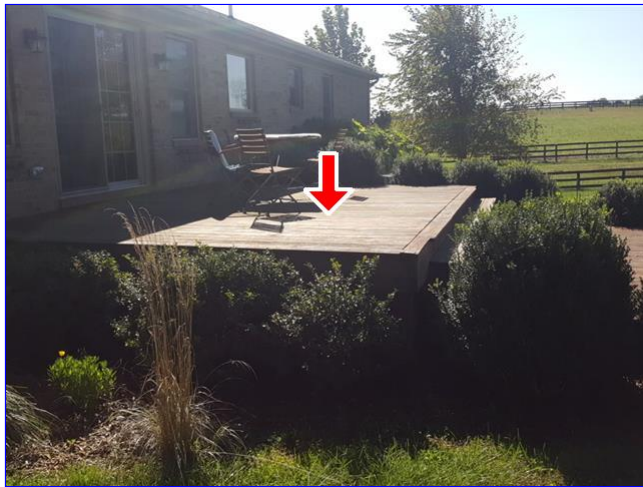
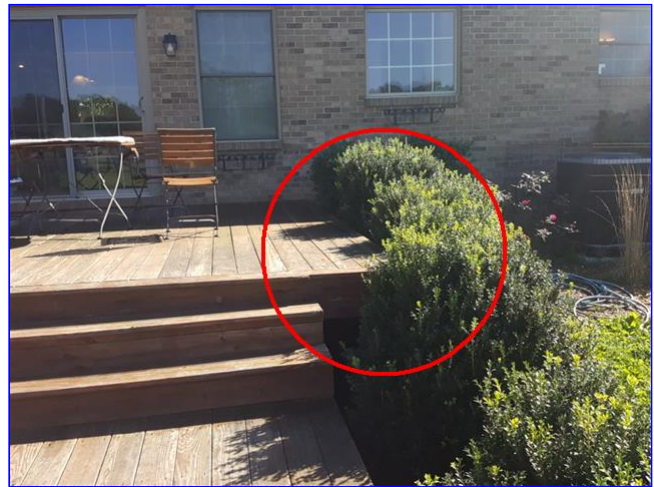
(1) The guard rail for the rear deck is missing in some areas. Recommend a guard rail be installed around the rear deck to prevent a fall from occurring which may result in an injury of a person. This is a potential safety issue. The railing needs to be at least 36 inches high and balusters need spacing to be at least 4 inches. Recommend a qualified contractor correct where needed for safety prior to moving in.

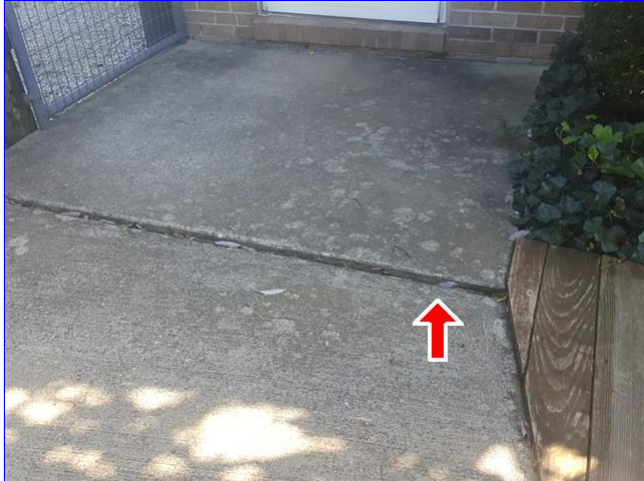
3.7 Item 1(Picture)

The rear walkway leading up to the garage at the rear left side of the home has settled creating a tripping hazard. For safety recommend the walkway be repaired or replaced to prevent a tripping hazard and/or a fall or injury from occurring. Recommend a qualified masonry contractor repair or replace as needed.

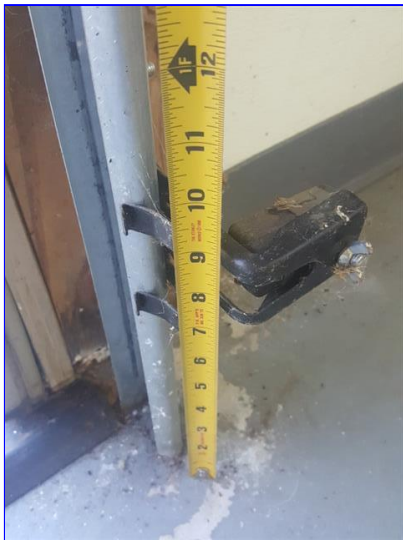
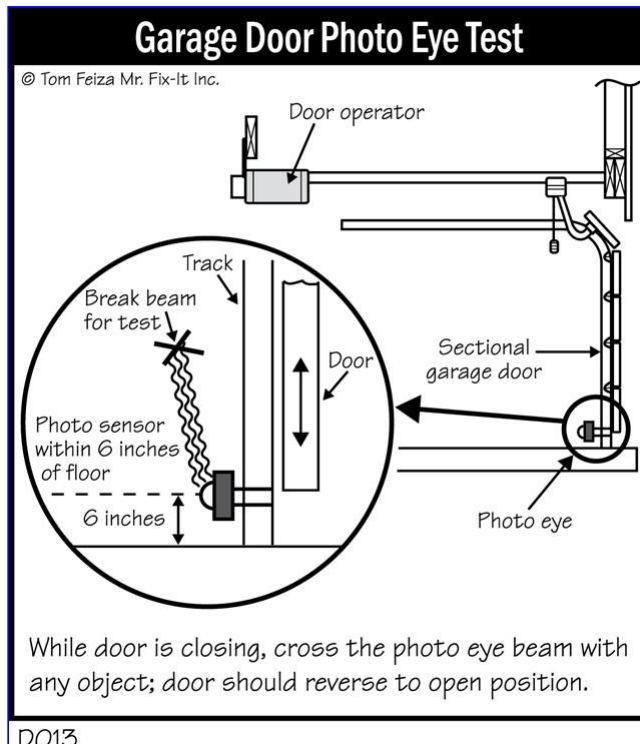
(2) The garage door opener electric eyes are installed too high. There is a serious risk of injury, particularly to children or pets, under this condition. The eyes should be placed 4" to 6" off the floor or as otherwise indicated in the installation manual. This should be dealt with immediately by a qualified garage installer.

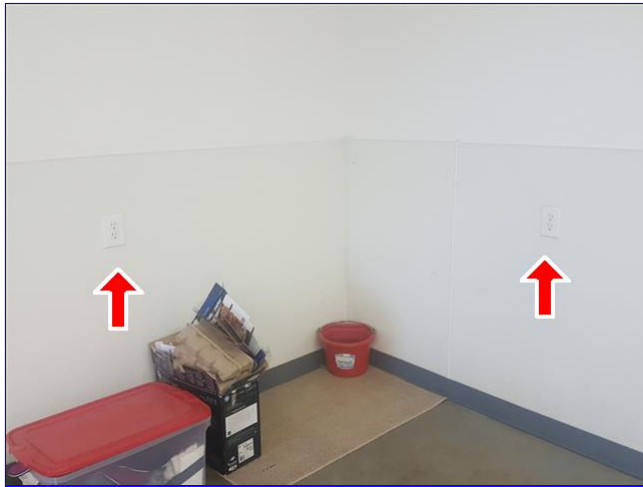
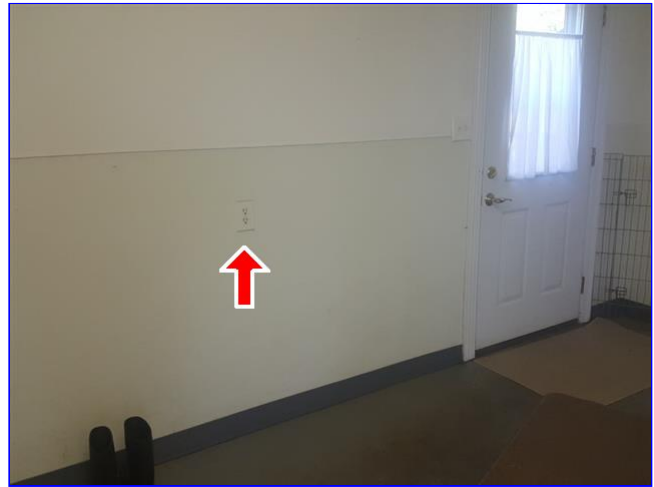
The GFCI outlet(s) in the garage where indicated in the photo(s) did not trip in response to testing during the inspection. This is a safety issue. The GFCI offers protection from shock or electrocution. Recommend a qualified licensed electrician repair as needed.

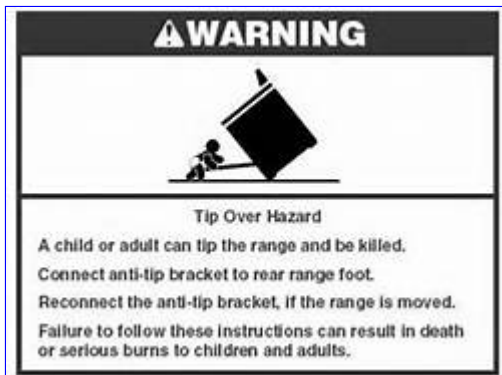
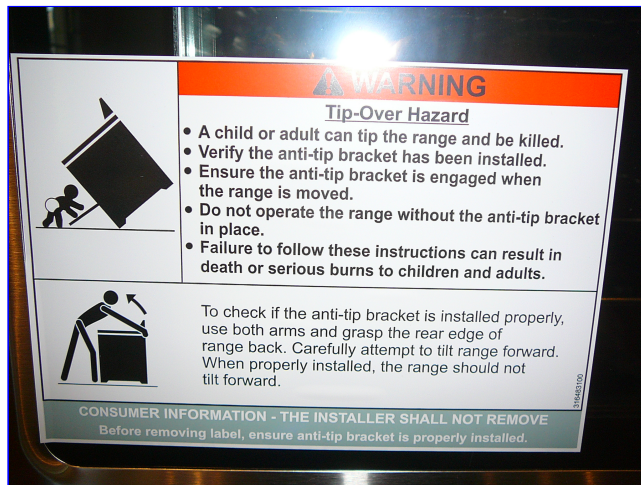
The "Anti Tip" bracket for the range has not been installed as required by manufacturer's installation instructions. This could allow the range to tip if it is pulled or if the oven door is pushed down or stepped on. This is a safety issue. A tip over hazard exists for small children and a serious injury or death could occur. Strongly recommend the bracket be installed for safety around small children or others. [Information about "anti tip" bracket](#)

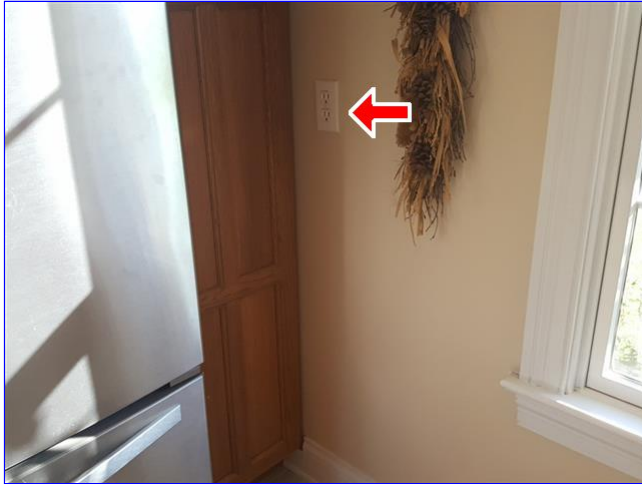
5.8 Item 1(Picture)

(3) The outlet(s) in the kitchen where indicated in the photo(s) are loose at the wall or in the outlet box. Electrical issues are considered a hazard until repaired. This is a safety issue that needs to be corrected due to an electric shock or fire from loose connections could occur if not repaired. Recommend a qualified licensed electrical contractor correct as needed.

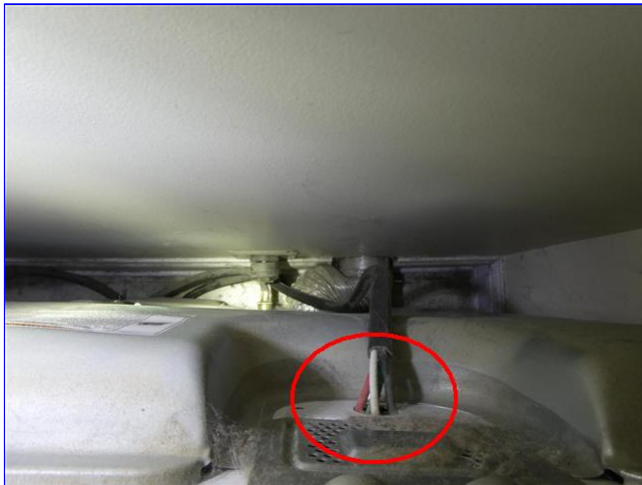
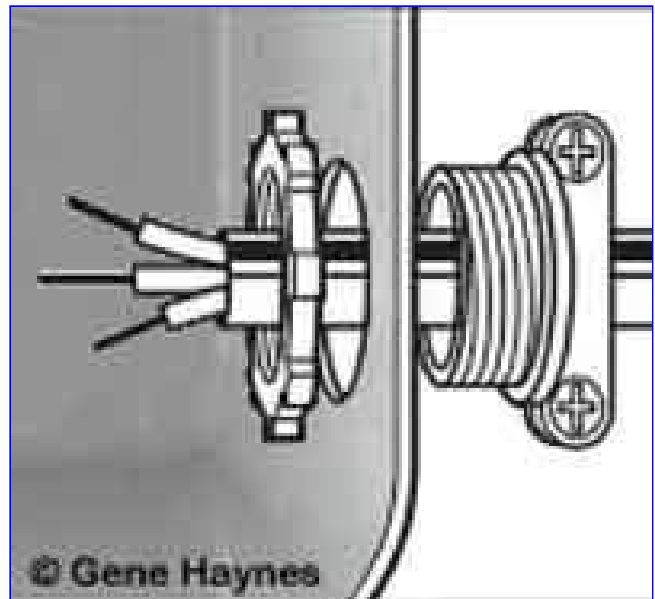
There is no strain-relief clamp connected to the wire at the back of the dryer. This is a safety issue. The insulation on the wires could be damaged via vibrations when the dryer is being used which could cause a short. Also, a child or person could easily pull the wire out of the disposal, touch an energized conductor, and be electrocuted causing possible death. Recommend a qualified licensed electrician repair as needed for safety prior to closing and using the dryer.

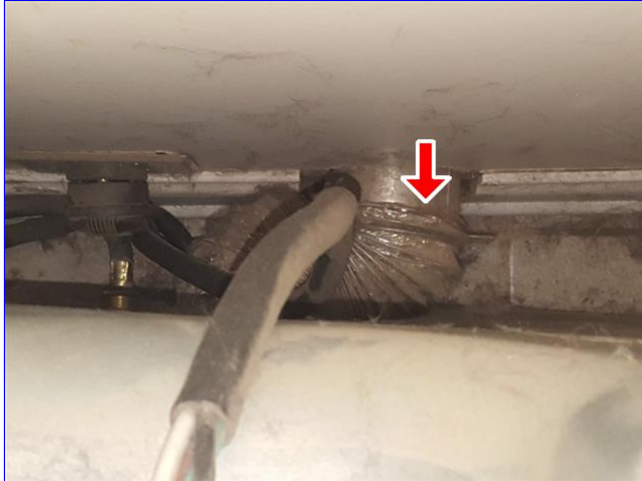
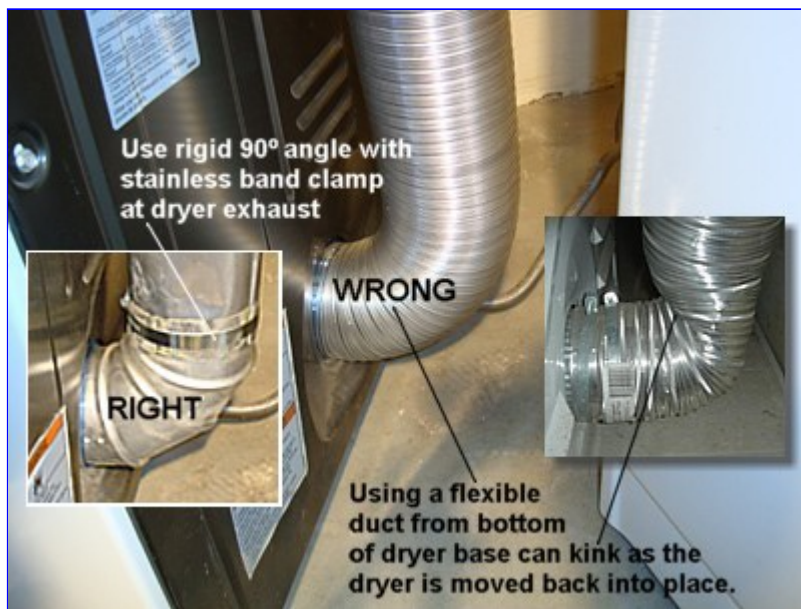
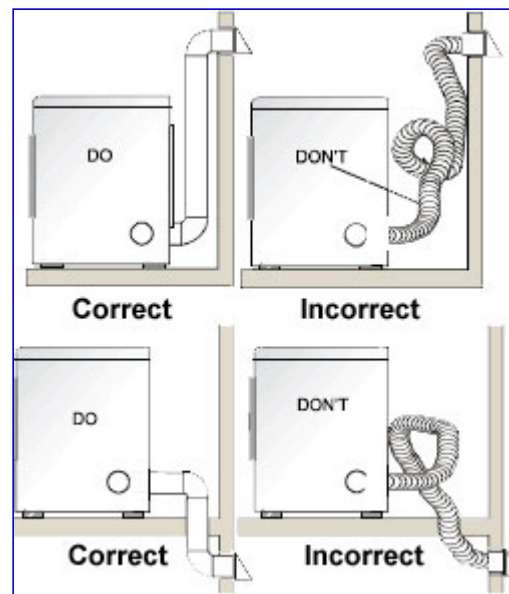
(1) A pleated Foil flex pipe is currently installed from the dryer to the exhaust vent. The current recommendations are for dryer vents to be heavy flexible or solid metal to help prevent crushing and

damage from fires. Dryer lint fires are reported to be the third leading cause of fires. Exhaust ducts should be constructed of minimum 0.016 inch thick rigid metal ducts, having smooth interior surfaces with joints running in the direction of air flow. Exhaust ducts shall not be connected with sheet metal screws or fastening means which extend into the duct. All dryer vents should be disconnected and cleaned twice a year. This is a very common cause of fires. Recommend replacing duct for proper operation and for your safety using a qualified contractor.

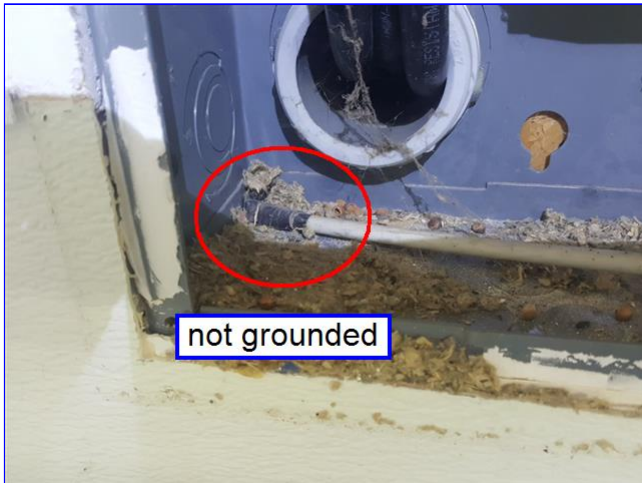
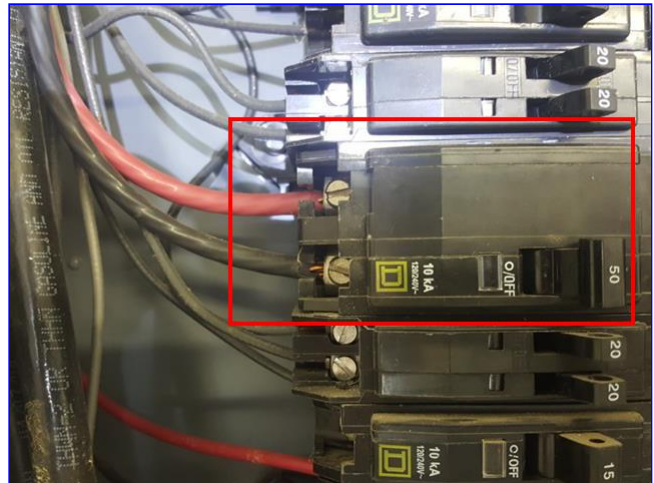
(1) The 50 amp gauge wire is not grounded in the panel. The current wire is connected to a 50 amp breaker. Could not determine what the function of the breaker is for. This is a potential safety issue as the appliance is not grounded. Strongly recommend a qualified electrician further evaluate and correct as needed prior to closing for safety of occupants in the home and to protect appliance.

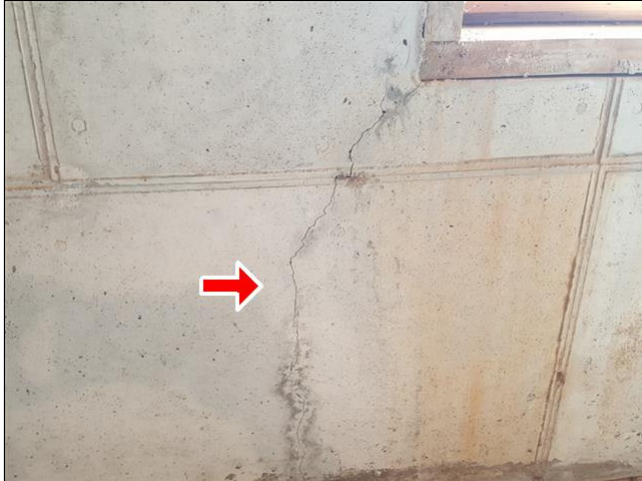
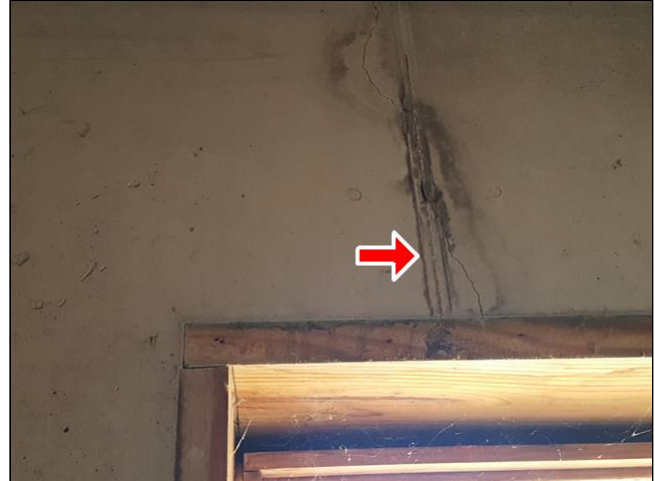
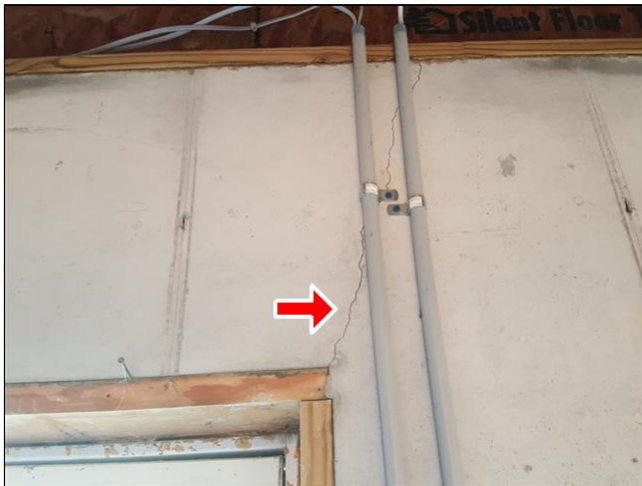
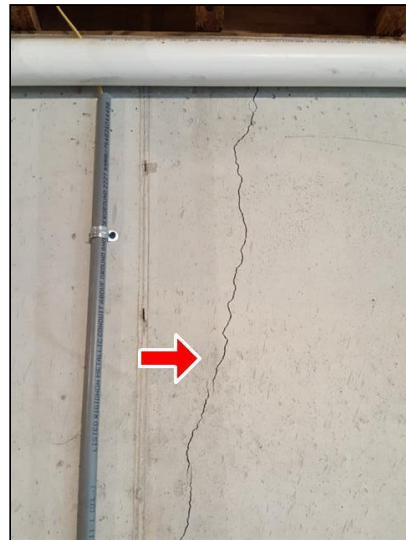
(2) The shrinkage/settlement crack(s) in the foundation wall in the basement was noted where indicated in the photos. These cracks do not appear significant. This condition is common in many homes and does not usually represent a serious structural concern unless the cracks are between an 1/8 or 1/4 inch thick. Recommend the cracks be sealed before the walls are painted or the basement is finished to prevent water intrusion and to minimize further deterioration. [Sealing Concrete Cracks](#)
It is recommended that you monitor periodically to see if further movement occurs and if so a foundation contractor should be consulted to correct and prevent further movement.

1.1 Item 2(Picture) below basement window

1.1 Item 3(Picture) above basement window

1.1 Item 4(Picture) above basement door

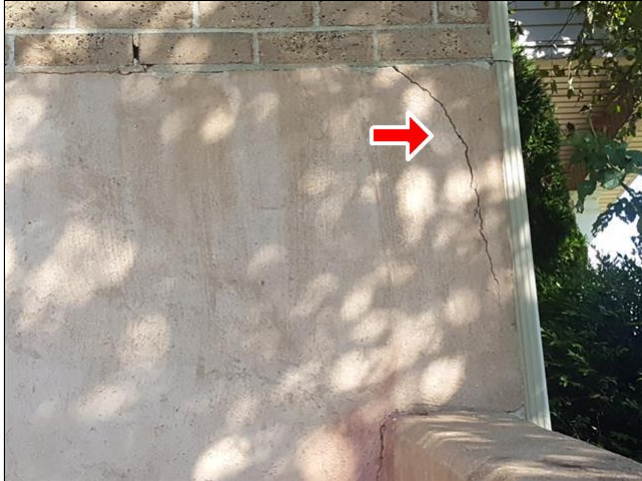
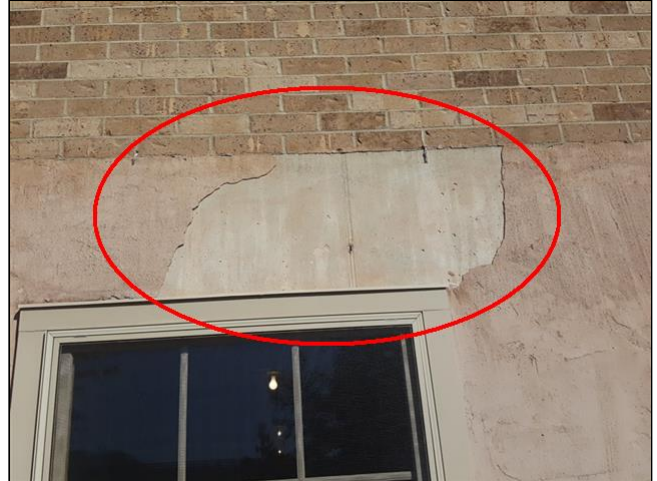
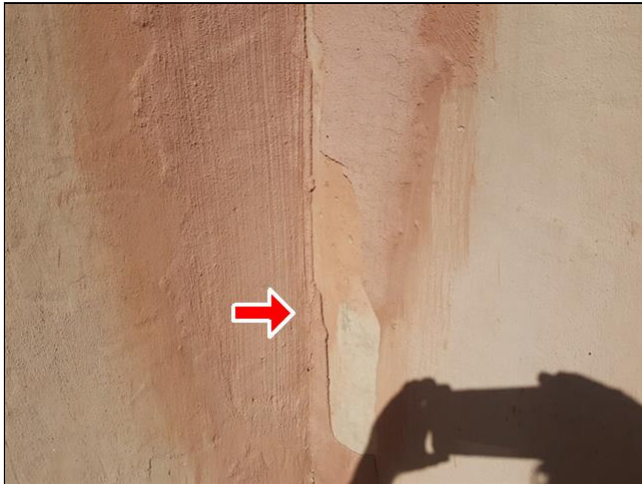
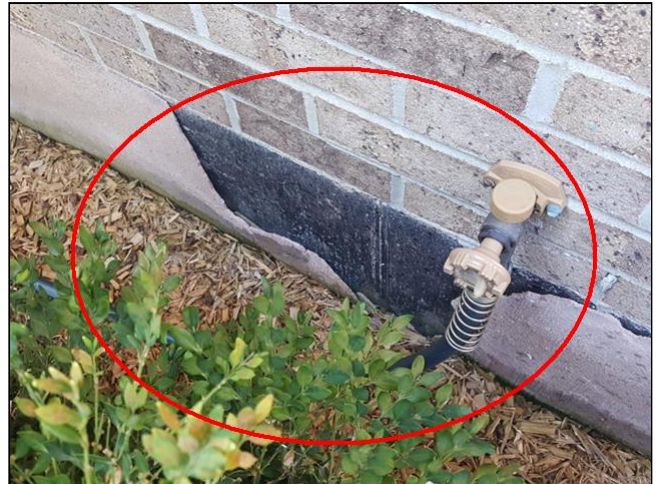
(4) Surface deterioration (cracking, spalling, crumbling material) was observed on the foundation walls on the concrete parging where indicated in the photos. This condition does not usually represent a serious structural concern unless there is a substantial loss of material. The concrete parging is designed to protect the concrete walls from moisture penetration. In an effort to prevent long term deterioration, recommend re-parging over deteriorated areas then sealing concrete with an exterior paint to prevent moisture penetration. [Here is a link explaining how to parge a foundation wall.](#)

1.1 Item 10(Picture) front left corner of home

1.1 Item 11(Picture) left side of home

1.1 Item 12(Picture) rear right corner of home

1.1 Item 13(Picture) front right side of home
