TALC
Home Inspe

Inspection Report

Property Address:
211 Wellington Road
Paris KY 40361

Date: 10/17/2018	Time: 10:00 AM till 02:00 PM	Report ID: 181017SCNEIDER
Property: 211 Wellington Road Paris KY 40361	Customer: Ms. Gail Schnieder	Real Estate Professional:

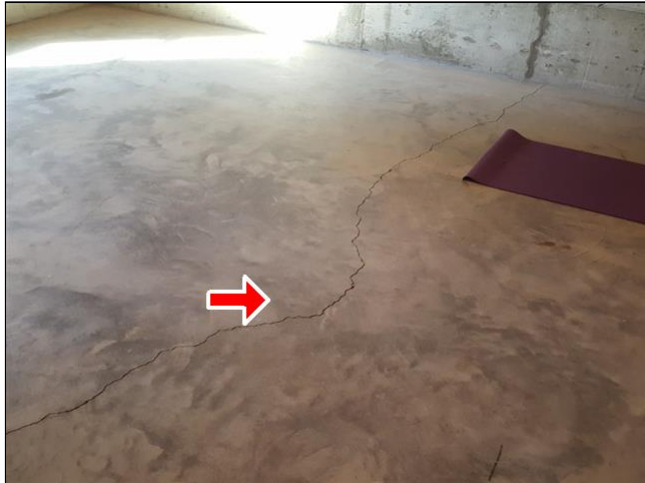
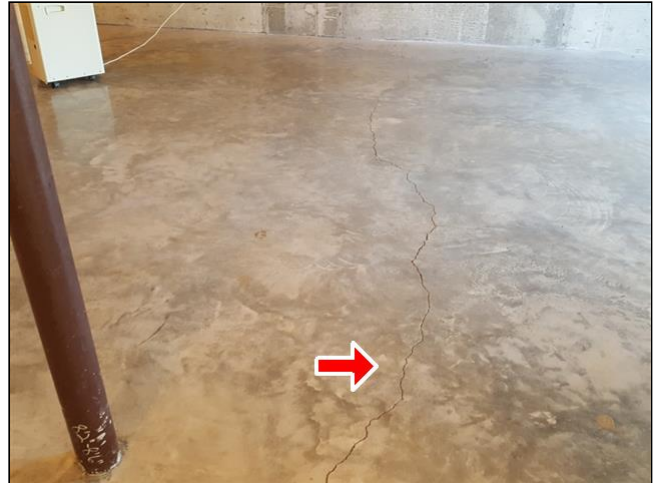
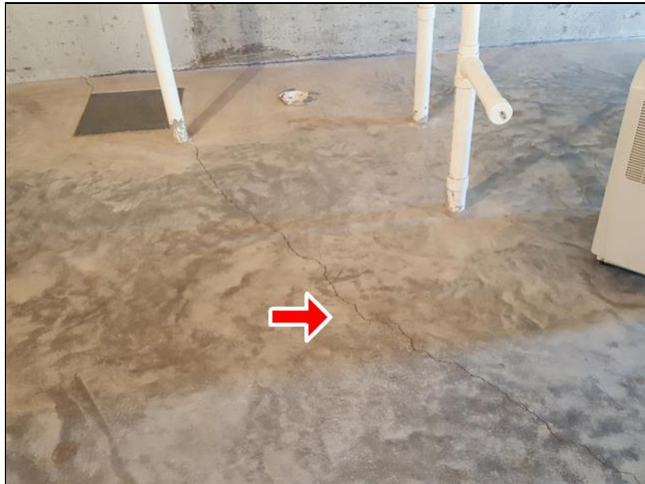
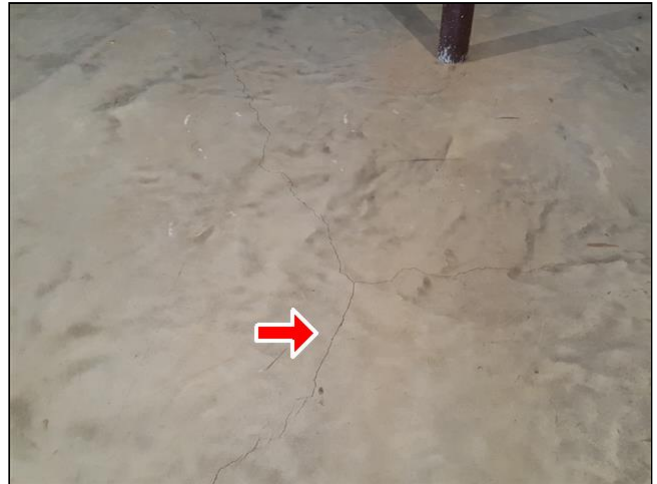
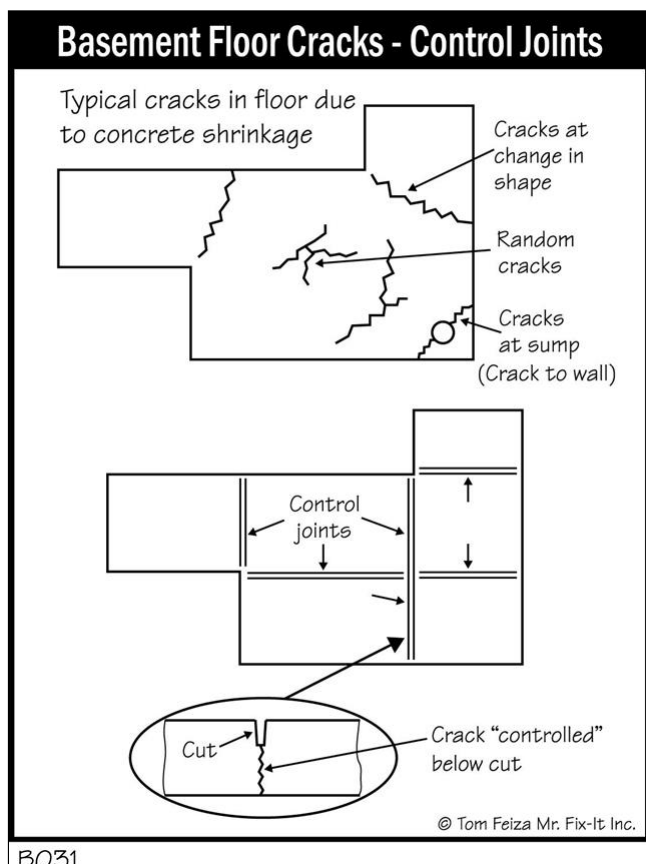
The basement flooring has typical cracks in areas highlighted in photos. These cracks do not appear significant and seem typical. Cracks that are usually 1/8 inch or wider are need for concern. The cracks are usually the result of shrinkage or settling of the slab. Recommend these cracks be sealed then apply an epoxy coating on the floor to ensure water intrusion does not occur. It is recommended that you monitor annually after repairs. [Caulk for Concrete Cracks](#)

Note: some of the cracks are located in areas where there is substantial weight/force placed on flooring and most cracks. It could be the result of missing control/expansion joints placed on the concrete flooring. If these cracks re-appear after repairs and are over 1/8 inch in opening, a structural engineer who is familiar with foundation repair or qualified foundation repair contractor should be consulted.

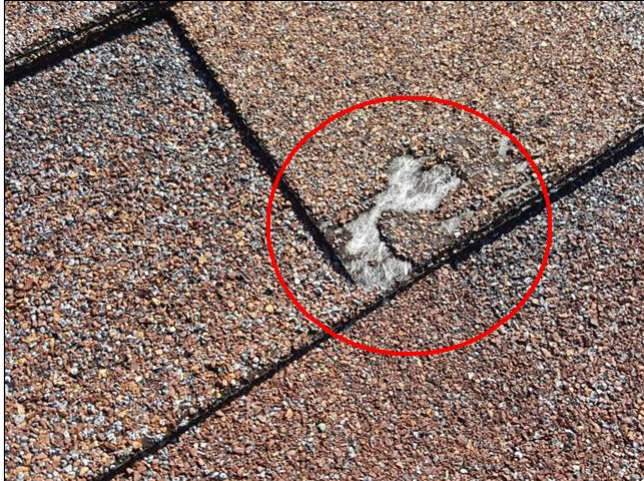
(1) Gravel covering is missing due to possible hail damage on the shingles of the home where indicated in photos. This usually leads to a shortened life expectancy and increases the potential for ultraviolet damage to the membrane which may result in roof leaking. Shingles with missing gravel should be replaced or repaired before leaks occur. Recommend repair as needed by a qualified roofer.

2.0 Item 1(Picture) below master bedroom area rear of home

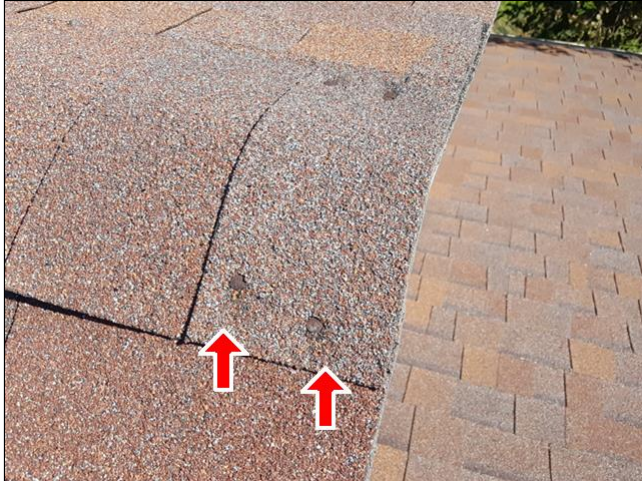
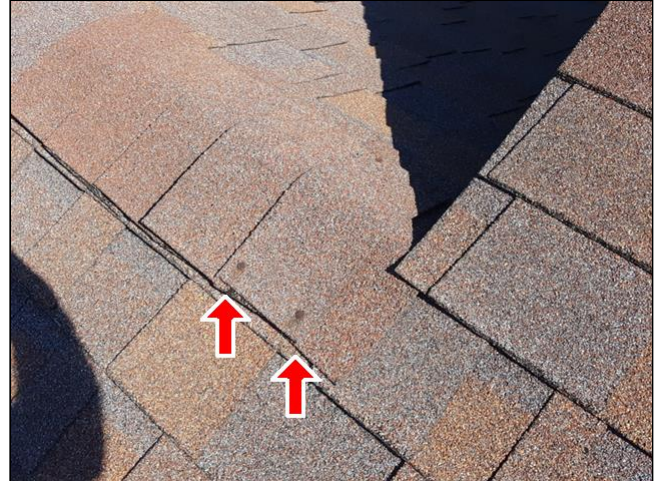
(2) Exposed nail heads were seen at the roof near the peak ends. All exposed nails should be properly sealed by a qualified roofing contractor. A sealant compatible with the roofing or flashing material should be applied to the nail. This will prevent and reduce future water entry and/or leaks into the attic.

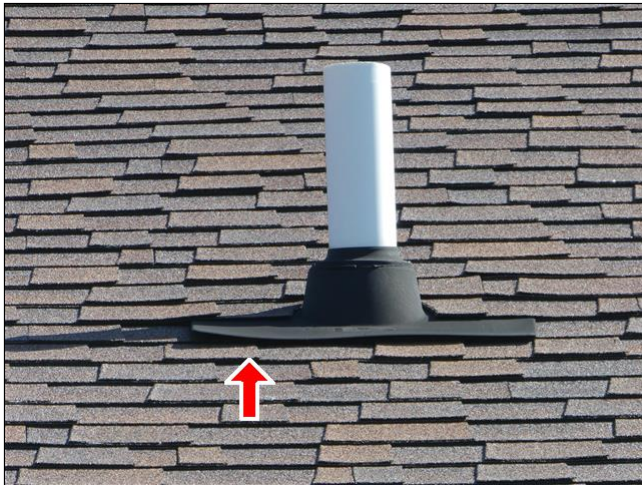
2.2 Item 1(Picture)

The flashing on the roof below the plumbing vent at the rear right side of the home has lifted and needs flattening to avoid water leaks. Water leaks can cause deterioration of the roof sheathing and trim. Recommend they be re-secured by a qualified roofing contractor to prevent water entering underneath the flashing and to allow the ease of water runoff to reduce the risk of leaks in the home.

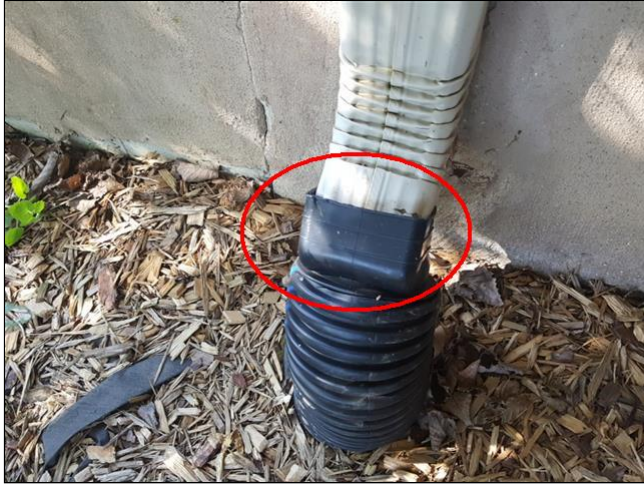
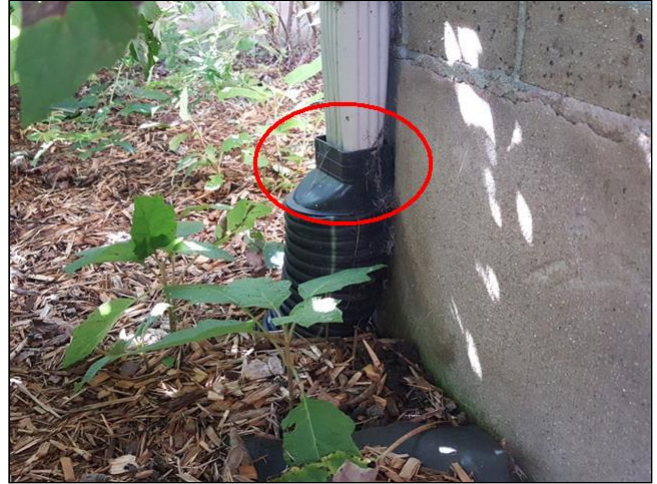
(2) Recommend the downspout extension(s) be attached to the downspout where indicated in the photos by placing a screw at the top and bottom where it connects to the downspout to ensure the extension(s) does not pull away from the downspout(s). Failing to do this may create future problems to the foundation around the home due to soil erosion and water entering the basement which may result in the foundation settlement if the extension detaches from the downspout.

2.3 Item 7(Picture) front left corner of home

2.3 Item 8(Picture) front right side of home

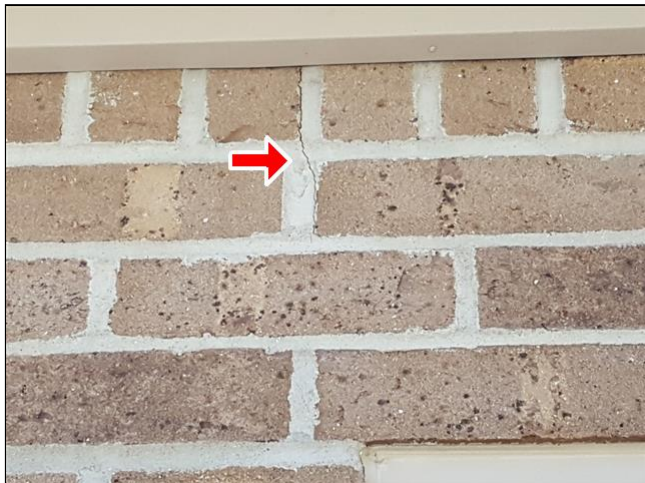
3.0 Item 2(Picture) above garage left corner

(2) Typical shrinkage cracks, at the mortar joints on the exterior siding was observed at the front left corners of the garage. These cracks do not appear significant. Shrinkage cracking is the result of moisture in the concrete mortar evaporating and shrinking. This generally is not a cause for concern as all concrete shrinks. Due to freeze/thaw via water intrusion, the cracks should be sealed to minimize further cracking, flaking or deterioration. A qualified contractor or skilled masonry contractor should perform the repairs via tuck pointing mortar. It is recommended that you monitor periodically. Should any of these cracks begin to grow, then further attention and evaluation would be recommended.

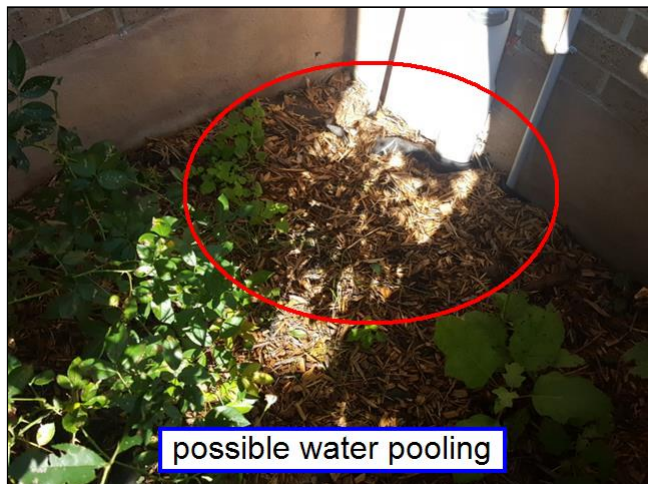
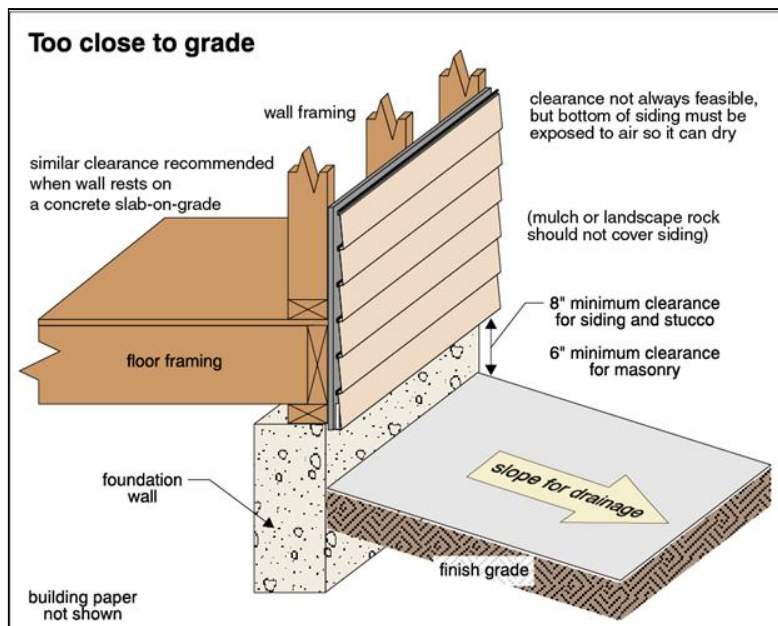
(1) There are depressions in the soil around the foundation perimeter at the front right side of the home near the electric meter. Recommend filling all depressions and re-grading the soil so the soil slopes away from the home around the foundation to ensure water pooling does not occur in these areas. Water pooling could lead to to basement leakage.

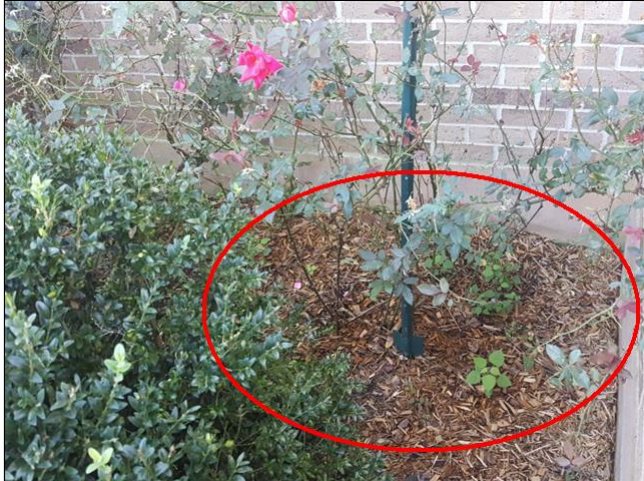
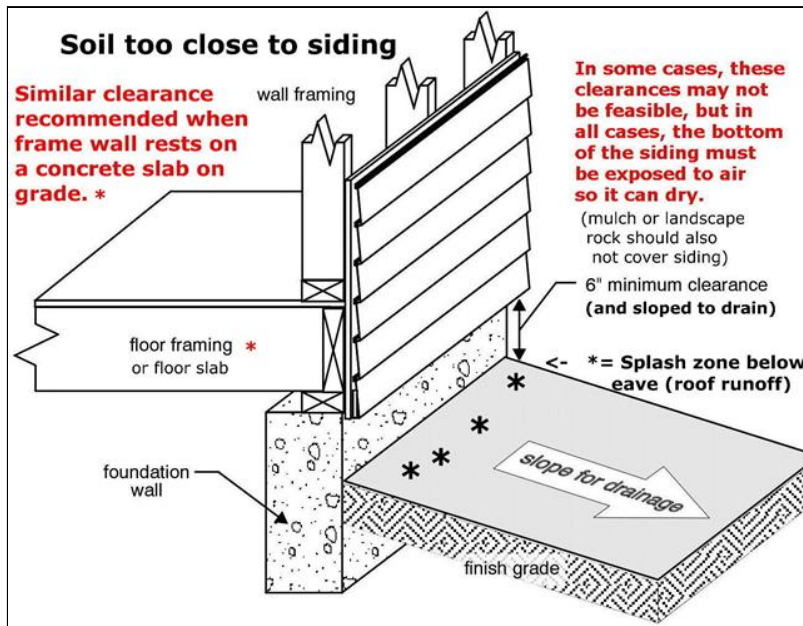
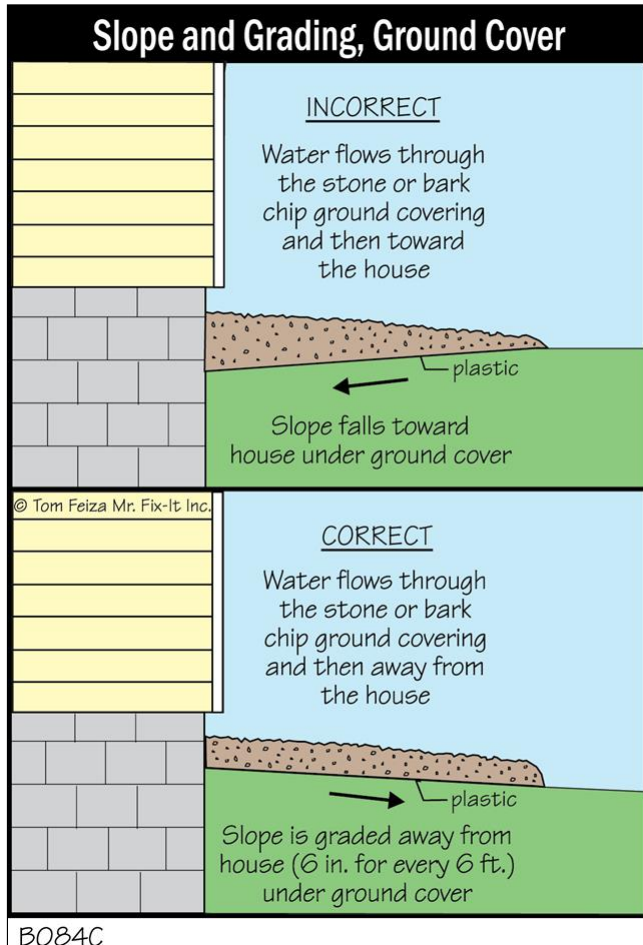
(2) The grading of soil at the rear left side of the home between the garage and the washer dryer room area should be improved to promote the flow of storm water away from the foundation perimeter. This can often be accomplished by the addition of top soil. (Ensure that the soil is at least 6 inches below siding). The ground should slope away from the house at a rate of one inch per square foot. This slope should extend at least five to six feet from the home and will also prevent water intrusion near the foundation perimeter to prevent house from settlement and basement leakage. Recommend correcting as needed.

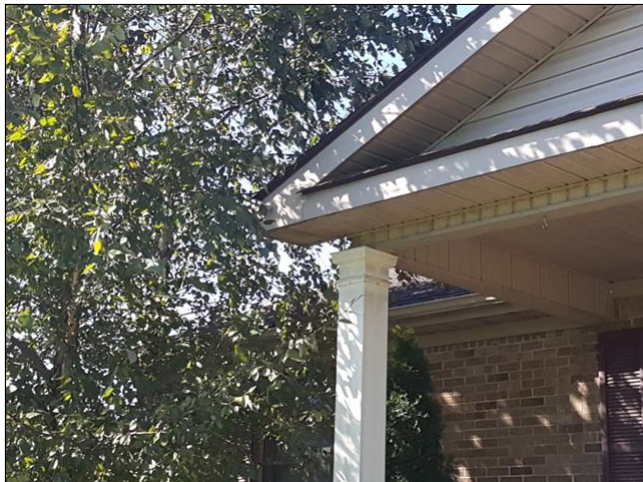
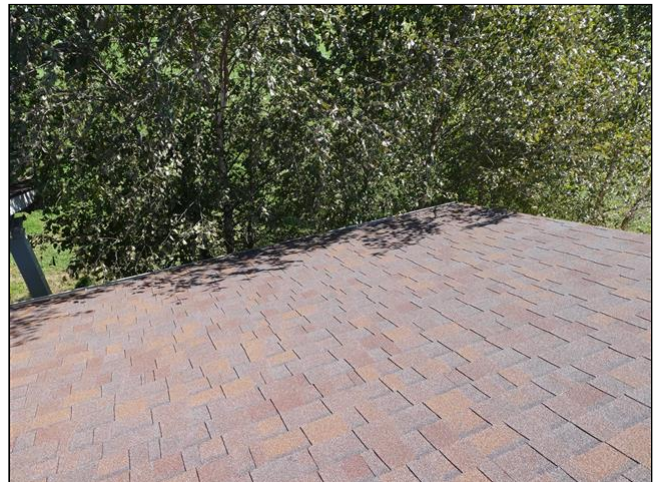
(1) The tree limbs that are in contact or hanging near the roof at the front left corner of the home should be trimmed to prevent damage to the shingles and from scraping on the roof surface. They will also clog gutters which will cause water run off problems around the home. Recommend cutting back tree branches as needed.

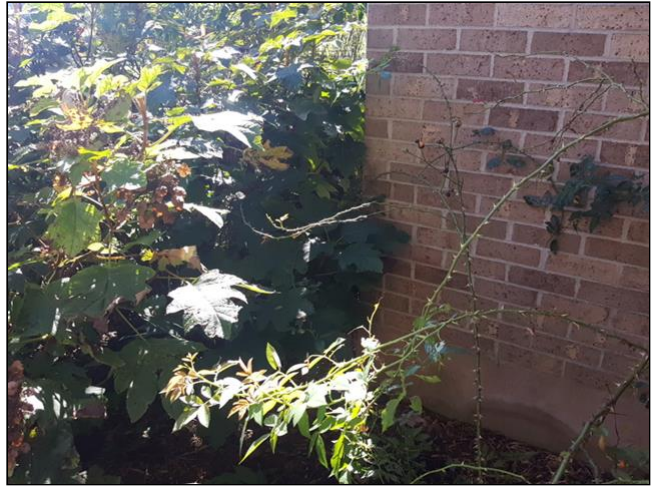
(2) The vegetation is overgrown around the perimeter of the home where indicated in the photo(s). Recommend that all bushes, shrubs and trees where applicable be kept neatly trimmed and away from the foundation, wall siding, and window frames to prevent damage to the home and allow proper venting and inspection of house. A 6" clearance is recommended.

3.10 Item 4(Picture) front right side of home

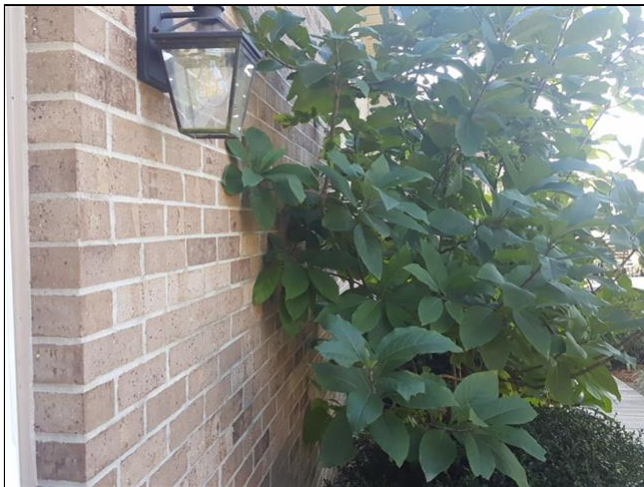
3.10 Item 5(Picture) rear of garage

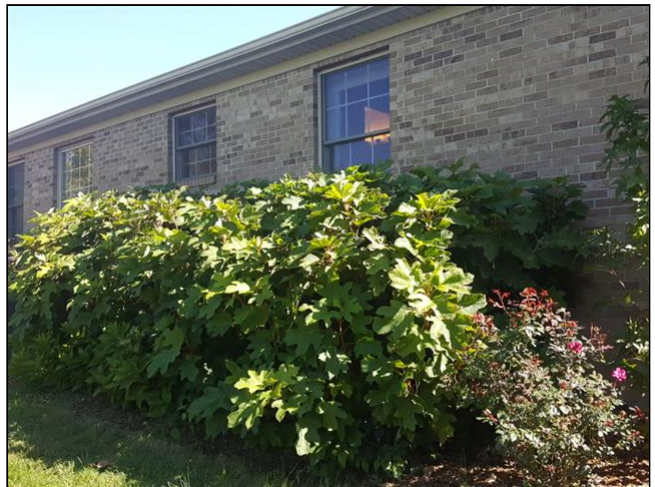
3.10 Item 6(Picture) rear right side of home

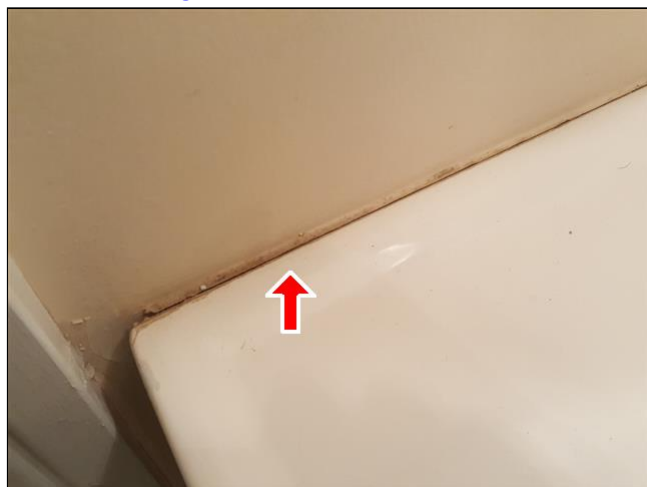
7.1 Item 2(Picture)

(2) Recommend caulking around the counter top in the 2nd bathroom to seal the crack. Water may enter which can cause damage to the drywall and cabinets, then result in possible mold forming.

Repair using a quality caulk that is resistant to moisture and is expandable. Here is a link on [How to Choose the right Caulk](#)

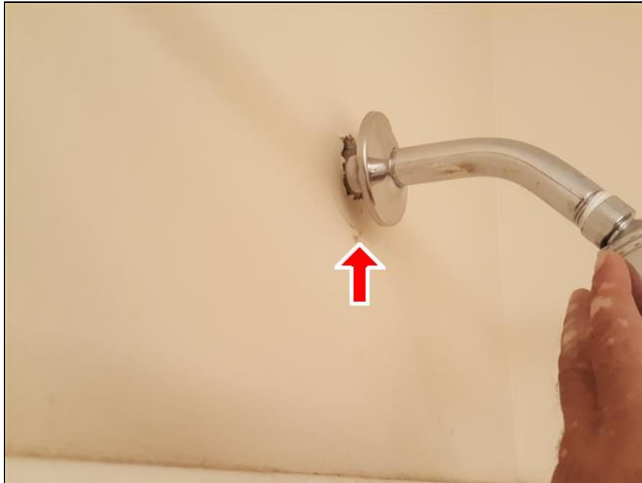
7.4 Item 3(Picture)

(2) The shower head is loose and not secured to the wall and does not seal against the enclosure correctly in the 2nd bathroom. Recommend it be secured and sealed correctly to prevent a possible plumbing leak from occurring at the pipe joints. If a leak develops this can cause mold to develop and deterioration of the wall framing can occur. A qualified plumber is recommended for these repairs.

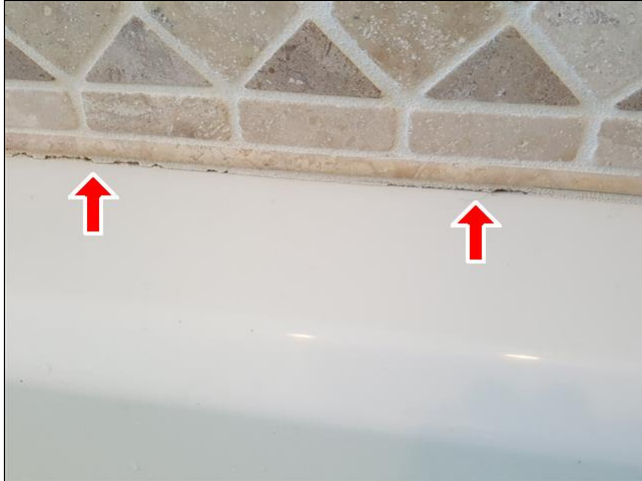
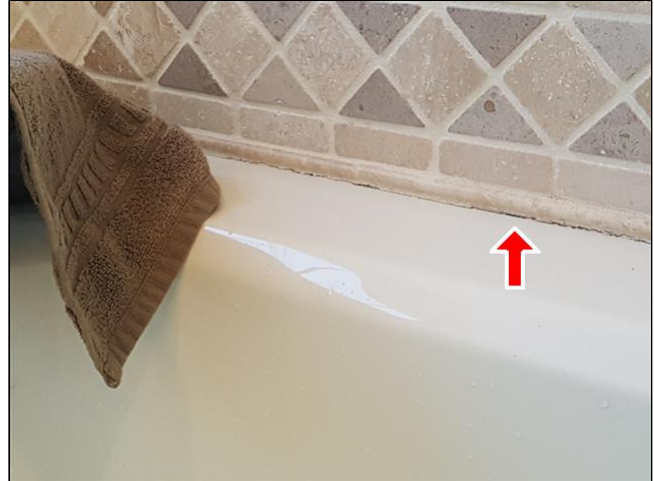
(3) Cracked grout around the jacuzzi enclosure should be cleaned or removed and replaced with new grout to prevent water entry behind the finished materials. If the grout is damaged and not properly repaired it could allow water entry. Water entry can damage the walls, framing or loosen the tiles and cause mold growth. A qualified contractor should be able to make any repairs that are needed.

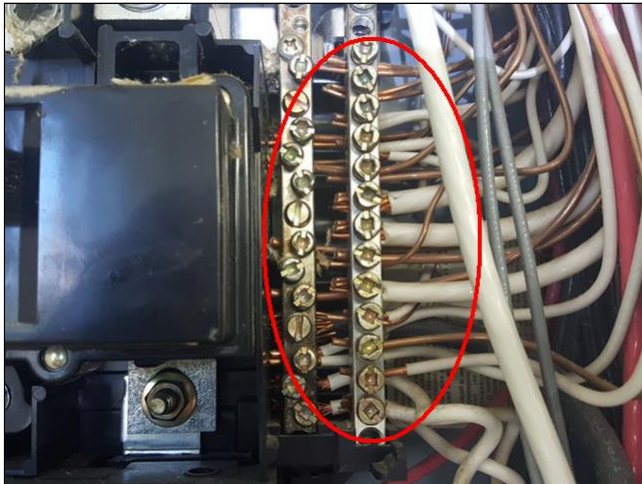
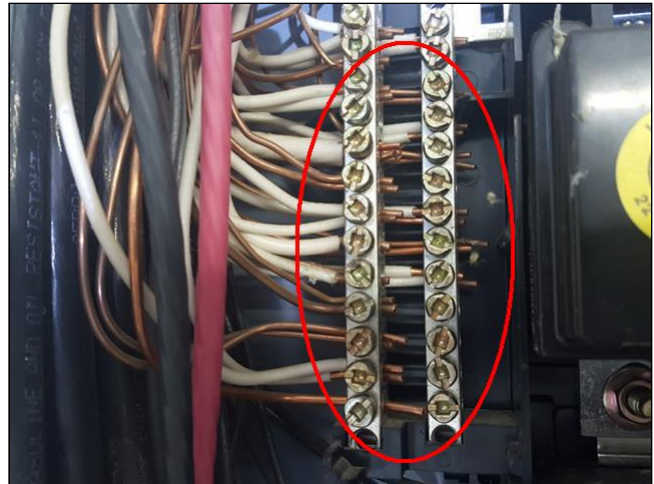
(2) More than one common (white wires) on a single lug of the neutral bar is not recommended but was found in this panel. Separation of these commons is recommended when any other electrical work is done by a qualified licensed electrician.

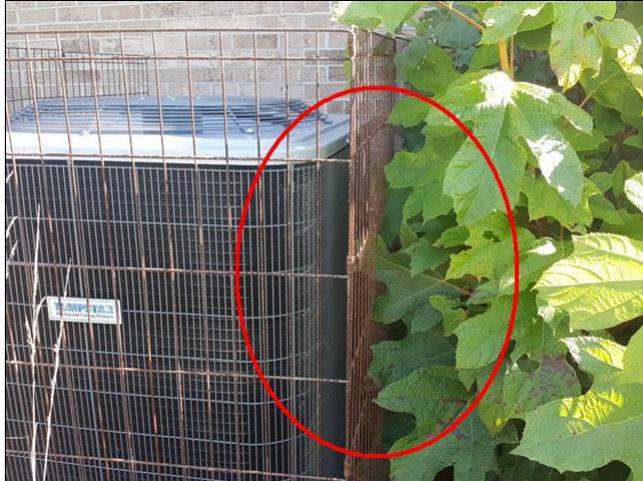
10.0 Item 1(Picture)

(3) Vegetation in the vicinity of the outdoor unit of the Heat Pump should be cut back to prevent obstruction of the airflow. This can cause damage to the unit via running hot, shorten its life expectancy, and cause it to run inefficient. Recommend removing all the vegetation surrounding the unit so that the fins are not obstructed.
