Kennedy Inspections
115 Gable Rd
Paoli PA 19301
610-833-8220
RossDKennedy@gmail.com

Report: 2102

Confidential Inspection Report

September 4, 2018

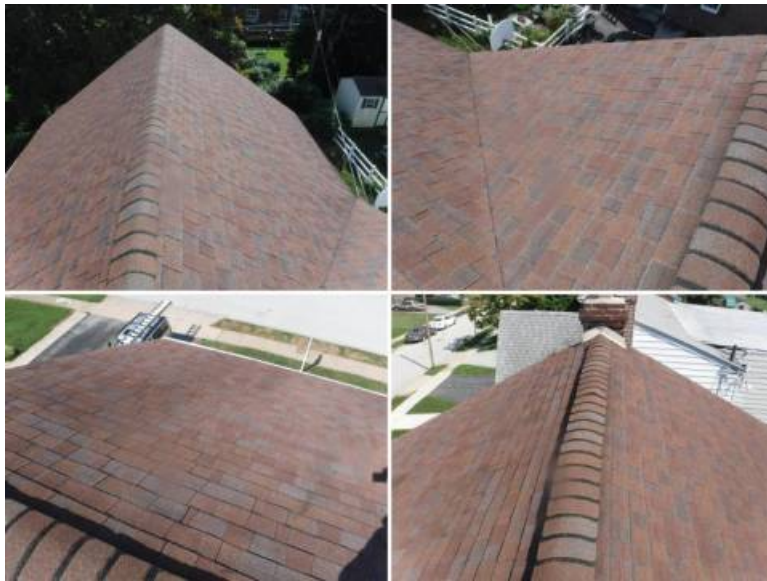
Style:

Gable.

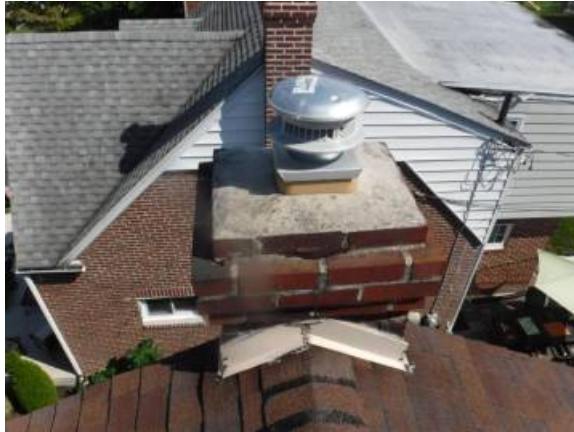
Chimney Exterior:

- Brick.

- Heating appliance flue. i.e. furnace or boiler, Terra Cotta clay, Metal liner. A rain cap was noted at the top of the flue. This is essential to keep the rain and animals from entering the chimney.
