## **Inspection Report**

**Property Address:**  
3002 Wheeler Street  
Georgetown KY 40324

**Talon Home Inspections, LLC**

<b>Date:</b> 8/22/2018	<b>Time:</b> 12:00 PM till 04:00 PM	<b>Report ID:</b> 140822WILLOUGHBY
<b>Property:</b> 3002 Wheeler Street Georgetown KY 40324	<b>Customer:</b> Mr. Mark Stevens	<b>Real Estate Professional:</b>

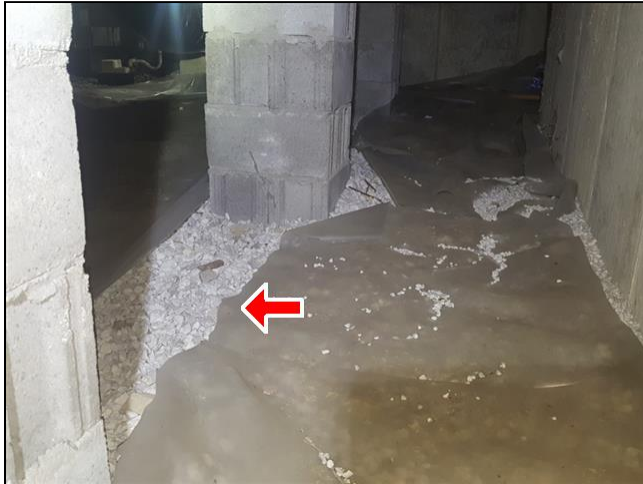
1.2 Item 2(Picture)

**1.2** (2) There are some gaps in the coverage of the vapour barrier in the crawl space floor where indicated in the photo(s). The vapor barrier in the crawl space floor should be adjusted to cover all areas of exposed soil. These gaps are allowing moisture vapor entry into the crawl space which promotes condensation, humidity and mold/mildew growth on the floor joists. The plastic vapour barrier should be a minimum of 9mil thick in Kentucky (recommend using 15 or 20 mil) straightened and/or added to as needed to cover the entire crawlspace floor to prevent excessive moisture entering. Recommend correcting as needed using a qualified contractor.

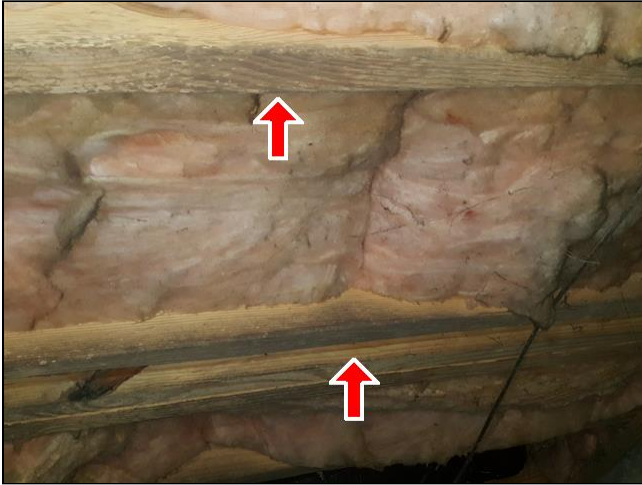
1.4 Item 1(Picture)

**1.4 (1)** Mildew was noted on some of the floor joists in the crawlspace mainly at the rear of the home. This is usually due to excess humidity and/or poor ventilation. Foundation moisture problems should be addressed. Proper ventilation helps control humidity and reduces the risk of rot. This is for your information. Recommend the crawlspace be monitored during the seasons and if condensation occurs, recommend a qualified contractor further investigate to determine cause and correct problem as needed.

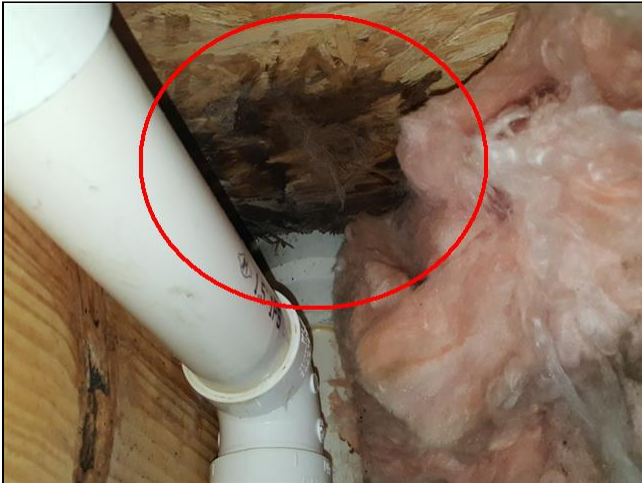
1.4 Item 3(Picture)

**1.4 (2)** Old water stain on the floor joist and sub floor was noted under the master bathroom, shower area in the crawlspace. There was no evidence of water leaking at the time of inspection. The wood is firm and not rotted. The area tested dry at the time of the inspection. Check with the owner for possible explanation. If they are unaware recommend this area be monitored to see if a leak does exist or you may wish to have a qualified plumber further investigate to determine if a leak does exist.

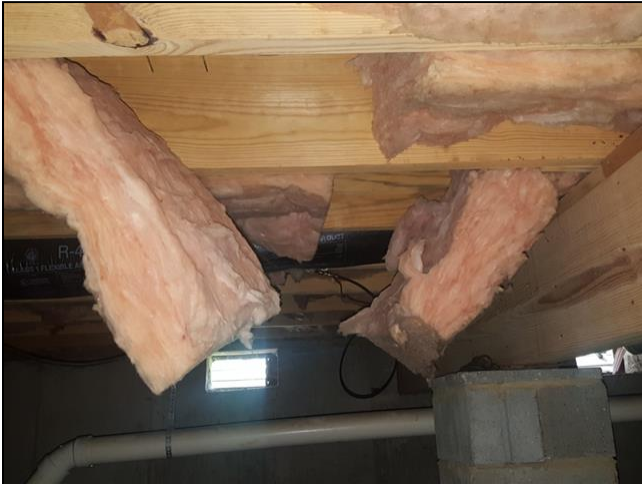
1.5 Item 1(Picture)

1.5 The insulation is loose/fallen in the crawlspace under the 3rd bedroom area. Recommend repair/correction as needed.

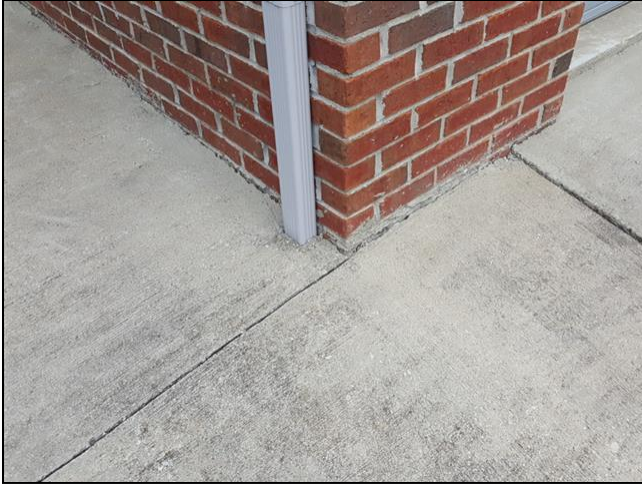
2.3 (1) Downspouts that discharge below grade level should be monitored. If they are ever suspected to be clogged or disconnected below grade, they should be redirected to discharge at least 10 feet from the building or into a storm sewer system. Foundation leakage adjacent to a downspout is an indication of a problem below grade.

2.3 Item 1(Picture) front left corner of garage

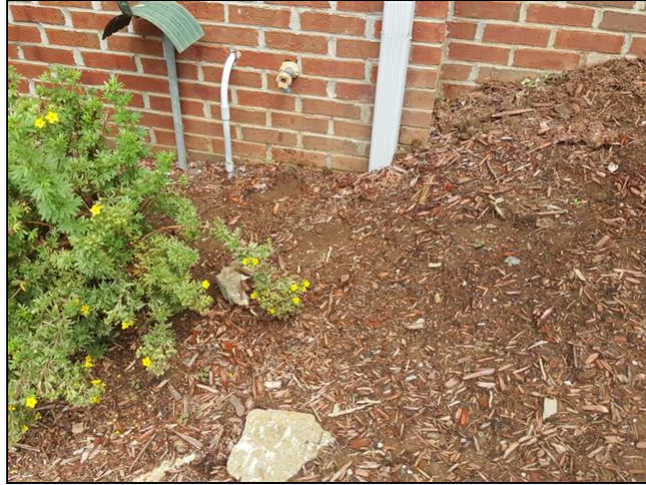
2.3 Item 2(Picture) front center of home

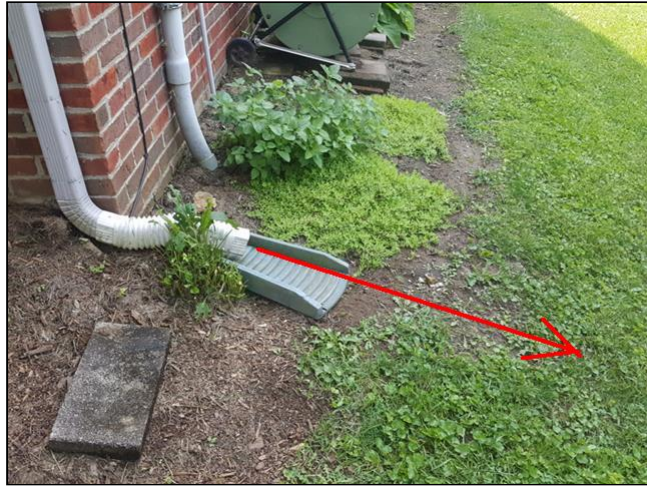
**2.3** (3) Recommend the downspout(s) at the home where indicated in the photo(s) be extended at least 6 feet and flow onto splashblocks. This will ensure water is kept away from the foundation perimeter, soil erosion does not occur and water cannot leak into the crawlspace area which may cause settlement of the foundation.

2.3 Item 6(Picture) rear right corner of home

Note: You may wish to consider burying the extension to prevent a tripping hazard. See photos for example.

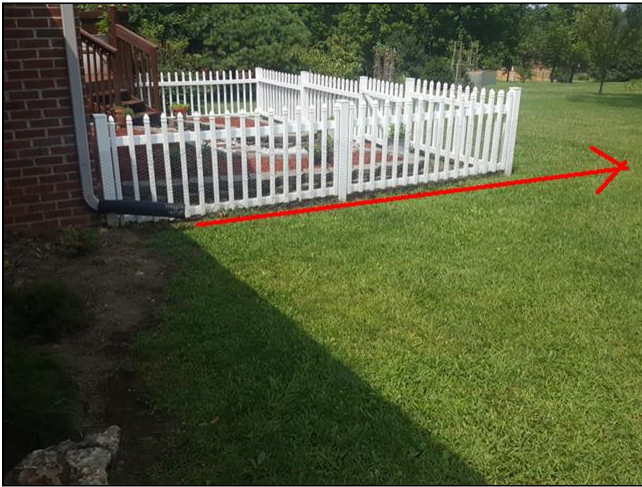
2.3 Item 7(Picture) rear left side of home

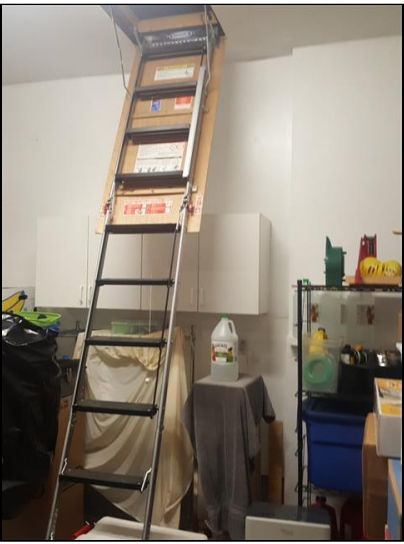
**2.4** Attic access location (see photo)

2.4 Item 1(Picture) garage

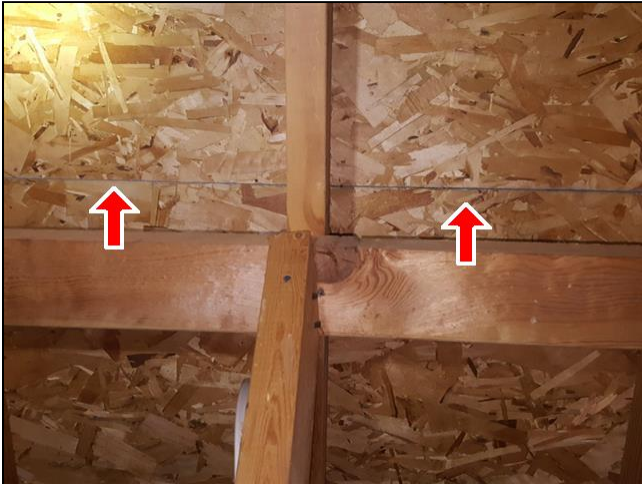
2.5 Item 1(Picture)

2.5 There is no 1/8" spacing or ply clips at the ends, joins or sides of the roof sheathing as is recommended. Without this space the edges of the sheathing could raise if moisture enters and expands the sheathing. The raised areas could then be easily seen as the shingles conform to the surface of the roof sheathing on the outside. No problems were found at time of inspection. If this condition appears and is bothersome the shingles will need to be removed and the sheathing replaced or if possible a relief joint cut at the edges of the sheathing by a qualified roofing contractor. At the moment this is not a high priority. Strongly recommend that when a new roof is installed that this be done then.

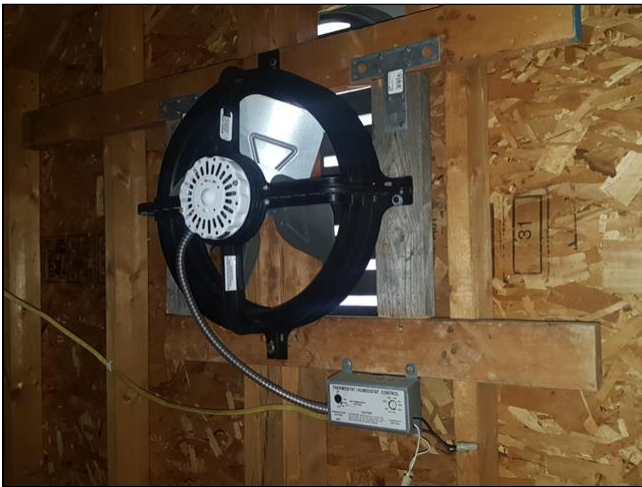
2.7 Item 1(Picture)

2.7 The thermostatic controlled vent fan in the garage attic was working at the time of the inspection.

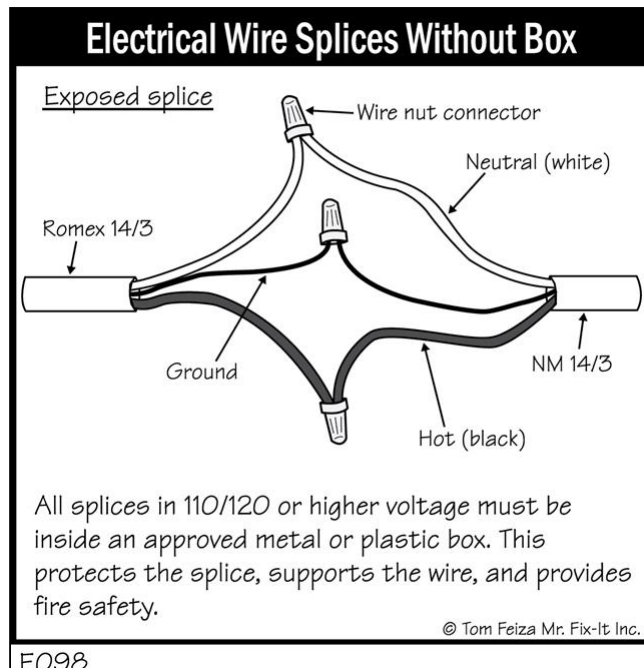
2.9 Item 2(Picture)

2.9 The wiring installation of the power vent in the garage attic is non-standard. It is suspected that an amateur, rather than a licensed electrician or HVAC contractor performed the installation. Splices in electrical wiring should be enclosed in junction boxes and fitted with cover plates. This is a safety issue . Recommend a licensed electrician repair as needed to prevent accidental electric shocks.

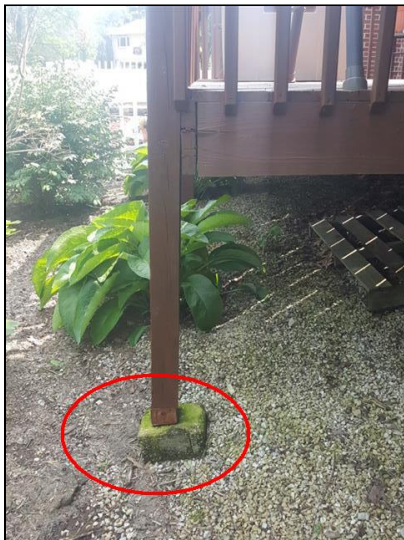
3.5 Item 1(Picture)

**3.5 (1)** Some of the concrete footers have settled creating the post to pull away and tilt from the band board. Over time further settlement of the footers may cause the deck to possibly fail in the future. This is a safety issue. Recommend a qualified contractor repair as needed to ensure structural integrity of the deck and to prevent further settlement or leaning of the posts.

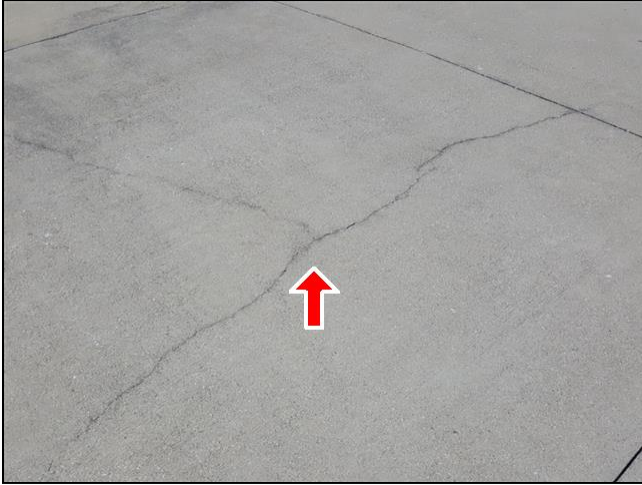
3.6 Item 1(Picture)

**3.6** (1) Common settlement crack(s) were noted at the concrete drive. This is not a tripping hazard as yet at this time. I also do not see these small cracks as an indication of a structural issue. Further deterioration and/or settlement can occur to the driveway via water intrusion if not repaired. Recommend repairs via a masonry caulk as needed then monitor annually. Here is a link for [Sealing Concrete Cracks](#)

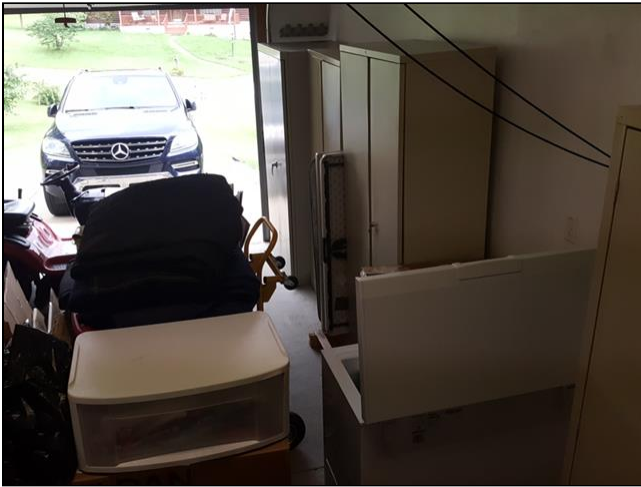
4.7 Item 1(Picture)

**4.7** Note: Limited Inspection of the garage was performed due to excessive personal property, unable to view most of the walls, slab and access switches and outlets. Recommend further inspection of these item(s) / areas prior to closing.

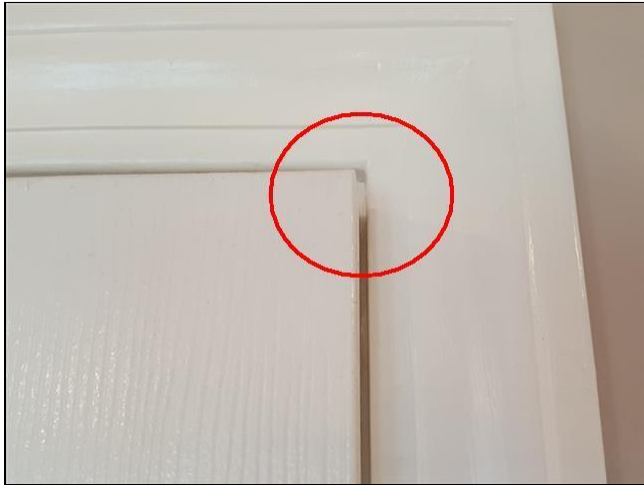
5.5 Item 1(Picture)

5.5 The kitchen pantry door hits the door jamb at the top and does not close shut. This is a maintenance issue. Sometimes correcting the door opening can require door trim to be removed and painting touch up, and/or door hinges may need reseating to ensure correct closure of door. Recommend a general contractor repair as needed.

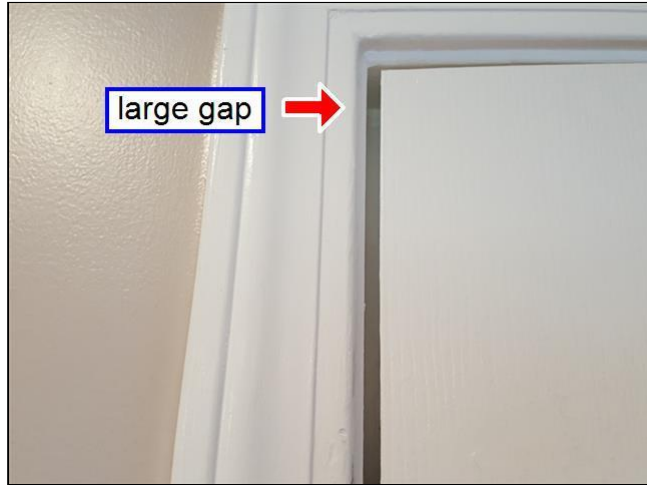
5.5 Item 2(Picture) top of frame

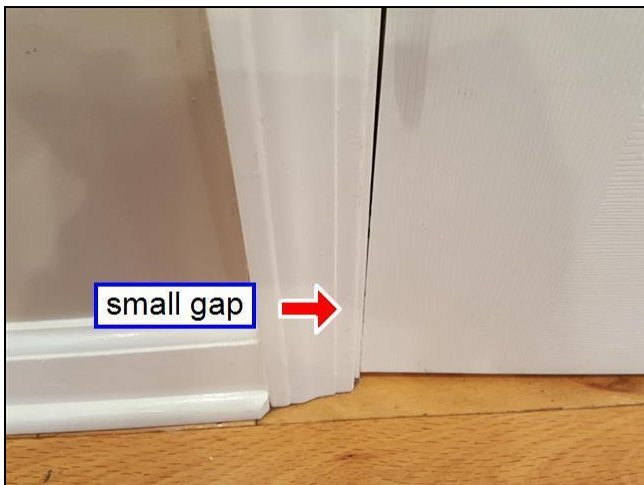
5.5 Item 3(Picture) bottom of frame

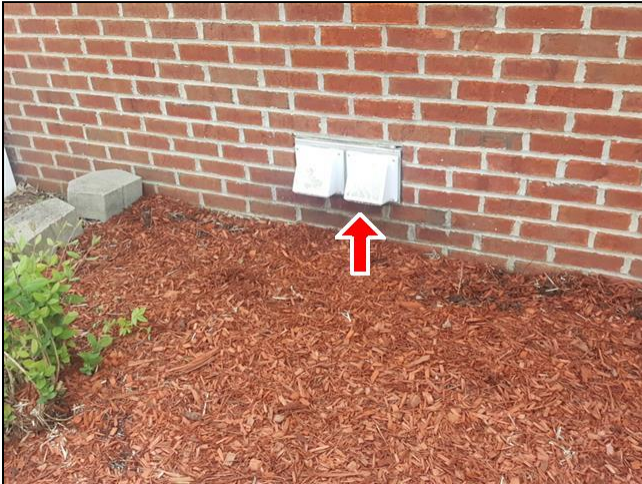
5.8 Item 1(Picture)

5.8 (1) The exterior port for the dryer vent pipe is located at the rear left side of the home. (see photo for location) This is for your information.

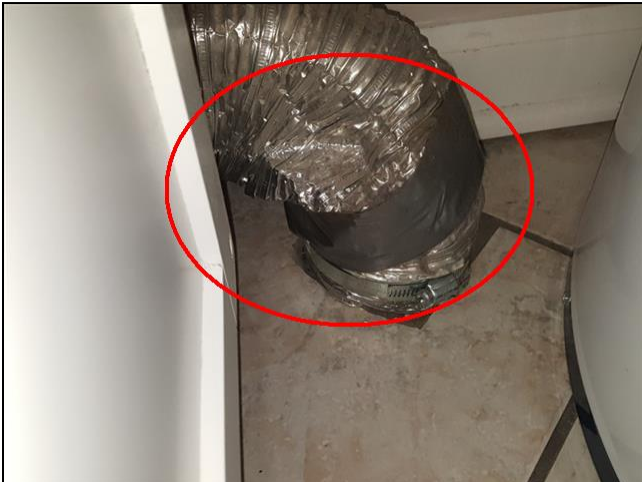
5.8 Item 2(Picture)

5.8 (2) The dryer vent piping is kinked. Damaged or bends in piping can cause an obstruction of lint that has a possibility to create a fire hazard. Recommend replacing flexible line prior to using dryer.

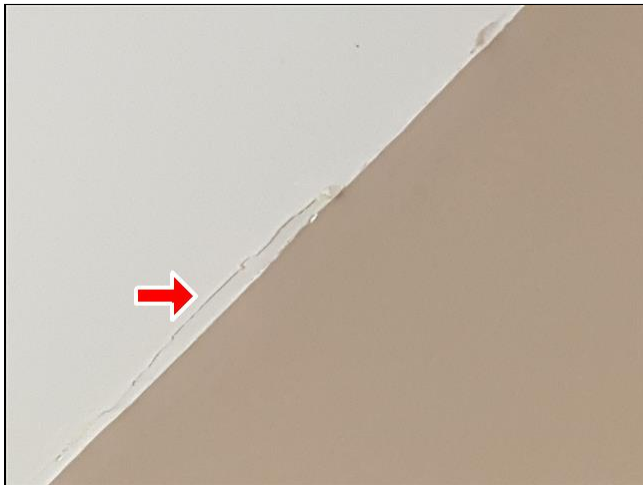
6.0 Item 1(Picture)

**6.0** (1) There are seams in the drywall ceiling in the living room which are loose. This is a cosmetic issue. This is common and often caused by moisture, changing temperature, or framing shrinkage due to lack of ventilation of vaulted ceilings. Repairs are recommended to improve the ceilings appearance. This is for your information.

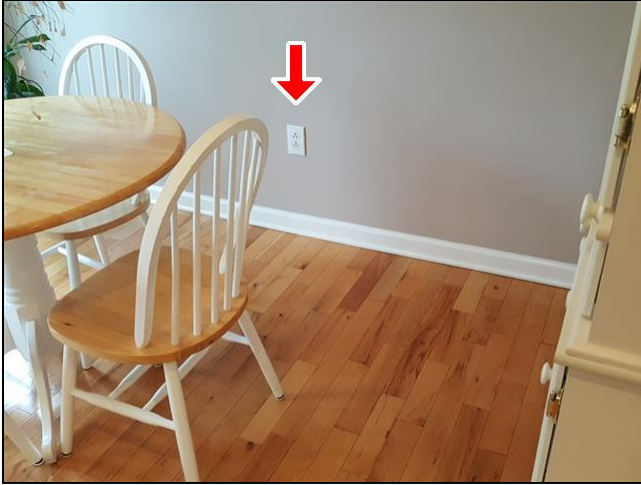
6.7 Item 1(Picture) dining room

6.7 The outlet(s) where indicated in the photo(s) are loose at the wall or in the outlet box. Electrical issues are considered a hazard until repaired. This is a safety issue that needs to be corrected due to an electric shock or fire from loose connections could occur if not repaired. Recommend a qualified licensed electrical contractor correct as needed.

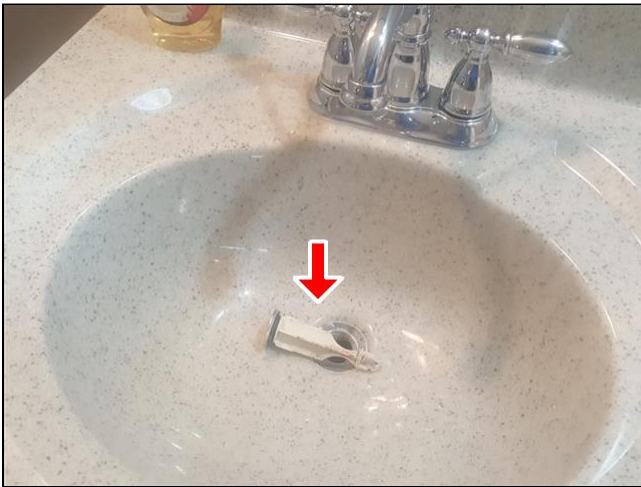
7.4 Item 3(Picture) left side closest to 2nd bedroom

7.4 (2) The drain control stopper is not connected at the sink and does not function in the 2nd bathroom (closest to 2nd bedroom). Recommend correcting to allow easy use of the drain lever and to ensure it functions properly. Repair or correct as needed.

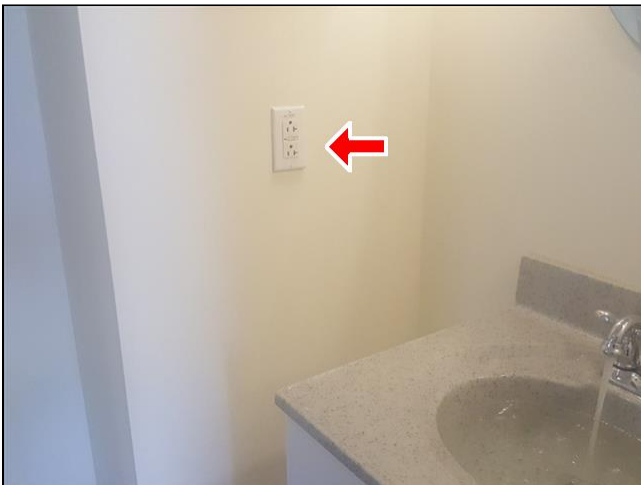
7.6 Item 1(Picture)

7.6 (3) The outlet(s) in the 2nd bathroom where indicated in the photo(s) is loose in the wall or at the outlet box. Electrical issues are considered a hazard until repaired. This is a safety issue that needs to be corrected due to an electric shock or fire from loose connections could occur if not repaired. Recommend a qualified licensed electrical contractor correct as needed.

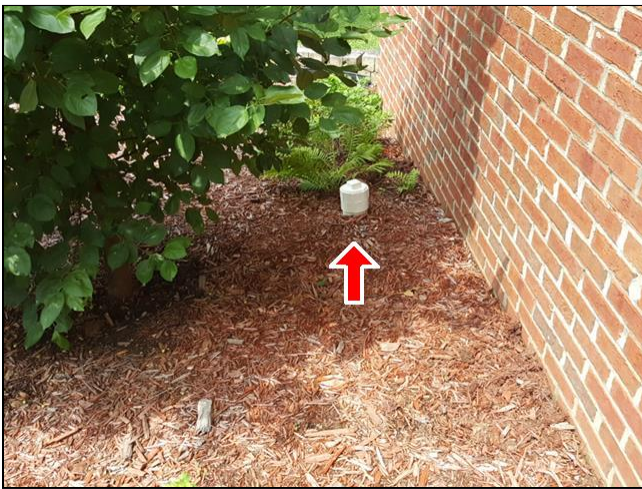
8.0 Item 1(Picture)

**8.0** The sewer clean out cap is located at the front left side of the home. This is for your information.

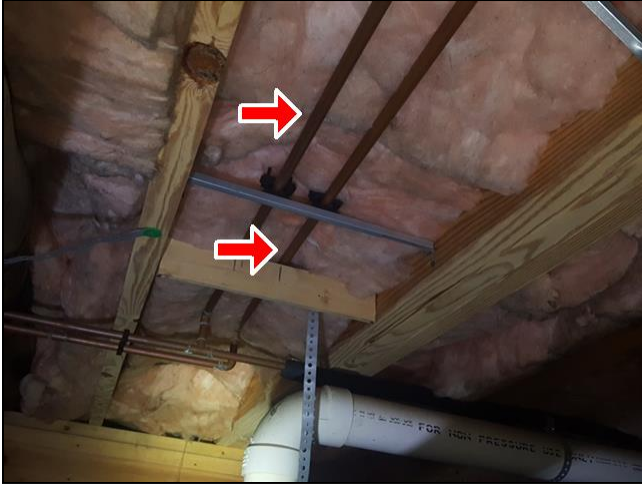
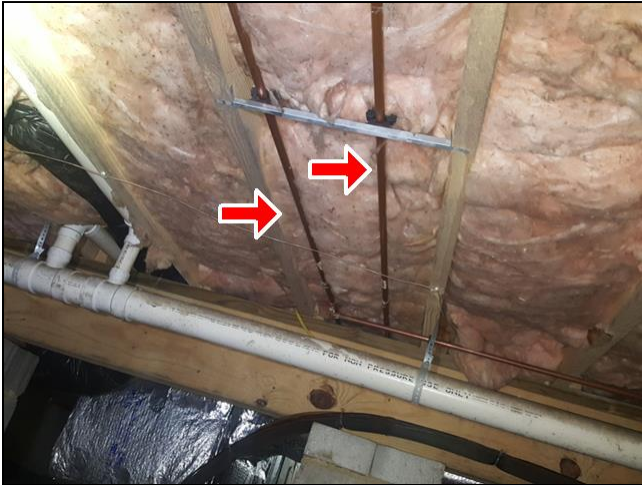
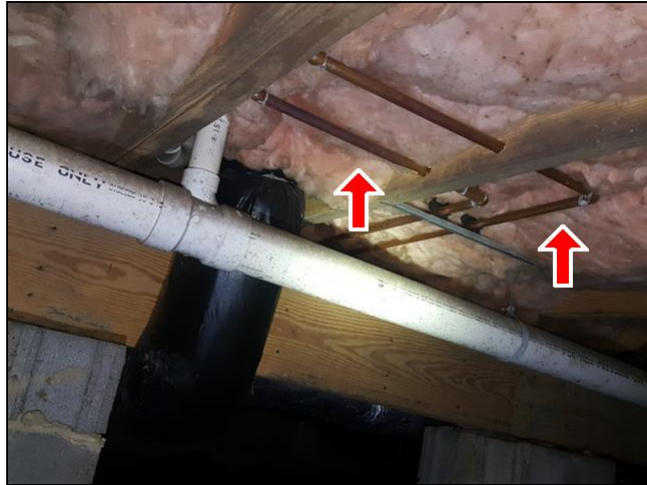
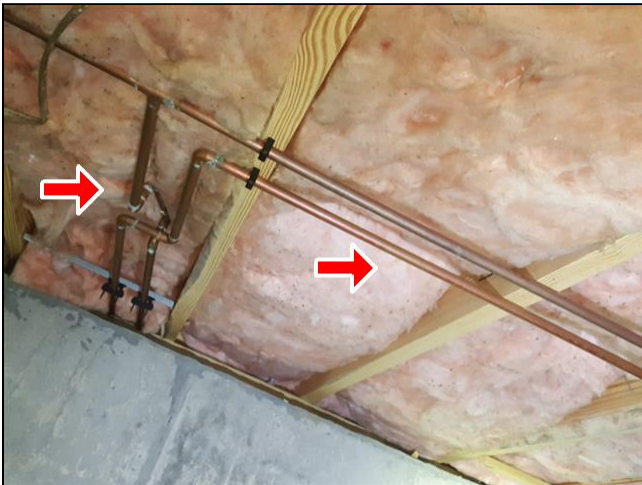
8.1 (2) Recommend insulating the water supply pipes underneath in the crawlspace (hot and cold) to ensure pipes do not freeze in winter which may cause a serious plumbing leak in the crawlspace, and to prevent heat loss of water when hot water is flowing into home. This will improve efficiency. This is for your information.

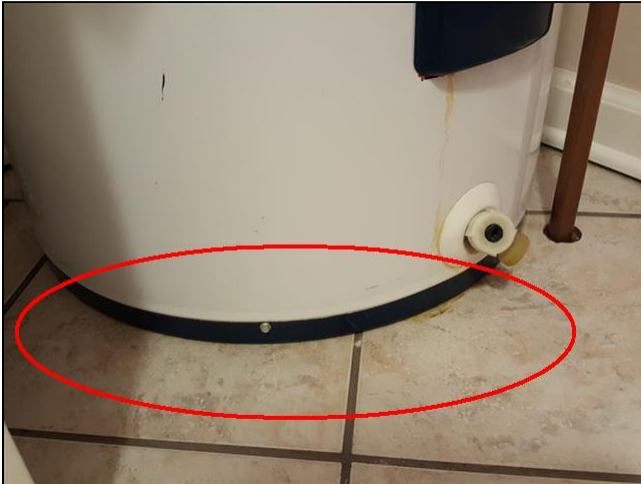
8.2 Item 2(Picture) right unit

**8.2 (2)** Your water heaters do not have a "Thermal Expansion tank" installed to prevent a possible leak at the TPR or "pop-off" valve. If the water pressure gets high enough it can damage valves in the plumbing fixtures, joints in the supply pipes and even the water heater. Thermal expansion always occurs in water heaters. Like most substances, water expands as it is heated. There were no visible leaks or drips at the TPR valve during the inspection. If your water heater does begin to drip or leak, then a thermal expansion tank may be needed. This is for your information.

8.2 (3) The water heater on a finished floor has the potential to cause severe damage if a leak should develop. Consider installing a drain pan under the water heater to prevent damage to the home if a leak develops. This will allow any water leaks to safely drain without damaging the finished materials, floor or furnishings. A qualified plumber could examine and install the drainage pan and drain line, but may need to install a drain line with a trap to the current drainage system. As an inexpensive safe-guard a drain pan with a moisture alarm can easily be installed as another option. Recommend a qualified plumber make the necessary corrections if desired.

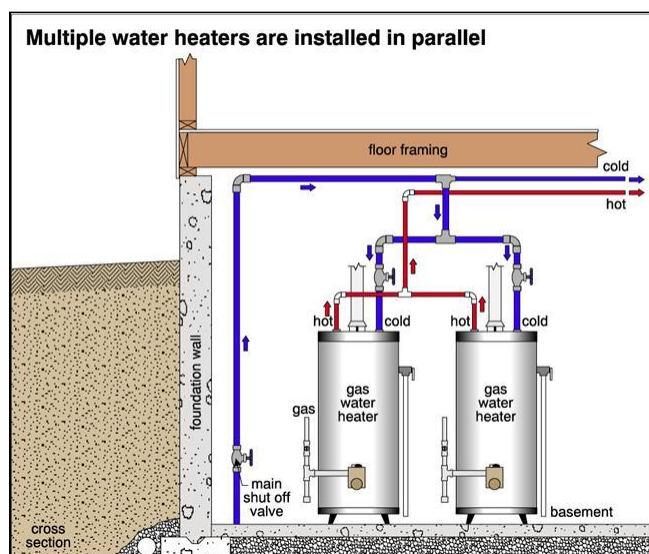
8.2 Item 5(Picture)

**8.2** (4) Your two water heaters appear to be hooked up in a parallel connection. Cannot verify for sure due to pipes are covered behind the wall. Piping in parallel allows you to use both heaters equally. It allows the system to act as one heater rather than independent. By drawing hot water out of both heaters equally, you are able to equalize the life of your heaters. The piping arrangement to and from parallel connected water heaters are extremely important to ensure the water is evenly distributed and does not take the path of least resistance (short circuit). This is for your information.

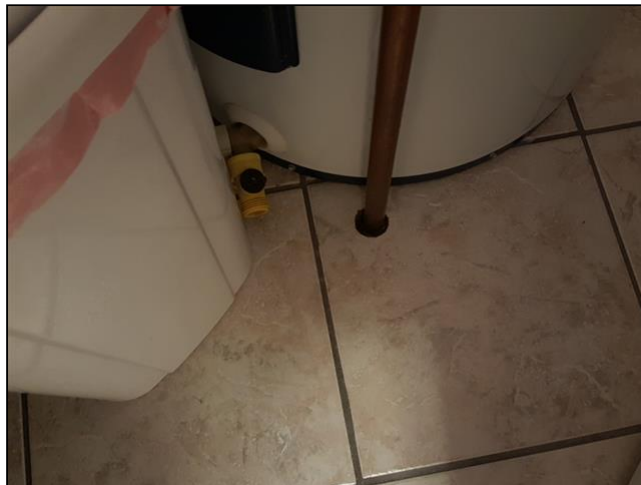
8.3 Item 2(Picture) left unit

**8.3** (1) Could not identify or visibly see where the drainage for the TPR line for both water heaters is draining to the exterior. Recommend contacting the owner for location. The TPR drain line maybe located in the crawlspace. Water should not be dumped in a crawlspace as it can lead to mildew or mold on building materials and perhaps deterioration of the wood floor structure. The drain line(s) should exit to the exterior of the home and kept away from the foundation structure. Recommend a licensed plumber correct if needed.

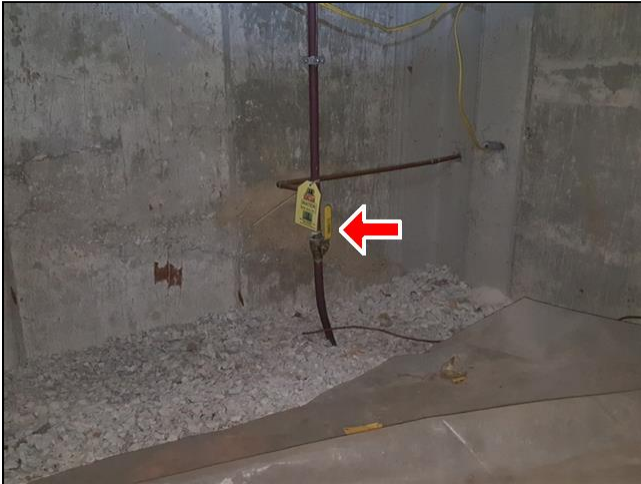
8.4 Item 1(Picture)

**8.4** (1) The main water shut off is the yellow lever located underneath in the crawlspace on the front wall under the 3rd bedroom area. This is for your information.

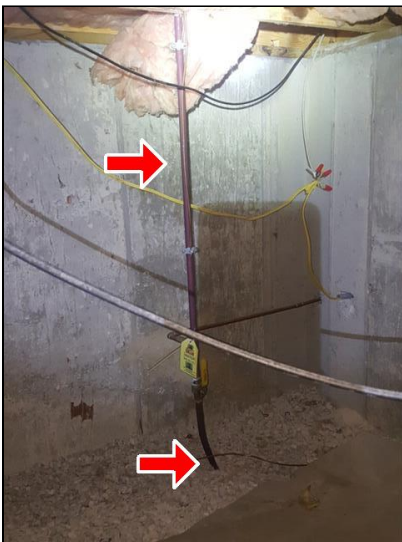
8.4 Item 2(Picture)

**8.4** (2) Recommend insulating the main water supply line pipe in the crawlspace due to the pipe is located in an unconditioned area. This will ensure that the pipe does not freeze in winter which may cause a serious plumbing leak and prevent costly damage to the home. This is for your information.

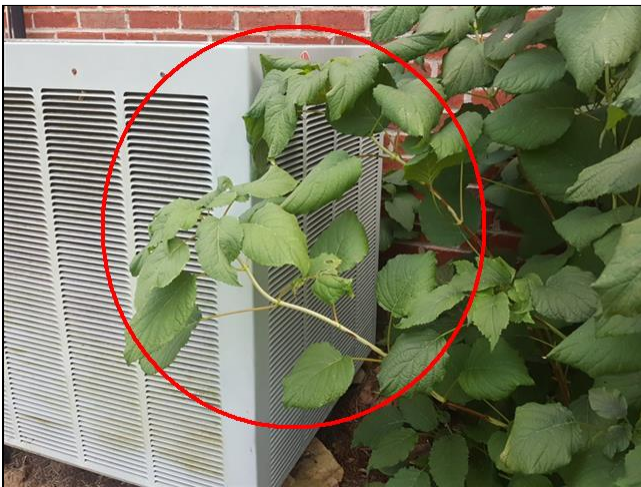
10.0 Item 1(Picture)

**10.0 (2)** Vegetation in the vicinity of the outdoor unit of the Heat Pump should be cut back to prevent obstruction of the airflow. This can cause damage to the unit via running hot ,shorten it's life expectancy, and cause it to run inefficient. Recommend removing all the vegetation surrounding the unit so that the fins are not obstructed.

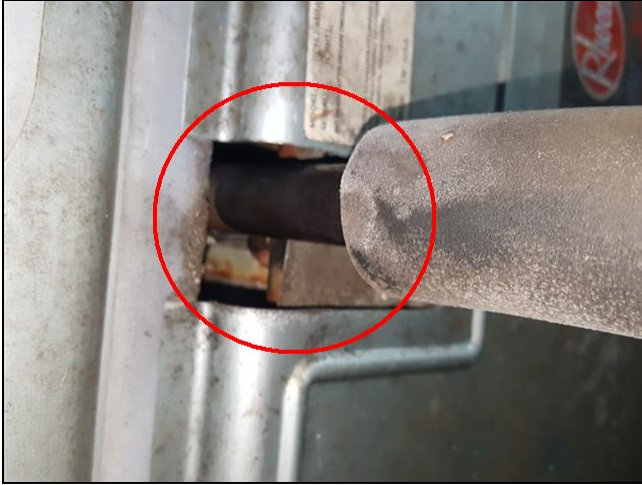
10.0 Item 4(Picture)

**10.0** (5) The refrigerant lines that enter the Air Handler are missing grommets where they enter the evaporative coil. Conditioned air is discharging into the crawlspace which can result in condensation/moisture occurring in the attic. This is inefficient, all the warm/cool air should be directed to the ducts. Recommend a qualified HVAC contractor repair as needed.

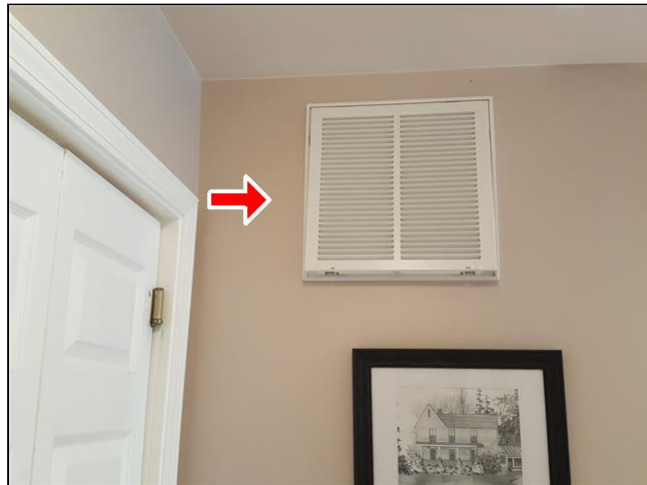
10.1 Item 2(Picture) hallway

**10.1** (2) The filter in the hallway is dirty at the return register which reduces the efficiency of the HVAC system and shortens it's life. Your filter is designed to keep airborne dirt from clogging your blower. If the filter itself gets clogged, then the system cannot move enough air, and it won't perform efficiently. Filters should be checked once a month or according to manufacturers recommendations and replaced as needed. Recommend the filters be replaced now.

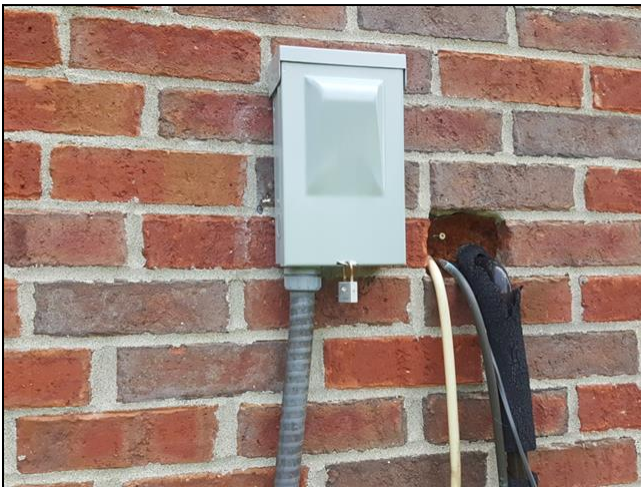
10.2 Item 1(Picture)

**10.2** The inside of the disconnect box was not inspected due to a lock has been placed on the box and the key was not available at time of inspection. There may be issues inside due to box not been secured to the wall. Recommend asking owner for the key and have a qualified contractor or electrician inspect before closing.

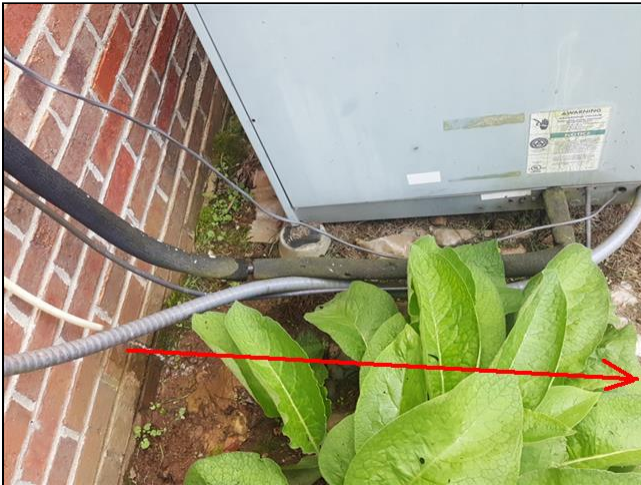
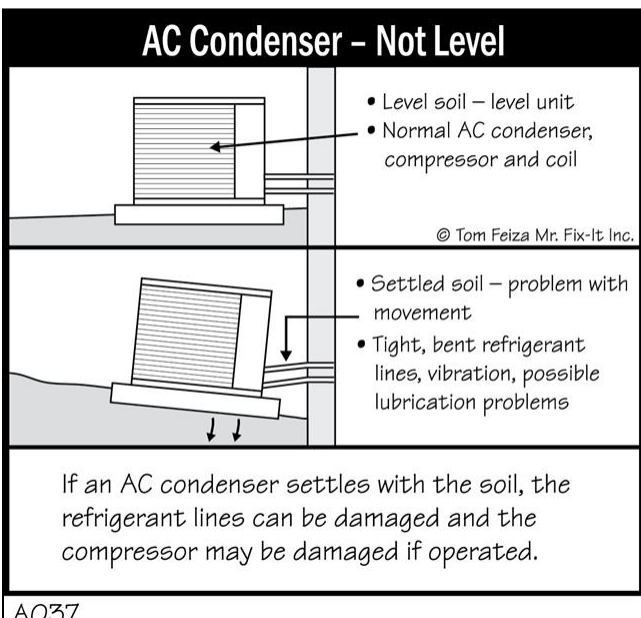
10.3 (1) Recommend the discharge for the condensate drain line be improved via installing a splash block and extending the drain line at the left side of the home. This will prevent water pooling near the foundation which could cause settlement of the foundation wall, soil erosion and water leakage into the crawlspace. Also to prevent possible settling of the platform for the Heat Pump. A qualified HVAC contractor is recommended for these repairs.

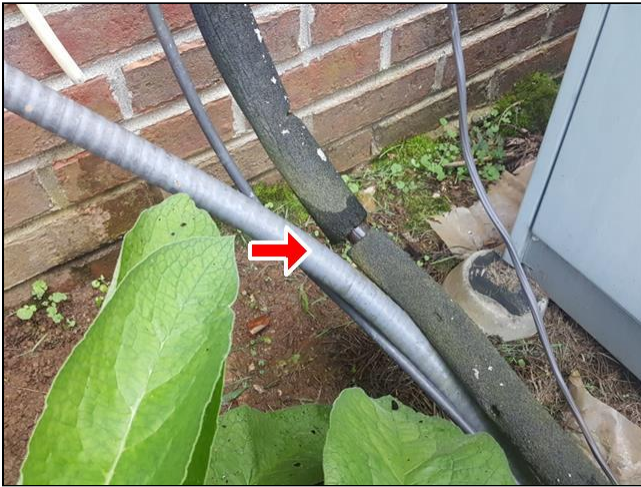
10.3 Item 4(Picture)

**10.3 (2)** The foam sleeve on the large suction line for the outside Heat Pump is deteriorated and missing at areas. This can cause condensation and increased system operating costs via the unit not operating efficiently. This is a small repair. This insulation is to maintain or stabilize the temperature of the gas used in the system. The outside temperature can influence this gas and cause efficiency fluctuations of the unit. Recommend installing a new sleeve, this will help maintain efficiency of the compressor.

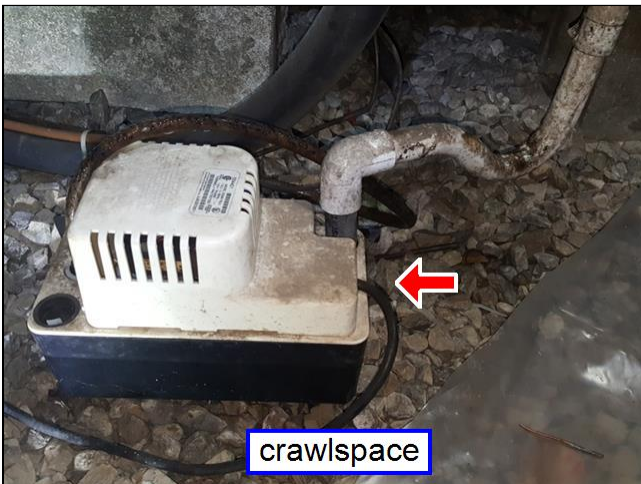
10.3 Item 6(Picture)

**10.3 (3)** The condensate pump was tested and was working at time of inspection.

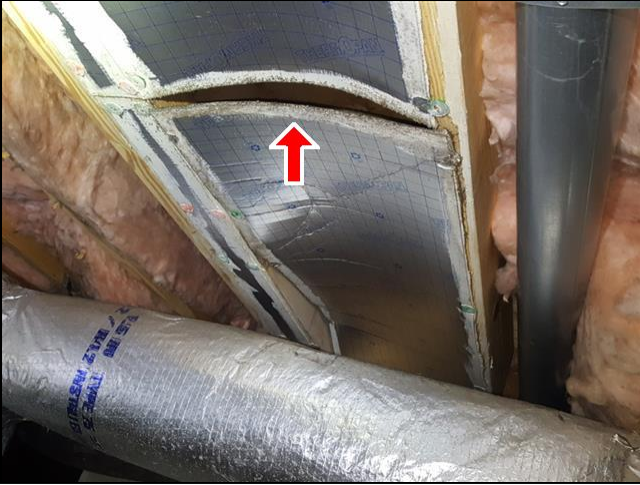
10.4 Item 1(Picture)

**10.4 (2)** The return air duct is not sealed at the plenum at the Air Handler in the crawlspace. This is allowing unfiltered air in the crawlspace to enter the home via the blower which is allowing contaminants to enter the unit. This is a health issue. This can also cause damage to the unit and blower, increase heating/cooling costs. Recommend a qualified HVAC repair ductwork where necessary.

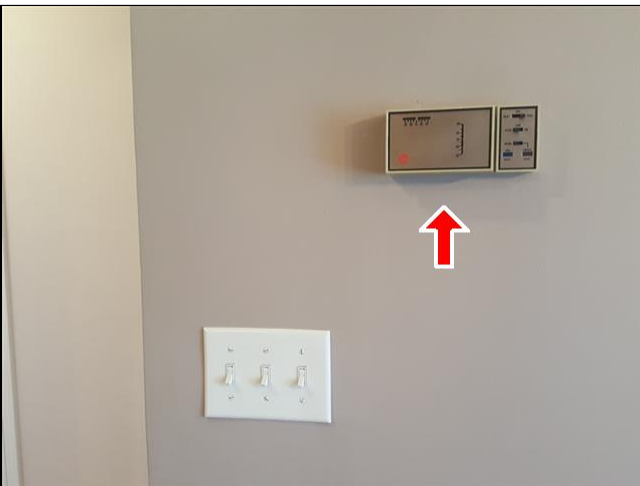
10.6 Item 1(Picture)

**10.6 (1)** A digital or programmable thermostat is a real energy saver up to 25% in energy bills and is more accurate. Recommend updating thermostat if desired. This is for your information.

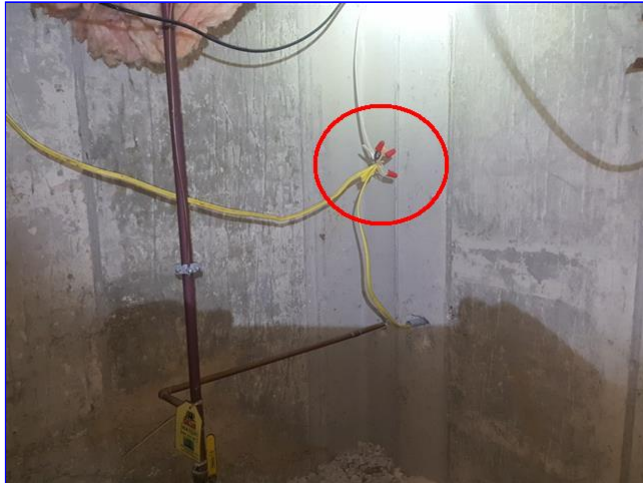
1.9 Item 1(Picture) under 3rd bedroom area

Wires that are connected with twist caps in a crawlspace need to be placed in a junction box to prevent tampering, protect the wire connections, and for personal protection. This is a safety issue that needs to be corrected. If a leak was to occur it could result in a short then a fire in the home. Recommend a qualified licensed electrician correct as needed.

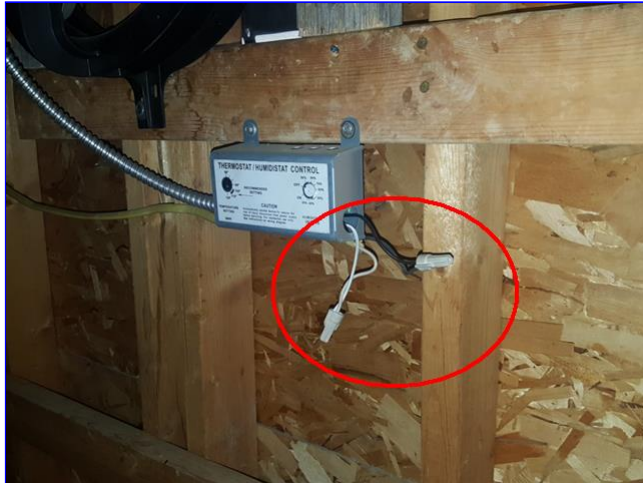
2.9 Item 1(Picture)

The wiring installation of the power vent in the garage attic is non-standard. It is suspected that an amateur, rather than a licensed electrician or HVAC contractor performed the installation. Splices in electrical wiring should be enclosed in junction boxes and fitted with cover plates. This is a safety issue . Recommend a licensed electrician repair as needed to prevent accidental electric shocks.

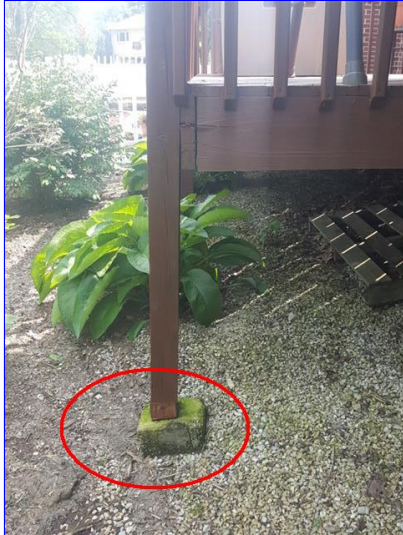
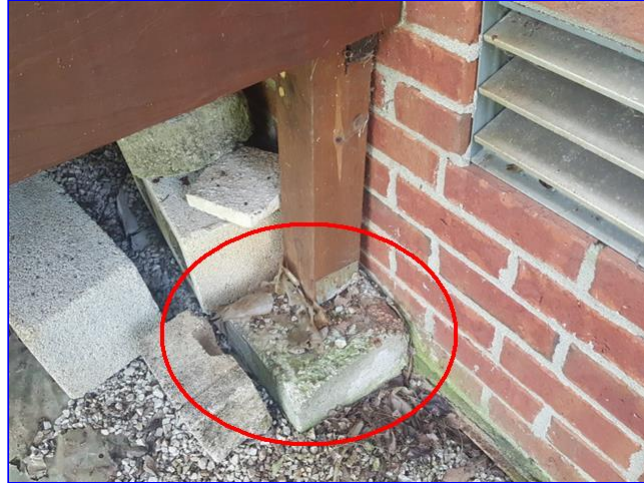
(1) Some of the concrete footers have settled creating the post to pull away and tilt from the band board. Over time further settlement of the footers may cause the deck to possibly fail in the future. This is a safety issue. Recommend a qualified contractor repair as needed to ensure structural integrity of the deck and to prevent further settlement or leaning of the posts.

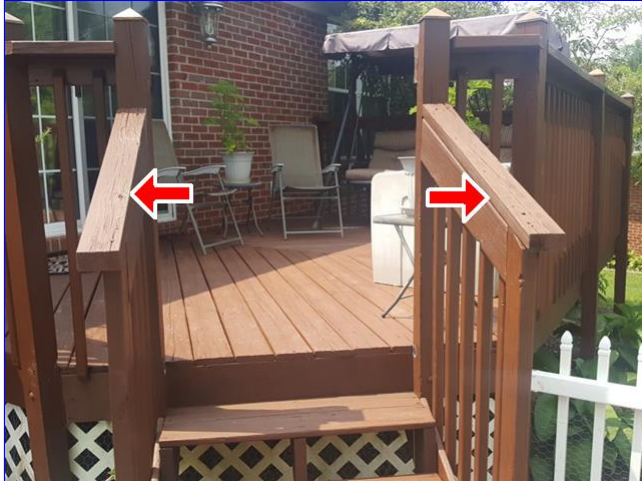
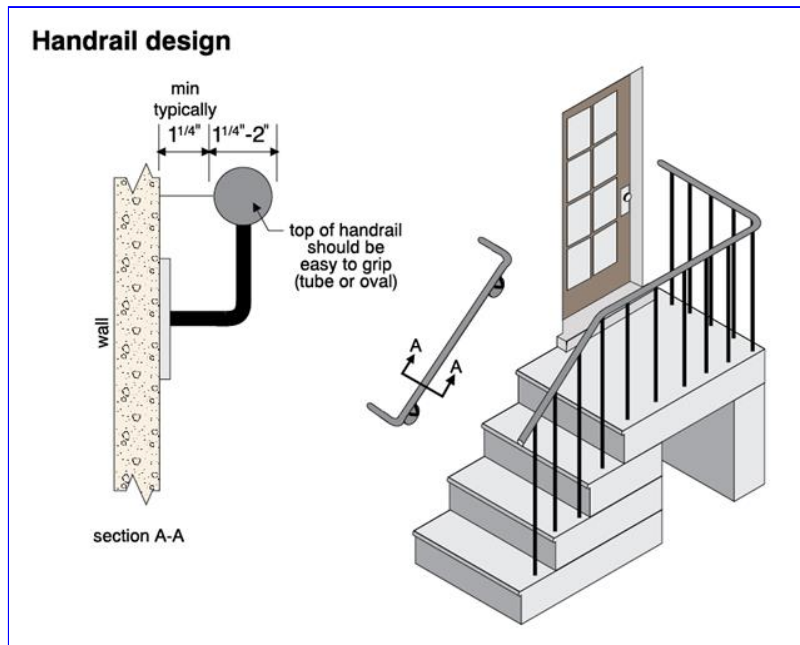
(2) 2x4s are installed for handrails for the deck staircase and are not considered "gripable" by industry standards. This is a safety issue and an injury could occur if not corrected. Recommend that a standard approved handrail be installed for safety by a general contractor.

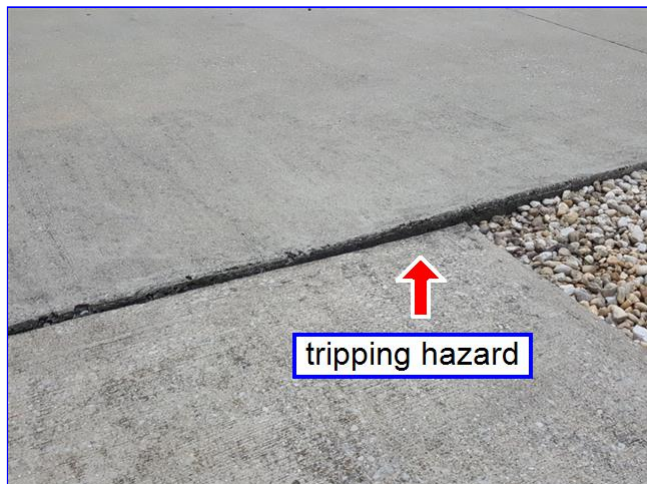
3.6 Item 3(Picture)

(2) The front walkway has settled where it butts up to the driveway creating a possible tripping hazard. I do not see this as an indication of a structural issue. However, for safety and to prevent a tripping hazard and a fall or injury from occurring, recommend a qualified masonry contractor repair as needed.

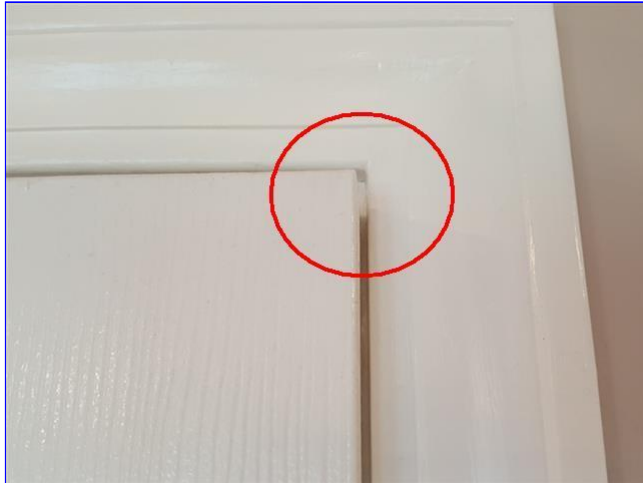
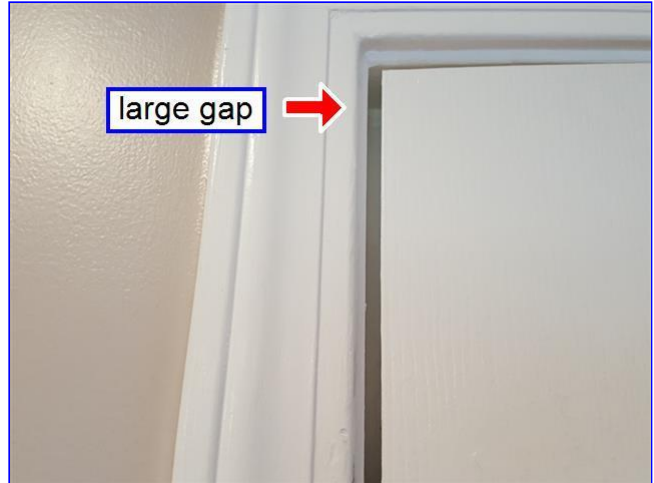
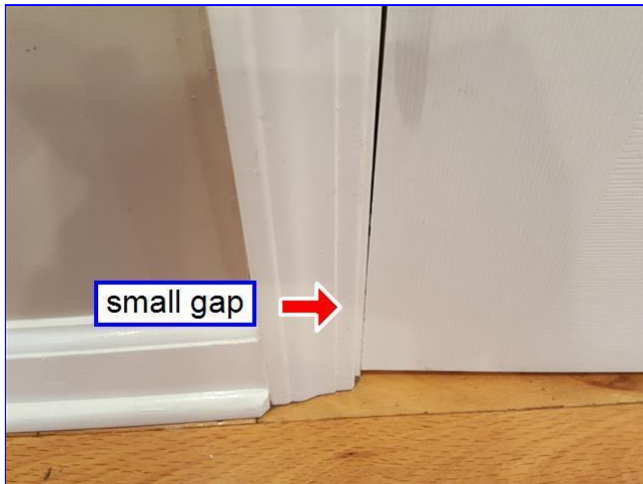
The kitchen pantry door hits the door jamb at the top and does not close shut. This is a maintenance issue. Sometimes correcting the door opening can require door trim to be removed and painting touch up, and/or door hinges may need reseating to ensure correct closure of door. Recommend a general contractor repair as needed.

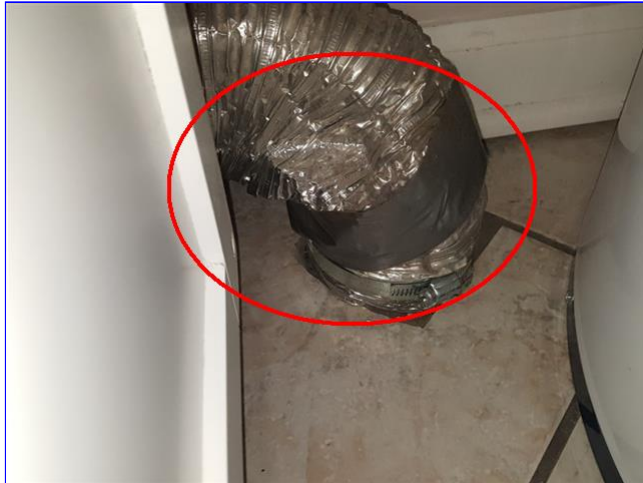
5.8 Item 2(Picture)

(2) The dryer vent piping is kinked. Damaged or bends in piping can cause an obstruction of lint that has a possibility to create a fire hazard. Recommend replacing flexible line prior to using dryer.

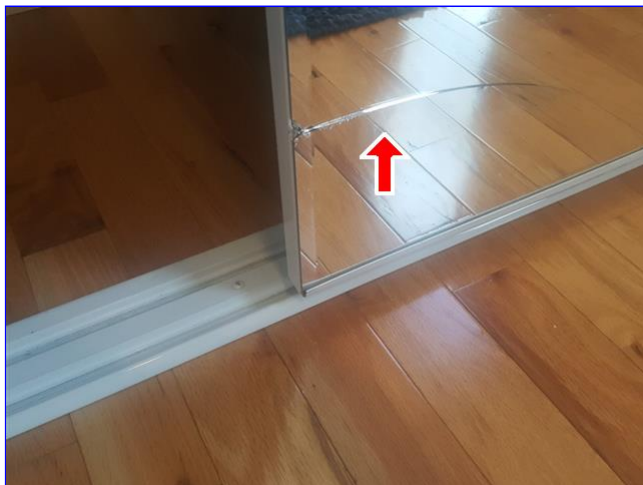
6.6 Item 1(Picture)

The mirrored closet door in the 3rd bedroom is cracked. This is a potential safety issue as a person or child could be injured or be cut. Recommend replacement as needed by a general contractor.
