## **Inspection Report**

**Property Address:**  
3002 Wheeler Street  
Georgetown KY 40324

**Talon Home Inspections, LLC**

<b>Date:</b> 8/22/2018	<b>Time:</b> 12:00 PM till 04:00 PM	<b>Report ID:</b> 140822WILLOUGHBY
<b>Property:</b> 3002 Wheeler Street Georgetown KY 40324	<b>Customer:</b> Mr. Mark Stevens	<b>Real Estate Professional:</b>

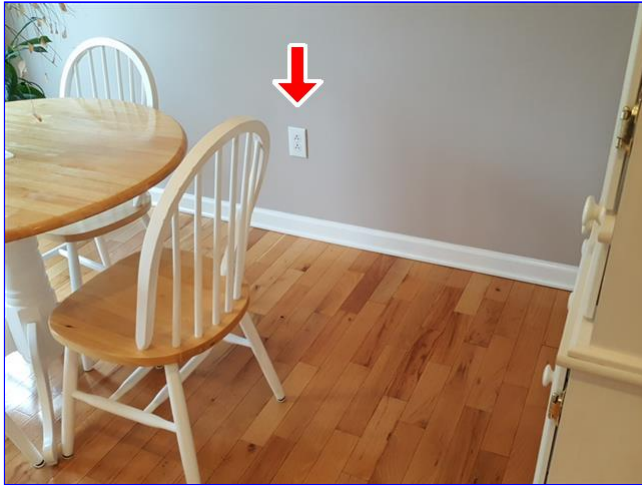
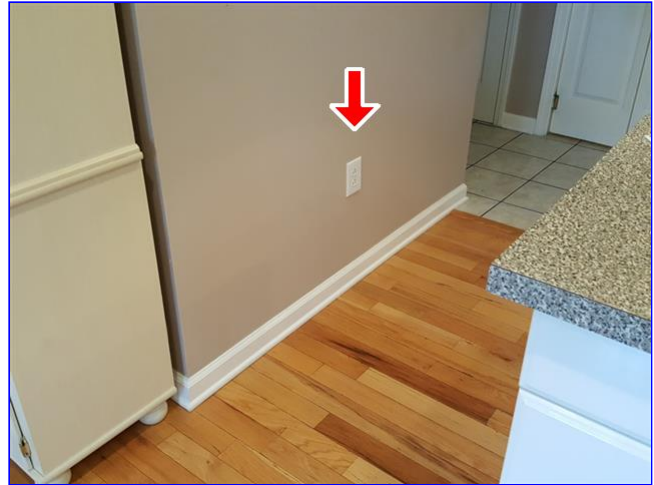
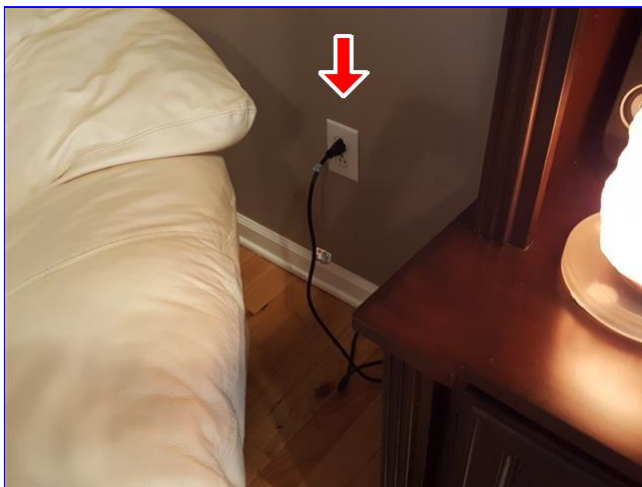
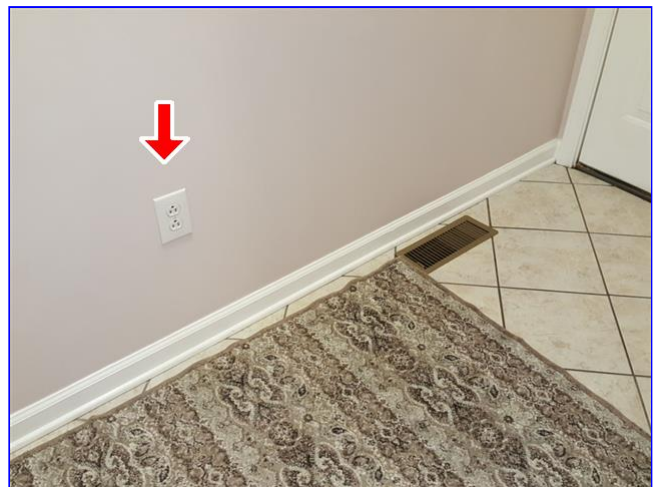
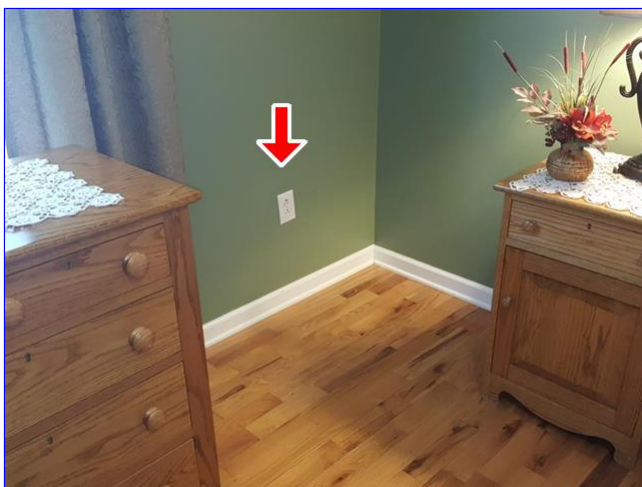
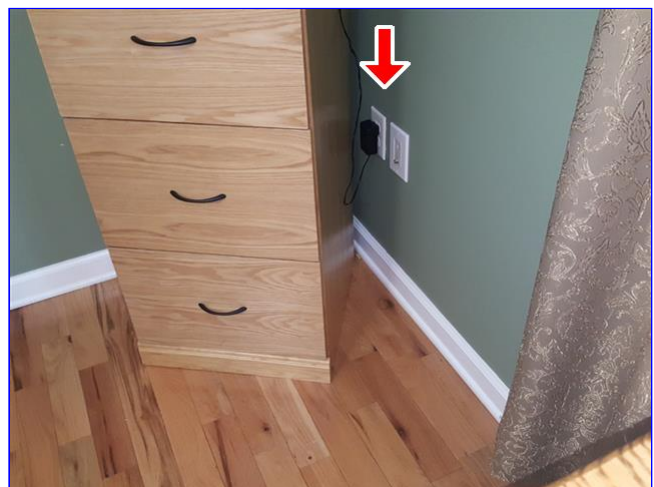
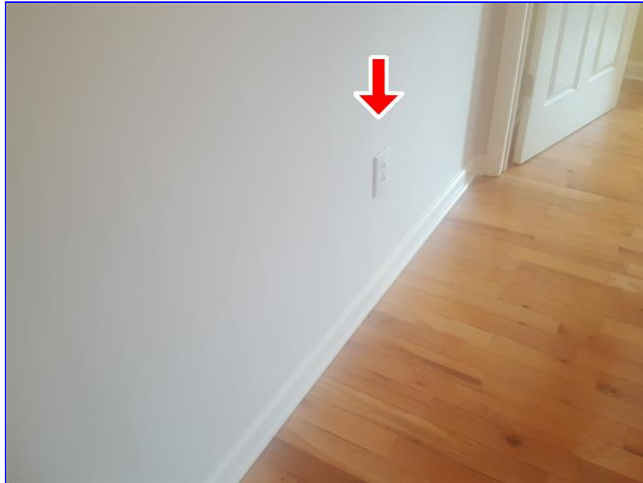
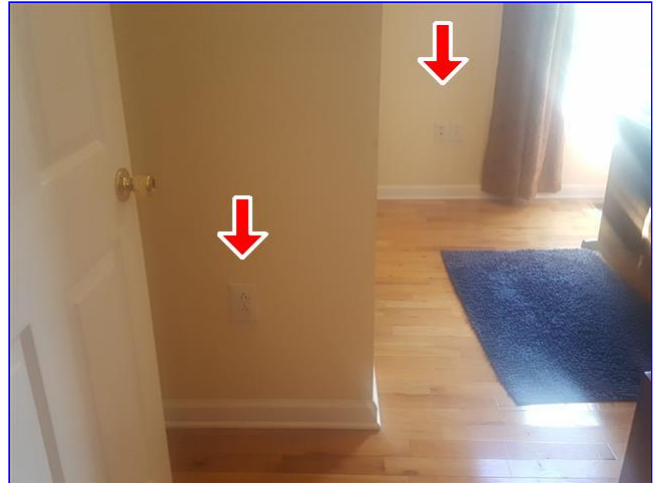
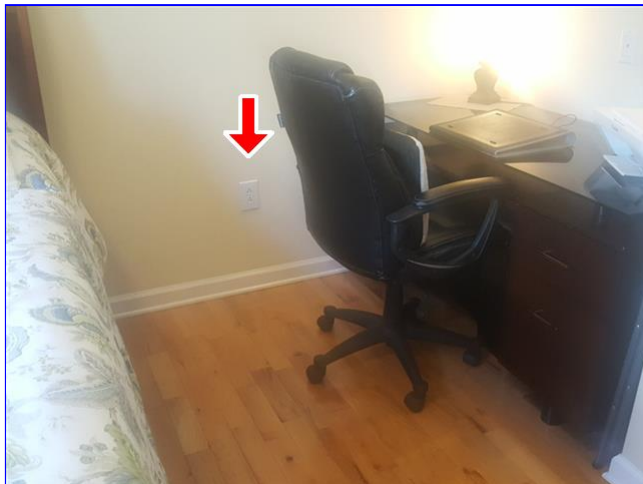
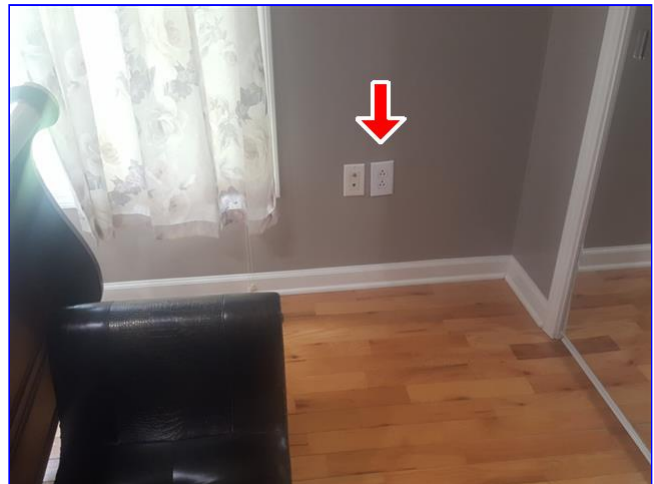
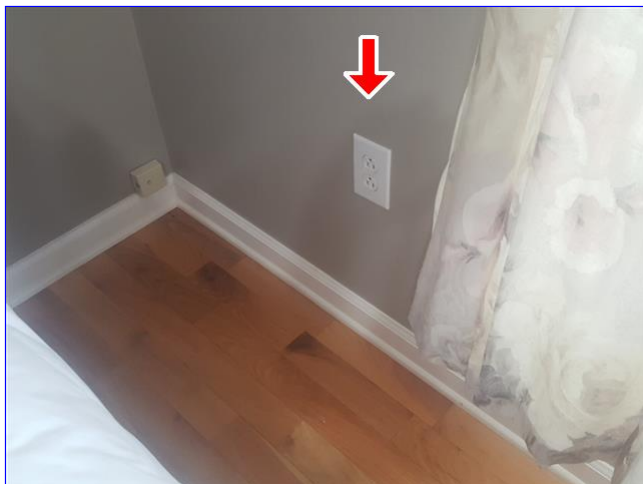
The outlet(s) where indicated in the photo(s) are loose at the wall or in the outlet box. Electrical issues are considered a hazard until repaired. This is a safety issue that needs to be corrected due to an electric shock or fire from loose connections could occur if not repaired. Recommend a qualified licensed electrical contractor correct as needed.

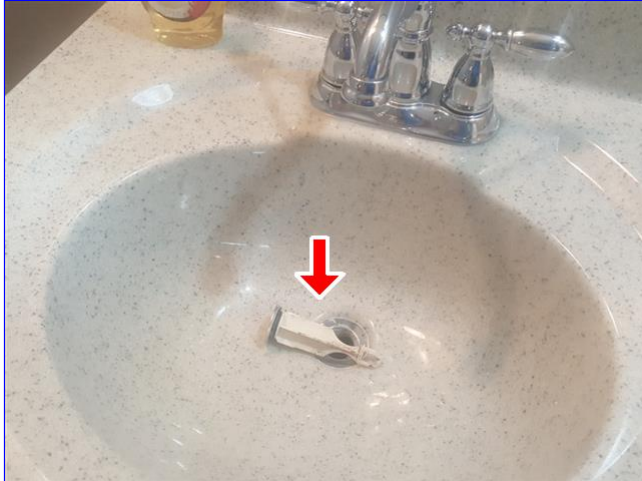
(2) The drain control stopper is not connected at the sink and does not function in the 2nd bathroom (closest to 2nd bedroom). Recommend correcting to allow easy use of the drain lever and to ensure it functions properly. Repair or correct as needed.

7.4 Item 3(Picture) left side closest to 2nd bedroom

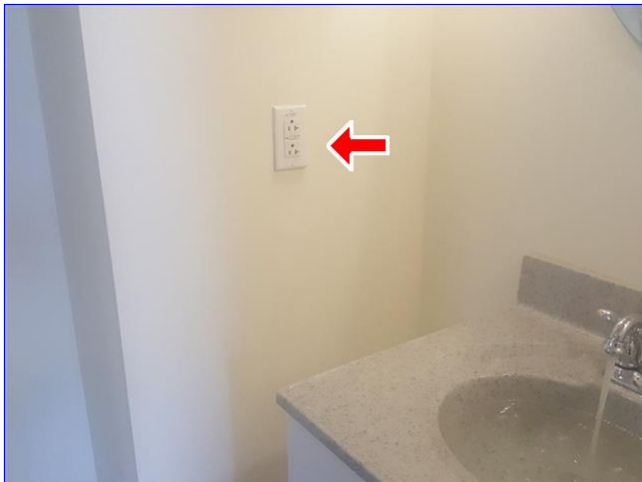
7.6 Item 1(Picture)

(3) The outlet(s) in the 2nd bathroom where indicated in the photo(s) is loose in the wall or at the outlet box. Electrical issues are considered a hazard until repaired. This is a safety issue that needs to be corrected due to an electric shock or fire from loose connections could occur if not repaired. Recommend a qualified licensed electrical contractor correct as needed.

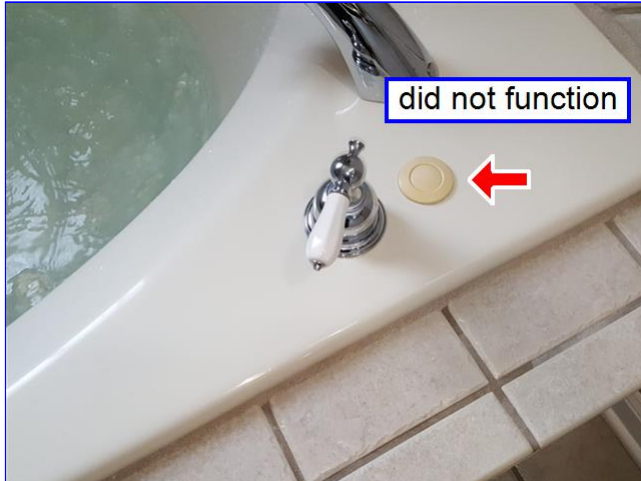
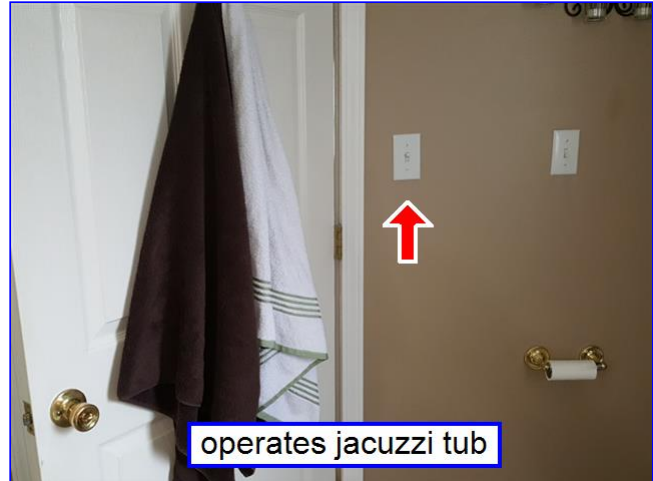
(3) The on/off switch for the operation of the pump for the jacuzzi does not function at the tub. The unit was operated at the wall switch in the bathroom. Recommend an electrician repair or replace switch as needed for ease of use.

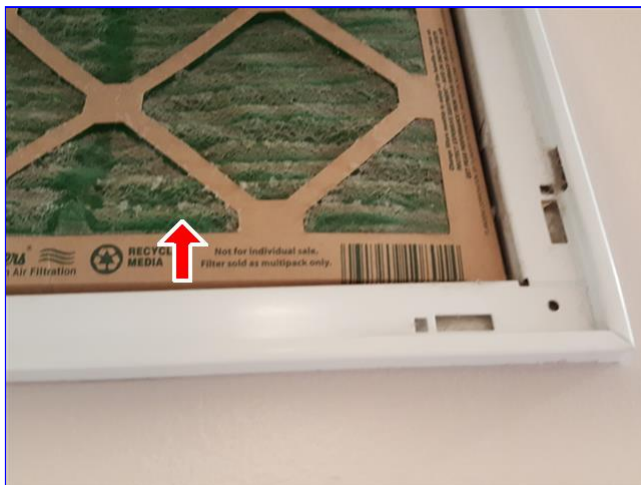
10.1 Item 3(Picture)

(2) The filter in the hallway is dirty at the return register which reduces the efficiency of the HVAC system and shortens it's life. Your filter is designed to keep airborne dirt from clogging your blower. If the filter itself gets clogged, then the system cannot move enough air, and it won't perform efficiently. Filters should be checked once a month or according to manufacturers recommendations and replaced as needed. Recommend the filters be replaced now.

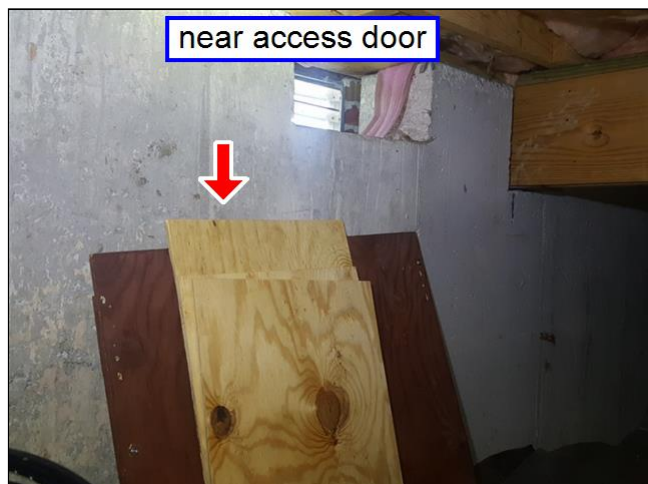
1.2 Item 1(Picture)

(1) All wood should be removed from the crawlspace floor. Wood debris risks rotting and can attract wood eating insects into the crawlspace which can lead to more costly repairs later. Recommend all types of debris resting on the crawlspace floor be removed to prevent damage to the wood structure of the home.

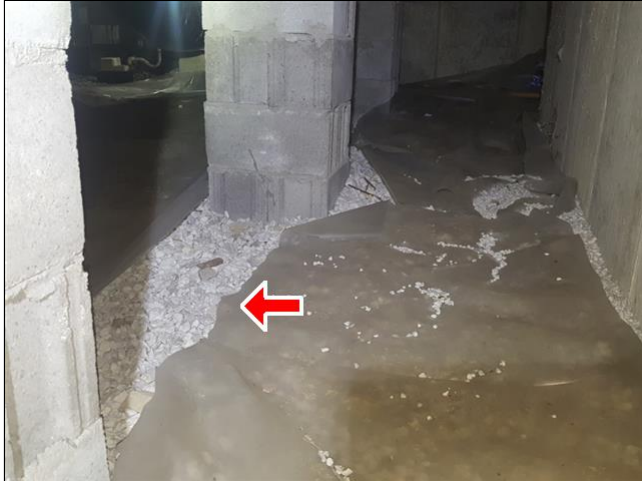
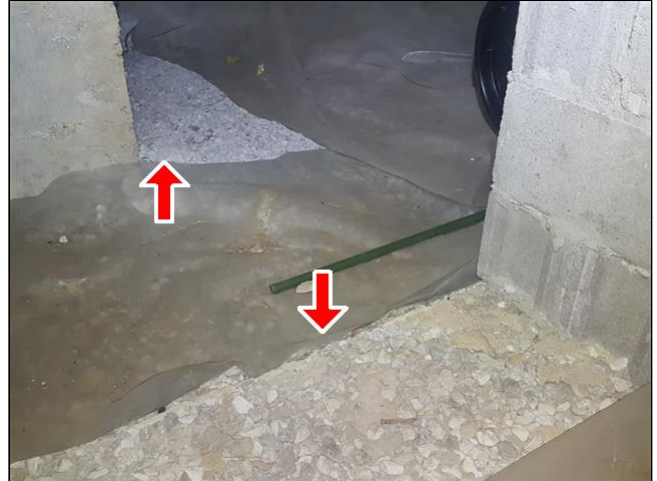
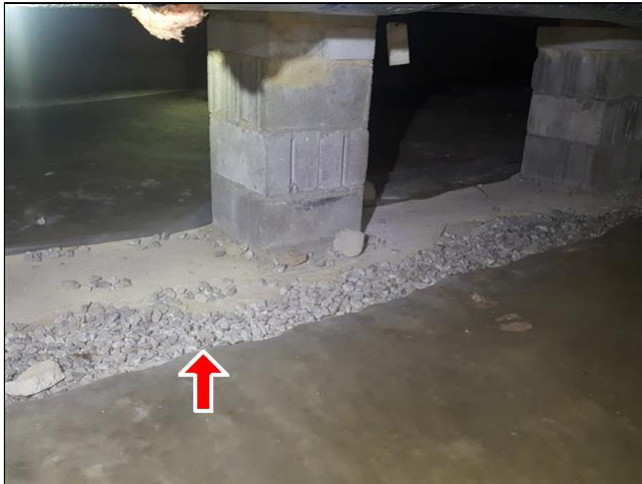
(2) There are some gaps in the coverage of the vapour barrier in the crawl space floor where indicated in the photo(s). The vapor barrier in the crawl space floor should be adjusted to cover all areas of exposed soil. These gaps are allowing moisture vapor entry into the crawl space which promotes condensation, humidity and mold/mildew growth on the floor joists. The plastic vapour barrier should be a minimum of 9mil thick in Kentucky (recommend using 15 or 20 mil) straightened and/or added to as needed to cover the entire crawlspace floor to prevent excessive moisture entering. Recommend correcting as needed using a qualified contractor.

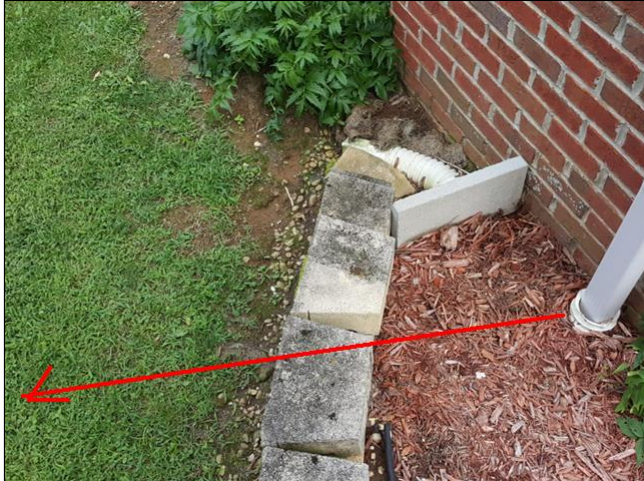
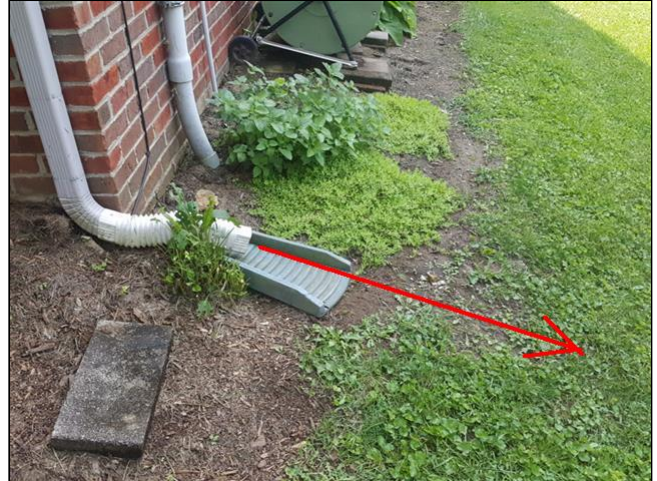
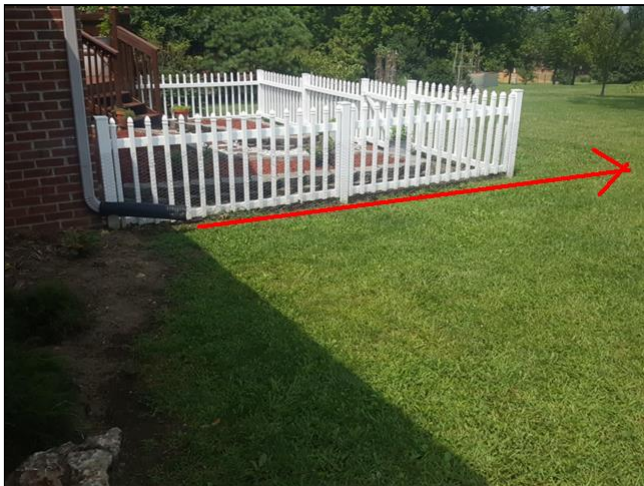
(3) Recommend the downspout(s) at the home where indicated in the photo(s) be extended at least 6 feet and flow onto splashblocks. This will ensure water is kept away from the foundation perimeter, soil erosion does not occur and water cannot leak into the crawlspace area which may cause settlement of the foundation.

2.3 Item 5(Picture) front left corner of home

2.3 Item 6(Picture) rear right corner of home

2.3 Item 7(Picture) rear left side of home

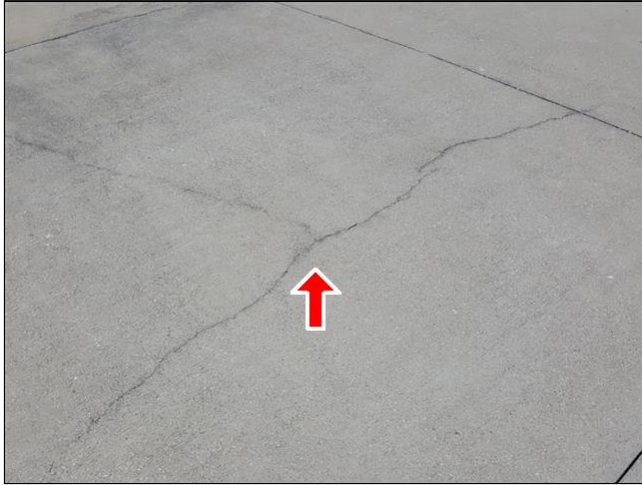
3.6 Item 1(Picture)

(1) Common settlement crack(s) were noted at the concrete drive. This is not a tripping hazard as yet at this time. I also do not see these small cracks as an indication of a structural issue. Further deterioration and/or settlement can occur to the driveway via water intrusion if not repaired.

Recommend repairs via a masonry caulk as needed then monitor annually. Here is a link for [Sealing Concrete Cracks](#)

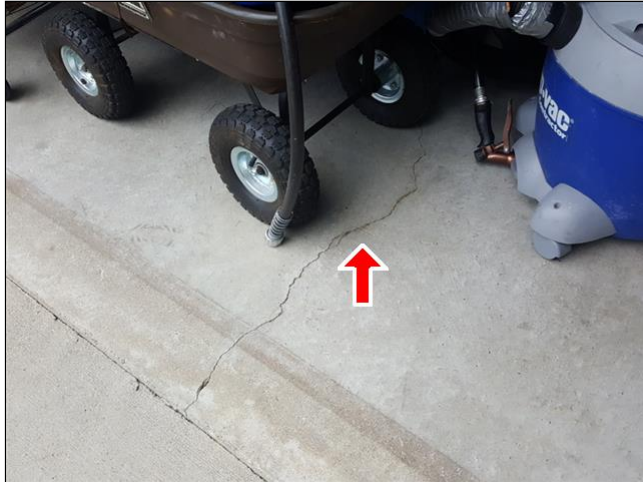
4.2 Item 1(Picture)

The garage flooring has typical cracks in areas highlighted in photos. These cracks do not appear significant and seem typical. Cracks that are usually 1/8 inch or wider are need for concern. The cracks are usually the result of shrinkage and/or settling of the slab. Recommend these cracks be sealed then apply an epoxy coating on the floor to ensure water intrusion does not occur. It is recommended that you monitor annually after repairs. If these cracks should reoccur a masonry contractor who is familiar with foundation repair should be consulted. [Caulk for Concrete Cracks](#)

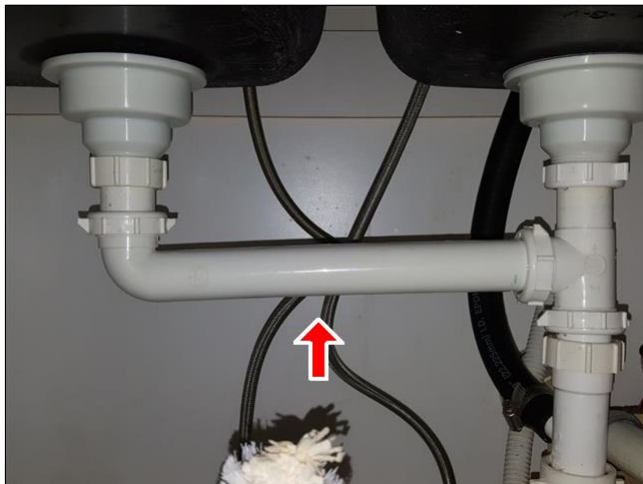
5.1 Item 1(Picture)

The disposal drain line is incorrectly pitched to the sink drain line from the disposal unit under the sink in the kitchen. This can cause the drain line to clog. Recommend a qualified plumber correct as needed.

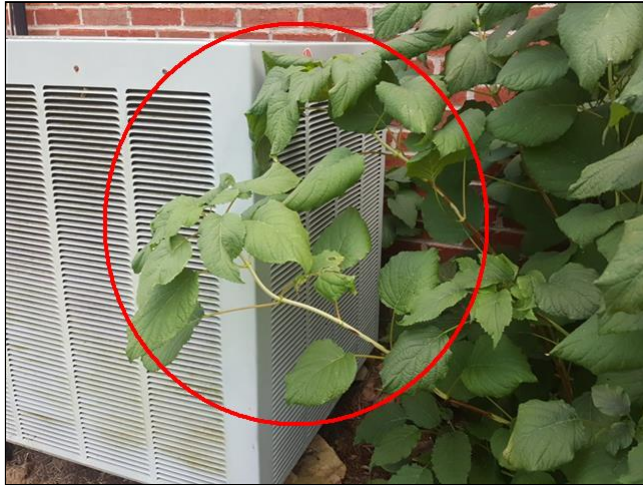
10.0 Item 1(Picture)

(2) Vegetation in the vicinity of the outdoor unit of the Heat Pump should be cut back to prevent obstruction of the airflow. This can cause damage to the unit via running hot, shorten its life expectancy, and cause it to run inefficient. Recommend removing all the vegetation surrounding the unit so that the fins are not obstructed.

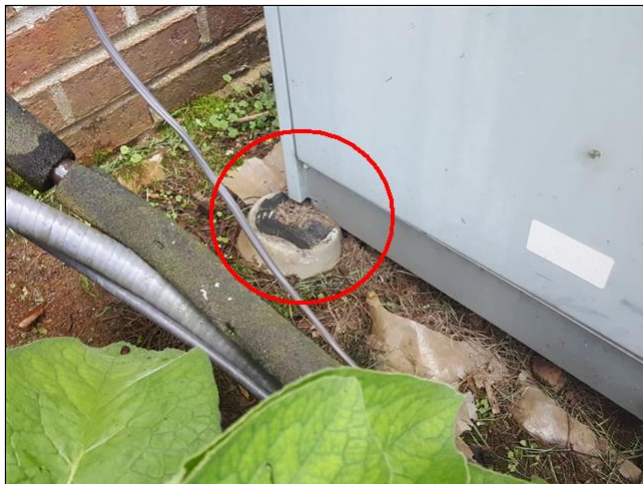
10.0 Item 3(Picture)

(3) The platform foot for the Heat Pump unit is not supporting the corner of the unit correctly. Over time this may settle further causing the unit to fall off its support which could result in a leak at the large suction line. It could also result in the unit to be unstable. Recommend a qualified HVAC contractor correct as needed to avoid this in the future.

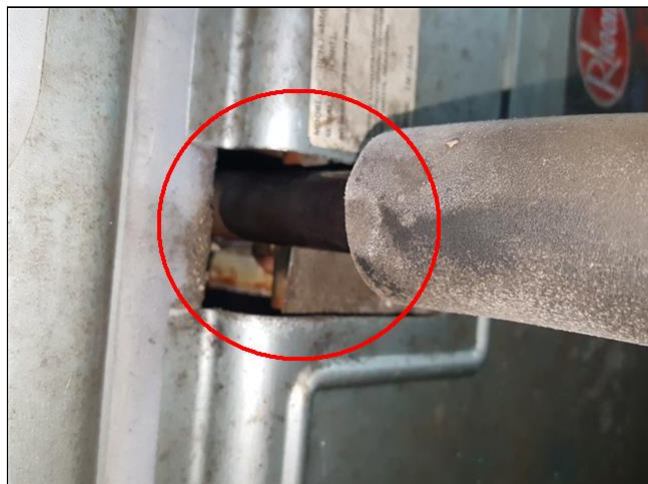
10.0 Item 4(Picture)

(5) The refrigerant lines that enter the Air Handler are missing grommets where they enter the evaporative coil. Conditioned air is discharging into the crawlspace which can result in condensation/moisture occurring in the attic. This is inefficient, all the warm/cool air should be directed to the ducts. Recommend a qualified HVAC contractor repair as needed.

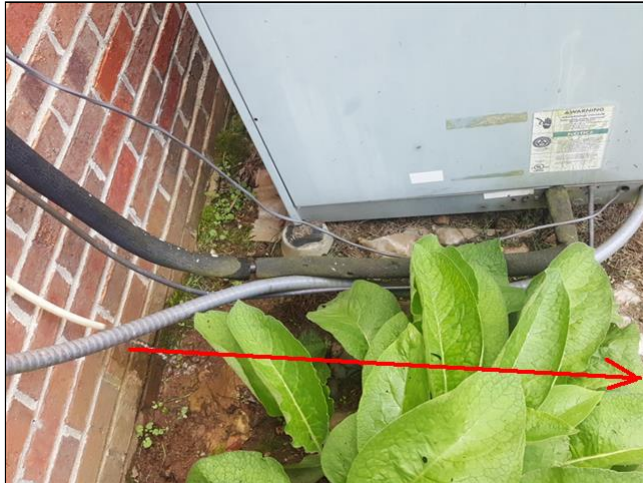
10.3 Item 1(Picture)

(1) Recommend the discharge for the condensate drain line be improved via installing a splash block and extending the drain line at the left side of the home. This will prevent water pooling near the foundation which could cause settlement of the foundation wall, soil erosion and water leakage into the crawlspace. Also to prevent possible settling of the platform for the Heat Pump. A qualified HVAC contractor is recommended for these repairs.

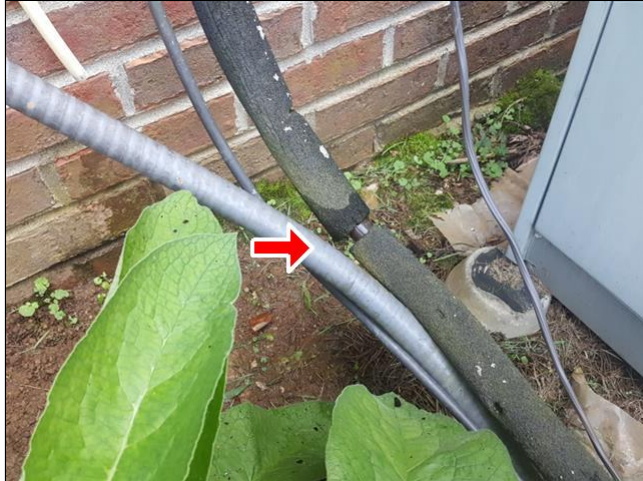
10.3 Item 4(Picture)

(2) The foam sleeve on the large suction line for the outside Heat Pump is deteriorated and missing at areas. This can cause condensation and increased system operating costs via the unit not operating efficiently. This is a small repair. This insulation is to maintain or stabilize the temperature of the gas used in the system. The outside temperature can influence this gas and cause efficiency fluctuations of the unit. Recommend installing a new sleeve, this will help maintain efficiency of the compressor.
