DEPARTMENT OF REGULATORY
AND ECONOMIC RESOURCES

MINIMUM INSPECTION PROCEDURAL GUIDELINES
FOR BUILDING ELECTRICAL RECERTIFICATION

- a. Name on Title: Village at Dadeland Condominiums (E)
- b. Street Address: 7360 SW 82nd St. Miami, Florida 33143
- c. Legal Description: Village at Dadeland Condominiums
- d. Owner's Name: Village at Dadeland Condominiums
- e. Owner's Mailing Address: 7360 SW 82nd St. Miami, Florida 33143
- f. Folio Number of Property on which Building is Located: 30-4035-047-XXXX
- g. Building Code Occupancy Classification: R2 - Residential
- h. Present Use: Condominium, Residential
- i. General Description, Type of Construction, Size, Number of Stories, and Special Features

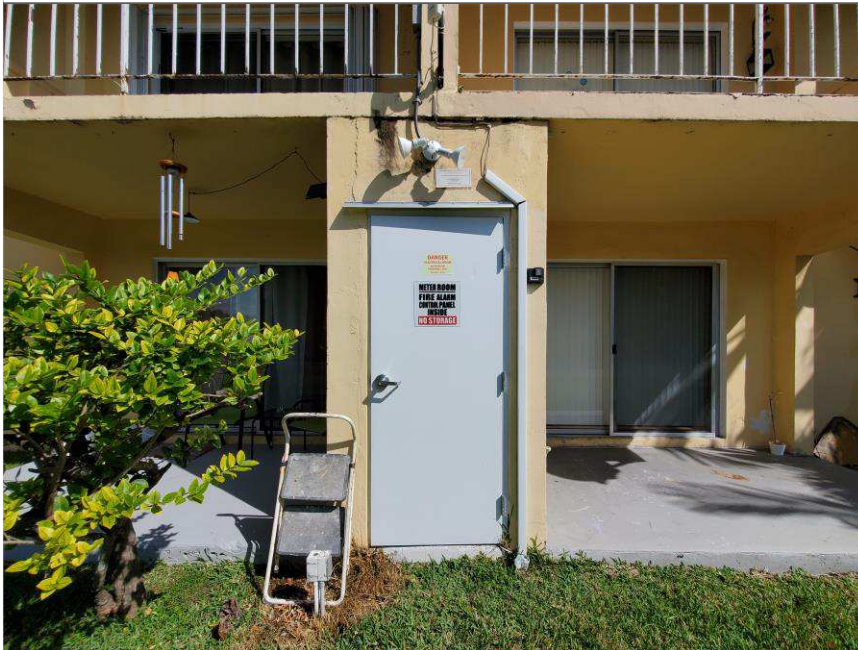
Photo 1 – Village of Dadeland Condominium Association

Existing Electrical Room - 1st FL
Provide sign with Building
Number

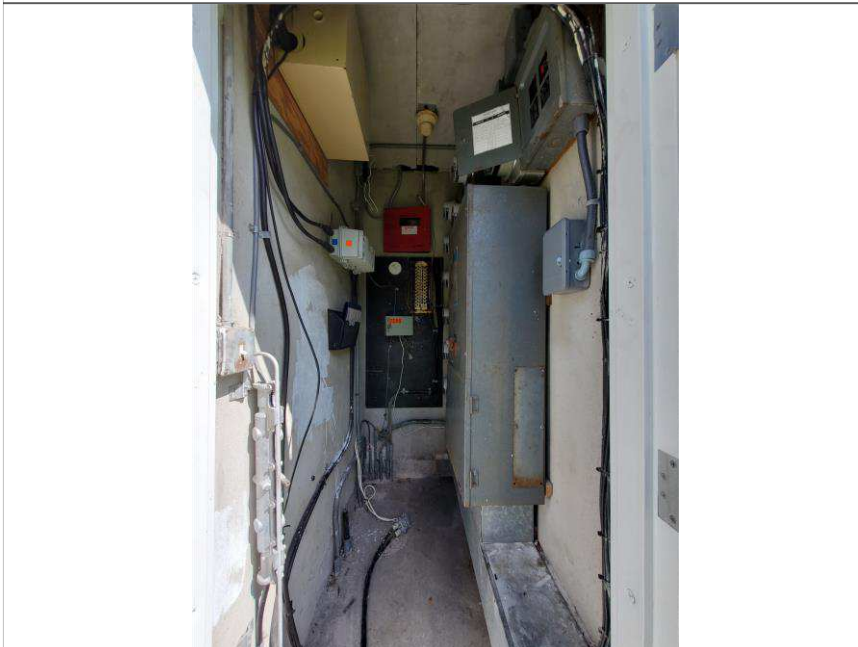
Photo 2 – Village of Dadeland Condominium Association

Existing Electrical Room - 1st FL
Main Switches for Apartments,
Meters, Gutter, and Fire Alarm
Panel

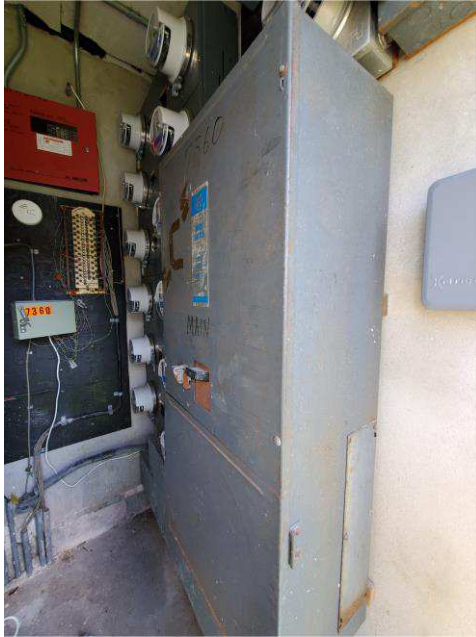
Photo 3 – Village of Dadeland Condominium Association

Existing Electrical Room - 1st FL
Building Main Disconnect
(front/side view) is considerably
oxidized.
50 year old electrical
component.

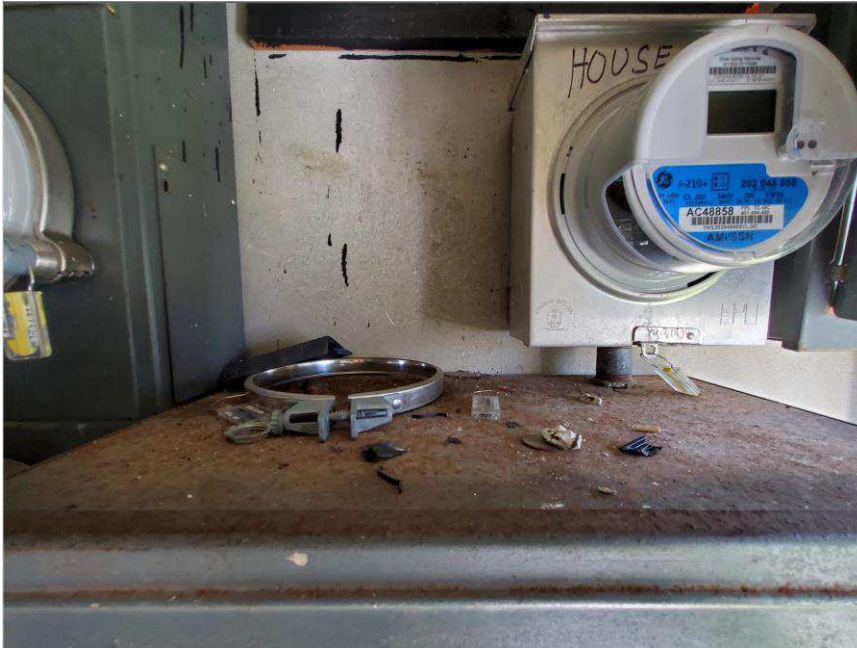
Photo 4 – Village of Dadeland Condominium Association

Existing Electrical Room - 1st FL
Building Main Disconnect (top
view) is considerably oxidized.
50 year old electrical
component.

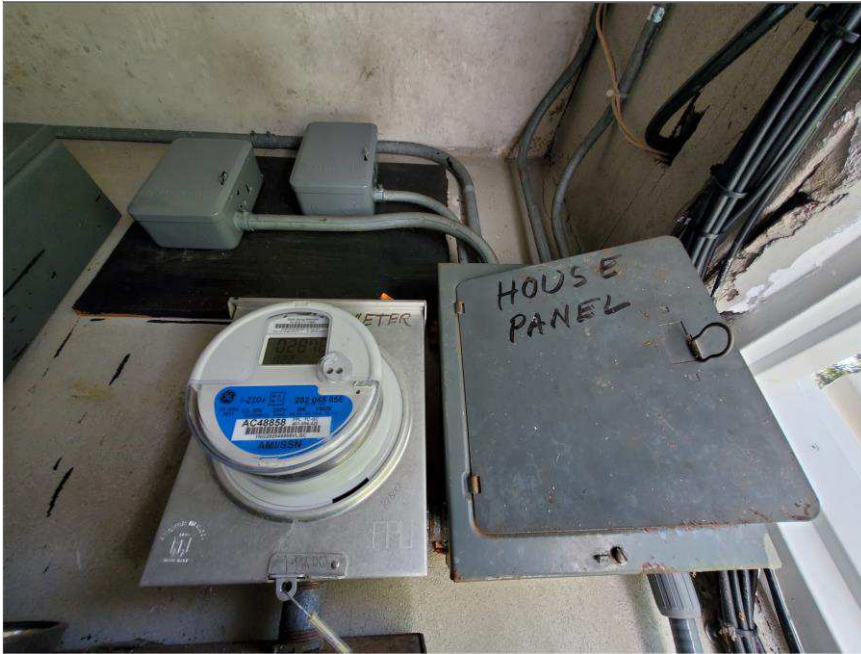
Photo 5 – Village of Dadeland Condominium Association

Existing Electrical Room - 1st FL
House Panel Board and Meter

Time Clocks installed too high.

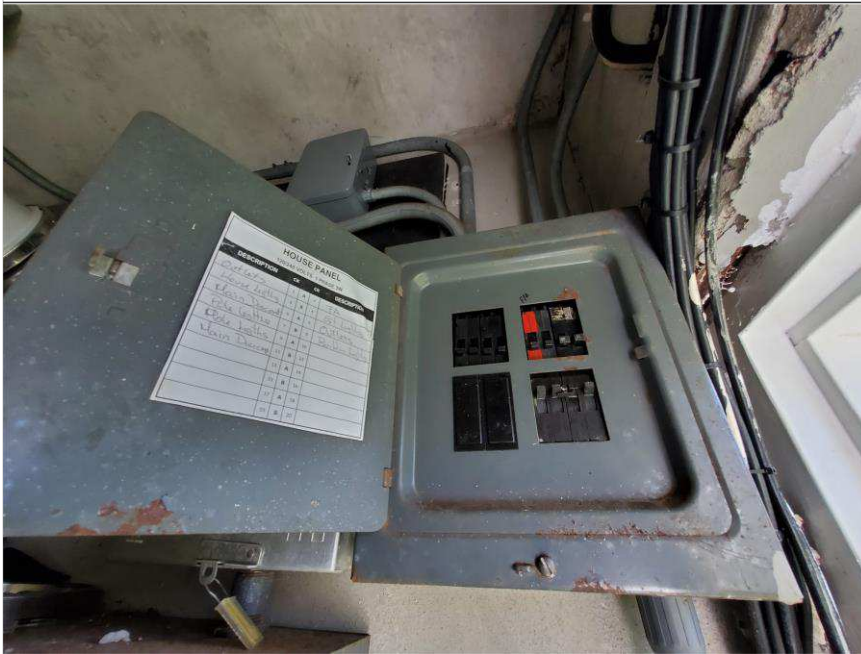
Photo 6 – Village of Dadeland Condominium Association

Existing Electrical Room - 1st FL
House Panel Board and
breakers are oxidized.
50 year old electrical
components.

Covered Name Plate Rating.

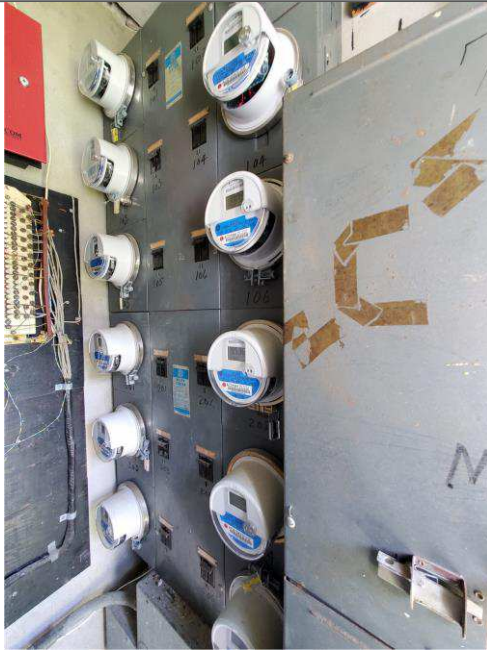
Photo 7 – Village of Dadeland Condominium Association

Existing Electrical Room - 1st FL
Apartment Meters and Main
Switches.

Old and oxidized meter stacks.

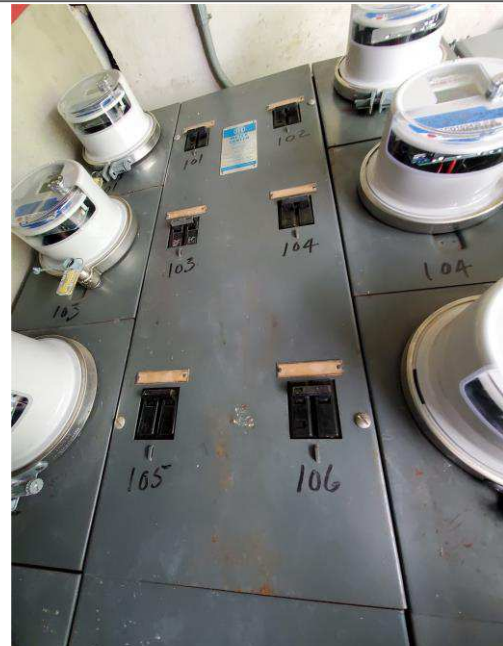
Photo 8 – Village of Dadeland Condominium Association

Existing Electrical Room - 1st FL
Apartment Meters and Main
switches.

Old and oxidized meter stacks.

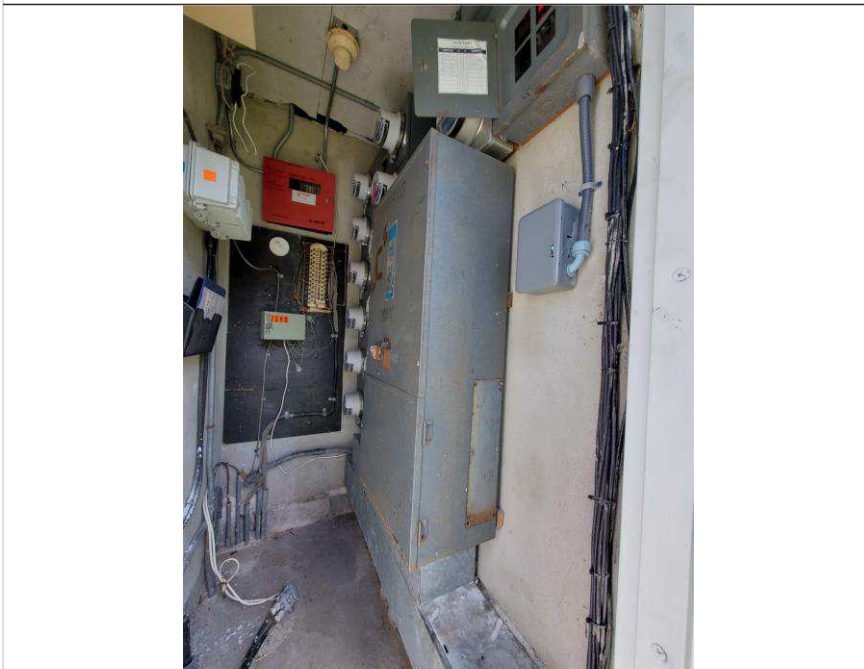
Photo 10 – Village of Dadeland Condominium Association

Existing Electric Room - 1st FL

Insufficient clearance at
electrical components.

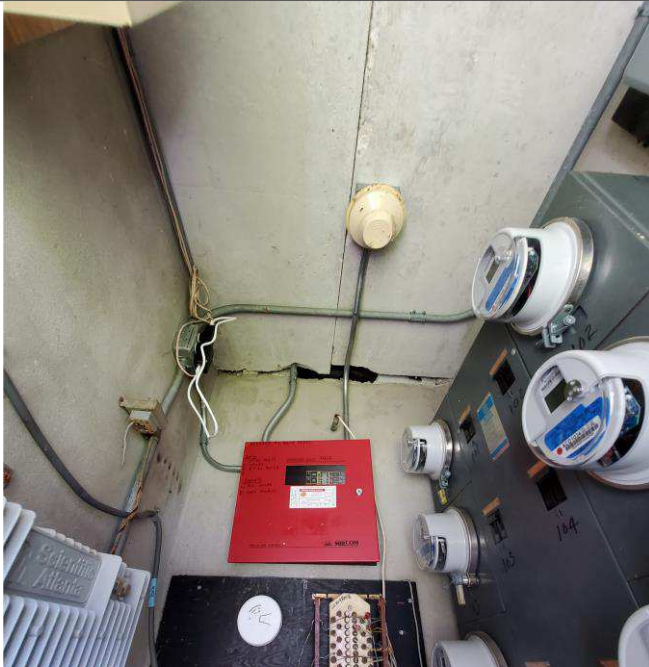
Photo 13 – Village of Dadeland Condominium Association

Existing Electrical Room - 1st FL
Fire Alarm Panel

All penetrations or openings in
walls are to be fire caulked.

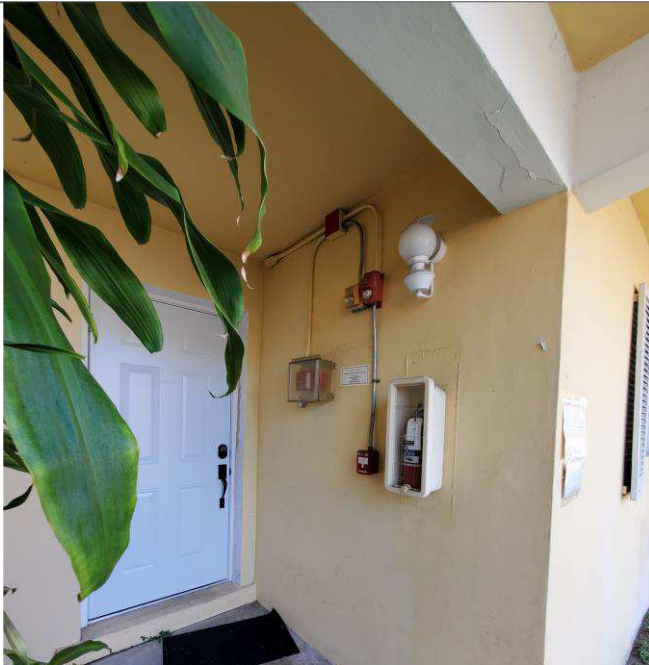
Photo 14 – Village of Dadeland Condominium Association

Level 1
Fire Alarm - Old and Weathered
Fire Alarm Devices and Control
Center

Old Strobe Horn/Strobe Device

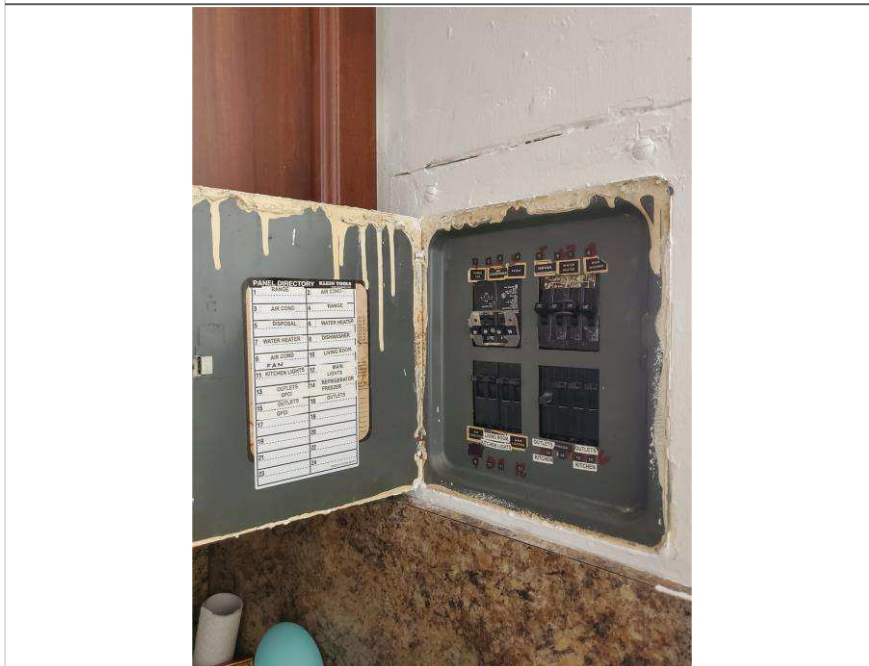
Photo 18 – Village of Dadeland Condominium Association

Apartments - Old Electrical Panels

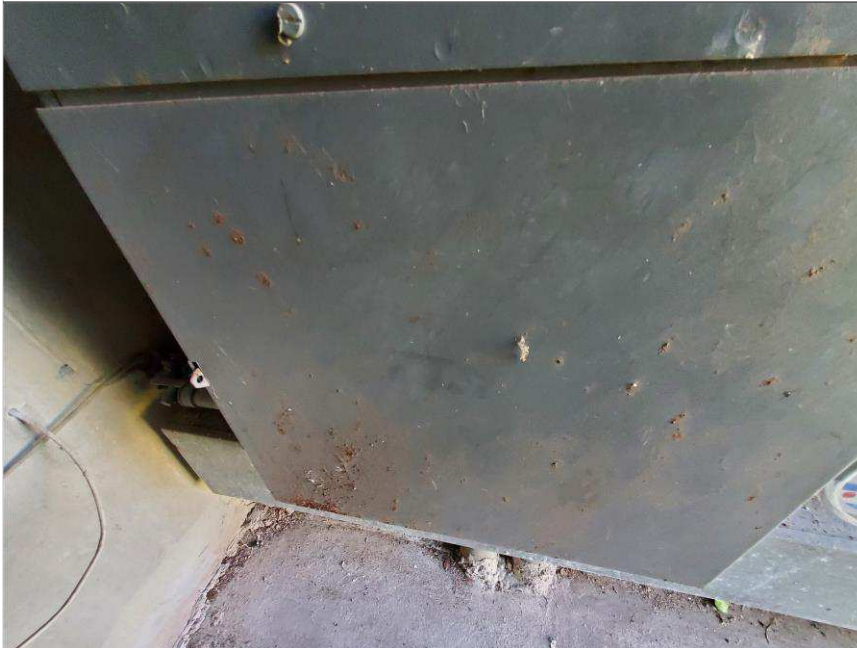
Photo 4 – Village of Dadeland Condominium Association

Existing Electrical Room - 1st FL
Building Main Disconnect is
considerably oxidized.
50 year old electrical
component.

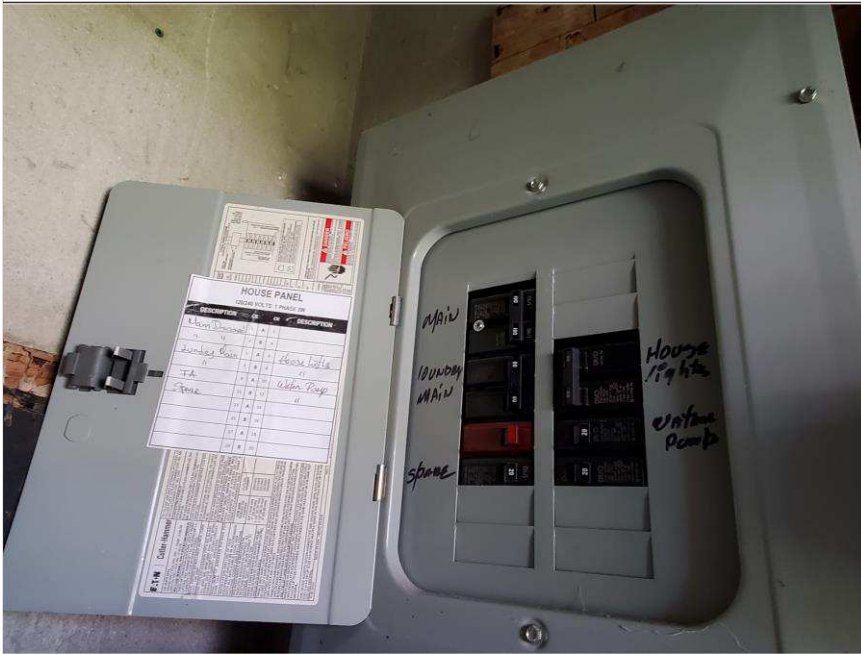
Photo 6 – Village of Dadeland Condominium Association

Existing Electrical Room - 1st FL
House Panel Board

Name Plate covered.

Time clocks installed very high.

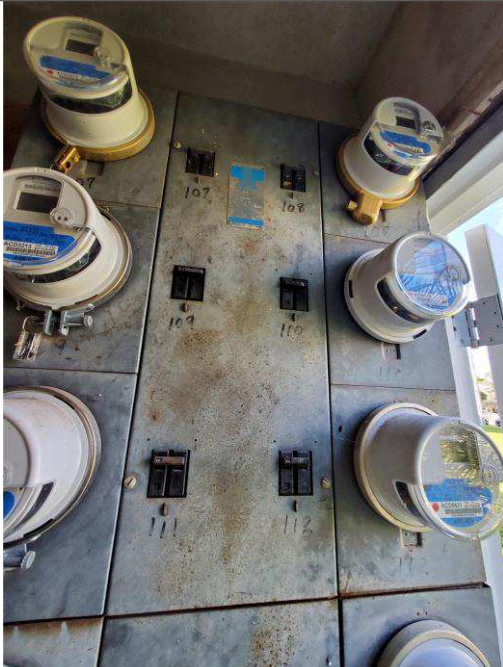
Photo 9 – Village of Dadeland Condominium Association

Existing Electrical Room - 1st FL
Main Switches and Meters for
Apartments.

Old and oxidized meter stacks.

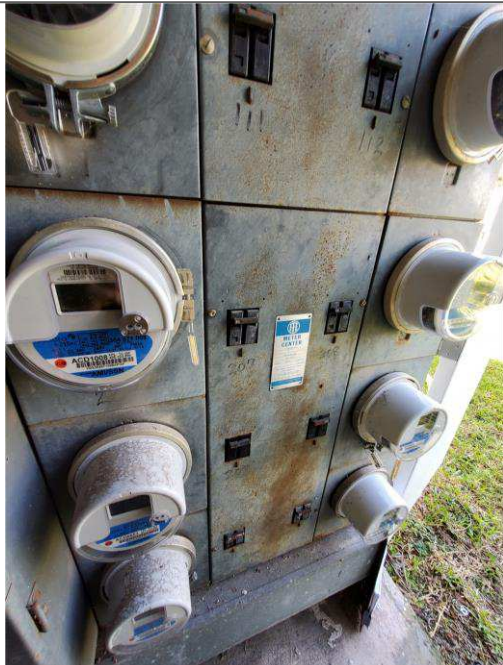
Photo 10 – Village of Dadeland Condominium Association

Existing Electrical Room - 1st FL
Main Switches, Meters, and
Gutter.

Old and oxidized meter stacks
and breakers.

Oxidized gutter.

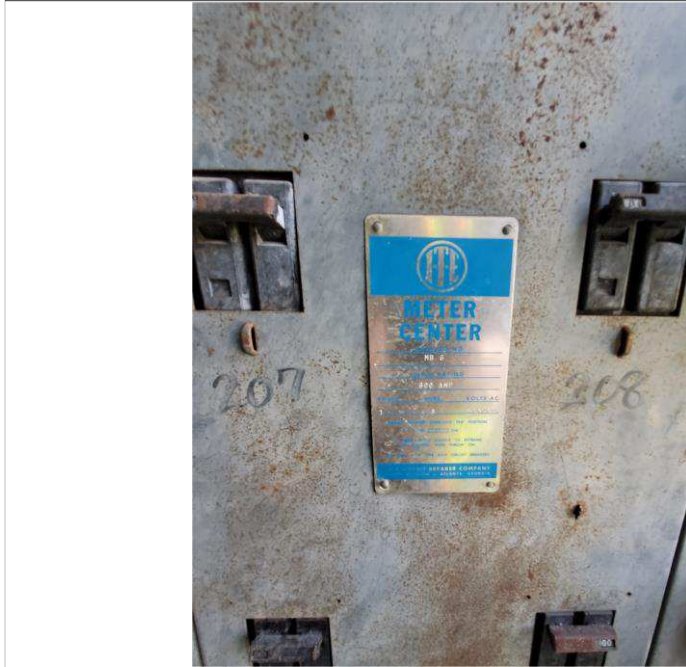
Photo 11 – Village of Dadeland Condominium Association

Existing Electrical Room - 1st FL
Apartment Meters and Main
Switches

Old and oxidized meter stacks
and gutter.

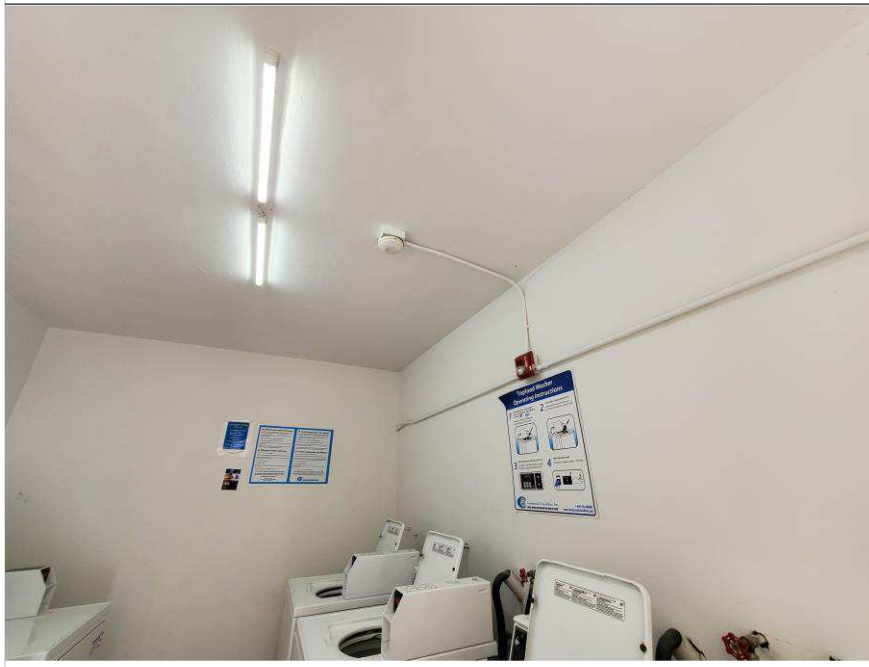
Photo 20 – Village of Dadeland Condominium Association

Laundry Room -
Old smoke detector.

Comments: All old smoke detectors to be replaced. Smoke detectors to be installed and maintained in all .
main electric rooms. Apartments - Not all apartments have smoke detectors in the living room, hallways,
and/or bedrooms. As observed in Units E211, all other units to be verified for compliance.

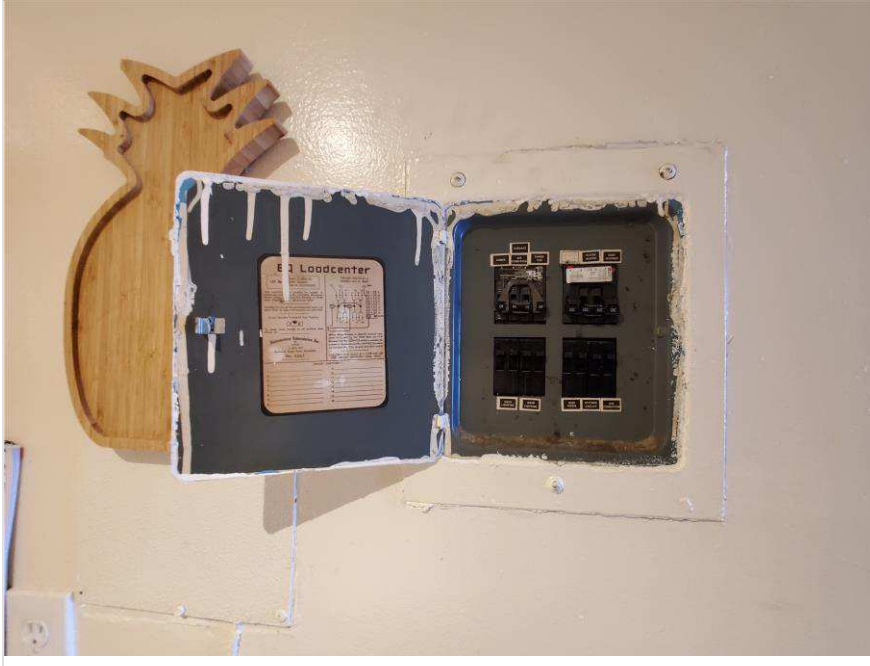
Photo 22 – Village of Dadeland Condominium Association

Apartments - Old Electrical
Panels

| 9. Electrical Panels in the apartments have considerable oxidation and are to be replaced. |

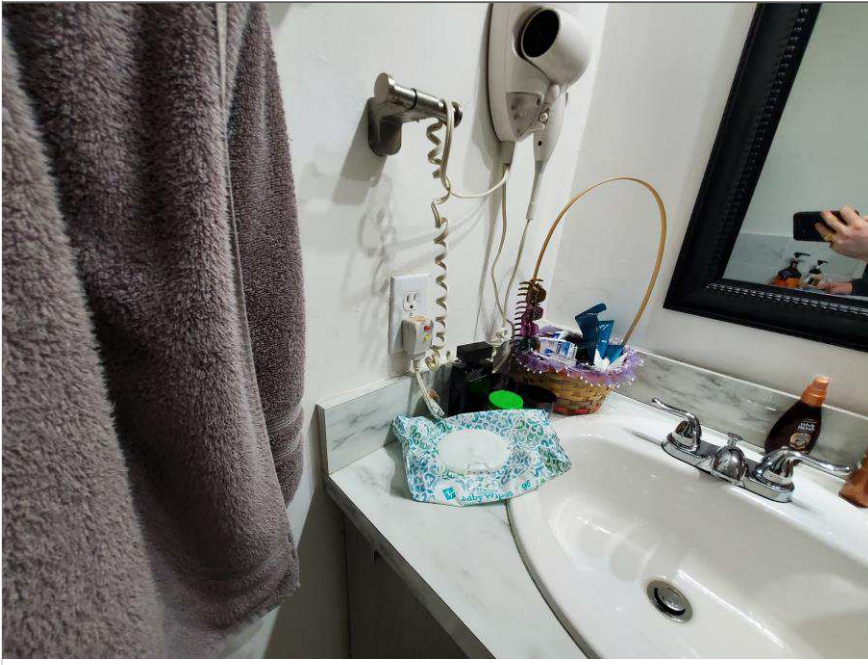
Photo 24 – Village of Dadeland Condominium Association

Apartments - Bathroom outlets
not GFCI type

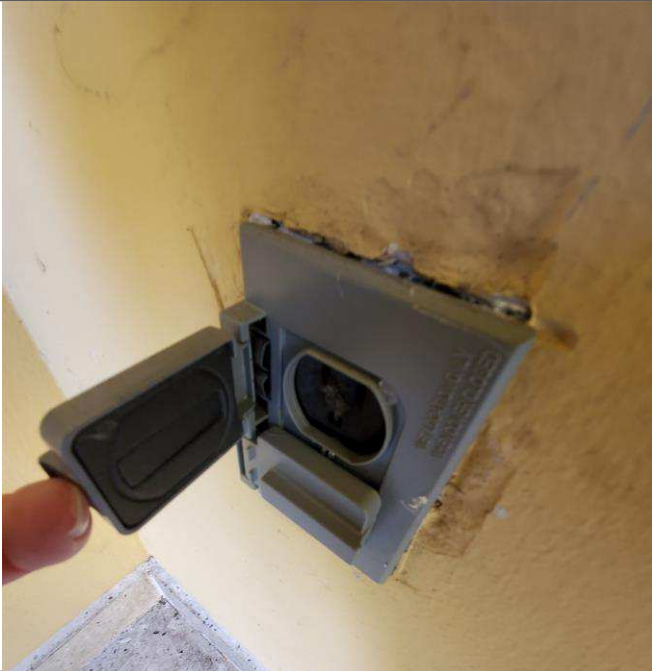
Photo 25 – Village of Dadeland Condominium Association

Apartments - Balcony outlets
not GFCI type.

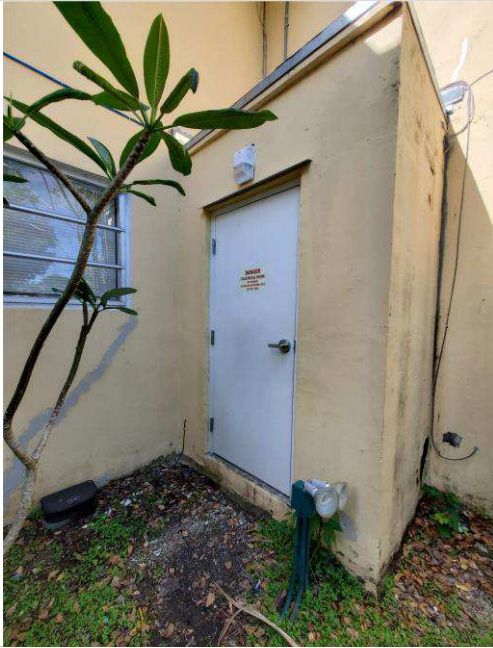
Photo 1 – Village of Dadeland Condominium Association

Existing Electrical Room - 1st FL
No Storage Permitted
Provide sign with Building
Number

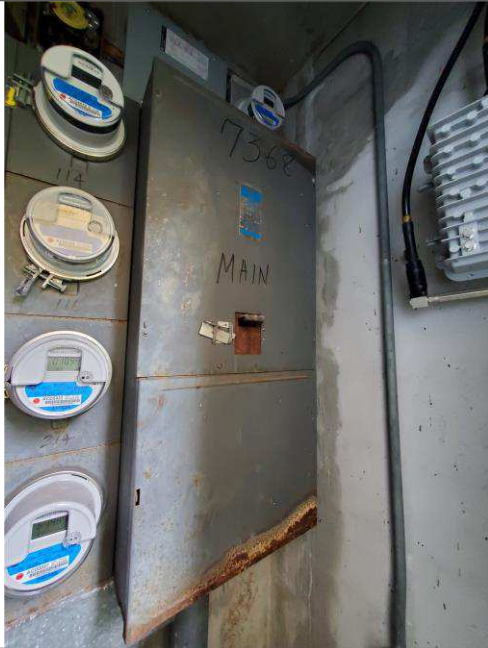
Photo 3 – Village of Dadeland Condominium Association

Existing Electrical Room - 1st FL
Building Main Disconnect is
considerably oxidized.
50 year old electrical
component.

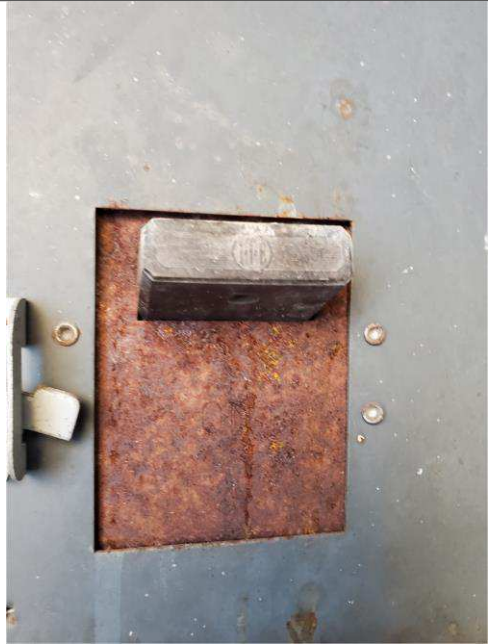
Photo 4 – Village of Dadeland Condominium Association

Existing Electrical Room - 1st FL
Building Main Disconnect is
considerably oxidized.
50 year old electrical
component.

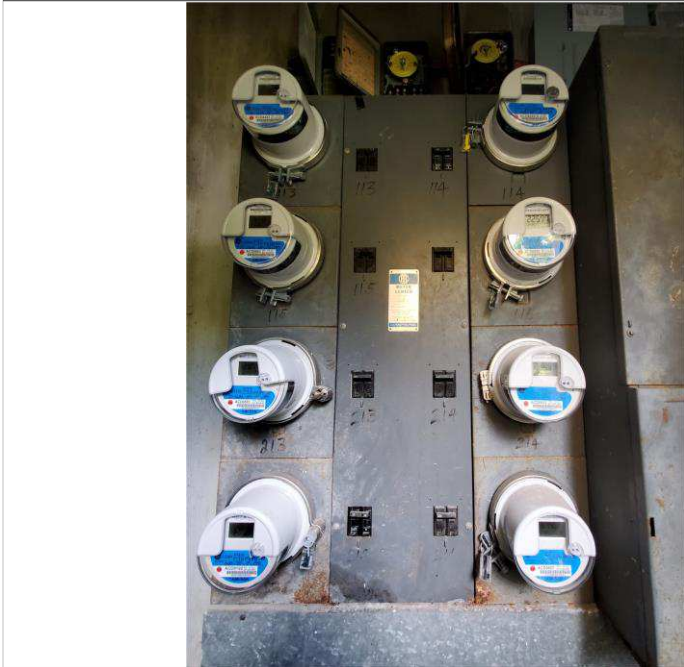
Photo 7 – Village of Dadeland Condominium Association

Existing Electrical Room - 1st FL
Apartment Meters, Main
Switches and Gutter.

Old and oxidized meter stacks.

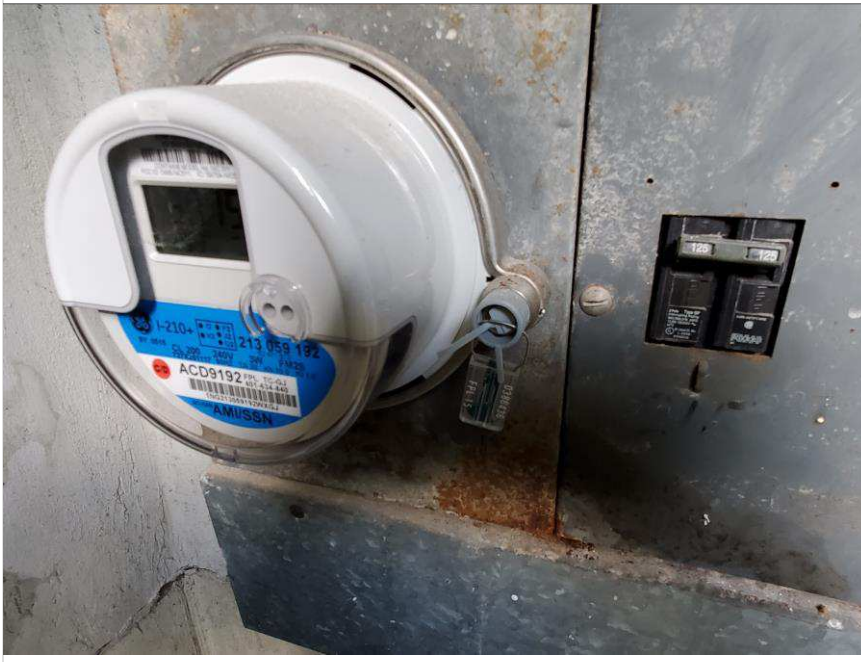
Photo 8 – Village of Dadeland Condominium Association

Existing Electrical Room - 1st FL
Apartment Meters, Main
Switches and Gutter.

Old and oxidized meter stacks.

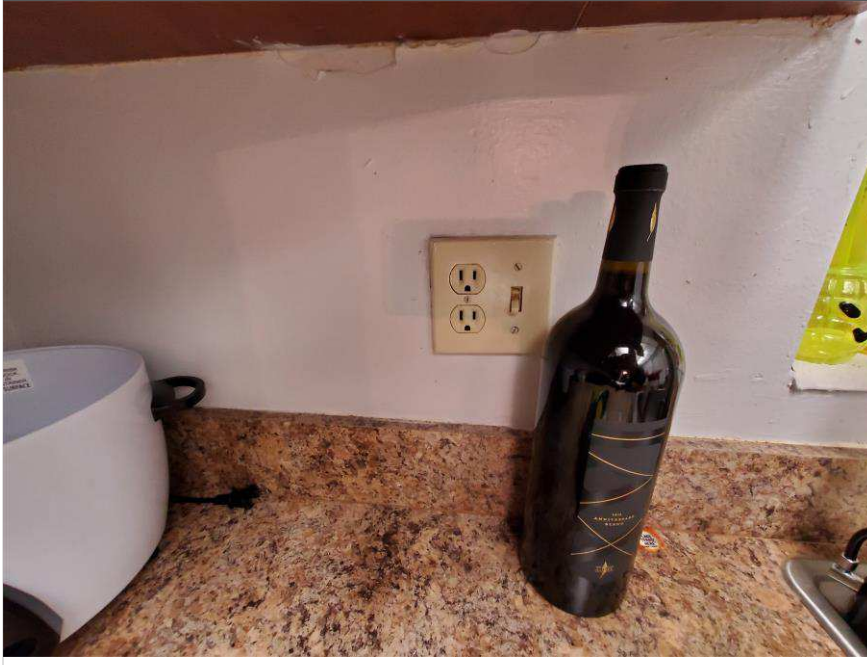
Photo 15 – Village of Dadeland Condominium Association

Apartments - Kitchen outlets
not GFCI type

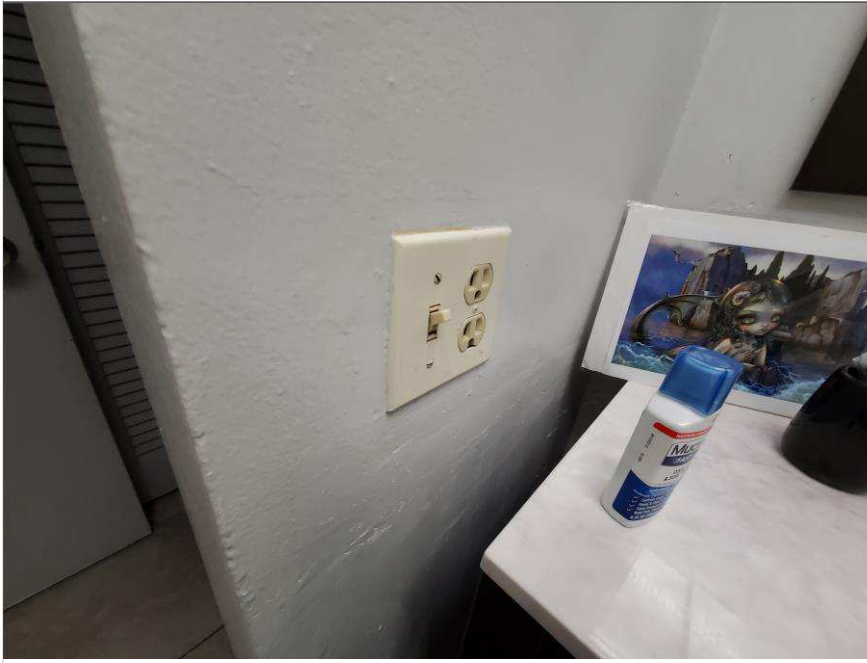
Photo 16 – Village of Dadeland Condominium Association

Apartments - Bathroom outlets
not GFCI type

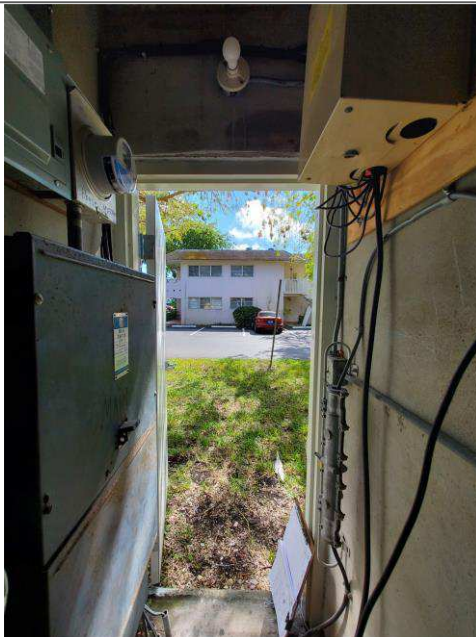
Photo 4 – Village of Dadeland Condominium Association

Existing Electrical Room - 1st FL
Main Disconnect

Insufficient clearance in front of
Main Disconnect.

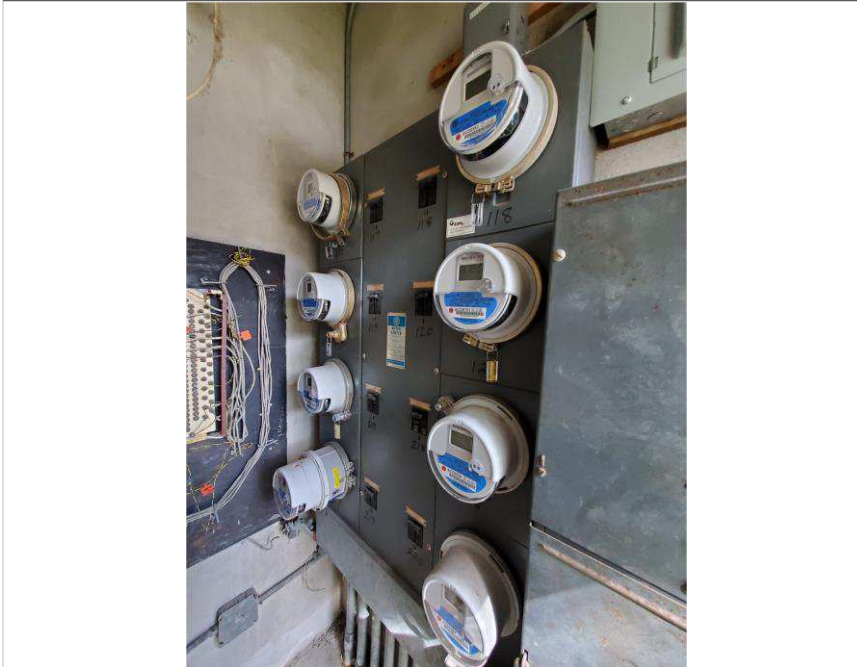
Photo 7 – Village of Dadeland Condominium Association

Existing Electrical Room - 1st FL
Main Switches for Apartments,
Meters, and Gutter.

Old and oxidized meter stacks.

Time clocks are installed too
high.

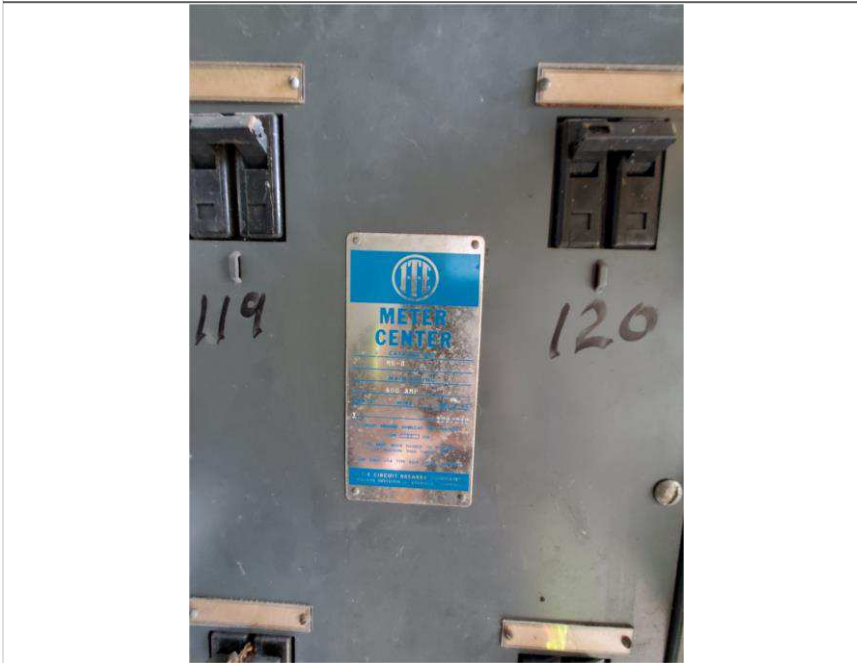
Photo 8 – Village of Dadeland Condominium Association

Existing Electrical Room - 1st FL
Main Switches for Apartments

Old and oxidized meter stacks.

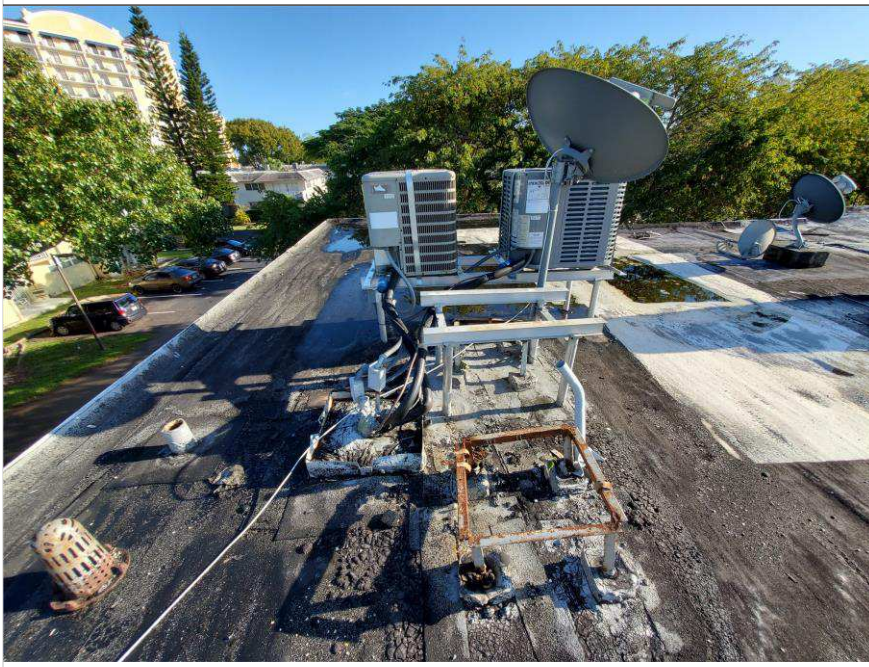
Photo 12 – Village of Dadeland Condominium Association

Rooftop Condenser Units -
Oxidized junction boxes and
conduits.

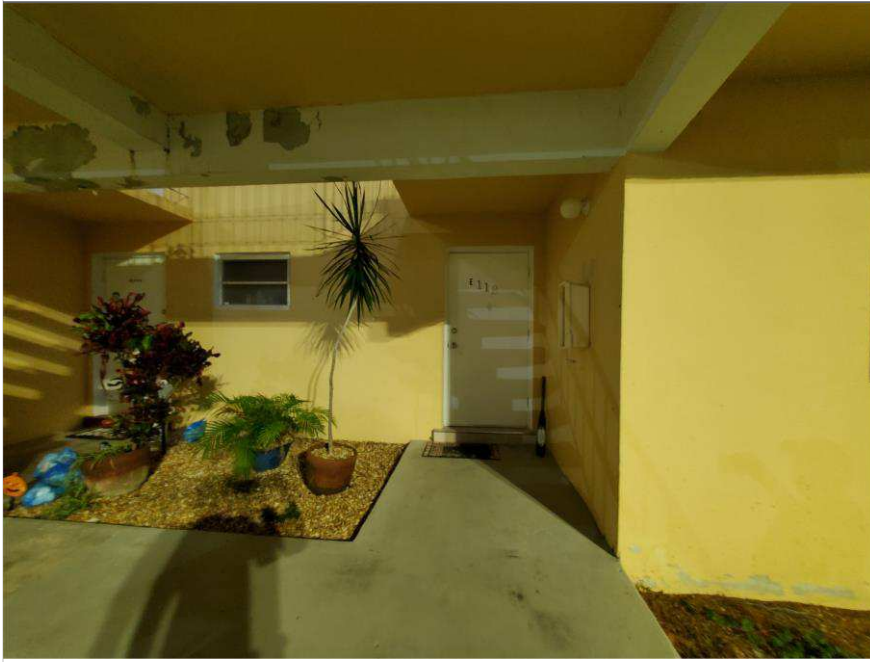
Photo 13 – Village of Dadeland Condominium Association

Catwalks

Poorly illuminated sidewalks.
Exterior lights not functional

Light out at point of egress.

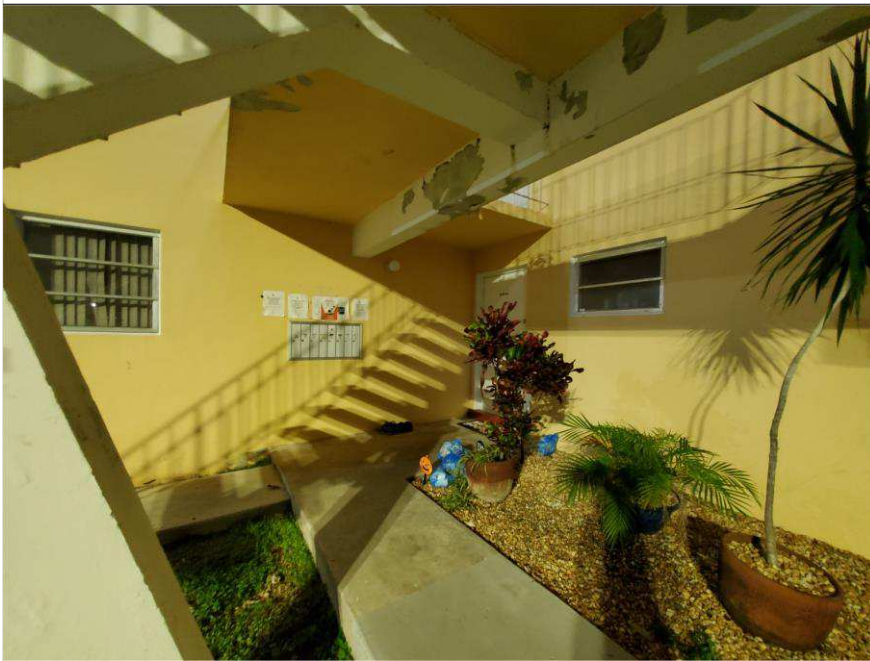
Photo 14 – Village of Dadeland Condominium Association

Catwalks

Poorly illuminated sidewalks.
Exterior light not functional
