MINIMUM INSPECTION PROCEDURAL GUIDELINES FOR BUILDING ELECTRICAL RECERTIFICATION

Table with 1 column and 13 rows containing structure details: a. Name on Title: Village at Dadeland Condominiums (D), b. Street Address: 7420 SW 82nd St. Miami, Florida 33143, c. Legal Description: Village at Dadeland Condominiums, d. Owner's Name: Village at Dadeland Condominiums, e. Owner's Mailing Address: 7420 SW 82nd St. Miami, Florida 33143, f. Folio Number of Property on which Building is Located: 30-4035-047-XXXX, g. Building Code Occupancy Classification: R2 - Residential, h. Present Use: Condominium, Residential, i. General Description, Type of Construction, Size, Number of Stories, and Special Features. Additional Comments: The condominium building was built in 1968. Is a two story building comprised of concrete slab on compacted grade and stucco covered cmu exterior load bearing wall. The second floor catwalk consists of pre-cast concrete slabs, concrete tie columns and tie beams along exterior walls up to the roof level. The roof is a low slope roof and comprised of timber trusses and plywood decking covered with a bituminous asphalt membrane. At the perimeter of the roof there are timber

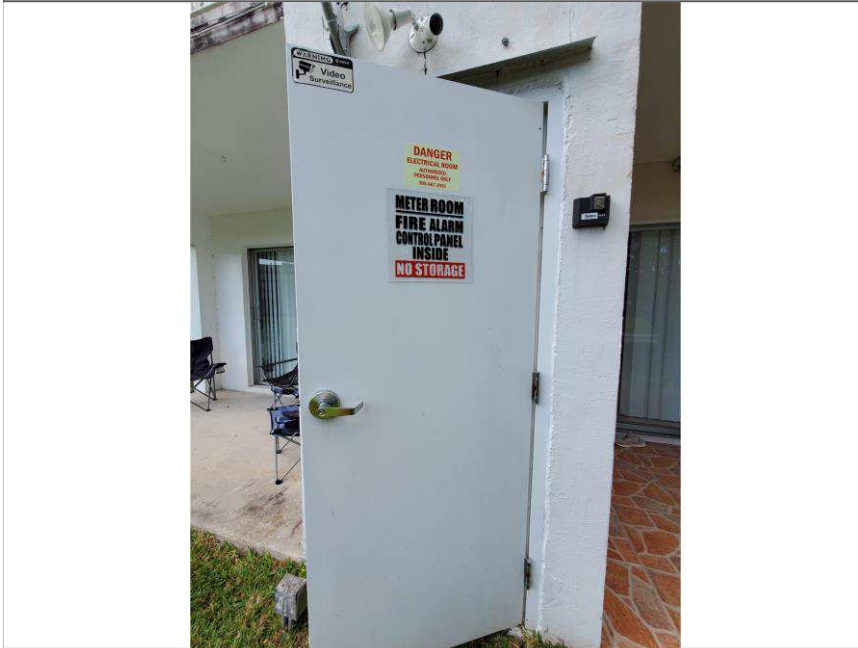
Photo 1 – Village of Dadeland Condominium Association

Existing Electrical Room - 1st FL  
Provide sign with Building  
Number

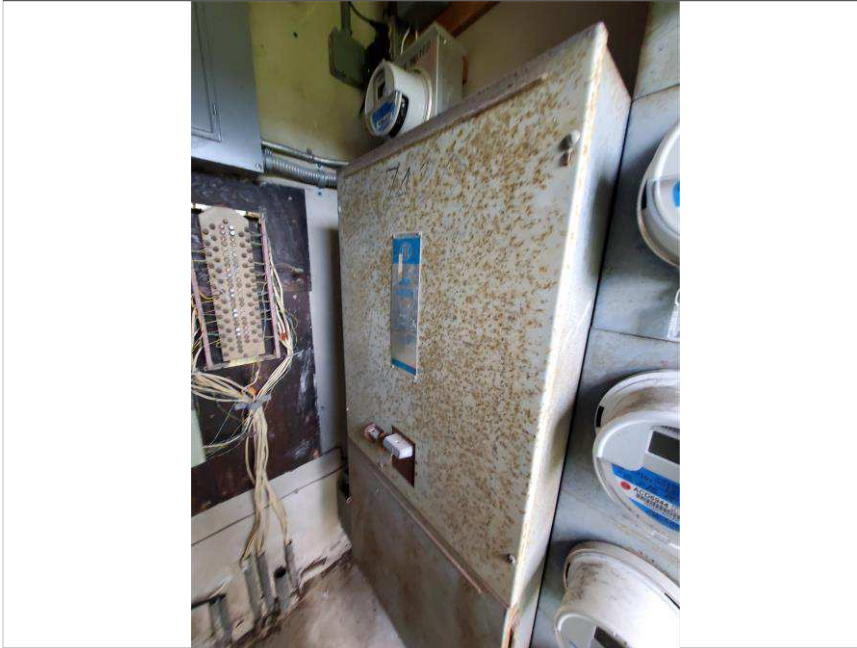
Photo 3 – Village of Dadeland Condominium Association

Existing Electrical Room - 1st FL  
Building Main Disconnect is  
considerably oxidized.  
50 year old electrical  
component.

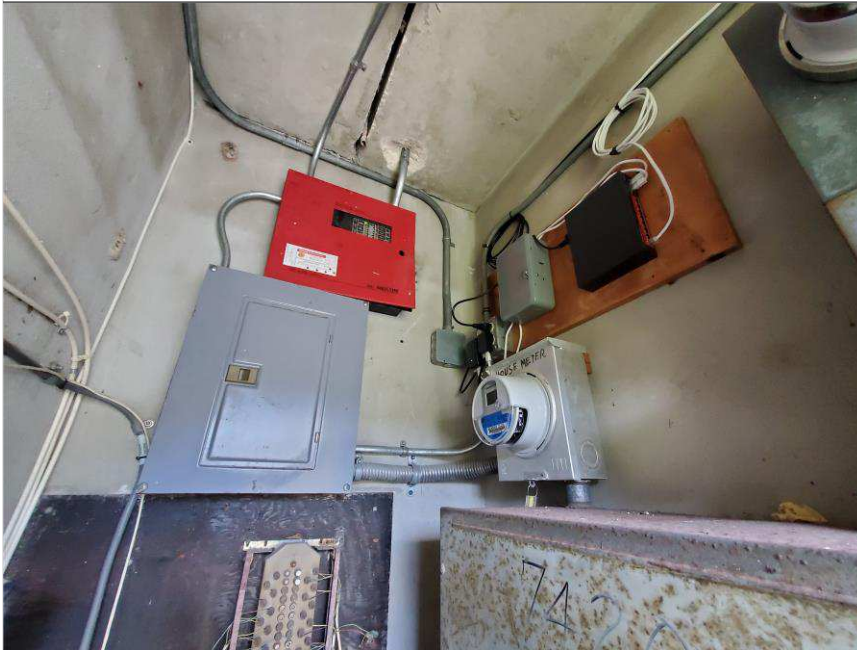
Photo 4 – Village of Dadeland Condominium Association

Existing Electrical Room - 1st FL  
Building Main Disconnect is  
considerably oxidized.  
50 year old electrical  
component.

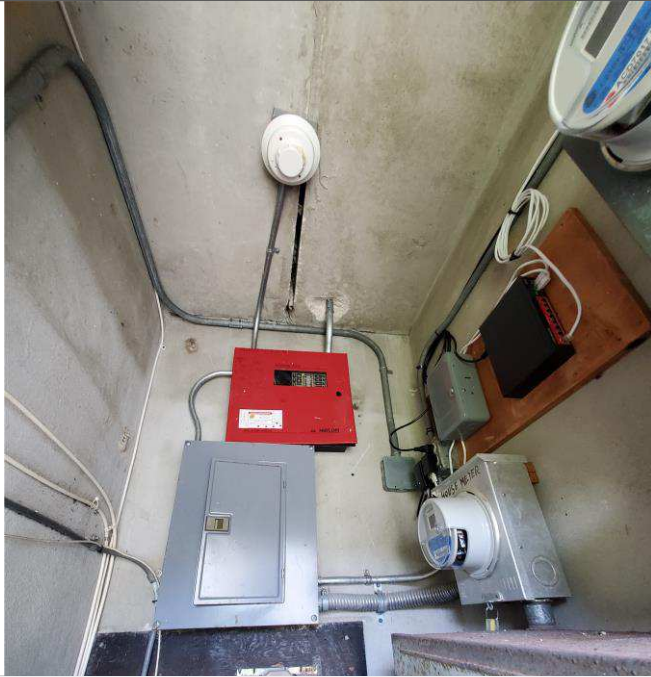
Photo 5 – Village of Dadeland Condominium Association

Existing Electrical Room - 1st FL  
House Panel Board and Meter.

Time Clocks installed too high.

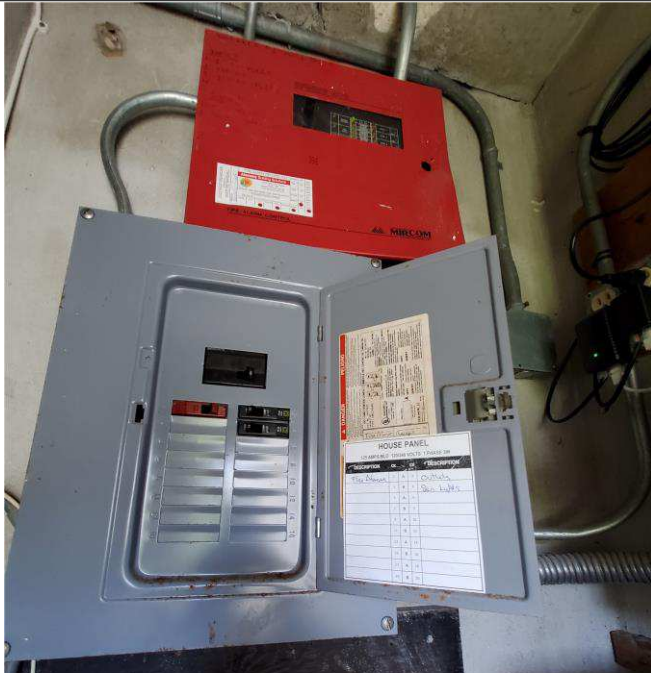
Photo 6 – Village of Dadeland Condominium Association

Existing Electrical Room - 1st FL  
House Panel Board and  
breakers are oxidized.  
50 year old electrical  
components.

Covered Name Plate Rating.

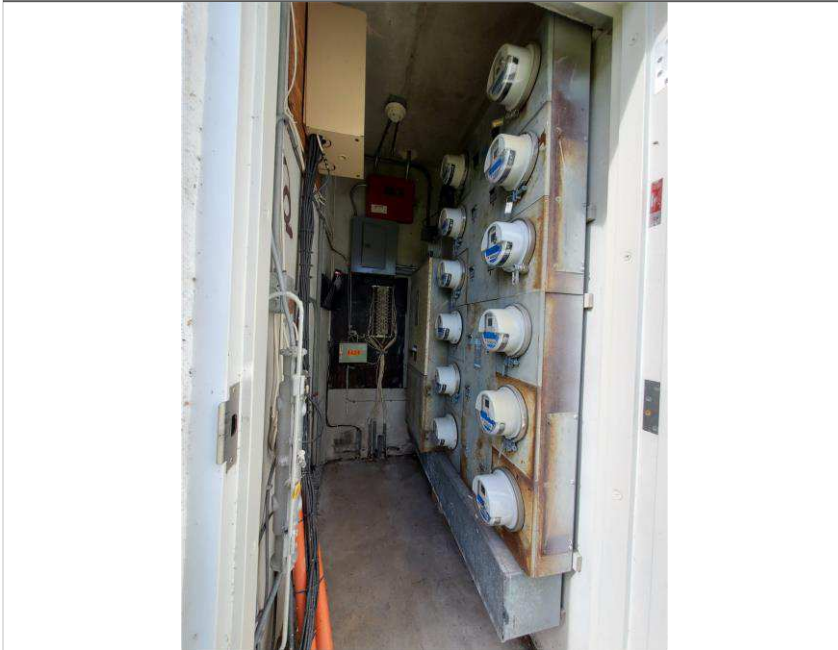
Photo 7 – Village of Dadeland Condominium Association

Existing Electrical Room - 1st FL  
Apartment Meters, Main  
Switches and Gutter.

Old and oxidized meter stacks.

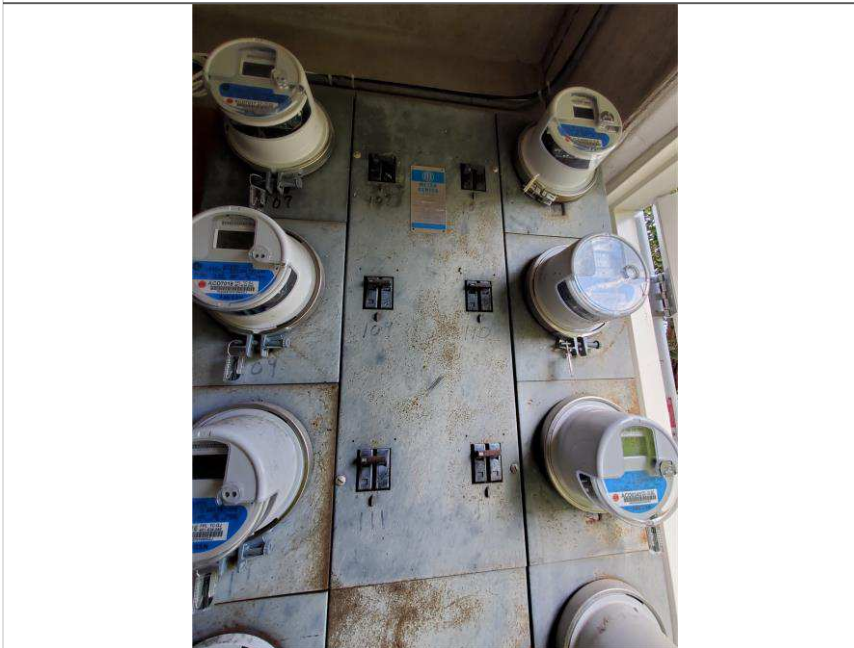
Photo 8 – Village of Dadeland Condominium Association

Existing Electrical Room - 1st FL  
Apartment Meters, Main  
switches and Gutter

Old and oxidized meter stacks.

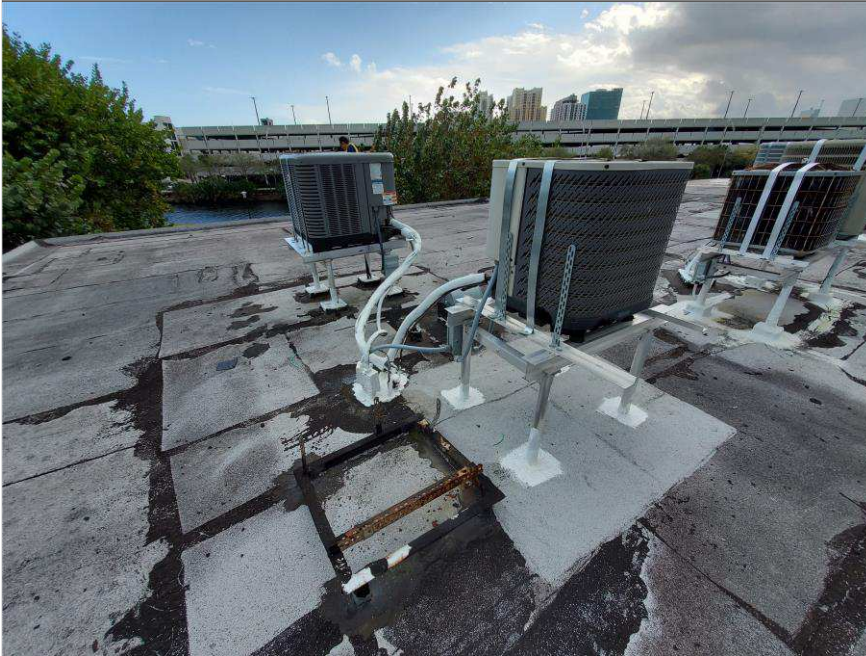
Photo 12 – Village of Dadeland Condominium Association

Rooftop Condenser Units -

Junction boxes not properly supported and not completely sealed.

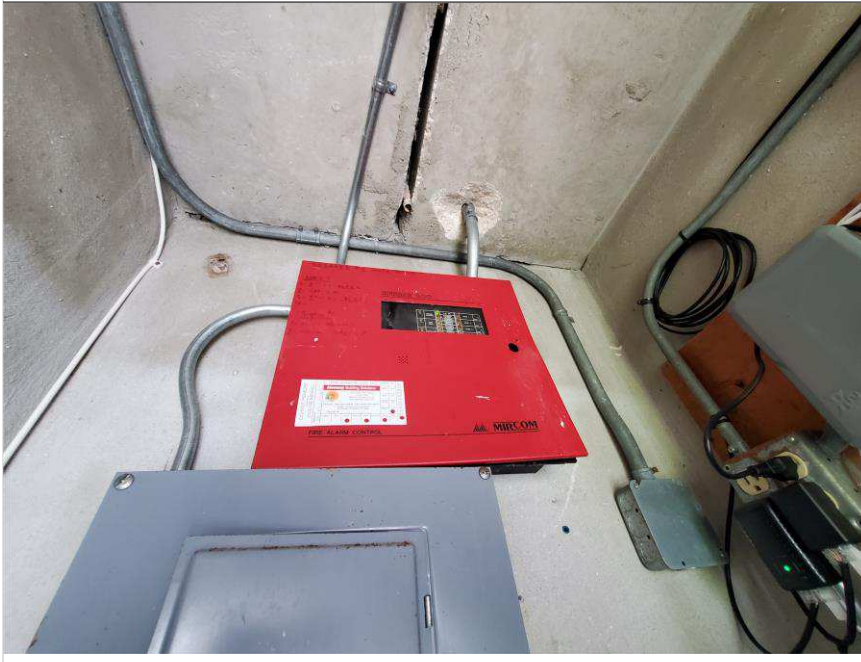
Photo 13 – Village of Dadeland Condominium Association

Existing Electrical Room - 1st FL  
Fire Alarm Panel

Fire Alarm Panel installed too high.

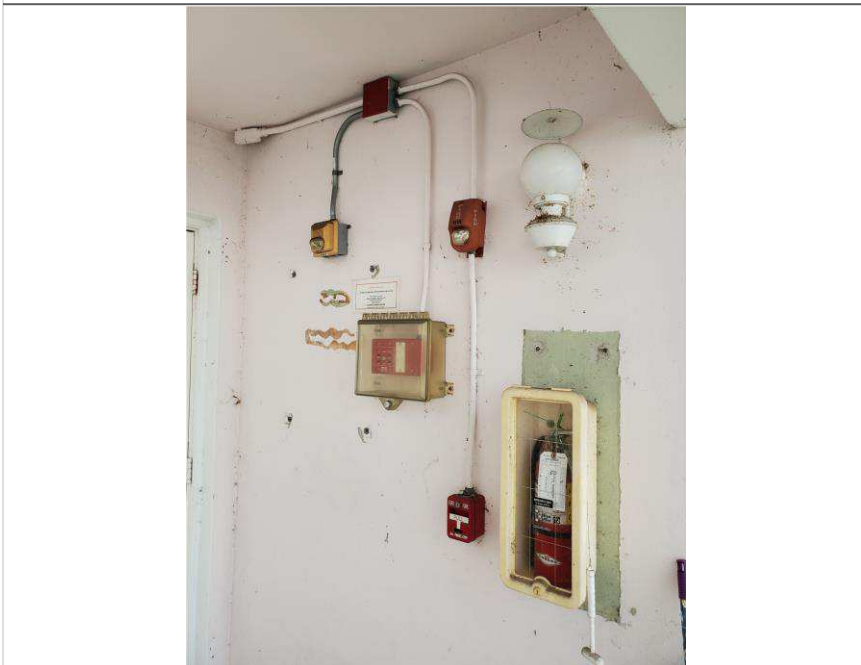
Photo 14 – Village of Dadeland Condominium Association

Level 1  
Fire Alarm Devices and Control  
Center  
Fire Alarm - Old and Weathered  
Old Strobe Horn/Strobe Device

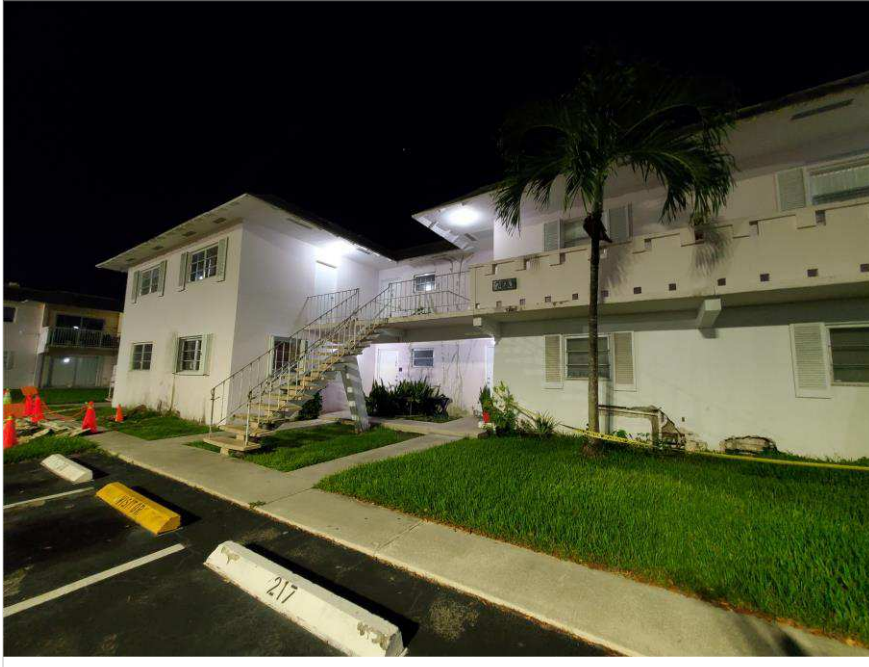
Photo 17 – Village of Dadeland Condominium Association

Catwalks - Poorly illuminated.  
Building Points of Egress and  
Catwalks - Light Fixture are too  
far apart, and some exterior  
lights not functional.

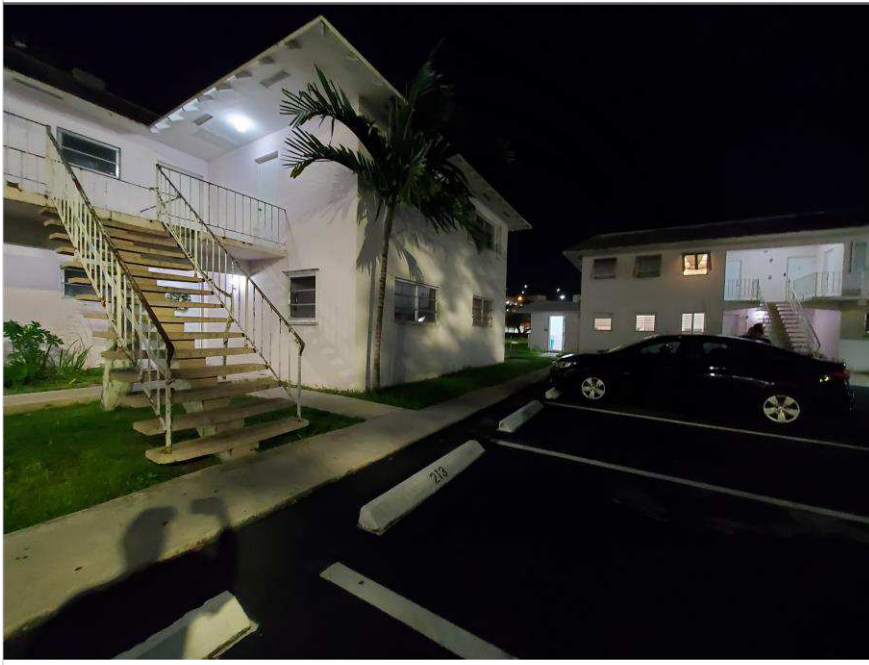
Photo 18 – Village of Dadeland Condominium Association

Parking - Poorly illuminated.  
Exterior lights not functional.  
Insufficient illumination at stairs.

Comments: Open parking areas have low illumination levels creating unsafe conditions and security concerns. Additional lighting is required to illuminate the parking walking surfaces for safety and security purposes. Parking light mounted on building is out - Repairs Required.

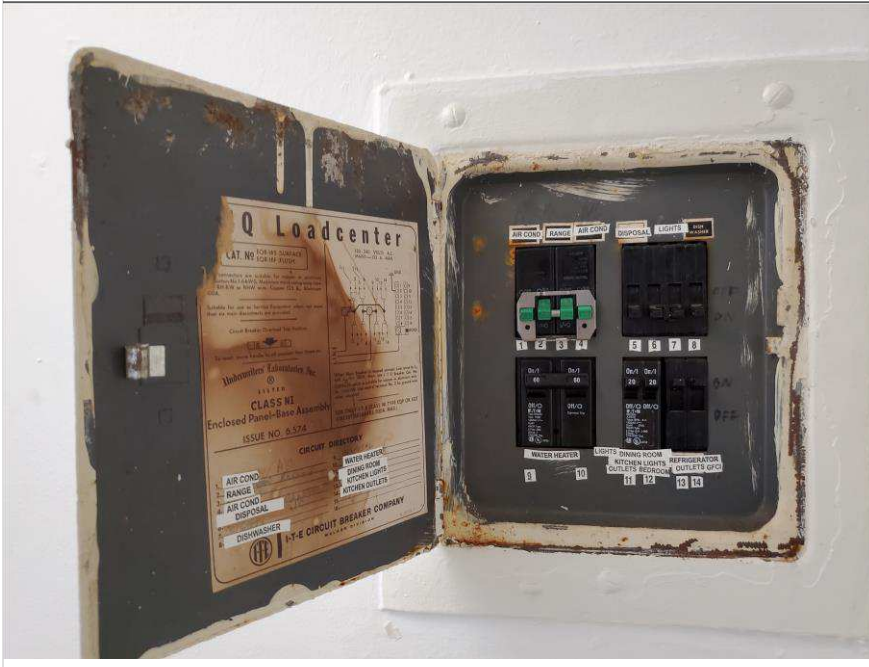
Photo 20 – Village of Dadeland Condominium Association

Apartments - Old Electrical Panels

9. Electrical Panels in the apartments have considerable oxidation and are to be replaced.

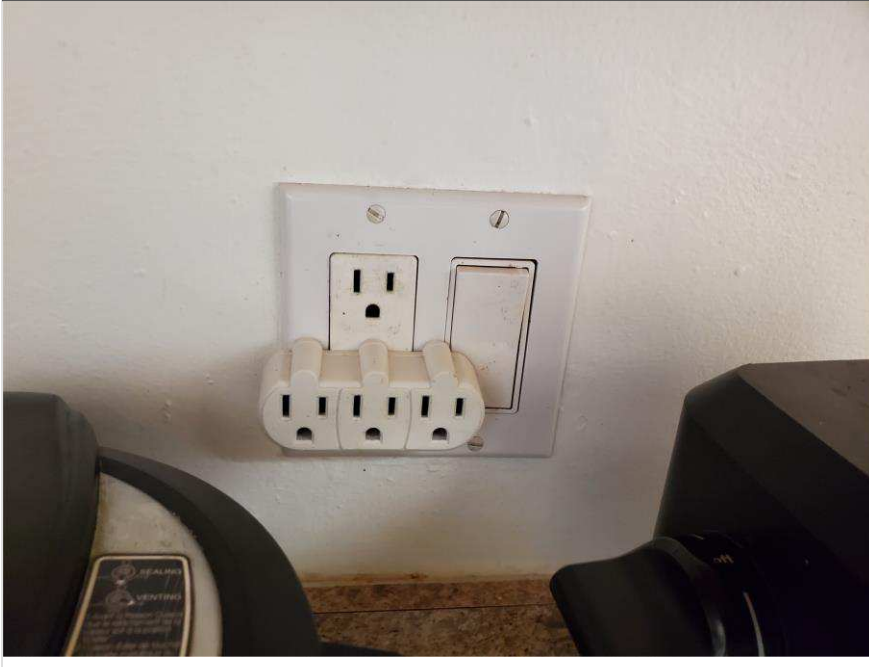
Photo 21 – Village of Dadeland Condominium Association

Apartments - Kitchen outlets  
not GFCI type

3. Unit D113, D213 - Kitchen outlets are not GFCI type , Repairs Required

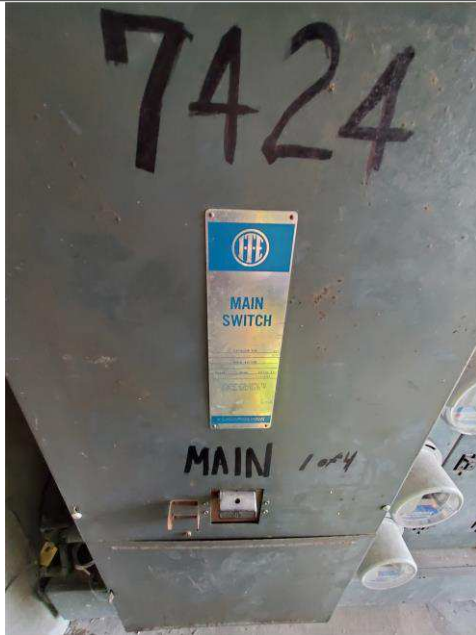
Photo 4 – Village of Dadeland Condominium Association

Existing Electrical Room - 1st FL  
Building Main Disconnect is  
considerably oxidized.  
50 year old electrical  
component.

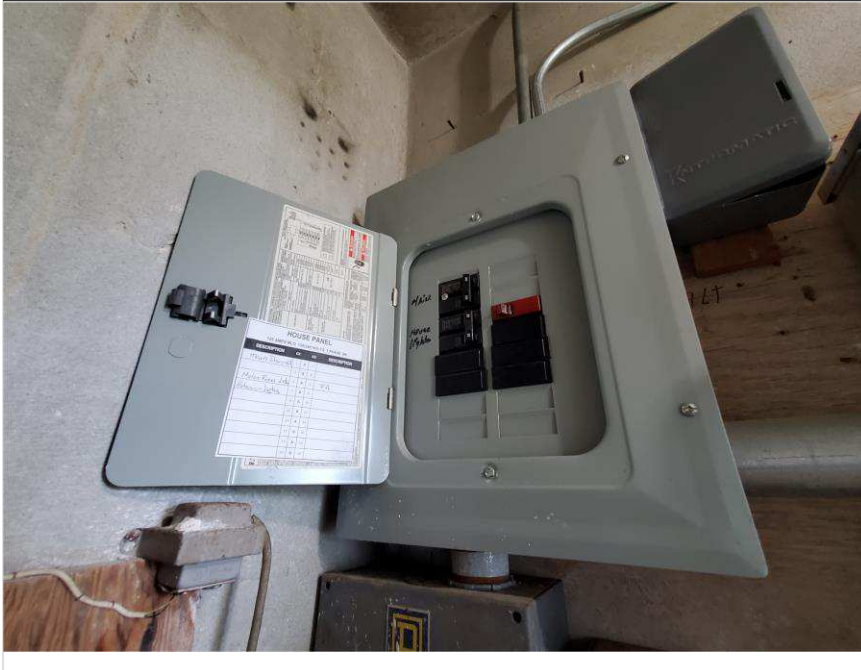
Photo 6 – Village of Dadeland Condominium Association

Existing Electrical Room - 1st FL  
House Panel Board

Name Plate covered.

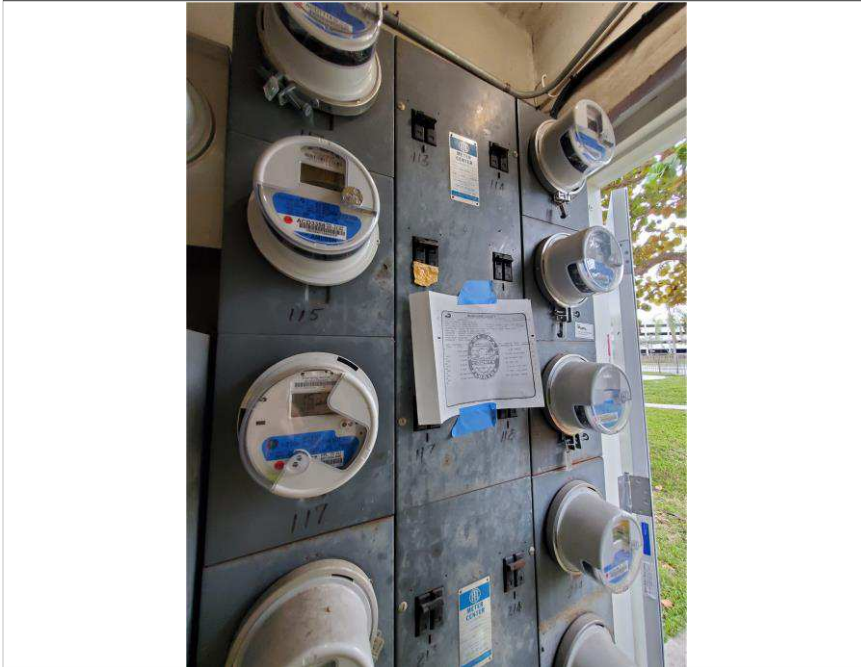
Photo 9 – Village of Dadeland Condominium Association

Existing Electrical Room - 1st FL  
Main Switches for Apartments,  
Meters, and Gutter.

Old and oxidized meter stacks.

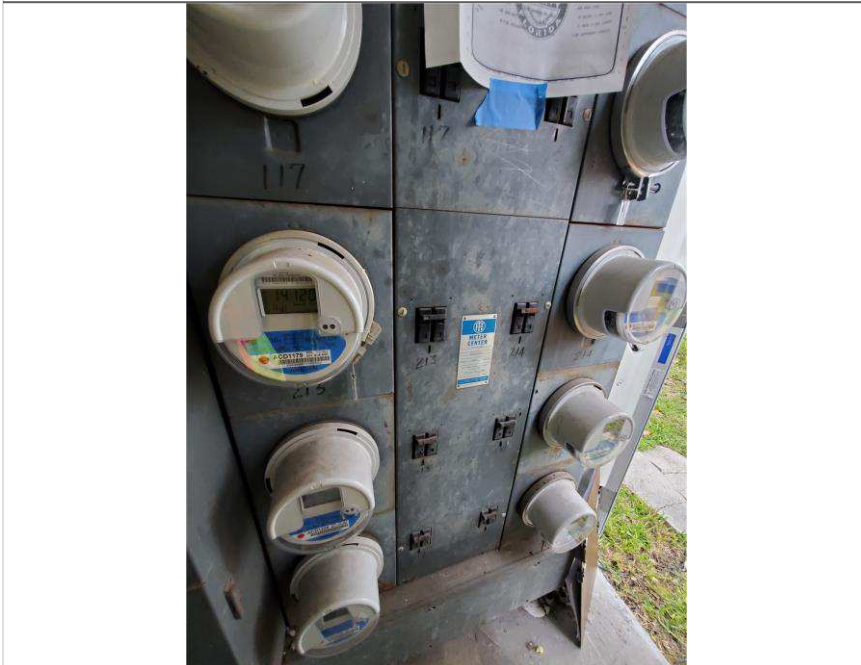
Photo 10 – Village of Dadeland Condominium Association

Existing Electrical Room - 1st FL  
Main Switches for Apartments,  
Meters, and Gutter.

Old and oxidized meter stacks  
and breakers.

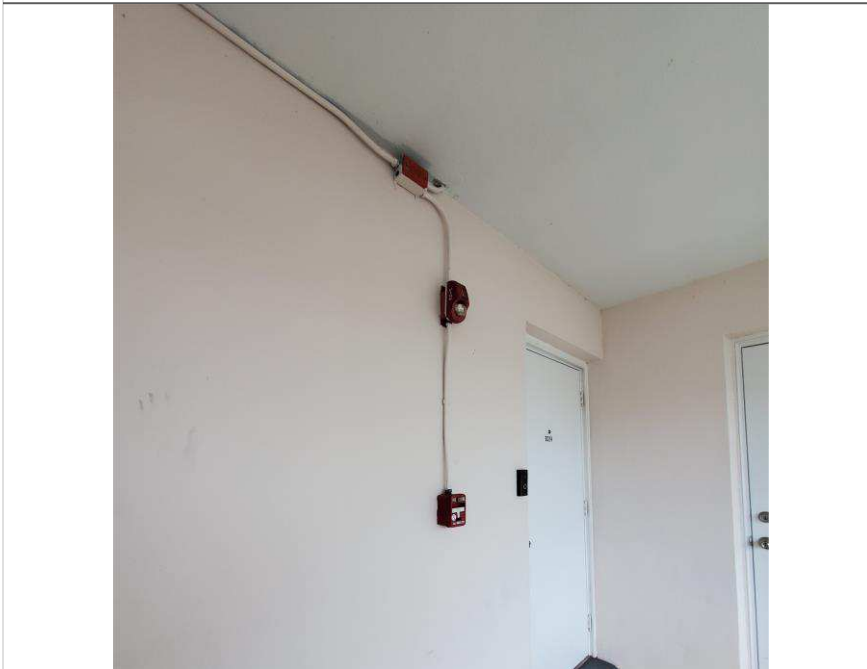
Photo 18 – Village of Dadeland Condominium Association

Level 2  
Fire Alarm - Old and Weathered  
Fire Alarm Devices and Control  
Center

Old Strobe Horn/Strobe Device  
and Pull Stations

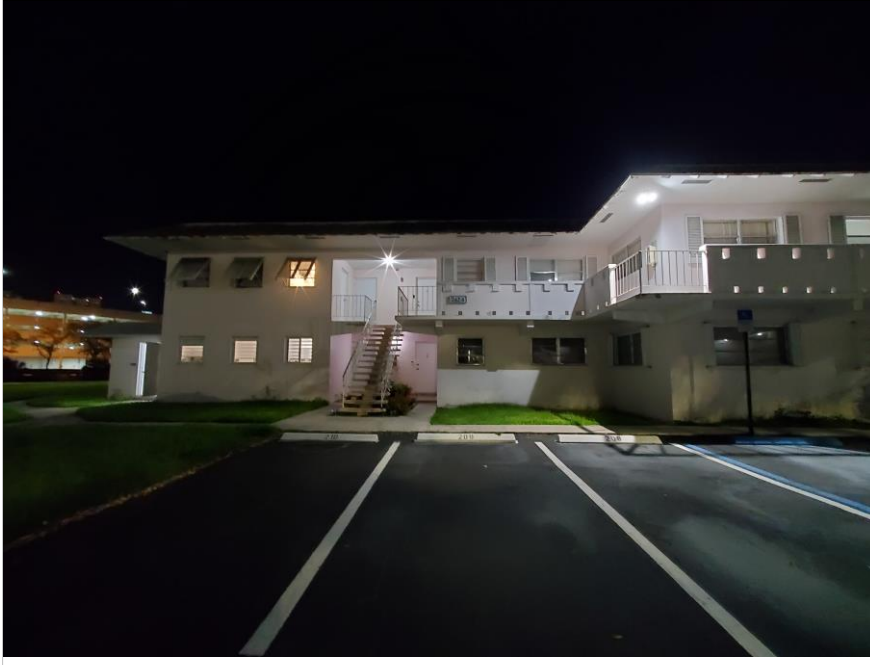
Photo 19 – Village of Dadeland Condominium Association

Parking - Poorly illuminated  
Exterior light not functional.

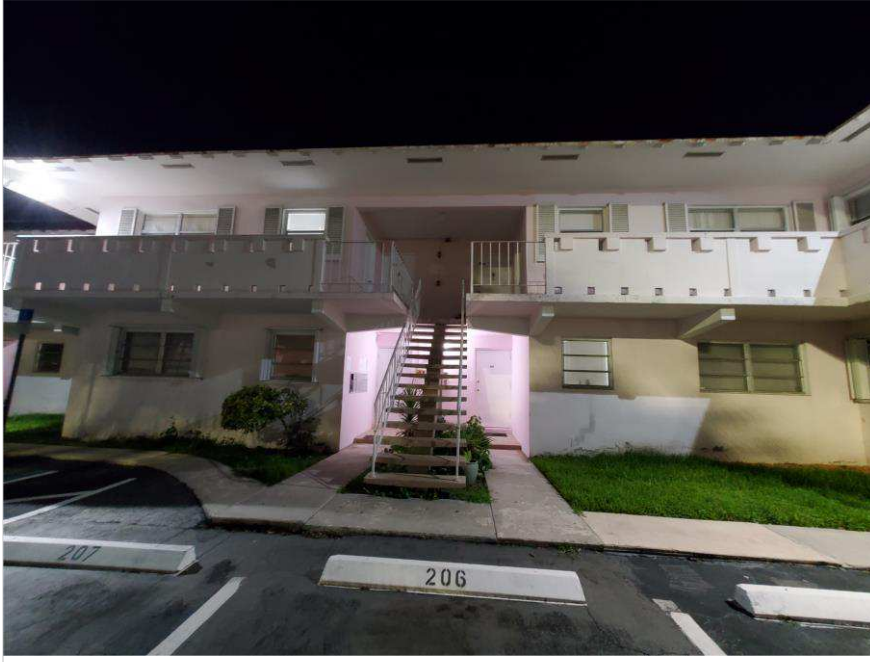
Photo 20 – Village of Dadeland Condominium Association

Catwalks - Poorly illuminated  
Catwalks and Points of Egress.  
Exterior lights not functional.

Insufficient illumination at Stairs  
and Catwalks

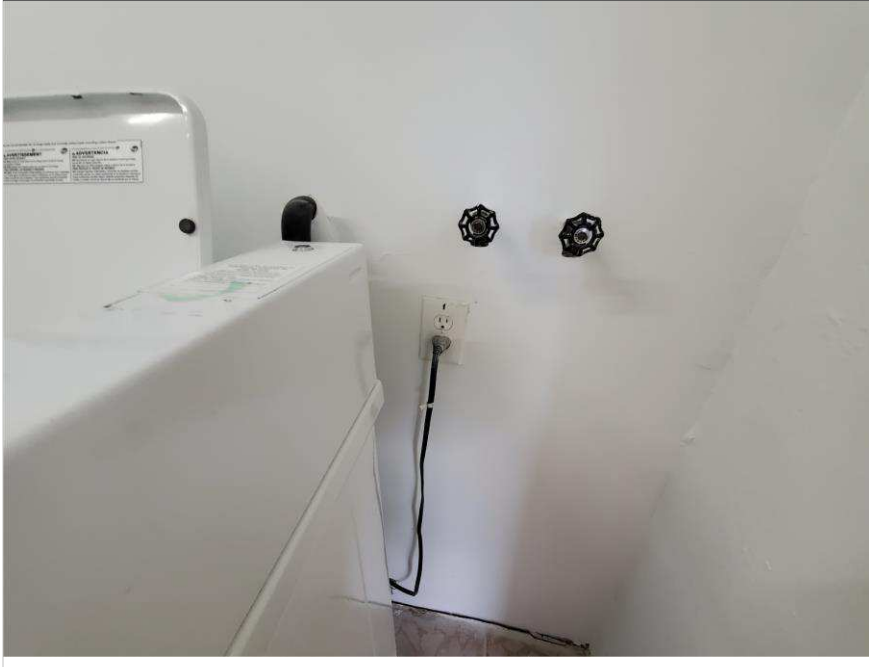
Photo 21 – Village of Dadeland Condominium Association

Laundry Room – Outlets are not GFCI type.

18. Outlets in laundry room and water heater room are not GFCI - Repairs Required.

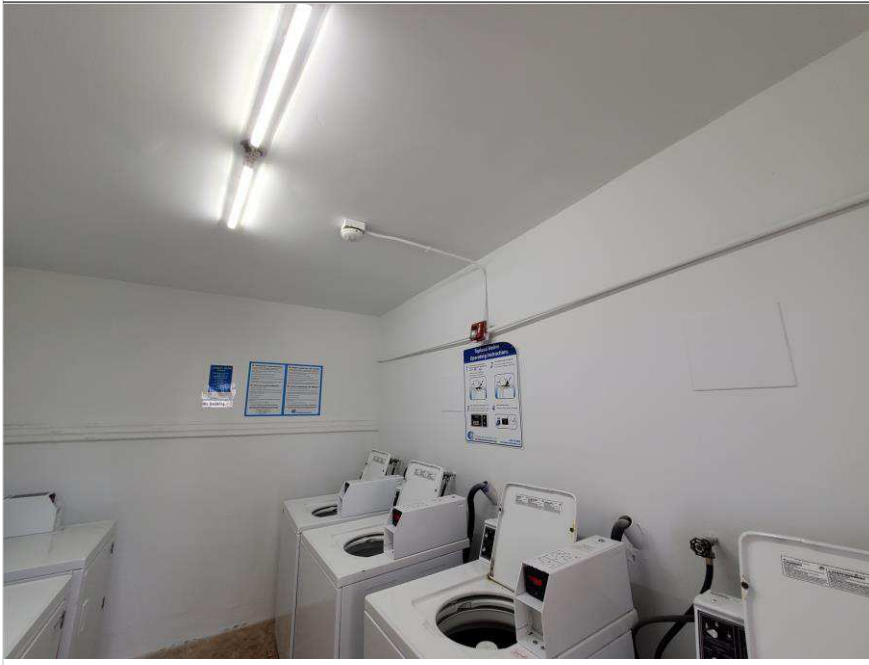
Photo 22 – Village of Dadeland Condominium Association

Laundry Room –  
Old smoke detector.

Comments: All old smoke detectors to be replaced. Smoke detectors to be installed and maintained in all .  
main electric rooms. Apartments - Not all apartments have smoke detectors in the living room, hallways,  
and/or bedrooms. As observed in Units D113 all other units to be verified for compliance.

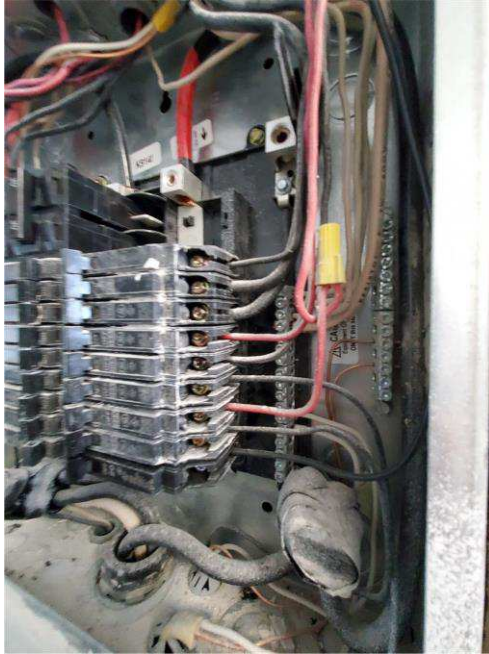
Photo 25 – Village of Dadeland Condominium Association

Apartments - Electrical Panels

Main feeders spliced copper to aluminum. Connections to be verified for compliance.

19. Unit D113 - Spliced main feeders - Repairs Required.

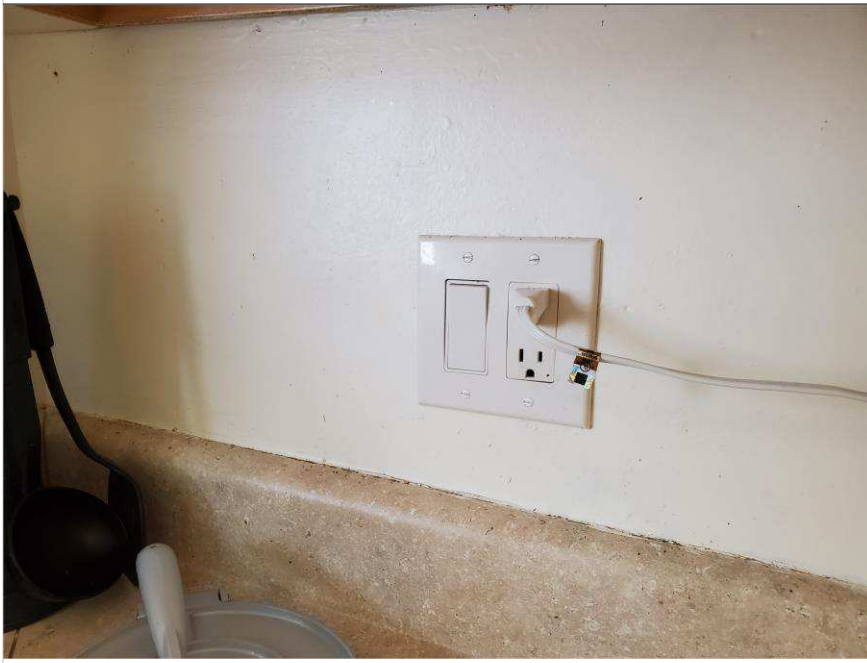
Photo 26 – Village of Dadeland Condominium Association

Apartments - Kitchen outlets  
not GFCI type

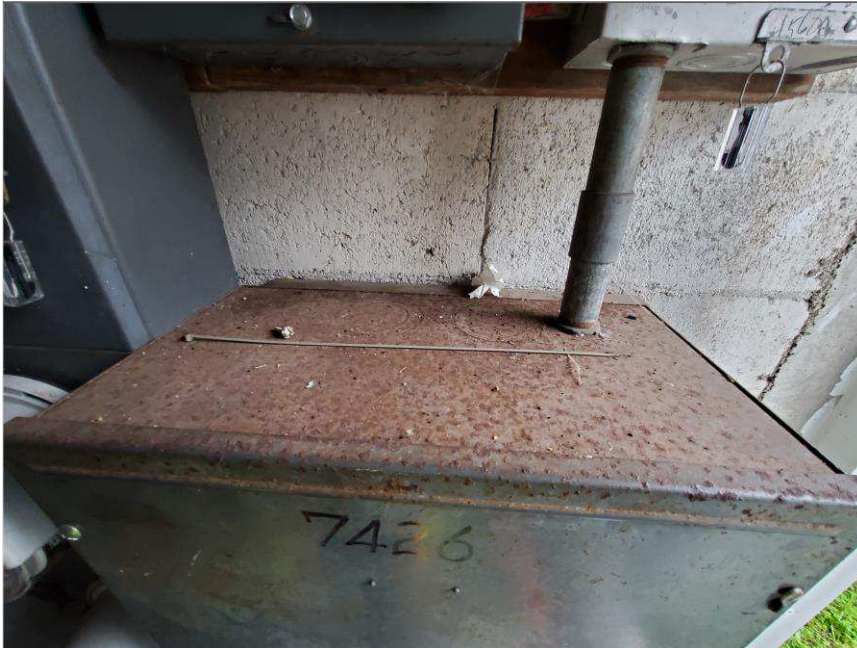
Photo 4 – Village of Dadeland Condominium Association

Existing Electrical Room - 1st FL  
Main Disconnect

Oxidized top of Main  
Disconnect.

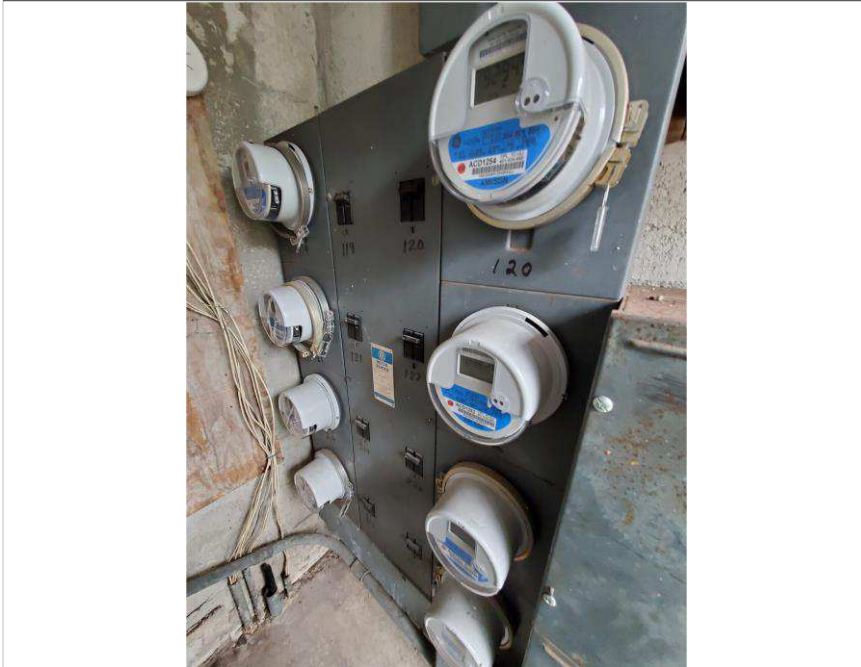
Photo 7 – Village of Dadeland Condominium Association

Existing Electrical Room - 1st FL  
Main Switches for Apartments,  
Meters, and Gutter.

Old and oxidized meter stacks.

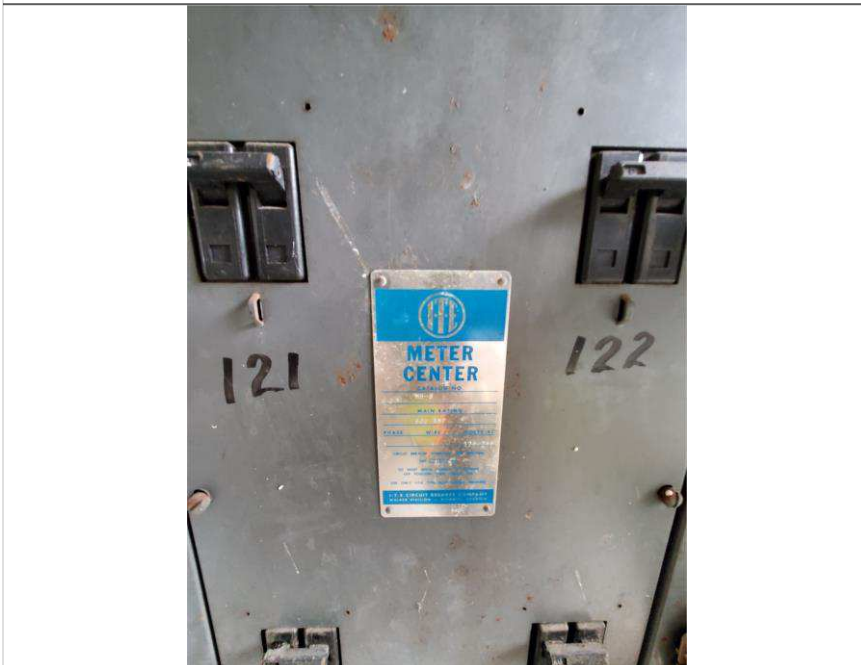
Photo 8 – Village of Dadeland Condominium Association

Existing Electrical Room - 1st FL  
Main Switches for Apartments,  
Meters, and Gutter.

Old and oxidized meter stacks.

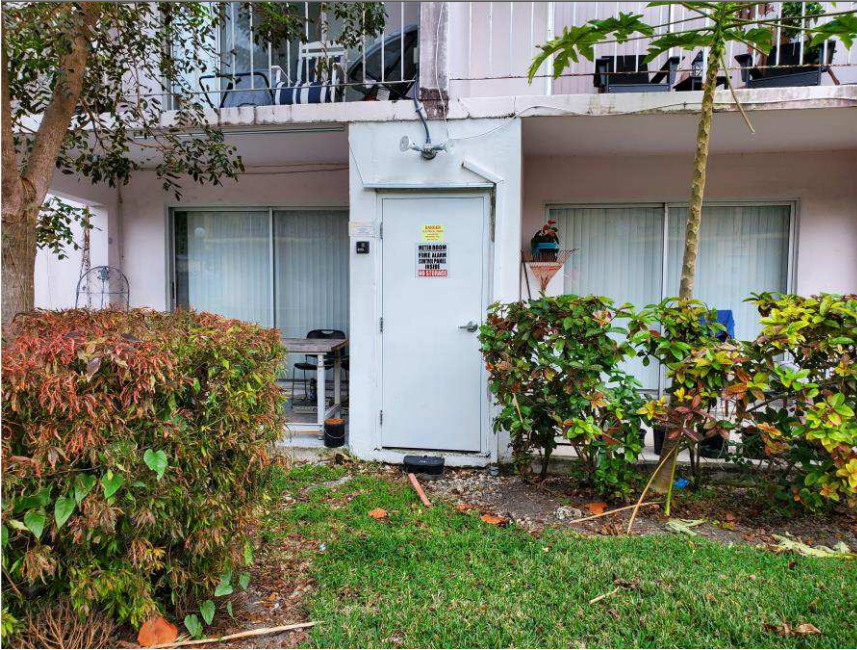
Photo 1 – Village of Dadeland Condominium Association

Existing Electrical Room - 1st FL  
Provide sign with Building  
Number

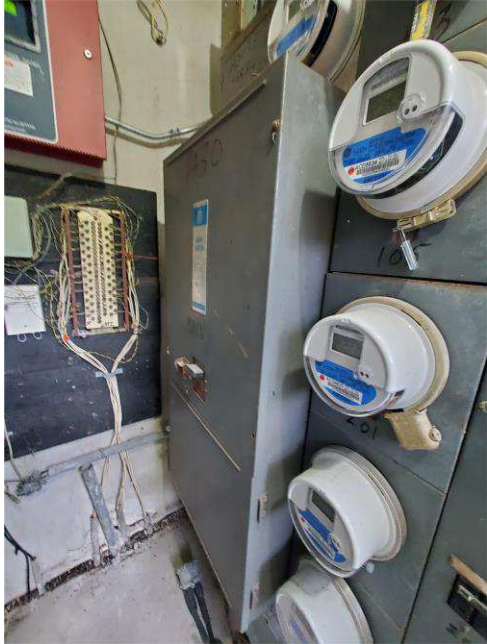
Photo 3 – Village of Dadeland Condominium Association

Existing Electrical Room - 1st FL  
Building Main Disconnect is  
considerably oxidized.  
50 year old electrical  
component.

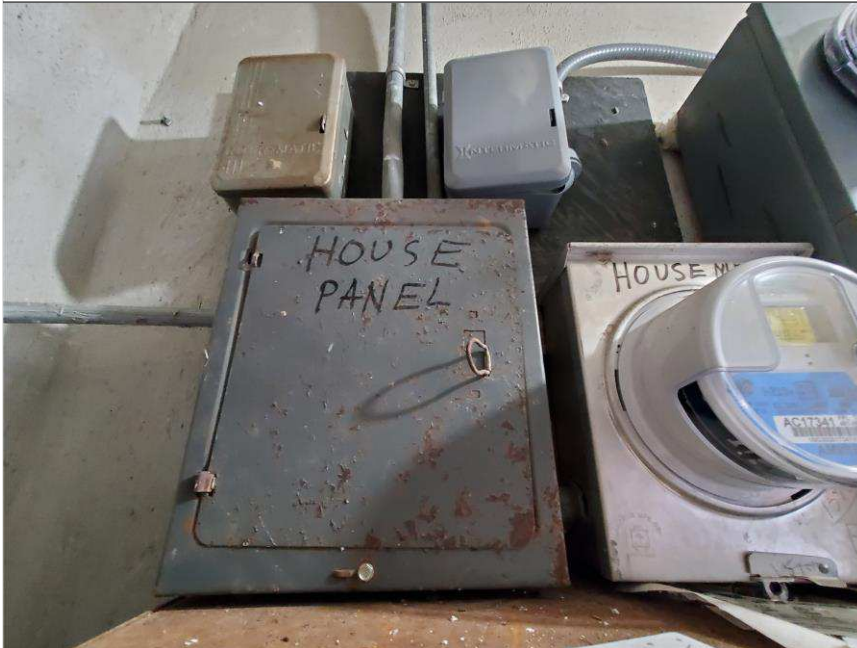
Photo 4 – Village of Dadeland Condominium Association

Existing Electrical Room - 1st FL  
House Panel and Meter.  
50 year old electrical  
component.

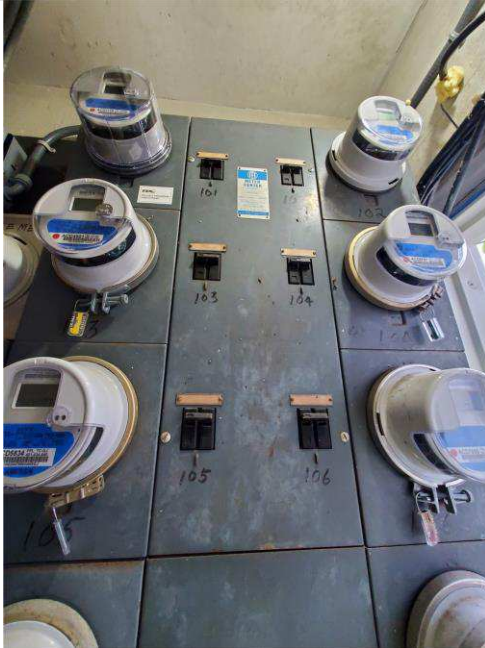
Photo 7 – Village of Dadeland Condominium Association

Existing Electrical Room - 1st FL  
Main Switches for Apartments,  
Meters, and Gutter.

Old and oxidized meter stacks.

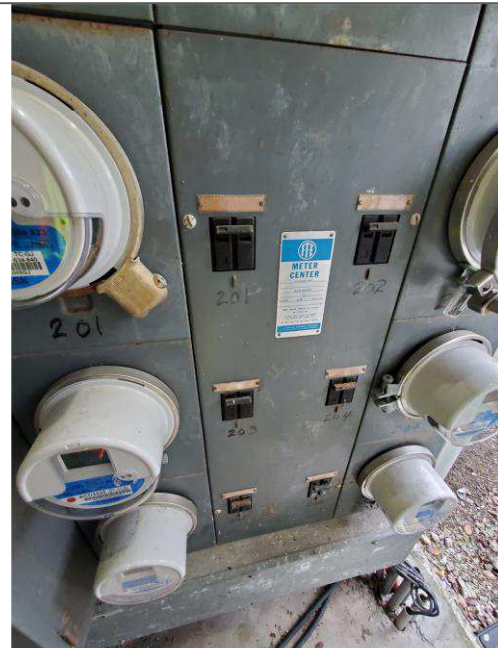
Photo 9 – Village of Dadeland Condominium Association

Existing Electrical Room - 1st FL  
Main Switches for Apartments,  
Meters, and Gutter.

Old and oxidized meter stacks.

Oxidized Gutter.

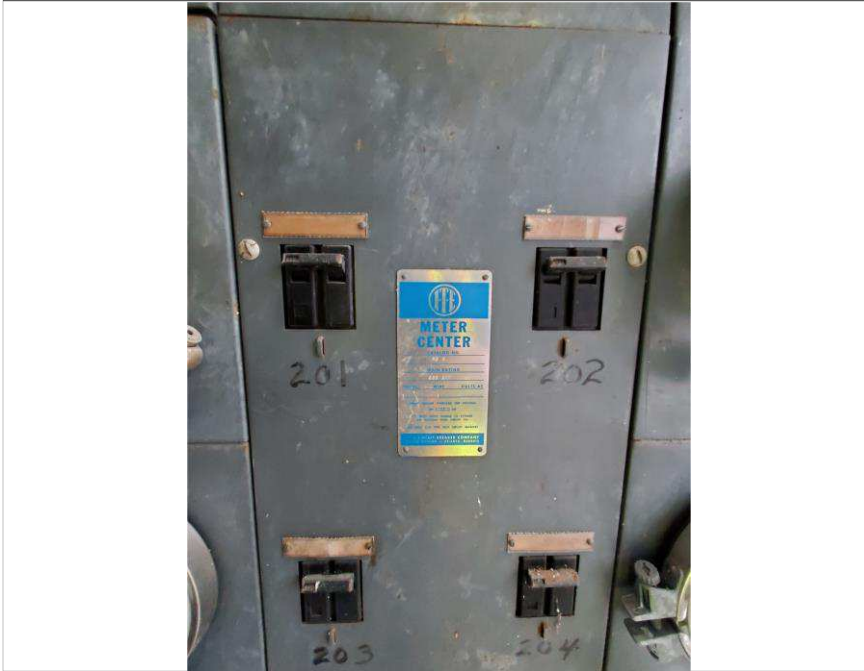
Photo 10 – Village of Dadeland Condominium Association

Existing Electrical Room - 1st FL  
Main Switches for Apartments,  
Meters, and Gutter.

Old and oxidized meter stacks.

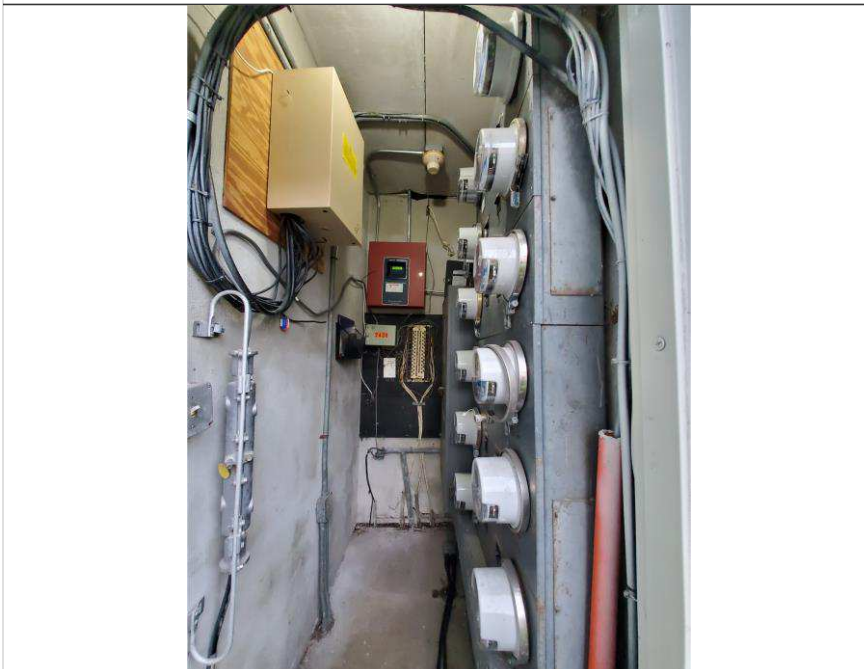
Existing Electric Room - 1<sup>st</sup> FL  
Main Switches for Apartments,  
Meters, and Gutter.

Insufficient clearance at  
electrical components.

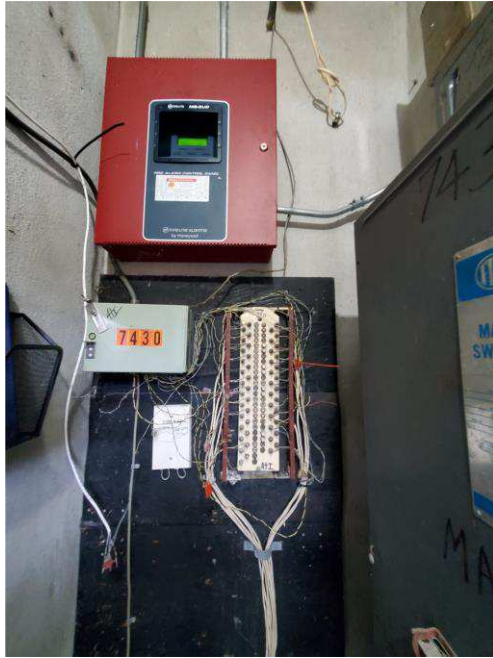
Photo 14 – Village of Dadeland Condominium Association

Existing Electrical Room - 1st FL  
Fire Alarm Panel

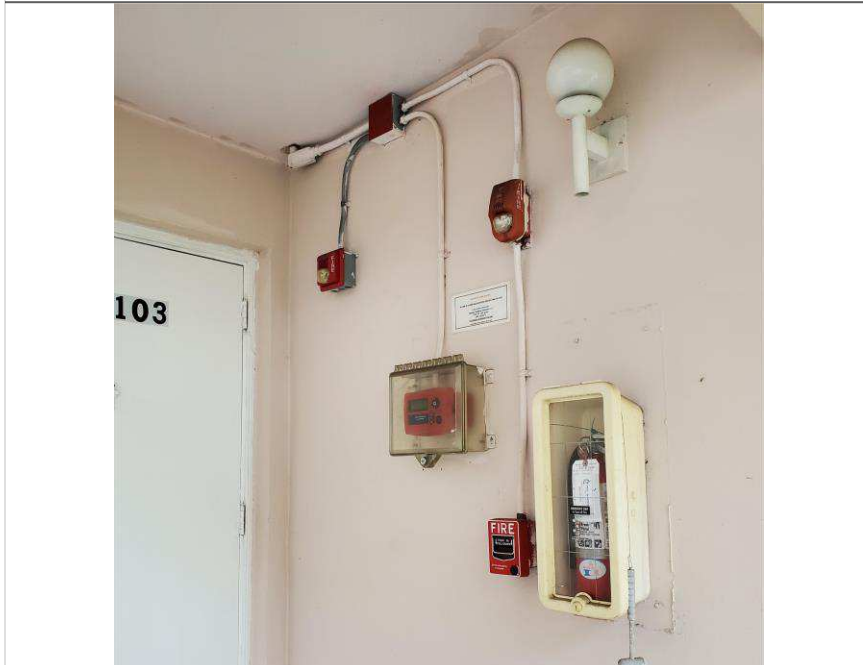
Level 1  
Fire Alarm - Old and Weathered  
Fire Alarm Devices and Control  
Center

Old Strobe Horn/Strobe Device

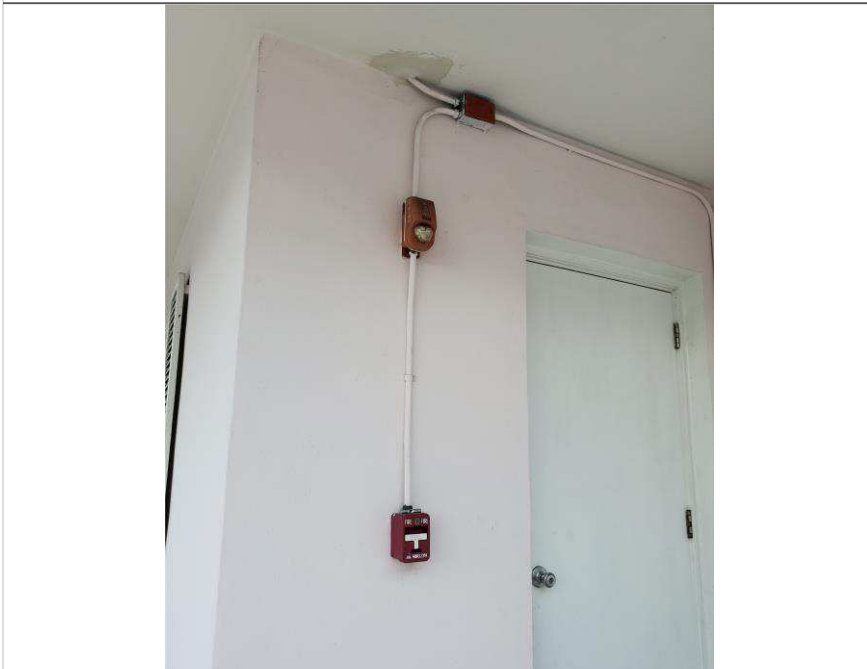
Photo 17 – Village of Dadeland Condominium Association

Level 2

Fire Alarm - Old and Weathered  
Fire Alarm Devices and Control  
Center

Old Strobe Horn/Strobe Device  
and Pull Stations

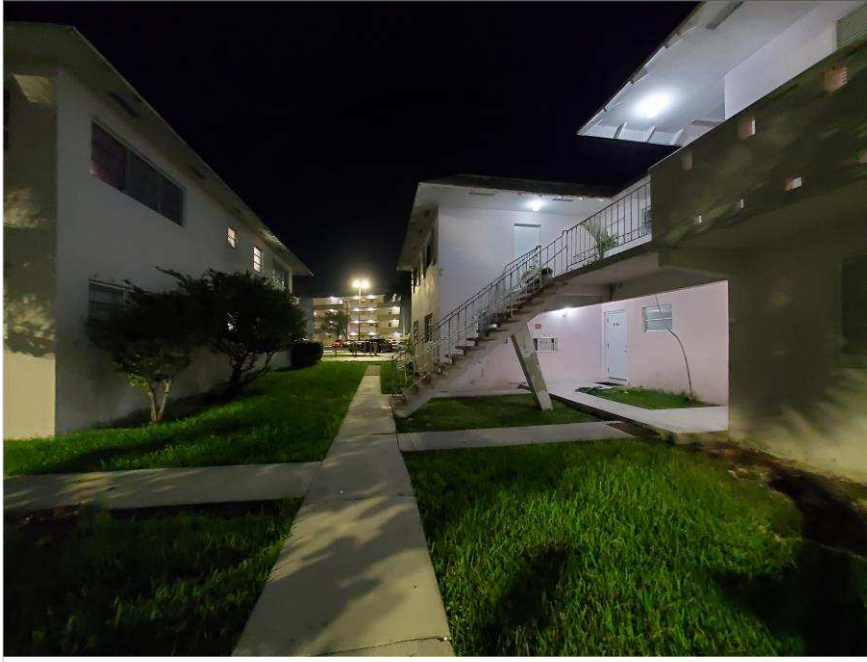
Photo 18 – Village of Dadeland Condominium Association

Catwalks - Poorly illuminated.  
Exterior lights not functional  
Building Points of Egress and  
Catwalks - Light Fixture are too  
far apart.

Insufficient illumination at  
stairs, catwalks, and sidewalks.
