MINIMUM INSPECTION PROCEDURAL GUIDELINES FOR BUILDING ELECTRICAL RECERTIFICATION

Table with 1 column and 13 rows containing structure details: a. Name on Title: Village at Dadeland Condominiums (D), b. Street Address: 7420 SW 82nd St. Miami, Florida 33143, c. Legal Description: Village at Dadeland Condominiums, d. Owner's Name: Village at Dadeland Condominiums, e. Owner's Mailing Address: 7420 SW 82nd St. Miami, Florida 33143, f. Folio Number of Property on which Building is Located: 30-4035-047-XXXX, g. Building Code Occupancy Classification: R2 - Residential, h. Present Use: Condominium, Residential, i. General Description, Type of Construction, Size, Number of Stories, and Special Features. Additional Comments: The condominium building was built in 1968. Is a two story building comprised of concrete slab on compacted grade and stucco covered cmu exterior load bearing wall. The second floor catwalk consists of pre-cast concrete slabs, concrete tie columns and tie beams along exterior walls up to the roof level. The roof is a low slope roof and comprised of timber trusses and plywood decking covered with a bituminous asphalt membrane. At the perimeter of the roof there are timber

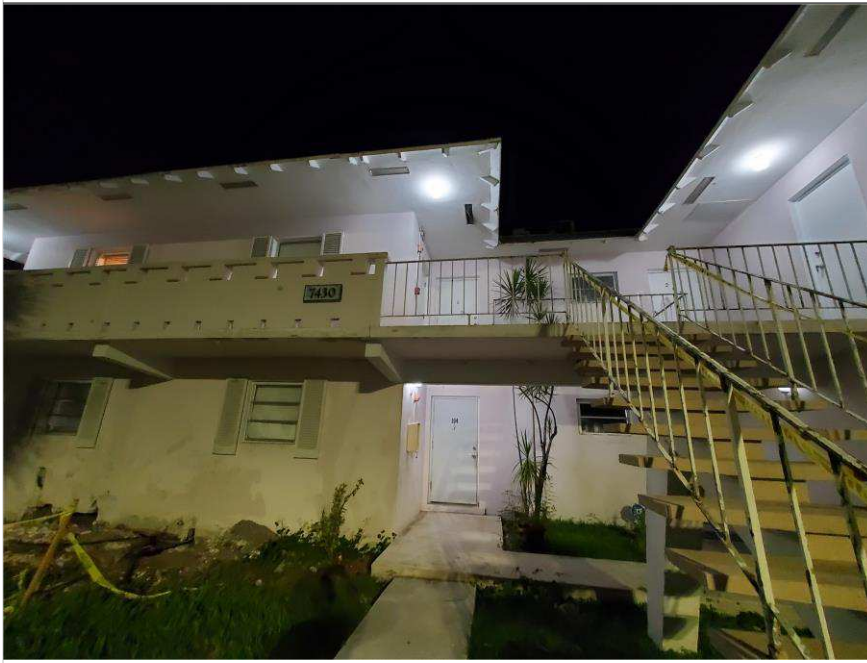
Catwalks - Poorly illuminated.  
Exterior lights not functional.

Insufficient illumination at stairs,  
catwalks, and sidewalks.

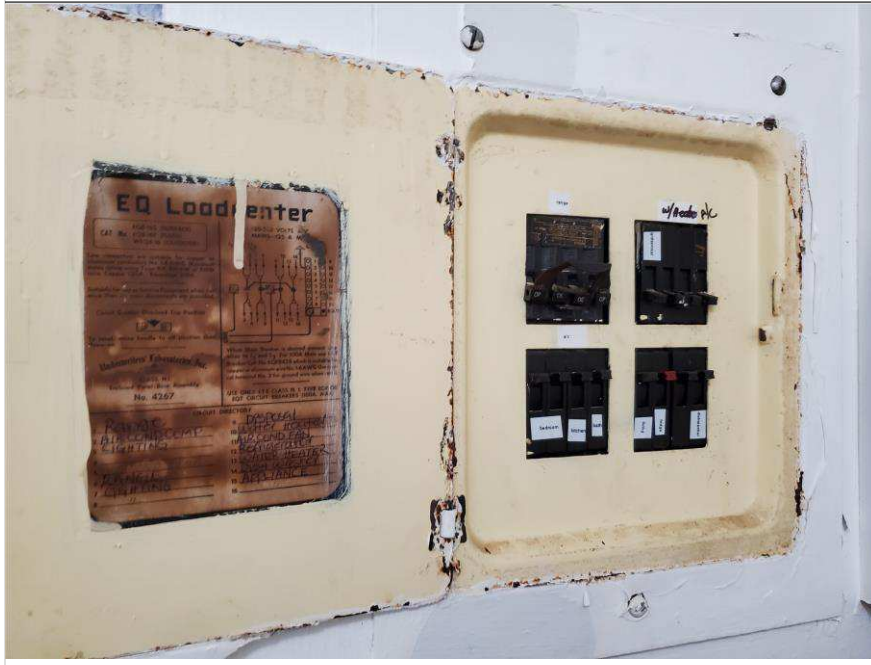
Photo 21 – Village of Dadeland Condominium Association

Apartments - Old Electrical Panels

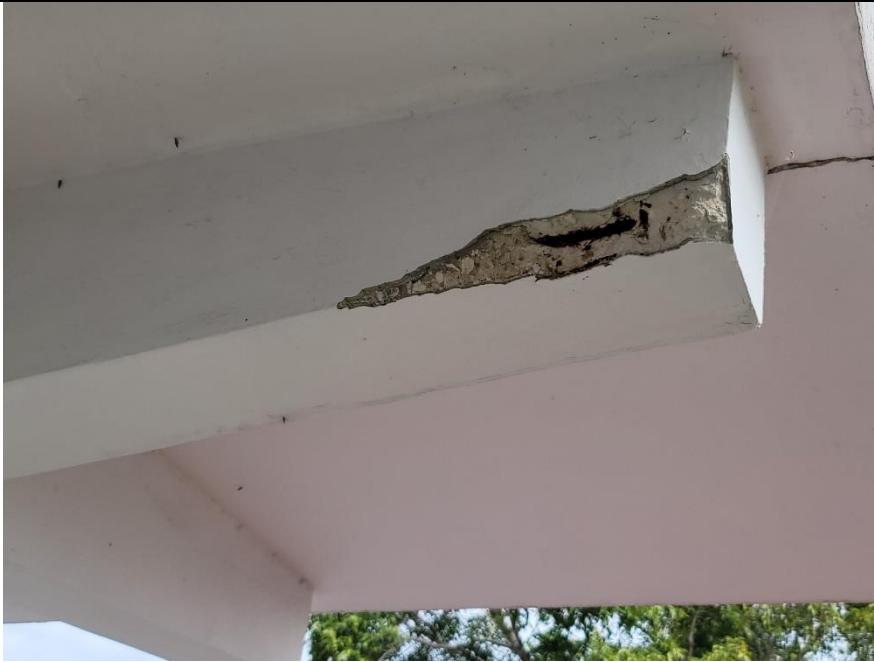
Photo #3:

Unsound concrete surfaces detected at the cantilevered beams of the front catwalks.

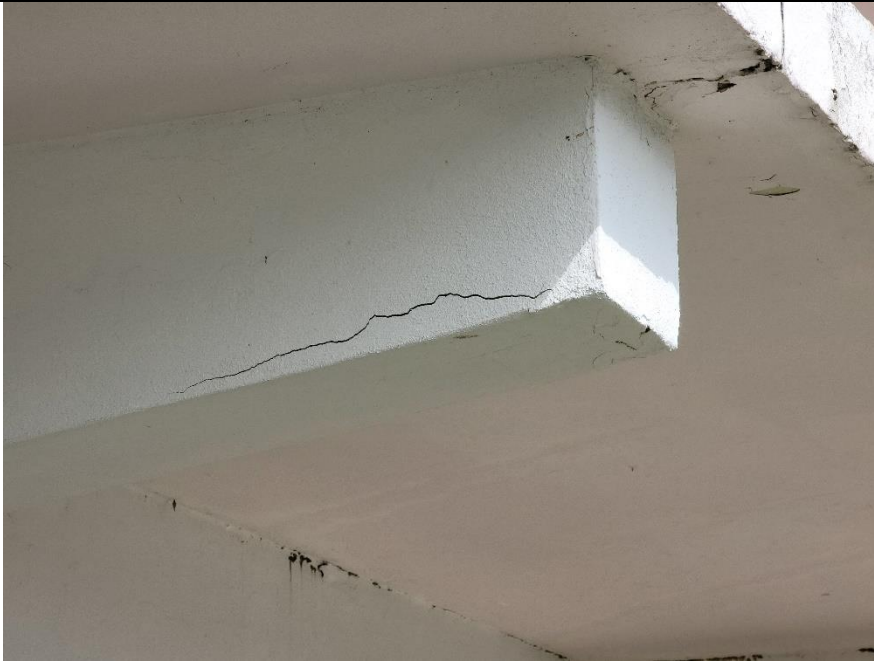
Photo #3:

Unsound concrete surfaces detected at the cantilevered beams of the front catwalks.
