## **Inspection Report**

**Property Address:**  
211 Mangini Street  
Nicholasville KY 40356

<b>Date:</b> 9/12/2018	<b>Time:</b> 10:00 AM till 02:30 PM	<b>Report ID:</b> 180912PETERS
<b>Property:</b> 211 Mangini Street Nicholasville KY 40356	<b>Customer:</b> Mr. Trevor Peters	<b>Real Estate Professional:</b>

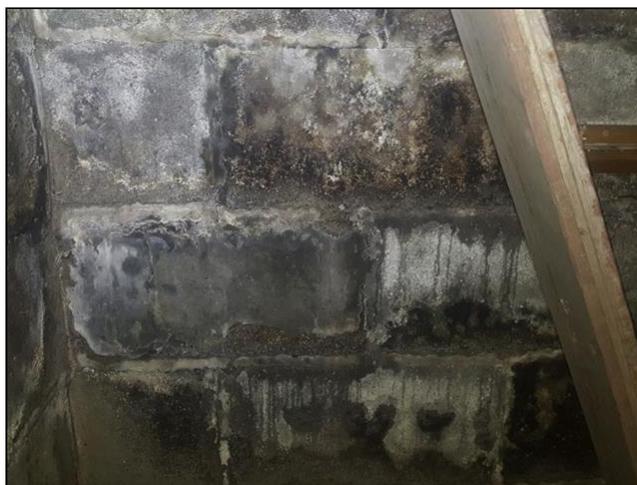
1.0 Item 2(Picture)

1.0 (1) Fungi growth, black stains on the masonry block walls and mildew where located in various areas in the basement, especially under the kitchen, dining room and 2nd bathroom areas in the home. When entering the basement in this area a very strong odor (musty smell) was experienced. This could be mold. Only lab testing of the mold/mildew can determine the type or if it is considered to be dangerous. Recommend a certified mold expert further evaluate and conduct testing and sampling before closing. They will be able to best advise you how to clean up, remove and/or treat areas affected. EPA guidelines state that homeowners can clean areas less than 100 square feet with water using laundry detergent. Due to the amount of mold/mildew found **I do not recommend** this, have a qualified contractor do this after mold expert has advised remedies for cleanup.

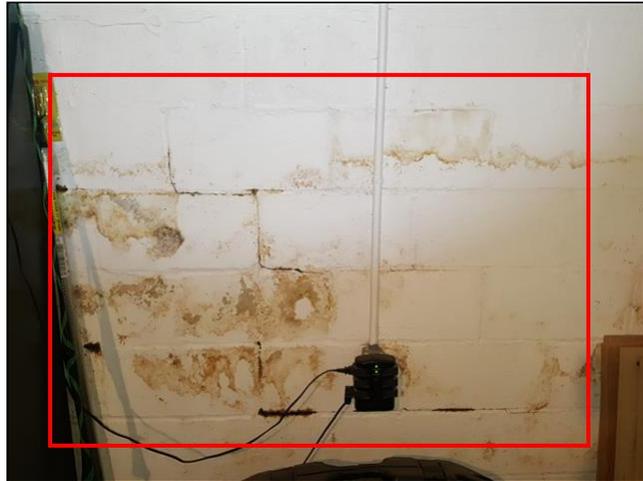
1.0 Item 6(Picture) right side of home

**1.0** (2) The basement shows evidence of moisture penetration in the masonry block walls at the rear of the home. It is impossible to predict the severity or frequency of moisture penetration on a one-time visit to home. Virtually all basements exhibit signs of moisture penetration and virtually all basements will indeed leak at some point in time. Further monitoring of the foundations will be required to determine what improvements, if any, will be required. Basement leakage rarely affects the structural integrity of a home. The vast majority of basement leakage problems are the result of insufficient control of storm water at the surface. The ground around the house should be sloped to encourage water to flow away from the foundations. Gutters and downspouts should act to collect roof water and drain the water at least 6 feet from the foundation, or into a functional storm sewer. Downspouts that are clogged or broken below grade level, or that discharge too close to the foundation, are the most common source of basement leakage. Please refer to the Roofing and Exterior sections of the report for more information. In the event that basement leakage problems are experienced, lot and roof drainage improvements should be undertaken as a first step.

**1.0** (3) White efflorescence (powder substance) was found in some areas in the basement which indicates moisture is in contact with the masonry. The white chemical deposits (Efflorescence) are caused by water evaporation from the exterior. This does not necessarily indicate that water intrusion is occurring in the in the basement. Recommend checking the gutters and the downspout drain lines for proper operation. Also, a water proofing paint could be applied to the interior side of the block if necessary to protect the walls. Efflorescence is found on many homes without water intrusion occurring inside the home. But, it should alert you to the possibility that future steps may be needed.

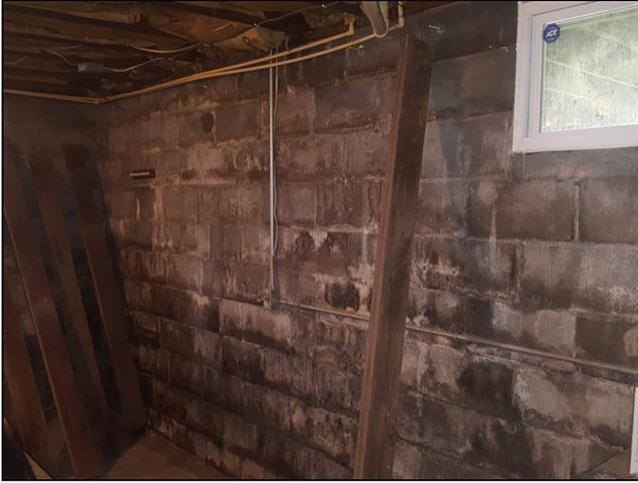
1.0 Item 10(Picture) rear of home

**1.0** (4) Visible signs of water intrusion/stains in the basement walls at the rear of the home. 90% of water entry into the foundation walls has been found to be caused by improper grading or defective gutter/ drainage systems. Refer to Roofing and Exterior of this report for improvements and recommendations. However I would recommend consulting a qualified basement foundation contractor to determine what other corrections maybe needed to prevent future water penetration in the masonry block walls due to this appears to be an ongoing problem and due to the fungi growth on the walls.

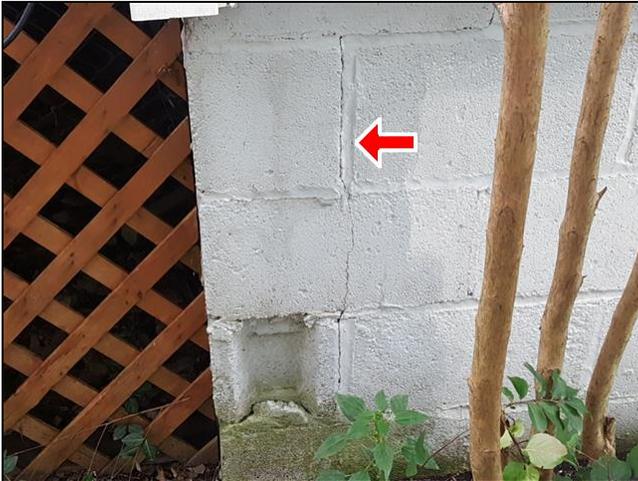
1.1 Item 1(Picture)

**1.1** (1) Minor vertical settlement crack at the rear right corner of the home in the foundation wall was noted at the exterior. These cracks do not appear significant. This condition is common in many homes and does not usually represent a serious structural concern unless the cracks are between an 1/8 or 1/4 inch thick. Recommend the crack be sealed to prevent water intrusion into the basement and minimize further deterioration. [Sealing Concrete Cracks](#) It is recommended that you monitor periodically to see if further movement occurs and if so a foundation contractor should be consulted to correct and prevent further movement.

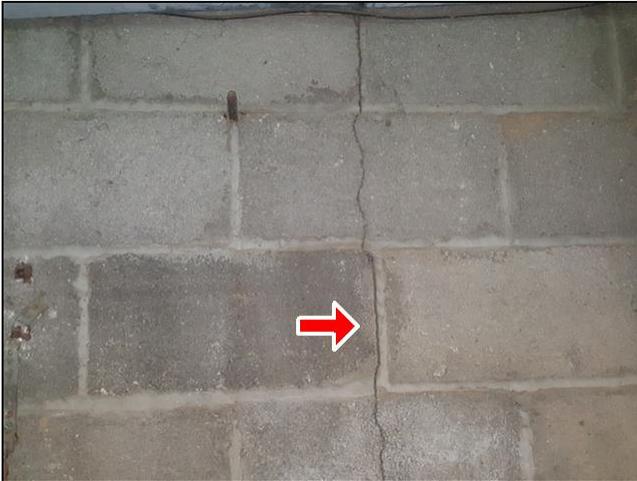
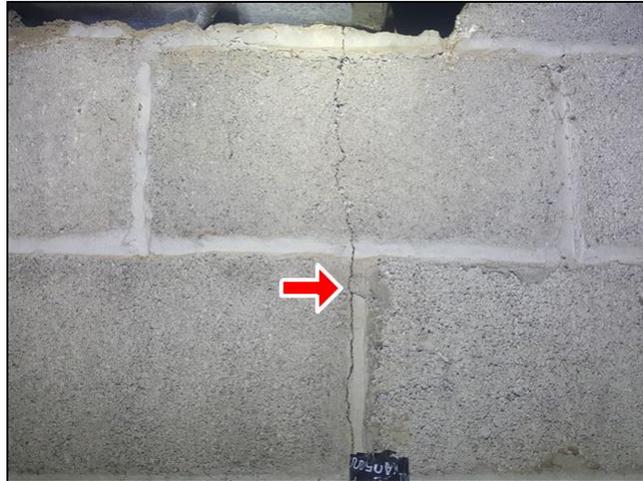
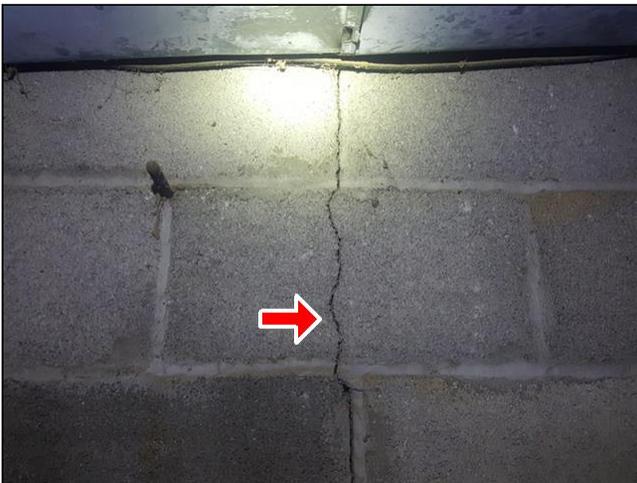
1.1 (2) Vertical cracks in the masonry block wall in the center of the home in the basement between the kitchen and formal dining room area was noted. These cracks do not appear significant. This condition is common in many homes and does not usually represent a serious structural concern unless the cracks are between an 1/8 or 1/4 inch thick. Recommend the crack be sealed to prevent water intrusion into the basement and minimize further deterioration. [Sealing Concrete Cracks](#) It is recommended that you monitor periodically to see if further movement occurs and if so a foundation contractor should be consulted to correct and prevent further movement.

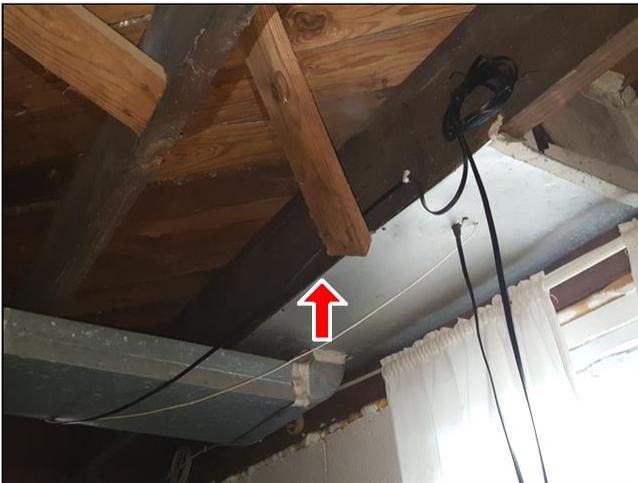
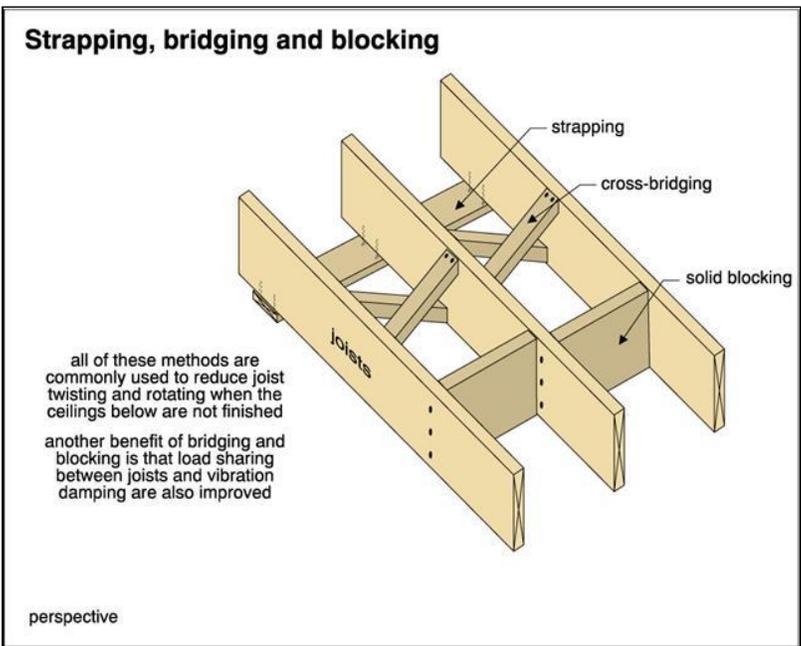
**1.2** The cross bracing is loose and not secured to the ceiling joists in the basement left side of the home under the formal dining room area. Recommend repair by a general contractor to prevent deflection of the joist and help with the support of load of the joist.

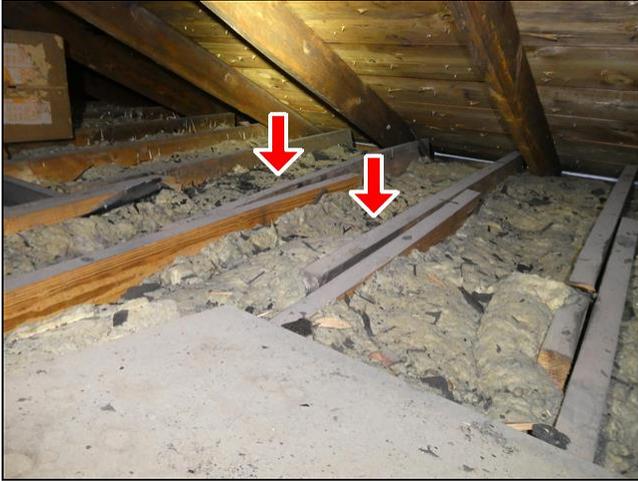
1.7 Item 1(Picture)

**1.7** The ceiling joists in the main attic show signs of deflection. Strengthening the ceiling joists would resist further movement and prevent the rafters from pulling away. Recommend a qualified roof framing contractor further evaluate the ceiling structure to determine what corrections if needed should be performed to ensure structural integrity of the ceiling and roof structure.

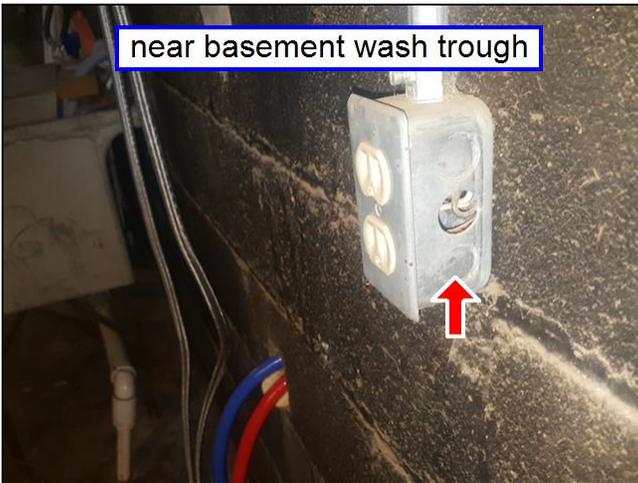
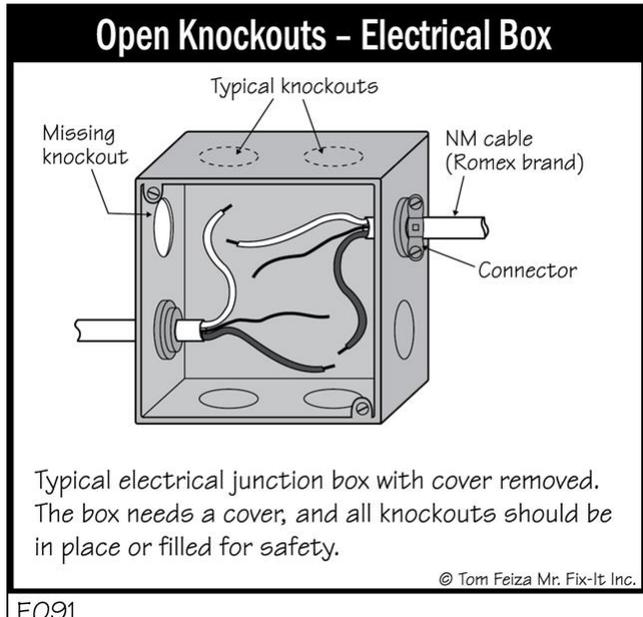
**1.9** Bushings or grommets are required to fill openings in a junction box. The exposed opening is a serious safety issue. Openings should be installed to prevent touching the sides of the devices to prevent an electric shock which can cause an injury or death. A qualified licensed electrical contractor should correct as needed prior to moving in.

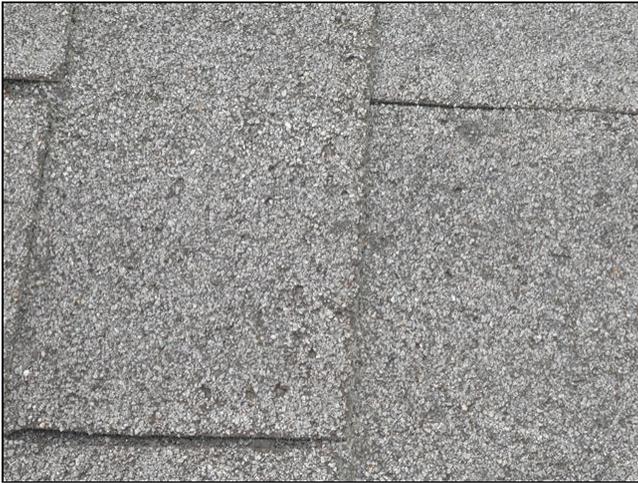
2.0 Item 1(Picture) above kitchen area

2.0 (1) Signs of loss of protective granules, drying and fibers exposed of the roof shingles are starting to appear especially at the front of the home. This indicates that the roof is close to the end of its life span. This usually increases the potential for ultraviolet damage to the membrane. Recommend a qualified roofing contractor further evaluate the roof to determine if replacement is required now before roof leaks start to develop. If the roof is not to be replaced it should be closely watched and repaired or replaced at the first sign of leaking to prevent damage to the interior finishes or roof framing in the attic.

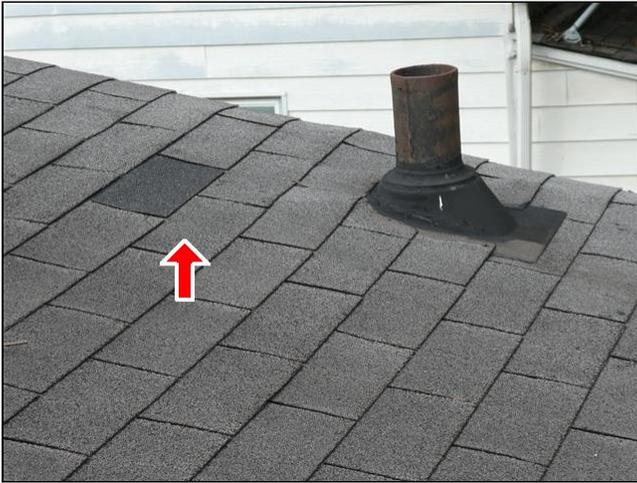
2.0 Item 9(Picture) rear right side of home

2.0 (2) Prior repairs to the roofing are evident at the where indicated in the photos. This would suggest that problems have been experienced in the past. Verify with the owner that there is not an ongoing problem. This area should be monitored and if further repairs are needed recommend using a qualified roofer.

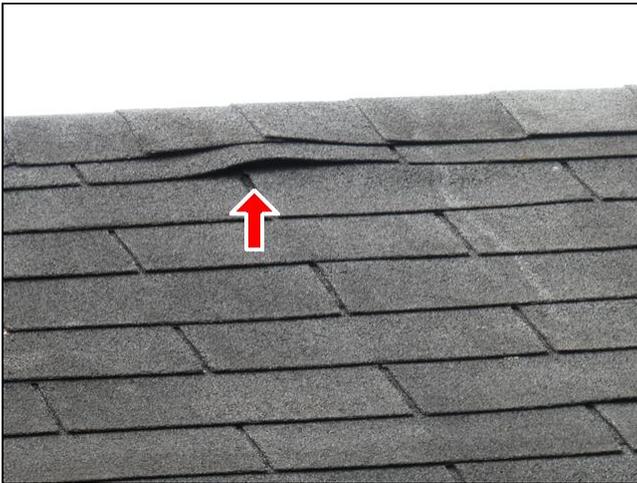
2.0 Item 12(Picture) rear right side of home

**2.0** (3) Some of the shingles are starting to lift on the roof in various places, (see photos for location) This is probably due to a lack of ventilation or age of the covering. Generally, lifting shingles are caused by ventilation issues and the shingles are baked from the inside out. Over time, this heat causes the sealants on the back of the shingles to detach from the course underneath and the shingles start to lift. The shingles are less resistant to the action of ice and wind. Recommend a qualified roofing contractor further evaluate the roof to determine if replacement is needed now and repair lifting shingles where needed. Consideration for a new roof is expected in the near future.

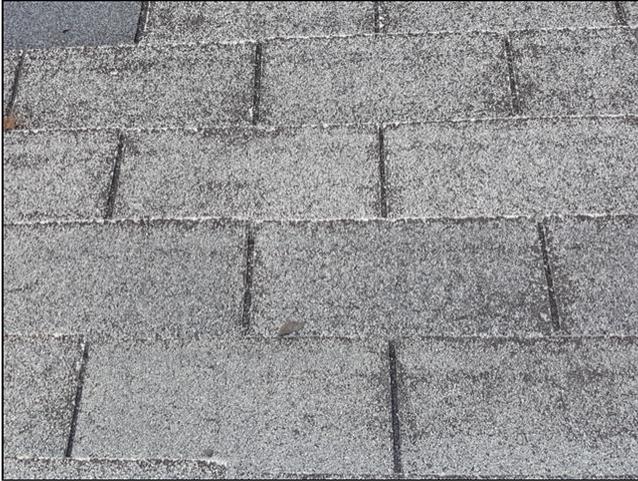
2.0 Item 18(Picture)

2.0 (4) The roof covering above the front porch is old, starting to deteriorate rapidly and shows signs of previous repairs, and the life of the covering has expired. The covering does need to be replaced. While it could last a year or so, some areas may need patching with tar as leaks develop. Recommend a qualified roofing contractor further evaluate to determine if replacement of this section of the roof is needed now prior to closing.

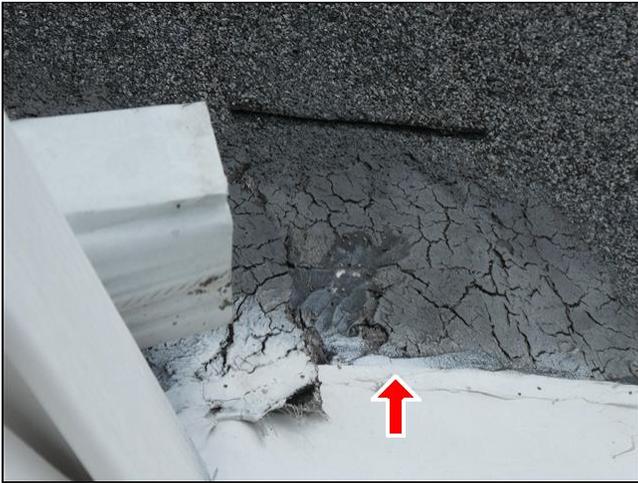
2.1 Item 1(Picture) above kitchen area

2.1 (2) The step flashing and wall/roof intersection has been tarred all around the metal flashing. The flashing is suspected to be in poor condition. Tar is a temporary patch and will eventually fail. Deteriorated or leaking flashing should be replaced. This indicates that previous water leaks had existed. This type of repair is not recommended as it is prone to further leaking due to direct sunlight on the sealant which can cause cracks. The cracking can allowing water to enter. Recommend a qualified roofing contractor further inspect and make the necessary repairs if needed.

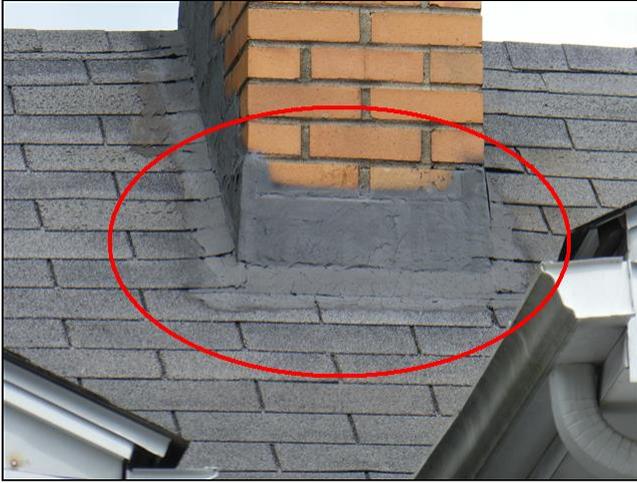
2.2 Item 1(Picture)

2.2 (2) The chimney has been tarred all around the metal flashing. The flashing is suspected to be in poor condition. Tar is a temporary patch and will eventually fail. Deteriorated or leaking flashing should be replaced. This indicates that previous water leaks had existed. This type of repair is not recommended as it is prone to further leaking due to direct sunlight on the sealant which can cause cracks. The cracking can allow water to enter. Recommend a qualified roofing contractor further inspect and make the necessary repairs as needed.

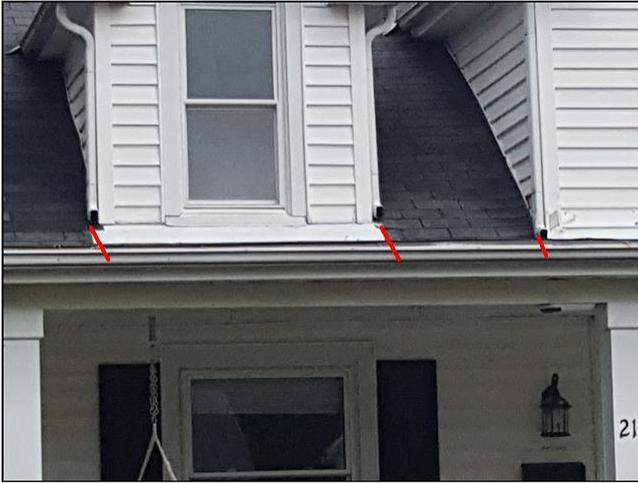
2.4 Item 1(Picture) front of home

**2.4** (1) Recommend the downspout(s) that discharge onto the roof around the home be extended to discharge water directly into the gutter below. This condition, if left unattended, can result in premature deterioration and staining of the roofing material under the end of the downspout. The excessive discharge of storm water onto the roof from the downspout also puts stress on building materials designed to prevent water entry into the structure of home. Recommend correcting all around the home as needed using a qualified gutter installer.

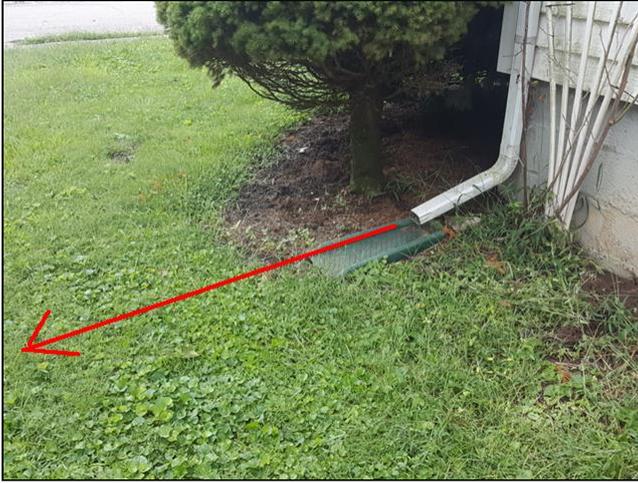
2.4 Item 6(Picture)

**2.4** (2) Recommend the downspout(s) at the front right corner of the home be extended at least 6 feet and flow onto splashblocks. This will ensure water is kept away from the foundation perimeter, soil erosion does not occur and water cannot leak into the basement area which may cause settlement of the foundation.

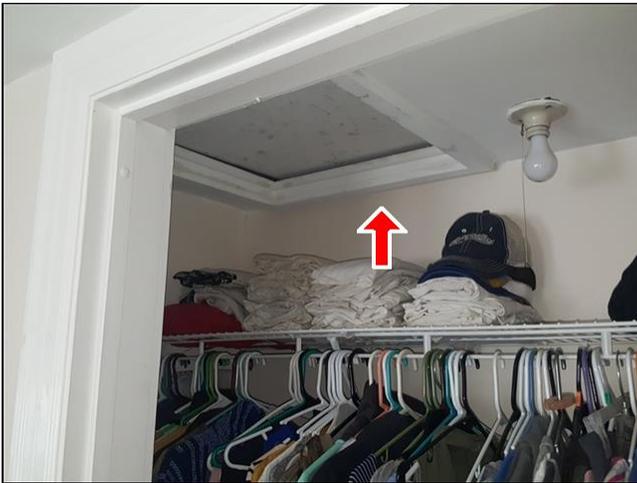
2.5 Item 1(Picture) 2nd bedroom closet

2.5 (2) Recommend the attic access hatch in the 2nd bedroom closet be insulated to prevent air and heat loss for energy conservation.

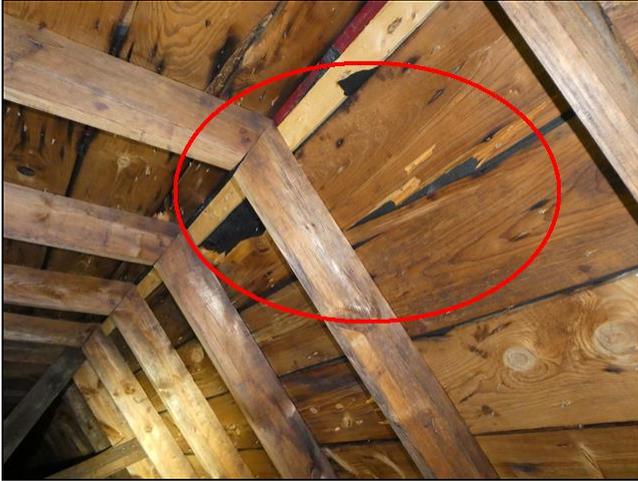
2.6 Item 1(Picture)

**2.6** (1) The roof sheathing near the scuttle hole entry is broken. This area is a potential source for a water leak to occur due to shingles have not been secured correctly and to prevent shingle damage. The roof felt is visible. There were no signs of water leaks in this area at time of inspection. Recommend a qualified contractor repair as needed.

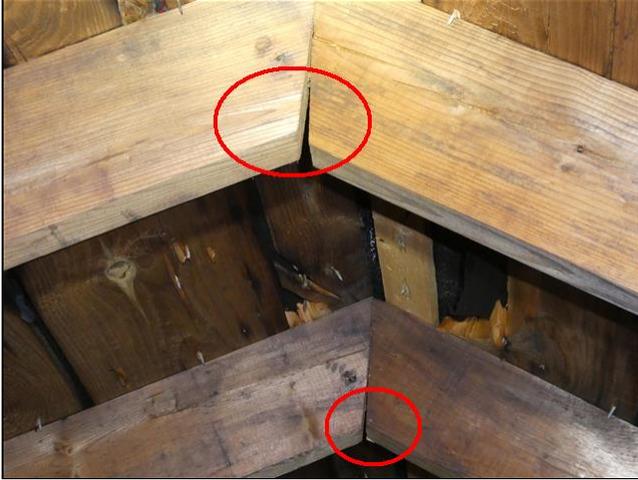
2.6 Item 2(Picture)

2.6 (2) Various rafters are pulling away at the joints in the attic. Repairs are needed to maintain the stability of the roof. Excess loads on the roof like snow can cause further separation if not reinforced. Recommend collar ties (horizontal members running between each rafter, near their mid span) or vertical supports to the rafters in the attic to add extra support to the roof structure and to resist rafters from sagging further separation and cracking in the future. Recommend a qualified framing roofing contractor further investigate and make any necessary improvements or repairs to the roof structure as needed and correct any other problems found prior to closing.

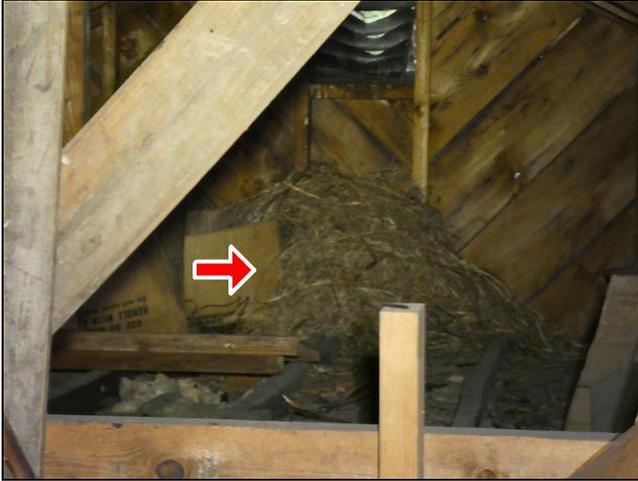
2.6 Item 7(Picture)

**2.6** (4) There is evidence of vermin activity/nest in the attic at the rear of the home near the gable vent. No animals were seen in the attic at the time of the inspection. However, recommend a pest control specialist be consulted in this regard and have nest removed. Then replacement or repair of the gable vent by a qualified contractor is recommended to prevent further critters entering the attic.

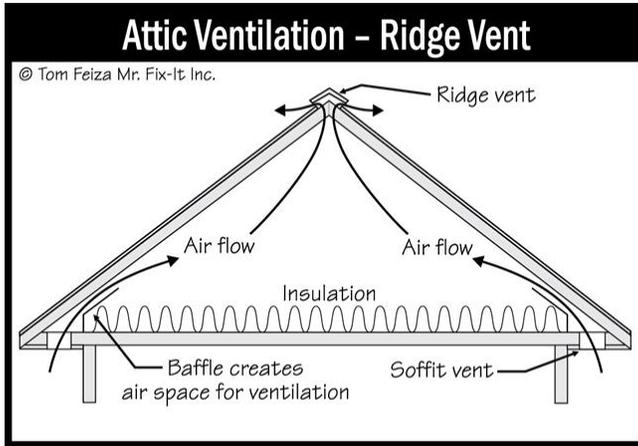
2.7 Item 1(Picture)

2.7 The level of ventilation is marginal and can be improved. Old homes tend to be constructed more loosely and have natural ventilation. It is generally recommended that one square foot of free vent area be provided for every one hundred and fifty square feet of ceiling area. Half of the ventilation should be at the ridge and the other half at the eaves. Proper ventilation will help to keep the house cooler during warm weather and extend the life of roofing materials. In the winter, it will help reduce the potential for ice dams on the roof and condensation within the attic. [Here is a link explaining ventilation. Look at Trap 4.](#) Recommend improving the ventilation at the next replacement of the roof coverings.

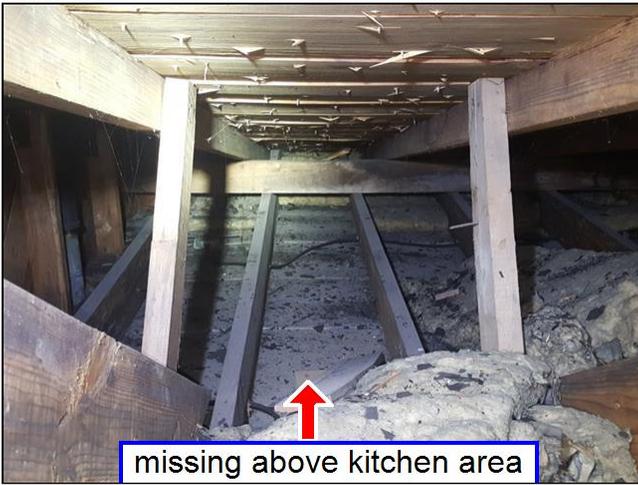
2.8 Item 1(Picture) master bedroom attic

**2.8** The insulation is old, has settled and is missing in some areas in the attic. Insulation that is missing and/or settled should be replaced due to the "R" value has diminished. The insulation should form an unbroken blanket to prevent heat/cool loss. Heat/cool loss can occur more on this home than one that is properly insulated. This can cause condensation to occur which can lead to mold or wood deterioration. Also, Low valued insulation will increase cooling and heating costs in the home which leads too high energy bills and puts stress on the HVAC system trying to keep the house cool and heated during the seasons. Strongly recommend additional and/or replacement of the insulation by a qualified contractor where needed to reduce heat/cool loss within the home and to prevent possible ice dams forming in winter.

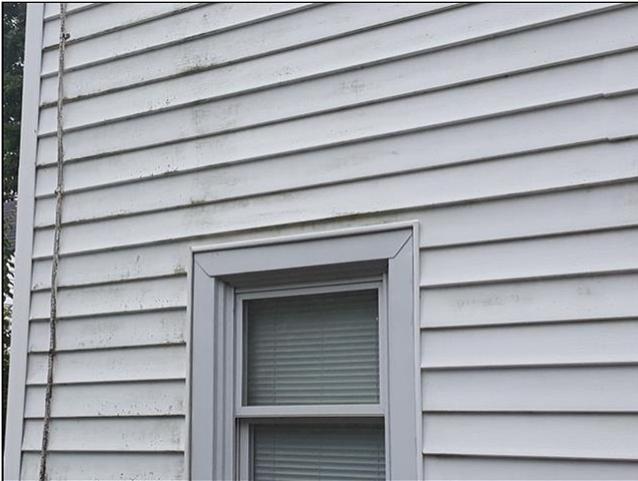
3.0 Item 1(Picture) rear left side of home

3.0 (2) Algae was seen on the Vinyl siding on the where indicated in the photos. This side of the home does not receive direct sunlight and this growth is common in shady areas. Recommend cleaning with soap and water and also removal of plants that are in contact with the wall siding as they attract moisture.

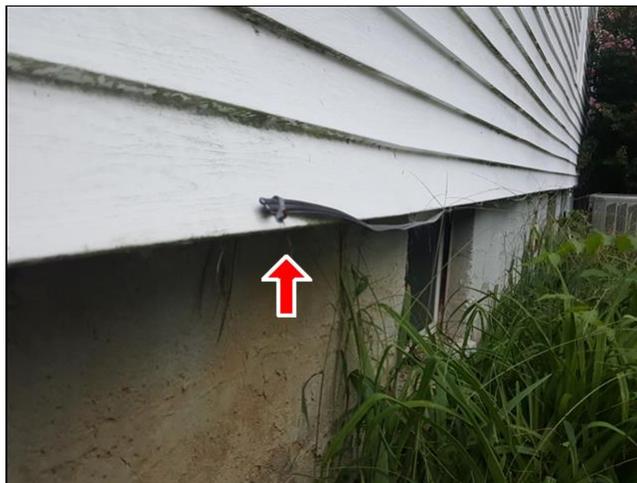
3.0 Item 5(Picture) right side of home

3.0 (3) The vinyl siding around the entire perimeter of the home from the bottom is not secured to the home. The loose siding should be re-secured to prevent it from being blown off and to protect the building from weather entry. It may not have been installed correctly due to the original wood siding behind. Recommend a qualified siding installer further investigate and correct as needed.

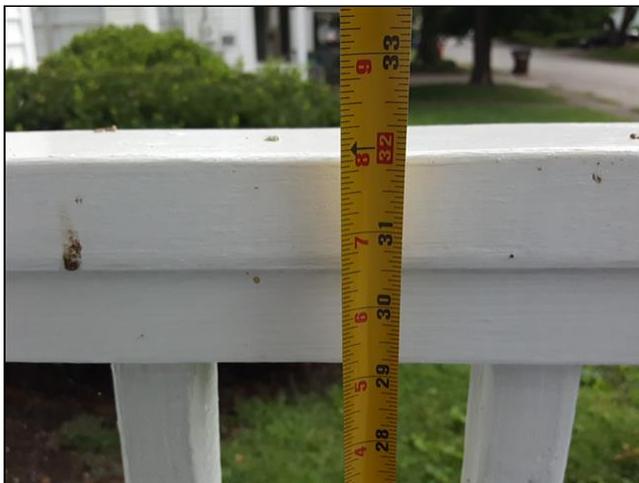
3.4 Item 1(Picture)

3.4 (1) The guard rail at the front porch is lower than 36 inches from the floor. A fall or injury could occur if not corrected. This is a safety issue. Ensure the baluster spacing is 4 inches apart to prevent a child or pet from falling through. A qualified contractor should repair or replace as needed.

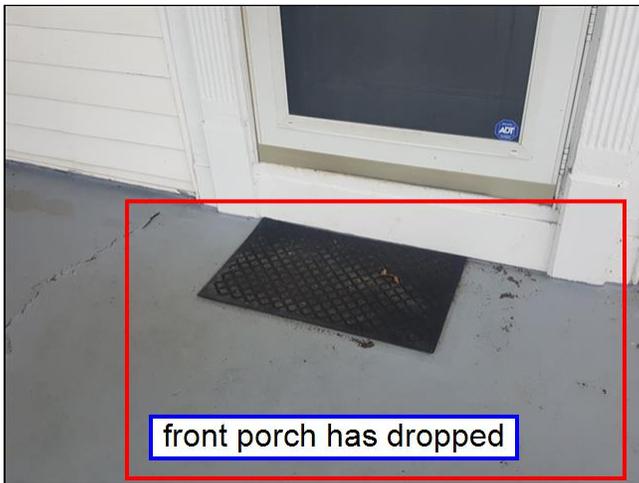
3.4 Item 2(Picture)

3.4 (2) The front step at the porch is higher than the recommended height of 8 and 3/4 inches. This is a potential safety issue and a fall or injury could occur if not corrected. The front porch has dropped at the front of the home causing this to occur. Recommend a qualified masonry contractor correct and repair as needed. Also, recommend filling cracks to prevent water intrusion to prevent further settlement. Then further monitor for more movement after repairs. If such movement occurs in the future, you may need to investigate cause and rectify using a qualified masonry contractor.

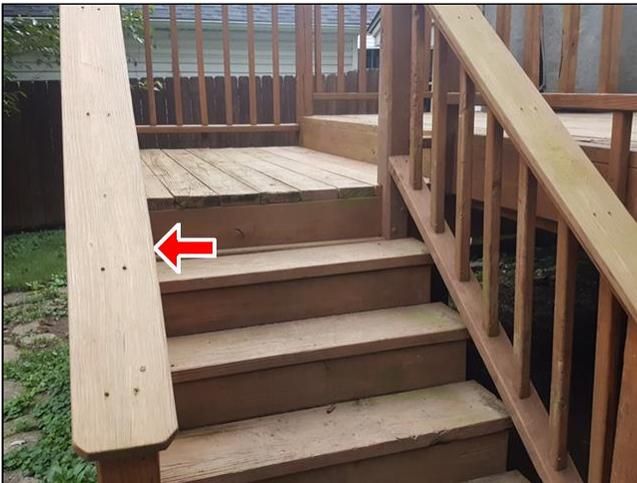
3.5 Item 1(Picture)

3.5 (1) 2x6s are installed for handrails for the deck staircases and are not considered "gripable" by industry standards. This is a safety issue and an injury could occur if not corrected. Recommend that a standard approved handrail be installed for safety by a general contractor.

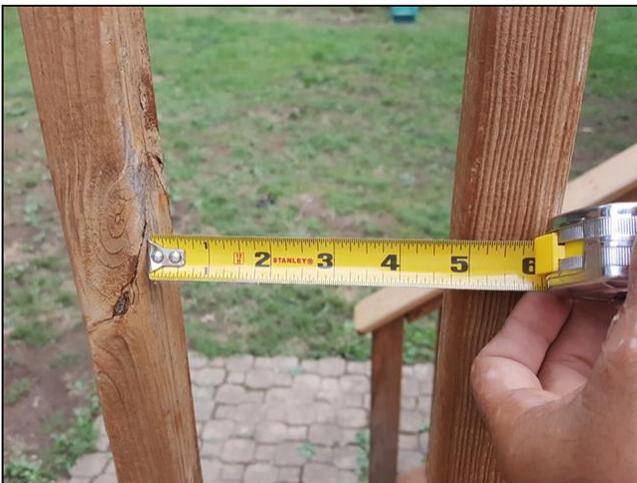
3.5 Item 3(Picture)

3.5 (2) The guard rail for the deck have large spaces between the ballusters. This is a safety issue. A fall or injury could occur if not corrected as this condition could allow a child or pet to fall through which may result in a death. The current recommendations are for spacing to be no more than 4" to prevent these accidents. A qualified contractor should make the necessary repairs and corrections where needed for safety.

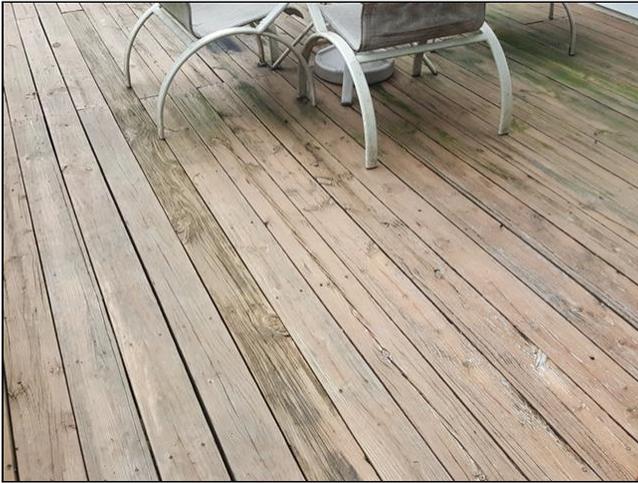
3.5 Item 5(Picture)

**3.5** (3) Treated wood used for decks and railings has a limited life span of 10-15 years. The stain on the deck is getting thin. It should be re-stained to prevent excessive aging and deterioration. This is for your information.

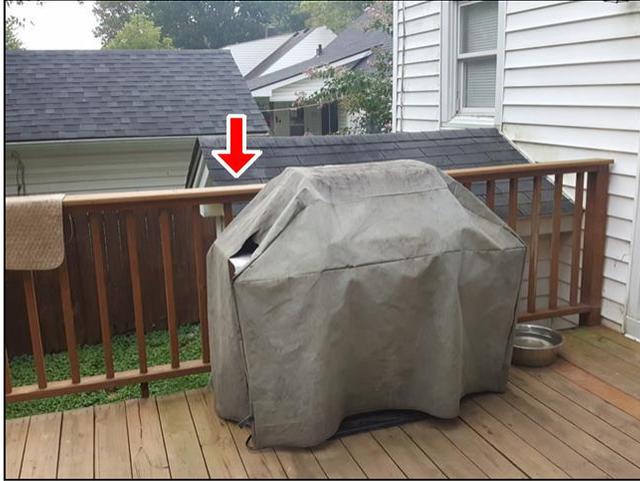
3.5 Item 7(Picture)

3.5 (4) The guard rail for rear deck is unstable and not secured properly. This is extremely dangerous and is a major safety concern. It may fail under a medium or heavy force or if someone was pushed against or was leaning on the railing. For your safety it should be strengthened and secured. Recommend a qualified contractor repair as needed.

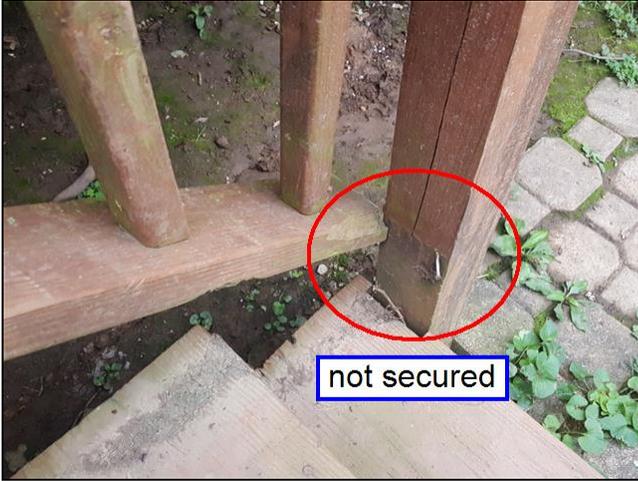
3.5 Item 10(Picture)

3.5 (5) The stair case rail at the deck, rear left side of the home is unstable and not secured properly. This is extremely dangerous and is a safety concern. It may fail under a medium or heavy force or if someone was pushed against or was leaning on the railing. For your safety it should be strengthened and secured. Recommend a qualified contractor repair as needed before closing.

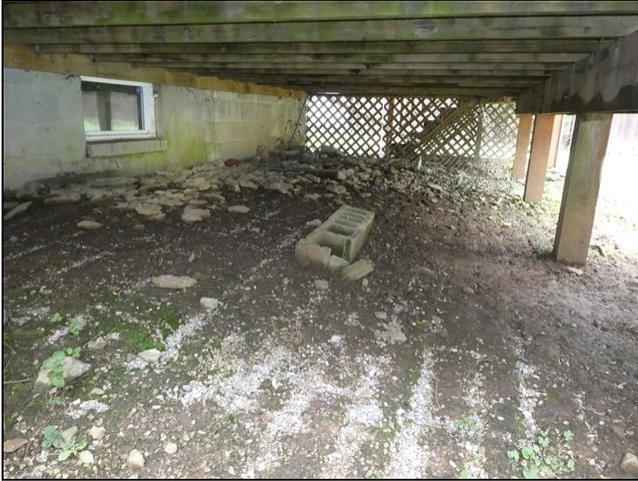
3.8 Item 1(Picture)

3.8 Recommend installing a plastic sheet covering under the deck at about 2 feet wide or entire underneath of deck to prevent water entering the basement foundation perimeter. This improvement will prevent excess water draining into the soil along the foundation which can lead to water intrusion inside the basement and prevent foundation settlement.

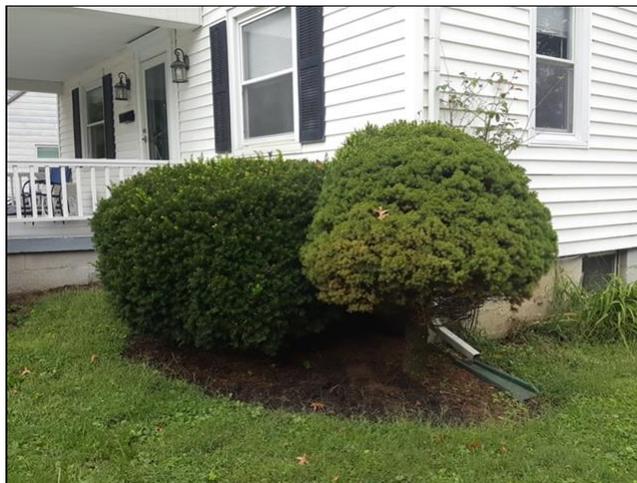
3.9 Item 2(Picture) front right corner of home

**3.9** (1) The vegetation is overgrown where indicated in the photos. Recommend that all bushes, shrubs and trees where applicable be kept neatly trimmed and away from the foundation, wall siding, and window frames to prevent damage to the home and allow proper venting and inspection of house. A 6" clearance is recommended.

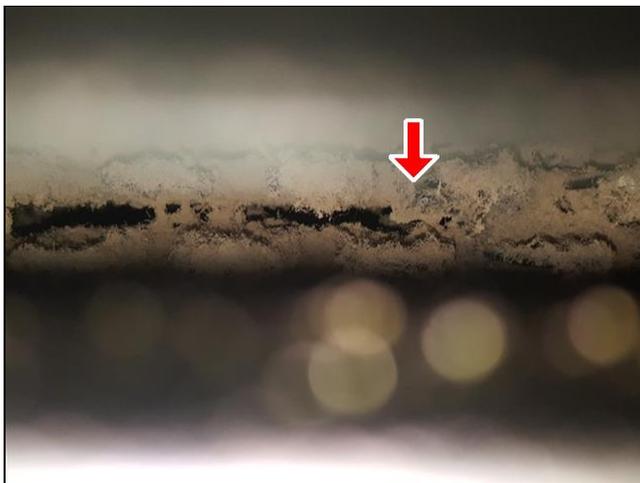
4.6 Item 1(Picture)

4.6 (1) Strongly recommend cleaning the coil below the refrigerator in the kitchen. This is causing the refrigerator to work hard in keeping items cool. If not cleaned refrigerator may fail to operate over time.

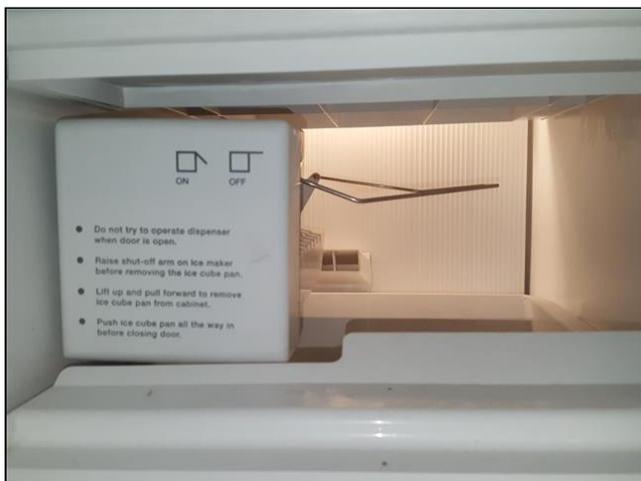
4.6 Item 3(Picture)

**4.6** (2) The refrigerator does have a water supply line connected to it. The ice maker was turned off at time of inspection. Therefore the ice dispenser was not inspected. The water dispenser does work. This is for your information.

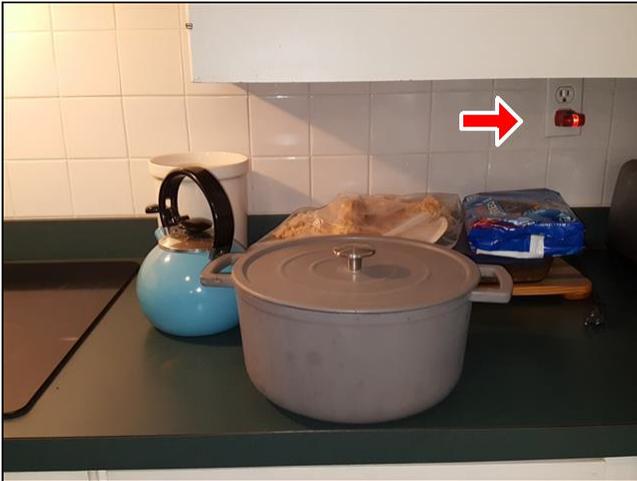
4.9 Item 1(Picture)

4.9 (2) The outlet(s) on the right side of the stove in the kitchen is showing an open ground circuit. This is a safety issue and this type of electrical hazard is extremely dangerous. Major appliances using three prong cords should never be connected to these two slot receptacles. Recommend a qualified licensed electrician correct the outlet so that it is grounded, then ensuring all receptacles are GFCI protected and tripped when tested.

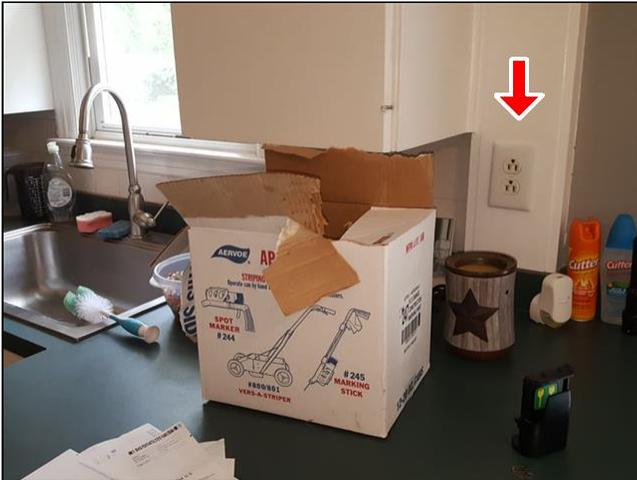
4.9 Item 2(Picture)

4.9 (3) The outlet(s) is not GFCI protected in the kitchen in the home where indicated in the photo. Although GFCIs may not have been required at the time that this house was built, these are now required and recommended for safety within any water source as a safety feature when any changes to the outlets are made. GFCI outlet offers protection from shock or electrocution. Recommend a licensed electrician correct as needed.

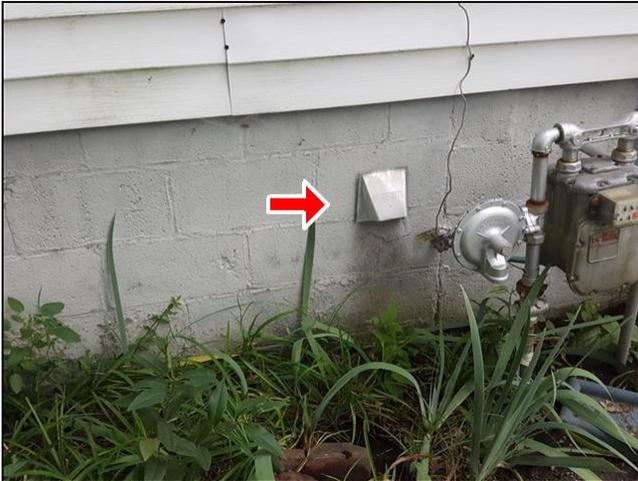
4.10 Item 1(Picture)

**4.10** (1) The exterior port for the dryer vent pipe is located at the left side of the home. (see photo for location) This is for your information.

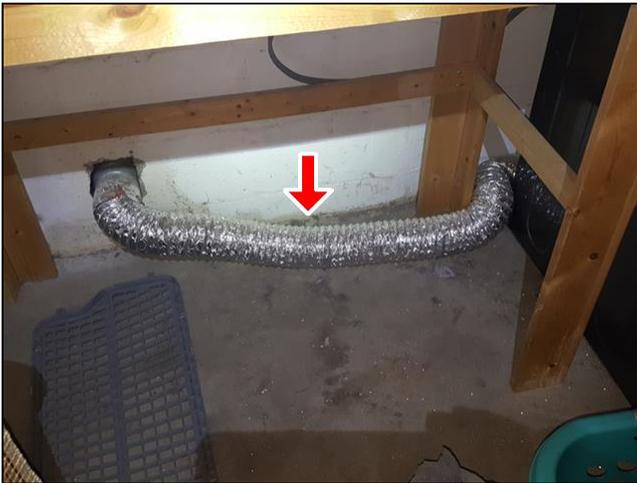
4.10 Item 2(Picture)

**4.10** (2) A pleated Foil flex pipe is currently installed from the dryer to the exhaust vent. The current recommendations are for dryer vents to be heavy flexible or solid metal to help prevent crushing and damage from fires. Dryer lint fires are reported to be the third leading cause of fires. Exhaust ducts should be constructed of minimum 0.016 inch thick rigid metal ducts, having smooth interior surfaces with joints running in the direction of air flow. Exhaust ducts shall not be connected with sheet metal screws or fastening means which extend into the duct. All dryer vents should be disconnected and cleaned twice a year. This is a very common cause of fires. Recommend replacing duct for proper operation and for your safety using a qualified contractor.

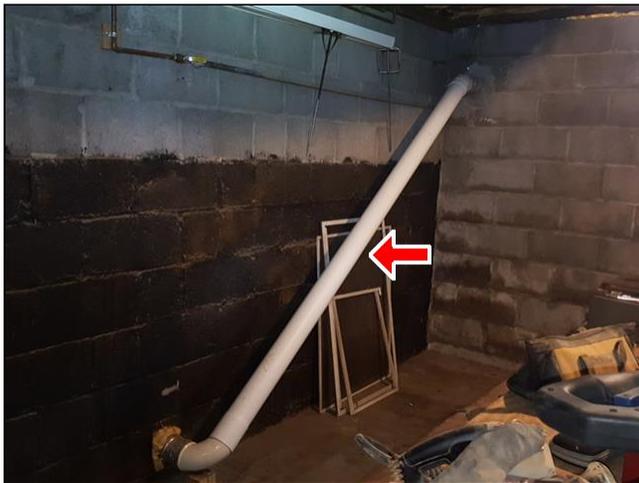
4.10 Item 6(Picture)

**4.10 (3)** The dryer vent in the basement is made of PVC pipe. This is a safety issue. Manufacturers state that "To reduce the risk of fire, DO NOT use plastic pipe or flexible plastic pipe to exhaust the dryer" PVC piping increases the risk of a dryer vent fire due to it creates static electricity which causes the lint to build up, and that PVC is only rated at 140 degrees of heat. Dryers get hotter. Recommend PVC pipe be converted to flexible metal ridge or solid metal pipe for your safety. Replace as needed.

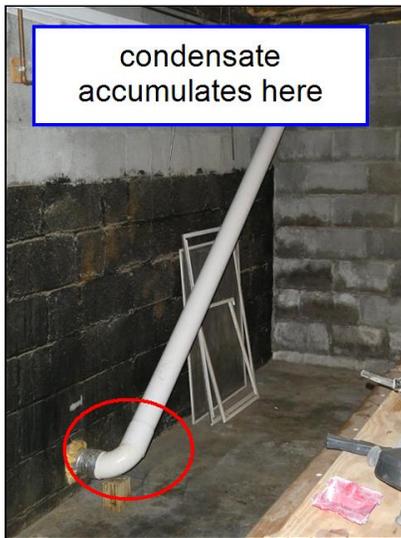
4.10 Item 7(Picture)

**4.10** (4) The vent pipe for the dryer is not pitched correctly for proper venting. There should be a 1/8 pitch rise per foot to prevent condensate accumulating in the duct. Recommend correcting as needed by a general contractor.

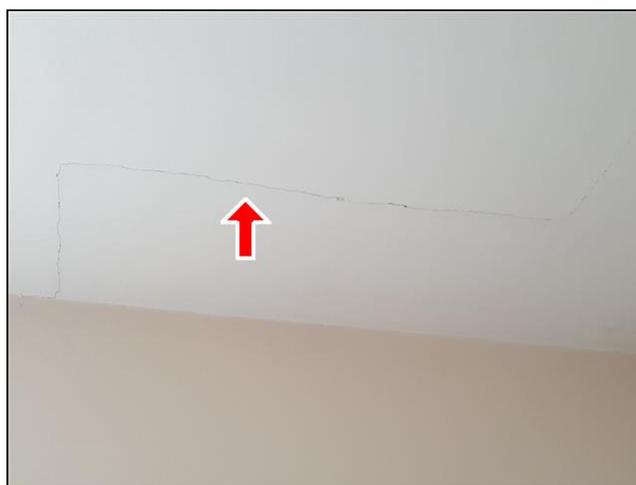
5.0 Item 2(Picture) 2nd bedroom

**5.0** The cracks in the ceiling in the (upstairs) family room and 2nd bedroom (see photos for location) appear to be common settlement cracks. Cracks larger than 1/16" are of concern only. Minor settlement of the home has occurred due to the age of the home and from perhaps framing shrinkage. Cracks of this nature are also caused by moisture, changing temperature, or framing shrinkage due to a lack of ventilation. Recommend repairing cracks then paint and monitor. If cracks reappear and become larger than 1/16" then would recommend a structural engineer further investigate to determine cause and suggest repairs.

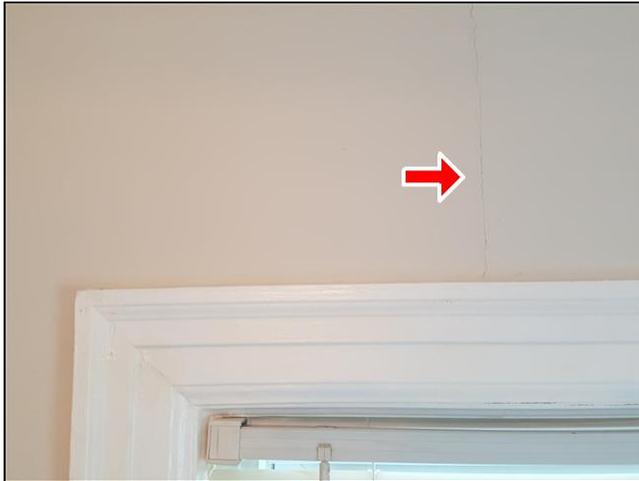
5.1 Item 1(Picture) 3rd bedroom

5.1 The crack(s) noted on the walls where indicated in the photo(s) at various rooms above and below windows, (see photos for location) are common minor settlement vertical crack(s). Cracks larger than 1/8" wide are of concern only. Minor settlement of the home has occurred due to the age of the home and from perhaps via framing shrinkage. This damage is considered to be cosmetic and a small repair issue for your information. Recommend prep prime and paint as needed.

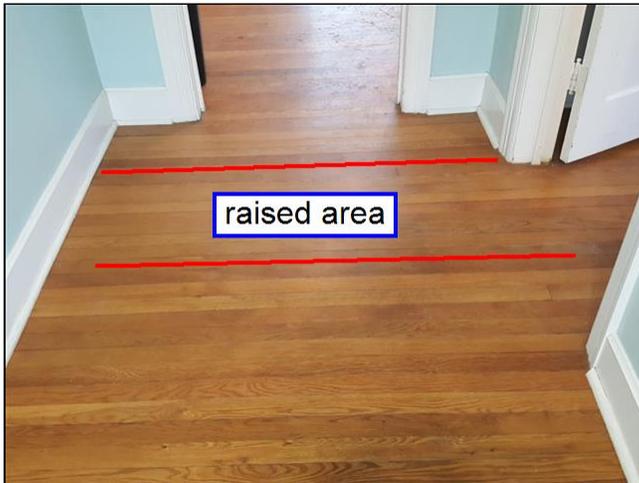
5.2 Item 1(Picture)

**5.2** The floor has a raised area in the hallway where indicated in the photo. This is due to additional support columns that have been placed directly above the wood beam in the basement. This is not a structural concern and is normal and to be expected in a house of this age. This is for your information.

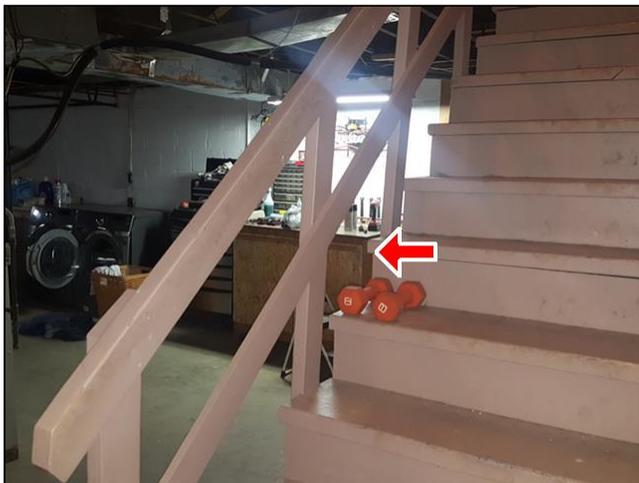
5.3 Item 1(Picture)

**5.3** The guard rail balusters are installed horizontally at the basement staircase. This is a potential safety issue as a child may climb the guard rail which may result in a fall, injury or death to occur. Recommend vertical balusters be installed for safety and ensure they are spaced 4 inches apart to prevent these accidents. A qualified contractor should make the necessary repairs and corrections where needed for safety.

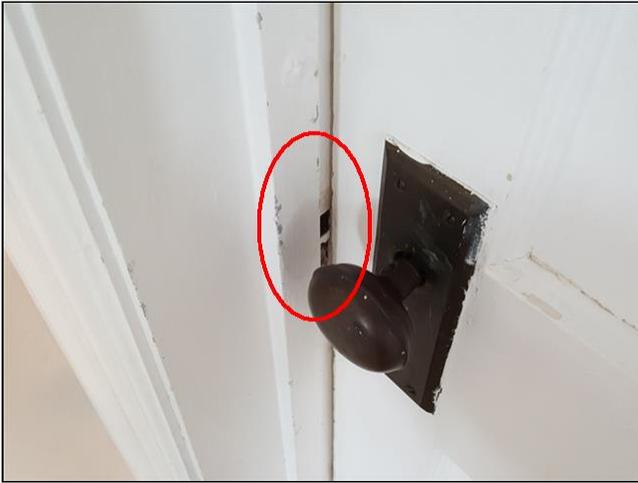
5.4 Item 1(Picture)

5.4 The door knob hardware is not latching in the Master Bedroom where indicated in the photo. It requires an adjustment. The strike plate may need to be adjusted or trimmed to be able to lock/close the door. Recommend repair as needed.

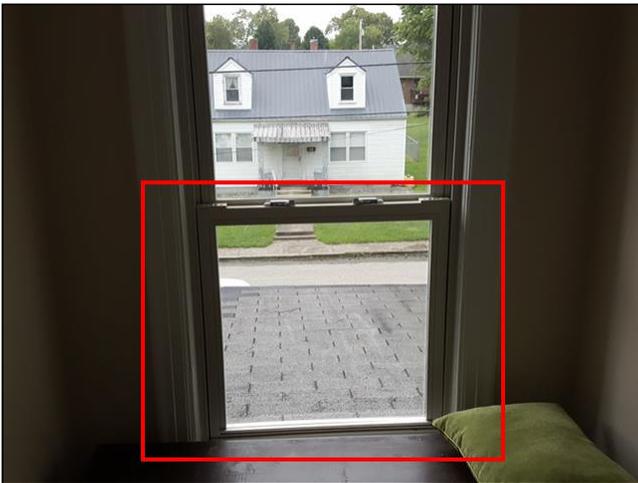
5.5 Item 1(Picture)

5.5 (1) The window in the master bedroom where indicated in the photo is missing a screens. Recommend these be installed to prevent insects entering the home when the window is opened. Replace as needed.
