## **Inspection Report**

**Property Address:**  
211 Mangini Street  
Nicholasville KY 40356

<b>Date:</b> 9/12/2018	<b>Time:</b> 10:00 AM till 02:30 PM	<b>Report ID:</b> 180912PETERS
<b>Property:</b> 211 Mangini Street Nicholasville KY 40356	<b>Customer:</b> Mr. Trevor Peters	<b>Real Estate Professional:</b>

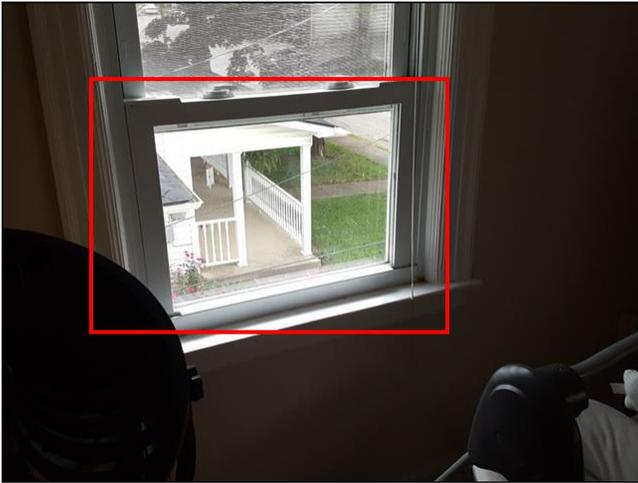
5.5 Item 2(Picture)

5.5 (2) The window in the 2nd Bedroom (right side of the home) will not stay up without a prop. The springs or sash cords may not be connected or they may be broken. This causes the window to slam closed very quickly and harm anything beneath it especially a persons hand. This is a safety issue. Correction or replacement of the spring or sash cord by a qualified window installer or contractor is recommended for the safety of children and adults.

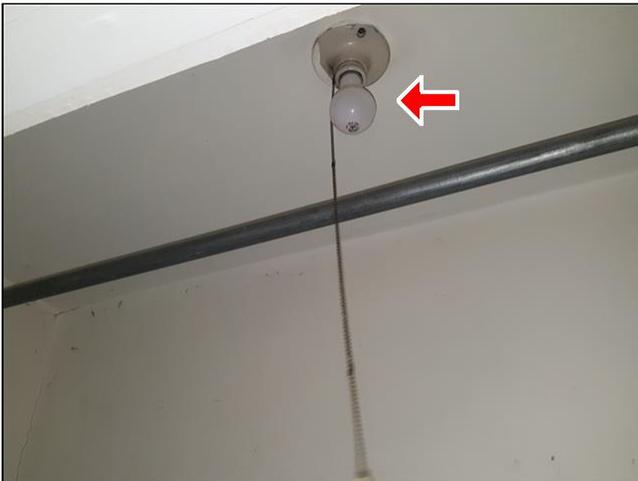
5.6 Item 1(Picture) guest bedroom

5.6 The light in the bedroom closets where indicated in the photo(s) are missing a fixture. Light bulbs in closets should have fixtures or be replaced with fluorescent bulbs to prevent fires from bulbs being in contact with clothing or storage items. This is a safety issue. Recommend correcting as needed.

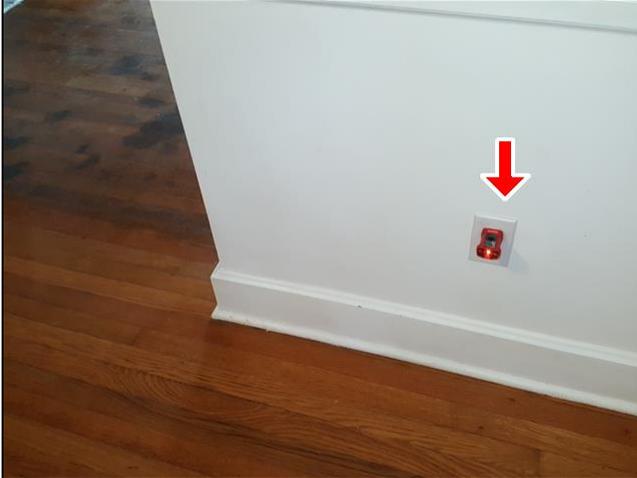
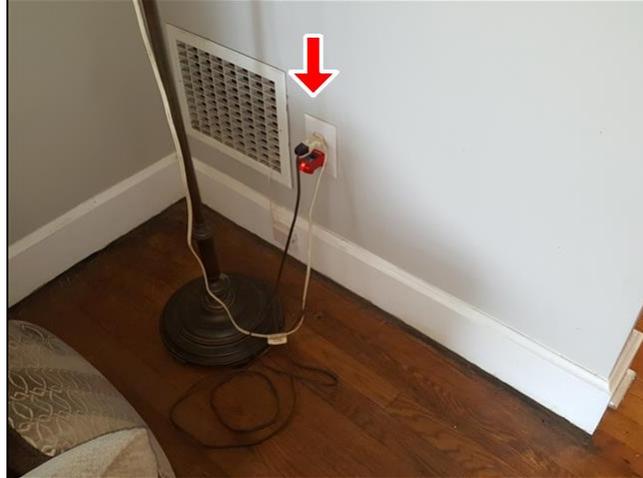
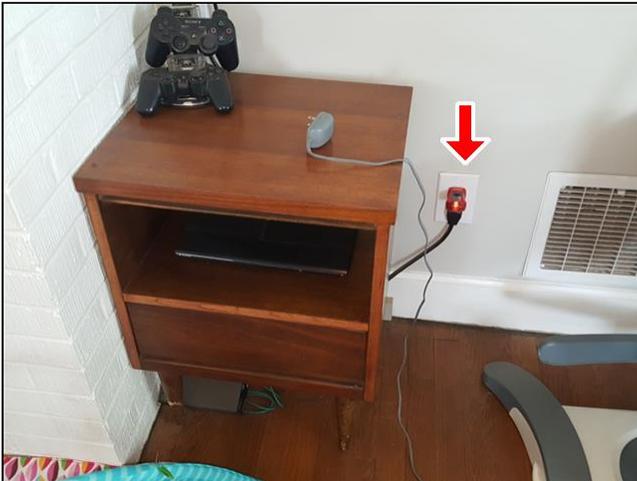
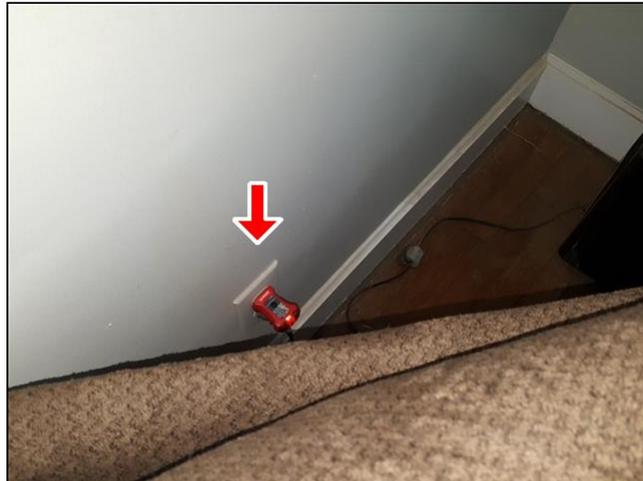
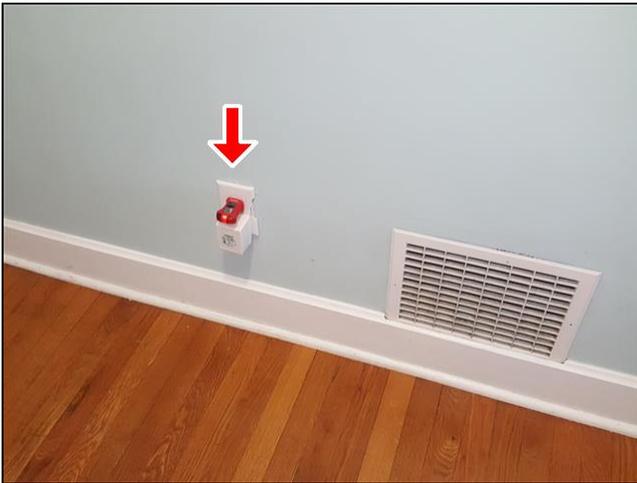
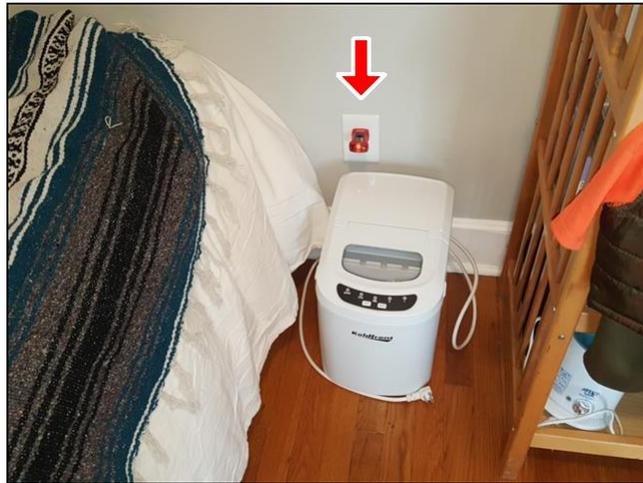
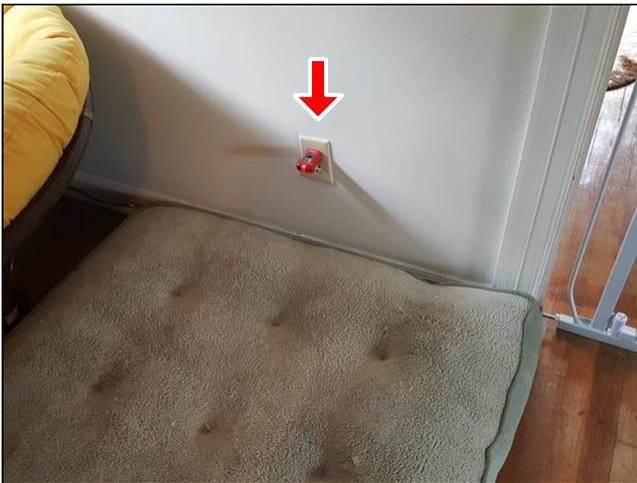
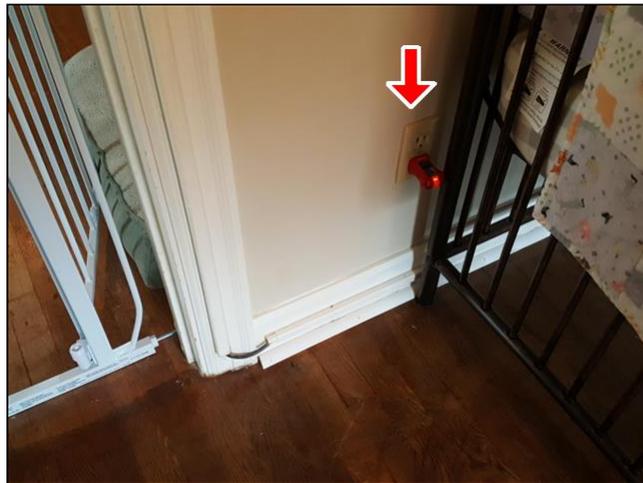
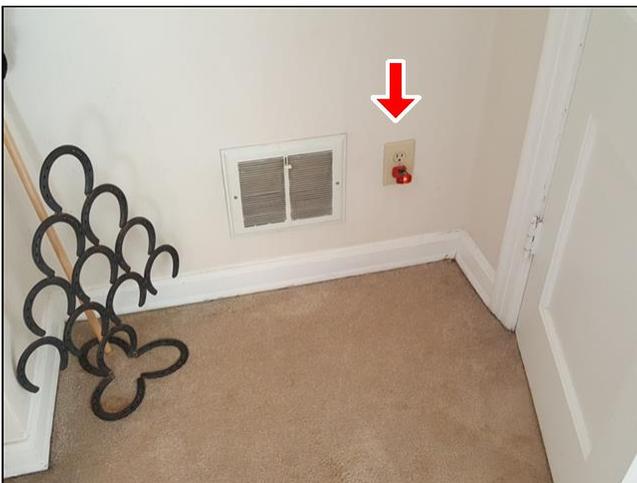
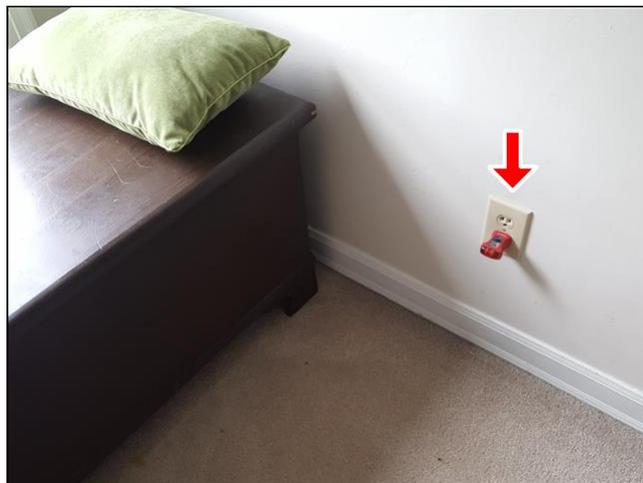
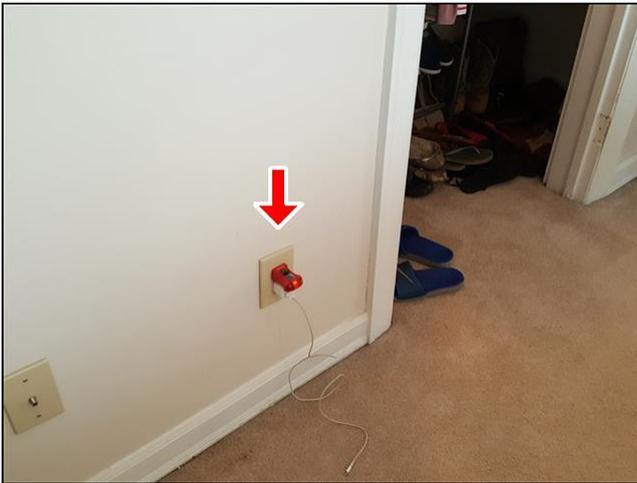
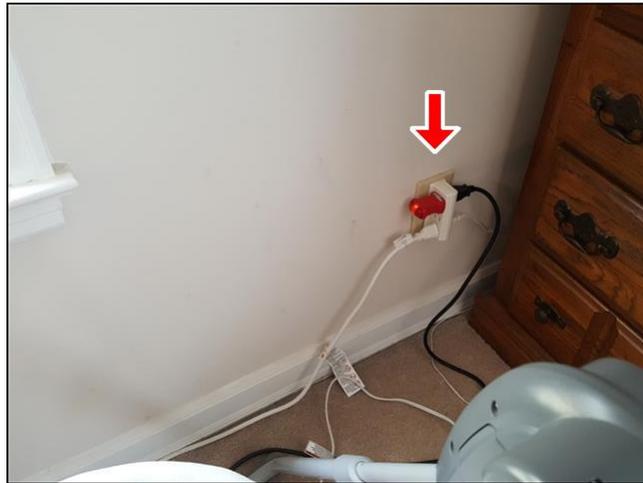
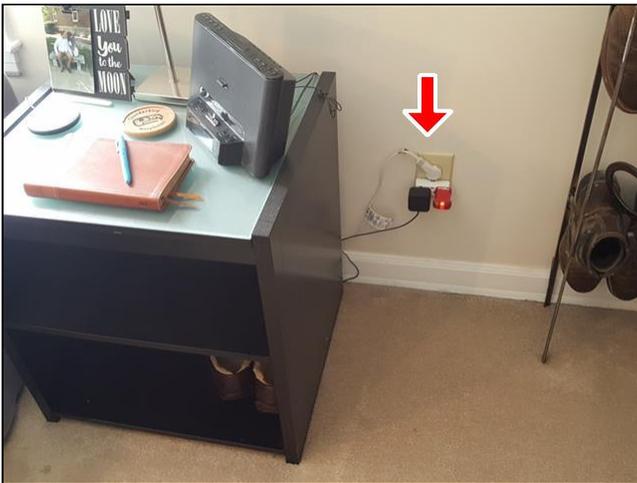
5.7 (1) The outlets shown in the photo are showing an open ground. These were originally a 2 prong receptacle when the home was built and have been converted to a 3 prong receptacle without being grounded. This is a safety issue. Major appliances using three prong cords should never be connected to these receptacles unless the appliance manufacturer allows the connection. Many lamps and other small appliances do not have or require the three slot electrical receptacles. When updating outlets in a home they should be converted to today's standards for safety. Recommend a qualified electrician correct and upgrade connections to these outlets as needed.

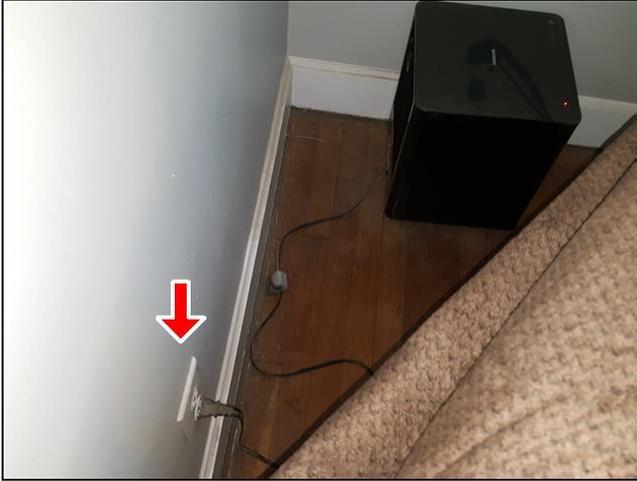
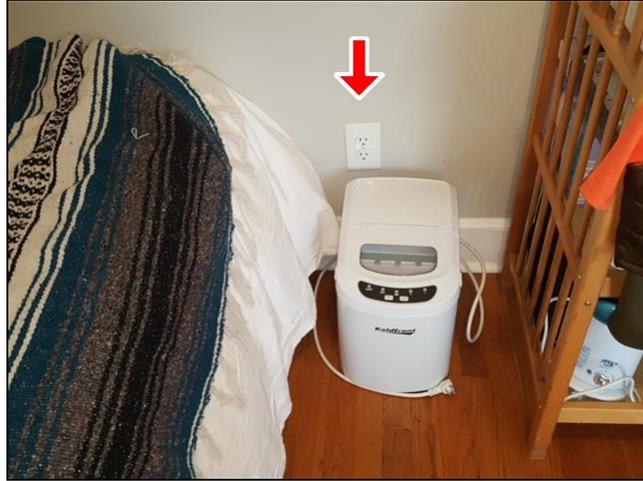
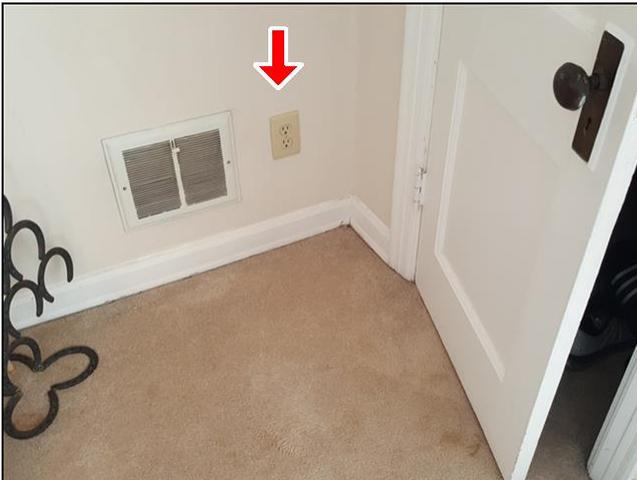
5.7 (2) The outlet(s) where indicated in the photo(s) are loose at the wall or in the outlet box. Electrical issues are considered a hazard until repaired. This is a safety issue that needs to be corrected due to an electric shock or fire from loose connections could occur if not repaired. Recommend a qualified licensed electrical contractor correct as needed.

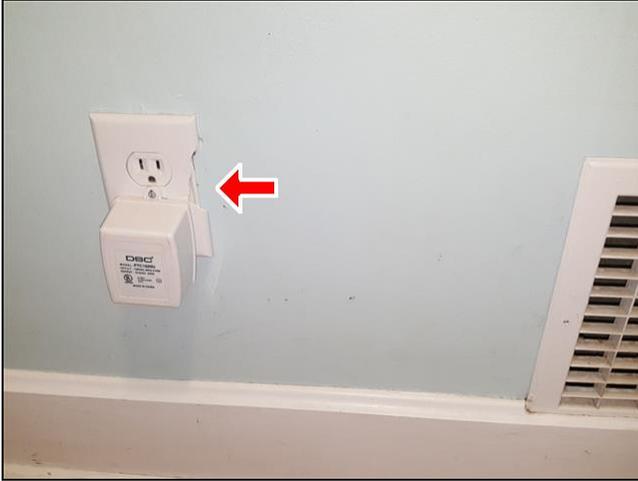
5.7 Item 17(Picture)

**5.7 (3)** The cover plate for the the outlet is broken in the hallway. Recommend the cover be replaced to prevent touching the sides of the device to prevent an electric shock which can cause an injury or death. Electrical issues are considered a hazard until repaired, and this is considered to be unsafe. A qualified licensed electrical contractor should correct as needed.

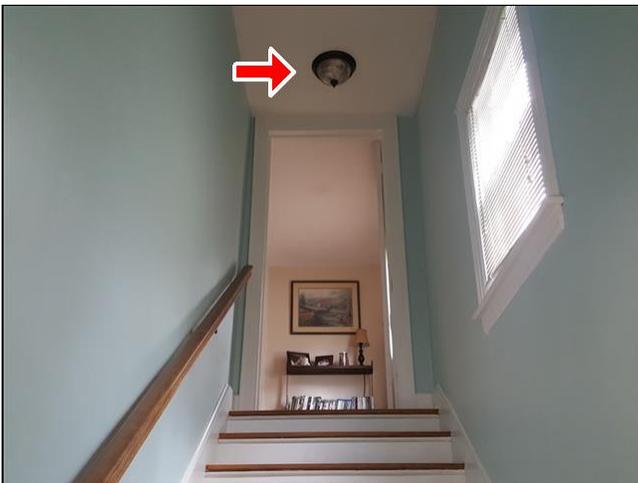
5.7 Item 18(Picture)

**5.7 (4)** The light fixture does not work (try bulb first) in the (at top of stairs) upstairs. If the bulb is not burned out, the fixture or circuit should be repaired using a qualified electrician.

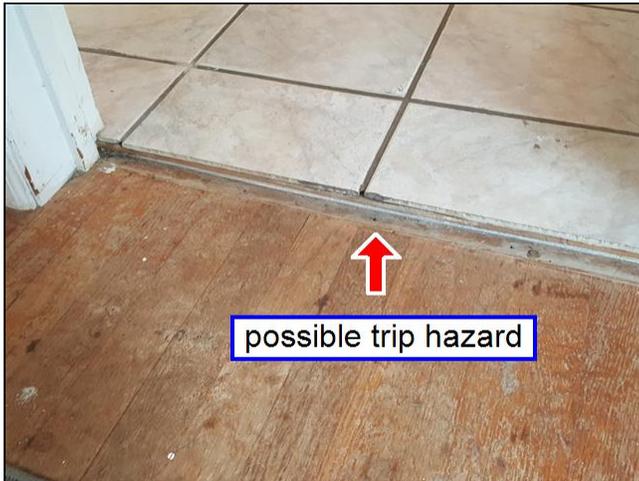
6.0 Item 1(Picture)

**6.0** The floor in the family room is lower than the floor in the master bathroom. This is a safety issue and a possible tripping hazard. A serious injury could occur if not corrected. Recommend a qualified contractor correct as needed for your safety. A molding strip maybe needed.

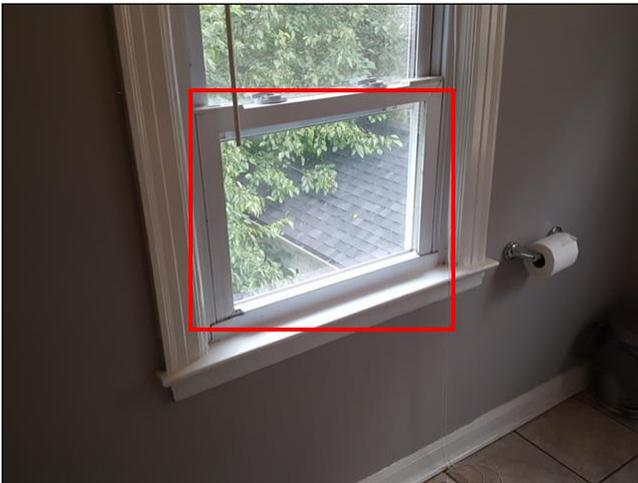
6.3 Item 1(Picture)

6.3 The window in the master bathroom where indicated in the photo is missing a screen. Recommend these be installed to prevent insects entering the home when the window is opened for ventilation. Replace as needed.

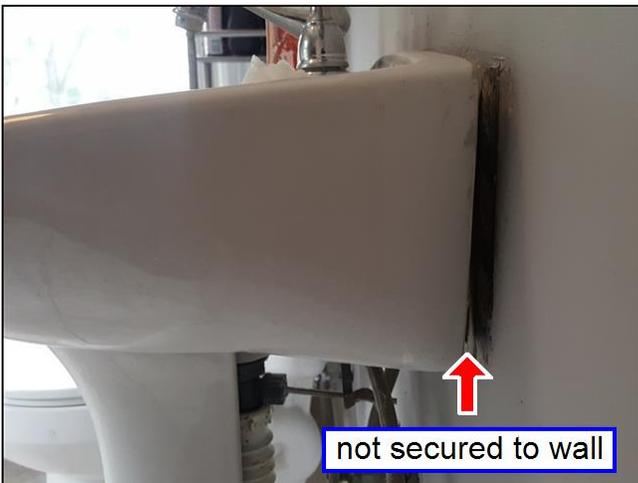
6.4 Item 1(Picture)

6.4 The pedestal sink in the master bathroom is loose and not secured to the wall correctly. This is a safety issue. The sink may fall which could result in an injury of a person and/or place strain on plumbing pipes which could result in a leak. Recommend this be better secured, then caulk the area to prevent water penetration. A general contractor is recommend for this repair.

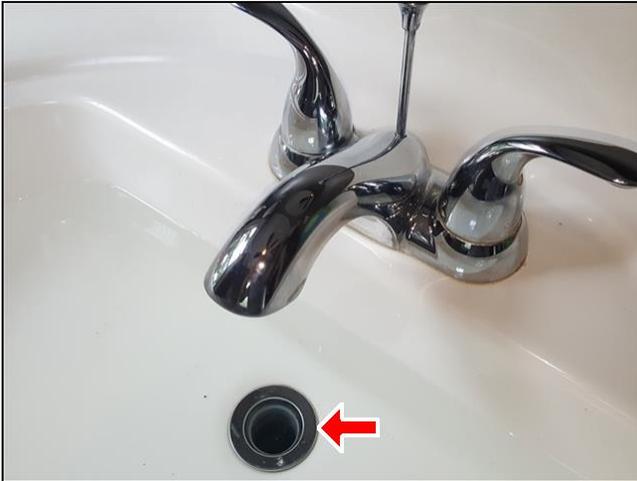
6.5 Item 1(Picture) 2nd bathroom

6.5 (1) The drain plug is missing at the sinks in both bathrooms. Replacement or repair of the drain plug is recommended to allow use of the drain lever.

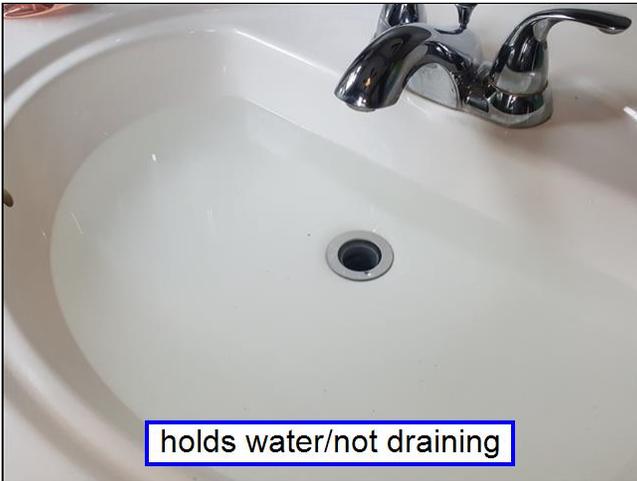
6.5 Item 3(Picture)

6.5 (2) The sink in the 2nd bathroom when filled does not drain correctly. When tested, the water started to drain and then stopped. Over time the water eventually completely drained. There maybe a blockage in the drain lines or the the drains may not be vented correctly or there is a blockage in the vent pipe. Recommend a qualified licensed plumber further investigate and repair as needed.

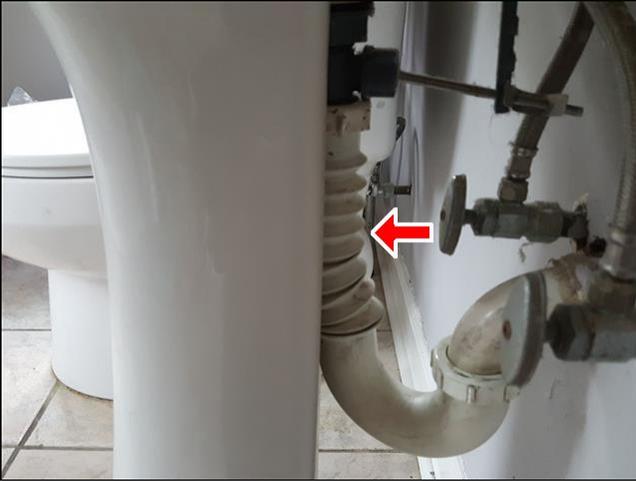
6.5 Item 5(Picture)

**6.5 (3)** Flexible ridged pipe is being used for the connection to the drain line under the sink in the master bathroom. The pipe ridges will hold and trap debris which could clog the drain. Plan on cleaning the drain from time to time. Smooth pipe would be better but may be difficult to fit to the existing drain lines. Recommend you seek a qualified licensed plumber to evaluate and correct if needed as this type of work is not to standard workman like practices.

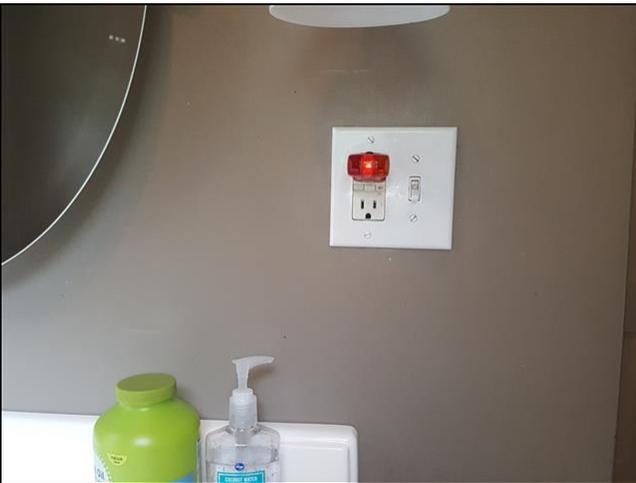
6.6 Item 1(Picture)

**6.6 (1)** The outlet(s) in the 2nd bathroom is a non-grounded outlet which is currently acceptable, however, they maybe GFCI protected and if so they should be labeled a non-grounded GFCI and it is not as safe as a grounded GFCI. This is for your information. I would recommend a qualified electrician further check to see if this outlet is GFCI protected.

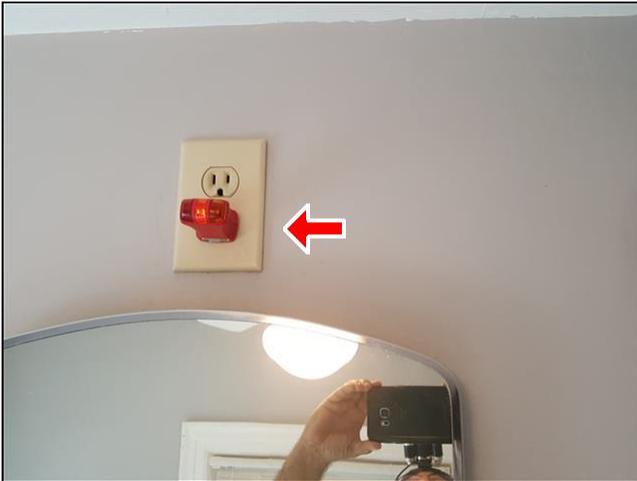
6.6 Item 2(Picture)

6.6 (2) The outlet(s) is not GFCI protected and is not grounded in the Master bathroom in the home. Although GFCIs may not have been required at the time that this house was built, these are now required and recommended for safety within any water source as a safety feature when any changes to the outlets are made. GFCI outlet offers protection from shock or electrocution. Recommend a licensed electrician correct as needed.

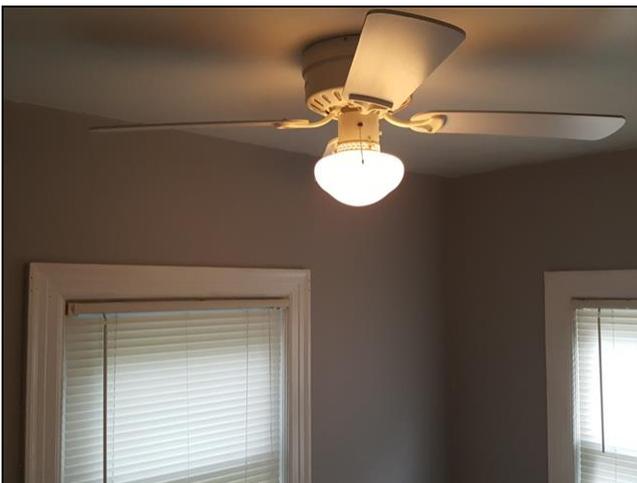
6.6 Item 4(Picture)

6.6 (3) The ceiling fan does work in the Master bathroom, but is mounted less than 7 feet and could be too low to stand under. This is hazardous and a serious safety issue. If not removed a serious injury could occur for persons close to 5'6" high and above. Strongly recommend removing the ceiling fan to avoid an injury prior to moving in. Recommend a qualified contractor correct as needed.

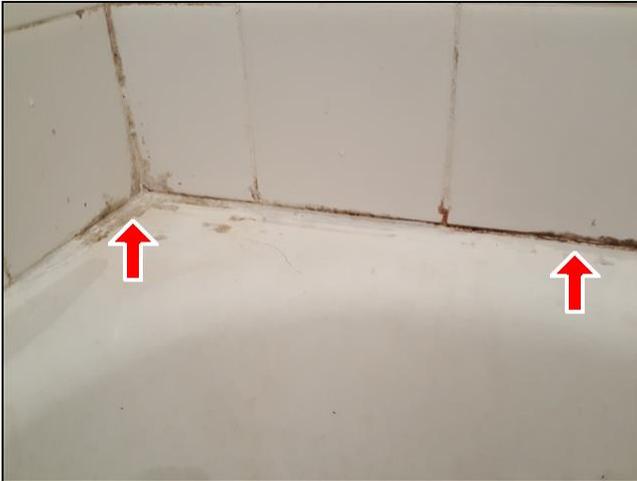
6.7 Item 1(Picture)

6.7 Old, shrinking, or dirty caulk with cracks was seen in the master bathroom shower enclosure. All of the caulk should be kept in perfect condition to prevent further cracking or more holes appearing to reduce the possibility of water leaking underneath the shower enclosure and tiled wall. If not corrected mold and/or deterioration of the floor/wall framing can occur beneath the shower enclosure. Recommend re-caulking where needed to seal openings and deteriorated caulk. Use a quality silicone caulk that is expandable and moisture resistant. [Choosing the right caulk](#) Would recommend a qualified general contractor repair as needed.

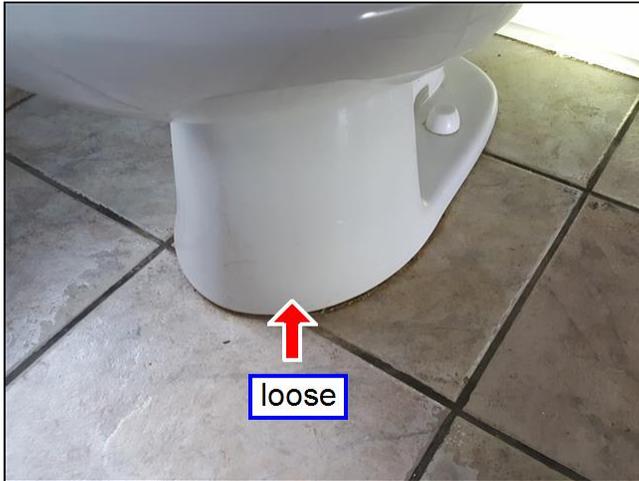
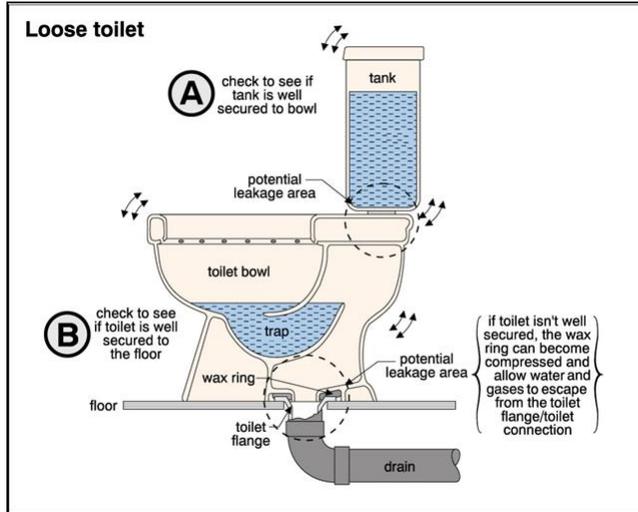
6.8 Item 1(Picture)

**6.8** The toilet tank base is loose at the floor in the master bathroom. The screws may need tightening to secure the toilet base to the floor to prevent a water leak between the toilet and the drain line connection. If tightening the screws at the base of the toilet does not secure the toilet, repairs may involve re-setting the toilet on a new wax seal and/or repairs to the floor may be required. Recommend a qualified licensed plumber repair or correct as needed.

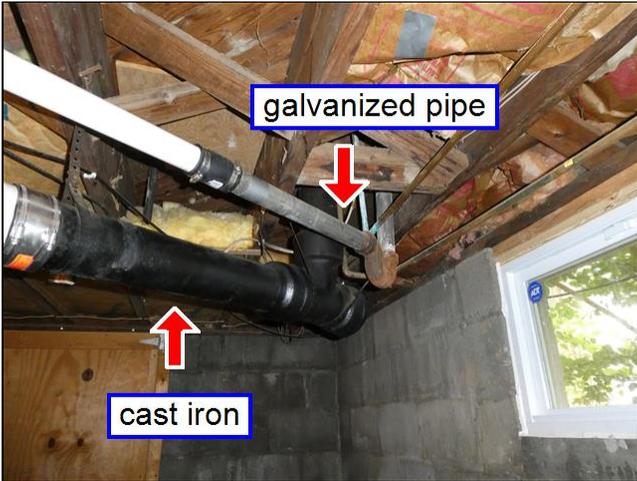
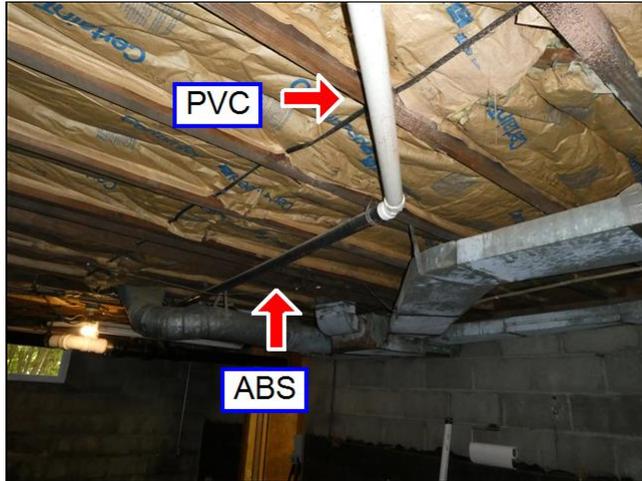
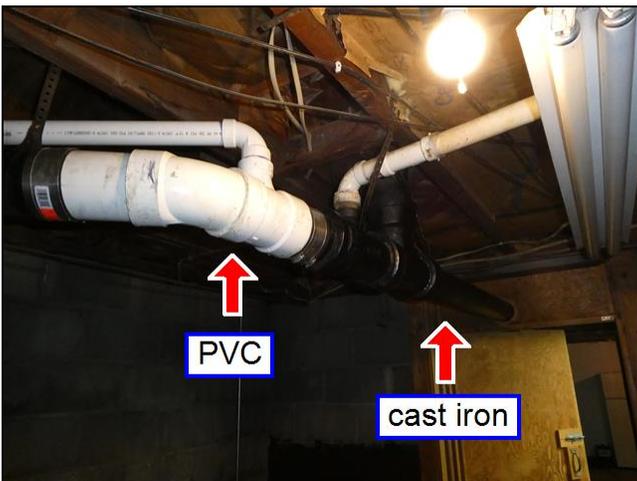
7.0 Item 1(Picture)

**7.0 (1)** Cast Iron drain lines are known to corrode internally and will leak at the joins after a long period of time. The corrosion will eventually restrict the drainage and leaks will occur. The cast iron drainage lines are fifty or more years old and could fail at any time. Replacement of the drainage lines should be strongly considered before major leaks occur. This is for your information. There were no present leaks visible at time of inspection.

7.0 (2) Different types of drain lines have been installed in this house through the years. They may have been added as upgrades or for repair of the lines. No leaks were found during the inspection but BE AWARE that older systems can develop problems that cannot be seen until leaks appear. Watch for any signs of failure and have the lines repaired before they become major problems. This is for your information.

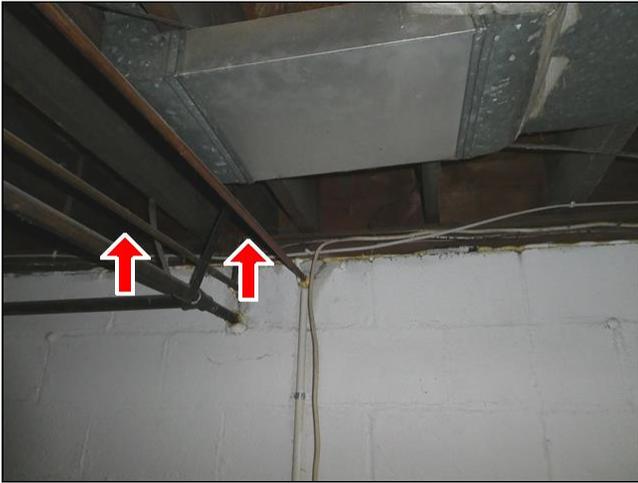
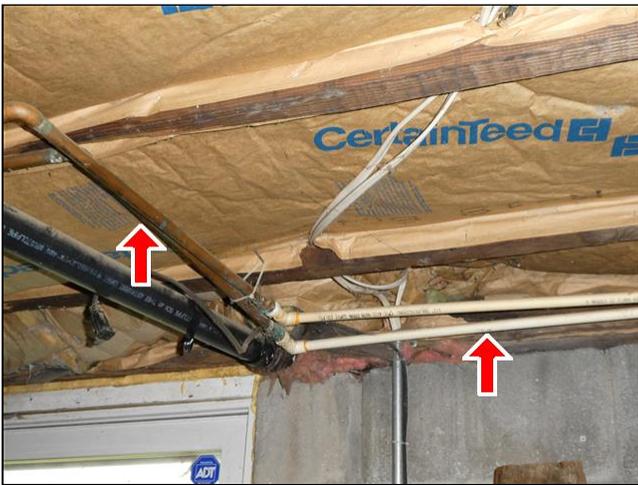
7.1 Item 1(Picture)

7.1 (2) Recommend insulating the water supply pipes in the basement (hot and cold) to ensure pipes do not freeze in winter which may cause a serious plumbing leak in the basement, and to prevent heat loss of water when hot water is flowing into home. This will improve efficiency. This is for your information.

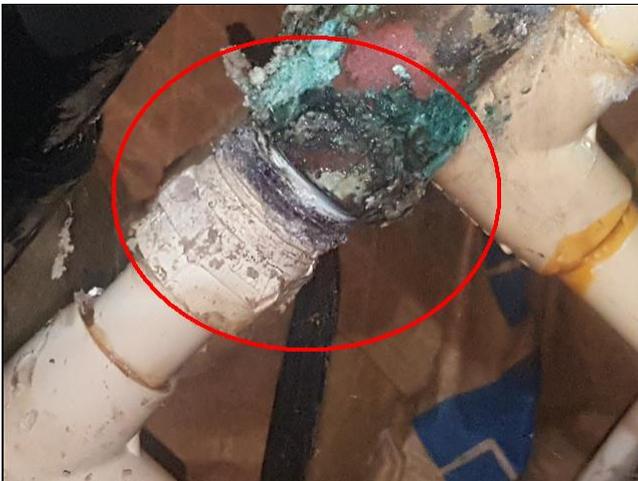
7.1 Item 4(Picture) under kitchen area

7.1 (3) Mineral deposits/scale build up was noted on a water supply line connection in the unfinished basement at the left side of the home. There was a minor leak at the connection. Recommend a qualified licensed plumber repair as needed before a major water leak develops in the basement.

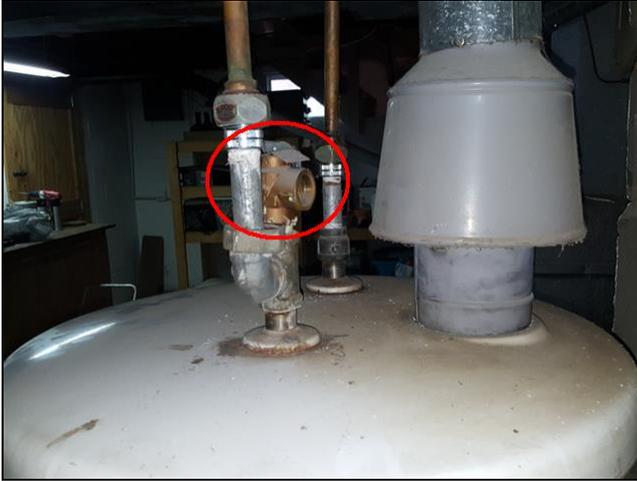
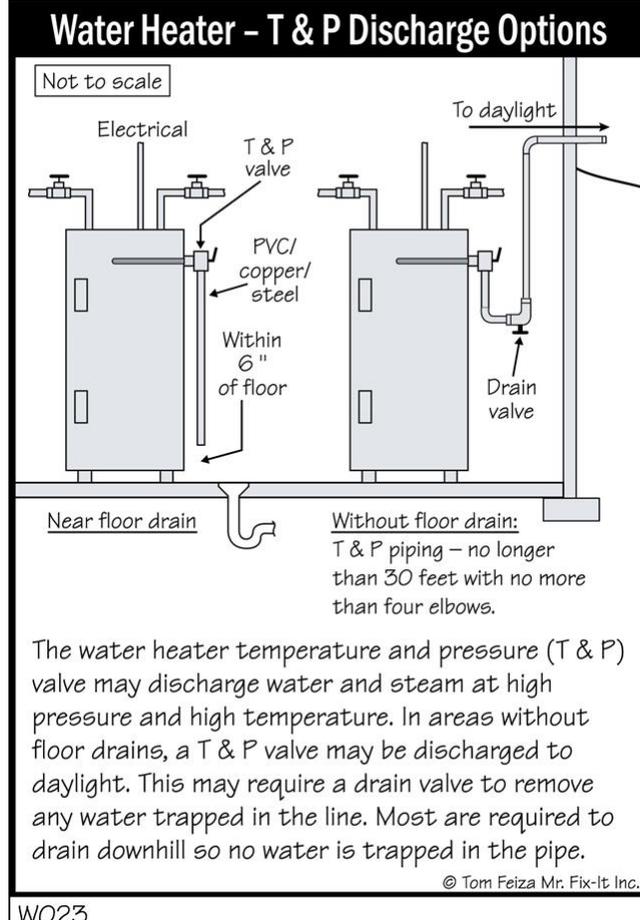
7.3 Item 1(Picture)

7.3 (1) The T&P (Test and Pressure) valve on the water heater is missing a drain line. The drain line needs to be a 3/4" threaded copper pipe to extend within 6 inches, then the end should be visible and drain to the exterior of the home, not in a crawlspace. (PVC is not approved for hot water use and CPVC is not recommended). Recommend a qualified plumber correct as needed for safety.

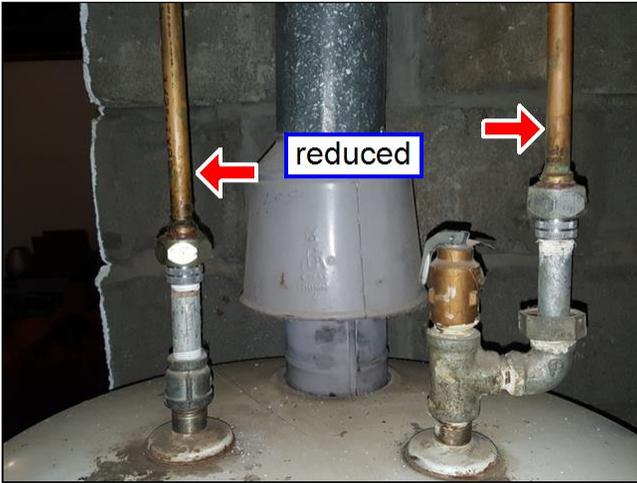
7.3 Item 3(Picture)

**7.3** (2) The cold water supply line and the hot supply line pipes leading into the water heater have been reduced to 1/4 inch pipe. They should be 3/4 inch pipe. This reduces the water pressure leading in wards and outwards from the water heater which can cause damage to the unit and result in poor water pressure for the hot water supply lines in the home. Most manufacturers recommend the pipes that are connected to the water heater are to be 3/4 inch pipes in diameter. Recommend a qualified licensed plumber further investigate and repair/correct as needed prior to moving in.

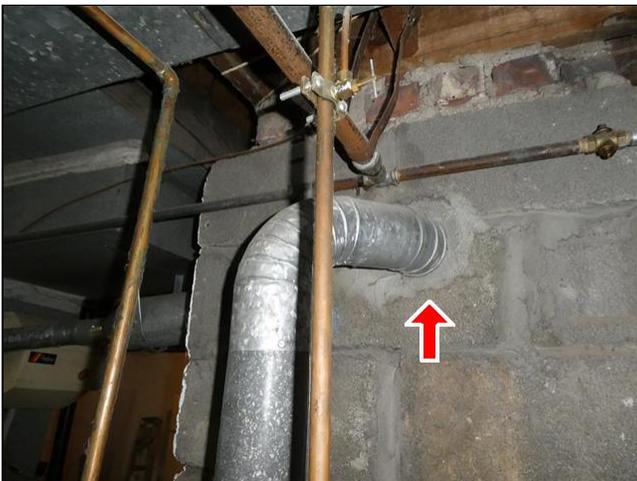
7.4 Item 1(Picture)

**7.4** This chimney is being used for venting the gas water heater. It is important to remember that if the flue tiles are cracked it could allow C.O. (carbon monoxide) into the home. C.O. will damage the clay tiles and mortar joints. The flue size may be larger than recommended to allow proper drafting of the gas appliance using this vent. Strongly recommend a qualified licensed plumber check the size of the flue and install a correctly sized steel liner to allow the water heater to draft well and perform safely.

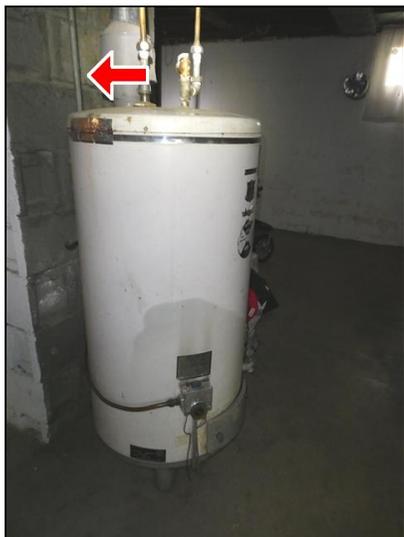
7.7 Item 1(Picture)

**7.7** Gas lines are usually of black iron pipe or CSST piping. Galvanized pipes is not normally recommended but can be used as a cheap alternative. The Galvanized Pipe will eventually flake and the flakes can plug your appliance burner. Your water heater does have a drip leg which is designed to collect any sediment. Would recommend that the pipe be replaced when a new water heater is installed in the home. This is for your information.

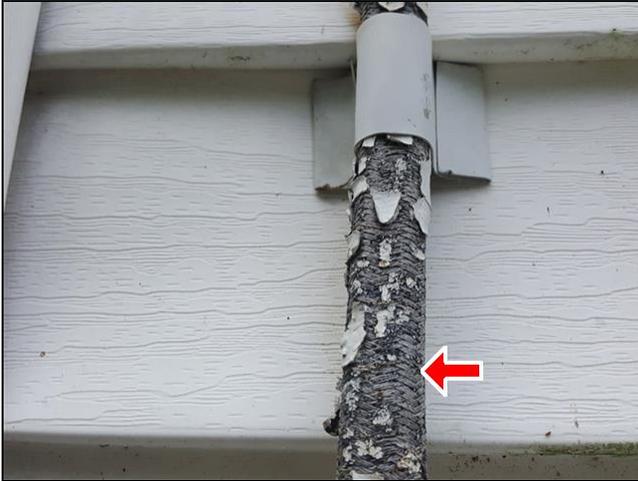
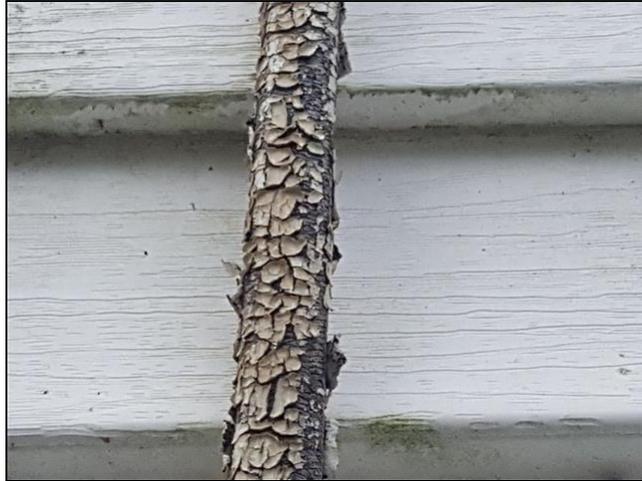
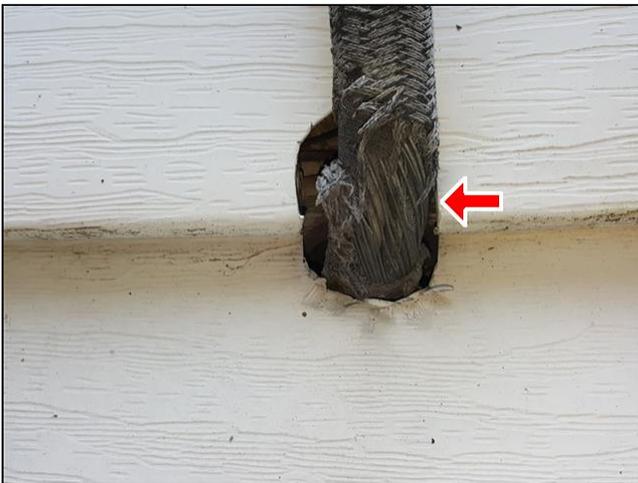
8.0 Item 1(Picture)

**8.0** (1) The electrical service conductors entering the home and meter are frayed at the wire sheathing at the rear left corner of the home. For safety the wiring should be placed in a conduit to prevent further deterioration and to prevent it from being touched by a person and/or child. Recommend a qualified electrician correct for safety prior to closing.

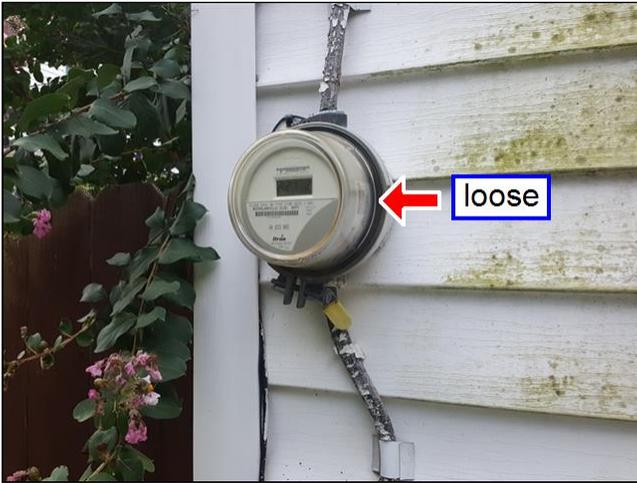
8.0 Item 4(Picture)

**8.0** (2) The meter box is loose and not secured correctly to the wall at the rear left corner of the home. It appears to be held by the wires leading into the meter which are secured to the wall. Excess strain may be placed on connections which may fail causing power to go out. This is **extremely dangerous** as a fire or electrocution could occur if not corrected. Recommend contacting KU to repair or to determine who is responsible for fixing. If the owner is responsible then a qualified licensed electrician will be needed to make the repairs.

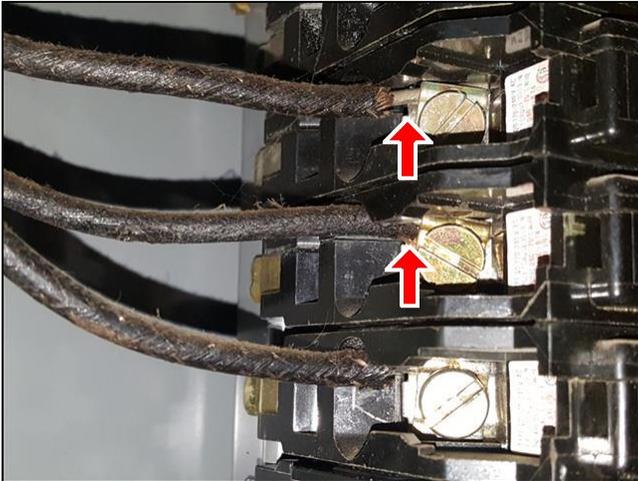
8.3 Item 1(Picture)

8.3 (2) When aluminium wiring is used as noted in this panel at the 15 and 20 amp breakers it should be coated with a good antioxidant. The antioxidant grease is missing. When aluminium wire is exposed to the atmosphere a film of aluminium oxide forms. This is hazardous and a safety issue because the current is supplied at a much lower rate of voltage and as the oxidation builds up, it builds up resistance which creates heat. Also movement of the wire can occur from oxidation due to expansion/contraction of the wire and can cause loose connections. Recommend a qualified licensed electrician further inspect and correct/repair as needed.

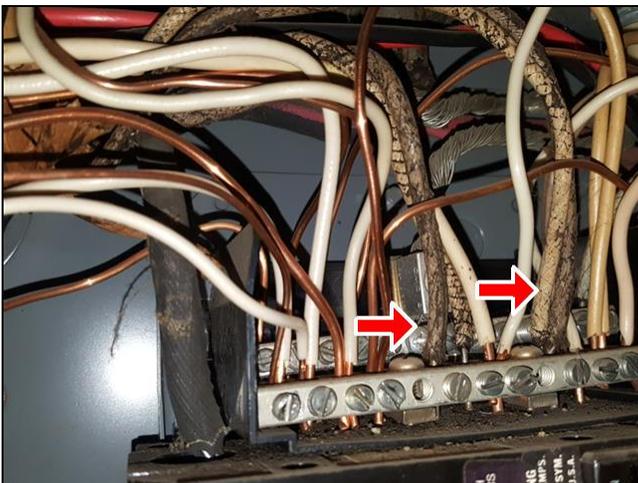
8.3 Item 2(Picture)

8.3 (3) Cloth covered wires are visible in the panel box. These circuits are older systems with cloth coverings that fray and become brittle with age. It is wire encased in brittle rubber which then has a woven cloth covering tightly over the wire similar to the actual old knob and tube wiring. This was then surrounded by a coated cloth woven jacket that made the entire jacket stiff and difficult to bend easily. The biggest issue with it was that the rubber used was of somewhat poor quality and as this wiring is bent or moved, the rubber coating around the wire being so brittle from age and quality, tends to just fall apart. This rubber is generally so brittle, it can be removed from the wiring with just a fingernail. This can be a safety issue if this rubber coating disintegrates or falls off a wire in an attic or behind a wall, and the bare hot and neutral wires make contact with each other, arcing can occur, which can lead to house fires. Be aware that some insurance companies will not issue policies on homes with this type of wiring. Recommend contacting a qualified licensed electrician and your insurance carrier to determine what needs to be done to make this system safer prior to closing.

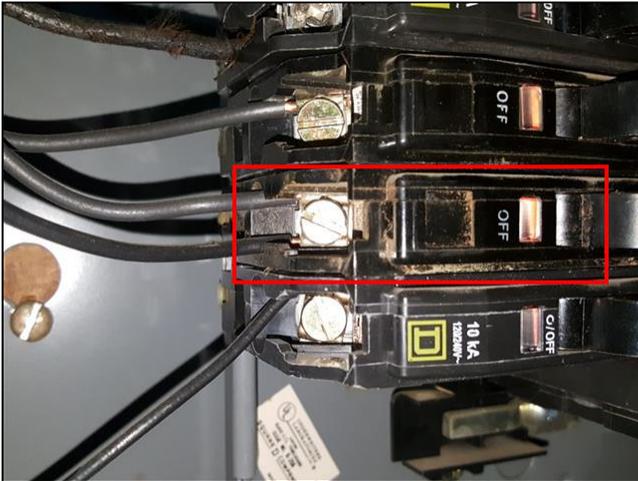
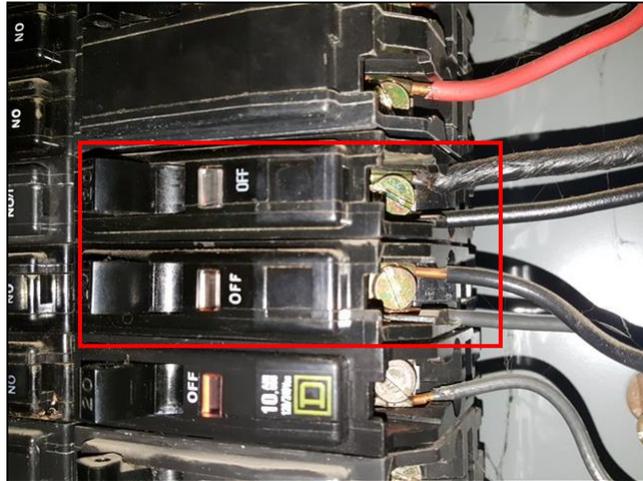
8.3 (4) Multiple tap wiring (more than one hot wire attached to the same breaker) was found in the panel. This panel and breakers are NOT MADE or DESIGNED to provide adequate holding power for multiple wires on a single breaker. A separate breaker should serve each circuit. This is a very hazardous and is a safety issue. May cause a fire or short. Recommend a qualified electrician further evaluate the panel box for further issues and repair and correct as needed.

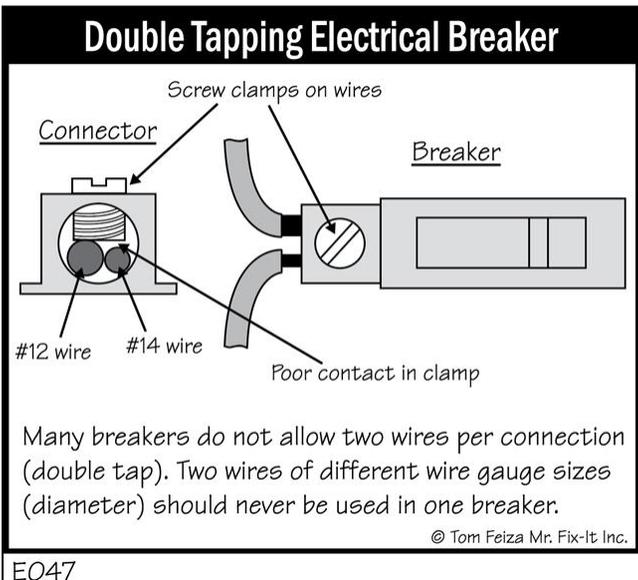
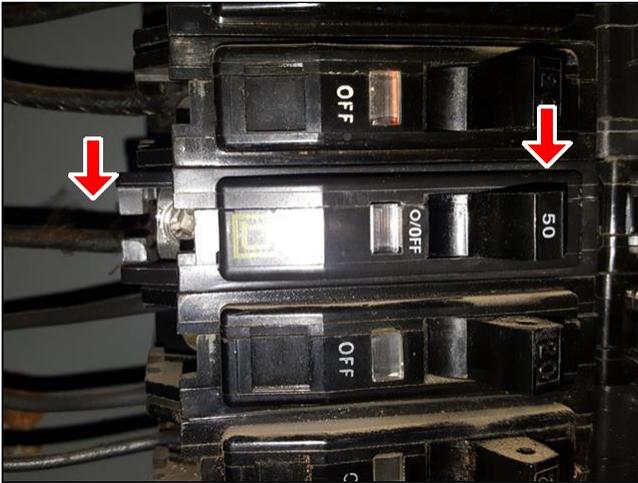
8.3 (5) There are incorrect amperage gauge wire sizes connected to non matching amperage circuit breakers in the panel box where indicated in the photo(s). This is extremely dangerous and could result in an electrical fire within the home. The wires could over heat and catch fire without tripping the circuit breakers. As an example a 15 amp wire should not be connected to a 20 amp circuit breaker. Recommend a licensed electrician further evaluate wire size connected to the circuit breaker in the panel box where indicated and for other faults or hazards then repair or replace as needed.

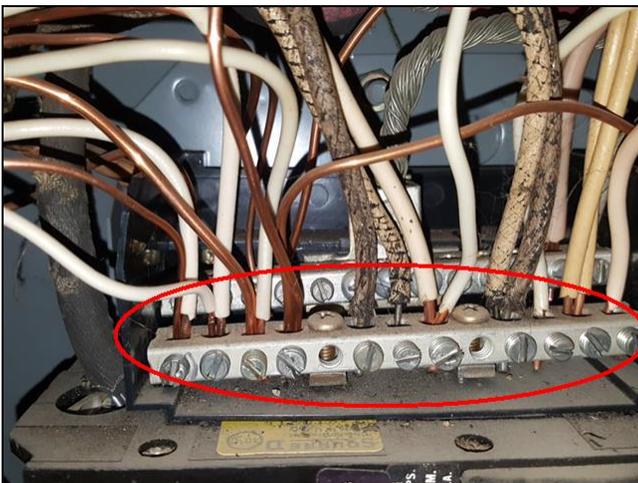
8.3 Item 9(Picture)

8.3 (6) More than one common (white wires) on a single lug of the neutral bar is not recommended but was found in this panel. Separation of these commons is recommended when any other electrical work is done by a qualified licensed electrician.

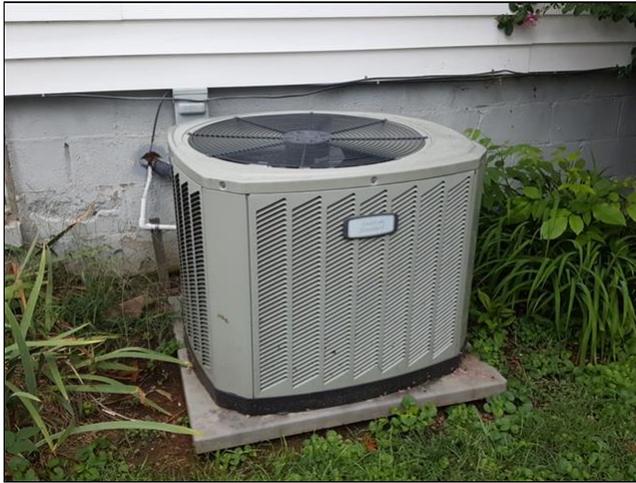
air conditioner/right side of home

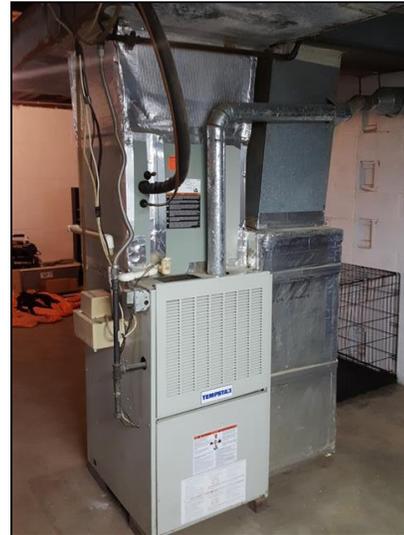
gas furnace/basement

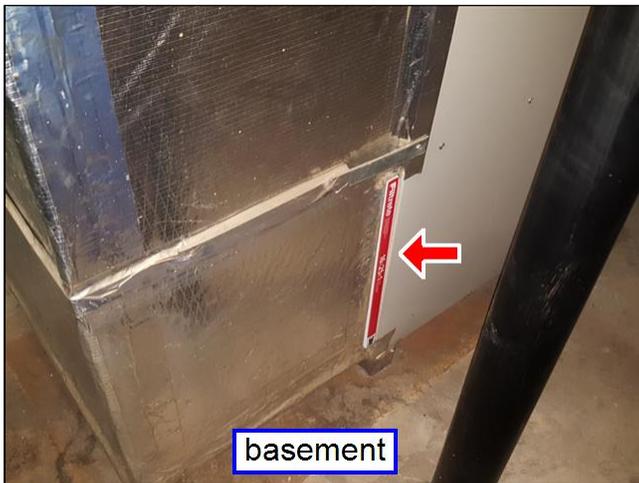
9.2 Item 1(Picture)

**9.2** (1) Filter location (see photo). The arrow on the filter should always point towards the blower.

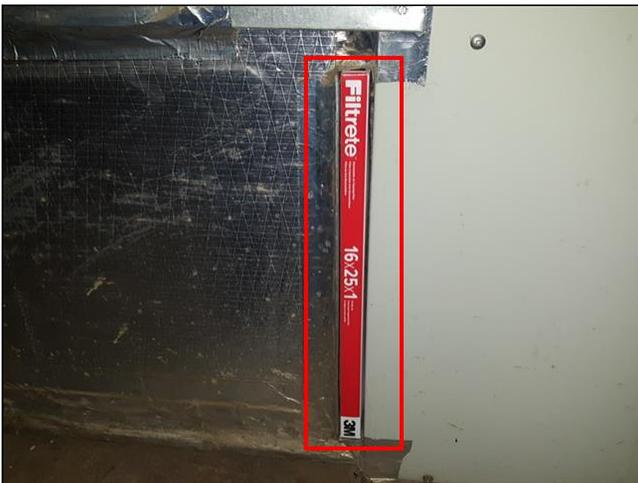
9.2 Item 2(Picture)

**9.2** (2) The door to access the filter next to the Gas Furnace is missing at the basement. This can allow dirt and debris to bypass the filter. The filter ensures clean air is distributed within the home and also protects the equipment from small debris entering which can lead to problems with the unit and duct work. Recommend replacement/correcting as needed by a qualified HVAC contractor.

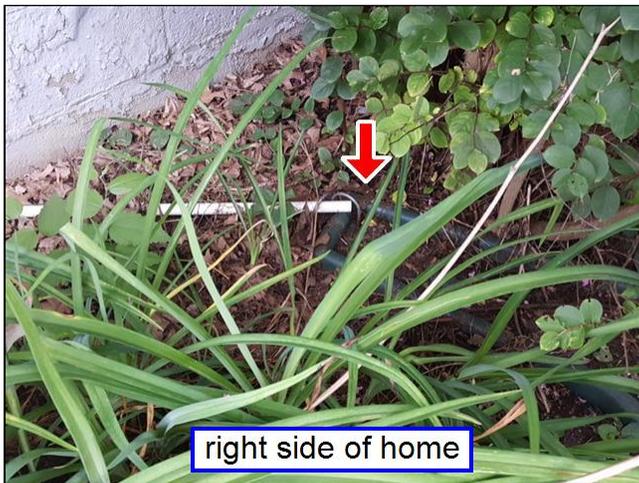
9.5 Item 1(Picture)

9.5 (1) Location of the condensate drain line to the exterior. (see photo)
