## **Inspection Report**

**Property Address:**  
211 Mangini Street  
Nicholasville KY 40356

<b>Date:</b> 9/12/2018	<b>Time:</b> 10:00 AM till 02:30 PM	<b>Report ID:</b> 180912PETERS
<b>Property:</b> 211 Mangini Street Nicholasville KY 40356	<b>Customer:</b> Mr. Trevor Peters	<b>Real Estate Professional:</b>

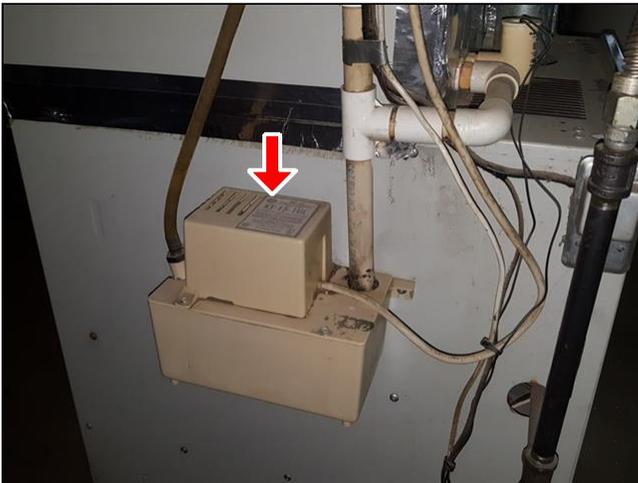
9.5 Item 2(Picture)

9.5 (2) The condensate pump was tested and was working at time of inspection.

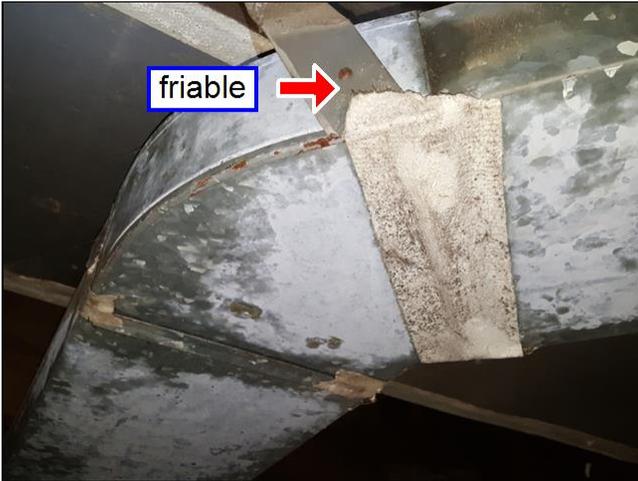
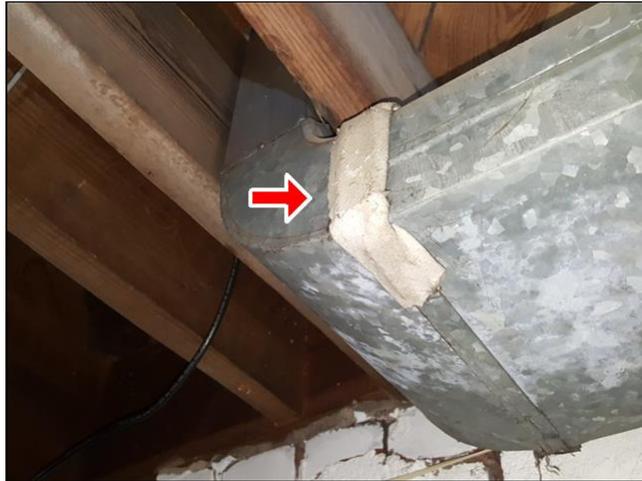
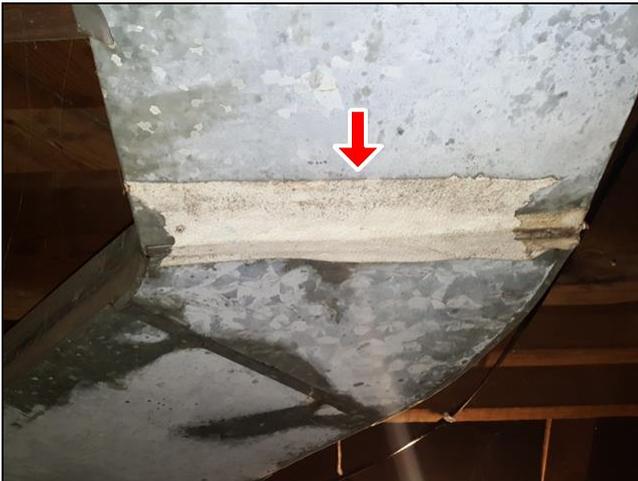
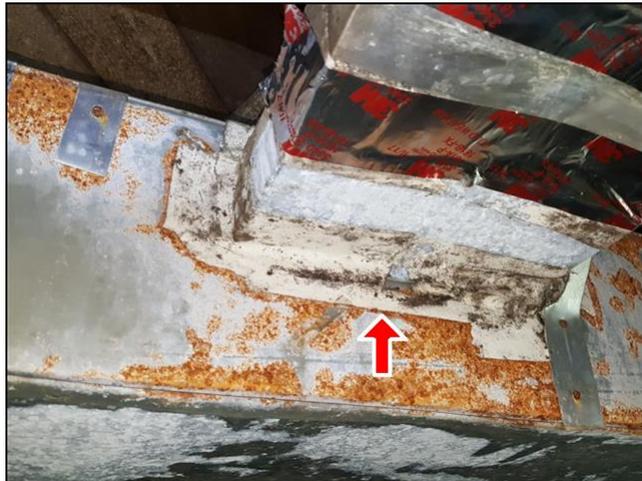
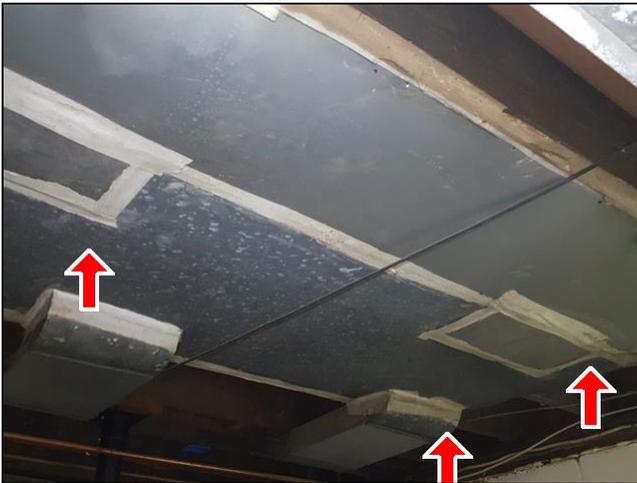
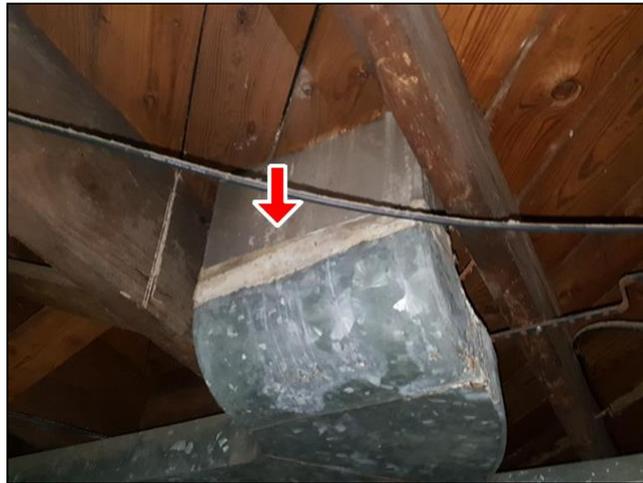
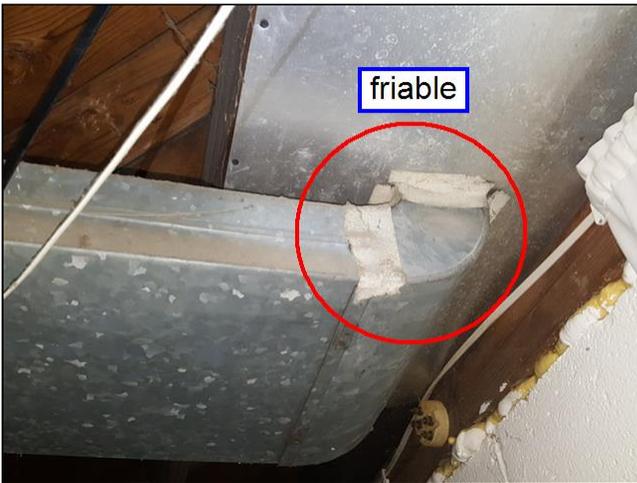
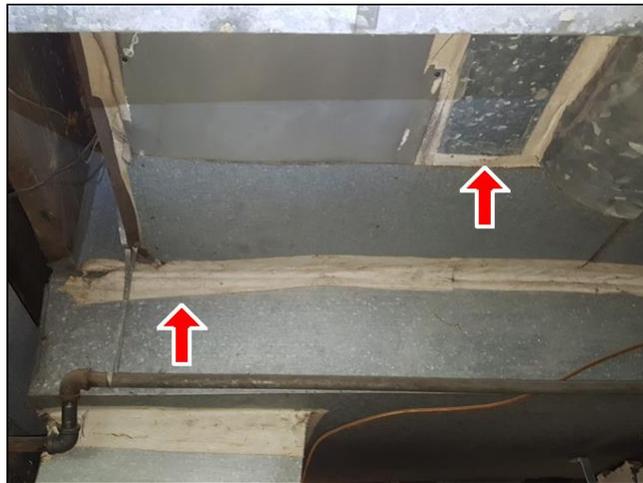
9.6 (3) The white tape covering all of the joints in the duct work in the unfinished basement may be asbestos. Some of the tape is damaged and maybe harmful to occupants in the home if the product is asbestos and due to the product is exposed and friable (damaged). Only laboratory testing can determine the presence of asbestos. Professional removal of any known asbestos material is sometimes needed. Covering the white material with furnace tape is suggested if the material is in good condition. This traps any particles and prevents spreading them into the home. [Here is a link to the EPA explaining more information about asbestos.](#) **Strongly** recommend a qualified asbestos contractor further inspect to determine if this product is asbestos and if correcting/removing product is needed prior to closing to ensure safety and health within the home. You may wish to have an air quality test done within the home also if the product is asbestos.

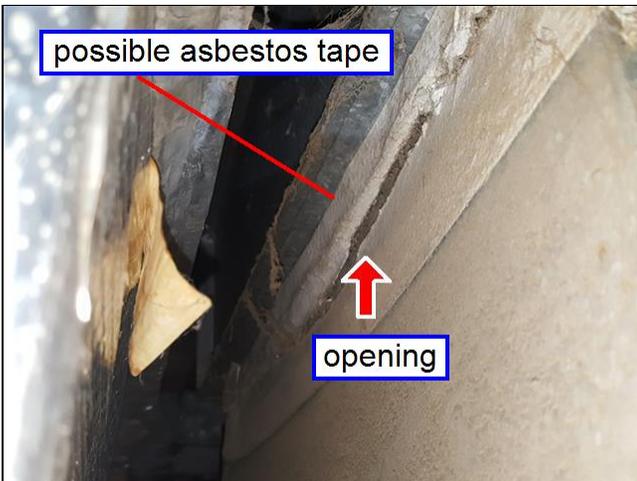
9.6 Item 9(Picture)

9.6 (4) The return air plenum has an opening where the possible white asbestos tape has failed and split. Firstly this can cause the HVAC system to run inefficient and is drawing return air from the basement instead of inside the home. Secondly if the white tape is an asbestos product, asbestos particles can be drawn into the system and then spread throughout the home. Strongly recommend a qualified HVAC contractor repair as needed and have an air quality test performed in the home prior to closing for health reasons. Asbestos can cause cancer and is a health risk to occupants in the home.

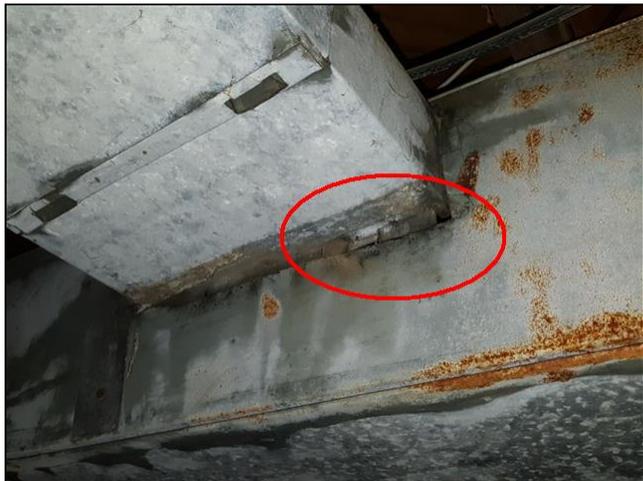
9.6 Item 10(Picture)

**9.6** (5) The air supply duct pipe is not sealed correctly and leaks air at the joint where indicated in the photo in the basement. Leaking ductwork increases heating/cooling costs and can also cause building damage. To prevent air loss, recommend the joints be sealed with a high temperature sealant or furnace tape. This will direct all the conditioned air to the desired locations and will improve the efficiency of the system. A qualified HVAC contractor is recommend for these repairs.

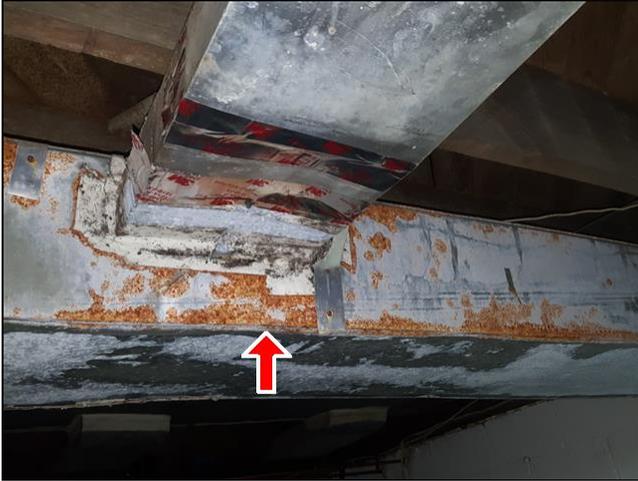
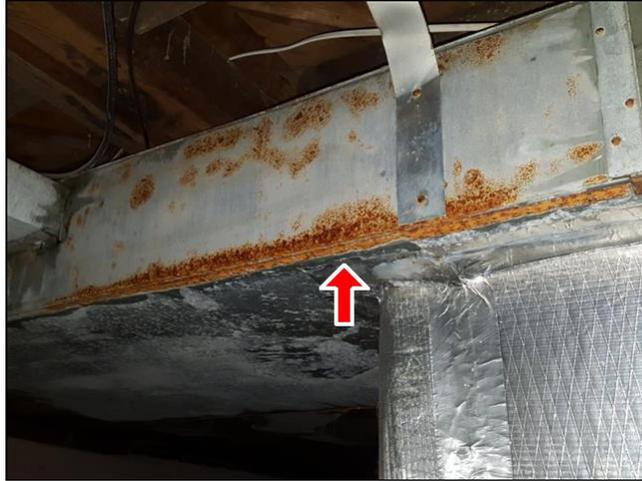
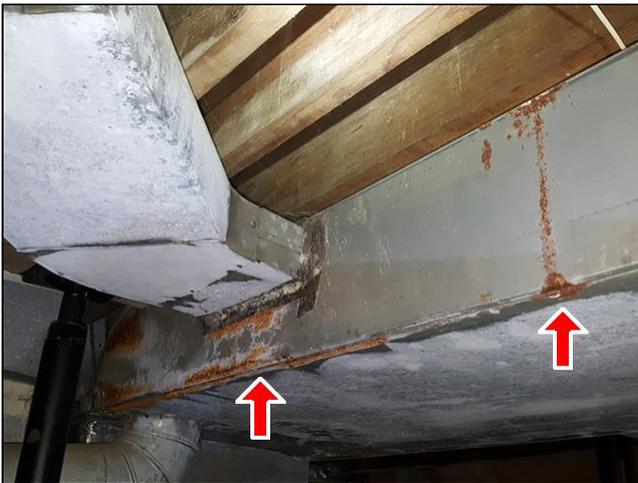
9.6 (7) Some of the uninsulated supply ducts have surface rust due to possible condensation forming in the past. These areas will eventually fail due to openings will occur in the future. There were no visible holes noted. Recommend monitoring ducts annually and if a leak or holes develops, recommend repairs or replacement by a qualified HVAC contractor. You may wish to consider installing insulated ducting next time a new furnace and/or air conditioner is to be installed. This will improve efficiency. This is for your information.

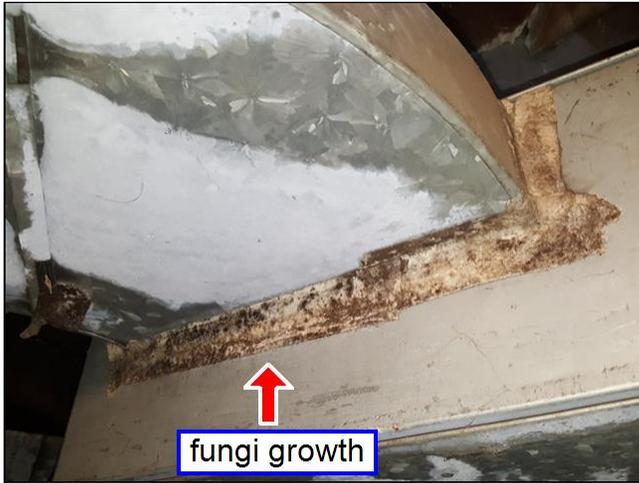
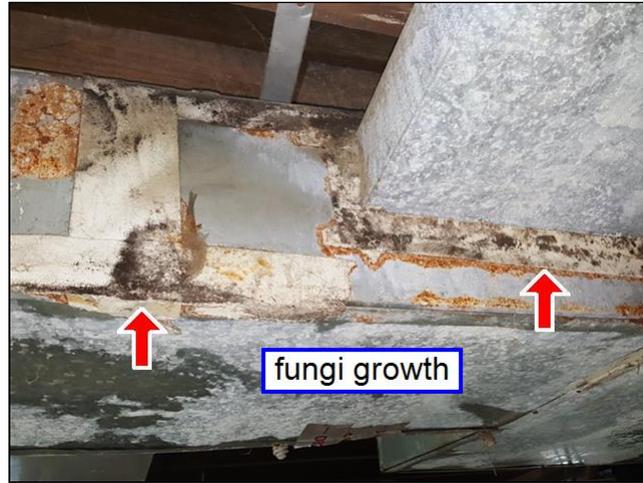
**9.6 (8)** Various areas where the possible white asbestos tape is being used at the joints show signs of fungi growth. This could be possible mold and may also be inside the ducts. Recommend a qualified HVAC contractor and Mold specialists further investigate to determine if this substance is mold, inspect inside duct pipes, and if mold is present then treat and correct as needed by the qualified contractor for safety and health of occupants in the home. You may also wish to have an air quality test done in the home if this substance is mold.

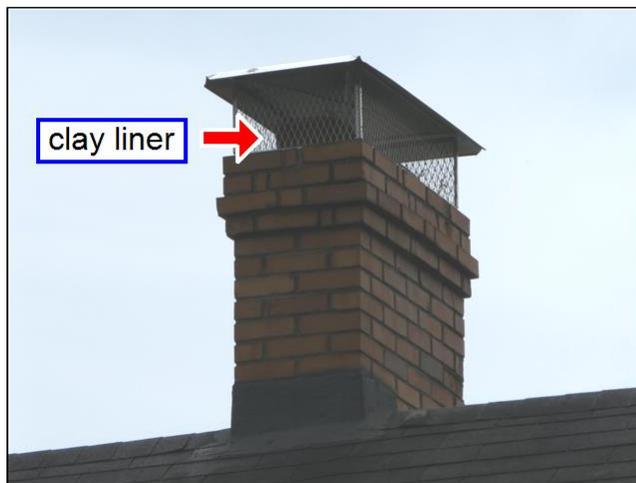
9.10 Item 2(Picture)

**9.10** The chimney is being used for venting a gas furnace. A stainless steel vent pipe should be installed and properly sized for the gas appliance to prevent damage to the interior of the chimney mortar joints, possible entry of CO (carbon monoxide) gases into the home, and sized to promote good drafting of the gas appliance. Clay flue tile is usually to large to allow proper drafting. A cap should be installed at the same time. Strongly recommend that a qualified licensed plumber examine the chimney to determine if the chimney or flues have been damaged and require repairs to prevent CO entry into the home and to verify that the flue or clay liner is properly sized to provide good drafting of the gasses.

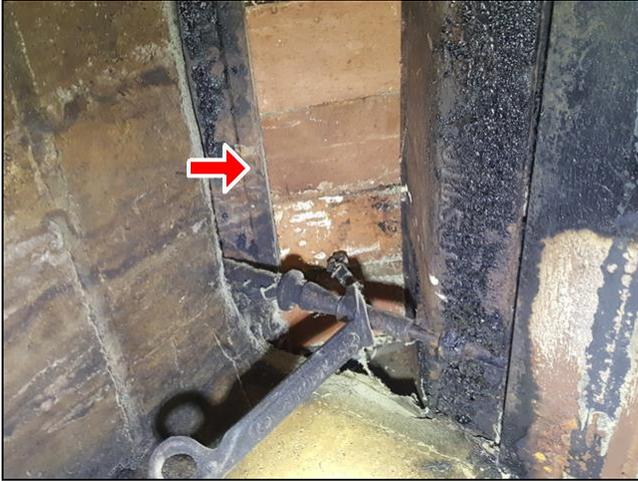
9.12 Item 1(Picture)

**9.12** Our inspection of the chimneys is limited to the readily visible portions only. The inner reaches of a flue are relatively inaccessible and have been sealed off, therefore the chimney is not in use for the fireplace. Inspection of the chimney was from the ground only. Our restricted view from the top or bottom is not adequate to discover possible deficiencies or damage. This is for your information.

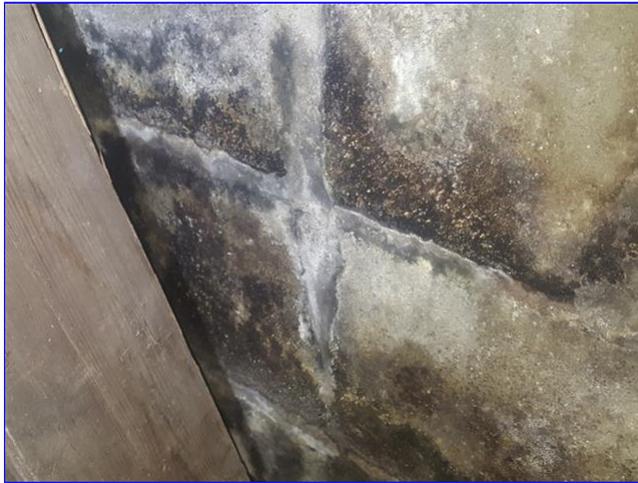
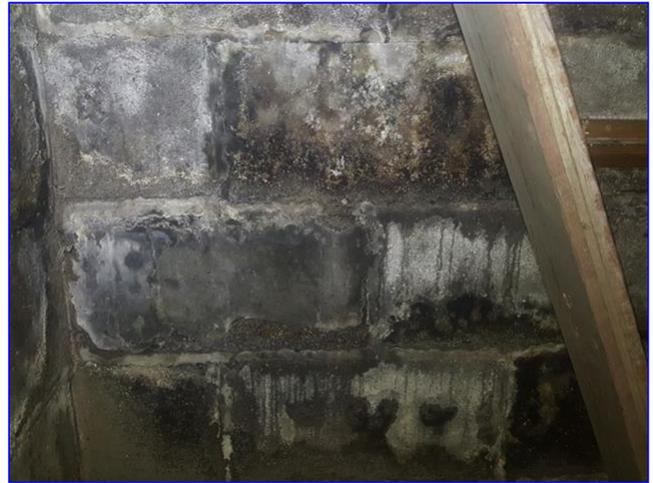
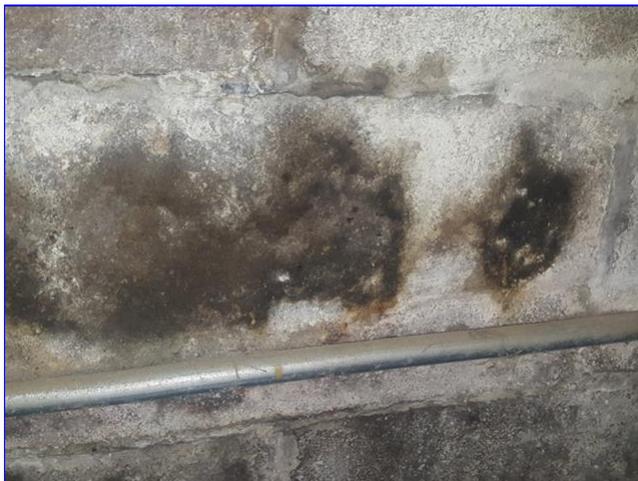
(1) Fungi growth, black stains on the masonry block walls and mildew where located in various areas in the basement, especially under the kitchen, dining room and 2nd bathroom areas in the home. When entering the basement in this area a very strong odor (musty smell) was experienced. This could be mold. Only lab testing of the mold/mildew can determine the type or if it is considered to be dangerous. Recommend a certified mold expert further evaluate and conduct testing and sampling before closing. They will be able to best advise you how to clean up, remove and/or treat areas affected. EPA guidelines state that homeowners can clean areas less than 100 square feet with water using laundry detergent. Due to the amount of mold/mildew found **I do not recommend** this, have a qualified contractor do this after mold expert has advised remedies for cleanup.

Note: Water/moisture is necessary for mold or mildew to occur, To correct these conditions the soil grade and keeping the gutters clean, free flowing, and discharging away from the foundation or to an

underground drain should solve these water/moisture conditions in the basement. Refer to Roofing and Exterior sections of this report.

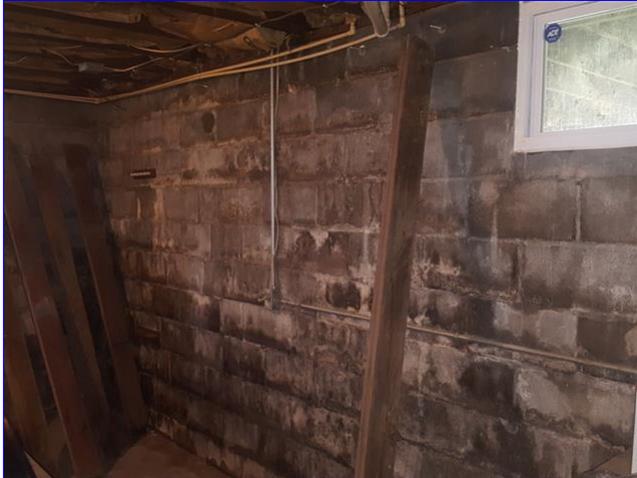
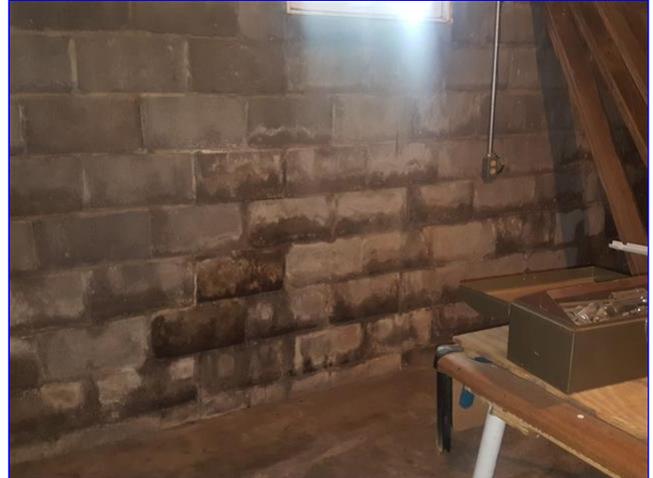
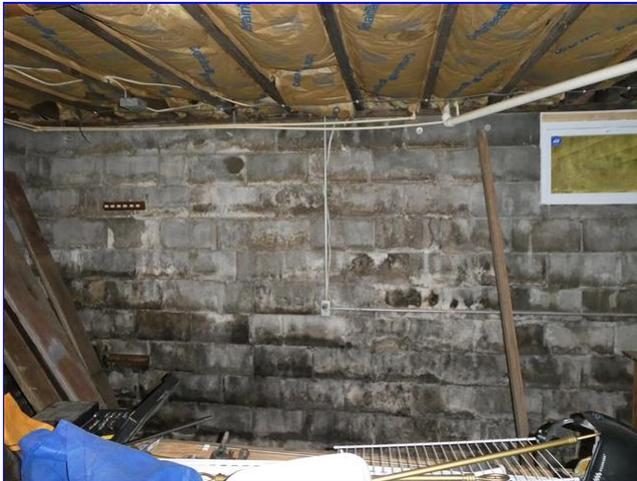
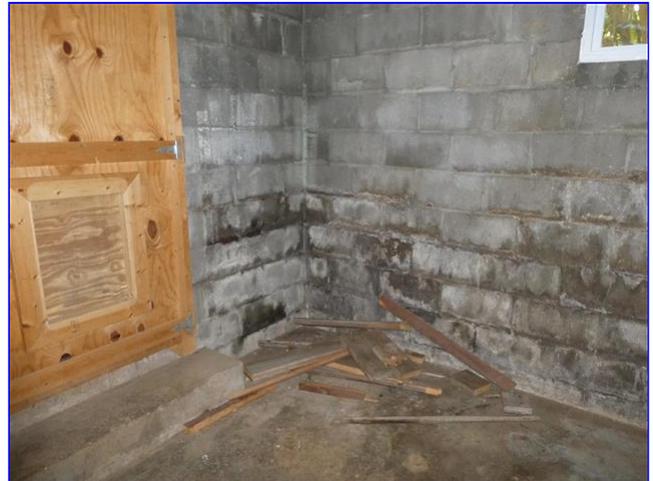
(4) Visible signs of water intrusion/stains in the basement walls at the rear of the home. 90% of water entry into the foundation walls has been found to be caused by improper grading or defective gutter/drainage systems. Refer to Roofing and Exterior of this report for improvements and recommendations. However I would recommend consulting a qualified basement foundation contractor to determine what other corrections maybe needed to prevent future water penetration in the masonry block walls due to this appears to be an ongoing problem and due to the fungi growth on the walls.

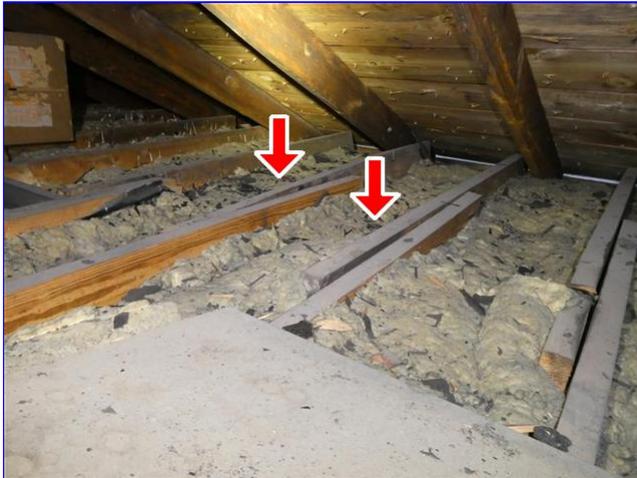
1.7 Item 1(Picture)

The ceiling joists in the main attic show signs of deflection. Strengthening the ceiling joists would resist further movement and prevent the rafters from pulling away. Recommend a qualified roof framing contractor further evaluate the ceiling structure to determine what corrections if needed should be performed to ensure structural integrity of the ceiling and roof structure.

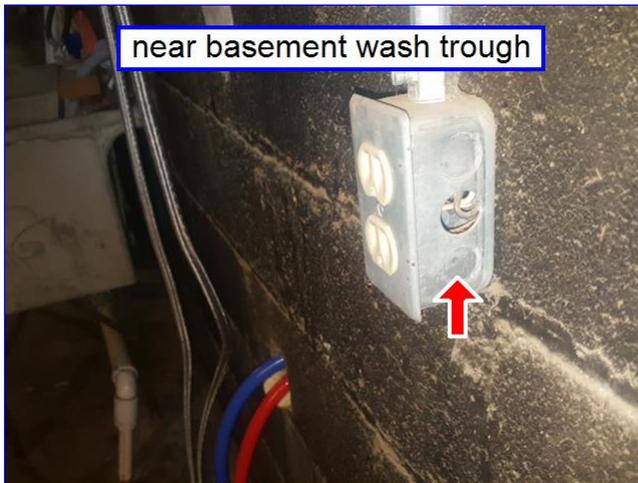
1.9 Item 1(Picture)

Bushings or grommets are required to fill openings in a junction box. The exposed opening is a serious safety issue. Openings should be installed to prevent touching the sides of the devices to prevent an electric shock which can cause an injury or death. A qualified licensed electrical contractor should correct as needed prior to moving in.

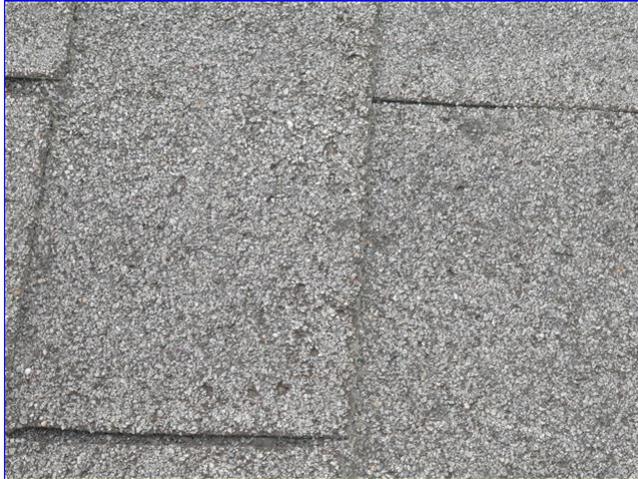
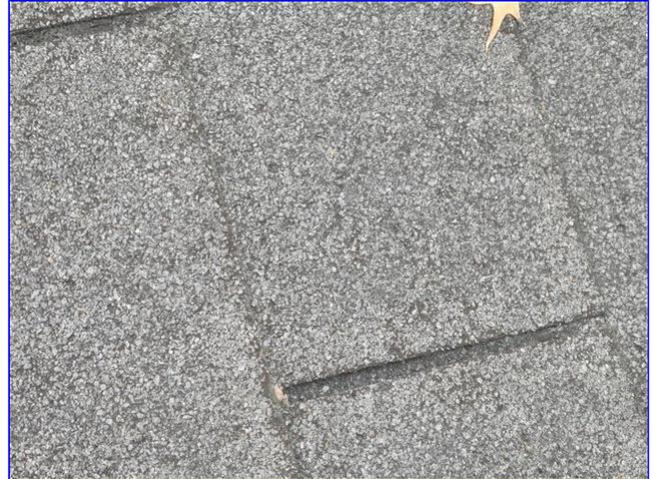
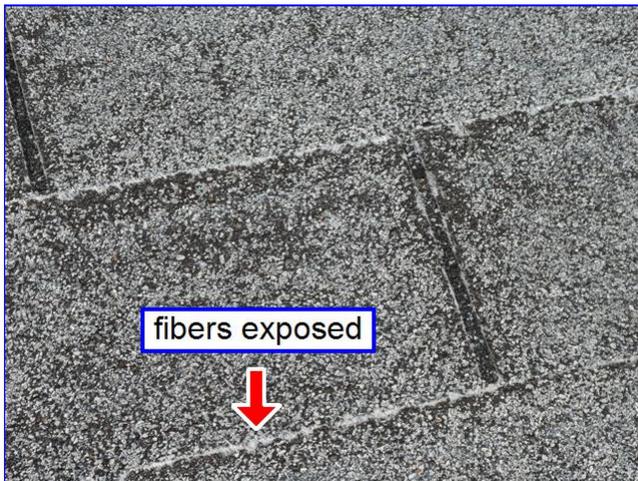
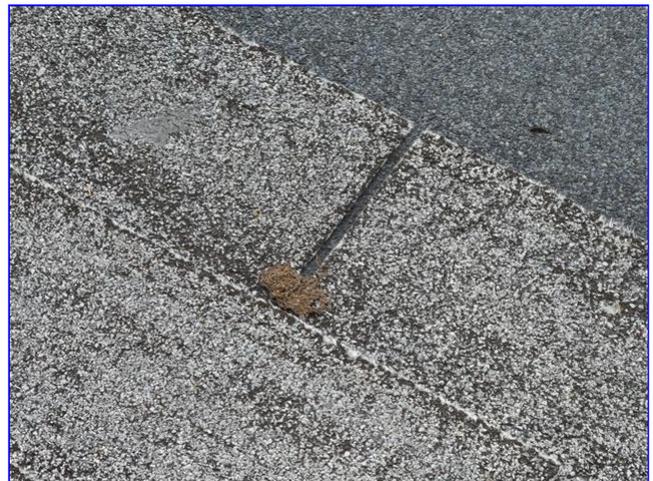
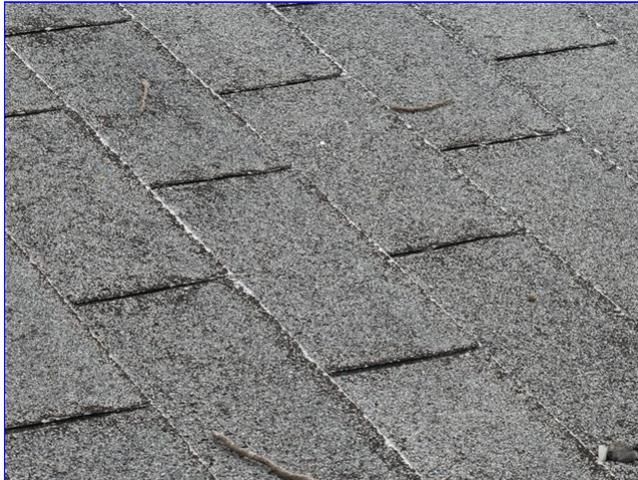
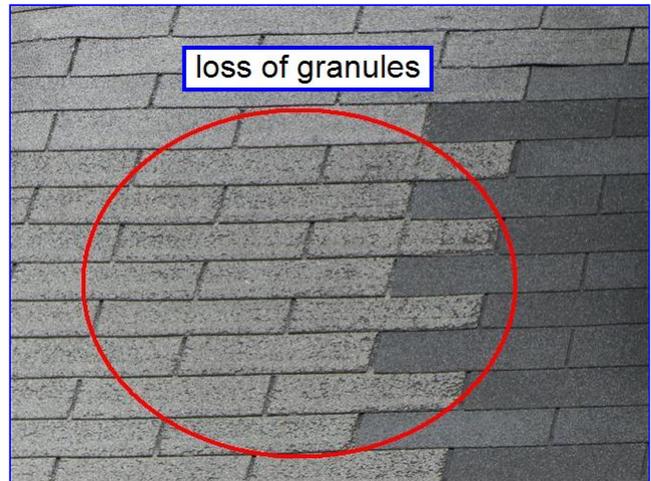
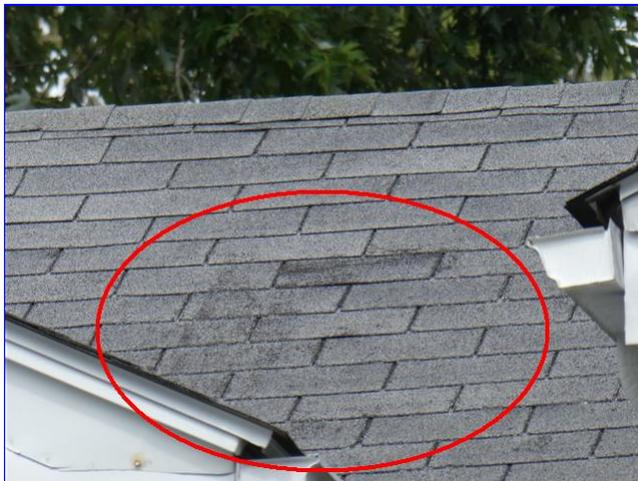
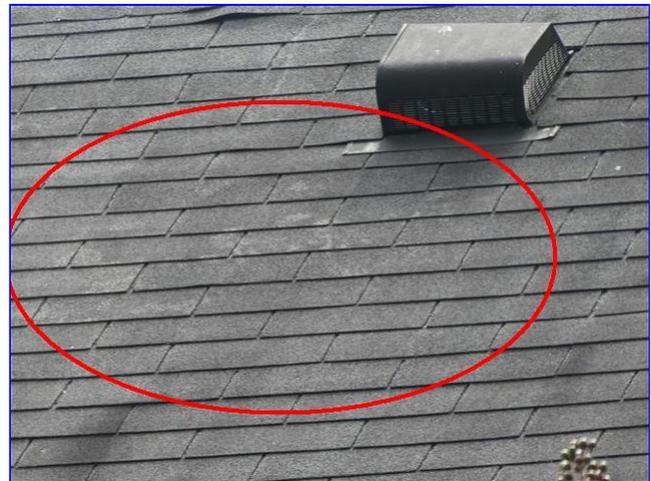
(1) Signs of loss of protective granules, drying and fibers exposed of the roof shingles are starting to appear especially at the front of the home. This indicates that the roof is close to the end of its life span. This usually increases the potential for ultraviolet damage to the membrane. Recommend a

qualified roofing contractor further evaluate the roof to determine if replacement is required now before roof leaks start to develop. If the roof is not to be replaced it should be closely watched and repaired or replaced at the first sign of leaking to prevent damage to the interior finishes or roof framing in the attic.

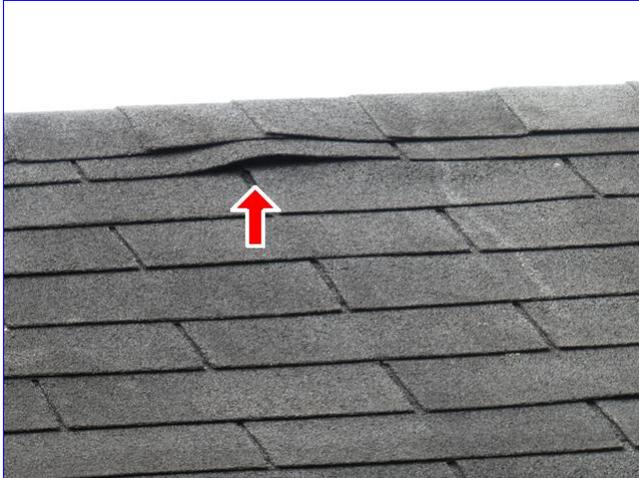
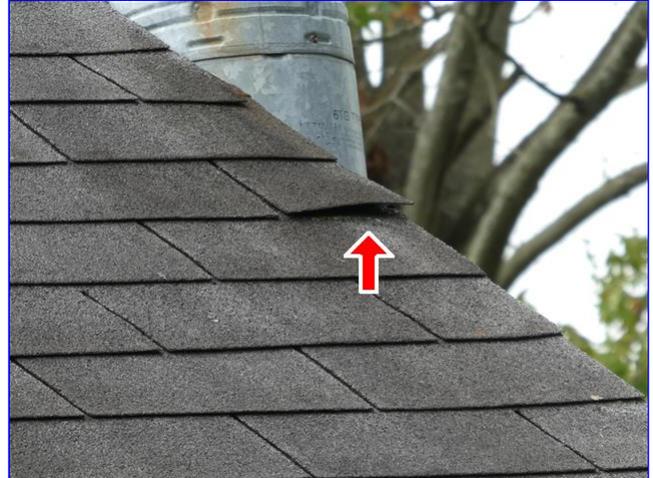
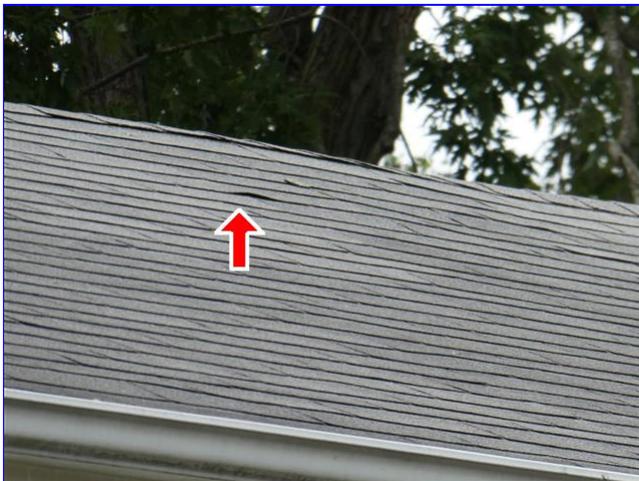
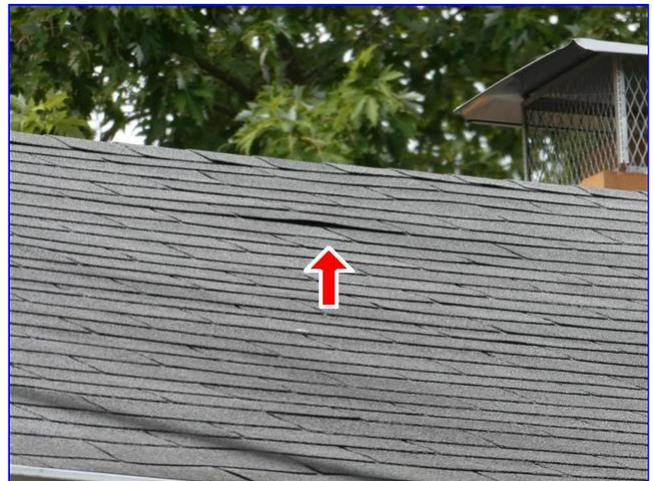
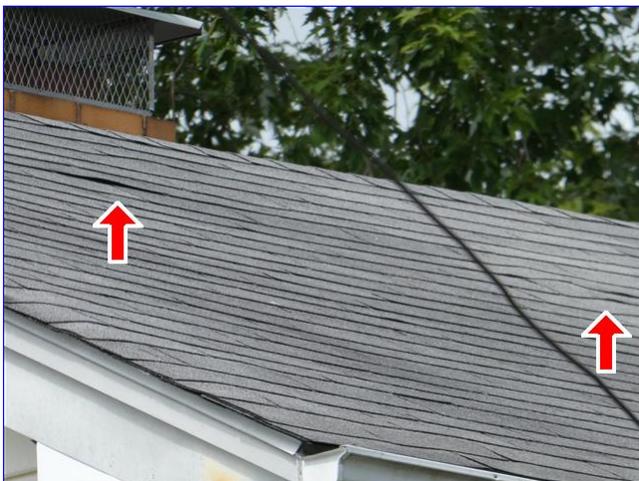
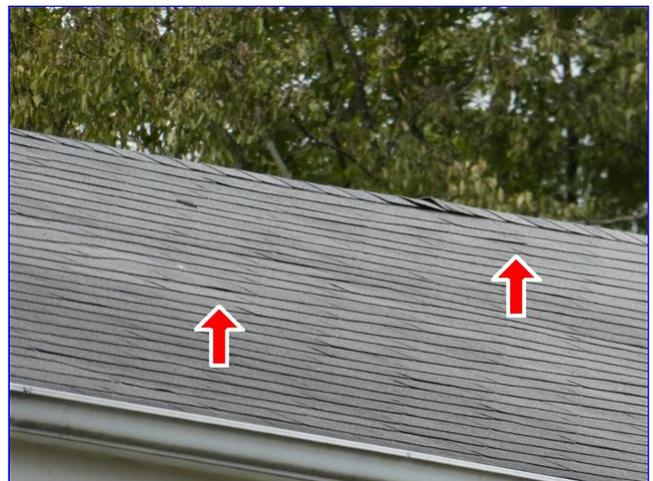
(3) Some of the shingles are starting to lift on the roof in various places, (see photos for location) This is probably due to a lack of ventilation or age of the covering. Generally, lifting shingles are caused by ventilation issues and the shingles are baked from the inside out. Over time, this heat causes the sealants on the back of the shingles to detach from the course underneath and the shingles start to lift. The shingles are less resistant to the action of ice and wind. Recommend a qualified roofing contractor further evaluate the roof to determine if replacement is needed now and repair lifting shingles where needed. Consideration for a new roof is expected in the near future.

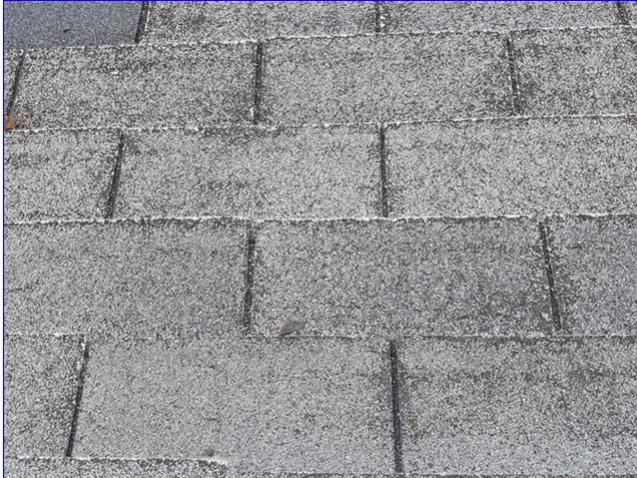
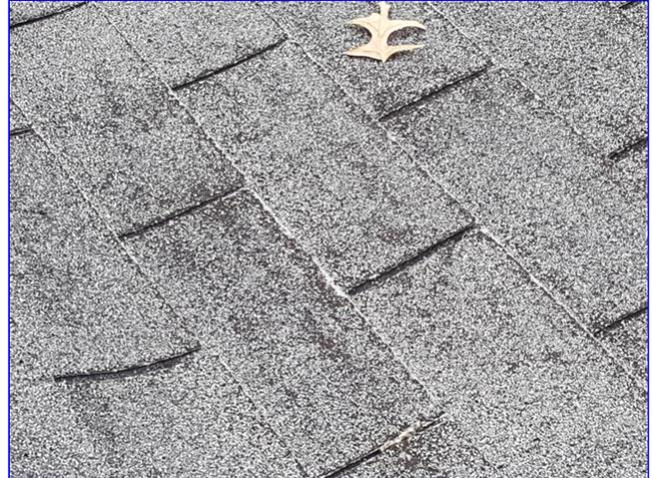
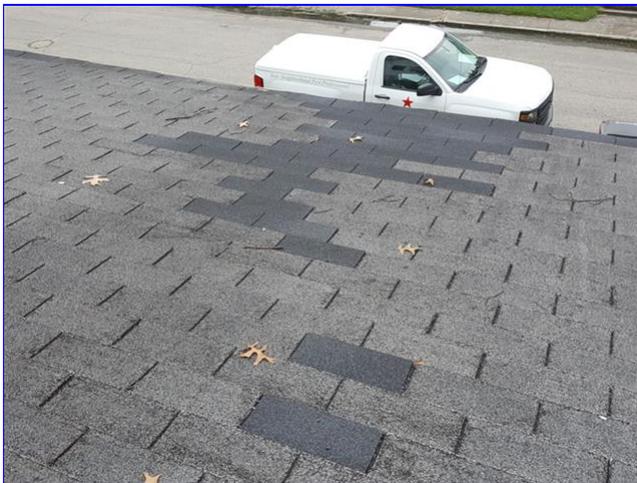
(4) The roof covering above the front porch is old, starting to deteriorate rapidly and shows signs of previous repairs, and the life of the covering has expired. The covering does need to be replaced. While it could last a year or so, some areas may need patching with tar as leaks develop. Recommend a qualified roofing contractor further evaluate to determine if replacement of this section of the roof is needed now prior to closing.

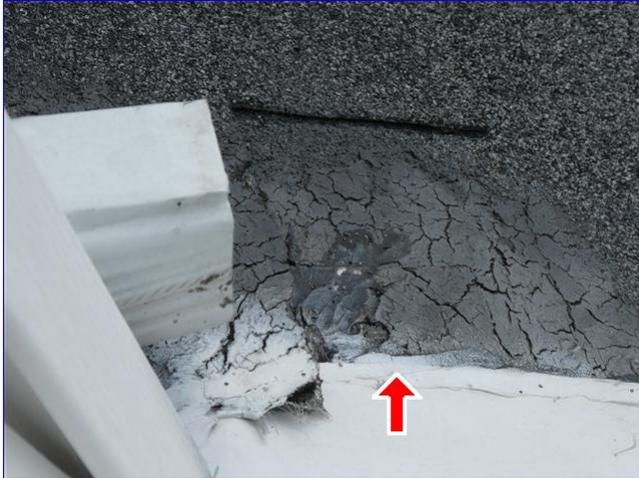
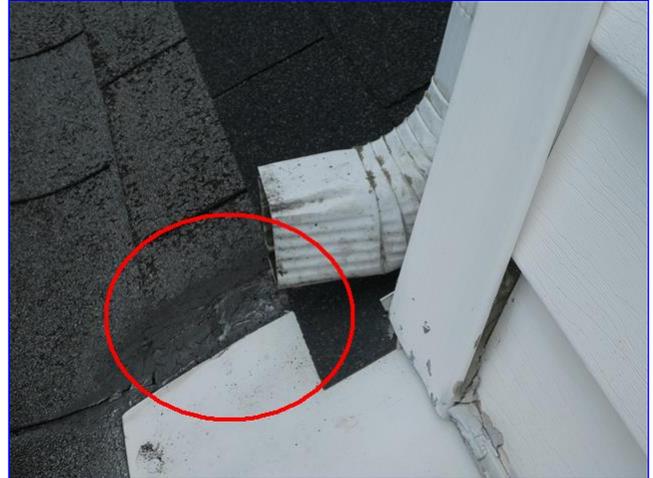
(2) The step flashing and wall/roof intersection has been tarred all around the metal flashing. The flashing is suspected to be in poor condition. Tar is a temporary patch and will eventually fail. Deteriorated or leaking flashing should be replaced. This indicates that previous water leaks had existed. This type of repair is not recommended as it is prone to further leaking due to direct sunlight on the sealant which can cause cracks. The cracking can allow water to enter. Recommend a qualified roofing contractor further inspect and make the necessary repairs if needed.

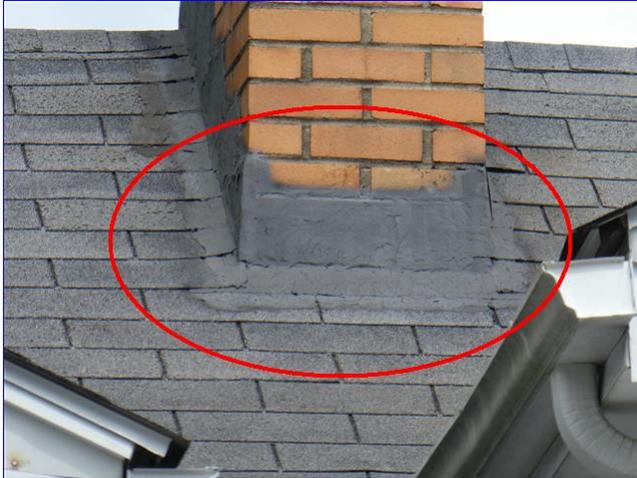
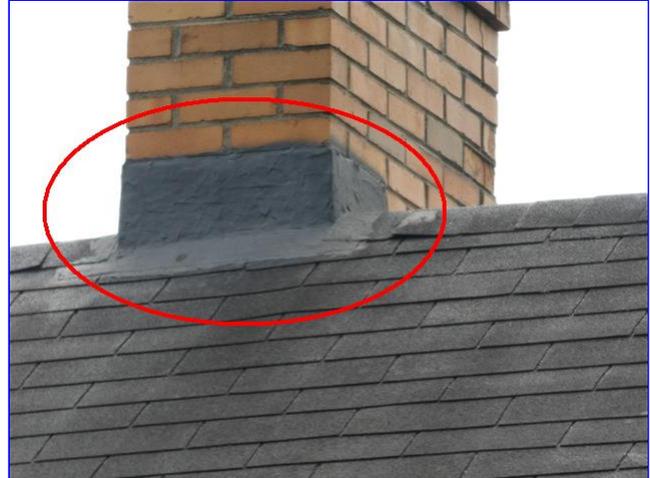
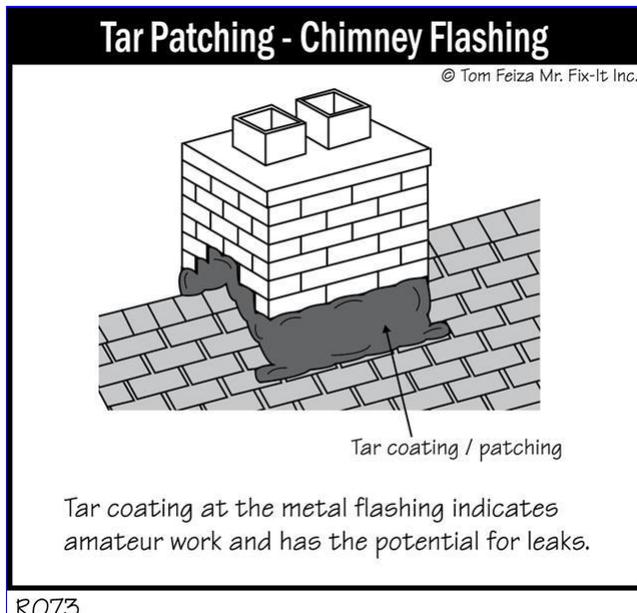
(2) The chimney has been tarred all around the metal flashing. The flashing is suspected to be in poor condition. Tar is a temporary patch and will eventually fail. Deteriorated or leaking flashing should be replaced. This indicates that previous water leaks had existed. This type of repair is not recommended as it is prone to further leaking due to direct sunlight on the sealant which can cause cracks. The cracking can allowing water to enter. Recommend a qualified roofing contractor further inspect and make the necessary repairs as needed.

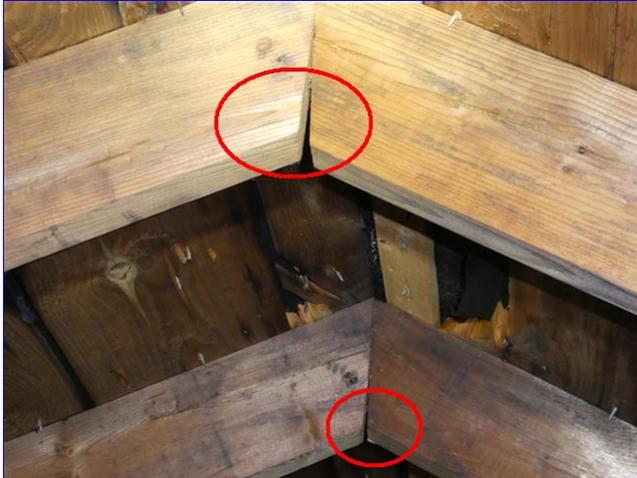
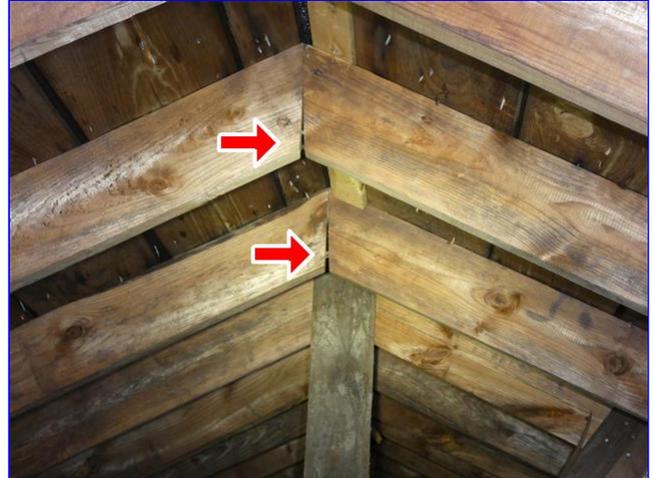
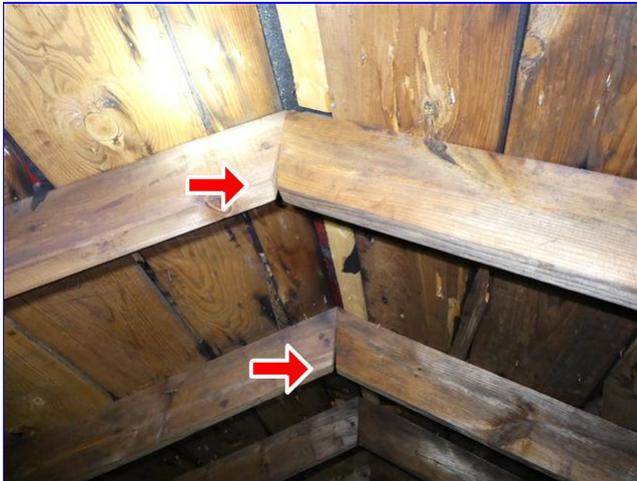
(2) Various rafters are pulling away at the joins in the attic. Repairs are needed to maintain the stability of the roof. Excess loads on the roof like snow can cause further separation if not reinforced. Recommend collar ties (horizontal members running between each rafter, near their mid span) or vertical supports to the rafters in the attic to add extra support to the roof structure and to resist rafters from sagging further separation and cracking in the future. Recommend a qualified framing roofing contractor further investigate and make any necessary improvements or repairs to the roof structure as needed and correct any other problems found prior to closing.

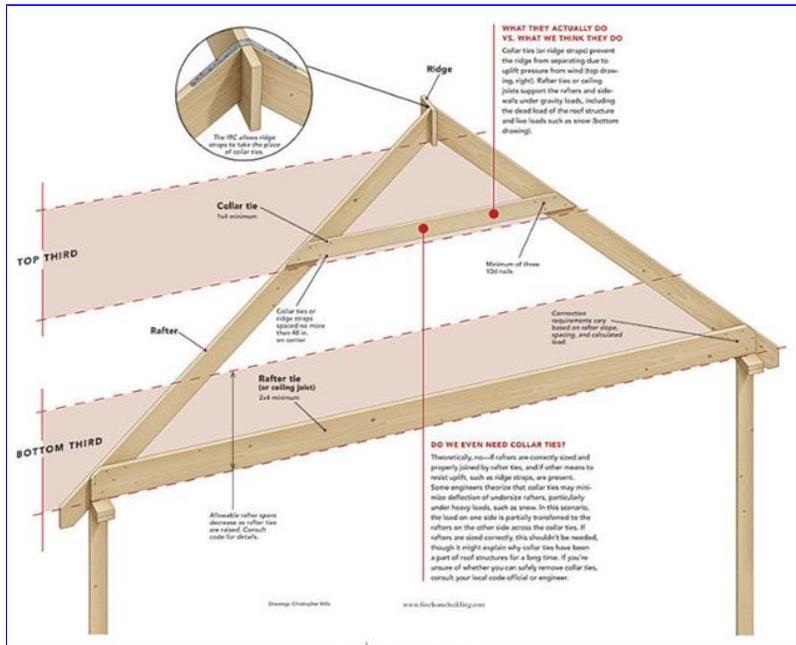
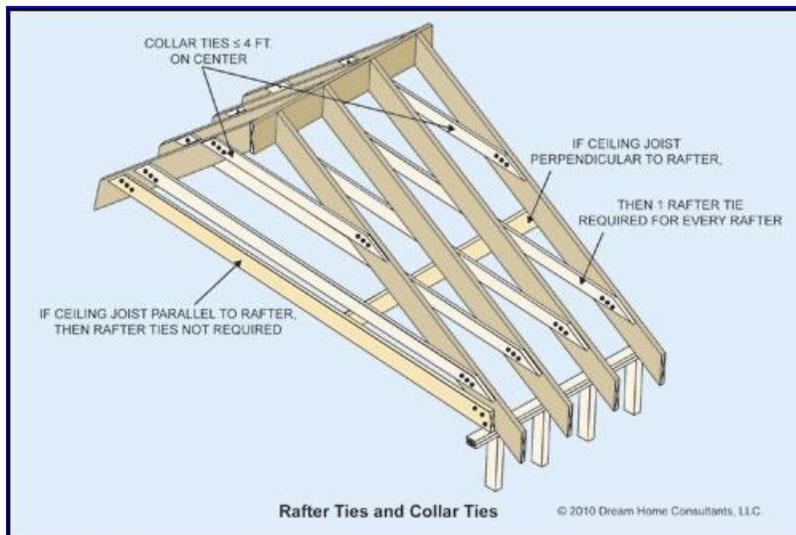
(3) Recommend additional collar ties (horizontal members running between each rafter, near their mid span) to add extra support to the roof structure and to resist rafters from sagging and/or pulling away in the future. Heavy loads such as snow may cause the roof to sag, cracked rafters appearing or the roof to develop leaks near these areas from stress. There are no gusset plates between the rafters to support current roof structure. Recommend a qualified roof framing contractor further evaluate the roof structure and make the necessary repairs as needed.

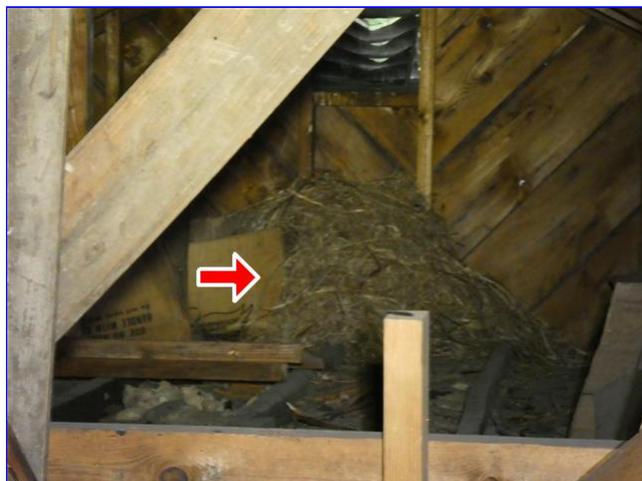
2.6 Item 7(Picture)

(4) There is evidence of vermin activity/nest in the attic at the rear of the home near the gable vent. No animals were seen in the attic at the time of the inspection. However, recommend a pest control specialist be consulted in this regard and have nest removed. Then replacement or repair of the gable vent by a qualified contractor is recommended to prevent further critters entering the attic.

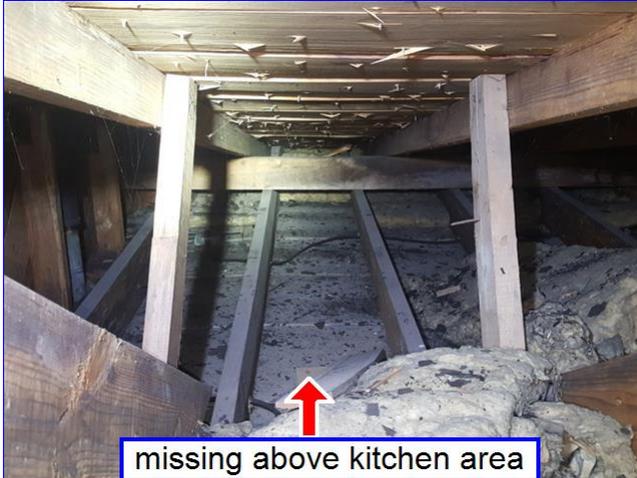
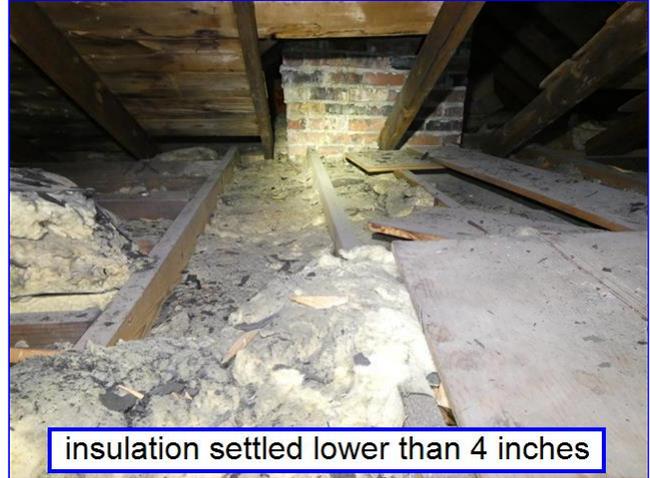
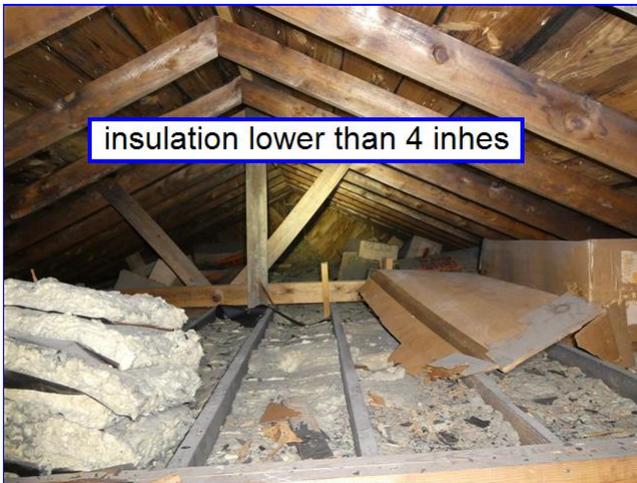
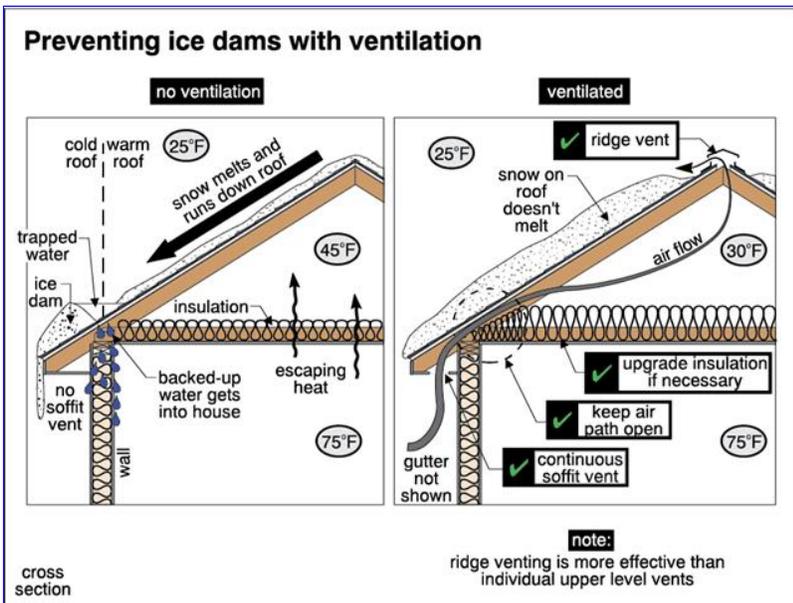
The insulation is old, has settled and is missing in some areas in the attic. Insulation that is missing and/or settled should be replaced due to the "R" value has diminished. The insulation should form an unbroken blanket to prevent heat/cool loss. Heat/cool loss can occur more on this home than one that is properly insulated. This can cause condensation to occur which can lead to mold or wood deterioration. Also, Low valued insulation will increase cooling and heating costs in the home which leads too high energy bills and puts stress on the HVAC system trying to keep the house cool and heated during the seasons. Strongly recommend additional and/or replacement of the insulation by a qualified contractor where needed to reduce heat/cool loss within the home and to prevent possible ice dams forming in winter.

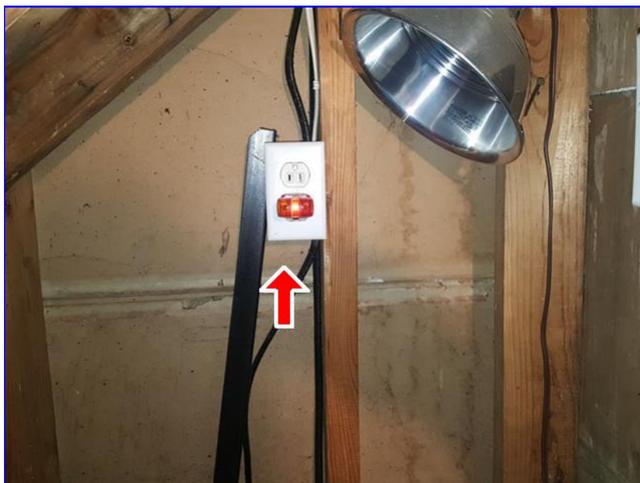
2.9 Item 1(Picture)

The receptacle(s) in the Master Bedroom attic where indicated in the photo(s) is showing an open ground. This is a safety issue. Major appliances using three prong cords should never be connected to these two slot receptacles unless the appliance manufacturer allows the connection. Many lamps and other small appliances do not have or require the three slot electrical receptacles. This is for your information. Recommend a licensed qualified electrician repair as needed.
