## **Inspection Report**

**Property Address:**  
211 Mangini Street  
Nicholasville KY 40356

<b>Date:</b> 9/12/2018	<b>Time:</b> 10:00 AM till 02:30 PM	<b>Report ID:</b> 180912PETERS
<b>Property:</b> 211 Mangini Street Nicholasville KY 40356	<b>Customer:</b> Mr. Trevor Peters	<b>Real Estate Professional:</b>

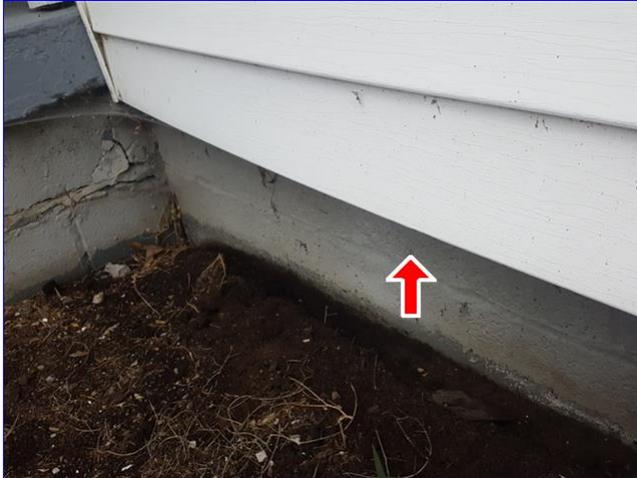
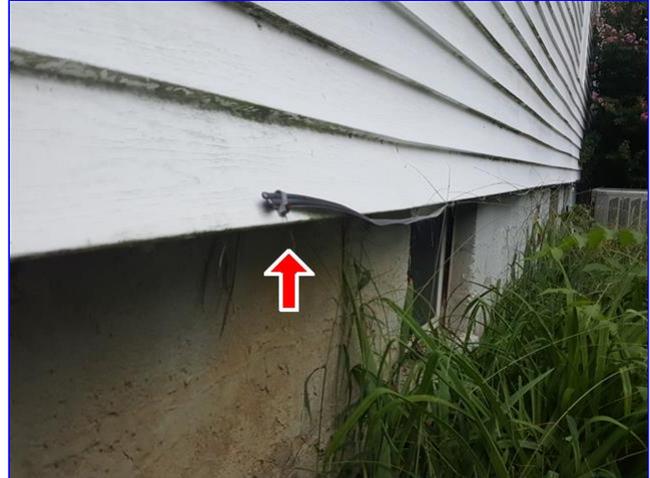
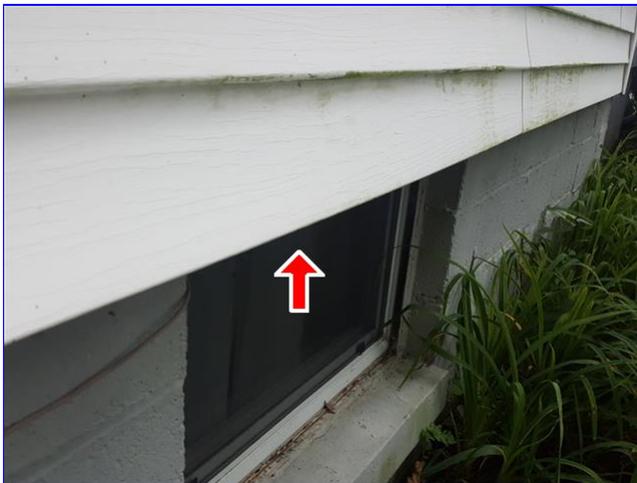
(3) The vinyl siding around the entire perimeter of the home from the bottom is not secured to the home. The loose siding should be re-secured to prevent it from being blown off and to protect the building from weather entry. It may not have been installed correctly due to the original wood siding behind. Recommend a qualified siding installer further investigate and correct as needed.

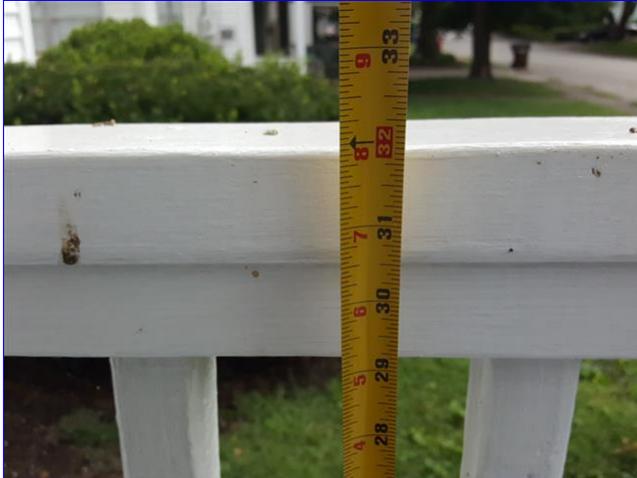
3.4 Item 1(Picture)

(1) The guard rail at the front porch is lower than 36 inches from the floor. A fall or injury could occur if not corrected. This is a safety issue. Ensure the baluster spacing is 4 inches apart to prevent a child or pet from falling through. A qualified contractor should repair or replace as needed.

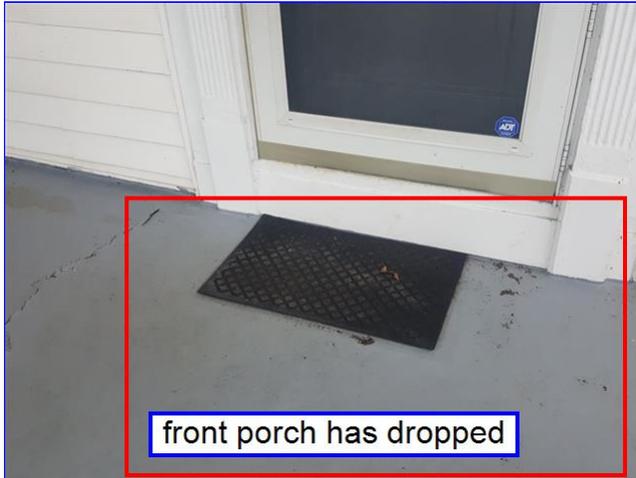
3.4 Item 2(Picture)

(2) The front step at the porch is higher than the recommended height of 8 and 3/4 inches. This is a potential safety issue and a fall or injury could occur if not corrected. The front porch has dropped at the front of the home causing this to occur. Recommend a qualified masonry contractor correct and repair as needed. Also, recommend filling cracks to prevent water intrusion to prevent further settlement. Then further monitor for more movement after repairs. If such movement occurs in the future, you may need to investigate cause and rectify using a qualified masonry contractor.

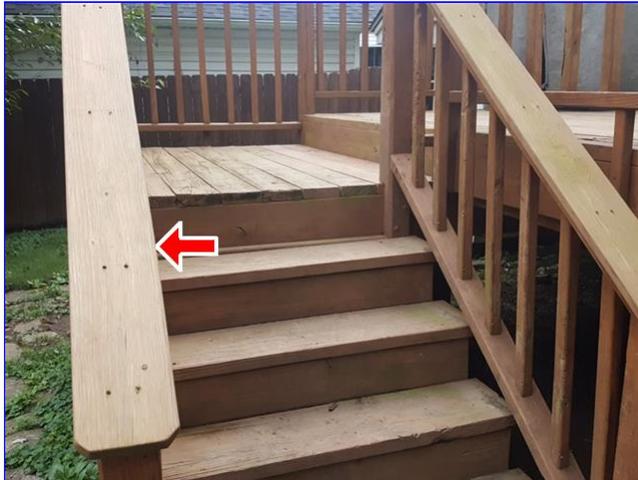
3.5 Item 1(Picture)

(1) 2x6s are installed for handrails for the deck staircases and are not considered "gripable" by industry standards. This is a safety issue and an injury could occur if not corrected. Recommend that a standard approved handrail be installed for safety by a general contractor.

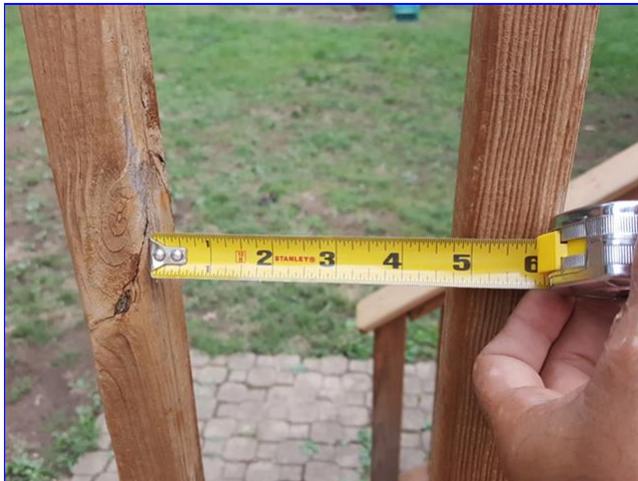
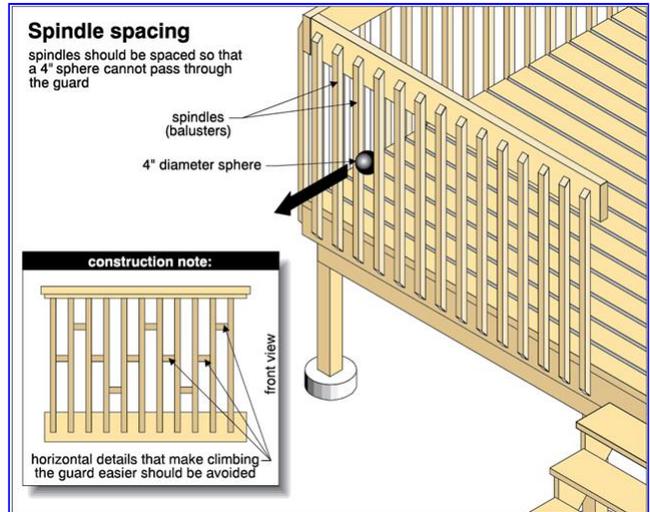
(2) The guard rail for the deck have large spaces between the ballusters. This is a safety issue. A fall or injury could occur if not corrected as this condition could allow a child or pet to fall through which may result in a death. The current recommendations are for spacing to be no more than 4" to prevent these accidents. A qualified contractor should make the necessary repairs and corrections where needed for safety.

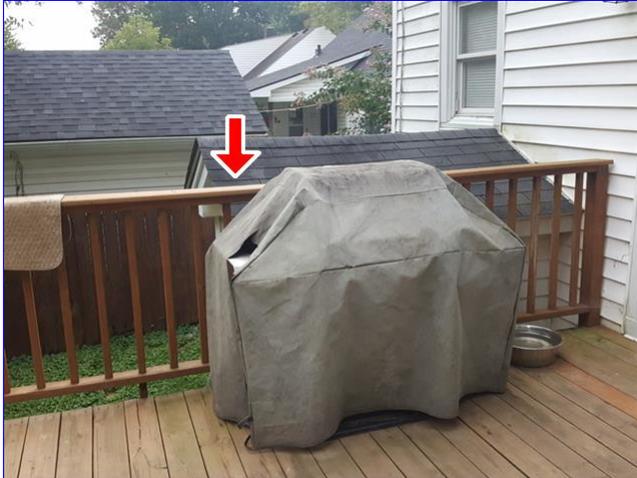
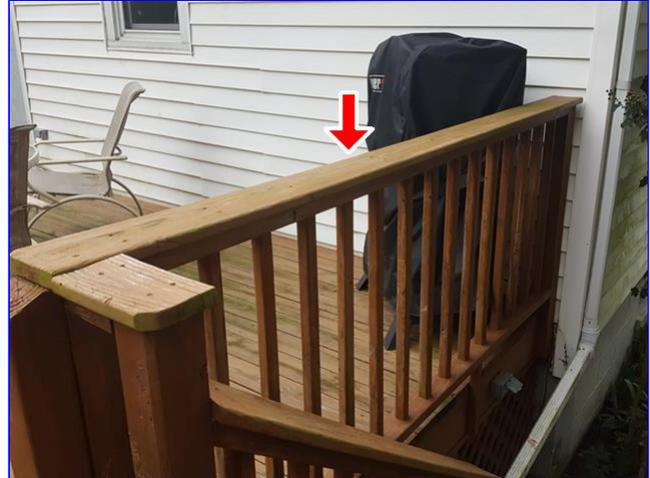
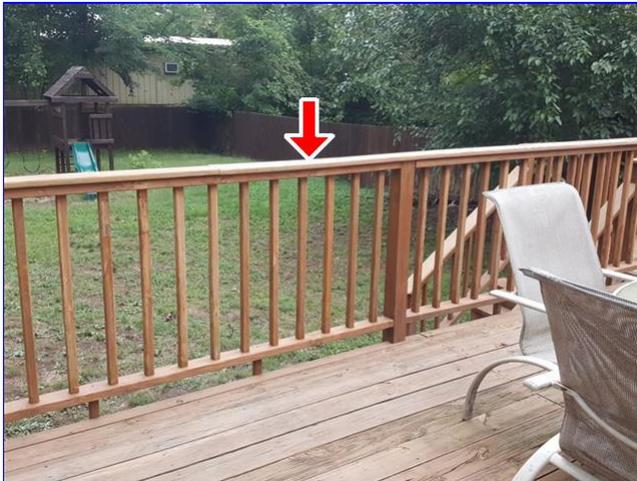
(4) The guard rail for rear deck is unstable and not secured properly. This is extremely dangerous and is a major safety concern. It may fail under a medium or heavy force or if someone was pushed against or was leaning on the railing. For your safety it should be strengthened and secured. Recommend a qualified contractor repair as needed.

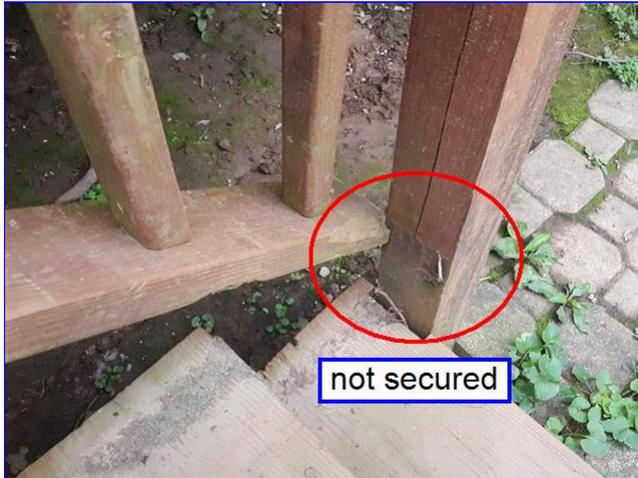
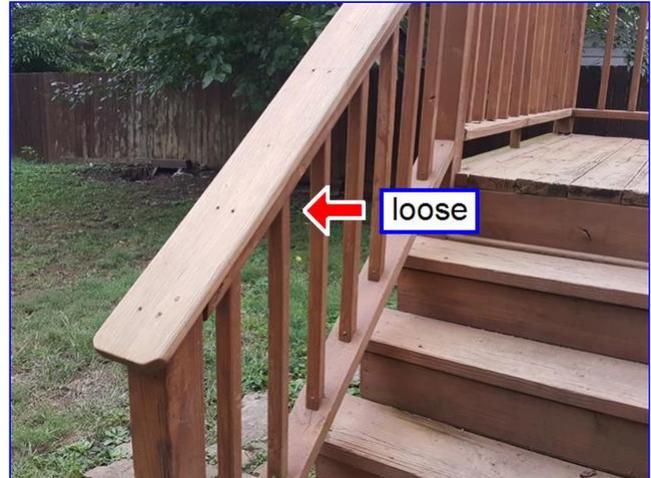
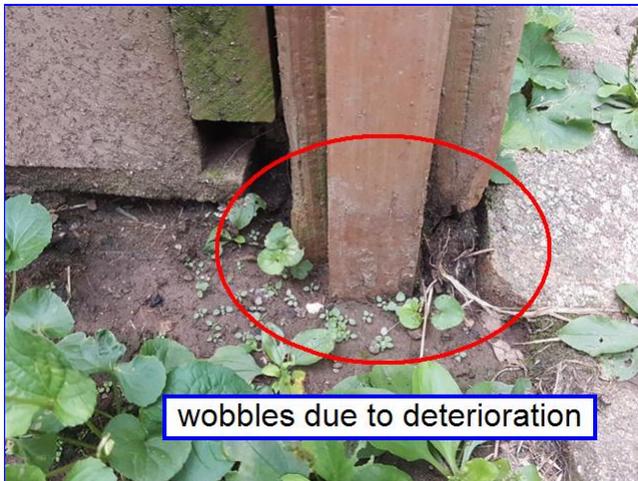
(5) The stair case rail at the deck, rear left side of the home is unstable and not secured properly. This is extremely dangerous and is a safety concern. It may fail under a medium or heavy force or if someone was pushed against or was leaning on the railing. For your safety it should be strengthened and secured. Recommend a qualified contractor repair as needed before closing.

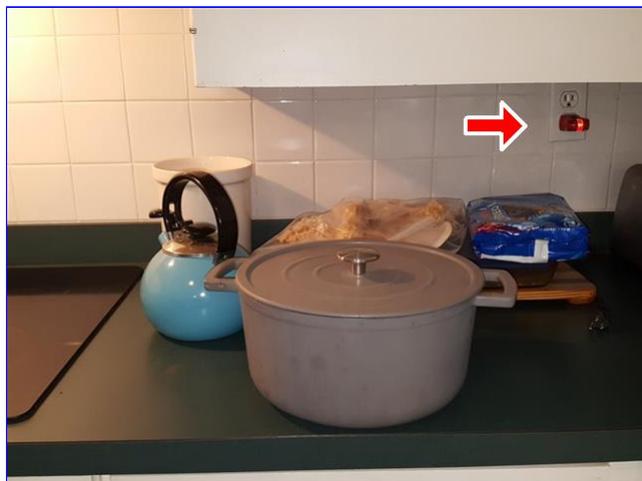
4.9 Item 1(Picture)

(2) The outlet(s) on the right side of the stove in the kitchen is showing an open ground circuit. This is a safety issue and this type of electrical hazard is extremely dangerous. Major appliances using three prong cords should never be connected to these two slot receptacles. Recommend a qualified licensed electrician correct the outlet so that it is grounded, then ensuring all receptacles are GFCI protected and tripped when tested.

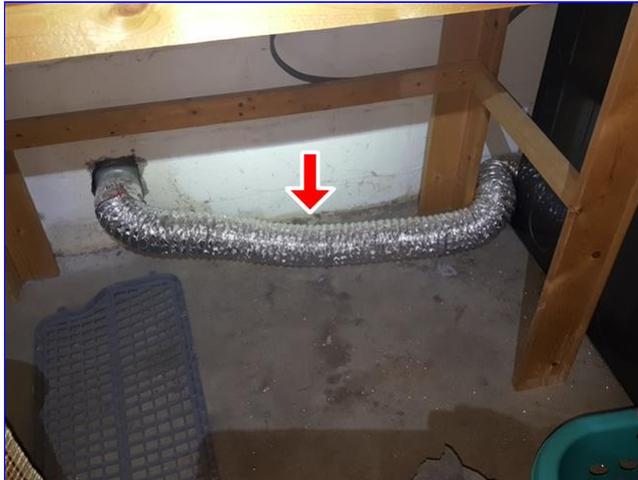
4.10 Item 2(Picture)

(2) A pleated Foil flex pipe is currently installed from the dryer to the exhaust vent. The current recommendations are for dryer vents to be heavy flexible or solid metal to help prevent crushing and damage from fires. Dryer lint fires are reported to be the third leading cause of fires. Exhaust ducts should be constructed of minimum 0.016 inch thick rigid metal ducts, having smooth interior surfaces with joints running in the direction of air flow. Exhaust ducts shall not be connected with sheet metal screws or fastening means which extend into the duct. All dryer vents should be disconnected and cleaned twice a year. This is a very common cause of fires. Recommend replacing duct for proper operation and for your safety using a qualified contractor.

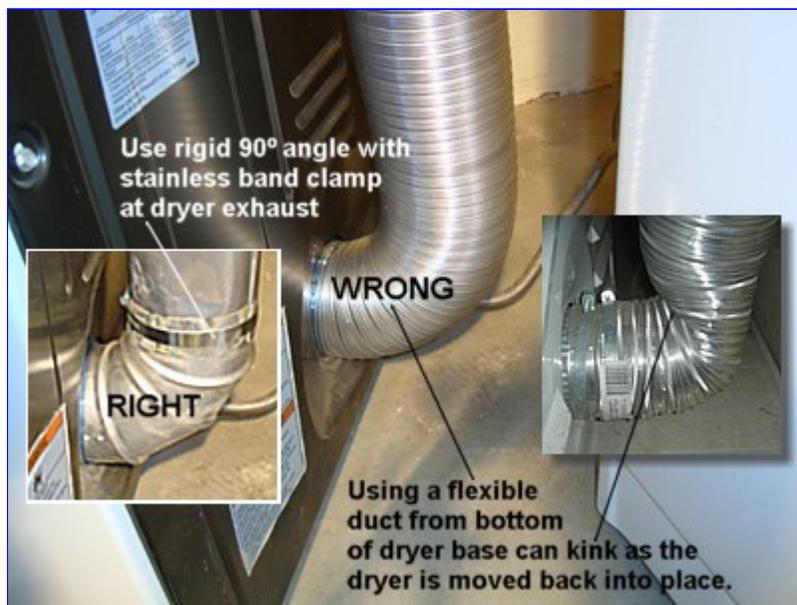
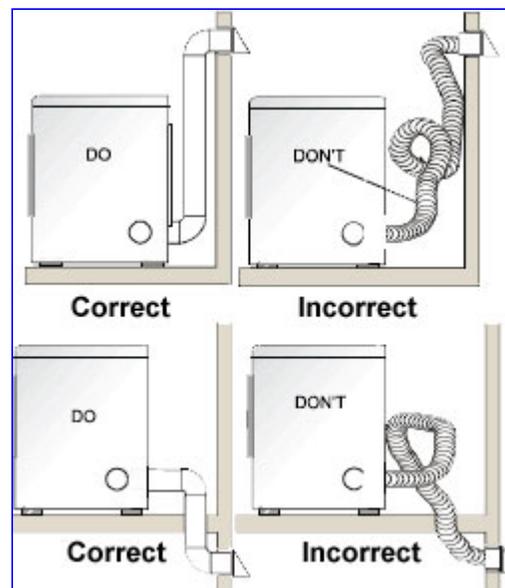
(3) The dryer vent in the basement is made of PVC pipe. This is a safety issue. Manufacturers state that "To reduce the risk of fire, DO NOT use plastic pipe or flexible plastic pipe to exhaust the dryer" PVC piping increases the risk of a dryer vent fire due to it creates static electricity which causes the lint to build up, and that PVC is only rated at 140 degrees of heat. Dryers get hotter. Recommend PVC pipe be converted to flexible metal ridge or solid metal pipe for your safety. Replace as needed.

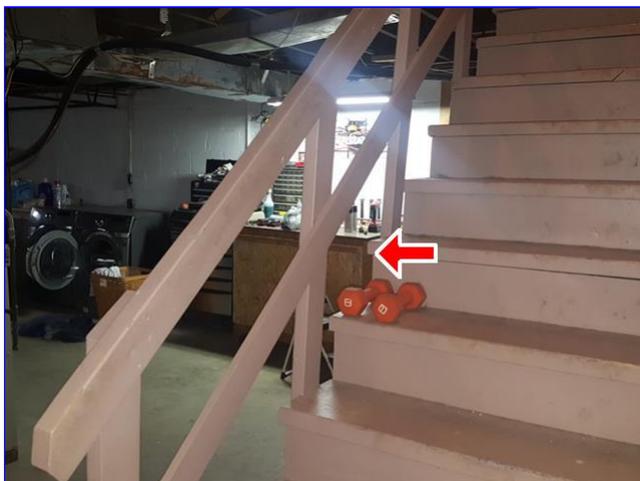
5.3 Item 1(Picture)

The guard rail balusters are installed horizontally at the basement staircase. This is a potential safety issue as a child may climb the guard rail which may result in a fall, injury or death to occur. Recommend vertical balusters be installed for safety and ensure they are spaced 4 inches apart to prevent these accidents. A qualified contractor should make the necessary repairs and corrections where needed for safety.

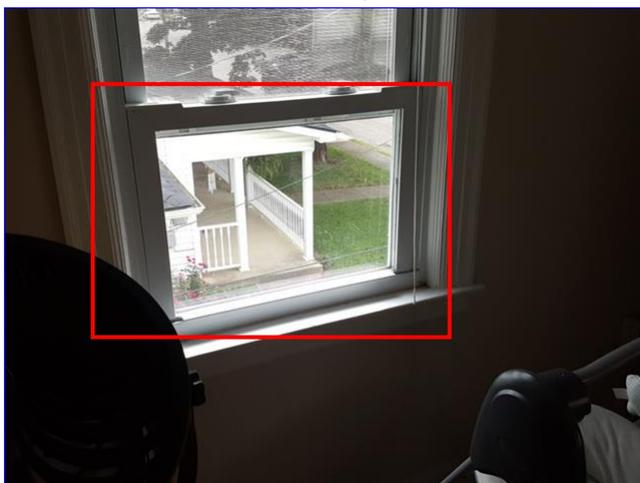
5.5 Item 2(Picture)

(2) The window in the 2nd Bedroom (right side of the home) will not stay up without a prop. The springs or sash cords may not be connected or they may be broken. This causes the window to slam closed very quickly and harm anything beneath it especially a persons hand. This is a safety issue. Correction or replacement of the spring or sash cord by a qualified window installer or contractor is recommended for the safety of children and adults.

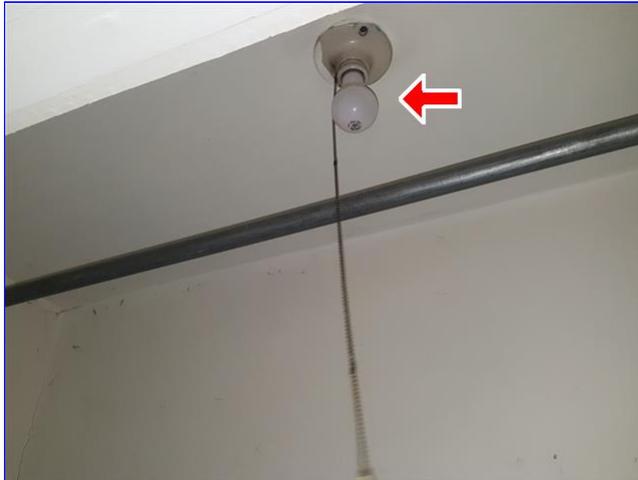
5.6 Item 1(Picture) guest bedroom

The light in the bedroom closets where indicated in the photo(s) are missing a fixture. Light bulbs in closets should have fixtures or be replaced with fluorescent bulbs to prevent fires from bulbs being in contact with clothing or storage items. This is a safety issue. Recommend correcting as needed.

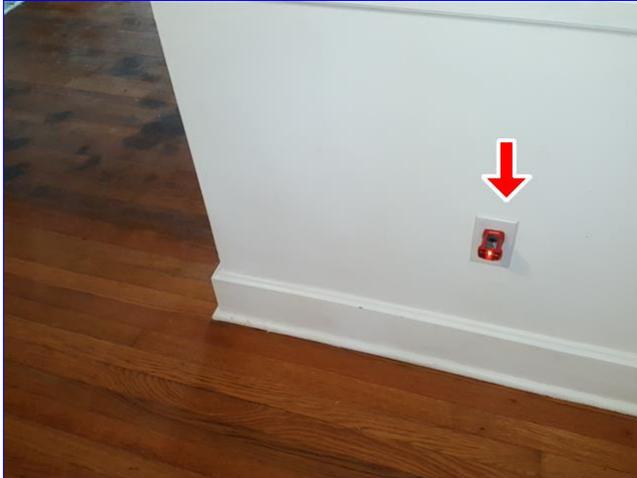
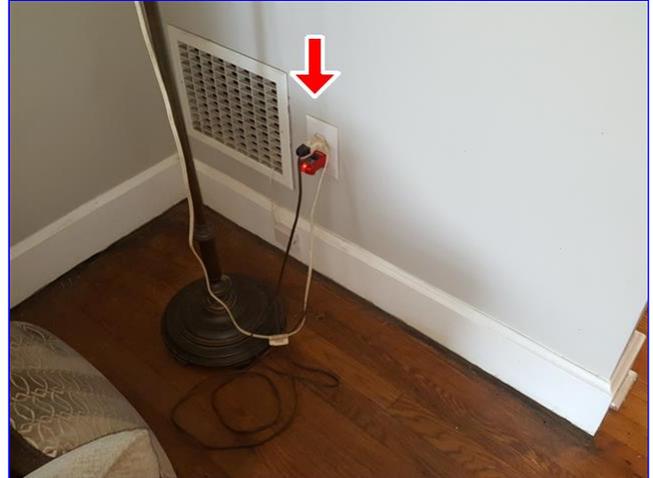
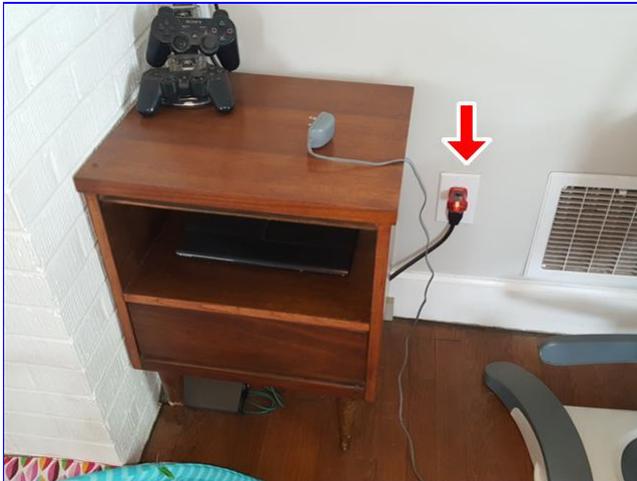
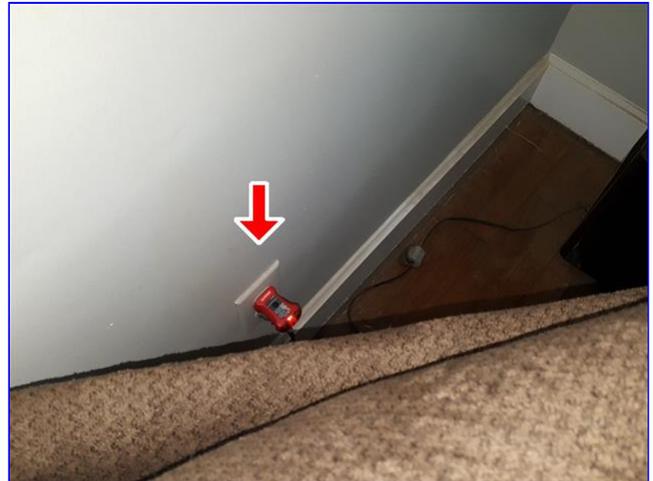
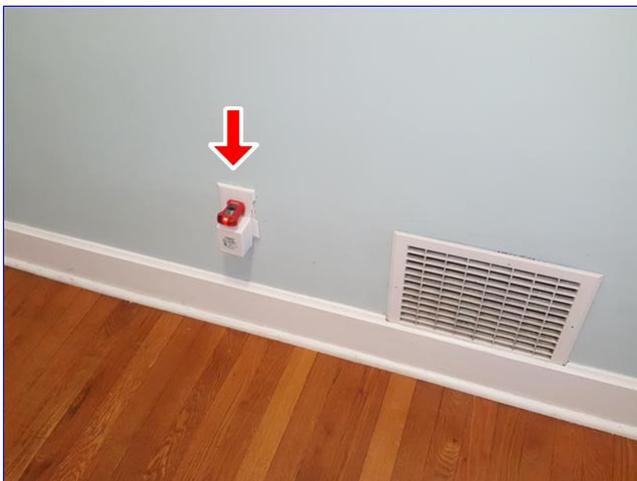
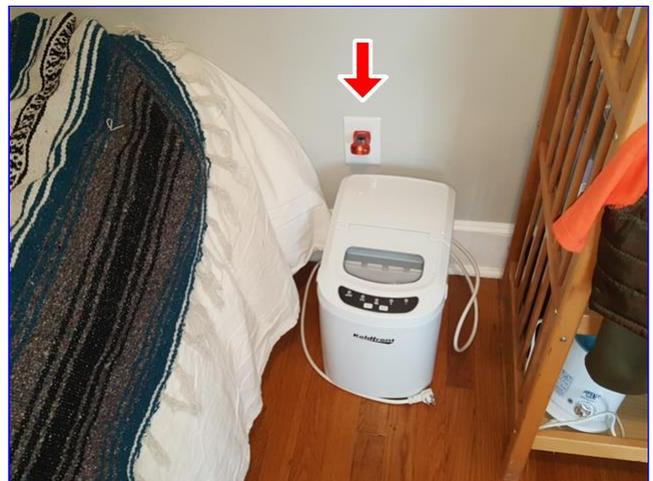
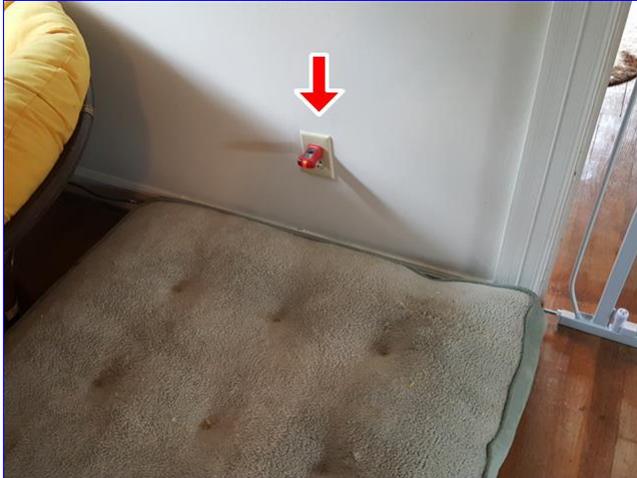
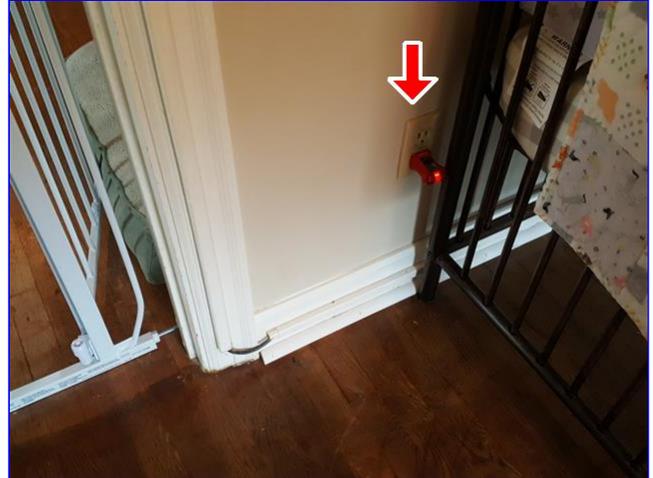
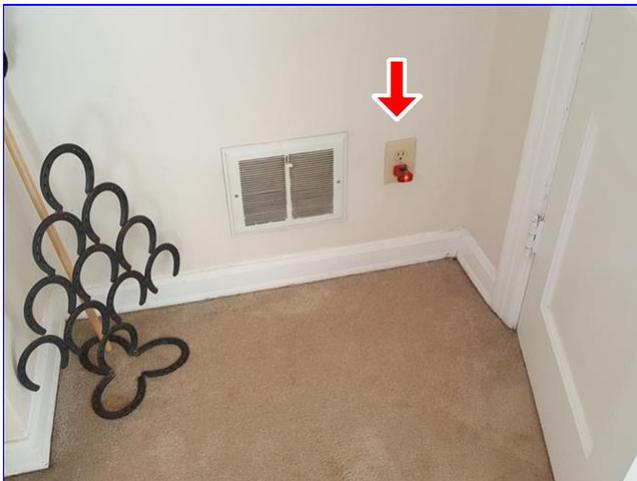
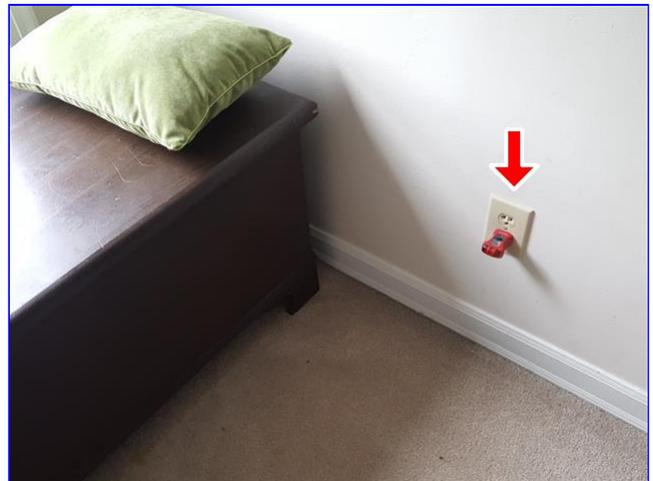
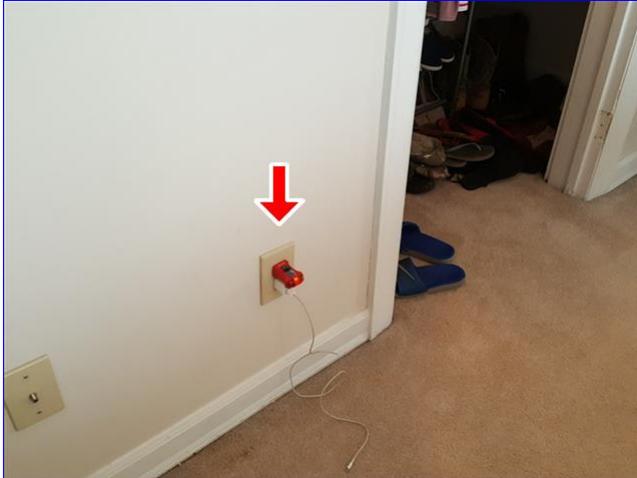
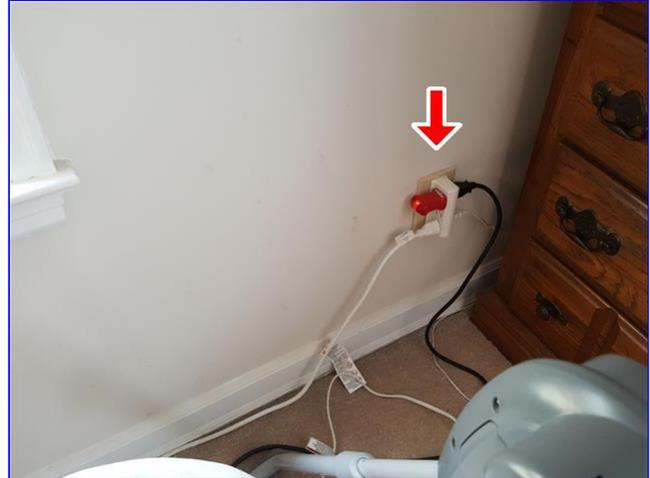
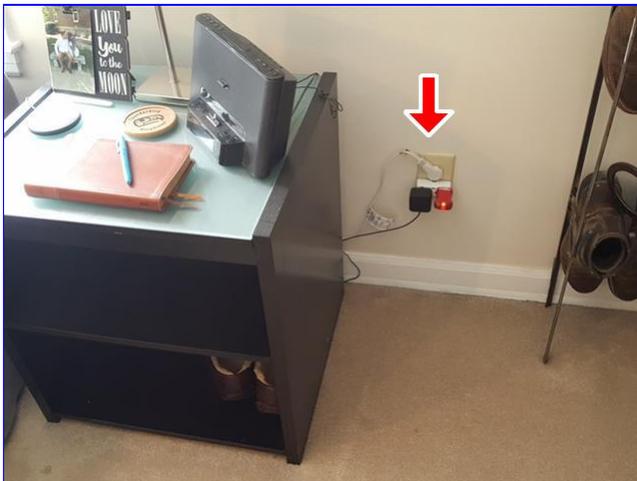
(1) The outlets shown in the photo are showing an open ground. These were originally a 2 prong receptacle when the home was built and have been converted to a 3 prong receptacle without being grounded. This is a safety issue. Major appliances using three prong cords should never be connected to these receptacles unless the appliance manufacturer allows the connection. Many lamps and other small appliances do not have or require the three slot electrical receptacles. When updating outlets in a home they should be converted to today's standards for safety. Recommend a qualified electrician correct and upgrade connections to these outlets as needed.

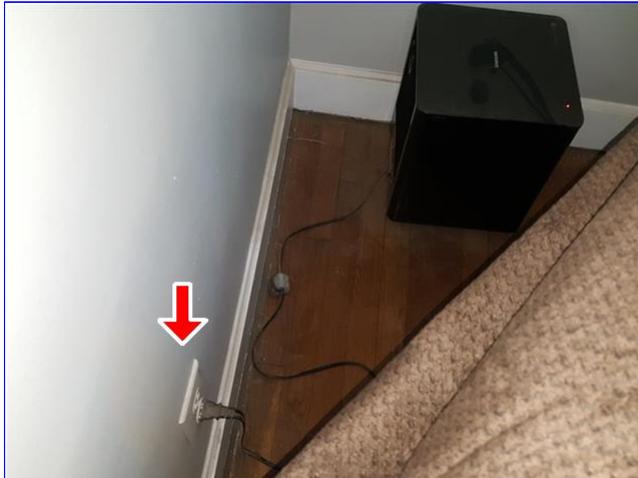
5.7 Item 14(Picture) living room

(2) The outlet(s) where indicated in the photo(s) are loose at the wall or in the outlet box. Electrical issues are considered a hazard until repaired. This is a safety issue that needs to be corrected due to an electric shock or fire from loose connections could occur if not repaired. Recommend a qualified licensed electrical contractor correct as needed.

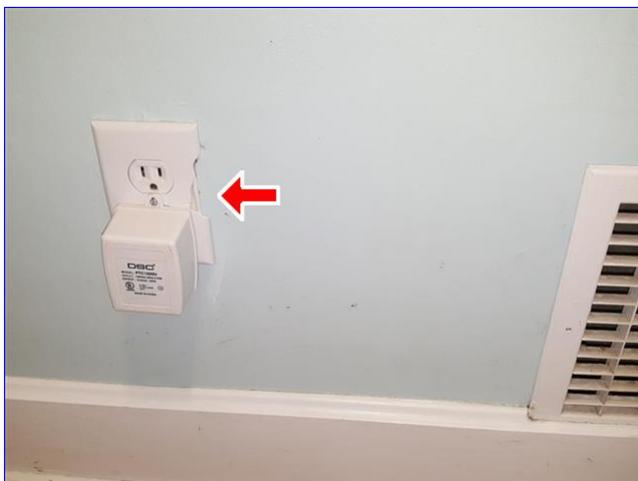
5.7 Item 17(Picture)

(3) The cover plate for the the outlet is broken in the hallway. Recommend the cover be replaced to prevent touching the sides of the device to prevent an electric shock which can cause an injury or death. Electrical issues are considered a hazard until repaired, and this is considered to be unsafe. A qualified licensed electrical contractor should correct as needed.

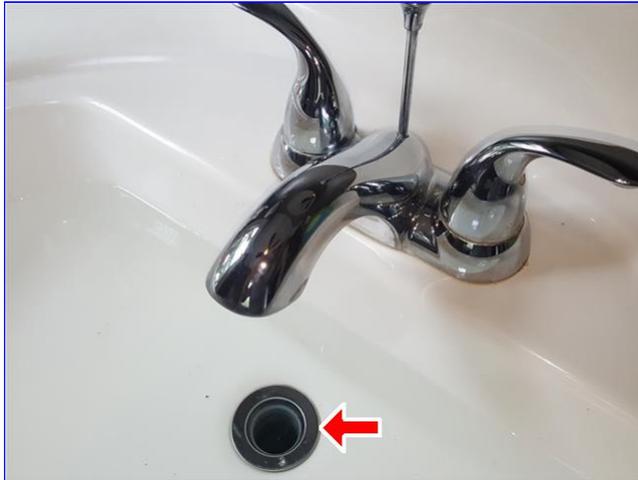
6.5 Item 1(Picture) 2nd bathroom

(1) The drain plug is missing at the sinks in both bathrooms. Replacement or repair of the drain plug is recommended to allow use of the drain lever.

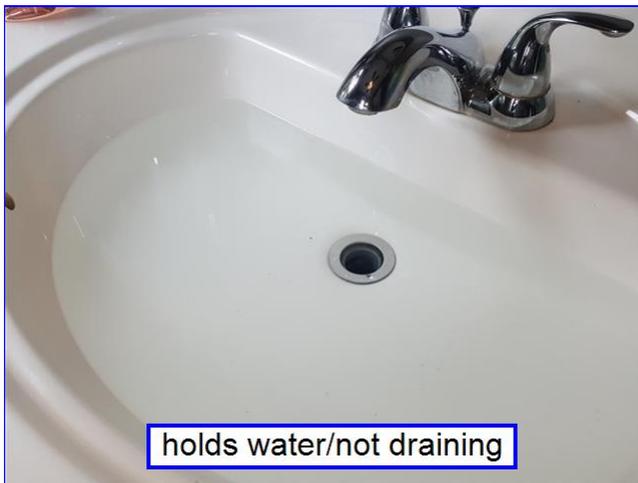
(2) The sink in the 2nd bathroom when filled does not drain correctly. When tested, the water started to drain and then stopped. Over time the water eventually completely drained. There maybe a blockage in the drain lines or the the drains may not be vented correctly or there is a blockage in the vent pipe. Recommend a qualified licensed plumber further investigate and repair as needed.

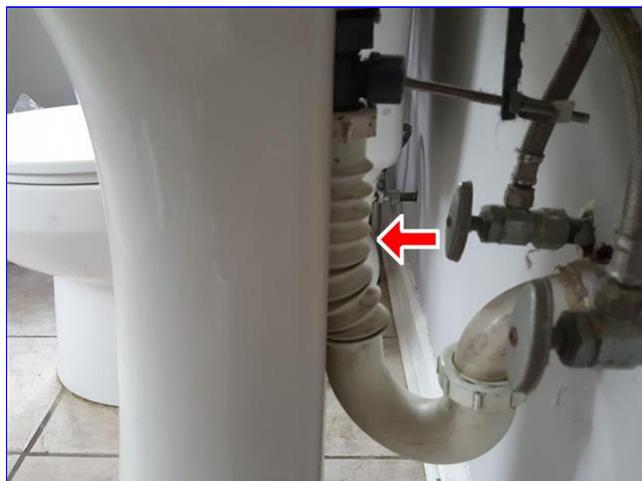
6.5 Item 5(Picture)

(3) Flexible ridged pipe is being used for the connection to the drain line under the sink in the master bathroom. The pipe ridges will hold and trap debris which could clog the drain. Plan on cleaning the drain from time to time. Smooth pipe would be better but may be difficult to fit to the existing drain lines. Recommend you seek a qualified licensed plumber to evaluate and correct if needed as this type of work is not to standard workman like practices.

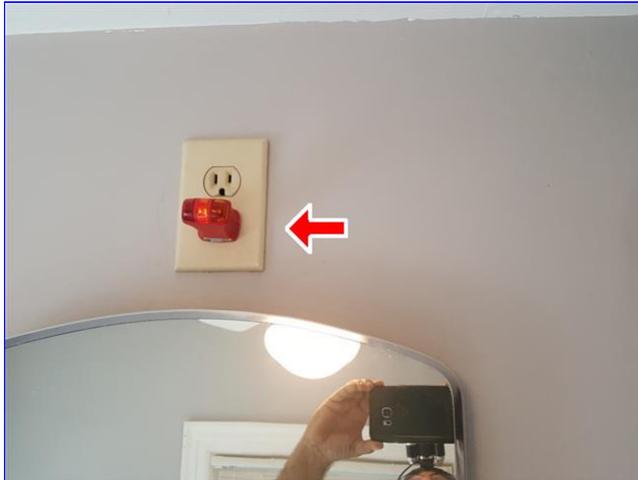
6.6 Item 2(Picture)

(2) The outlet(s) is not GFCI protected and is not grounded in the Master bathroom in the home. Although GFCIs may not have been required at the time that this house was built, these are now required and recommended for safety within any water source as a safety feature when any changes to the outlets are made. GFCI outlet offers protection from shock or electrocution. Recommend a licensed electrician correct as needed.

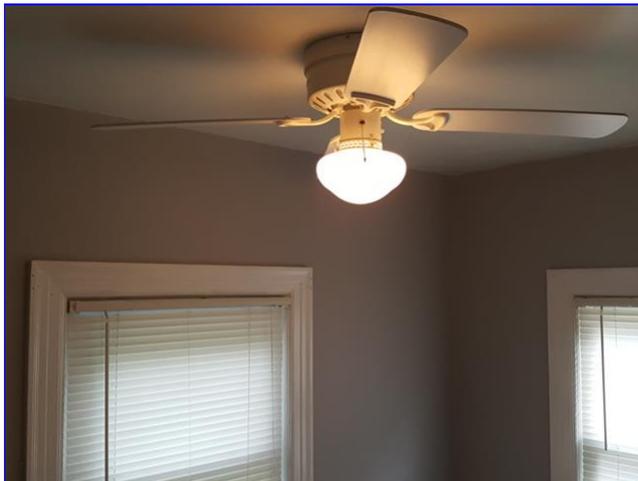
6.6 Item 4(Picture)

(3) The ceiling fan does work in the Master bathroom, but is mounted less than 7 feet and could be too low to stand under. This is hazardous and a serious safety issue. If not removed a serious injury could occur for persons close to 5'6" high and above. Strongly recommend removing the ceiling fan to avoid an injury prior to moving in. Recommend a qualified contractor correct as needed.

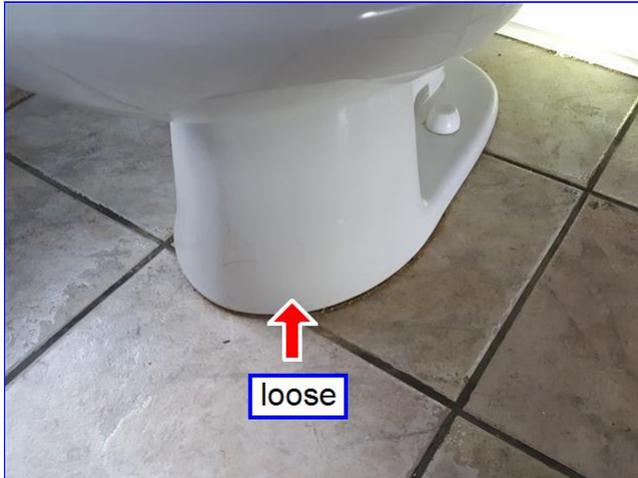
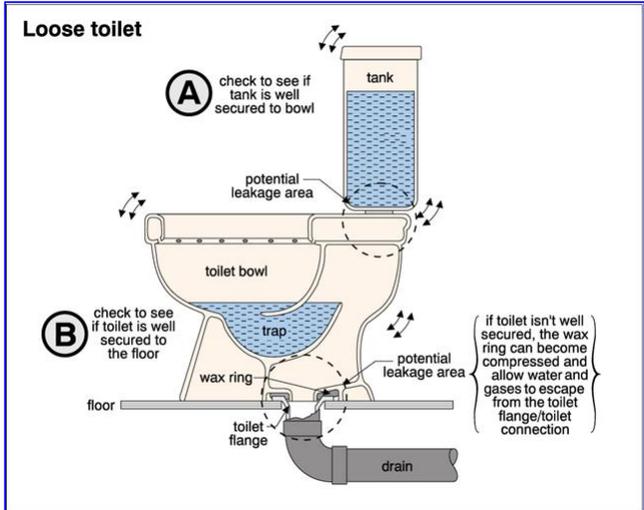
The toilet tank base is loose at the floor in the master bathroom. The screws may need tightening to secure the toilet base to the floor to prevent a water leak between the toilet and the drain line connection. If tightening the screws at the base of the toilet does not secure the toilet, repairs may involve re-setting the toilet on a new wax seal and/or repairs to the floor may be required. Recommend a qualified licensed plumber repair or correct as needed.

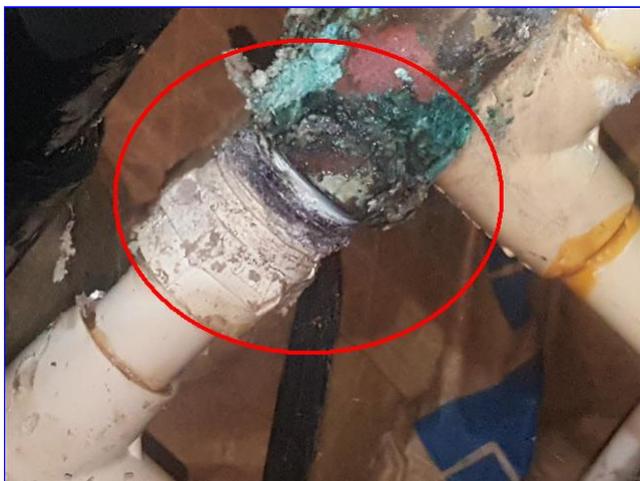
7.1 Item 4(Picture) under kitchen area

(3) Mineral deposits/scale build up was noted on a water supply line connection in the unfinished basement at the left side of the home. There was a minor leak at the connection. Recommend a qualified licensed plumber repair as needed before a major water leak develops in the basement.

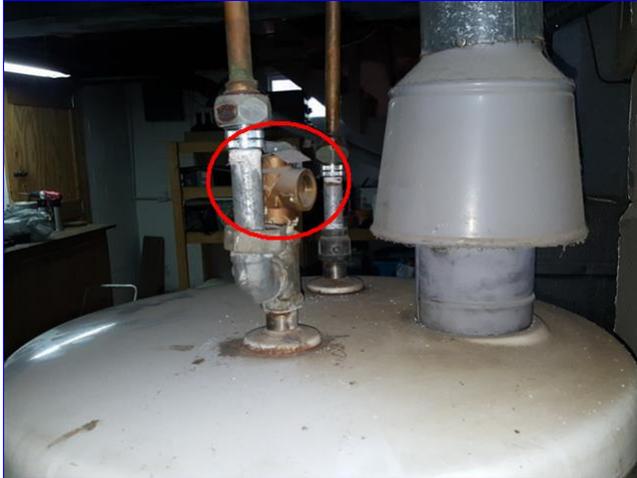
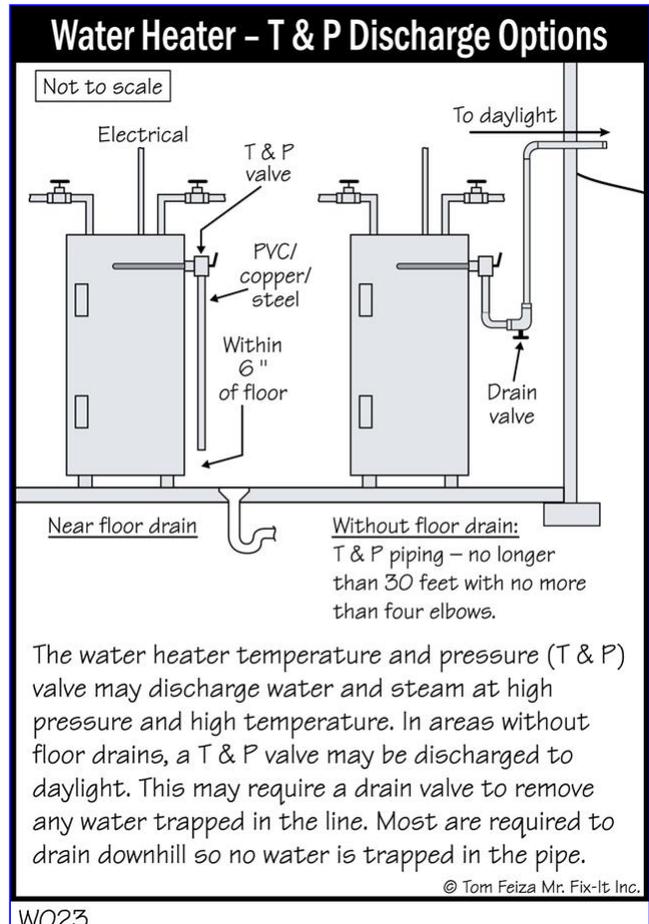
(1) The T&P (Test and Pressure) valve on the water heater is missing a drain line. The drain line needs to be a 3/4" threaded copper pipe to extend within 6 inches, then the end should be visible and drain to the exterior of the home, not in a crawlspace. (PVC is not approved for hot water use and CPVC is not recommended). Recommend a qualified plumber correct as needed for safety.

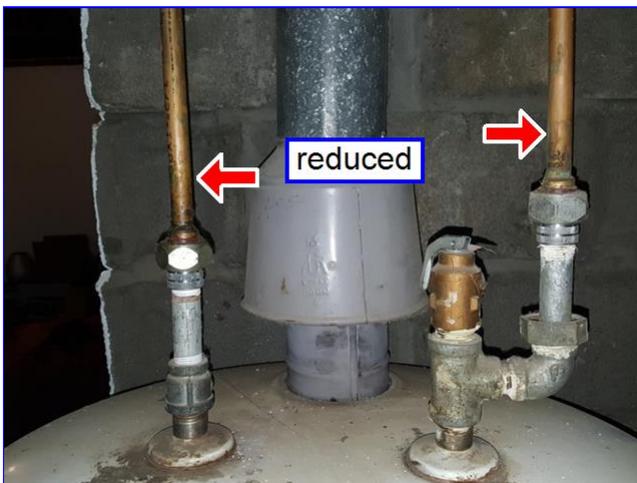
7.3 Item 3(Picture)

(2) The cold water supply line and the hot supply line pipes leading into the water heater have been reduced to 1/4 inch pipe. They should be 3/4 inch pipe. This reduces the water pressure leading in wards and outwards from the water heater which can cause damage to the unit and result in poor water pressure for the hot water supply lines in the home. Most manufacturers recommend the pipes that are connected to the water heater are to be 3/4 inch pipes in diameter. Recommend a qualified licensed plumber further investigate and repair/correct as needed prior to moving in.

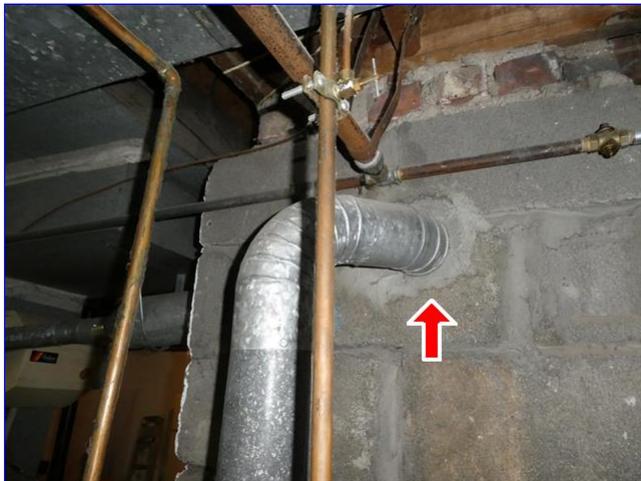
7.4 Item 1(Picture)

This chimney is being used for venting the gas water heater. It is important to remember that if the flue tiles are cracked it could allow C.O. (carbon monoxide) into the home. C.O. will damage the clay tiles and mortar joints. The flue size may be larger than recommended to allow proper drafting of the gas appliance using this vent. Strongly recommend a qualified licensed plumber check the size of the flue and install a correctly sized steel liner to allow the water heater to draft well and perform safely.

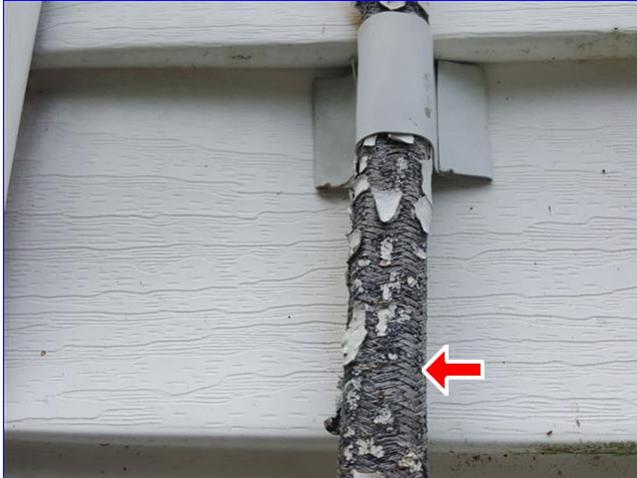
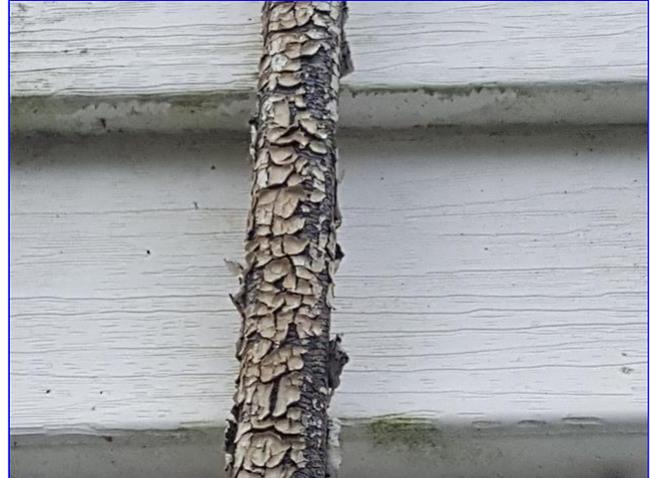
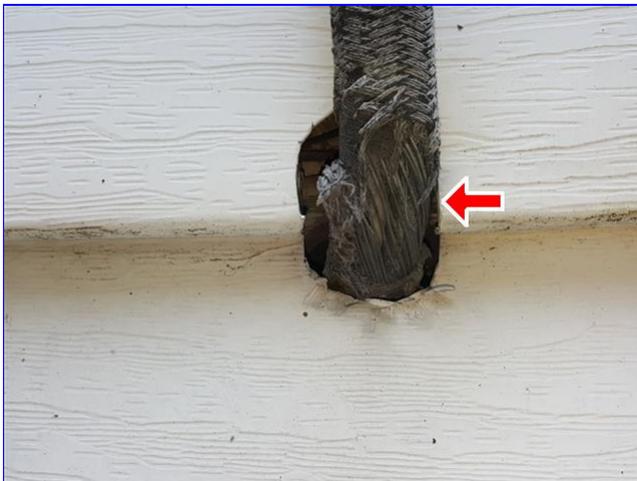
(1) The electrical service conductors entering the home and meter are frayed at the wire sheathing at the rear left corner of the home. For safety the wiring should be placed in a conduit to prevent further deterioration and to prevent it from being touched by a person and/or child. Recommend a qualified electrician correct for safety prior to closing.

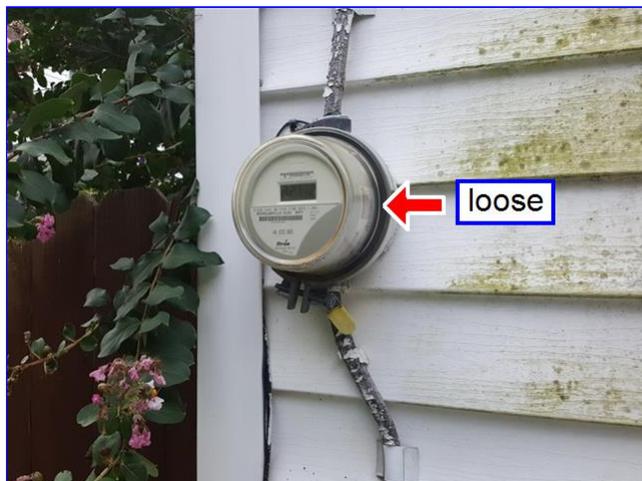
8.0 Item 4(Picture)

(2) The meter box is loose and not secured correctly to the wall at the rear left corner of the home. It appears to be held by the wires leading into the meter which are secured to the wall. Excess strain may be placed on connections which may fail causing power to go out. This is **extremely dangerous** as a fire or electrocution could occur if not corrected. Recommend contacting KU to repair or to determine who is responsible for fixing. If the owner is responsible then a qualified licensed electrician will be needed to make the repairs.

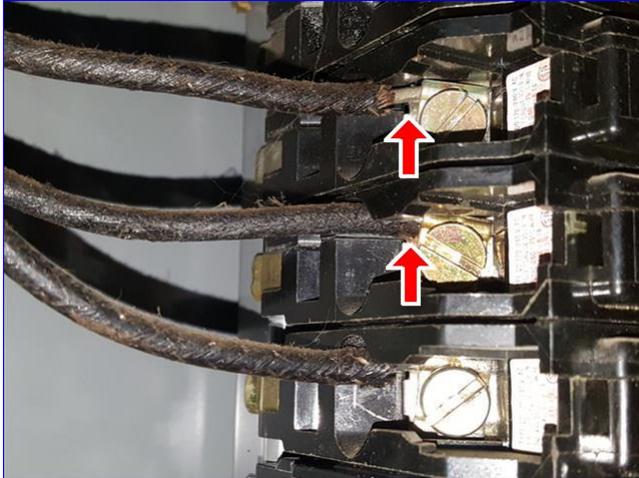
8.3 Item 1(Picture)

(1) Aluminum wire is installed on 120 VAC (volts (electrical pressure) of alternating current) branch electrical circuits in the subject house. These single-strand, branch circuit aluminum wires were used widely in houses during the mid-1960s and 1970s. According to the U.S. Consumer Product Safety Commission, problems due to expansion can cause overheating at connections between the wire and devices (switches and outlets) or at splices, which has resulted in fires. For further information on aluminum wiring, contact the U.S. Consumer Product Safety Commission via the Internet at <http://www.cpsc.gov/>. It is recommended that the electrical system be evaluated by a licensed electrical contractor.

(2) When aluminum wiring is used as noted in this panel at the 15 and 20 amp breakers, it should be coated with a good antioxidant. The antioxidant grease is missing. When aluminum wire is exposed to the atmosphere, a film of aluminum oxide forms. This is hazardous and a safety issue because the current is supplied at a much lower rate of voltage and as the oxidation builds up, it builds up resistance which creates heat. Also, movement of the wire can occur from oxidation due to expansion/contraction of the wire and can cause loose connections. Recommend a qualified licensed electrician further inspect and correct/repair as needed.

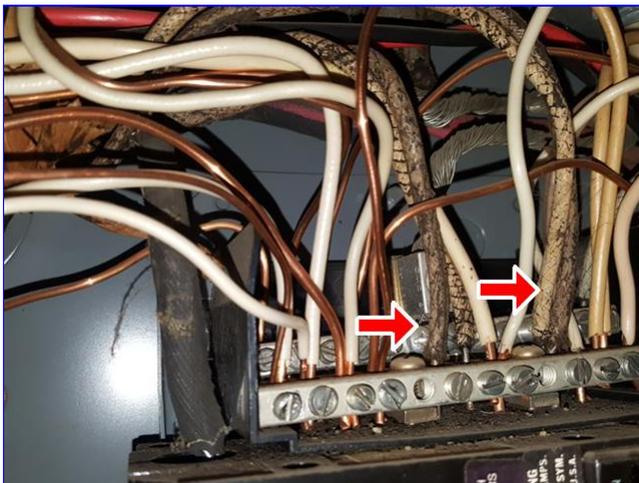
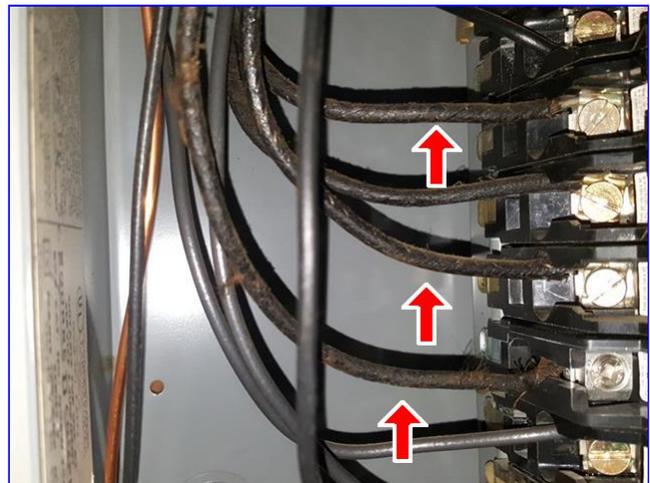
(3) Cloth covered wires are visible in the panel box. These circuits are older systems with cloth coverings that fray and become brittle with age. It is wire encased in brittle rubber which then has a woven cloth covering tightly over the wire similar to the actual old knob and tube wiring. This was then surrounded by a coated cloth woven jacket that made the entire jacket stiff and difficult to bend easily. The biggest issue with it was that the rubber used was of somewhat poor quality and as this wiring is bent or moved, the rubber coating around the wire being so brittle from age and quality, tends to just fall apart. This rubber is generally so brittle, it can be removed from the wiring with just a fingernail. This can be a safety issue if this rubber coating disintegrates or falls off a wire in an attic or behind a wall, and the bare hot and neutral wires make contact with each other, arcing can occur, which can lead to house fires. Be aware that some insurance companies will not issue policies on homes with this type of wiring. Recommend contacting a qualified licensed electrician and your insurance carrier to determine what needs to be done to make this system safer prior to closing.

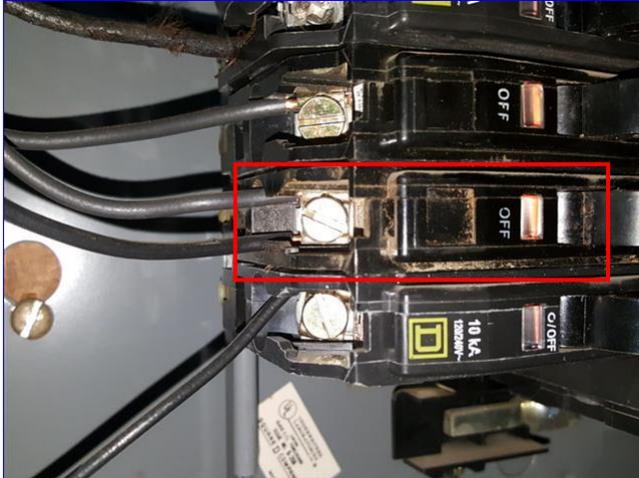
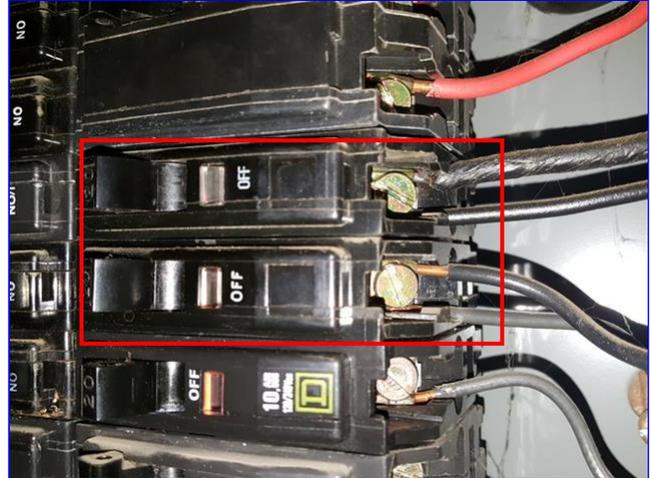
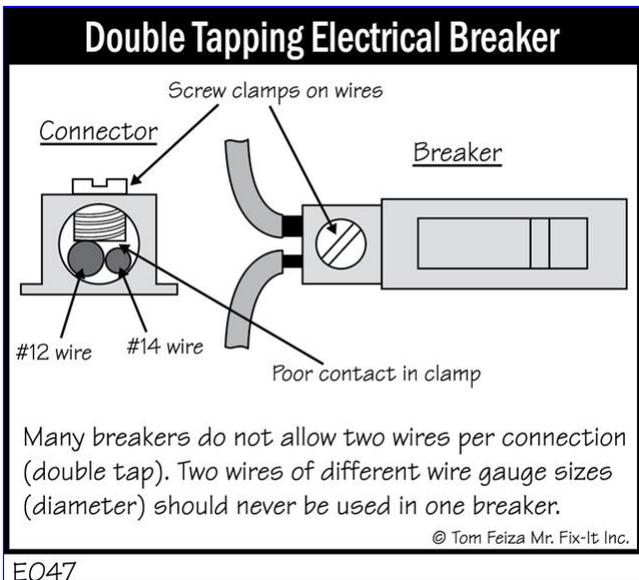
(4) Multiple tap wiring (more than one hot wire attached to the same breaker) was found in the panel. This panel and breakers are NOT MADE or DESIGNED to provide adequate holding power for multiple wires on a single breaker. A separate breaker should serve each circuit. This is a very hazardous and is a safety issue. May cause a fire or short. Recommend a qualified electrician further evaluate the panel box for further issues and repair and correct as needed.
