## **Inspection Report**

**Property Address:**  
211 Mangini Street  
Nicholasville KY 40356

<b>Date:</b> 9/12/2018	<b>Time:</b> 10:00 AM till 02:30 PM	<b>Report ID:</b> 180912PETERS
<b>Property:</b> 211 Mangini Street Nicholasville KY 40356	<b>Customer:</b> Mr. Trevor Peters	<b>Real Estate Professional:</b>

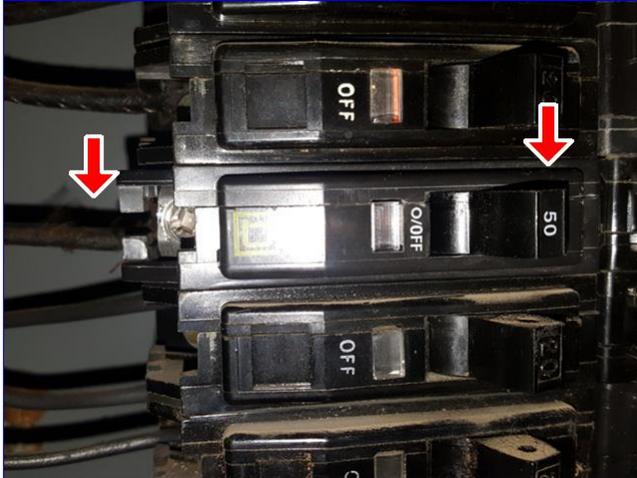
8.3 Item 7(Picture)

(5) There are incorrect amperage gauge wire sizes connected to non matching amperage circuit breakers in the panel box where indicated in the photo(s). This is extremely dangerous and could result in an electrical fire within the home. The wires could over heat and catch fire without tripping the circuit breakers. As an example a 15 amp wire should not be connected to a 20 amp circuit breaker. Recommend a licensed electrician further evaluate wire size connected to the circuit breaker in the panel box where indicated and for other faults or hazards then repair or replace as needed.

Wire size must match or exceed breaker/fuse size or the wire may overheat and create a fire hazard.

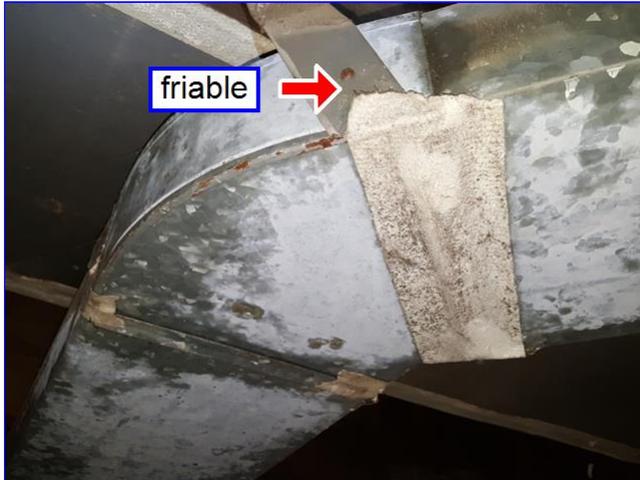
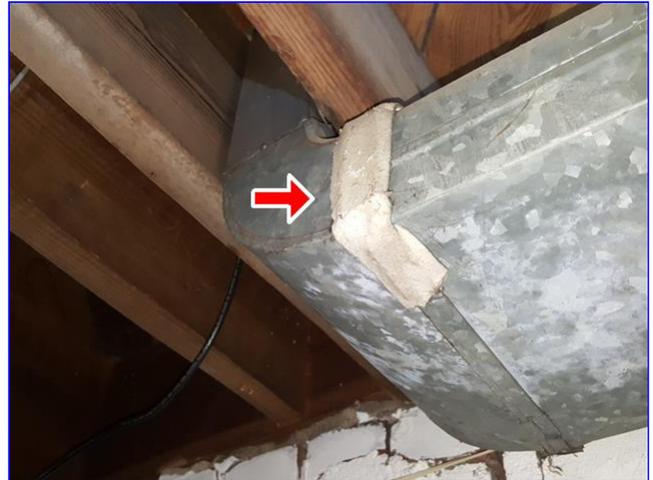
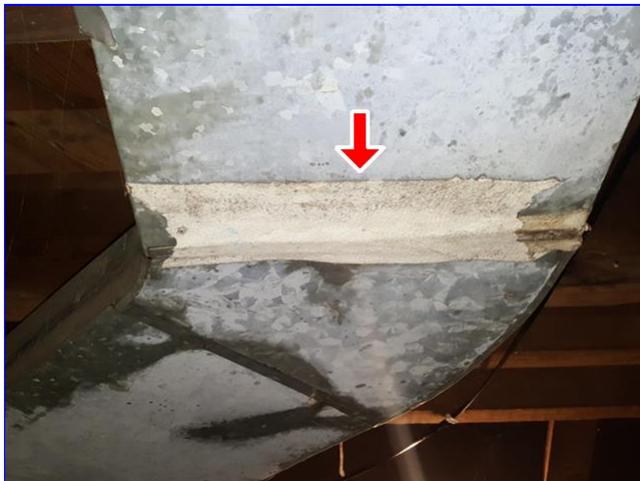
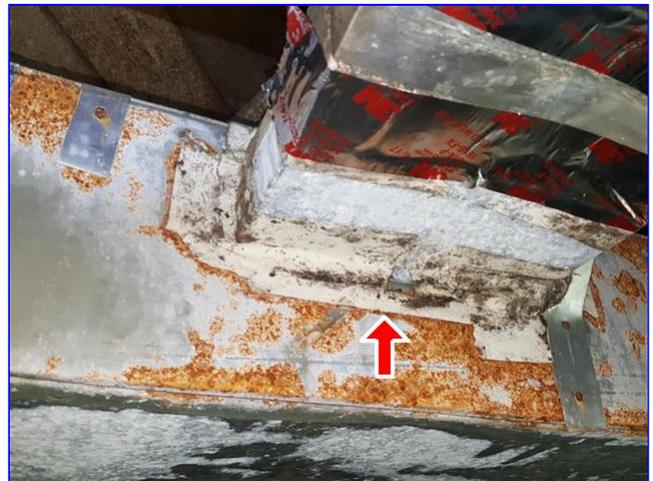
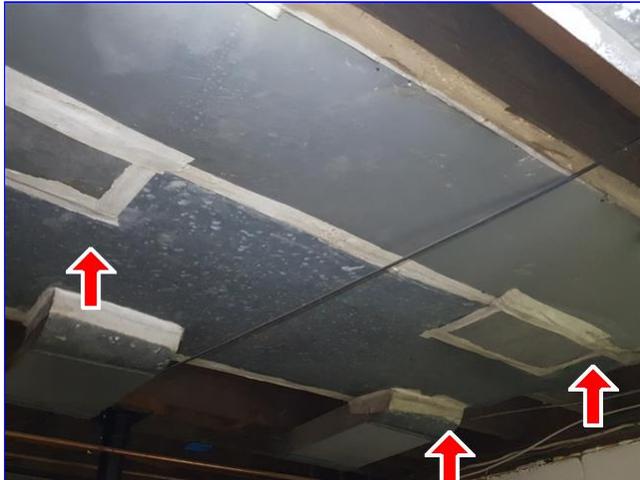
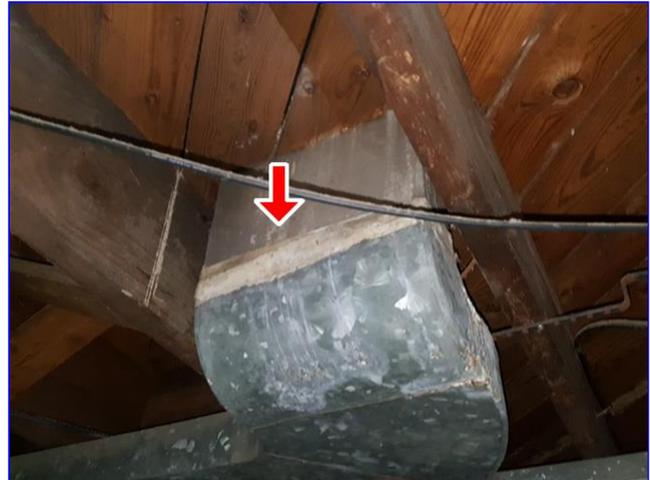
(3) The white tape covering all of the joints in the duct work in the unfinished basement may be asbestos. Some of the tape is damaged and maybe harmful to occupants in the home if the product is asbestos and due to the product is exposed and friable (damaged). Only laboratory testing can determine the presence of asbestos. Professional removal of any known asbestos material is sometimes needed. Covering the white material with furnace tape is suggested if the material is in good condition. This traps any particles and prevents spreading them into the home. [Here is a link to the EPA explaining more information about asbestos.](#) **Strongly** recommend a qualified asbestos contractor further inspect to determine if this product is asbestos and if correcting/removing product is needed prior to closing to ensure safety and health within the home. You may wish to have an air quality test done within the home also if the product is asbestos.

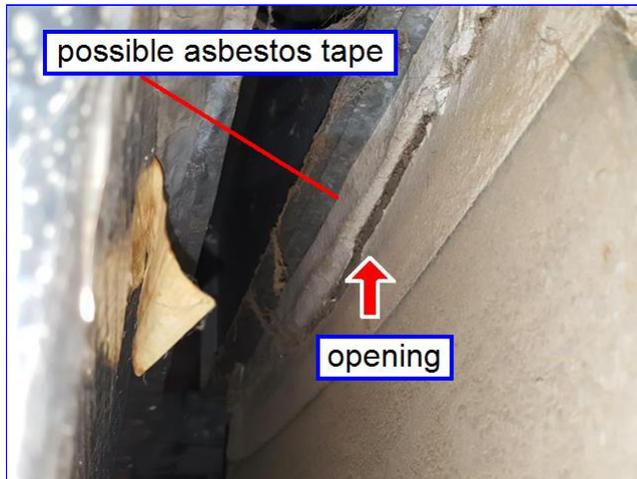
9.6 Item 9(Picture)

(4) The return air plenum has an opening where the possible white asbestos tape has failed and split. Firstly this can cause the HVAC system to run inefficient and is drawing return air from the basement instead of inside the home. Secondly if the white tape is an asbestos product, asbestos particles can be drawn into the system and then spread throughout the home. Strongly recommend a qualified HVAC contractor repair as needed and have an air quality test performed in the home prior to closing for health reasons. Asbestos can cause cancer and is a health risk to occupants in the home.

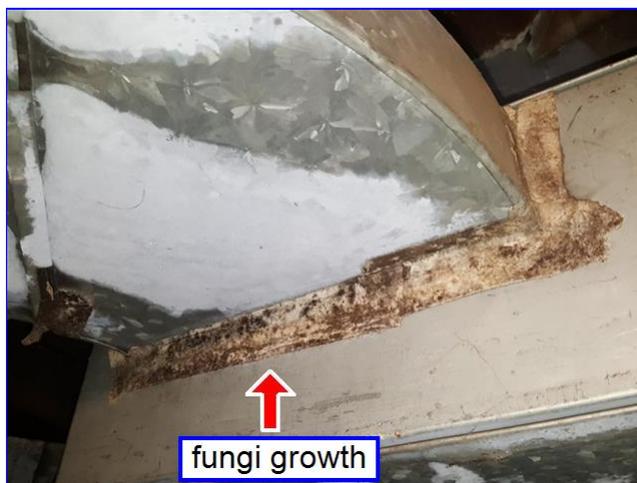
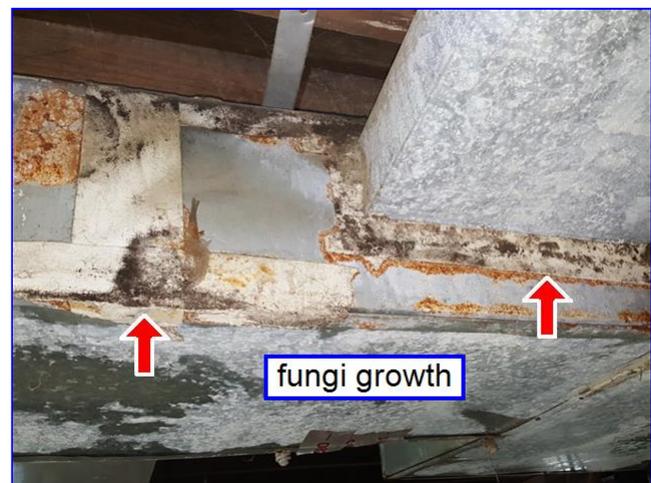
(8) Various areas where the possible white asbestos tape is being used at the joins show signs of fungi growth. This could be possible mold and may also be inside the ducts. Recommend a qualified HVAC contractor and Mold specialists further investigate to determine if this substance is mold, inspect inside duct pipes, and if mold is present then treat and correct as needed by the qualified contractor for safety and health of occupants in the home. You may also wish to have an air quality test done in the home if this substance is mold.

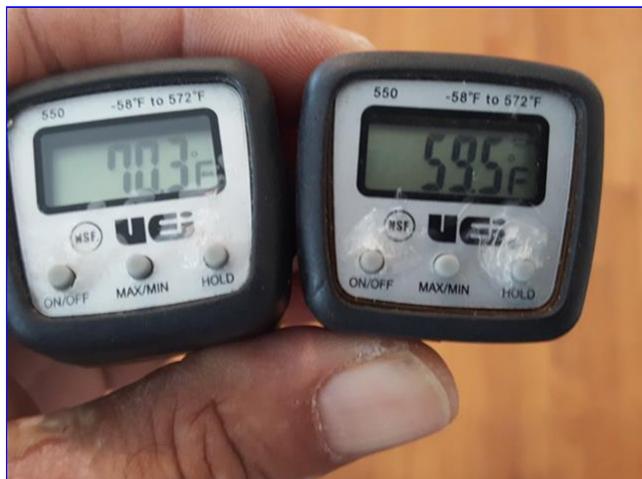
9.9 Item 1(Picture)

The ambient air test was performed by using thermometers at the registers closest to the blower to determine if the difference in temperatures of the supply and return air are between 14 degrees and 22 degrees which indicates that the unit is cooling as intended. The supply air temperature on your system read 59 degrees, and the return air temperature was 70 degrees. This indicates that the unit is **not** cooling properly and a qualified licensed Heat/Air contractor should inspect for cause or problem. Note: There maybe a leak in the refrigerant line or the refrigerant levels need topping up.

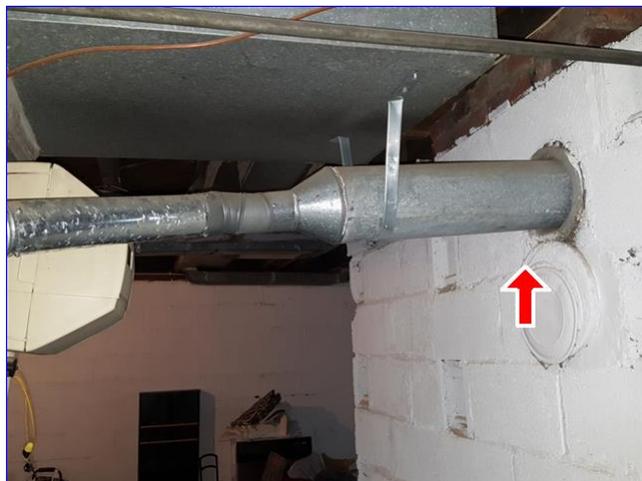
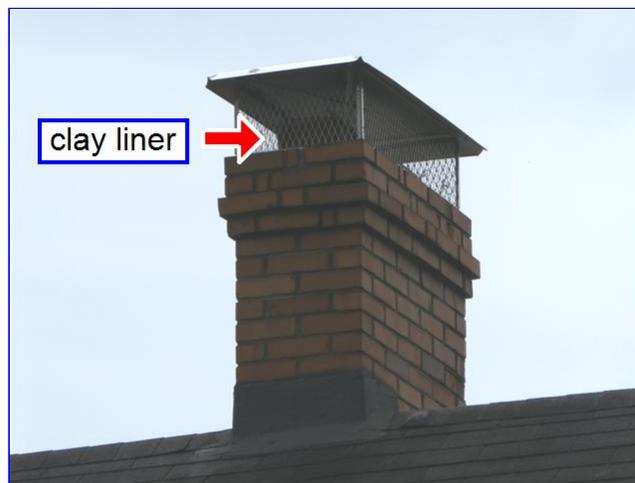
The chimney is being used for venting a gas furnace. A stainless steel vent pipe should be installed and properly sized for the gas appliance to prevent damage to the interior of the chimney mortar joints, possible entry of CO (carbon monoxide) gases into the home, and sized to promote good drafting of the gas appliance. Clay flue tile is usually too large to allow proper drafting. A cap should be installed at the same time. Strongly recommend that a qualified licensed plumber examine the chimney to determine if the chimney or flues have been damaged and require repairs to prevent CO entry into the home and to verify that the flue or clay liner is properly sized to provide good drafting of the gasses.

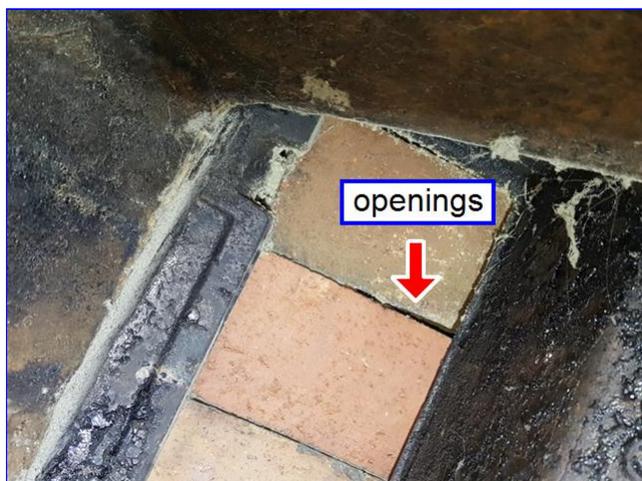
9.11 Item 2(Picture)

(3) Because the home is equipped with a vent less gas fireplace, The burn area needs to be sealed. The missing damper has been replaced with bricks, however there are slight openings. This can effect the gas fireplace and creates partial venting of a vent less gas log fireplace. This could cause carbon monoxide to be produced. Before using the gas fireplace in the living room, **strongly** recommend a qualified fireplace contractor further inspect the fireplace burn area and correct or repair if needed for safety of occupants in the home.

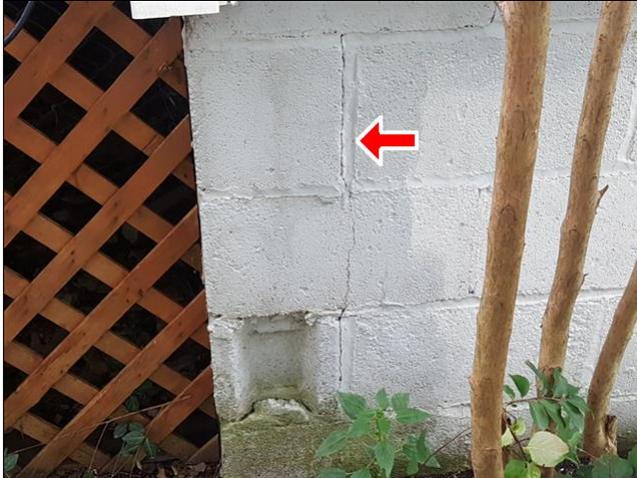
1.1 Item 1(Picture)

(1) Minor vertical settlement crack at the rear right corner of the home in the foundation wall was noted at the exterior. These cracks do not appear significant. This condition is common in many homes and does not usually represent a serious structural concern unless the cracks are between an 1/8 or 1/4 inch thick. Recommend the crack be sealed to prevent water intrusion into the basement and minimize further deterioration. [Sealing Concrete Cracks](#) It is recommended that you monitor periodically to see if further movement occurs and if so a foundation contractor should be consulted to correct and prevent further movement.

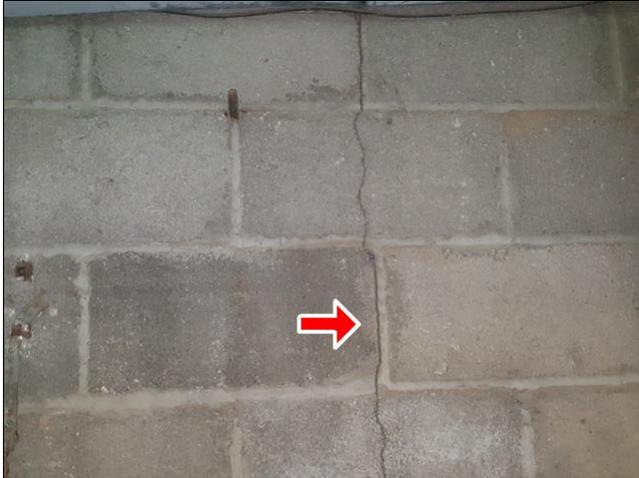
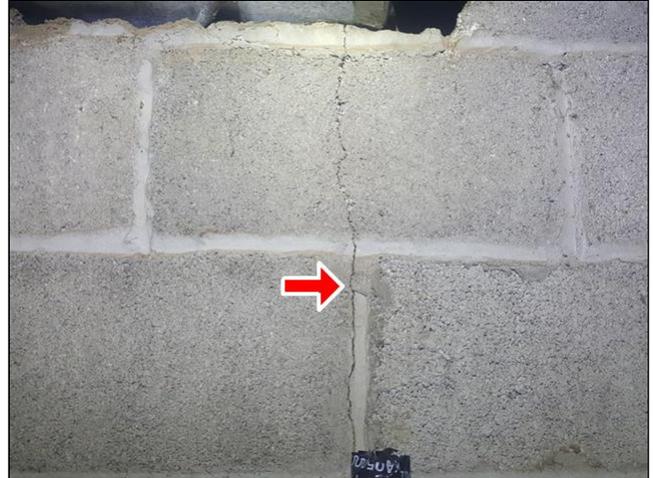
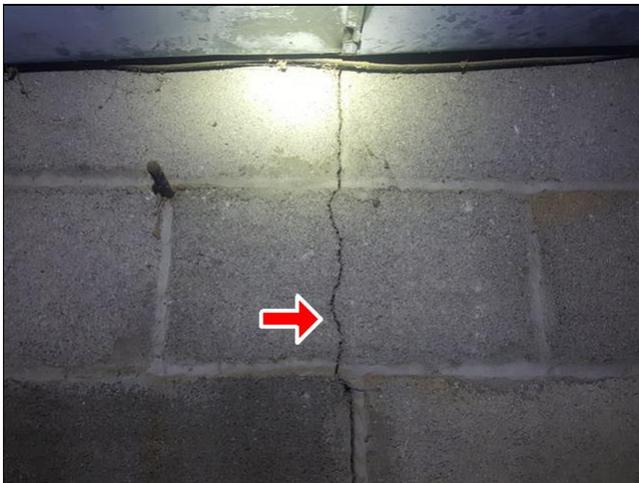
(2) Vertical cracks in the masonry block wall in the center of the home in the basement between the kitchen and formal dining room area was noted. These cracks do not appear significant. This condition is common in many homes and does not usually represent a serious structural concern unless the cracks are between an 1/8 or 1/4 inch thick. Recommend the crack be sealed to prevent water intrusion into the basement and minimize further deterioration. [Sealing Concrete Cracks](#) It is recommended that you monitor periodically to see if further movement occurs and if so a foundation contractor should be consulted to correct and prevent further movement.

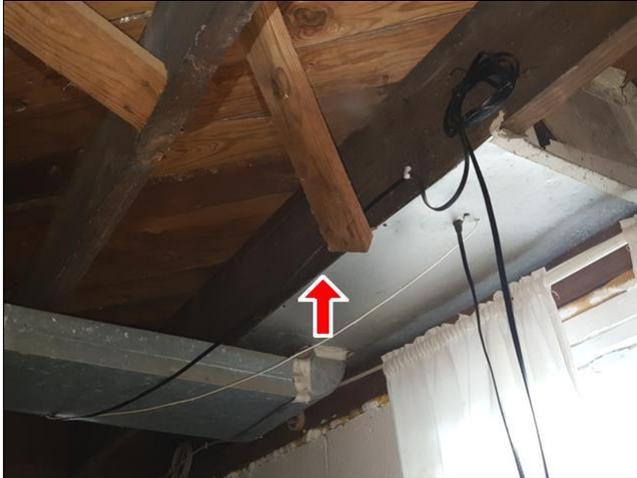
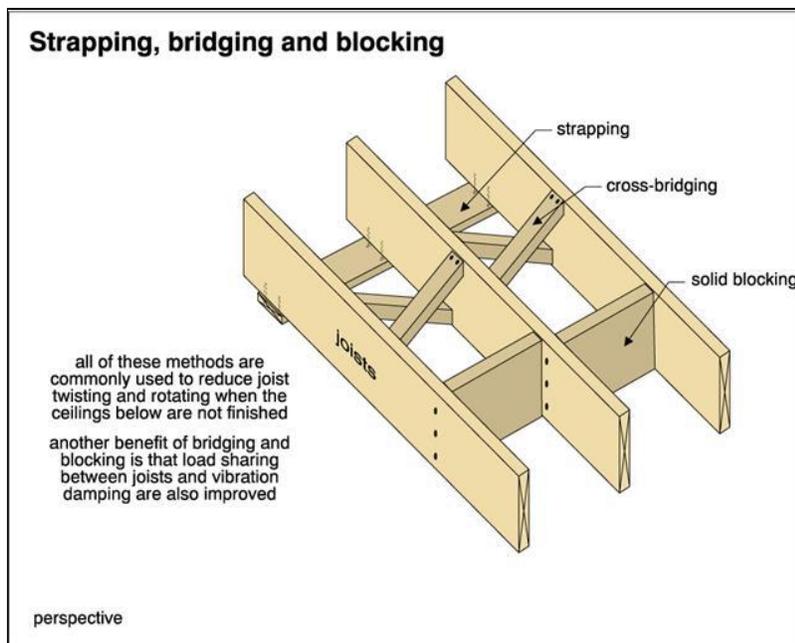
The cross bracing is loose and not secured to the ceiling joists in the basement left side of the home under the formal dining room area. Recommend repair by a general contractor to prevent deflection of the joist and help with the support of load of the joist.

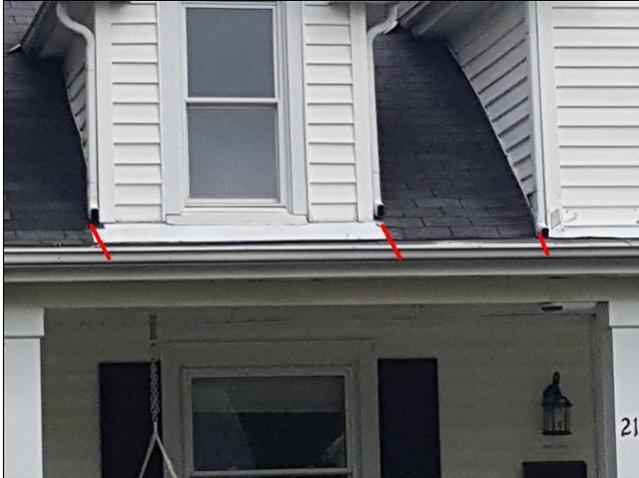
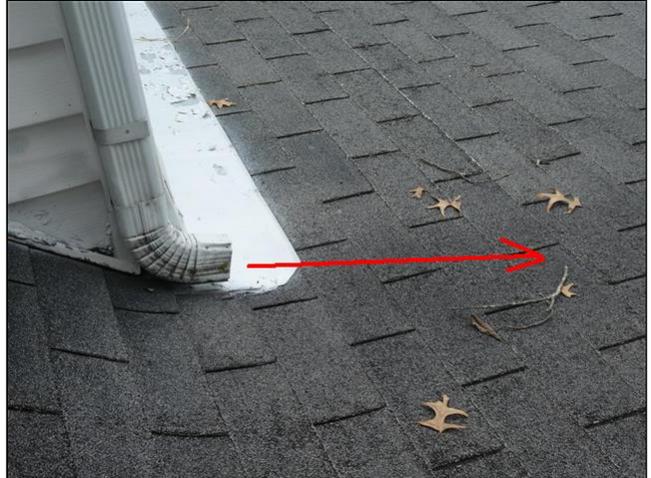
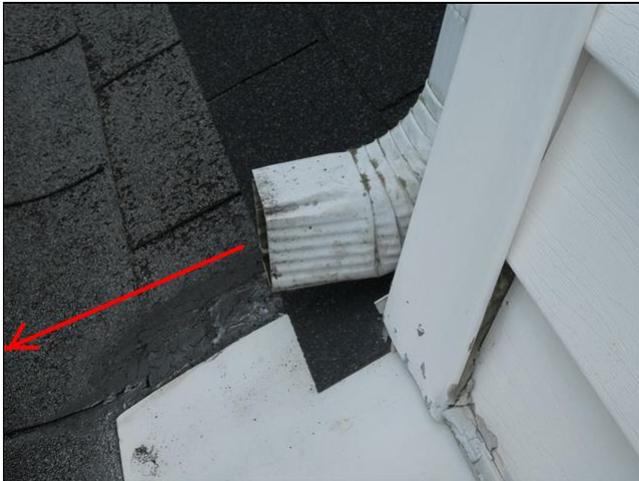
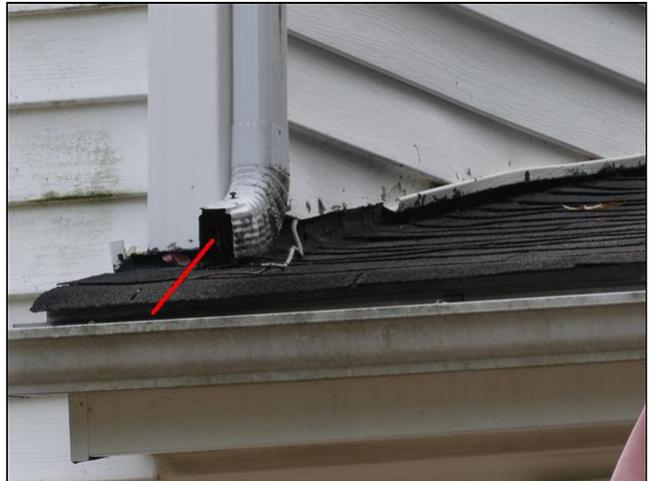
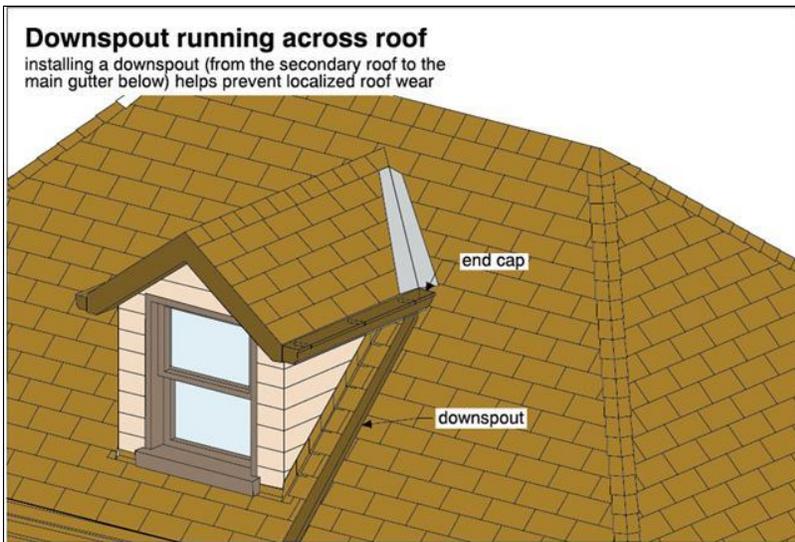
(1) Recommend the downspout(s) that discharge onto the roof around the home be extended to discharge water directly into the gutter below. This condition, if left unattended, can result in premature deterioration and staining of the roofing material under the end of the downspout. The excessive discharge of storm water onto the roof from the downspout also puts stress on building materials designed to prevent water entry into the structure of home. Recommend correcting all around the home as needed using a qualified gutter installer.

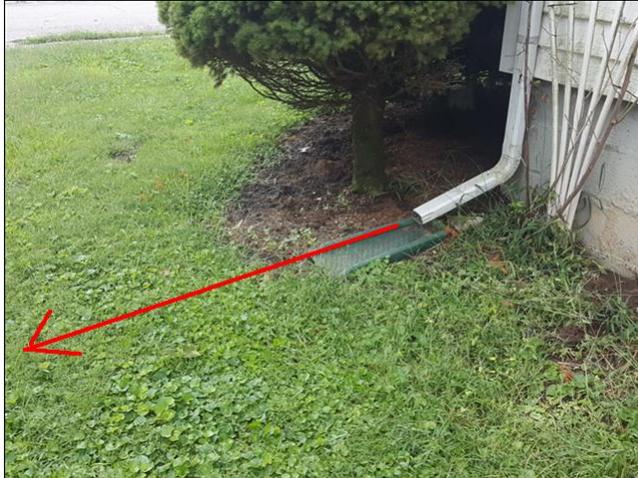
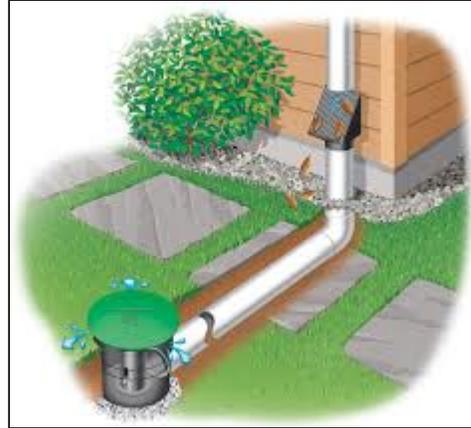
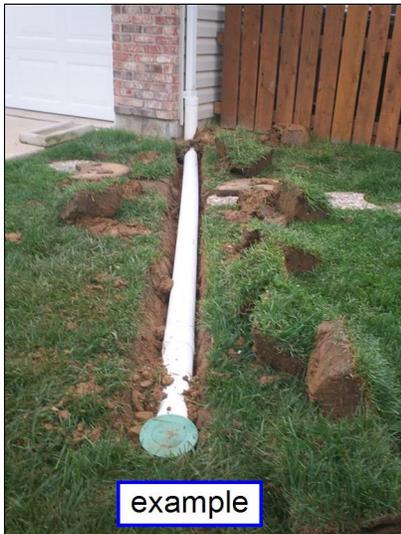
(2) Recommend the downspout(s) at the front right corner of the home be extended at least 6 feet and flow onto splashblocks. This will ensure water is kept away from the foundation perimeter, soil

erosion does not occur and water cannot leak into the basement area which may cause settlement of the foundation.

Note: You may wish to consider burying the extension to prevent a tripping hazard. See photos for example.

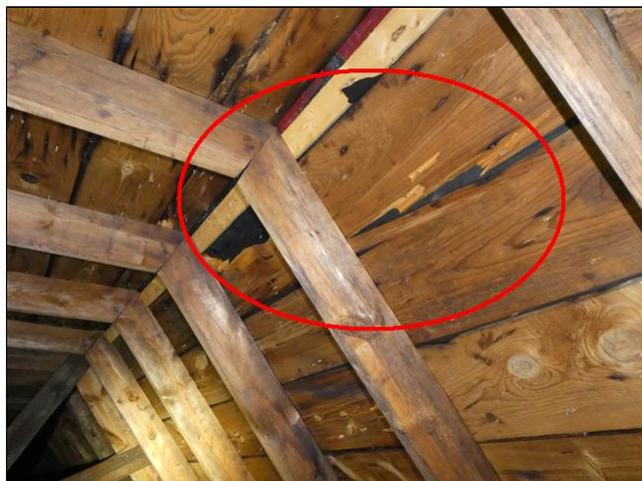
2.6 Item 1(Picture)

(1) The roof sheathing near the scuttle hole entry is broken. This area is a potential source for a water leak to occur due to shingles have not been secured correctly and to prevent shingle damage. The roof felt is visible. There were no signs of water leaks in this area at time of inspection. Recommend a qualified contractor repair as needed.

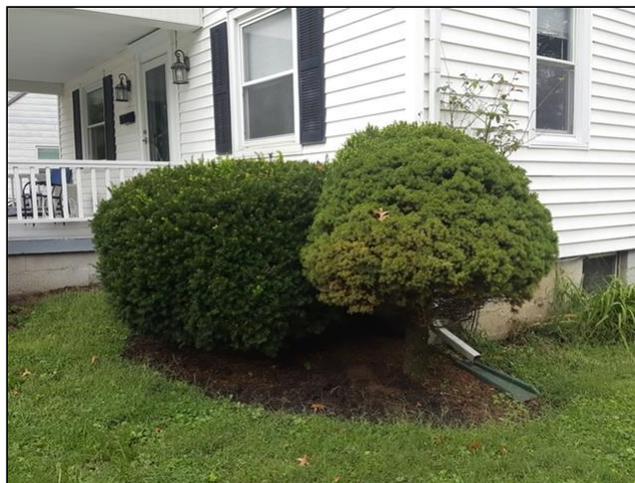
3.9 Item 2(Picture) front right corner of home

(1) The vegetation is overgrown where indicated in the photos. Recommend that all bushes, shrubs and trees where applicable be kept neatly trimmed and away from the foundation, wall siding, and window frames to prevent damage to the home and allow proper venting and inspection of house. A 6" clearance is recommended.

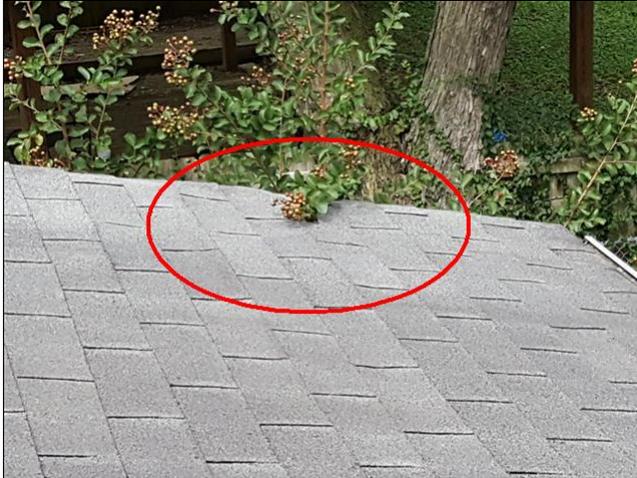
3.9 Item 3(Picture)

(2) The tree limbs that are in contact or hanging near the roof at the rear right corner of the home should be trimmed to prevent damage to the shingles and from scraping on the roof surface. They will also clog gutters which will cause water run off problems around the home. Recommend cutting back tree branches as needed.

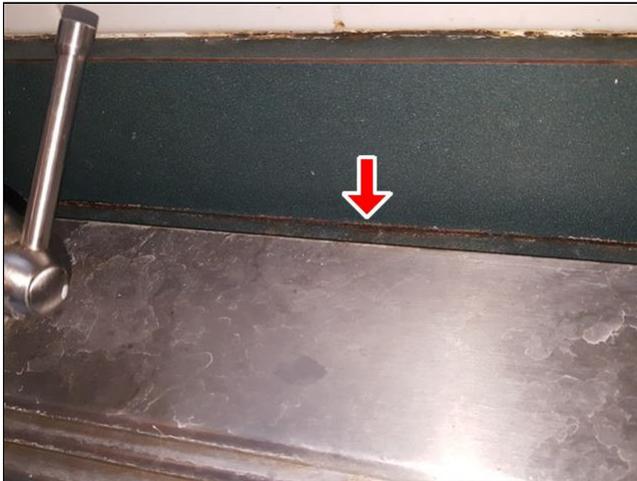
4.8 Item 1(Picture)

Recommend caulking around the counter top in the kitchen to seal the gap/crack. Water may enter which can cause damage to the drywall and cabinets, then result in possible mold forming. Repair using a quality caulk that is resistant to moisture and is expandable. Here is a link on [How to Choose the right Caulk](#)

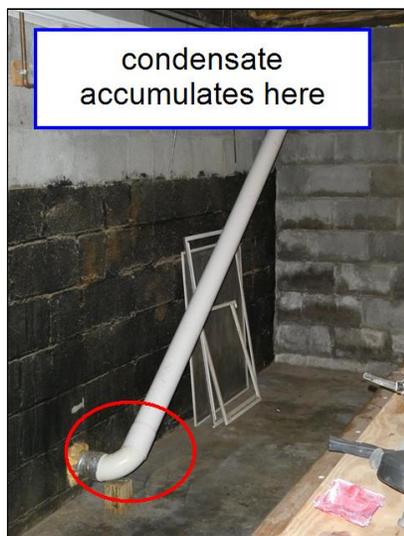
4.10 Item 7(Picture)

(4) The vent pipe for the dryer is not pitched correctly for proper venting. There should be a 1/8 pitch rise per foot to prevent condensate accumulating in the duct. Recommend correcting as needed by a general contractor.

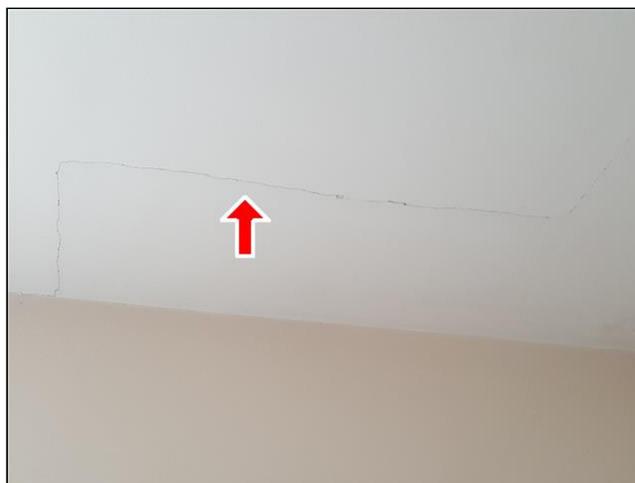
5.0 Item 2(Picture) 2nd bedroom

The cracks in the ceiling in the (upstairs) family room and 2nd bedroom (see photos for location) appear to be common settlement cracks. Cracks larger than 1/16" are of concern only. Minor settlement of the home has occurred due to the age of the home and from perhaps framing shrinkage. Cracks of this nature are also caused by moisture, changing temperature, or framing shrinkage due to a lack of ventilation. Recommend repairing cracks then paint and monitor. If cracks reappear and become larger than 1/16" then would recommend a structural engineer further investigate to determine cause and suggest repairs.

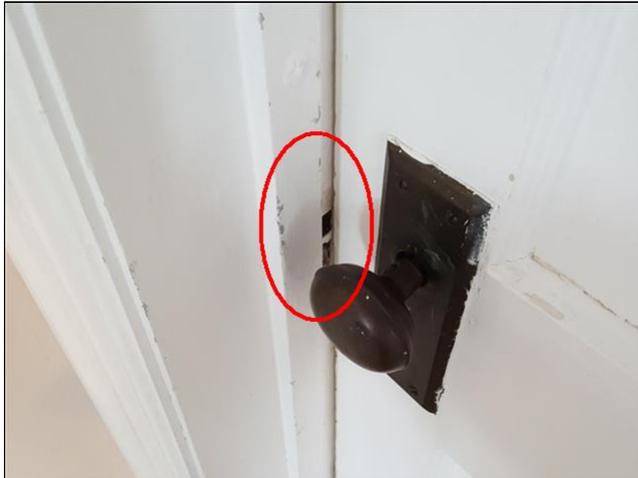
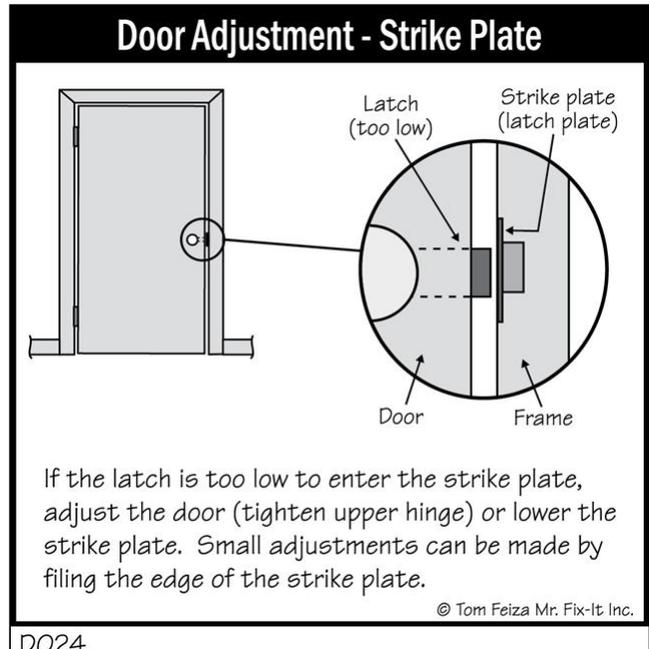
The door knob hardware is not latching in the Master Bedroom where indicated in the photo. It requires an adjustment. The strike plate may need to be adjusted or trimmed to be able to lock/close the door. Recommend repair as needed.

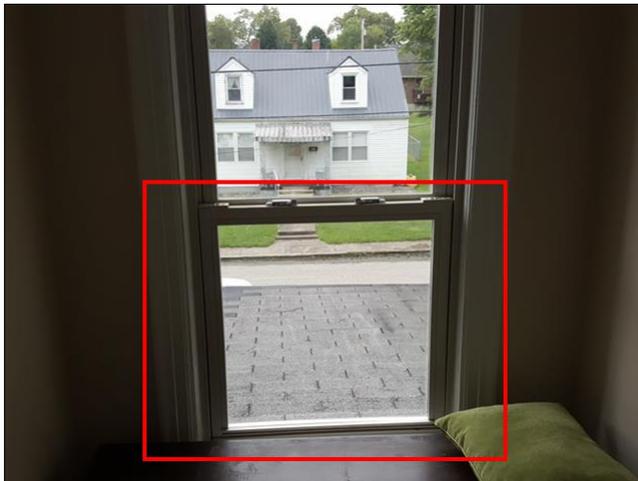
5.5 Item 1(Picture)

(1) The window in the master bedroom where indicated in the photo is missing a screens. Recommend these be installed to prevent insects entering the home when the window is opened. Replace as needed.

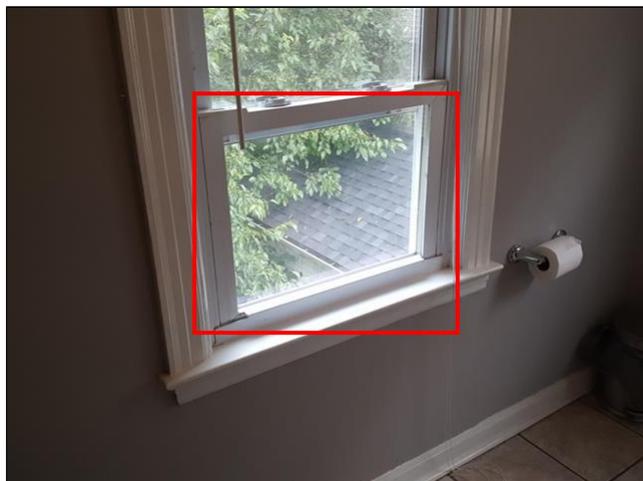
6.3 Item 1(Picture)

The window in the master bathroom where indicated in the photo is missing a screen. Recommend these be installed to prevent insects entering the home when the window is opened for ventilation. Replace as needed.

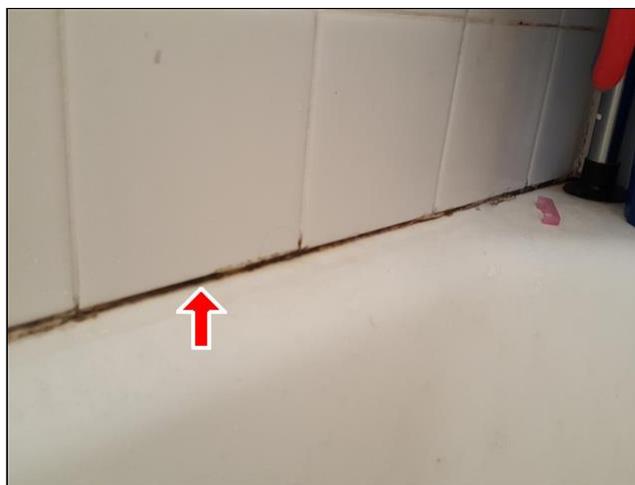
6.7 Item 2(Picture)

Old, shrinking, or dirty caulk with cracks was seen in the master bathroom shower enclosure. All of the caulk should be kept in perfect condition to prevent further cracking or more holes appearing to reduce the possibility of water leaking underneath the shower enclosure and tiled wall. If not corrected mold and/or deterioration of the floor/wall framing can occur beneath the shower enclosure. Recommend re-caulking where needed to seal openings and deteriorated caulk. Use a quality silicone caulk that is expandable and moisture resistant. [Choosing the right caulk](#) Would recommend a qualified general contractor repair as needed.

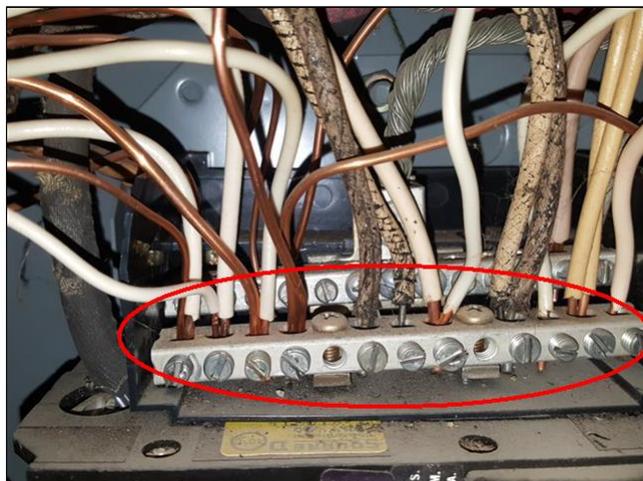
8.3 Item 9(Picture)

(6) More than one common (white wires) on a single lug of the neutral bar is not recommended but was found in this panel. Separation of these commons is recommended when any other electrical work is done by a qualified licensed electrician.

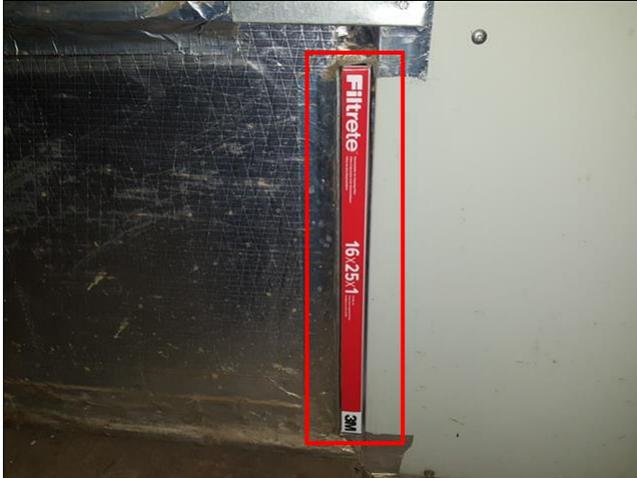
9.2 Item 2(Picture)

(2) The door to access the filter next to the Gas Furnace is missing at the basement. This can allow dirt and debris to bypass the filter. The filter ensures clean air is distributed within the home and also protects the equipment from small debris entering which can lead to problems with the unit and duct work. Recommend replacement/correcting as needed by a qualified HVAC contractor.

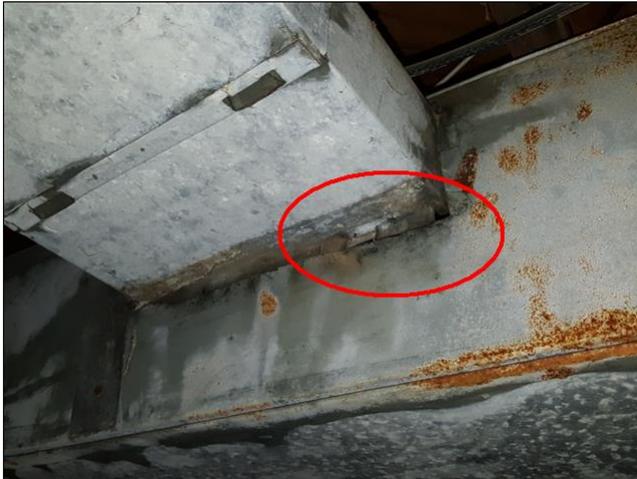
9.6 Item 10(Picture)

(5) The air supply duct pipe is not sealed correctly and leaks air at the joint where indicated in the photo in the basement. Leaking ductwork increases heating/cooling costs and can also cause building damage. To prevent air loss, recommend the joints be sealed with a high temperature sealant or furnace tape. This will direct all the conditioned air to the desired locations and will improve the efficiency of the system. A qualified HVAC contractor is recommend for these repairs.
